Report No. KS-04-2  
FINAL REPORT

## **CONSTRUCTION AND PERFORMANCE OF ULTRA-THIN WHITETOPPING IN KANSAS**

SEPTEMBER 2005

**KANSAS DEPARTMENT OF TRANSPORTATION**

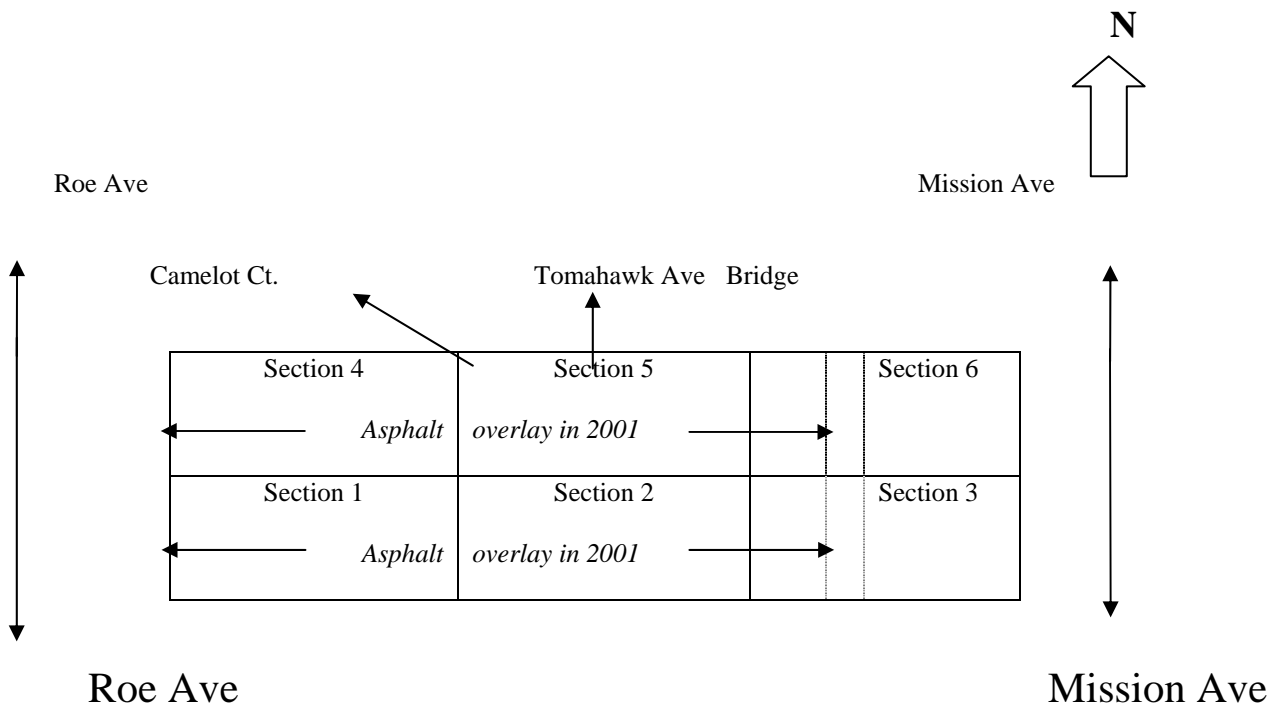
**FIGURE 1: Test Section Layout**

The UTW project was built on the 119<sup>th</sup> street in the City of Leawood, Kansas, a suburb of Kansas City, Mo. between Mission and Roe Avenues. The street is functionally classified as a secondary arterial. The project has 800 m (half mile) of a nominal 50 mm (two-inch) inlay constructed in 1995 and three sections of about 244 m (800 feet) in length in each direction. The project starts at station 50+30.50 and ends at station 76+10.75.

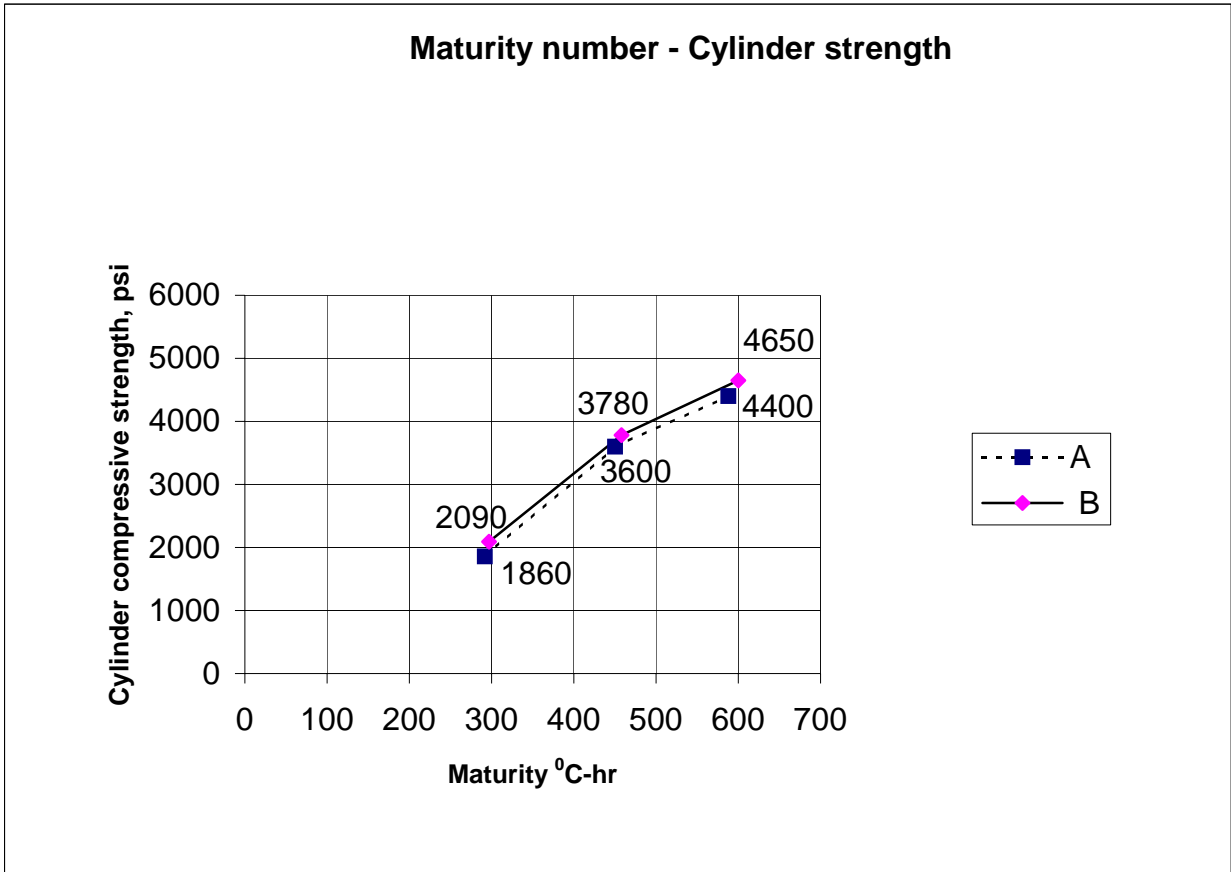
**FIGURE 4: Relationship between Maturity Number and Compressive Strength**

In addition to measuring the compressive strength of the mixture at regular intervals during the first 24 hours after mixing, maturity data was collected on a 150 mm by 300 mm (6 inch by 12-inch) cylinder cast from the mixture. The relationship between the maturity number and compressive strength for both mixtures A and B (shown in Table 5) is shown graphically in Figure 4. The maturity number is expressed as the number of degrees Celsius hours beginning at the time of mixing of the materials, using zero degrees Celsius as a base. Interpolation of the data for mixture A, recommended for use in the project, indicated that the mixture developed the desired compressive strength of 20.7 MPa (3,000 psi) in a cylinder at a maturity number of approximately 385. This condition occurred in between 15 and 16 hours after mixing the water and the cement. Additional testing with the maturity system was performed to assess the probable effect of climatic conditions on the thin 50 mm (2 in.) overlay that was used in the project. The testing program consisted of casting two 300 mm x 460 mm x 50 mm (12 in. x 18 in. x 2 in.) thick test specimens from mixture A. One specimen was cured under relatively controlled conditions, limiting the ambient air temperatures to between 17<sup>0</sup> C (63<sup>0</sup> F) and 23<sup>0</sup> C (74<sup>0</sup> F). The second specimen was cured under uncontrolled conditions, with ambient air temperatures ranging from 7<sup>0</sup> C (45<sup>0</sup> F) to 21<sup>0</sup> C (70<sup>0</sup> F). Temperature within the test slabs was monitored and recorded on an hourly basis. The results of this comparison are presented in Table 6. It is noted that while the 150 mm x 300 mm (6 in x 12 in) standard cylinder specimen, cured under relatively controlled conditions, developed the 20.7 MPa (3,000 psi) strength in 15 to 16 hours, the 50 mm (2 in) thick slab cured under similar conditions, developed that strength in approximately 17 hours, and the 50 mm (2 in) thick slab cured under uncontrolled and

generally lower ambient air temperatures did not develop the 20.7 MPa (3,000 psi) strength until approximately 28 hours after mixing.

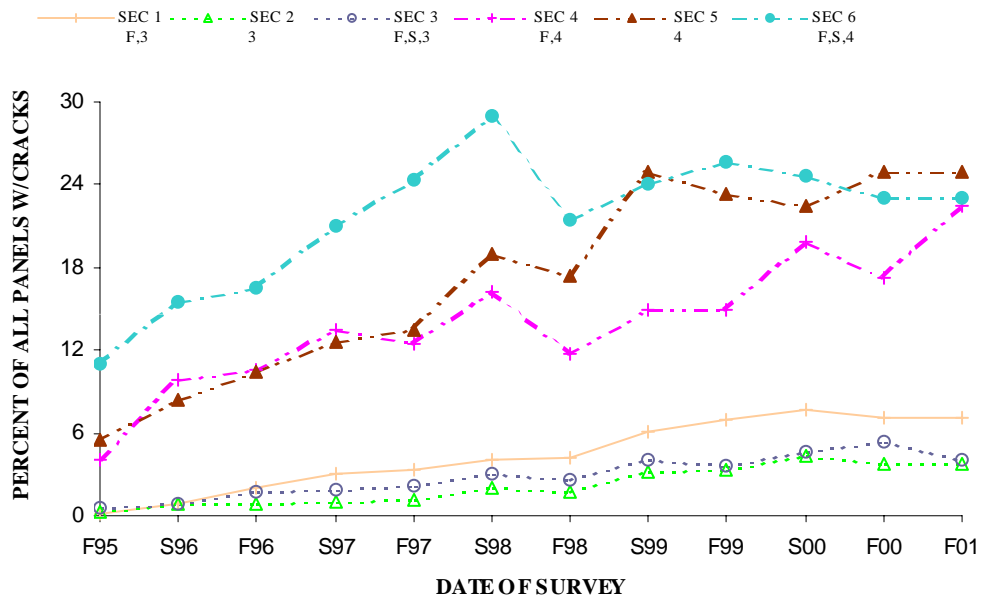
## UTW 119TH STREET CRACKS

**FIGURE 5: Survey Results for Cracked Panels**

Visual distress surveys have been made since 1995. Interface bond was assessed by “chain dragging.” Figures 5, 6 and 7 show the annual survey results for cracked panels, hollow panels, and spalled panels, respectively. Joint faulting on each section was also assessed as shown in

In the spring of 1998, section 6 had 29% panels cracked and section 2 had only 2% panels cracked. Survey in the fall of 1999 showed 20% of the panels in section 6 cracked. Some of the panels on this section have been replaced. Section 5 also had similar number of panels cracked. Section 2 still had the lowest number of panels cracked. That year, the cracks were

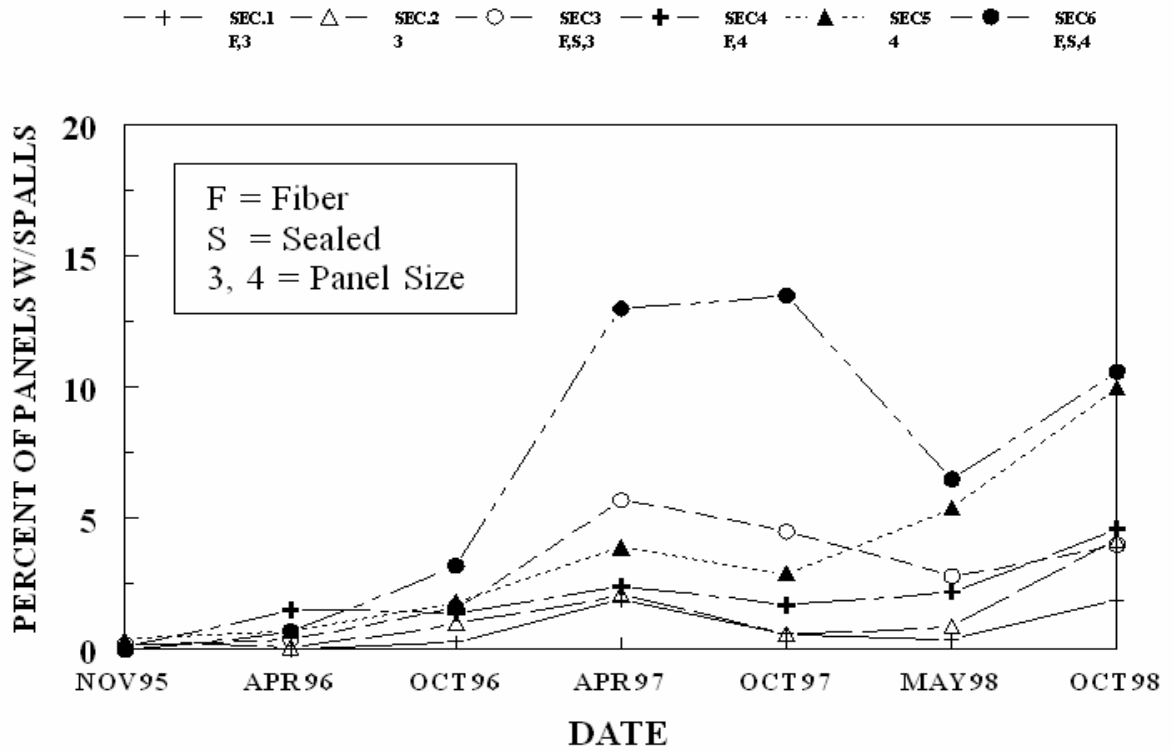
# UTW 119TH STREET SPALLS

**FIGURE 7: Survey Results for Spalled Panels**

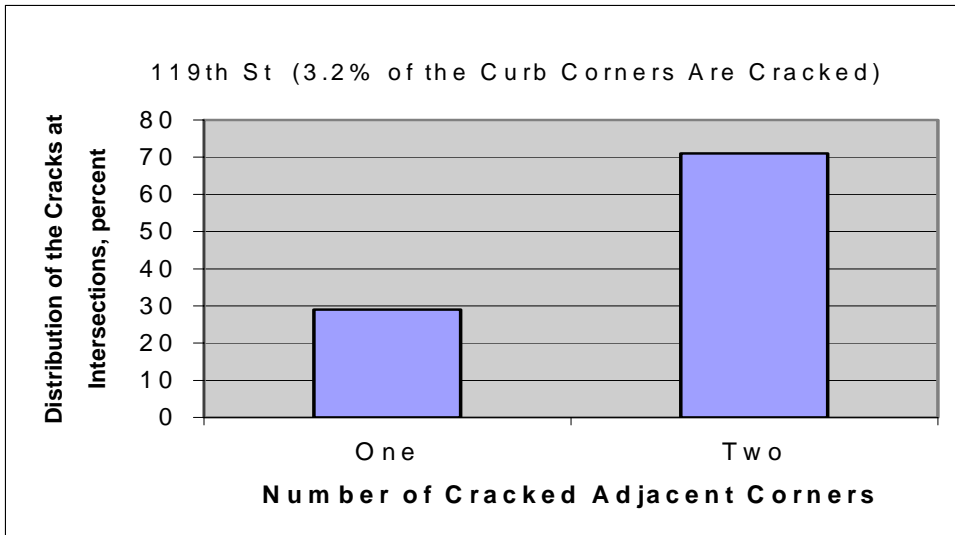
(a) Corner Cracks at Curb Locations

FIGURE 9: Occurrence of Corner Cracks

In the fall of 2000, some sections with replaced panels had some of those cracked again. Also, some panels were badly cracked. One hundred five (6%) cracked or broken panels had been overlaid with an asphalt patch in section No. 5. Corner cracks occurred, around the joint intersections where four panels meet and the curbs where two panels meet (Figure 9(a)). Corner cracks at the mid-slab locations were also very prominent (Figure 9(b)). Sections 4, 5 and 6 with 1.2 m (4-ft) panels had considerable more distresses than Sections 1, 2 and 3 with 0.9 m (3-ft) panels. The 2000 survey also showed that sections 5 and 6 had the highest number of replaced panels. Forty one percent of the replaced panels had cracked on section 6. Only six percent of the replaced panels had shown cracks for section 5. Sections 3, 4 and 5 appeared to have higher faulting than any other sections (Figure 8).

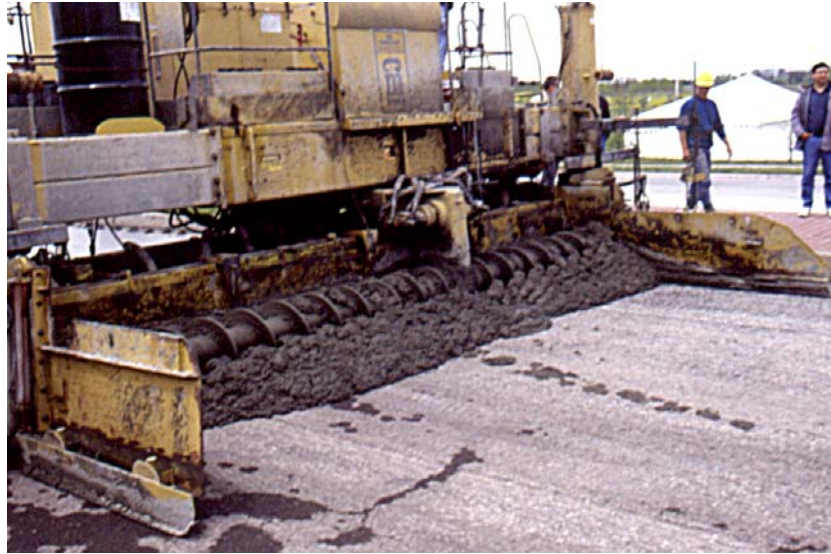
**PHOTO 1: Concrete Placement**

Construction started in April 1995 in with a cool 13<sup>0</sup> C (56<sup>0</sup> F) weather and very windy condition on the first day. A CMI 350 paver was used to place the concrete 6.7 m (22 ft) wide in a single pass on the milled asphalt surface. Prior to paving, the milled surface was cleaned by a

power broom and then air blasted. Texture on the UTW was provided by transverse tining, and curing followed with a curing compound. The second day was also cool with light winds, with the westbound lane being completed. On May 2, the construction began on the eastbound lanes, with somewhat milder weather conditions. Turn bays and gaps were completed in about a week and placed by hand. No particular problems occurred during construction. The project was fully opened to traffic on May 12 after 21 working days. The existing roadway and various construction operations are shown in Photographs 1 to 6.

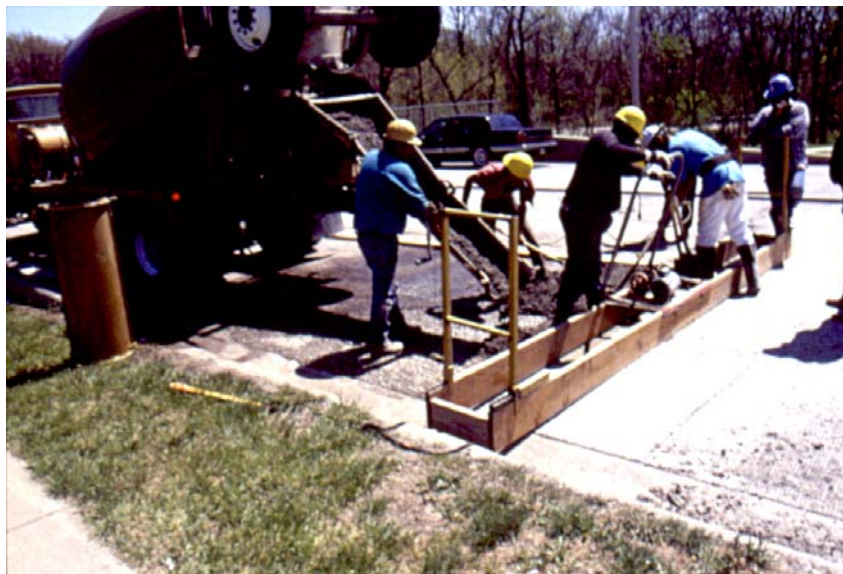
**PHOTO 2: Hand Pour**

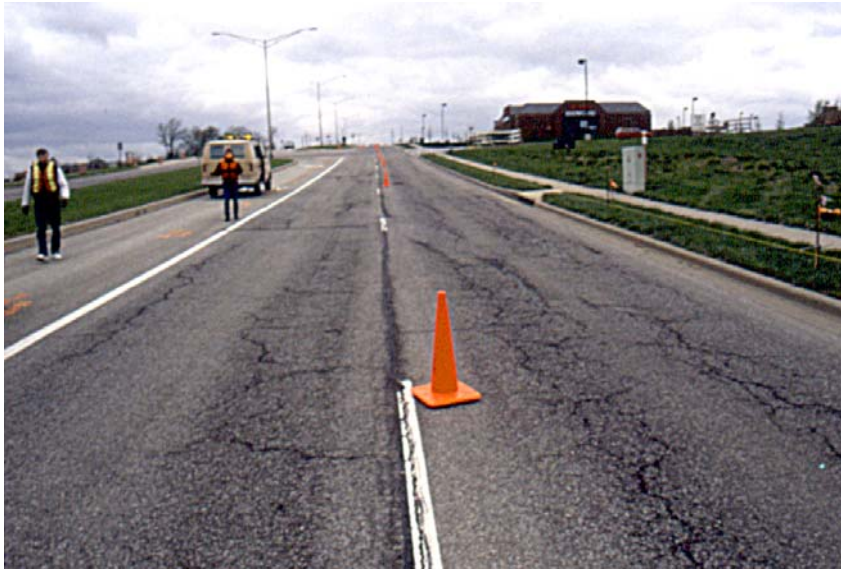
**PHOTO 3: Existing Highway**

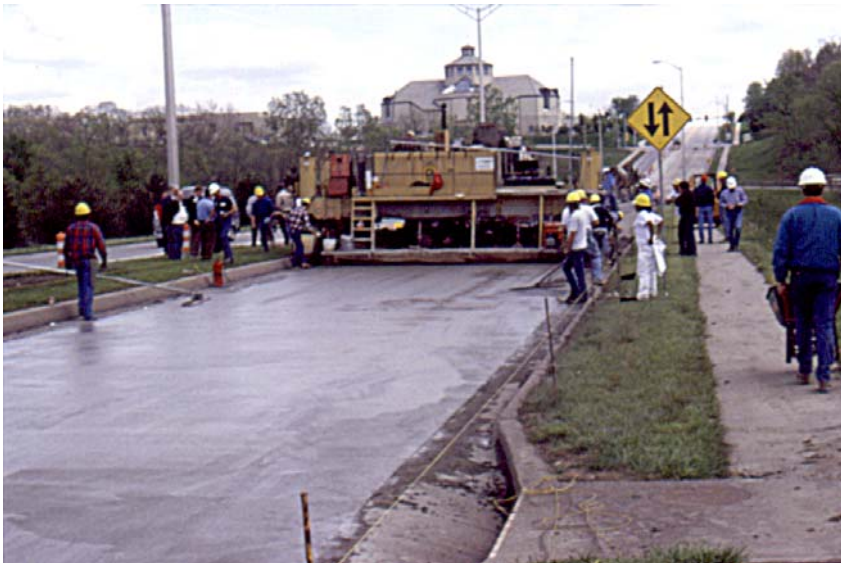
**PHOTO 4: Main Line Paving**

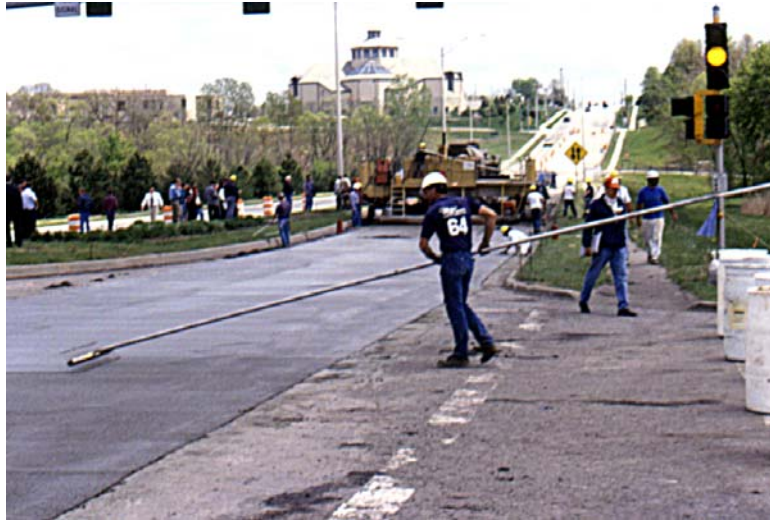
**PHOTO 5: Surface Finish**

Texturing with a metal comb was done transversely. The joints requiring sealing were dry sawed, air blasted, sand blasted, and given a final air blast before sealing with a silicone sealant. The pavement smoothness was measured with a profilograph and evaluated against the KDOT specifications for roadways with 72 km/h (45 mph) or less posted speed limit.

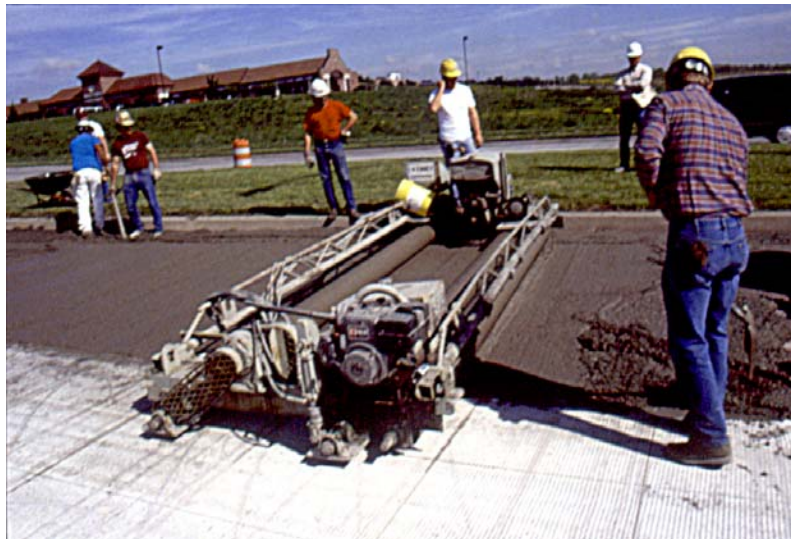
**PHOTO 6: Turning Lane Paving**
