REPORT NO. FRA-OR&D 75-23

# COMPUTER SIMULATION OF TANK CAR HEAD PUNCTURE MECHANISMS

## Classification Yard Accidents

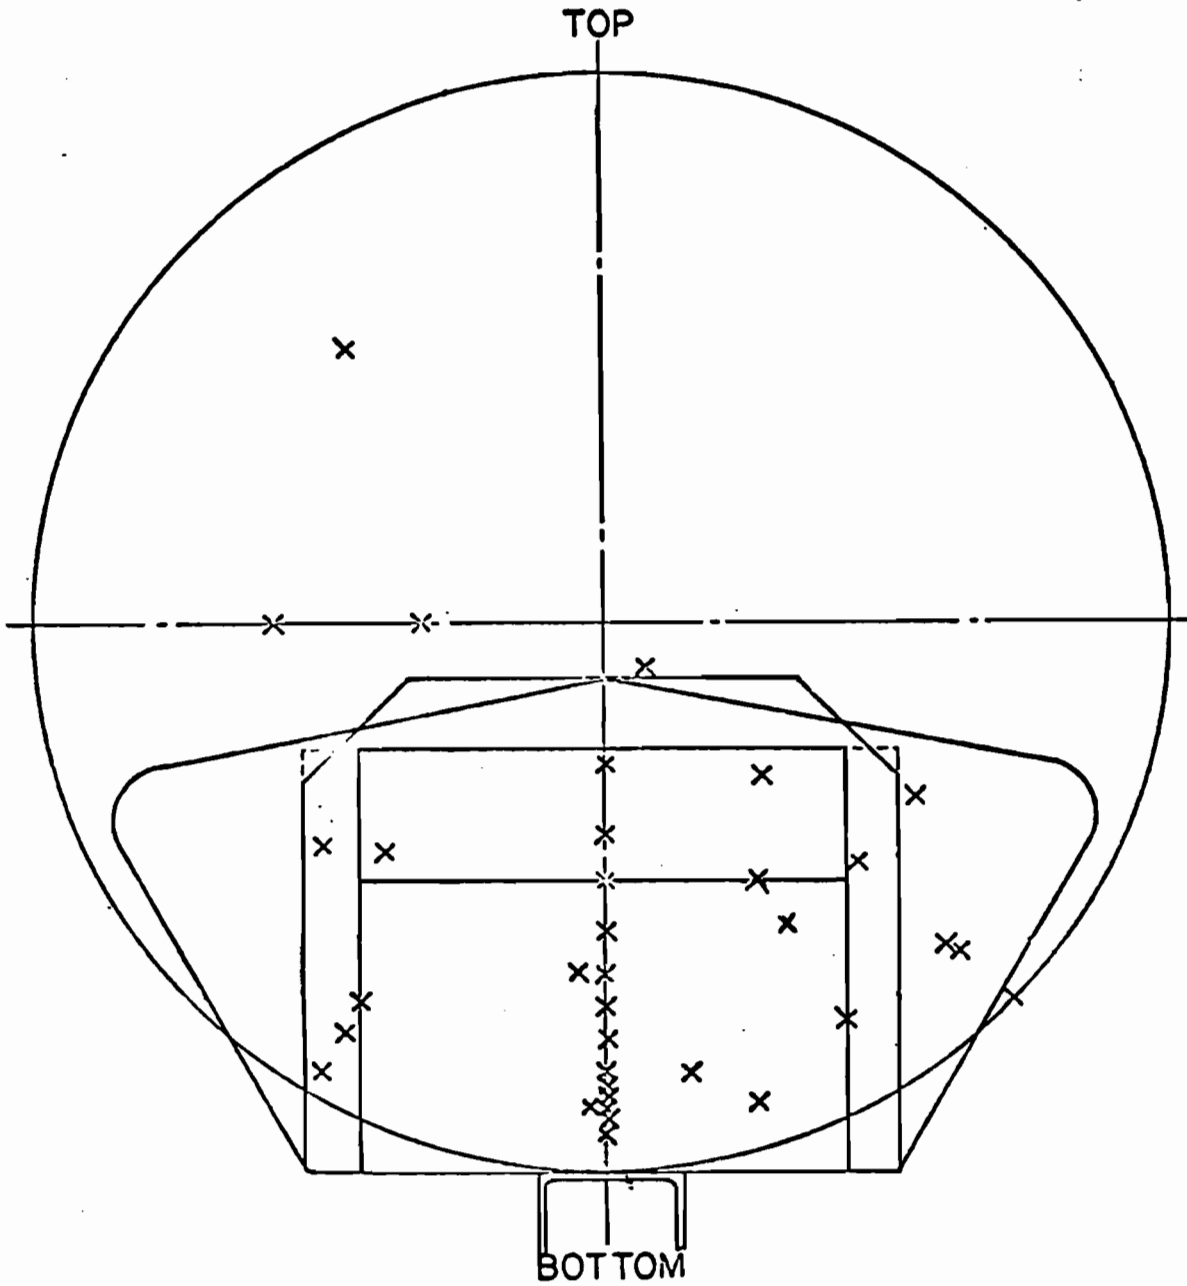
Figure 2

Proposed head shield schemes.  
The location of recorded head punctures is marked by X.

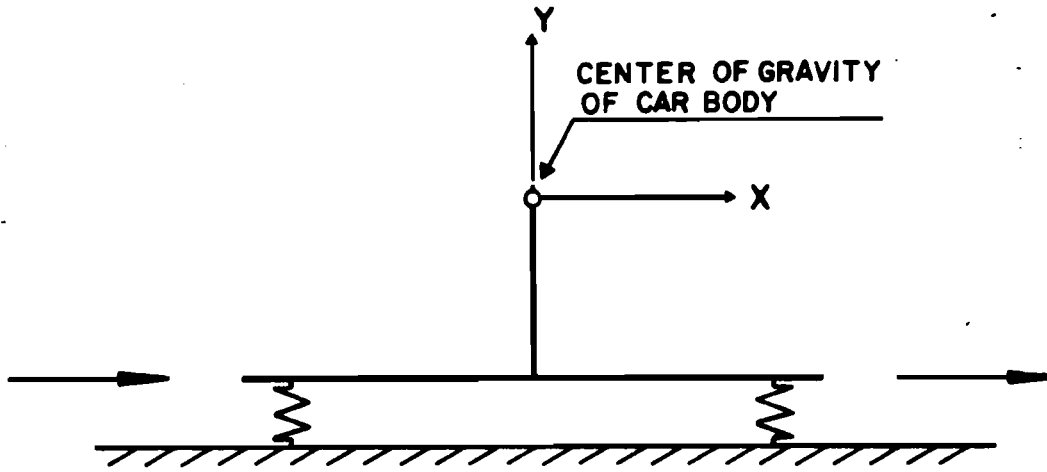
Figure 3

Excitation of pitching motion about the center of gravity by longitudinal coupler forces

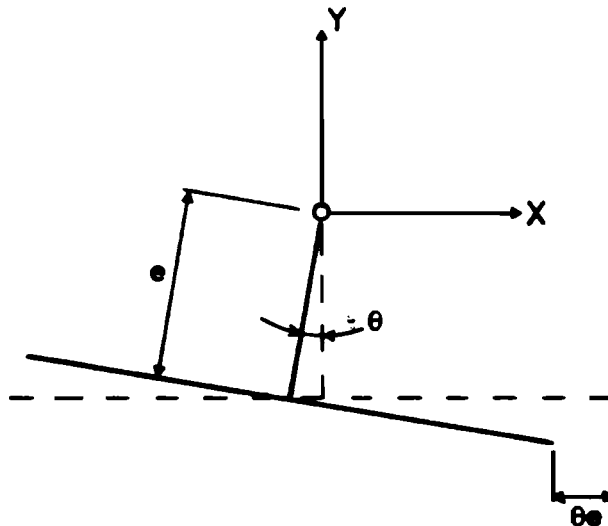
Figure 4

Excitation of longitudinal motion by pitching about the center of gravity

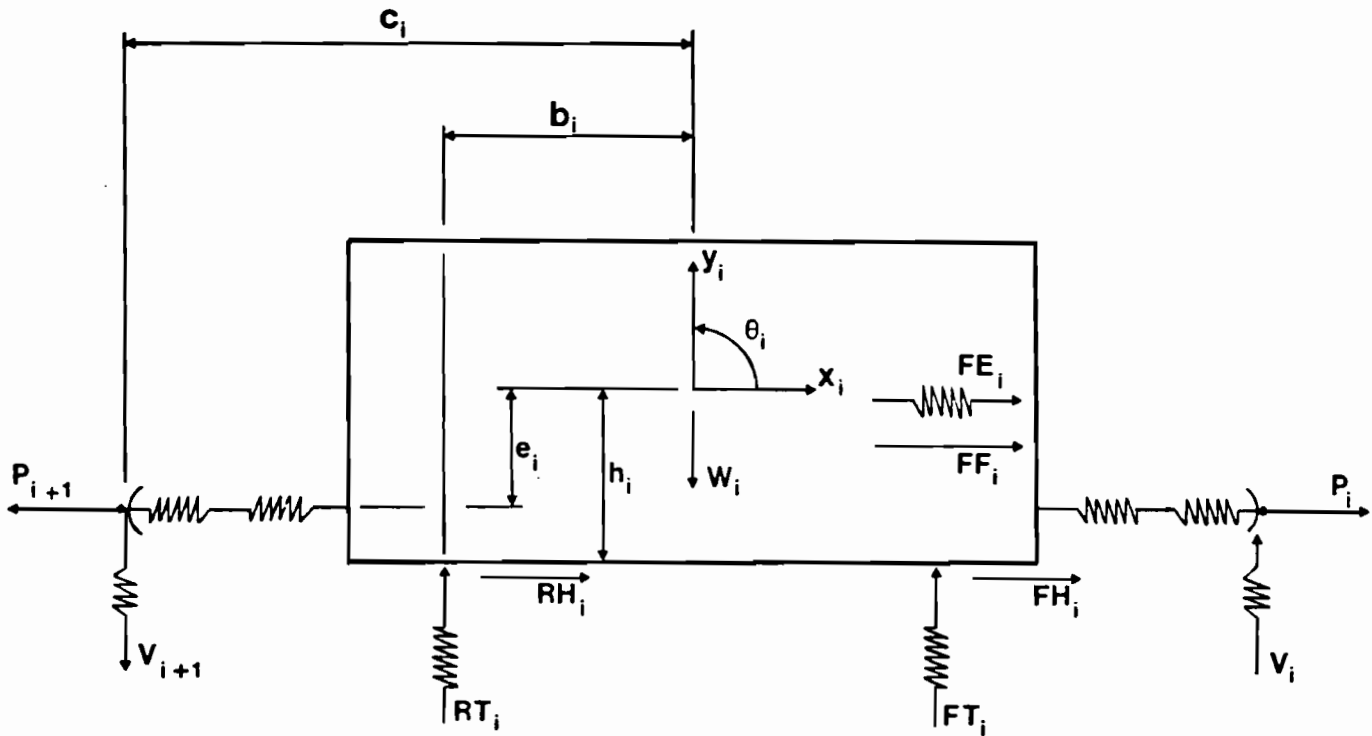
Figure 5  
Idealized car body

The model provides a state variable representation of the problem. It admits arbitrary force-displacement hysteresis loops and arbitrary loops for the horizontal coupler forces. The car body and lading are idealized as rigid bodies. The notation is shown on figures 5 and 6.

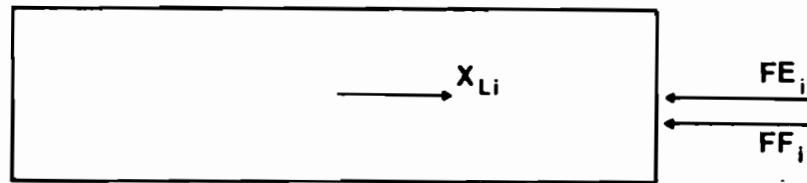
Figure 6  
Idealized lading

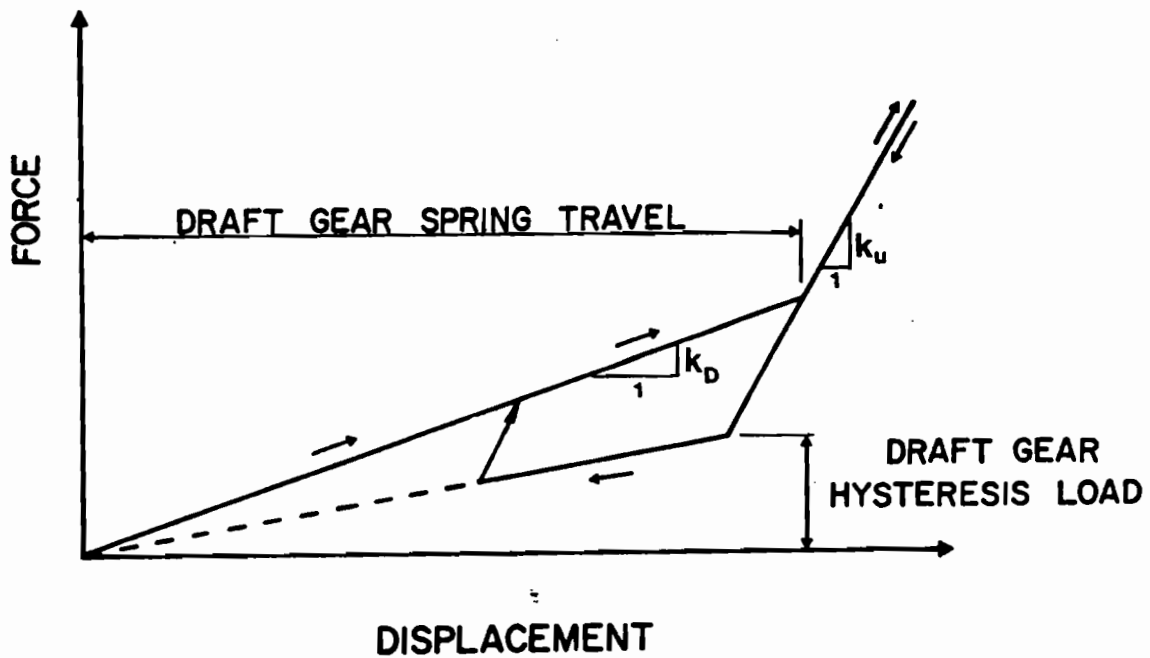
Figure 7

Loading, unloading and immediate reloading of draft gear .

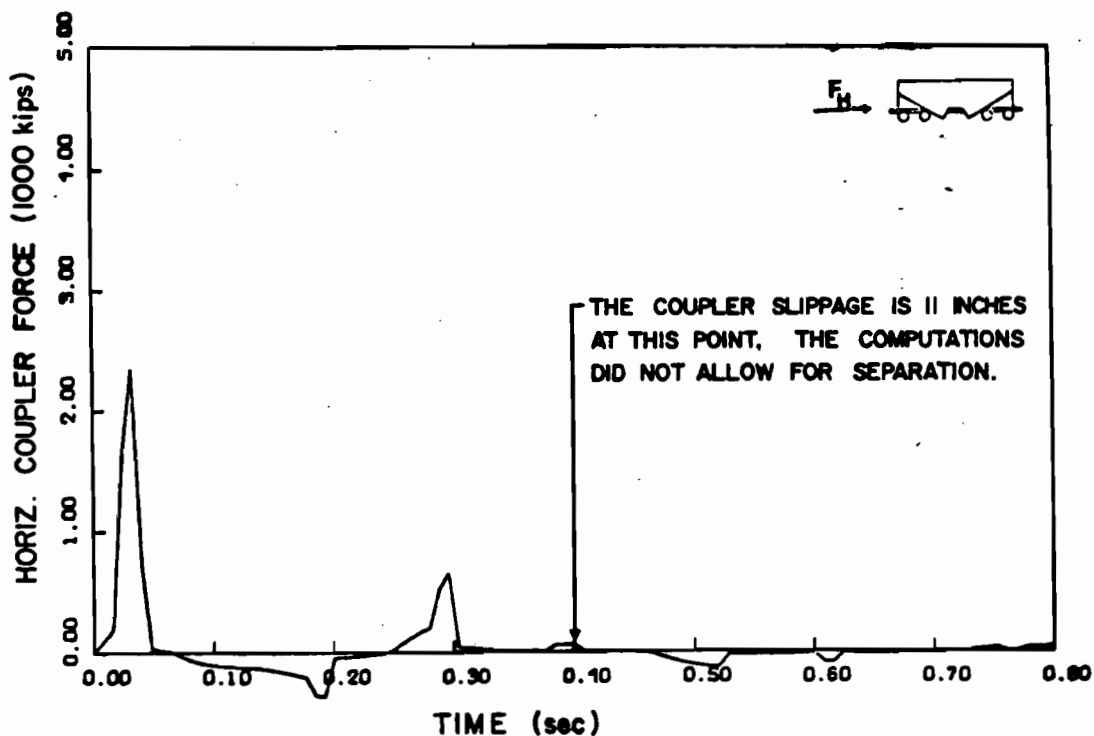
Figure 8a  
 Horizontal coupler force at trailing (impact) end of hopper car

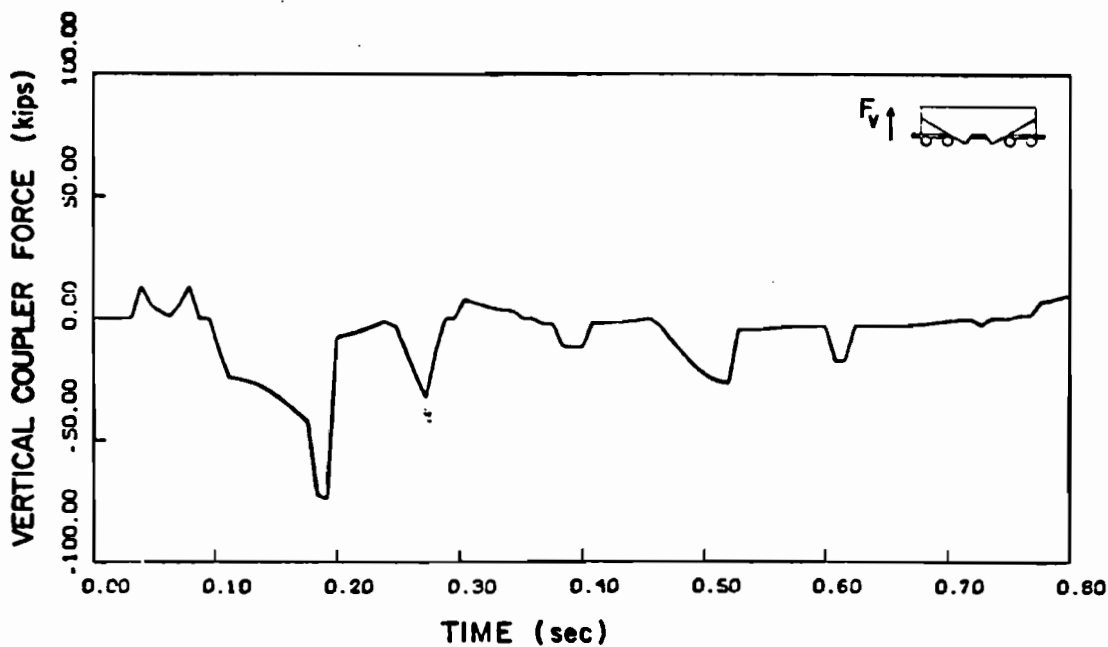
Figure 8b  
 Vertical coupler force at trailing (impact) end of hopper car

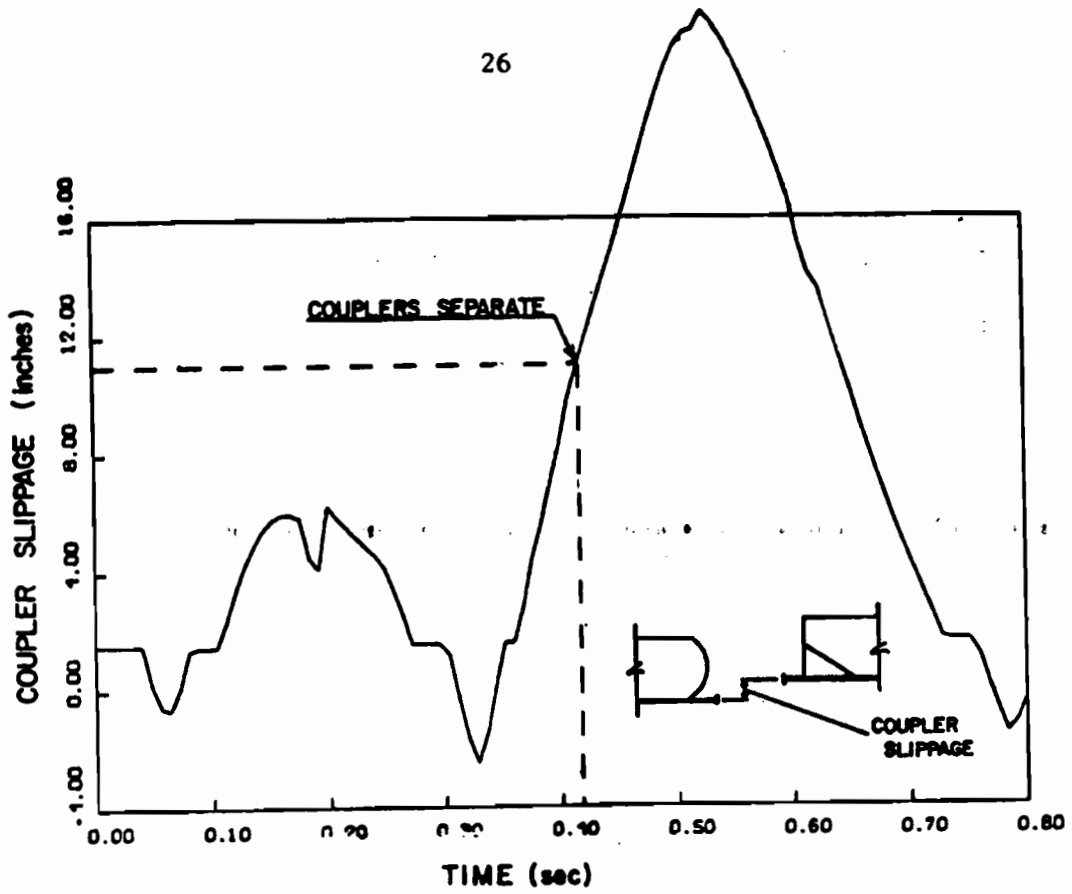
Figure 8c  
Coupler slippage at trailing (impact) end of hopper car

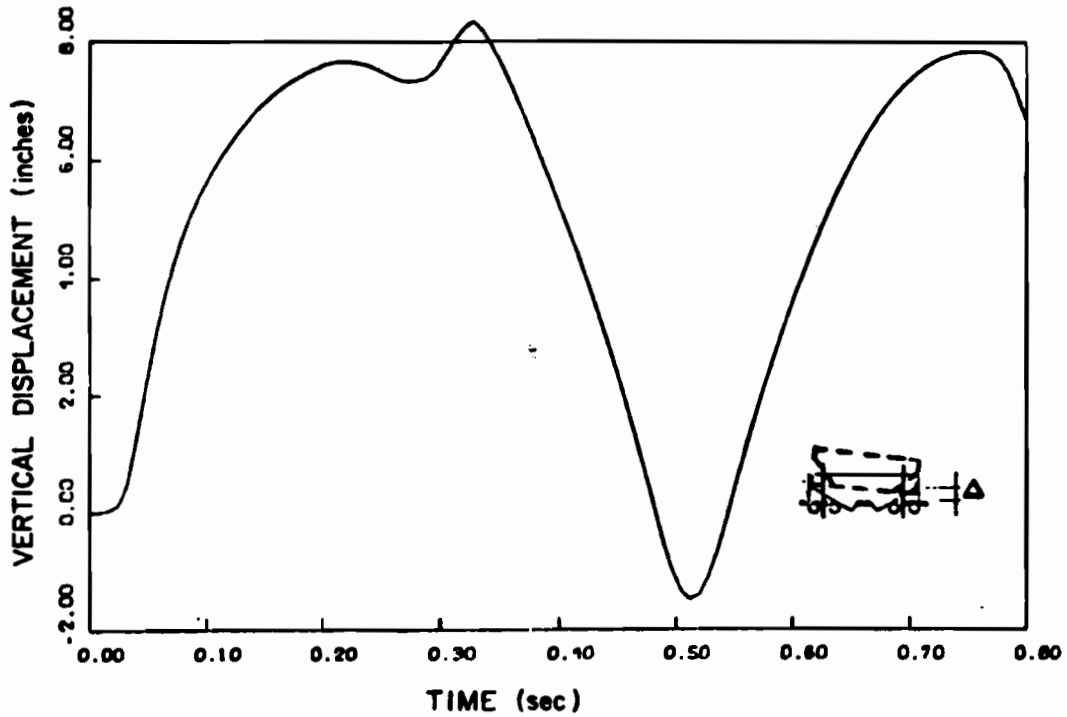
Figure 8d  
Car body center plate displacement at leading (free) end of hopper car

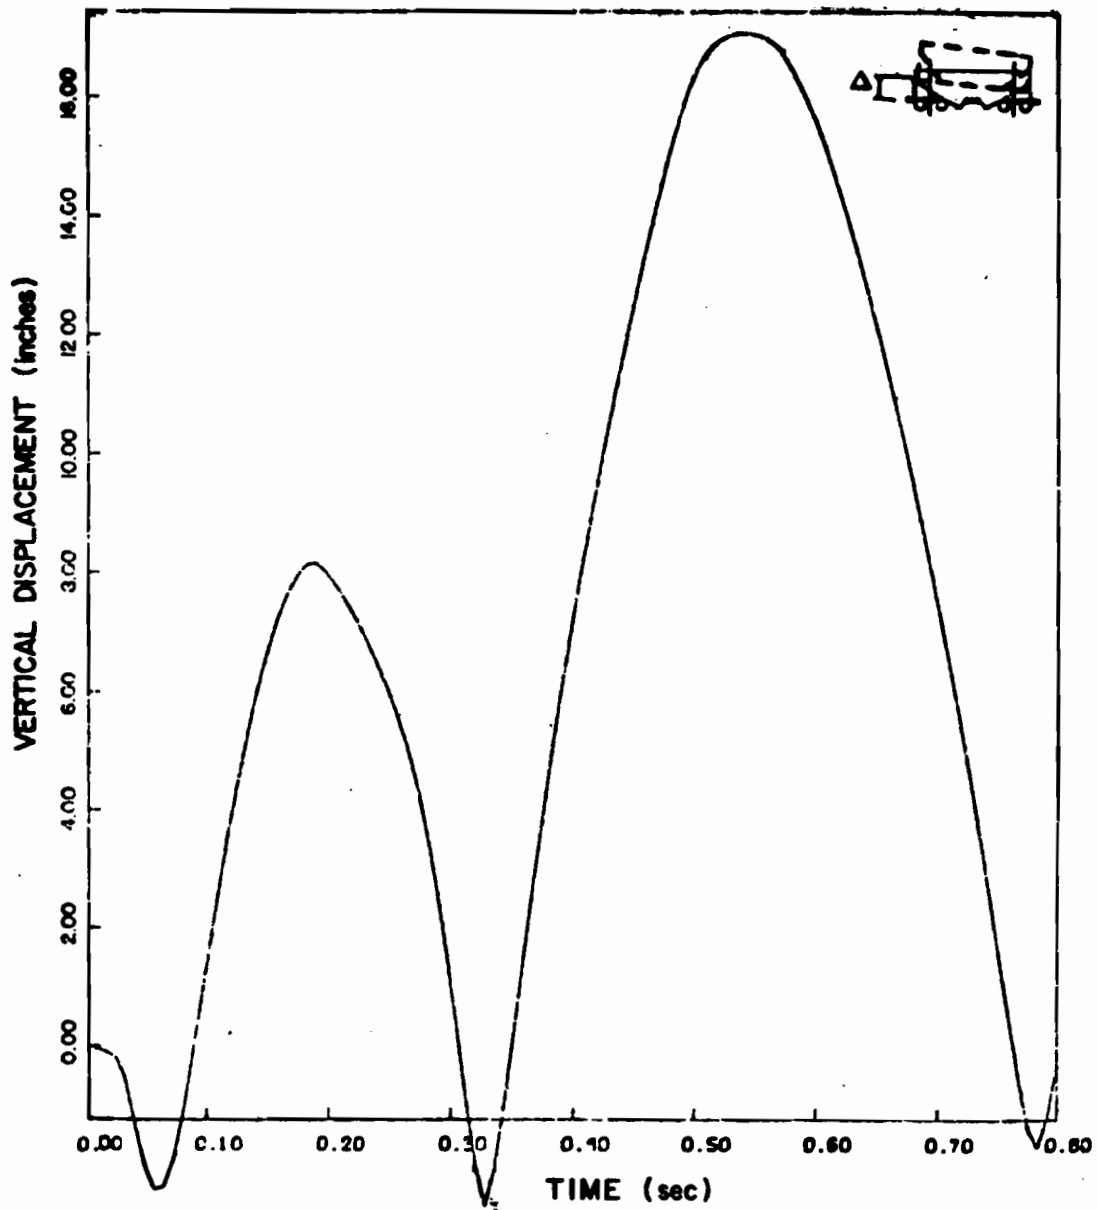
Figure 8e

Car body center plate displacement  
at trailing (impact) end of hopper car

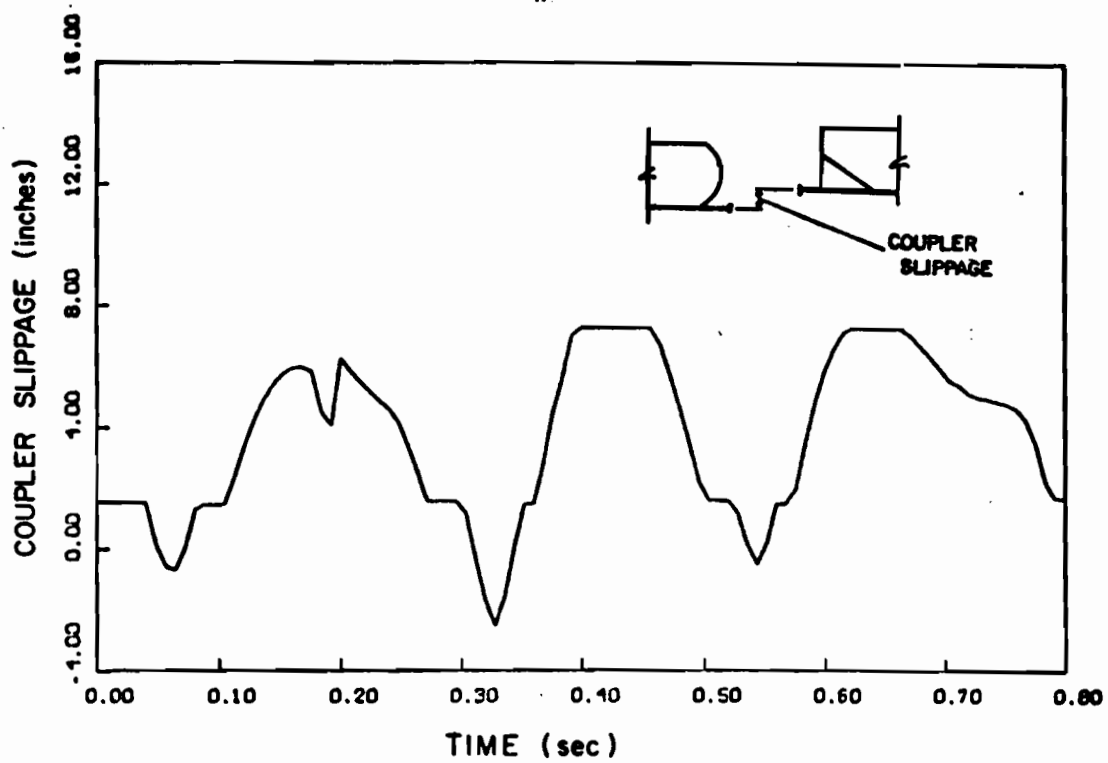
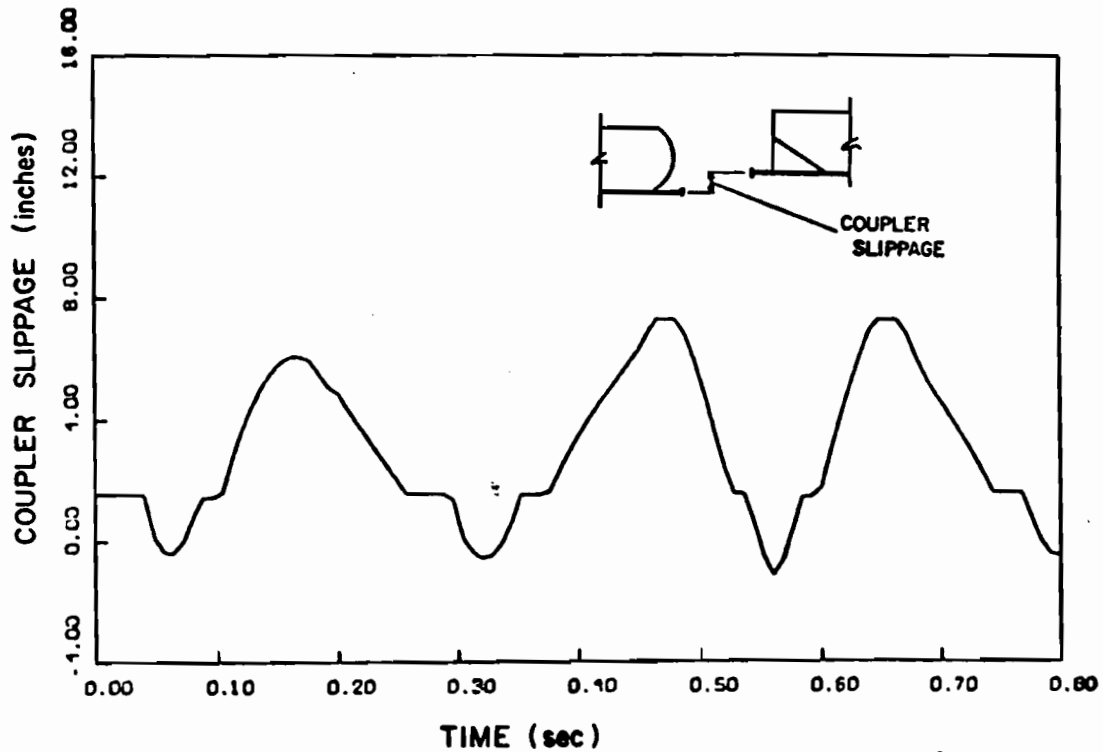
Figure 9a  
Effect of vertical coupler spring rate on coupler slippage  
at trailing (impact) end of hopper

The effect of vertical coupler spring rate on coupler slippage, vertical coupler force and car body center plate displacements is illustrated on figures 9a to 9d.

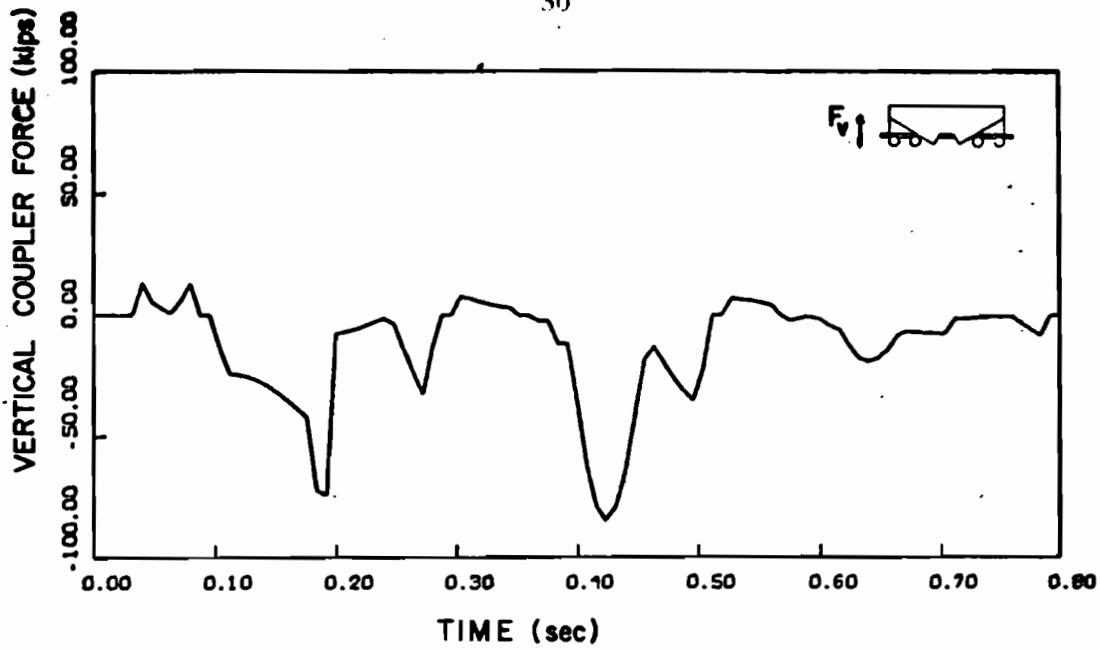
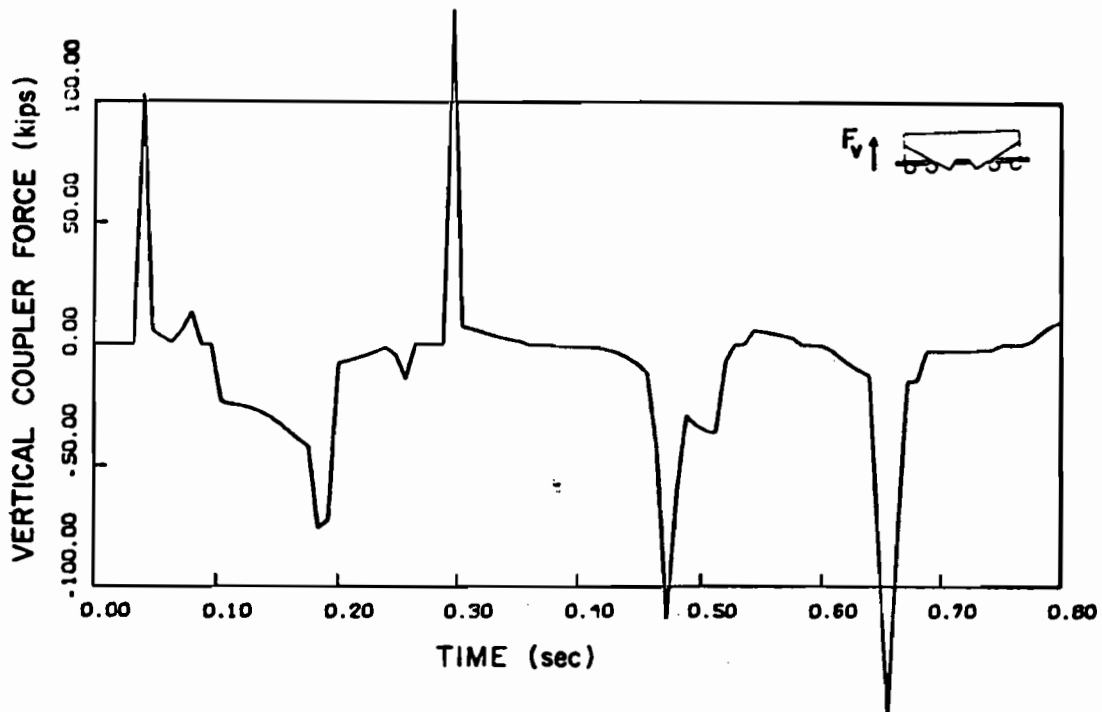
Vertical coupler spring rate: 50 kips/inch

Vertical coupler spring rate: 400 kips/inch

Figure 9b  
Effect of vertical coupler spring rate on  
vertical coupler force at the trailing (impact) end of hopper car

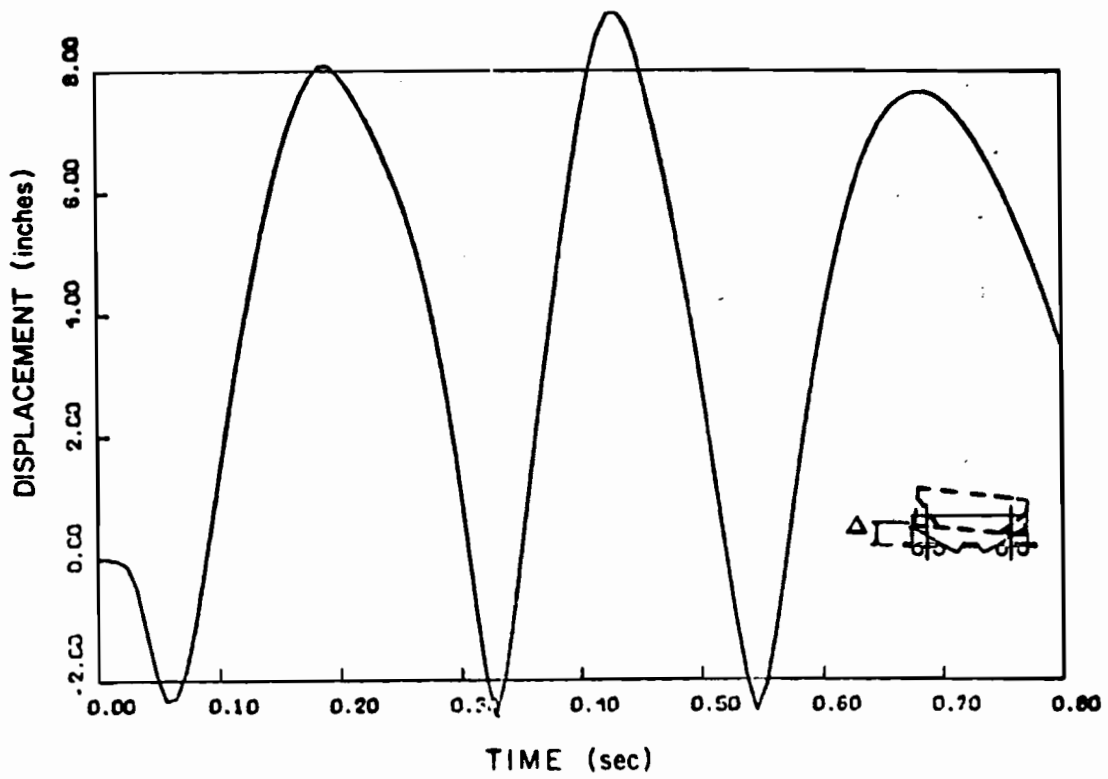
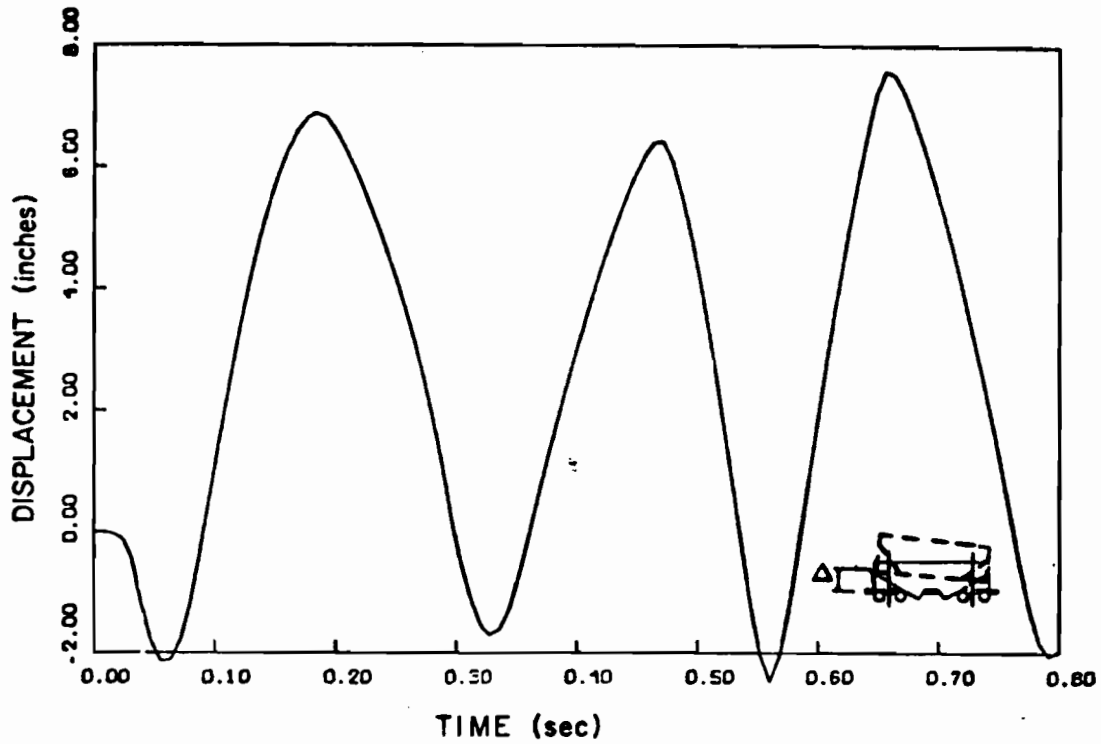
Vertical coupler spring rate: 50 kips/inch

Vertical coupler spring rate: 400 kips/inch

Figure 9c  
 Effect of vertical coupler spring rate on  
 car body center plate displacement  
 at the trailing (impact) end of hopper car

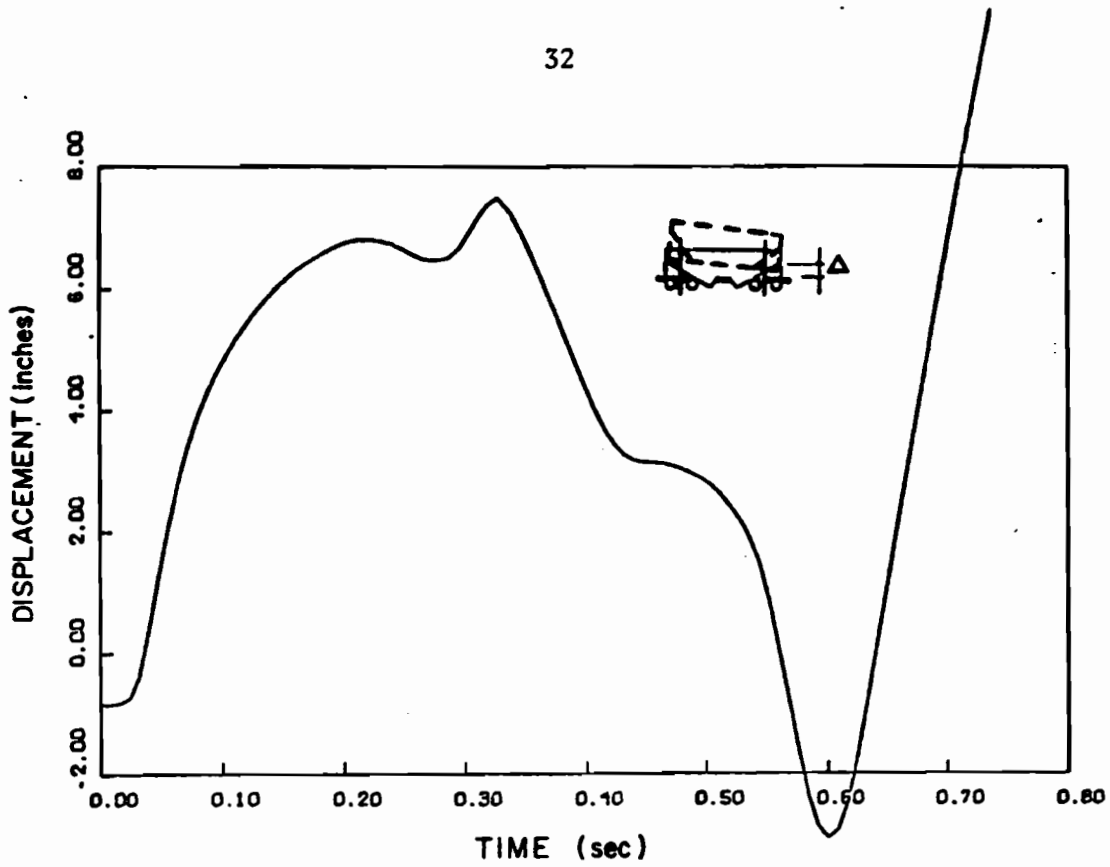
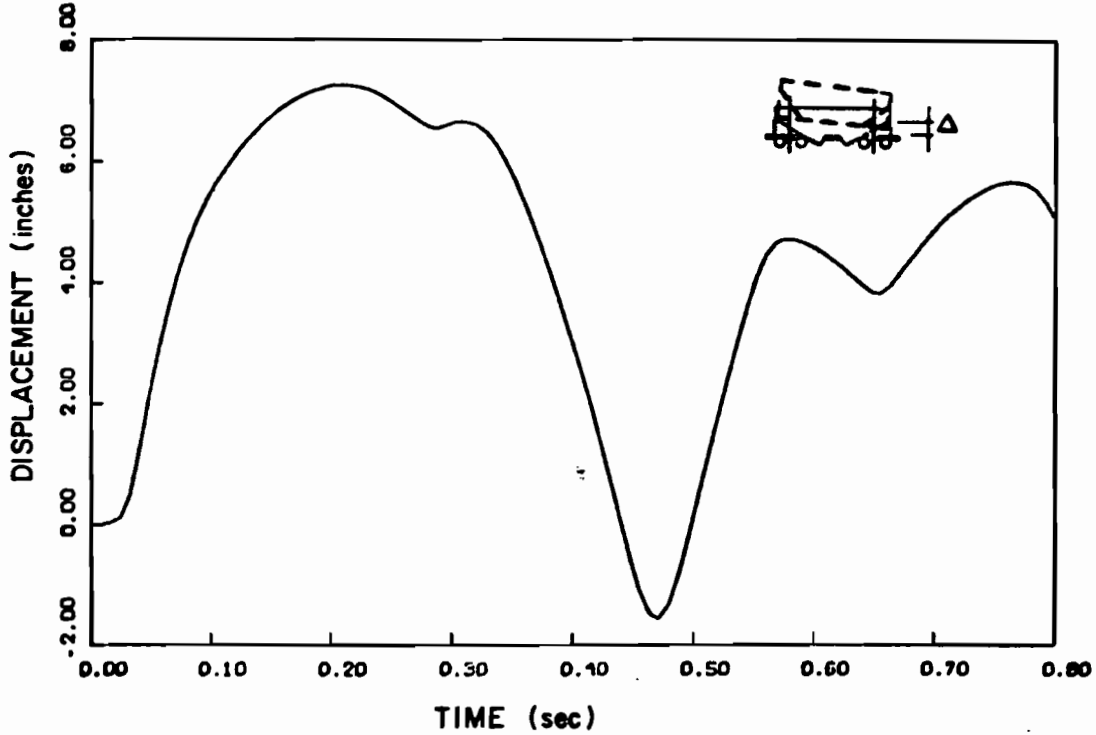
Vertical coupler spring rate: 50 kips/inch

Vertical coupler spring rate: 400 kips per inch

Figure 9d  
Effect of vertical coupler spring rate  
on car body center plate displacement  
at the leading (free) end of hopper car

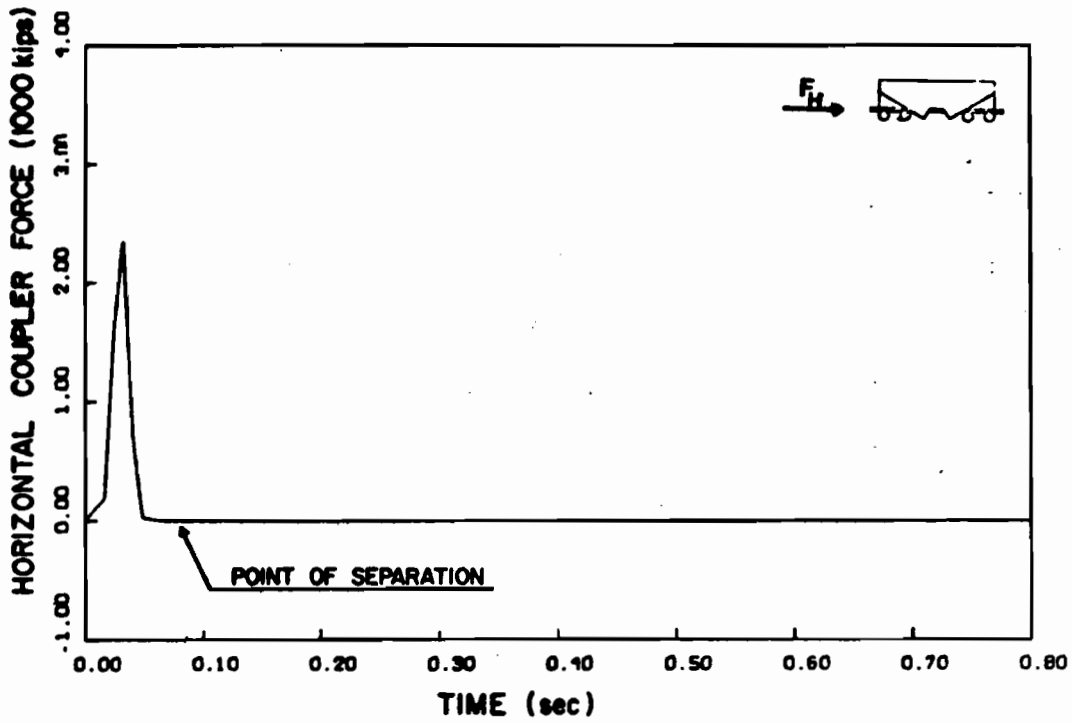
Figure 10a  
Horizontal coupler force at trailing (impact) end of hopper car

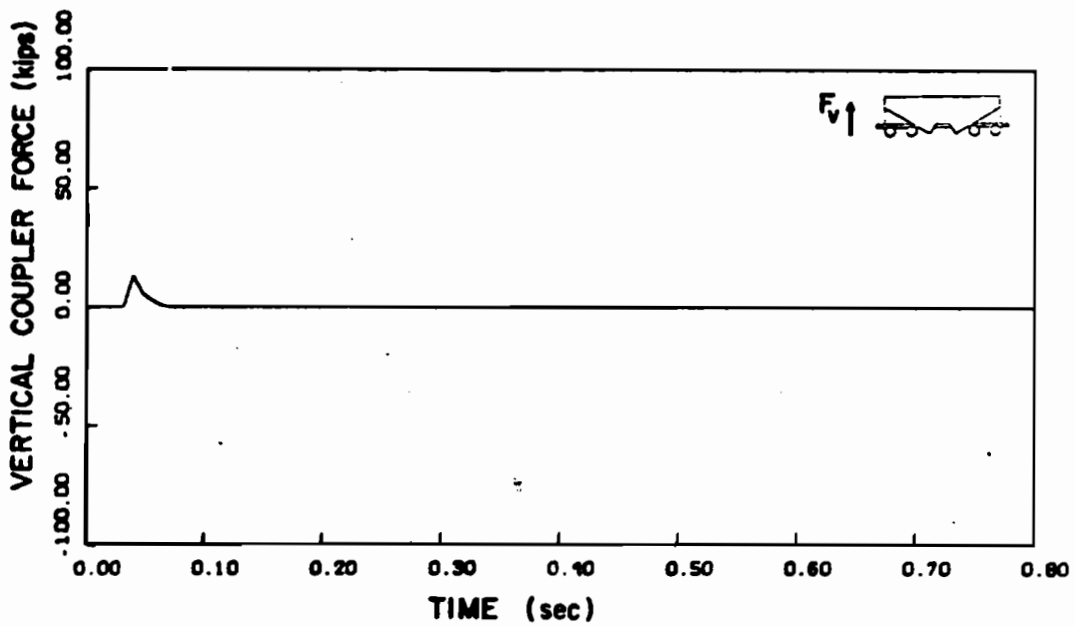
Figure 10b  
Vertical coupler force at trailing (impact) end of hopper car

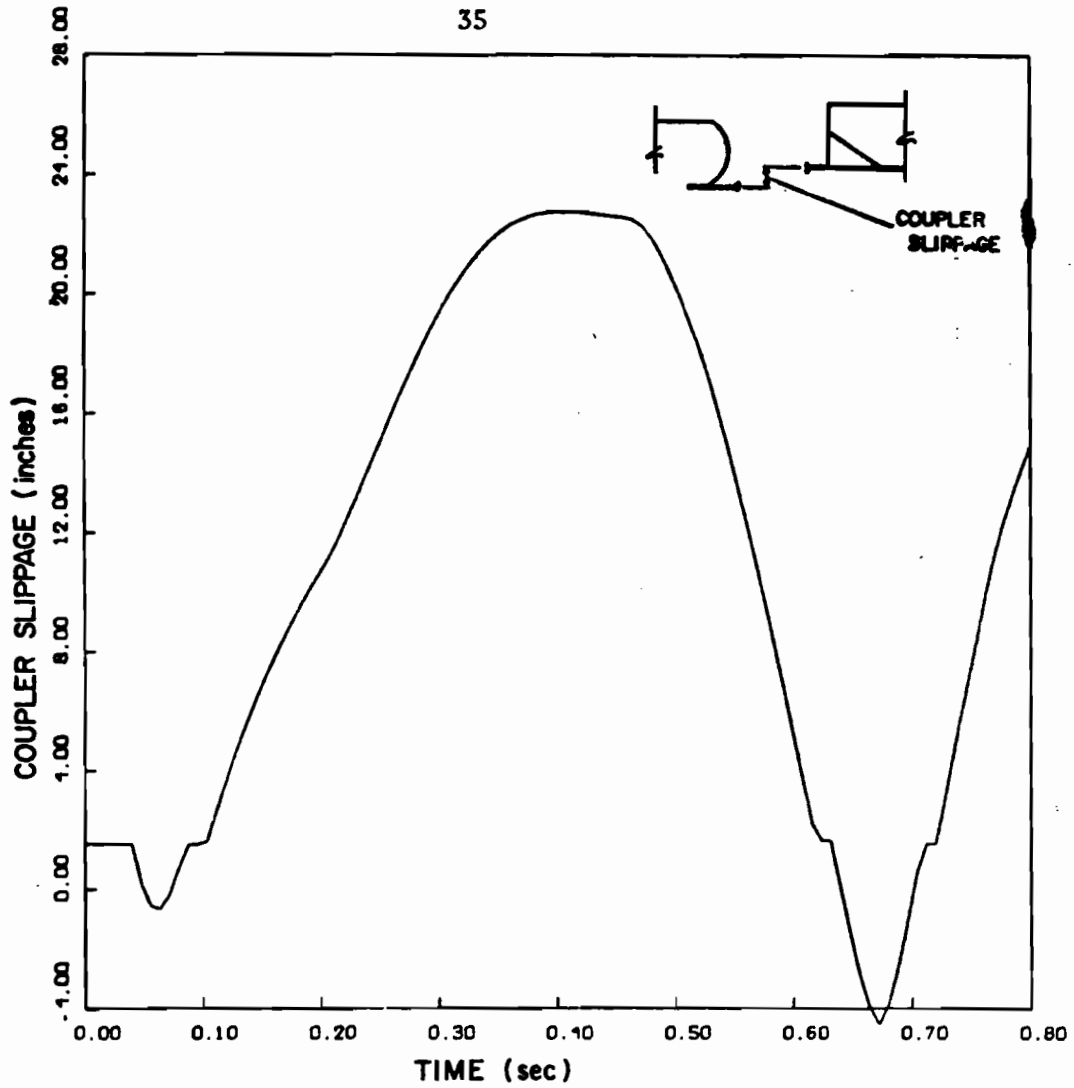
Figure 10c  
Coupler slippage at trailing (impact) end of hopper car

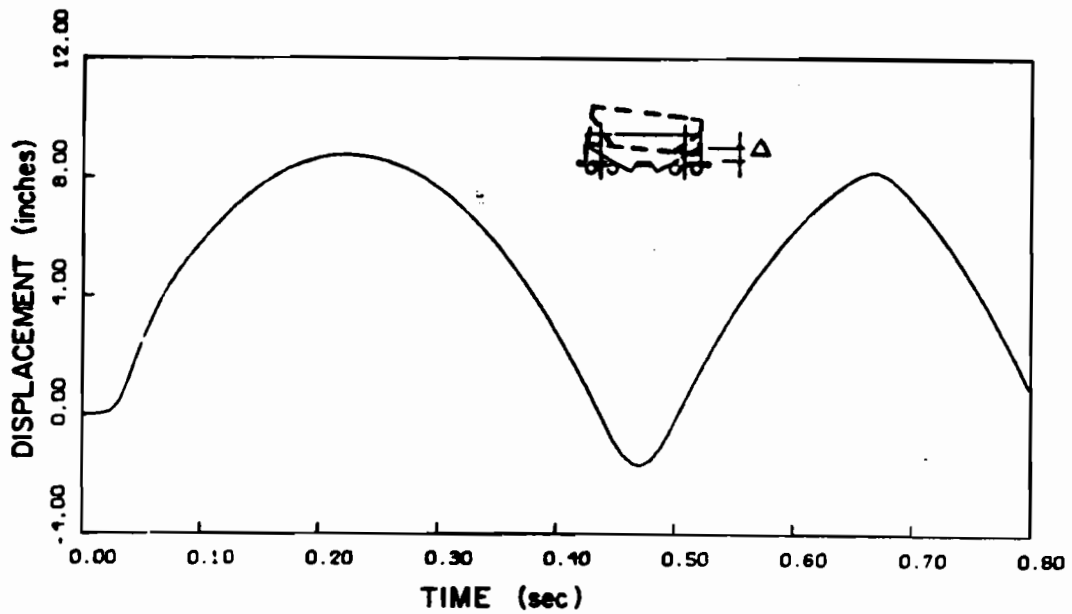
Figure 10d  
Car body displacement at leading (free) end of hopper car

The center plate displacements were sufficiently large for detrucking to occur on both ends of the hopper car (figures 10d, e).

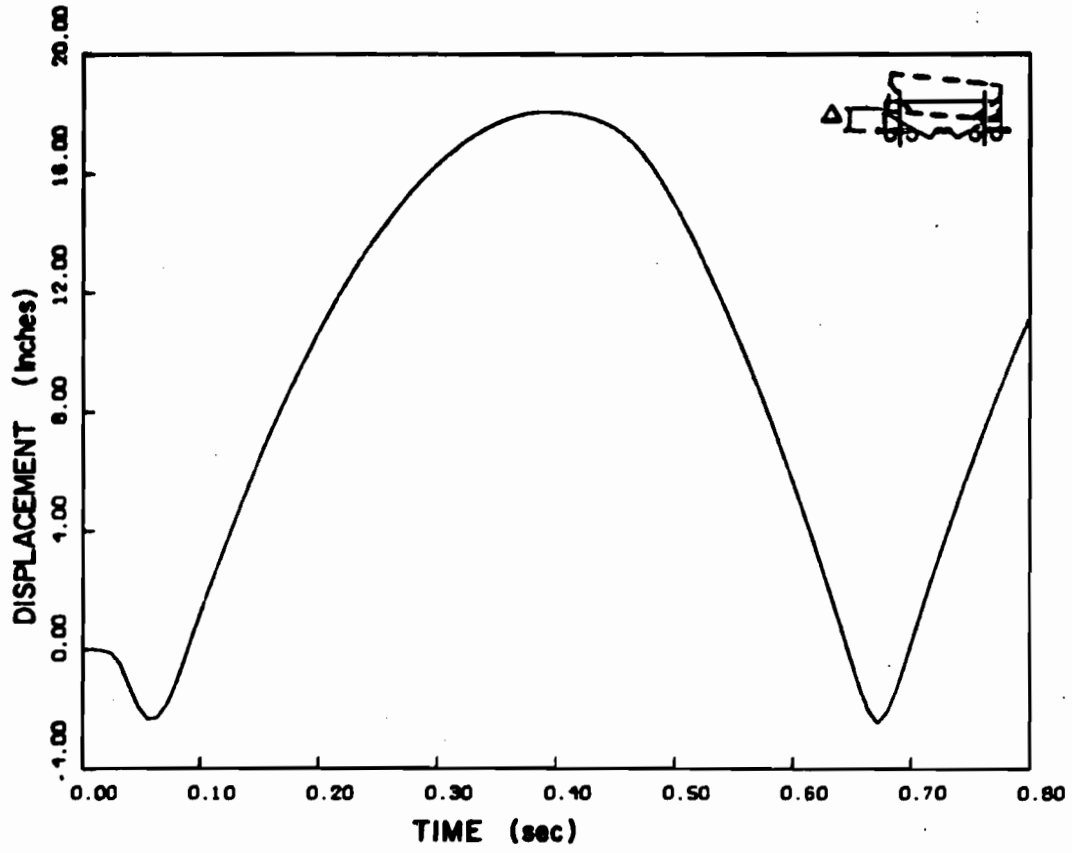
Figure 10e

Car body center plate displacement  
at trailing (impact) end of hopper car

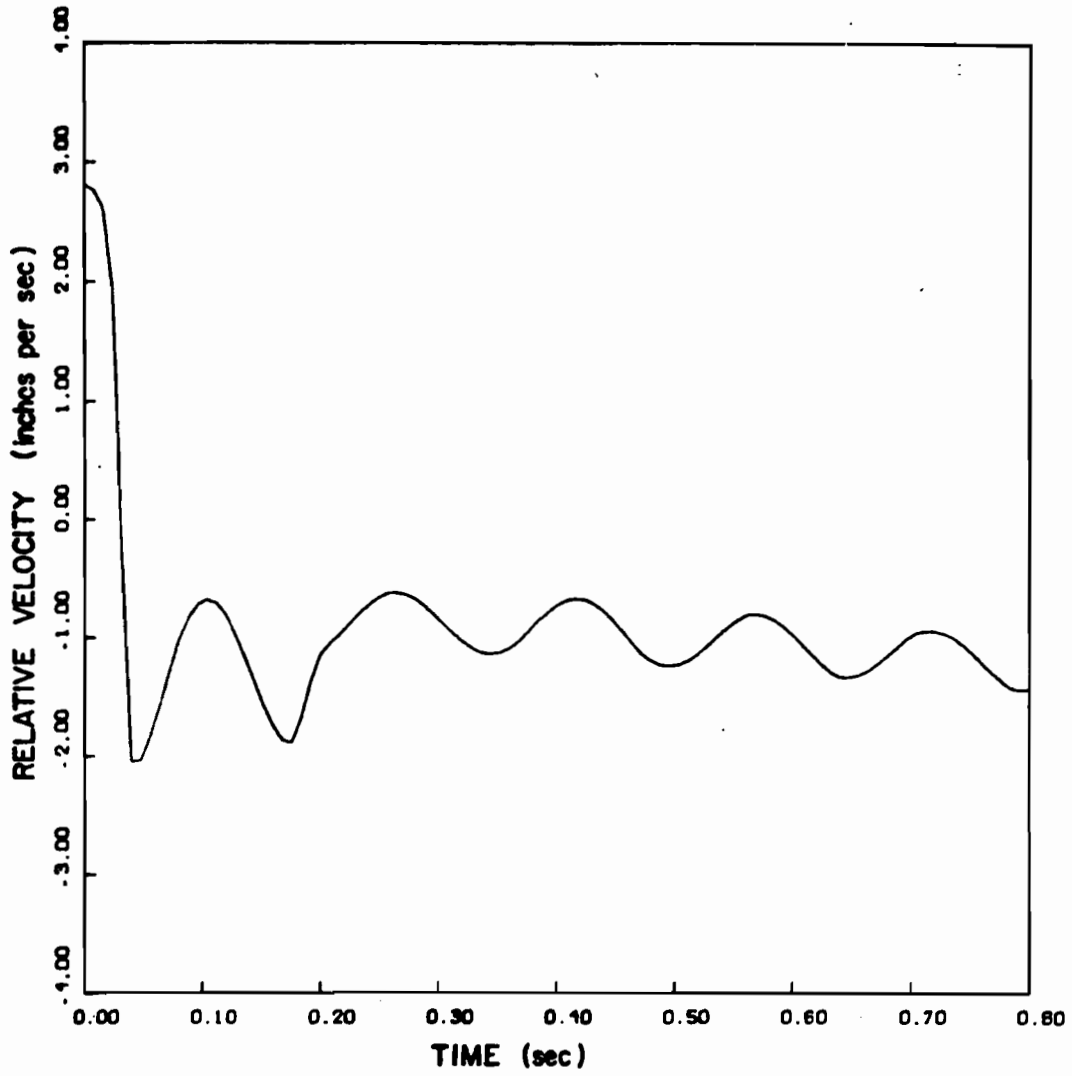
Figure 10f

Relative velocity between hopper car and  
leading tank car  
(Oscillation is due to lading motion).

The relative velocity between the hopper car and leading tank car is shown on fig. 10f. The absolute velocities after impact were: 21 miles per hour for the hopper car and an average of 14 miles per hour for the tank cars.

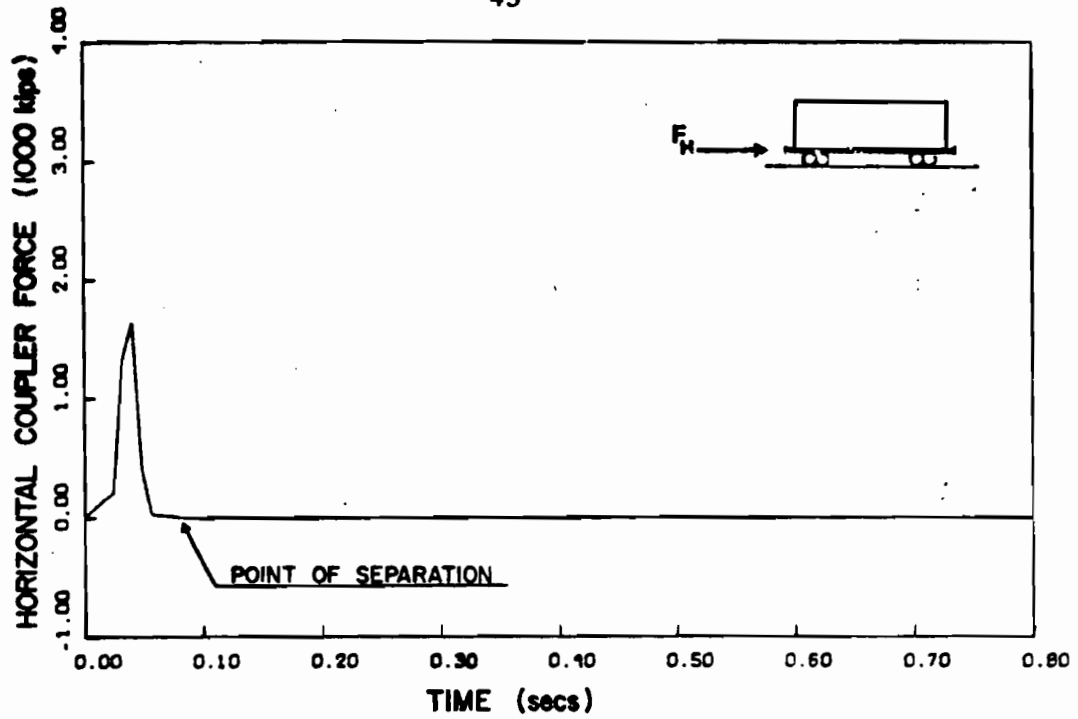
Figure 11a

Horizontal coupler force at the trailing (impact) end of the box car

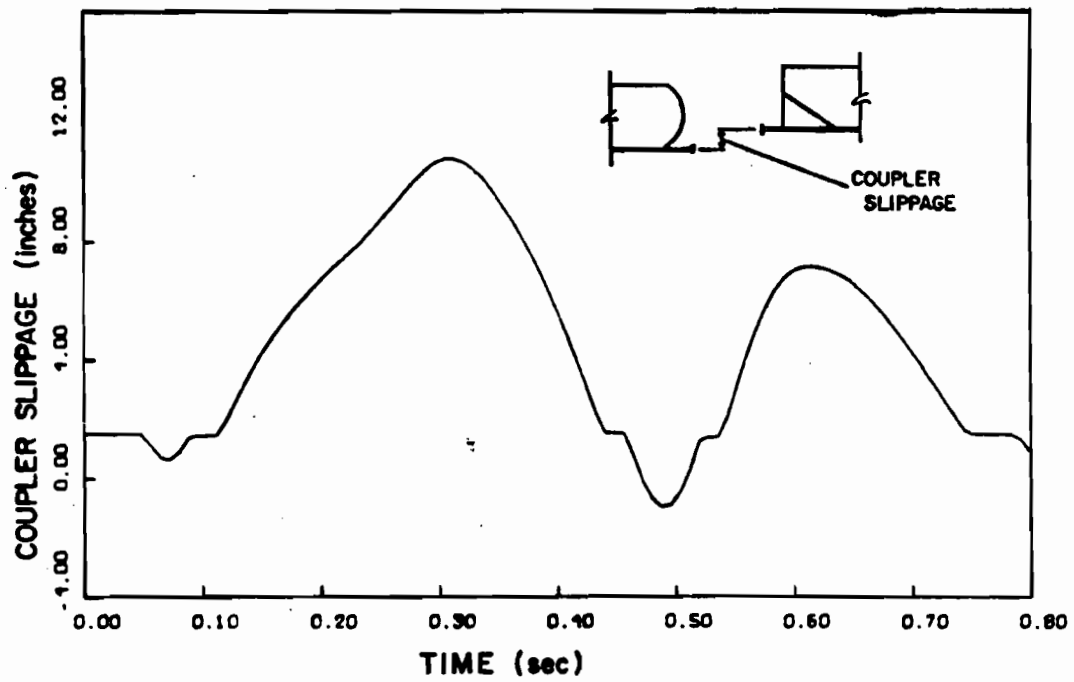
Figure 11b

Coupler slippage at the trailing (impact) end of the box car
