REPORT NO. FRA-OR&D 75-23

# COMPUTER SIMULATION OF TANK CAR HEAD PUNCTURE MECHANISMS

## Classification Yard Accidents

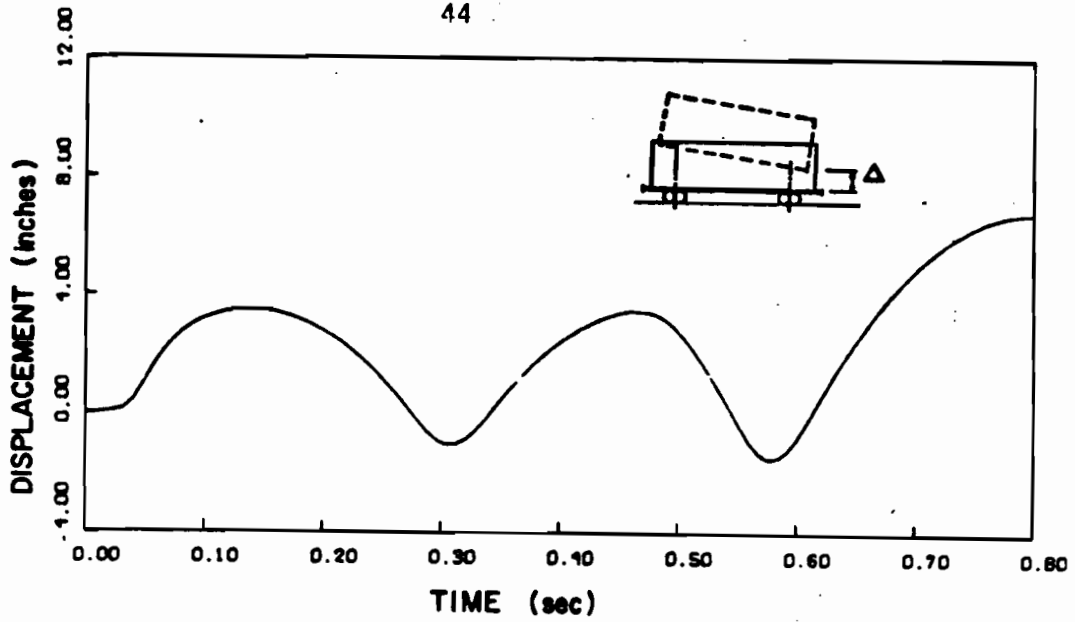
Figure 11c  
 Car body center plate displacement  
 at the leading (free) end of the box car

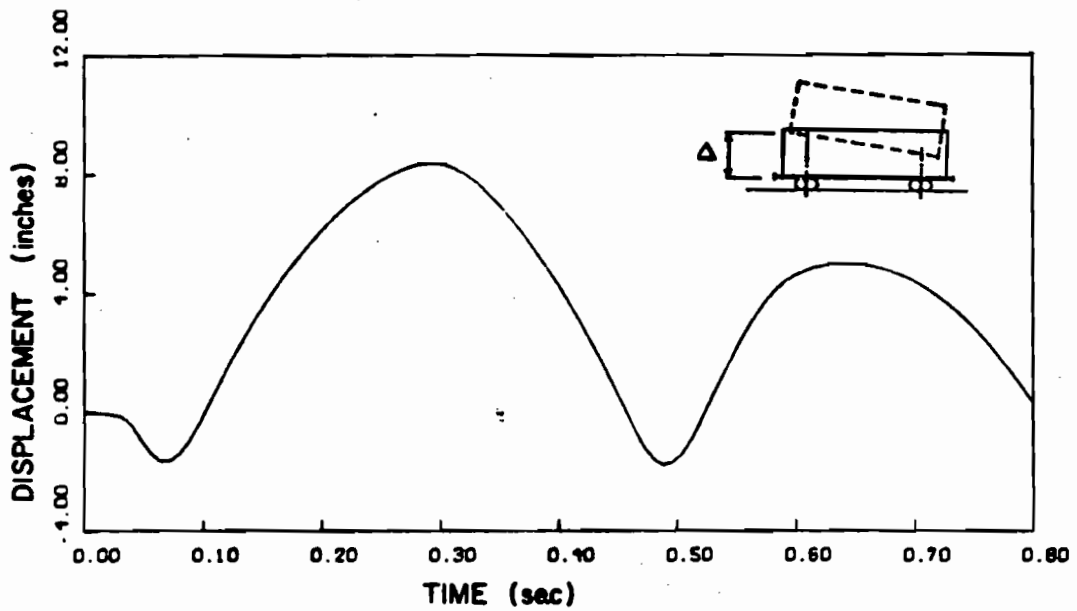
Figure 11d  
 Car body center plate displacement  
 at the trailing (impact) end of box car

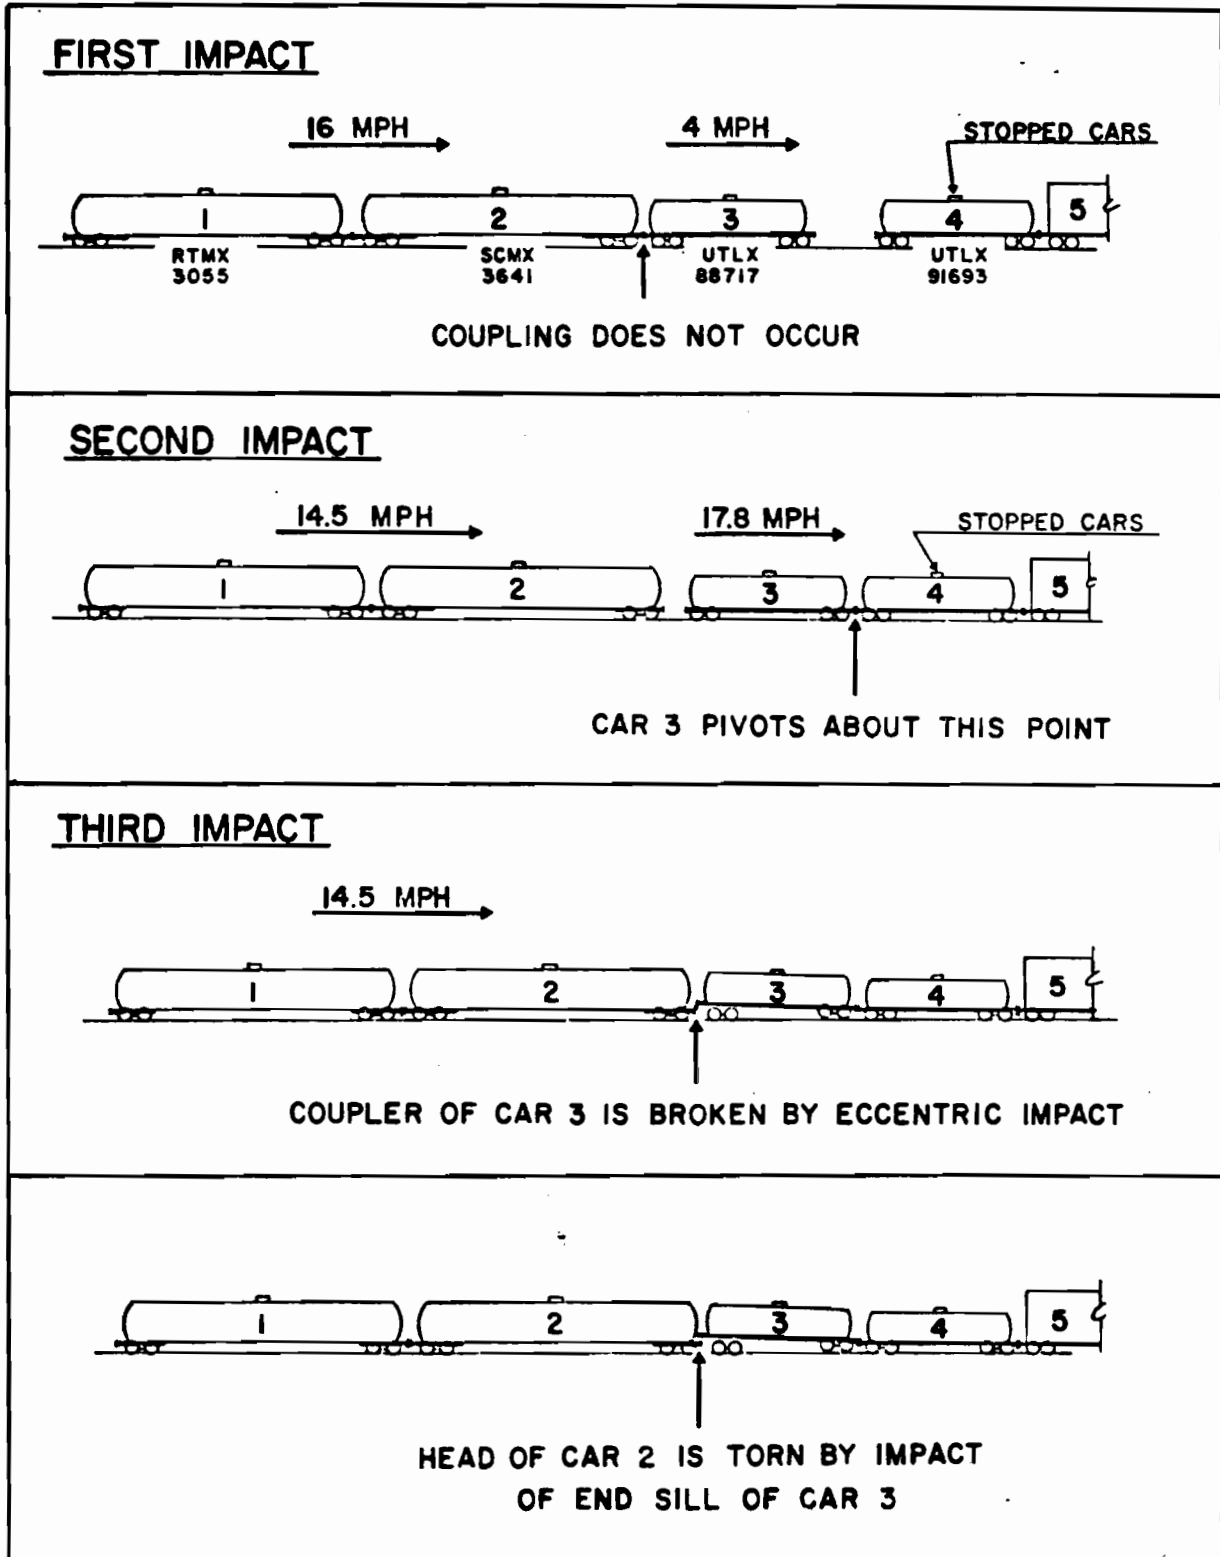
Figure 15

Sequence of impacts. Houston accident.

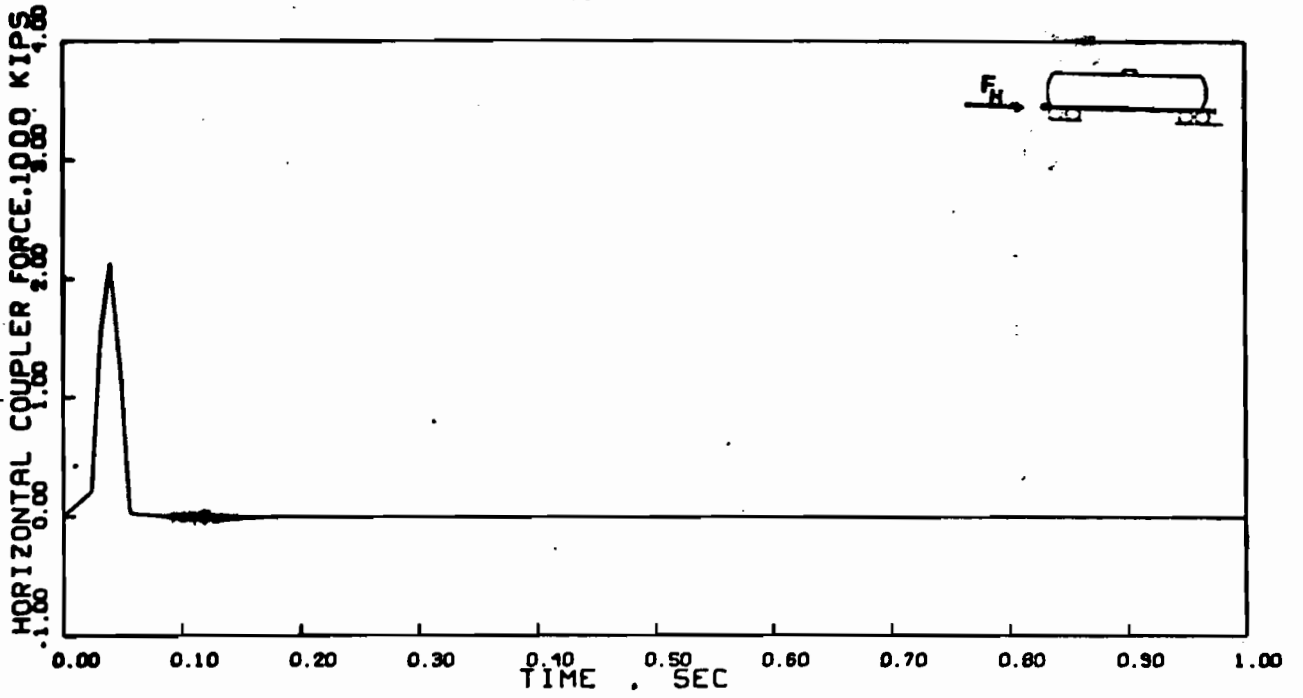
Figure 16a

Horizontal coupler force at trailing  
(impact) end of car No. 3 (first impact)

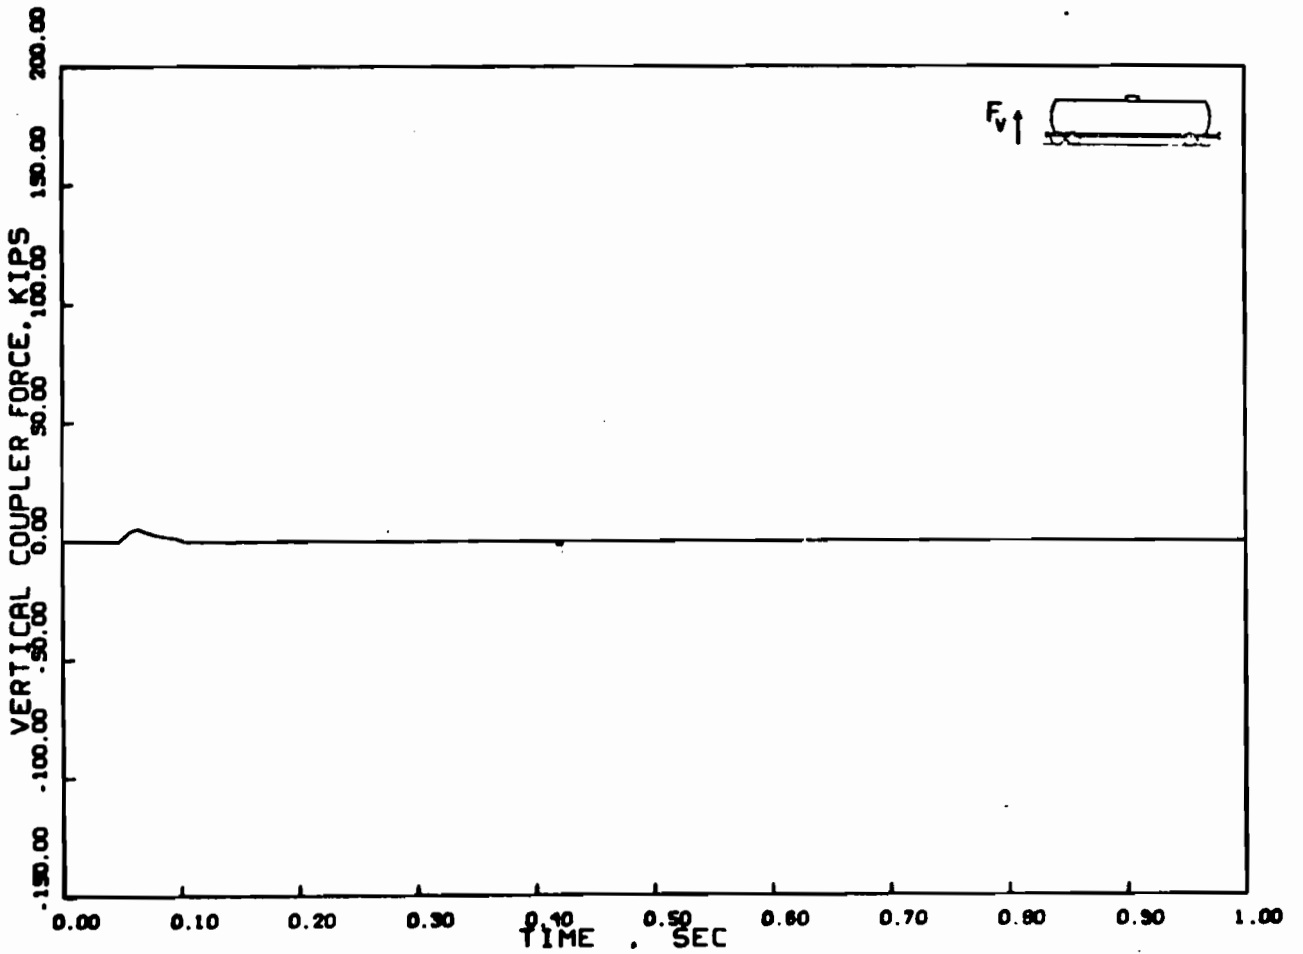
Figure 16b

Vertical coupler force at trailing  
(impact) end of car No. 3 (first impact)

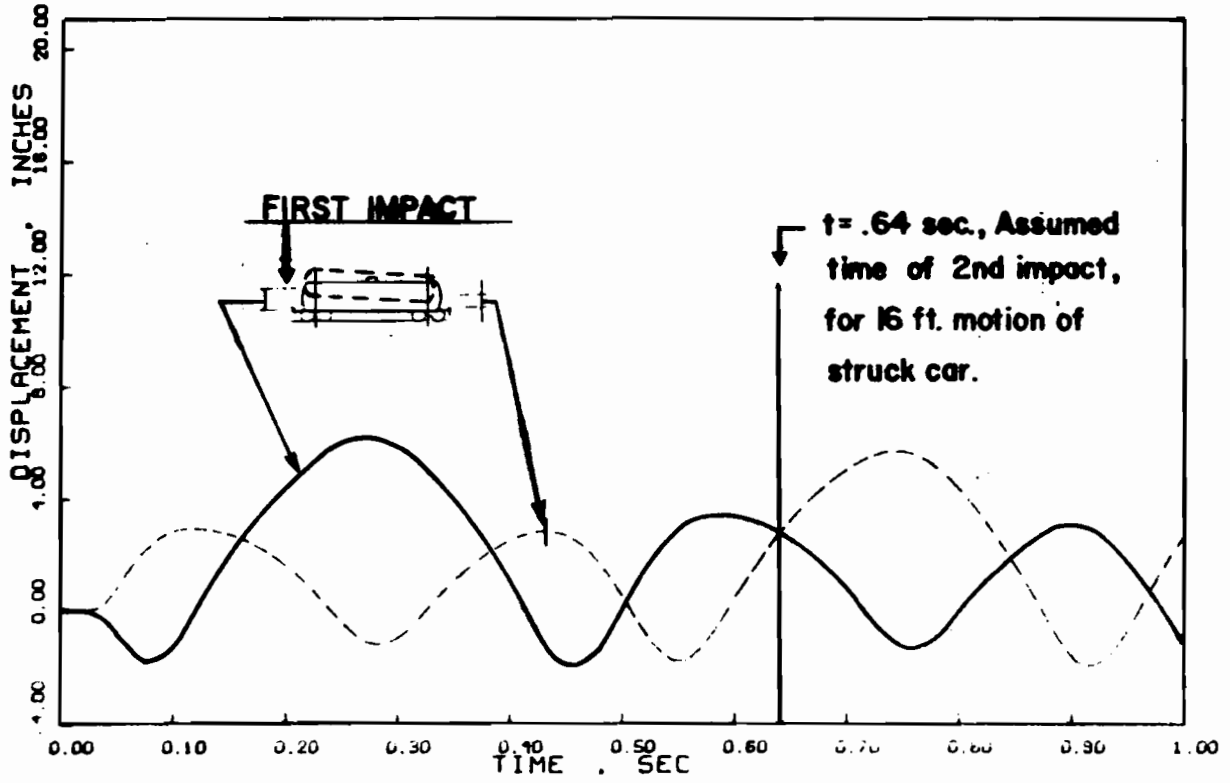
Figure 16c  
 Car body center plate displacements, car No. 3  
 (first impact)

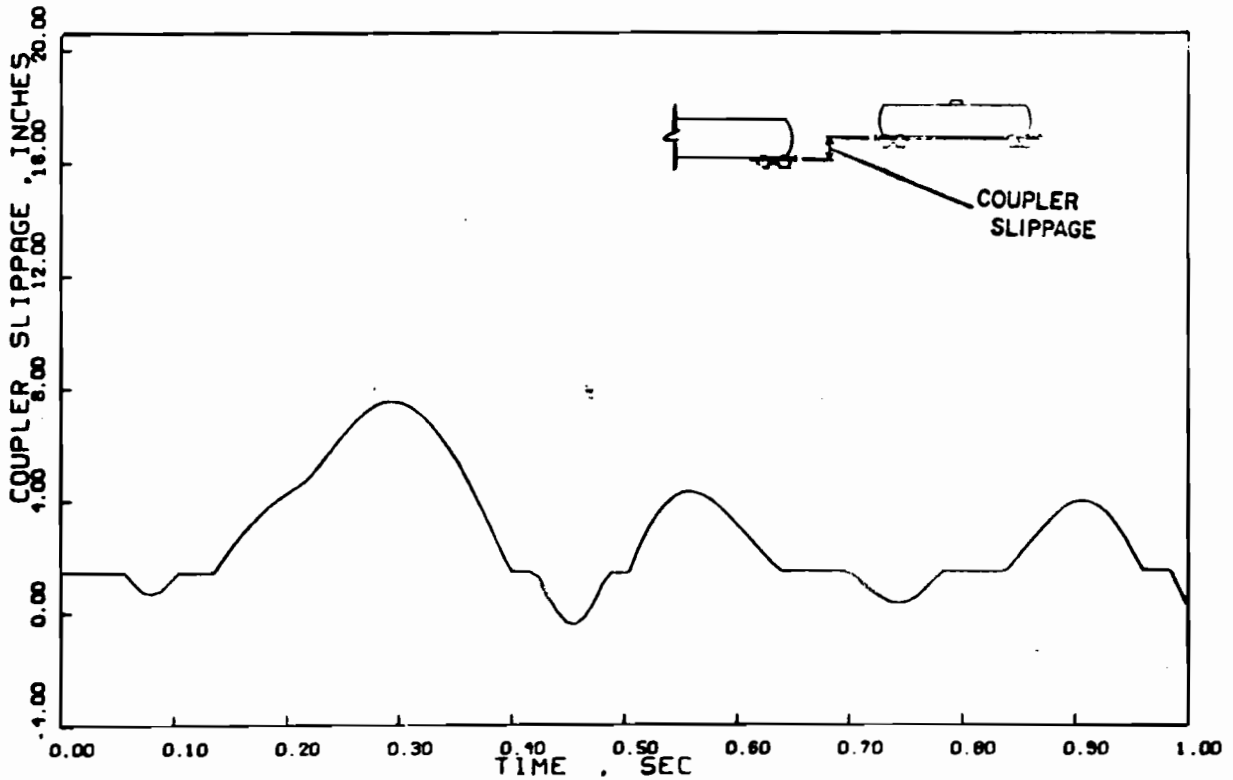
Figure 16d  
 Coupler slippage at trailing  
 (impact) end of car No. 3 (first impact)

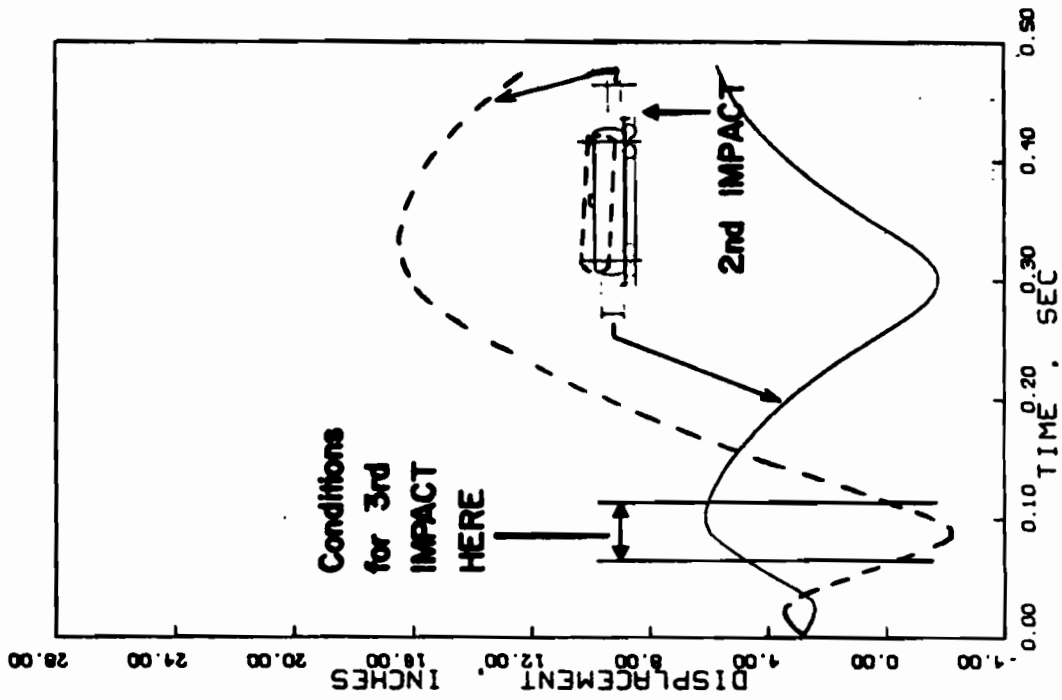
Figure 17h

Car body center plate displacements car 3, second impact

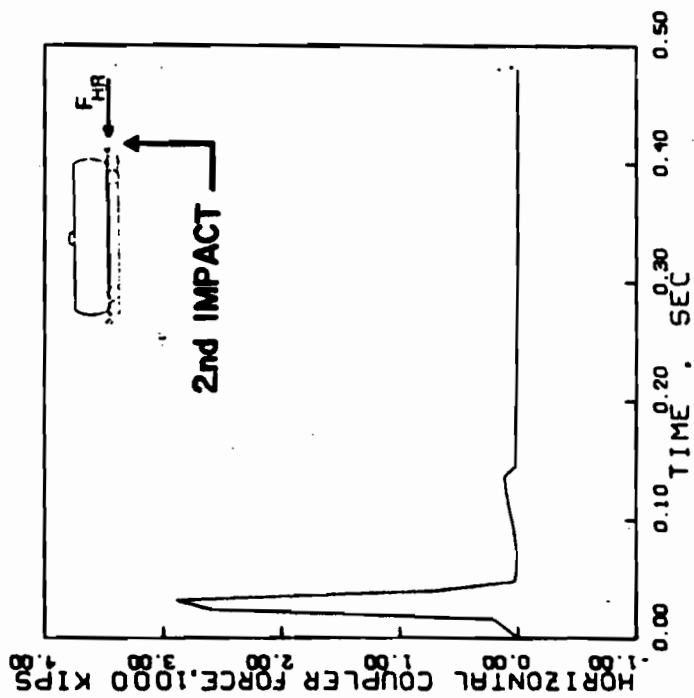
Figure 17a

Horizontal coupler force at the leading (impact) end of car 3. Second impact

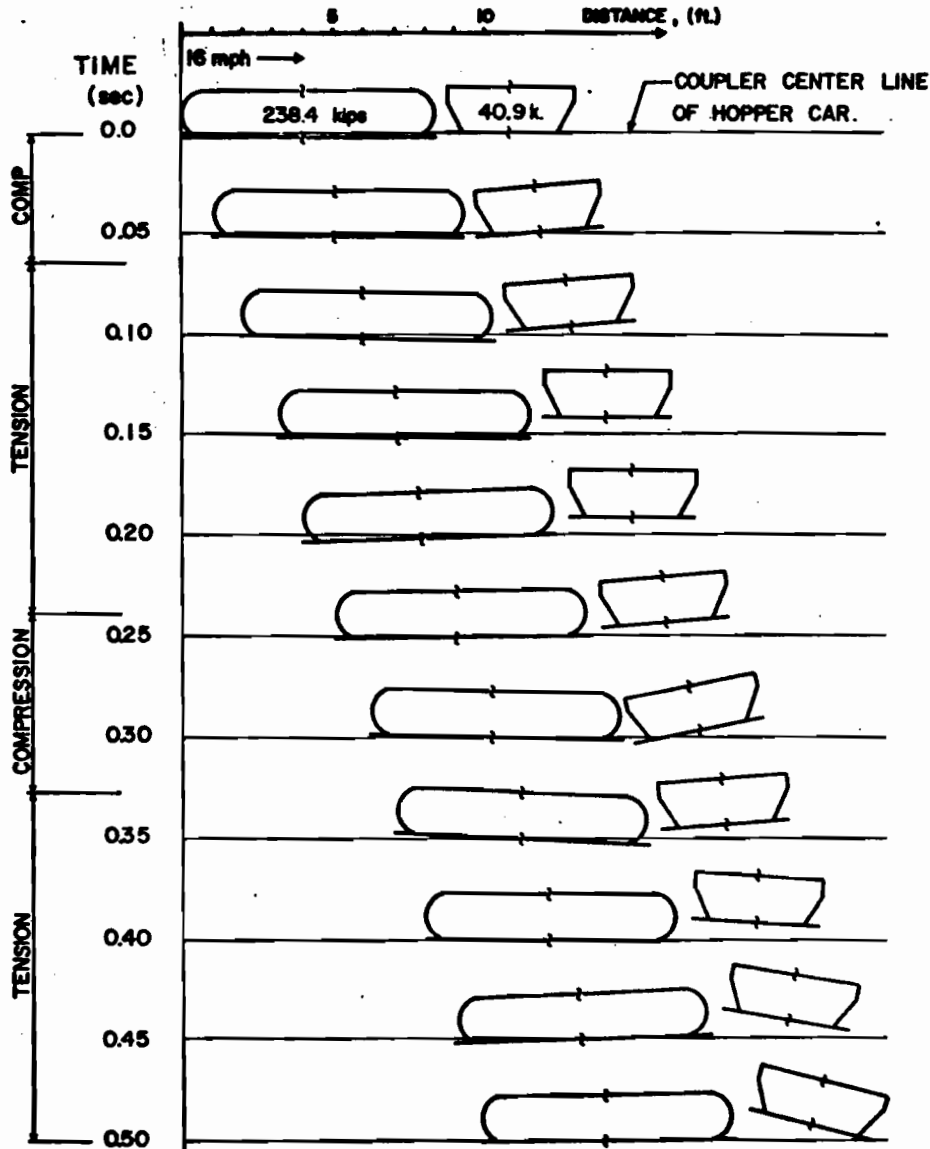
Figure 18a  
Impact of heavy tank car into free-standing hopper car.  
Cars not to scale. Other length scale as shown.  
Note alternating compression and tension  
(buff and draft) between the cars.

When a free-standing railroad car is impacted, it accelerates in the direction of impact, the car body undergoes pitching oscillations about its center of gravity and it moves up and down on its springs. A typical impact, involving a heavy, moving tank car and a light, stationary hopper car, is illustrated in figure 18. It was assumed, in this case, that coupling occurred on impact. In the interest of clarity, the vertical displacements were exaggerated however the final configuration was drawn to proper scale.

It is seen that the impacted end moves first down, then up and down again. The simulations indicated that, for a rather wide range of parameters, these motions correspond to impact in compression followed by tension and by compression again. Consequently, energy is imparted to the light car over one and a half cycles of the longitudinal impact force. This results in an increase in the amplitude of oscillations over two cycles. The diagrams also

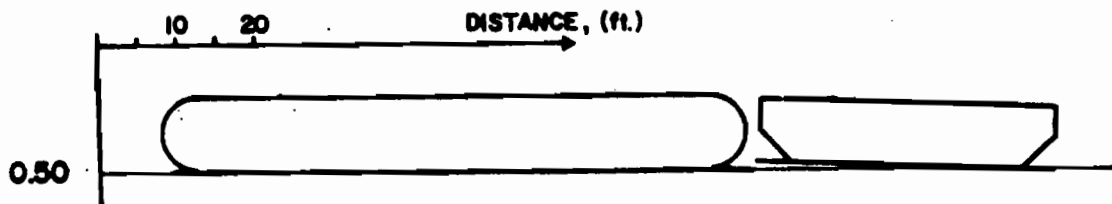
Figure 18b  
Impact of heavy tank car into free-standing hopper car.  
Configuration at 0.500 seconds after impact. Scale as shown.

indicate that the car body moves in such a way that, if the amplitude of motion is sufficiently large, it will lose contact with both of its trucks simultaneously. When coupling does not occur on impact, the maximum pitch of the impacted light car occurs on the first oscillation.

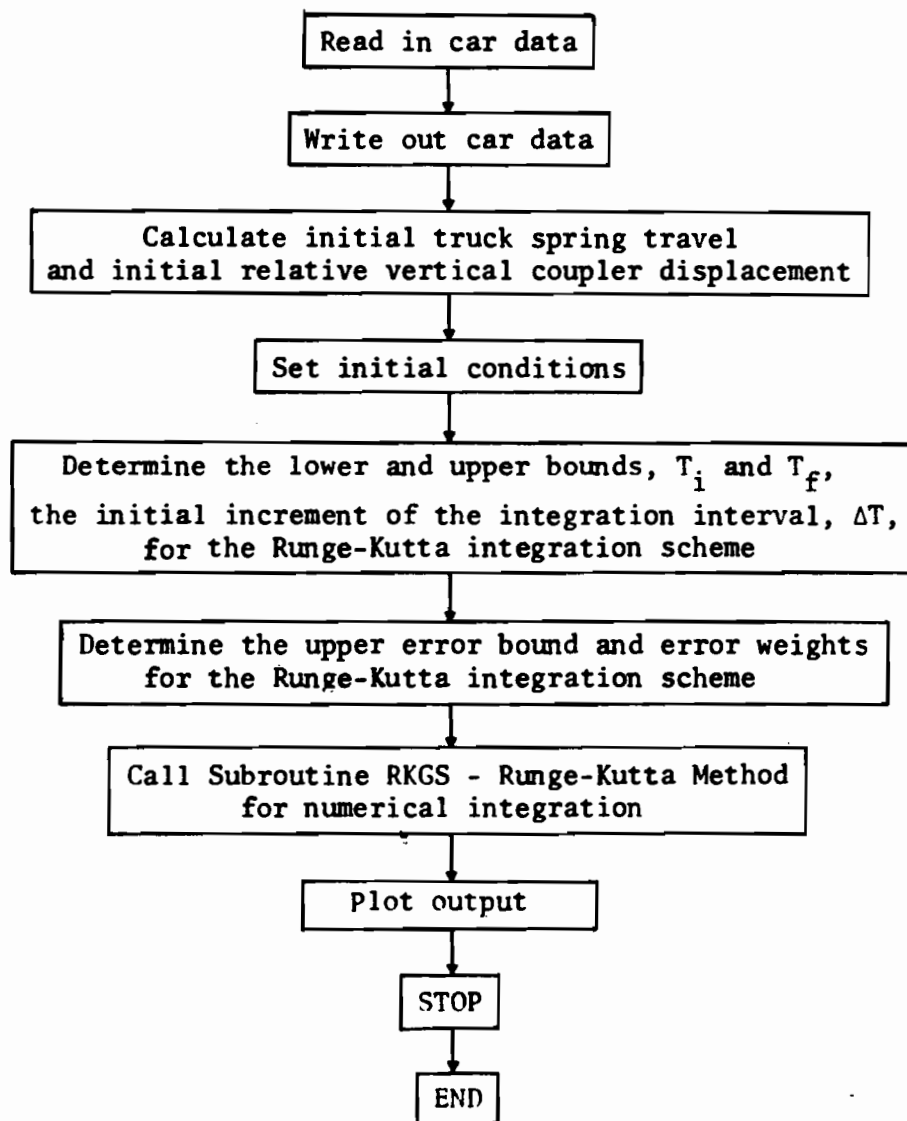
Main Program Flow Chart

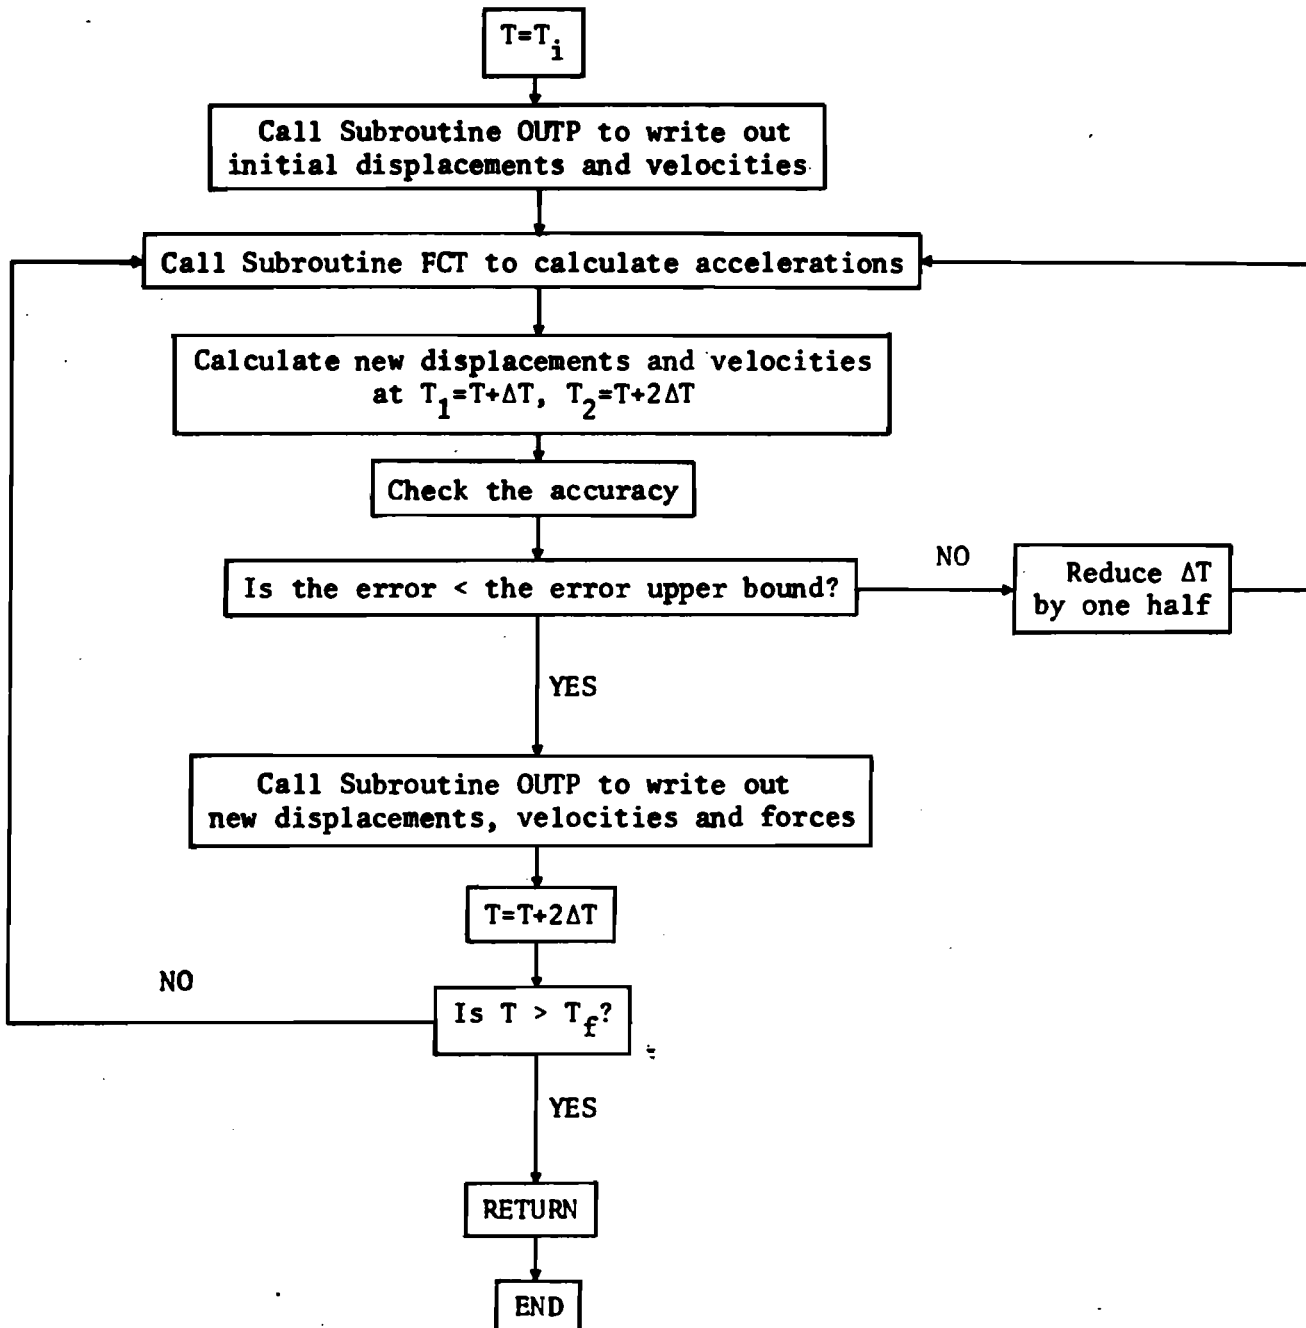
Subroutine RKGS Flow Chart

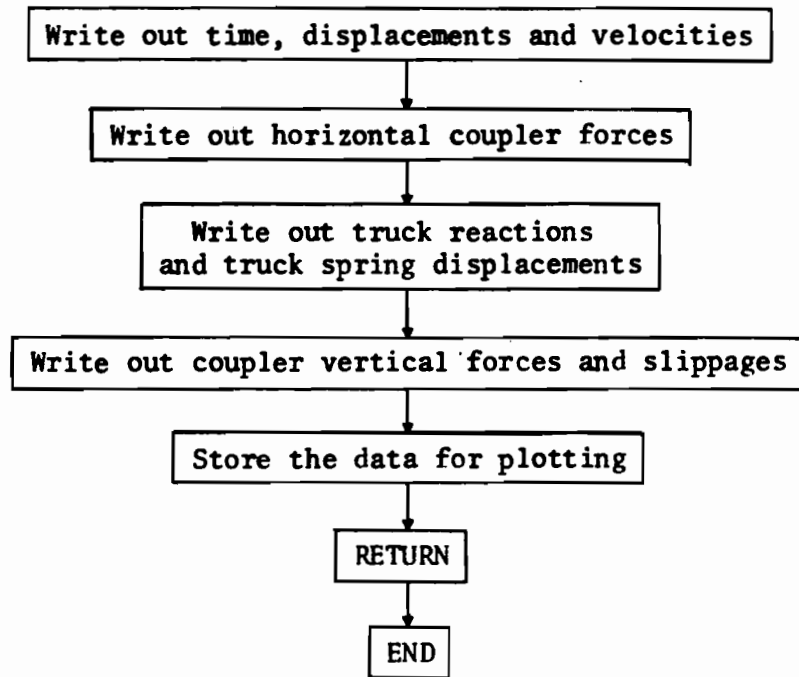
Subroutine OUP Flow Chart (OUP is called by RKGS)

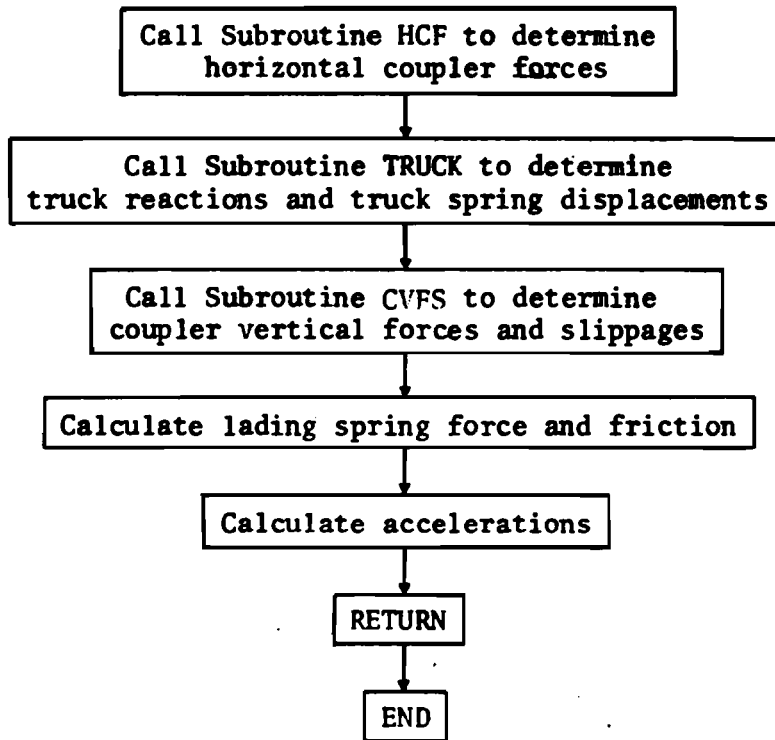
Subroutine FCT Flow Chart (FCT is called by RKGS)

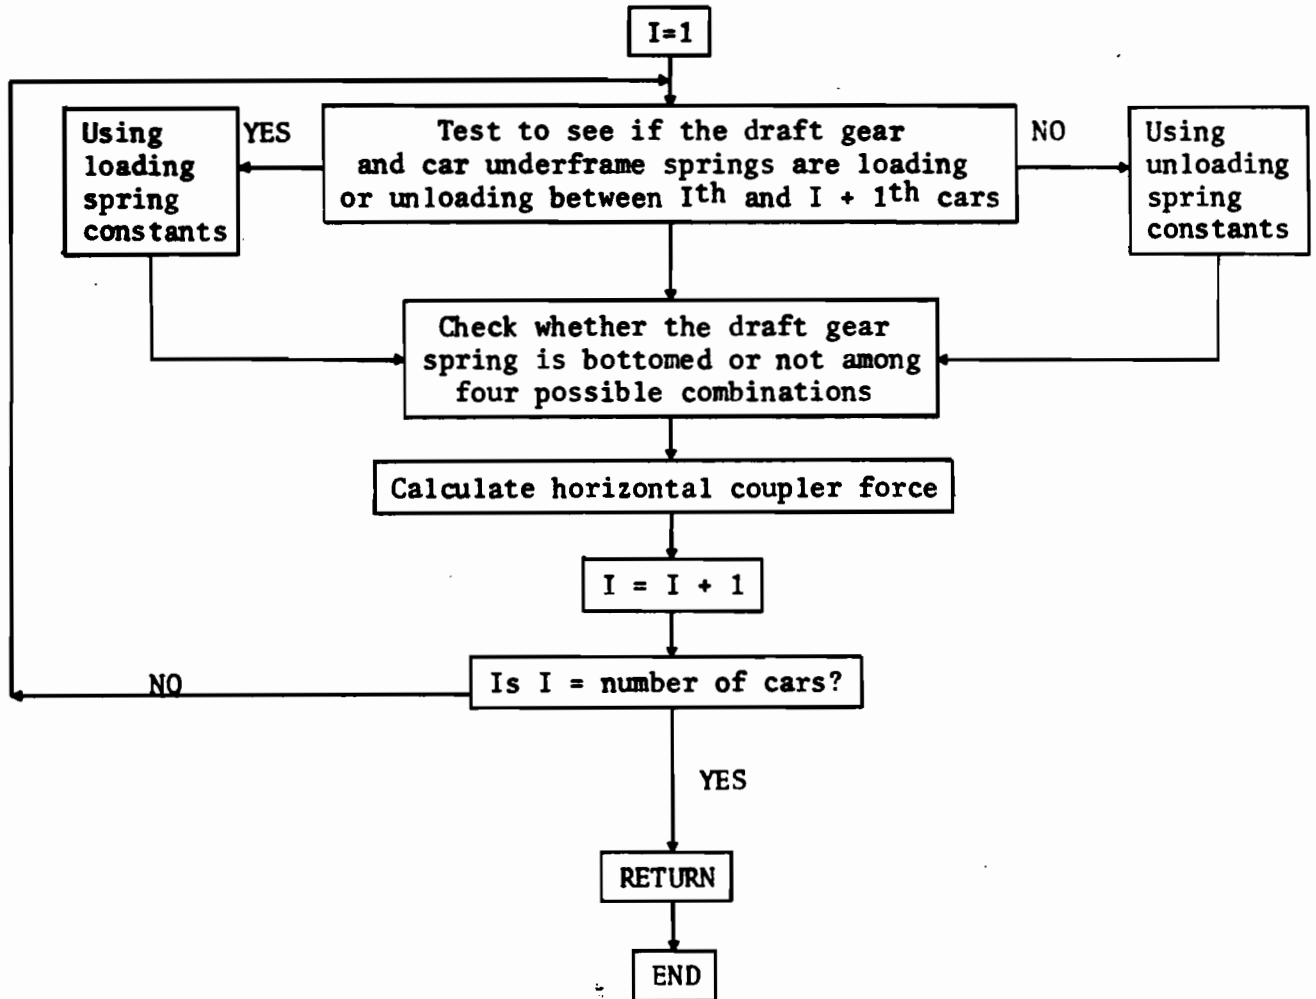
Subroutine HCF Flow Chart (HCF is called by FCT)

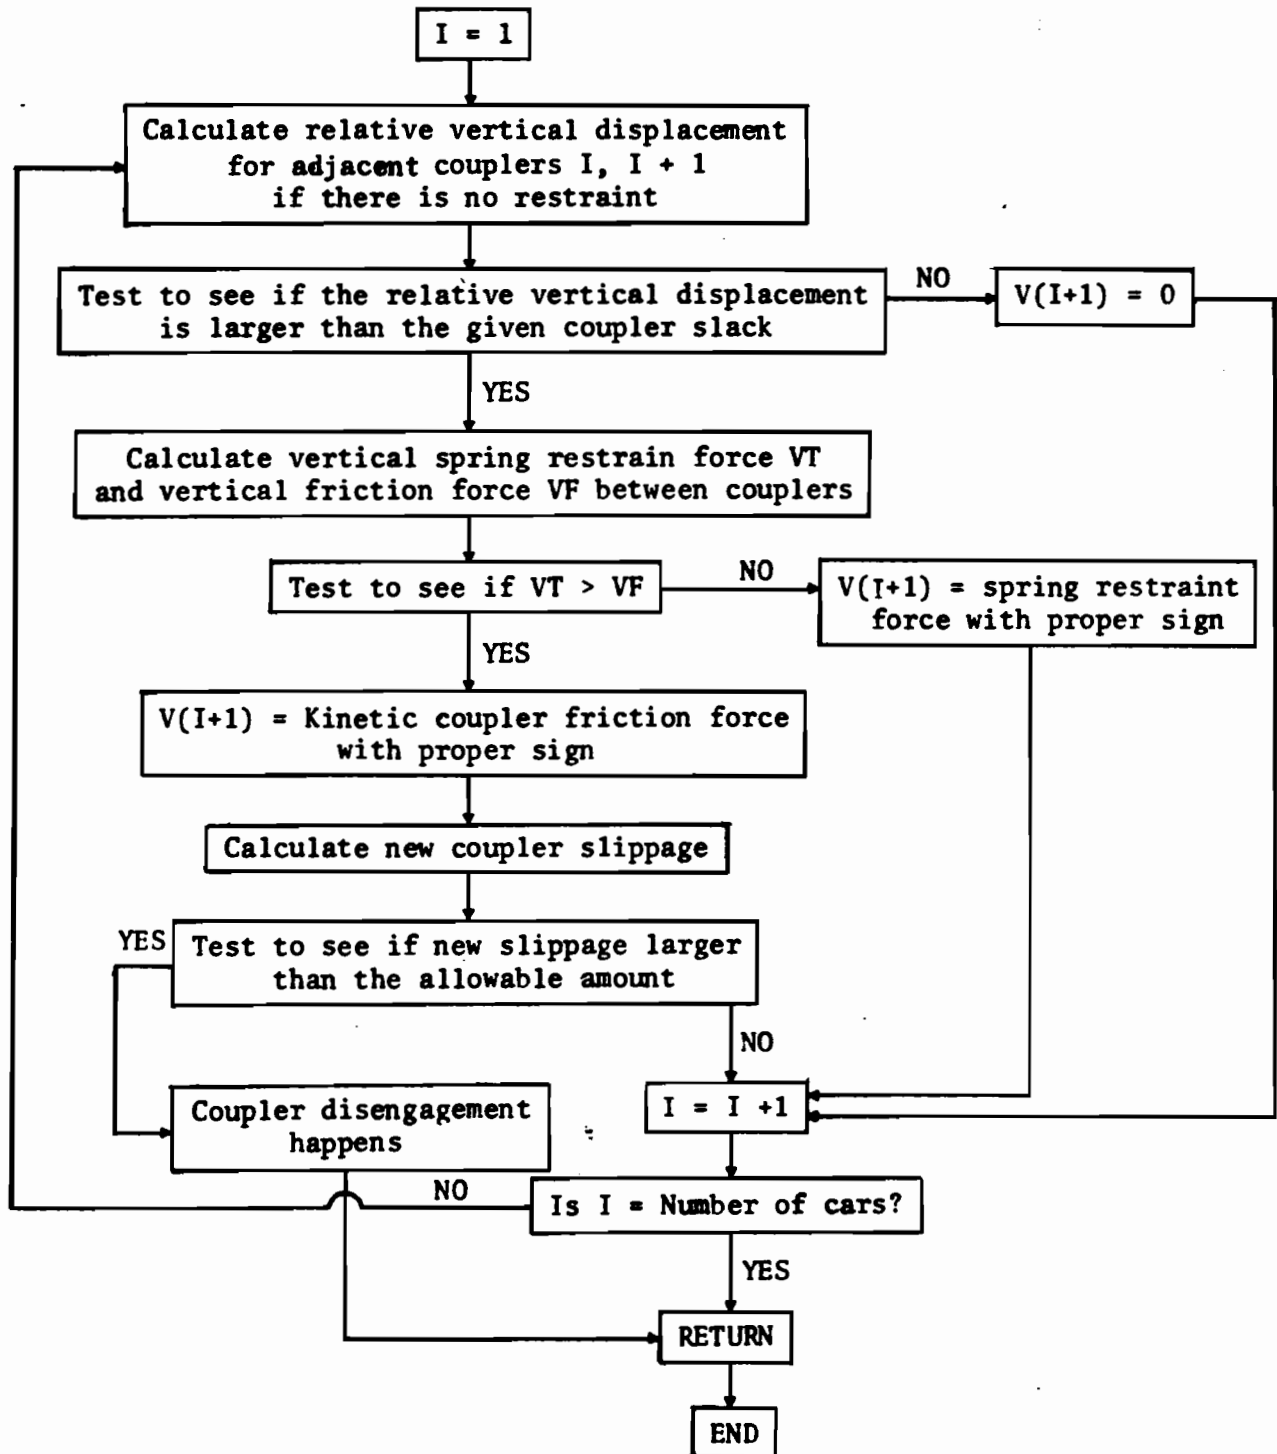
Subroutine CVFS Flow Chart (CVFS is called by FCT)

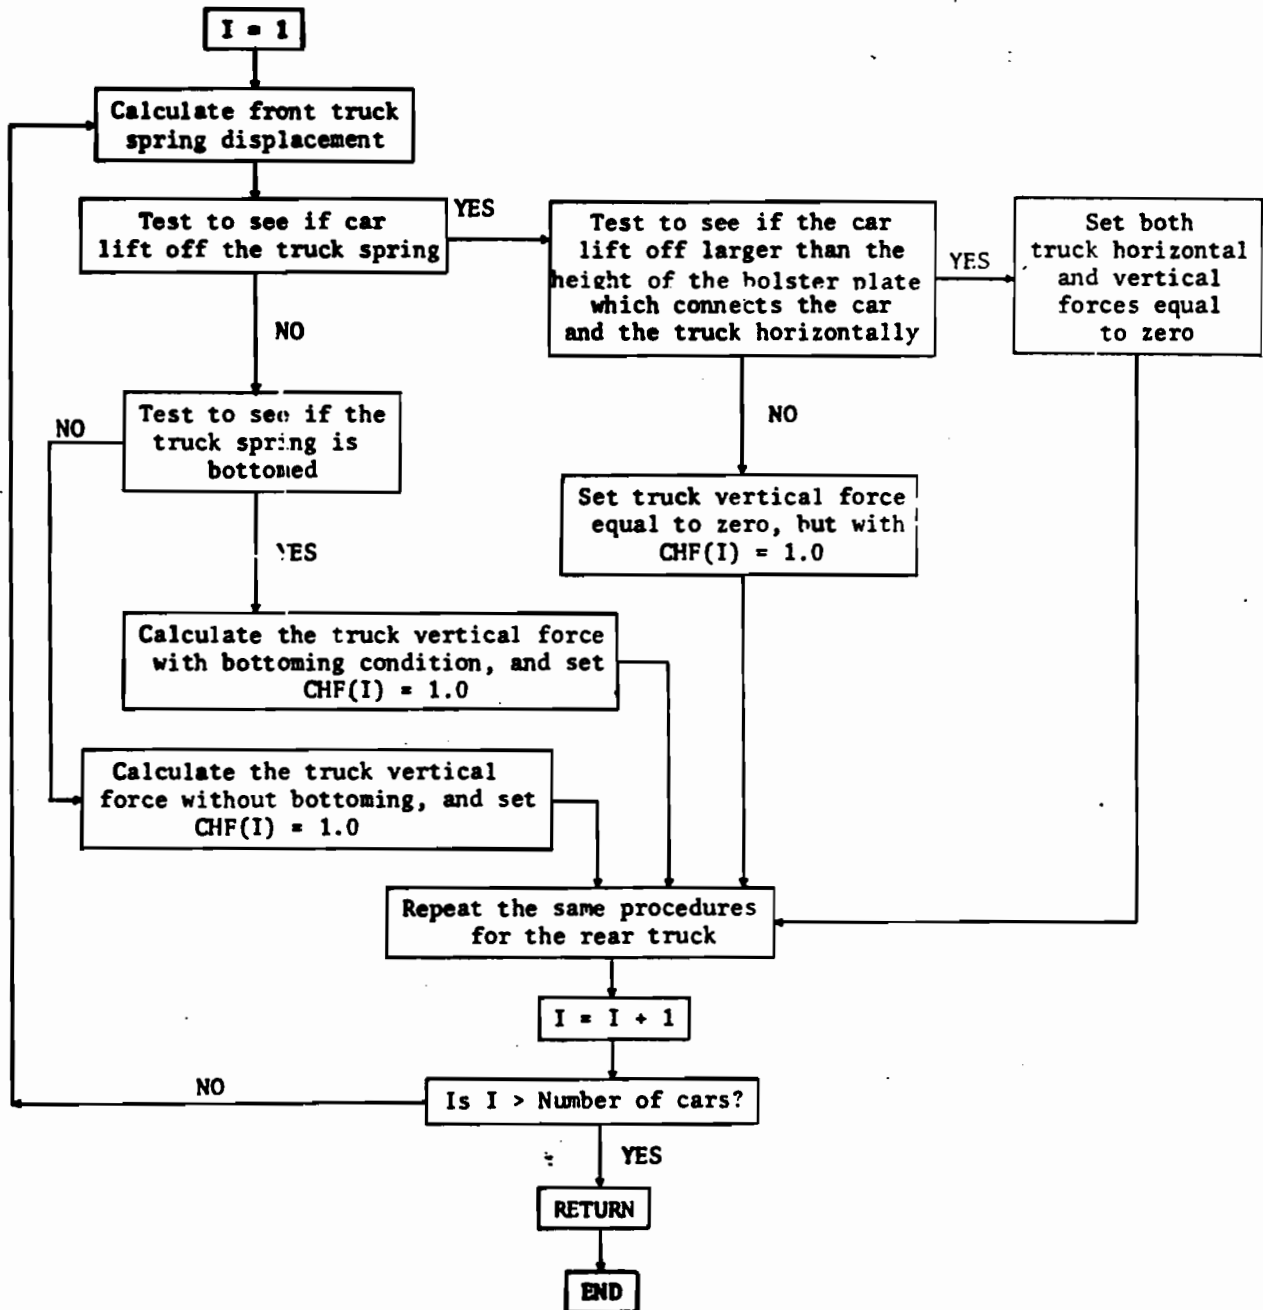
Subroutine TRUCK Flow Chart (TRUCK is called by PCT)
