U.S. Department of
Transportation

Effect of Grade Separation on Pedestrian Railroad Trespass Activity at Shuttlesworth Drive in Collegeville, AL

1. AGENCY USE ONLY (Leave blank)		2. REPORT DATE May 2019	3. REPORT TYPE AND DATES COVERED Final Report June 2014 - August 2018	
4. TITLE AND SUBTITLE Effect of Grade Separation on Pedestrian Railroad Trespass Activity at Shuttlesworth Drive in Collegeville, AL			5. FUNDING NUMBERS RR97A7/RJ1K4 RR97A8/RD601

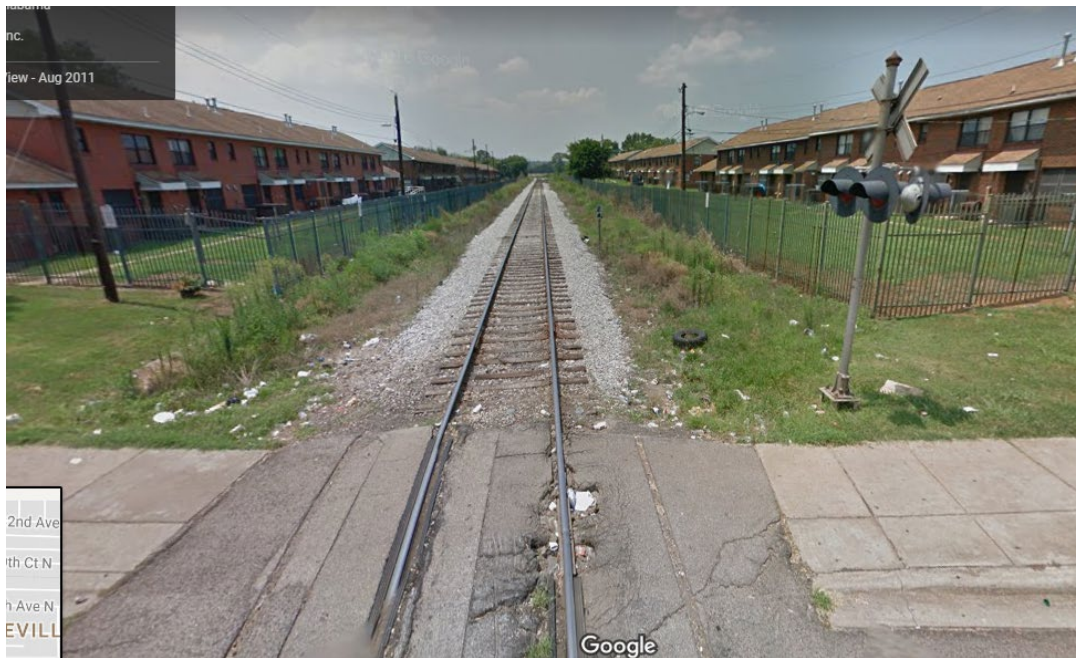
There is one lane of traffic and a sidewalk that intersect the Shuttlesworth Drive crossing. To the west side of the crossing, there is a public housing complex consisting of approximately 400 units. The housing complex is bisected by CSX tracks that run through the middle of the entire width of the housing complex, spanning approximately 1,100 feet. Although both sides of the housing complex that border the railroad tracks are fenced off, there are holes in the fence that trespassing pedestrians use to loiter on the railroad ROW or use as shortcuts to get to the other side of the complex or to the middle school located approximately 1,200 feet to the north of the crossing. Many school children with backpacks were observed crossing the tracks through these

holes or climbing over the fence. [Figure 3](#) shows the Google Street View of the west side of the crossing.

Figure 3. Google Street View of the West Side of the Shuttlesworth Drive Crossing

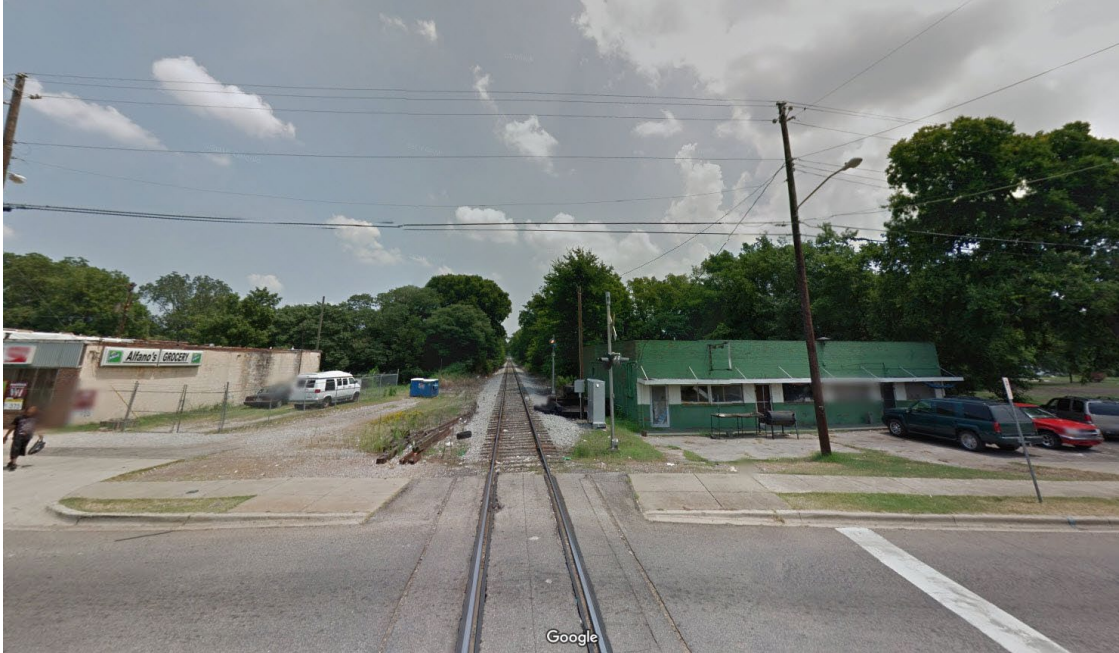
The area monitored for trespass activities on the east side of the Shuttlesworth Drive crossing spans approximately 2,000 feet from the grade crossing to the 34th Street grade crossing. There is one lane of traffic and a sidewalk that intersect the crossing. Immediately adjacent to the crossing, there is a grocery store on the northeast corner and a commercial building on the southeast corner, followed by residential homes that dot both sides of the tracks along the ROW up to the 34th street crossing. Between these two crossings, but closer to the 34th street crossing, are three dead-end streets that lead up to the tracks. Researchers observed a significant number of trespassing pedestrians using these locations as shortcuts to travel to the other side of the tracks. This entire ROW is not fenced. [Figure 4](#) shows the Google Street View of the east side of the Shuttlesworth Drive crossing.

Figure 4. Google Street View of the East Side of the Shuttlesworth Drive Crossing

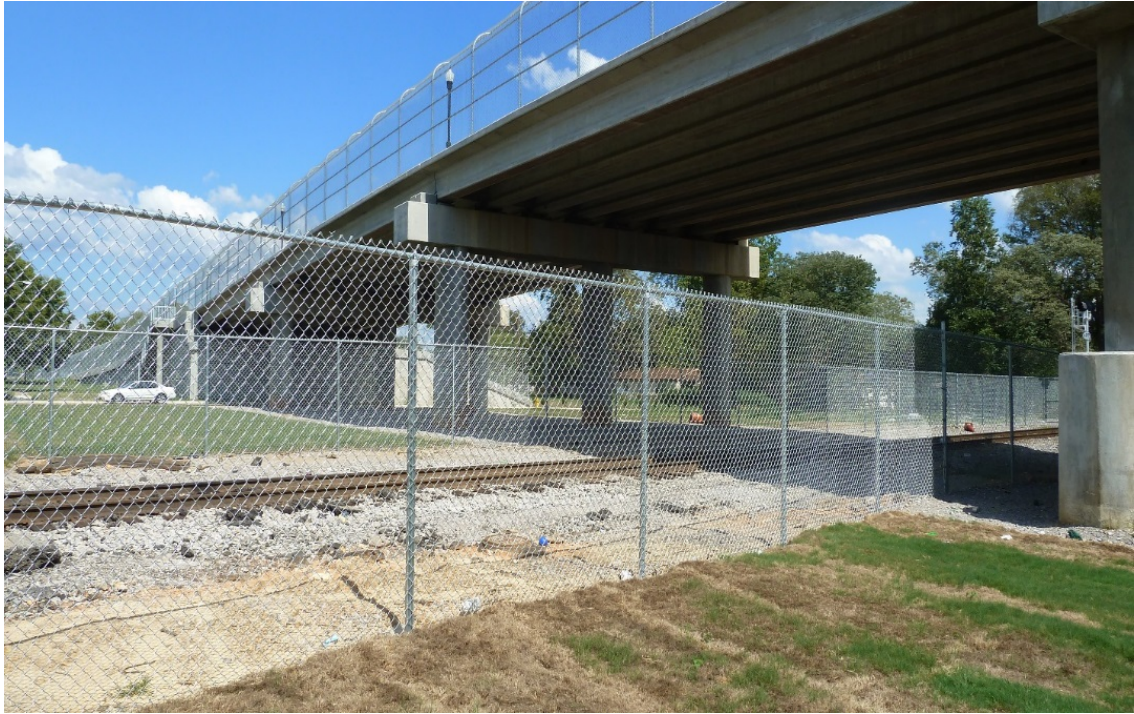
Figure 5. Maxine Herring Parker Bridge

The bridge is an overpass over railroad tracks and connects Shuttlesworth Drive from 29th Avenue North to 32nd Avenue North. There are three lanes of traffic for motorists (one lane of traffic in each direction and a turning lane in the middle) and a sidewalk for pedestrians over the bridge. The sidewalk is located only on the west side of the bridge and is separated from motor vehicle traffic by a concrete barrier. The sidewalk can be accessed via a staircase located on both sides of the railroad tracks or via the existing sidewalk from 29th Avenue or 32nd Avenue. As part of the overpass bridge construction, the Shuttlesworth Drive grade crossing was closed and a chain link fence installed on both sides of the tracks that connects to the existing public housing complex fence and spans approximately 300 feet to the east.

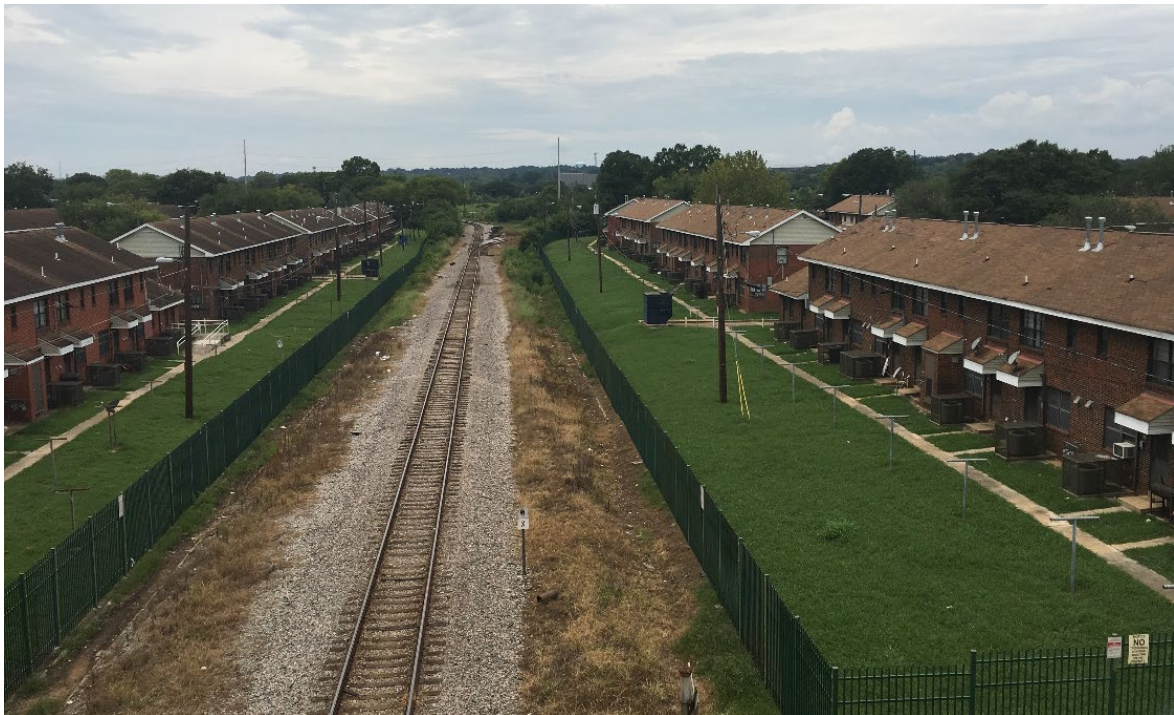
Figure 6. Railroad ROW to West of the Overpass Bridge

The site conditions to the west of the overpass bridge remain similar to the baseline conditions. However, the site conditions experienced significant changes from the baseline conditions to the east of the overpass bridge. The two neighborhood stores located adjacent to the crossing were demolished and a church located approximately 150 feet to the north of the crossing was relocated. As discussed earlier, a new chain link fence was installed after the closing of the crossing and it spans approximately 300 feet to the east of the closed crossing. [Figure 5](#) shows the overpass bridge over the closed crossing. Images of the railroad ROW to the west and to the east of the overpass bridge are shown in [Figure 6](#) and [Figure 7](#), respectively.

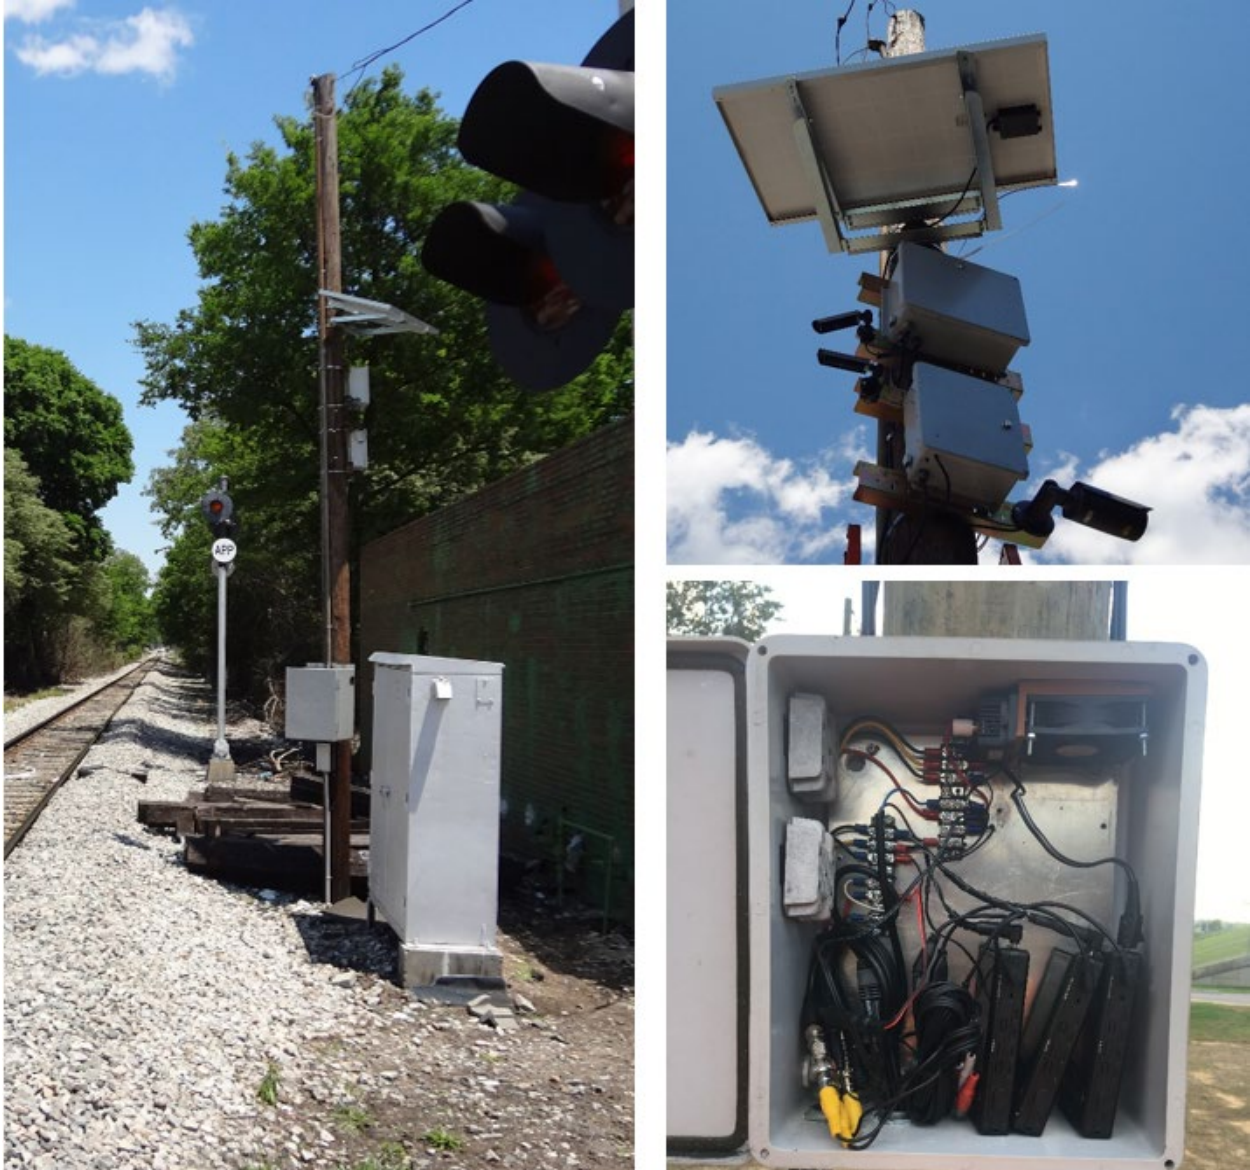
Figure 8. Baseline Video Data Collection Systems in Collegeville, AL

A video-based data collection system consisting of a solar panel, a camera, and a digital video recorder (along with supporting hardware contained in a utility box) was used to collect video of pedestrians trespassing on the railroad ROW along the Collegeville corridor. Three separate systems were mounted on a utility pole to monitor the study area. [Figure 8](#) shows pictures of the data collection system installed at the Shuttlesworth Drive grade crossing during the baseline data collection period.

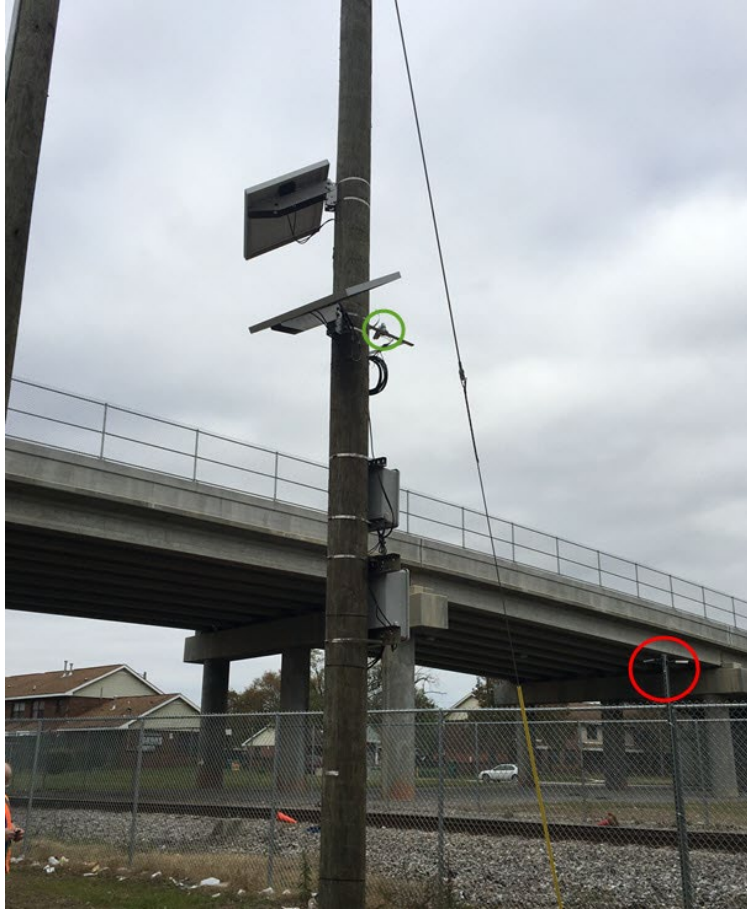
Figure 10. Post Construction Video Data Collection Systems in Collegeville, AL

The same video data collection systems were used to collect trespass activities after the construction of the new overpass bridge. However, they were mounted approximately 150 feet to the east of the crossing on a utility pole and adjacent to the new fence because the original utility pole used during the baseline data collection period was removed during the construction of the new bridge. [Figure 10](#) shows the video data collection systems used during the post-construction period. As can be seen, two solar panels, two utility boxes, and a camera pointed at the closed crossing (green circle) were mounted on a utility pole, and two cameras (red circle) that monitored east and west of the new bridge were mounted on the new fence. The video data collection systems were installed on September 27, 2017 and remained operational at the time of this report.

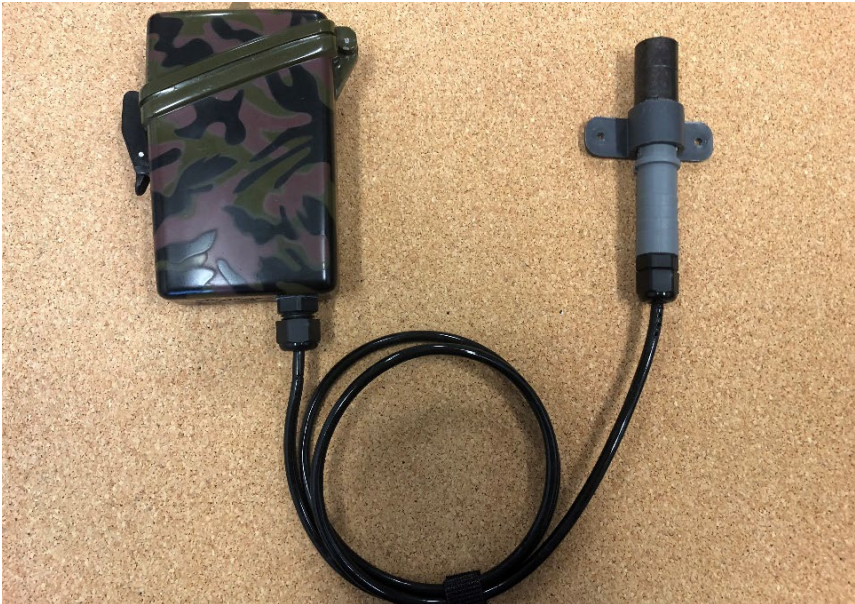
Figure 11. Pedestrian Counter

Pedestrian usage of the overpass bridge was collected using an automated pedestrian counter. The counter was housed inside a utility box and mounted on the bridge between the two staircases. Anyone using the bridge to cross the railroad tracks was counted. The counter was installed on October 30, 2017 and remained operational through December 7, 2017. [Figure 11](#) shows the pedestrian counter used to collect pedestrian usage of the overpass bridge.

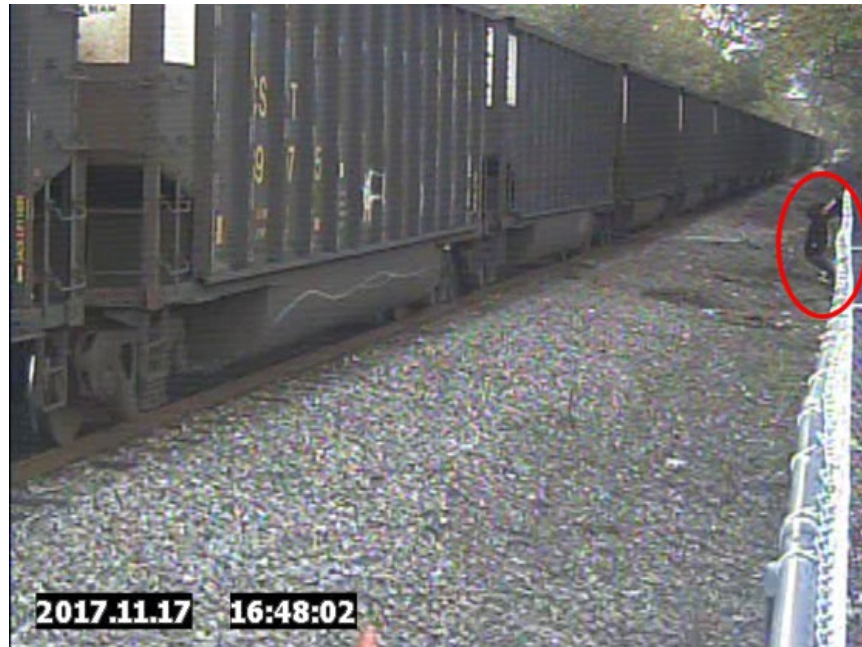
Examples of pedestrians trespassing onto the ROW are shown in Figure 15 through Figure 18. In Figure 15, a trespassing pedestrian is seen exiting the ROW by climbing over the chain link fence during the post construction period. The trespasser crossed between cars of a slow-moving train in Zone 7.

Figure 15. Post-Construction Example of Pedestrian Trespassing from the Area East of the Crossing (Zone 7)

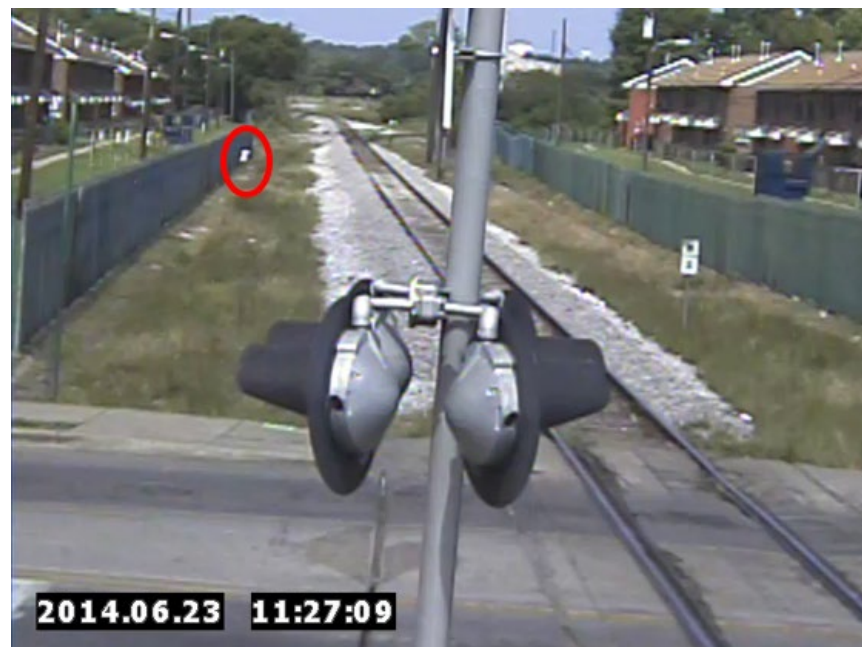
Figure 16 shows a snapshot of a pedestrian trespassing onto the railroad ROW by walking through a hole in the fence in Zone 3 south during the pre-construction period. The trespasser walked straight across the tracks and exited on the Zone 3 north side via a hole in the fence.

Figure 16. Pre-Construction Example of Pedestrian Trespassing from the Area West of the Crossing (Zone 3)

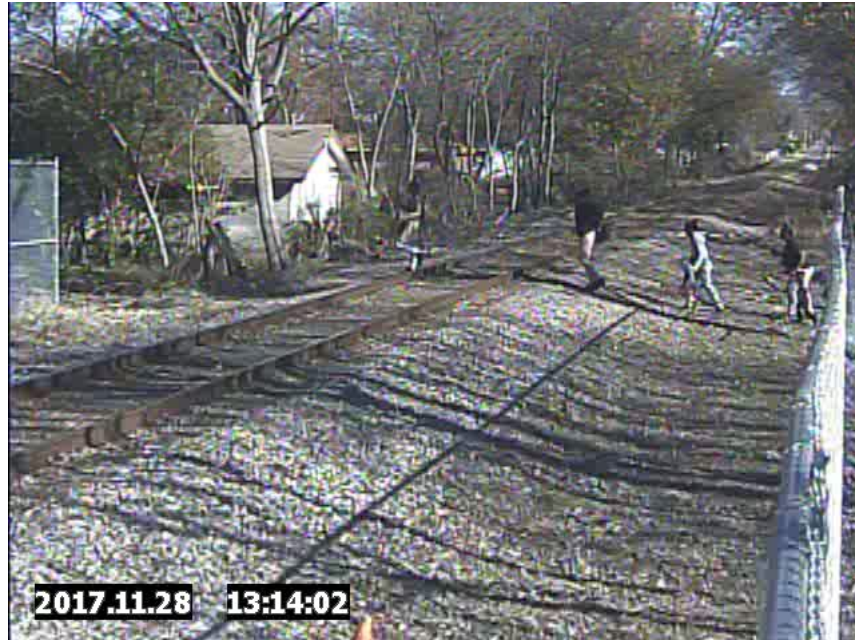
Figure 17 shows five pedestrians (3 adults and 2 toddlers) trespassing onto the railroad ROW from the south end of Zone 7 south by walking around the fence that was installed as a part of the overpass bridge construction. They walked straight across and exited the ROW by walking around the fence.

Figure 17. Post-Construction Example of Pedestrians Trespassing from the Area East of the Crossing (Zone 7)

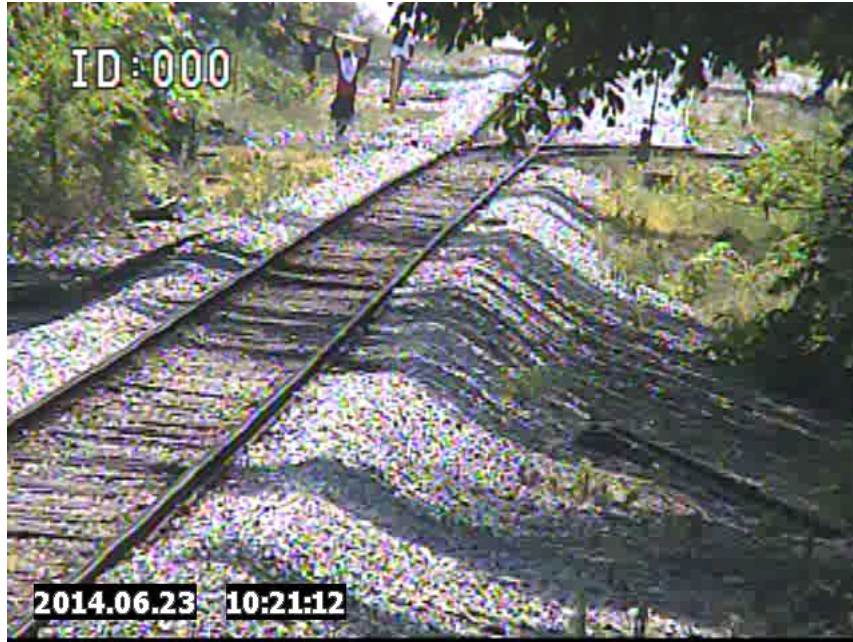
In Figure 18, a group of pedestrians trespassed onto the railroad ROW in Zone 8 to collect scrap metal that they had thrown off a train earlier in the day. They were on railroad ROW for approximately 26 minutes collecting the scrap metal. This event occurred during the pre-construction period.

Figure 18. Pre-Construction Example of Pedestrians Trespassing from the Area East of the Crossing (Zone 9)

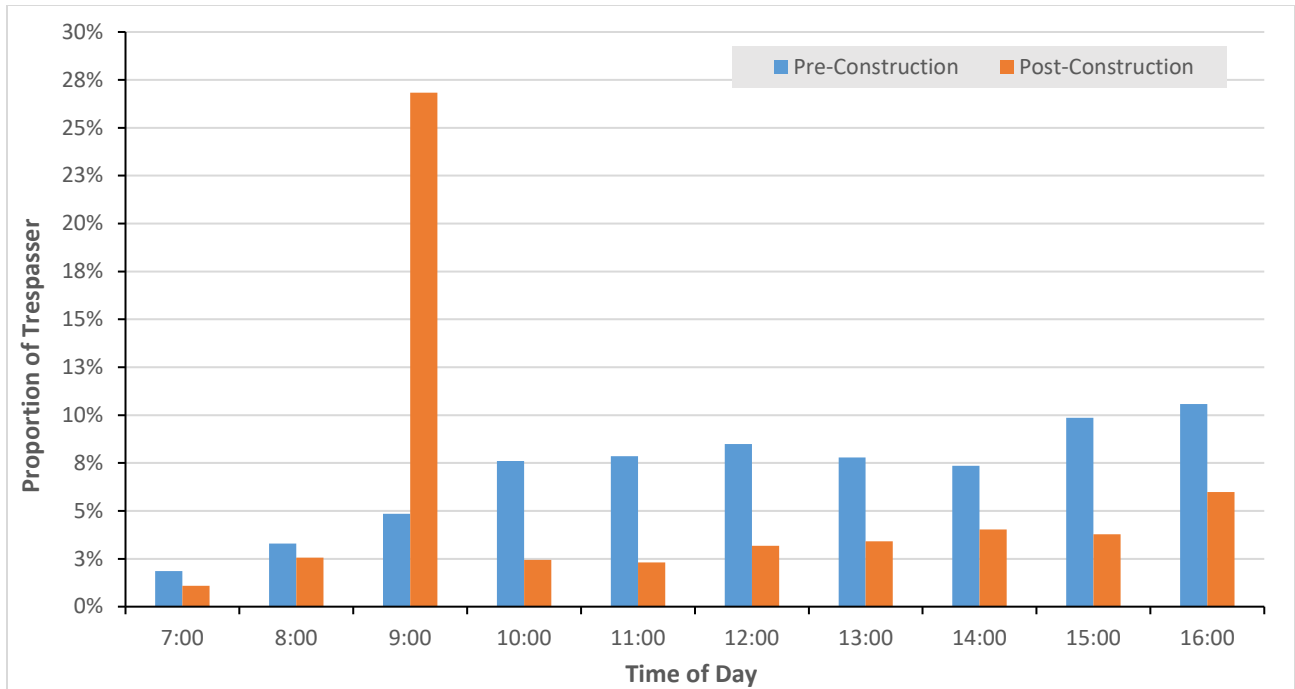
Figure 20. Proportion of Pedestrian Non-Trespassers by Time of Day (Pre-Construction n = 1,939 and Post-Construction n = 456)

Pedestrian non-trespasser data was collected on an hourly basis. [Figure 20](#) shows the distribution of pedestrian non-trespassers by the time of day for both pre- and post-construction periods. During the pre-construction period, pedestrians crossed the tracks via the at-grade crossing fairly consistently throughout the day. However, during the post-construction period, the use of the overpass bridge by pedestrians peaked during the morning rush hour from 9:00 a.m. to 10 a.m.

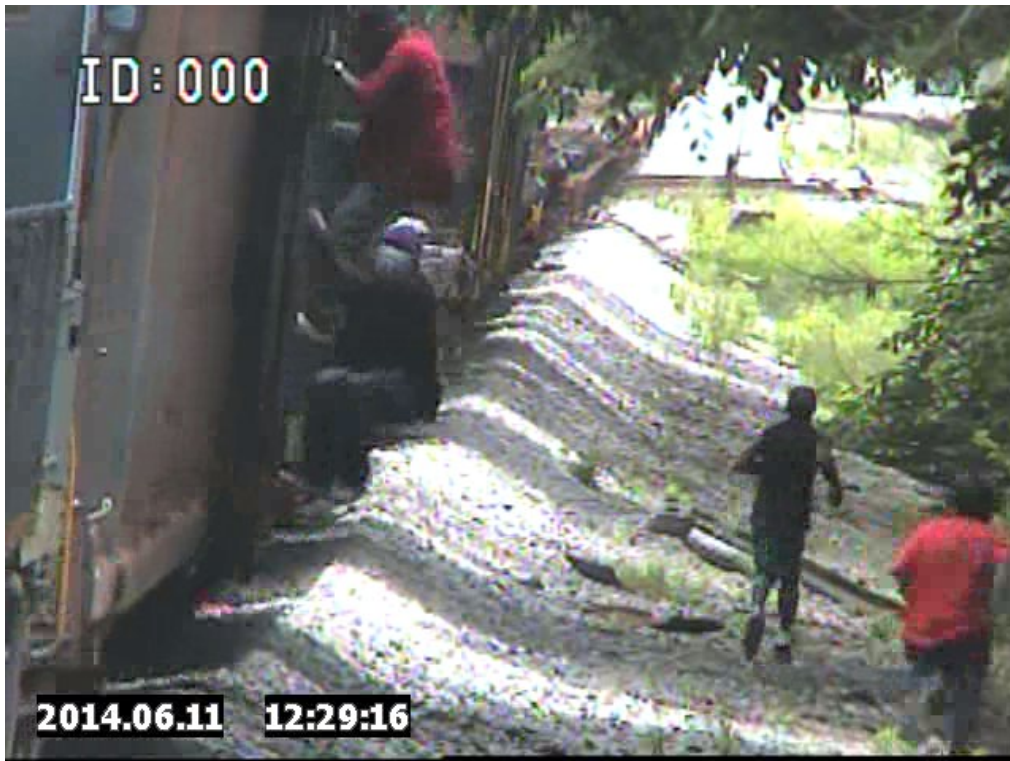
Examples of trespassing pedestrians in physical interactions with a train are shown in [Figure 21](#) and [Figure 22](#). In [Figure 21](#), six trespassers climbed onto a moving train from Zone 9 to steal scrap metal (threw scrap metal off the train and later came back to pick it up), and got off the train in Zone 9, approximately 2 minutes later. This event occurred during the pre-construction period.

Figure 21. Pre-Construction Example of Trespassers getting off a Moving Train in Zone 9

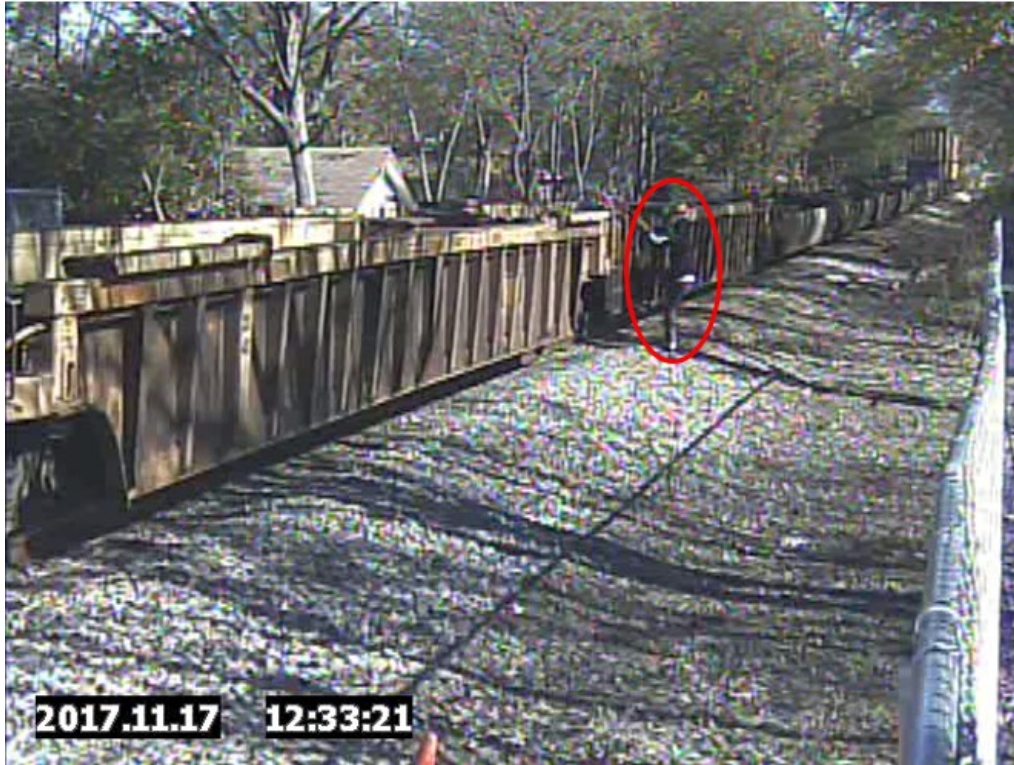
In [Figure 22](#), a trespasser can be seen climbing onto a stopped train during the post-construction period. The trespasser entered the railroad ROW from Zone 7 by walking around the newly installed fence and crossed the tracks by climbing over a stopped train.

Figure 22. Post-Construction Example of a Trespasser Climbing On Board a Stopped Train in Zone 7
