# DEVELOPMENT AND TESTING OF A NON-PINNED LOW-PROFILE END TREATMENT

**Test Report 9-1002-12-7**

TEXAS A&M TRANSPORTATION INSTITUTE  
COLLEGE STATION, TEXAS

1. Report No. FHWA/TX-13/9-1002-12-7		2. Government Accession No.		3. Recipient's Catalog No.	
4. Title and Subtitle DEVELOPMENT AND TESTING OF A NON-PINNED LOW-PROFILE END TREATMENT				5. Report Date Published: October 2013

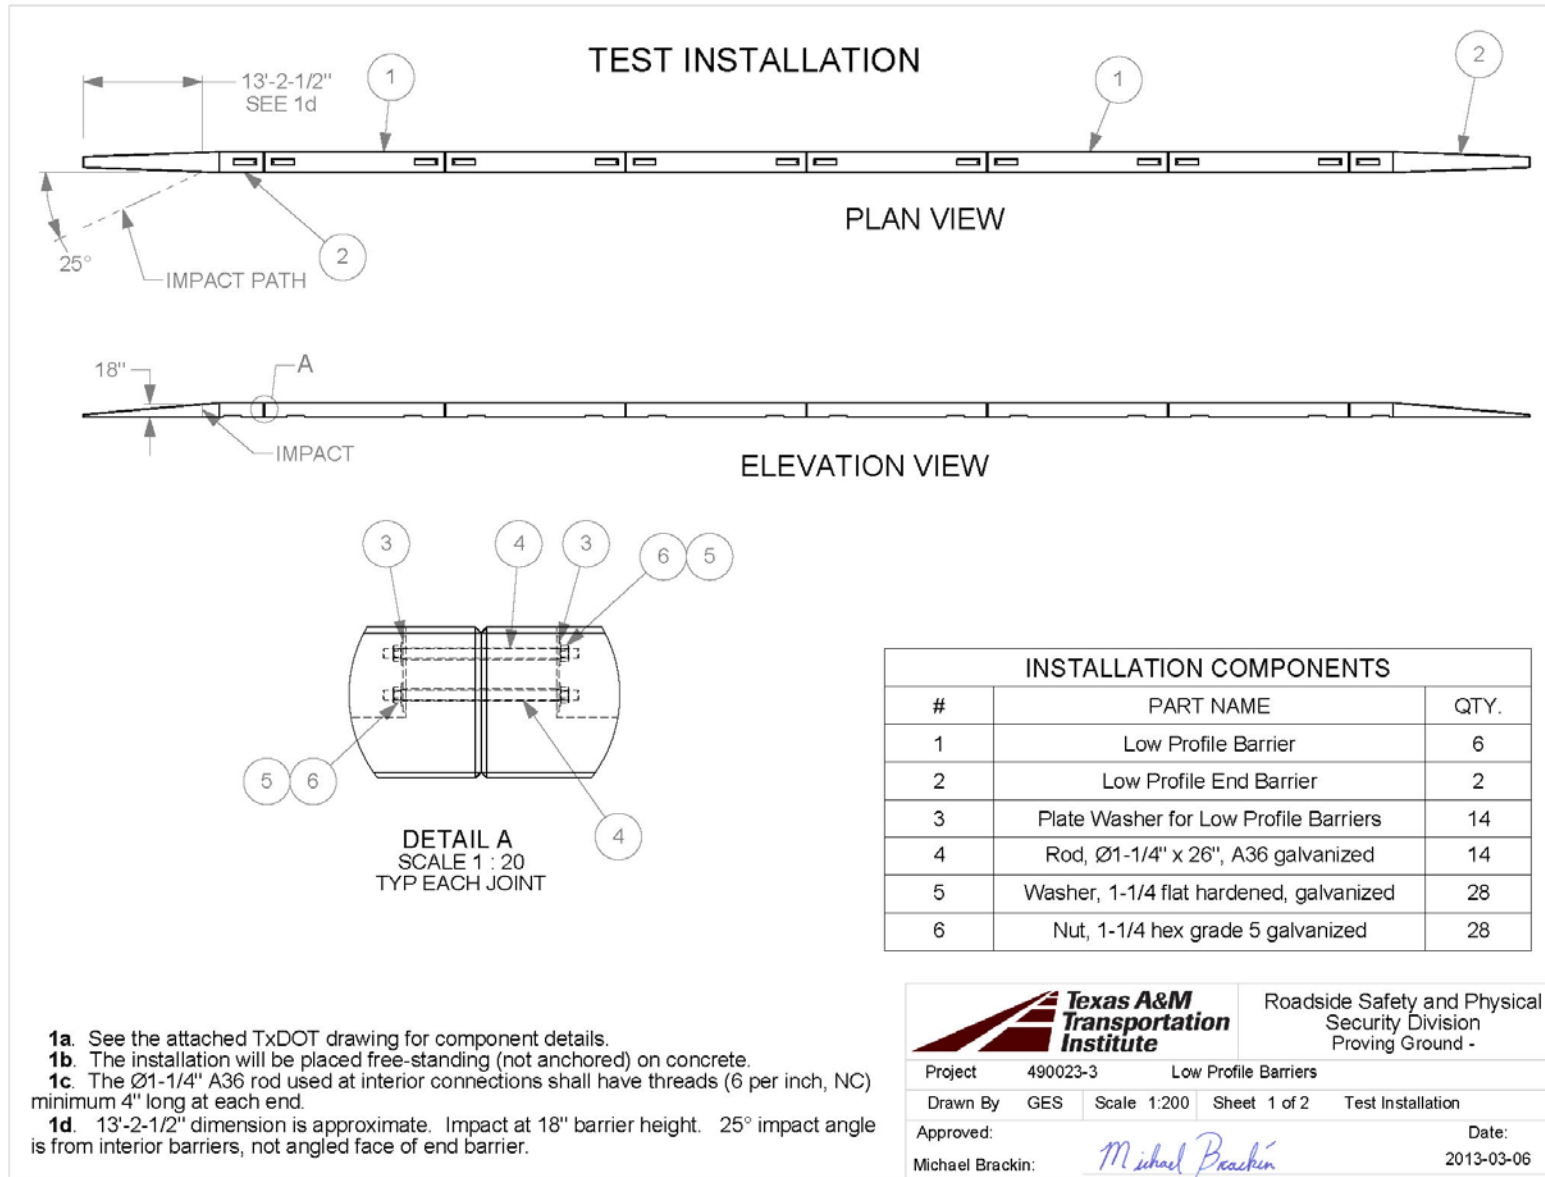
**Figure 2.1. Layout of the Non-pinned Low-Profile PCB Installation.**

The connection between two Low-Profile PCBs or a Low-Profile end treatment and Low-Profile PCB was accomplished by inserting two bolts through two precast holes in the mating barrier ends. These 1.25-inch diameter bolts were fabricated using ASTM A36 material with threads cut with Class 2A tolerances according to American National Standards Institute (ANSI B1.1). Standard USS washers and hex nuts were used. These nuts and washers met the requirements for Grade 5 according to Society of Automobile Engineers (SAE J429). These hex nuts met Class 2B tolerances for threads according to ANSI B1.1. All bolts, nuts, and washers were hot-dip galvanized according to ASTM A153.

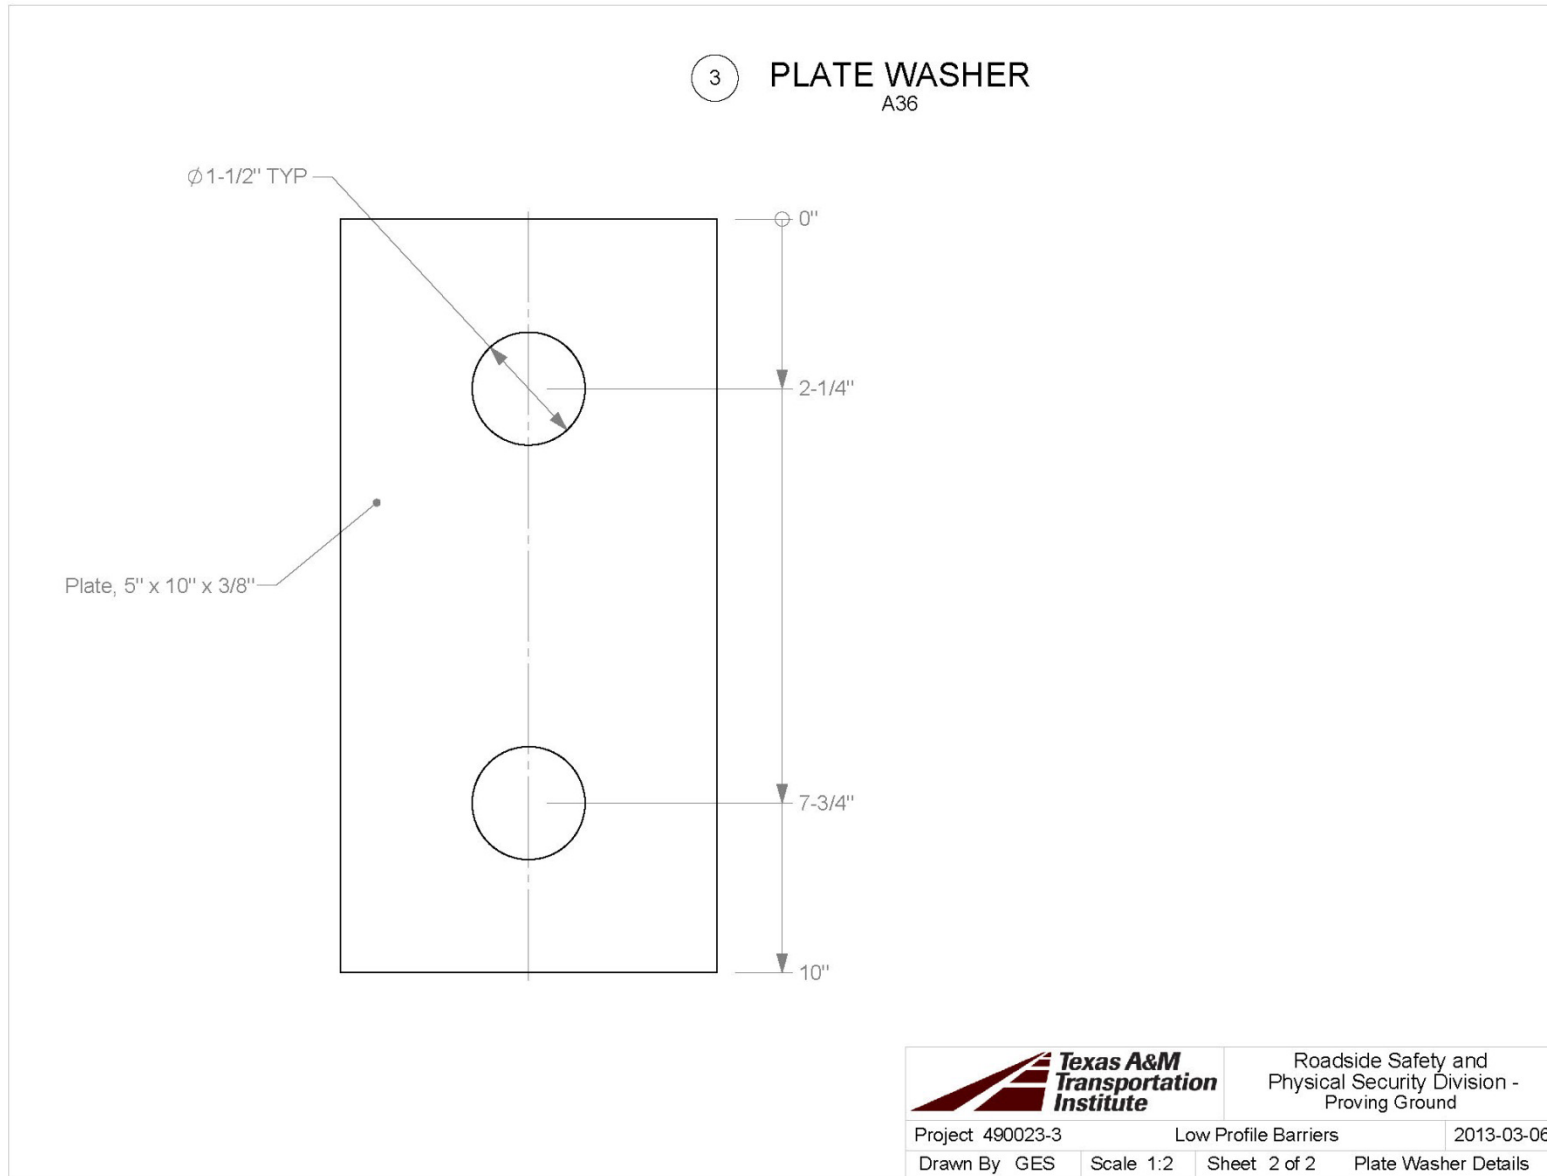
Figure 2.2. Details of the Plate Washer Used with the Non-pinned Low-Profile PCB.

To enhance the flexural rigidity of these connections, special plate washers with two symmetrically placed holes spaced to fit over both bolts were installed. These plate washers met the minimum specifications according to ASTM A36 material. For the tests presented herein, these plate washers were not hot-dip galvanized.

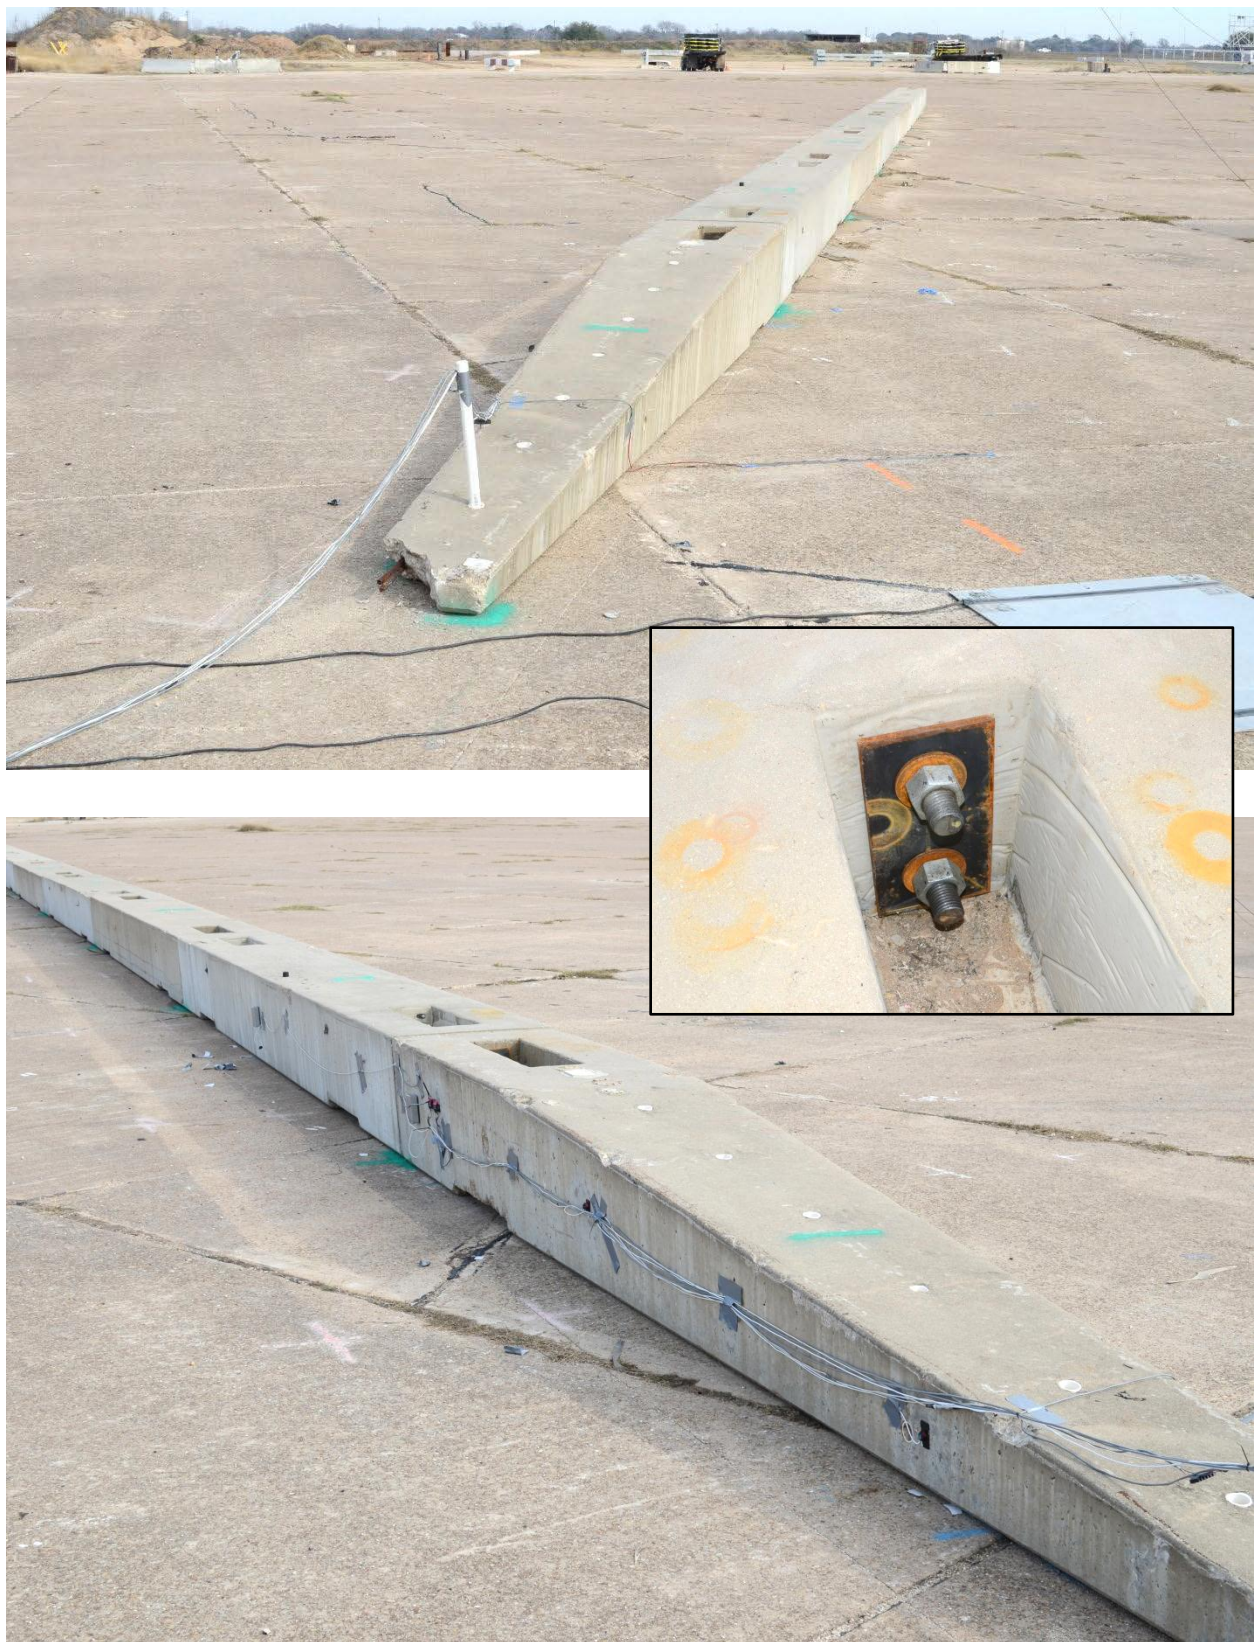
**Figure 2.3. Non-pinned Low-Profile End Treatment before Test No. 490023-7.**

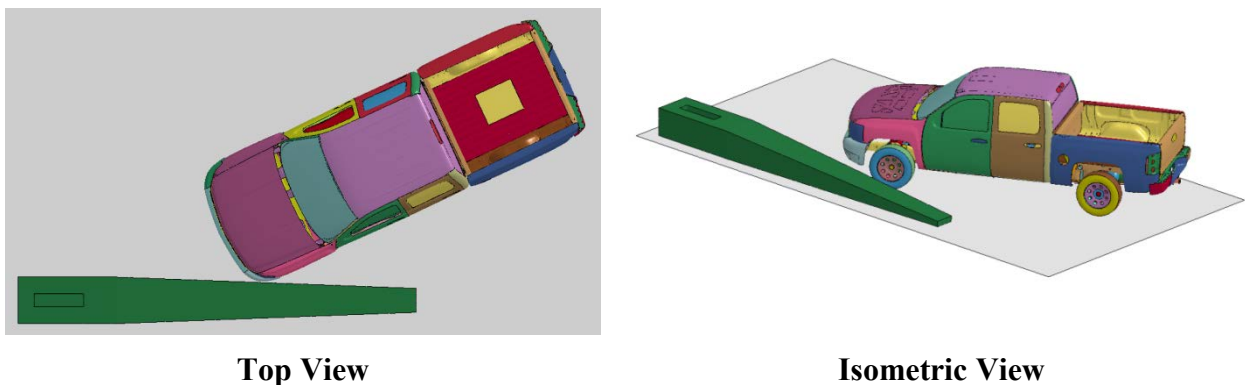
**Figure 3.1. FE Model of Non-pinned Low-Profile End Treatment for Determining CIP.**

For each FE analysis, a single Low-Profile end treatment was modeled using rigid material. These elements had no material failure or deformation capabilities. The end treatment was restrained from translational and rotational movements. It was the authors' intent to limit displacement and deformation of the end treatment to determine the CIP. It is reasonable to assume limiting displacement and deformation provides the worst case scenario to determine the CIP. The vehicle model used in the FE analyses was a Chevrolet Silverado that the National Crash Analysis Center (NCAC) developed. This model is available in the public domain and meets the specification criteria for the *MASH* 2270P design vehicle. Additionally, this vehicle model incorporated various modifications that TTI made to improve its performance and fidelity. Figure 3.1 shows the FE model described.

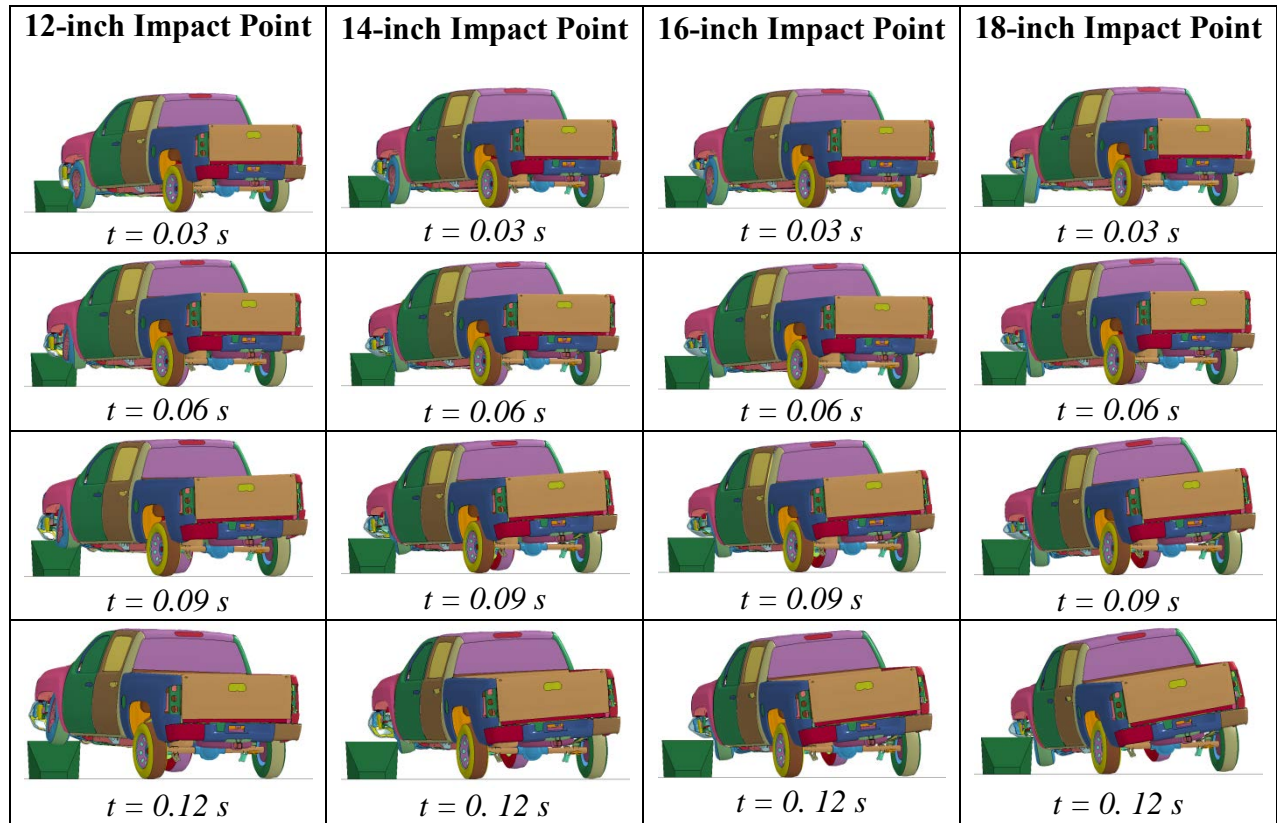
**Figure 3.2. Sequential Results from FE Analyses for Different Impact Points.**

All FE analyses were performed according to the criteria for *MASH* Test 2-35 involving the 2270P design vehicle impacting the end treatment at 25 degrees and 44 mi/h at the aforementioned impact points. Figure 3.2 below shows the result of this FE matrix.

As seen in Figure 3.2, a vehicle that impacts the Low-Profile end treatment at 12 or 14 inches in height will gate.

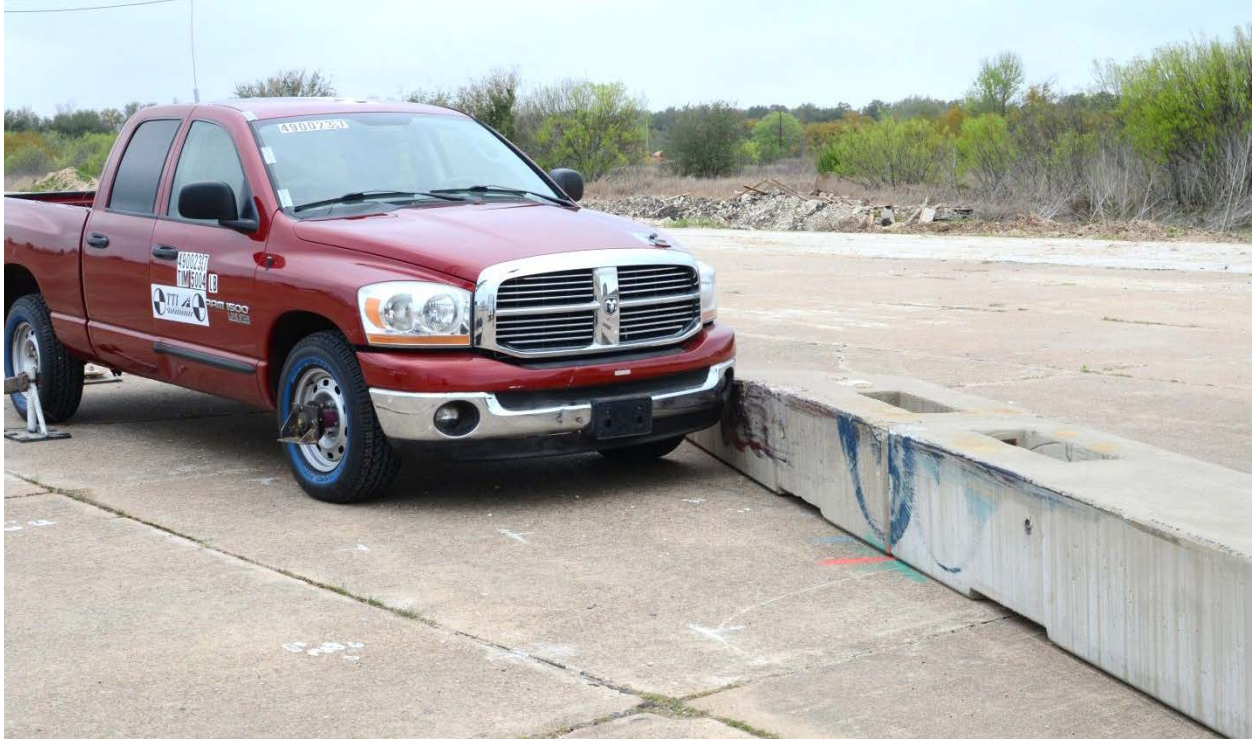
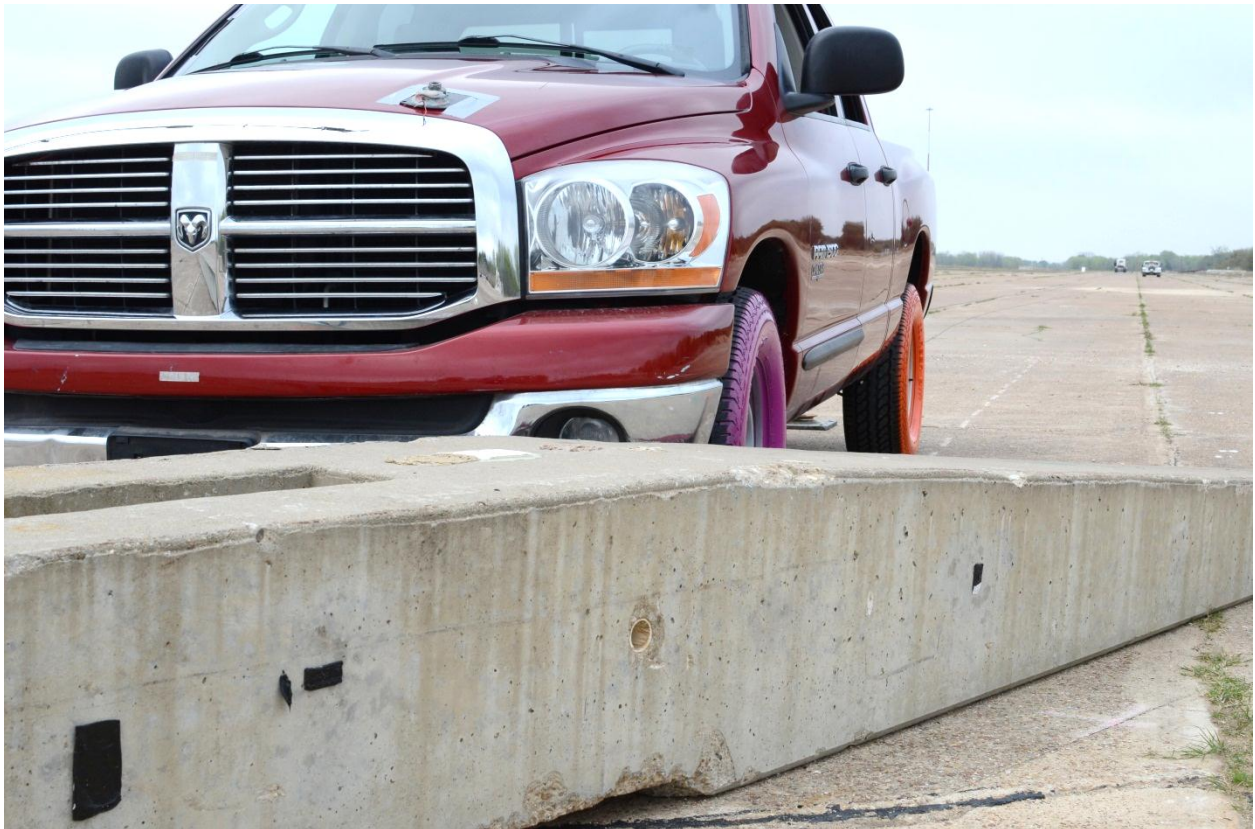
**Figure 5.1. Vehicle/Installation Geometrics for Test No. 490023-7.**

The 2006 Dodge Ram 1500 pickup truck, traveling at an impact speed of 45.0 mi/h, impacted the non-pinned Low-Profile end treatment 78 inches upstream of the splice at an impact angle of 25.3 degrees. At approximately 0.013 s, the vehicle began to redirect, and at 0.036 s, the end of the terminal began to deflect toward the field side. The vehicle was traveling parallel with the barrier at 0.297 s, and the rear of the vehicle contacted the barrier at 0.348 s. As the vehicle continued forward, it left the view of the overhead high-speed camera, and exit speed and angle were not obtainable. However, judging from tire tracks, the vehicle exited the barrier at approximately 10 degrees, and came to rest 160 ft downstream of impact and 171 ft toward traffic lanes. Figures C1 and C2 in Appendix C show sequential photographs of the test period.

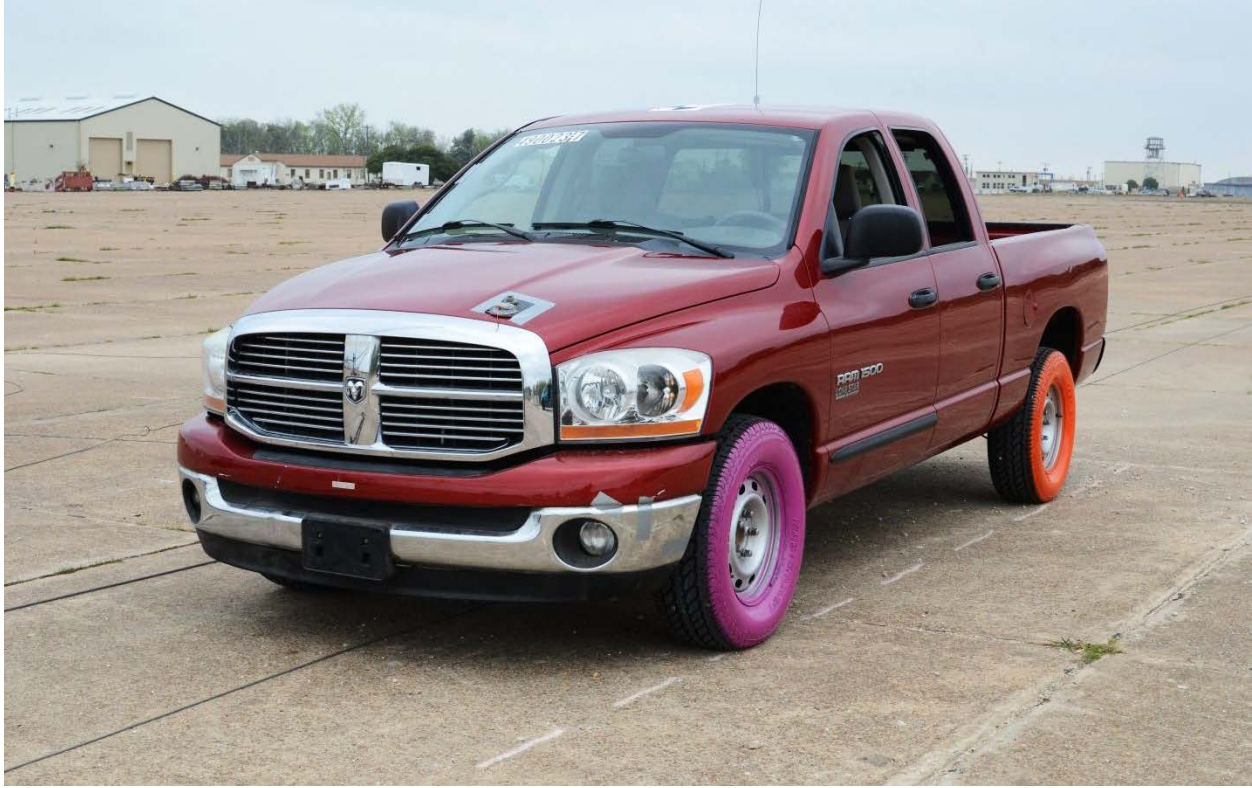
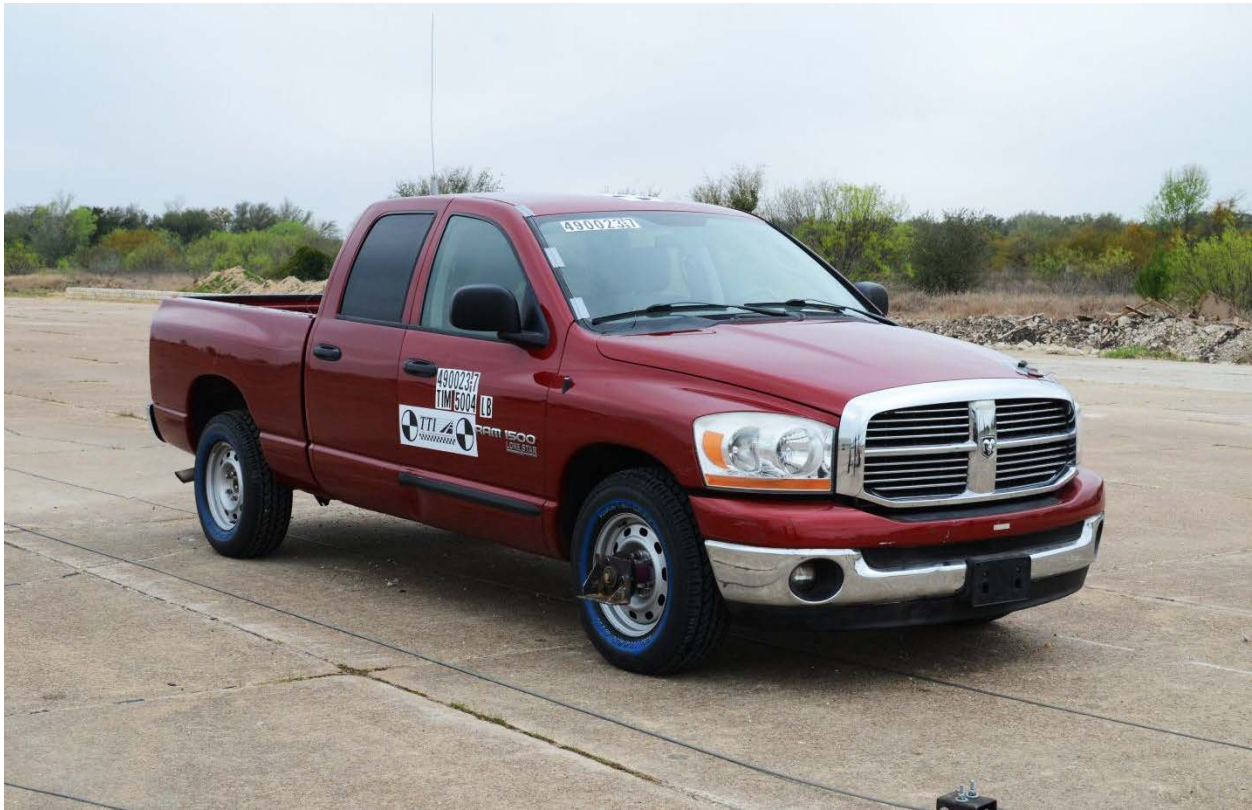
**Figure 5.2. Vehicle before Test No. 490023-7.**

Figures 5.1 and 5.2 show the 2006 Dodge Ram 1500 pickup truck used for the crash test. Test inertia weight of the vehicle was 5016 lb, and its gross static weight was 5016 lb. The height to the lower edge of the vehicle bumper was 15.25 inches, and it was 28.00 inches to the upper edge of the bumper. The height to the vehicle's center of gravity was 28.00 inches. Tables B1 and B2 in Appendix B give additional dimensions and information on the vehicle. The vehicle was directed into the installation using the cable reverse tow and guidance system, and was released to be freewheeling and unrestrained just prior to impact.

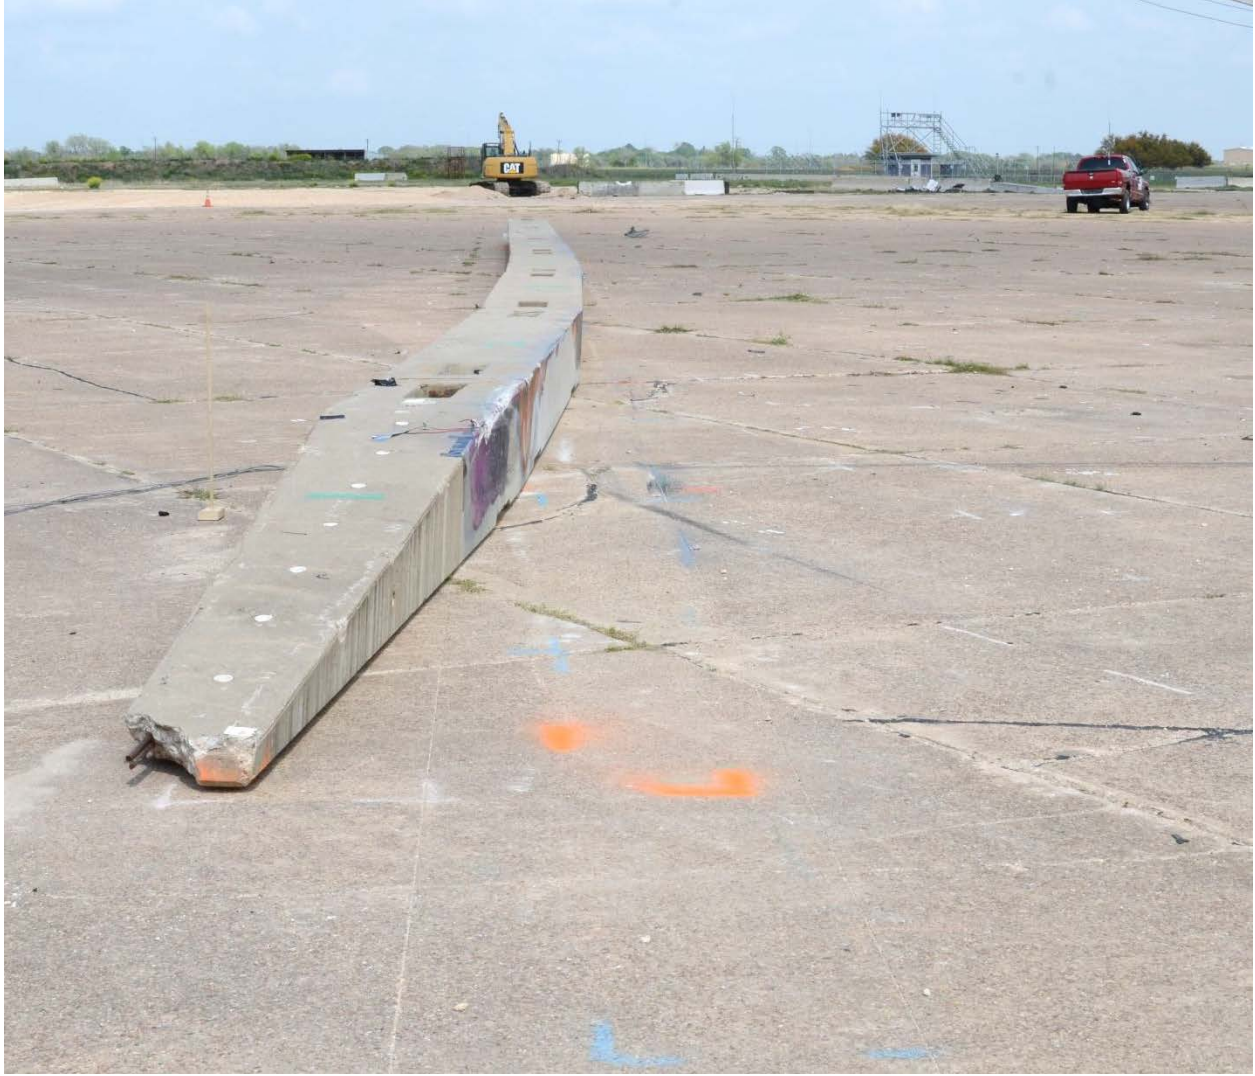
**Figure 5.3. Installation/Vehicle Positions after Test No. 490023-7.**

Figures 5.3 and 5.4 show damage to the installation, with tire marks and concrete spalling along the impact area on the traffic side and concrete spalling at joint 2-3 on the field side. Movement of the end treatment was 44 inches toward the field side at the upstream end, 25 inches toward the field side at joint 1-2, 9 inches toward the field side at joint 2-3, 2 inches toward the field side at joint 3-4 and 1 inch toward traffic lanes at joint 4-5. The 2270P vehicle remained in contact with the barrier for 29 ft-3 inches. Working width during the test was 55.0 inches, and vehicle intrusion was 27.7 inches. Maximum dynamic deflection during the test was 42.4 inches toward the field side, and maximum permanent movement was 42.4 inches toward the field side at the upstream end of the terminal section.

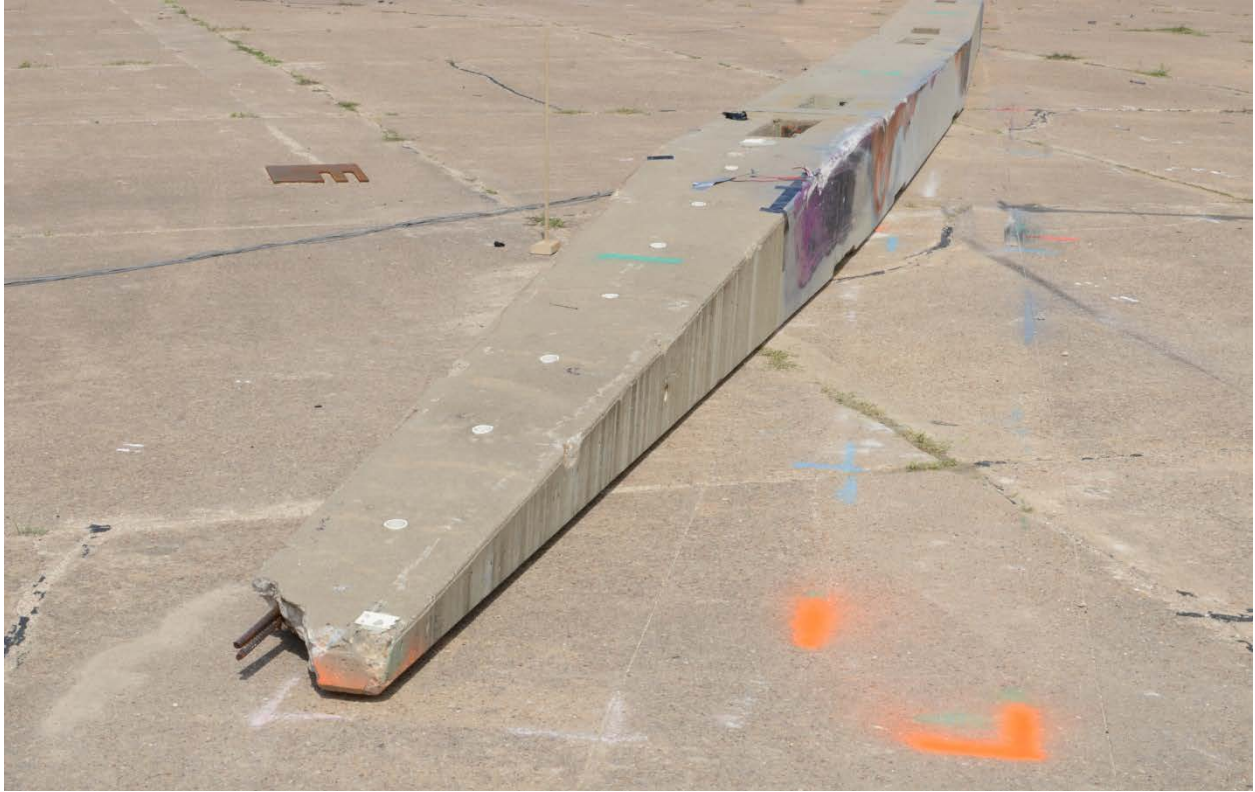
**Figure 5.4. Installation after Test No. 490023-7.**

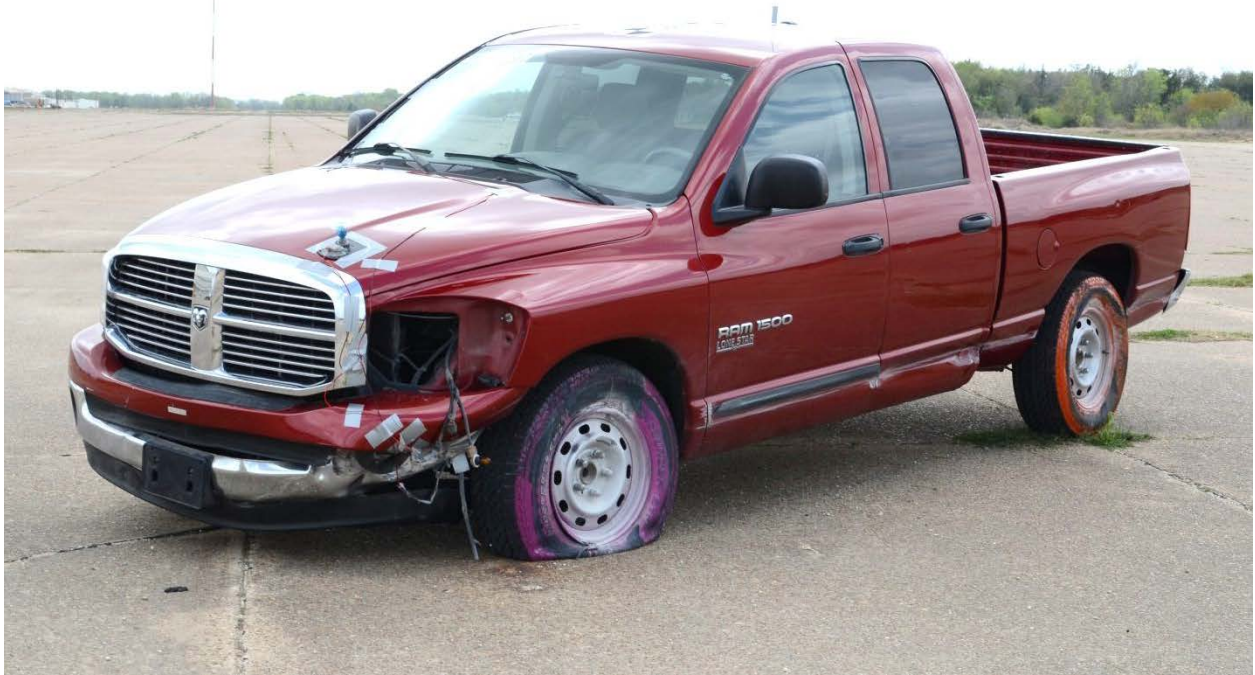
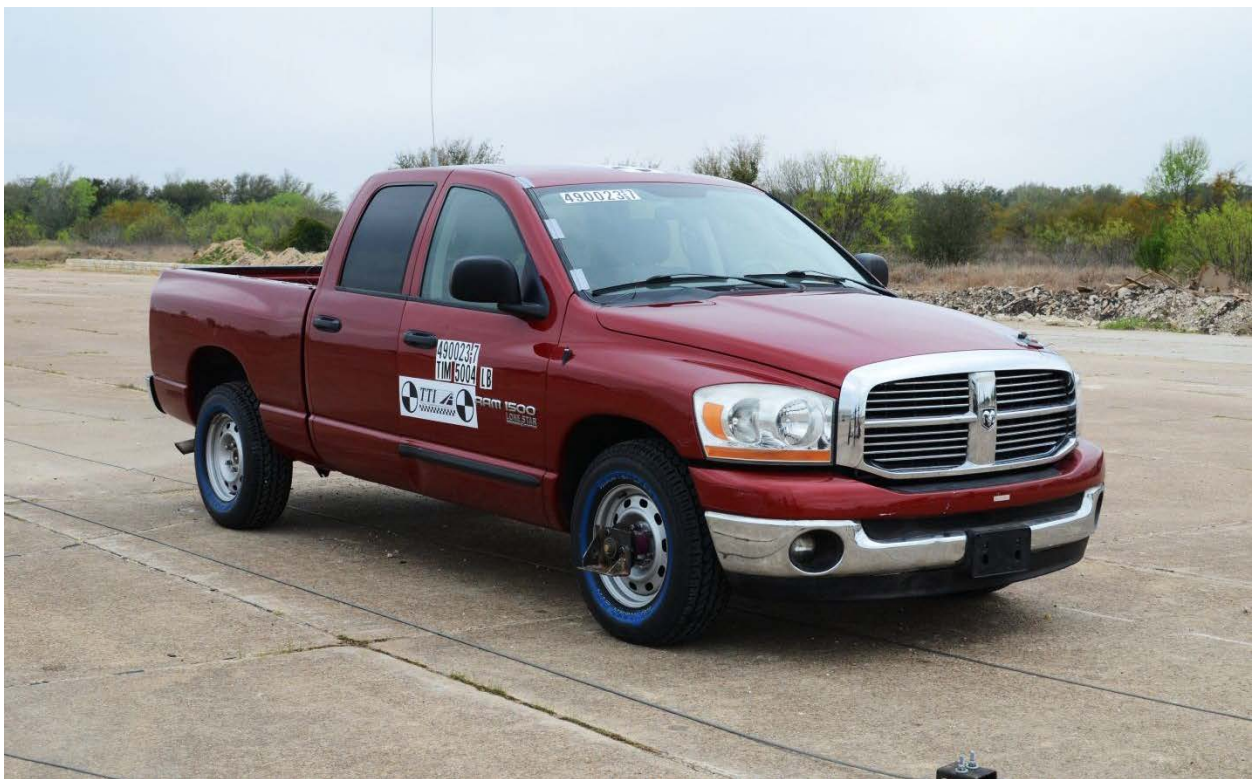
**Figure 5.5. Vehicle after Test No. 490023-7.**

Figure 5.5 shows damage to the vehicle. The left lower control arm was deformed. The front bumper, left front fender, left front tire and wheel rim, left front and rear doors, left rear of the cab, left exterior bed, left rear front tire and wheel rim, left front and rear doors, left lower corner of the cab, left rear exterior bed, left rear wheel rim, and the rear bumper were damaged. Maximum exterior crush to the vehicle was 14.0 inches in the front plane at the left front corner at bumper height. No occupant compartment deformation occurred. Figure 5.6 has photographs of the interior of the vehicle. Appendix C, Tables C3 and C4 show details of the exterior crush and occupant compartment.

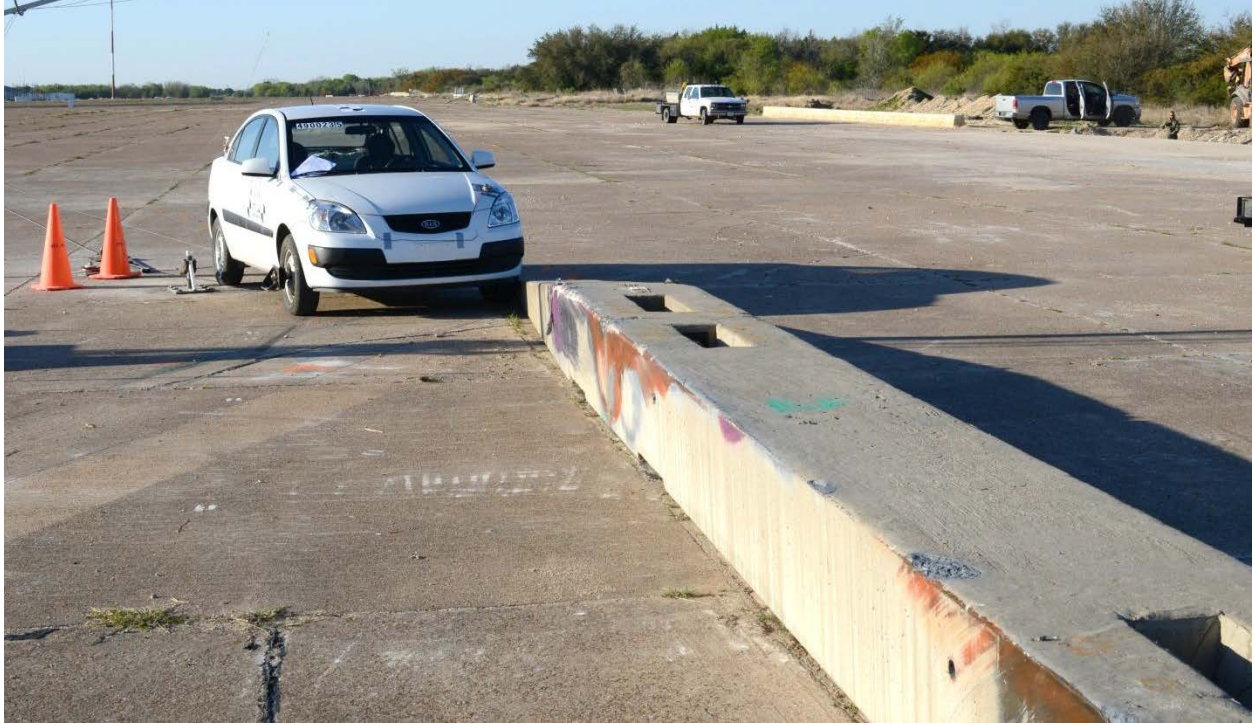
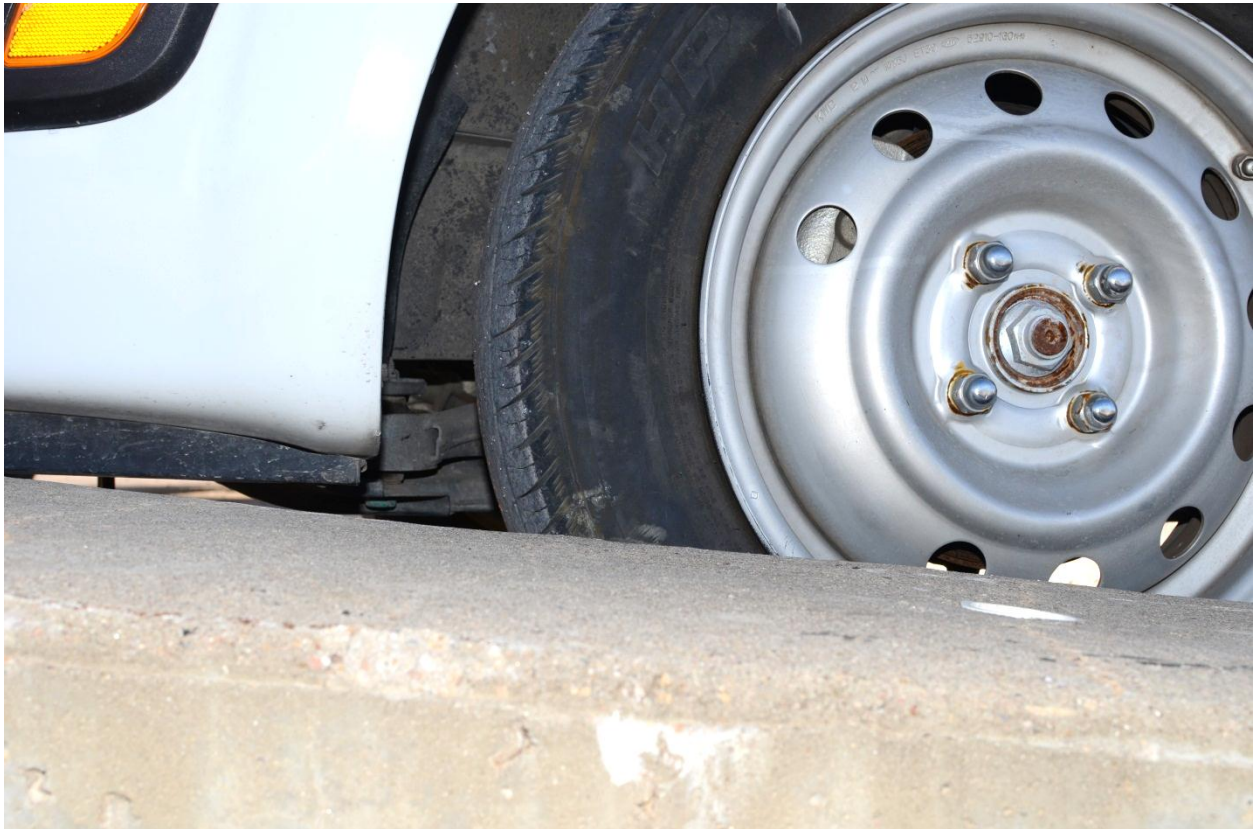
**Figure 6.1. Vehicle/Installation Geometrics for Test No. 490023-5.**

The 2008 Kia Rio, traveling at an impact speed of 43.9 mi/h, impacted the non-pinned Low-Profile end treatment 33.0 inches downstream from the tip at an impact angle of 15.2 degrees. At approximately 0.020 s, the left front tire began to ride up the traffic face of the end treatment, and at 0.029 s, air began to escape from the tire around the edge of the wheel rim. The left front wheel rim reached the top of the end treatment at 0.042 s, and the vehicle began to redirect at 0.048 s. At 0.084 s, the left front tire was on top the end treatment, and at 0.095 s, the left rear tire contacted the end treatment. The left rear tire climbed on top the end treatment at 0.178 s, and the vehicle was traveling parallel with the barrier at 0.576 s. As the vehicle continued forward, the vehicle rode over the end treatment and came to rest on the field side of the barrier. Figures C1 and C2 in Appendix C show sequential photographs of the test period.

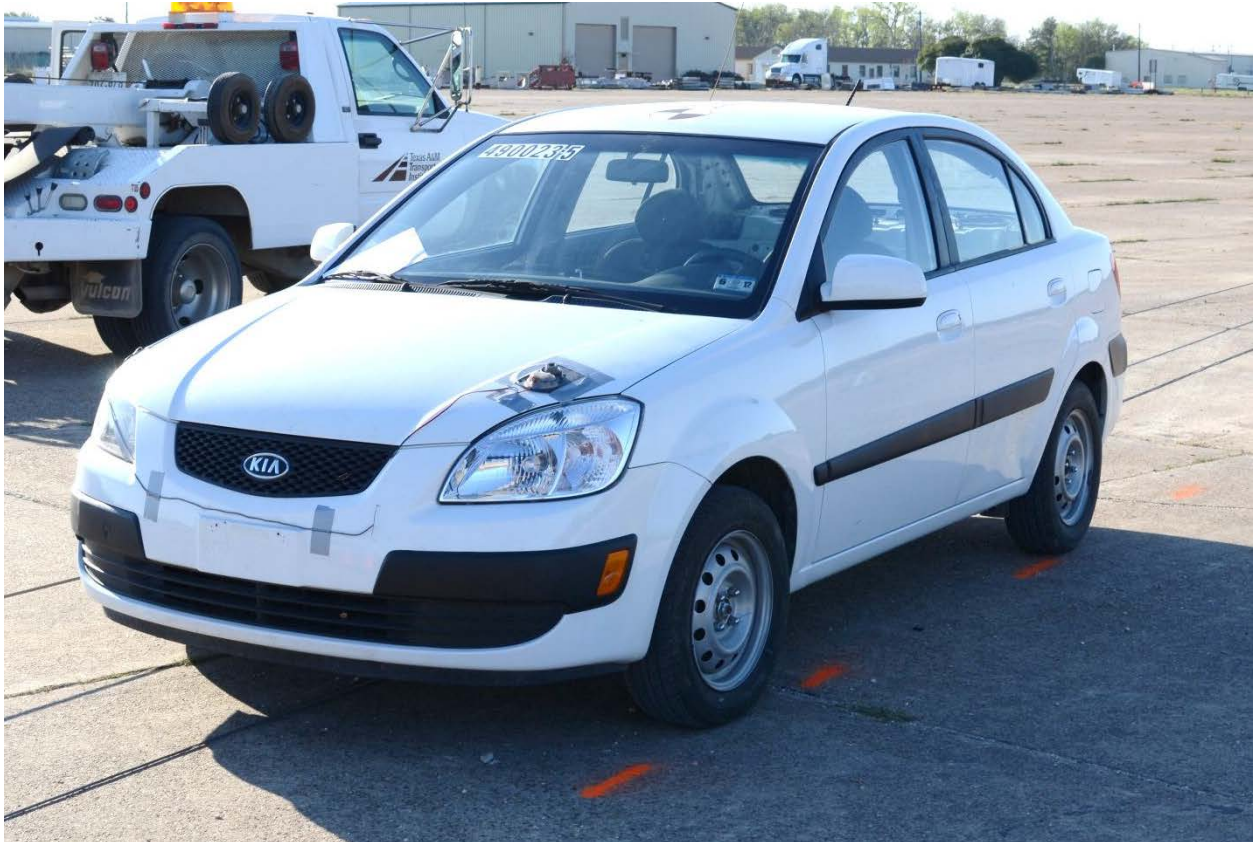
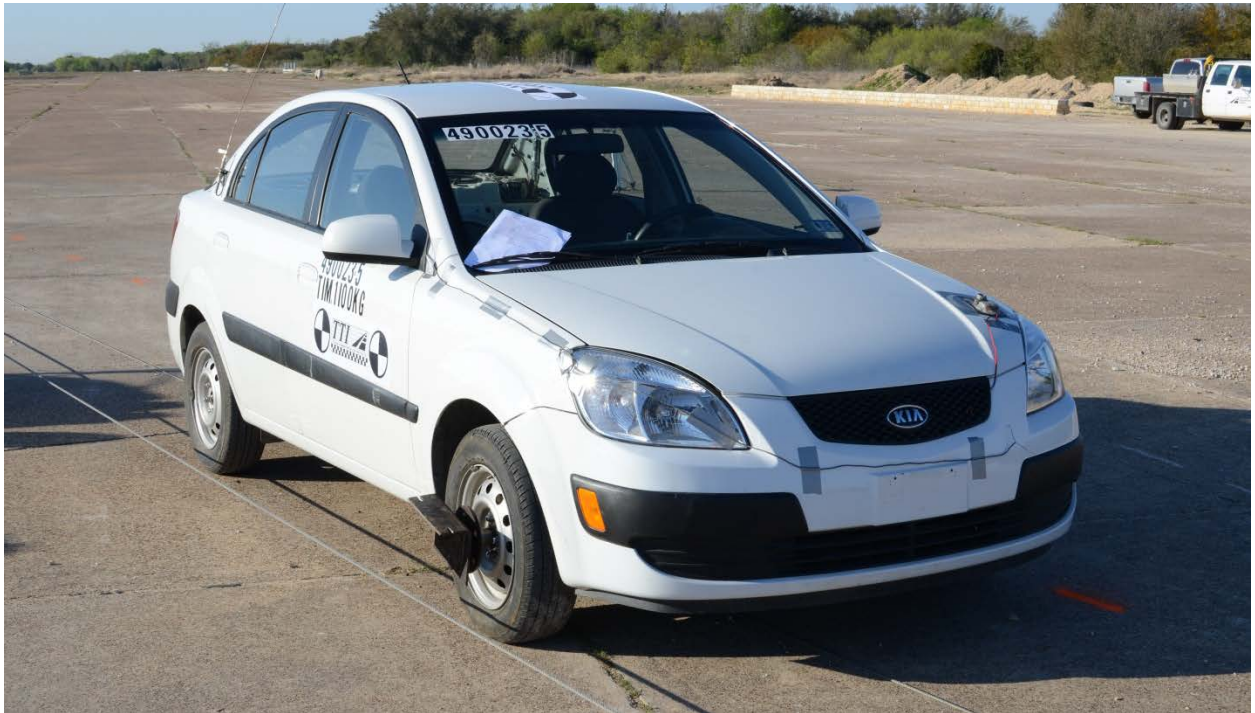
**Figure 6.2. Vehicle before Test No. 490023-5.**

Figures 6.1 and 6.2 show the 2008 Kia Rio that was used for the crash test. Test inertia weight of the vehicle was 2425 lb, and its gross static weight was 2614 lb. The height to the lower edge of the vehicle bumper was 7.12 inches, and it was 21.00 inches to the upper edge of the bumper. Tables C1 and C2 in Appendix C give additional dimensions and information on the vehicle. The vehicle was directed into the installation using the cable reverse tow and guidance system, and was released to be freewheeling and unrestrained just prior to impact.
