# DEVELOPMENT AND TESTING OF A NON-PINNED LOW-PROFILE END TREATMENT

**Test Report 9-1002-12-7**

TEXAS A&M TRANSPORTATION INSTITUTE  
COLLEGE STATION, TEXAS

1. Report No. FHWA/TX-13/9-1002-12-7		2. Government Accession No.		3. Recipient's Catalog No.	
4. Title and Subtitle DEVELOPMENT AND TESTING OF A NON-PINNED LOW-PROFILE END TREATMENT				5. Report Date Published: October 2013

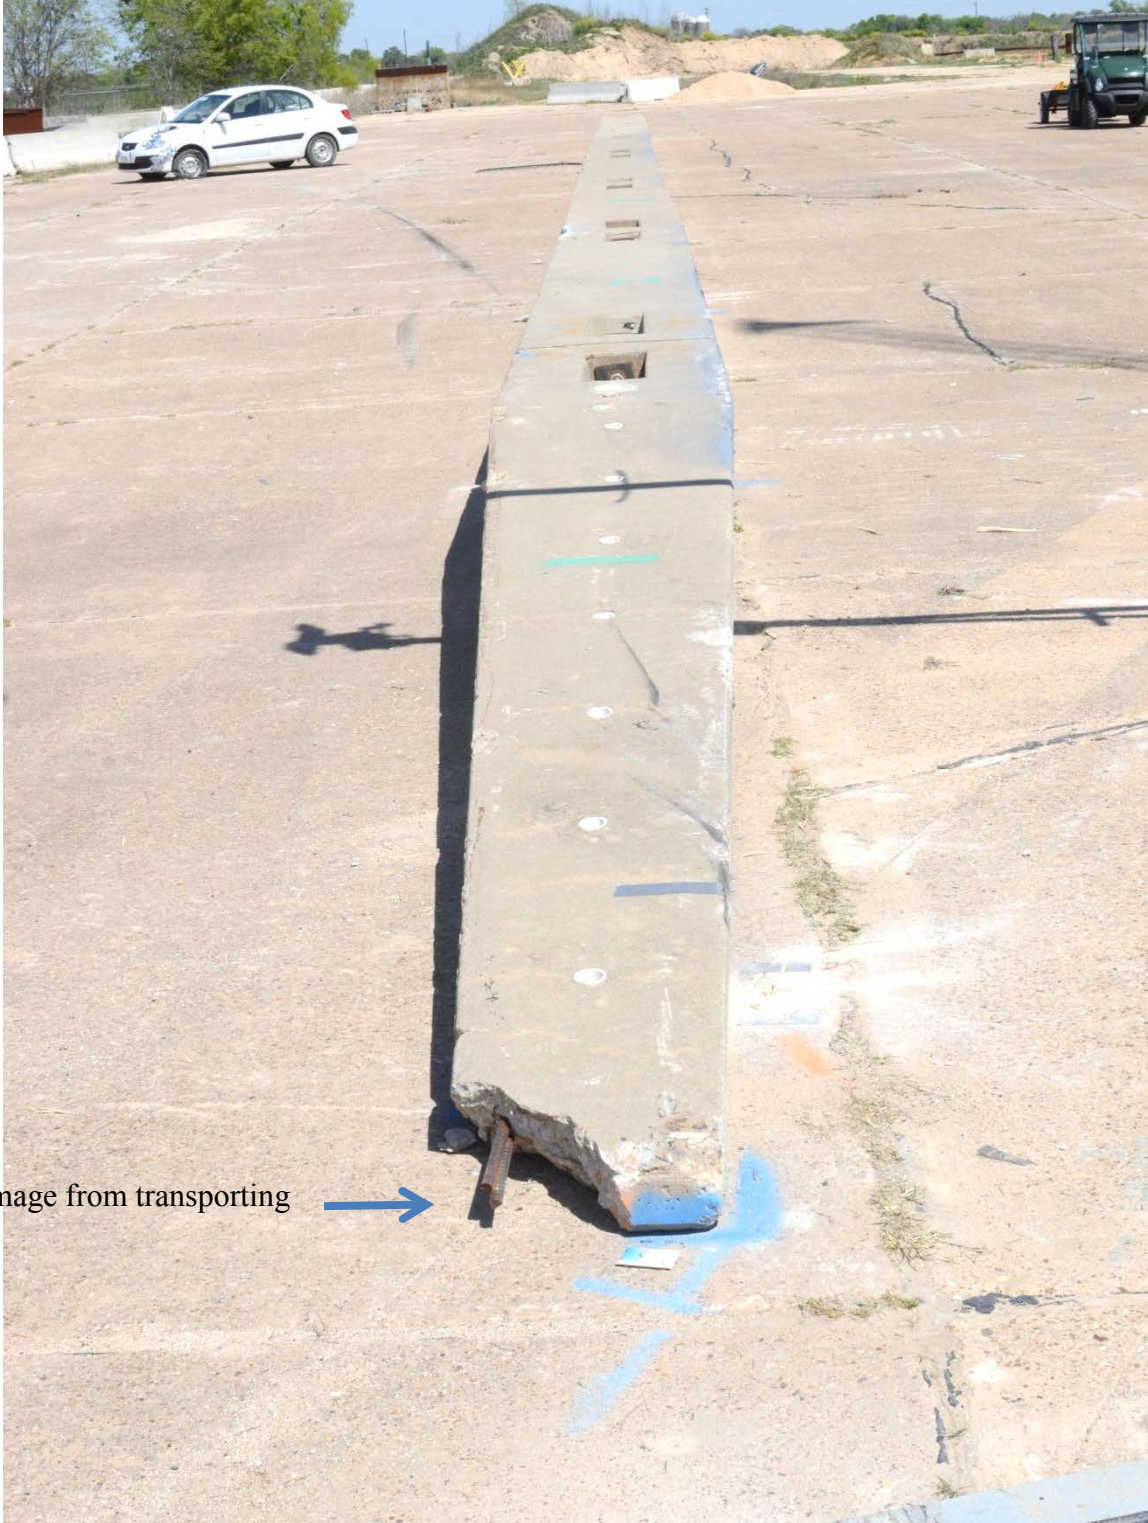
**Figure 6.3. Installation/Vehicle Positions after Test No. 490023-5.**

Figures 6.3 and 6.4 show damage to the installation, which was mostly cosmetic in nature with tire marks and concrete spalling along the impact area and tire marks only on the top surface of the barrier. Working width during the test was 28.75 inches, and vehicle intrusion was 32.3 ft. Maximum dynamic deflection during the test was 0.75 inch toward the field side, and maximum permanent movement was 0.75 inch toward the field side at the upstream end of the terminal section.

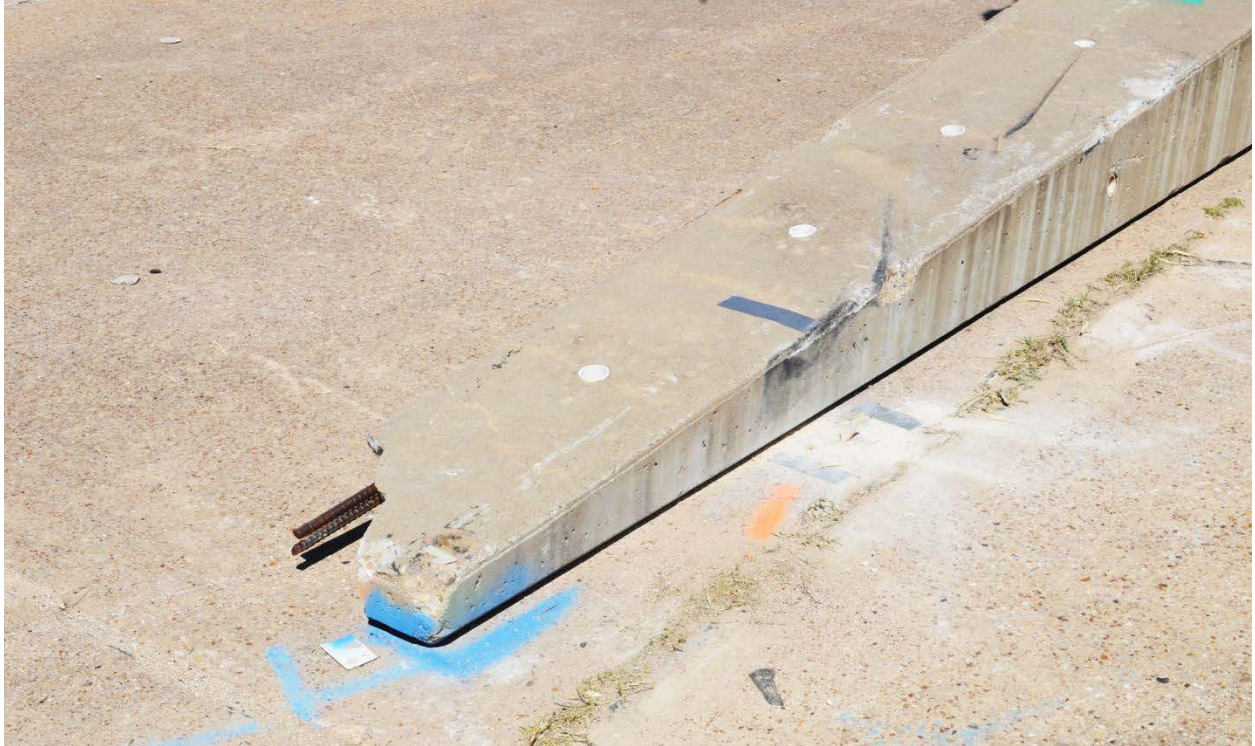
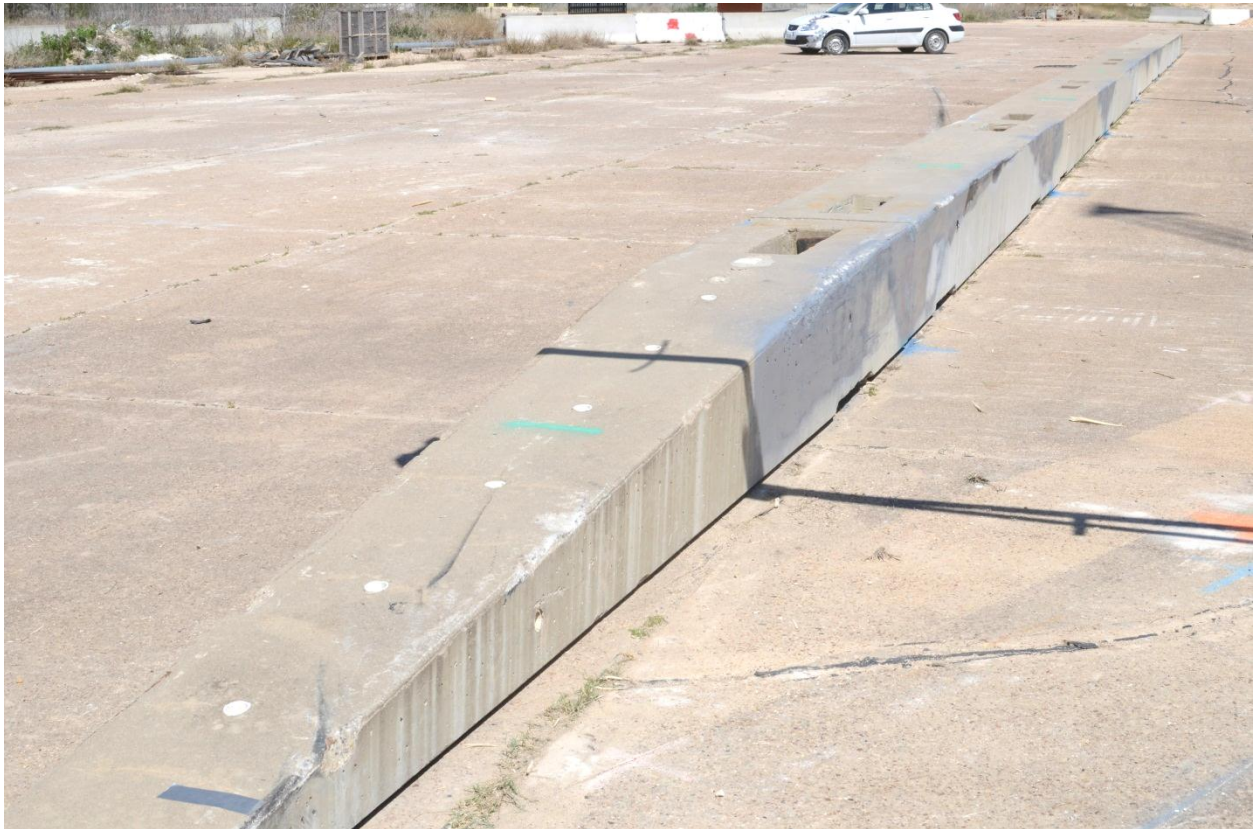
**Figure 6.4. Installation after Test No. 490023-5.**

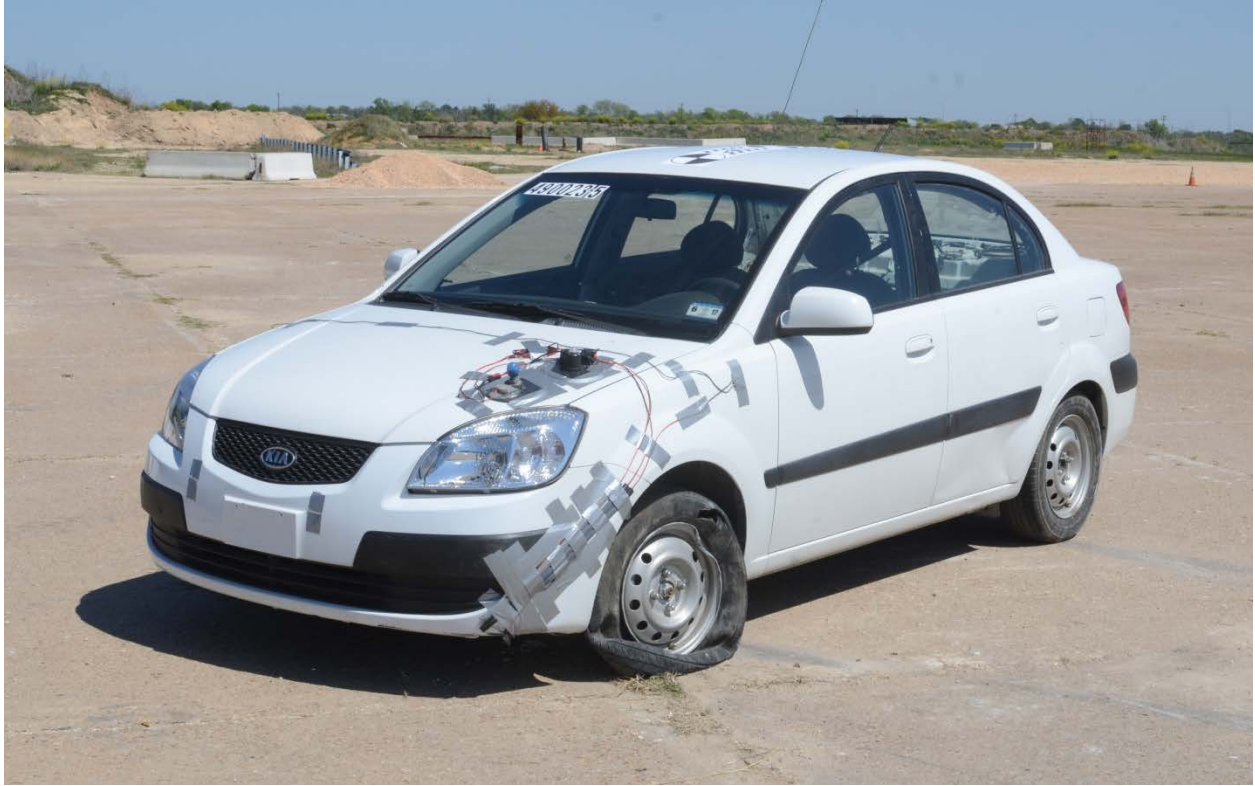
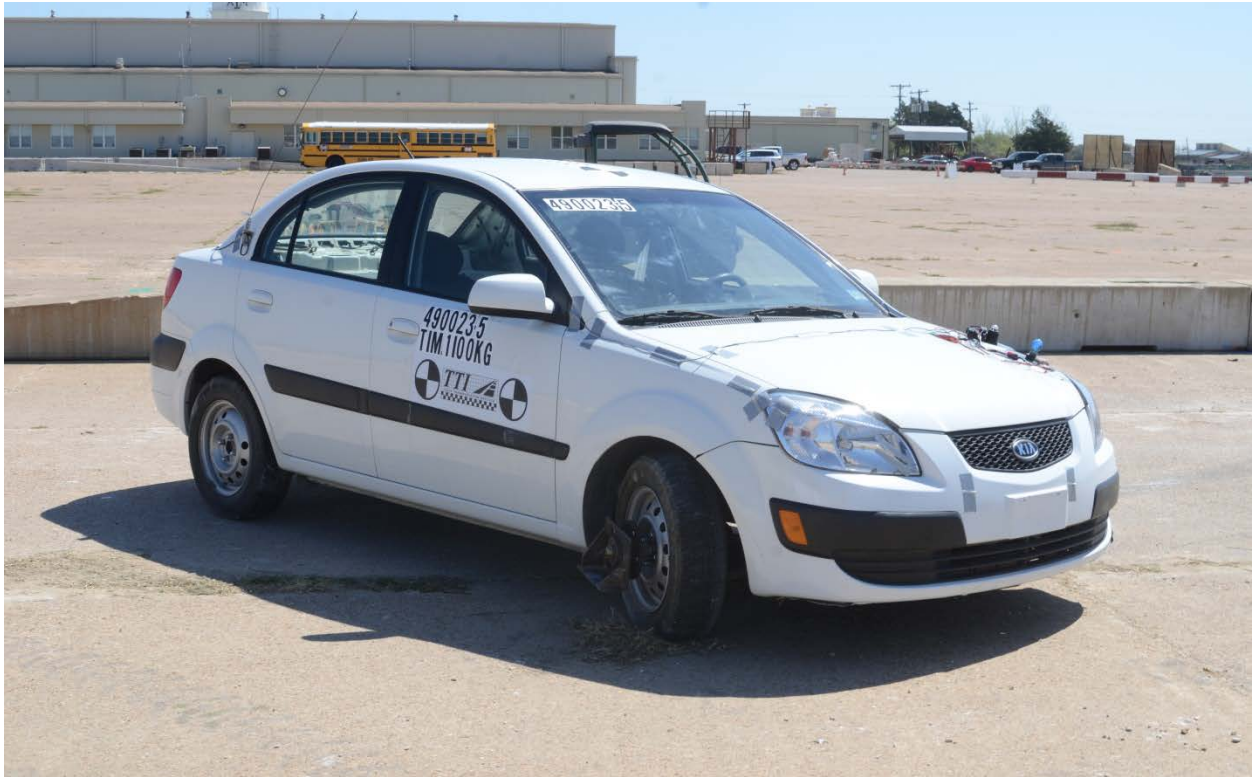
**Figure 6.5. Vehicle after Test No. 490023-5.**

Figure 6.5 shows damage to the vehicle. The left and right ends of the tie rod and the right lower control arm were deformed. Also, the left front tire and wheel rim and left rear wheel rim were damaged. No measureable exterior crush to the vehicle was noted, nor was there evidence of occupant compartment deformation or intrusion. Photographs of the interior of the vehicle are shown in Figure 6.6. Appendix C, Tables C3 and C4 show the details of the exterior crush and occupant compartment.

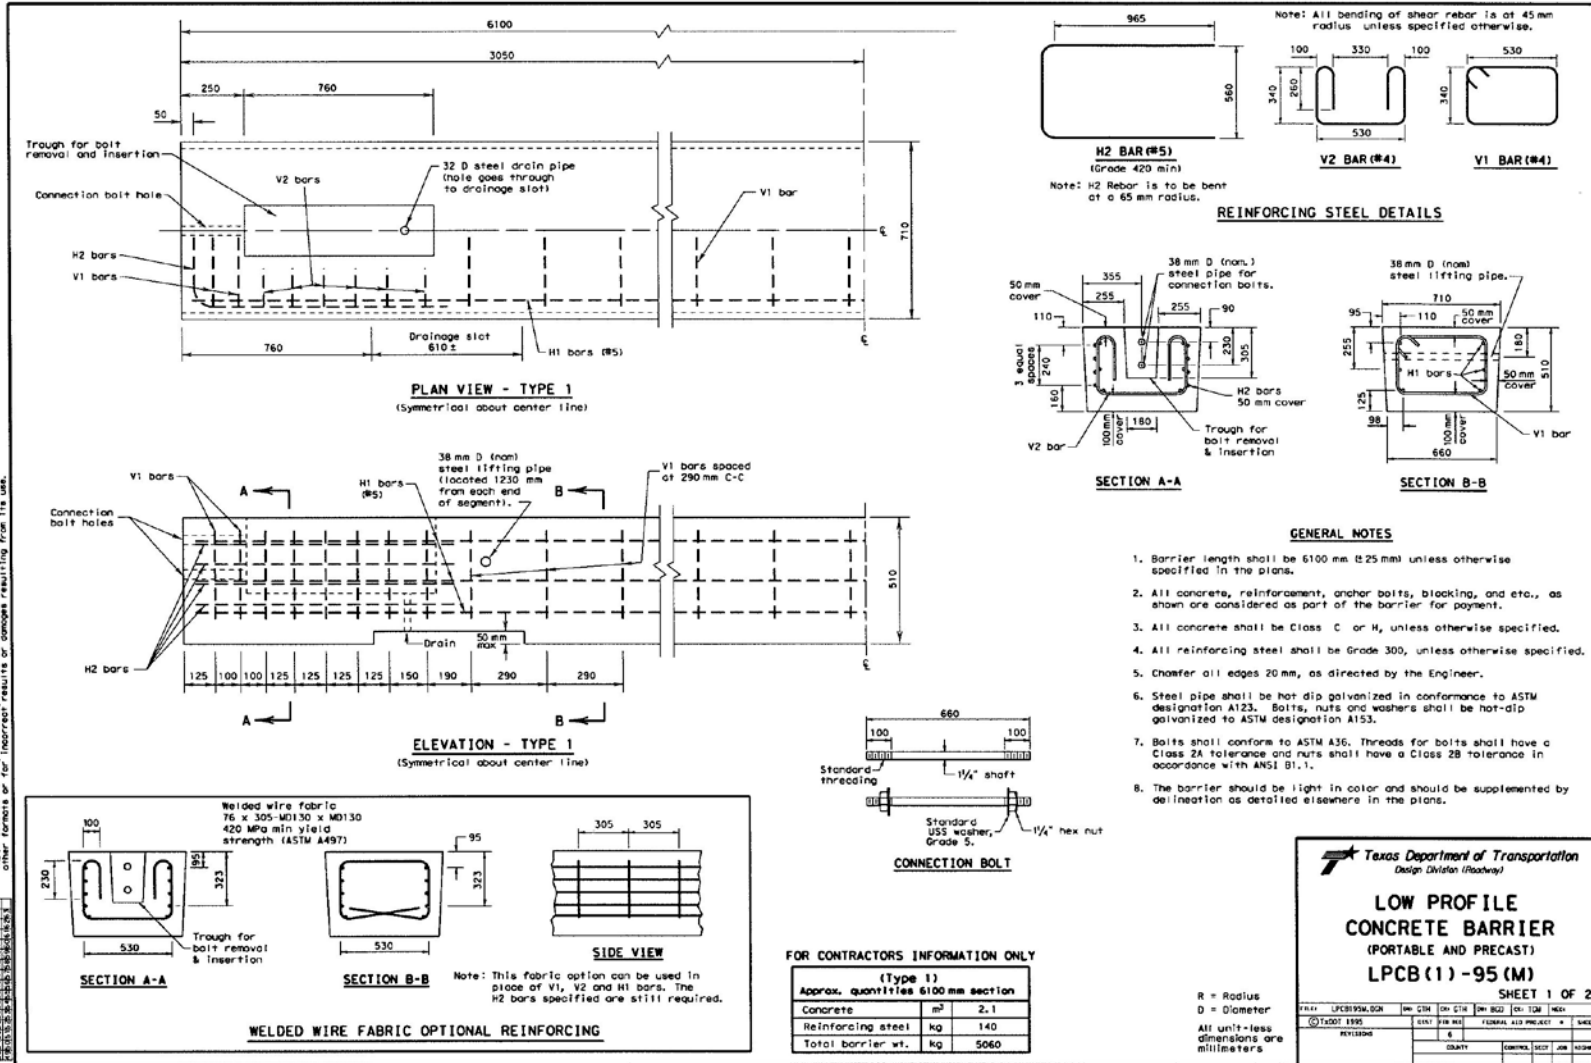
**LOW PROFILE  
CONCRETE BARRIER  
(PORTABLE AND PRECAST)  
LPCB (1) - 95 (M)**

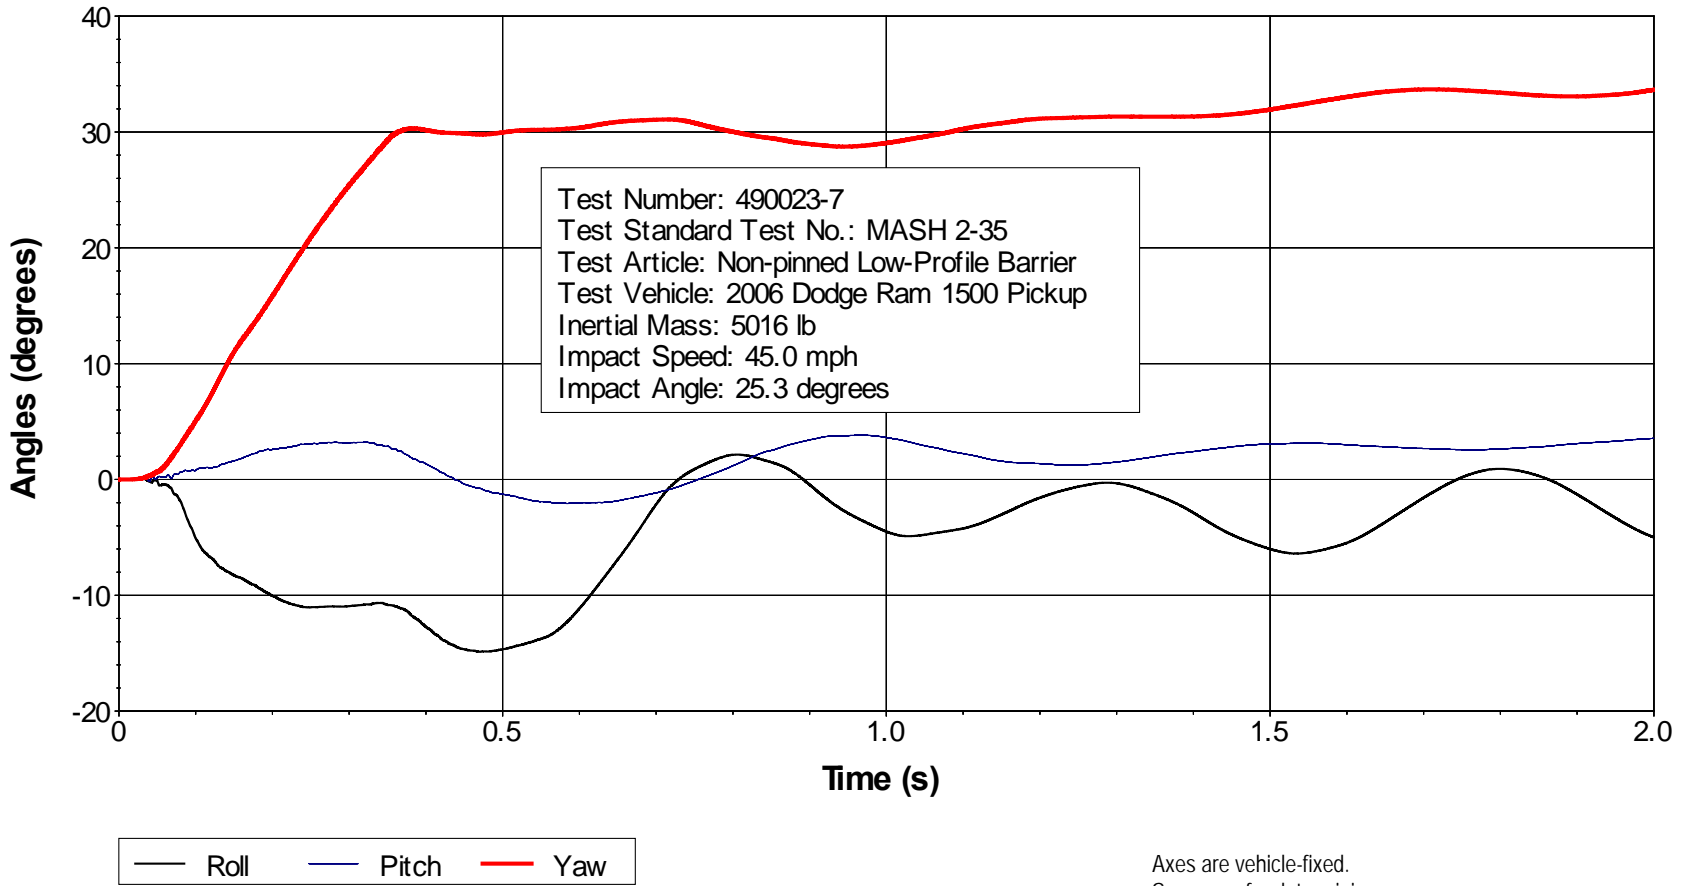
Axes are vehicle-fixed.  
 Sequence for determining orientation:

Figure C3. Vehicle Angular Displacements for Test No. 490023-7.

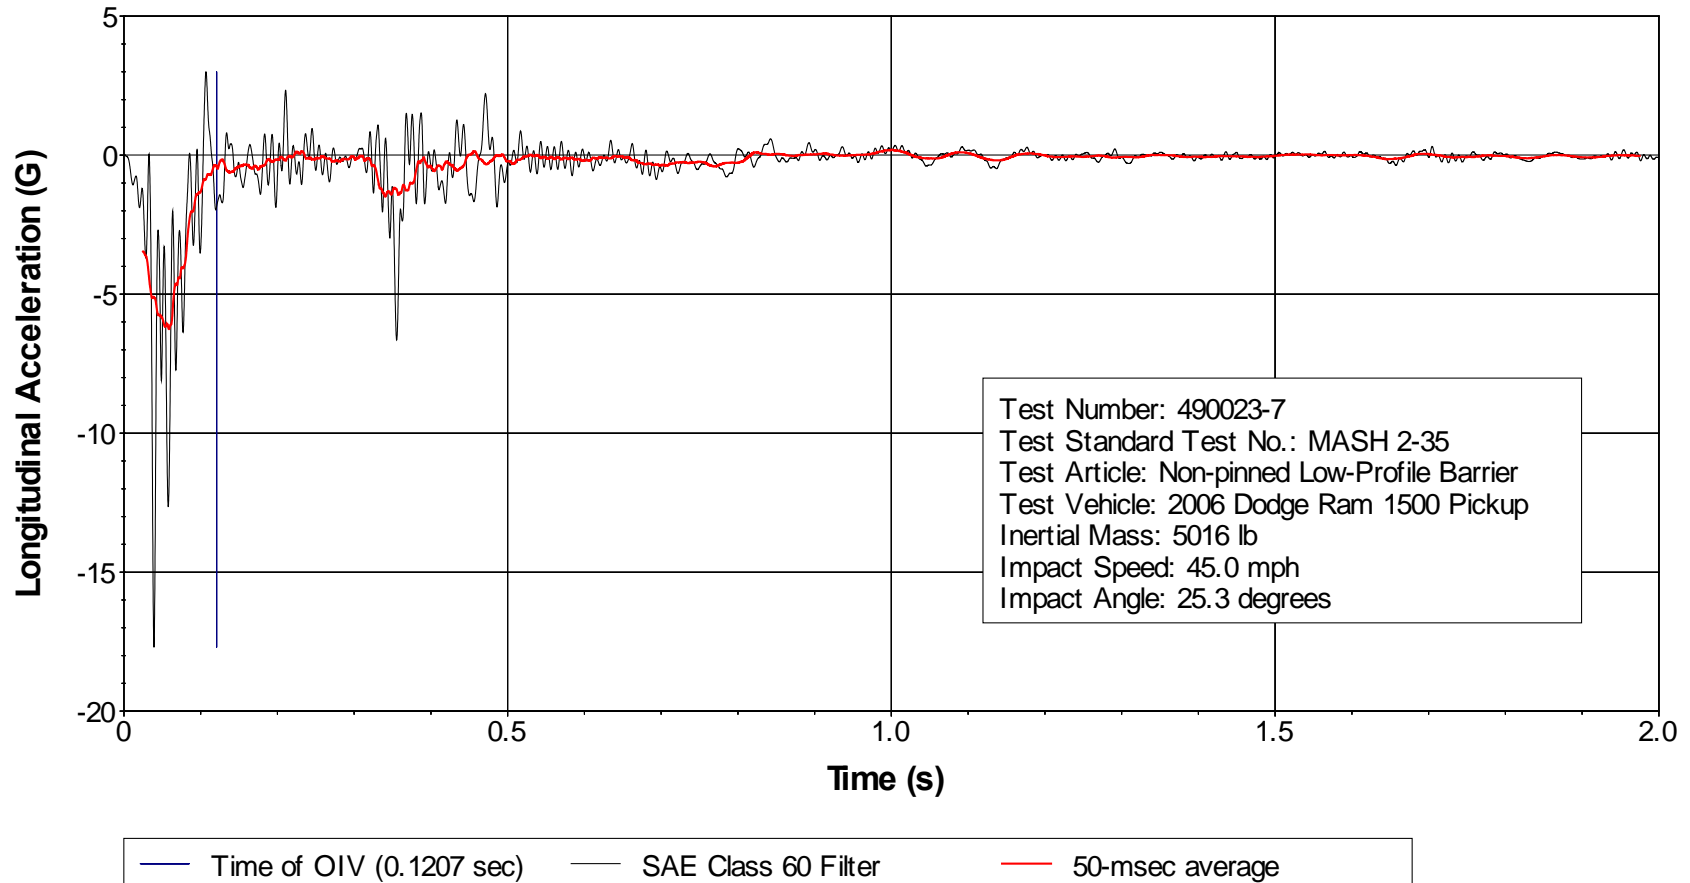
**Figure C4. Vehicle Longitudinal Accelerometer Trace for Test No. 490023-7 (Accelerometer Located at Center of Gravity).**

Data from the accelerometer, located at the vehicle center of gravity, were digitized for evaluation of occupant risk. In the longitudinal direction, the occupant impact velocity was 12.1 ft/s at 0.121 s, the highest 0.010-s occupant ridedown acceleration was 4.3 Gs from 0.352 to 0.362 s, and the maximum 0.050-s average acceleration was -6.3 Gs between 0.034 and 0.084 s. In the lateral direction, the occupant impact velocity was 15.4 ft/s at 0.121 s, the highest 0.010-s occupant ridedown acceleration was 5.3 Gs from 0.323 to 0.333 s, and the maximum 0.050-s average was 9.0 Gs between 0.040 and 0.090 s. Theoretical Head Impact Velocity (THIV) was 21.8 km/h or 6.1 m/s at 0.116 s; Post-Impact Head Decelerations (PHD) was 6.3 Gs between 0.352 and 0.362 s; and Acceleration Severity Index (ASI) was 1.13 between 0.035 and 0.085 s. Figure 5.7 summarized these data and other pertinent information from the test. Appendix C, Figures C3 through C9 show the vehicle angular displacements and accelerations versus time traces.

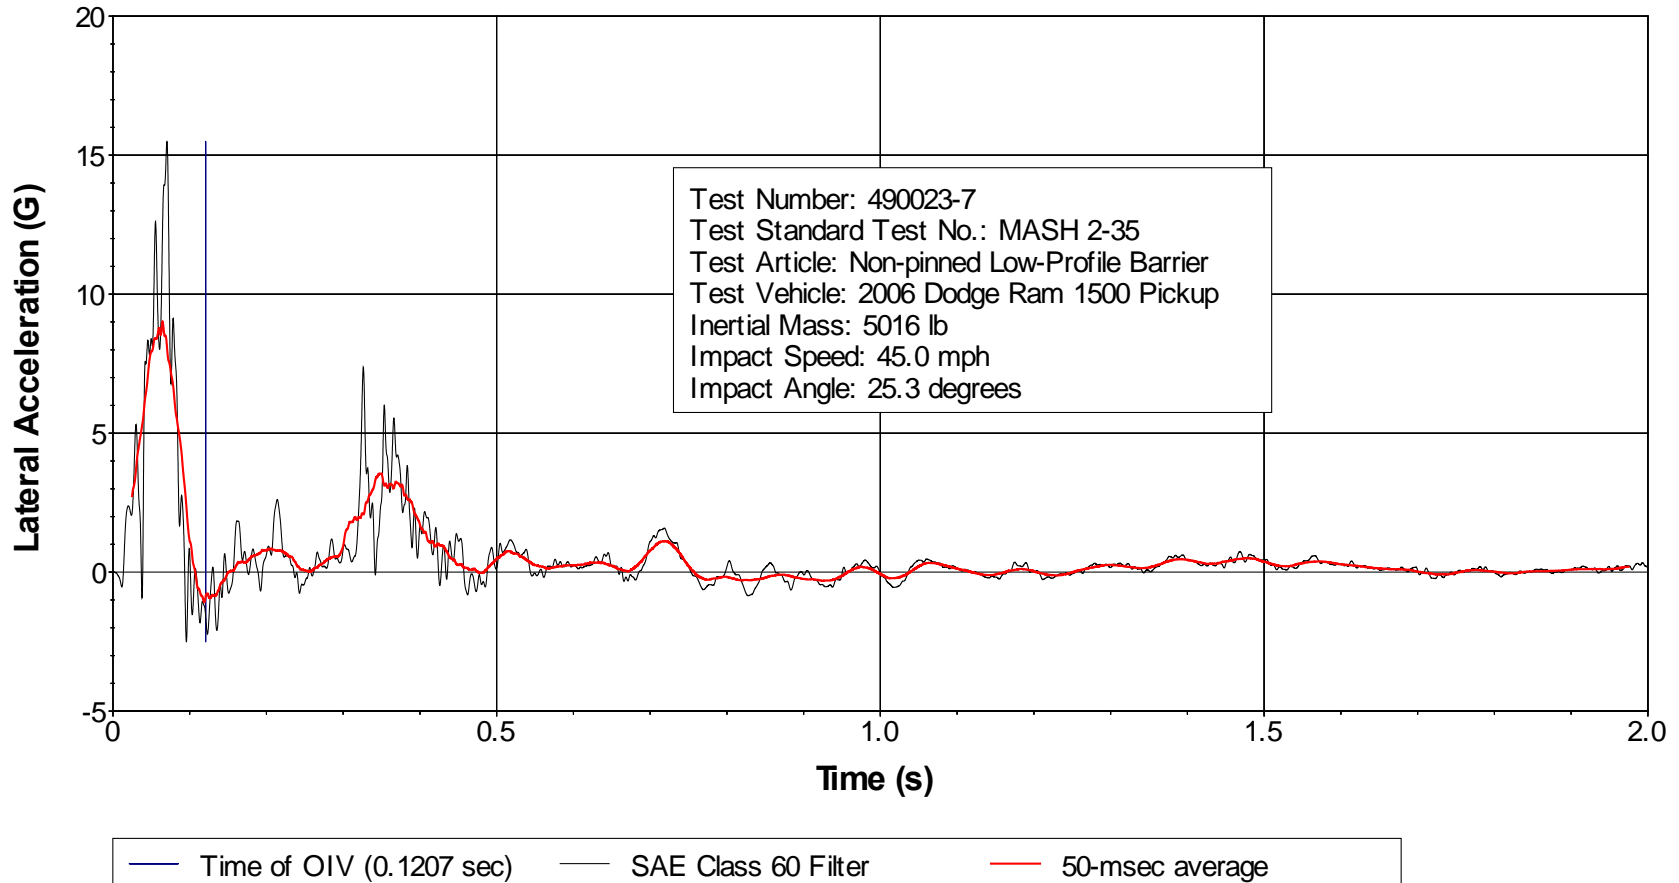
**Figure C5. Vehicle Lateral Accelerometer Trace for Test No. 490023-7 (Accelerometer Located at Center of Gravity).**

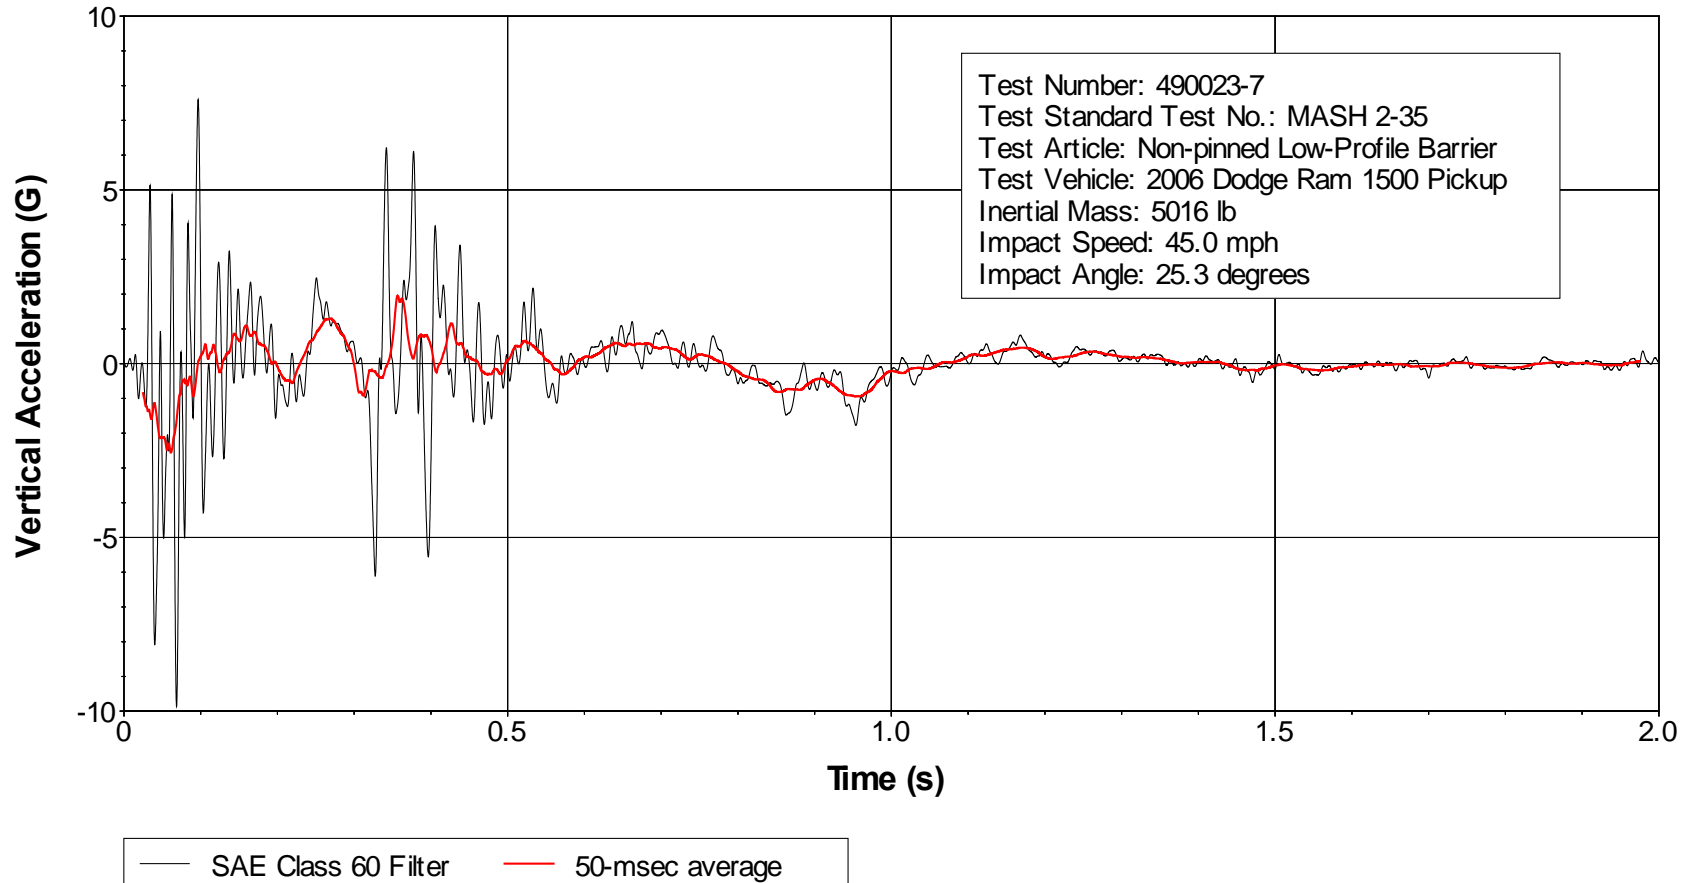
**Figure C6. Vehicle Vertical Accelerometer Trace for Test No. 490023-7 (Accelerometer Located at Center of Gravity).**

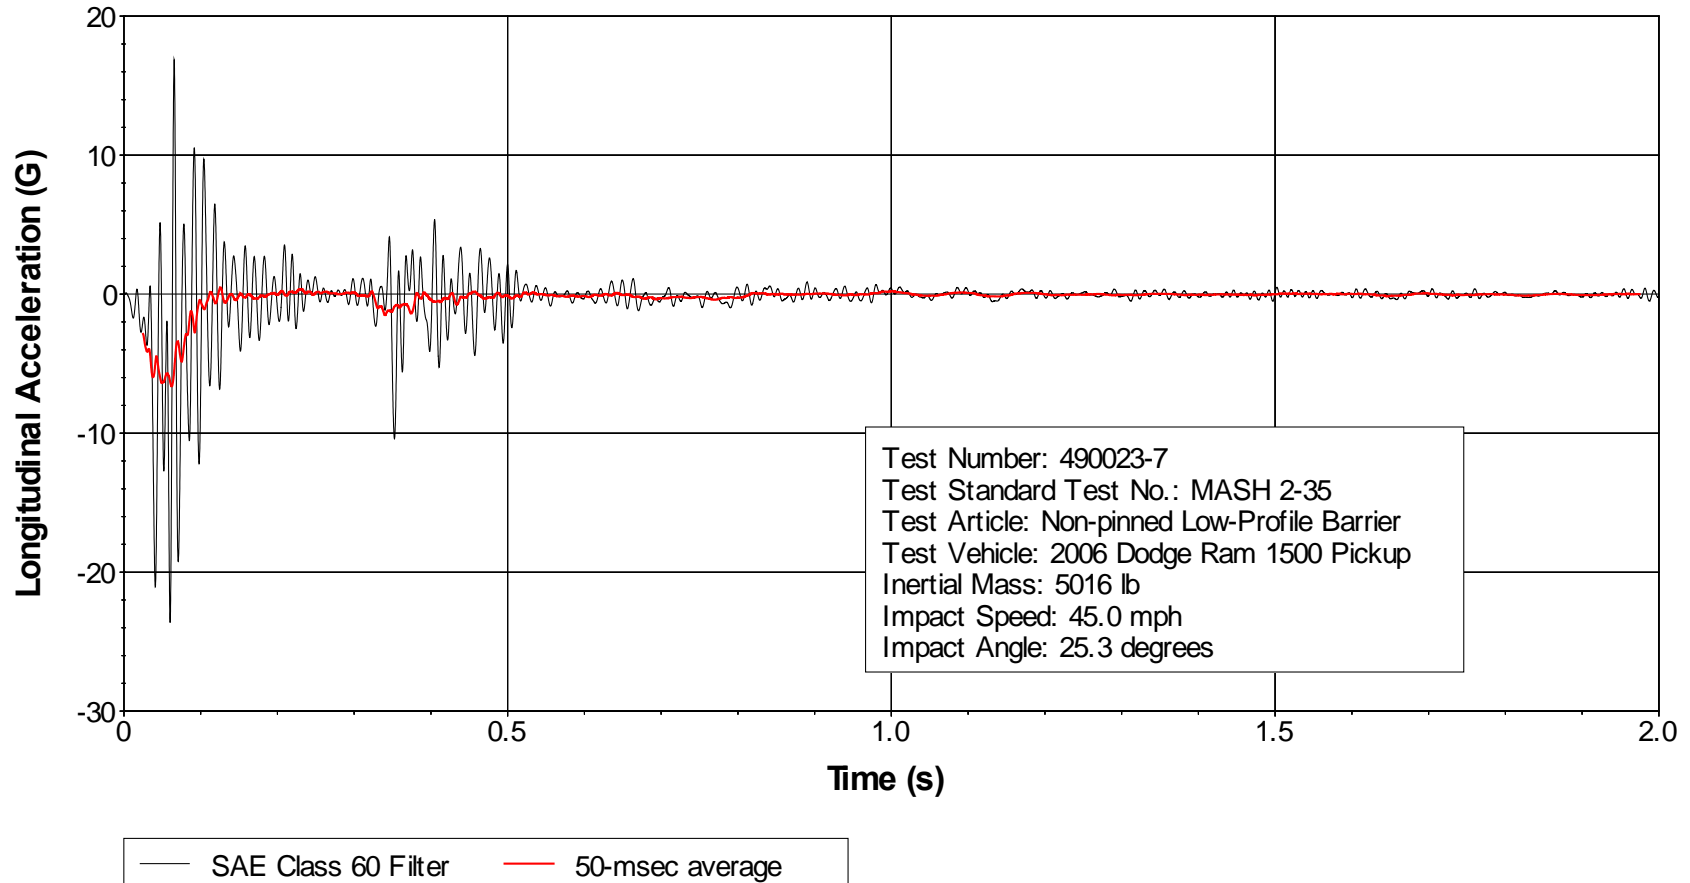
**Figure C7. Vehicle Longitudinal Accelerometer Trace for Test No. 490023-7 (Accelerometer Located Rear of Center of Gravity).**

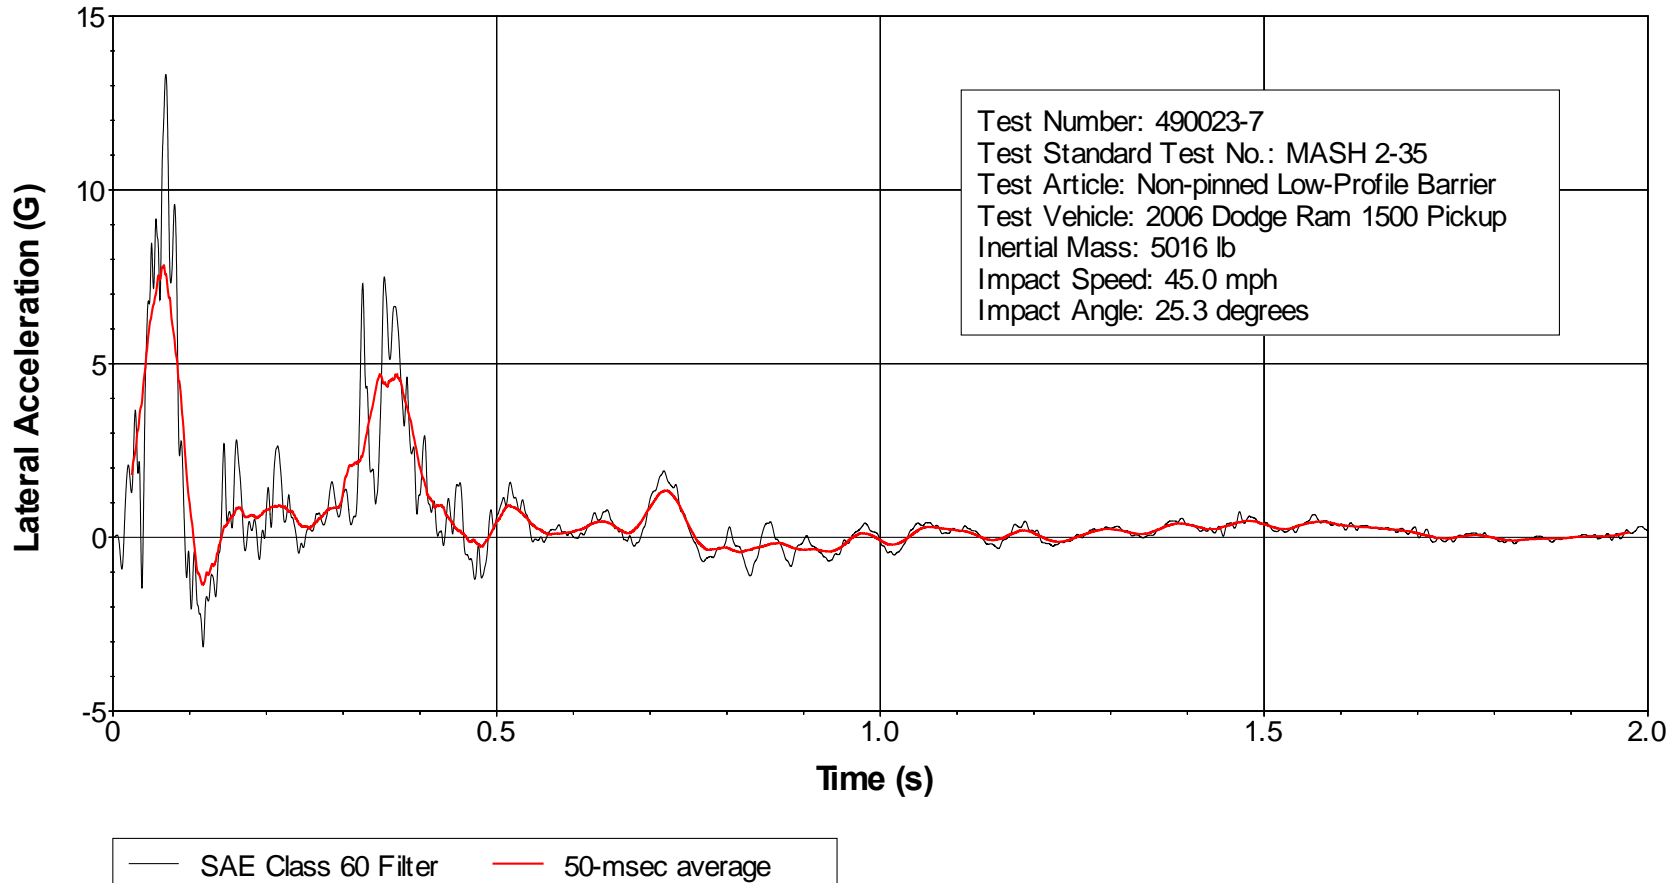
**Figure C8. Vehicle Lateral Accelerometer Trace for Test No. 490023-7 (Accelerometer Located Rear of Center of Gravity).**

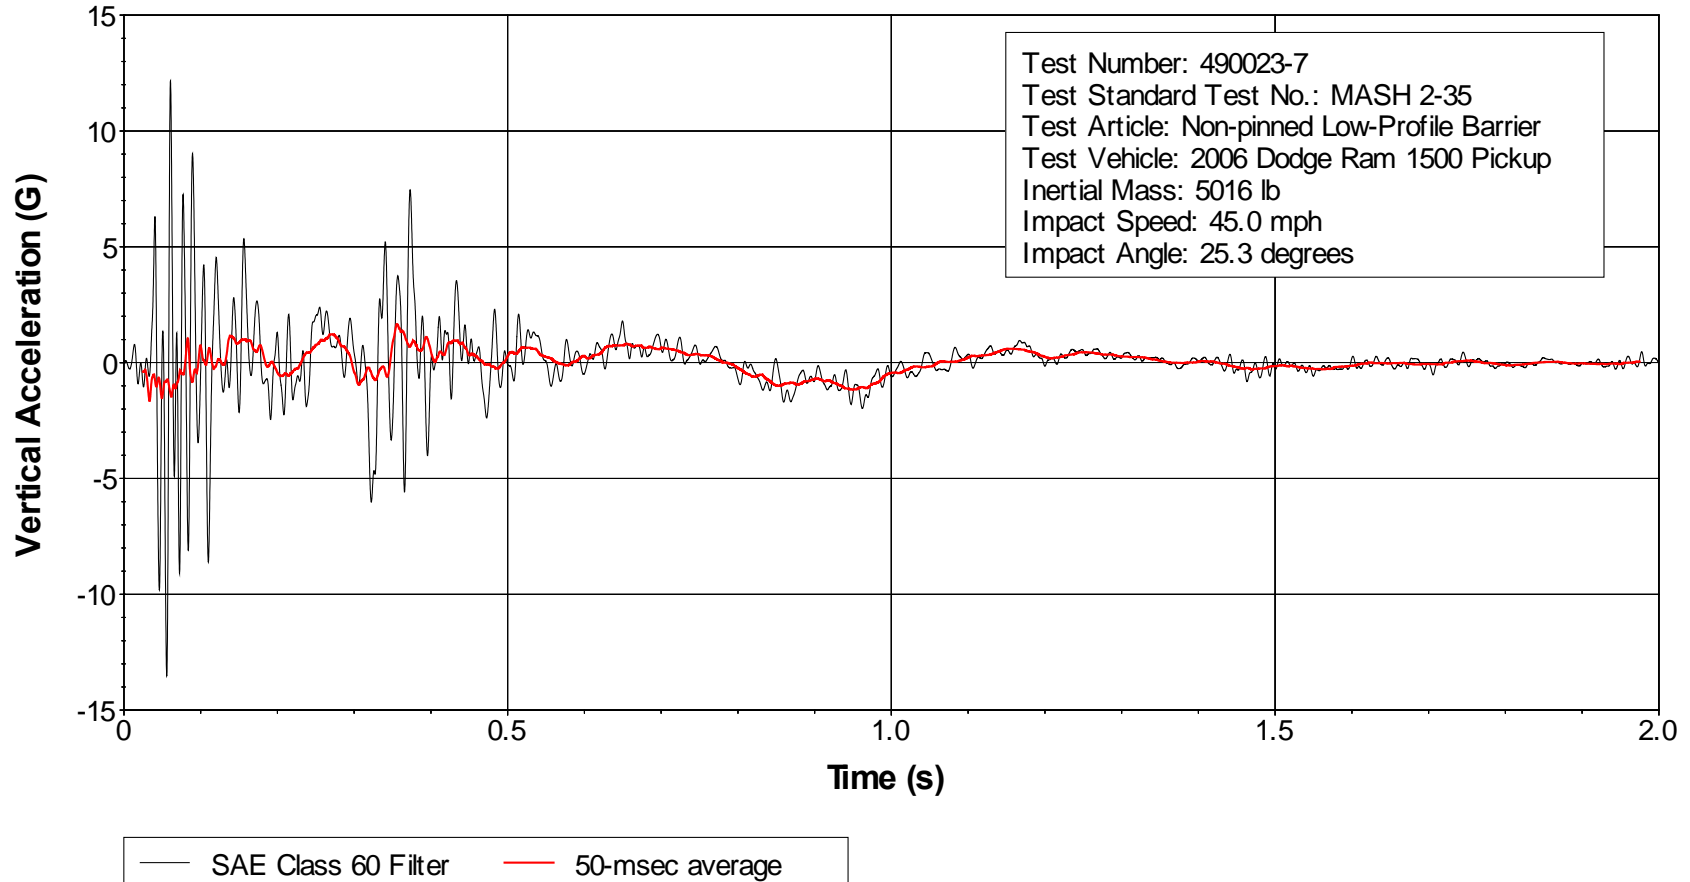
**Figure C9. Vehicle Vertical Accelerometer Trace for Test No. 490023-7 (Accelerometer Located Rear of Center of Gravity).**

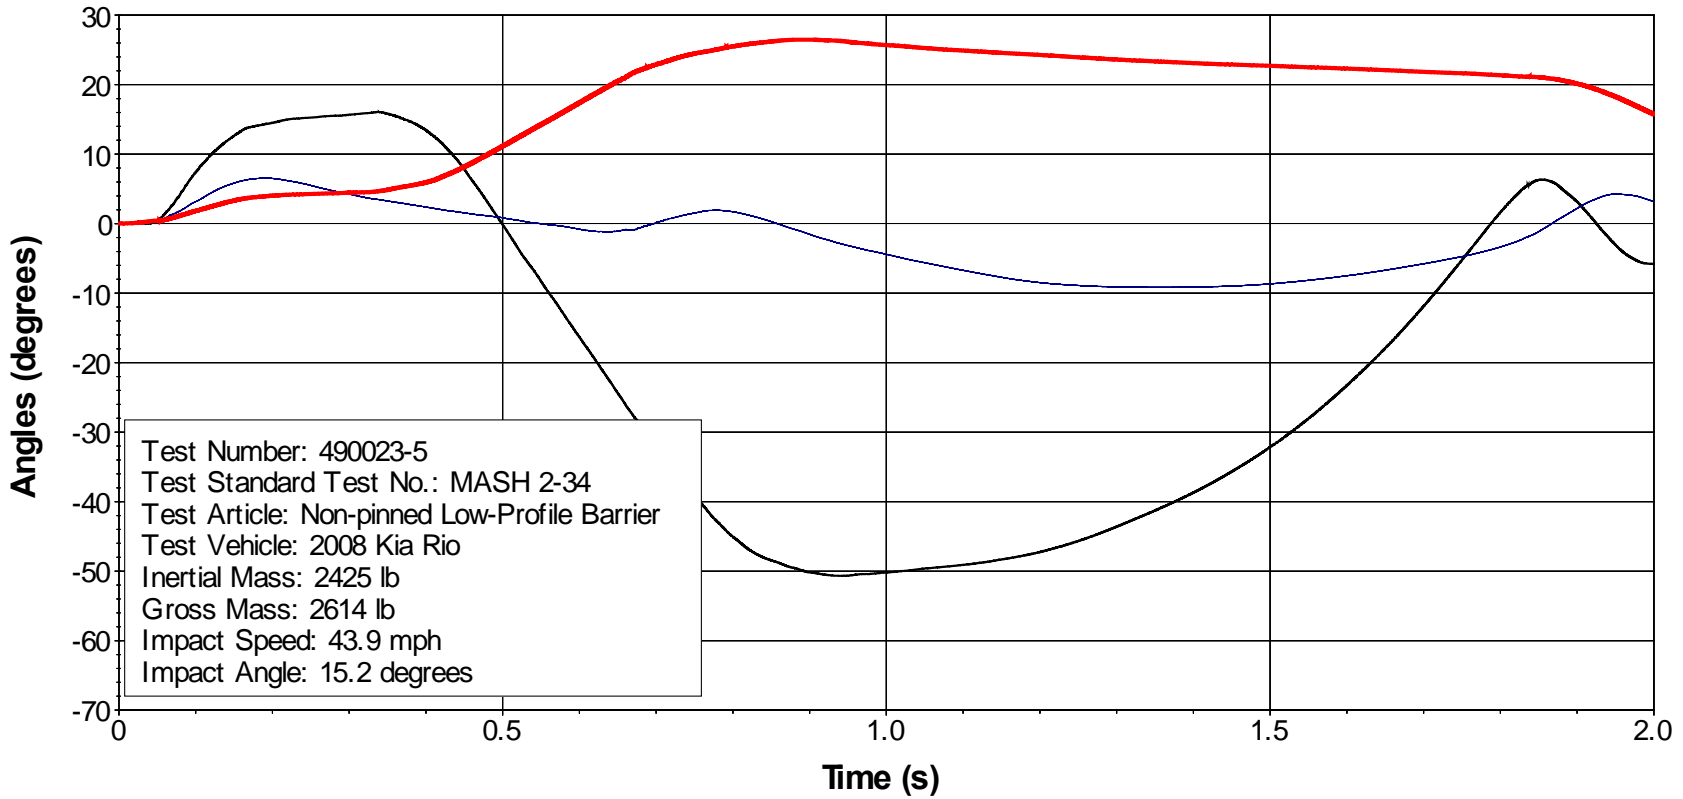
Test Number: 490023-5  
 Test Standard Test No.: MASH 2-34  
 Test Article: Non-pinned Low-Profile Barrier  
 Test Vehicle: 2008 Kia Rio  
 Inertial Mass: 2425 lb  
 Gross Mass: 2614 lb  
 Impact Speed: 43.9 mph  
 Impact Angle: 15.2 degrees

**Figure D3. Vehicle Angular Displacements for Test No. 490023-5.**

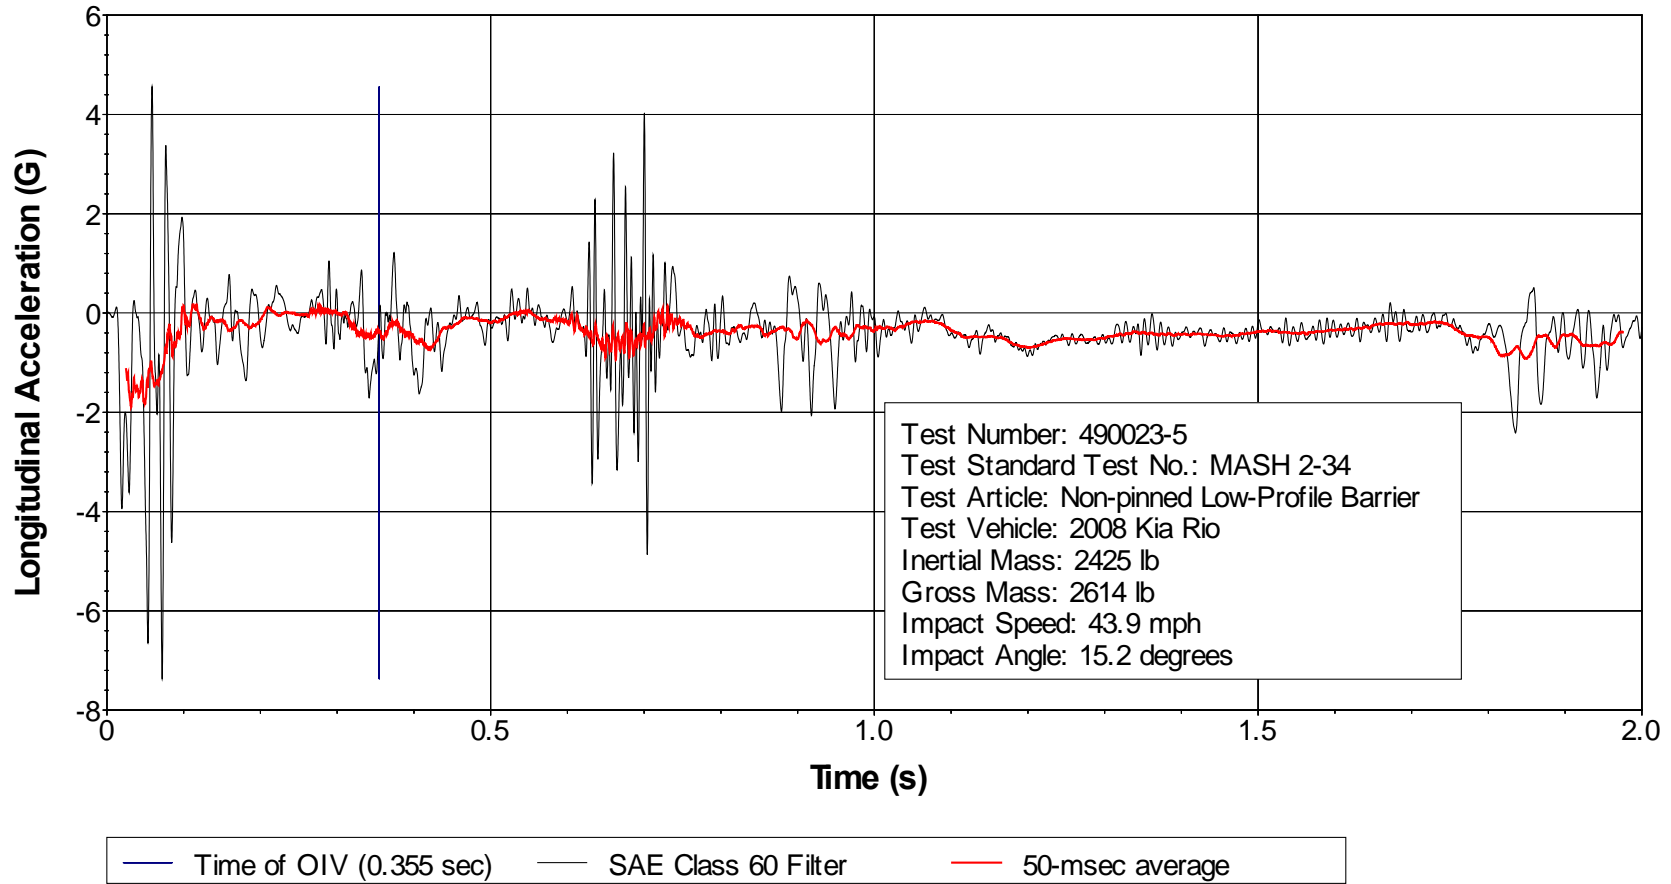
**Figure D4. Vehicle Longitudinal Accelerometer Trace for Test No. 490023-5 (Accelerometer Located at Center of Gravity).**

Data from the accelerometer, located at the vehicle center of gravity, were digitized for evaluation of occupant risk. In the longitudinal direction, the occupant impact velocity was 4.6 ft/s at 0.355 s, the highest 0.010-s occupant ridedown acceleration was 2.5 Gs from 0.664 to 0.674 s, and the maximum 0.050-s average acceleration was -1.9 Gs between 0.007 and 0.057 s. In the lateral direction, the occupant impact velocity was 4.9 ft/s at 0.355 s, the highest 0.010-s occupant ridedown acceleration was 3.7 Gs from 0.408 to 0.418 s, and the maximum 0.050-s average was 1.8 Gs between 0.372 and 0.422 s. THIV was 6.4 km/h or 1.8 m/s at 0.338 s; PHD was 3.8 Gs between 0.408 and 0.418 s; and ASI was 0.38 between 0.024 and 0.074 s. Figure 6.7 summarized these data and other pertinent information from the test. Appendix C, Figures C3 through C9 present the vehicle angular displacements and accelerations versus time traces.
