# DEVELOPMENT AND TESTING OF A NON-PINNED LOW-PROFILE END TREATMENT

**Test Report 9-1002-12-7**

TEXAS A&M TRANSPORTATION INSTITUTE  
COLLEGE STATION, TEXAS

1. Report No. FHWA/TX-13/9-1002-12-7		2. Government Accession No.		3. Recipient's Catalog No.	
4. Title and Subtitle DEVELOPMENT AND TESTING OF A NON-PINNED LOW-PROFILE END TREATMENT				5. Report Date Published: October 2013

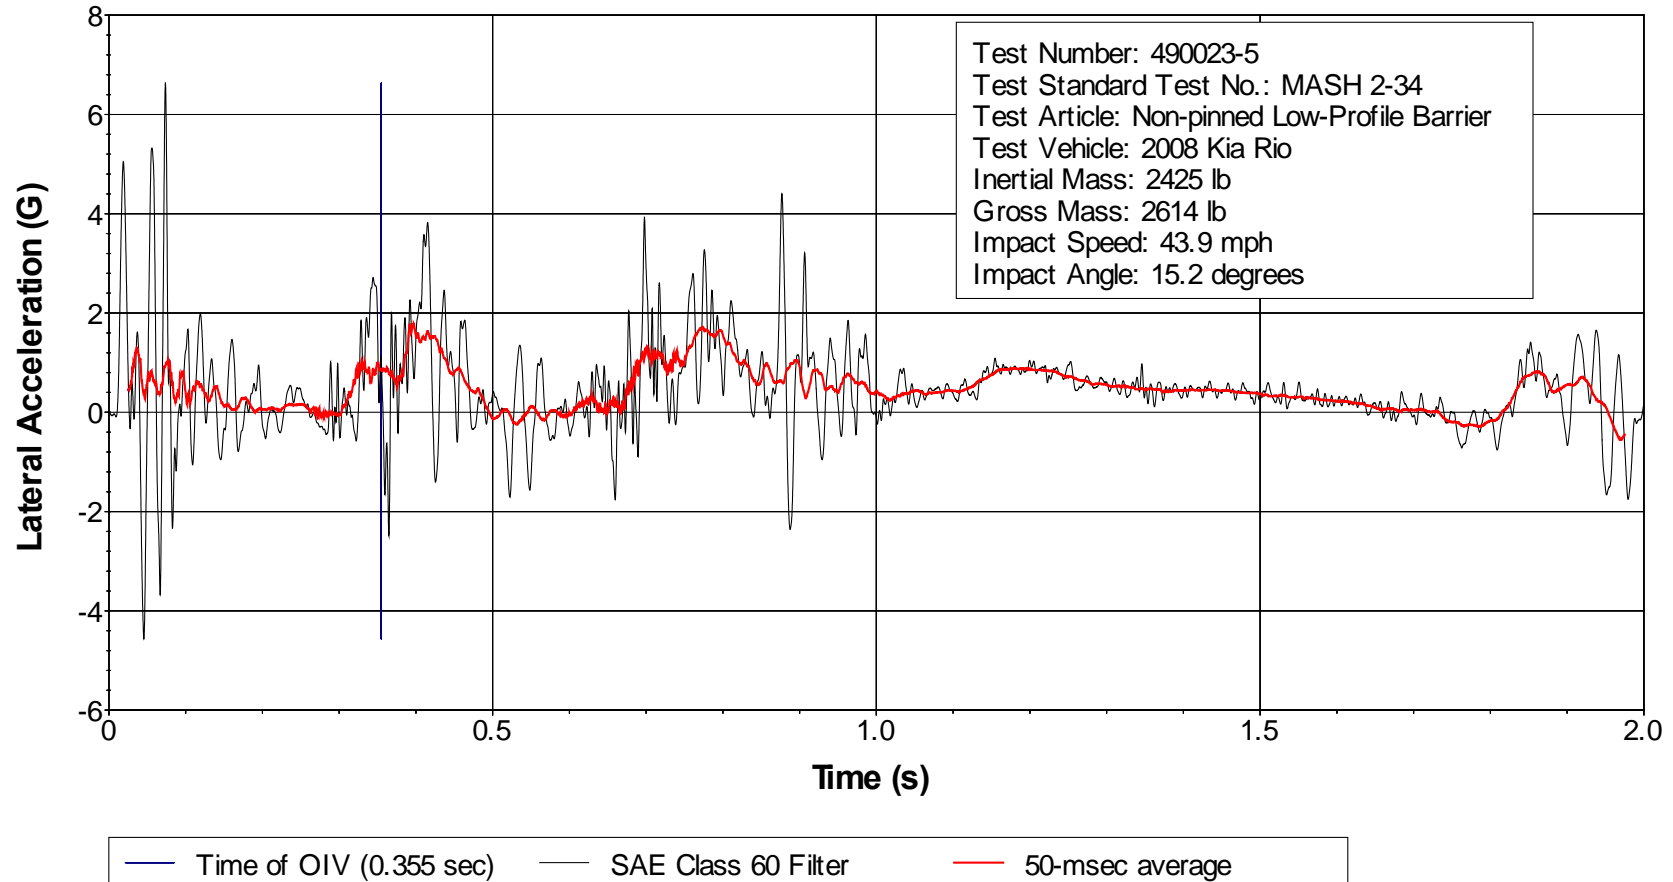
**Figure D5. Vehicle Lateral Accelerometer Trace for Test No. 490023-5 (Accelerometer Located at Center of Gravity).**

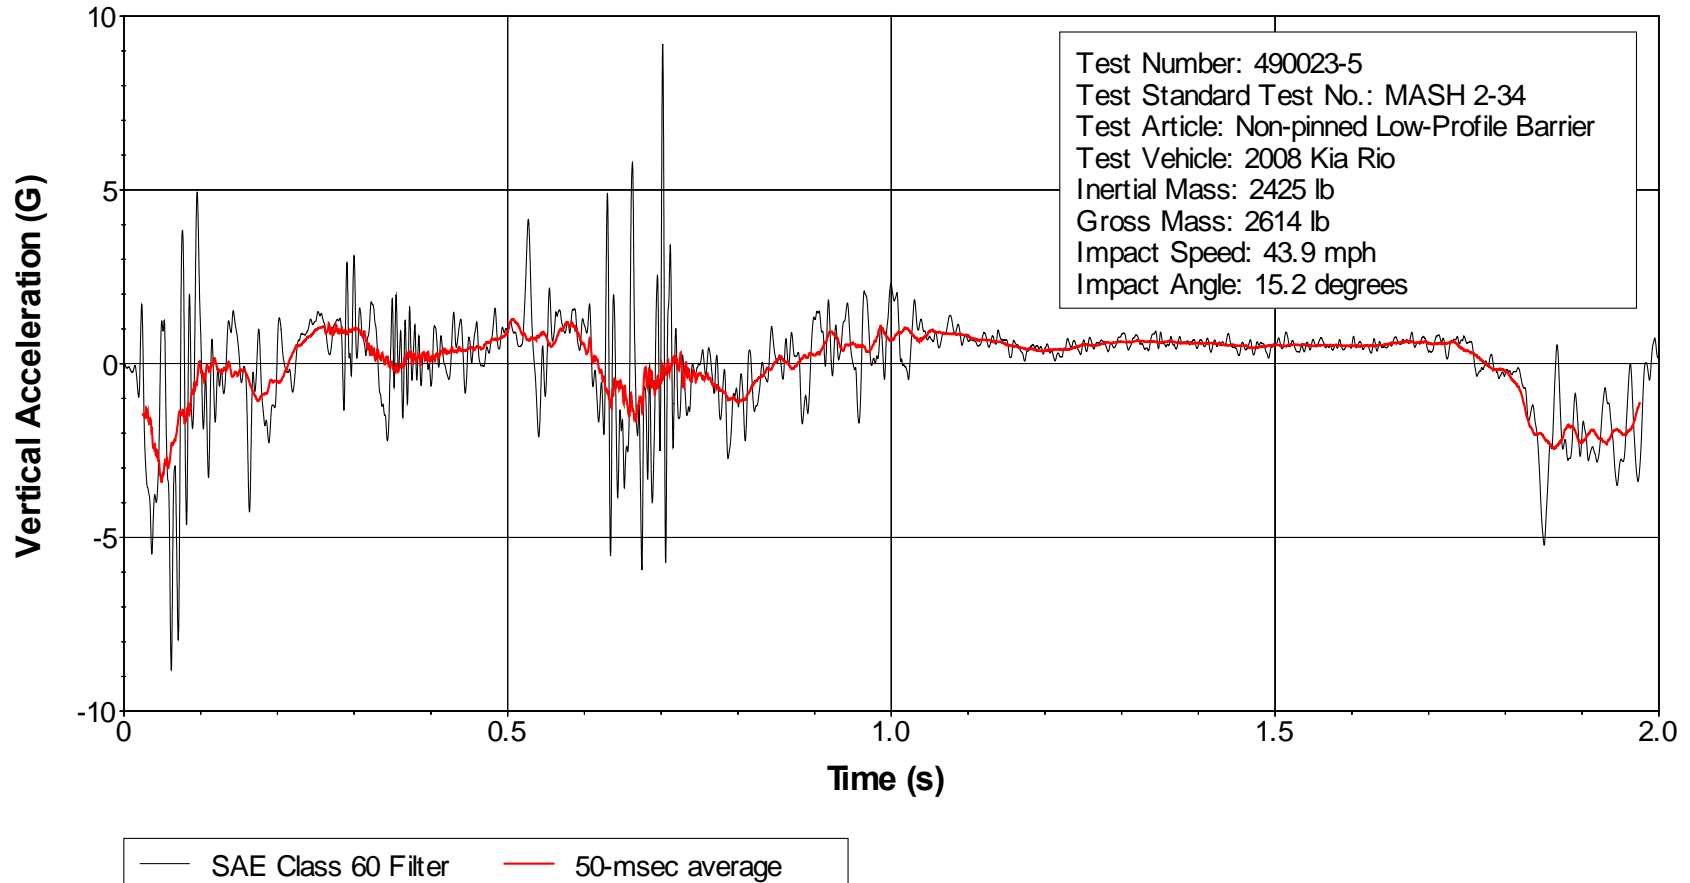
**Figure D6. Vehicle Vertical Accelerometer Trace for Test No. 490023-5 (Accelerometer Located at Center of Gravity).**

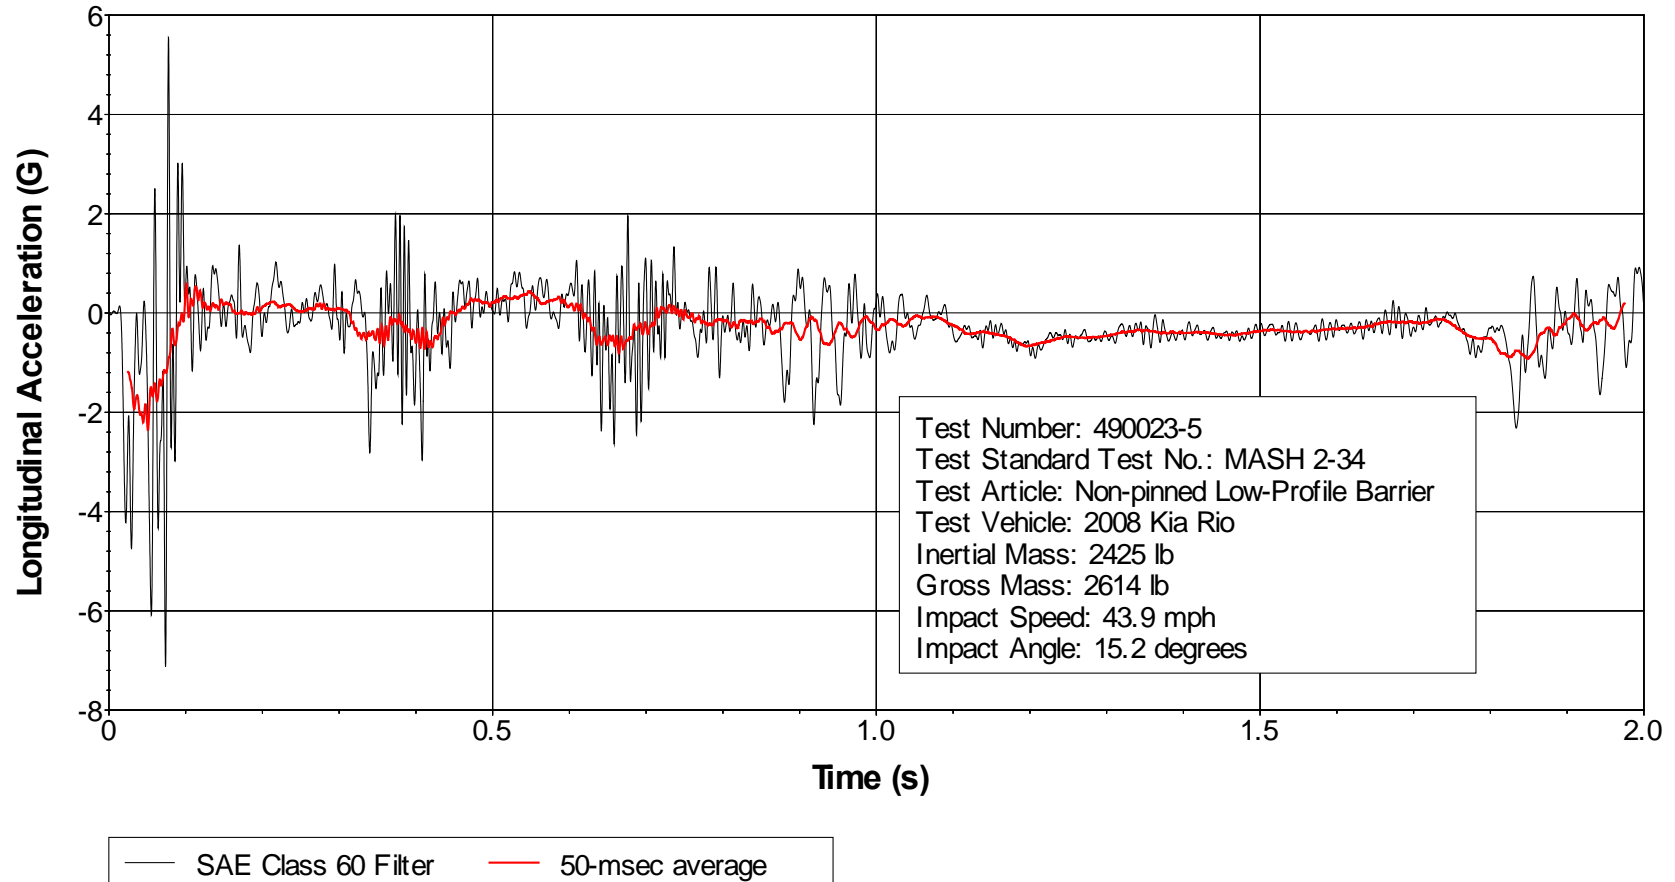
**Figure D7. Vehicle Longitudinal Accelerometer Trace for Test No. 490023-5 (Accelerometer Located Rear of Center of Gravity).**

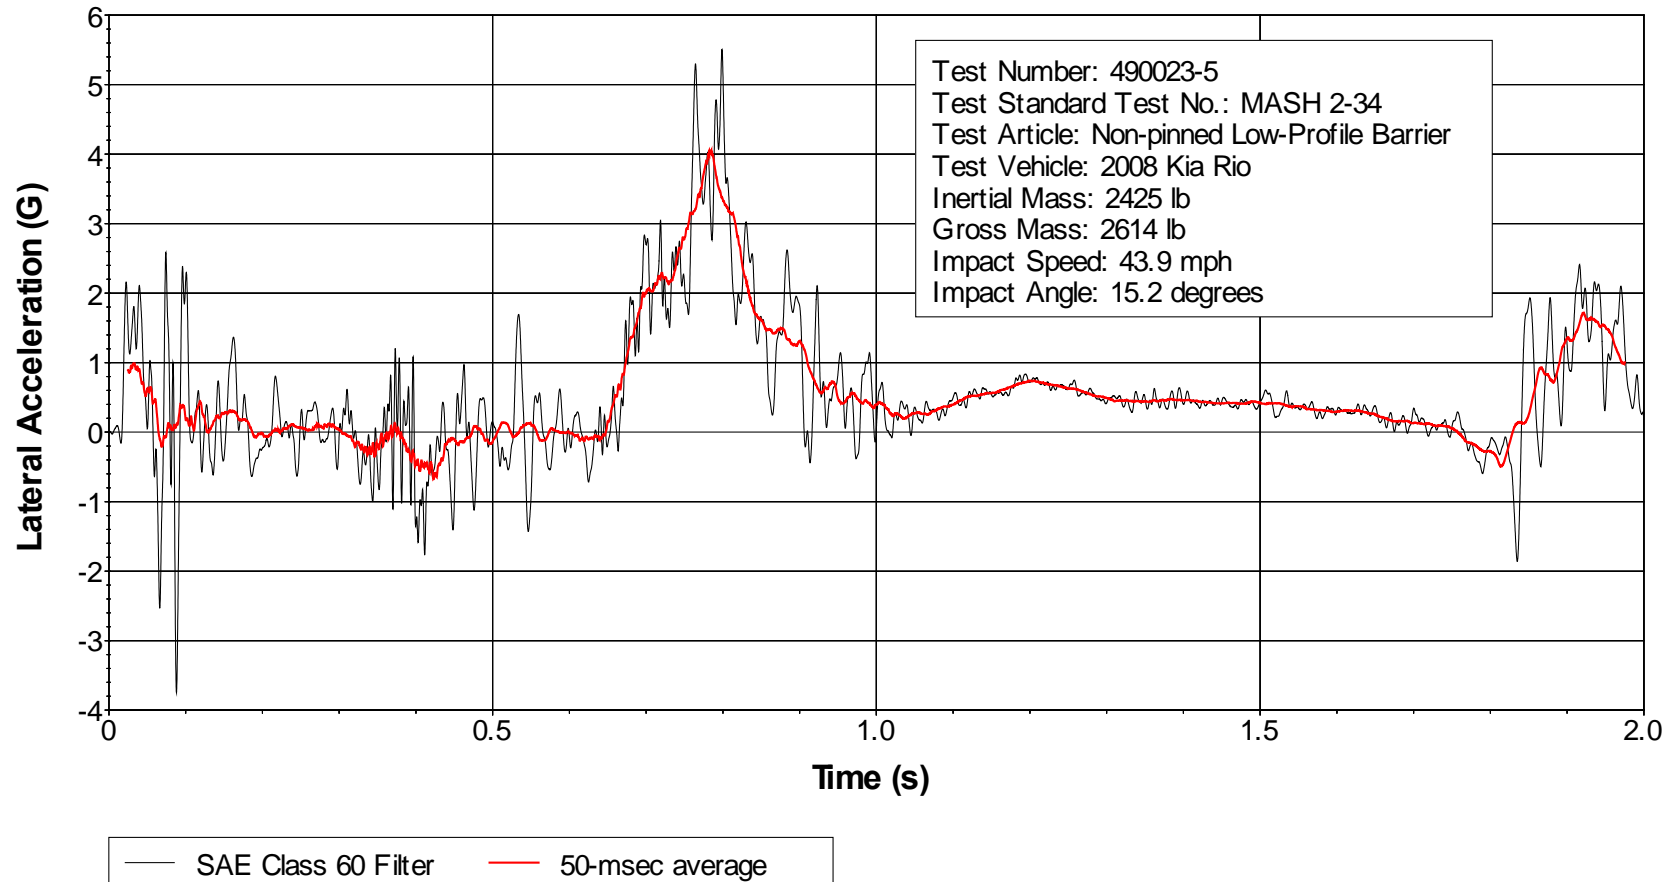
**Figure D8. Vehicle Lateral Accelerometer Trace for Test No. 490023-5 (Accelerometer Located Rear of Center of Gravity).**

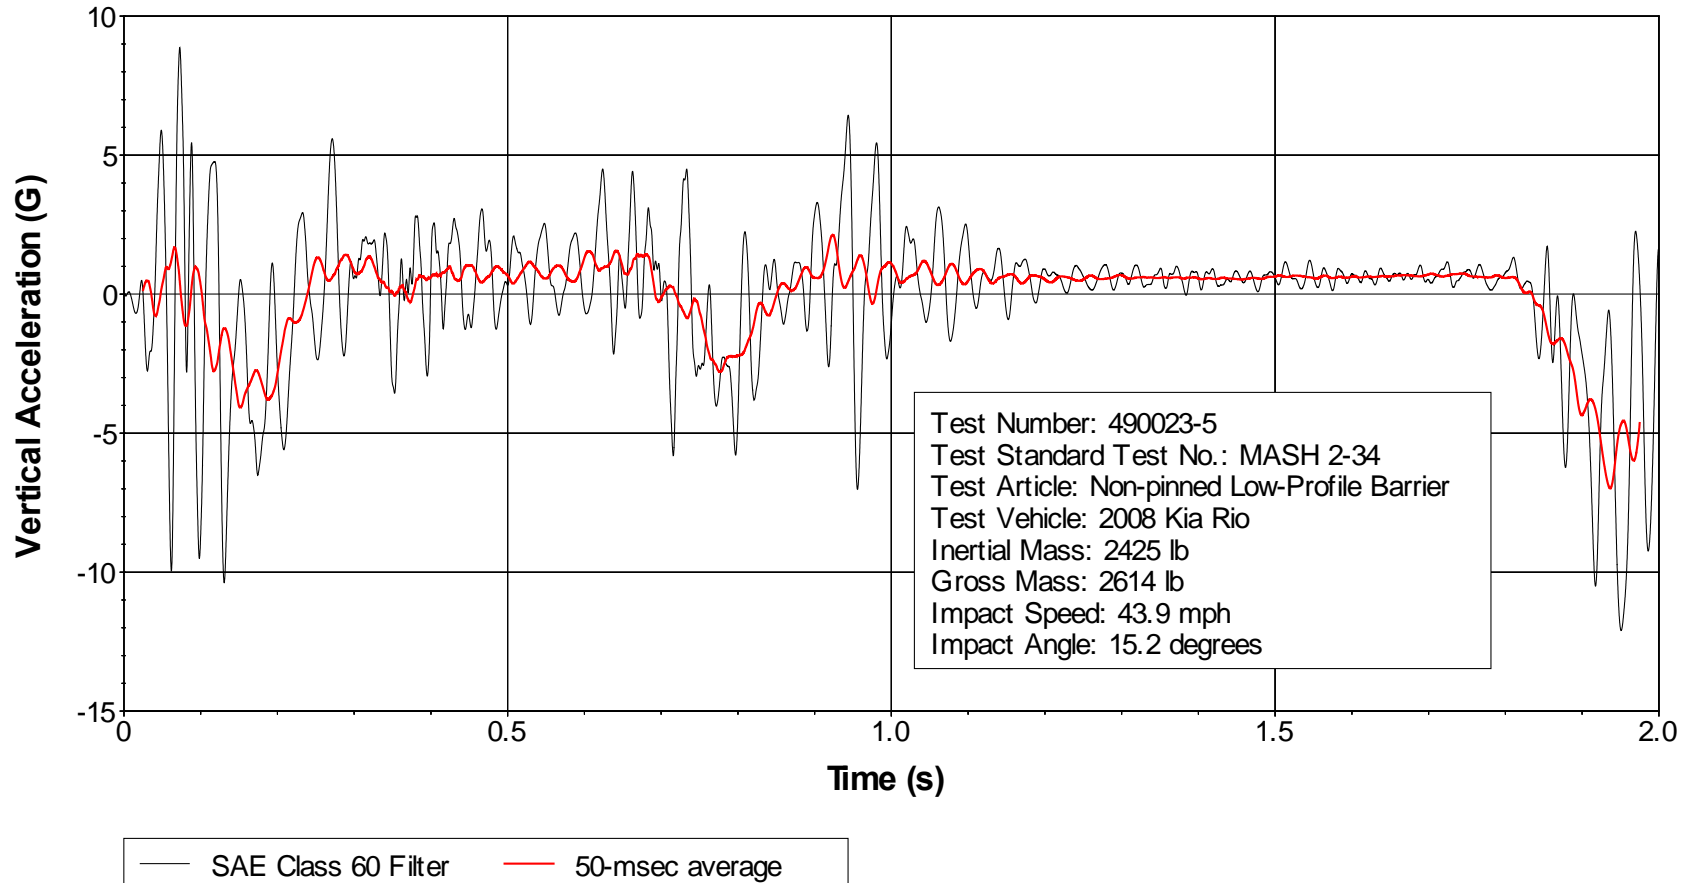
**Figure D9. Vehicle Vertical Accelerometer Trace for Test No. 490023-5 (Accelerometer Located Rear of Center of Gravity).**
