U.S. Department  
of Transportation  
**Federal Railroad  
Administration**

# **ALUMINUM/COLD TEMPERATURE TANK CAR PUNCTURE RESISTANCE TESTS: DATA REPORT**

DOT/FRA/ORD-92/29

August 1992  
Final Report

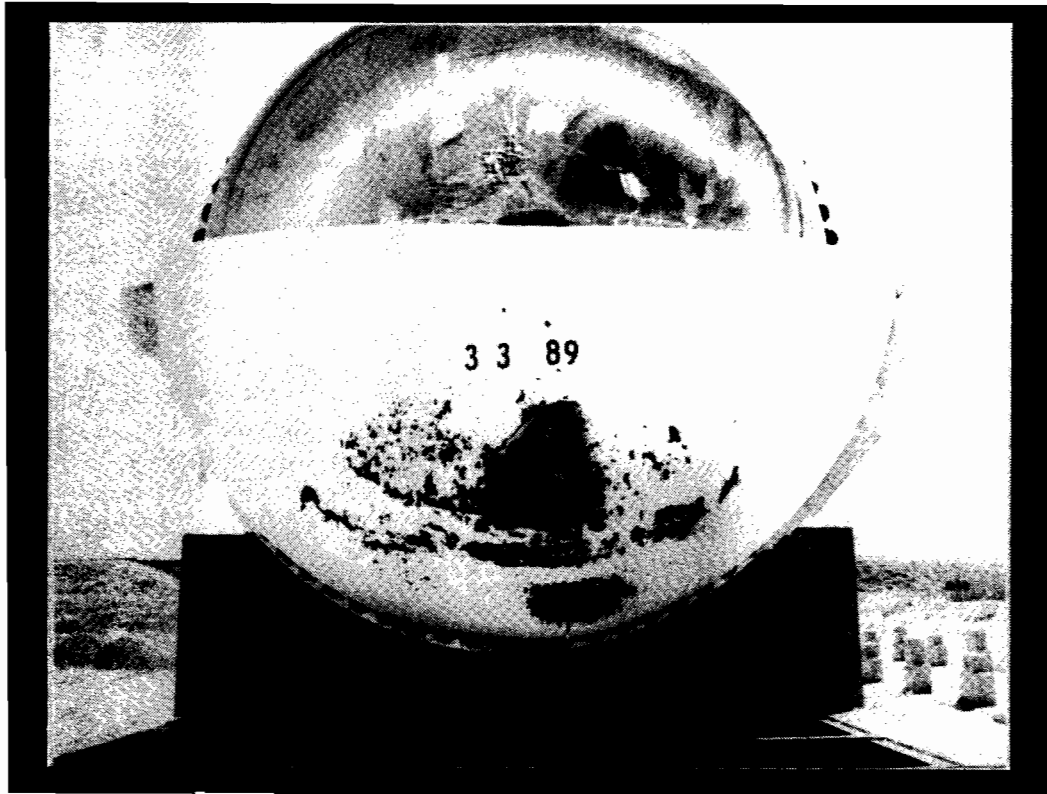
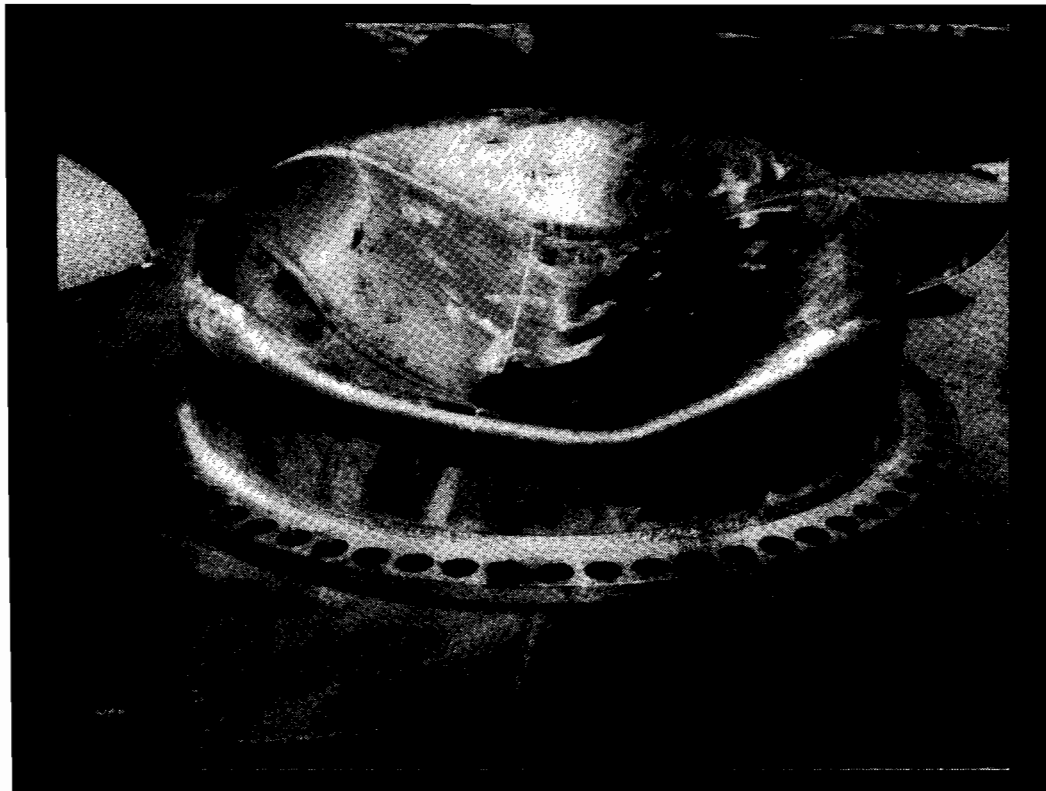
FIGURE 16. 111 SHIELDED HEAD FA-21 PUNCTURE - IMPACT SPEED 17.8 MPH - 1/2"-THICK SHIELD.

In the first test, FA-21, the head was impacted at a speed of 17.8 mph (Figures 16 and 17). As can be seen in the photographs, a full puncture of the coupler through the shield and head was the result. Also, severe folding and pinching of the aluminum head at the bottom sill area occurred much the same as in the related one-fifth scale tests. The head failure was initiated by shearing along the outside edge of the coupler jaw contact points. There was no evidence of coupler shank bending, as was experienced in a previous test program of steel heads. A new coupler was installed on the ram prior to this test run.

FIGURE 17. FA-21 HEAD, SHIELD REMOVED - NOTE DEFORMATION AT SILL AREA.

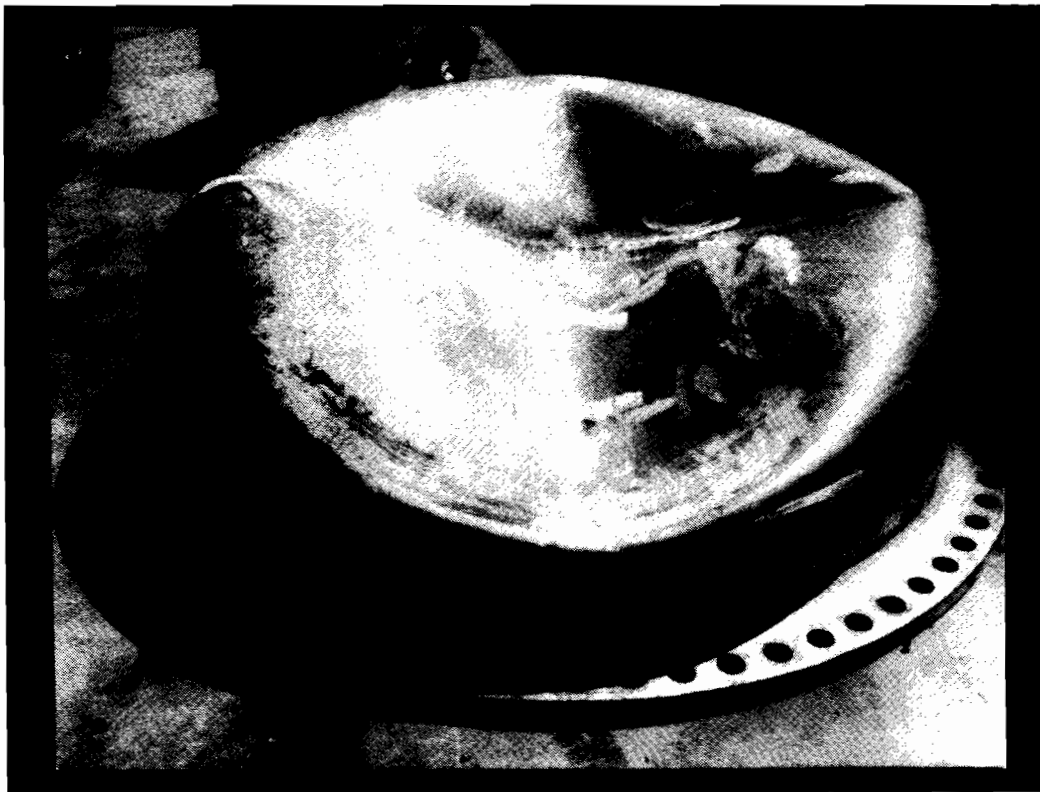
FIGURE 20. 111 SHIELDED HEAD FA-31 DENT FORMATION - IMPACT SPEED 17.5 MPH - 5/8"-THICK SHIELD.

No puncture occurred in this test. Deformation at the bottom sill area was again pronounced. However, it was noticed that the coupler knuckles on the Impact Car and Reaction Car were closed prior to and during the impact. After the impact, it was found that the couplers were wedged together and not fully coupled (Figure 22). It was suspected that the couplers' draft gear may have bottomed-out at impact, interfering with ram penetration depth. Therefore, the results may not be accurate and a retest would be recommended.

FIGURE 21. FA-31 HEAD, SHIELD REMOVED - NOTE DEFORMATION AT SILL AREA.

FIGURE 22. CLOSED COUPLERS IN FULL SCALE TEST FA-31.

The test of the aluminum head protected by a 5/8-inch-thick steel shield was not considered valid. Although the head survived a 17.5 mph impact, it was noted that the couplers of the Impact and the Reaction Cars had wedged together and did not fully couple. This may have interfered with the ram penetration depth. A retest of this configuration would be recommended.

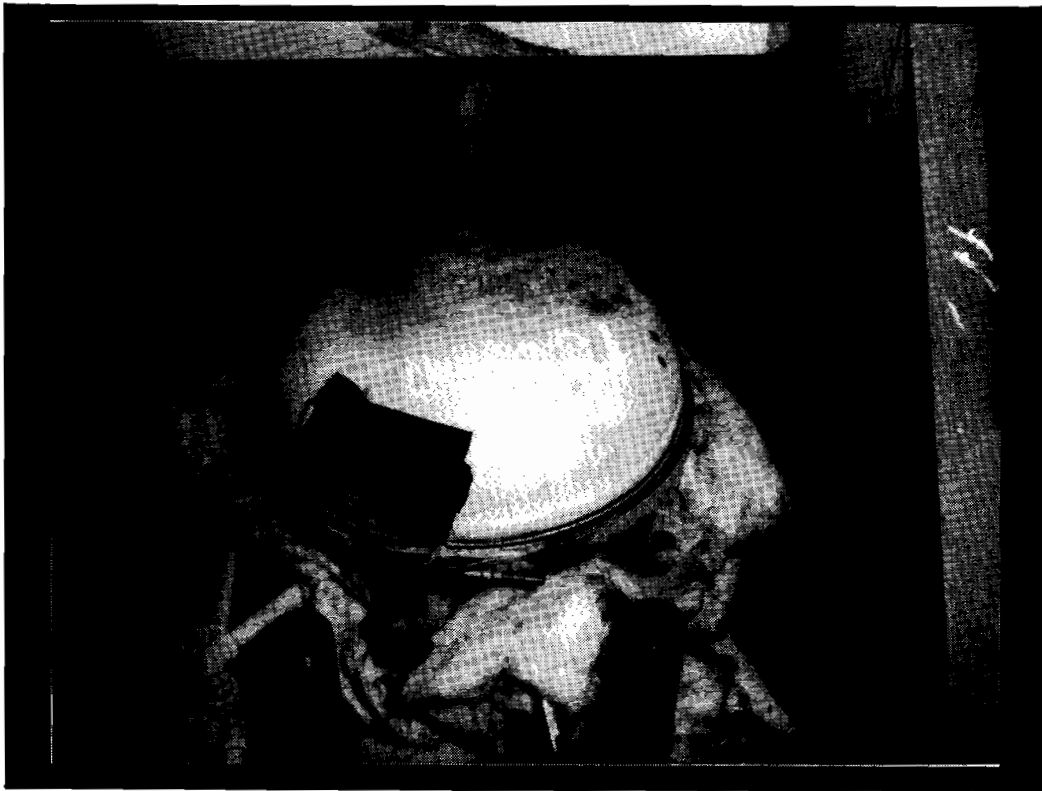
FIGURE 28. ONE-FIFTH SCALE 111 HEAD AT  $-20^{\circ}\text{F}$ .

chilled liquid was circulated through the model tank vessel until the head temperature dropped to that specified in Test Matrix 3. The tank vessel and head were insulated during the chill down cycle, and removed just prior to impact testing (Figures 28 and 29).

FIGURE 29. ONE-FIFTH SCALE HEAD DURING CHILL DOWN ROUTINE.

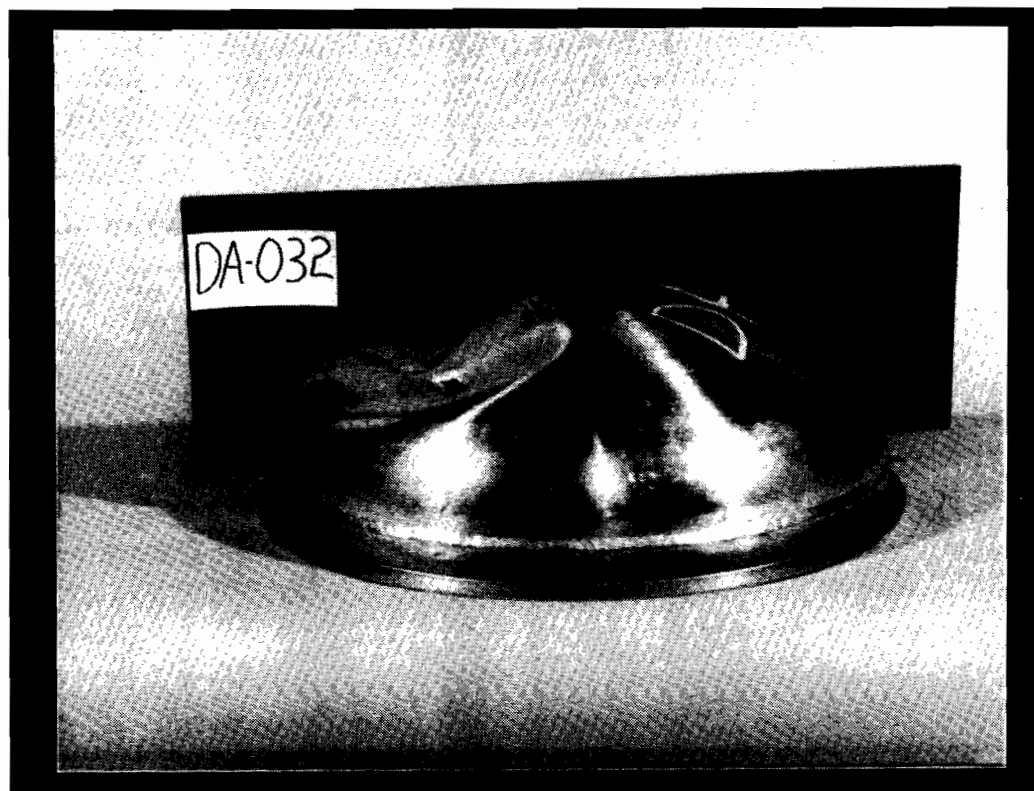
FIGURE 30. ONE-FIFTH SCALE HEAD MEASUREMENT SCALE.

A flat profile template was used to measure the formation of the dent at the center of the head profile and corresponding coupler center line (Figures 30 and 32). Dent depth distances were measured between the tank head and template curve, and along scribed lines parallel with the cylindrical center line of the tank and head assembly. These scribed lines were 1 1/2 inches apart and were numbered starting at the tank bottom and progressing to the tank center. All measurements taken were noted on the test logs. Maximum dent depth was also measured and recorded on the test log for use in the dent depth/velocity curves.

FIGURE 32. PROFILE TEMPLATE USED TO MEASURE DENT DEPTH.

adjusted by dropping a plumb bob (weight) from the coupler center line to the impact point. The impact point was found by using the tank head template (Figures 30-32).

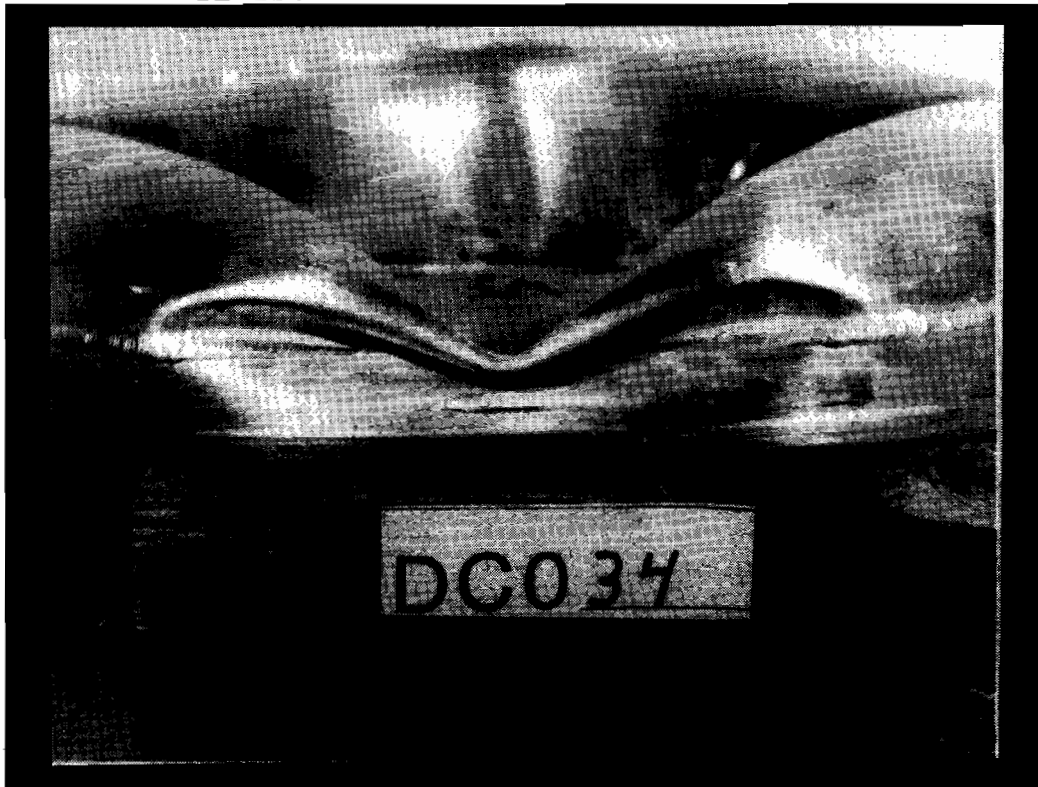
FIGURE 44. VIEW OF IMPACTED 111 HEAD, SHIELD REMOVED, AT SILL AREA - NOTE SEVERE FOLDING AND PINCHING AT FLANGE WELD AREA.

The test results from series DA-04 and DA-06 through DA-08 show that head shield protection increases puncture resistance dramatically, while the light gage jacket material provides only a modest increase (Figure 48 and 50, 51 and 52). The shield protected aluminum heads, regardless of head thickness, deformed easily with no punctures occurring at the impact area. Further deformation by the impactor coupler was prevented by contact with the inner air tank of the pressure vessel. In one test series (DA-07), a leak did appear at the weld joint between the head and the cylindrical section during a 12 mph impact. This was a result of extreme folding and pinching at the sill area; Figure 44 is an example of this.

<sup>3</sup> Failure occurred as crack at pinched perimeter flange weld/sill area; visible leakage. See Fig. 44 for a typical example.
