Dynamic Compaction of Roadways  
Final Report

August, 1986

STATE OF ALASKA  
DEPARTMENT OF TRANSPORTATION AND PUBLIC FACILITIES  
RESEARCH SECTION  
2301 Peger Road  
Fairbanks, Alaska 99701-6394

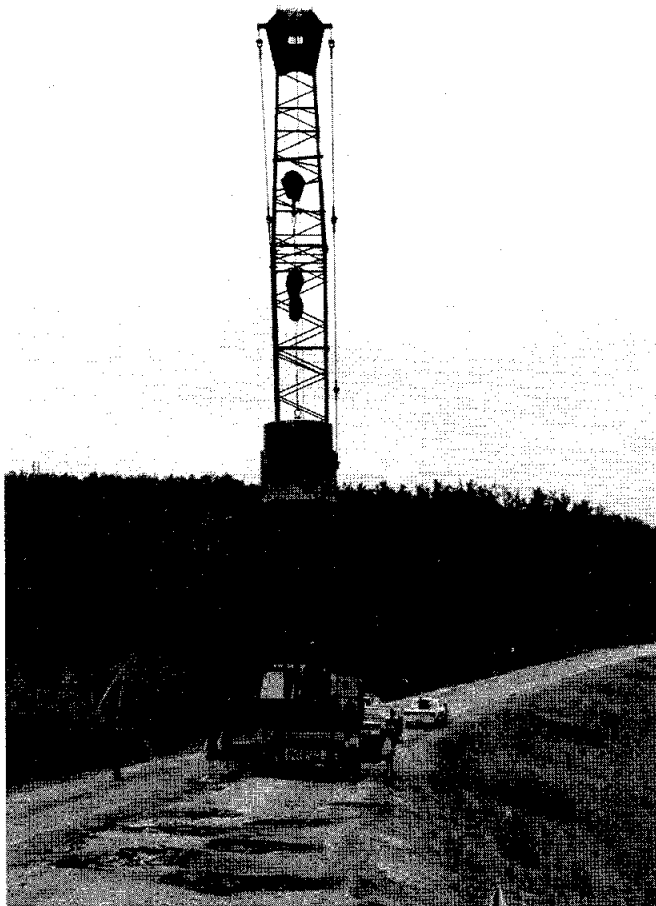
Figure 1.  
Dynamic Compaction Operation

The compaction was obtained by dropping a 5' diameter steel tank filled with reinforced concrete onto the road surface by use of a crane (See Figures 1 and 2). The 10 ton weight was typically dropped 8 times per location from a height of 25 feet. The number and height of drops were varied on part of the third site for comparative purposes. Drop locations were generally spaced 15 feet apart in each wheelpath; this was reduced to 7-1/2 feet on part of the third site.

\* More precisely, the block was attached to an old tire, which was attached to the tamper. The tire protected the pulley block from damage by acting as a shock absorber (see Figures 1 and 2).

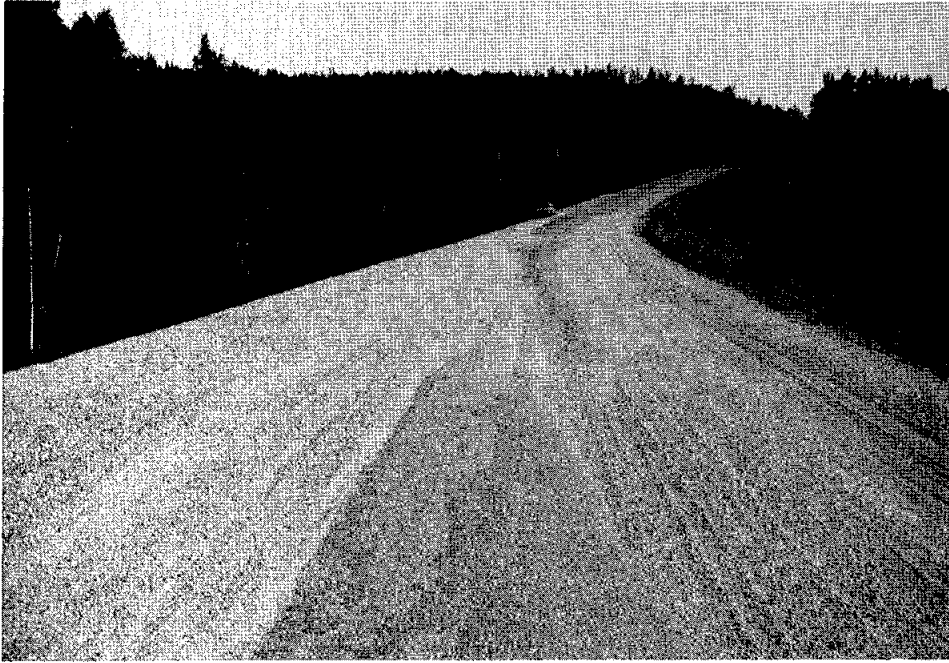
Figure 4.  
7-Mile Test Site

The first test site is located 7 miles from Fox (see photo, Figure 4). The road alignment at the site crosses a small, east-facing drainage. The road at the site is in both a horizontal and sag vertical curve. The centerline fill depth exceeds 25 feet at the bottom of the sag<sup>1</sup>.

Throughout this test area, the embankment was thicker than the expected depth of density improvements from the dynamic compaction (see "Discussion of Test Results" below). The densification was thus expected to be entirely in the fill material. Borings showed this to be 1" maximum diameter gravel mixed with sand and traces of silt near the surface. Maximum size increased, and sand and silt content decreased, with depth. All of the material encountered (up to 18' depth) was thawed.

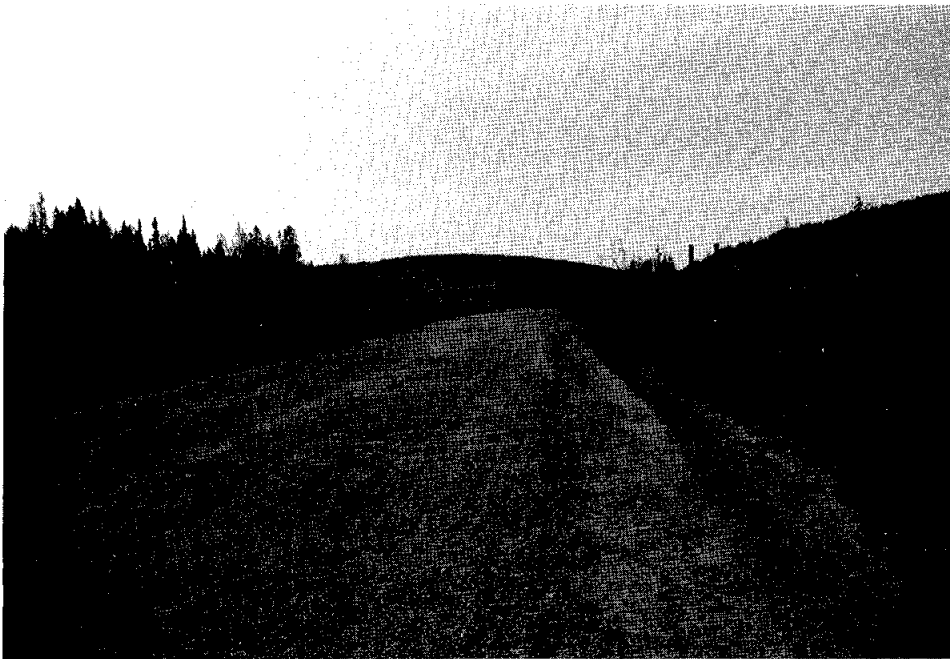
Figure 5.  
1-Mile Test Site

The second and third test sites are both located at approximately 1 mile from Fox (see Figure 5), where 1,500' of roadway was divided into five 300' sections. The second and fourth of these were test sections; the remainder are control sections. The entire 1,500' length is a straight, almost level fill section, with embankment depth at centerline ranging from about 9 to 15 feet.

Borings showed the fill material to be gravels similar to those found at the first test site. Moisture content was low near the surface ( $\approx 2\%$ ) and increased to nearly saturated at the bottom of the fill. 1-1/2 to 2 feet of material at the bottom of the fill was frozen when borings were made on July 1, 1985. This is presumed to have thawed by the time the compaction was done (almost a month later).

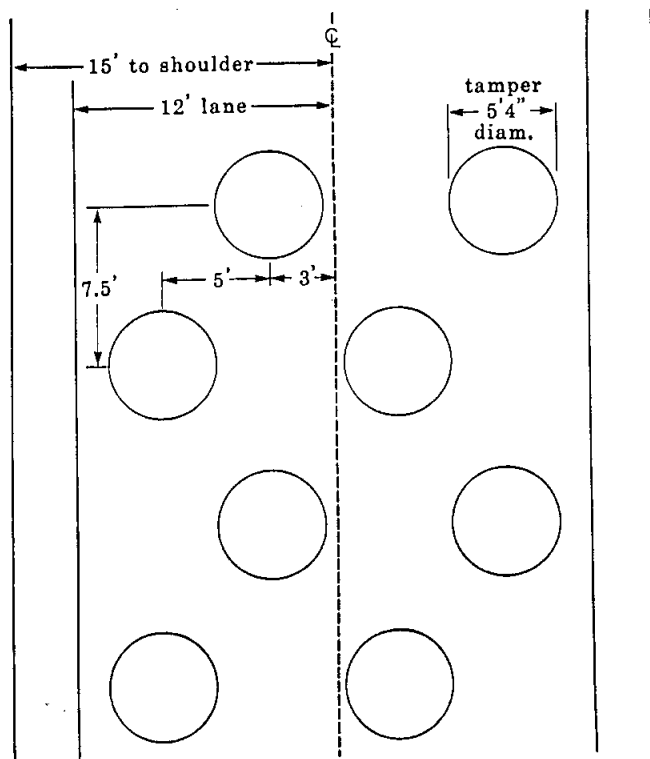
Dynamic Compaction Crater Spacing Plan

Work began on the afternoon of July 23, 1985. The afternoon was primarily a learning experience, as none of the personnel were experienced in the work. Only one crater was completed. The next morning measurements were made of crater depth after each drop of the tamper for the first few crater sites. The elevation of the area surrounding the craters was also measured before and after compaction to check for heaving. Based on the measurements, it was decided to make eight drops from 20' at each crater site, with the craters spaced 15' apart in each of the four wheelpaths along the length of the road (see Figure 6). This pattern was followed throughout the demonstration at the first site. The procedure followed was to work on two wheelpaths (i.e. one lane of the road) at a time; flagmen directed traffic past the site in the other lane when drops were not being made. Work at the first site continued through July 25, by which time 77 craters spaced over 285 feet of roadway had been completed.

The second site was compacted on July 26. Crater spacing and the number and height of drops at each crater site were identical to that of the first site. Seventy-eight craters were completed that day, substantially completing compaction of the 300 foot section.

The final day of dynamic compaction demonstrations was July 27th. Sixty craters were completed that day spaced over 230 feet of roadway at the third test site. Crater spacing was reduced from 15 feet to 7-1/2 feet in each of the four rows for a short (25') section of roadway at the site. At another section (50' long) drop height was increased to 30' (from 20') and the number of drops per crater site was reduced to 5 (from 8). At the remainder of this test site, the pattern used at the previous two sites was used.

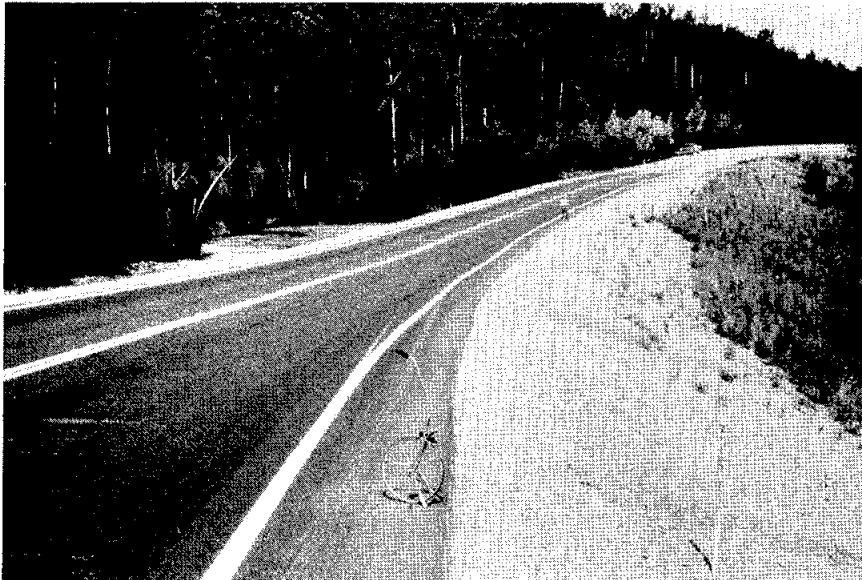
Figure 7.  
7-mile Test Site, 9 Months After Completion

The test sites and adjacent control areas were inspected in June 1986, nine months after the paving was completed on the reconstructed road. At this time, all test and control areas appeared in nearly new condition (see Figures 7 and 8). No substantial distress of any kind was observed in the roadway.

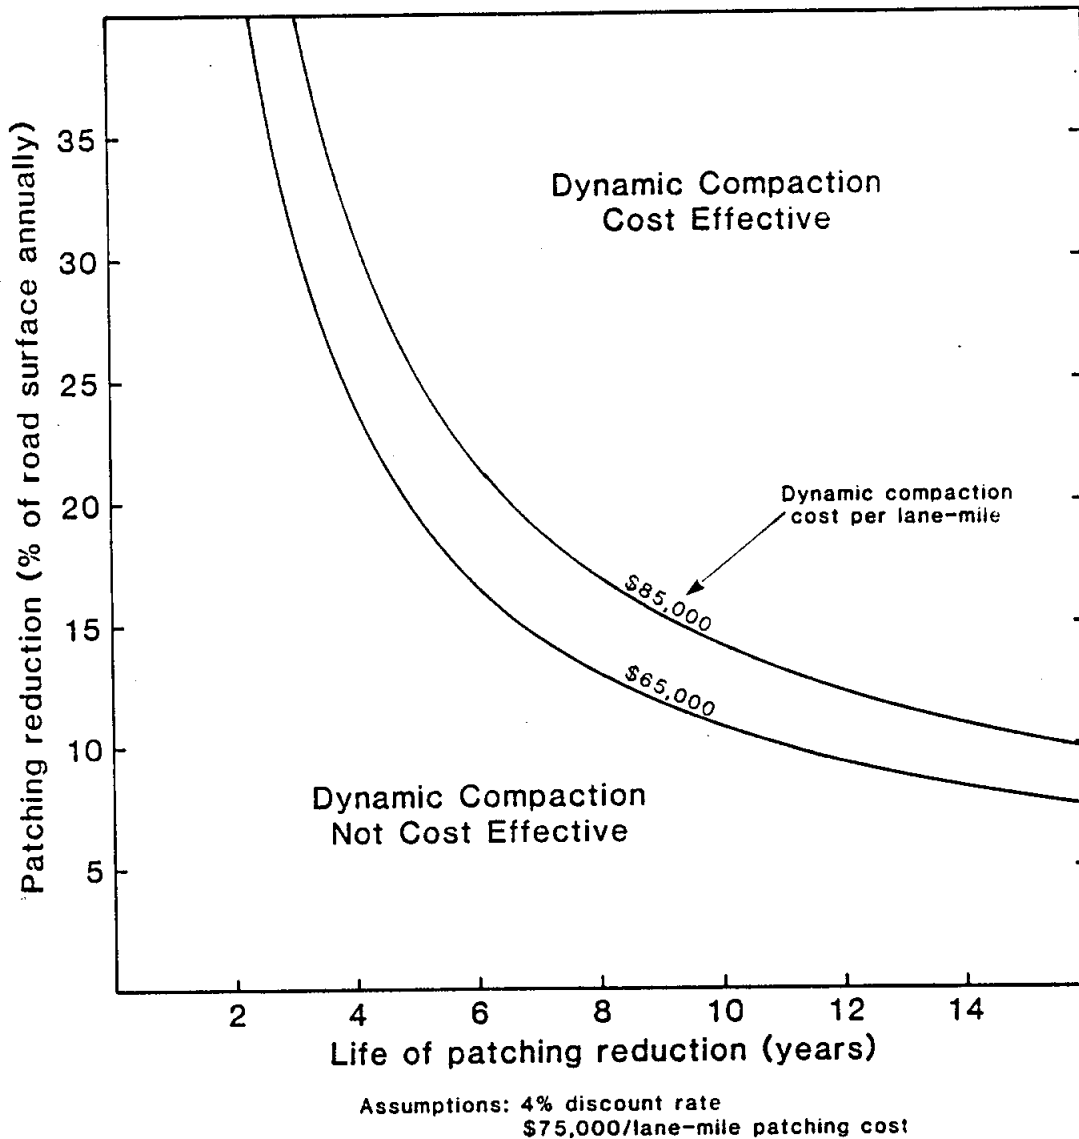
Figure 9.  
 Cost Effectiveness  
 (Based on a Period of Reduced Patching)

The magnitude and longevity of maintenance cost reductions required to make dynamic compaction a cost effective procedure is shown in Figure 9, based on these cost estimates and a 4% discount rate.

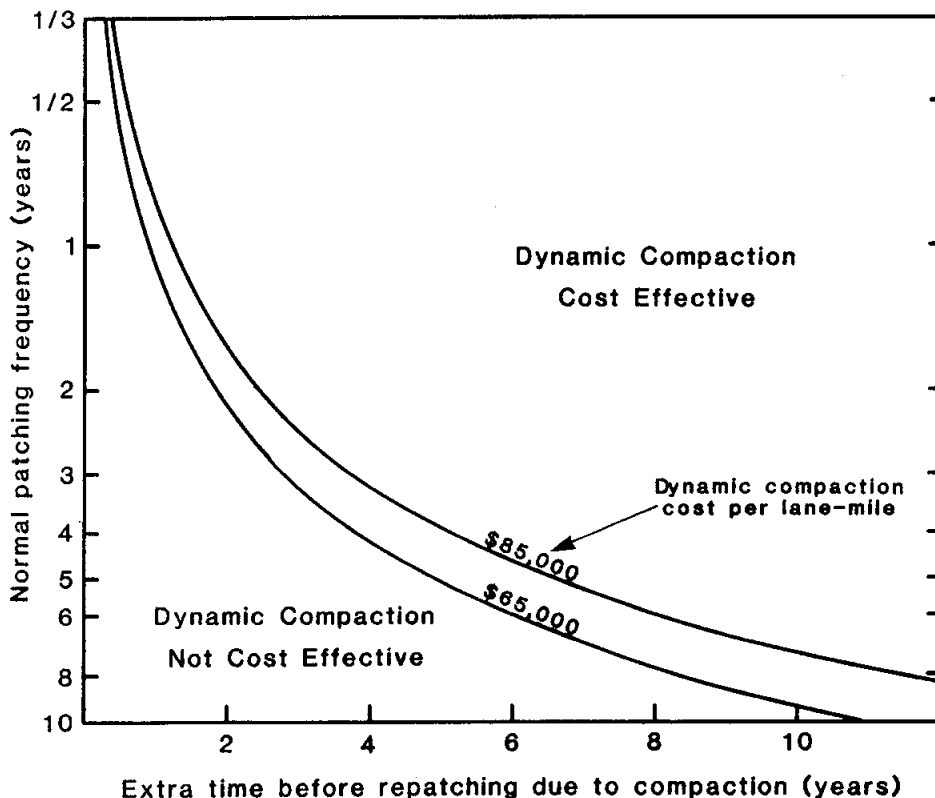
Figure 10.  
Cost Effectiveness  
(Based on Extension of Time Until Repatching is Required)

The results of such an analysis are shown in Figure 10 again based on assumptions of \$75,000 per lane-mile patching costs and a 4% (real) discount rate.

Assumptions: 4% discount rate  
\$75,000/lane-mile patching cost

It will be some time before there are sufficient results in from the dynamic compaction test sites to make a good judgement as to the treatment's success. It appears from the analyses above, however, that the prospects for such success are reasonably good. At \$65,000 per lane-mile, for example, dynamic compaction appears to be cost effective if a road which would otherwise need to be patched in three years did not need patching until five years after treatment. Roads in most locations do not need major patching with anything like this frequency. There are, however, a significant number of "problem areas" in Interior Alaska where roads crossing ice-rich permafrost require this level of effort.

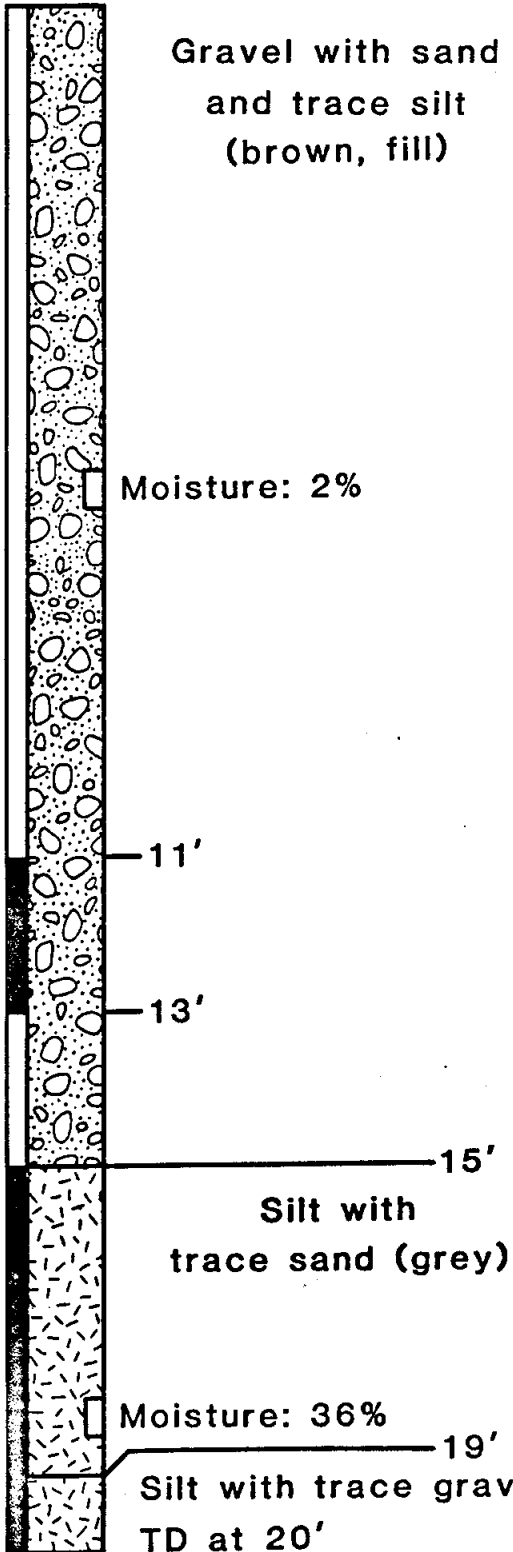
## SITE 3 STATION 53+40

# Figure A-2: Boring Logs, Sites 2 & 3

Frozen grey silt with traces of sand and/or gravel was encountered below the fill. Moisture contents of this frozen material were between 30 and 40 percent; no segregated ice was observed.
