# ALTERNATE VERTICAL SHEAR REINFORCEMENT IN PRESTRESSED CONCRETE BEAMS: FINAL REPORT

William R. Burkett, W. Pennington Vann,  
Rafael Cedeno-Rosete, and Selim Turkyilmaz

Department of Civil Engineering  
Texas Tech University

Texas Department of Transportation

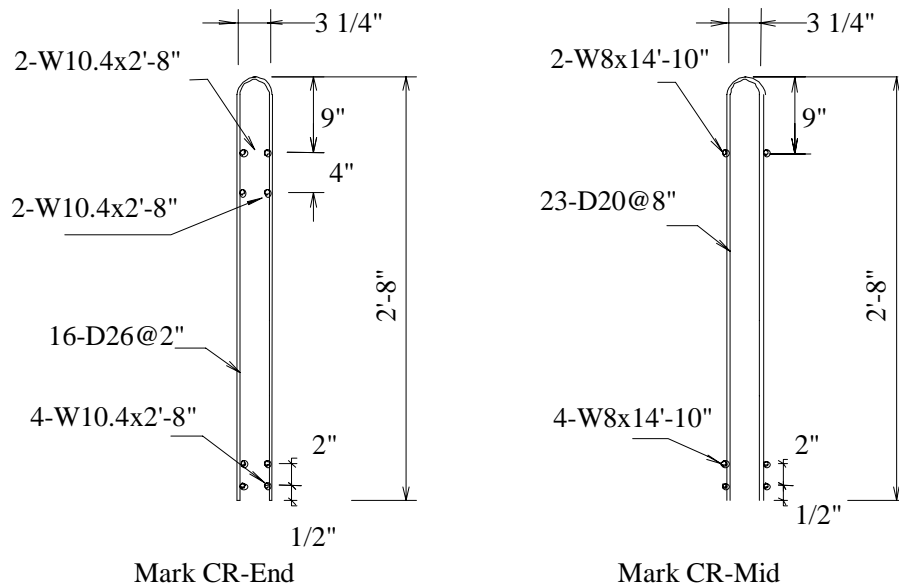
**Figure 2.5** Simplified WWF Detail

end region into a single size wire with an equal area of steel. Thus D26 wires were placed at 2-inch c/c spacings in lieu of alternating D20 and D31 wires every 2 inches. The Simplified WWF reinforcing detail steel used a 60 Grade design wire value. However, it should be noted that the wire actually comes as a 70 Grade wire even if 60 Grade is specified. The basic wire material starts as a 60 Grade but when the first cold drawing occurs to make the wire the proper size, the wire material properties increase to a 70 Grade. Test specimens fabricated using the Simplified WWF detail were made using NSC and HSC as shown in Table 2.1.

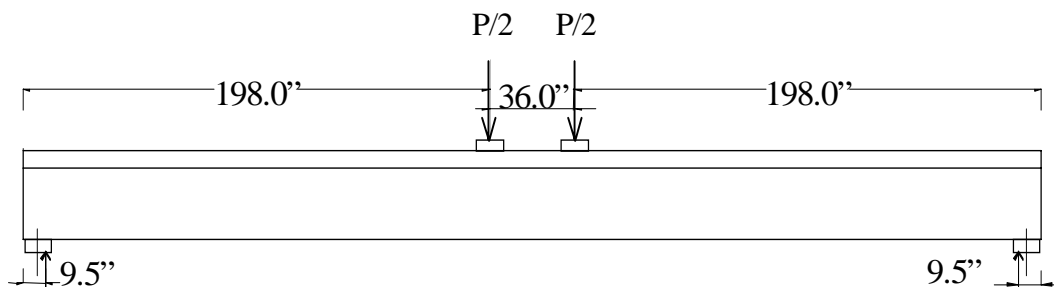
**Figure 2.14** Configuration for the Middle Region Flexural Test

One specimen of every pair, except pairs No. 8 and No. 9, was tested for flexural behavior by supporting it at its ends and applying two symmetrically centered loads as shown in Figure 2.14. This test was conducted to demonstrate the type of structural performance for which such a prestressed bridge girder is primarily designed; that is, sized and reinforced to prevent flexural failure. It may be noted that the assumed locations of the end supports were 9.5 inches from the ends of the girder. This assumption was based on the use of an 11-inch wide elastomeric bearing pad and the assumption of a triangular reaction stress pattern on the inside 6 inches of the support pad, as shown in Figure 2.15. The two equal loads were three feet apart symmetrically placed about the midpoint of the specimen. The two applied loads were only allowed to cause an internal moment that slightly exceeded the theoretical ultimate moment capacity of the specimen but that was less than its actual failure moment. The specimen was not completely failed in flexure. This approach allowed later testing of each end of the flexural specimen in shear.

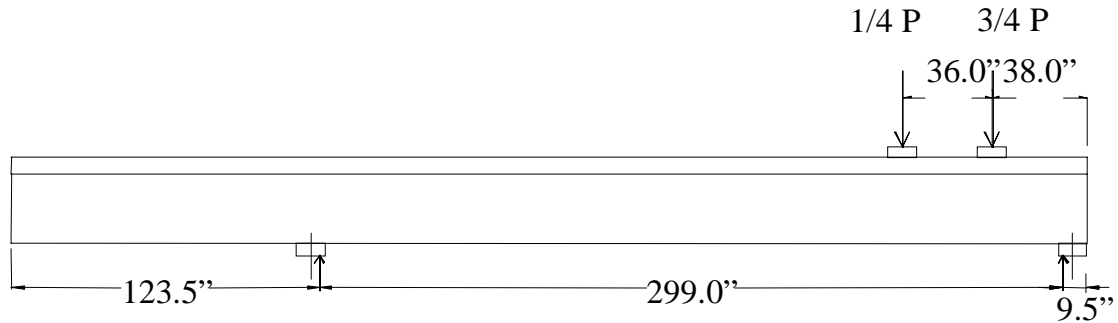
**Figure 2.16** Configuration for the First End Region Shear Test

The first end region shear test was one of the three load conditions used to specifically study the shear behavior of the WWF reinforcement, and it is illustrated in Figure 2.16. It had two unequal loads that were three feet apart placed near the right end of the beam. Here the applied load nearest the end of the specimen was only 38 inches from the end, which was the location of the transition point between the first and second end regions. The three-fourths/one-fourth load ratio for “P” shown in Figure 2.16 was used to provide an approximately constant moment region between the load points during the second and intermediate end region shear tests. This ratio was maintained during the first end region shear tests for consistency. This choice was important in limiting the peak moment in the second and intermediate end region shear tests so that a premature flexural failure could be avoided if possible.

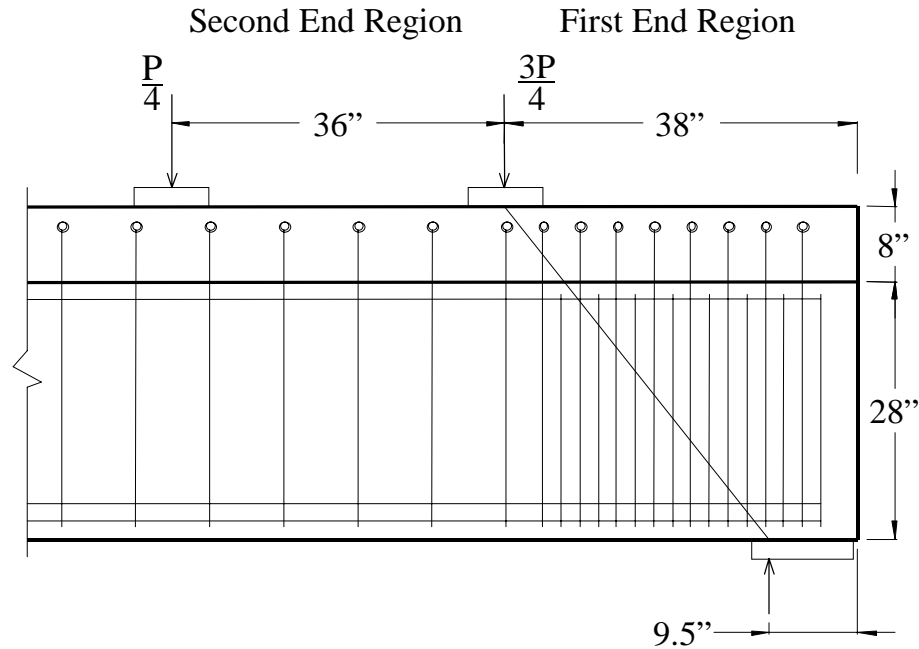
**Figure 2.17** Expected Cracking Behavior in the First End Region Shear Test

A detailed view of the load positions and shear reinforcement for the first end region test is shown in Figure 2.17. This load arrangement should have caused a shear failure in the first end region if the added S-bars did not contribute to the shear strength, as assumed in the calculations. A diagonal compression strut effect could also develop between the pad support and the first applied load. It should be noted that the placement of the left support ten feet from the left end in Figure 2.16 had essentially no effect on the right end shear test behavior. At the shear failure load, the maximum moment was the same no matter where the left-hand support was placed if the load positions were the same and the dead weight of the beam was neglected. The chosen location of the left-hand support assured that a pristine segment of the left end of the beam was not affected by the loading of the right end except for dead weight effects. The 10-foot long segment cantilevered over the left-hand support was the longest possible segment without causing negative moment problems in the left end of the specimen.

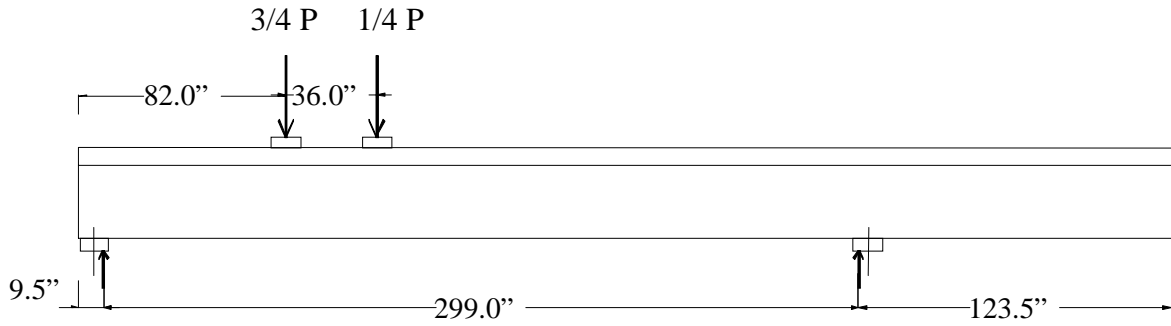
**Figure 2.18** Configuration for the Second End Region Shear Test

The second end region shear test was another of the three load conditions used to specifically study the shear behavior of the WWF reinforcement, and it is illustrated in Figure 2.18. It had two unequal loads three feet apart placed near the left end of the specimen. Also, the support for the right end of the beam was not at the very end of the specimen but about ten feet from its right end. This was done to remove the right end of the beam from the load path since the right end of the beam was previously tested to failure during the first end region shear test, which was always conducted prior to the second end region shear test.

The purpose of this set-up was to test the shear cracking and shear strength of the “second end region” on the left end of the specimen. The placement of the loads was carefully selected to develop a shear failure in the second end region without too much risk of a flexural (rather than shear) failure and without having any diagonal shear cracks that would develop in the second end region end up at their lower left extremity in the first end region.

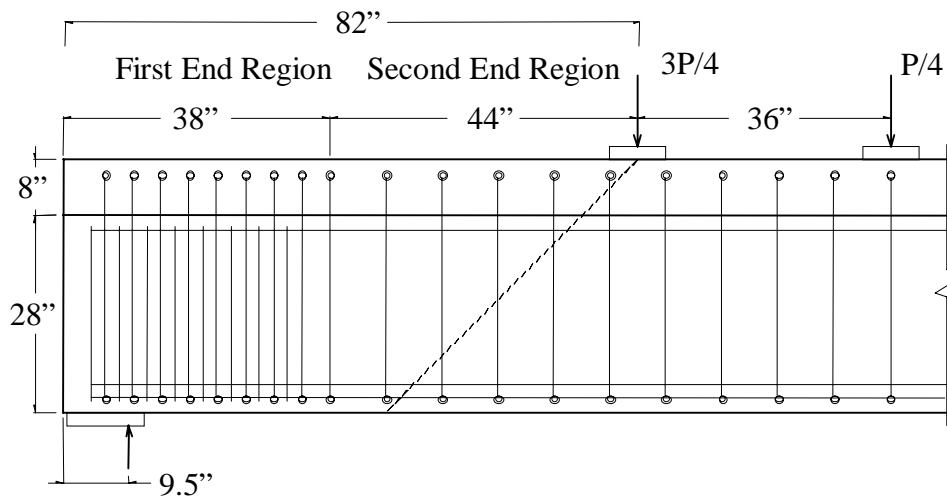
**Figure 2.19** Expected Cracking Behavior for the Second End Region Shear Test

The dashed inclined line in Figure 2.19 illustrates how the cracking was expected to appear in relation to the end support, the two applied loads, and the shear reinforcement in the second end region test. The load nearest the end was again made to carry three-quarters of the total applied load  $P$ , so as to produce an approximately constant moment region between the loads. With this configuration, the theoretical moment capacity was at least 19 percent larger than the applied moment throughout the length of the beam. This 19 percent margin of safety against a moment failure instead of a shear failure could not have been maintained if the loads had been moved farther to the right. On the other hand, it was desirable to place the loads farther to the right to make the expected 45-degree shear cracks in the second end region reach the bottom of the beam before intersecting any of the vertical bars in the first end region. As shown in Figure 2.19, with the larger applied load 82 inches from the end of the beam, a 45-degree crack starting at that load would reach the bottom of the beam before reaching the second R-bar of the second end region. Thus, the effect of such a crack on the anchorage of that bar, as might occur in a real beam in service, would be fully tested.

The configuration of Figure 2.19 made the failure truly representative of the shear strength of the second end region, including the anchorage of the R-bars in that region. However, the second end region shear test configuration shown in Figure 2.18 and Figure 2.19 was not maintained for all of the second end region tests. The first test with this configuration conducted on the flexural specimen of Beam Pair No.1 failed in flexure rather than shear in spite of the 19 percent margin of safety predicted by the AASHTO equations. Accordingly, the loads were moved so that the closest one was only 74 inches from end of the specimen in the next second end region shear test, which was conducted on the flexural specimen of Beam Pair No. 2. When it again failed in flexure, despite a 26 percent margin of safety against premature flexure failure, the loads were again moved so that the closest one was only 66 inches from the end of the specimen for all the remaining second end region shear tests. This position was the closest that could be used without having a 45-degree shear crack, coming down from the 3/4 P load point, intersect more than two R-bars in the first end region. This final position gave a margin of safety against premature flexural failure of 40 percent.

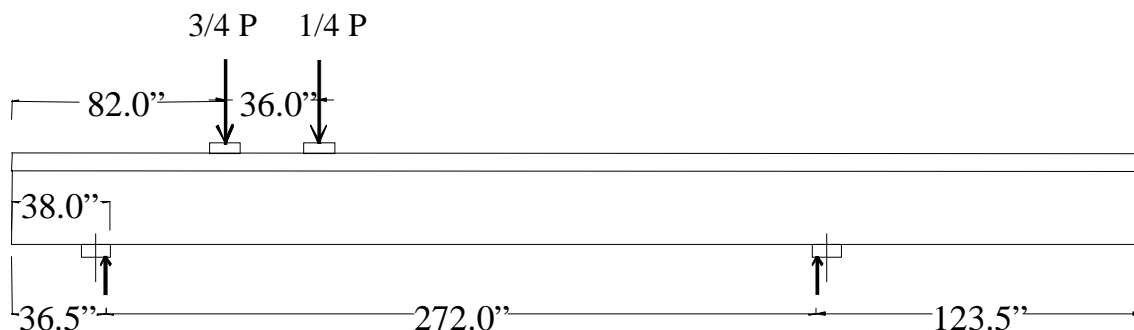
**Figure 2.20** Configuration for the Intermediate End Region Shear Test

The intermediate end region shear test was the last of the three load conditions used to specifically study the shear behavior of the WWF reinforcement, and it is illustrated in Figure 2.20. Three of the last four beams of this study were tested using this modified second end region test. It involved shifting the position of the left support as well as the load points. It provided an alternative to the second end region type of test by moving the left support to the inner edge of the first end region in order to reduce the bending moment in the second end region. Reducing the applied bending moment in this way greatly increased the probability of getting a shear failure instead of a flexural failure where there were only R-bars at an 8-inch spacing. The purpose of this set-up was to fail the specimen in shear in the second end region and observe the relative behavior of the WWF and the traditional shear reinforcement. Figure 2.21 shows a detail of the left support and how the expected 45-degree shear cracking would appear in relation to the end support, the two applied loads, and the shear reinforcement in the first and second end regions.

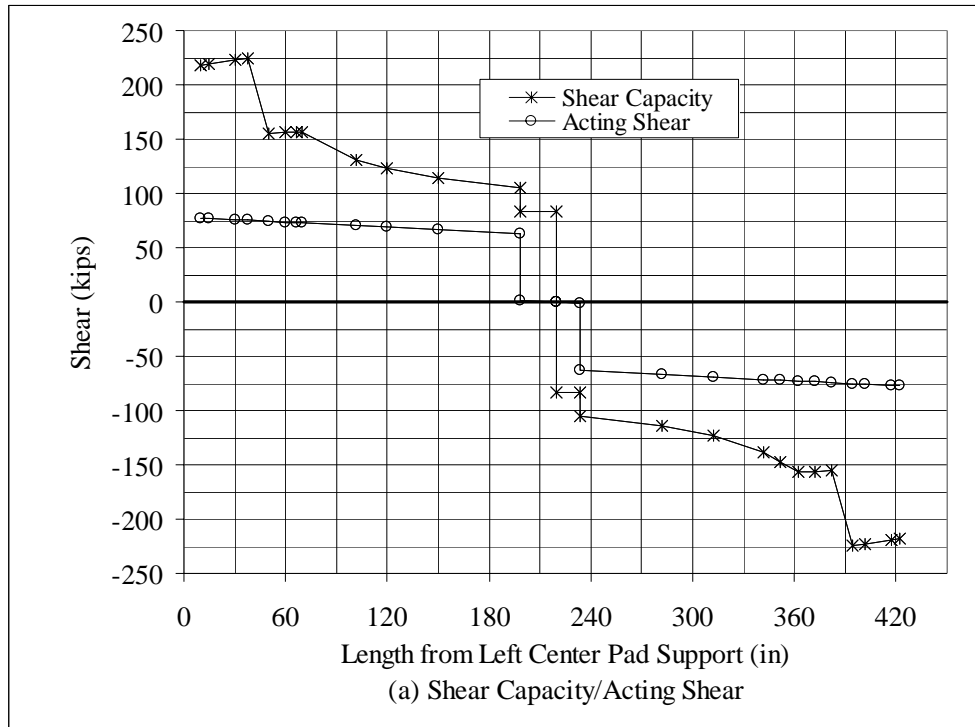
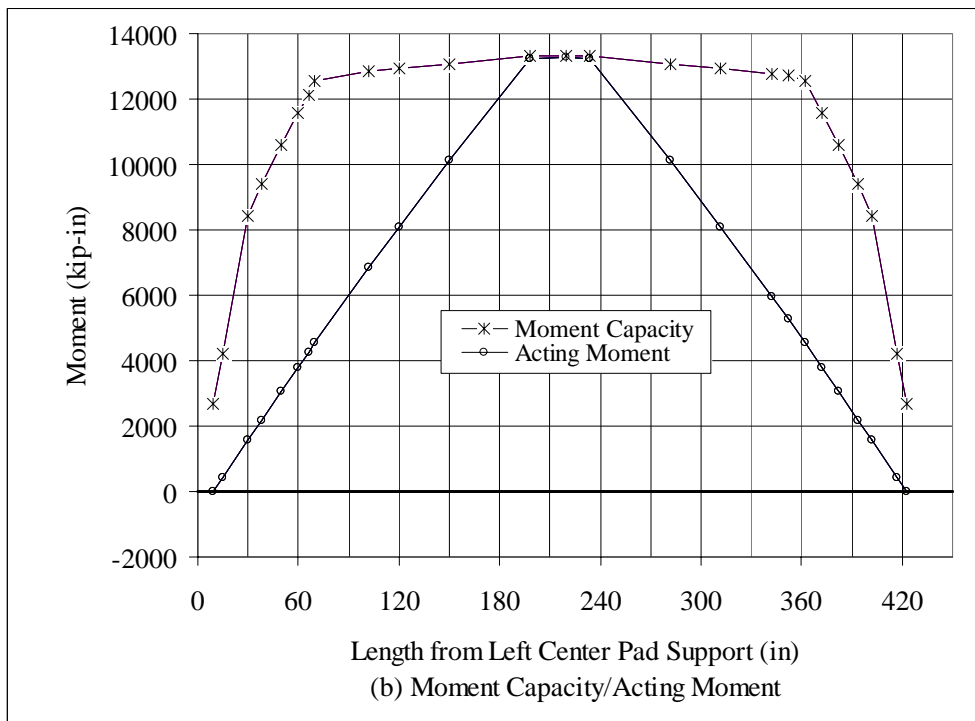
**Figure 2.22** Applied and Resisting Shears and Moments: Flexural Test

Part (b) of Figure 2.22 shows that the moment capacity is less near each end due to the reduced strand effectiveness in the transfer and flexural bond regions of the development length. Still, there is a sizable factor of safety against moment failure everywhere except

near the center. Similarly, Part (a) of Figure 2.22 shows that there is a sizable factor of safety against shear failure everywhere in the beam, even though the shear capacity varies quite a bit throughout the length.

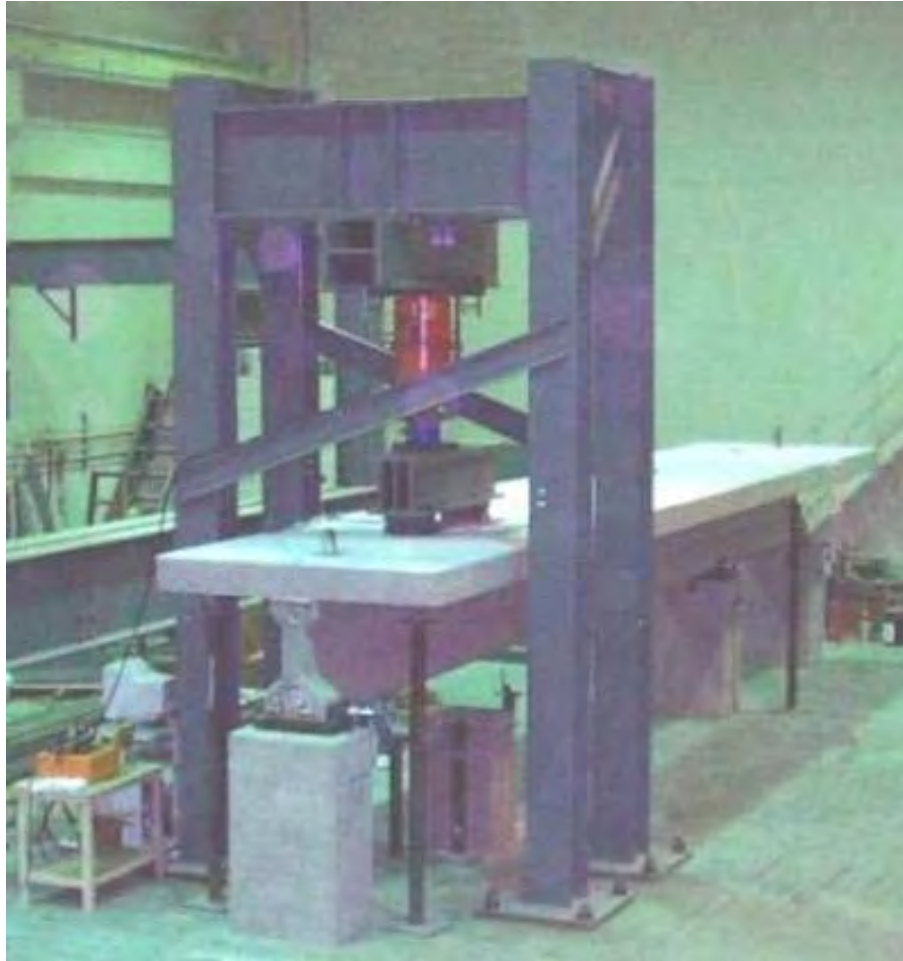
During any one of the 4 basic types of load tests that were conducted during this project (middle region flexure test, first end region shear test, second end region shear test, or intermediate end region shear test), similar steps were followed. A view of the general test setup is shown in Figure 3.1. Each specimen and its support pedestals were properly located and aligned on the structural test deck in the horizontal, longitudinal, and vertical directions. Once proper alignment was achieved, 3-inch thick elastomeric bearing pads were placed between the specimen and the 48-inch tall support pedestals to allow longitudinal movement and rotation at the supports during loading. A 1/4-inch thick bearing pad was also placed on top of the concrete deck slab at each of the two load points to provide even bearing pressures between the top surface of the concrete deck slab and the bottom surface of the steel rocker bearing plates located at each end of the load spreader beam. Once the spreader beam was properly aligned, the load frame containing a hydraulic ram, described in Section 3.4, was located over the specimen and bolted down to the structural test deck. Once the instrumentation and the data acquisition system was in place, loading of the specimen was completed as described in Section 3.4. During middle region flexural tests, the specimens were loaded to magnitudes that caused internal moments greater than their theoretical ultimate moment capacities but not to failure to allow additional testing to be conducted on the flexural specimens. All first, second, and intermediate end region shear tests were loaded to failure. After a test was completed, the load frame and supports were moved to new locations along the length of the specimen, if additional tests were to be conducted on the specimen, and the overall setup and test procedure were repeated. If no additional test(s) was to be conducted on the specimen, all the instrumentation and load equipment were removed, and the specimen was lowered onto the test deck for demolition and disposal. Once the specimen was removed, another I-beam was set in place and the overall process was repeated until 43 load tests had been completed on 18 specimens.

**Figure 3.1** General Test Setup

Load was applied to each specimen using a Power Team, Model RD50013, hydraulic ram having a 1,000-kip rated capacity at 10,000 psi, an effective cylinder area of 99.402 square inches, and a 13-inch stroke. As shown in Figure 3.1, the ram was attached to the reaction load frame that was bolted down to the structural test deck by 16, 2-inch diameter, high strength threaded steel rods. The structural test deck has a 30-foot by 60-foot floor area and a 2-foot center-to-center grid of tie-down points to provide adequate movement and alignment of the load frame. Hydraulic pressure was provided to the ram via a pneumatically actuated, manually controlled, Power Team, Model PA6D, hydraulic pump rated for 10,000 psi. The ram transmitted its load to the test specimen via a steel

spreader beam. This beam was supported on top of the specimen by two bearing plates that were 3 feet apart and centered over the longitudinal axis of the I-beam. The locations of these two bearing plates represent the two load points shown in the various test configurations in Chapter 2. The magnitude of the total load that went to each load point was controlled by the location of the ram with respect to the bearing plates at each end of the spreader beam. Final longitudinal alignment of the ram was accomplished after the load frame was bolted to the structural test deck. The final alignment of the ram was accomplished via a roller system between the ram and the overhead cross-beam seen in Figure 3.1. For all middle region flexural tests, the ram was centered between the bearing plates, resulting in two equal point loads and a constant internal moment region in the test specimens between the two load points. For all of the shear tests, the ram was positioned so that  $\frac{3}{4}$  of the ram load would be transmitted to the bearing plate closest to the end of the test specimen and  $\frac{1}{4}$  of the ram load would be transmitted to the other bearing plate. This load distribution was selected to provide an approximately constant internal moment region in the specimens for the second end region shear tests and was maintained for consistency in the first and intermediate end region shear tests.

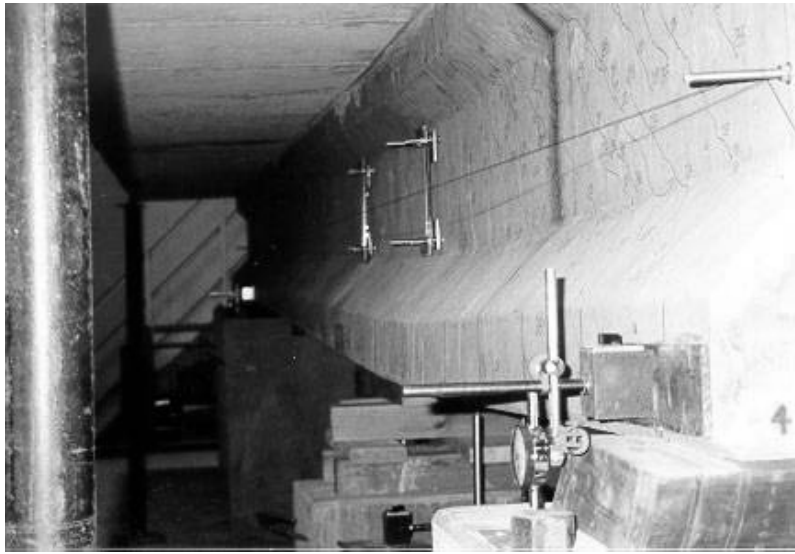
A taut piano wire attached to the beam provided another source of information for the two vertical displacements of the specimens, maximum elastic and plastic. The piano wire was attached to a hilty bolt at the mid height of the web and centered over each support bearing pad. Thus, its end points moved as the supports settled. A straight chalk line previously drawn on the web of the beam behind the wire gave a visual reference line.

Scales with a precision of a hundredth of an inch and mirrors were attached to the beam at the elastic and plastic displacement points to furnish the numerical displacements values. By taking scale readings at every load increment, changes in vertical displacement could be determined. The mirrors were used to insure a horizontal line of sight between the wire and the scales. Vertical deflections determined from this method were deformations of the specimen itself since the ends of the wire moved as the elastomeric bearing pads settled at the supports. This arrangement also provided a visual sense of the deformed shape of the specimen throughout the load sequence. Figure 4.2 shows a view along a beam of this wire gage instrumentation.

**Figure 4.2** Wire Gage Deflection Device

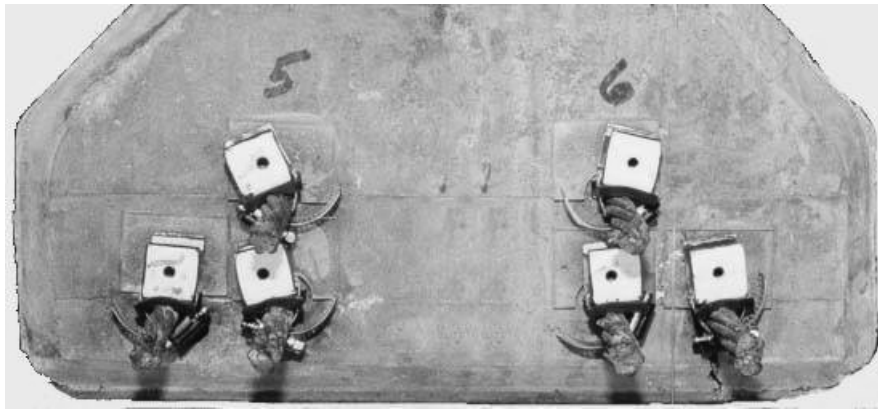
**Figure 4.3** End-Slip Measurement Brackets

Strand end-slip measurements were taken during first and second end region shear tests to monitor the potential for an impending bond-slip failure. End-slip measurements were only taken during first and second end region shear tests in which the maximum internal moments occurred within the theoretical development length of the strand. Strand end-slip measurements were initially taken at every other load increment until significant slippage began to occur, and then they were taken at every load increment. A small plastic plate glued to the concrete surface on the end of the beam provided a smooth reference surface. With a digital caliper, the length between the face of a bracket clamped to the strand and the plastic surface was read for each of the monitored strands. Initial readings at zero load were the references for future readings. Changes in readings represented strand end-slip. Figure 4.3 shows the setup of the metallic brackets attached to the strands. The small holes in the brackets provided consistent alignment of the digital caliper during measurements.

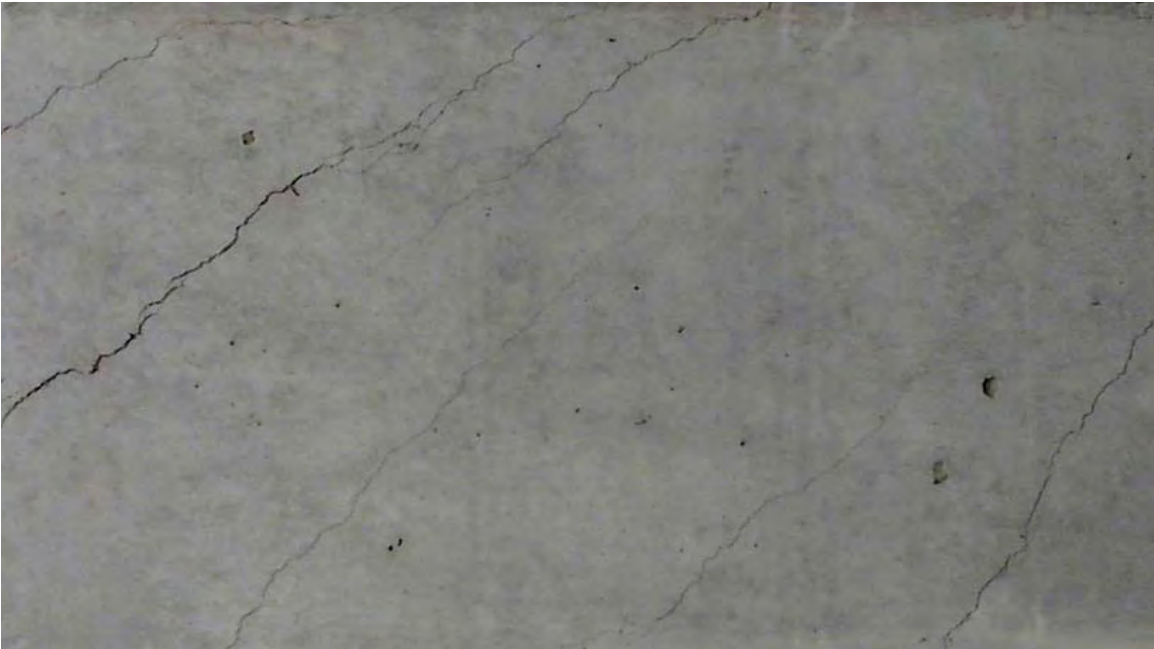
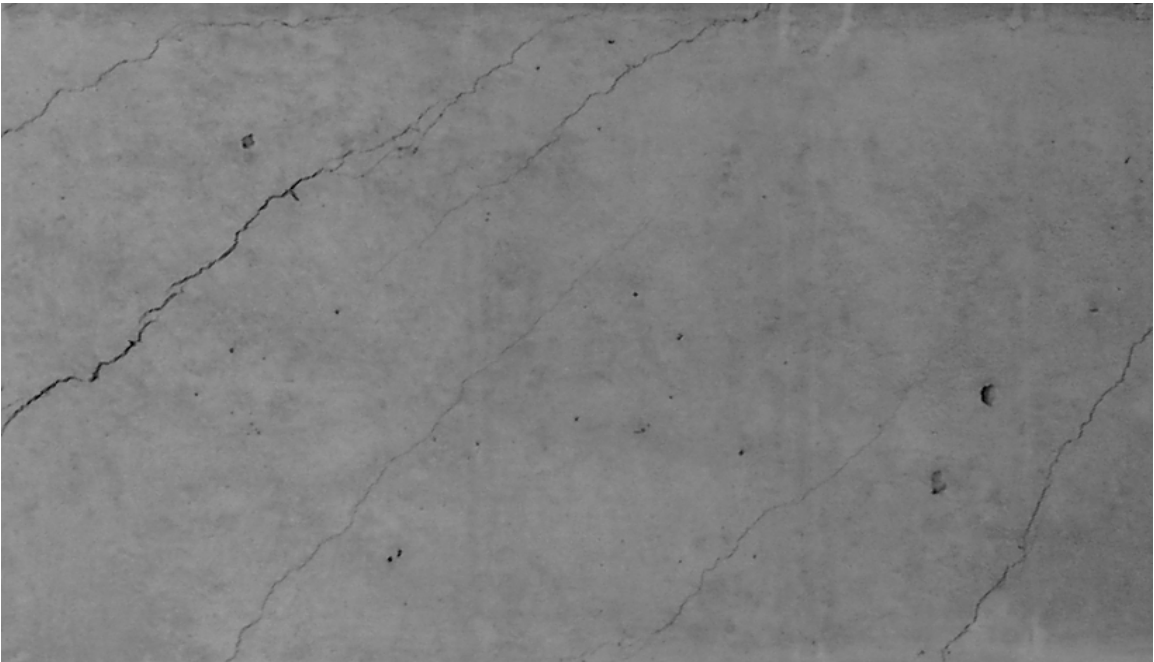
$$L_m = 0.229R + 0.587G + 0.114B \quad (5.1)$$

(a) RGB Image of Shear Cracks

(b) Corresponding Grayscale Image of Shear Cracks

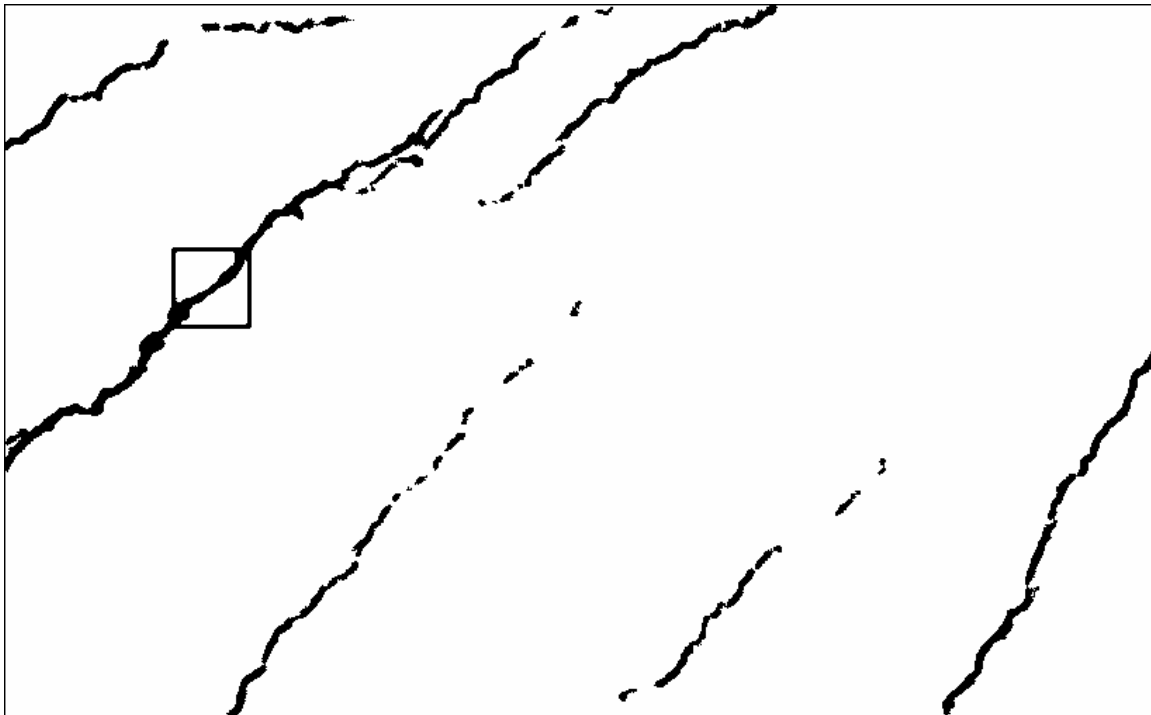
(a) Full Image

An edge-enhanced image consists of depictions of the boundaries of the cracks, and they generally are not completely solid representations. The crack bodies usually have hollows and white spots after edge detection. These affect the quantitative analysis of the image. For this reason, these openings in the cracks are filled for more accurate analysis. Figure 5.11 shows the resulting image of Figure 5.8 after the hole-filling algorithm.

**Figure 5.11** Images of Figure 5.8 after the Hole Filling Process

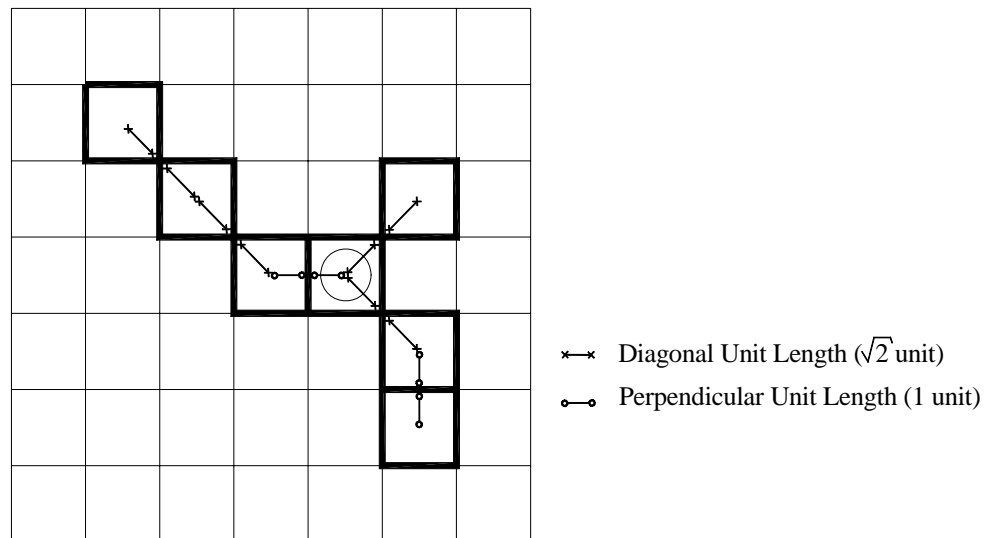
**Figure 5.14** Crack Length Calculation Process

Before starting to calculate the lengths, the cracks are first skeletonized. The skeletonization is simply done by applying the MATLAB thinning algorithm repeatedly until the crack width is only one pixel. A portion of a skeletonized crack with a branch is shown in Figure 5.14. After a crack is skeletonized, the lengths of the connections between the pixels are checked. For two vertically or horizontally connected pixels, the distance between the centers of the pixels is one pixel length. For two diagonally connected pixels, on the other hand, the length between the centers is the length of a pixel diagonal. The algorithm detects how many pixels are connected to each individual pixel and the directions of these connections. In the example of Figure 5.14, for the pixel in row 4 and column 5 there are three connected pixels. Two of them are connected diagonally and one is connected horizontally. Thus, two diagonal and one perpendicular pixel length contribute to the total length from this pixel.

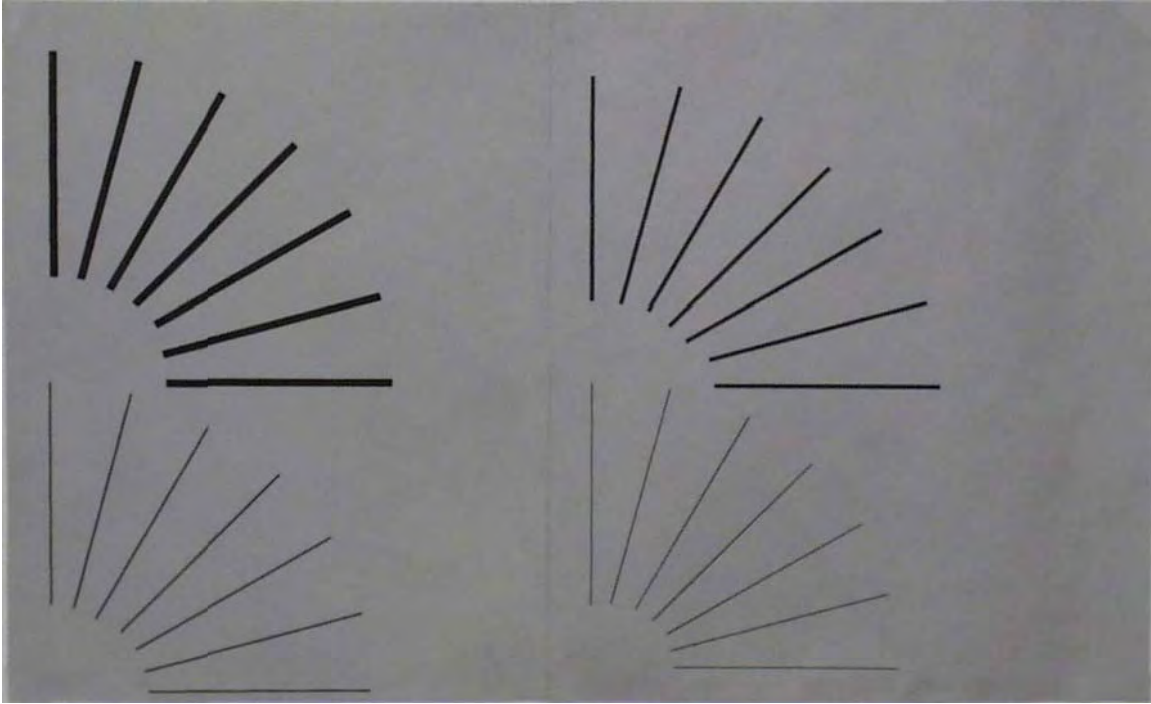
**Figure 5.15** Crack Quantification Control Image

A control image was processed to check the accuracy of the foregoing crack detection and quantification methods. The control image, as seen in Figure 5.15, consisted of a set of lines at different angles on a background similar to the beam web background. There were four groups of lines of equal length, with each group having a different width. These widths were: 0.1181 inches, 0.0591 inches, 0.0197 inches, and 0.0098 inches. Each group had lines with lengths of 3.54 inches at angles of  $0^\circ$ ,  $15^\circ$ ,  $30^\circ$ ,  $45^\circ$ ,  $60^\circ$ ,  $75^\circ$ , and  $90^\circ$ . The size of the image selected was the same as the standard image region of the beams, which was 11"x 18".

The “crack determined” image of Figure 5.15 by the method of Section 5.2 is shown in Figure 5.16. Careful examination of this figure reveals there are some slight breaks and discontinuities in the borders of the lines. An example of this effect for an inclined line, where the image must represent the line with a horizontal layout of pixels, is shown enlarged in the inset. Irregularities are also seen, however, in the lines that are theoretically perfect vertically and horizontally. It should be remembered in this regard that in taking a picture of a sheet of paper with a camera, it is impossible to align the camera exactly. Nevertheless, the important concerns in this process are the total crack areas and the average crack widths. These line edge deviations did not affect the results very much.

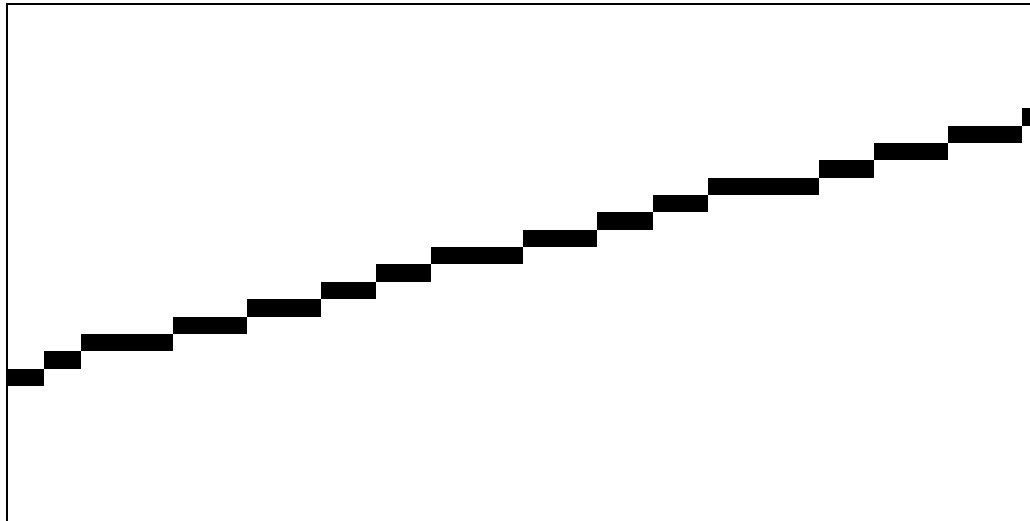
**Figure 5.17** Digital Image Representation of a 15° Straight Line

The errors in the lengths of the lines in the control image were, as expected, smaller than those for the widths. The maximum length error was found to be 6% among all of the lines. This error depended on the irregular inclination of the pixels at certain angles. Figure 5.17 shows the digital image representation of a skeletonized line at a 15° angle, for which the maximum error occurred. The vertical and horizontal arrangement of the pixel did not accurately calculate the length in this case.

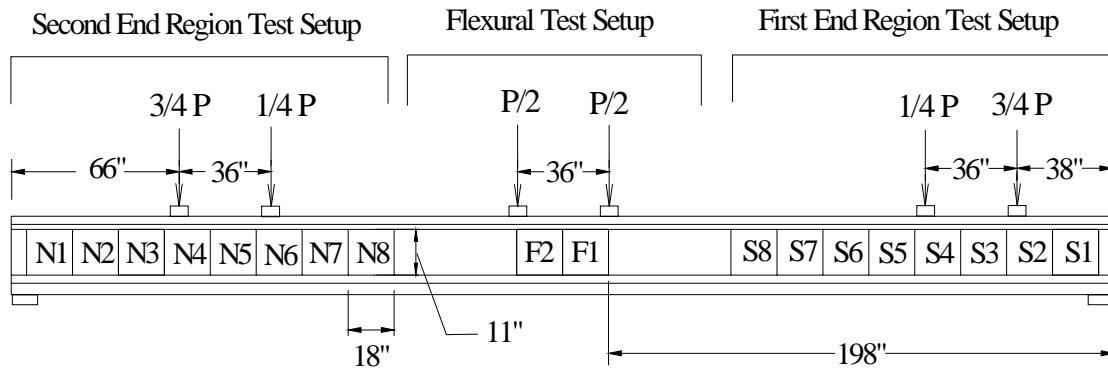
**Figure 5.18** Digital Image Regions Associated with the Load Conditions

not shown in Figure 5.18, the region numbers with respect to the support was held similar to the second end region shear test. Regions of primary interest are regions F1 and F2 for the middle region flexural tests, regions S1 and S2 for the first end region shear tests, and regions N1, N2, N3, and N4 for the second and intermediate end region shear tests. Digital images at common load levels for common test parameters were processed and compared using the techniques described in this chapter.

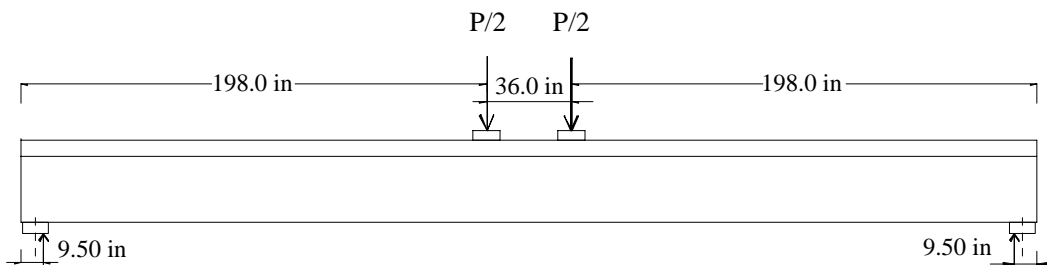
**Figure 6.1** Configuration for the Middle Region Flexural Test

The flexural tests were set up in a traditional way as shown in Figure 6.1. The 36-foot specimen was supported with standard elastomeric bearing pads on four-foot-high concrete pedestals, and the assumed effective length between vertical reactions was 413 inches. The two equal applied loads were centered about midspan and increased in predetermined load increments as described in Section 3.4. The total applied loads, LVDT deflections, and strain gage strains were recorded on the computer at each load increment, and dial gage deflections were hand recorded at the same intervals. Pictures of cracks were taken less frequently, both

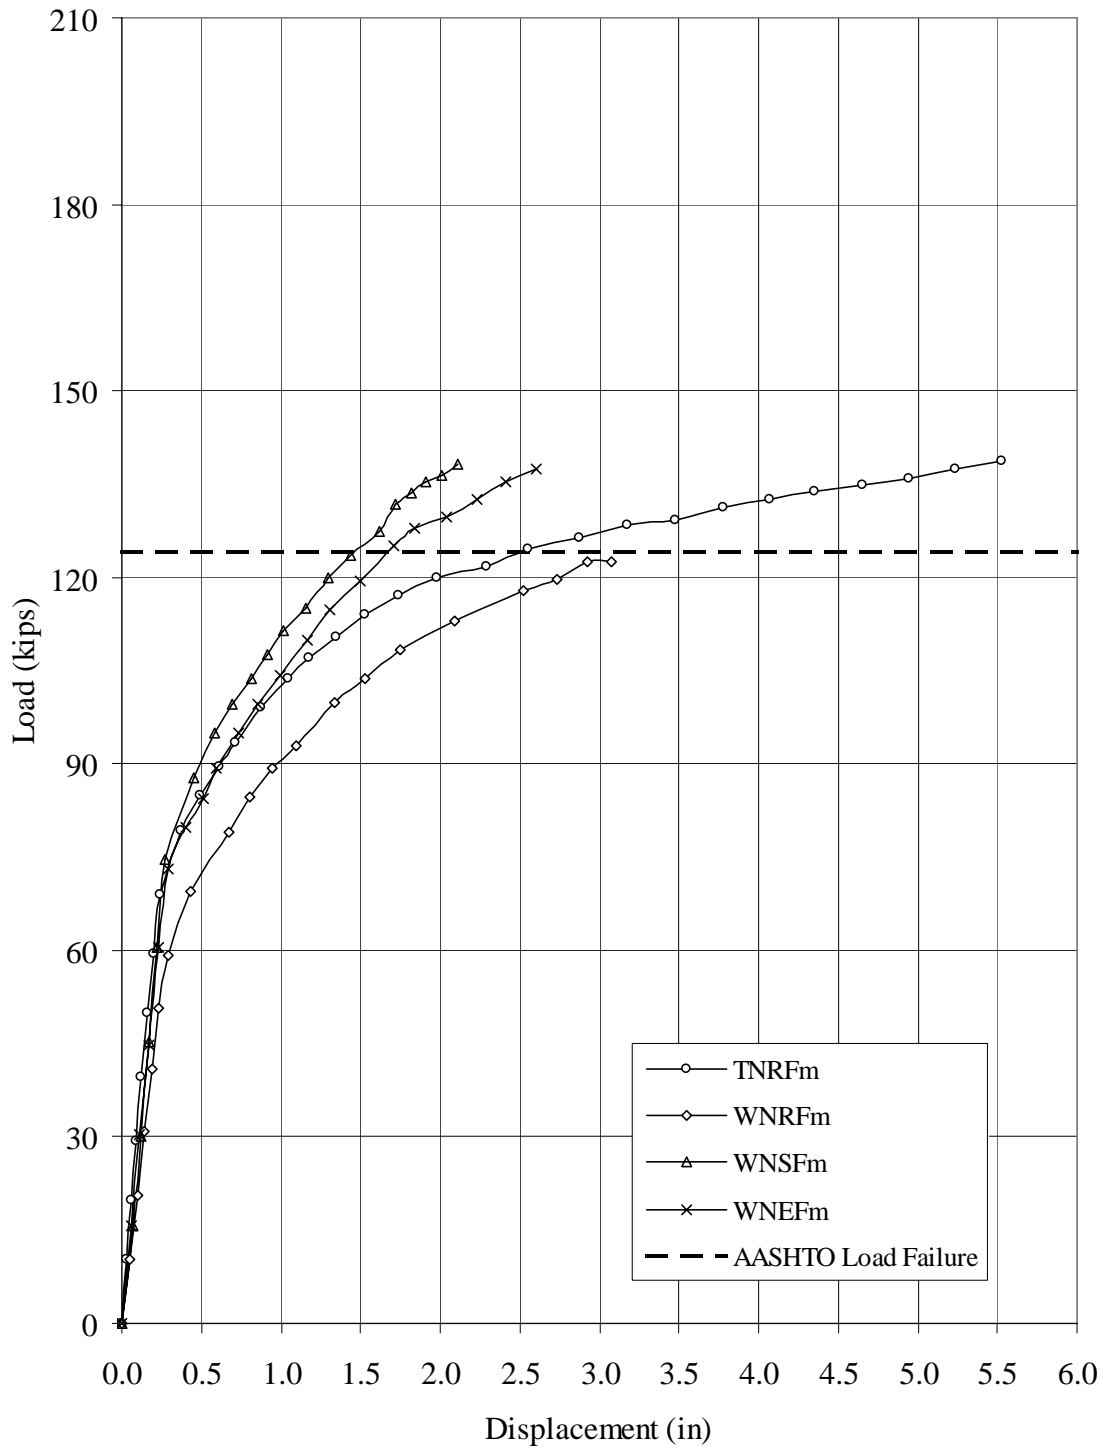
**Figure 6.2** Load-Deflection Curves for NSC Flexural Beam Middle Region Tests

Load-deflection curves for the four different NSC beams tested in flexure are shown together in Figure 6.2. The horizontal dashed line indicates the load corresponding to the AASHTO moment capacity for the nominal material properties for which the specimens were designed (6-ksi beam concrete, 5-ksi slab concrete, 270-ksi strand strength). All of the specimens reached the expected AASHTO moment capacity, although the stiffnesses and maximum deflections varied somewhat, as discussed below.

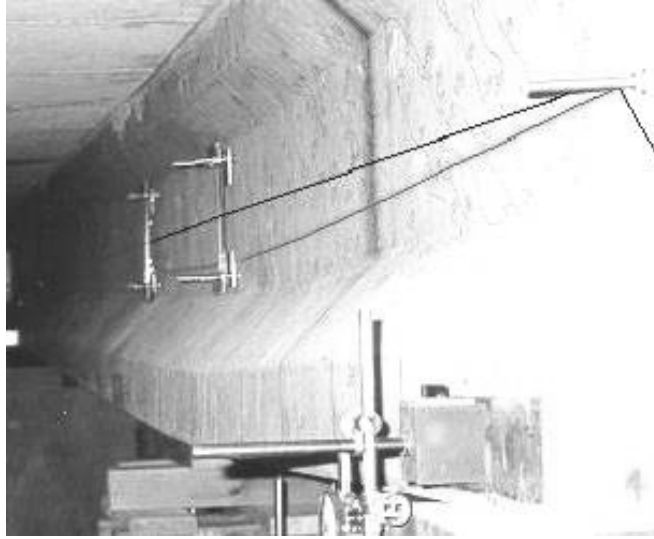
**Figure 6.3** Final Deflected Shape of the Specimen TNRm

One of the striking realizations that a person observing this test was bound to have was that the traditionally reinforced beam had a tremendous capacity to deform without failing. The 5.5-inch maximum deflection at the center of the beam at maximum load, shown from an end view in Figure 6.3, made a vivid impression on all observers that a prestressed concrete beam and slab is truly a ductile structural system in bending.

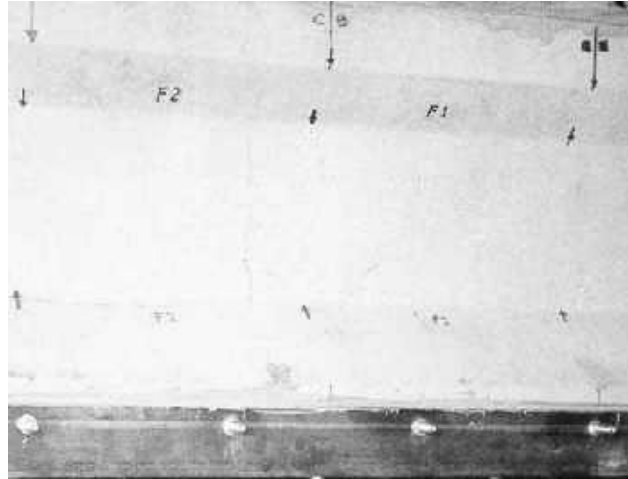
**Figure 6.4** Retrofitted Bottom Flange Reinforcement for Specimen WNR Fm

The reason for the early termination of this test in terms of its applied load was that a loud popping sound was heard at the last load shown, and it was feared that one of the strands had broken. Since the flexural strength of the specimen would be needed for subsequent shear tests on the end portions, the test was stopped at this point, and both corners of the lower flange were reinforced with angles to ensure safety during the later tests. This reinforcement is shown in Figure 6.4. As the result of later tests on the end portions of this and other beams, it was determined that the popping noise was not due to breakage of a strand, but instead was due to breakage of one of the lower longitudinal WWF wires used to complete the WWF cage and provide bottom anchorage of the stirrups. These wires naturally took tension in bending along with the strands. Thus, the test could have been continued to show that the full AASHTO load was exceeded and a larger ductility could have been achieved. However, in the first experience of the phenomenon of longitudinal WWF wire breakage, extra caution was exercised.

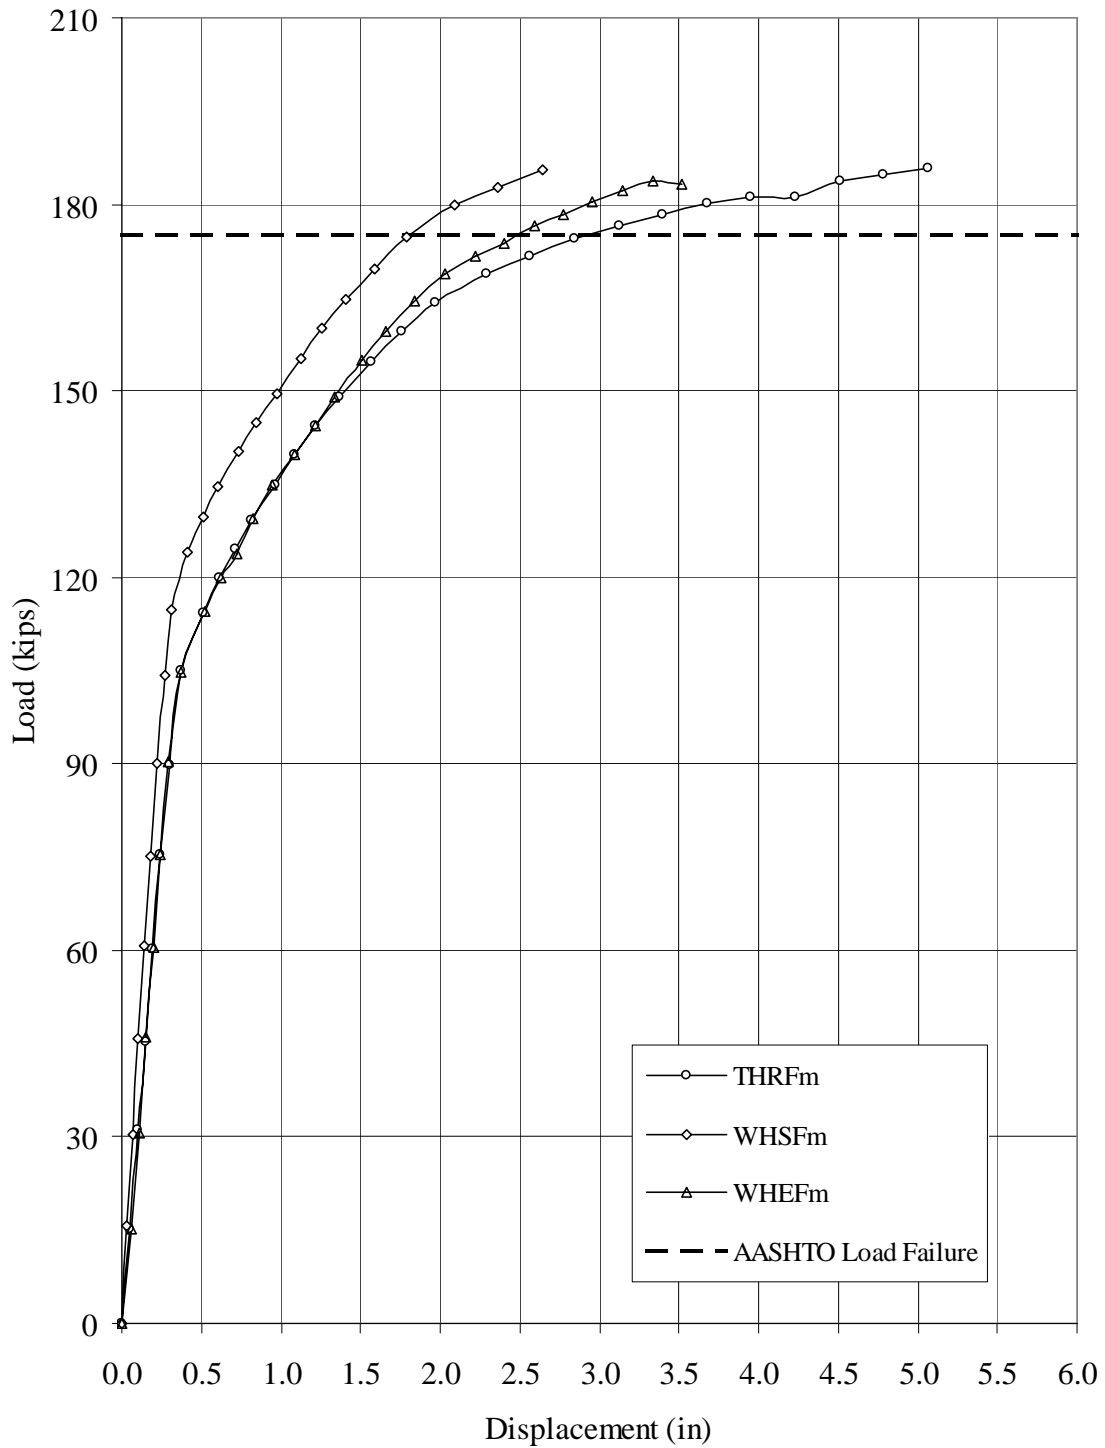
**Figure 6.6** Load-Deflection Curves for HSC NSC Flexural Beam Middle Region Tests

Load-deflection curves for the three high strength concrete beams are shown together in Figure 6.6. The horizontal dashed again line indicates the load corresponding to the AASHTO moment capacity determined using material design values. All of the specimens reached the expected AASHTO moment capacity, but only after a considerable amount of deformation,

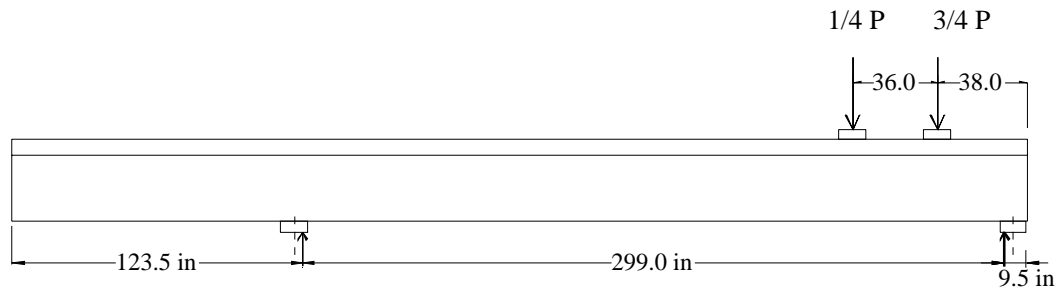
**Figure 7.1** Configuration for the First End Region Shear Test

In order to determine the shear strength of the first end region of each beam, which for an A-type beam extends 38 inches from the end of the beam as shown in Figure 2.2, the loading and support configuration was set up as shown in Figure 7.1. Since the load nearer the end of the beam was three-fourths of the total, the moment diagram was approximately constant between the two loads. With a standard elastomeric bearing pad at the support, the distance between the resulting support reaction and the first load was approximately 28.5 inches. This horizontal distance was almost the same as the depth of the beam, 28 inches, so the zone of maximum shear, neglecting the slab, was virtually square. Once again, the load was increased in predetermined load increments as described in Section 3.4.
