# ALTERNATE VERTICAL SHEAR REINFORCEMENT IN PRESTRESSED CONCRETE BEAMS: FINAL REPORT

William R. Burkett, W. Pennington Vann,  
Rafael Cedeno-Rosete, and Selim Turkyilmaz

Department of Civil Engineering  
Texas Tech University

Texas Department of Transportation

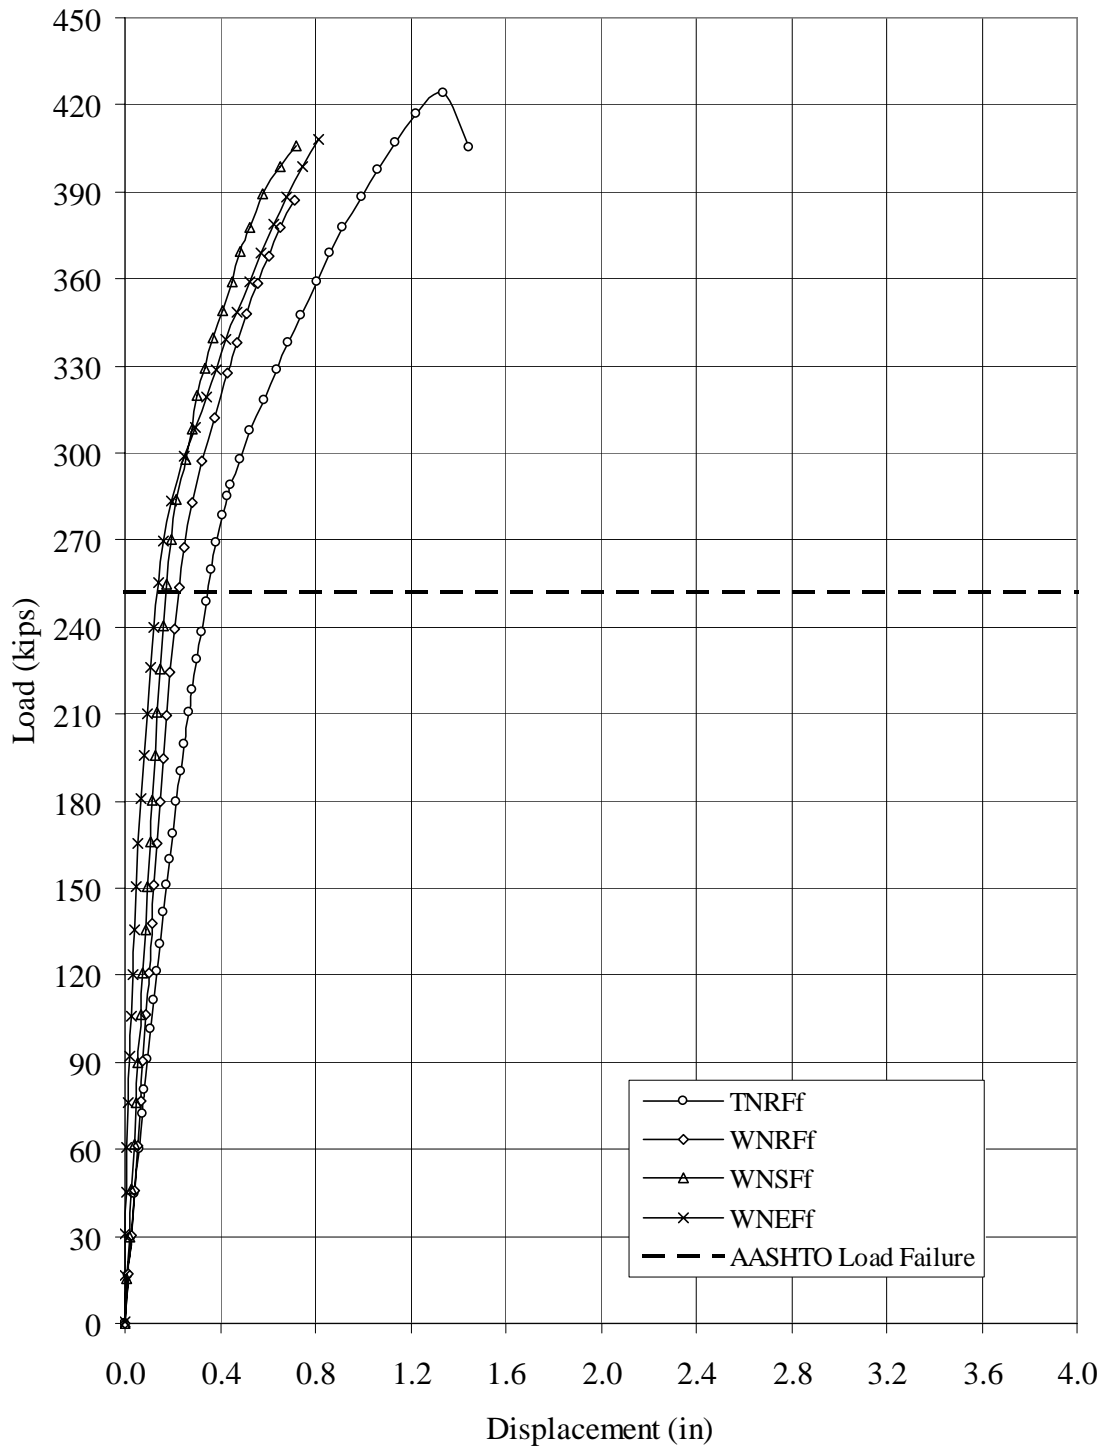
**Figure 7.2** Load-Deflection Curves for the NSC Flexural Beam First End Region Tests

Table 7.1 presents numerical values for the same key parameters of the load-deflection curves of Figures 7.2 and 7.3 as presented in Table 6.1 for the flexural tests. Table 7.2 shows a comparison between the AASHTO design loads for the specimens and the observed peak loads, plus the mode of failure, which varied between strand slip and compression strut failure. While all of the specimens exceeded the expected AASHTO shear capacity by a considerable margin, there were trends that are worth noting.

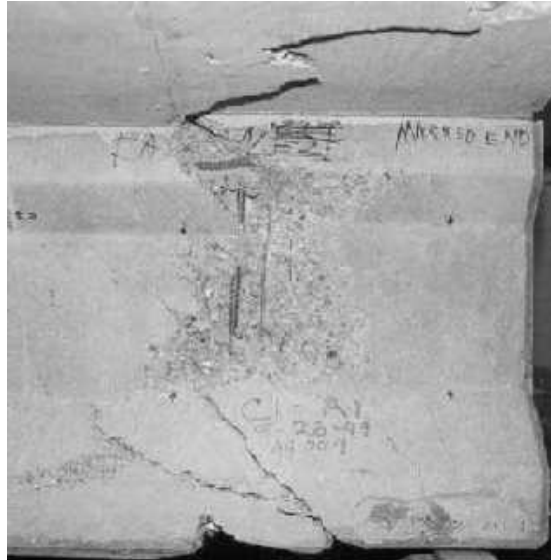
slight margin, and its failure was distinguished from all of the other first end region failures by the extent to which compression strut failure seemed to combine with strand slip and pure shear. This feature was evidenced by a shear crack all the way through the slab so that the load point nearest the end appeared to have punched through the slab, as shown in Figure 7.4. Significant strand slip seemed to hold off until the compression strut failure occurred, which was not true in most of the tests. Figure 7.5 shows a side view of the compression strut failure of the TNRFf specimen.

**Figure 7.5** Compression Strut Failure of the TNRFf Specimen

the six unharped ones are numbered from left to right across the bottom row, then from left to right in the top row. Figure 7.6 shows that slip initiated first in the top two unharped strands, which was typical for the normal strength concrete specimens. Apparently, the upward reaction at the end of the beam helped to confine the concrete around the lower strands enough to keep them from slipping first. In Figure 7.6, once slip in all the strands had started, the rate of slip (slope of the slip curve) seemed to be approximately constant up to the failure load in diagonal compression. Note that the largest slip up to failure was only 0.04 inches in this case, and past experience (Burkett, et al, 1999) has shown that a slip failure typically does not develop until a slip of approximately 0.10 inches. This is a further indication that the terminal load in this particular case was controlled by the compression strut failure.

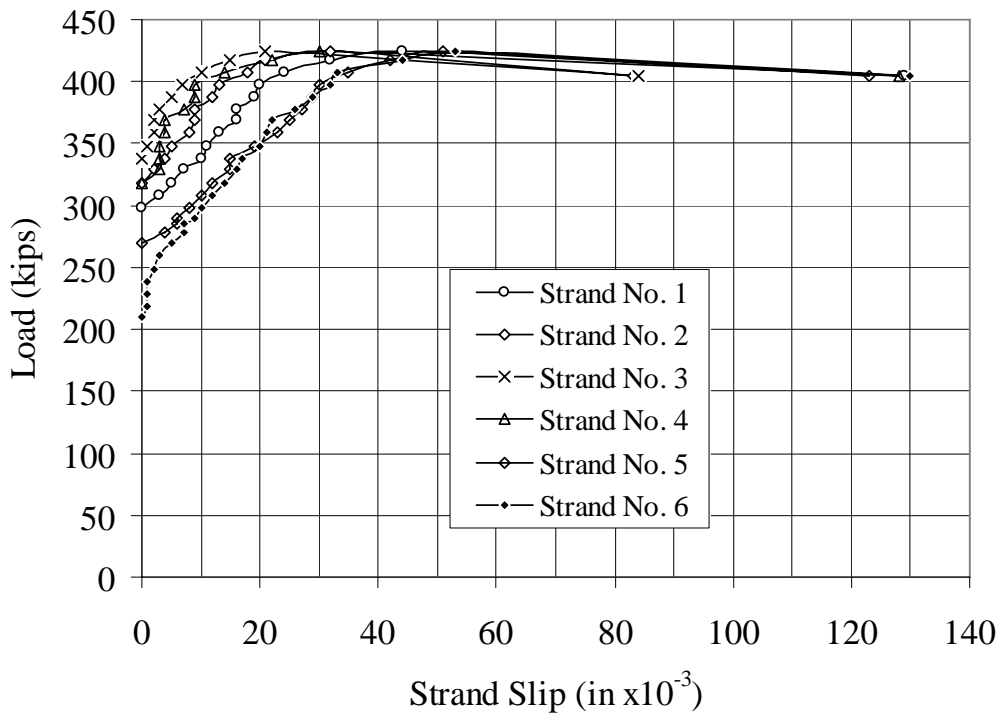
**Figure 7.6** Load vs. Strand Slip for the TRNFf Specimen

Since strand slip played a role in nearly all of the first end region tests, it is useful to examine it more carefully. Figure 7.6 shows the measured strand slips as functions of the applied load for the TNRFf specimen. The ten strands are shown in Figure 7.7, where

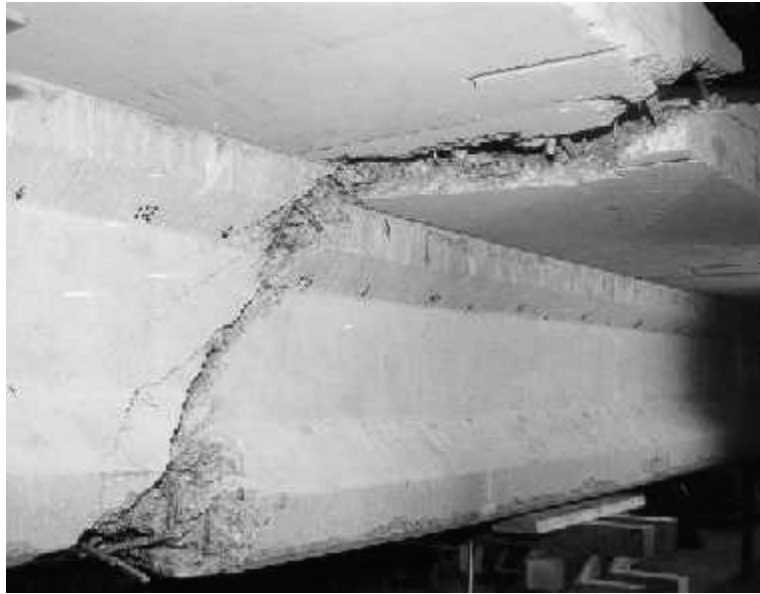
While the results in Figure 8.3 are well within experimental error, there was one major distinction among the types of failure. Unlike the other four specimens, the specimen with high-strength WWF wires exhibited a true shear failure, not a combined shear-flexure failure. A typical shear failure is illustrated in Figures 8.4 and 8.5, where the second end region of the WNEPs specimen is shown after the test. There was breakage of the vertical steel stirrups in tension and a wide separation along a shear crack that extended all the way from the bottom of the beam through the top of the slab. A so-called “dominant” shear crack also developed in the other second end region tests, indicating that a shear failure was imminent, but it never quite caused the type of separation seen in Figures 8.4 and 8.5. Interestingly enough, the WNEPs specimen did not have the smallest ductility despite its true shear failure. The breakage of the WWF stirrups before any type of loss of anchorage in the bottom of the beam certainly illustrates the adequacy of the

**Figure 8.4** Second End Region Shear Failure of the Specimen WNEP

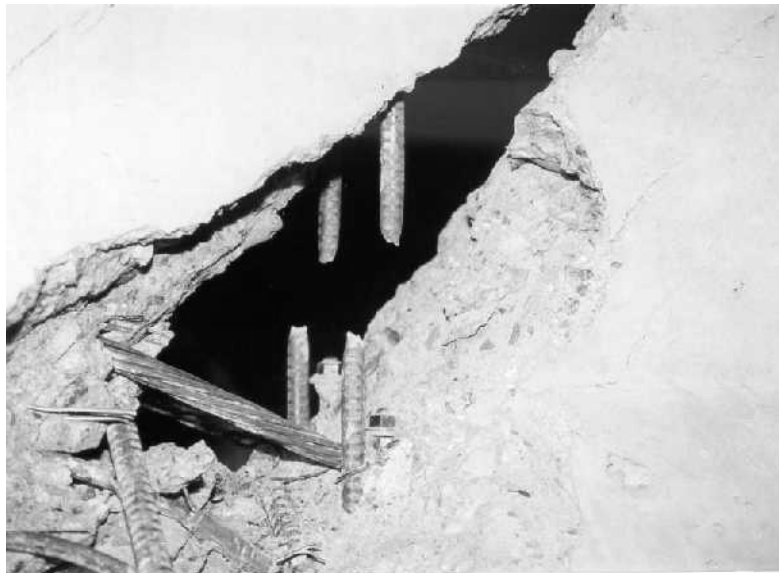
**Figure 8.5** Detail of Second End Region Stirrup Failure in the WNEP Beam

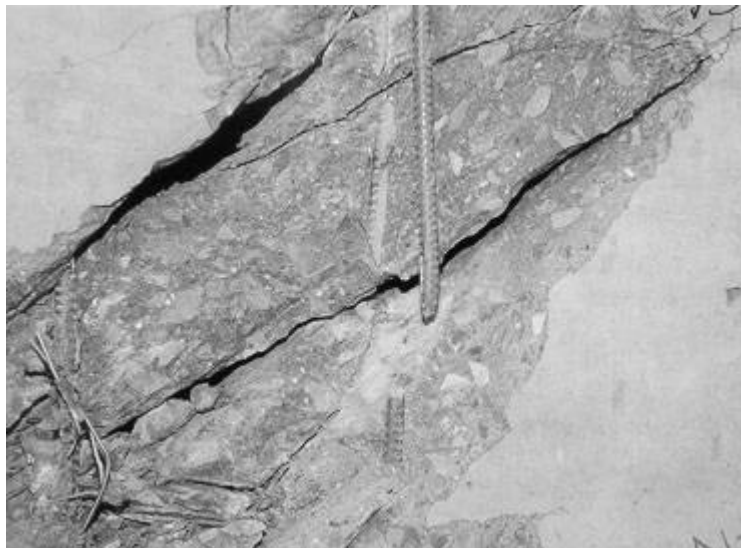
(b) Detail of the Stirrup Failure

(80-ksi) steel in the WHEFs specimen did not restrict the cracking as much as the larger R-bars in the beams with 60-ksi steel and seemed to allow a full shear failure more readily. Pictures of the shear failure of this specimen are shown in Figure 8.8. All of the flexural specimens of Figure 8.7 showed little if any deviation from elastic behavior until after the AASHTO design load had been passed, although very slight web cracking was detected in each case below the AASHTO value. As before, adequate failure load and ductility ratios can be seen in Tables 8.4 and 8.5 for all of these flexural specimens.

**Figure 8.8** Shear Failure of the Second End Region Test on Specimen WHEFs

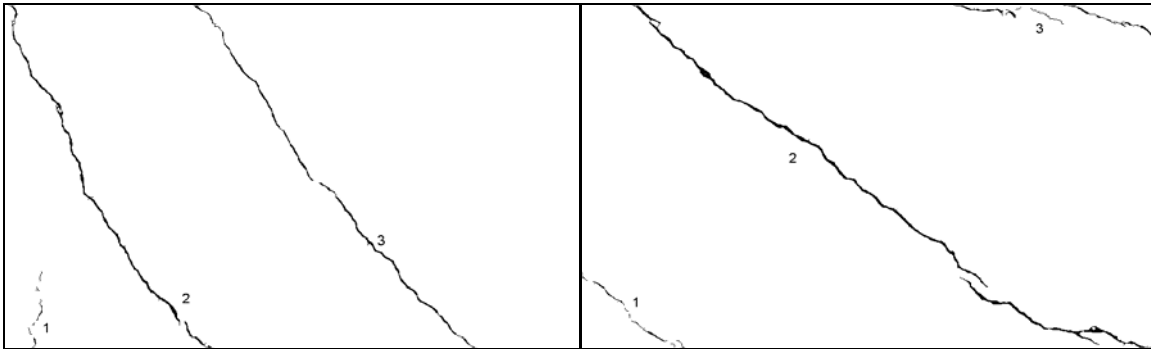
For each of the intermediate end region shear tests, digital pictures were again taken at several high load levels, this time, of three 11 x 18-inch web regions: regions 1, 2, and 3 from the support. These pictures were then processed by the techniques described in Chapter 5. Selected digital imaging crack results for the six tests of Figure 9.2 are shown in Table 9.3. Data and pictures from only 2 regions of each test (N2 or S2 and N3 or S3), where the major cracking occurred, are provided here. Additional data and pictures are available in Turkyilmaz (2001). In Table 9.3, the numbers of cracks range from 3 to 6 in each region. With an 18-inch image width, three cracks average to a spacing of about 6 inches. Images for regions 2 and 3 are displayed in Figures 9.5 through 9.10. The results are quite comparable for the four reinforcement details considered.

**Figure 9.5** Final Crack Image of TNRPi1 at 319 kips (S3 & S2)
