Evaluation of WisDOT Quality Management Program (QMP) Activities and Impacts on Pavement Performance

WisDOT ID no. 0092-15-05

October 2018

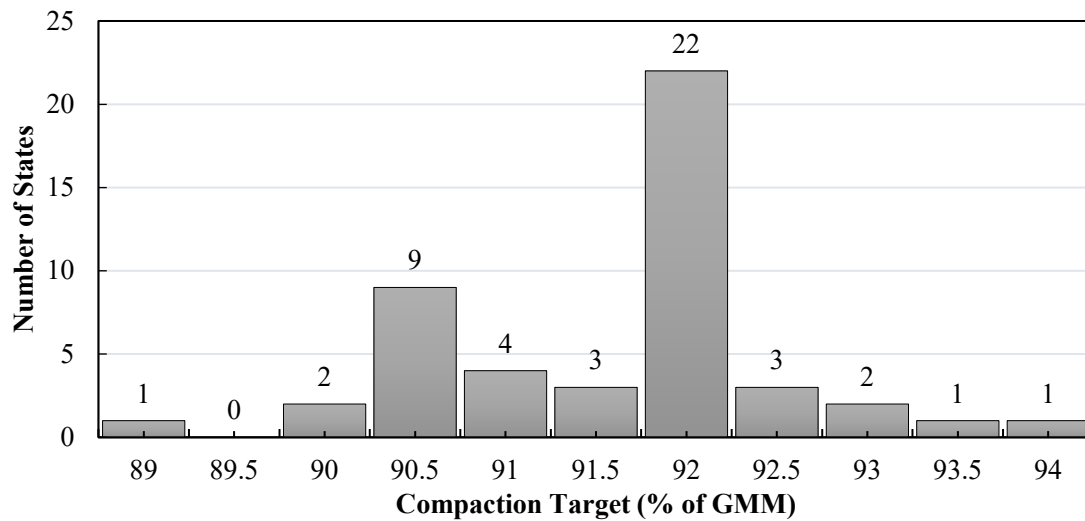
Figure 1-1 Compaction target density for different states, (after AASHTO 2007 SOM survey)

Construction methods and compaction efforts are influencing the behavior of the pavement in the field. Different methods result in producing different HMA densities, which ultimately affect the mechanical properties of the pavement. Therefore, due to the importance of the density, many agencies are trying to control it in order to protect pavements from further density related issues in the performance. Figure 1-1 shows the density levels required by different states as part of the QC/QA programs (Based on AASHTO Subcommittee on Materials 2007 Survey).

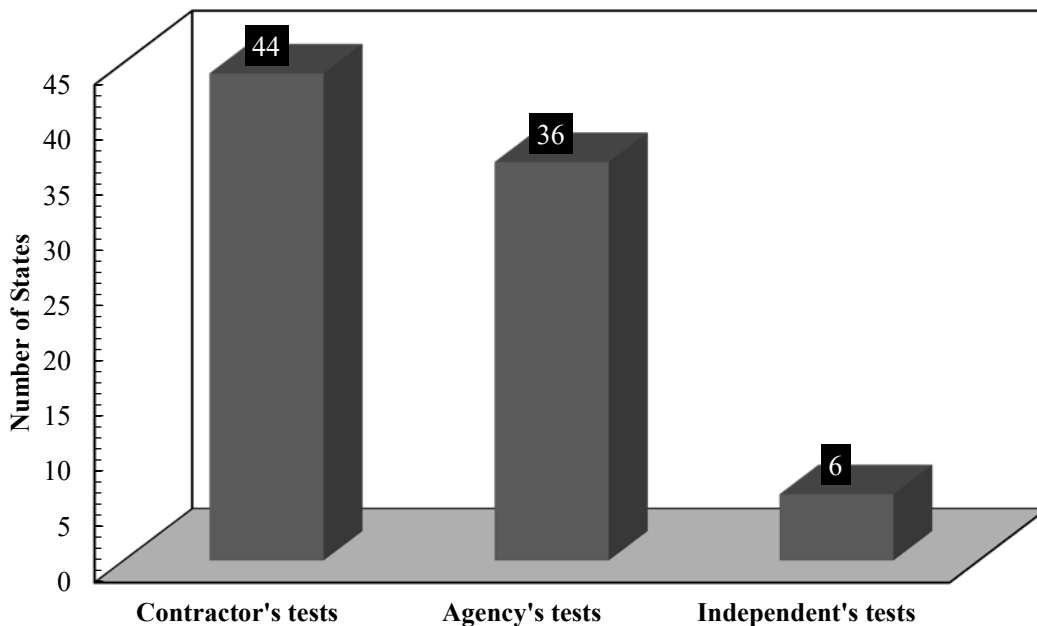
Figure 1-2 Type of quality control and assurance programs

Figure 1-2 is shown that all 44 surveyed states are using the quality control tests from contractors. Out of these, 36 agencies are combining quality testing with in-house tests. Moreover, there are 6 states that require an independent party to perform validation quality tests. It is observed that 14 agencies are using the same frequency of the test with contractors for QA programs, while the other agencies have a different frequency for test assurance. There are also 14 agencies that have the similar acceptable tolerance for their measurements compared to the contractors.

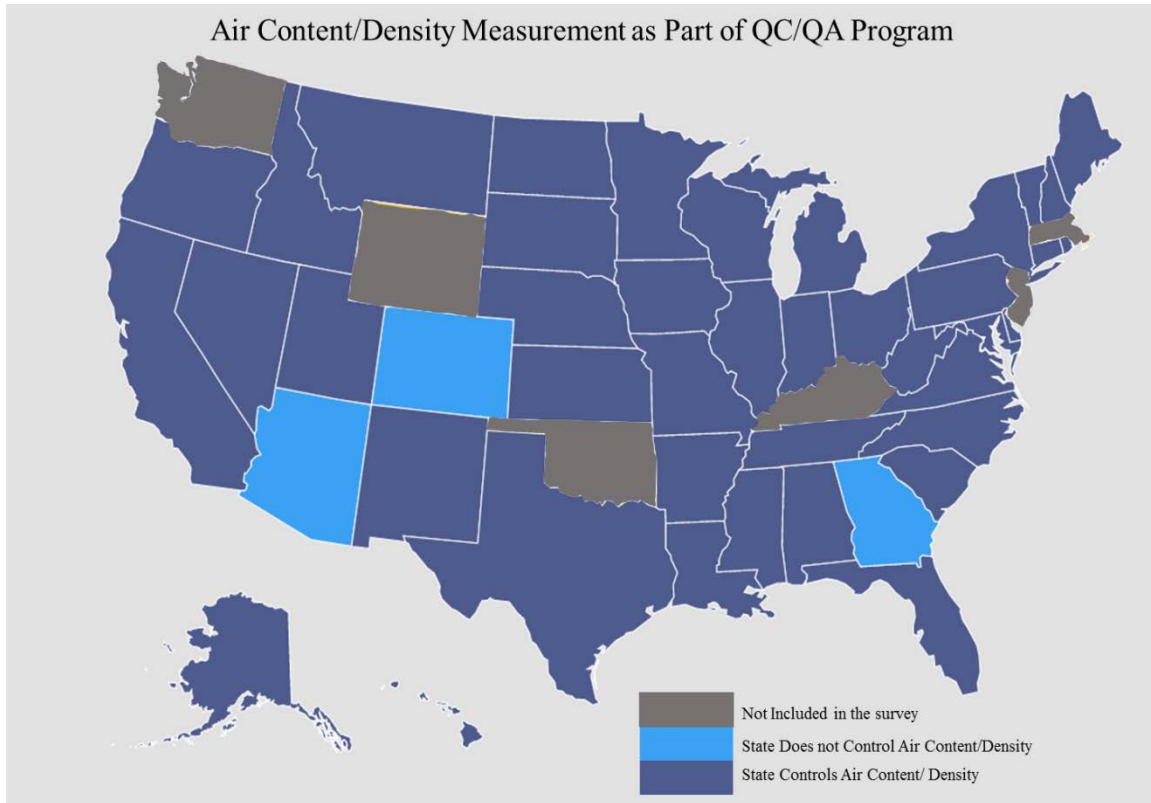
Figure 1-3 Air content/ Density measurement as part of QC/QA program

The amount of air voids in the mix is controlled both on the production stage (as a volumetric of the mix) and during the construction by measuring the density of the laid pavement. The majority of the surveyed states are controlling these properties by different methods (41 authorities). Controlling the air void in the lab and during production for (30) states and monitoring the compaction by taking cores and nuclear density tests in (27) states and (16) states are controlling both. The frequency of QC and QA control measurements for these items are varied from 1 sample per 500 tons (1), 700 tons (1), 750 tons (4), 1000 tons (3), 4000 tons (1), subplot (3) half a subplot (1), day (2) and half a day (2), and other standard frequencies for air void measurements. Also, the frequency of the test for construction stage measurements are 1 sample per 200 tons (1), 500 tons (2), 750 tons (3), 800 tons (1), 1000 tons (1), 10000 (1), lot (1), day (1), half a day (1), and other frequencies. QC control limit for the tolerance of measurement is also varied from 1% to up to the 2 %. Distribution of this data by State is shown in Figure 1-3.

Wisconsin DOT is controlling the mix air void through the quality control and quality verification programs by calculation in accordance to the AASHTO T269 (Appendix I). The number of contractor samples is determined on the amount of produced mix; generally, 1 in 1000 tons of mixture produced. The department verifies the mixture air voids by testing 1 in 5000 tons of mixture produced. The air void target has recently been changed to 3.0% for dense graded mixtures with a tolerance of +/- 1.3% for department verification tests and 4 point running average for contractor tests. The compaction of the mix and density of the asphalt layer is controlled during construction by the contractor's certified nuclear density technician to assure its compliance with the specifications. The department verifies 10% of the number of contractor's density tests.

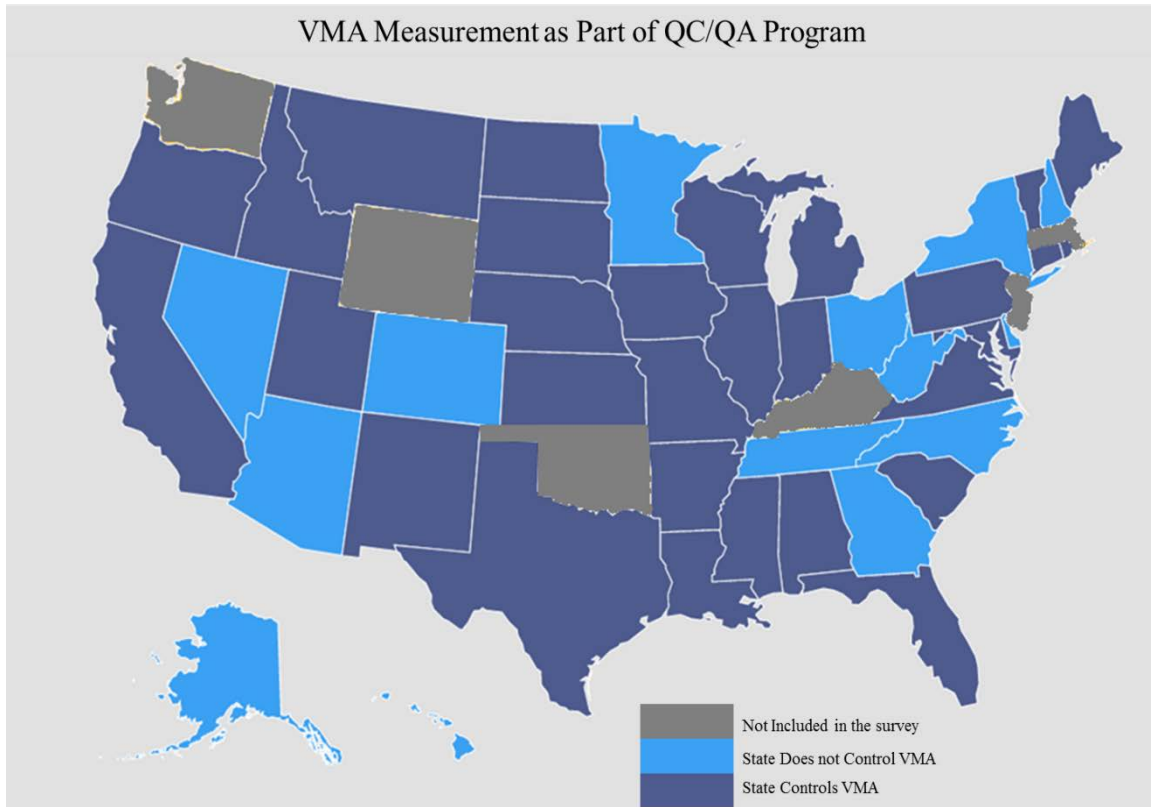
Figure 1-4 VMA measurement as part of QC/QA program

Voids in the mineral aggregate are the spaces in the aggregates in the compacted mix including the filled spaces with asphalt. VMA is a parameter that correlates the necessary air void of the mix as well as the available spaces for the asphalt binder. This parameter is being tracked for (31) states. The measurement for QA and QC is varied from one sample per 500 tons (2), 750 tons (5), 1000 (4), subplot (2), day (2), half a day (2). The tolerance of the acceptance is also varied from 0.5% to up to the 2% variation from the state’s required level. VMA control measurement as part of QC/QA programs is shown in Figure 1-4.

Wisconsin DOT controls VMA of the HMA mix throughout the QC/QA programs by calculating it in accordance to the AASHTO 35 test (Appendix I). The sampling frequency is the same as air voids for both contractor and department. The tolerance of acceptance is 0.5% of the required level

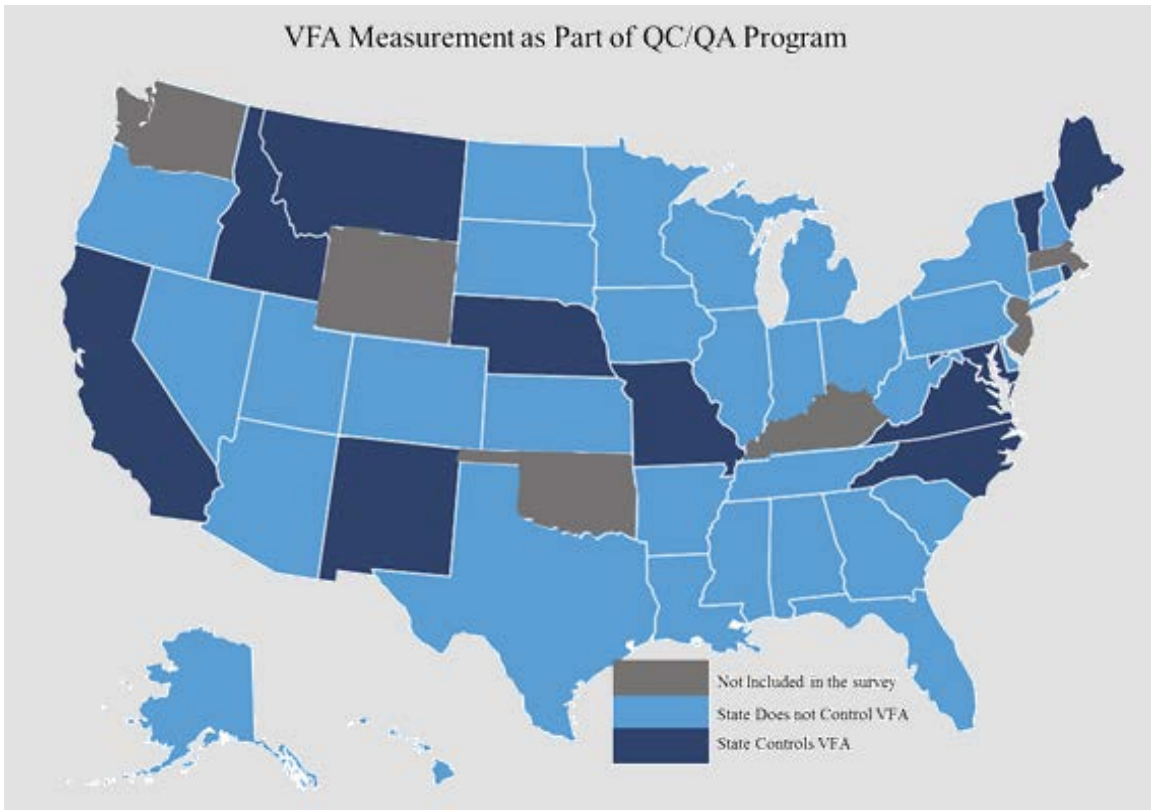
Figure 1-5 VFA measurement as part of QC/QA program

The VFA is an important factor for durability of asphalt as well as it is a relation to the density. Controlling the VFA helps to avoid mixes that are susceptible to rutting especially for highways with higher traffic levels. However, the majority of state agencies do not track this property (32 states). The ones that track it in (12) states have different frequency of QC and QA measurements, which is commonly similar to the other volumetric measurements' requirements. The accepted tolerance for the VFA values is different for each state with the maximum of 5% for two states (Vermont and Idaho).

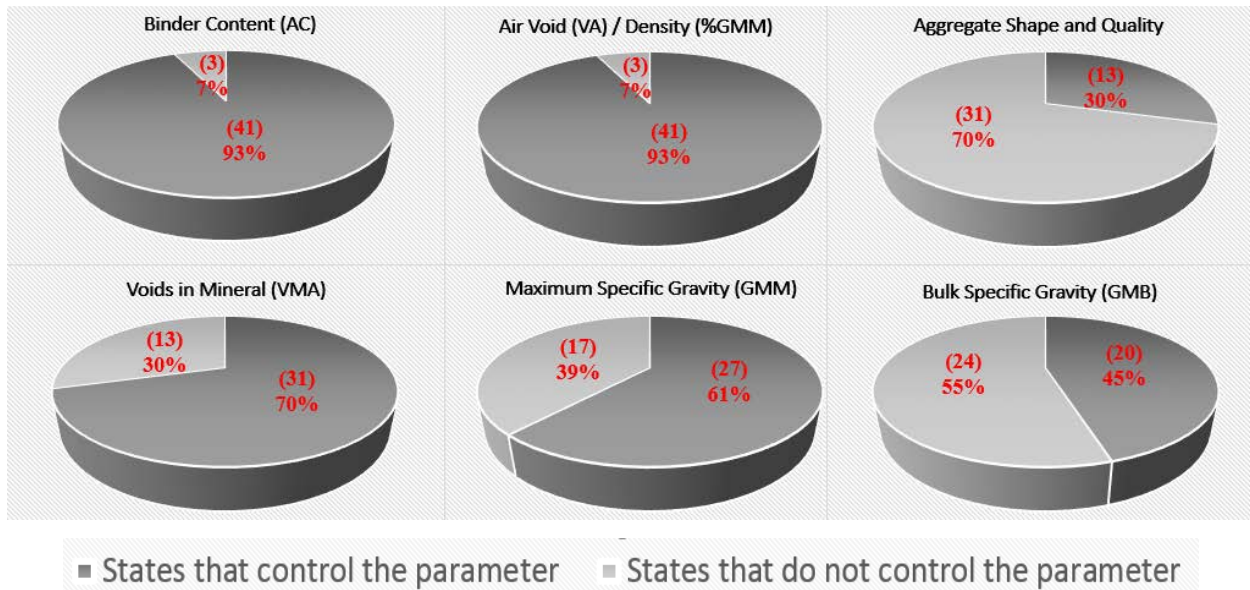
Figure 1-6 Implementation of different QC/QA items for surveyed states

Maximum density, as well as the bulk density, are the other Volumetrics that is being tracked for (27) states for Gmm, and (20) states for Gmb. The common frequencies of testing for them are one per 1000 tons (3), or one per 750 tons (2) one per 500 tons (1), one per half day (3) and one per day (1), or one per each time aggregate sample is taken for sieve analysis (1) or on a subplot basis (1). The acceptance tolerance is varied as low as %0.019 for (2) states to as high as 2% for (1) state. Some information about QC/QA specifications is shown in Figure 1-6.

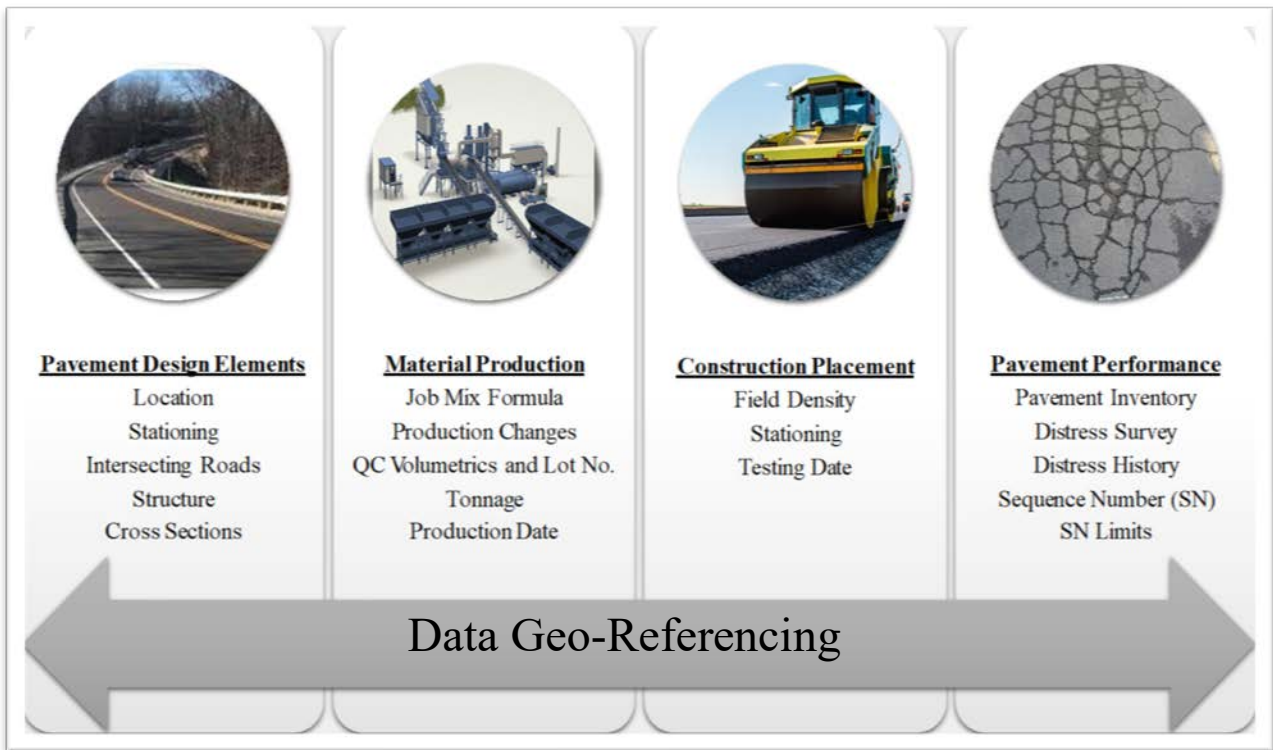
Figure 2-2 Data Fragments used to Create Relational Database

Figure 2-2 shows the data fragments used to connect pavement history into one relational database. The figure illustrates the details mentioned in the previous points.

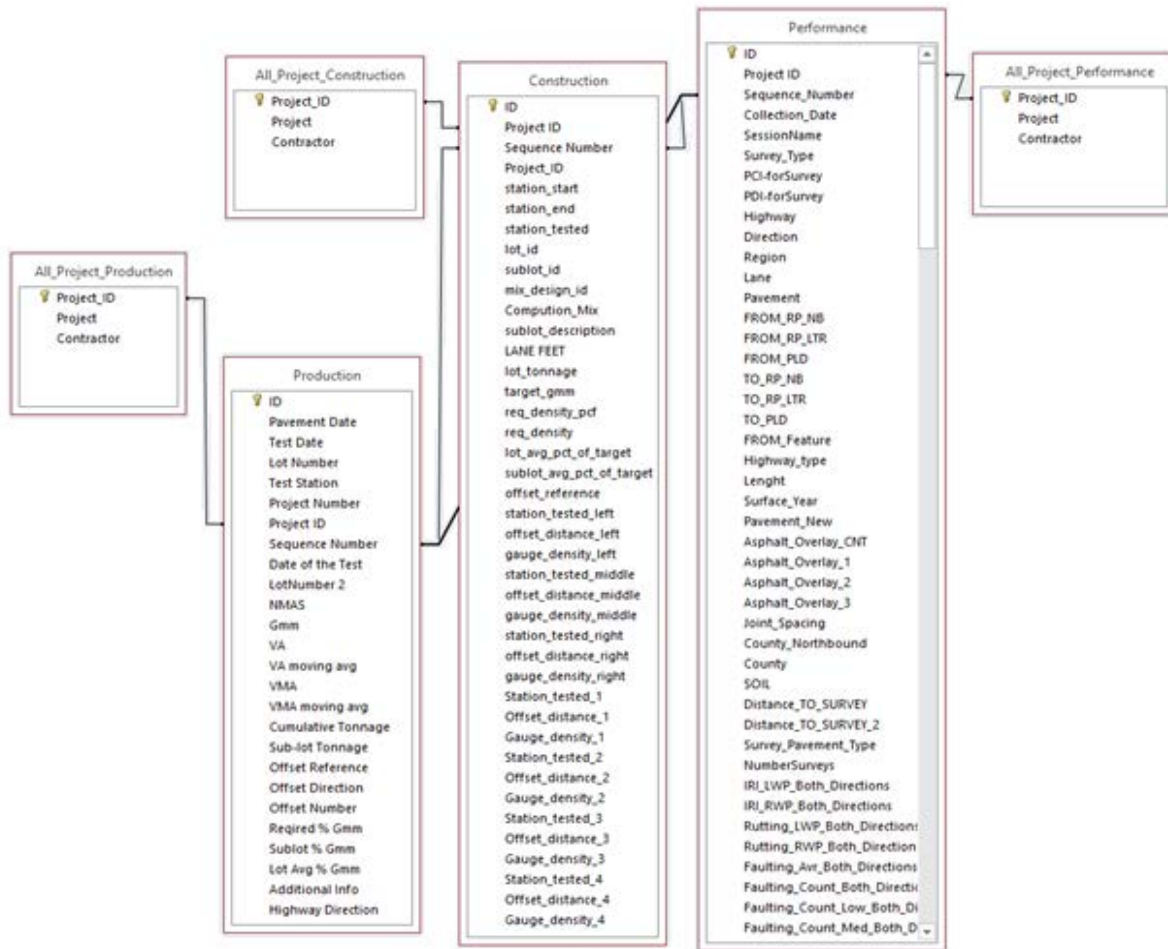
Figure 2-4 Database structure created using Microsoft Access®

Figure 2-3 does not include activities such as digitization of hard copies and some other details. The figure is intended to present the outline for creating relational database assuming all data is digitally available in a format that allows manipulation using commercial database software. For this study, Microsoft Access software is used to execute and process the large data points and integrate the different databases into one relational database. The Access-based relational database is built on three individual core databases, namely, Production, Construction, and Performance. The design of database relationships is shown in Figure 2-4. The structure of the database is such that it allows for extracting queries related to a level of quality under study, yet all information with respect to other components maintain their connection. For example, in order to investigate the effects of HMA density on rutting of pavements within the database, an Access-based query was used with rutting as the search object. The query will then include all pavement sections with rutting as reported distress, in addition, it will pull the construction and production data of these sections. All the data retrieved is then presented in one table that includes the different fragments shown in Figure 2-2. Therefore, the extracted information is used for further analysis for optimized investigation process, while the structure of the global relational database remains to be separate and independent. By using this feature, many queries regarding the effects of binder content, Va, VMA, In-Place Density on the individual distresses such as Rutting, Alligator, Transverse and Longitudinal cracking were extracted and analyzed, which the results are shown in next chapters.

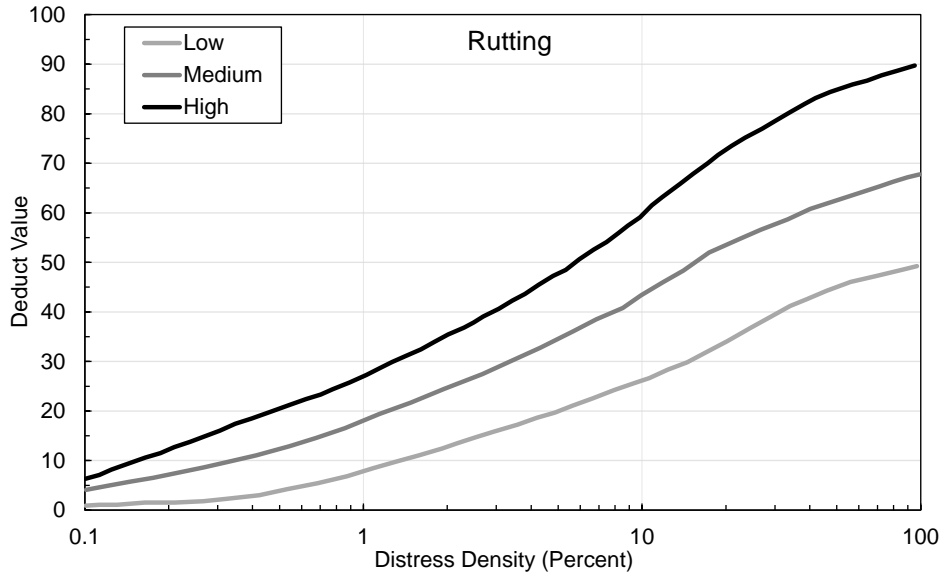
Figure 2-5 Deduct Value curves for different severities of Rutting (after Shahin 2005)

According to Shahin [111], there is a well-established procedure of essential steps in developing the Pavement Condition Index (PCI) value, which is a widely accepted parameter for describing the pavement distress state (ASTM D6433-09) [107]. However, this study focuses on the four types of distresses mentioned above. Based on the PCI method, the first step is to define each pavement distress types, the level of severity, and extent of distress. The next step is calculating the deduct value by using the deduct curves developed by Shahin [111], the deduction value curves are shown in Figure 2-5, Figure 2-6 and Figure 2-7 for Rutting, Alligator cracking, and Longitudinal/Transverse cracking respectively.

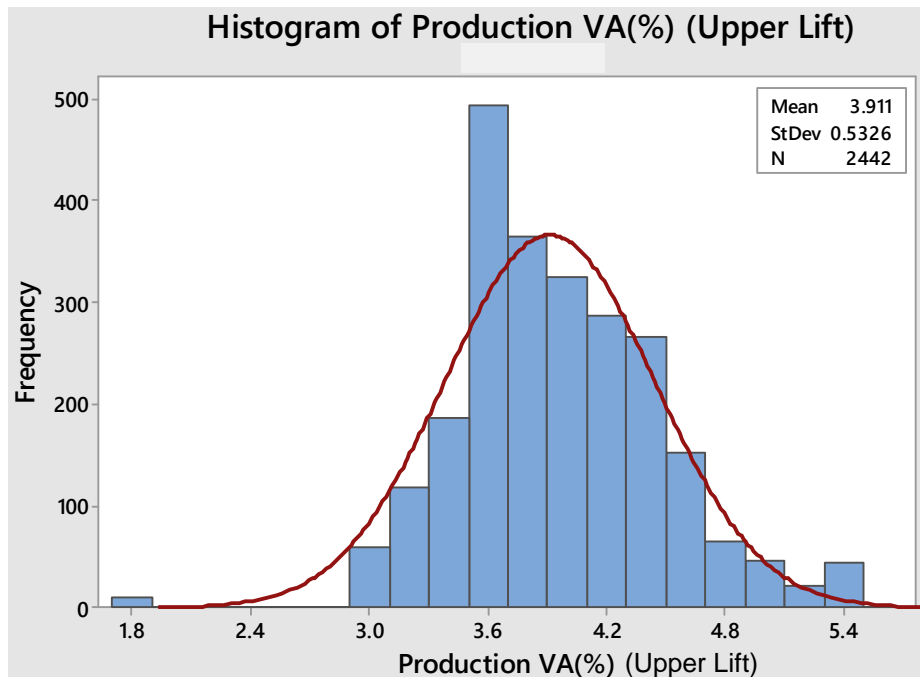
Figure 3-1 Distribution of Va for all Mixes Used for Upper Lift

The distribution of the production mix air void shows a wide range of values (1.8% to 5.4%) for the upper lift and much wider range for the lower lift (2.25% to 6.75). However, given that most designs are targeting 4% with the tolerance of +/- 1.3%, the average of the distribution overlaps with this value (3.91% for upper and 4.05 for the lower lift). Figure 3-1 shows the distribution of Va from 2442 individual data points produced by the contractors for 12.5mm mixes used for the upper lift of pavement. The values are the exact measurements, and no average value is included. Figure 3-2 shows the distribution of the 19mm lower lift mixes.

The distributions in Figure 3-1 and Figure 3-2 conveys the intention of designers to conform to the DOT specifications. The distributions also confirm that for the surface layer the majority of the mixes try to avoid falling below 3 % Va as shown in Figure 3-1. The range of 3.6 to 4.8% contains the majority of the data points. For the 19mm mix, this trend is not as clear. By assuming a normal distribution, the data suggests that 64% of the 12.5mm mixes fall between 3.5% and 4.5% Va. For 19mm mixes the percentage is 60%.

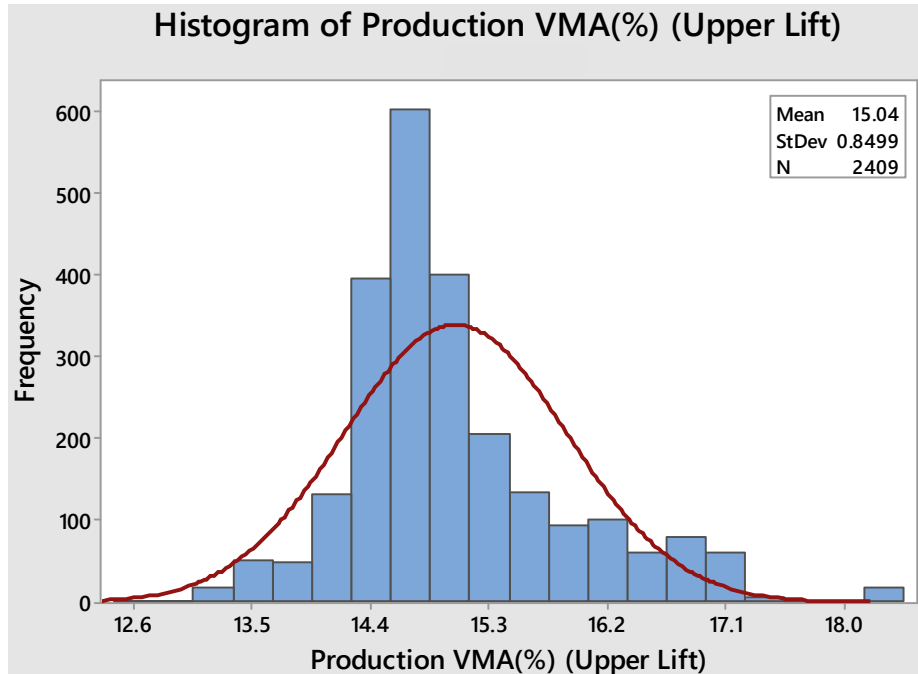
Figure 3-3 Distribution of VMA for Upper Lift Mixes

For VMA, the mix design typically aims to exceed the minimum required value. The mixes included in this study are 12.5mm and 19mm for top and bottom lifts respectively. According to the Wisconsin DOT specifications (Appendix I), the minimum VMA for 12.5mm is 14% and for 19mm is 13% with the Job Mix Formula (JMF) limit of -0.5% and warning limit of 0.2%. By examining the distribution of the data, it can be noticed that the average value exceeds these minimums. The VMA for upper lift mixes ranges from 12.75% to 18%, for lower lift 19mm mixes the range is from 12.75% to 16.75%. This means that the bottom lift mixes are generally conforming to the specifications, while for the top lift, about 11% of all data did not meet the minimum level of specification.

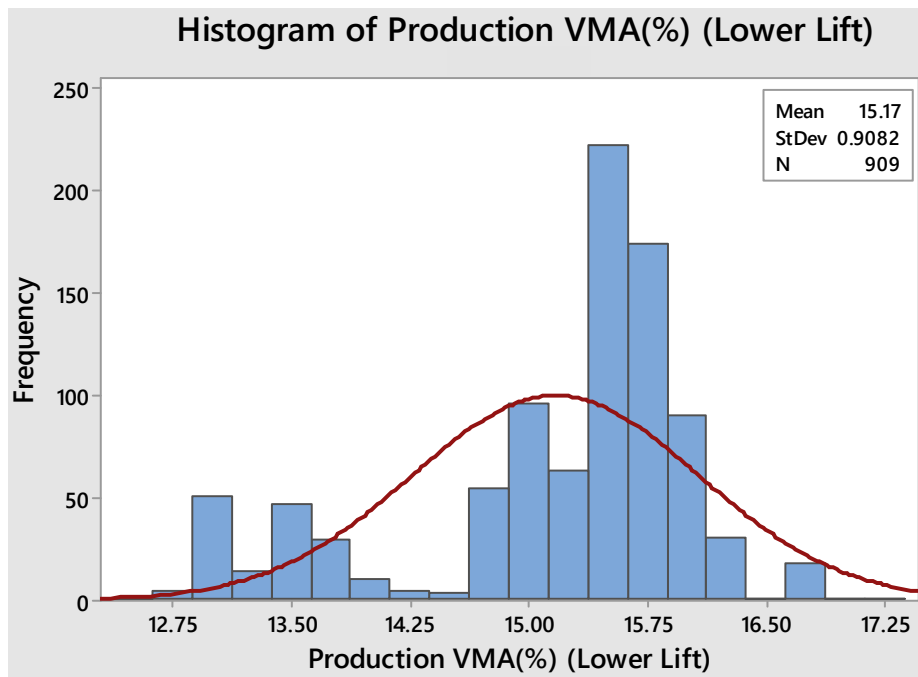
Figure 3-4 Distribution of VMA for Lower Lift Mixes

The distribution of the lower lift in Figure 3-4 shows two peaks. This observation indicates the possibility of two classes of mixes is used in the lower lift. The wide range is a natural product of the specifications as it calls for the minimum value of VMA. On the other hand, it is clear that there is a bias in production towards higher VMA for mixes.

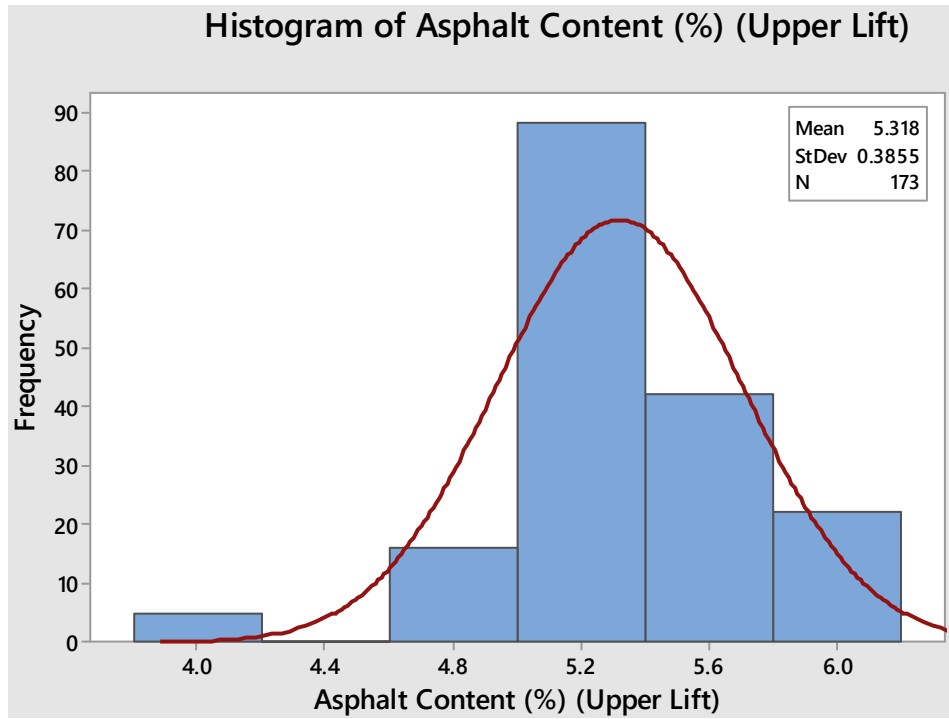
Figure 3-5 Distribution of Asphalt Binder Content Used in the Upper Lift 12.5mm Mixes

The asphalt content ranged from 4% to 6% for the upper and lower lifts. The upper lift average AC value is slightly higher (5.32%) than the lower lift mixes (5.16%). The distribution of the AC% indicates a bias in the distribution towards values above 5%.

It is important to note that for both types of mixes, the content of 5.2% took place in more than 50% of all mixes produced and included in this study. This represents a challenge to establish a relationship between the AC and performance given the lack of variation in the AC content.

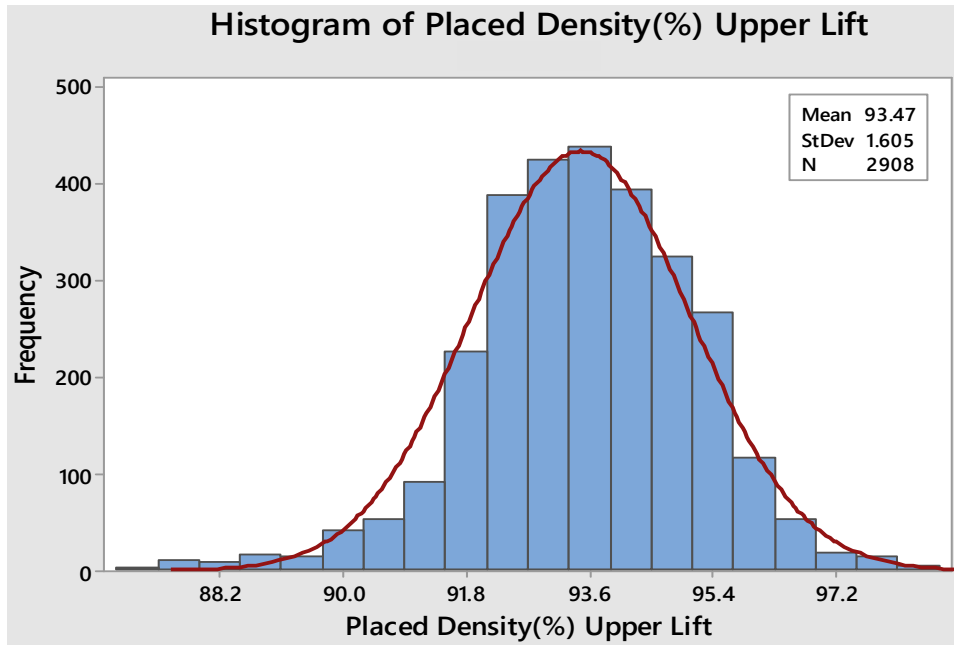
Figure 3-7 Distribution of Compaction Level as Measured by the Relative Density of the Upper Lifts

The distribution of the In-place density can be used as an indicator of construction quality. The distributions of all the measurements are shown in Figure 3-7 and Figure 3-8. The data pool for this property is the largest of all the data collected.

Assuming the data is normally distributed, the mean and standard deviation for the upper and lower lifts can be used to estimate the proportion of tests not meeting the target values for in-place density. For the upper lift, about 11% of the distribution falls below the 91.5% relative density. For the lower lift, the portion below the 90.5% is only 0.16%. Thus, virtually all lower lift compactions met the target density of WisDOT specifications at the time of construction. The

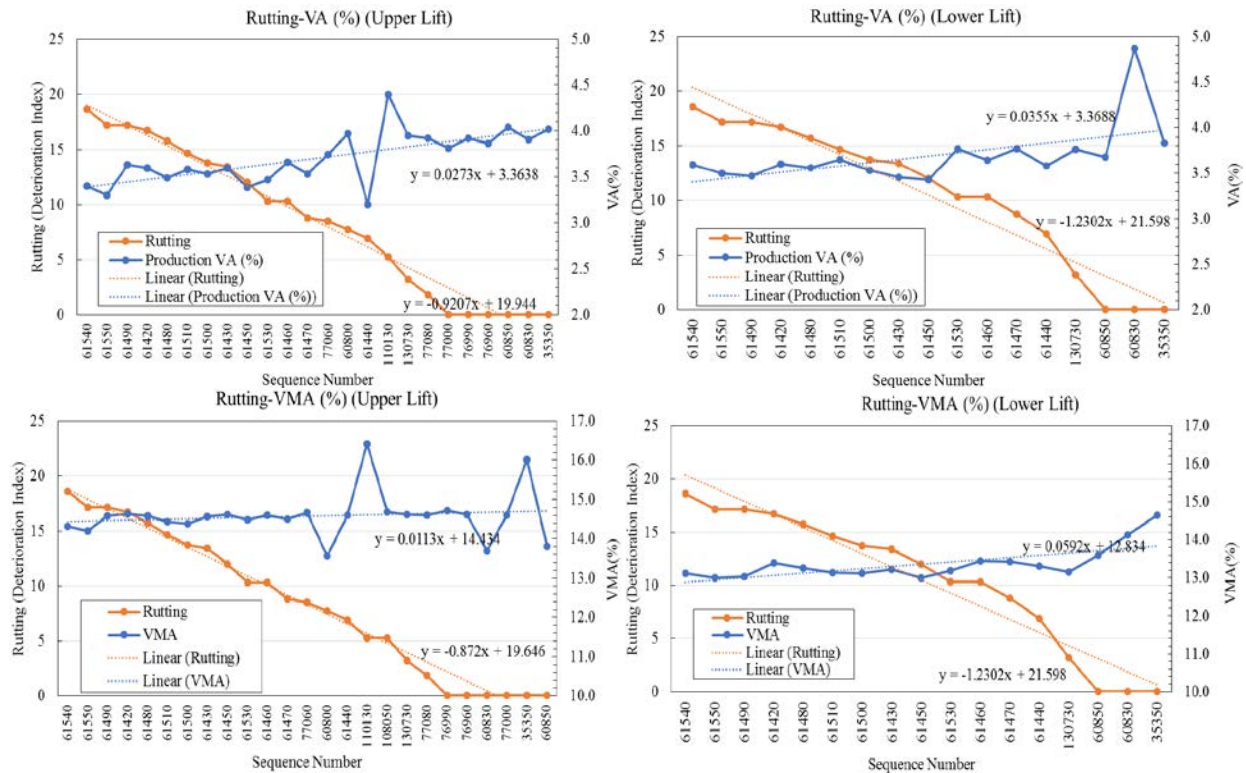
Figure 3-9 Rutting Against Production Quality Indicators

The following plots show the SN exhibiting non-zero values for Rutting and their corresponding rutting quality indicator values. The SNs are plotted in descending order with respect to their rutting DI values; the higher DI means, the worse Rutting problem. Comparing the slopes of quality indicator property against rutting helps in isolating potential correlations for further analysis.

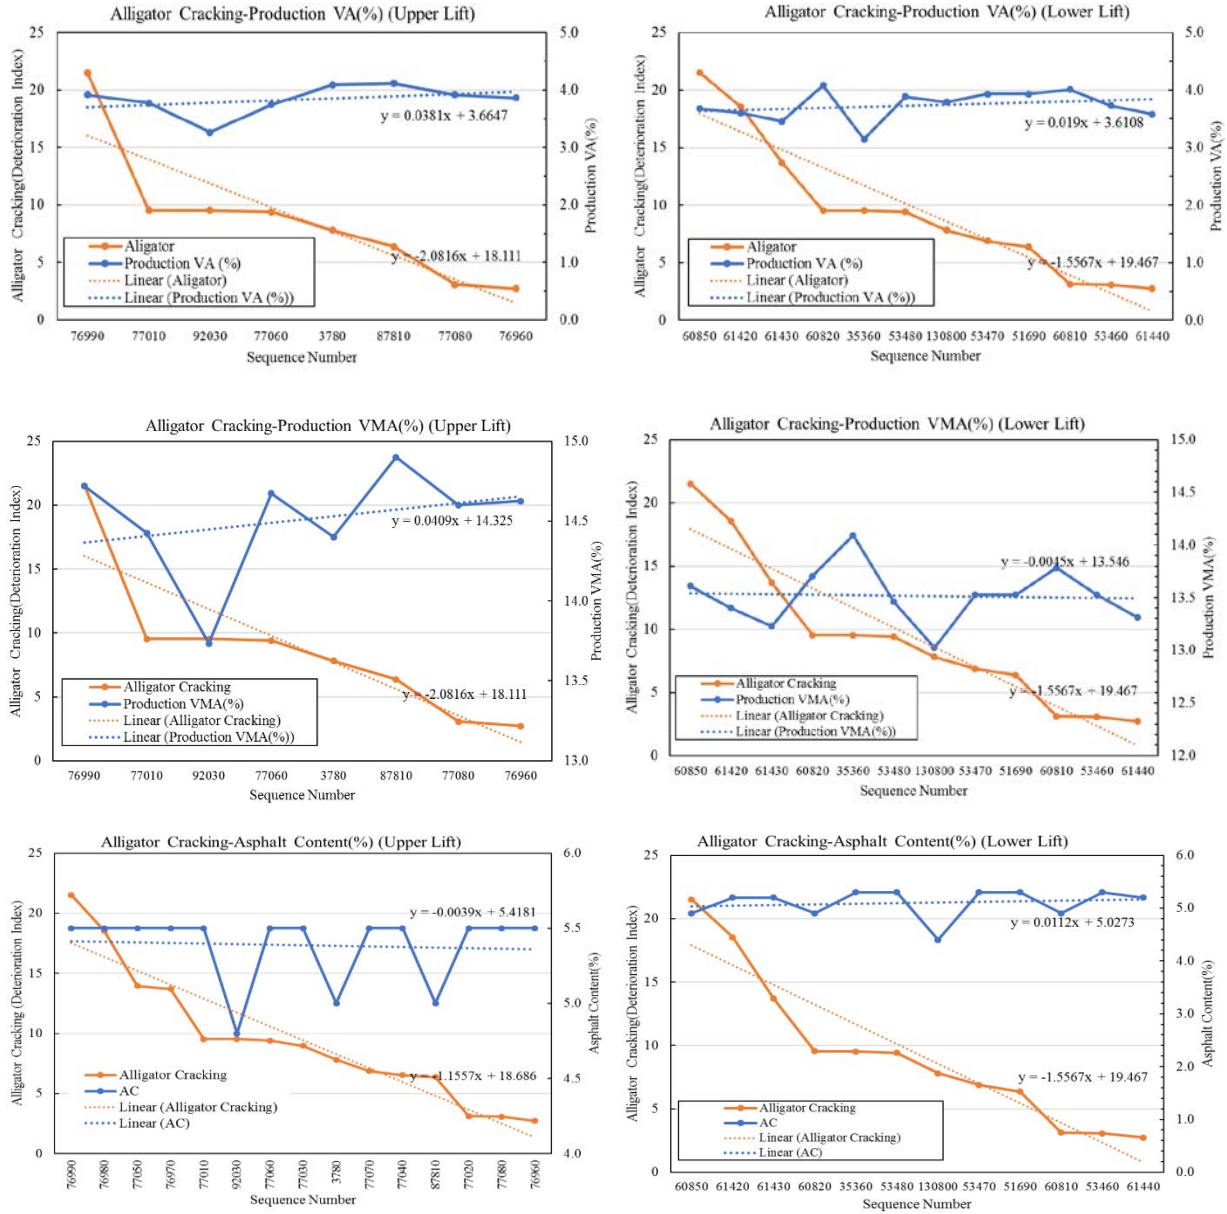
Figure 3-11 Alligator Cracking Against Production Quality Indicators

The plots show the alligator cracking as reported in the PIF. Fewer SNs are reported to experience alligator cracking compared to the rutting.

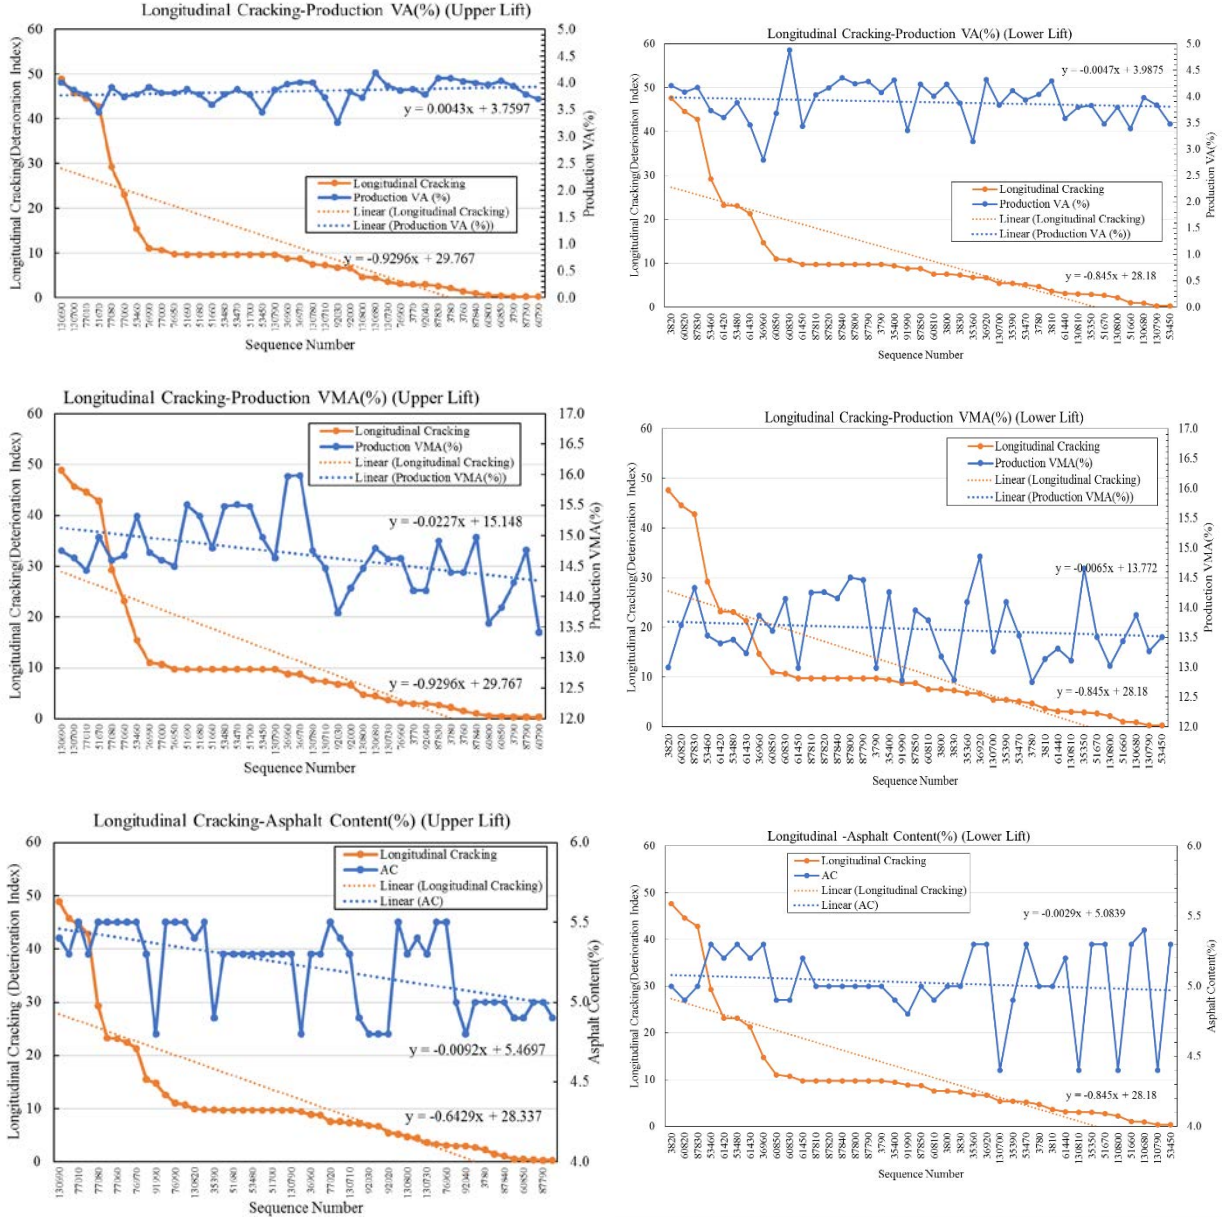
Figure 3-13 Longitudinal Cracking Against the Production Quality Indicators

Longitudinal cracking is the most common in the database. The SNs with non-zero DI for Longitudinal Cracking are plotted below.

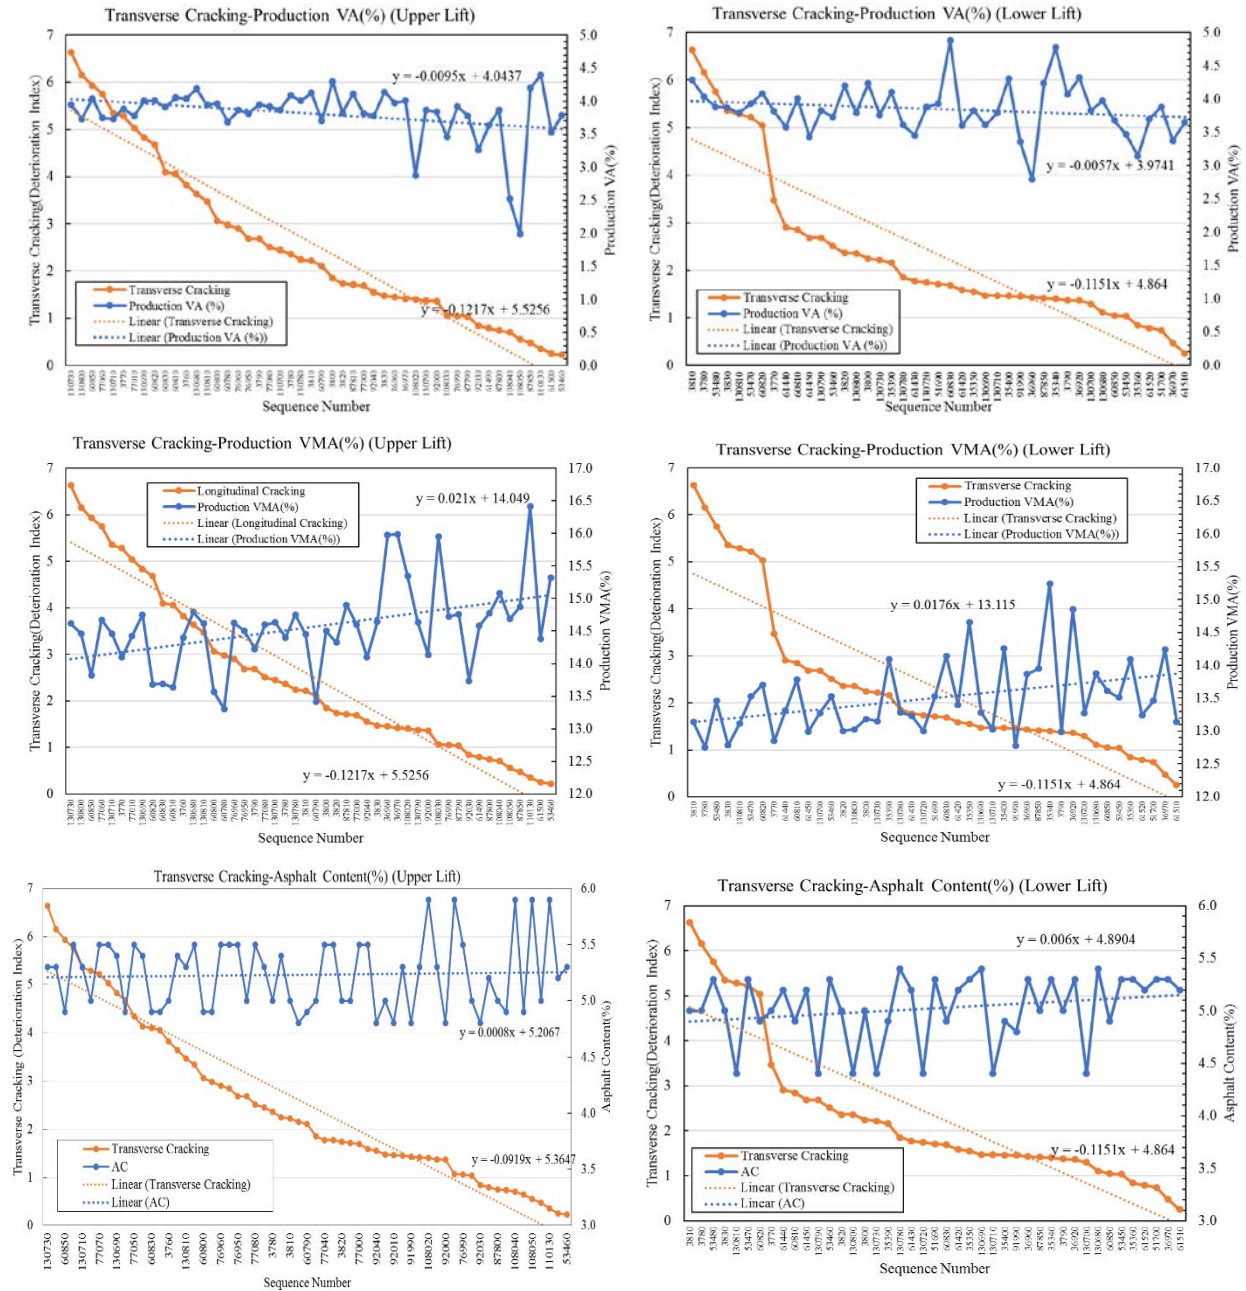
Figure 3-15 Transverse Cracking Against the Production Quality Indicators

Based on the distribution of Transverse Cracking at the global level, the graphs were prepared based on non-zero values of DI for Transverse Cracking.

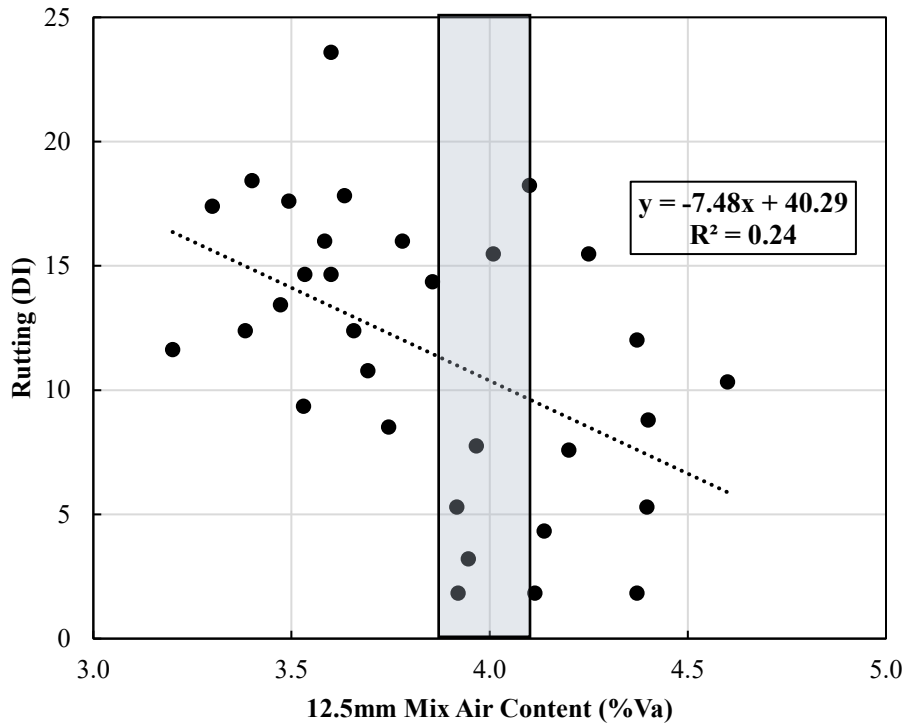
Figure 3-17 Rutting Against the Va(%) of the 12.5mm Mixes

DI values for Rutting at 12.5mm pavement lift is found to possibly correlate with multiple factors related to mix production quality and placement quality indicators. The following series of plots demonstrate these correlations leading to a regression model combining these factors into one equation.

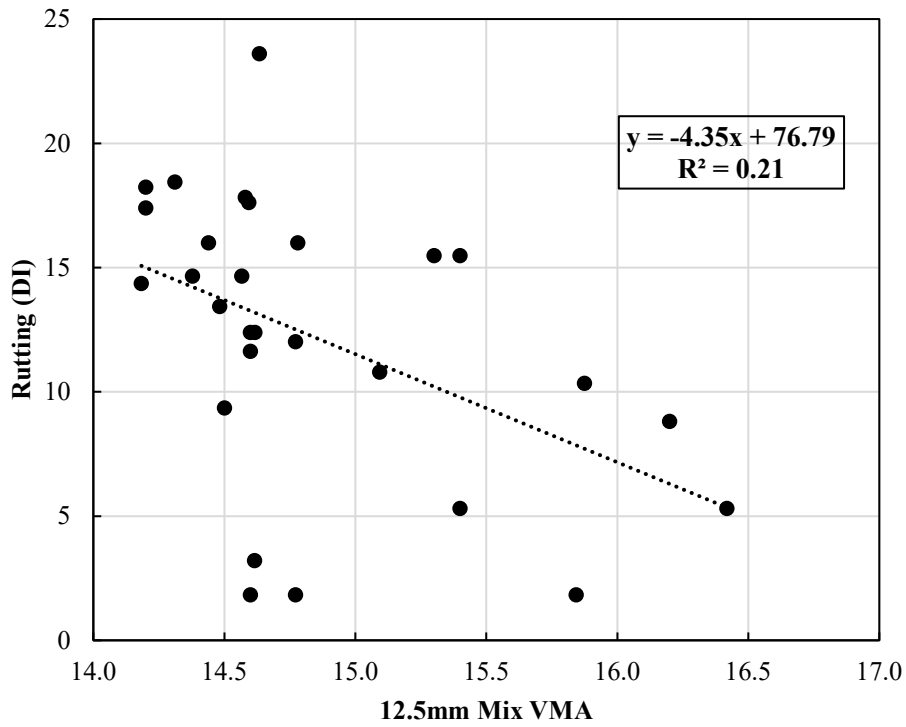
Figure 3-18 Rutting Against the VMA(%) of the 12.5mm Mixes

The aggregate structures as indicated by the VMA also shows a trend of influence on the rutting DI. While most of the mixes meet the required VMA, yet its higher level of values correlate with a reduction in rutting damage. (Figure 3-18)

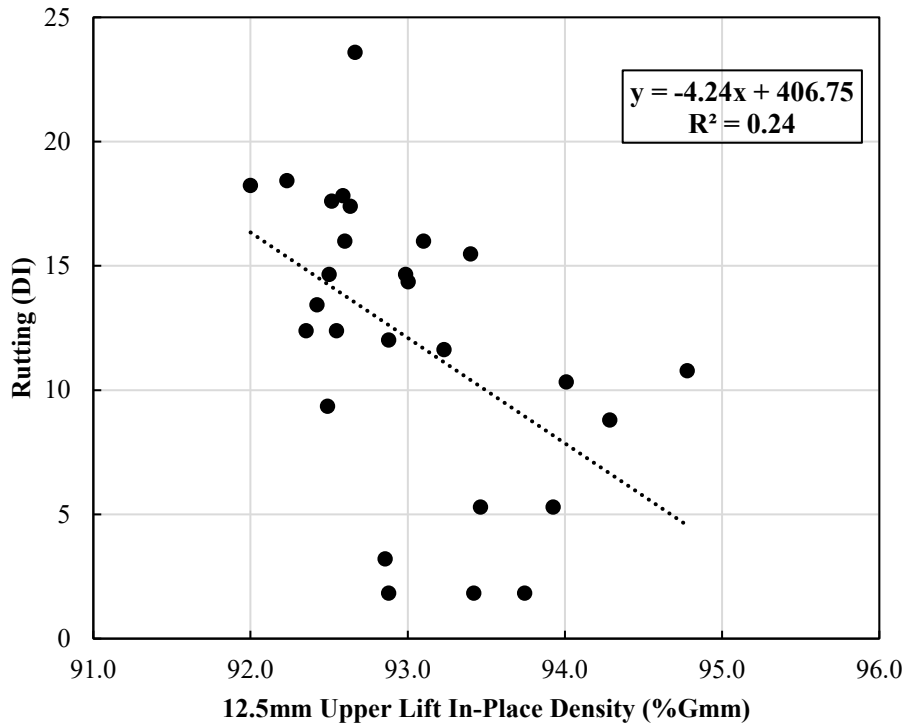
Figure 3-19 Rutting Against the In-Place Density of the 12.5mm Mixes

With respect to construction, Figure 3-19 shows a consistent trend in reduction of the rutting damage when the pavement is compacted well above the minimum required density. The trend shown in Figure 3-19 shows that increasing in-place density from 92% to 94% correlates with a 50% reduction in rutting deterioration.

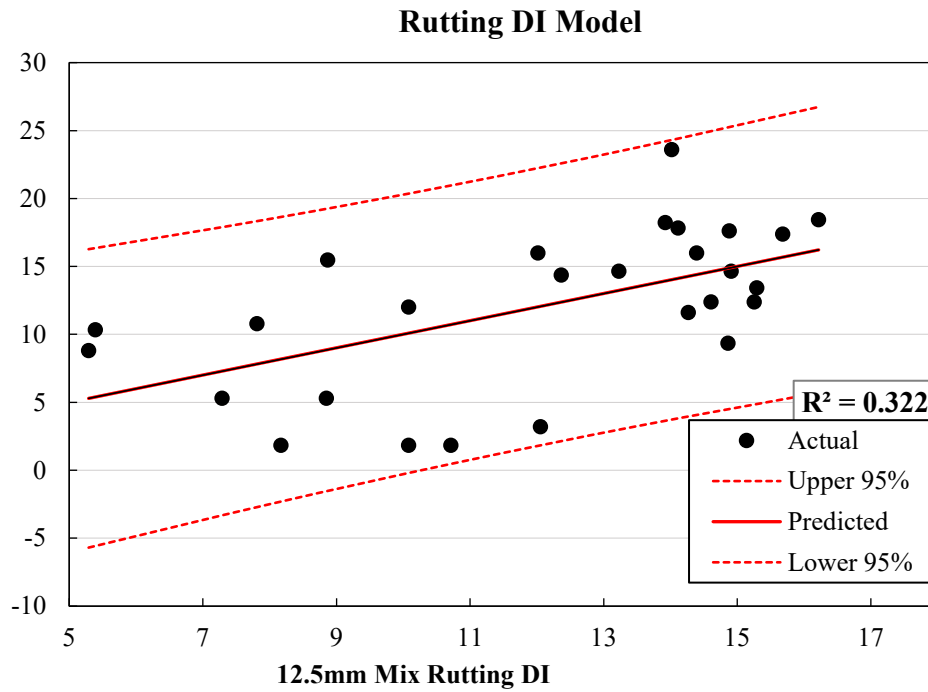
Figure 3-20 DI Model of Rutting for 12.5 mm Mixes

The model maintains the trends observed earlier. Figure 3-20 shows the actual rutting DI plotted against the predicted and the 95% confidence interval. The figure shows that the model is able to predict all the data points with 95% confidence.
