Evaluation of WisDOT Quality Management Program (QMP) Activities and Impacts on Pavement Performance

WisDOT ID no. 0092-15-05

October 2018

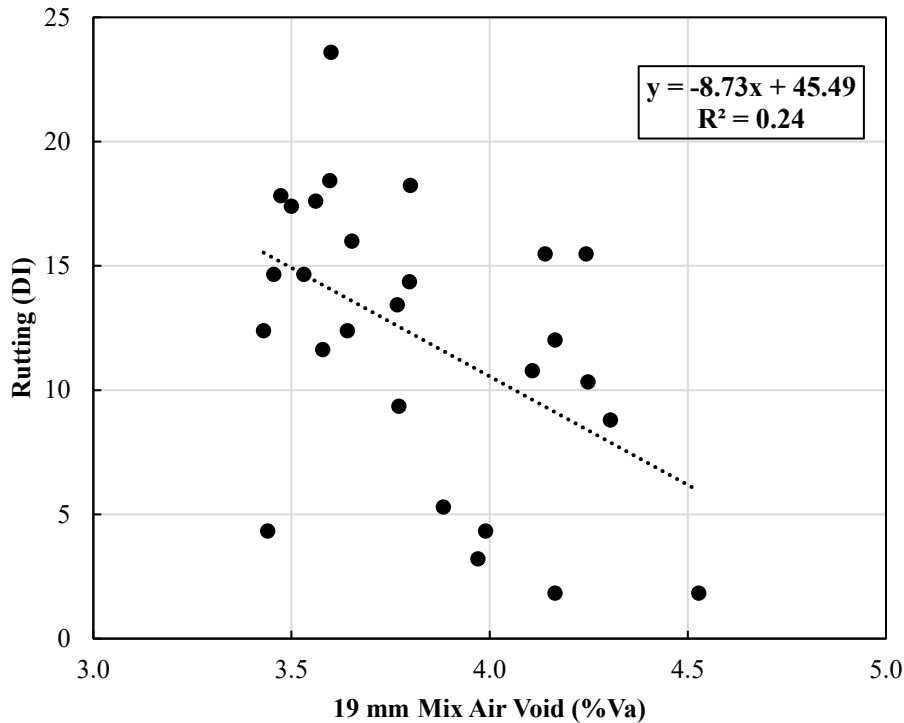
Figure 3-21 Rutting Against the Va(%) of the 19 mm Mixes

With respect to the 19mm pavement lifts, the rutting factor shows some correlation with the mix Va. Figure 3-21 shows that the trend is similar to that noticed for the 12.5mm mixes, whereas the Va increases, the rutting damage is decreased.

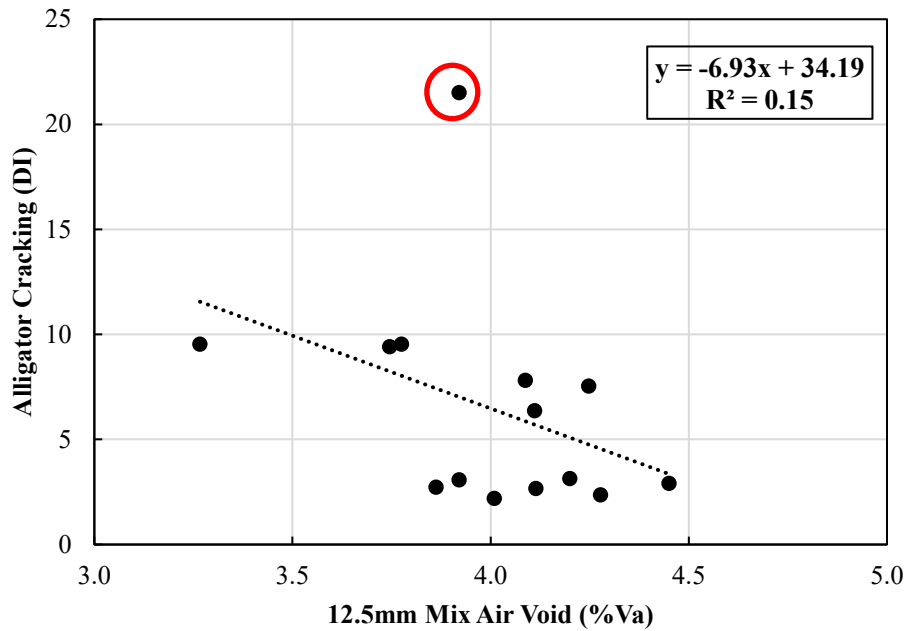
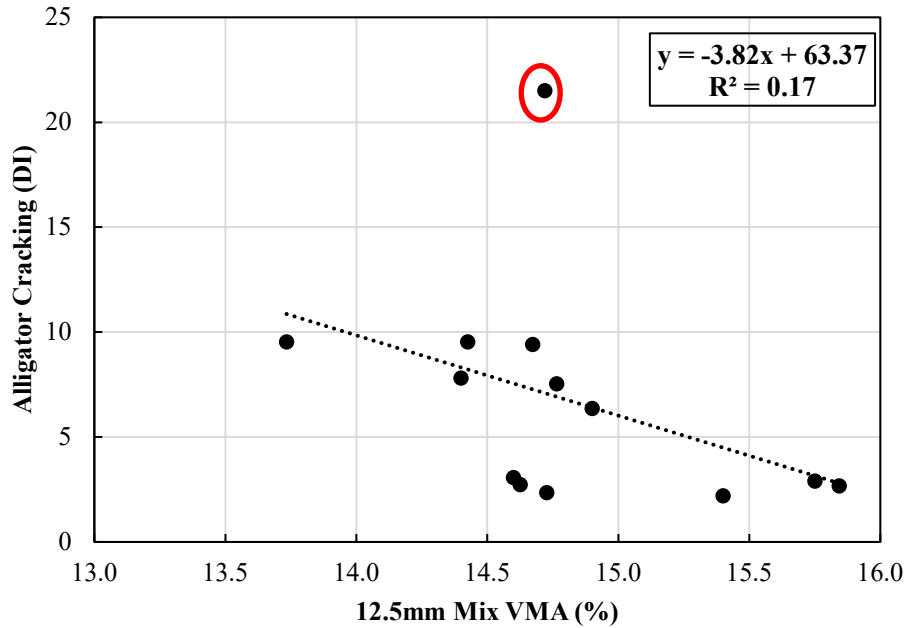
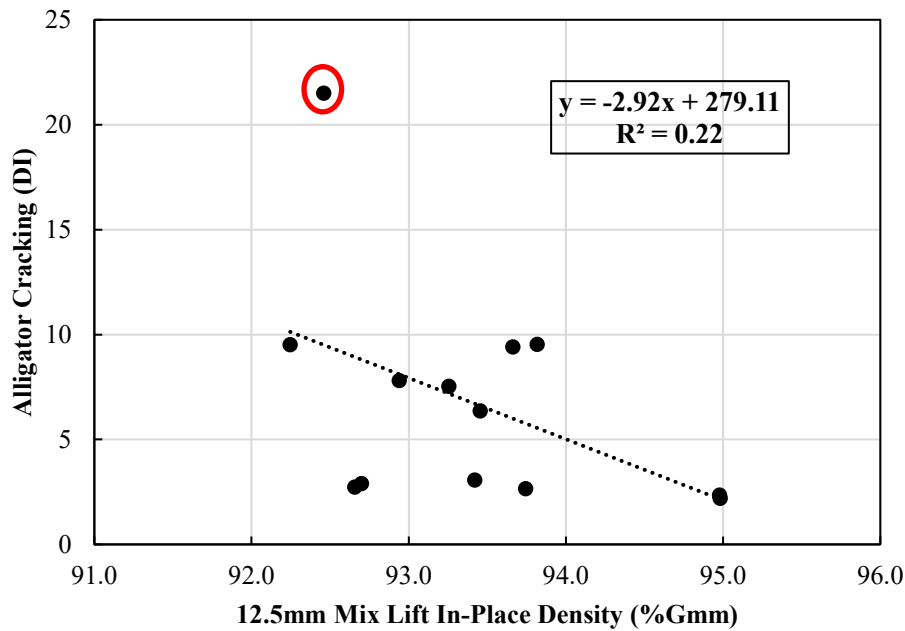
For alligator cracking for the 12.5mm mix also show a logical trend against the production and construction quality indicators. The following figures (Figure 3-22, Figure 3-23 and Figure 3-24) show that alligator cracking damage is reduced at higher Va, higher VMA, and higher in-place density.

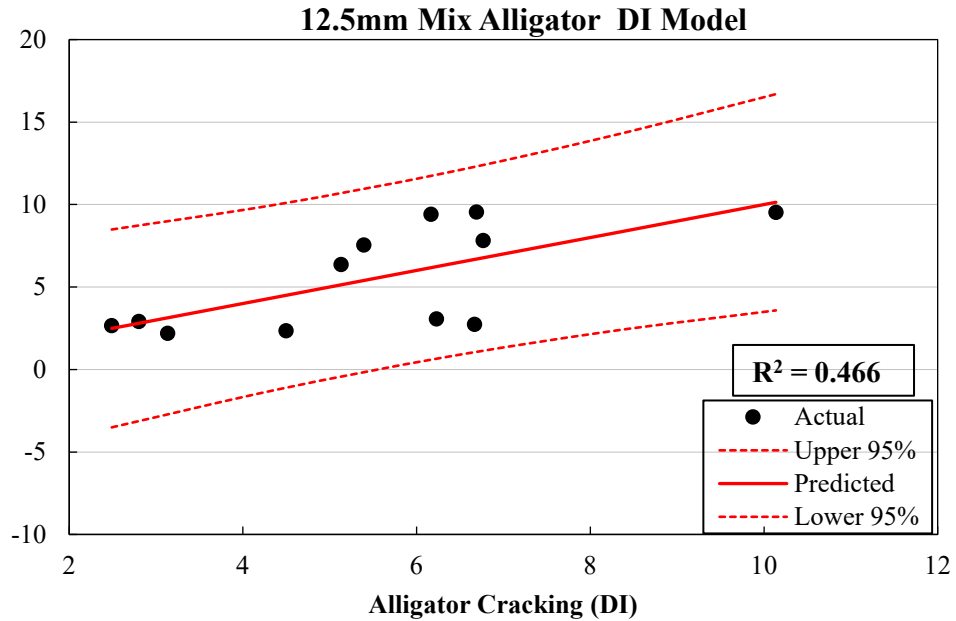
Figure 3-25 Alligator Cracking DI Model for 12.5mm Mixes

The comparison between the actual and predicted fatigue damage is shown in Figure 3-25. The comparison includes 95% confidence interval of the regression model.

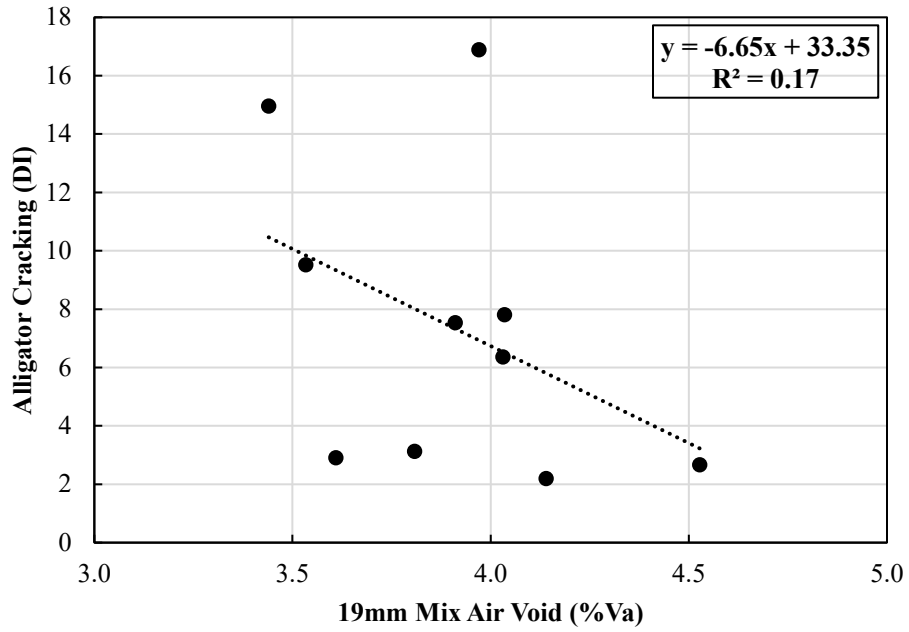
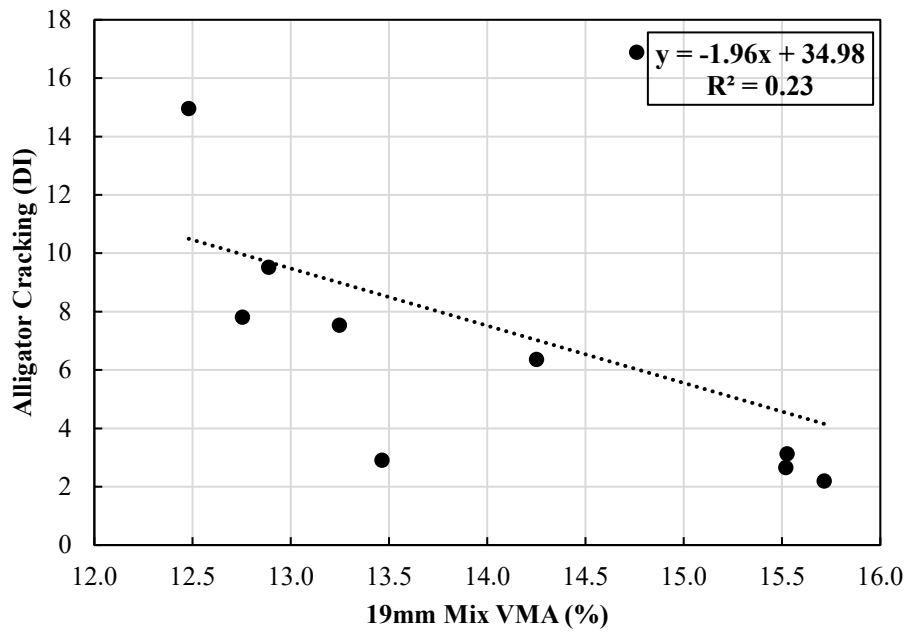
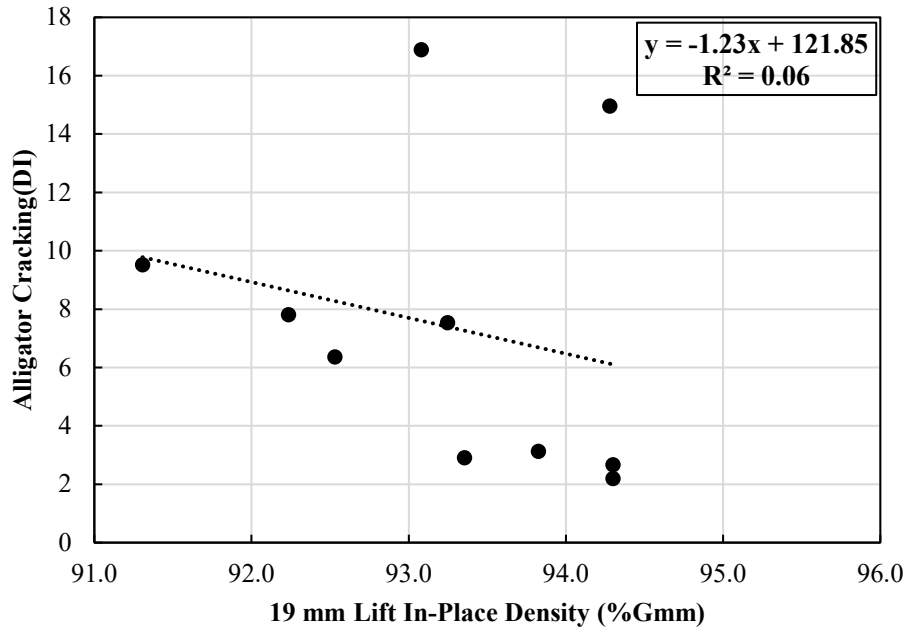
For the 19 mm mix, similar trends are observed for the production and construction quality indicators. The following set of figures (Figure 3-26, Figure 3-27, and Figure 3-28) establish the correlation between the quality indicators and the alligator DI. While the correlation coefficients are not strong, the trends follow expectations.

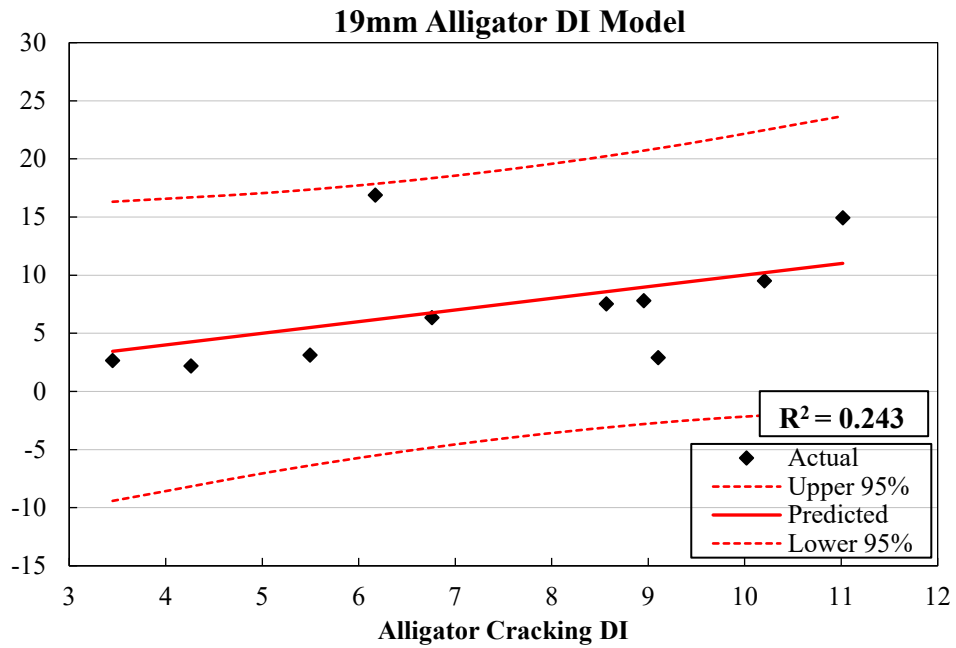
Figure 3-29 Alligator Cracking DI Model for 19 mm Mixes

The regression model prepared using the quality indicators, provide adequate prediction within 95% confidence interval. Also, the coefficients of the model follow the expected trends. This model could encompass the data points with 95% confidence as shown in Figure 3-29.

$$19 \text{ mm Alligator DI} = 40.828 - (2.848) (Va) - (1.471) (VMA) - (0.018) (\%Gmm)$$

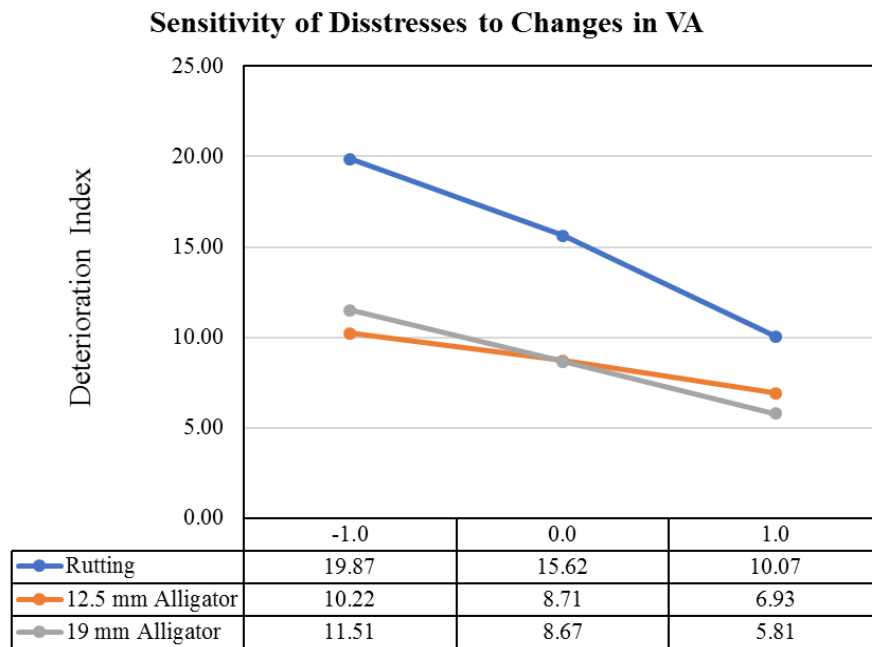
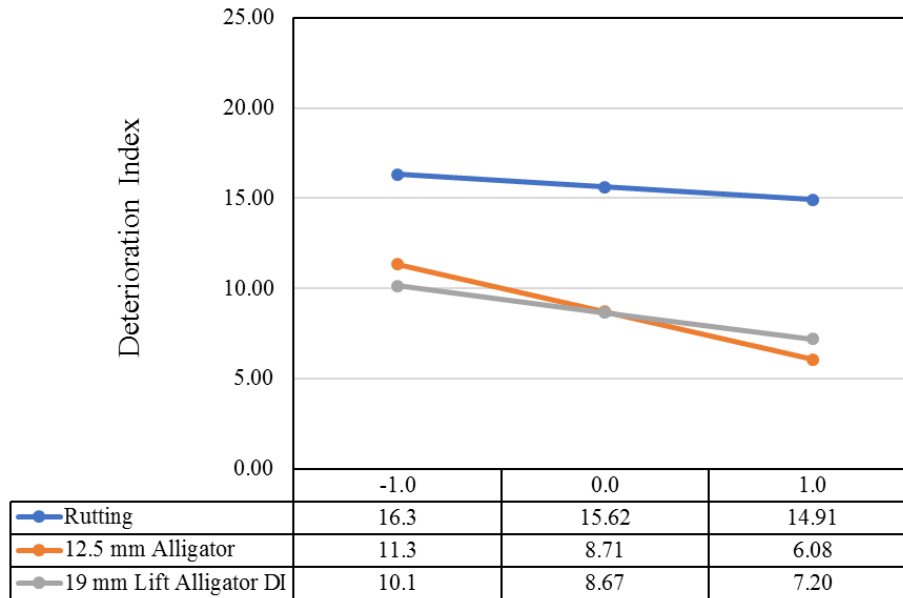
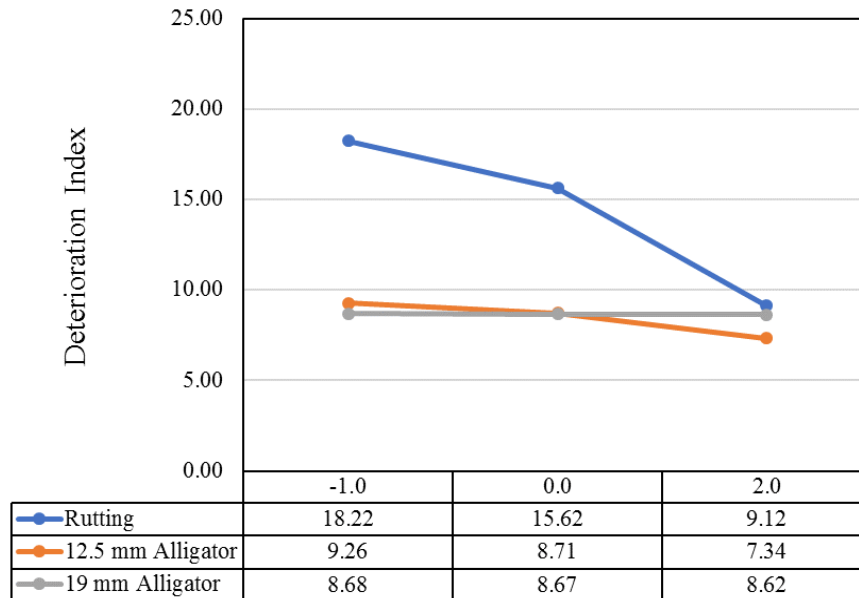
Using the regression models, the influence of the quality indicators can be evaluated through a simple sensitivity analysis. The starting point should be what is the status of the distresses after 7-8 years of service if all the quality indicators are met? The sensitivity analysis examines the change in the distresses due to the $\pm 1\%$ deviation in Va and VMA and -1% and $+2\%$ changes in in-place density while the remaining ones stay constant. The following plots (Figure 3-30, Figure 3-31 and Figure 3-32) show these changes.

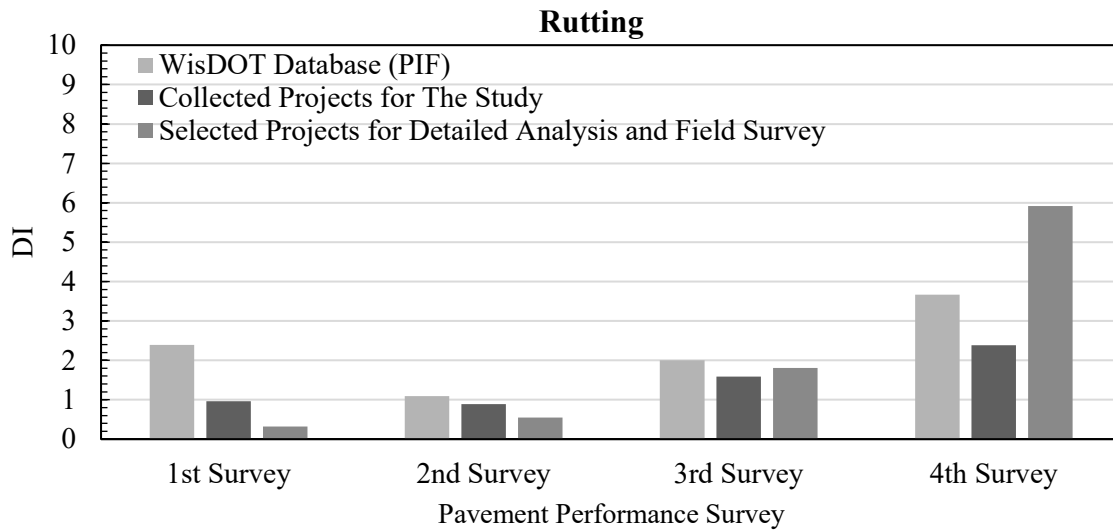
Figure 4-1 Comparison of Rutting DI for Selected Field Projects and the Created Database with PIF

On average, the rutting is not major distress in the projects included in the database. As seen in Figure 4-1, the average rutting for all projects scores below 10 out of a maximum of 100. The average rutting of the selected projects for field survey is slightly higher than the average of the collected database. This can help the analysis to look at more details and investigate the causes of this problem. However, considering that the score is out of 100, the averages are comparable. Figure 4-2 shows that most of the SN within the collected database (101 SNs) show no rutting on their fourth conducted survey. The distribution in Figure 4-2 shows that the first three quartiles of the SN experience no rutting.

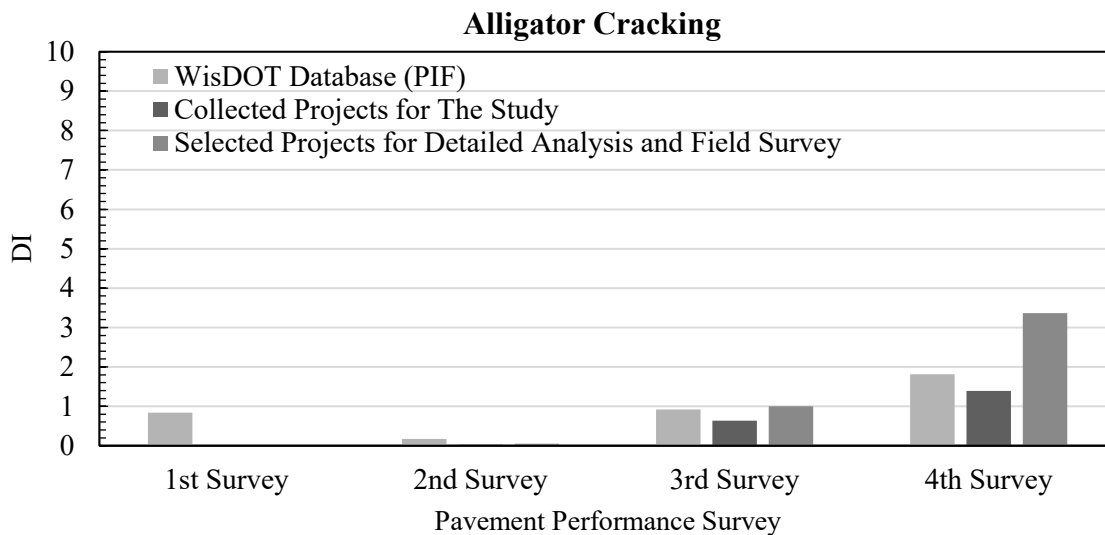
Figure 4-3 Comparison of Alligator Cracking Deterioration Index for Selected Field Projects and the Created Database with PIF

With respect to alligator cracking, Figure 4-3 shows that the 30 collected projects have a comparable level of alligator cracking to the network. Although, the seven selected projects for the field survey are showing a comparatively higher alligator cracking problem, which again, enables the more detailed research on its causes.

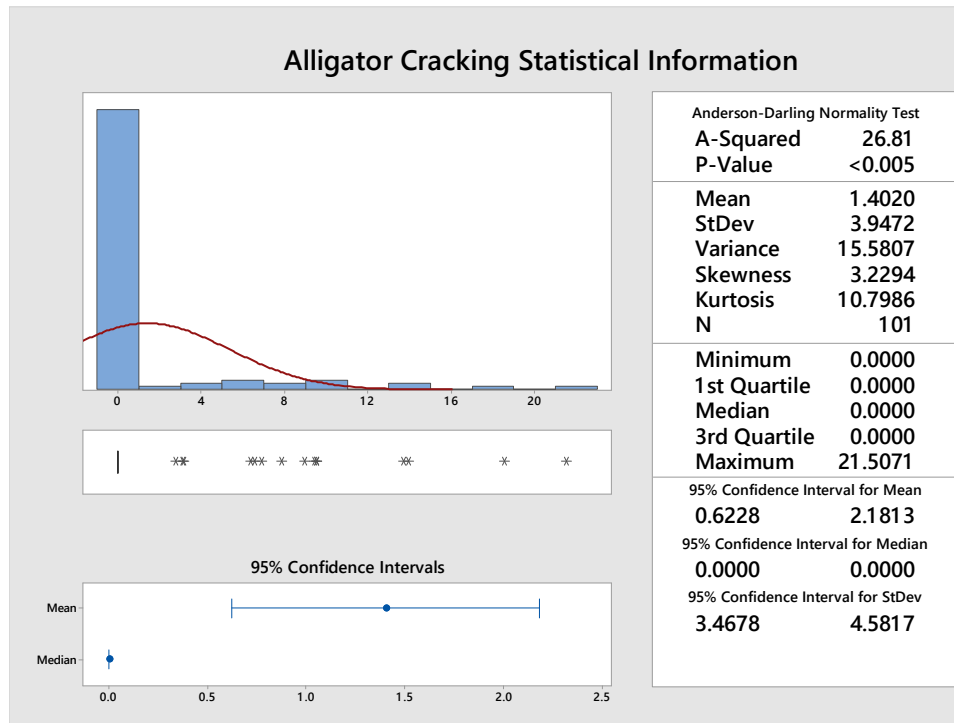
Figure 4-4 Distribution of Alligator Cracking DI for the Database

The distribution of the database of all the SNs based on the fourth conducted survey shows a similar distribution to that of the rutting. therefore, data used to generate the distribution reflect 7-8 years of service (Figure 4-4). The distribution shows that the 95% confidence interval for the alligator DI ranges from 0.623 to 2.181.

The Figure is showing that the majority of the sections are reporting a low level of alligator DI. Only few sections (within the fourth quartile of the distribution) are showing high level of DI at maximum of 21.5.

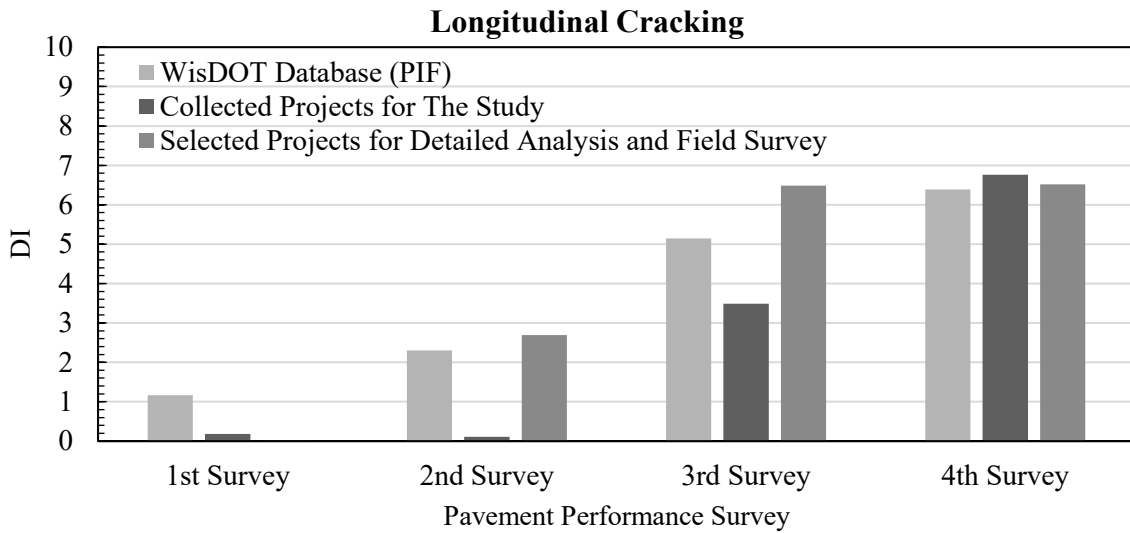
Figure 4-5 Comparison of Longitudinal Cracking DI for Selected Field Projects and the Created Database with PIF

The selected SNs for the field survey are also comparable to the network with respect to the longitudinal cracking damage. This is shown in Figure 4-5. In fact, the selected projects are on average slightly higher than the database (according to the fourth survey).

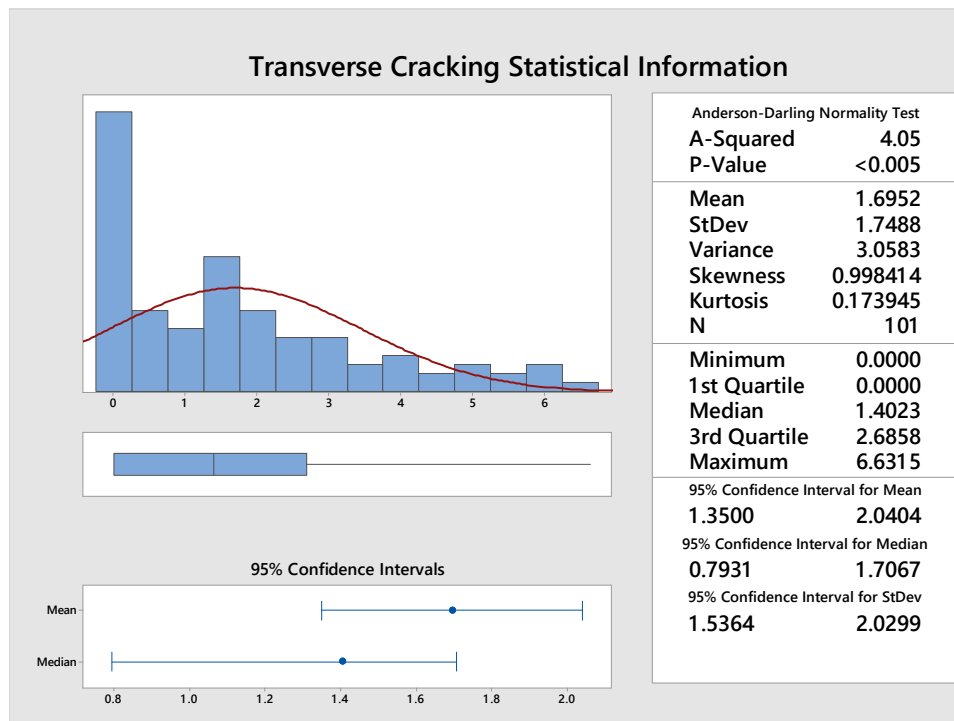
Figure 4-8 Distribution of Transverse Cracking DI for the Database

Transverse cracking is also prevalent in the database. However, the extent of the deterioration due to transverse cracking is minimal compared to the longitudinal cracking. The maximum value for the DI is only 6.6. (Figure 4-8)

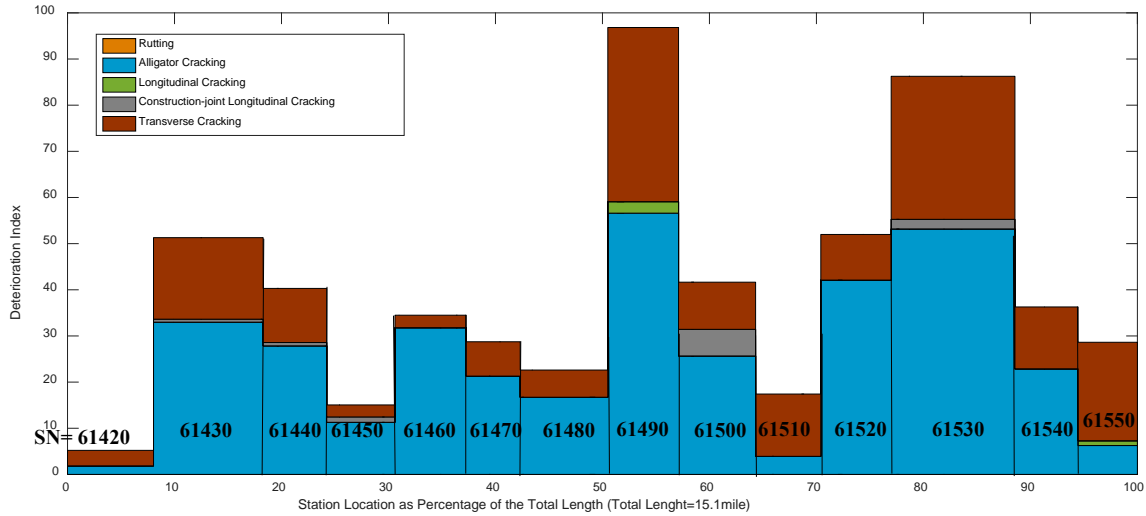
Figure 4-11 Performance of the project USH 45 (based on the on-site survey, 2017)

Figure 4-11 does not include rutting because it was not examined in the field due to the traffic control issues. In addition, alligator cracking is the most dominating followed by transverse cracking. No falling weight deflectometer (FWD) testing was conducted on this project, again due to the traffic-related issues. Therefore, it is impossible to verify if the cracking is because of the structural issues or related to the materials quality indicators.

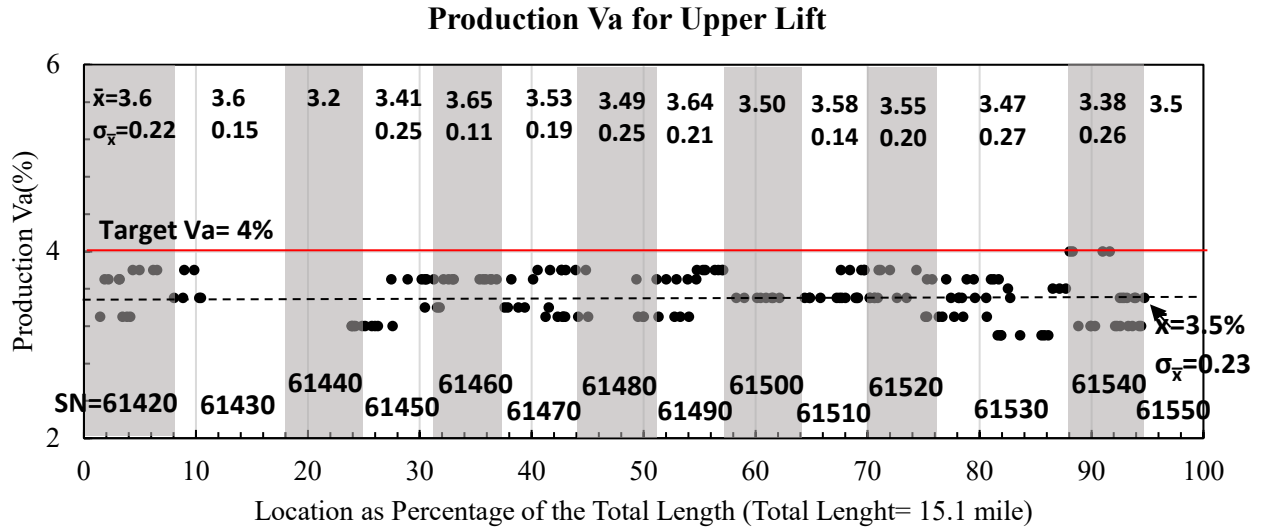
Figure 4-12 Production information air voids (Va) based on station locations (Project USH 45) (Upper Lift)

Production quality data were obtained from the contractors. The production lots were converted to mat area based on the design thickness in the plans. As a result, the production quality data is associated with the appropriate SN. Figure 4-12 and Figure 4-13 show the average air content of the gyratory samples tested at the contractor’s lab. The figures are for the mixes used for the upper and lower lifts. With the target being 4% air, both mixes are showing total averages of much lower values.

Based on the statistical analysis conducted in chapter 3, Va for the 12.5 mm and 19 mm mixes are consistently lower values (less than 4). This level of Va is associated with higher level of alligator cracking. Figure 4-12 and Figure 4-13 clearly show that the majority of the tests for both types of mixes are lower than 3.75%. In fact, only a few of the tests met the 4% Va target.

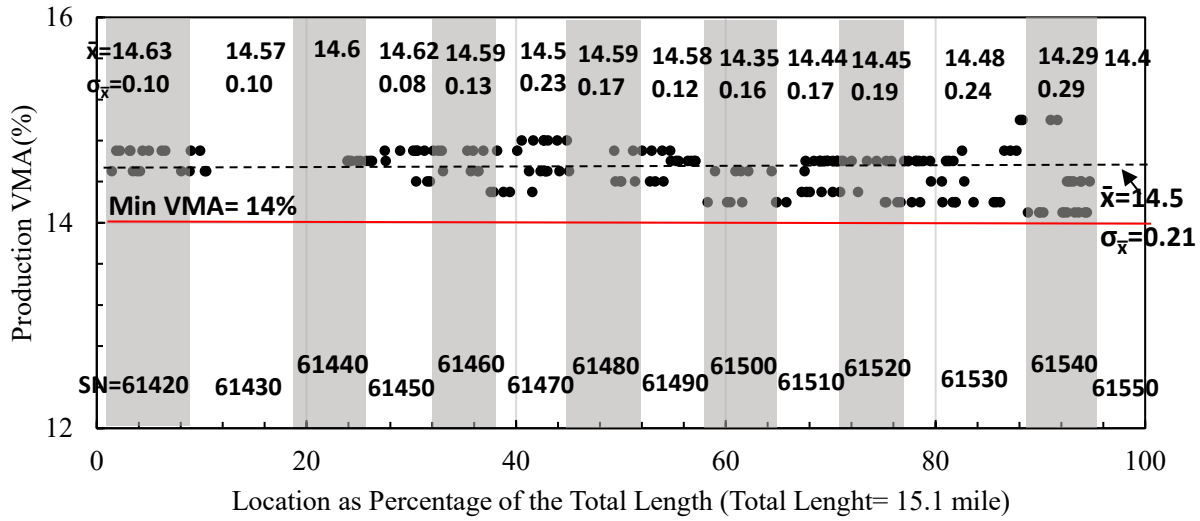
Figure 4-14 Production information of voids in mineral aggregates (VMA) based on station locations (Project USH 45) (Upper Lift)

The values of the VMA are also aligned with the trends noted in the global analysis. This project production data is highly consistent with minimal variability. This consistency did not prevent the pavement from showing a high level of cracking at early ages. (Figure 4-14 and Figure 4-15)

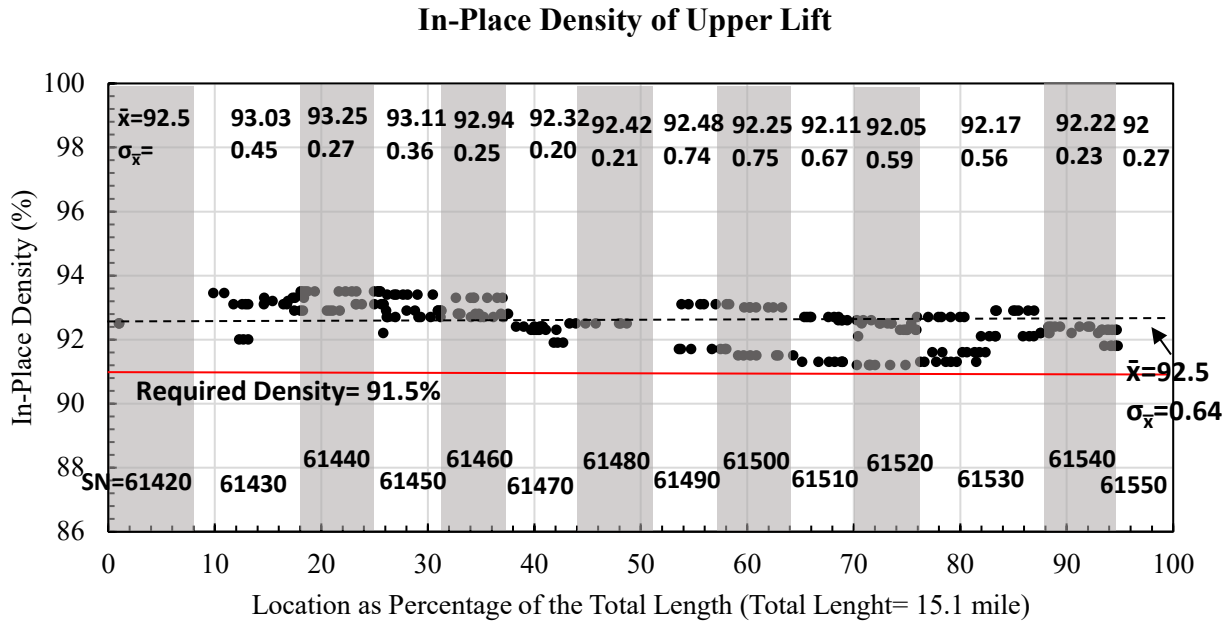
Figure 4-16 In-Place density (Gmm %) based on station locations (project USH 45) (Upper Lift)

Figure 4-16 and Figure 4-17 show the placement density for both lifts. The top lift is averaging 1.0% above the required density, while the lower lift is averaging 3.1% above the required density.

1. The in-place density for the SN presented in the figures show consistent values around the average. This is confirmed by the low value for the standard deviations within the individual SN and the pooled data. The results represent an attention-grabbing situation. While low V_a is correlated with high alligator cracking, the high in-place density is correlated with low alligator cracking. Examining the regression coefficients, and correlation trends presented in the global analysis (chapter 3), the weight impact of changing one unit of V_a on alligator cracking DI is about three times that of the in-place density. This could be the reason.

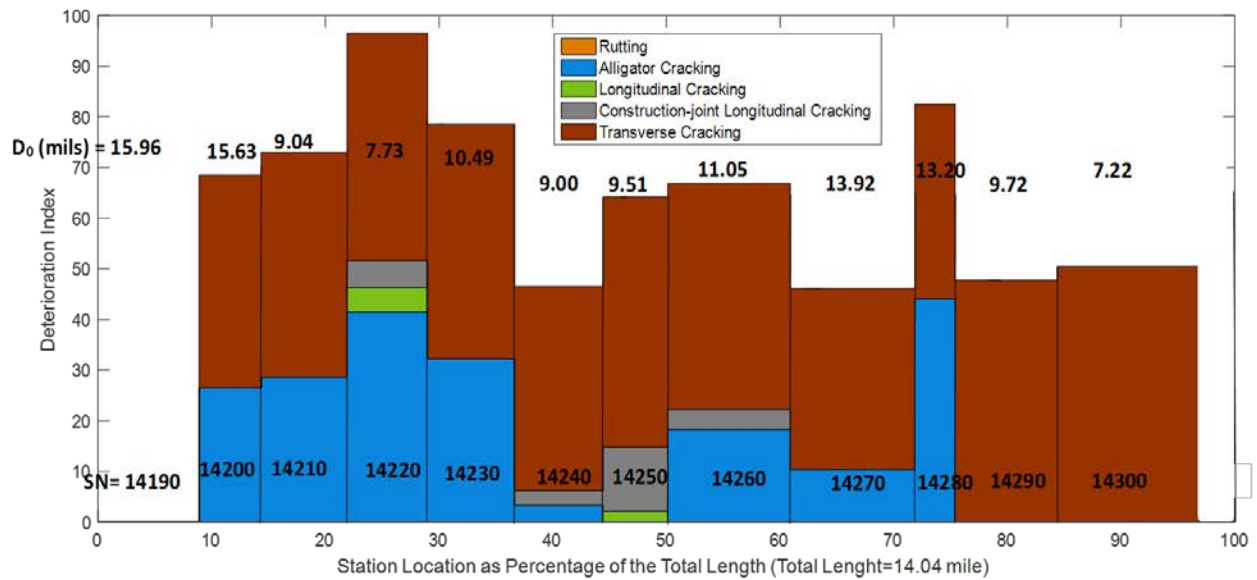
Figure 4-20 Performance of the project STH 13 (based on the research group survey) (2017)

Figure 4-20 shows the DI distribution for the different distresses based on the on-site distress survey. Again, the results are different compared to the PIF in terms of the extent of the distresses,

although the survey was conducted only one year after the PIF. However, both sources agree on the types of distresses observed. The PIF data for SN 14310 reflects distresses not included in this project as it is at the edge of the project.

SN 14220 shows the most deterioration among these SNs for this highway. It is important to note the FWD test revealed that the pavement structure for this SN is one of the strongest as shown by the low value of deflection (D_0) under the load reported in Figure 4-20. For this report the D_0 values are used to screen potential dependency of the distresses on structural issues. Based on experience, the following levels of D_0 are used to evaluate structure stability: Good: $D_0 < 10$, Moderate: $10 < D_0 < 15$, Poor: $15 < D_0$.

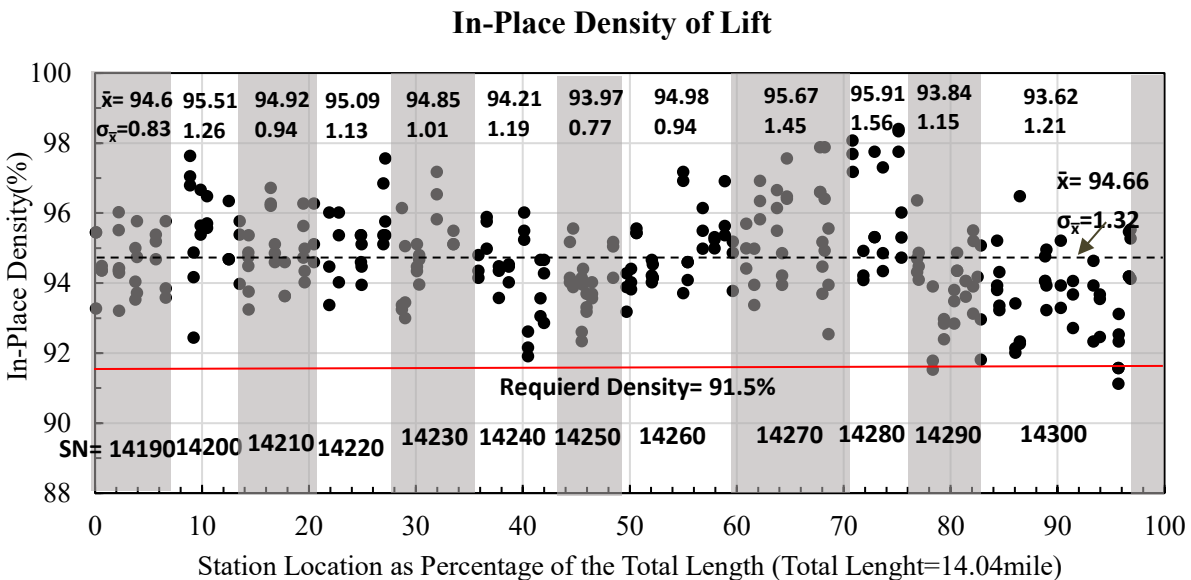
Figure 4-24 Construction information of in-place density (Gmm %) based on station locations (project STH 13)

Field compaction on this project achieved to an average of high density at 3.16% above target required density. Figure 4-24 shows the distribution of the in-place density quality. The variability in the in-place density is also prevalent similar to the production variability. SN 14220, which is the one showing the most cracking, in general, has a 4% wide range of density measurements, but all the individual tests exceed specification requirements. In fact, only one data point was compacted below target density in the entire project.

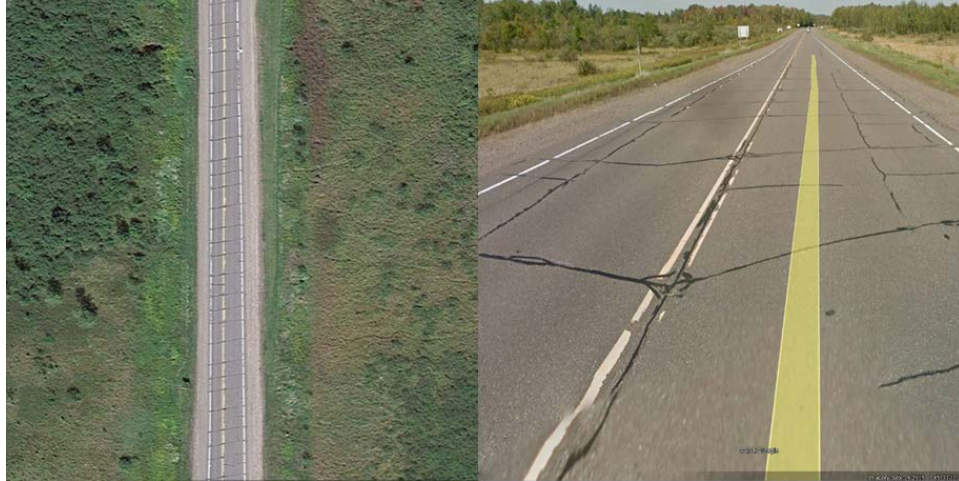
Figure 4-25 Satellite and street view photos from Google Earth ® of the distresses (SN 14300)

- 3- Several types of distresses are observed. Causes for some could be due to reflective cracking. Figure 4-25 shows sample pictures from the project. This level of cracking after five years of service is highly likely to be due to reflective cracking, especially that the pavement is only 2” thick over old HMA. Thus, the analysis focuses on alligator cracking

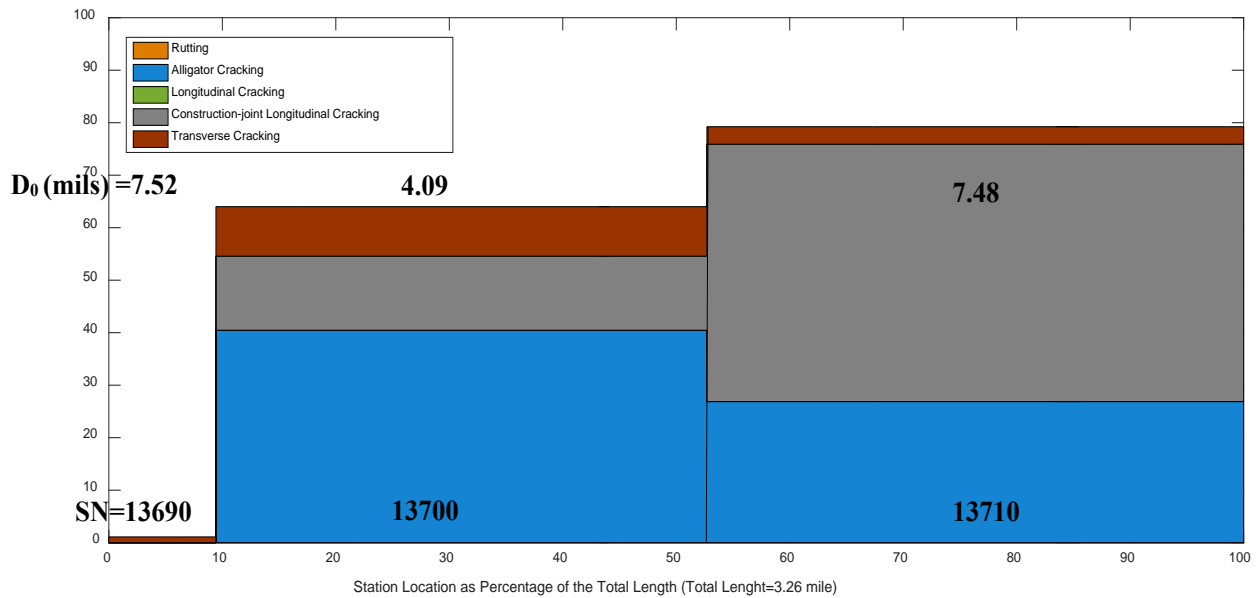
Figure 4-28 Performance of the project STH13 (based on research group survey) (2017)

Based on the information presented in Figure 4-28 significant construction joint longitudinal cracking is observed. There is a consistent presence of the transverse cracking but at a lower level. The results show that two of the three SNs are having significant alligator cracking. The FWD deflection under the drop weight (D_0) is also shown in the figure. These values are consistently on

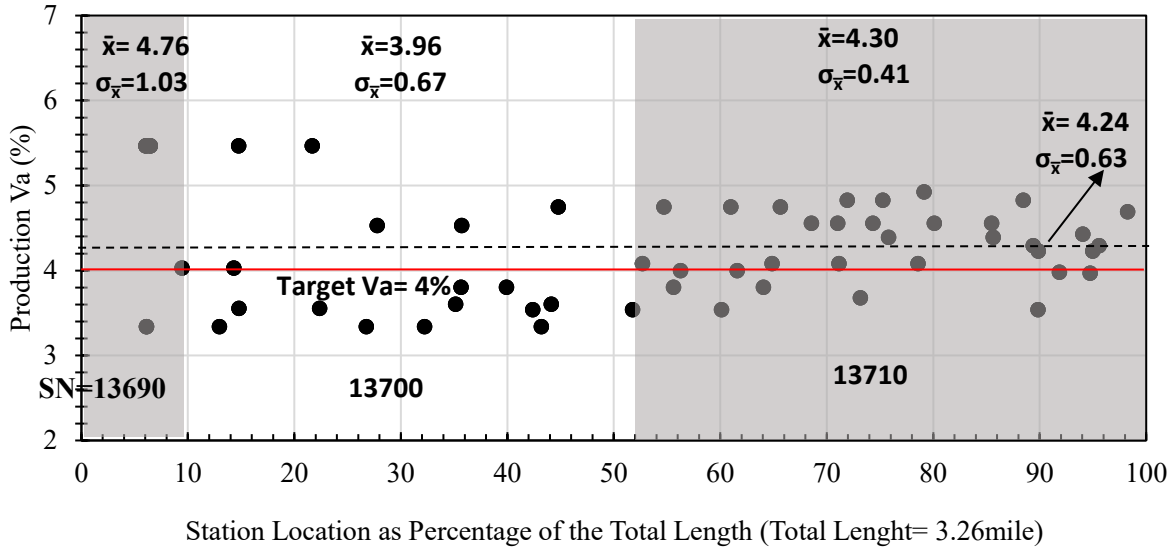
Figure 4-31 Production information air voids (Va %) based on station locations (project STH 13)

The Va data is on average meeting the target level of 4%. That is on spec. However, SN 13700 is showing high variability as demonstrated by the standard deviation (correspond to the coefficient of variability of 17% respectively). Assuming normal distribution, 53% of the area is below 4% Va, and 38% is below 3.75%. This is a low level of Va according to the global analysis conducted in the previous chapter and is associated with Alligator cracking. SN 13710 show ideal values for Va with minimal variability, yet it experienced alligator cracking as well. VMA data show the lower level of variability and 100% conformity. The distribution is shown below. There is no apparent association between the VMA and the observed performance.

With respect to data used for evaluating this quality, the only available data was for the 12.5 mm NMAS top lift mix. Data for the 19 mm bottom lift was not available. Figures 4-31 and 4-32 show the Va and VMA production data by location on the project and SN.

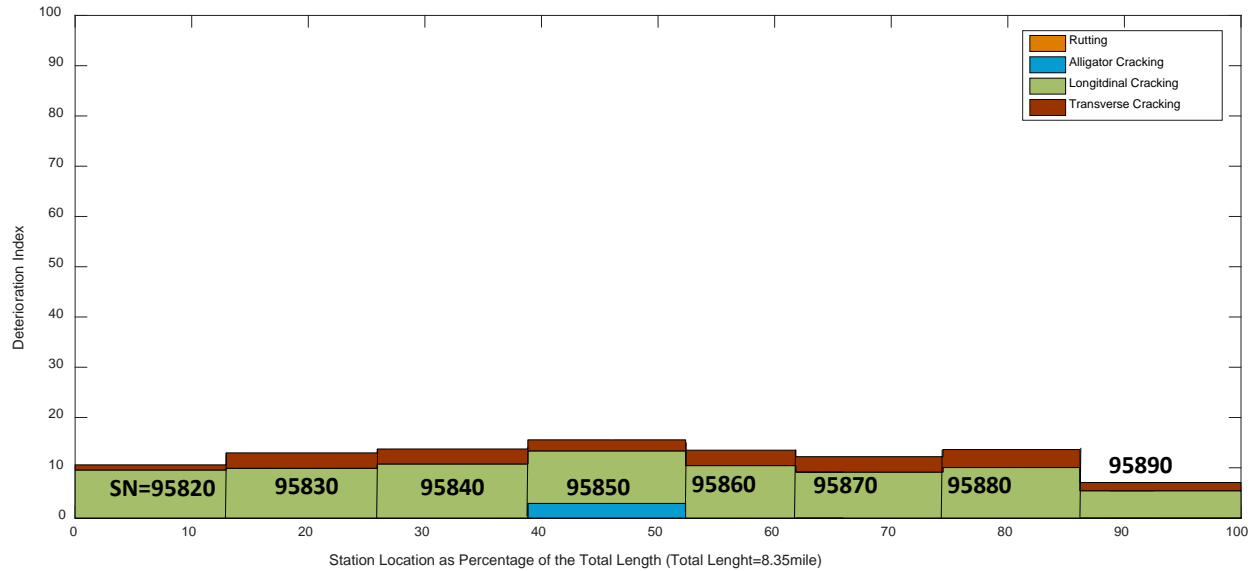
Figure 4-36 Performance of the project STH 75 (based on the DOT information) (2016)

The performance of the project STH 75 as reported in the PIF is shown in Figure 4-36. Transverse and longitudinal cracking are the most common among all the SNs. Alligator cracking is reported in one SN only. In any case, all these distresses are reported to have low DI value. The on-site survey is again documenting higher levels of distresses. The survey shows that the longitudinal cracking distributed between centerline construction joint cracking, and in line longitudinal cracking. The on-site survey noted alligator cracking in all SN. The extent of the distress is greatest at the ends of the project limits as shown in Figure 4-36.

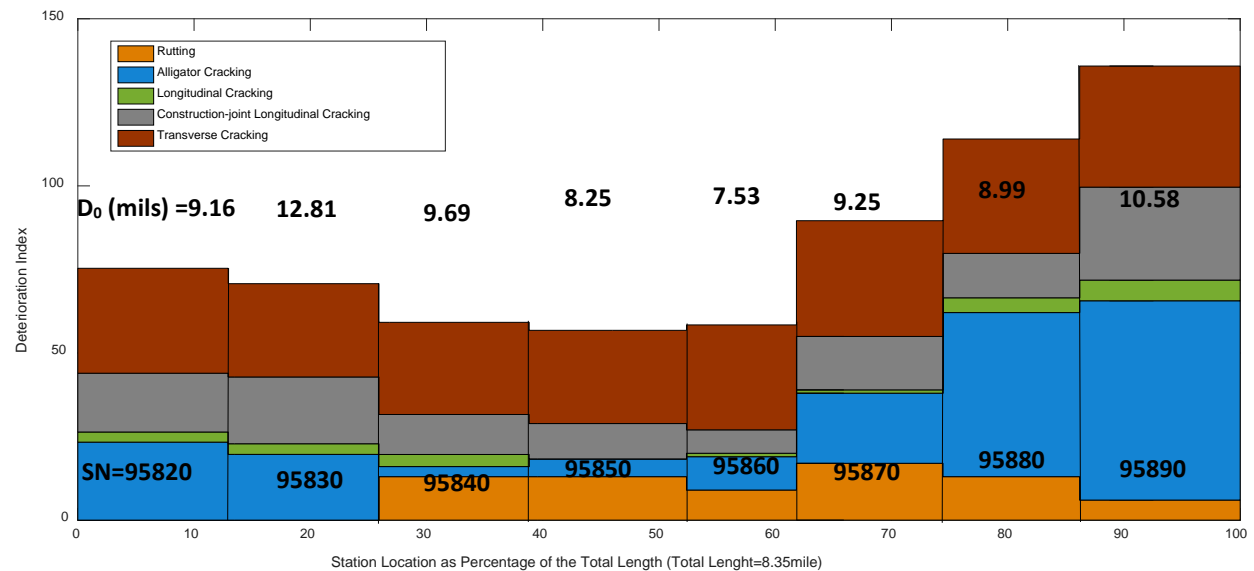
Figure 4-37 Performance of the project STH 75 (based on the research group survey) (2017)

As seen in Figure 4-37, transverse cracking is uniformly distributed over all the SNs of the project, same as the longitudinal cracking. While the middle portion of the project shows the least amount of distress overall, which contradicts with the PIF, minor rutting is also noted in this portion of the project. Examining the D_0 average values for these SNs, the structure appears to be stable. Thus, the distresses are not expected to be due to structural failures.

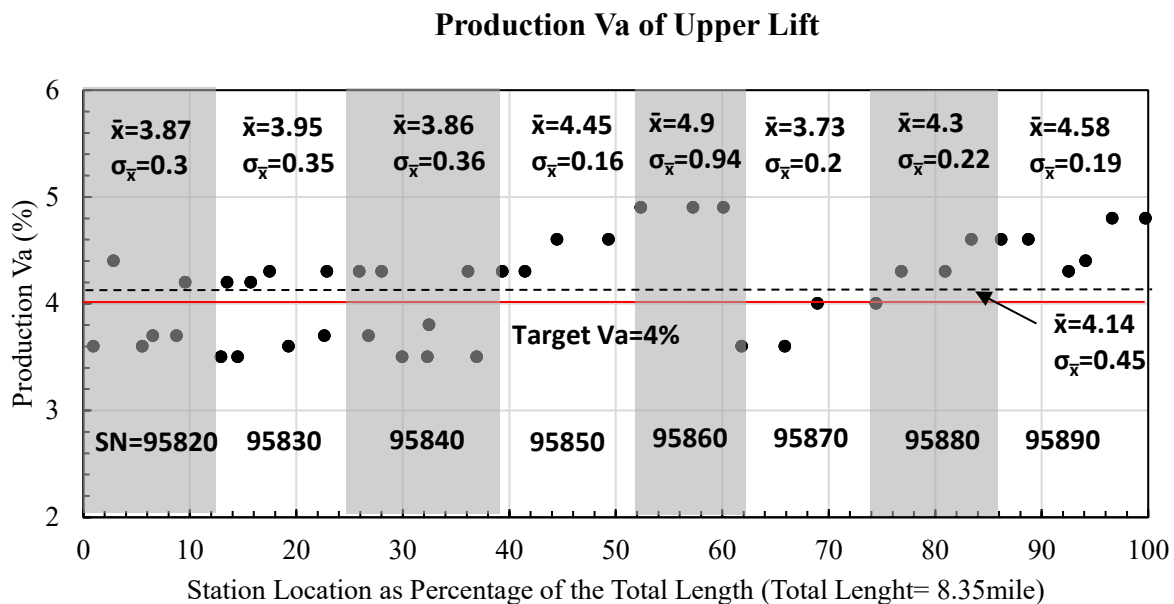
Figure 4-38 Production information of air voids (V_a %) based on station locations (project STH 75) (Upper Lift)

Production quality shown in Figure 4-38 and Figure 4-39 reflects the V_a and VMA of the 12.5 mm upper lift. With respect to V_a , the average of the projects is on spec, with the individual SNs show on spec V_a as well. However, SN 95860 show high standard deviation (COV = 19%) due to the variation of about 1.5% air within the SN. The VMA data reported show minimal variability, with all the data points exceeding the minimum required value.

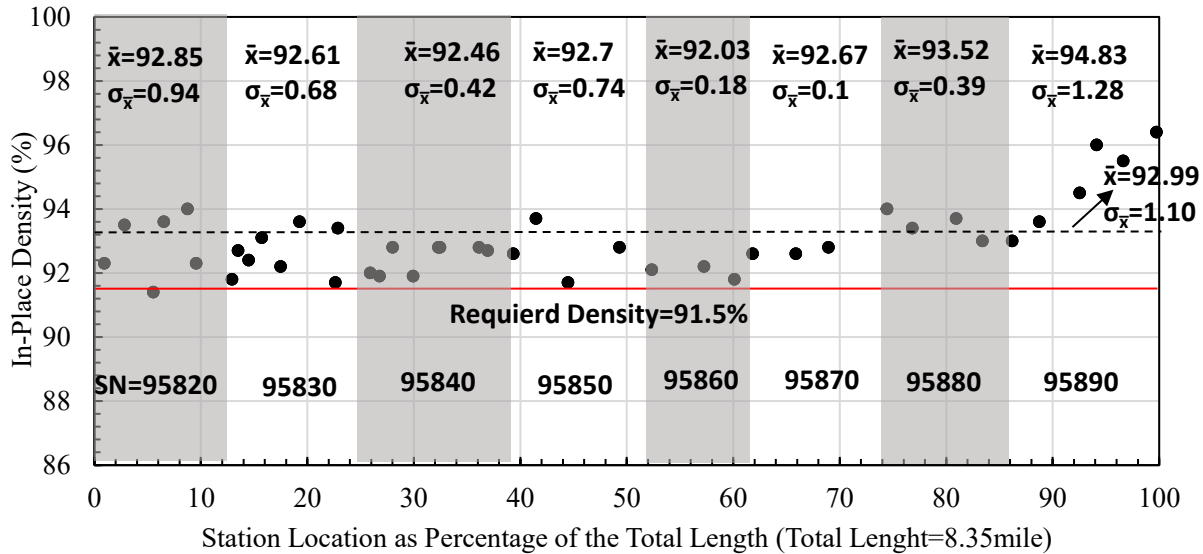
Figure 4-40 Construction information of In-Place Density (Gmm %) based on station locations (project STH 75) (12.5 mm Lift)

Placement quality data show all data conforming to the required density value. SN 95890 show the incomparable average density of 94.83%; this is about 2% above all other SNs in the project.

The placement density shows consistent compaction throughout the first 90% of the project length. SN 95890 is showing on average 1.5% more compaction than required at %Gmm of 92.99. This is due to few spots showing a very high level of densification as high as 96.4%. For a 2in lift, this level of compaction is dangerous. Combining this over compaction with the fact that the mix at this location shows high resistance to compaction in as demonstrated by the high level of mix Va. There is a good chance that the severe level of deterioration observed is due to crushing of the mix during construction.
