Evaluation of WisDOT Quality Management Program (QMP) Activities and Impacts on Pavement Performance

WisDOT ID no. 0092-15-05

October 2018

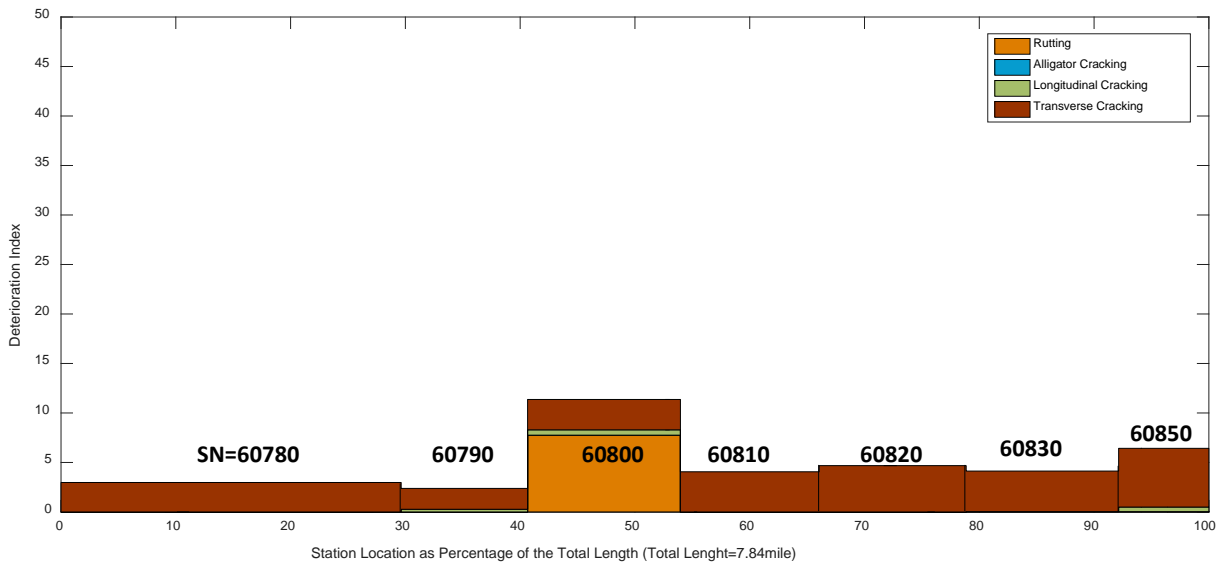
Figure 4-42 Performance of the project STH 76 (based on the DOT information) (2016)

Performance survey (Figure 4-42) of this project, is showing the distribution of the distresses on the entire length of the project. The degree of deterioration is minimal throughout the project length with minor transverse cracking distributed uniformly. SN 60800 is showing noticeable rutting and minimal longitudinal cracking.

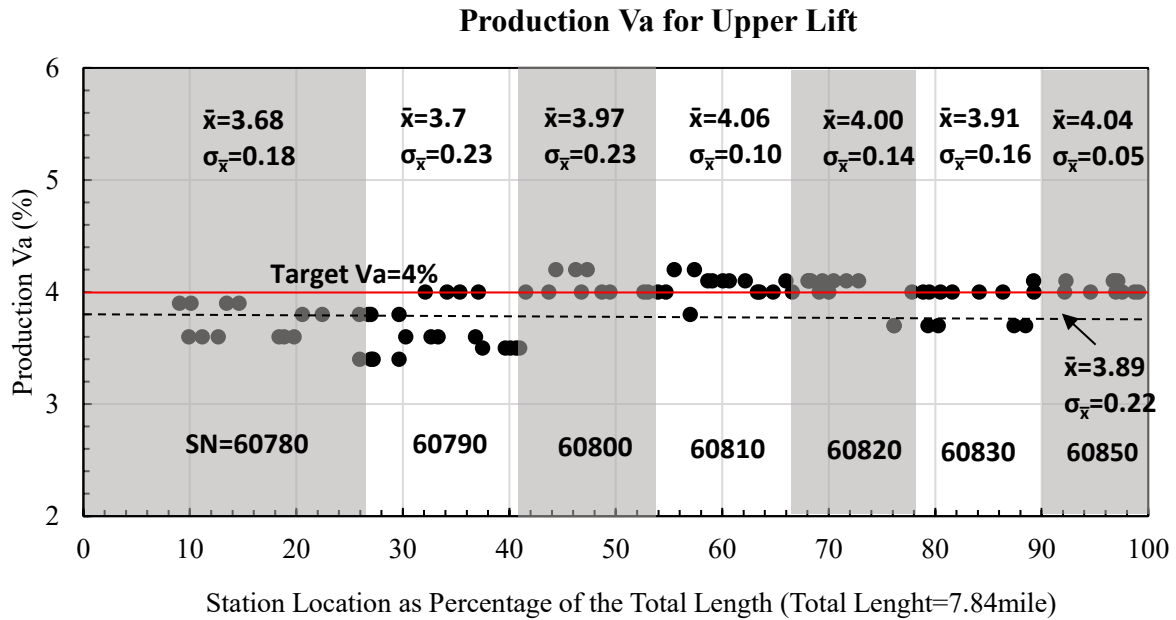
Figure 4-44 Production information of air voids (Va %) based on station locations (project STH 76) (Top lift, NMA=12.5 mm)

Production information shown in Figure 4-44, Figure 4-45 are reflecting the Va information for the upper and lower lift of the project STH 76. The VMA information for the upper and lower lift are also shown in Figure 4-46 and Figure 4-47 respectively.

The 12.5 mm mix compaction resistance as measured by Va is consistent throughout the project except for SN 60790 which shows some tests below the 3.75%. This section is the only SN showing measurable levels of alligator cracking. The case is a bit different for the 19 mm mix. This is because a higher level of variability observed in the available data. The VMA of the 12.5 mm mix is consistently non-conforming, for all the SN.

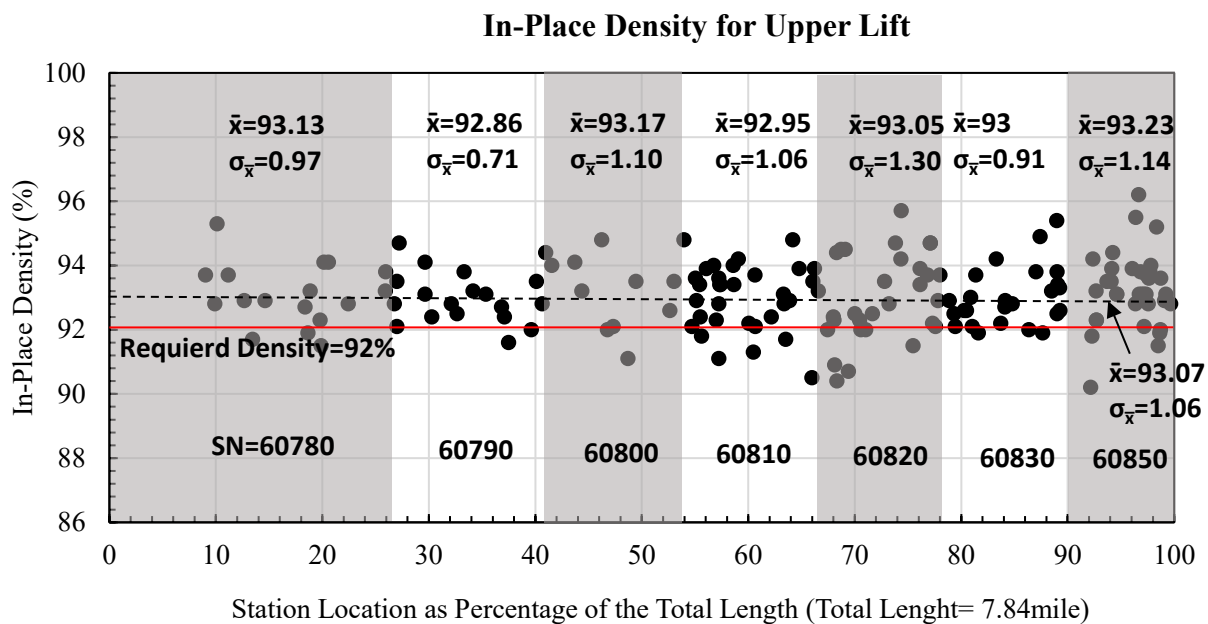
Figure 4-48 Construction information of in-place density (Gmm %) based on station locations (project STH 76) (Top lift)

Production quality shown in Figure 4-48 and Figure 4-49 does not show over compaction. However, it shows higher variability with some test points falling below the minimum accepted density for both distresses.

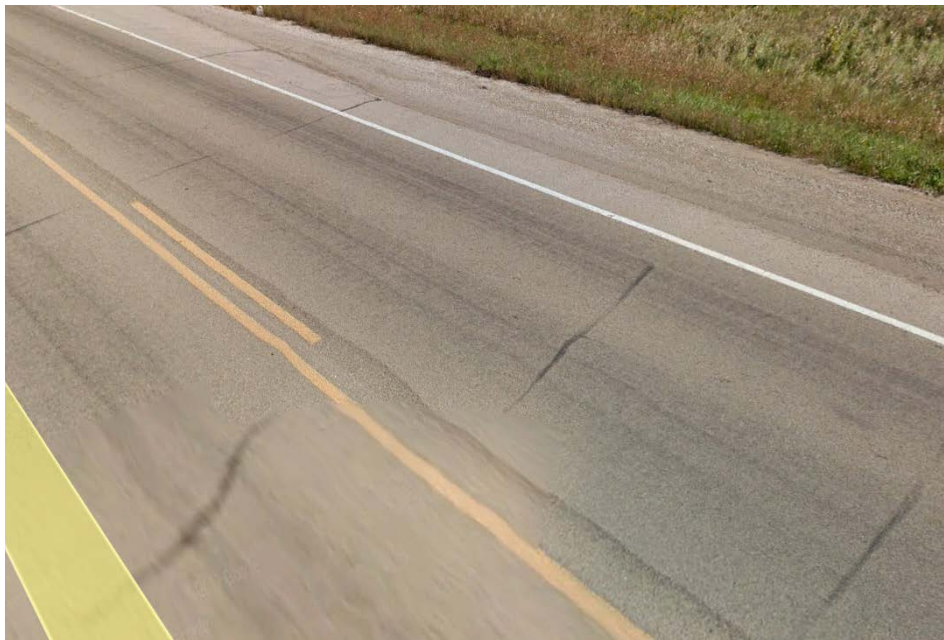
Figure 4-50 Pavement condition on the place with the highest compaction variation (SN=60850)

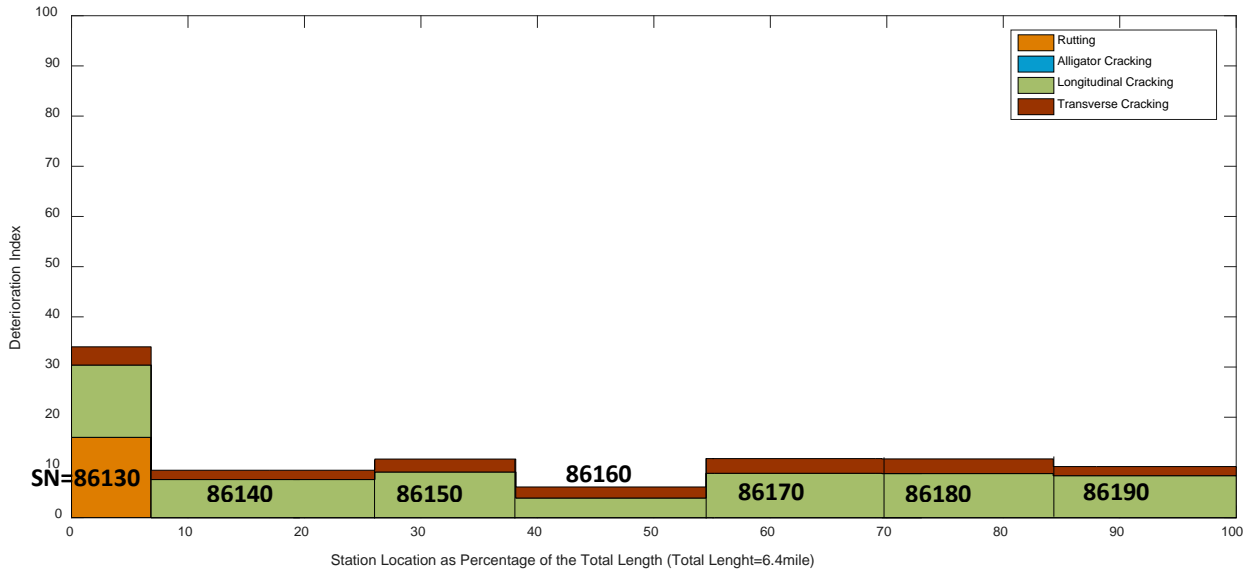
Figure 4-52 Performance of the project STH 64 (based on the DOT information) (2016)

The long-term performance can be investigated through the performance indicators that are shown in Figure 4-52. According to the PIF, the longitudinal and transverse cracking recorded are of the minimal level; only SN 86130 is showing noticeable rutting.

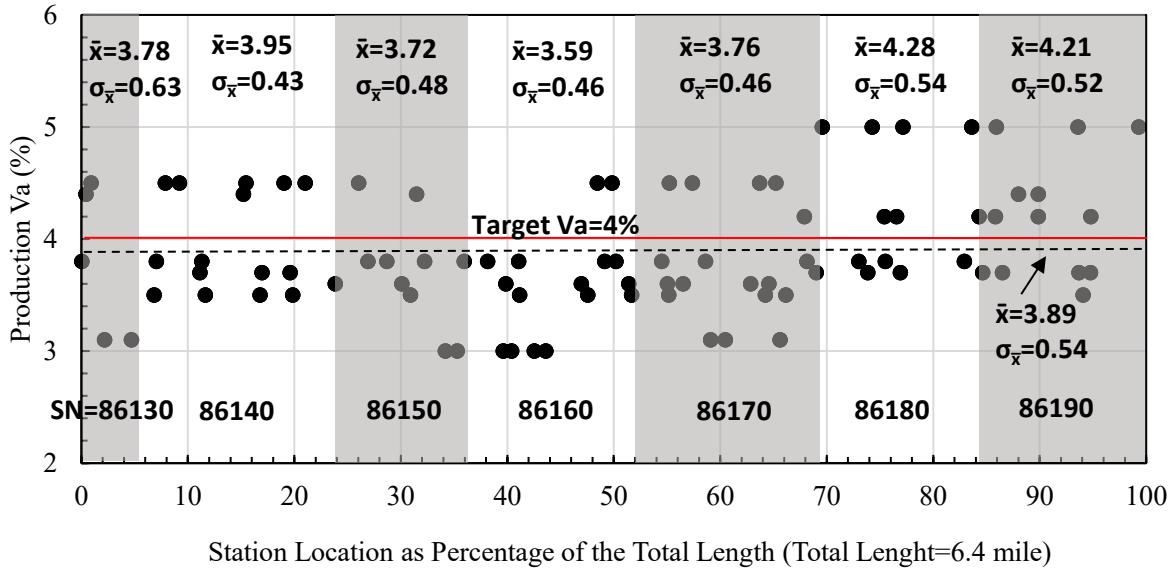
Figure 4-56 Production information of air voids (Va %) based on station locations (project STH 64)

The production mix Va is shown in Figure 4-56 provides a noticeable trend. For the first 70% of the project length, mix compaction Va is consistently below the 4.0 % level. Some mix tests had Va value of as low as 3%. For the remaining 30% of the project is constructed with more compaction resistant mix of average air above 4.2%. The same region of the project is the one with the least distresses.

1. Low Va are associated with high deterioration.
2. The only alligator cracking SN in the onsite survey is associated with the lowest level of Va in the entire project. The same SN show placement quality record including the most under compacted test point (less than 92%Gmm), and the most compacted test point (more than 96%Gmm).
3. FWD D₀ are highest at the top-distressed sections. Yet the values of the D₀ are within typical well-performing structures. The modulus values for the base and subgrade for these sections are also at adequate levels. This indicates that the surface layer is soft.

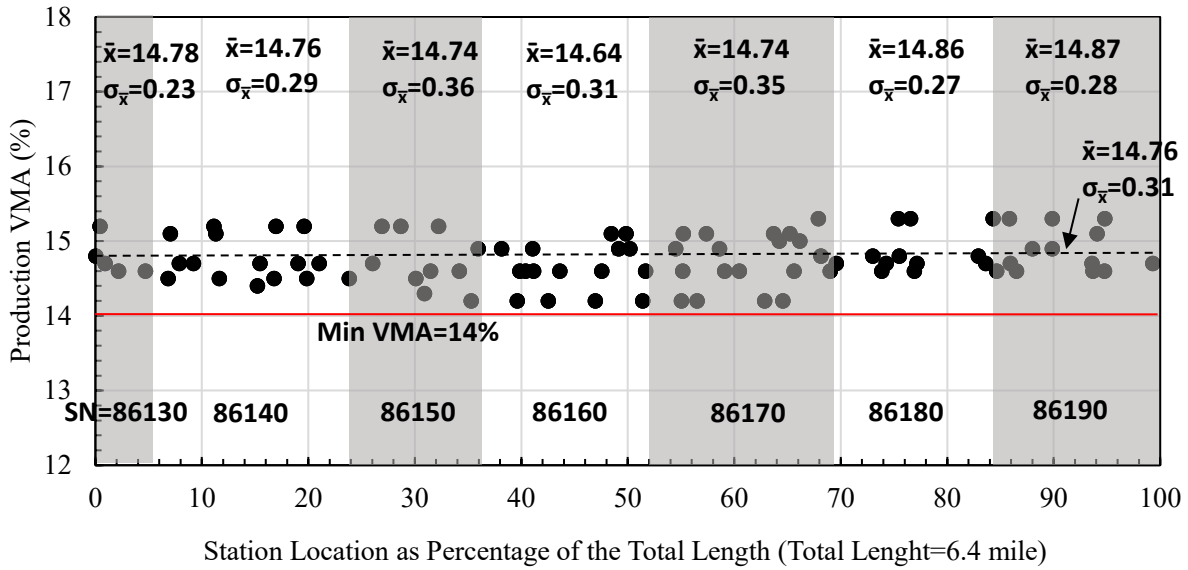
Figure 4-57 Production information of voids in mineral aggregates (VMA %) based on station locations (project STH 64)

The mix VMA is showing a lower level of variability and more conformity compared to Va (Figure 4-57). There is no apparent association between the VMA of this mix and the noted performance.

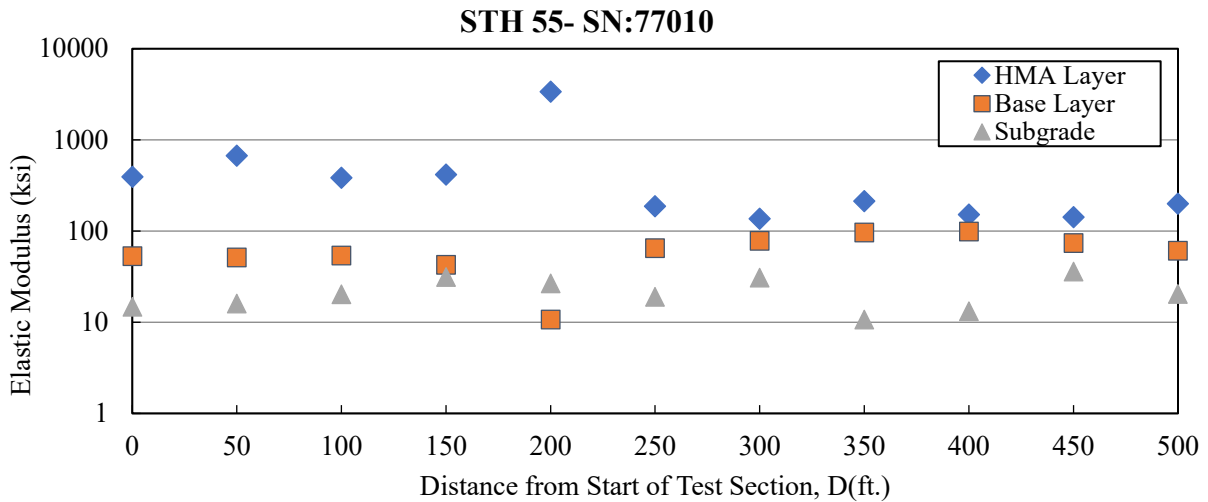
Figure 4-63 E modulus of subgrade for SN=77010

Figure 4-61 also shows the D_0 values. The values are showing are mostly within the moderate range for the D_0 . This indicates a potential interaction between structural stability and materials. Therefore, the modulus for the pavement layers are calculated and shown for all SN in the following figure. With respect to SN 77010, the most distressed in the project, a plot of the individual FWD tests conducted is shown in Figure 4-63 with the distresses DI overlapped.

Based on the information above, pavement structure appears to be one of the influencing factors. The following sections discuss the quality measures for this project.

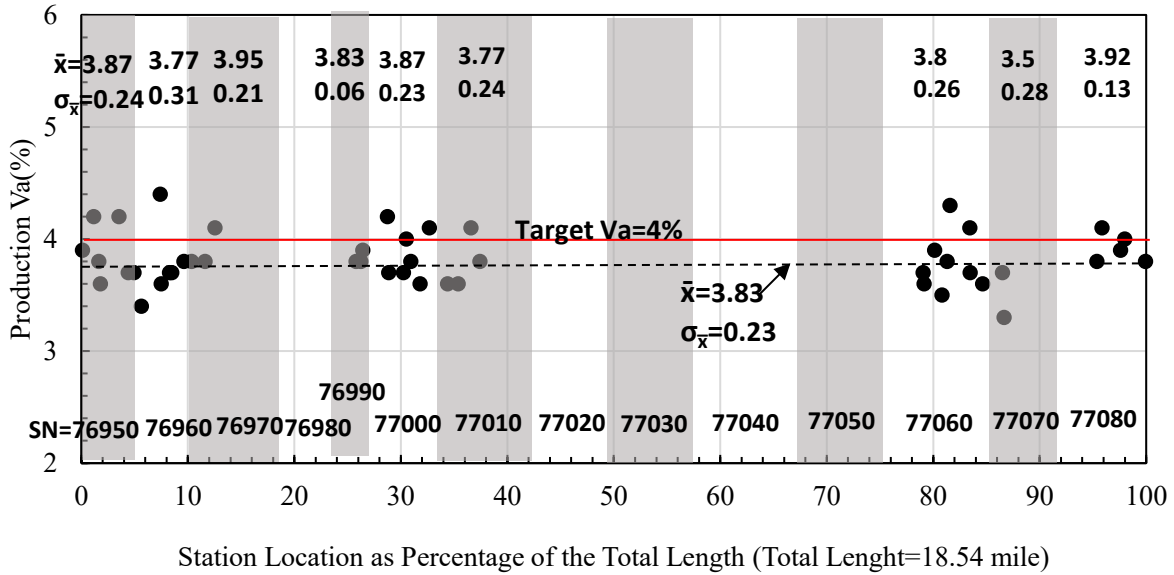
Figure 4-64 Production information of air voids (Va %) based on station locations (project STH 55)

The available results from the production quality data show that the Va values are not conforming on average, but the VMA values are on average above the minimum required. Low Va indicates a

soft mix which is associated with increased distresses, especially that this mix is used at 2-inch thickness.

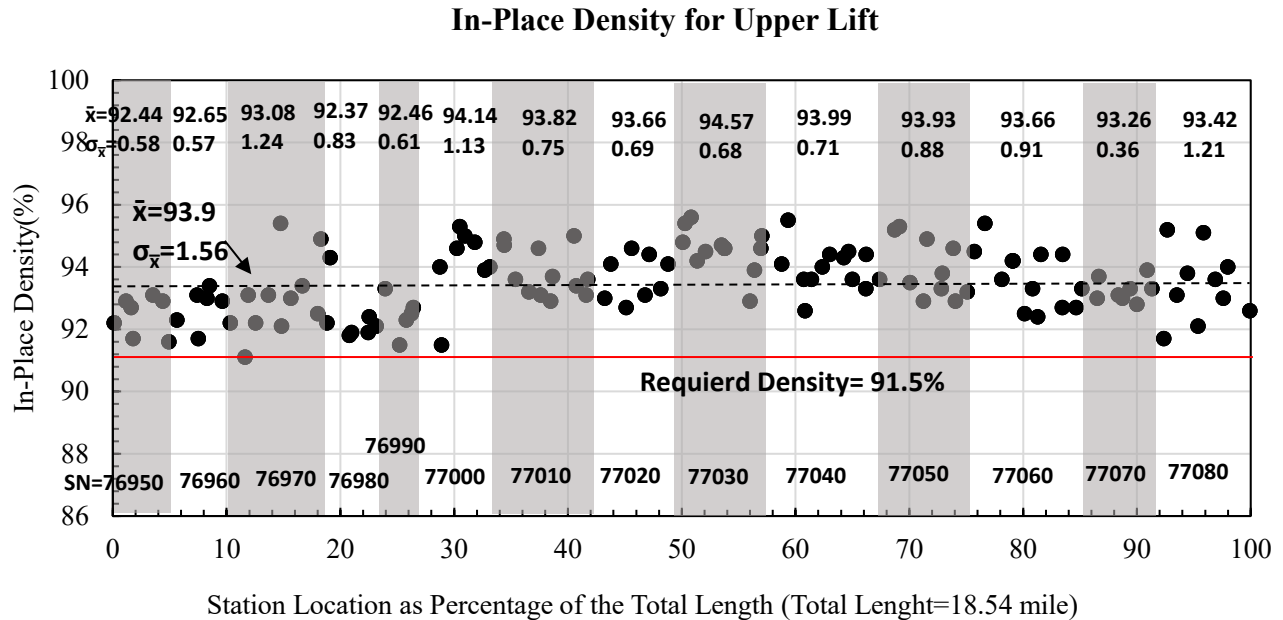
Figure 4-66 Construction information of in-place density (Gmm %) based on station locations (project STH 55)

Placement density shown in Figure 4-66 represents a full record of the %Gmm. The average density for the project is 93.9, which is 1.4% above the minimum required for all individual tests meeting or exceeding requirements. SN 77010 shows consistent densification values with the maximum value of about 95%Gmm (3.5% above the minimum required). For a soft mix (as shown by the Va and D₀) and thin lift of 2 inches over existing, this level of compaction may be excessive. This trend follows that noticed for STH 64, STH 75, and STH 13.

1. The available production data is inconclusive.
2. FWD results for the modulus values show that the sections with the highest level of deterioration are the ones with the lowest modulus values.
3. Placement compaction is in some cases 4% above the minimum required at 95.5%. This is a 2" layer paved over an existing compacted surface.
4. The same sections that are over compacted are showing the lower surface modulus. These sections have the highest DI.
