**Federal Railroad
Administration**

Long-Term Effect of Photo Enforcement-Based Education on Vehicle Driver Behavior at a Highway-Rail Grade Crossing

6. AUTHOR(S) Tashi Ngamdung and Marco daSilva				
7. PERFORMING ORGANIZATION NAME(S) AND ADDRESS(ES) U.S. Department of Transportation Office of the Assistant Secretary for Research and Technology John A. Volpe National Transportation Systems Center 55 Broadway Cambridge, MA 02142-1093			8. PERFORMING ORGANIZATION REPORT NUMBER DOT-VNTSC-FRA-19-03

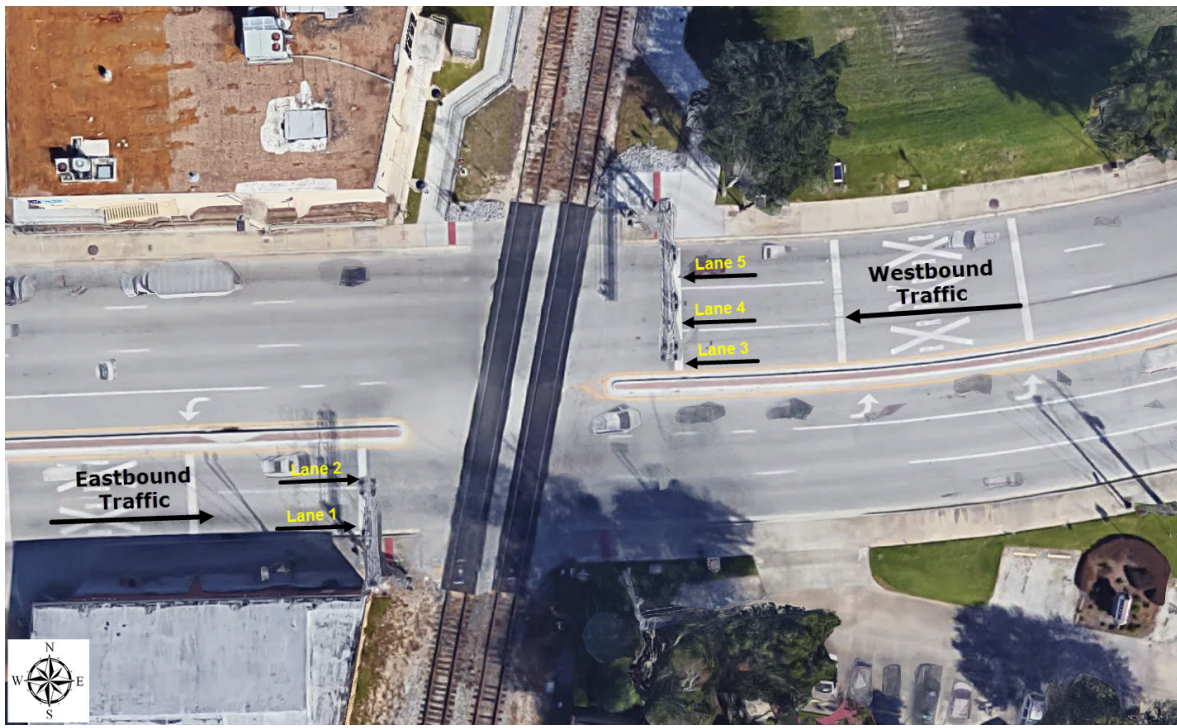
Figure 2. Lane Coding Scheme for East Princeton Street Grade Crossing

There are three lanes of traffic that intersect the crossing in the westbound direction. The innermost lane (lane 3) splits into two lanes immediately after the crossing with the innermost lane becoming a left-turn-only lane onto North Orange Avenue. The signalized intersection at North Orange Avenue is located approximately 260 feet west of the crossing. The traffic lights at the intersection are interconnected (advanced preemption) with the crossing signals allowing

traffic to clear the crossing during an activation. [Figure 2](#) shows the five lanes that intersect with the crossing and [Figure 3](#) shows a Google street view on approach to the crossing in the westbound direction.

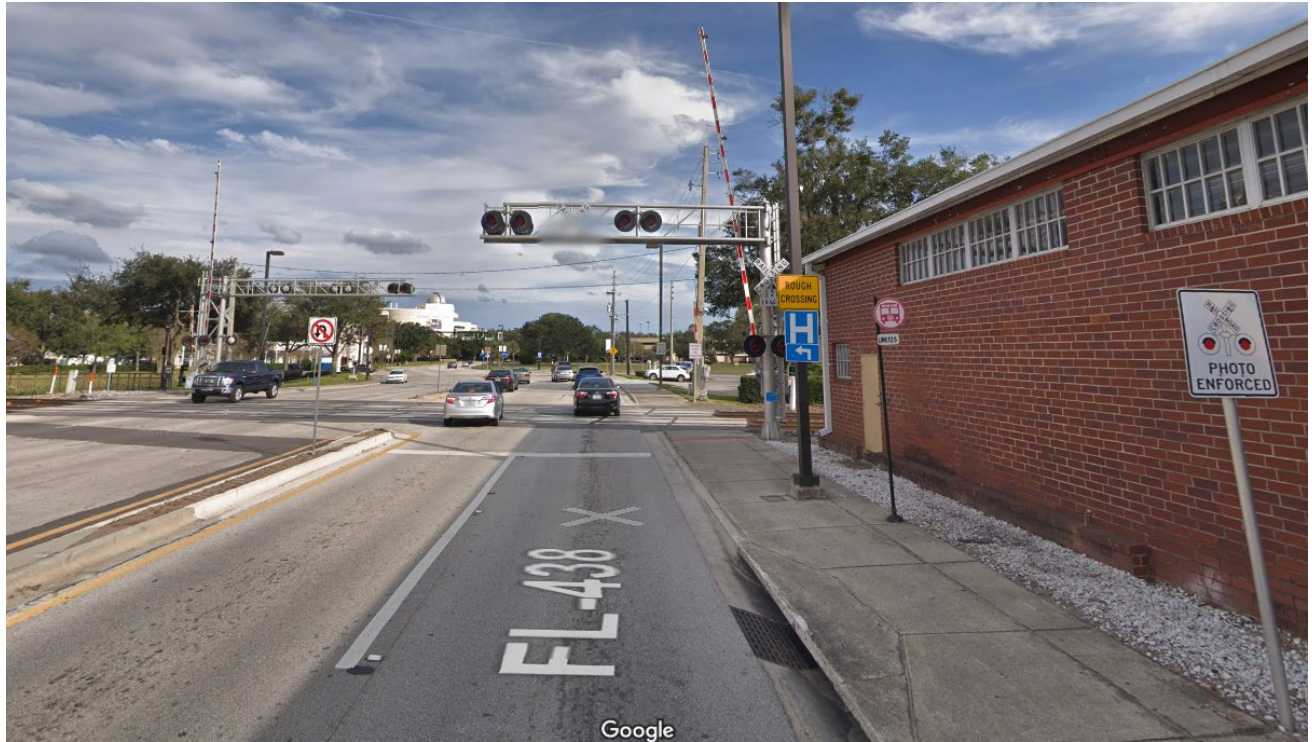
Figure 4. A Google Street View of the Crossing in the Eastbound Direction

There are two lanes of traffic that intersect the crossing in the eastbound direction. [Figure 4](#) shows Google street view on approach to the crossing in the eastbound direction. The innermost lane (lane 2) splits into two lanes immediately after the crossing, with one lane becoming a left-turn-only lane onto Alden Road. This road is the entrance to the SunRail Florida hospital located adjacent to the crossing on the northeast corner. The signalized intersection at Alden Road is located approximately 185 feet east of the crossing. The traffic lights at the intersection are interconnected (advanced preemption) with the crossing signals allowing traffic to clear the crossing during an activation.

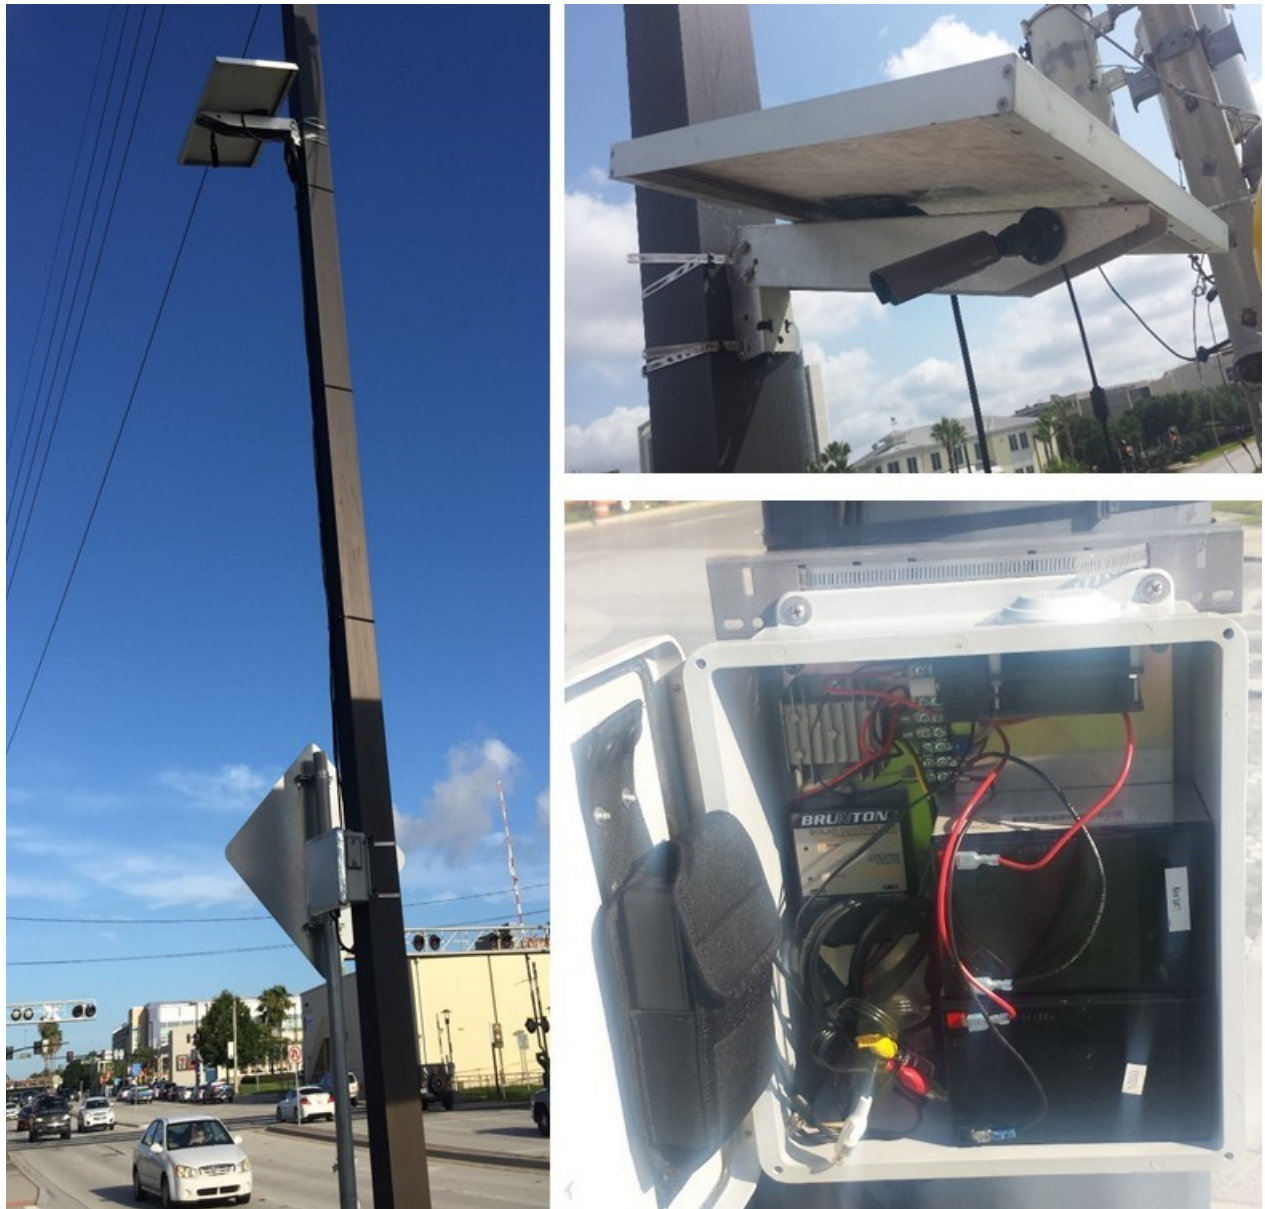
Figure 5. Video Data Collection System at East Princeton Street

A video-based data collection system consisting of a solar panel, a camera, and a digital video recorder along with supporting hardware contained in a utility box was used to collect video of vehicles travelling in both directions at the East Princeton Street grade crossing. [Figure 5](#) shows pictures of the data collection system installed at the East Princeton Street grade crossing.

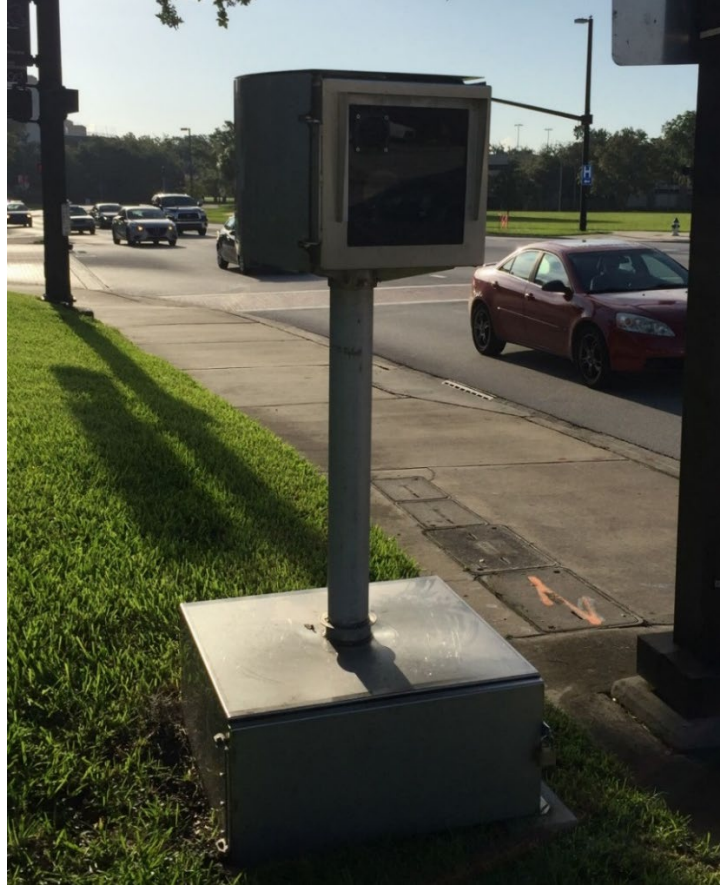
Figure 7. Photo Enforcement System at East Princeton Street

The system used for automated photo enforcement at the East Princeton street grade crossing was installed and operated by Sensys America, Inc. The system sits adjacent to the East Princeton Street sidewalk before the crossing in the westbound direction, approximately 130 feet from the crossing stop line. It is a turnkey portable system that consists of a battery bank in a lower enclosure, a pole, and an upper enclosure housing all of the cameras and sensors. The whole system weighs approximately 514 lbs and is approximately 44 inches tall. It was designed to be a self-contained and stand-alone system, not connected to the railroad signaling system, and temporarily installed off the roadway. The system was installed on August 8, 2016 and became operational on August 11, 2016.

The photo enforcement system captured violations for westbound traffic only. However, signage alerting drivers of the photo enforcement was installed for both directions of traffic. The signage for the westbound traffic was placed on an existing pole on the sidewalk located approximately 65 feet before the crossing stop line, and the signage for the eastbound traffic was placed on a pole on the sidewalk located approximately 45 feet before the crossing stop line. The signage was developed in collaboration with the City, FRA, and the Volpe Center. Images of the Sensys photo enforcement system and signage installation are shown in [Figure 7](#) and [Figure 8](#), respectively.

The photo enforcement system at the East Princeton street grade crossing is activated when a vehicle fails to stop before traversing the crossing during the gate-descend phase, resulting in a Type II violation. Several photos and video recordings of the violation are captured by the system and uploaded onto a secure password-protected website. A City staffer then reviews the video and determines whether to issue a warning notice to the vehicle owner. The warning notice looks very similar to an actual citation sent out by the City for red light violations but states very clearly that it is just a warning notice, and the owner is not required to pay any fines or go to court. The warning notice is accompanied by education materials about safe driving tips at grade crossings and a short survey. A copy of the warning notice, education materials, and survey questions are shown in [Appendix A](#), [Appendix B](#), and [Appendix C](#), respectively.

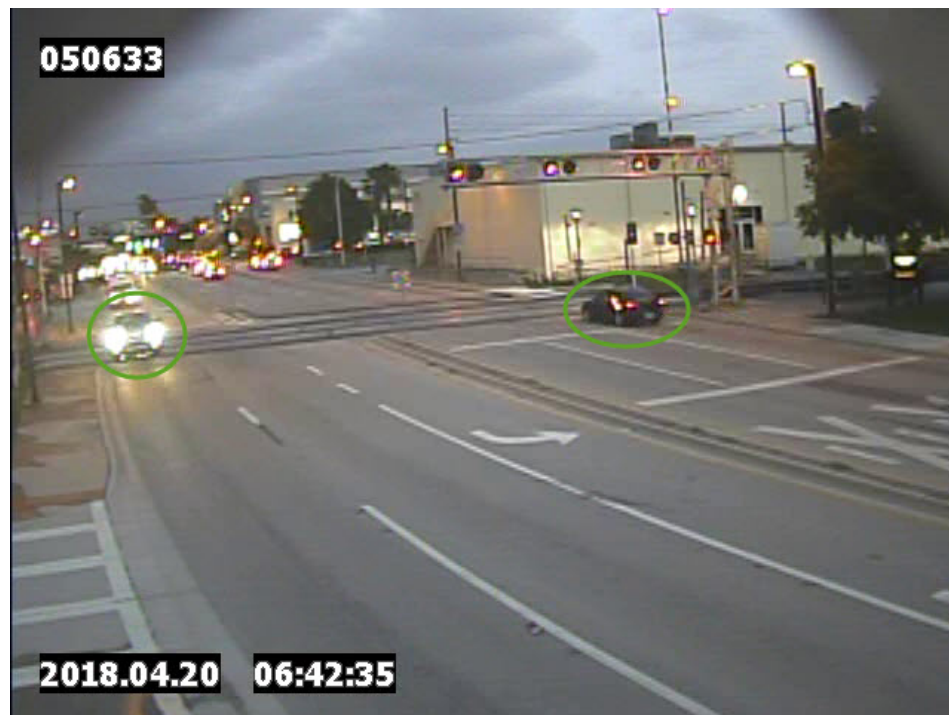
Figure 17. Example of Type I Violations (Green Circles)

An example of Type I violations is shown in Figure 17. The two vehicles (circled in green) committed a Type I violation by traversing the crossing during the flashing lights phase at 06:42:35. The crossing activation occurred at 06:42:32.

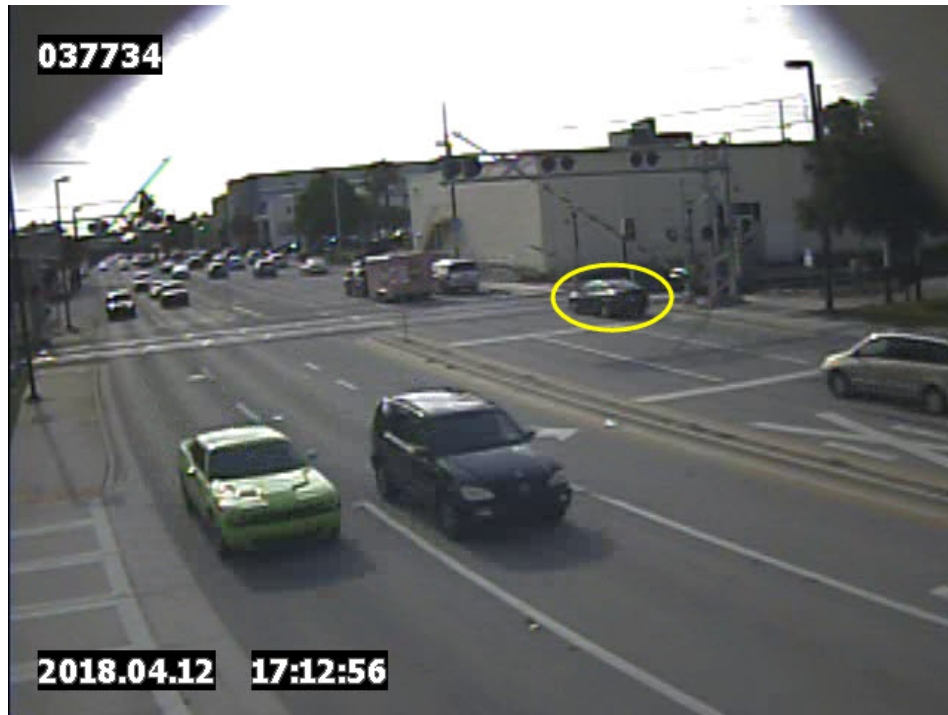
Figure 19. Example of Type II Violation in Westbound Direction (Yellow Circle)

An example of a Type II violation is shown in Figure 19. The vehicle (circled in yellow) committed a Type II violation by traversing the crossing during the gate descend phase at 17:12:56. The crossing activation occurred a full 10 seconds prior at 17:12:46.

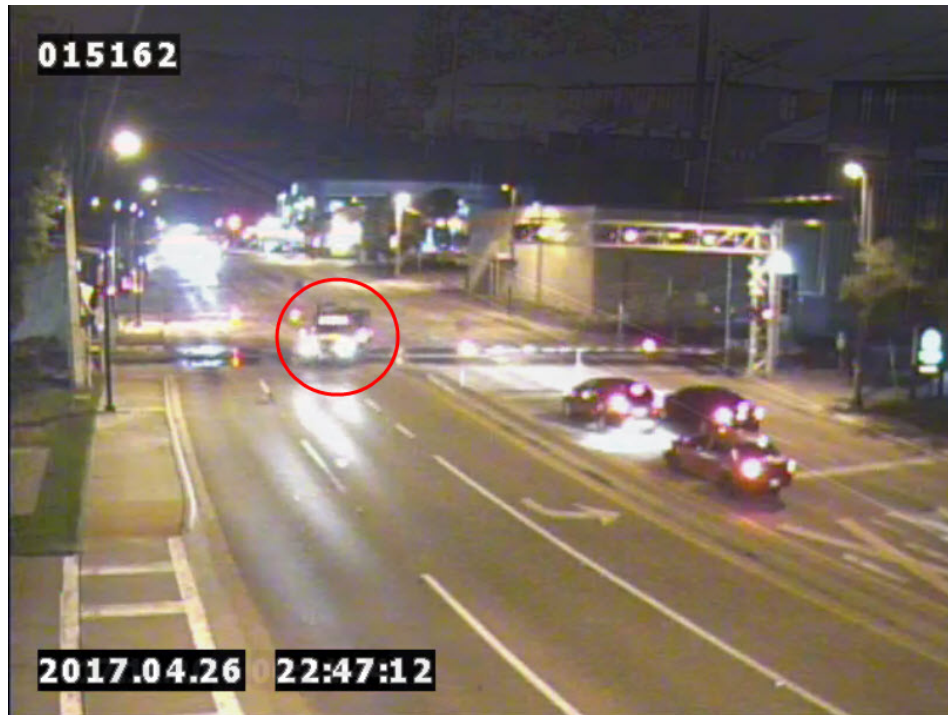
Figure 20. Example of Type III Violation in Eastbound Direction (Red Circle)

Type III Violations: Type III violations occur when vehicles traverse the crossing while the gates are in the horizontal position. There were total of two Type III violations over all three phases, one during Phase 1 and another during Phase 2.

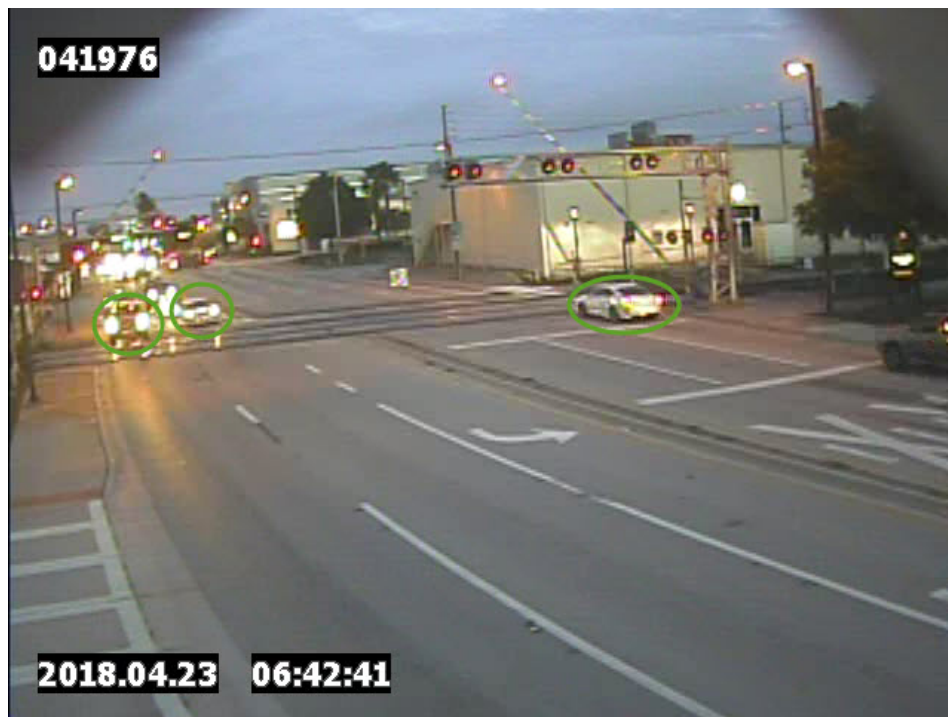
Figure 22. Example of Type IV Violations (Green Circles)

An example of Type IV violations is shown in [Figure 22](#), where 3 vehicles (circled in green) committed a Type IV violation by traversing the crossing during the gates ascent phase at 06:42:41. The crossing activation ended about 4 seconds later at 06:42:45.
