**National Highway
Traffic Safety
Administration**

DOT HS 812 717

Safety Performance of Rechargeable Energy Storage Systems

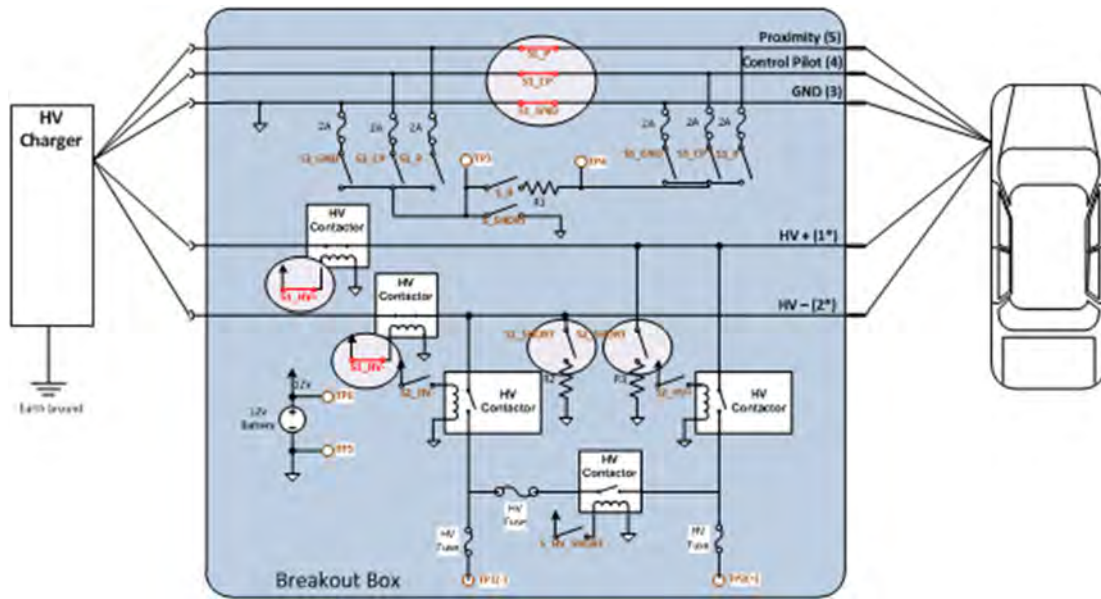
Figure 3 - Breakout box.

Several of these tests can be conducted with a breakout box, which is a device that interfaces between the vehicle charge coupler and the DC charger (see Figure 3). It allows the test technician to safely introduce various failure modes during testing by flipping appropriate switches. The procedure clearly identifies the switch setting sequence for each relevant failure mode test.

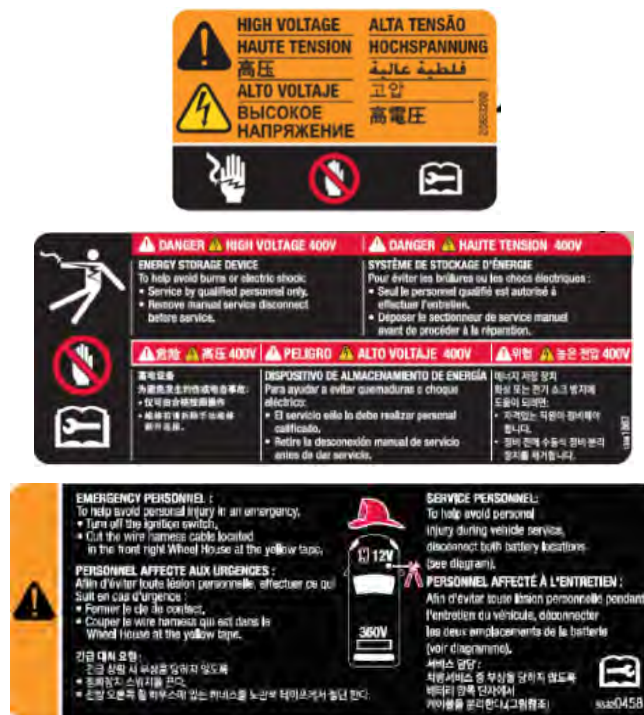
Figure 1 - Example high voltage warning labels (source: GM First Responder Guide).

- 5.1.1 When working on or around high voltage (HV) systems, always follow the appropriate safety precautions. For the vehicle/system under test, read and follow the recommended service procedures on high voltage systems and parts.
- 5.1.2 Be sure to wear the appropriate personal protective equipment (PPE), which includes Class 0 insulated rubber gloves with leather outer gloves. Always inspect the insulated gloves for any defects that might prevent the insulating properties and do not wear them if they are damaged.
- 5.1.3 Always observe HV warning labels (see Figure 1 for examples).

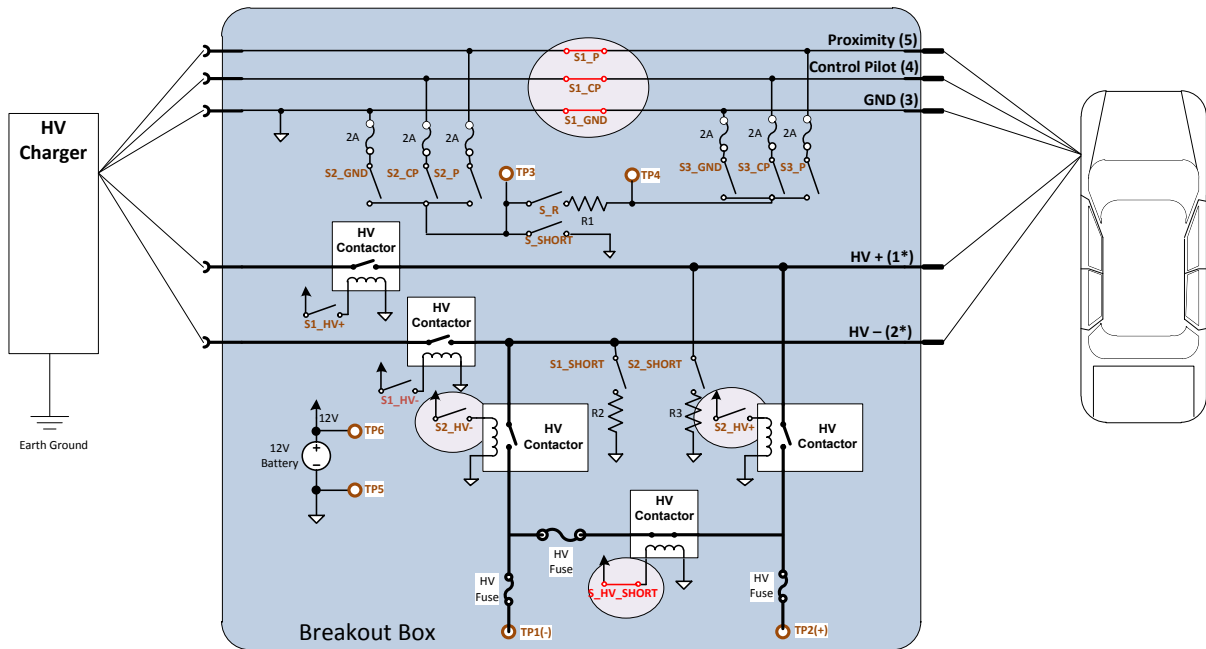
Figure 6 - Initial breakout box configuration for DC bus short test.

- 6.3.4.1 Connect the DC charger to the vehicle charge port through the breakout box as shown in Figure 6.
- 6.3.4.2 Configure the breakout box to perform the DC bus short test with the initial switch setting defined in Table 3.
- 6.3.4.3 Test the fuse with an ohmmeter before testing to ensure it is not blown (**TP1-TP2**). Replace as necessary.
- 6.3.4.4 Record the resistance value of the intact fuse.

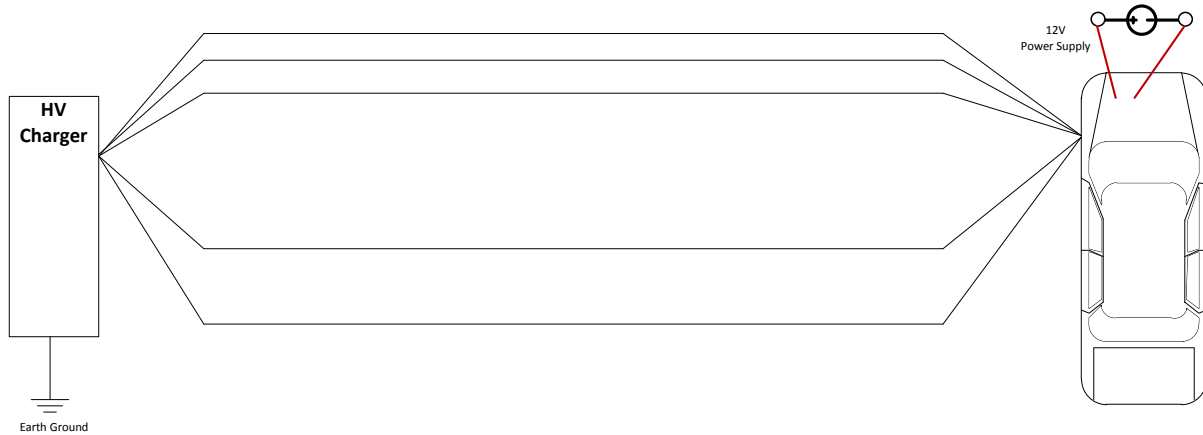
Figure 9 - 12 V Power Supply Connection.

- 6.6.4.1 Connect the DC charger directly to the vehicle charge port without the breakout box as shown in Figure 9.
- 6.6.4.2 Connect the DC power supply to the vehicle and configure it to provide 12 V power. Set the initial DC power supply voltage to 13.2 V. Ensure that the 12 V power to the vehicle is never interrupted during the installation.

- 6.6.4.3 In vehicle systems where there is a DC/DC converter connected to the 12 V battery that is activated during charging, it must not interfere with the reduction of the 12 V system voltage. It is therefore necessary to disconnect the DC/DC converter 12 V output from the vehicle system (if it is determined that it will not interfere with the charging operation). Alternatively, it is possible to install a 150 Ω (100 W) resistor at the output of the DC/DC inline to the 12 V board net. This resistor will limit the current the DC/DC converter can provide to the 12 V board net and allow the test to be conducted.

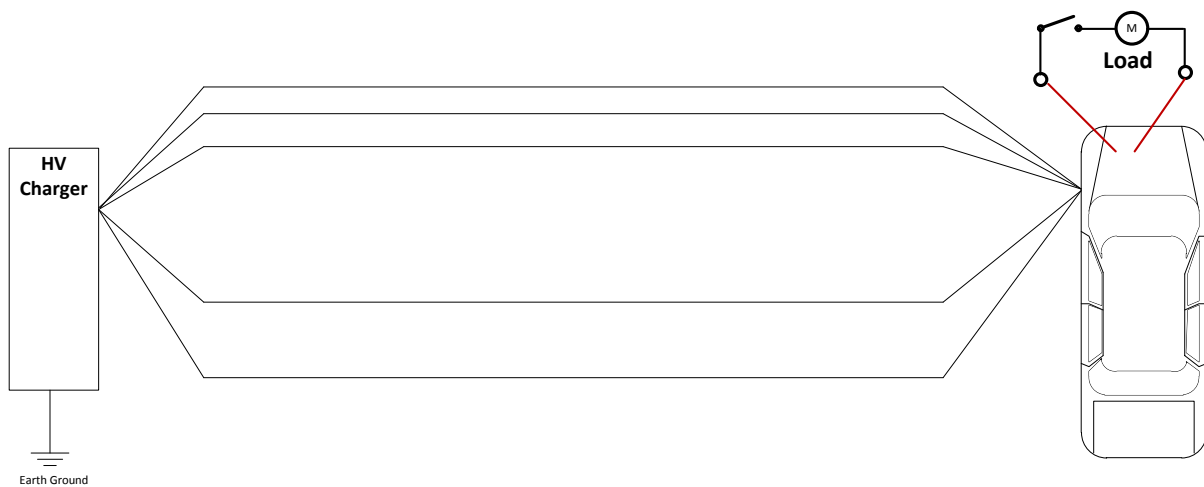
Figure 10 - 12 V Load Connection.

- 6.7.4.1 Connect the DC charger directly to the vehicle charge port without the breakout box as shown in Figure 10.
- 6.7.4.2 Connect the switchable load to the 12 V lead acid battery in the vehicle (Figure 10).

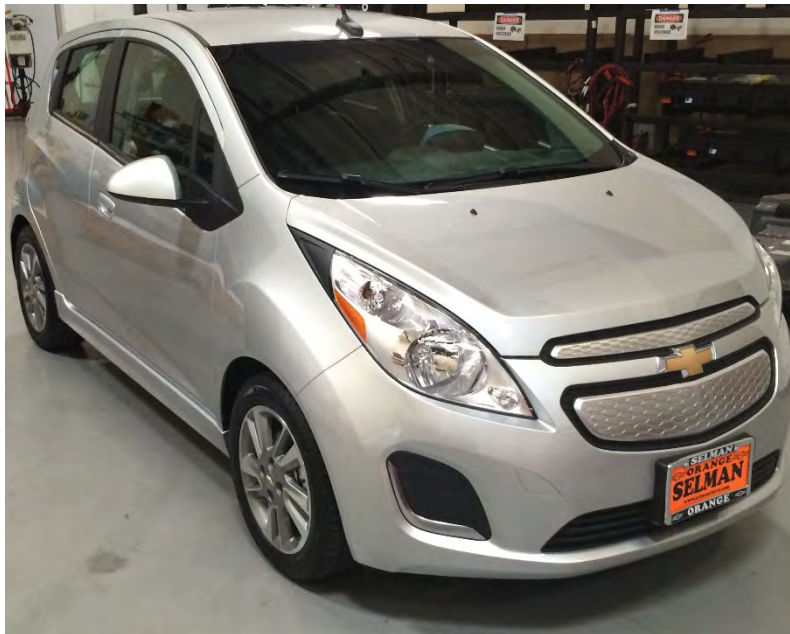
Figure 13 - GM Spark test vehicle.

Testing was conducted with a 2014 Chevrolet Spark Electric Vehicle (see Figure 13) using the following equipment:

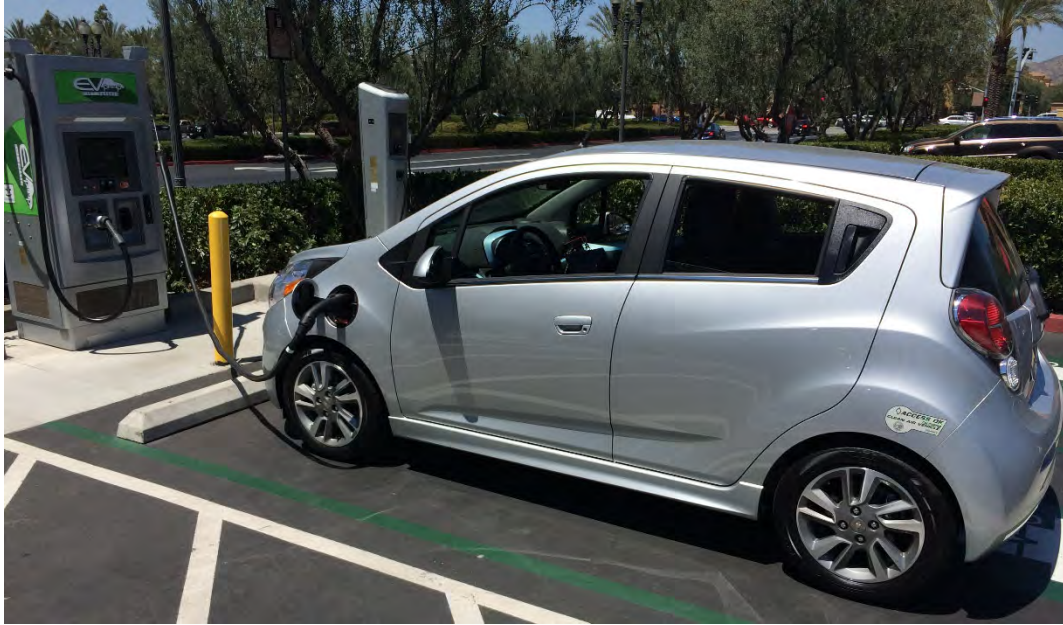
Figure 14 - Public charging station in Irvine, CA.

- A public charging station with an SAE fast charge port in Irvine, CA (Figure 14). The maximum available charge current for this station was 50 A.
- An engineering fast charging station with an SAE fast charge port in Santa Ana, CA. The maximum available charge current for this station was 70 A. It allowed the required software modifications to simulate some of the test conditions.
- A prototype breakout box (Figures 15 and 16).
- A Fluke DVM 289 (Figure 17a).
- A Fluke ScopeMeter 199C (Figure 17b).
- A Tektronix current probe A622 (Figure 18).
- A 12 V Everstart ES5LBS (4 Ah) lead acid battery (Figure 19).
- A CANalyzer (V8.0).
- A vehicle Scan Tool, “Global Diagnostic System 2”.

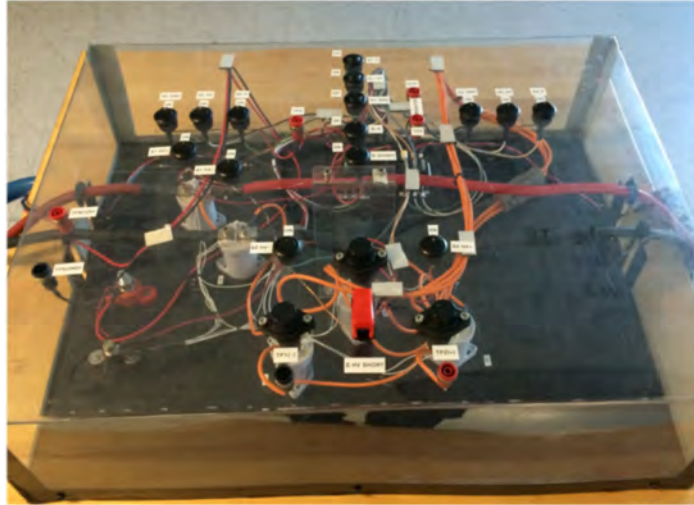
Figure 16 - Prototype breakout box.

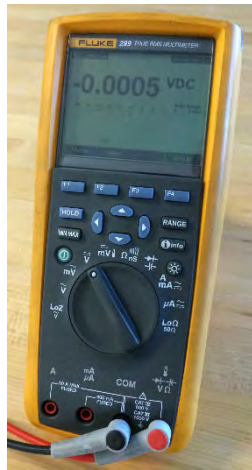
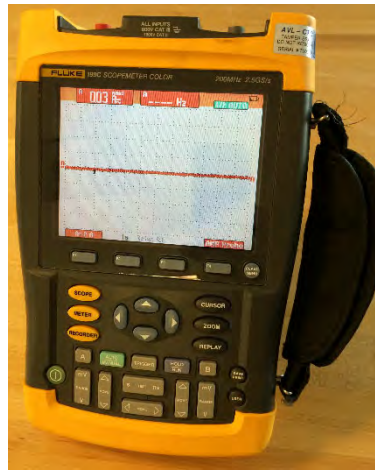
Figure 17 - (a) Fluke DVM and (b) Fluke hand held scope.

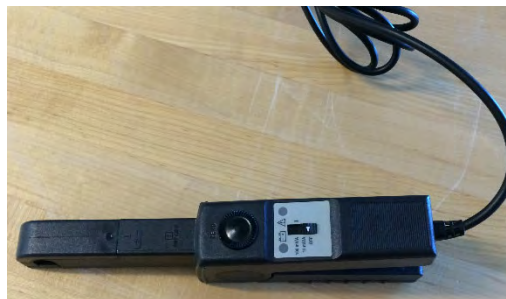
Figure 18 - Tektronix current probe.

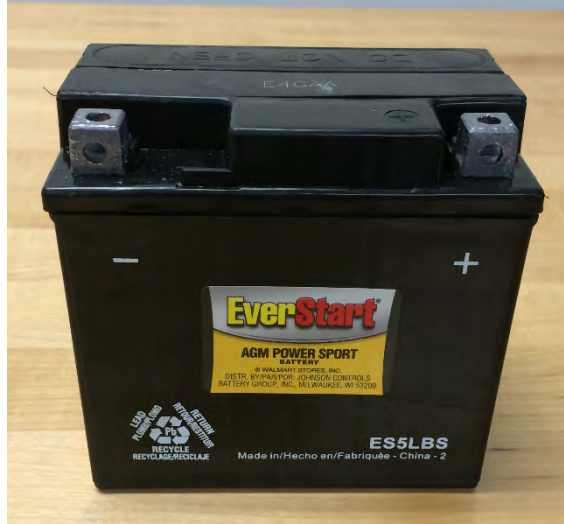
Figure 19 - 12 V lead acid battery.

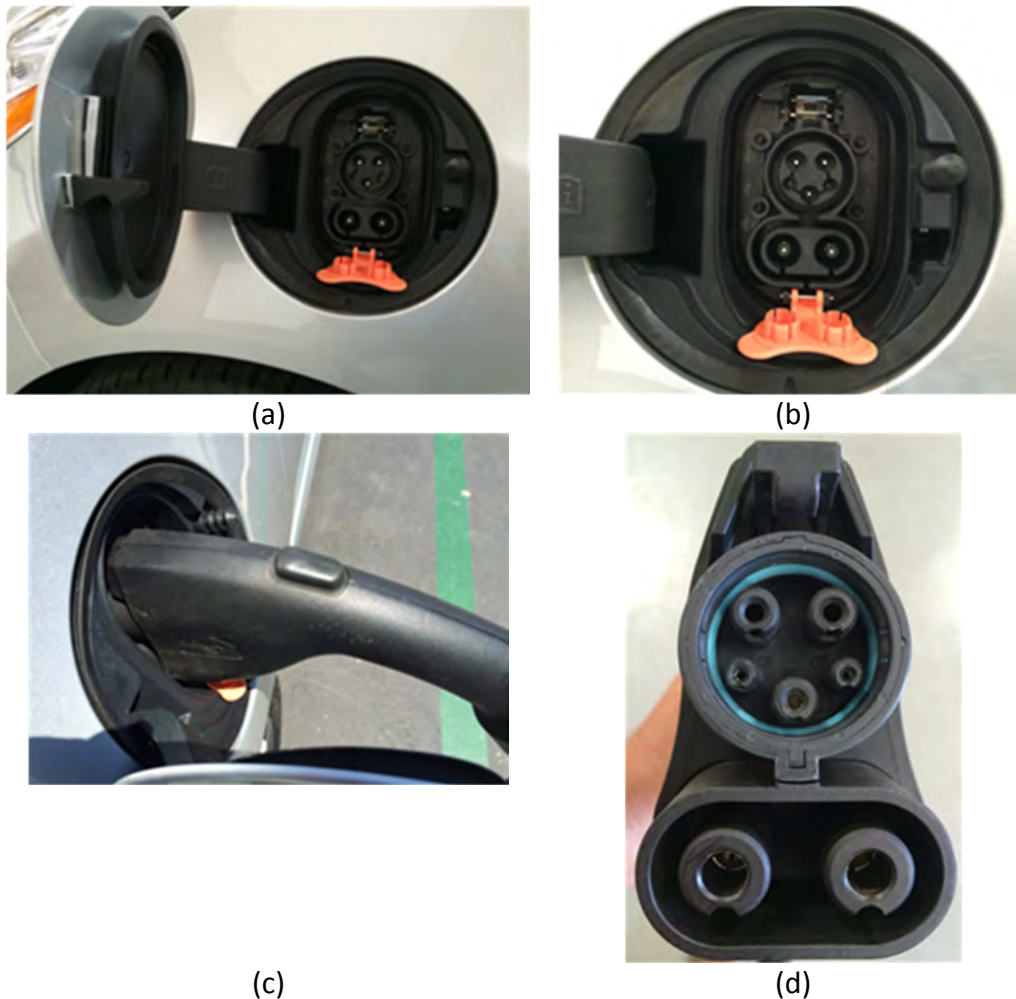
Figure 20 - Visual inspection of a) the vehicle charge receptacle, b) the vehicle charge receptacle (close-up), c) the charger coupler, and d) the charger coupler (close-up).

Note: Extensive testing with the charger revealed an inadequate mechanical switch on the charge coupler connection. This led to repeated random charge start failures that required wiggling of the charge coupler. The mechanical interlock connection for this coupler was not optimal.

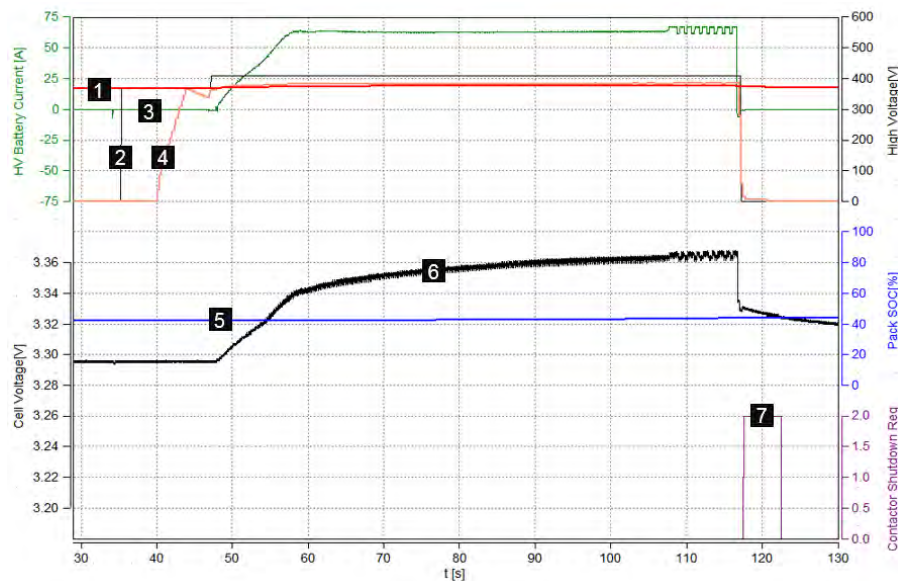
Figure 29 - Chassis ground offset with a 24Ω resistor before a fast charge is initiated.

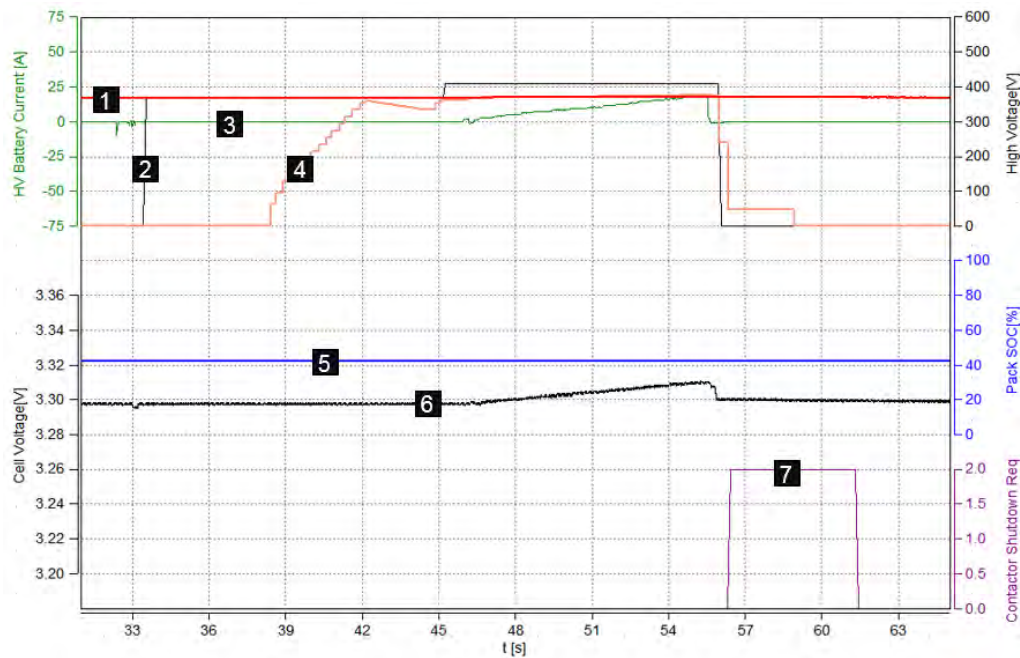
Figure 30 - Chassis ground offset with a 1 kΩ resistor during a charge session.

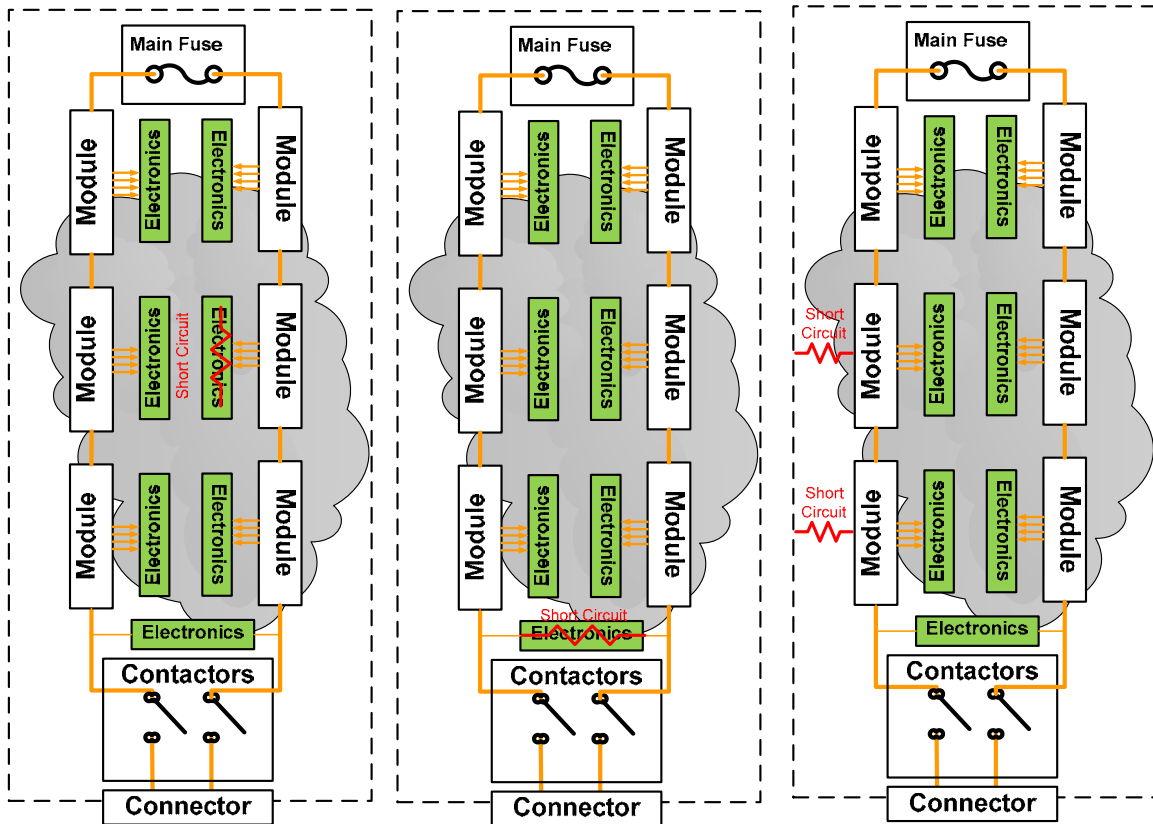
Figure 7 - Schematic of some possible short circuit pathways that could be created due to pollution of a RESS; a short circuit could form (from left to right) on module connected electronics components, on pack level electronics components, or between modules and the RESS enclosure.

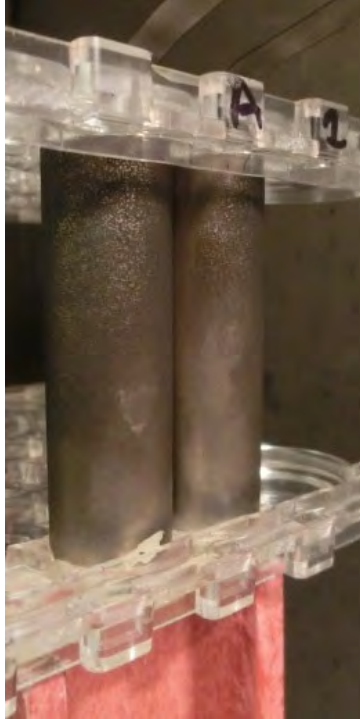
Figure 9 - Cylindrical cell coupon (two cells) after exposure to smoke from smoldering electrical wiring.

Small scale (coupon level) tests were conducted to examine the use of smoke as a source of pack pollution to induce a loss of insulation. Smoke exposure coupons were constructed from pairs of small cylindrical cells. Each coupon consisted of a pair of cells that were not electrically connected. The cells were placed within millimeters or each other, consistent with the architecture in the Manufacture A RESS. Each coupon was exposed to a smoke environment for a minimum of 60 minutes. Two coupons were tested with each smoke condition (Figure 9).

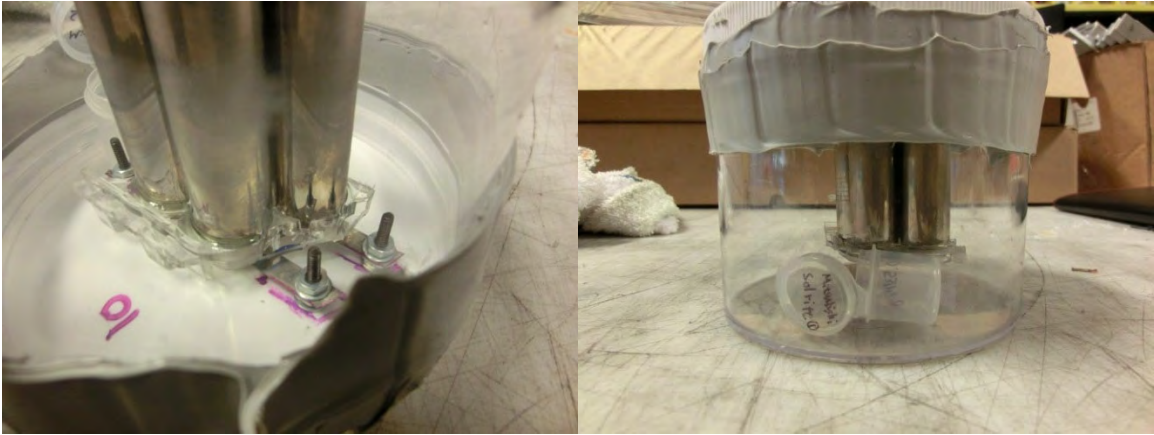
Figure 15 - An electrolyte exposure chamber containing four 18650 cells after 20 days of exposure. Cloudiness can be seen on the cell walls due to the electrolyte vapor.

An insulation resistance tester capable of evaluating resistances up to 11 GΩ at 1000 V was used to periodically test cell isolation. For some tests, a voltage bias up to 528 V was applied to cells within a coupon. When the bias was applied, it was only removed when the insulation tester was used to test cell isolation. The power source used to apply the voltage bias was capable of measuring current flow greater than 1 mA, which would have indicated development of a current path.

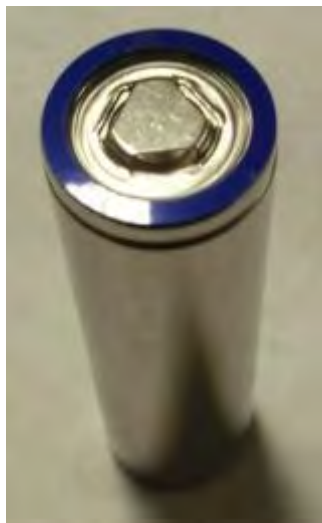
Figure 3 - Cell A; small cylindrical cell.

- **Cell A:** small cylindrical cell (Figure 3). The cylindrical cells had an 18 mm diameter and a 65 mm height. They had a rated capacity of 3 Ah and a mass of 47 g.
- **Cell B:** large hard case prismatic cell (Figure 4). The prismatic cells were 171 mm tall, not including the terminal screws, 101 mm wide and 43 mm deep. They had a rated capacity of 50 Ah and a mass of 1720 g.
- **Cell C:** large pouch cell (Figure 5). The pouch cells were 290 mm long and 216 mm wide. They had a rated capacity of 32.5 Ah and a mass of 787 g.

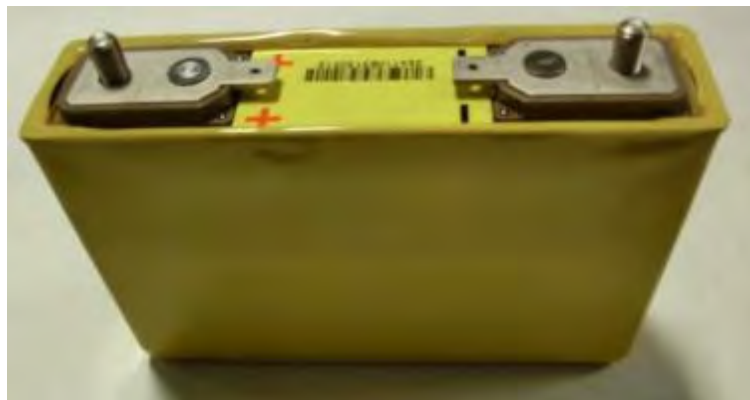
Figure 4 - Cell B; large hard case prismatic cell.

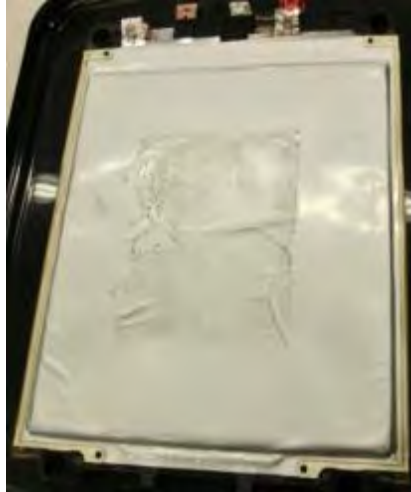
Figure 5 - Cell C; large pouch cell.

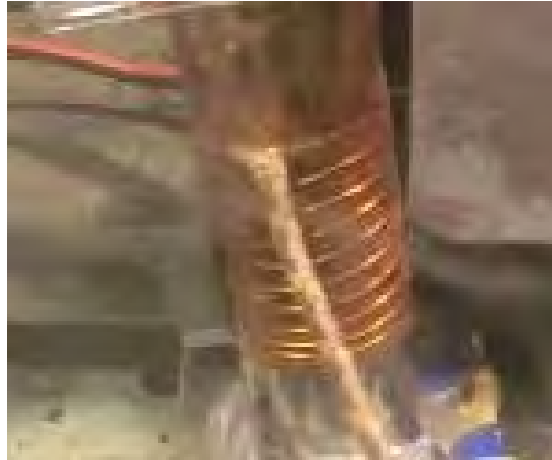
Figure 6 - Cylindrical cell with nichrome wire wrap.

heat transfer characteristics of the cells and modules by altering the gaps between cells. An example of a cell wrapped in nichrome wire is shown in Figure 6.

For this trial, 30 gauge nichrome wire was wrapped approximately 10 times around a cell for use as a resistance heater. The wire was held against the cell using polyimide tape. The tape was also used as a barrier to prevent short circuits between the wraps of wire. The resistance of the wire was measured to determine the voltage needed to produce 50 W of heating.

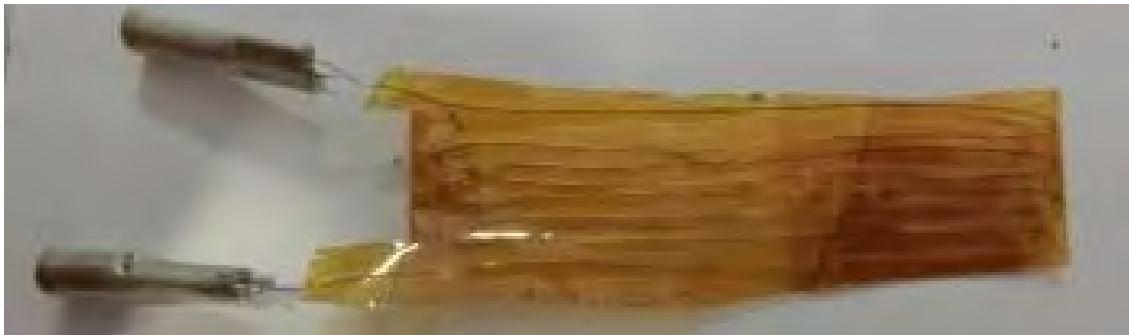
Figure 9 - Hand-made film heater.

This method was selected for trial because the heater is well thermally coupled to the cell, which should result in a short time to thermal runaway and low input energy to the system. It is a smaller power heater than the nichrome wrapped wire heater, but it provides a more localized heating zone and can be easier to install in a module. The hand-made film heater requires no changes to the electrical systems of the cell or battery and does not affect the designed gas flow or mechanical features; the heater is attached to the side of the cell can. This method can be applied to production cells. The small-gauge wire allows the film heater to be used in many battery modules and packs without special modifications. Depending on pack architecture, this method may affect some of the heat transfer characteristics of the cells and modules by altering the gaps between cells. However, because this heater is applied to a smaller area of the cell, it should provide less disruption than a nichrome wrapped wire device, and can be oriented to minimize the disruption. An example of a hand-made film heater is shown in Figure 9.

For this trial, a film heater was made using 30 gauge nichrome wire. The wire was wrapped in a back and forth pattern around eight pins to form a ½” x 2” rectangular pad. The wire wraps were held together using a polyimide tape. The film heater was placed against one side of the cell and attached to it using polyimide tape. The heater was oriented such that the long side of heater was parallel to the axial direction of the cell. The cell side wall temperature measurement was made 180 degrees opposite of the heater. A diagram of this setup is shown in Figure 10 along with the location of the temperature measurements. A constant current of 1.8 A was run through the heater, resulting in approximately 30 W of heating applied to the cell. The current was not increased past 1.8 A to prevent melting the nichrome wire.

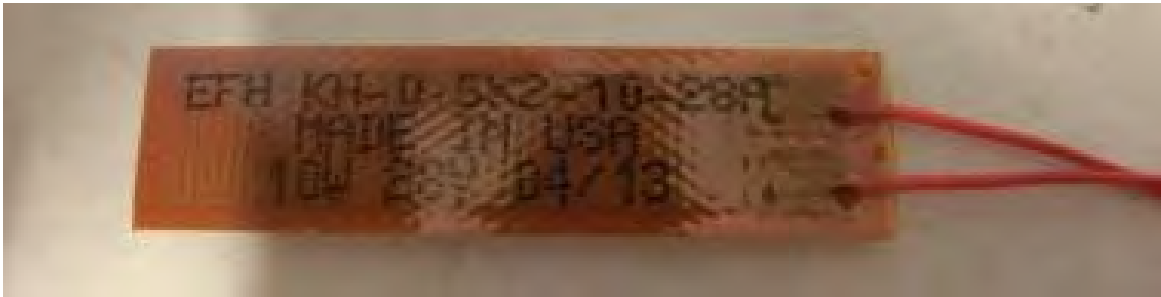
Figure 11 - Off-the-shelf film heater.

altering the gaps between cells. However, because this heater is applied to a smaller area of the cell and is very thin, it should provide less disruption than a nichrome wrapped wire device or a hand-made film heater and can be oriented to minimize the disruption. An example of an off-the-shelf film heater is shown in Figure 11.

For this trial, an off-the-shelf film heater was purchased from McMaster-Carr, part number 35475K283. This heater has a ½” x 2” rectangular pad and is rated to 10 W/sq. in. It has an adhesive backing which is used to attach to the cell. The cell side wall temperature measurements for this method are taken 180 degrees opposite of the heater. The setup of for this method is the same as for the hand-made film heater shown in Figure 10. The heater has a measured resistance of 76Ω, thus applying 0.65 A will produce approximately 32 W of heating. Applying a higher current will cause the heater to become open circuit from overheating.

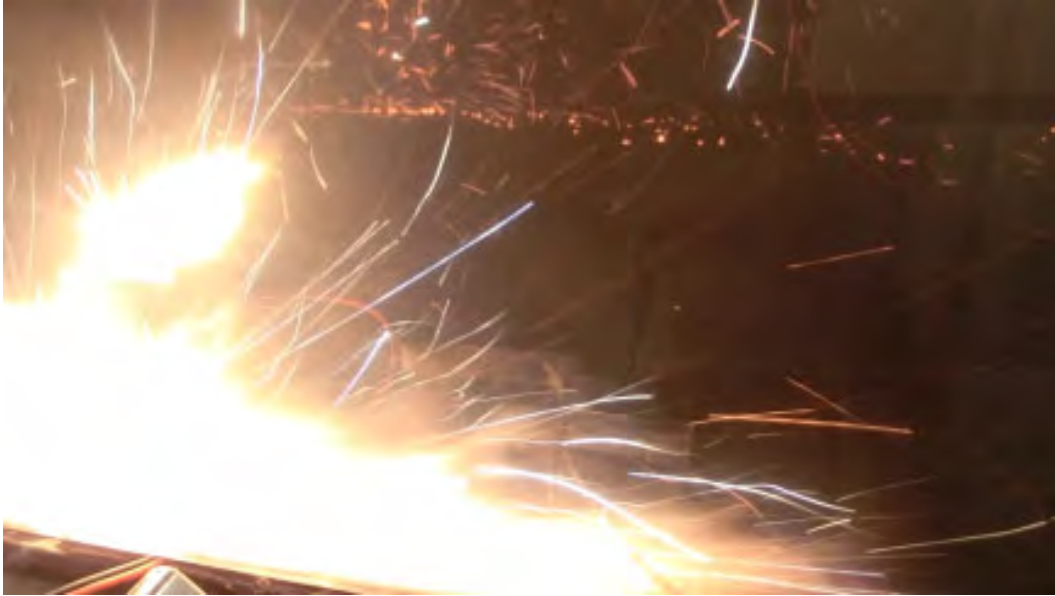
Figure 15 - Cylindrical cell undergoing thermal runaway; nichrome wrap heater method.

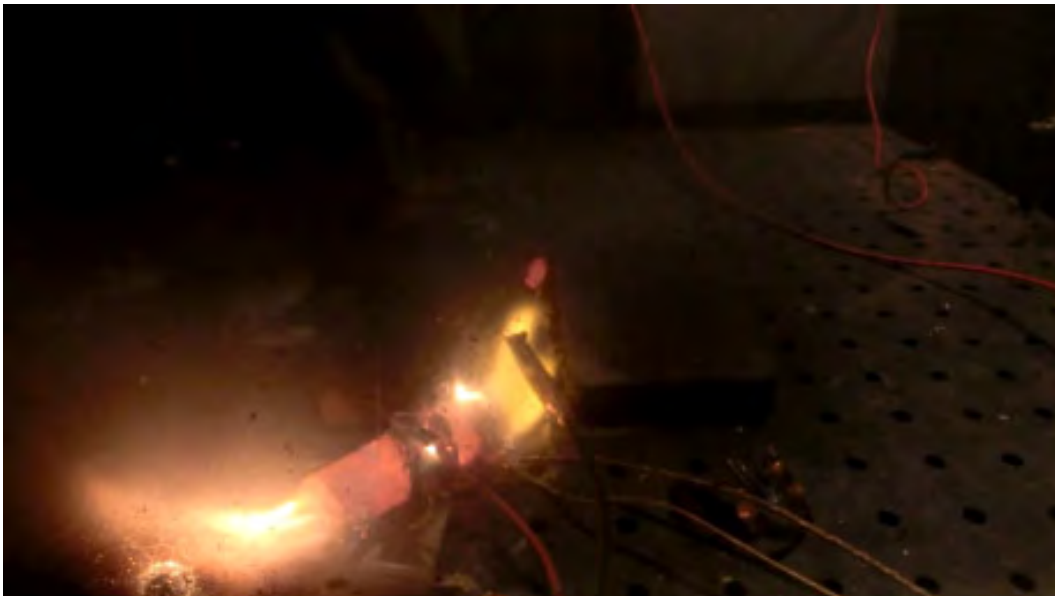
Figure 16 - Cylindrical nichrome wrap heater cell immediately after runaway.

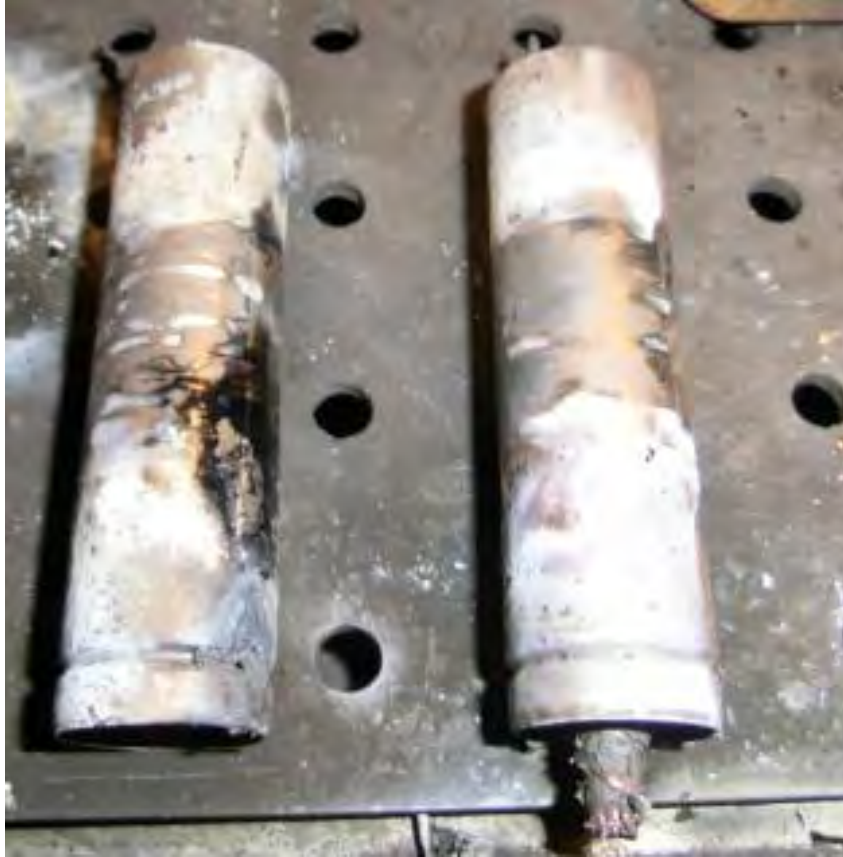
Figure 17 - Cells after nichrome wrap heater trials.

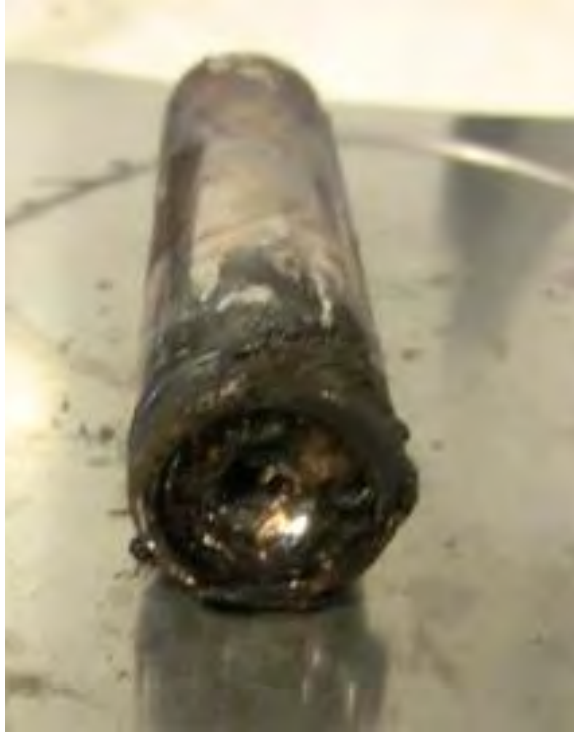
Figure 21 - Cylindrical cell after successful nail penetration trial.

The nail penetration test only successfully initiated one of the two samples in the trial. The temperature and voltage traces for the nail penetration trials are shown below in Figure 18 and Figure 19; the second penetration trial failed to produce a thermal runaway event. In the successful trial, thermal runaway began almost immediately after the nail penetration. The cell casing color was orange (see Figure 20), indicating that a casing temperature of at least 900°C was achieved. The cells from the successful and failed nail penetration trials are shown in Figure 21 and Figure 22, respectively. After the nail from the second trial was fully inserted into the cell and it failed to go into runaway, the ram was used to try to crush the cell in an attempt to induce thermal runaway. Even with this additional deformation, the cell failed to go into runaway. This method required no additional preparation of the cell prior to the test. Due to limited reliability of this method, nail penetration was eliminated from further testing with the small cylindrical cells.

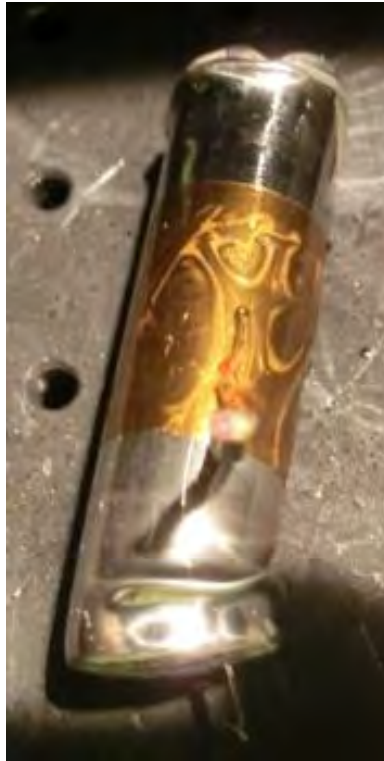
Figure 22 - Cylindrical cell after failed nail penetration trial.

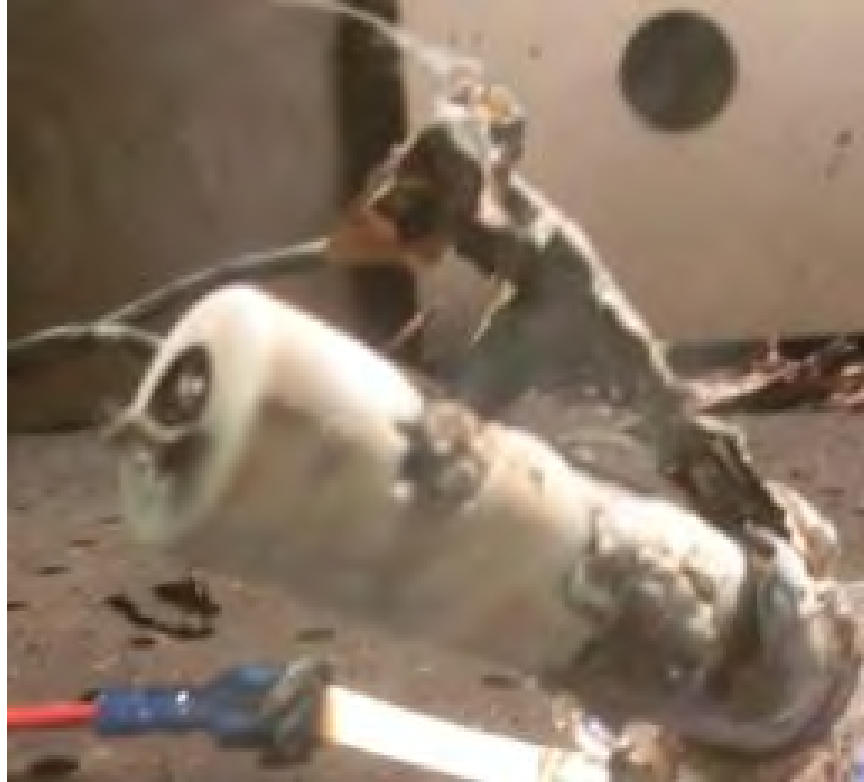
Figure 27 - Cylindrical cell after a hand-made film heater trial.

Both the hand-made and off-the-shelf thin film heaters successfully initiated thermal runaway for the cells with all five trials having similar results. The temperature and voltage traces for the hand-made film heater trials are shown in Figure 23 through Figure 25. One of the cells from the hand-made film heater trials is shown undergoing thermal runaway in Figure 26; Figure 27 shows the cell after testing. The temperature and voltage traces for the off-the-shelf heater trials are shown in Figure 28 and Figure 29. One of the cells from the off-the shelf film heater trial is shown undergoing thermal runaway in Figure 30; Figure 31 shows the cells after testing. These methods required a slightly longer time to achieve thermal runaway than the wrapped cell method, which can be attributed to their lower heating power. They can be easily applied to production cells and their smaller size makes them easier to attach to a cell in a battery module or pack. They did not obstruct the design venting features and their smaller, more localized heating is less likely to pre-heat the neighboring cells or influence thermal boundary conditions. These methods were further investigated in coupon verification testing (Section 8.2).

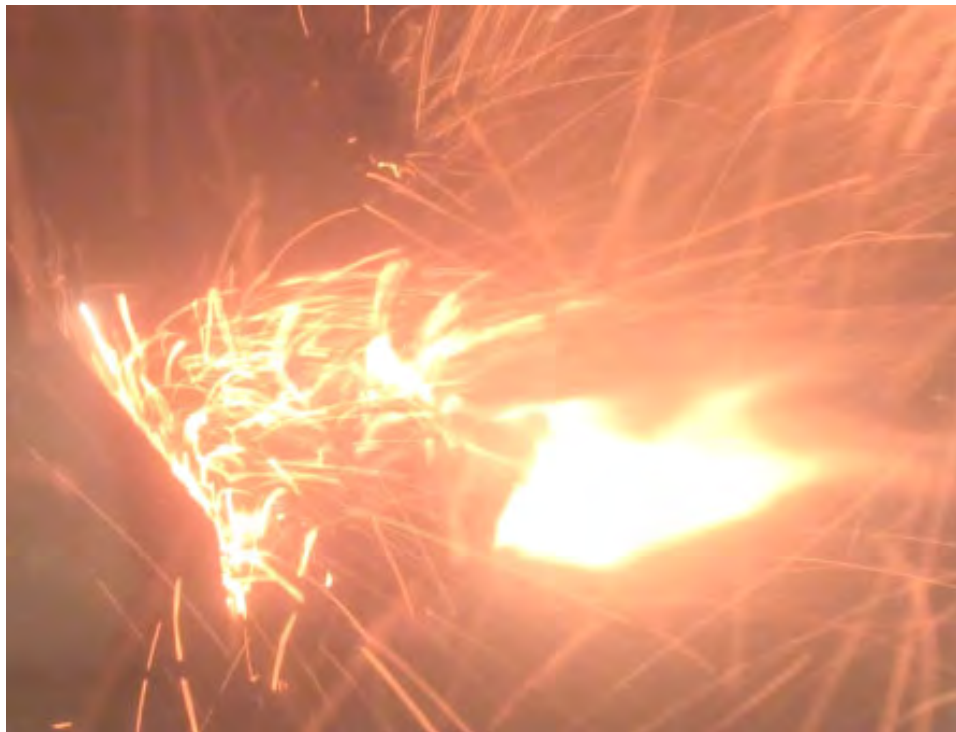
Figure 30 - Cylindrical cell undergoing thermal runaway; off-the-shelf heater method.

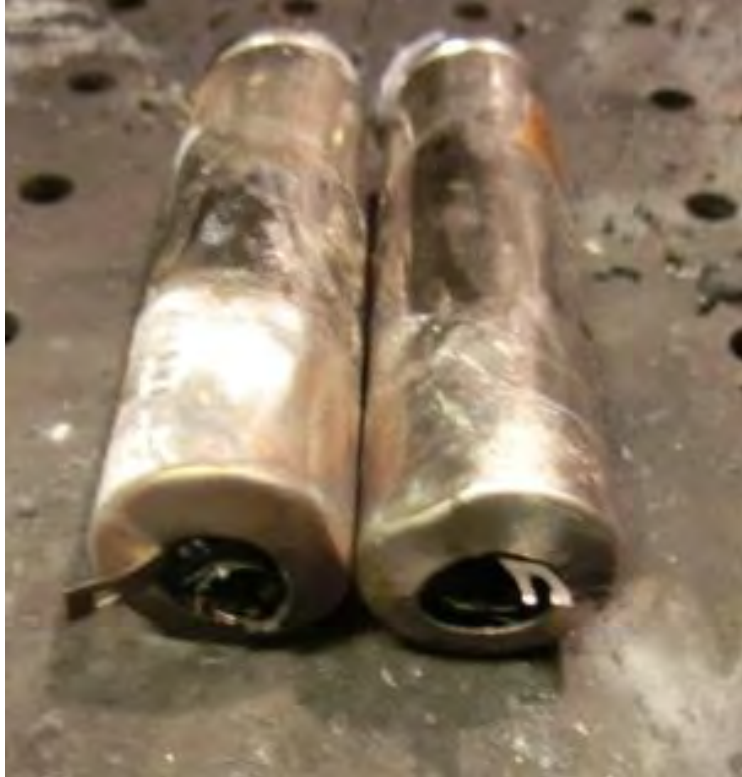
Figure 31 - Cylindrical cells after off-the-shelf film heater trials.

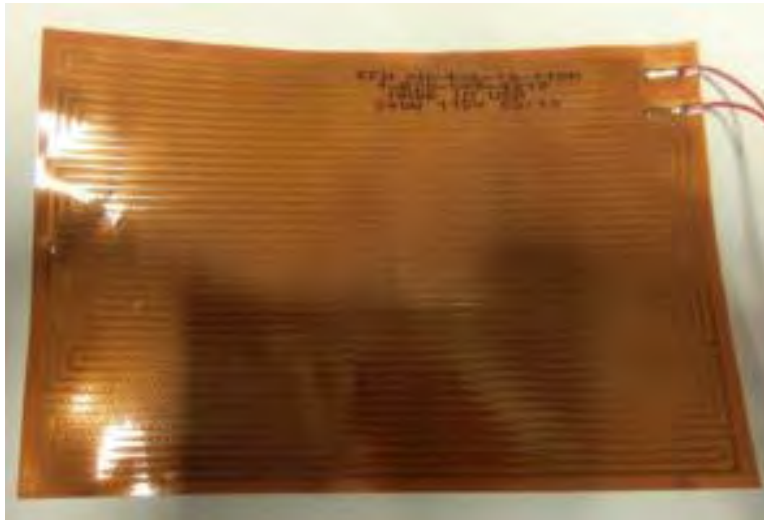
Figure 32 - Large off-the-shelf film heater.

For this trial, a large off-the-shelf film heater was purchased from McMaster-Carr, part number 35475K753 (Figure 32). The heater had a 4" x 6" rectangular pad and was rated to 10 W/ sq. in. The heater had an adhesive backing which was used to attach to the large face of the cell. As connected to 120 V_{AC}, the heater was rated to 240 W. One thermocouple was located on the opposite face of the cell and the second thermocouple was placed on an adjacent face. A schematic diagram of the test setup is shown in Figure 33.

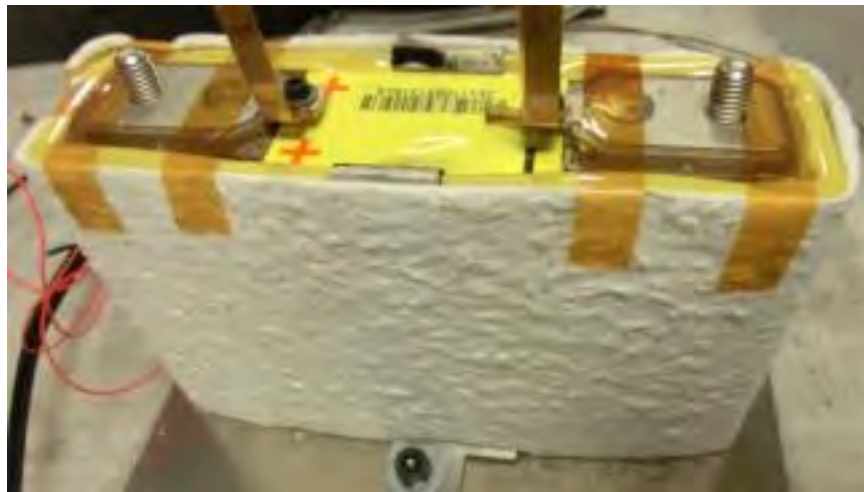
Figure 35 - Prismatic cell Trial #2 setup.

In the first trial, the cell was left completely exposed to the ambient air. The cell was strapped down to a large aluminum plate to secure it during the test and to prevent uncontrolled cell motion during thermal runaway. This setup is shown in (Figure 34). For the second trial, in an effort to reduce the time to thermal runaway and the total energy added to the system, a layer of 1/8" thick flexible ceramic insulation was wrapped around the cell to prevent the heat from escaping to the ambient air (Figure 35).

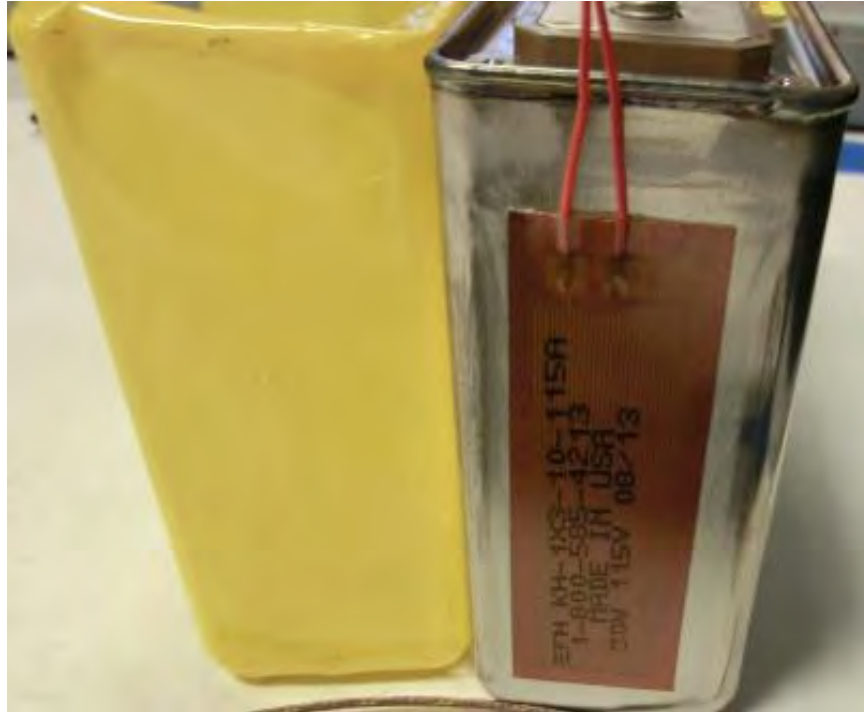
Figure 36 - One of the dual side heater pads.

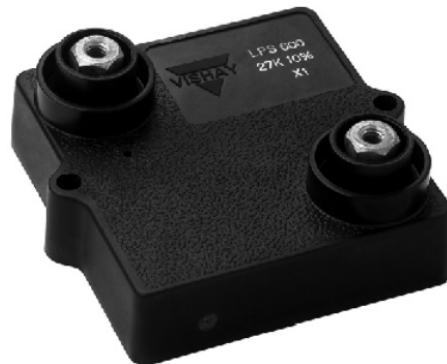
Figure 39 - Thick film resistor.

For this trial, a thick film resistor (Figure 39) measuring approximately 2" x 2" x 1" was attached to the side of the cell. The resistor had a rated power of 600 W and resistance of 10Ω. Thermal joint compound was placed between the resistor base and the cell face to aid in the heat transfer from the resistor to the cell. The resistor was attached using vinyl electrical tape so that once the cell entered thermal runaway the tape would melt and allow the resistor to become detached from the cell. Schematically this test is setup was identical to that of the large film heater test (Figure 33).

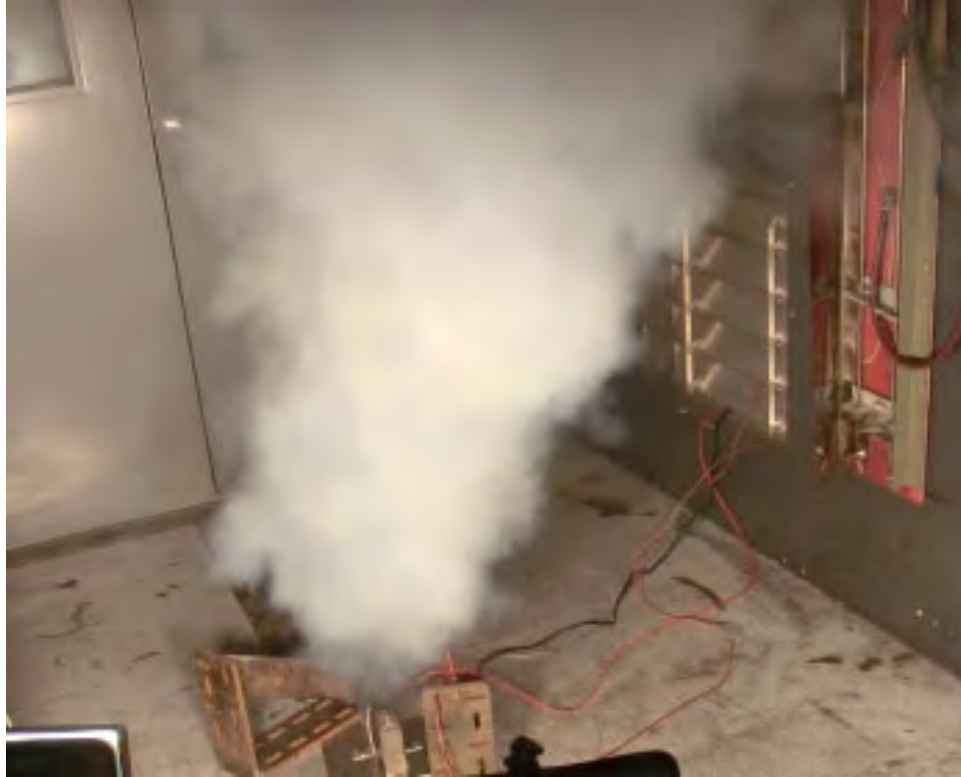
Figure 41 - Prismatic cell during thermal runaway; large film heater Trial #1.

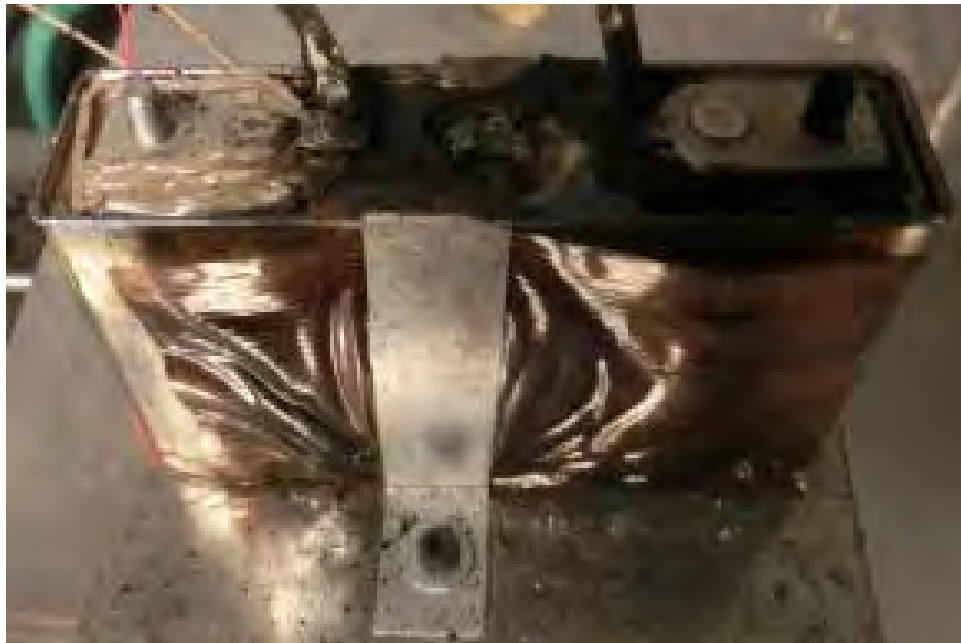
Figure 42 - Prismatic cell after thermal runaway.
