**National Highway
Traffic Safety
Administration**

DOT HS 812 717

Safety Performance of Rechargeable Energy Storage Systems

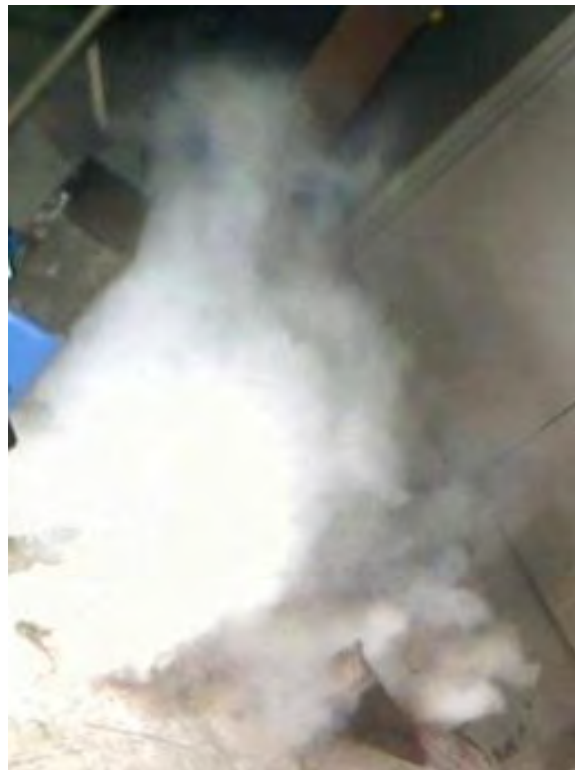
Figure 44 - Prismatic cell undergoing thermal runaway; large film heater Trial #2.

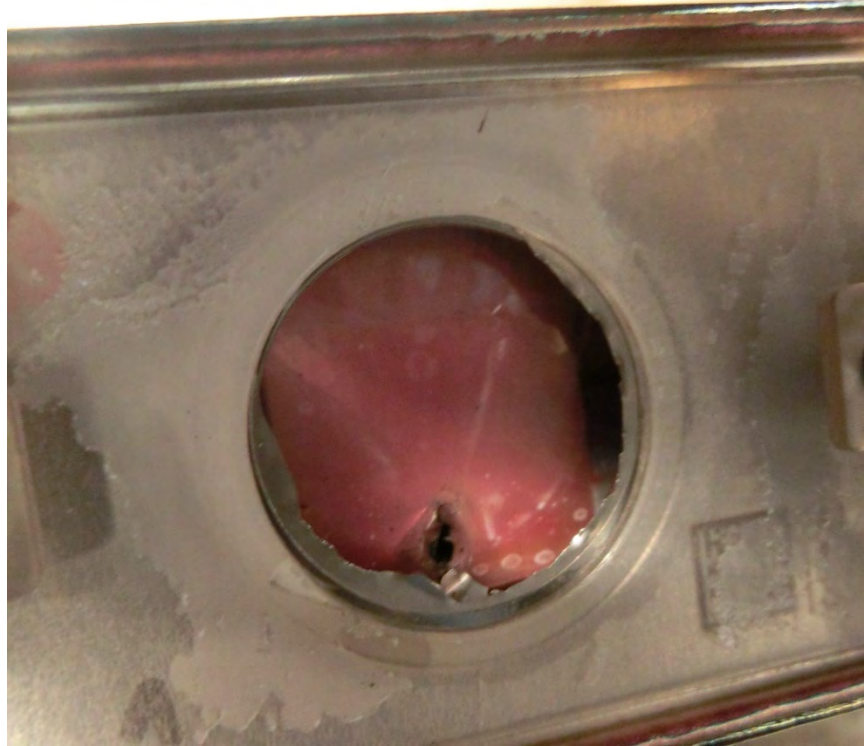
Figure 47 - Nail penetration damage.

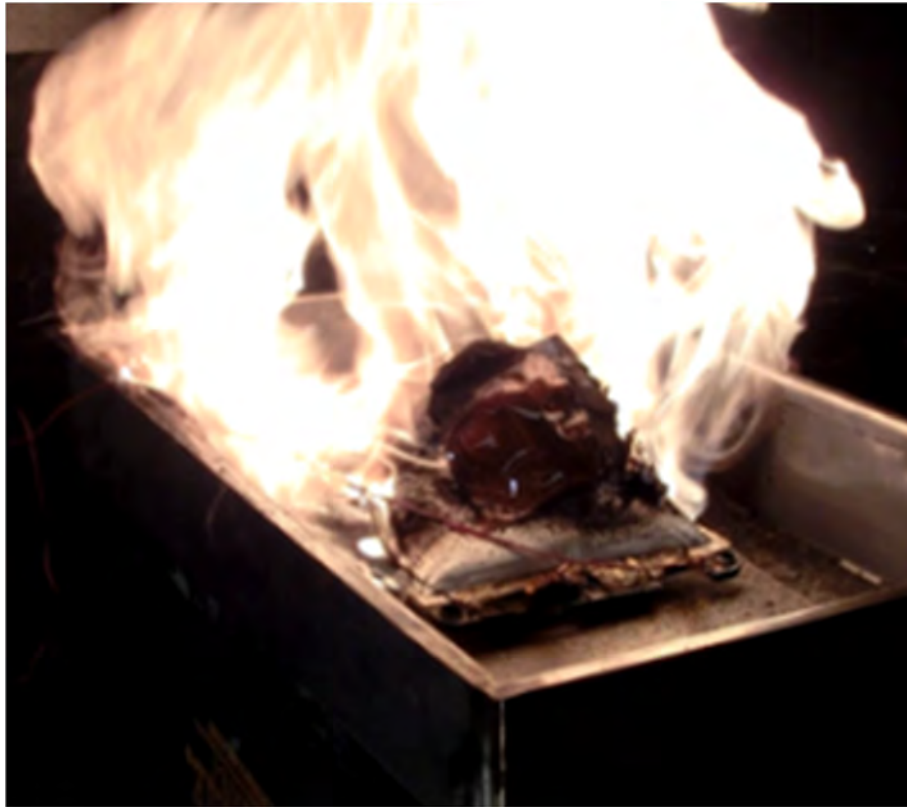
Figure 51 - Ignition of thermal runaway gases from pouch cell.

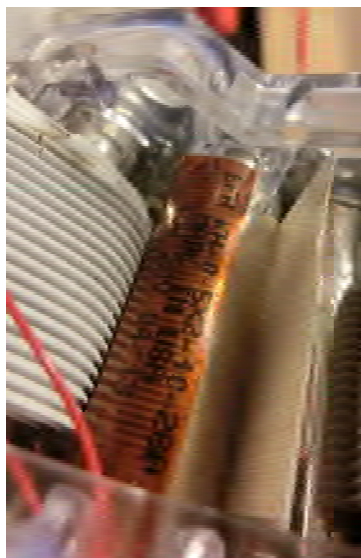
Figure 61 - Thin film heater attached to cell.

For the module level test, the thin film heaters were applied to the sides of the cells. Some small portions of plastic had to be trimmed to allow the heater to be fully adhered to the cell. The cell with the applied heater can be seen within a module in Figure 61.

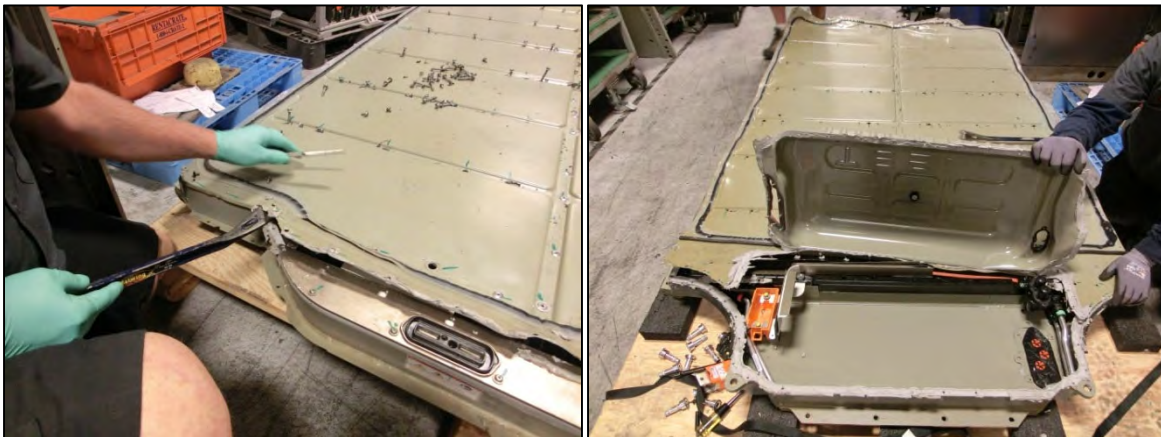
Figure 72 - Opening the cylindrical pack.

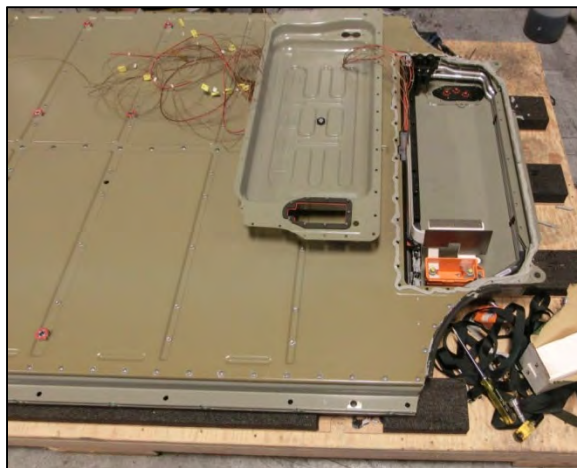
Figure 78 - The cylindrical battery pack with sealant applied to seal the flat main cover to the front cover.

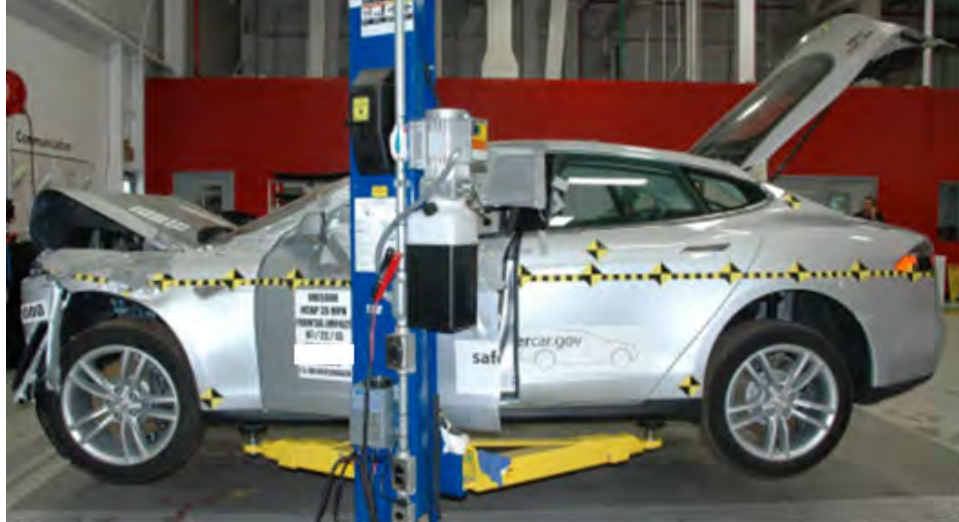
Figure 79 - The frontal crash Manufacturer A vehicle used for the demonstration of SCTRl testing.

To seal the cabin and allow measurement of gases that might enter from a thermal runaway reaction, windows that had been rolled down or were broken were covered with 0.010" clear plastic film.

The RESS was then mounted and bolted to the underside of the vehicle. The connector to the high voltage in the RESS was carefully monitored, secured and protected.

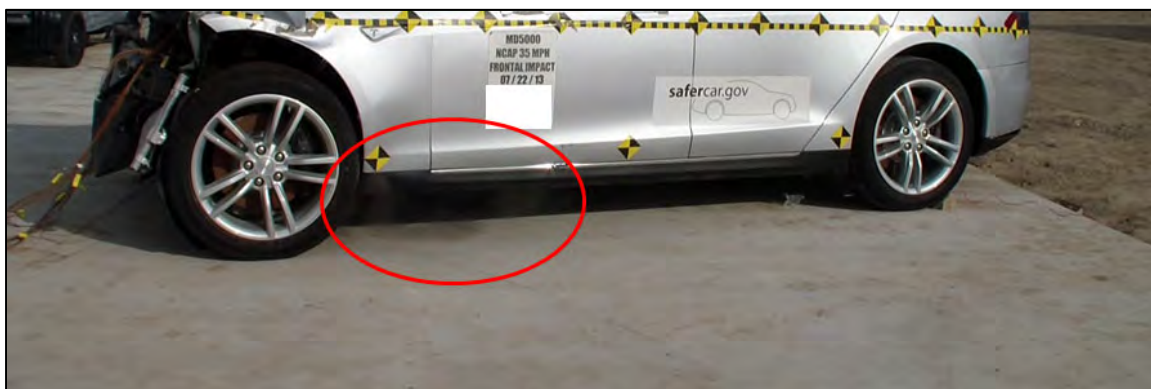
Figure 82 - Smoke escaping the battery pack as a result of thermal runaway of the initiating cell.

Once the initiating thermal runaway reaction was observed (i.e., with an audible noise and a visual indication of gas escape from the pack – Figure 82), power to the heater was switched off.

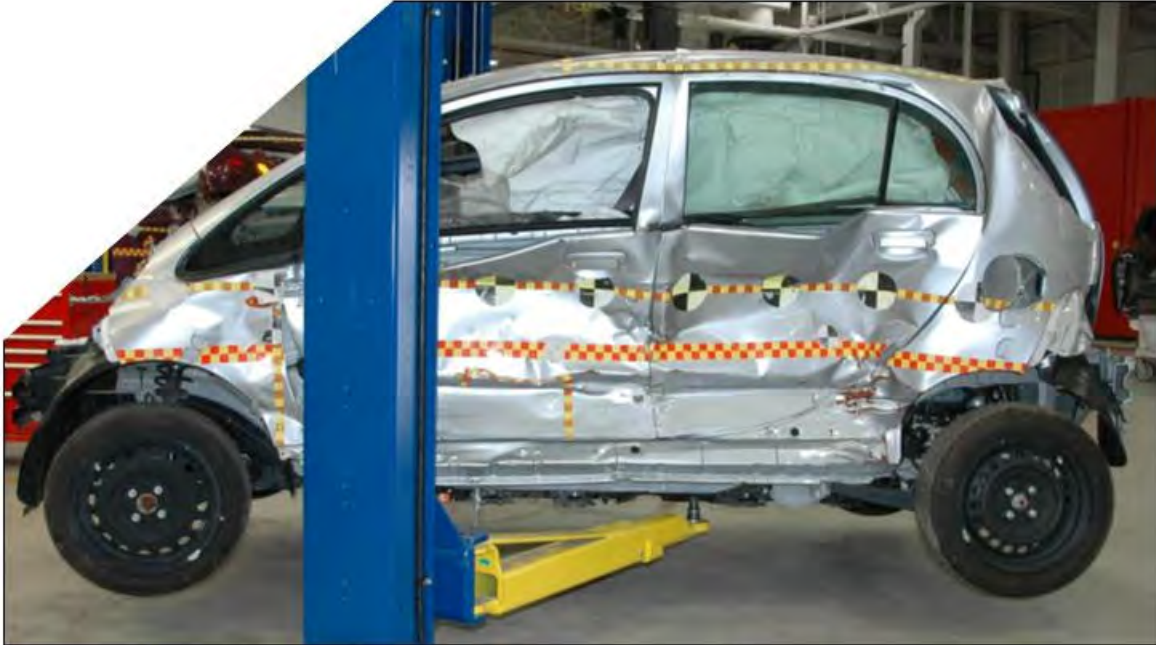
Figure 88 - Side impact Manufacturer B vehicle used for SCTRI testing.

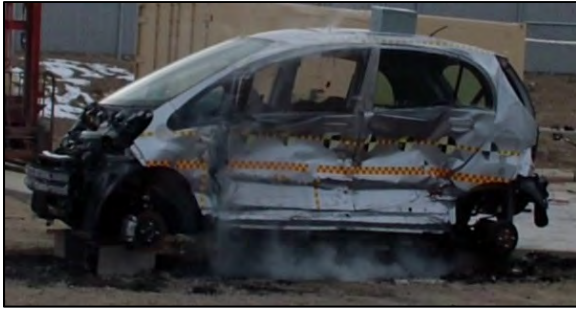
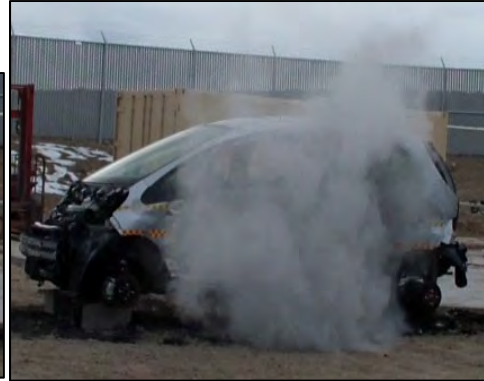
Figure 90 - Left: smoke starting during first runaway. Right: peak smoke emission during the first runaway.

The SCTR test with the Manufacturer B vehicle and RESS was conducted successfully. A summary of the results is provided in Table 10. Single cell thermal runaway initiation occurred after 11 minutes and 17 seconds. There was an audible popping noise followed by emission of a large amount of smoke from the underside of the vehicle (Figure 90). One minute later, the smoke alarm that was mounted on the dashboard inside the cabin was triggered. Approximately 10 minutes later the next cell underwent thermal runaway. Subsequent cells underwent thermal runaway in 4-5 minute intervals (Figure 91). A total of eight cells underwent thermal runaway during the test. The battery pack was allowed to sit for almost 3 hours after the last thermal runaway occurred as the remaining cells cooled. There was no ignition of flammable gases.

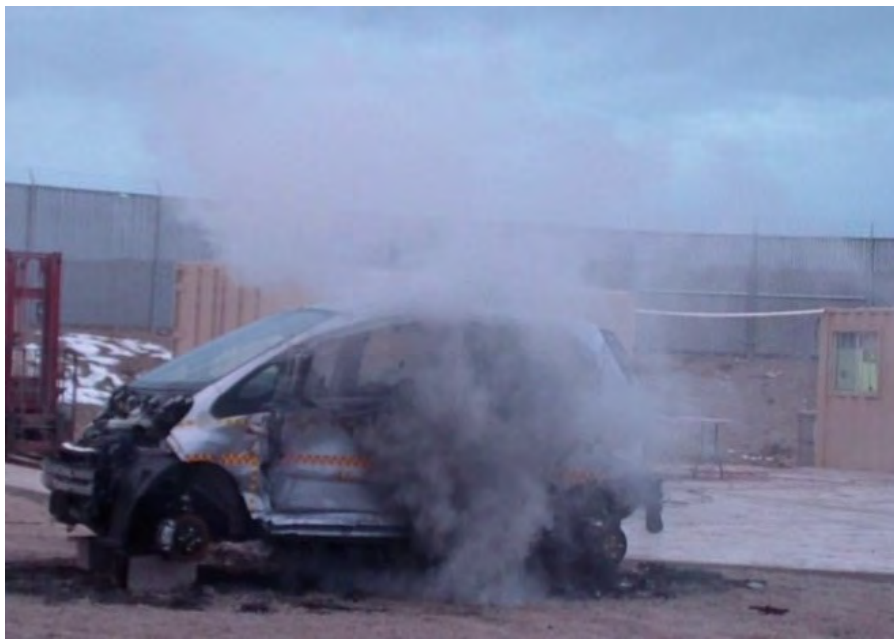
Figure 91 - Darkest smoke during the seventh runaway.

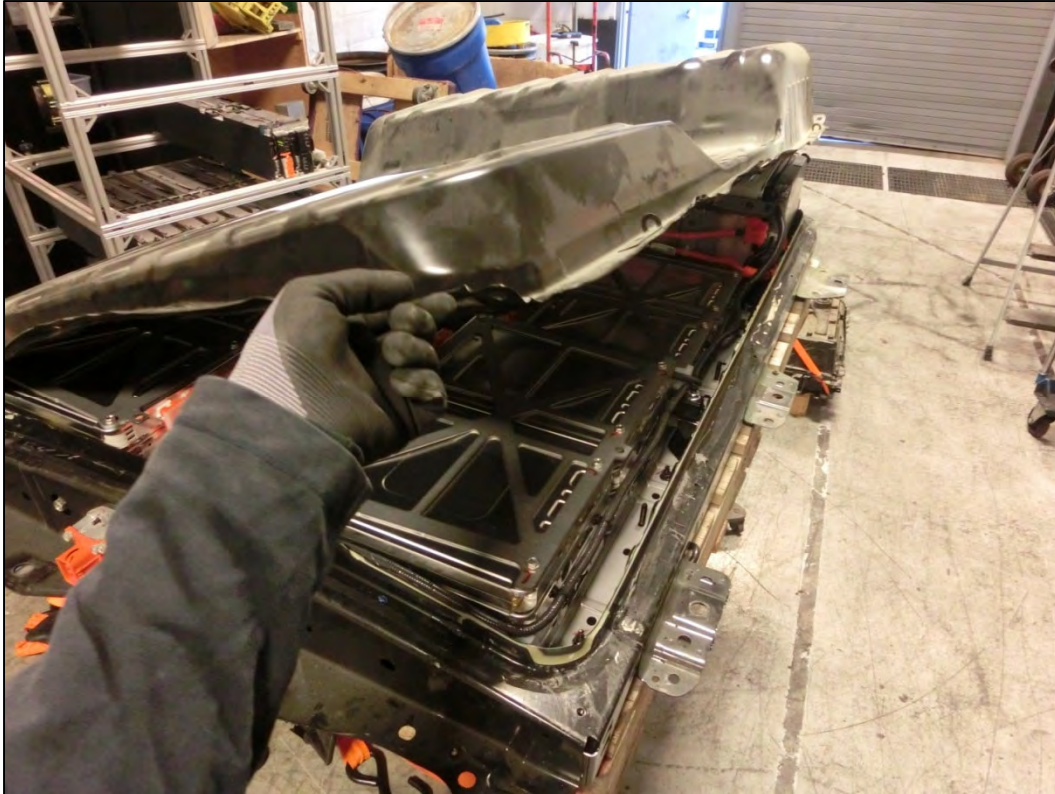
Figure 97 - The cover after removal from the battery pack.

Due to the strong adhesive sealant, the battery pack was opened using pry tools and hammers. The cover suffered minor local deformations as shown in Figure 97, but these were flattened and the cover was later resealed with generous application of sealant.

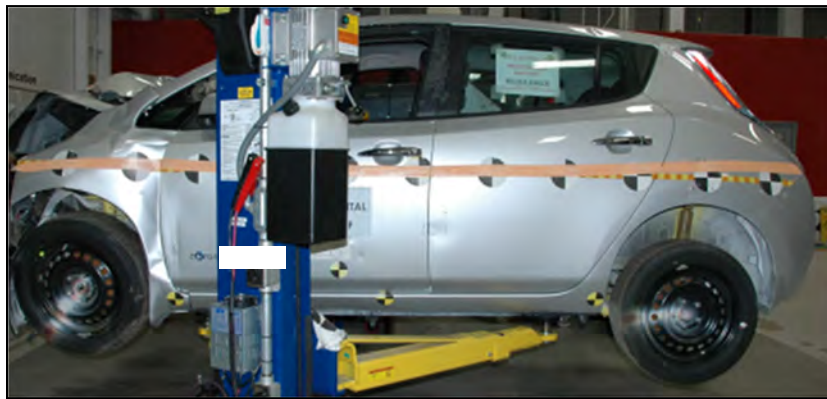
Figure 101 - The Manufacturer C frontal crash vehicle used for the test.

The Manufacturer C vehicle used to demonstrate SCTRI testing is shown in Figure 101. This vehicle had previously undergone a frontal crash per NCAP. There was little to no damage from the impact on the battery pack, although it had been opened and re-sealed following crash testing.

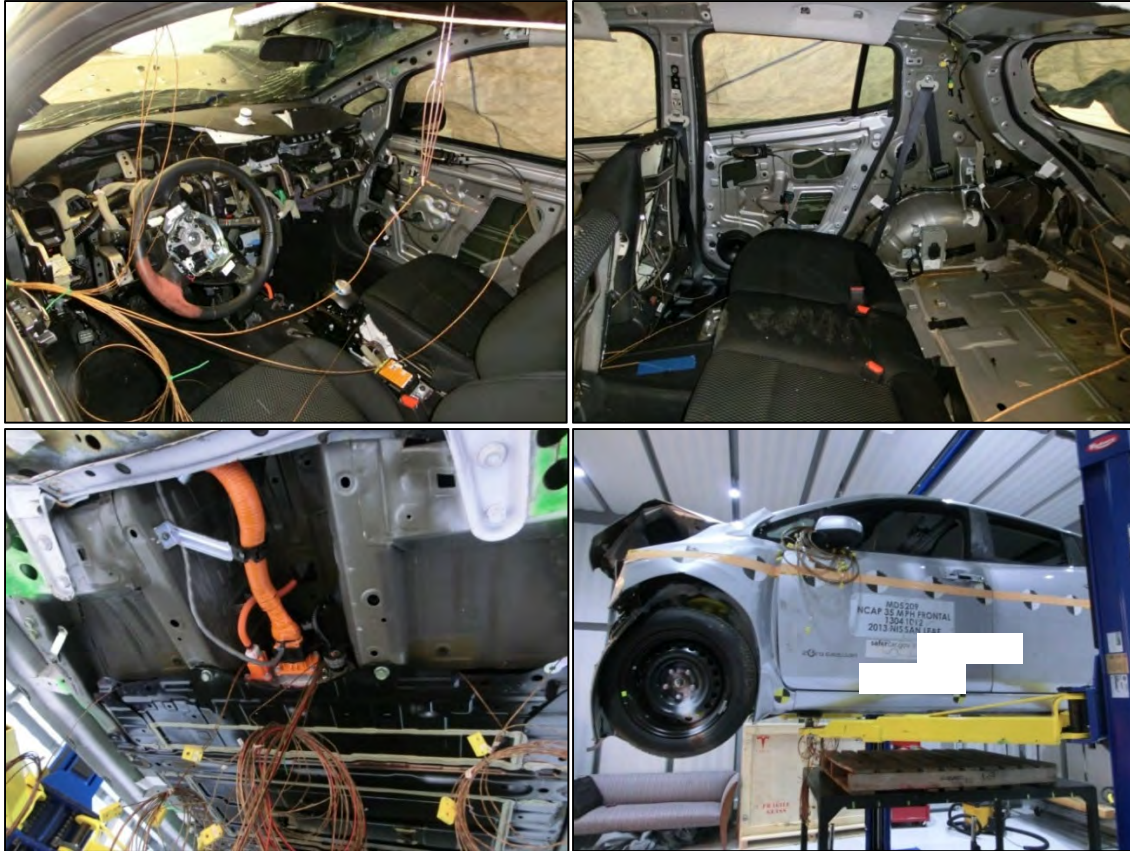
Figure 102 - The Manufacturer C vehicle with thermocouples installed and many flammable materials removed.

The vehicle was prepared by removing unnecessary flammable material (Figure 102). Material was removed to limit the extent and intensity of any vehicle fire that might occur. However, flammable materials that might be important for understanding hazard to the occupant in the case of a propagating thermal runaway reaction were left in place. Flammables closest to the battery pack were left intact (e.g., carpets, bottom seats), as well as some materials at the top of the vehicle (e.g., portions of headliner), but many other materials were removed (e.g., dashboard and center console, seatbacks, headrests, door trim). To reduce the risk of projectiles during testing, all airbags that had not been deployed during the previous crash test were removed.

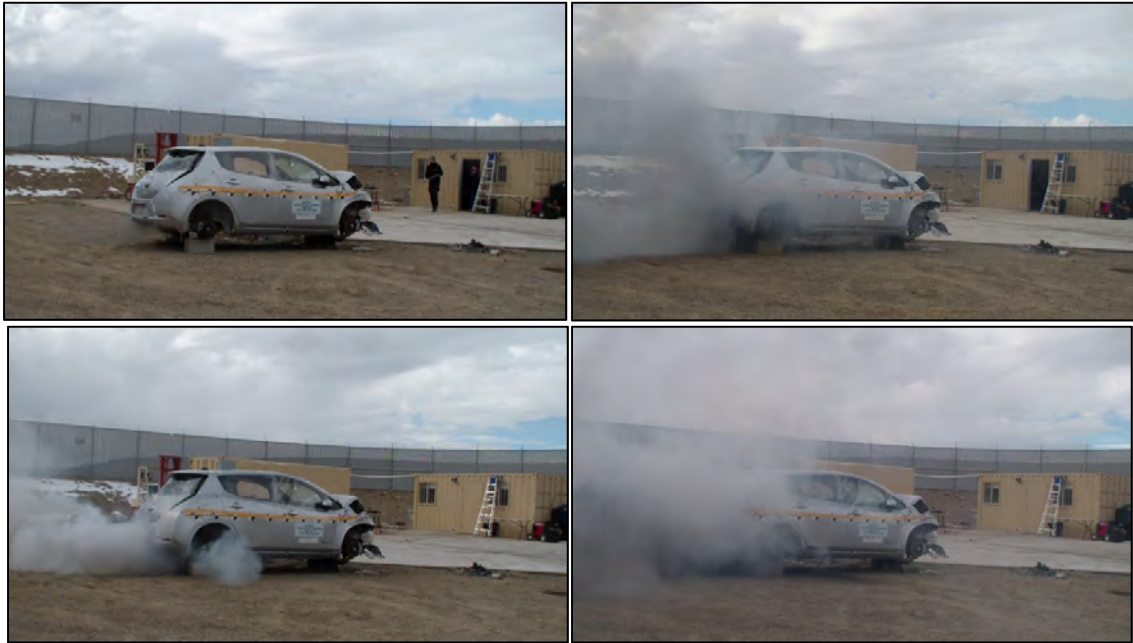
Figure 103 - Top left: 7:07, beginning of first runaway. Top right: 8:16, fourth cell runaway in the first module. Bottom left: 14:47, second module begins after lull. Bottom right: 22:10, several modules into event, ignition coming soon. Between runaways, the smoke cleared and resembled the top left image.

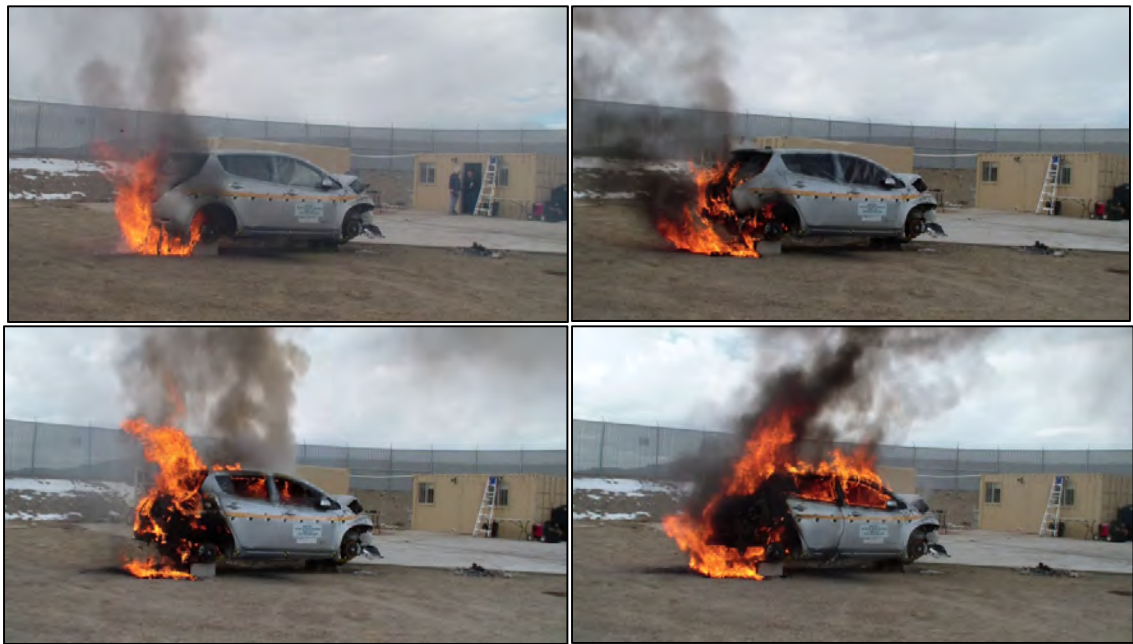
Figure 104 - Top left: 23:41, ignition has occurred. Top right: 26:44, rear flames continue. Bottom left: 28:22, flames inside cabin. Bottom right: 30:53, many internal flames.

Single cell thermal runaway initiation occurred after 6 minutes 55 seconds of heating (Figure 103). There was an audible noise followed by emission of smoke from the underside of the vehicle. Three additional thermal runaway events occurred in the module over the next 90 seconds. About 7 minutes later, a similar event (four thermal runaway reactions in rapid succession) was observed. Additional events occurred at increments between 2 minutes and 5 seconds, resulting in a steady smoke stream exiting the rear of the vehicle. At approximately 20 minutes, the smoke alarm within the vehicle activated. At 23 minutes, ignition of the vent gases occurred (Figure 104). Burning vent gases ignited the vehicle rear bumper. The cell runaways and vehicle fire continued, and flames were observed inside the cabin at approximately 28 minutes. The fire continued until approximately 50-55 minutes after heater initiation (Figure 105).

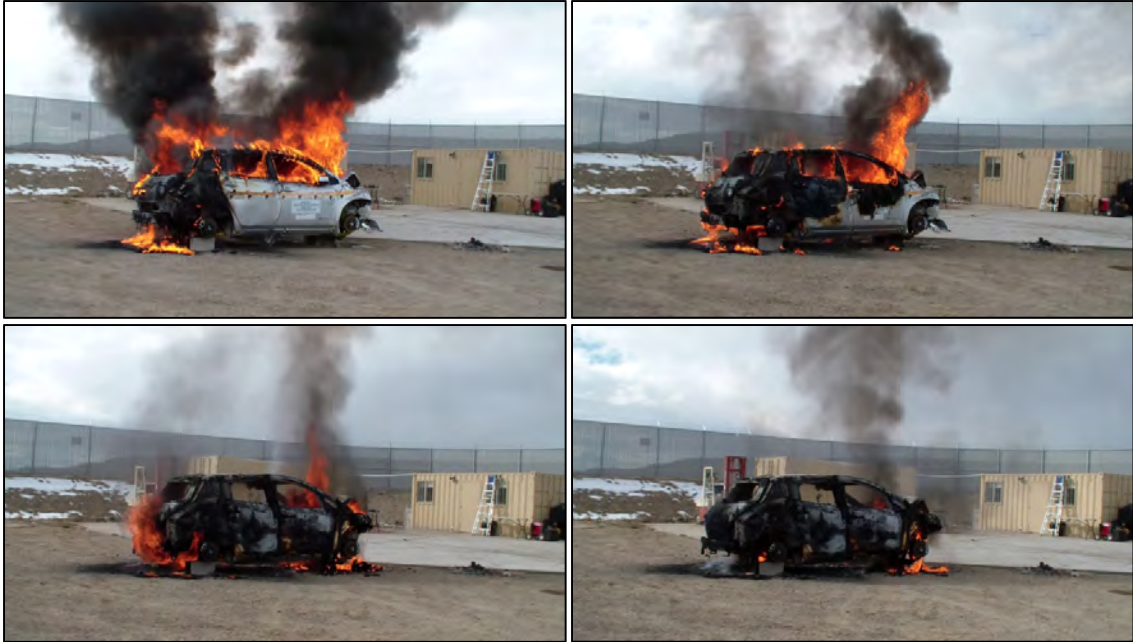
Figure 105 - Top left: 31:56, tallest flames. Top right: 36:04, vehicle fire concentrated in front. Bottom left: 46:03, event subsiding. Bottom right: 51:03, event nearing completion.

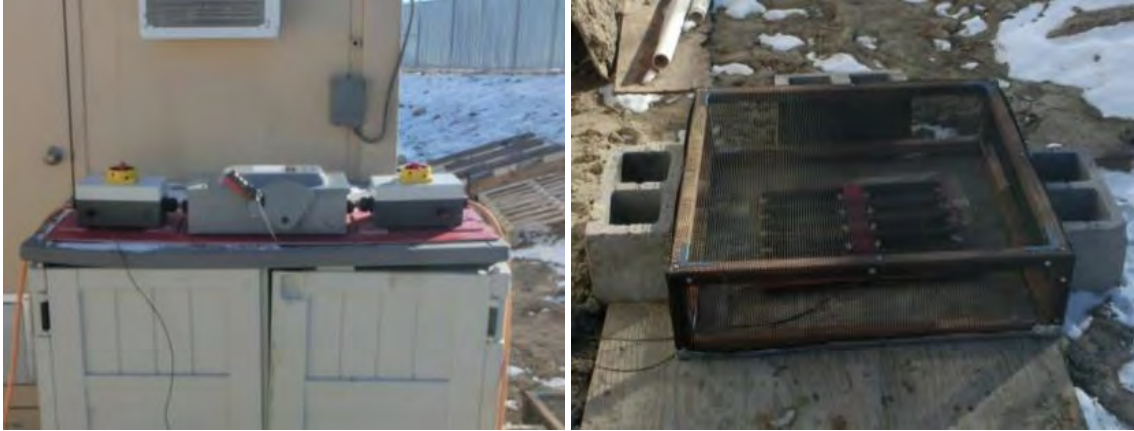
Figure 3 - The switchboard (left) and discharge resistor (right). The discharge resistor is protected beneath a mesh cage to prevent inadvertent contact by an operator. During use, a fan provided cooling air across the resistors to maintain temperature.

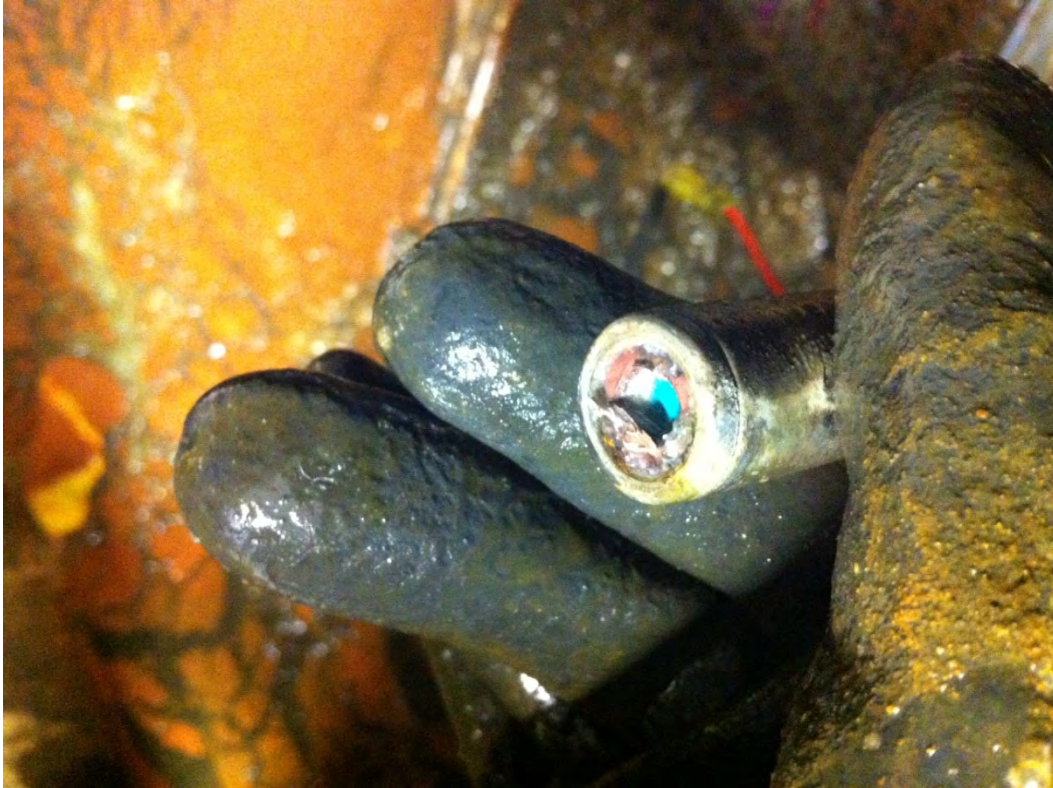
Figure 10 - An example of an 18650 cylindrical cell after a salt bath destructive discharge. The positive terminal has been removed by corrosion, thus exposing the cell interior.

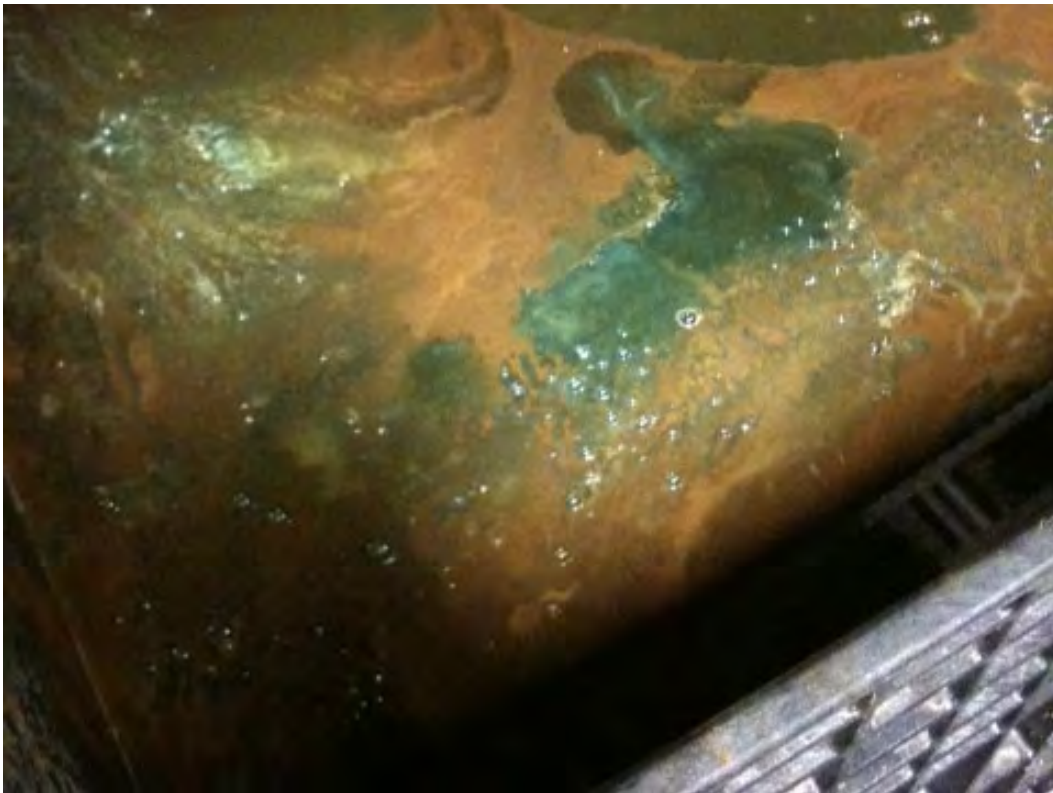
Figure 13 - An example of a salt bath with submerged modules. Note the bubbles of gas on the surface produced by electrolysis.

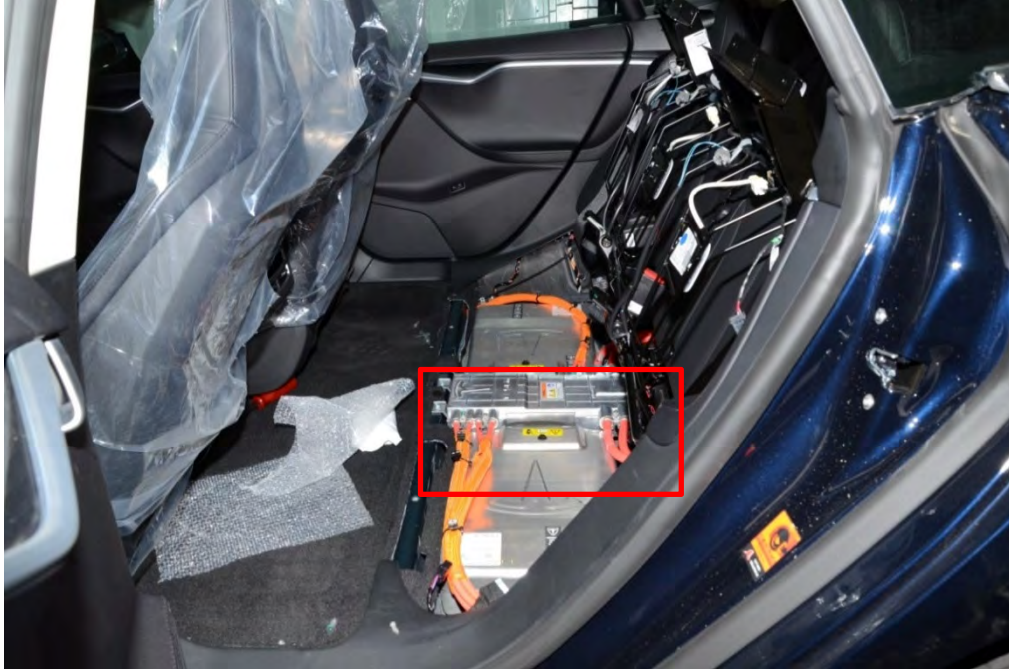
Figure 14 - Manufacturer A vehicle; the DC junction box beneath the rear seat with orange high voltage cables.

- Removing the first responder cut loop to ensure that the RESS contactors remain open and all vehicle high voltage systems are de-energized.
- Removing the DC junction box cover.
- Attaching the DC link cable directly to the high voltage terminals using the same lugs which are used to secure the other high current cables (Figure 15).
- Replacing the DC junction box cover.
- Reinstalling the first responder cut loop.

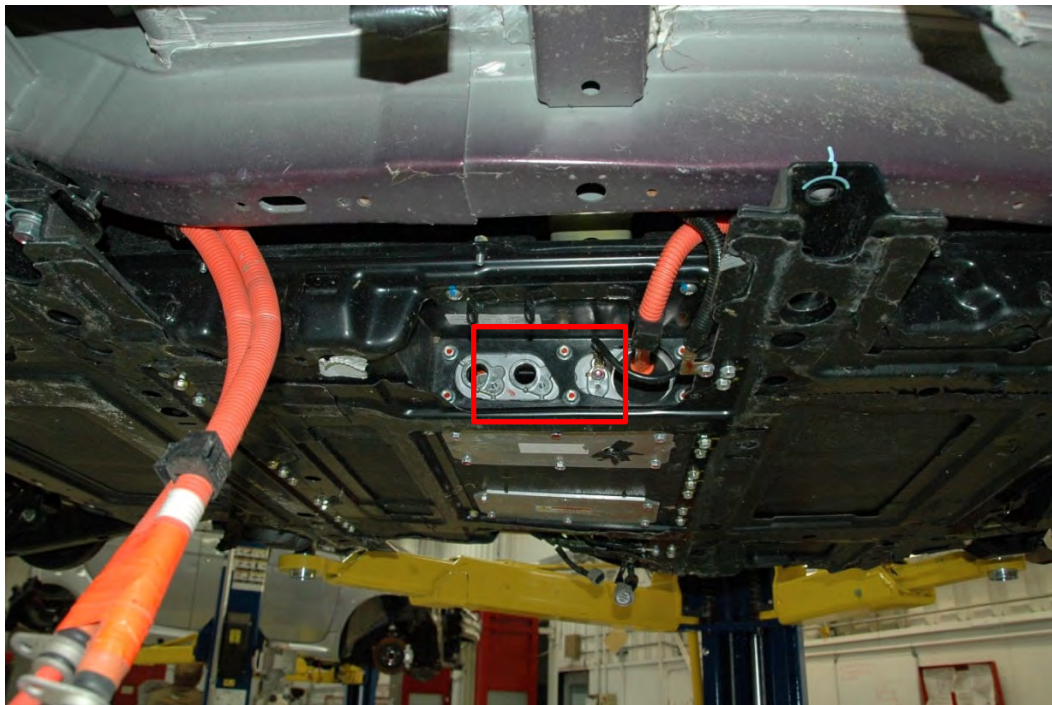
Figure 16 - Manufacturer B vehicle; the high voltage cable pass through (red box) into the RESS (the high voltage cables have been disconnected and are hanging on the left).

- Removing the service disconnect plug (from inside the vehicle cabin) to ensure that the RESS contactors remain open and all vehicle high voltage systems are de-energized.
- Connect the DC link terminal cables by splicing them into the pair of orange high voltage cables that enter the RESS (Figure 16), or by connecting to the RESS internal contacts and modifying the DC junction cover plate to allow a pass-through.
- Reinstalling the service disconnect plug.

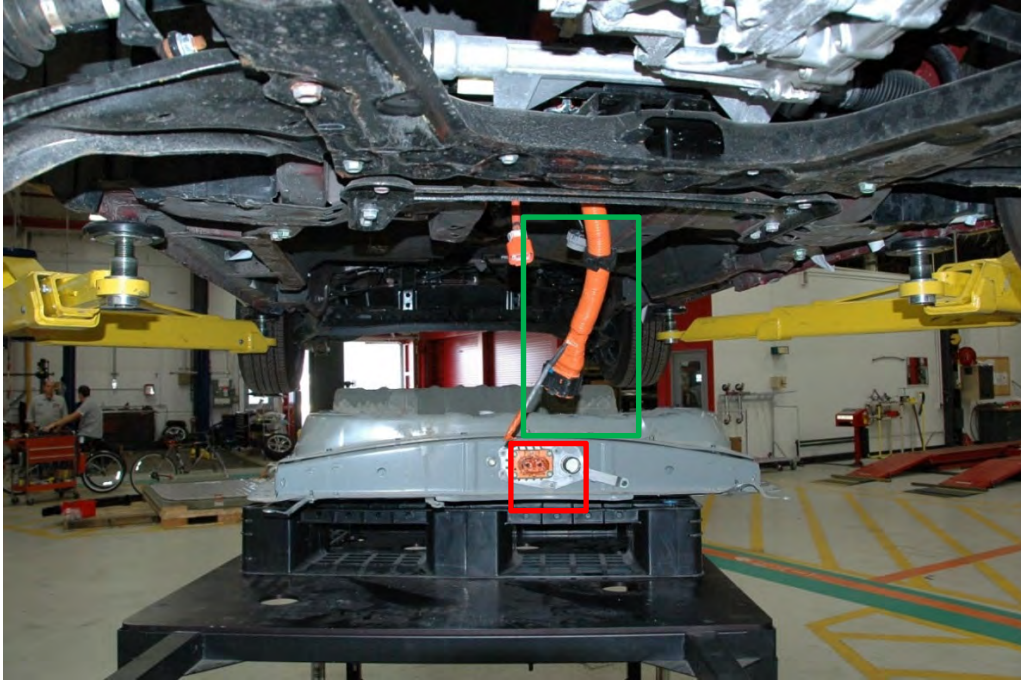
Figure 18 - Manufacturer C vehicle; RESS high voltage connection. The high voltage cable from the vehicle (green box) connects directly to the RESS (red box). The RESS was removed from the vehicle for demonstrative purposes. The high voltage connection can be accessed without RESS removal.

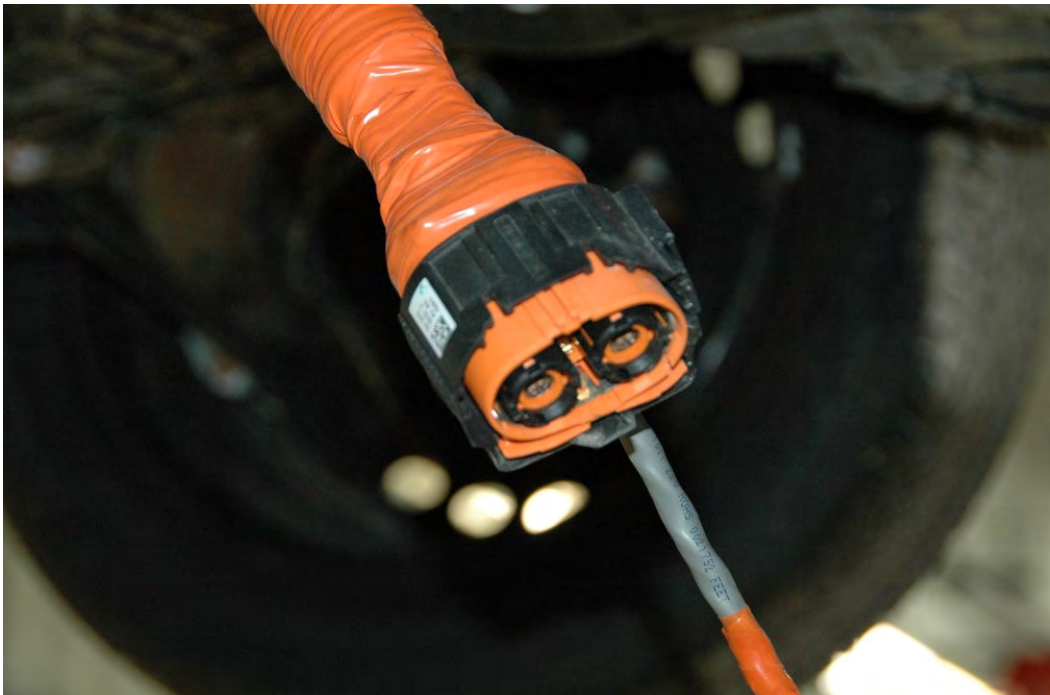
Figure 19 - Manufacturer C vehicle; high voltage cable connector.

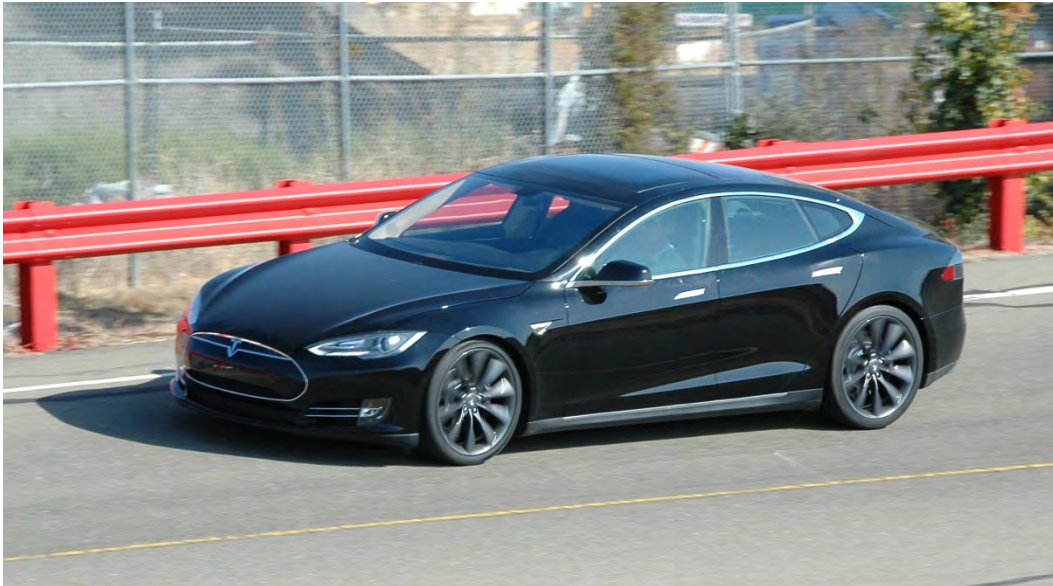
Figure 20 - The durability vehicle used to apply the preconditioning sequence.

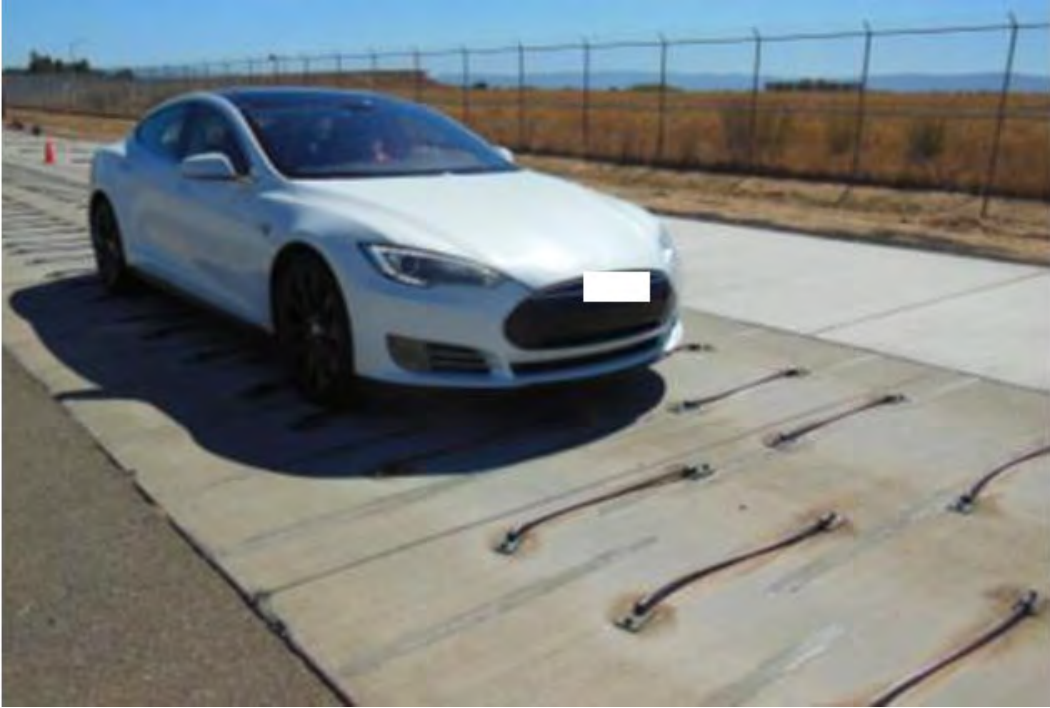
Figure 21 - An example of a vehicle on a rope road (i.e., rough road element).

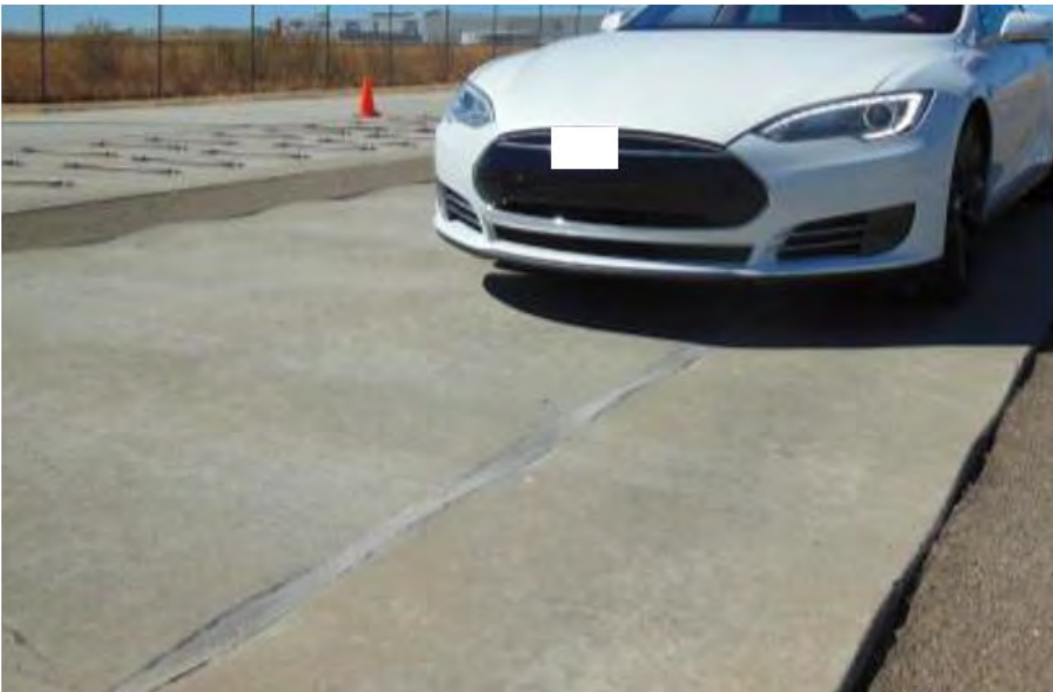
Figure 22 - An example of a vehicle on a wave / sinusoidal road (i.e., rough road element).

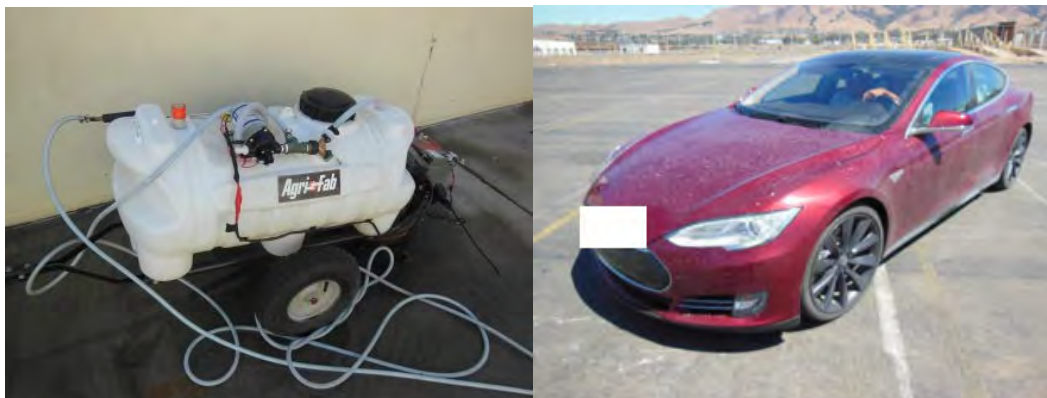
Figure 24 - Salt spray applicator (left) and an example of a vehicle after salt spray application (right).

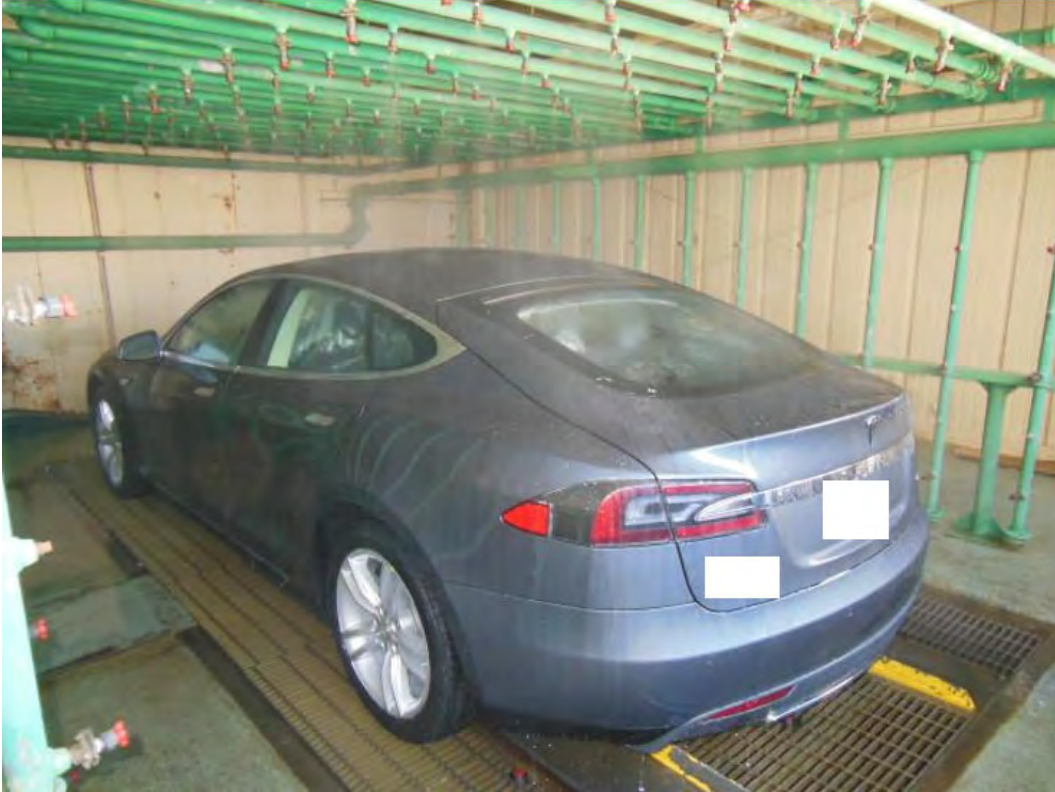
Figure 27 - An example of a vehicle installed in the booth used for rain and drizzle testing. Rain is simulated by applying a total water flow rate of 600 GPM divided into 150 GPM per side (top, left, right, and bottom).

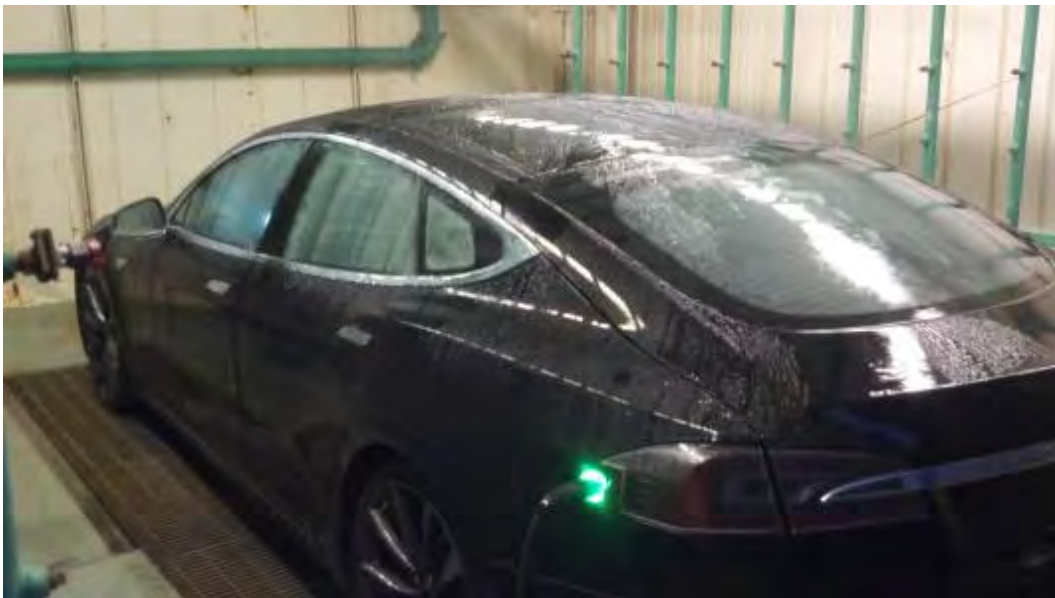
Figure 28 - An example of a vehicle subjected to drizzle chamber charging. Drizzle is simulated by applying a total water flow rate of 12 GPM from the top of the chamber only.

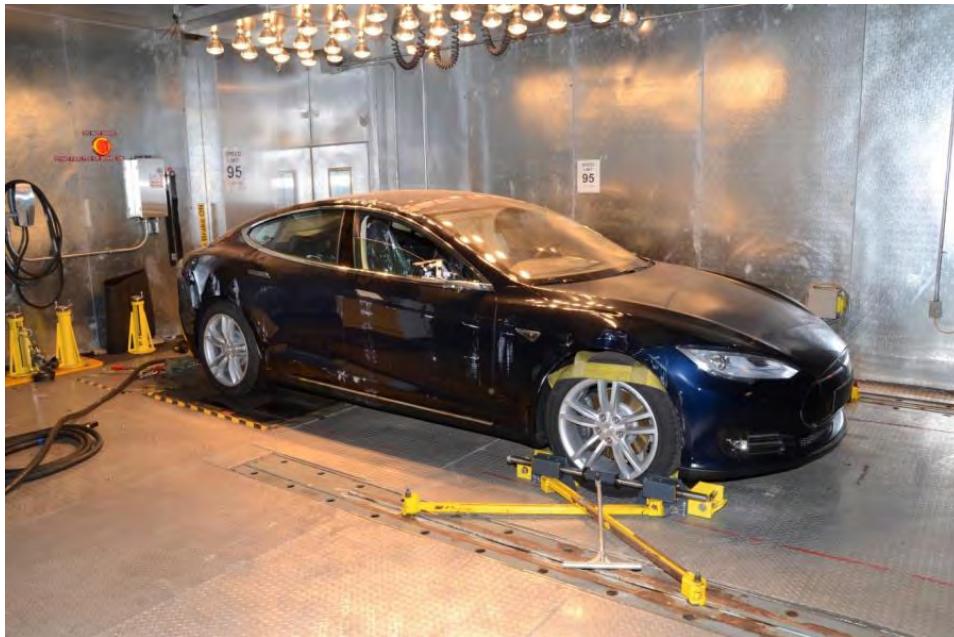
Figure 30 - The test vehicle installed on the dynamometer. Solar load lights are used to provide illumination for the image, but were not used during testing. The coiled Level 3 charge cable can be seen on the left.

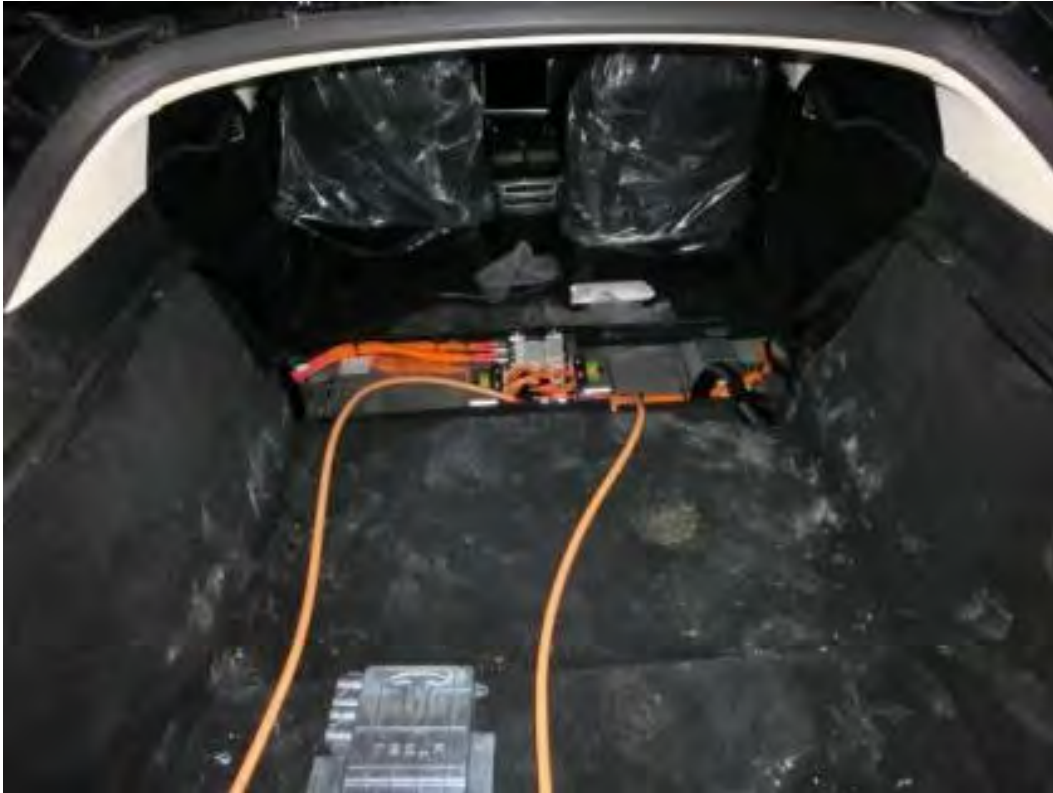
Figure 37 - The location of the exposed DC junction box in the Manufacturer A vehicle. The light orange leads connect to the DC link. Note that the vehicle rear seats have been removed. The junction box cover can be seen on the lower left.

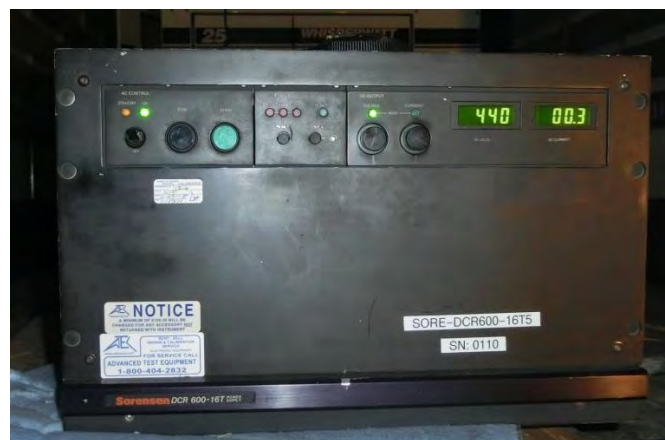
Figure 40 - The Sorenson DCR-600 DC power supply used for both overvoltage and overcurrent overcharge testing. It is rated for 600 V / 16 A (9.6 kW).
