**National Highway
Traffic Safety
Administration**

DOT HS 812 717

Safety Performance of Rechargeable Energy Storage Systems

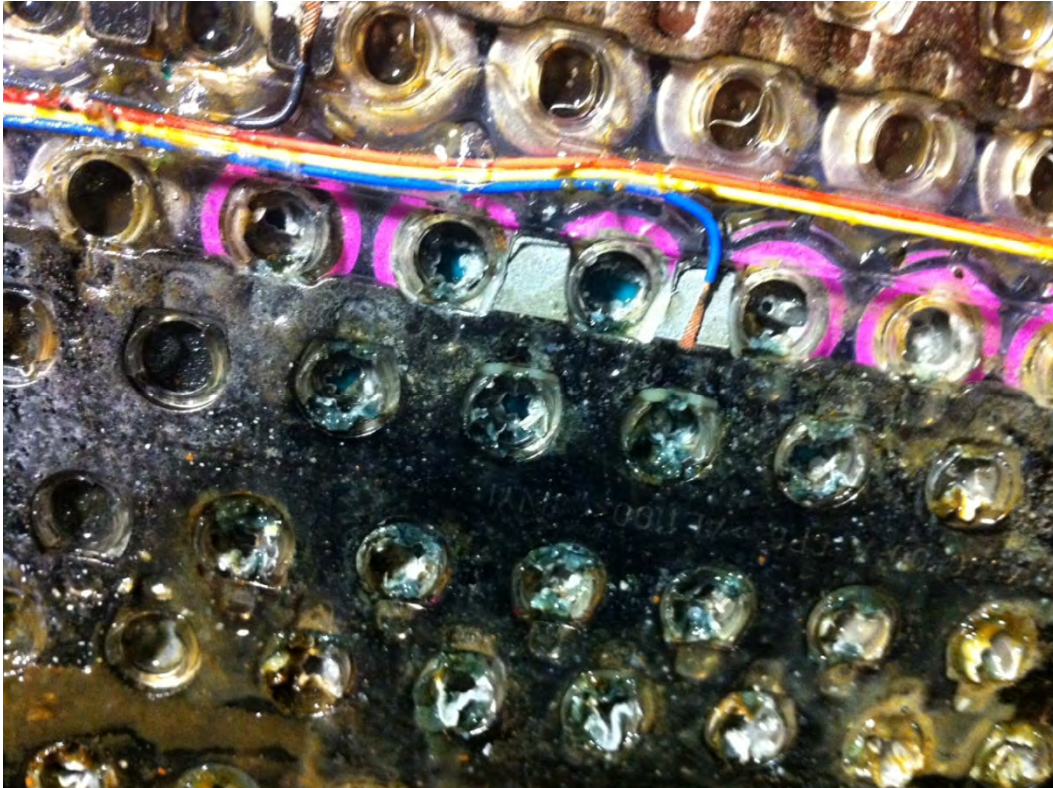
Figure 43 - An example of a Manufacturer A module after a salt bath destructive discharge.

Thus, the results of this assessment indicated that destructive discharge should be conducted at an individual module level, which was already demonstrated.

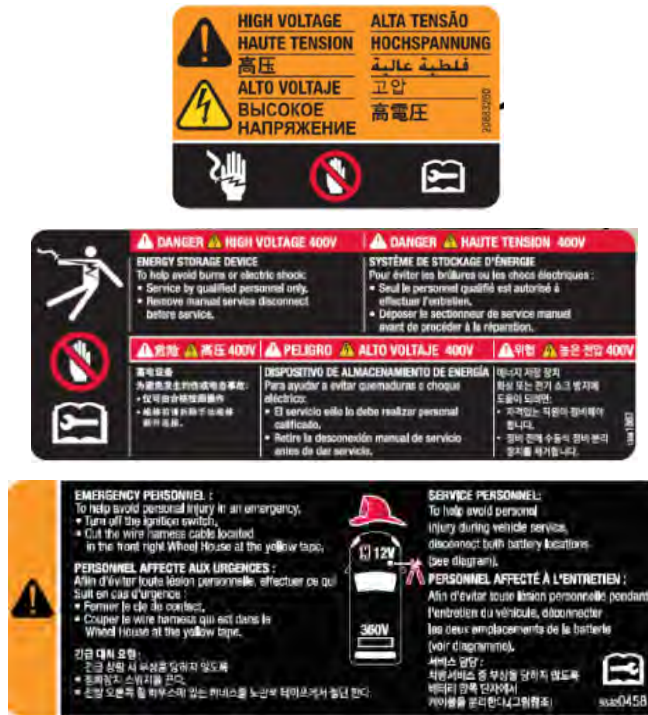
Figure 1 - Example high voltage warning labels (source: GM First Responder Guide).

- 5.1.4 When working on or around high voltage systems, always follow the appropriate safety precautions. Read and follow the recommended service procedures for HV systems and parts.
- 5.1.5 Ensure that immersion containers, mixing tanks, and other metallic equipment are well grounded per standard practices and electrical codes.
- 5.1.6 Always observe high voltage warning labels (see Figure 1 for examples).

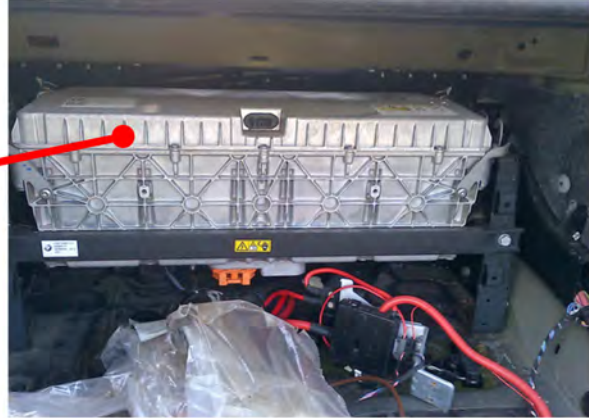
Figure 3 - Example HV RESS external case voltage sensing.

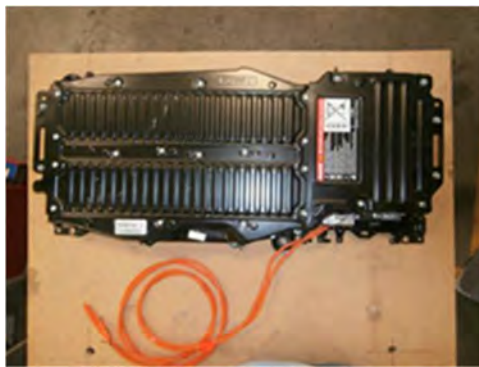
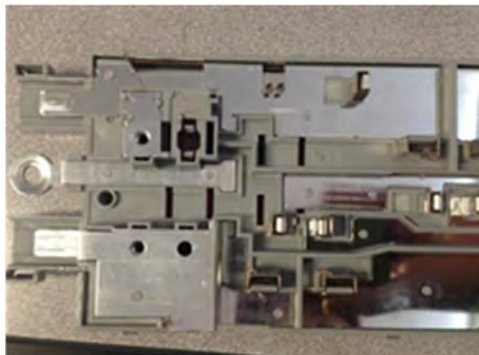
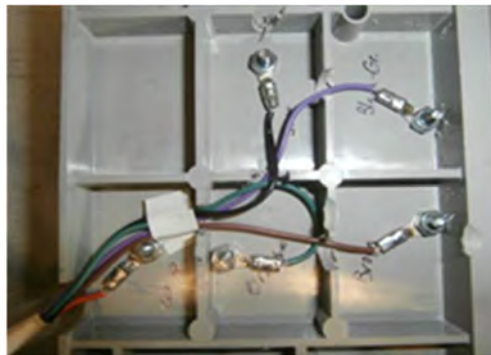
Figure 11 - Ford C-Max HEV HV connections: a) RESS removed from vehicle, b) contactor assembly, c) underside of contactor assembly, and d) measurement wires screwed to bus bars.

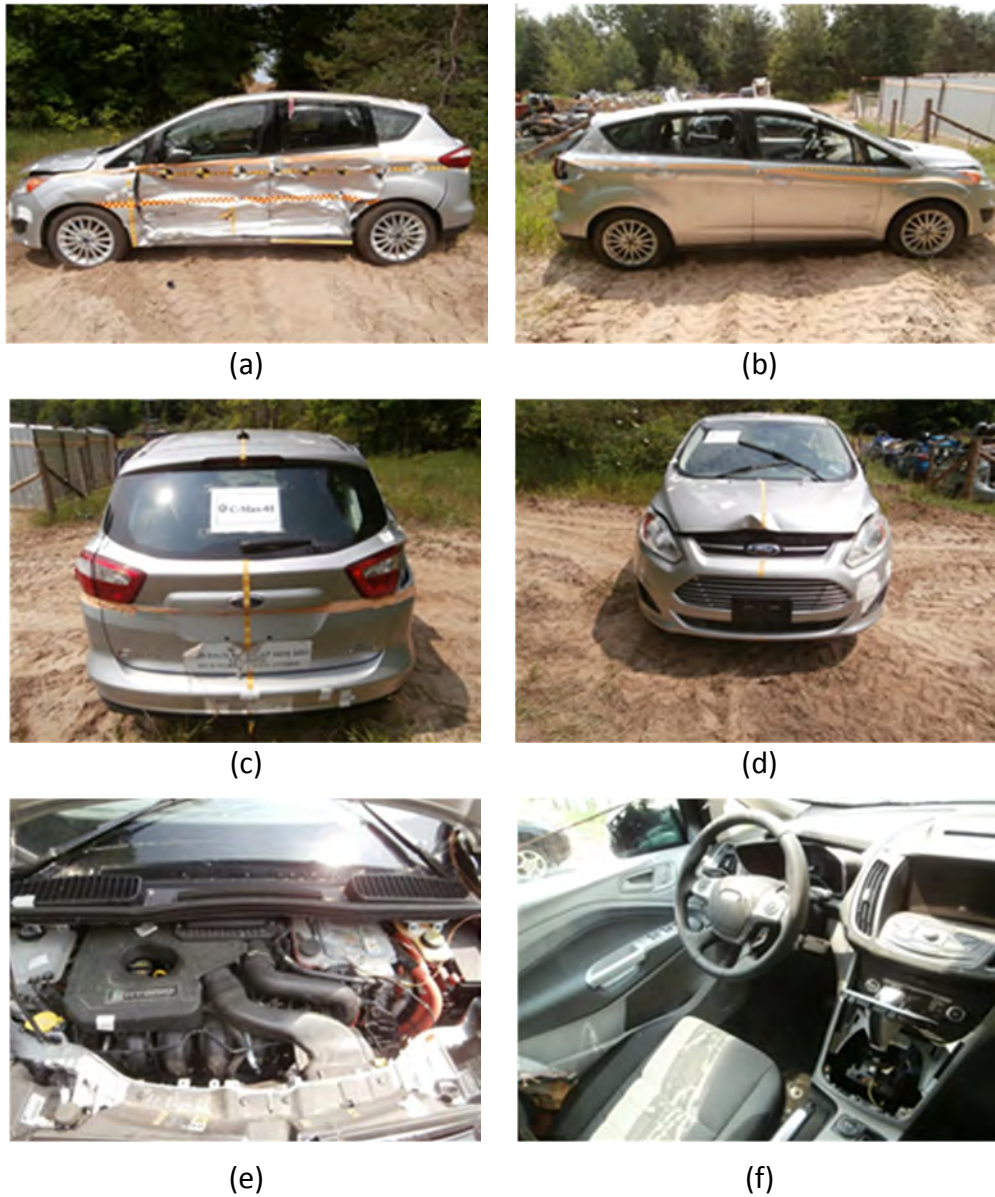
Figure 29 - Ford C-Max HEV post-test vehicle condition: a) left view, b) right view, c) rear view, d) front view, e) engine bay, and f) driver's seat.

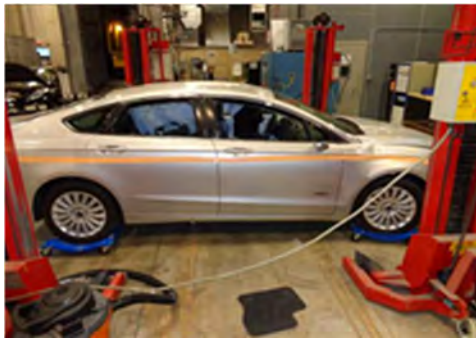
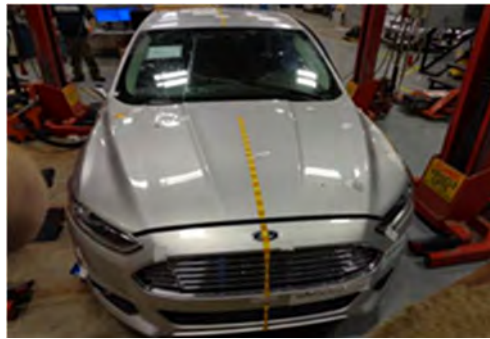
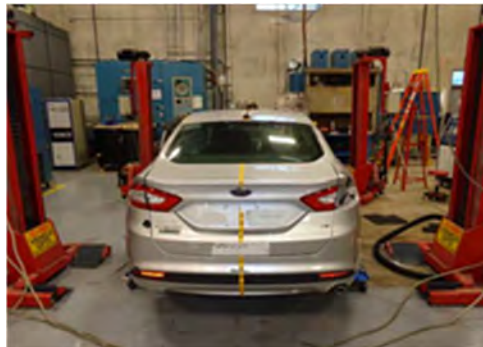
Figure 30 - Ford Fusion-1 PHEV initial vehicle condition: a) left view, b) front ³/₄ view, c) right view, d) front view, and e) rear view.

The Ford Fusion SE (Fusion-1) was a new production PHEV previously used for side impact testing, see Table 10. Figure 30 shows the as-received vehicle from multiple angles. Figure 10 (above) shows some of the equipment used for testing, including the DAQ system, the gas sensor, the video camera, and the immersion tank.

As received, the vehicle was not operational since all of the fluids (engine oil, brake fluid etc.) had been drained and needed to be refilled. It was also noted that the fuel tank was leaking; further inspection showed that the cover had been cut and a hole drilled into the tank. The fuel tank was patched with epoxy resin. The 12 V battery was below the minimum voltage and needed to be restored to health. The HV RESS was visually inspected and no damage from the side impact test was observed. All the loose interior parts were tagged and removed from the cabin. The vehicle was then successfully turned to the start position; it functioned in EV mode showing 75% charge. The engine was started and the transmission was placed into low gear. Once it was confirmed that the vehicle was operational, it was turned off for sensor installation.

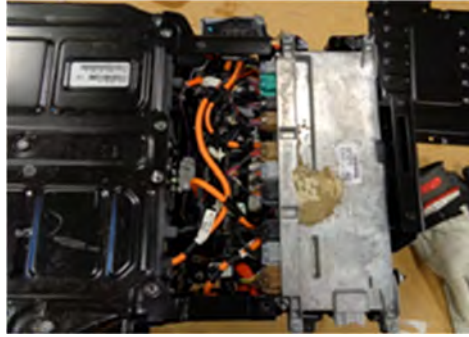
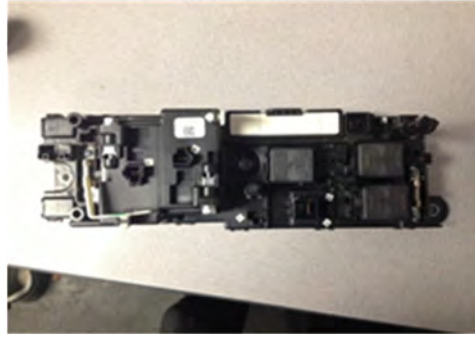
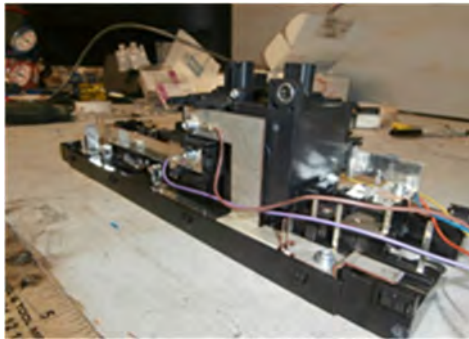
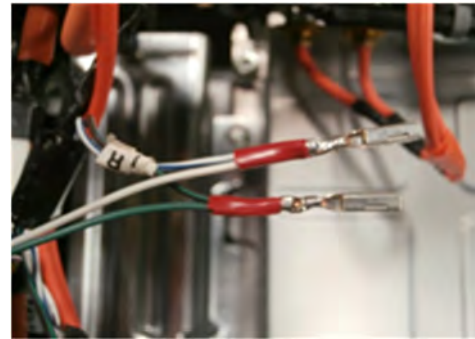
Figure 31 - Ford Fusion-1 PHEV HV connections: a) RESS removed from vehicle, b) contactor assembly, c) wires screwed to contactor assembly, and d) wires soldered to pin connectors.

For HV and isolation measurements, the RESS was removed from the vehicle and the contactor assembly was taken apart. The voltage sensors were tightly screwed to the bus bars of the assembly (see Figure 31). Since the RESS was not encased and sealed, no special measures to seal the measurement wire feedthroughs were needed. The contactor was reassembled and reinstalled in the pack; the RESS was then placed back into the vehicle. Voltage sense cables were also installed on the 12 V battery. The vehicle was re-tested for operation and no issues were encountered.

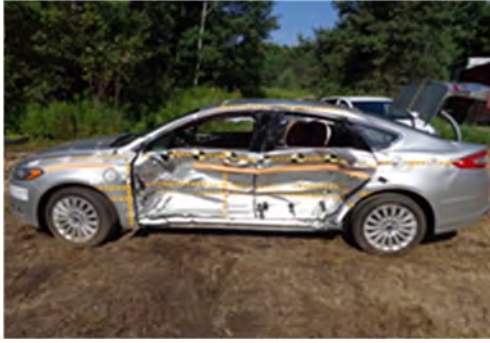
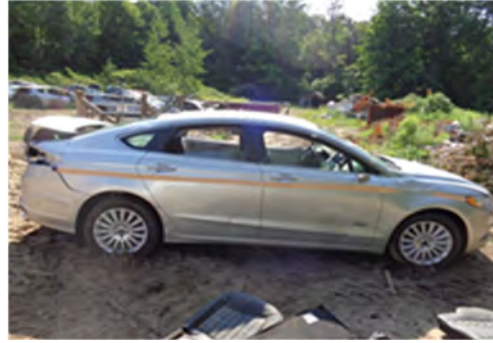
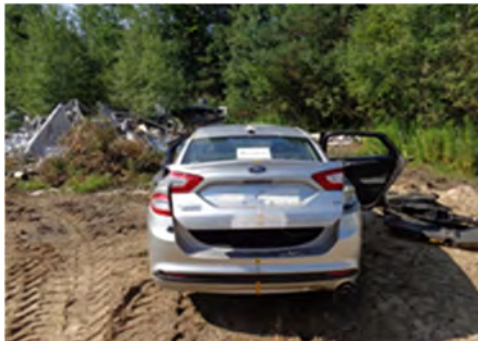
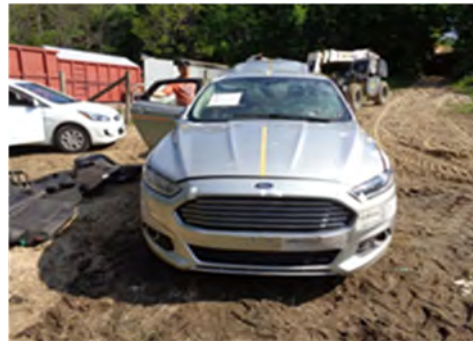
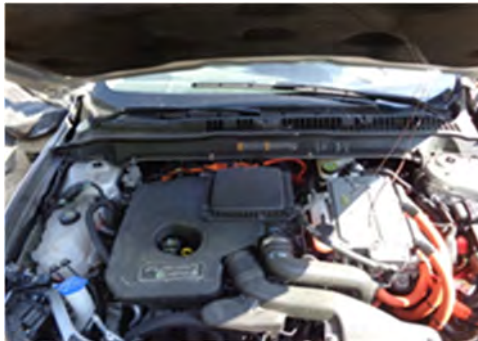
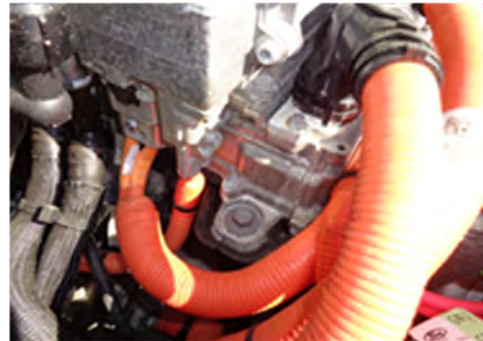
Figure 49 - Ford Fusion-1 PHEV post-test vehicle condition: a) left view, b) right view, c) rear view, d) front view, e) engine bay, and f) engine bay close-up.

Figures 49 through 52 show the vehicle and RESS from multiple angles after testing was complete. Post-mortem analysis did not indicate any evidence of behaviors that could result in an HSL higher than 4 (i.e., no anticipated fires, ruptures, or explosions) based on EUCAR standards. Although the temperature increased inside the RESS during immersion from -8°C to 30°C, it quickly declined to ambient levels after 3 hours and followed the diurnal ambient values until the end of the test. Additionally, the water immersion caused the RESS voltage to drop from 306 V to 8 V within the first hour of immersion; it then went down to 0 V until the end of the test. Therefore, no post-mortem analysis was conducted on the battery pack.

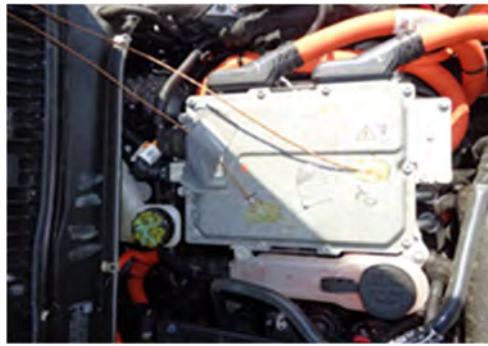
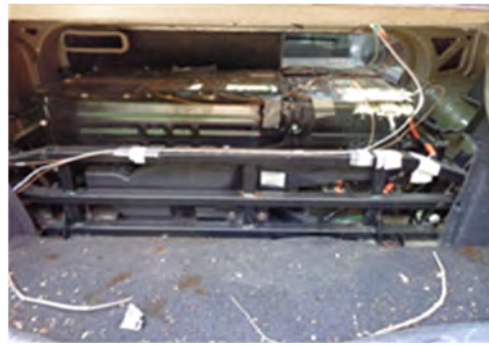
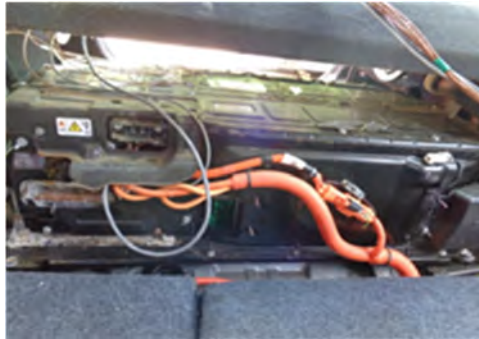
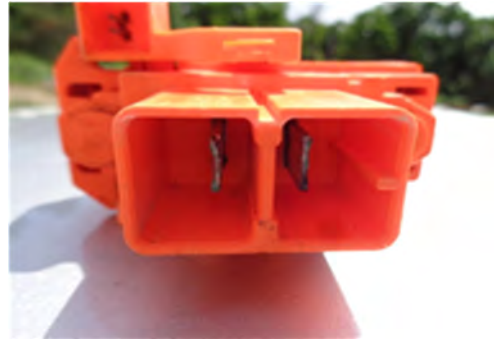
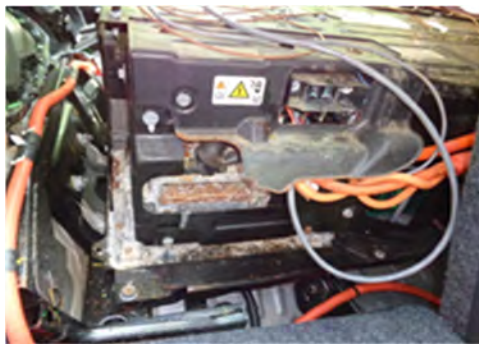
Figure 50 - Ford Fusion-1 PHEV post-test vehicle condition: a) control unit, b) interior trunk, c) interior cabin, RESS front, d) manual service disconnect, e) interior cabin charging harness, and f) cell close-up.

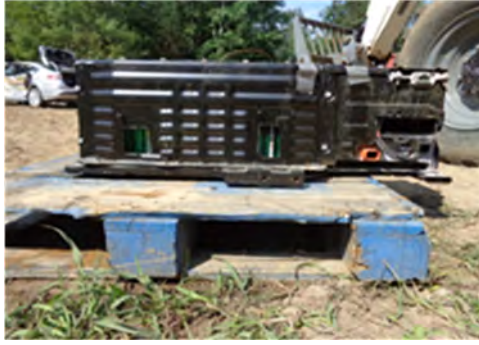
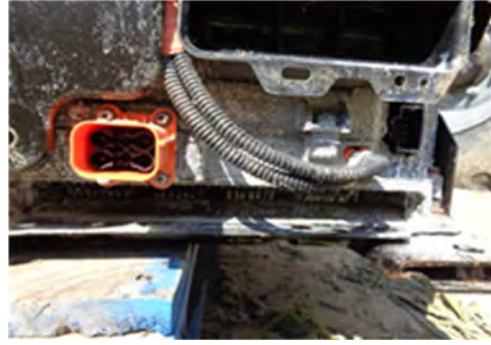
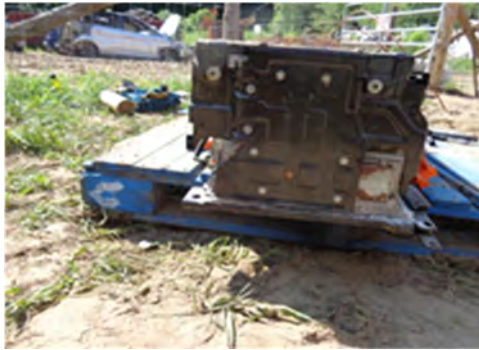
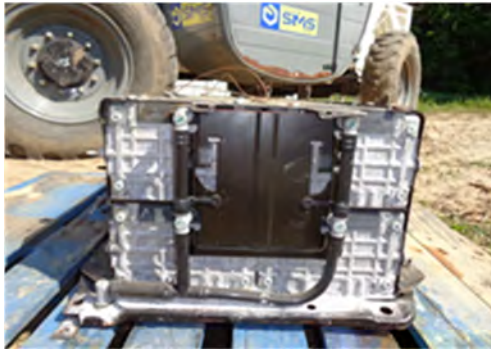
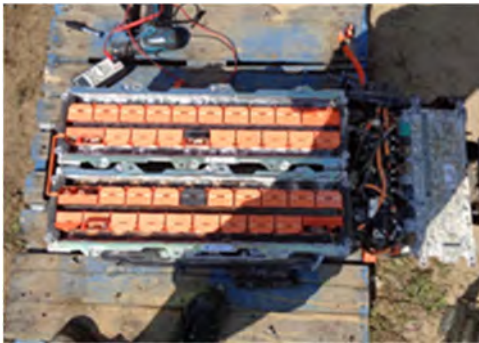
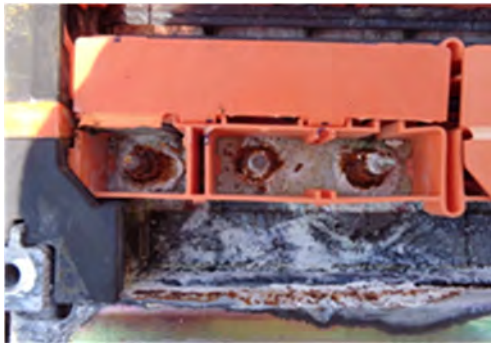
Figure 51 - Ford Fusion-1 PHEV post-test RESS condition: a) rear exterior, b) front view close-up, c) exterior right view, d) exterior left view, e) interior top view, and f) bus bar close-up.

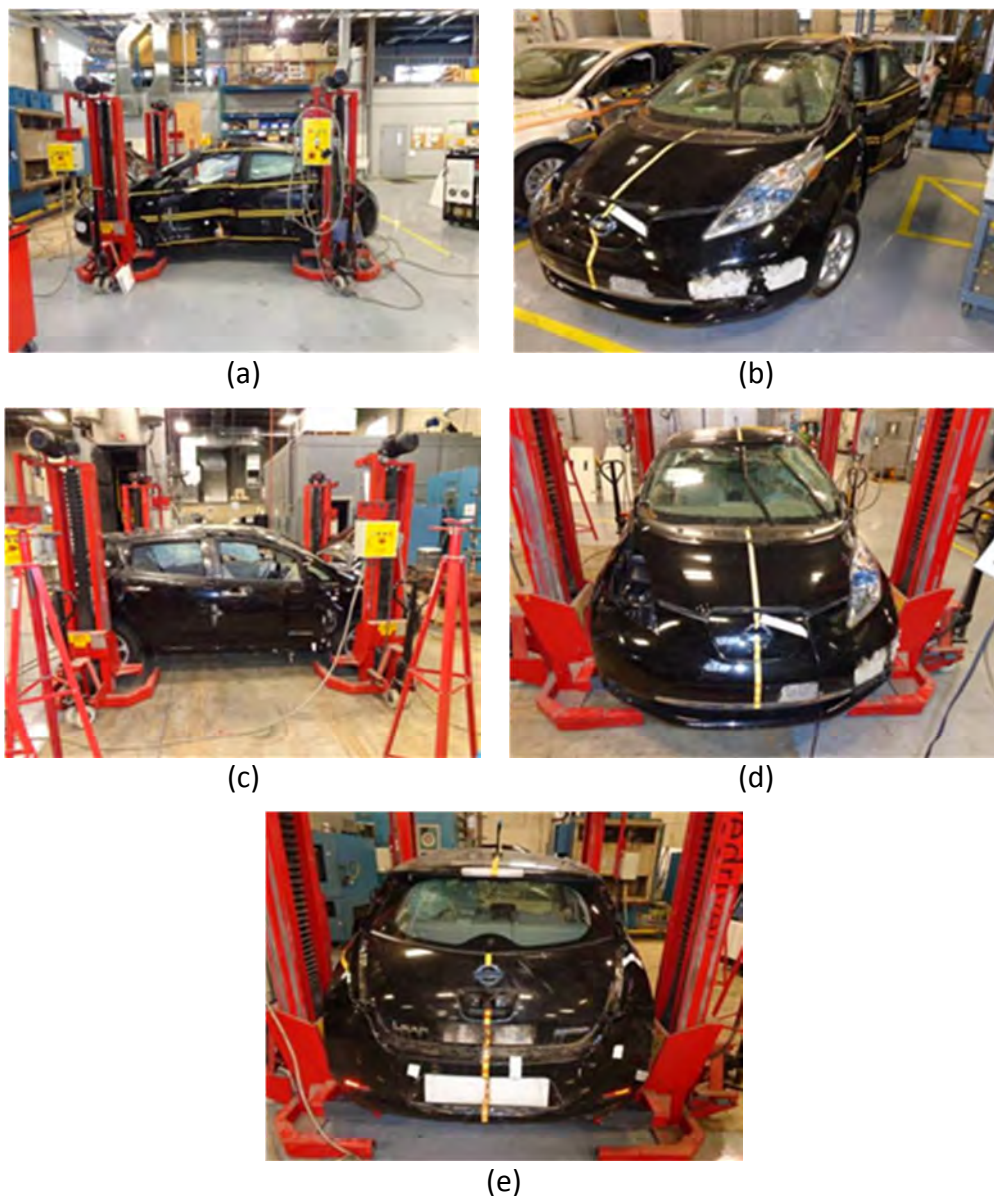
Figure 53 - Nissan Leaf-1 EV initial vehicle condition: a) left view, b) front $\frac{3}{4}$ view, c) right view, d) front view, and e) rear view.

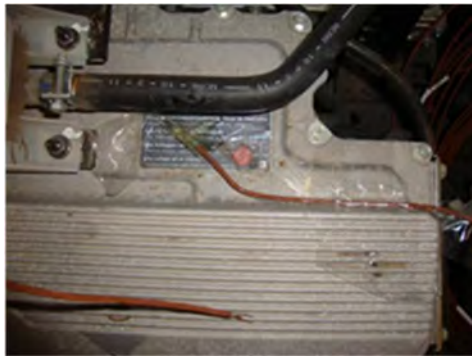
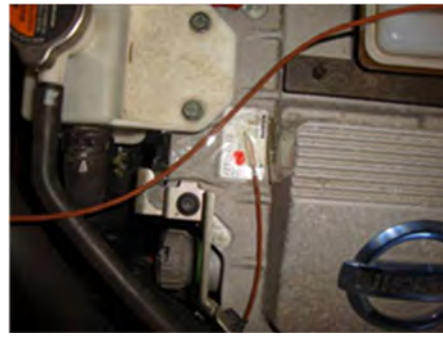
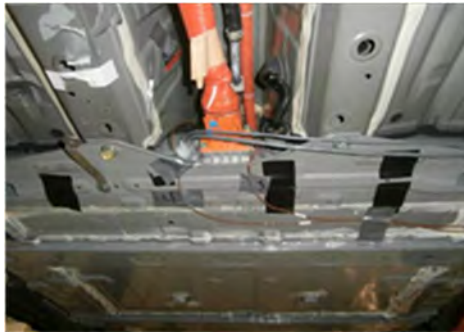
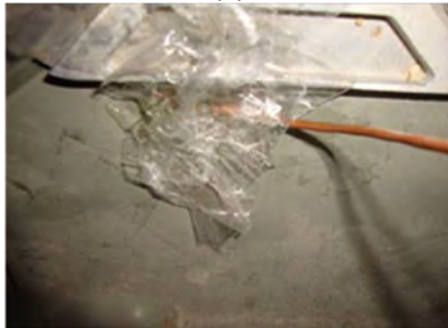
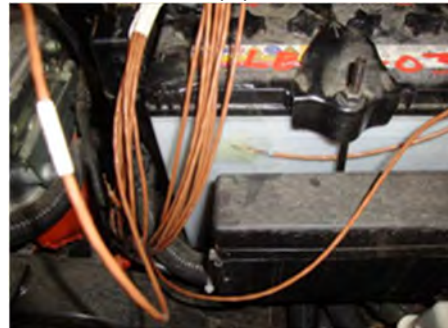
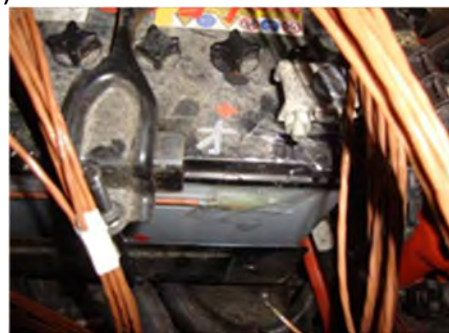
Figure 55 - Nissan Leaf-1 EV HV thermocouple placement: a) TC1 on the control unit, b) TC2 on the control unit, c) TC3 and TC4 on the center of the RESS, d) TC5 near the contactor, e) TC6 near the contactor, f) TC7 on the 12 V battery, and g) TC8 on the 12 V battery.

A total of eight thermocouples were installed as specified in test procedure (see Section 6.5.1.13), including the RESS enclosure, near contactors, the control unit, and the 12 V battery. Thermocouple locations are provided in Table 17 and shown in Figure 55. The thermocouples were held in position using epoxy adhesive.

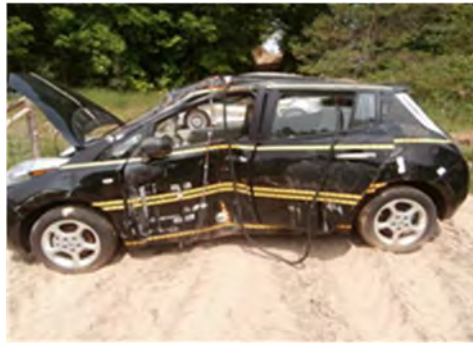
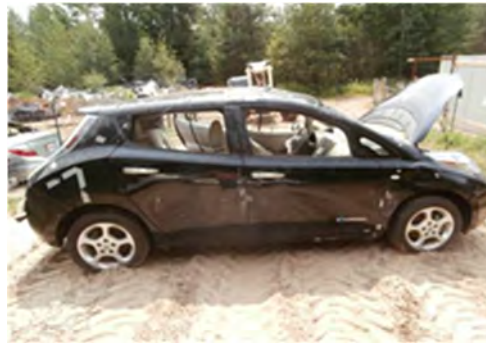
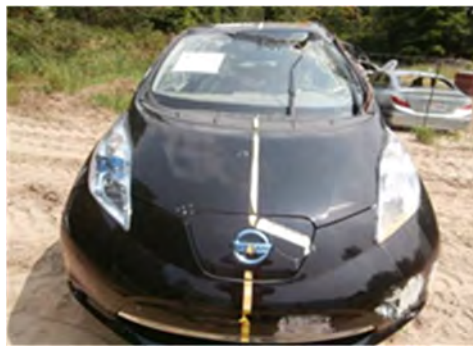
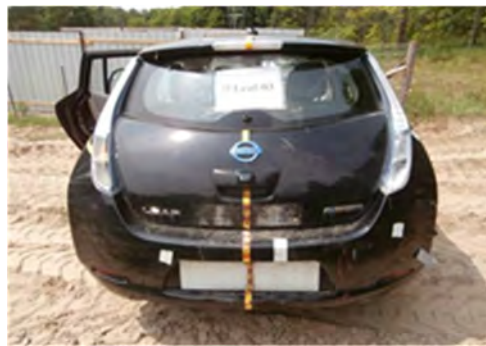
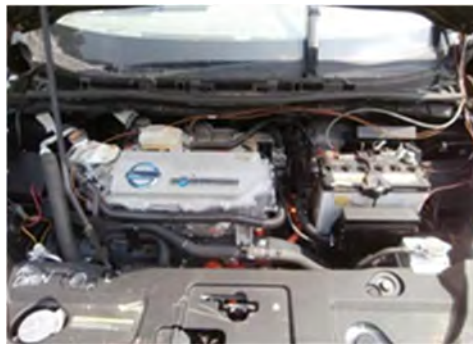
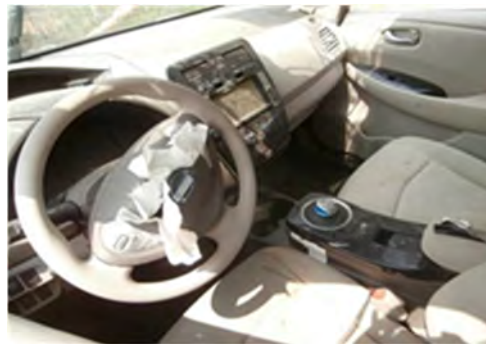
Figure 69 - Nissan Leaf-1 EV post-test vehicle condition: a) left view, b) right view, c) front view, d) rear view, e) engine bay, and f) front seats.

Figure 69 shows the vehicle from multiple angles after testing was complete. Post-mortem analysis did not indicate any evidence of behaviors that could result in an HSL higher than 4 (i.e., no anticipated fires, ruptures, or explosions)

based on EUCAR standards. Although the RESS temperature increased from -2°C just after immersion to 28°C, it quickly declined to ambient levels after 9 hours and followed the diurnal ambient values until the end of the test. In addition, the water immersion caused the RESS voltage to drop from 358 V to 170 V within the first 4 hours of the test and declined slowly to 140 V at end of test. Therefore, no post-mortem analysis was conducted on the battery pack.

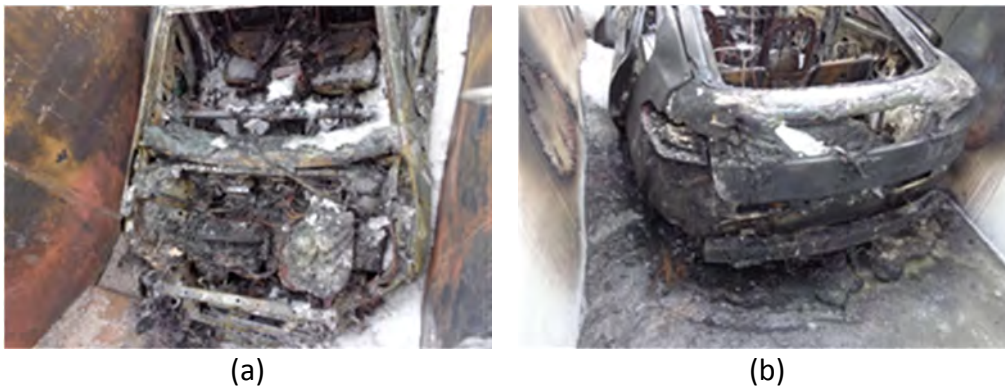
Figure 80 - GM Volt-1 PHEV post-test vehicle condition: a) front view and b) rear view.

The RESS was removed from the burned vehicle chassis and readied for teardown. Voltage measurements were attempted but most HV access points including the MSD were damaged beyond functionality. Figure 80 shows the vehicle damage (front and rear view).

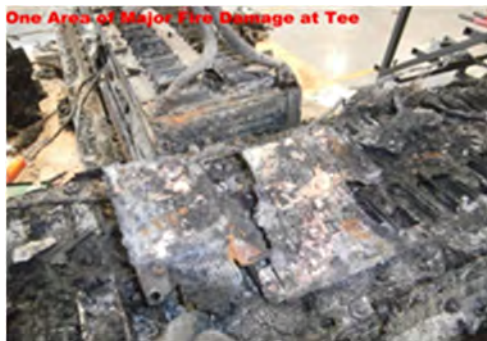
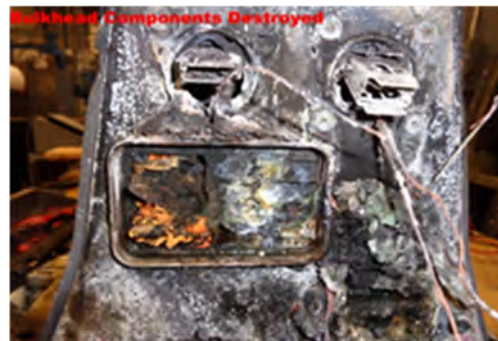
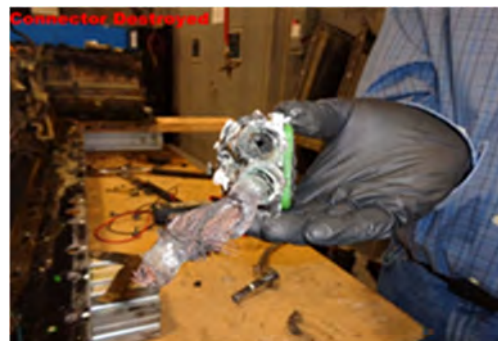
- Figure 81(a): Maximum fire damage occurred at the RESS “Tee”; cells were penetrated.
 - Figure 81(b): The connectors, sensor wires, and bulkhead panel show the extent of the fire and heat damage at the front of the RESS.
 - Figure 81(c): From a module disassembly to the the cell level, it was observed that the cooling plates between cells were still intact.
 - Figure 81(d): Heat damage was observed on the voltage sensing wires and salt deposits were on connector.
-
- Figure 82(a): A dismantled module was still structurally intact with some salt deposits.
 - Figure 82(b): Visual discoloration of RESS was observed, as well as residue of salt water.
 - Figure 82(c): An intact paper label was still adhered the bulkhead.
 - Figure 82(d): The extent of damage from heat to one typical control board.

Figure 81 - GM Volt-1 PHEV post-test vehicle condition: a) RESS Tee, b) bulkhead, c) RESS disassembly, and d) connectors.

Figures 81 and 82 show the extent of RESS damage due to the fire:

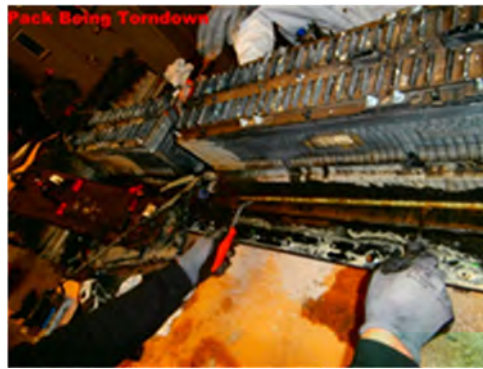
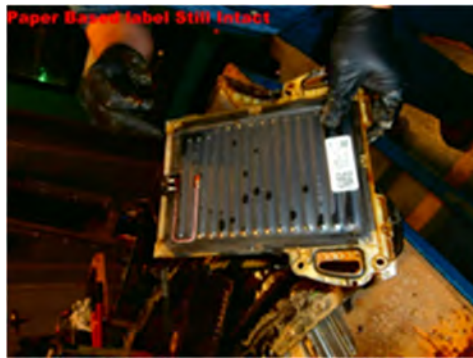
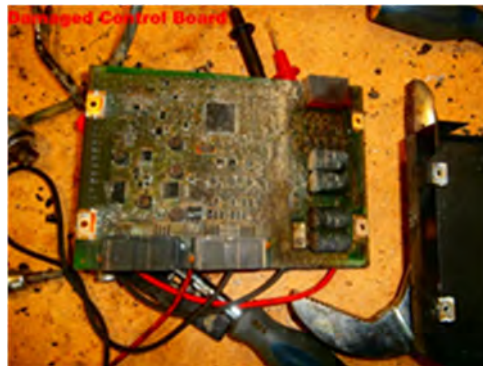
Figure 82 - GM Volt-1 PHEV post-test vehicle condition: a) module with minor damage, b) RESS tear-down, c) intact label, and d) control board.

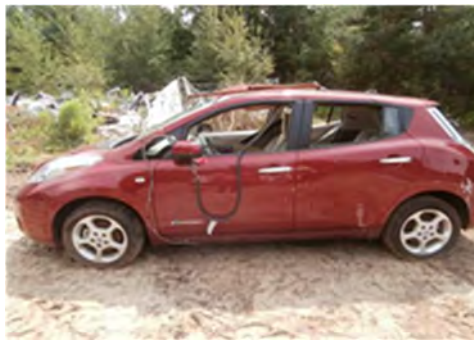
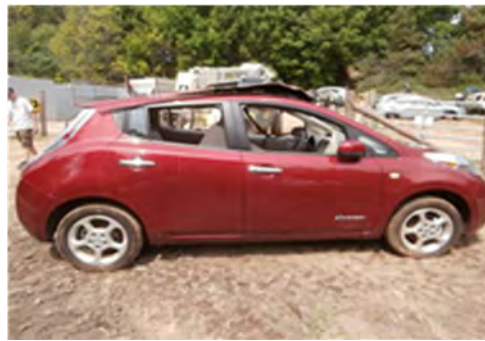
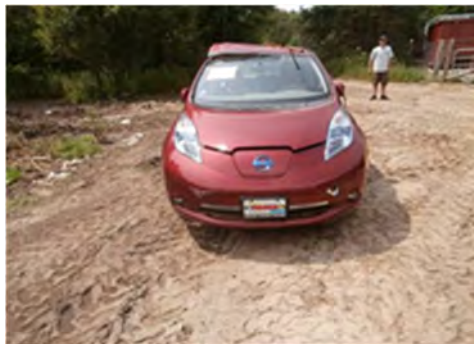
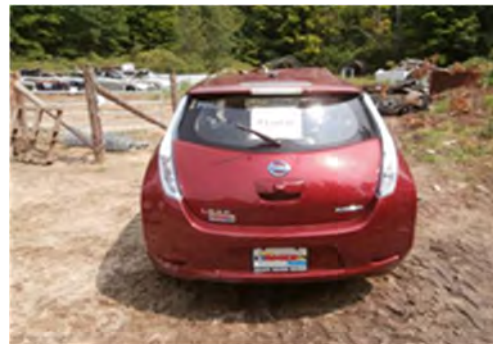
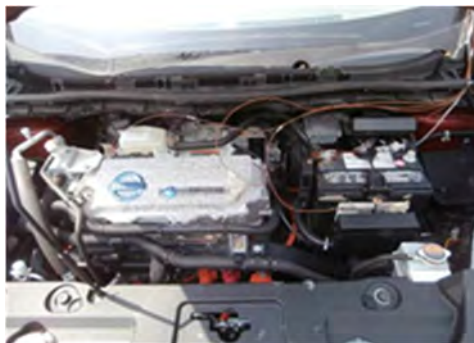
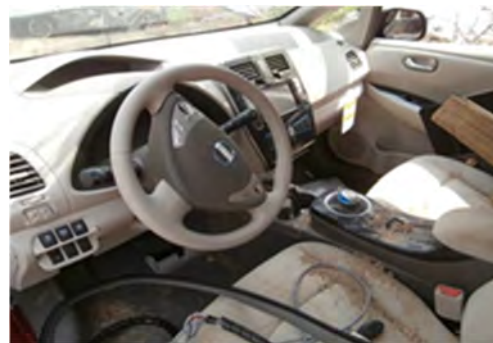
Figure 97 - Nissan Leaf-2 EV post-test vehicle condition: a) left view, b) right view, c) front view, d) rear view, e) engine bay, and f) front seats.

Figure 97 shows the vehicle from multiple angles after testing was complete. Post-mortem analysis did not indicate any evidence of behaviors that could result in an HSL higher than 4 (i.e., no anticipated fires, ruptures, or explosions) based on EUCAR standards. Temperatures increased inside the battery to air temperature after immersion in colder water. Diurnal values, however, started at about 8 hours after immersion and continued until the end of the test. Additionally, water immersion had no effect on the RESS voltage; it remained at 372 V. Therefore, no post-mortem analysis was conducted on the battery pack.

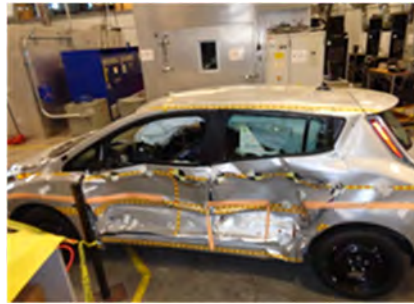
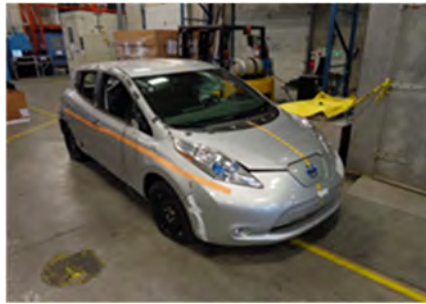
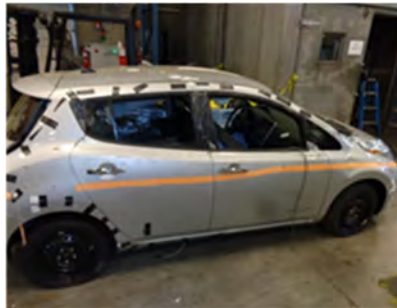
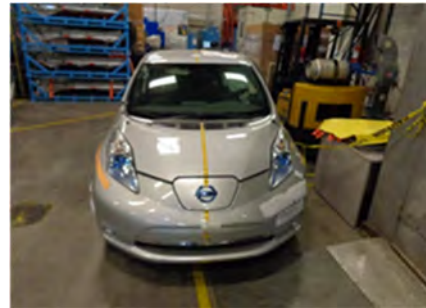
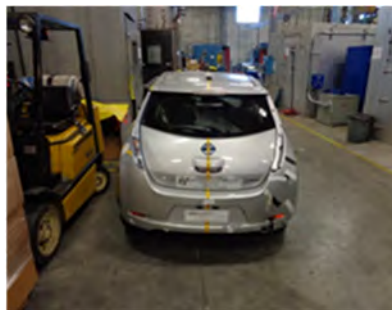
Figure 120 - Nissan Leaf-3 EV initial vehicle condition: a) left view, b) front $\frac{3}{4}$ view, c) right view, d) front view, and e) rear view.

The Nissan Leaf (Leaf-3) was a new production EV previously used for side impact testing, see Table 38. Figure 120 shows the as-received vehicle from multiple angles. Figure 121 shows the vehicle in its immersion tank.

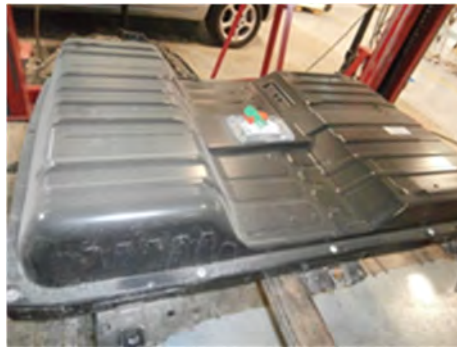
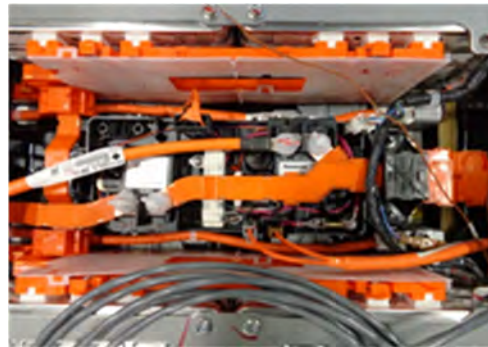
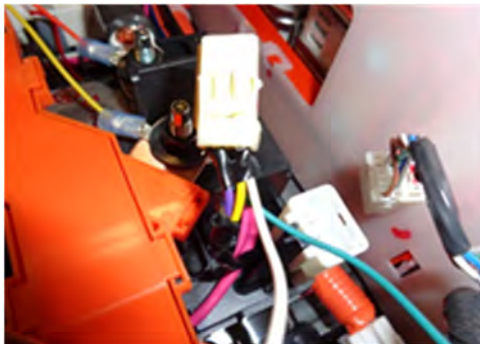
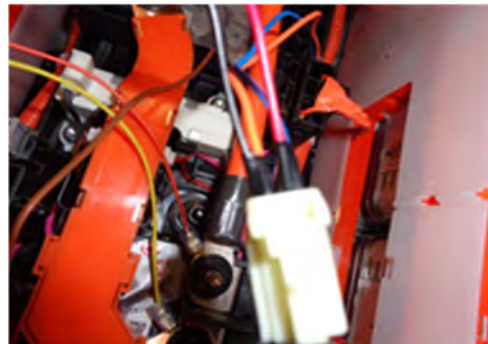
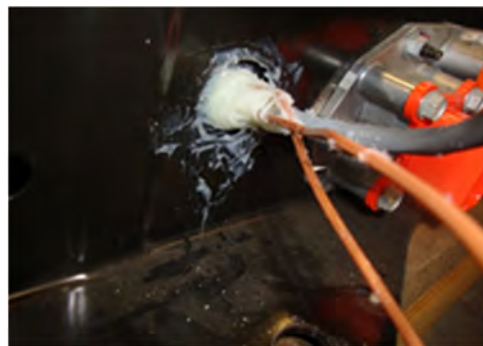
Figure 122 - Nissan Leaf-3 EV HV connections: a) RESS removed from vehicle, b) contactors assembly, c) coil wires, d) second image of coil wires, and d) wires sealed at case wall.

For HV and isolation measurements, the RESS was removed from the vehicle (see Figure 122). The perimeter bolts were removed and the silicone seal was cut to remove the lid. Isolation measurements were taken and HV measurement wires were tightly bolted to the contactor terminals. The coil sense wires were soldered into place. The RESS was then sealed to prevent water intrusion through the sense leads exiting the pack (see Section 8.1.2). Thermocouple wires, HV measurement wires, and coil wires were passed through a bolt hole on the RESS case, then epoxy was applied to hold the wires in place followed by silicone caulk to seal the hole. Silicone caulk was then replaced on the perimeter of the case lid; the case lid was bolted back onto the RESS and re-installed into the vehicle. Voltage sense wires were then attached to the positive and negative terminals of the 12 V battery (LV). All thermocouples, gas sense wires, and voltage sense wires were then wired into the DAQ system and the vehicle was loaded into the immersion container.

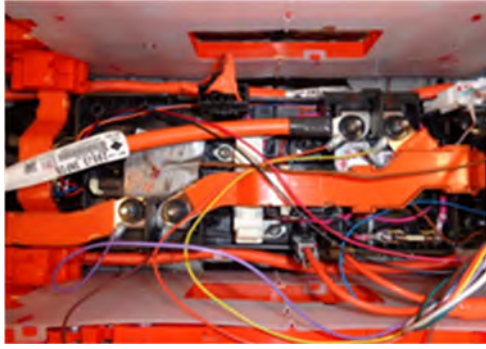
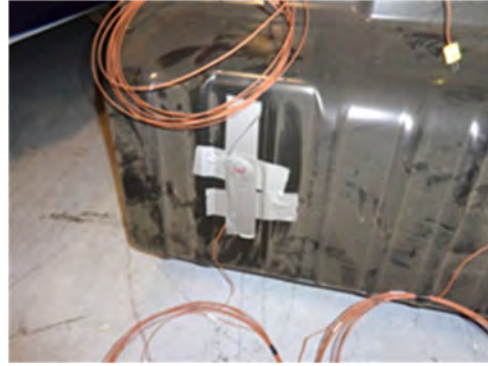
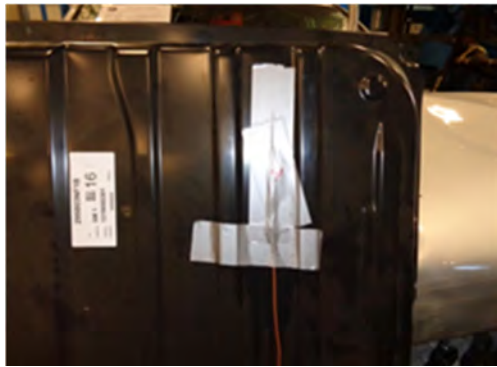
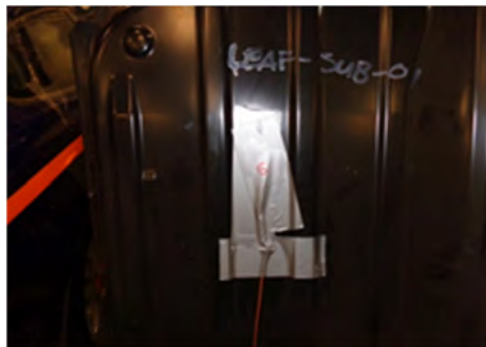
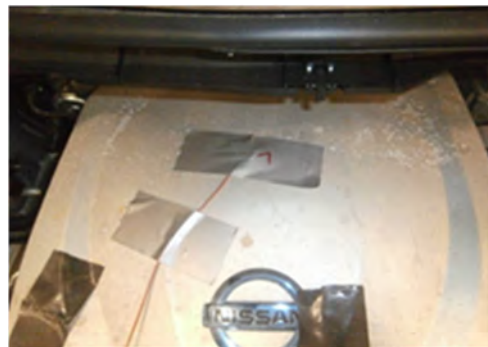
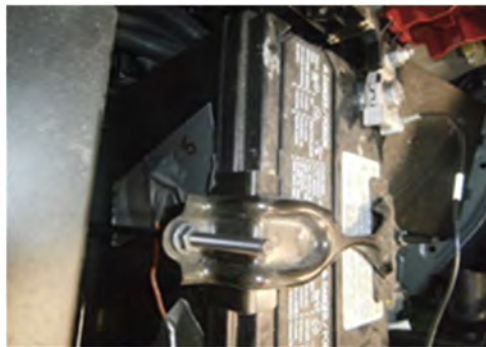
Figure 123 - Nissan Leaf-3 EV HV thermocouple placement: a) TC1 and TC2 on the contactor, b) TC3 on the RESS case, c) TC4 on the RESS case, d) TC5 on the RESS case, e) TC6 on the RESS case, f) TC7 on the control module, and g) TC8 on the 12 V battery.

A total of eight thermocouples were installed as specified in test procedure (see Section 6.5.1.13), including the RESS enclosure, near contactors, the control unit, and the 12 V battery. Thermocouple locations are provided in Table 39 and shown in Figure 123. The thermocouples were held in position using epoxy adhesive.

Number	Location
TC1, TC2	Contactors
TC3, TC4, TC5, TC6	RESS enclosure
TC7	Control module
TC8	12 V battery

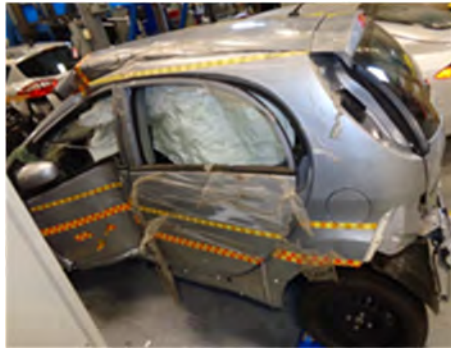
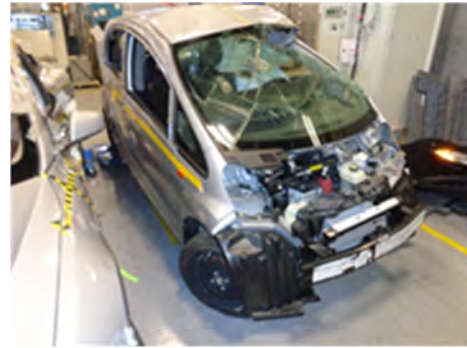
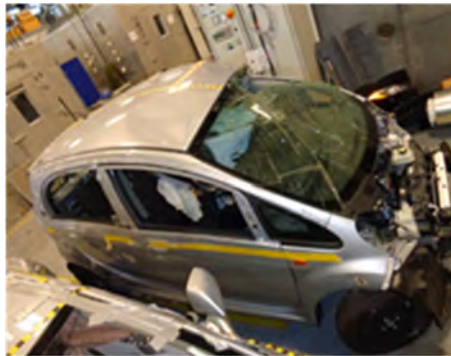
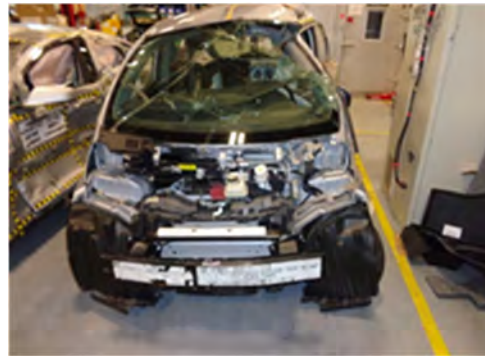
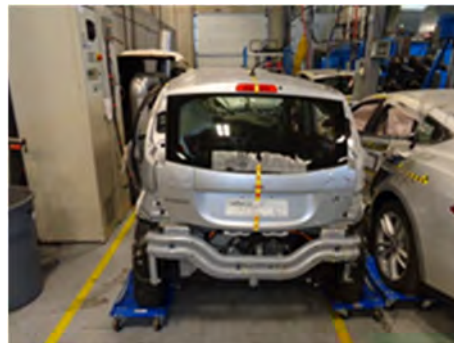
Figure 136 - Mitsubishi iMiev EV initial vehicle condition: a) left view, b) front 3/4 view, c) right view, d) front view, and e) rear view.

The Mitsubishi iMiev was a new production EV previously used for side impact testing, see Table 44. Figure 136 shows the as-received vehicle from multiple angles. Figure 137 shows the vehicle in its immersion tank.

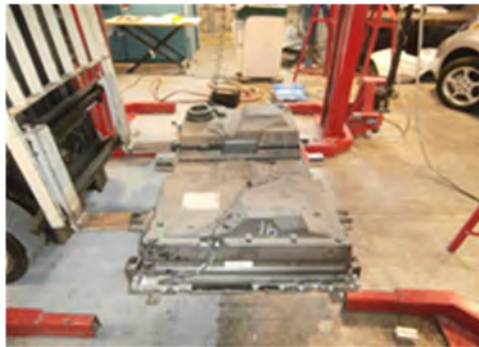
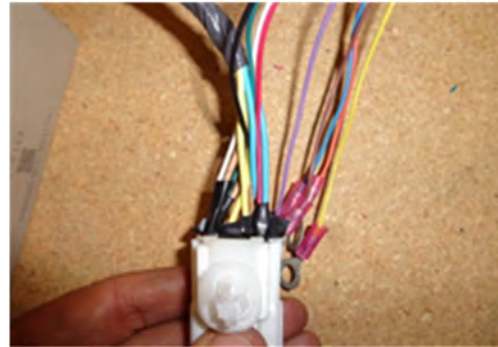
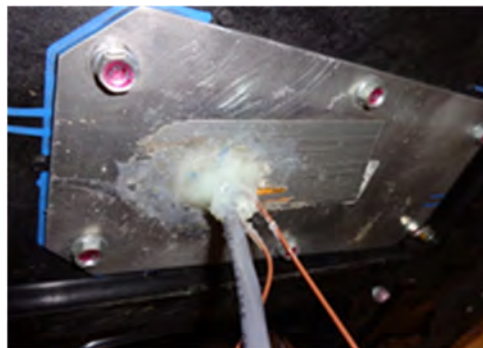
Figure 138 - Mitsubishi iMiev EV HV connections: a) RESS removed from vehicle, b) contactor assembly, c) measurement wires, d) coil wires, and e) wires sealed at case wall.

For HV and isolation measurements, the RESS was removed from the vehicle (see Figure 138). The perimeter bolts and lid were then removed. Isolation measurements were taken and HV measurement wires were tightly bolted to the contactor terminals. The coil sense wires were soldered into place. The RESS was sealed to prevent water intrusion through the sense leads exiting the pack (see Section 8.1.2). Thermocouple wires, HV measurement wires, and coil wires were passed through a hole on the RESS case and epoxy was then applied to hold the wires in place followed by silicone caulk to seal the hole. The case lid was bolted back on and the RESS was re-installed into the vehicle. Voltage sense wires were then attached to the positive and negative terminals of the 12 V battery (LV). All thermocouples, gas sense wires, and voltage sense wires were wired into the DAQ system and the vehicle was loaded into the immersion container.

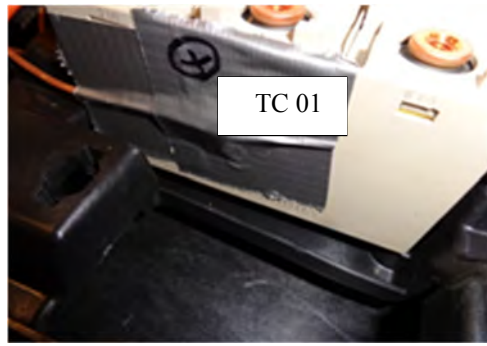
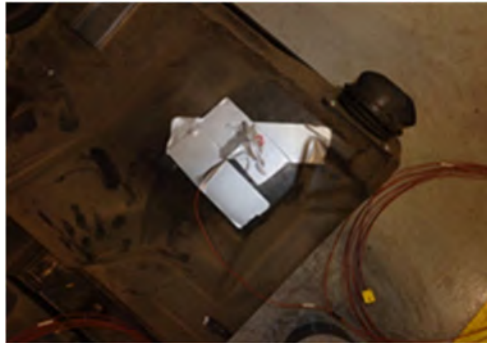
Number	Location
TC1, TC2	Contactor
TC3, TC4, TC5, TC6	RESS enclosure
TC7	Control module
TC8	12 V battery

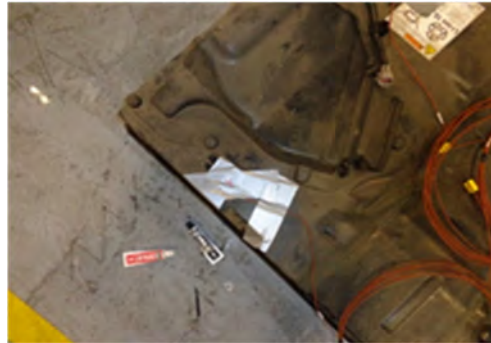
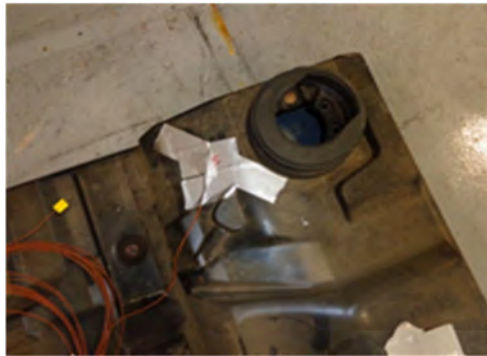
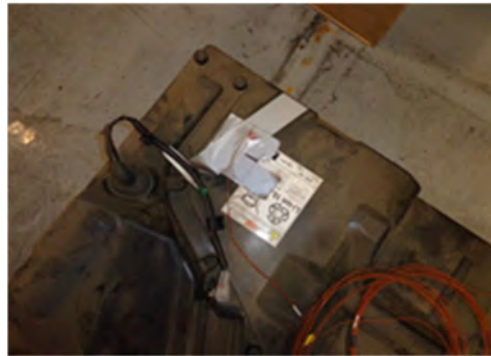
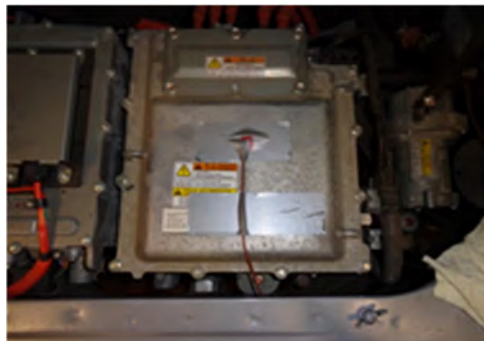
Figure 139 - Mitsubishi iMiev EV HV thermocouple placement: a) TC1 on the contactor, b) TC2 on the contactor, c) TC3 on the RESS case, d) TC4 on the RESS case, e) TC5 on the RESS case f) TC6 on the RESS case, and g) TC7 on the control module.

A total of eight thermocouples were installed as specified in test procedure (see Section 6.5.1.13), including the RESS enclosure, near contactors, the control unit, and the 12 V battery. Thermocouple locations are provided in Table 45 and shown in Figure 139. The thermocouples were held in position using epoxy adhesive.

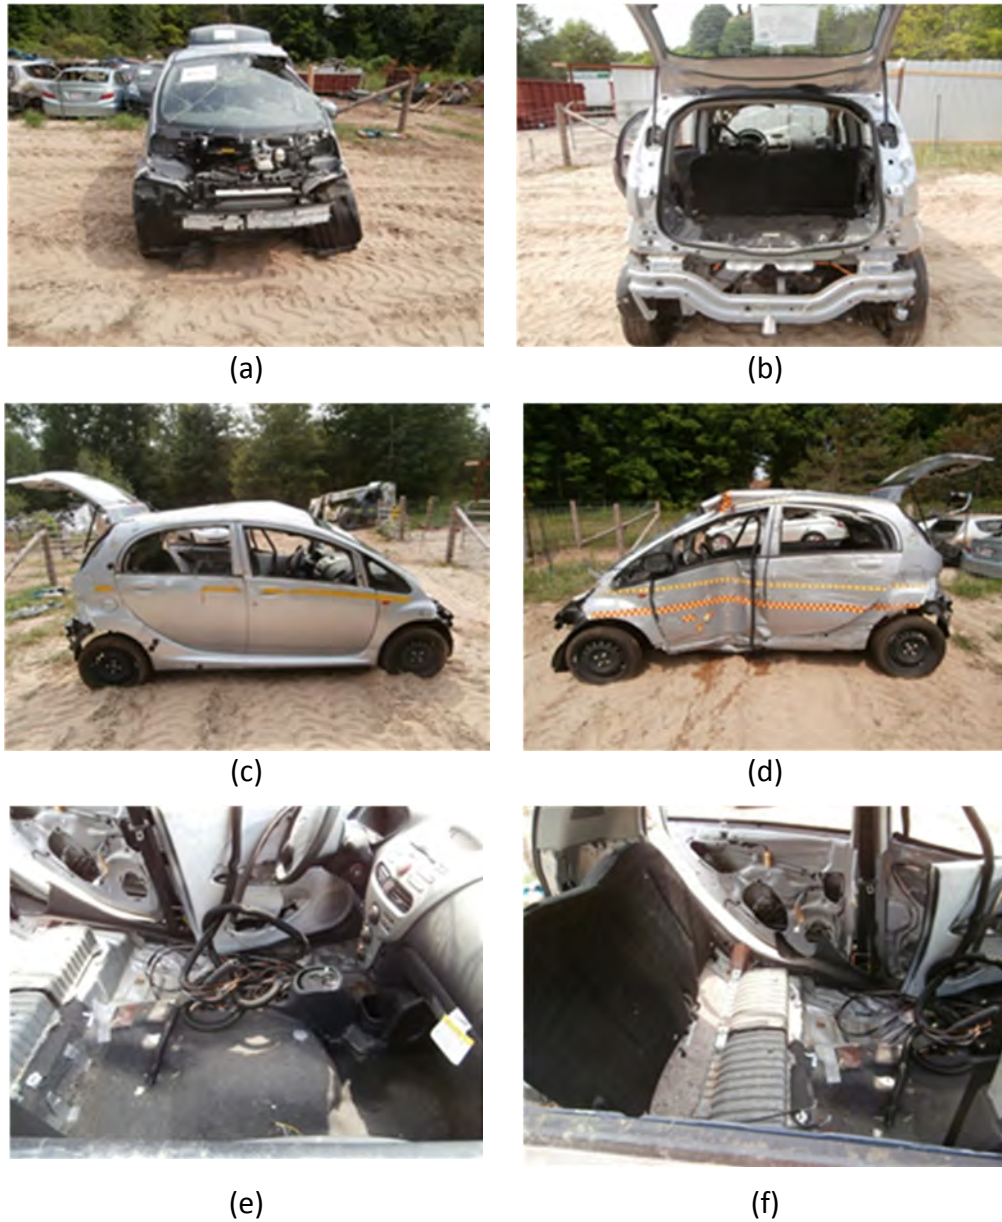
Figure 151 - Mitsubishi iMiev EV post-test vehicle condition: a) front view, b) rear view, c) passenger side view, d) driver's side, e) interior cabin (front), and f) interior cabin (rear).
