**National Highway
Traffic Safety
Administration**

DOT HS 812 717

Safety Performance of Rechargeable Energy Storage Systems

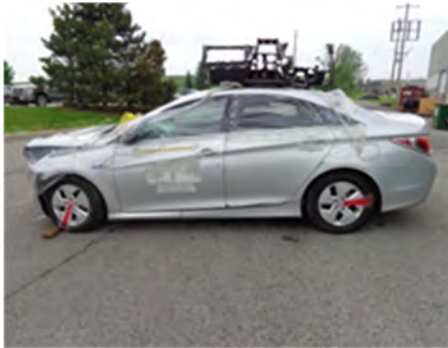
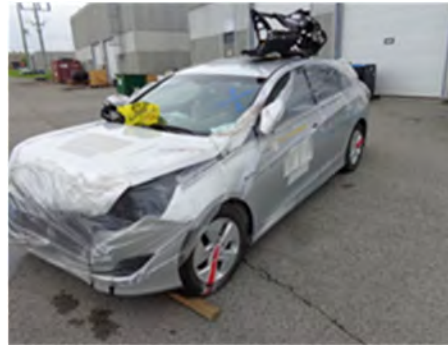
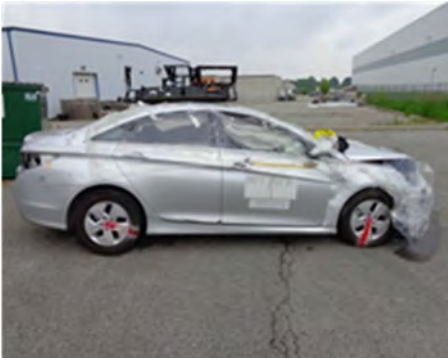
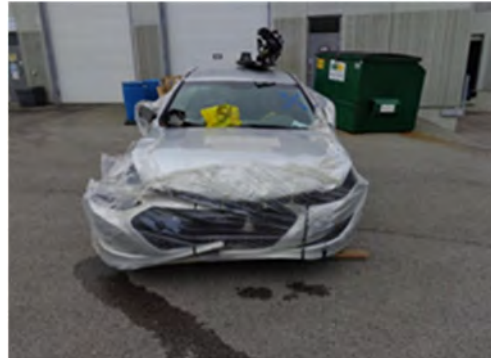
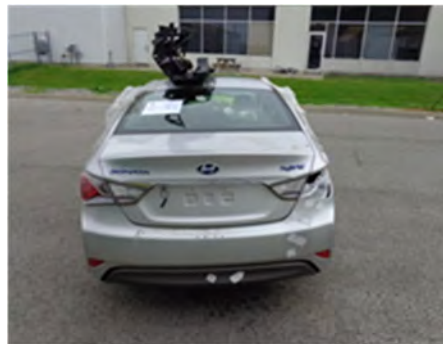
Figure 152 - Hyundai Sonata HEV initial vehicle condition: a) left view, b) front $\frac{3}{4}$ view, c) right view, d) front view, and e) rear view.

The Hyundai Sonata was a new production HEV previously used for front impact testing, see Table 50. Figure 152 shows the as-received vehicle from multiple angles. Figure 153 shows the vehicle in its immersion tank as well as the video camera setup.

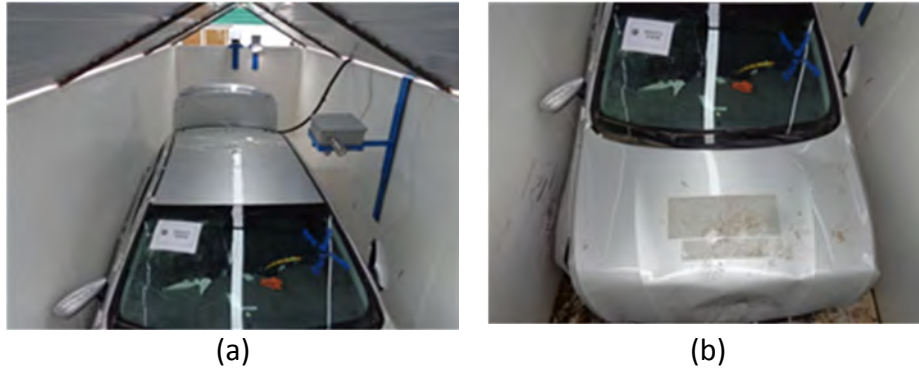
Figure 153 - Hyundai Sonata HEV setup: a) video camera, and b) the vehicle in its immersion container.

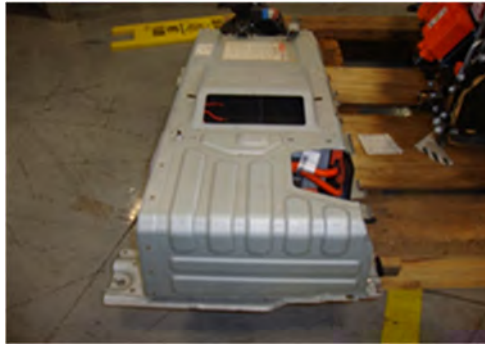
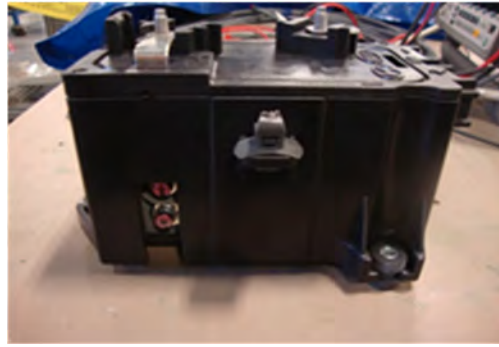
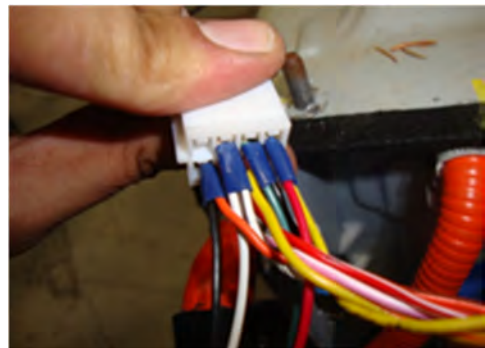
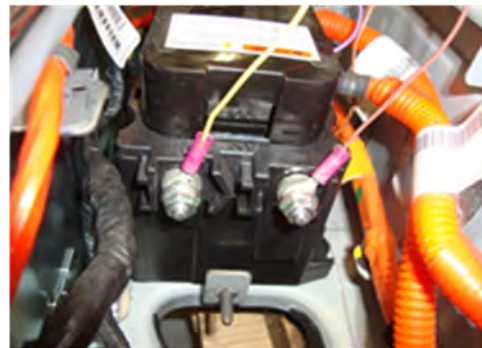
Figure 154 - Hyundai Sonata HEV HV connections: a) RESS removed from vehicle, b) contactor assembly, c) coil wires, and d) measurement wires.

For HV and isolation measurements, the RESS was removed from the vehicle (see Figure 154). The cover was removed from the contactors and then the contactors were removed. The contactor assembly was then taken apart. The measurement wires were tightly bolted to the bus bars of the assembly. The coil wires were soldered to the pins of the electrical connectors. The contactor was reassembled and re-installed; the RESS was then placed back into the vehicle. The rear seat was re-installed but there was no trunk interior provided. Voltage sense cables were installed on the 12 V battery.

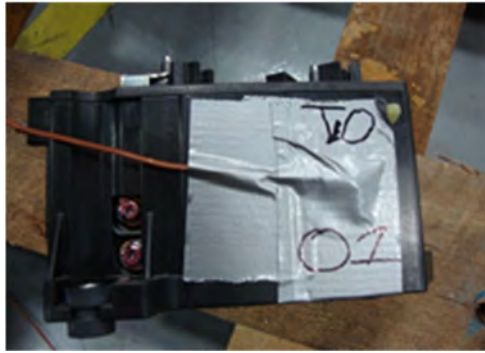
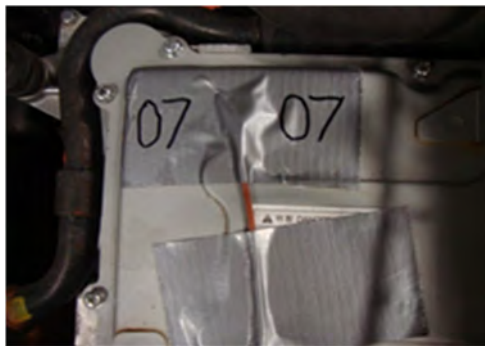
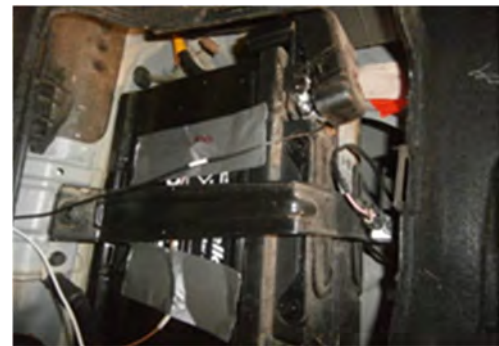
Figure 155 - Hyundai Sonata HEV HV thermocouple placement: a) TC1 on the contactor, b) TC2 on the contactor, c) TC4 on the RESS case, d) TC6 on the RESS case, e) TC7 on the control module, and f) TC8 on the 12 V battery.

A total of eight thermocouples were installed as specified in test procedure (see Section 6.5.1.13), including the RESS enclosure, near contactors, the control unit, and the 12 V battery. Thermocouple locations are provided in Table 51 and shown in Figure 155. The thermocouples were held in position using epoxy adhesive.

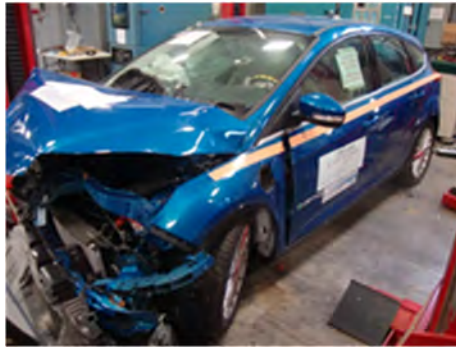
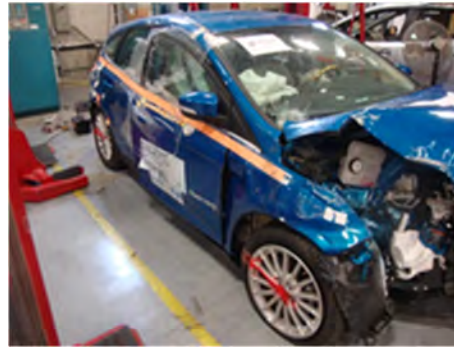
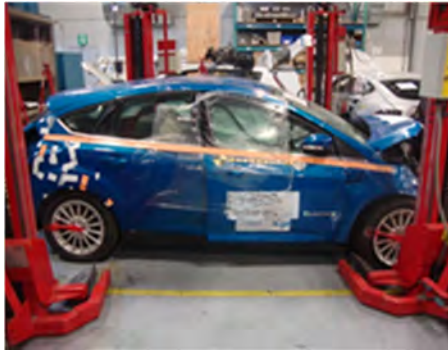
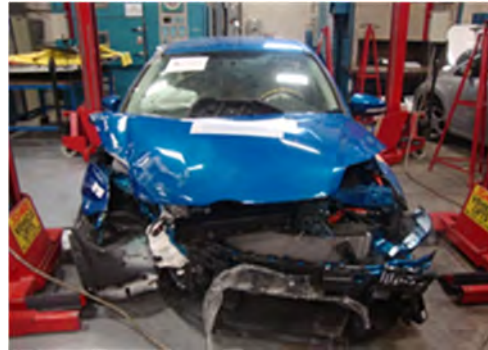
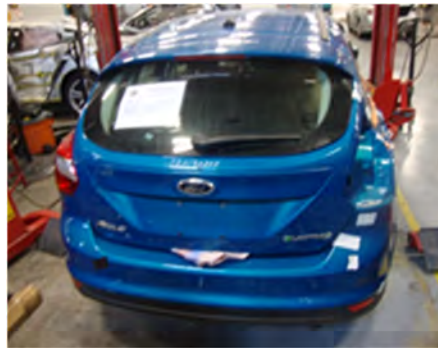
Figure 169 - Ford Focus LP EV initial vehicle condition: a) left view, b) front $\frac{3}{4}$ view, c) right view, d) front view, and e) rear view.

The Ford Focus was a new production EV previously used for front impact testing, see Table 56. Figure 169 shows the as-received vehicle from multiple angles. Figure 170 shows the vehicle in its immersion tank as well as the video camera setup. Note that the Ford Focus has two battery packs, so the testing was repeated twice. This report focuses on the lower pack (LP) RESS. The vehicle was immersed in brackish water made with sea salt crystals and fresh water formulated to be 17.5 g/kg for a duration of 1 hour.

The Ford Focus was a new production EV previously used for front impact testing, see Table 62. Figure 169 (above) shows the as-received vehicle from multiple angles. Figure 170 (above) shows the vehicle in its immersion tank as well as the video camera setup. Note that the Ford Focus has two battery packs, so the testing was repeated twice. This report focuses on the upper pack (UP) RESS. The vehicle was immersed in brackish water made with sea salt crystals and fresh water formulated to be 17.5 g/kg for a duration of 1 hour.

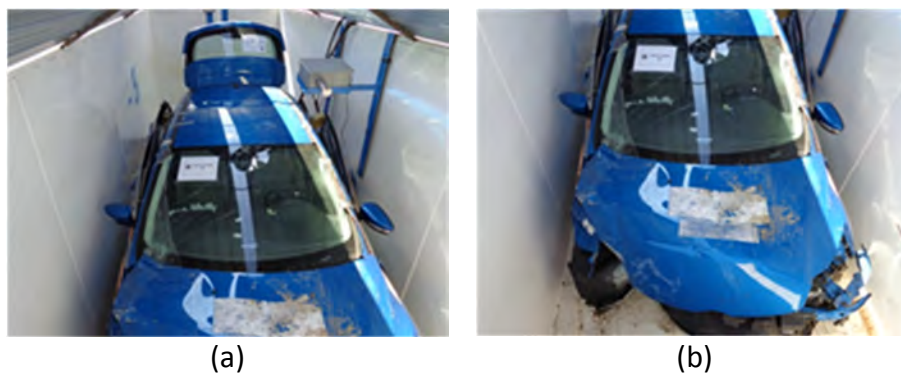
Figure 170 - Ford Focus LP EV setup: a) video camera, and b) the vehicle in its immersion container.

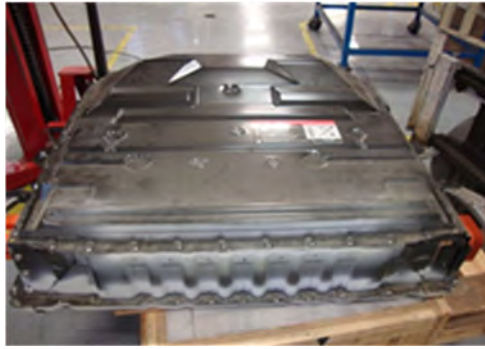
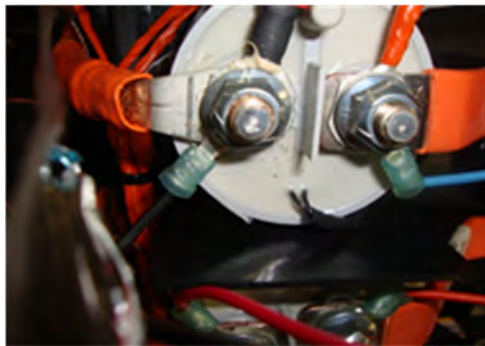
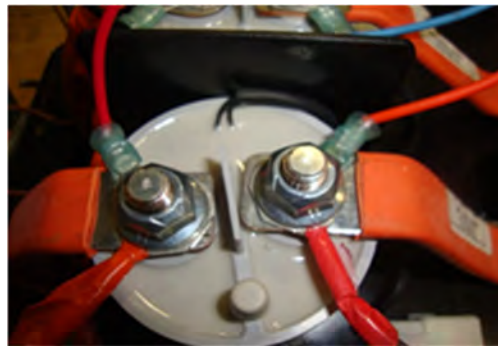
Figure 171 - Ford Focus LP EV HV connections: a) RESS removed from vehicle, b) contactor assembly, c) leads connected a bus bar, and d) leads connected a bus bar.

For HV and isolation measurements, the RESS was removed from the vehicle and the contactor assembly was taken apart (see Figure 171). The measurement wires were then tightly bolted to the bus bars. The RESS was sealed to prevent water intrusion through the sense leads exiting the pack (see Section 8.1.2). There was an additional hole that had been drilled by a previous test lab that was also sealed. The contactor was reassembled and re-installed in the RESS. Butyl tape was replaced where necessary to ensure sealing of the RESS enclosure. The RESS was placed back into the vehicle and the cooling system was re-filled. Voltage sense cables were installed on the 12 V battery.

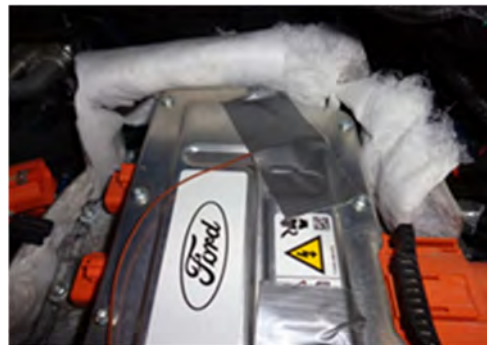
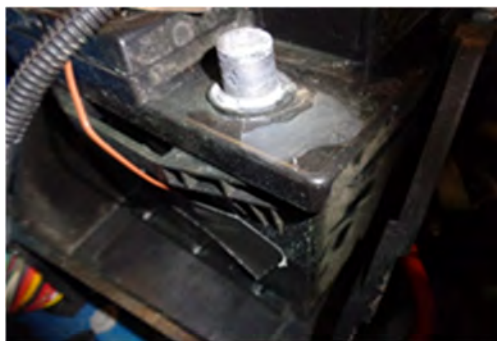
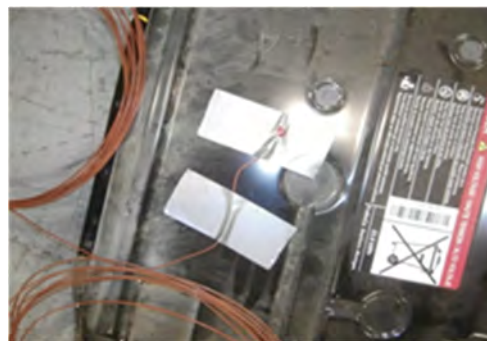
Figure 172 - Ford Focus LP EV HV thermocouple placement: a) TC1 on the RESS case, b) TC2 on the control unit, c) TC3 on the 12 V battery, and d) TC6 on the RESS case.

A total of eight thermocouples were installed as specified in test procedure (see Section 6.5.1.13), including the RESS enclosure, near contactors, the control unit, and the 12 V battery. Thermocouple locations are provided in Table 57 and shown in Figure 172. The thermocouples were held in position using epoxy adhesive.

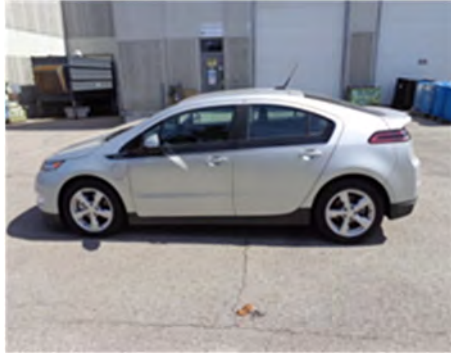
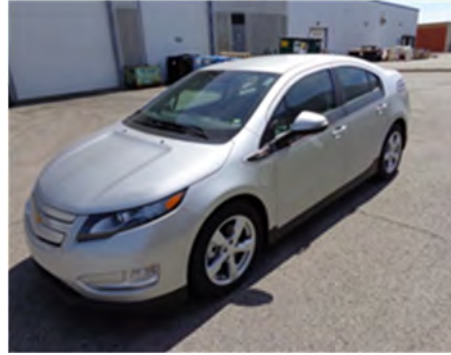
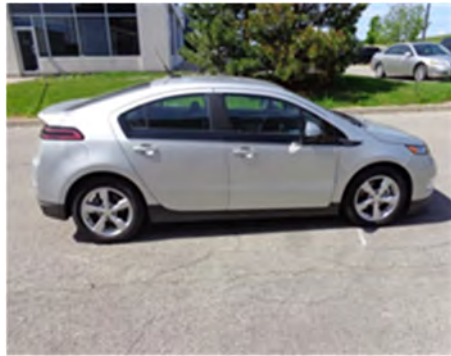
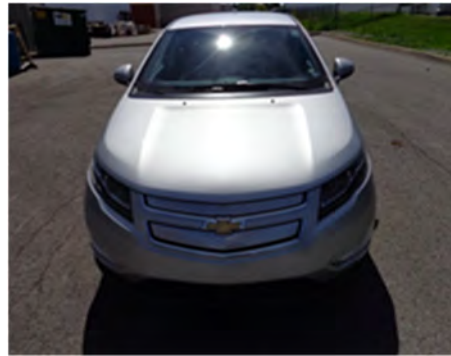
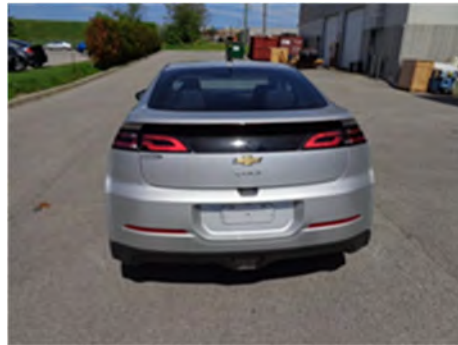
Figure 198 - GM Volt-2 PHEV initial vehicle condition: a) left view, b) front 3/4 view, c) right view, d) front view, and e) rear view.

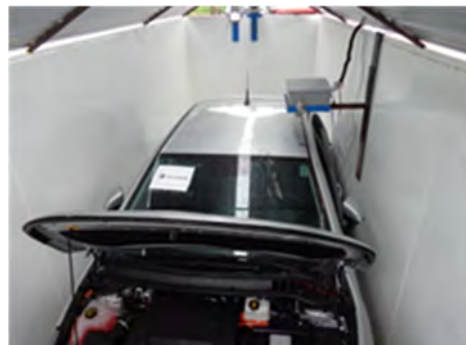
Figure 199 - GM Volt-2 PHEV in its immersion container.

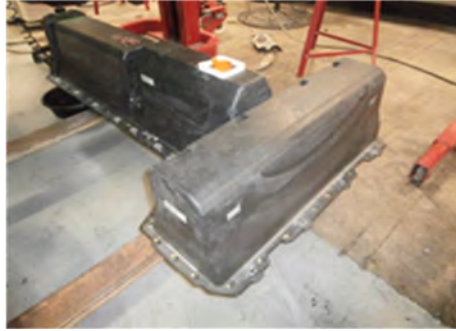
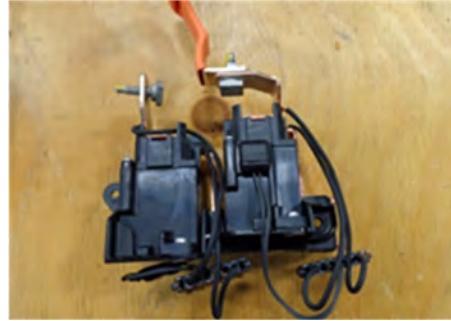
Figure 200 - GM Volt-2 PHEV HV connections: a) RESS removed from vehicle, b) contactor assembly, c) measurement wires attached to bus bar, and d) coil wires.

For HV and isolation measurements, the RESS was removed from the vehicle and the contactor assembly was taken apart (see Figure 200). The HV measurement wires were tightly bolted to the bus bars of the assembly. The coil wires were soldered to the pins of the electrical connectors. The RESS was sealed to prevent water intrusion through the sense leads exiting the pack (see Section 8.1.2). The contactors were reassembled and re-installed in the pack. The RESS was then charged to approximately 70% SOC to mimic the state of charge in the previous test. From an empty tank, 5 L of fuel was added (see Section 6.4). Voltage sense cables were installed onto the 12 V battery.

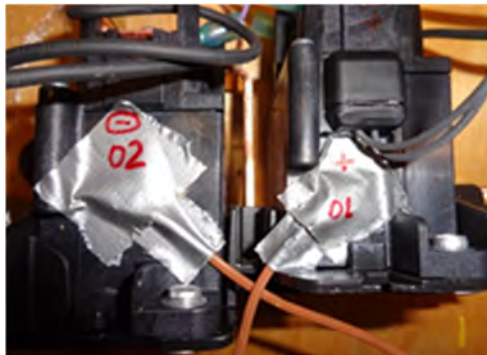
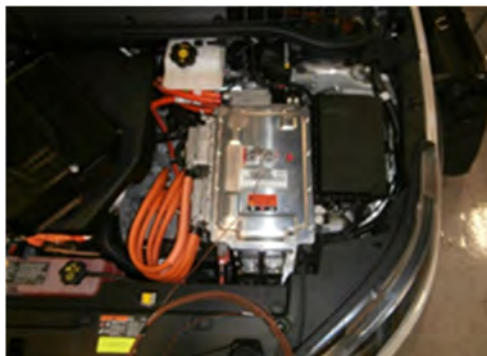
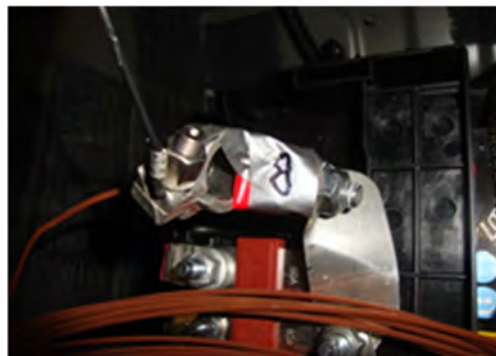
Figure 201 - GM Volt-2 PHEV HV thermocouple placement: a) TC1 and TC2 on the contactors, b) TC6 on the RESS case, c) TC7 on the control module, and d) TC8 on the 12 V battery.

A total of eight thermocouples were installed as specified in test procedure (see Section 6.5.1.13), including the RESS enclosure, near contactors, the control unit, and the 12 V battery. Thermocouple locations are provided in Table 69 and shown in Figure 201. The thermocouples were held in position using epoxy adhesive.

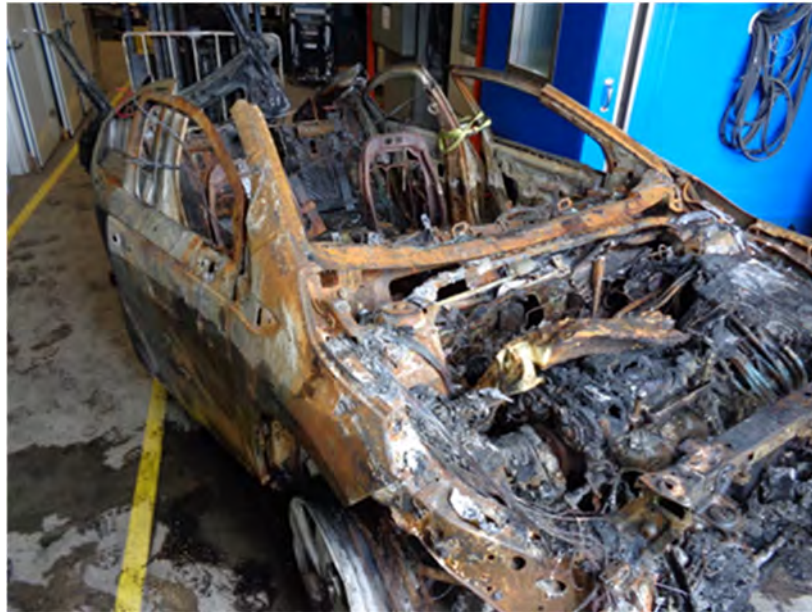
Figure 214 -GM Volt PHEV post fire and salt water discharge.

Immersion tests were run at opposite ends of the seasons (i.e., late winter and midsummer conditions). During winter testing, a GM Volt PHEV (Volt-1, see Section 8.2.4) became fully engaged in a vehicle fire about 5 hours after the 2-hour immersion period ended. The fire resulted in total destruction of the vehicle and nearby equipment (video camera, gas sensors), see Figure 214. While summer testing also tested a GM Volt (Volt-2, see Section 8.3.6), it did not undergo thermal runaway despite using the same immersion procedure.

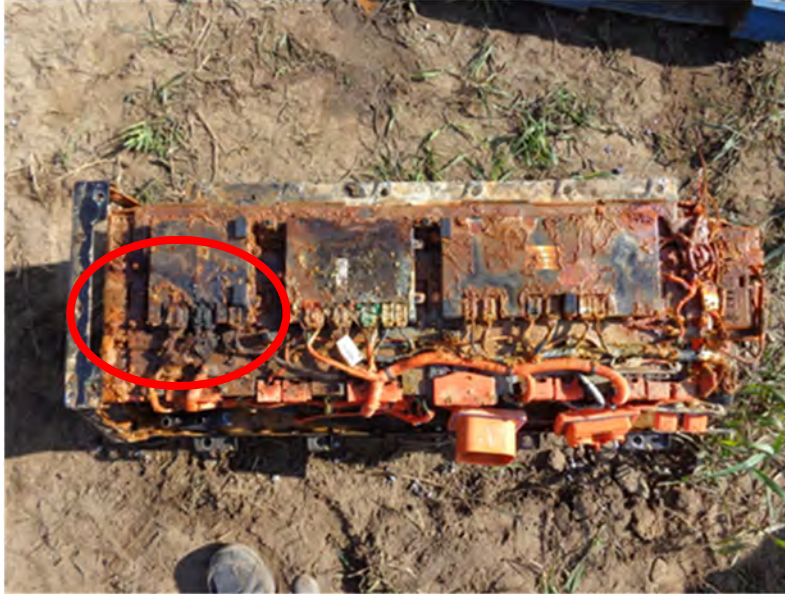
Figure 215 - Ford Focus UP EV post test electronic module connector heat damage.

During summer testing, a thermal excursion in the Ford Focus resulted in limited localized heat damage to an electronic module in the upper pack (see Section 8.3.5). The measured temperature of the RESS enclosure reached 99°C. However, the melted insulation on the affected connector indicated that the local temperature could have been higher. No cell damage was observed, see Figure 215 (this is the same as Figure 197(a)).
