# Thermal Integrity Profiling for Detecting Flaws in Drilled Shafts

Andrew Boeckmann, P.E. and J. Erik Loehr, Ph.D., P.E.

University of Missouri

WisDOT ID no. 0092-16-07

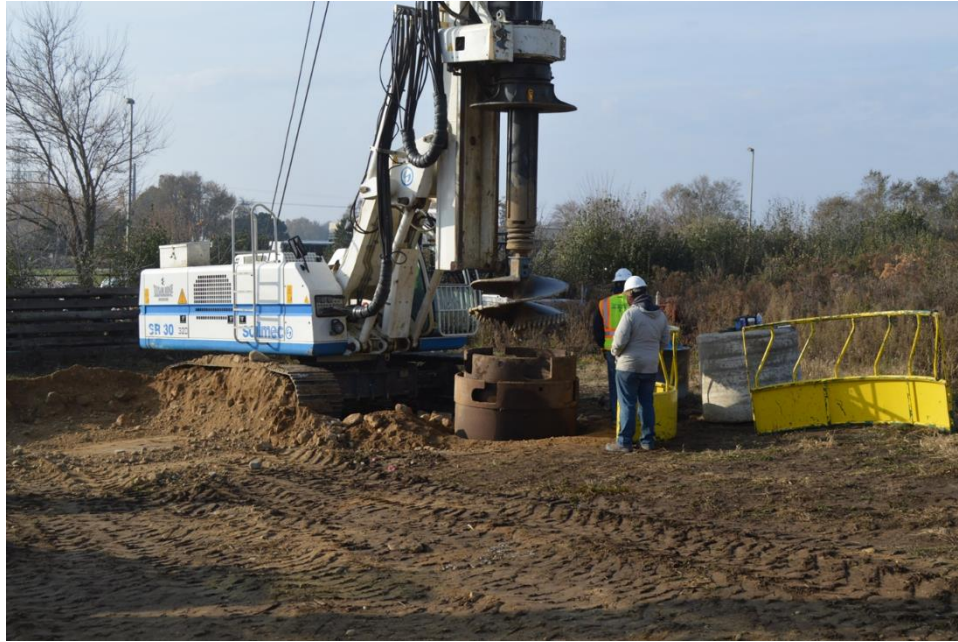
Photographs of the drilling process are shown in Figure 19 and Figure 20. The shafts were excavated with a 48 in. auger. Groundwater was not encountered for any of the shafts, but the sandy material was prone to raveling. Temporary casing was used to reduce raveling and improve hole stability, but the casings were not placed until after the material had been excavated (rather than driving the casing ahead of drilling), so the excavated shaft diameter is likely somewhat greater than the diameter of the casings. Below a depth of approximately 10 ft, cobbles were occasionally encountered in each of the shafts. The cobbles complicated drilling and casing placement, slowed progress, and likely increased the degree of overexcavation. The temporary casing was telescoped to reduce side friction and facilitate removal of the casing as concrete was placed. The diameter of the outer (upper) casing was 58 in., and the diameter of the inner casing was 52 in. The casings were placed in the holes after excavating to the depths shown in the as-built drawings.

**Figure 20: Excavation of shaft with 48 in. auger through telescoping casing.**

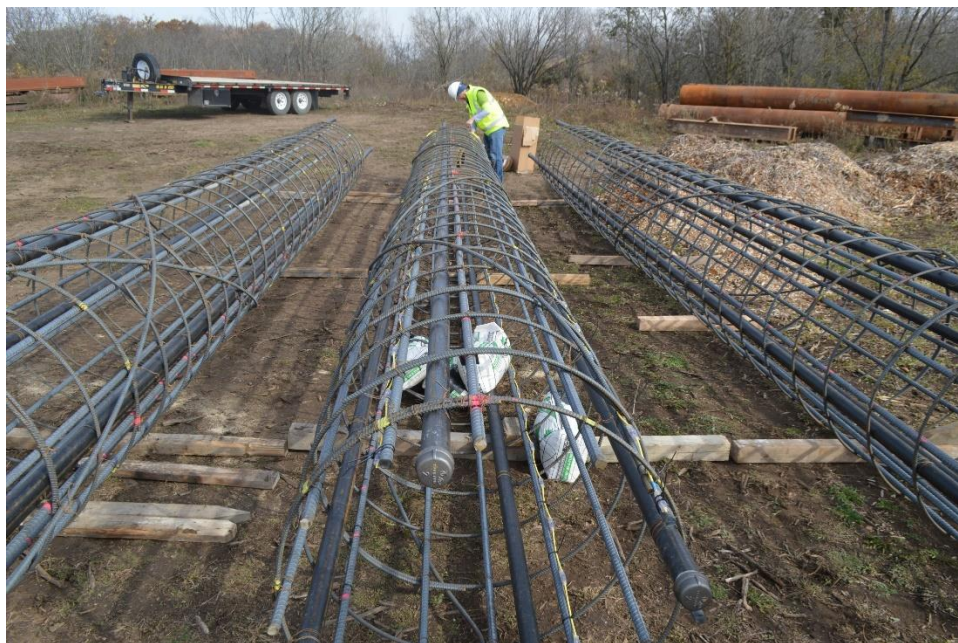
Reinforcing cages for the drilled shafts are shown in Figure 21. Longitudinal reinforcement consisted of twelve No. 8 reinforcing bars; transverse steel consisted of No. 4 stirrups on 12 in. centers. The reinforcing cages also included four 2 in. diameter Sch. 40 steel pipes for CSL testing and TIP testing by the probe method. The integrity testing pipes were installed on the inside of the cages, spaced evenly at 90 deg. As shown in Figure 21, additional steel was included around the outside of the reinforcing cages to improve cage stability. Reinforcing cages were lowered into the shafts with wheel spacers to keep the cages centered within the hole and with chairs to support the cages on the bottom of the hole.

**Figure 21: Reinforcing cages prior to installation of most defects.**

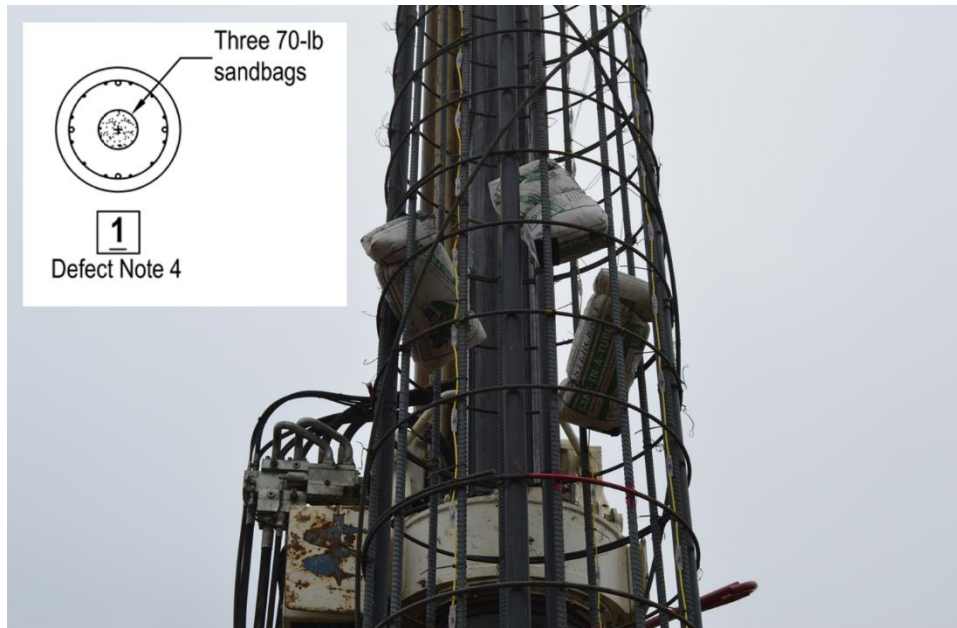
Defects 1 through 5 and 9 were affixed to the reinforcing cages prior to lowering the cages into the excavated shafts. Photographs of the defects affixed to the cages are shown in Figure 22 through Figure 28. The figure captions list details of the defects, which are also described in Table 7 and shown in the as-built drawings of Appendix B. Defects were tied to the reinforcing cages using rebar tie wire. For the inside-cage defects (Defects 1 and 9), sandbags were tied with extra tie wire length between the cage and the sandbags. The extra length was approximately equal to the reinforcing cage radius. The intention for including the extra tie wire length was for the sandbags to float toward the center of the reinforcing cage, thus creating a center-of-shaft defect for evaluation with TIP and CSL. The reinforcing cages were observed carefully as they were lowered into the excavated shafts; no defects were compromised.

**Figure 22: Defect 1 consisted of three 70 lb sandbags tied inside the reinforcing cage for the Control Shaft.**

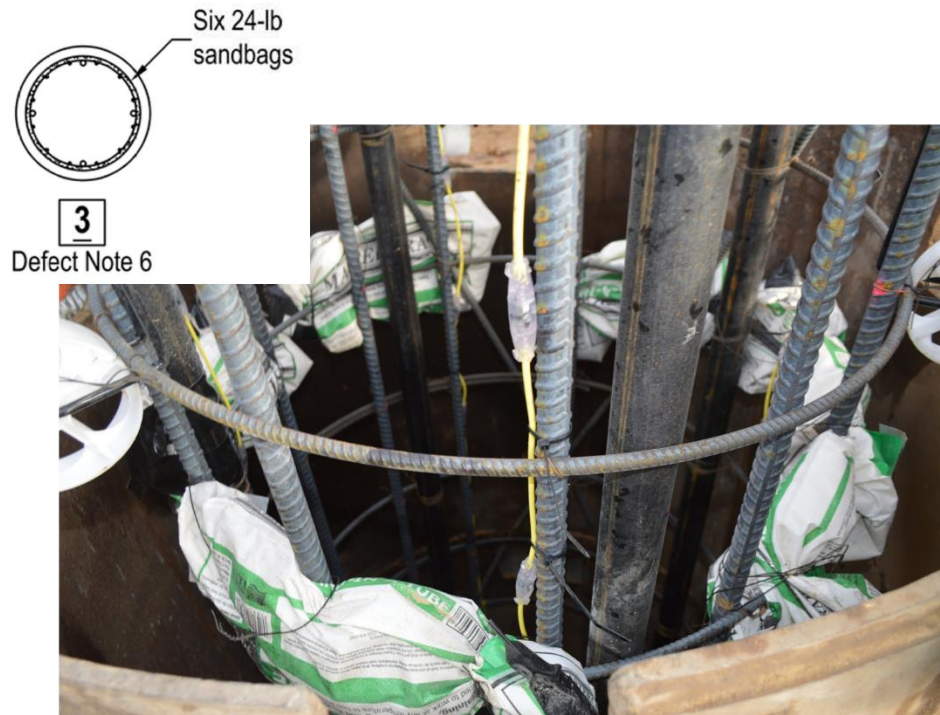
**Figure 24: Defect 3 consisted of six 24 lb sandbags tied concentrically around the edge of the reinforcing cage for Test Shaft 1 at a depth of 21 ft.**

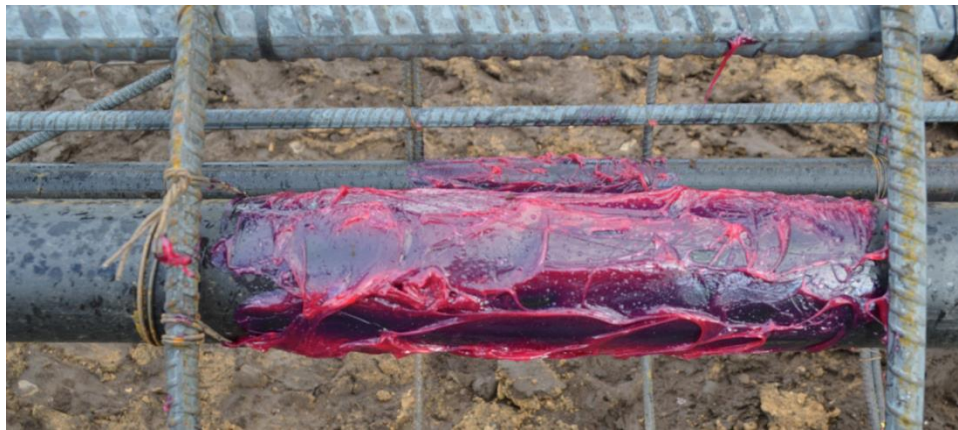
**Figure 25: Defect 4 consisted of wheel bearing grease applied around the outside of the access tubes for a length of 1 ft. Defect 4 was installed in two locations: at a depth of 16.5 ft in Test Shaft 1 and a depth of 4.5 ft in Test Shaft 2.**

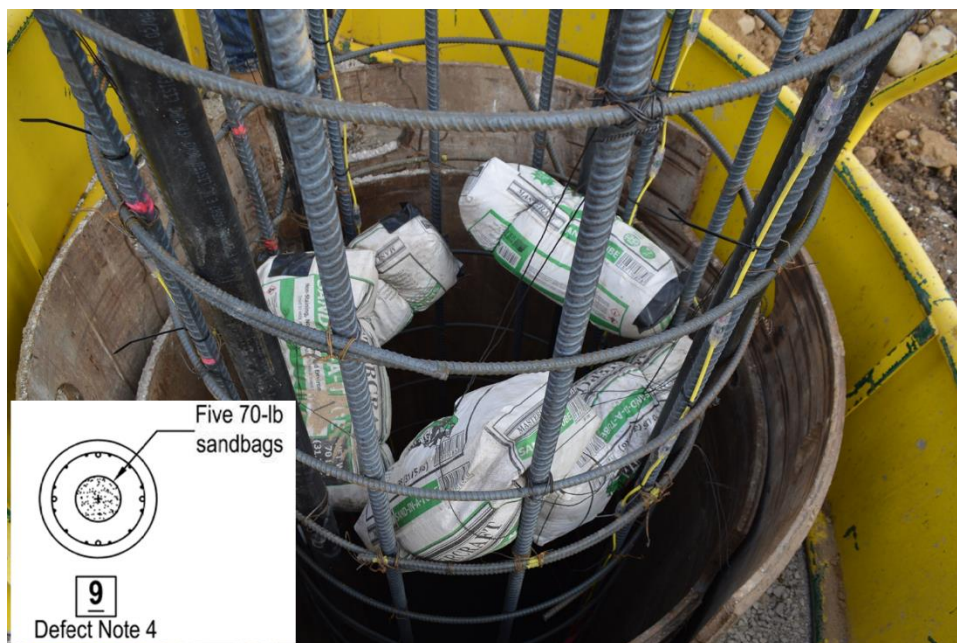
**Figure 27: Defect 9 consisted of five 70 lb sandbags placed inside the reinforcing cage for Test Shaft 2 at a depth of 12 ft. Defects 6, 7, and 8 are presented in the next section.**

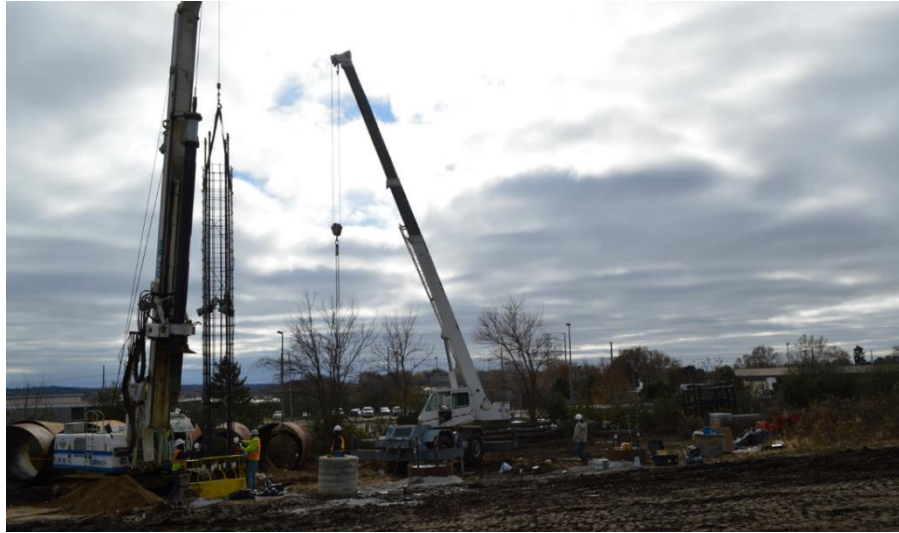
**Figure 28: Reinforcing cage is lowered into the hole for Test Shaft 2. Sandbags for Defect 9 are visible near the cage mid-height.**

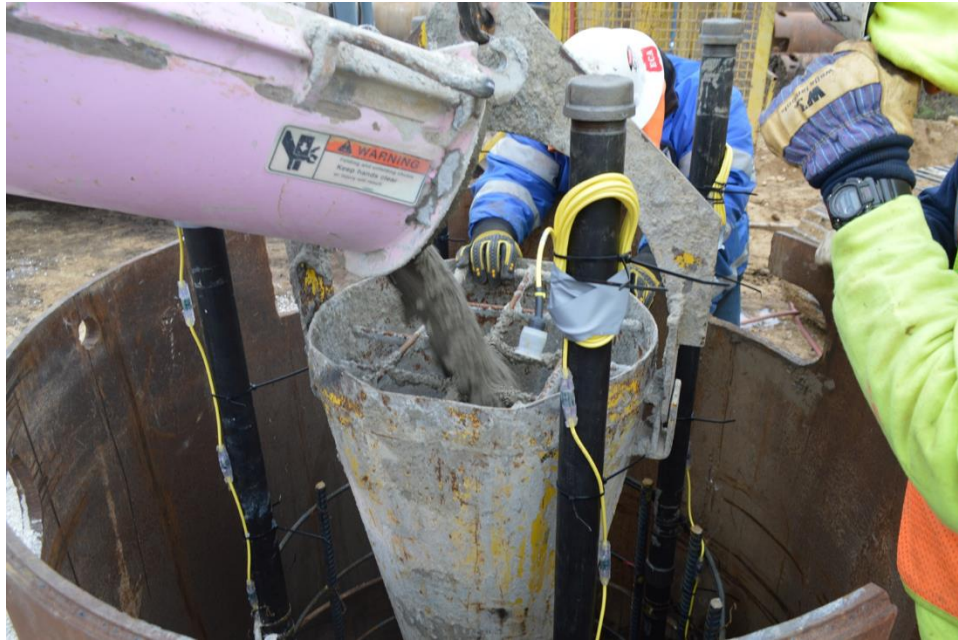
Detailed descriptions of concrete placement are included in the logs of Appendix D. As shown in Figure 29, concrete was placed in the dry holes using a tremie pipe supported by a crane. Concrete slump was tested per ASTM C143 for each truck, and cylinders were also cast for subsequent compressive strength testing per ASTM C39. A photograph of slump testing is shown in Figure 30. Except for concrete from one truck, slump values were all 10 to 11 in., which is above the target range of 7 to 9.5 in. However, the fluid concrete appeared cohesive and stable without signs of segregation or bleed. Quality assurance personnel from the concrete plant visited the test site to observe the delivered concrete during the concrete pour for Test Shaft 2. The following truck delivered concrete with a slump value of 7.5 in. (the lone value less than 10 in. referenced previously). The placement temperature of the fresh concrete ranged from 52 to 68° F.

**Figure 29: Placement of concrete from the concrete truck to the tremie pipe.**

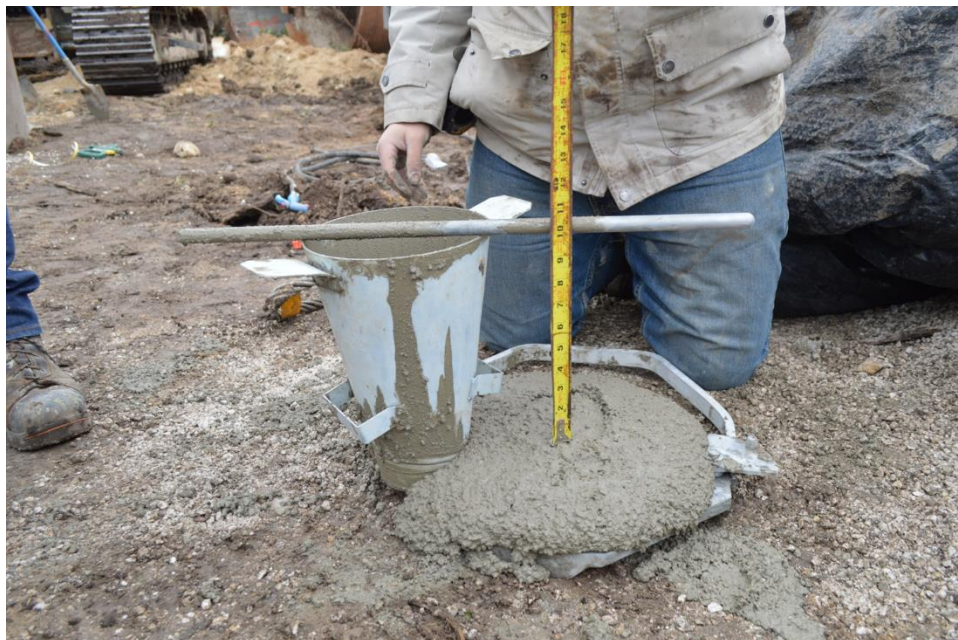
**Figure 30: Concrete slump test.**

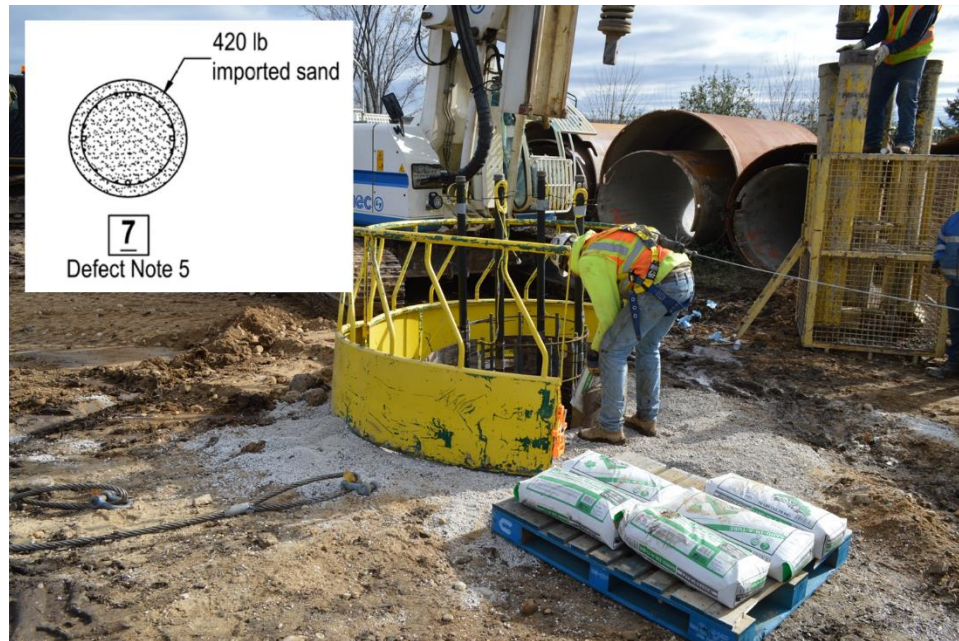
Defects 6, 7, 8, and 10 were installed during concrete placement, whereas the other defects were attached to the reinforcing cages. Photographs of the concrete placement defects are shown in Figure 32 through Figure 35. Defect 7 was intended to mimic soft bottom conditions. Similar to Defect 2, it consisted of 420 lb of sand at the bottom of the shaft, but the sand for Defect 7 was poured from the surface both inside and outside the reinforcing cage (Figure 32) whereas Defect 2 consisted of sandbags tied around the outside of the bottom of the reinforcing cage. Defect 8 was intended to mimic a tremie breach, which caused problems for the Zoo Interchange project. Since the shafts for this project were dry, the effect of a tremie breach was simulated by removing the tremie and then pouring 30 gallons of water and 70 lb of sand in the hole. After placing the water and sand for Defect 8, the remaining concrete was placed with the tremie suspended above the top of concrete surface. Defects 6 and 10 consisted of zones of weak concrete at the top of Test Shaft 1 and Test Shaft 2, respectively. To achieve weak concrete, the concrete placement by tremie was terminated when the top of concrete was 3 ft below the ground surface. The volume of concrete remaining in the truck was estimated from the yield plots (Figure 31), and water was added to the concrete in the truck to achieve a water-cement ratio of 0.6 for Defect 6 and 0.52 for Defect 10. The concrete was mixed in the truck after adding the water prior to placing the concrete by free fall. As shown in Figure 34, the weakened concrete was significantly more fluid than the normal concrete. The weakened concrete also produced significant bleed water, as shown in Figure 35.

**Figure 32:** After placing the reinforcing cage but prior to placing concrete for Test Shaft 2, 420 lbs of sand was poured into the bottom of the excavated shaft to simulate a soft bottom for Defect 7.

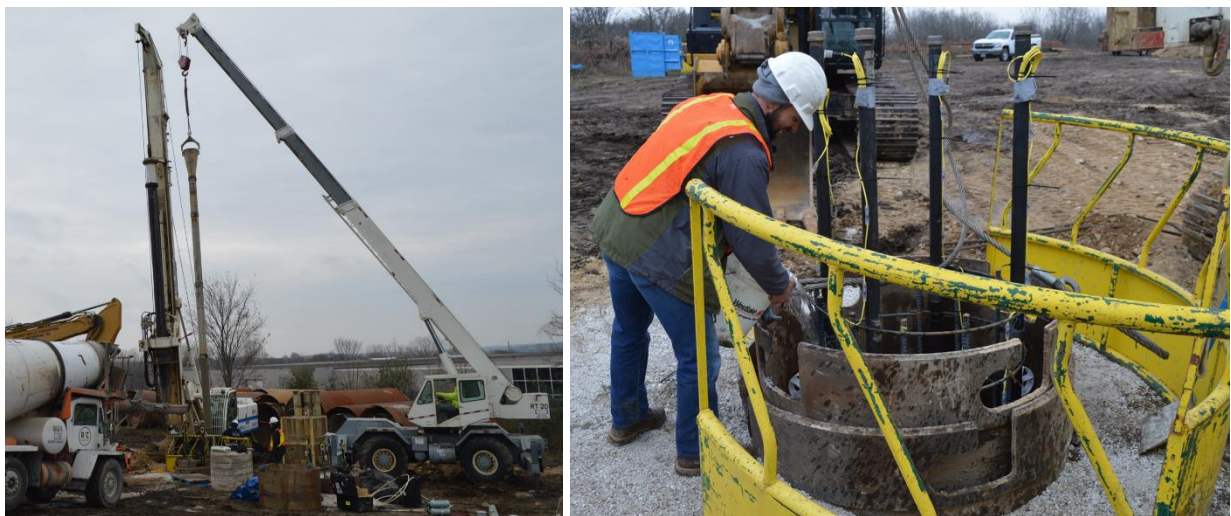
**Figure 33:** To simulate a tremie breach for Defect 8: (a) the tremie was removed from the shaft prior to (b) placing 30 gallons of water and 70 lbs of sand into the shaft (to simulate a tremie breach in a wet shaft).

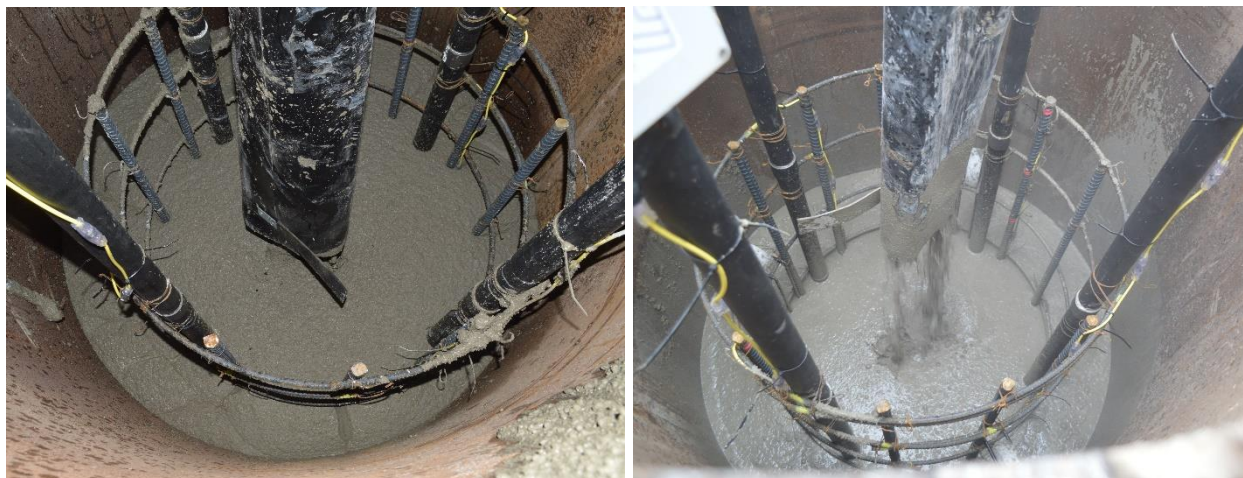
**Figure 34: Concrete placement near the top of shaft: (a) normal concrete in Control Shaft and (b) weak concrete for Defect 6 in Test Shaft 1.**

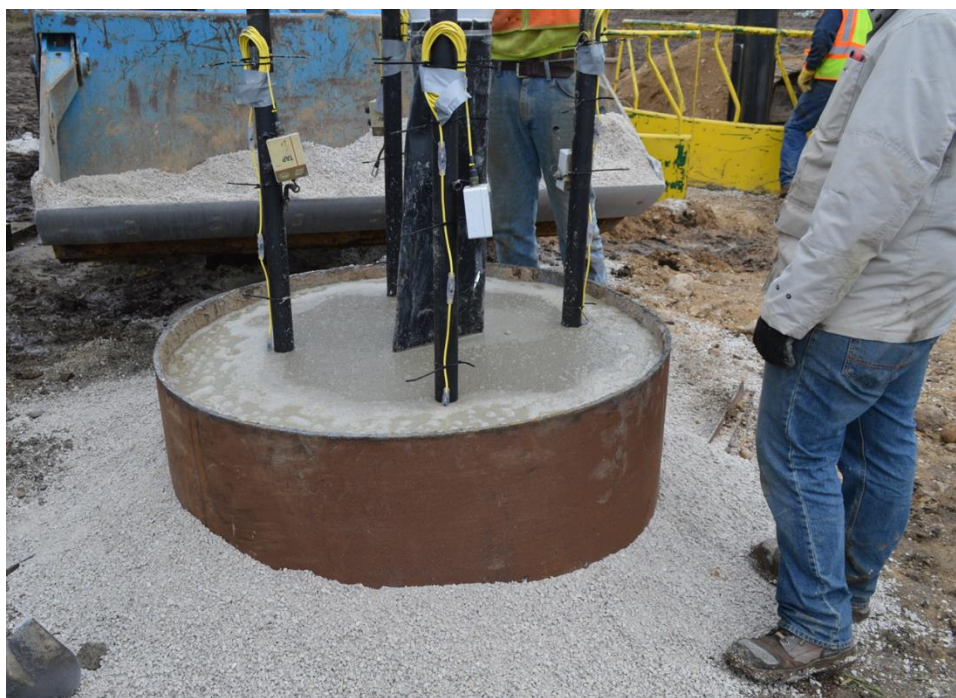
**Figure 35: Completed Test Shaft 1 shortly after completion of concrete placement. Bleed water from the weak concrete of Defect 6 is evident at the top of the shaft.**

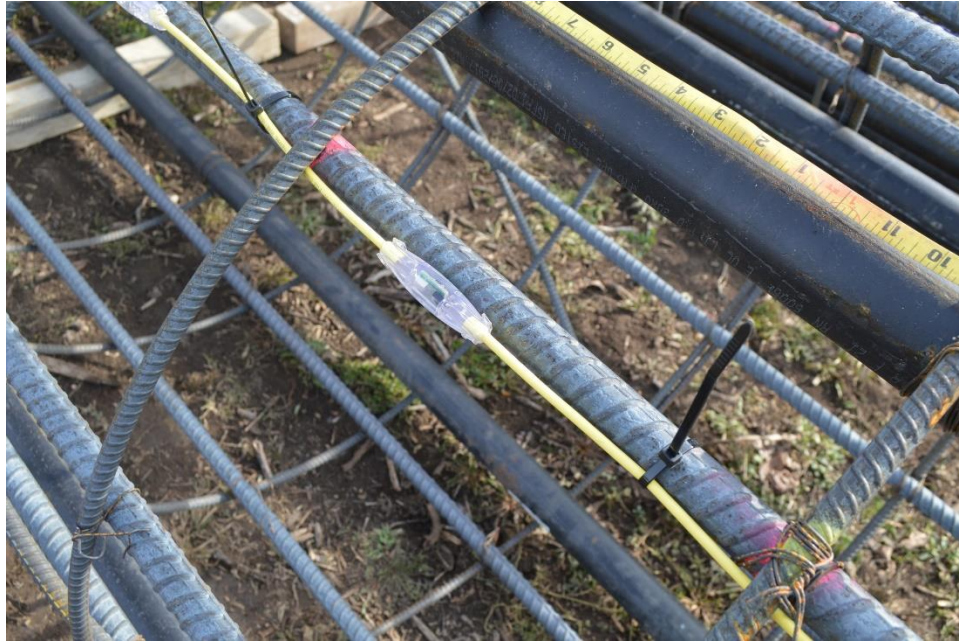
**Figure 36: Close view of a TIP wire with sensor.**

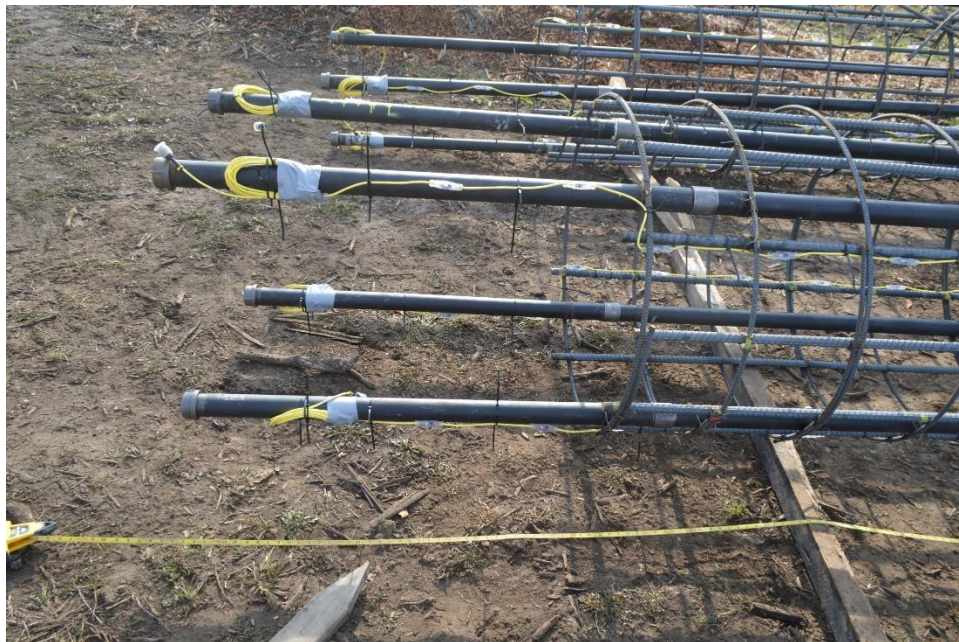
**Figure 37: TIP wires exiting the top of the reinforcing cages. Two sensors were above the top of the shaft to measure ambient temperature.**

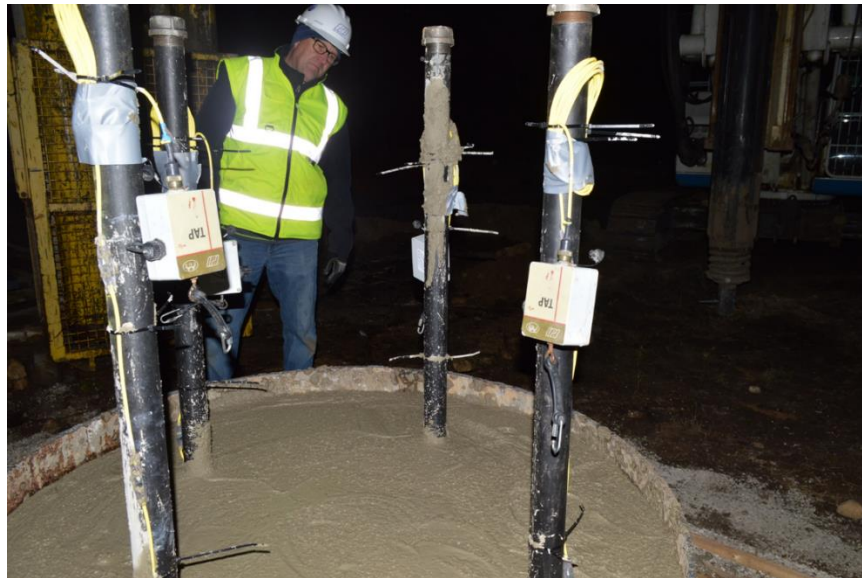
One Thermal Acquisition Port (TAP) was attached to the top of each wire to record data. A photograph of installed TAPs is shown in Figure 38. The TAPs began reading and recording temperature data shortly after they were connected to the TIP wires. By default, the TAPs record data every 15 minutes. The Thermal Integrity Profiler tablet, shown in Figure 39, was used to collect and review temperature data in the field. The TAPs were left in place for approximately three weeks after concrete placement before the final dataset was collected.

Figure 38: One TAP box was connected to each TIP wire to collect and store temperature data.

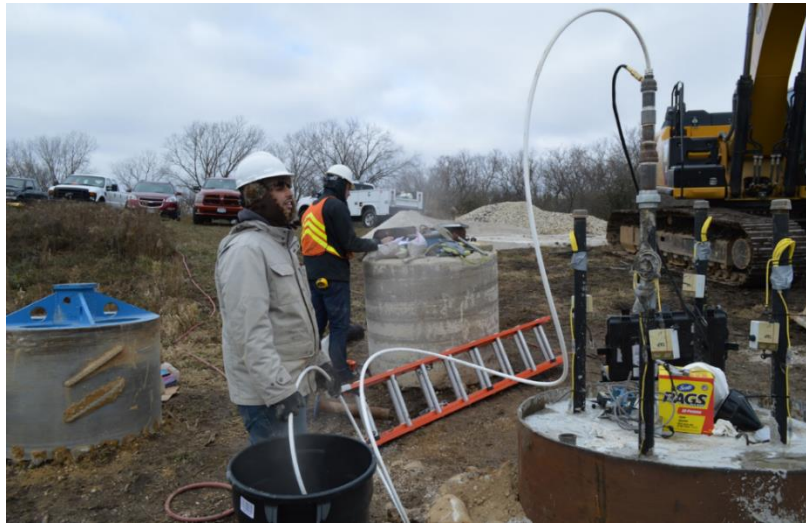
**Figure 40: The access tubes were dewatered prior to performing TIP test via probe method.**

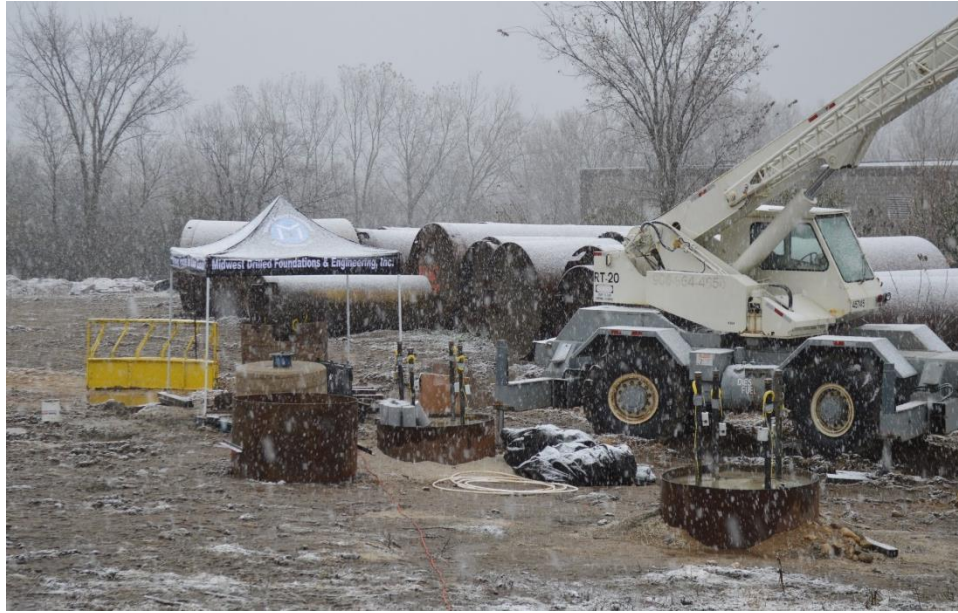
**Figure 42: TIP testing by probe method for Test Shaft 2 was completed with ambient temperatures near 30° F.**

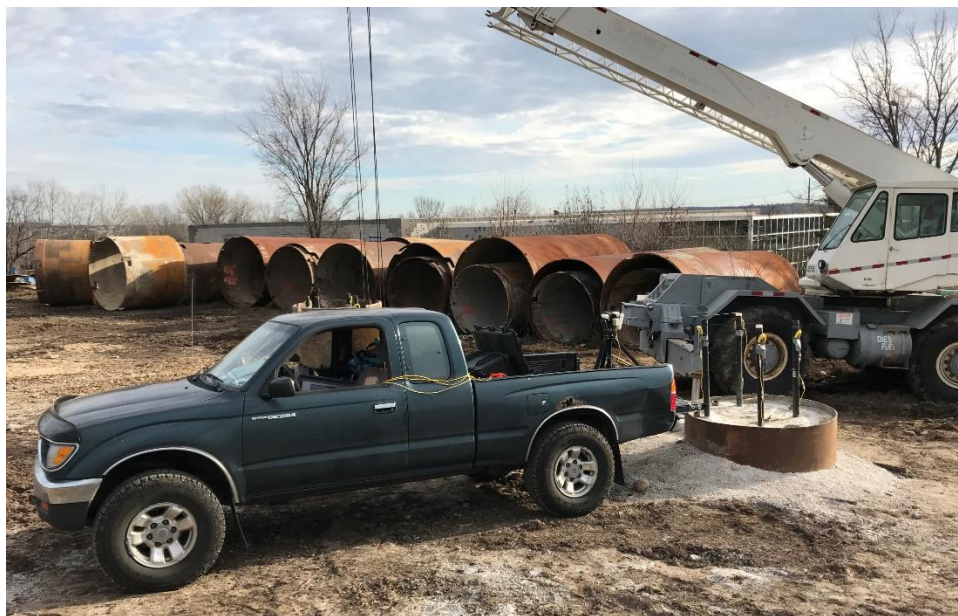
**Figure 43: CSL testing included all pairs of access tubes.**

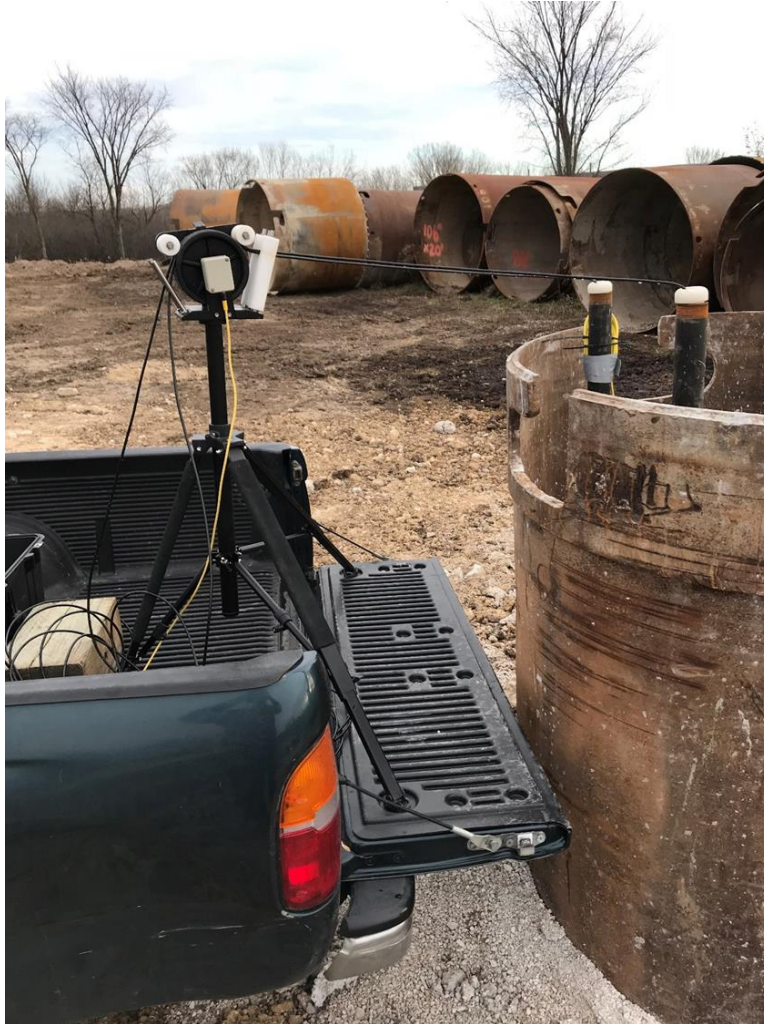
**Figure 44: CSL testing utilized equipment by Olson Instruments, Inc., including a dual depth encoder pulley used to lower the source and receiver probes down two access tubes simultaneously.**
