FHWA CONTRACT NO.  
DTFH61-86-Z-00046

THIRTY MPH BROADSIDE  
IMPACT OF A MINI-SIZED VEHICLE  
AND A BREAKAWAY LUMINAIRE SUPPORT

TEST RESULTS REPORT

TEST NUMBER 1785-SI#1-87

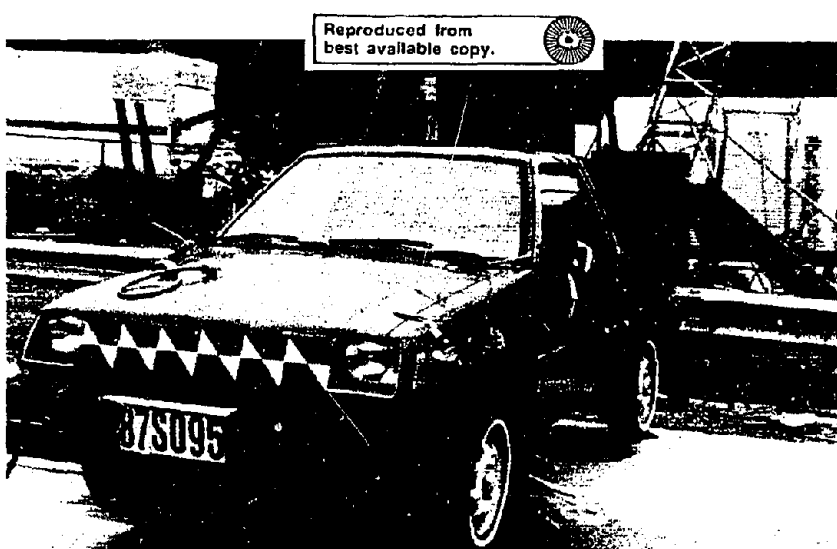
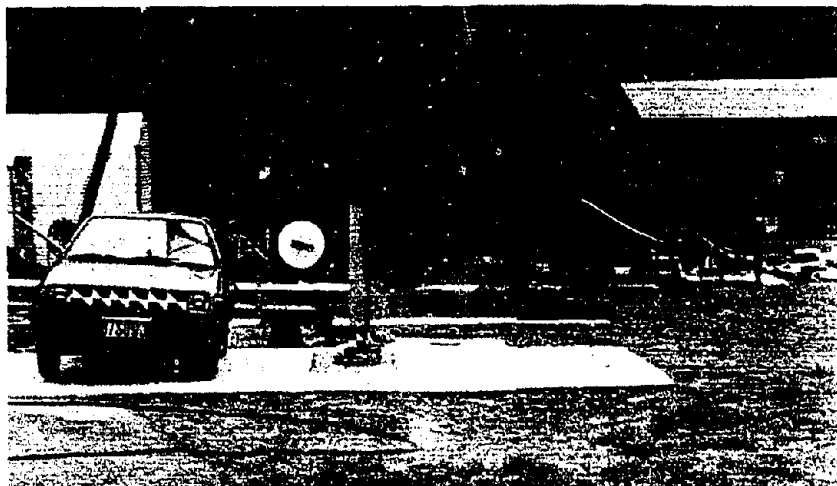
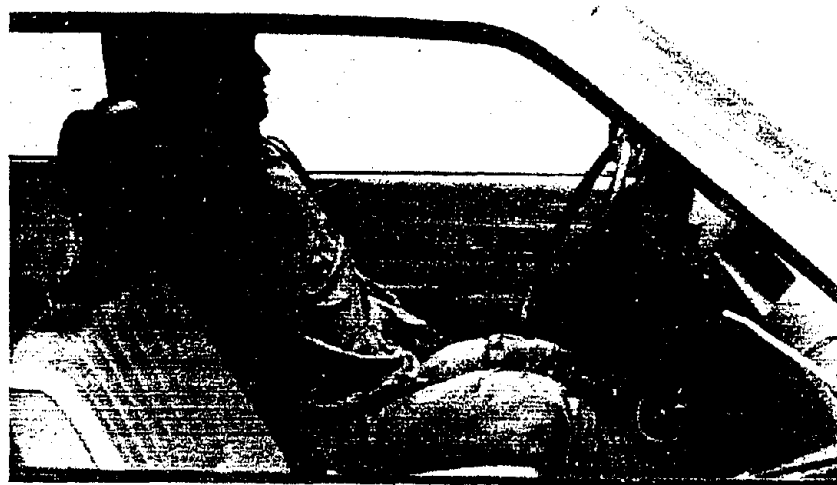
Figure 2. Pre-Test Photos of Vehicle

The test vehicle was a 1980 Plymouth Champ. The weight of the vehicle prior to incorporating the instrumentation for the test was 1908 pounds. The test inertial weight for the vehicle was 1849 pounds and the gross static weight when the occupant was included in the vehicle was 2009 pounds. The longitudinal center of gravity of the vehicle without the occupant was located approximately 33 inches behind the centerline of the front axle. The weight and inertial data of the vehicle in its as delivered and instrumented configuration are given in table 4. Inertial data was measured using the IMD.

The vehicle was equipped with a triaxial accelerometer package mounted on the lateral centerline of the vehicle at the longitudinal location of the center of gravity. Two rate gyros were also installed to the same mounting block to measure roll and yaw rates. The vehicle was also equipped with a contact switch mounted on the left door to permit vehicle and occupant data to be measured relative to the time of impact. A second triaxial accelerometer package was attached to the floor board located in front of the front right hand seat. This data was collected using the FOIL data system. The test vehicle is shown in figure 2.

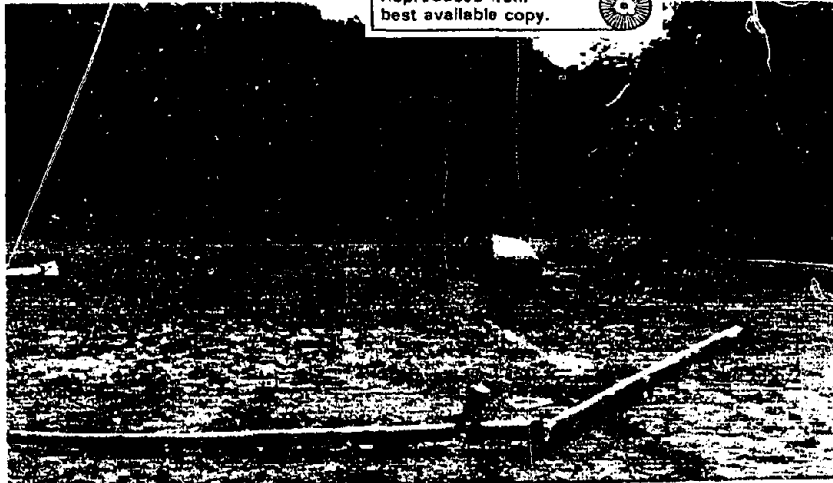
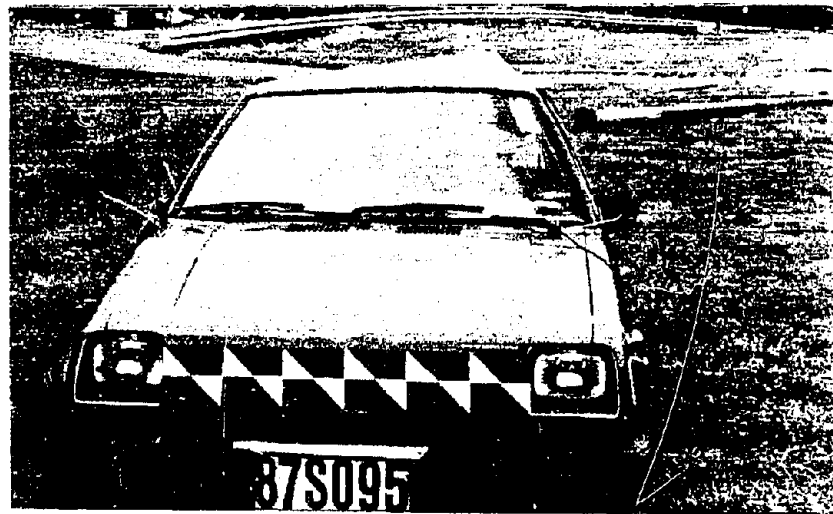
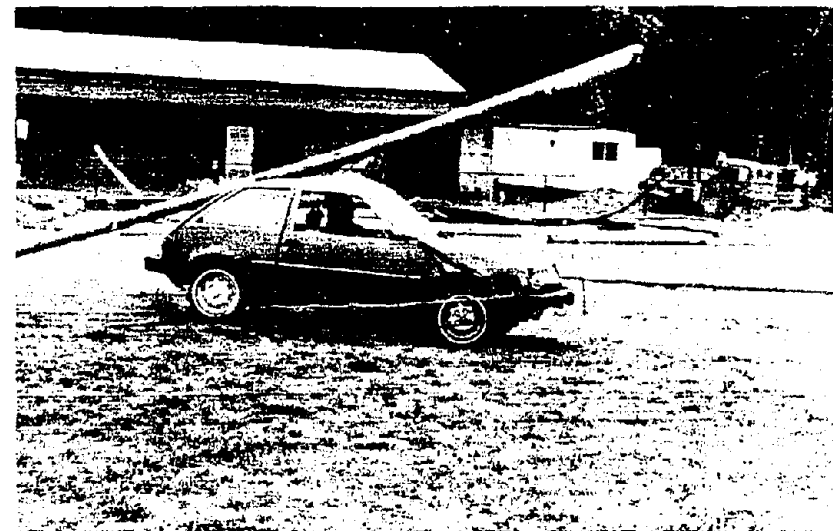
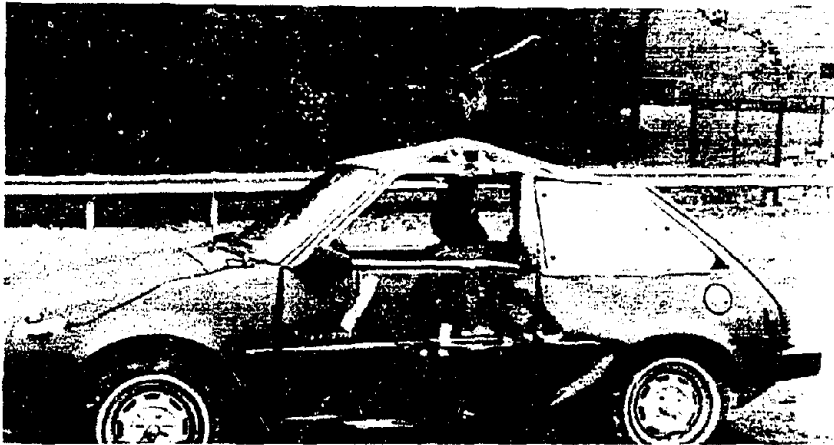
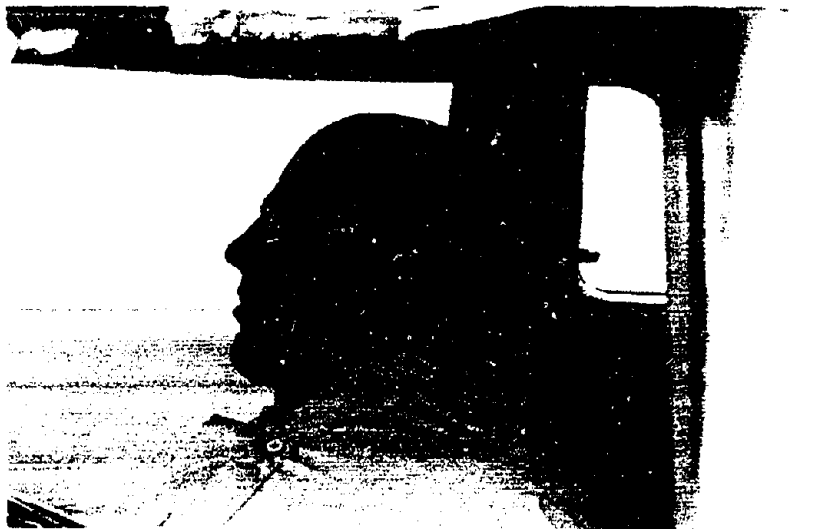
Figure 3. Post-Test Photos of Vehicle

The test vehicle momentum change due to impacting the pole at a speed of 29.36 mph (13.1 m/s) was 554 lb-sec. The velocity change corresponding to the observed vehicle momentum change was 6.06 mph or 8.89 ft/sec. The integrity of the vehicle was maintained throughout the test although severe intrusions occurred at the center of the driver's door. Maximum residual crush of the side of the vehicle was 10.00 inches.

The impact conditions were 29.36 mph (13.1 m/s) at a point on the left door in line with the occupant 18 in (.46 m) behind the longitudinal location of the center of gravity of the vehicle measured without the dummy in the vehicle. The vehicle had a  $4.6^{\circ}$  roll angle as it leaned toward the test pole due to the side sliding forces acting on the tires. The maximum residual crush of the vehicle at the impact point was 10 inches (.25 m). Photographs of the vehicle and luminaire support after the collision event are shown in figure 3.

The test pole readily activated in the predicted manner. There was, however, severe penetration of the passenger compartment due to the nature of the test. No undue hazard was generated to other traffic.

This pole/vehicle combination with the discussed impact conditions would have to be rated unacceptable due to the intrusion and very high occupant injury measurements.

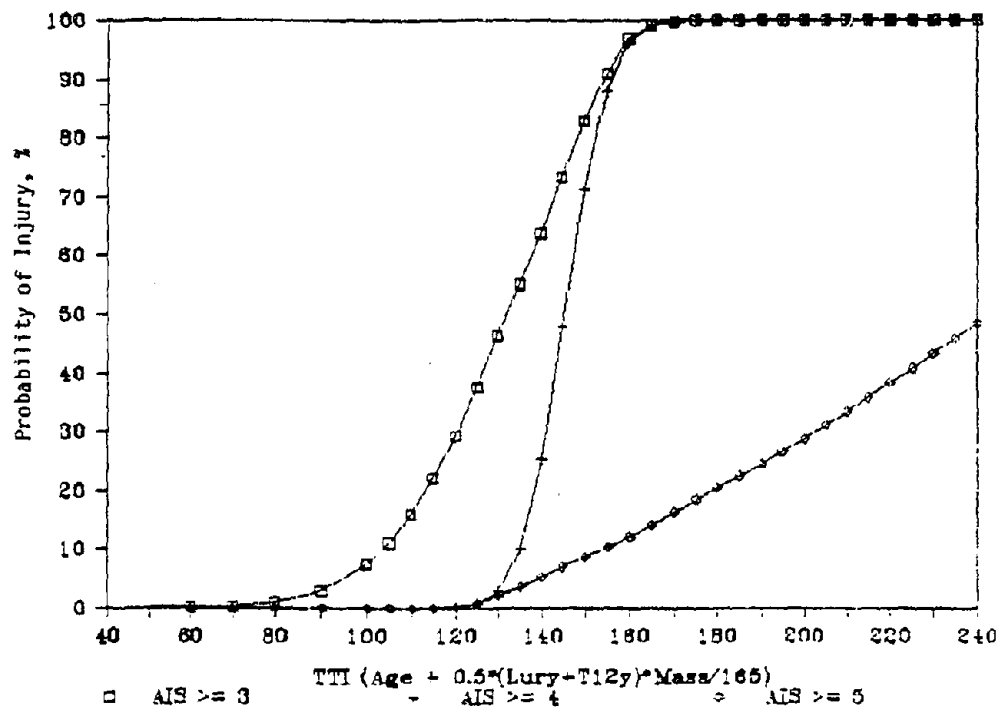
Figure 5. Thoracic Trauma Index Scale

$$TTI = Age + T12Y (Mass/165)$$

The T12Y data was taken from figure A24. The peak value of T12Y is 151 g's. Thus the TTI index is 151 plus occupant age. This value produces a 87% probability of injury of an AIS greater than 3, 77% probability of injury of an AIS greater than 4 and a 8% probability of injury of an AIS greater than 5 for age 0. See figure 5 for TTI values.

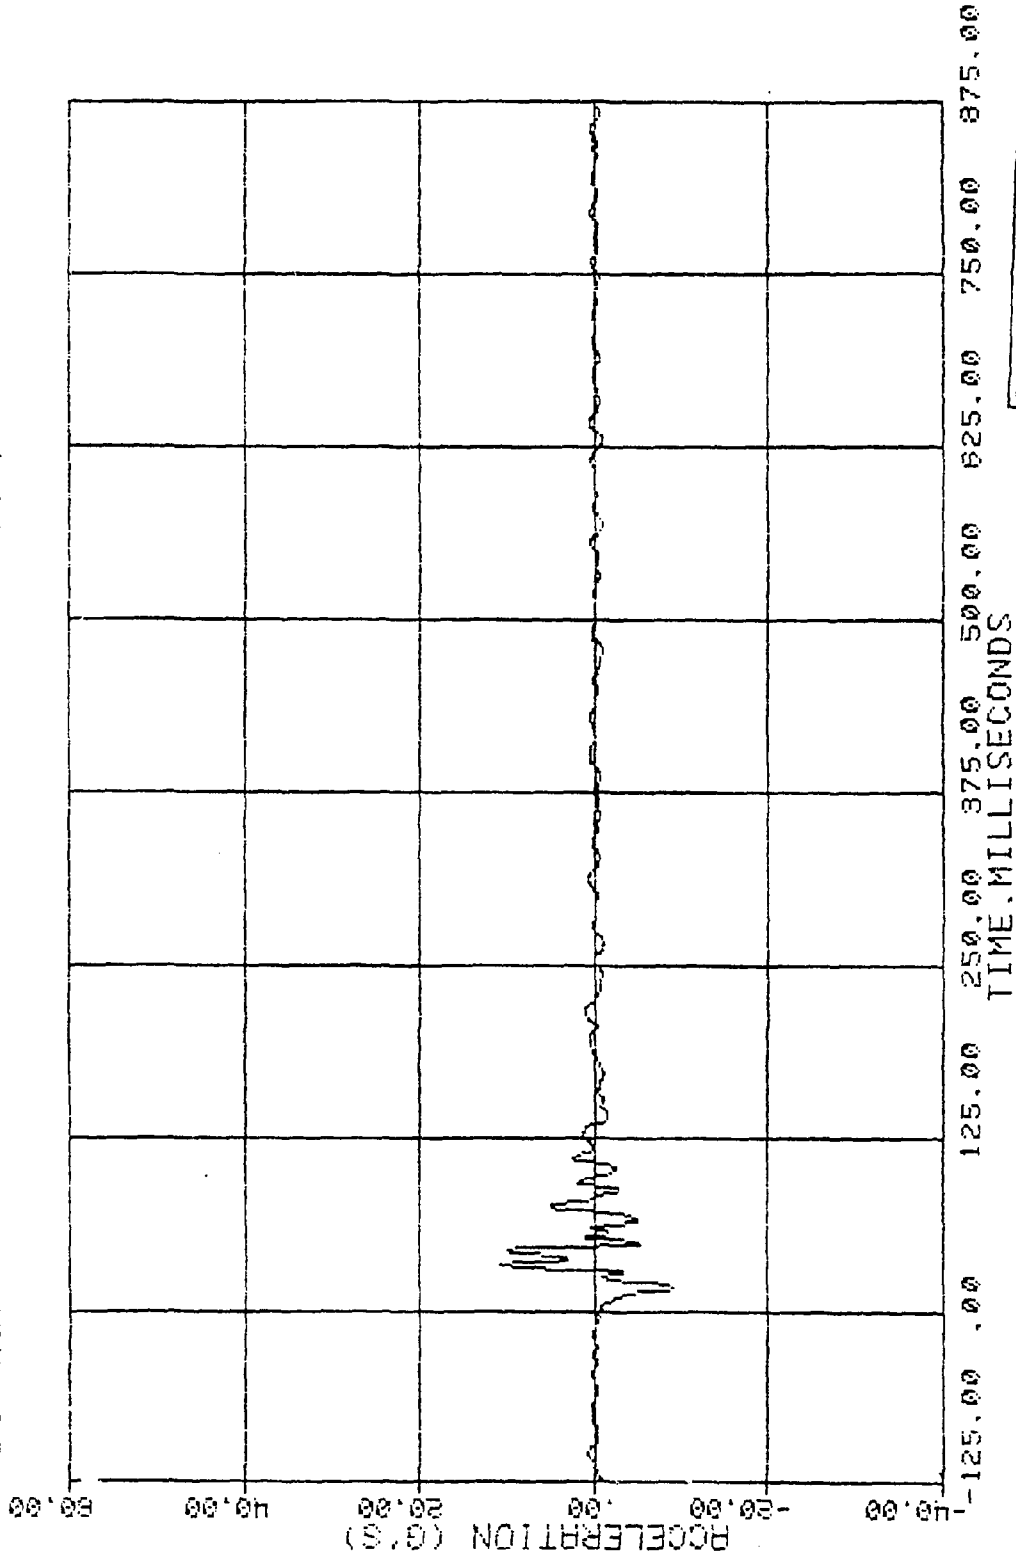
Figure A1. Vehicle Acceleration, X-Axis, 100 Hz

ENSO, INC.      CONTRACT NUMBER    CTFH61-86-Z-00017      TEST NUM 1785-ST-1-87  
 3/4 BROADSIDE IMPACT OF 80 PLYMOUTH CHAMP INTO LUMINAIRE SUPPORT  
 CHANNEL 13      VEHICLE C.O. ACCELERATION, X-AXIS  
 FILTER CUTOFF FREQ.    100      PEAKS    -0.30 ,    10.95

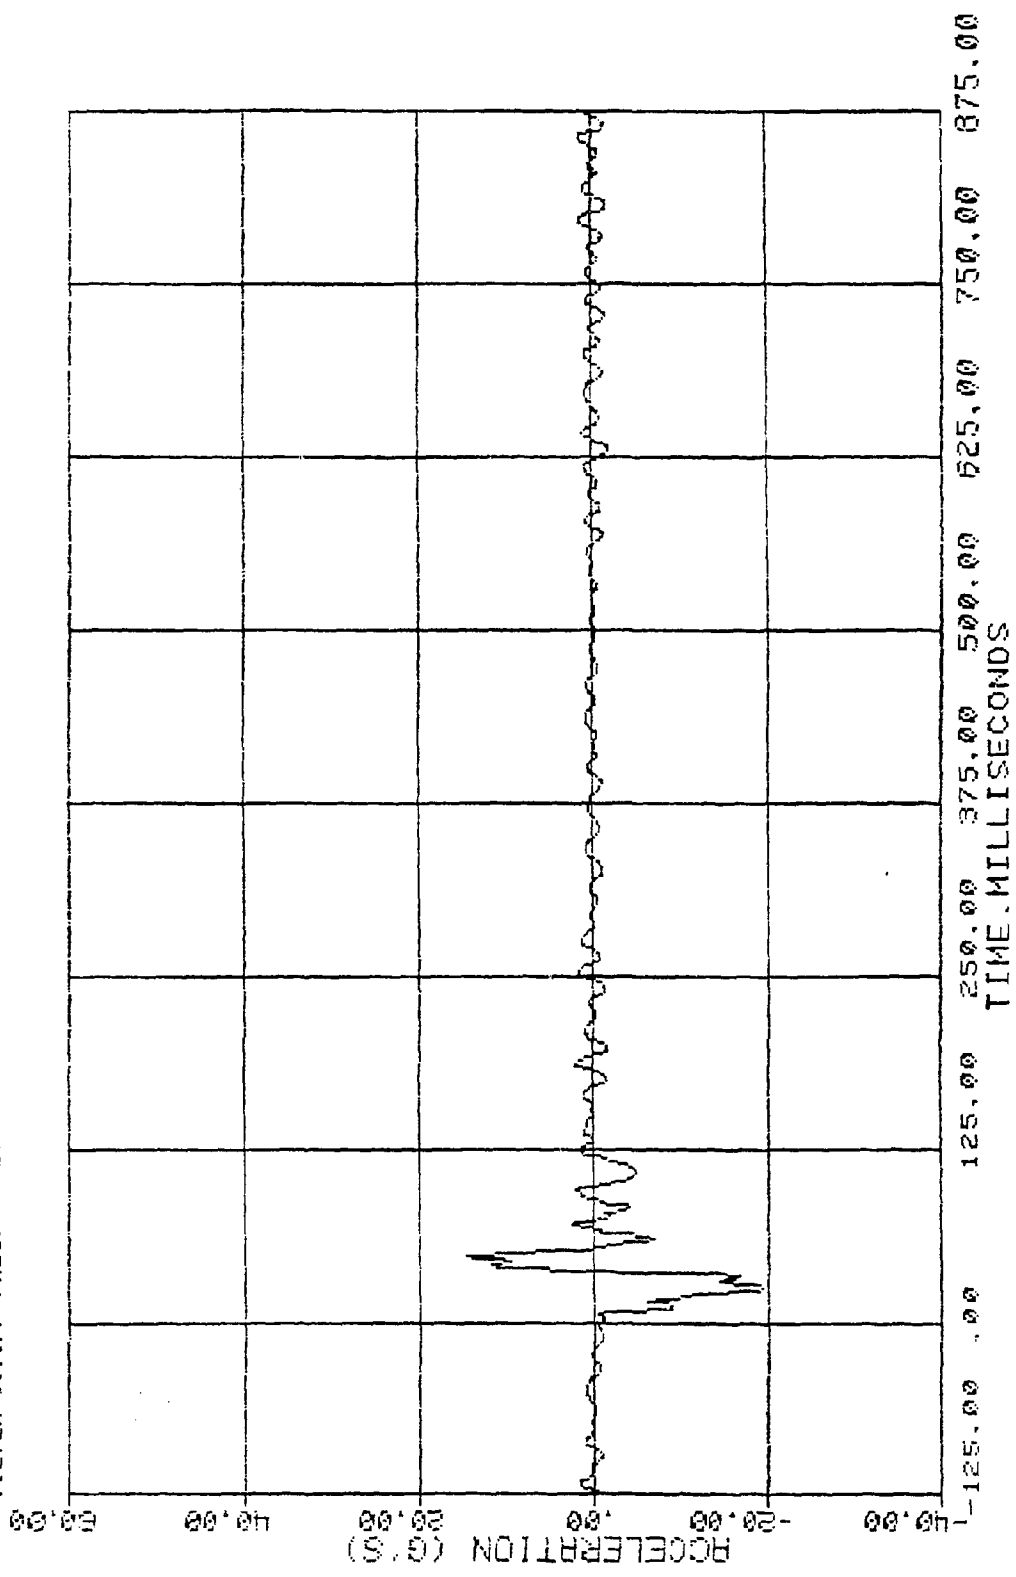
Figure A2. Vehicle Acceleration, Y-Axis, 100 Hz

ENSCO, INC.      CONTRACT NUMBER    DTFH61-86-Z-00047      TEST NUM 1795-81-1-87  
 30 MI/H BRADSIDE IMPACT OF 80 PLYMOUTH CHAMP INTO LUMINAIRE SUPPORT  
 CHANNEL 2N      VEHICLE G.O. ACCELERATION, Y-AXIS      PEAKS    -13.88 ,    14.50  
 FILTER CUTOFF FREQ.    100

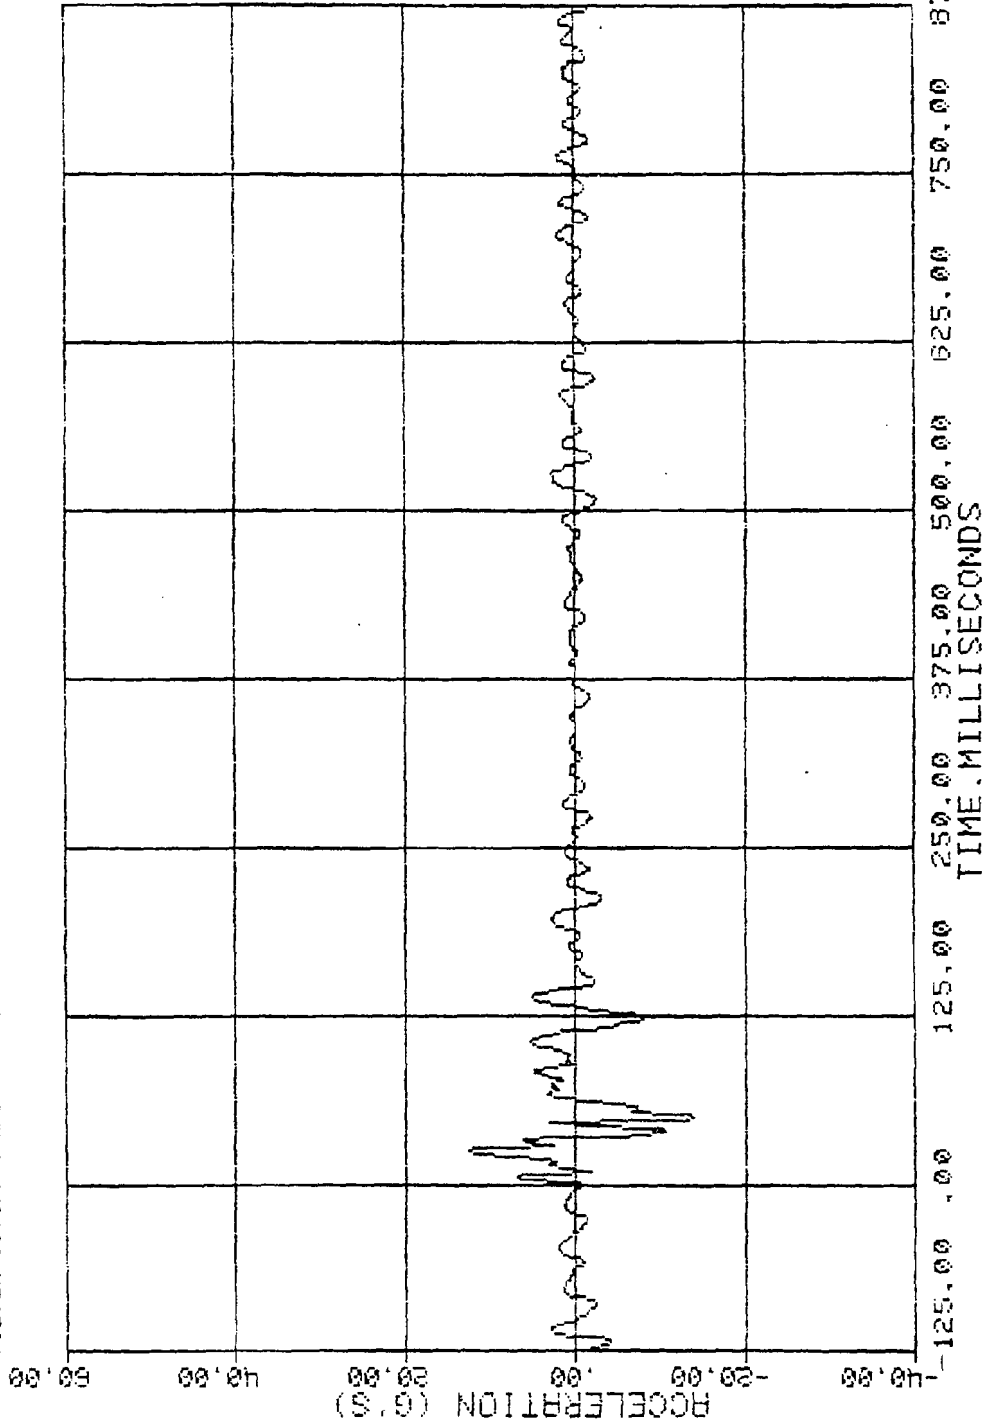
Figure A3. Vehicle Acceleration, Z-Axis, 100 Hz

ENSO, INC. CONTRACT NUMBER NTFHS1-86-Z-00047 TEST NUM 1785-SJ-1-87  
 38 MI/H BROWNSIDE IMPACT OF 80 FT. MOUTH CHAMP INTO LUMINAIRE SUPPORT  
 CHANNEL 24 VEHICLE C.O. ACCELERATION, Z-AXIS  
 FILTER CUTOFF FREQ. 100 PEAKS -14.01, 12.43

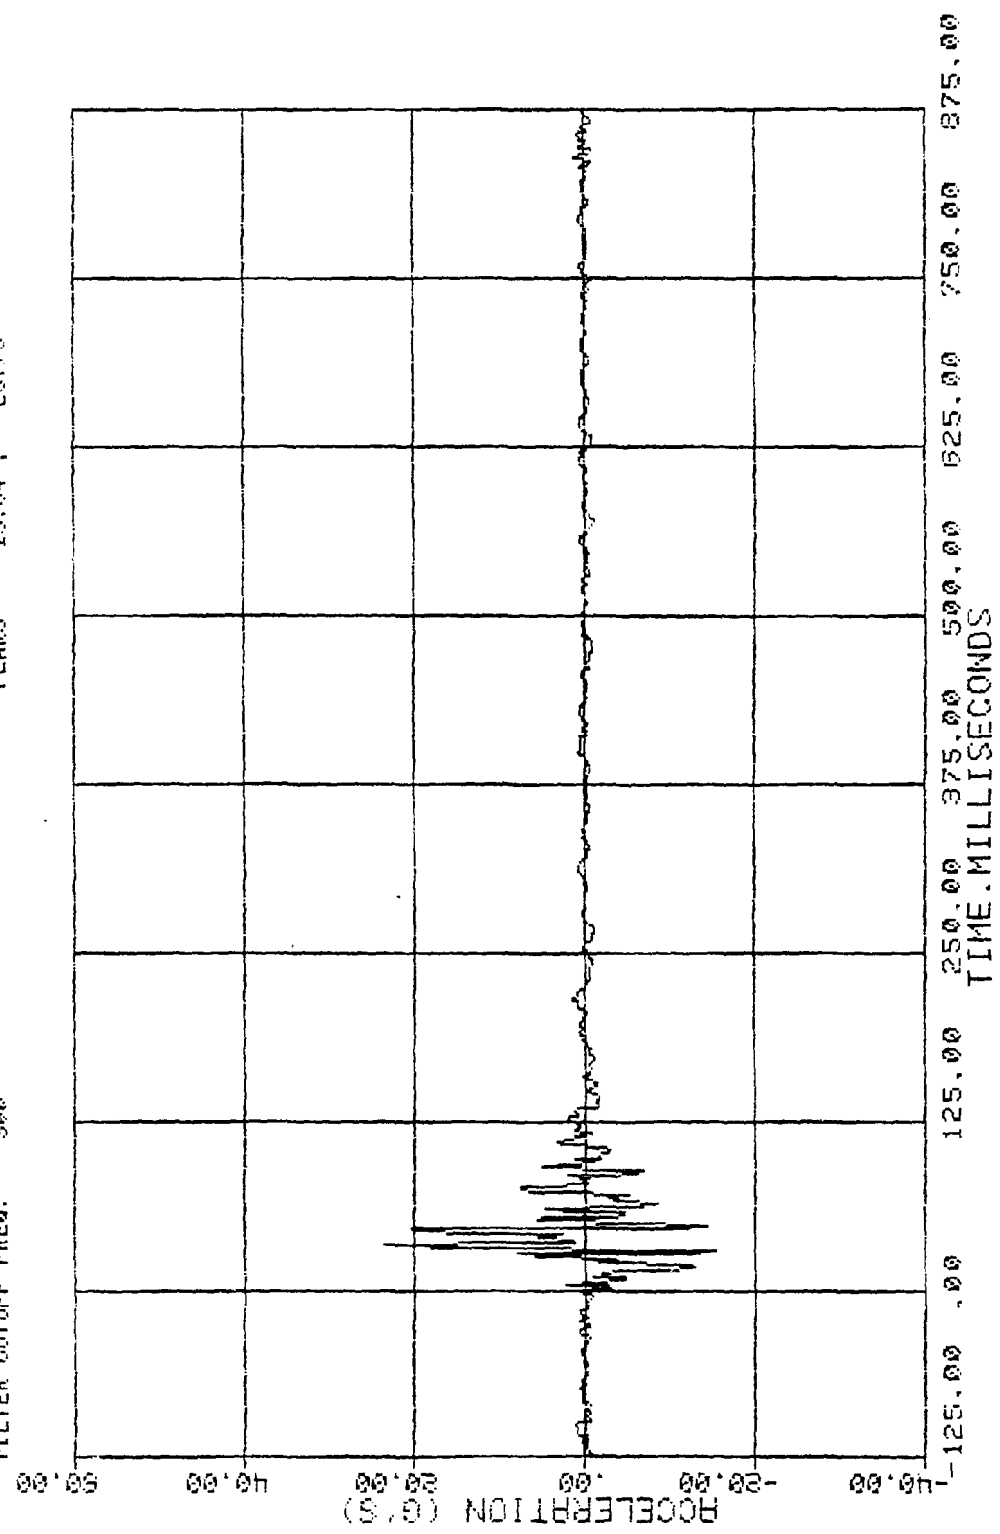
Figure A4. Vehicle Acceleration, X-Axis, 300 Hz

ENSO, INC.      CONTRACT NUMBER    DTFH61-86-Z-00047      TEST NUM 1785-SI-1-87  
 3M HIGH SPEEDSIDE IMPACT OF 80 PLYMOUTH CHAMP INTO LUMINAIRE SUPPORT  
 CHANNEL 13      VEHICLE C.O. ACCELERATION, X-AXIS  
 FILTER CUTOFF FREQ.    300      PEAKS    -15.64 ,    23.73

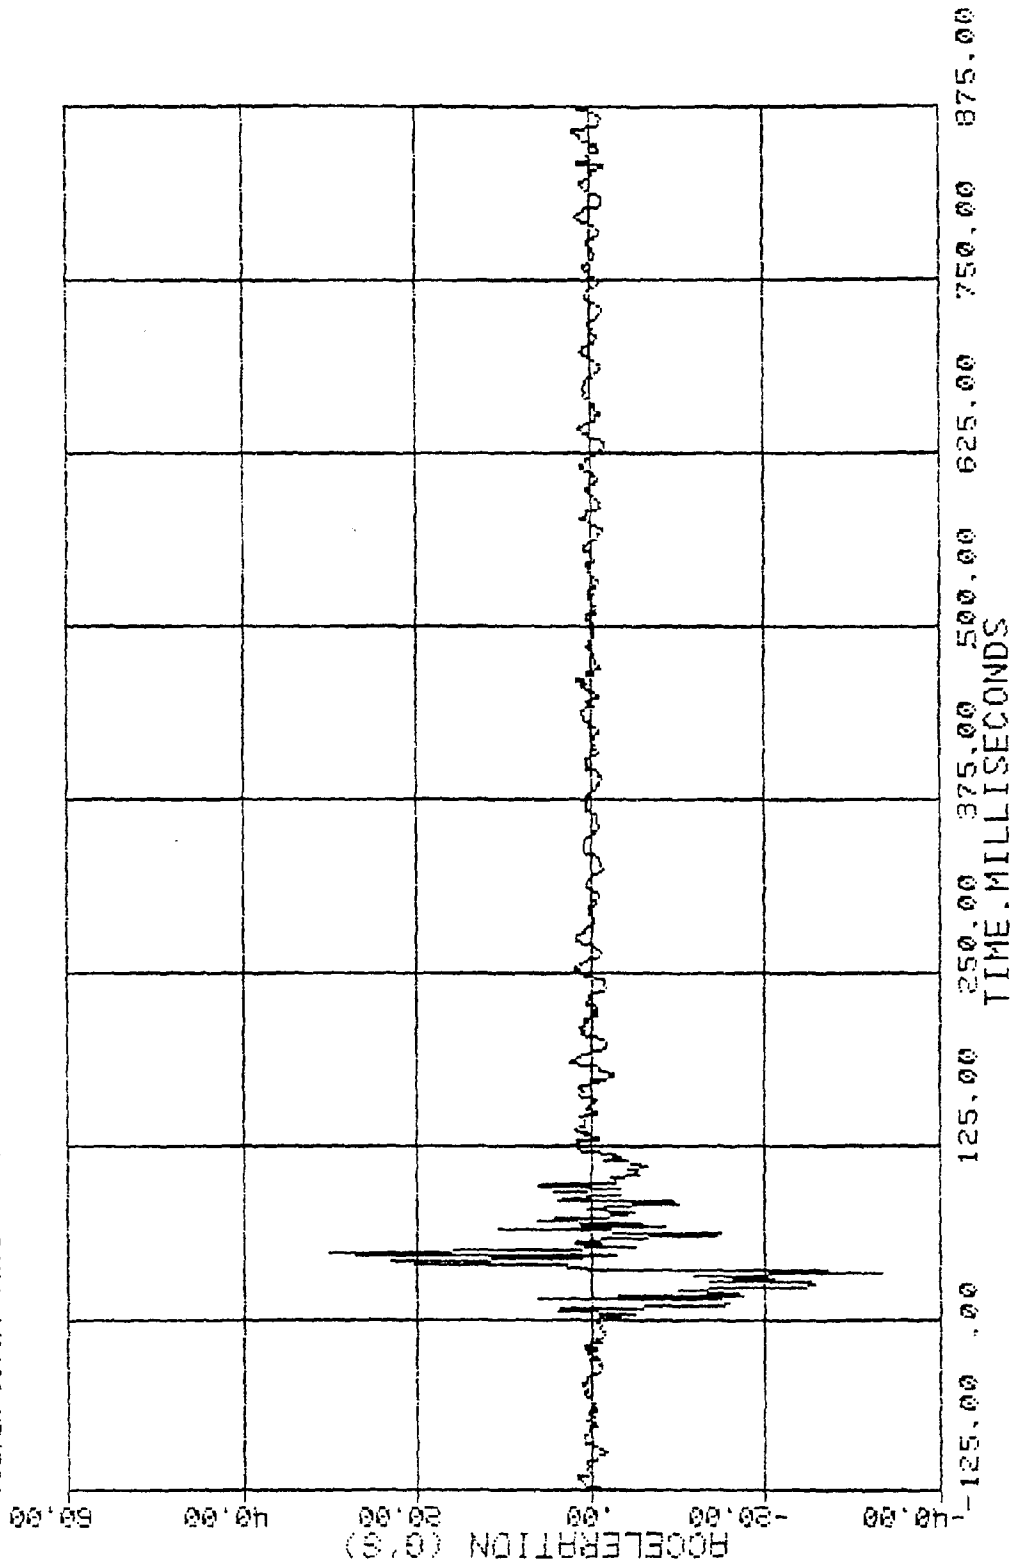
Figure A5. Vehicle Acceleration, Y-Axis, 300 Hz

EUSCO, INC. CONTRACT NUMBER D1H461-86-Z-00047 TEST NUM 1785-SI-1-07  
 30 MI/H BROADSIDE IMPACT OF 80 PLYMOUTH CHAMP INTO LUMINAIRE SUPPORT  
 CHANNEL 20 VEHICLE C.O.G. ACCELERATION, Y-AXIS  
 FILTER CUTOFF FREQ. 300 PEAKS -33.46 , 30.19

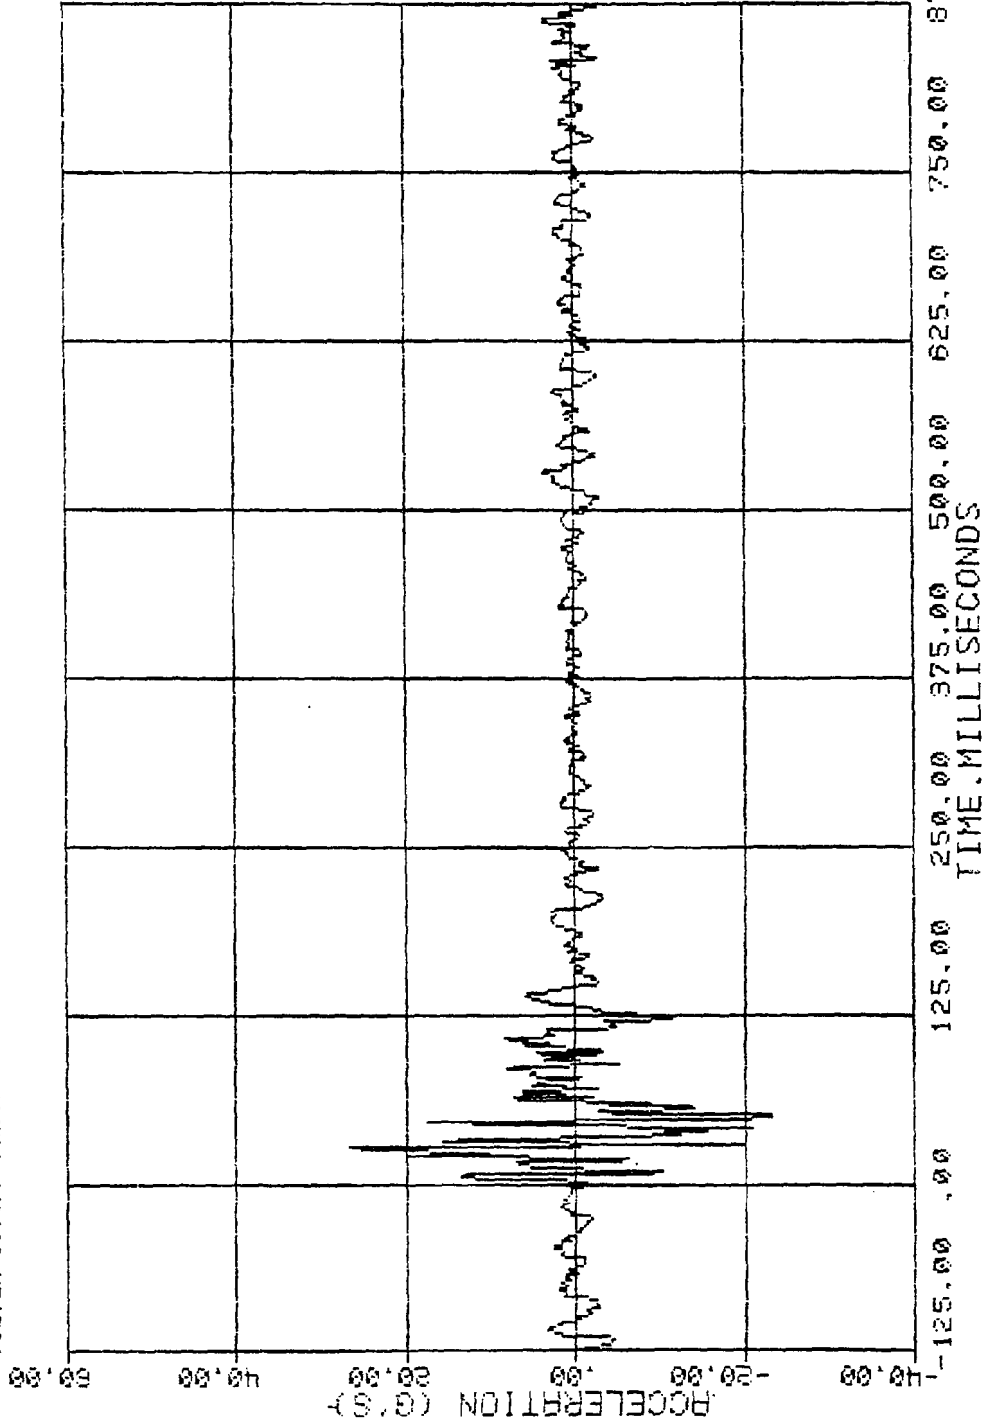
Figure A6. Vehicle Acceleration, Z-Axis, 300 Hz

ENSCO, INC. CONTRACT NUMBER DTFH61-86-Z-00047 TEST NUM 1785-SI-1-87  
 37 MI/H BROADSIDE IMPACT OF 80 PLYMOUTH CRMP INTO LUMINAIRE SUPPORT  
 CHANNEL 24 VEHICLE 0.0 ACCELERATION, Z-AXIS PEAKS -23.19 , 26.73  
 FILTER CUTOFF FREQ. 300

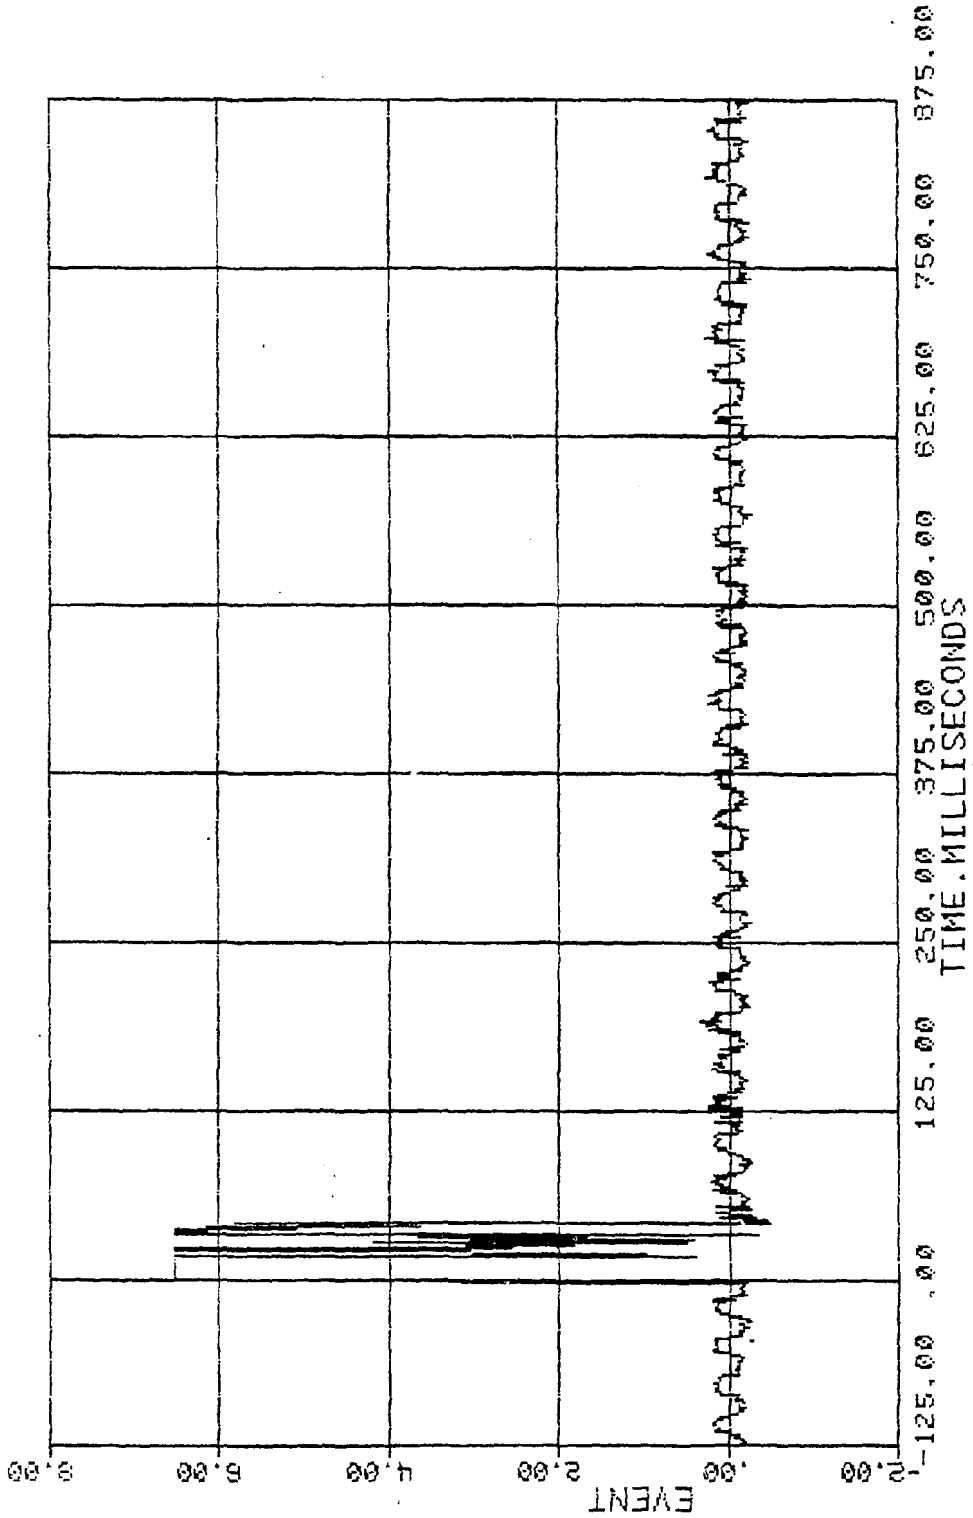
Figure A7. Event Marker, Impact

ENSCO, INC. CONTRACT NUMBER DTFH61-86-2-00017 TEST NUM 785-SI-1-87  
 30 MI/H BROADSIDE IMPACT OF 80 PLYWOOD CHAMP INTO LUMINAIRE SUPPORT  
 CHANNEL 21 IMPACT PEAKS -0.46 6.53  
 FILTER CUTOFF FREQ. 1650

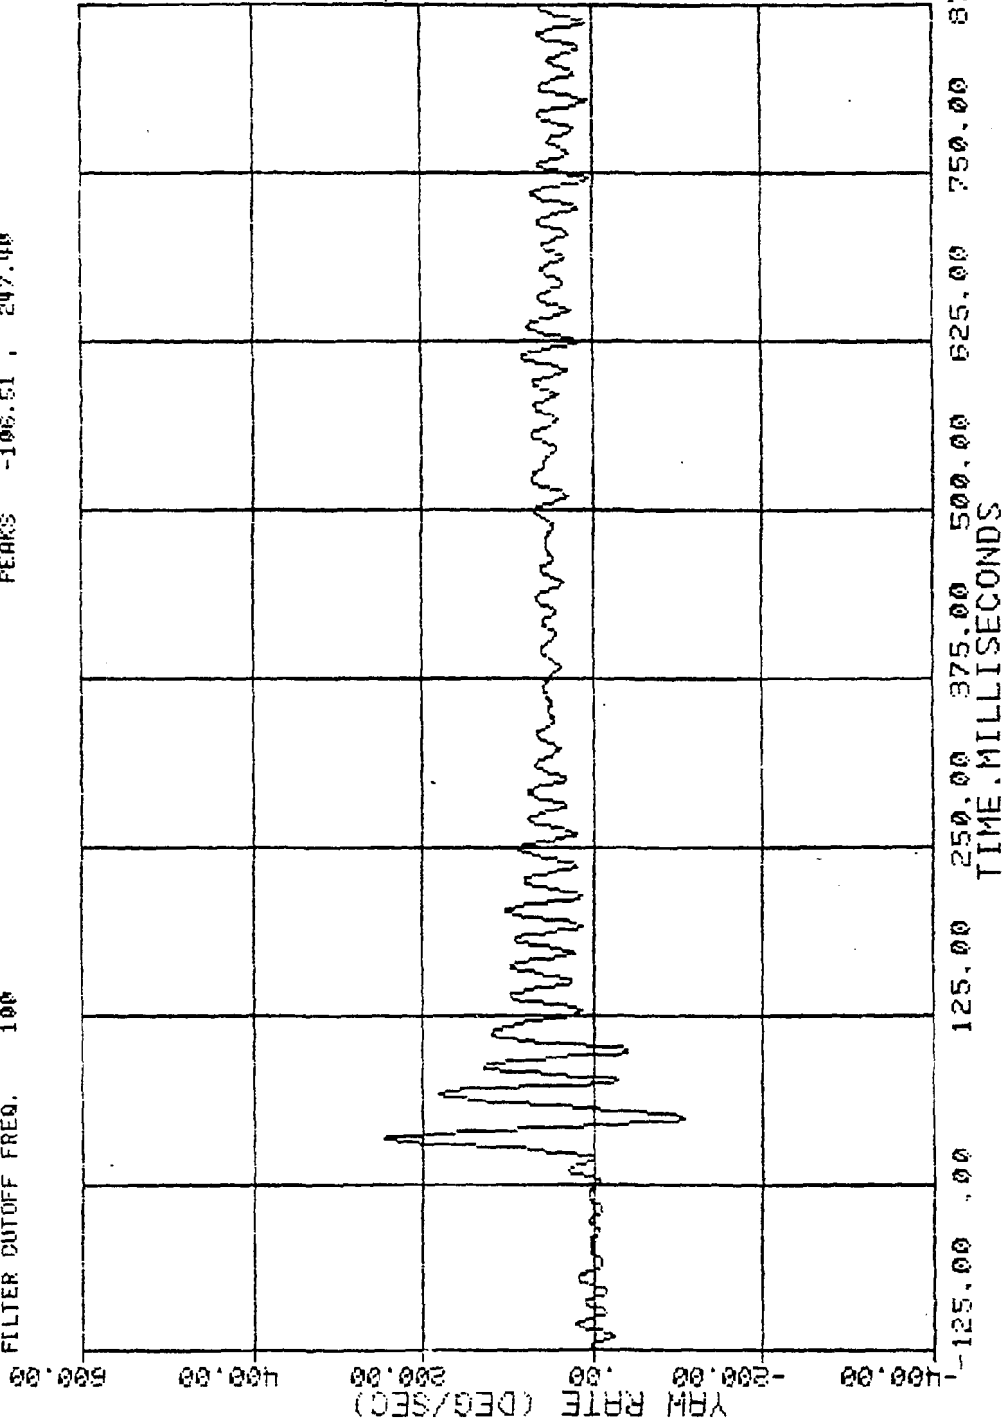
Figure A8. Vehicle Yaw Rate, 100 Hz

ENSO, INC.      CONTRACT NUMBER    DTFA81-86-Z-00047      TEST NUM1785-SI-1-87  
 36 MI/H GROUDBSIDE IMPACT OF 80 PLYMOUTH CHAMP INTO LUMINAIRE SUPPORT  
 CHANNEL 23      VEHICLE YAW RATE  
 FILTER CUTOFF FREQ.    100      PEAKS    -106.51 ,    247.40

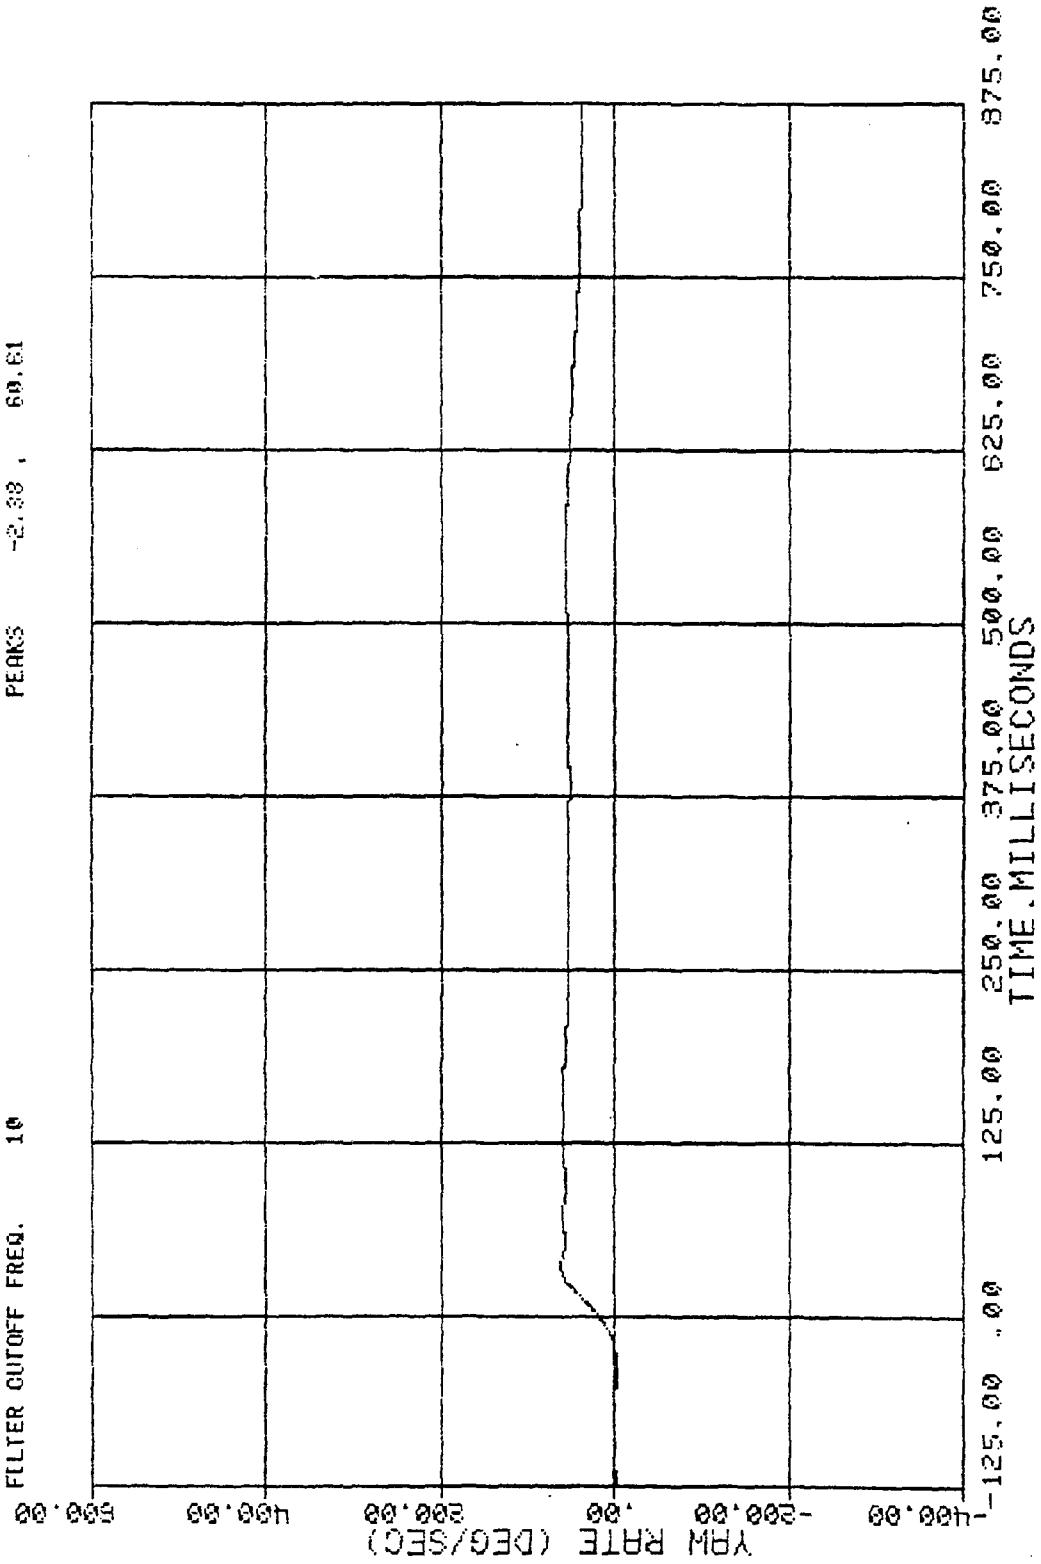
Figure A9. Vehicle Yaw Rate, 10 Hz

ENSCO, INC. CONTRACT NUMBER DTFH61-86-Z-00047 TEST NUM 785-SI-1-87  
 3P MI/H BROADSIDE IMPACT OF 80 PLYMOUTH CHAMP INTO LUMINAIRE SUPPORT  
 CHANNEL 23 VEHICLE YAW RATE  
 FILTER CUTOFF FREQ. 10 PEAKS -2.38 , 60.61

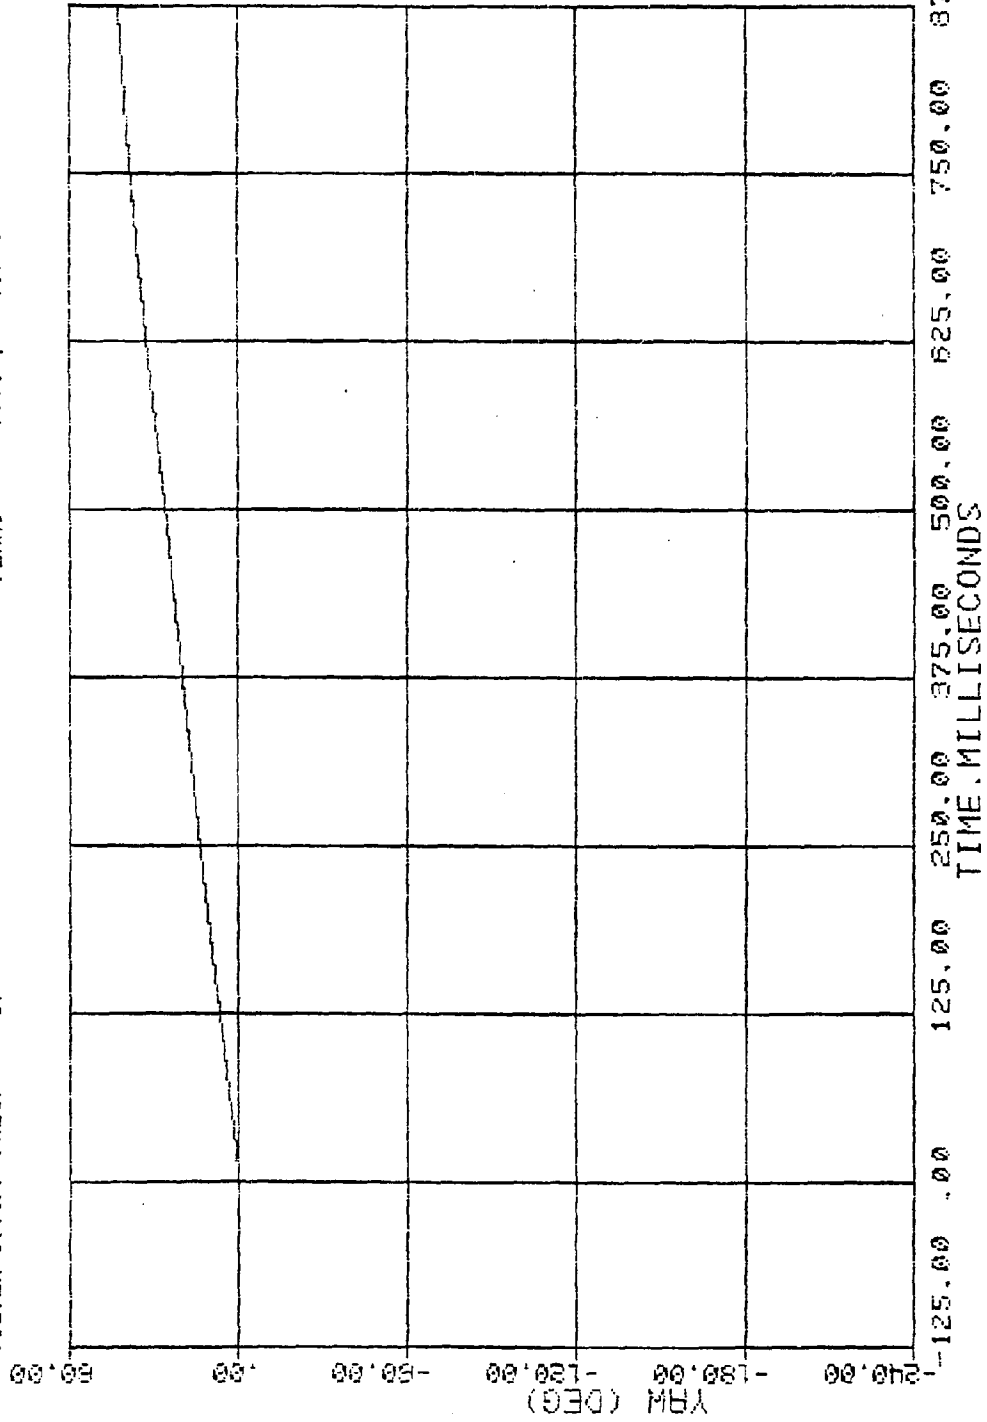
Figure A10. Vehicle Yaw, 10 Hz

ENSCO, INC. CONTRACT NUMBER DTMS1-85-2-00017 TEST NUM 1785-S1-1-87  
 3/4 MI/H BROADSIDE IMPACT OF 80 PLYMOUTH CHAMP INTO LUMINAIRE SUPPORT  
 CHANNEL 23 VEHICLE YAW  
 FILTER CUTOFF FREQ. 10 PEAKS -0.00, 43.34

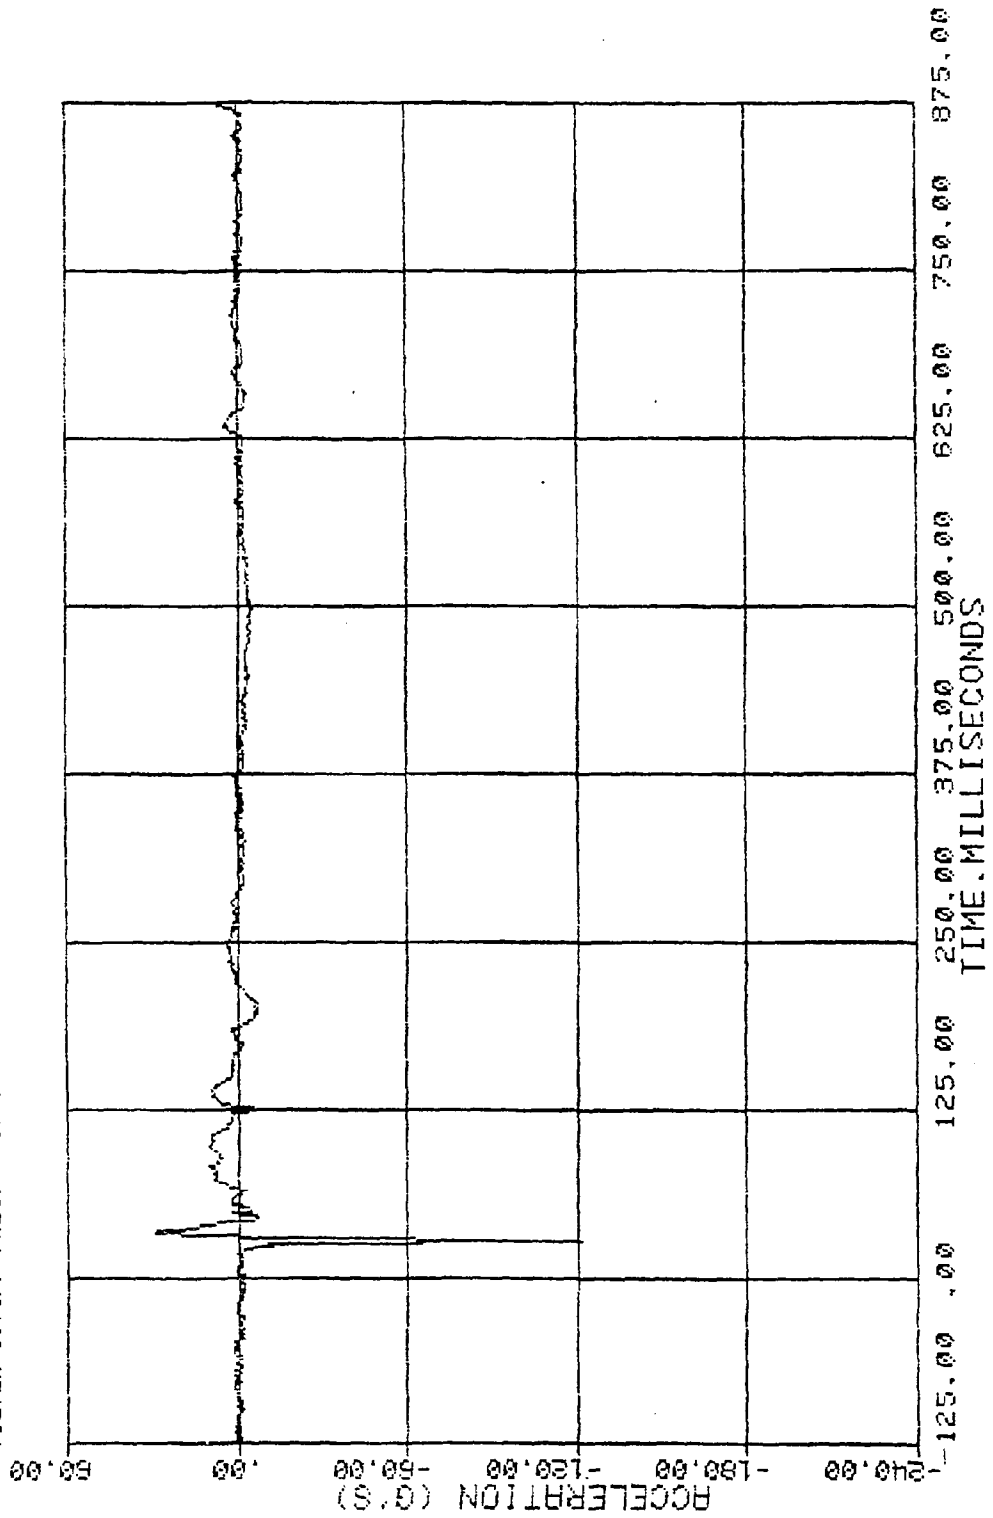
Figure A11. Driver's Head Acceleration, X-Axis, 1650 Hz.

ENSCO, INC.      CONTRACT NUMBER    DTFH81-86-Z-00047      TEST NUM 1785-SJ-1-87  
 30 MPH BROADSIDE IMPACT OF 80 PLYMOUTH CHAMP INTO LUMINAIRE SUPPORT  
 CHANNEL 13      DRIVER HEAD ACCELERATION, X-AXIS  
 FILTER CUTOFF FREQ. 1650      PEAKS    -121.10 ,    28.79

The data from the triaxial accelerometer sensor assembly in the head of the test dummy was filtered at SAE Class 1000 and used to evaluate the HIC. The data obtained from the triaxial accelerometer sensor assemblies located in the upper spine of the occupant was filtered at SAE Class 180 and was used to evaluate severity indices and maximum sustained accelerations experienced by the occupant. The data obtained from the accelerometers located on the ribs of the occupant were filtered at SAE Class 180. In addition, thoracic injury parameters associated with side impact conditions were analyzed using NHTSA's latest technique to determine side impact occupant injury.
