FHWA CONTRACT NO.  
DTFH61-86-Z-00046

THIRTY MPH BROADSIDE  
IMPACT OF A MINI-SIZED VEHICLE  
AND A BREAKAWAY LUMINAIRE SUPPORT

TEST RESULTS REPORT

TEST NUMBER 1785-SI#1-87

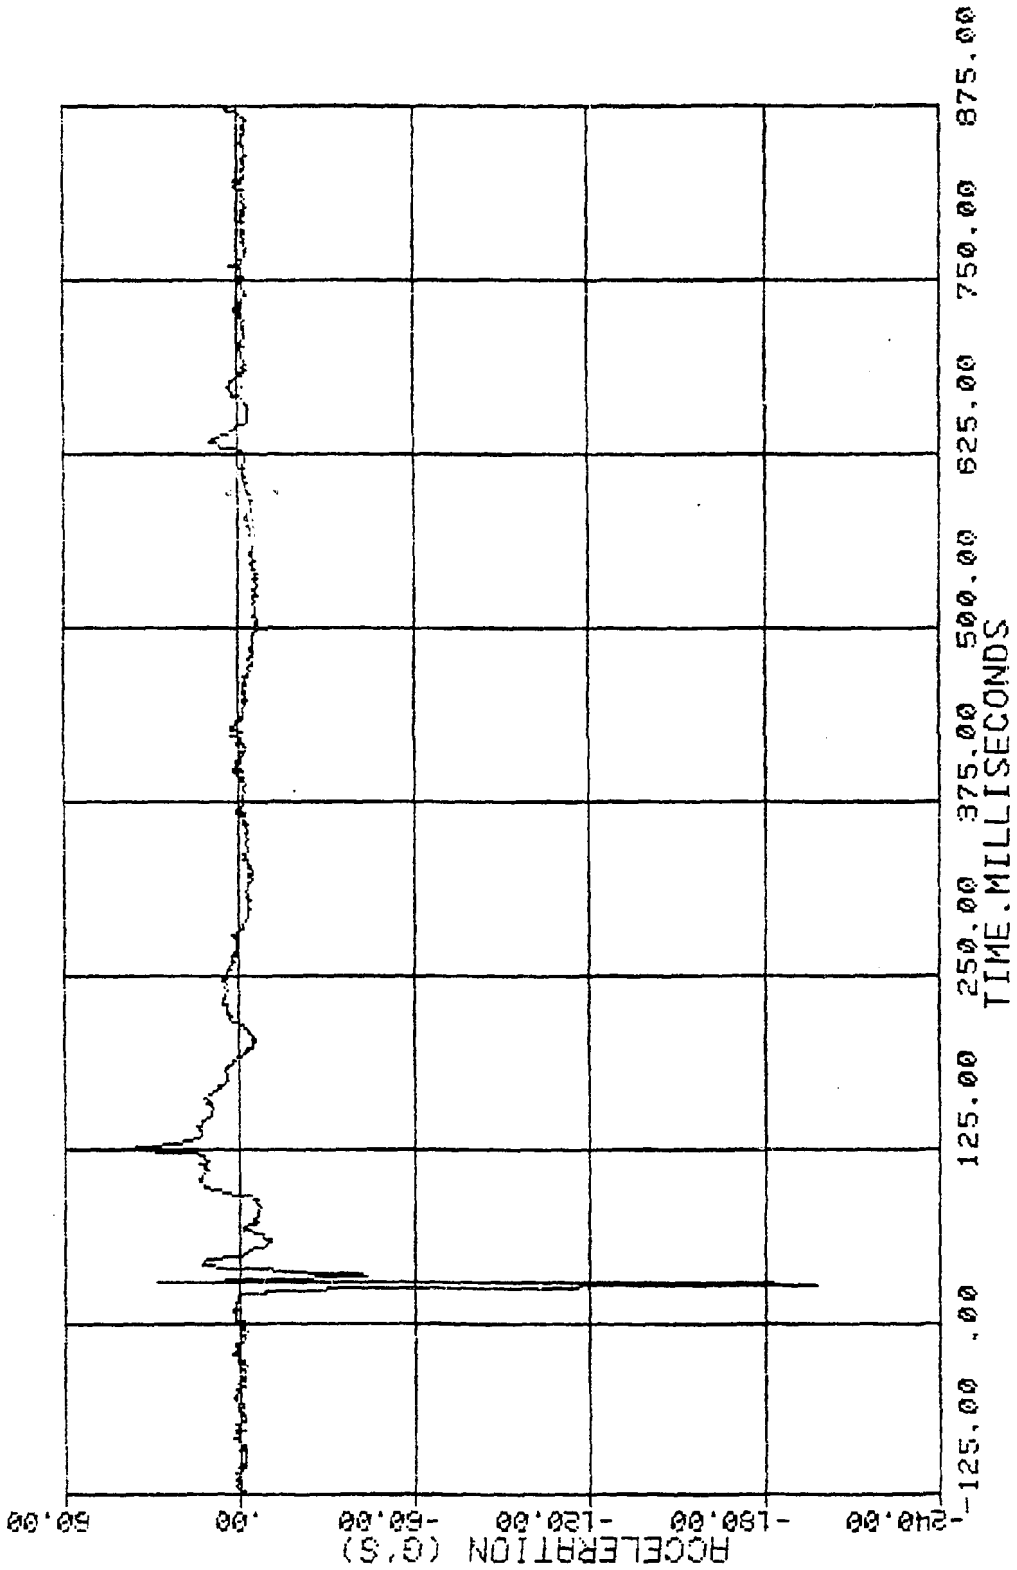
Figure A12. Driver's Head Acceleration, Y-Axis 1650 Hz

ENSO, INC. CONTRACT NUMBER DTFH61-86-Z-00047 TEST NUM 785-SI-1-07  
 30 MI/H BROADSIDE IMPACT OF 80 PLYMOUTH CHAMP INTO LUMINAIRE SUPPORT  
 CHANNEL 14 DRIVER HEAD ACCELERATION, Y-AXIS  
 FILTER CUTOFF FREQ. 1650 PEAKS -197.38 , 38.25

The data from the triaxial accelerometer sensor assembly in the head of the test dummy was filtered at SAE Class 1000 and used to evaluate the HIC. The data obtained from the triaxial accelerometer sensor assemblies located in the upper spine of the occupant was filtered at SAE Class 180 and was used to evaluate severity indices and maximum sustained accelerations experienced by the occupant. The data obtained from the accelerometers located on the ribs of the occupant were filtered at SAE Class 180. In addition, thoracic injury parameters associated with side impact conditions were analyzed using NHTSA's latest technique to determine side impact occupant injury.

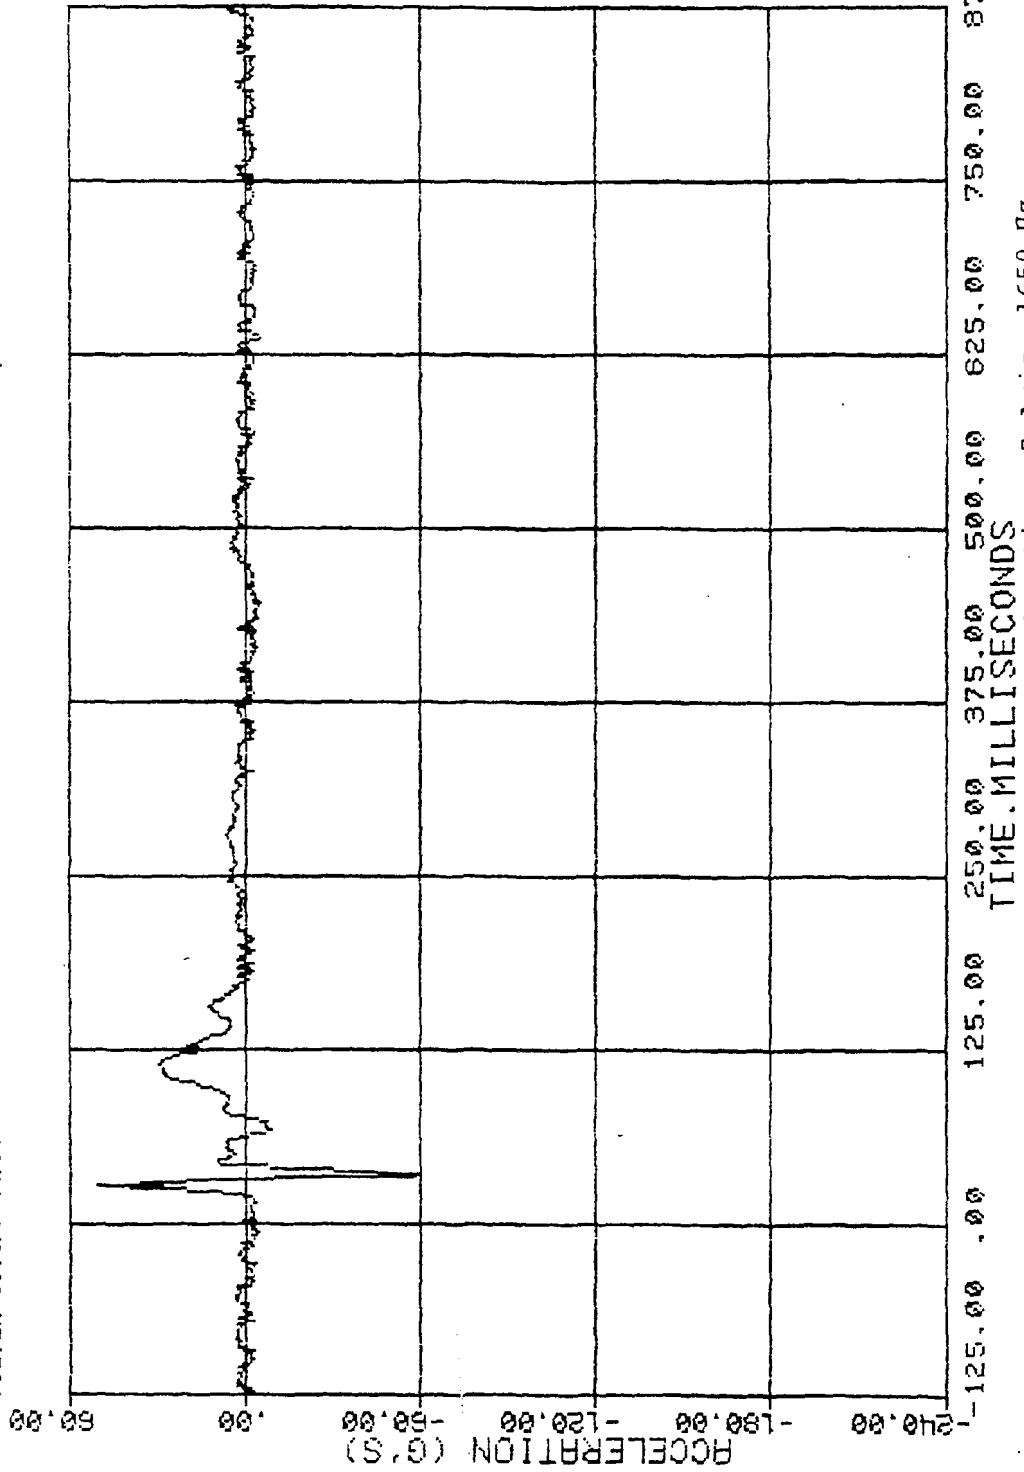
Figure A13. Driver's Head Acceleration, Z-Axis, 1650 Hz

ENSCO, INC.      CONTRACT NUMBER    DTFH61-86-Z-00047      TEST NUM1285-SI-1-87  
 30 MI/H BROADSIDE IMPACT OF 80 PLYMOUTH CHAMP INTO LUMINAIRE SUPPORT  
 CHANNEL 15      DRIVER HEAD ACCELERATION, Z-AXIS  
 FILTER CUTOFF FREQ. 1650      PEAKS    -53.48 ,    51.98

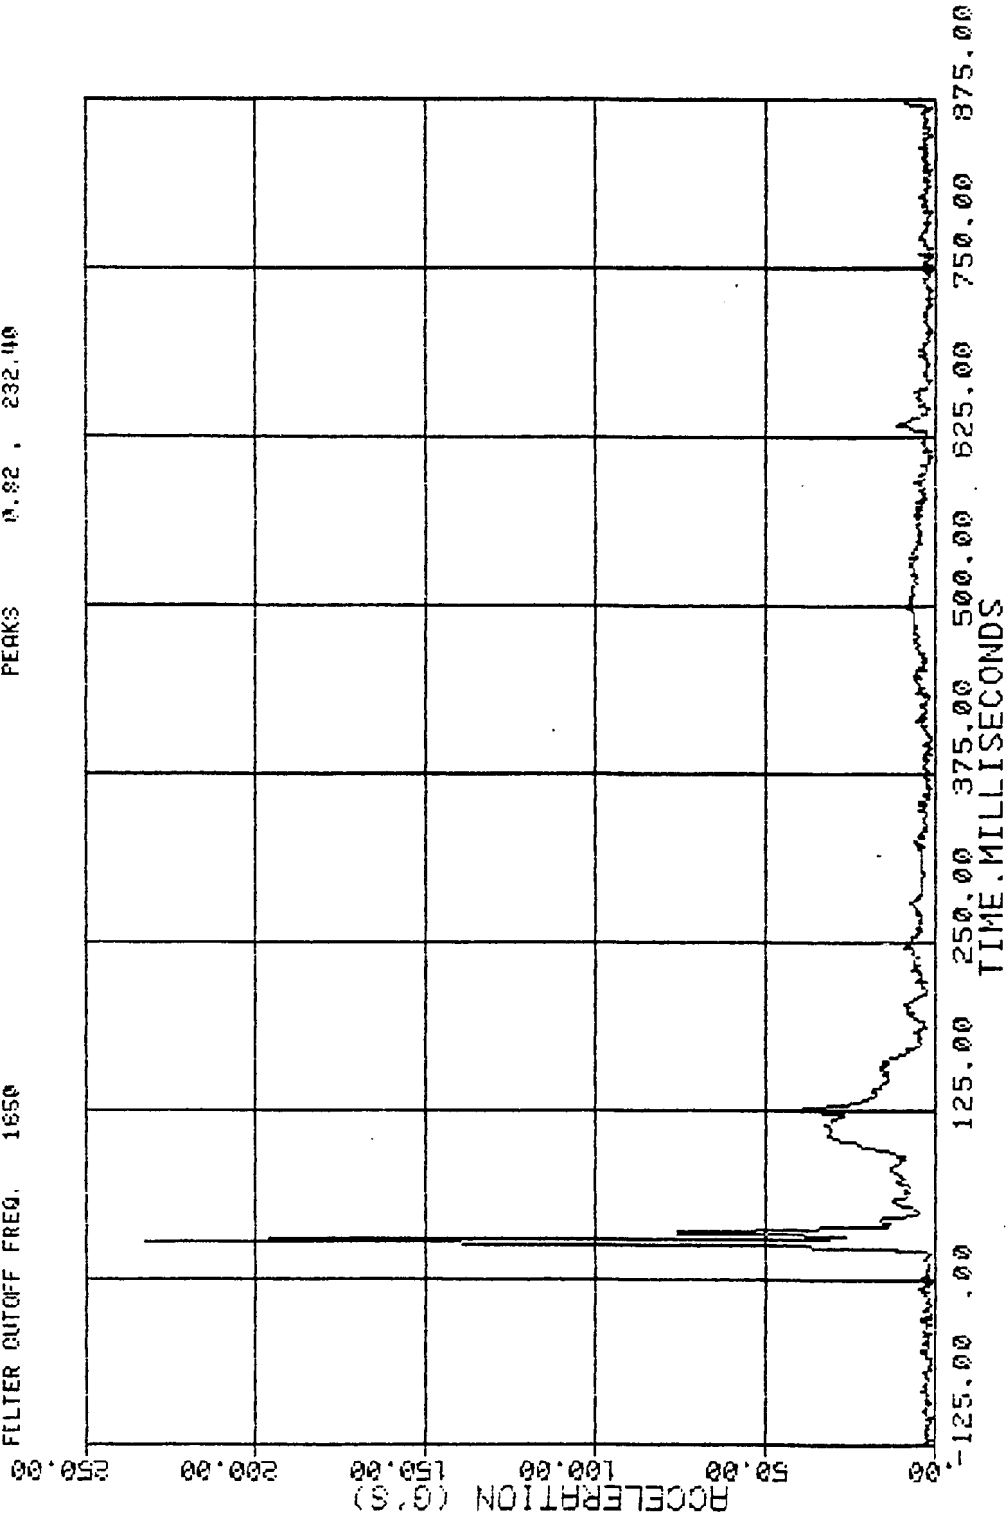
Figure A14. Driver's Head Acceleration, Resultant, 1650 Hz

ENSO, INC.      CONTRACT NUMBER    DTFH61-86-Z-00047      TEST NUM1785-SI-1-07  
 30 MI/H BROADSIDE IMPACT OF 80 PLYMOUTH CHAMP INTO LUMINAIRE SUPPORT  
 CHANNEL 0      DRIVER HEAD ACCELERATION, RESULTANT  
 FILTER CUTOFF FREQ.    1650      PEAKS      0.82      232.40

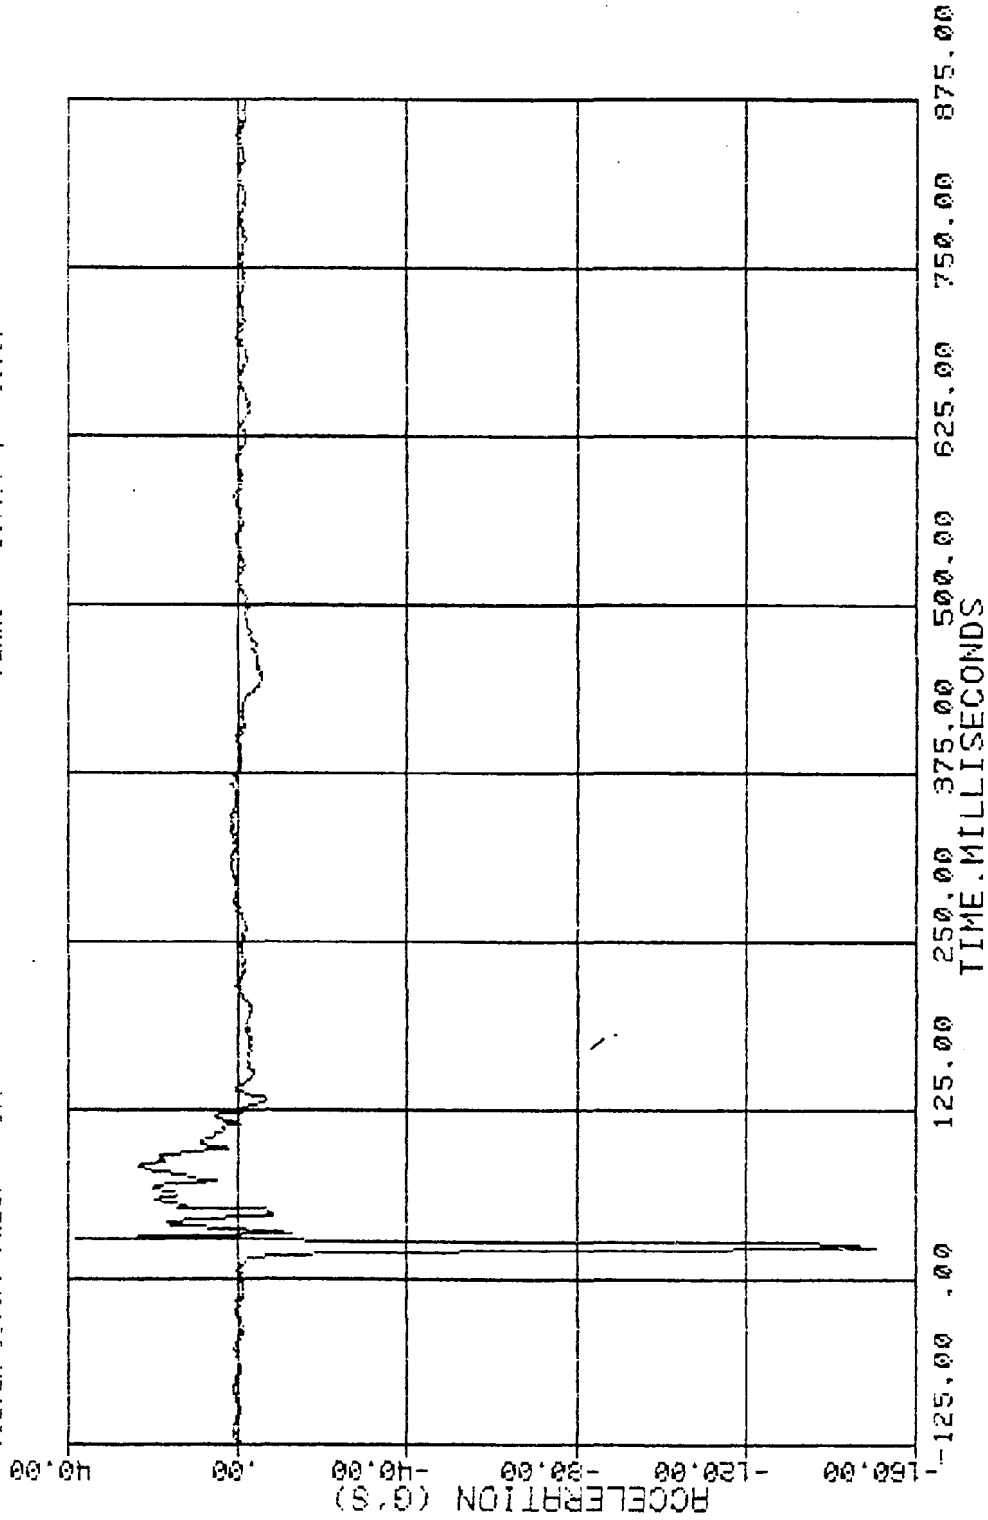
Figure A15. Driver's Lower Spine Acceleration, T12Y, 300 Hz

ENSCO, INC.      CONTRACT NUMBER    DTFH61-86-Z-00047      TEST NUM 1785-SI-1-87  
 3M MI/H BROADSIDE IMPACT OF 80 PLYMOUTH CHAMP INTO LUMINAIRE SUPPORT  
 CHANNEL 9      DRIVER THORAX, T12Y  
 FILTER CUTOFF FREQ.    300      PEAKS    -150.77 ,    38.80

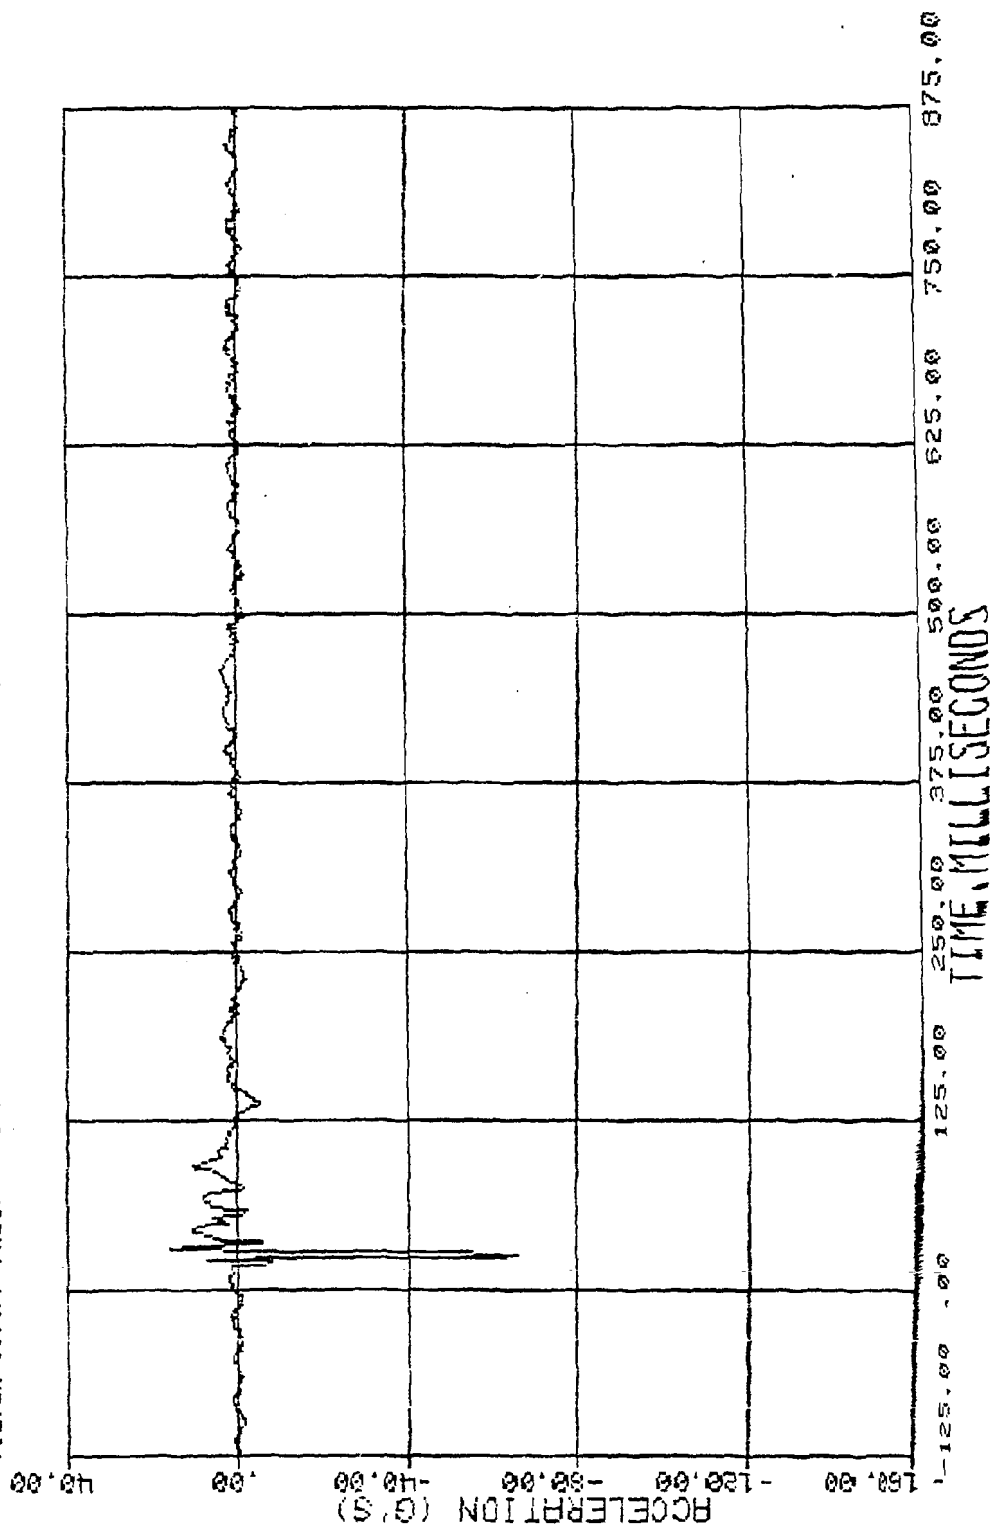
Figure A16. Driver's Lower Spine Acceleration, T12Z, 300 Hz

ENSO, INC.      CONTRACT NUMBER    DTIC1-86-7-0047      TEST NUM 1785-31-1-87  
 3P MI/H BROADSIDE IMPACT OF 80 PLYMOUTH CHAMP INTO LUMINAIRE SUPPORT  
 CHANNEL 18      DRIVER THROCK, T12Z  
 FILTER CUTOFF FREQ.    300      PEAKS    -85.74 ,    15.58

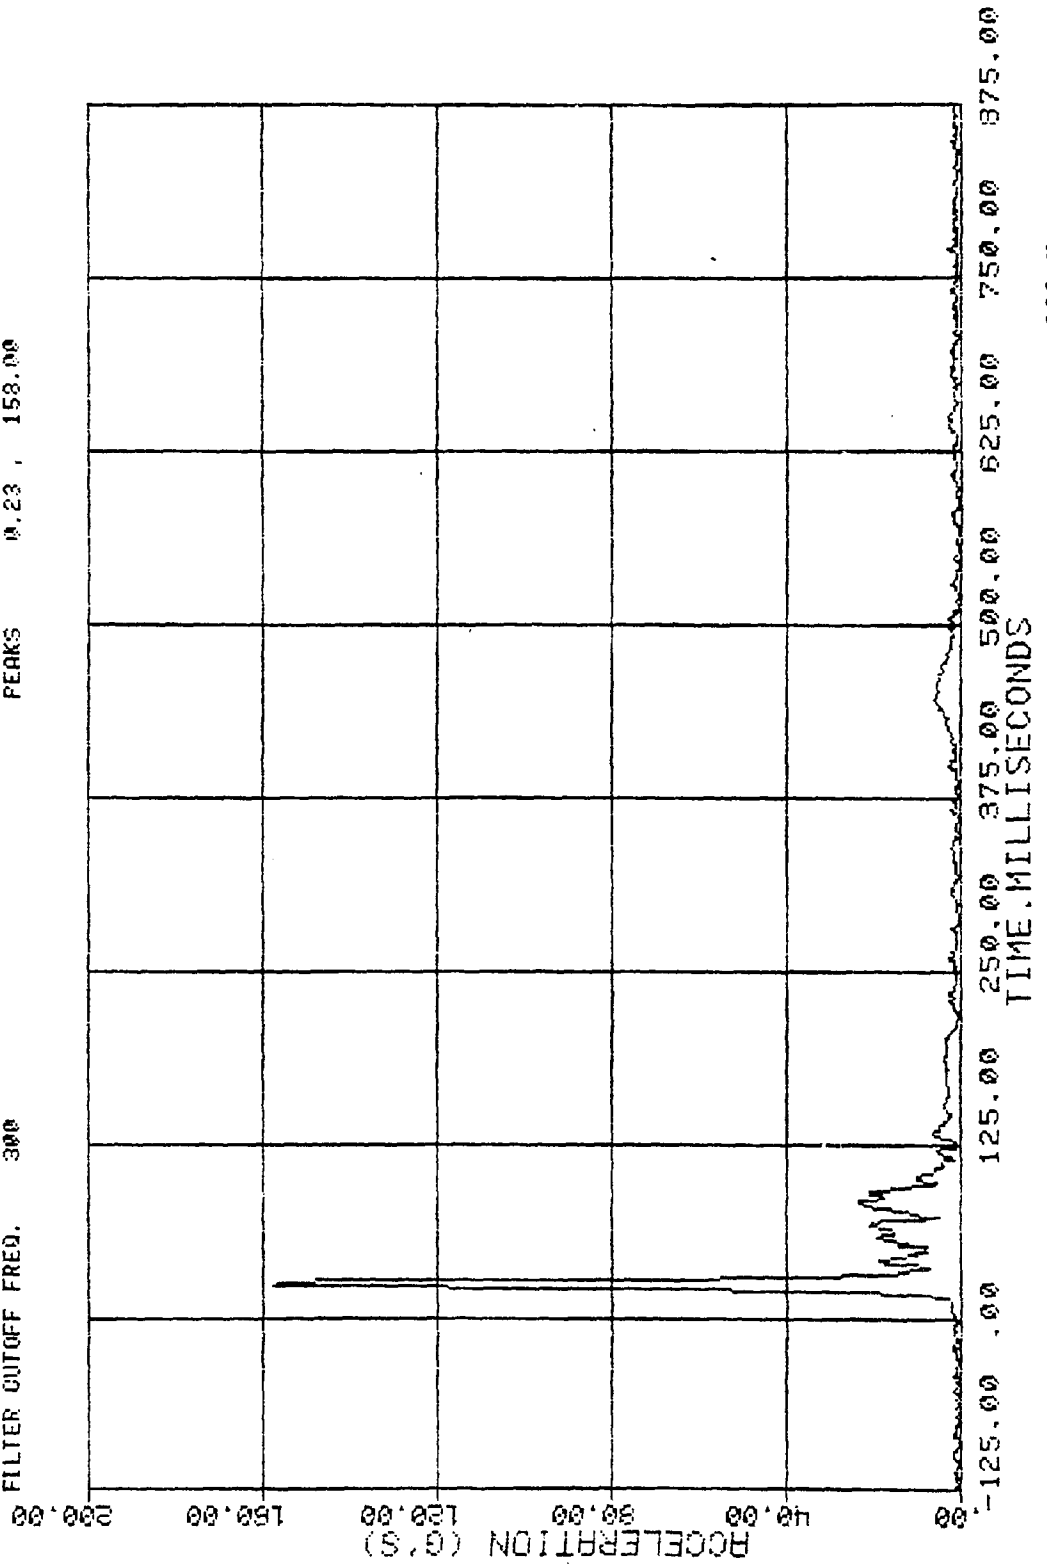
Figure A17. Driver's Lower Spine Acceleration, Resultant, 300 Hz

EISCO, INC.      CONTRACT NUMBER    DTFH61-86-Z-0047      TEST NUM 1785-SI-1-87  
 38 MI/H BROADSIDE IMPACT OF 80 PLYMOUTH CHAMP INTO LUMINAIRE SUPPORT  
 CHANNEL 0      DRIVER THORAX, T12, RESULTANT  
 FILTER CUTOFF FREQ.    300      PEAKS      0.23 ,    158.00

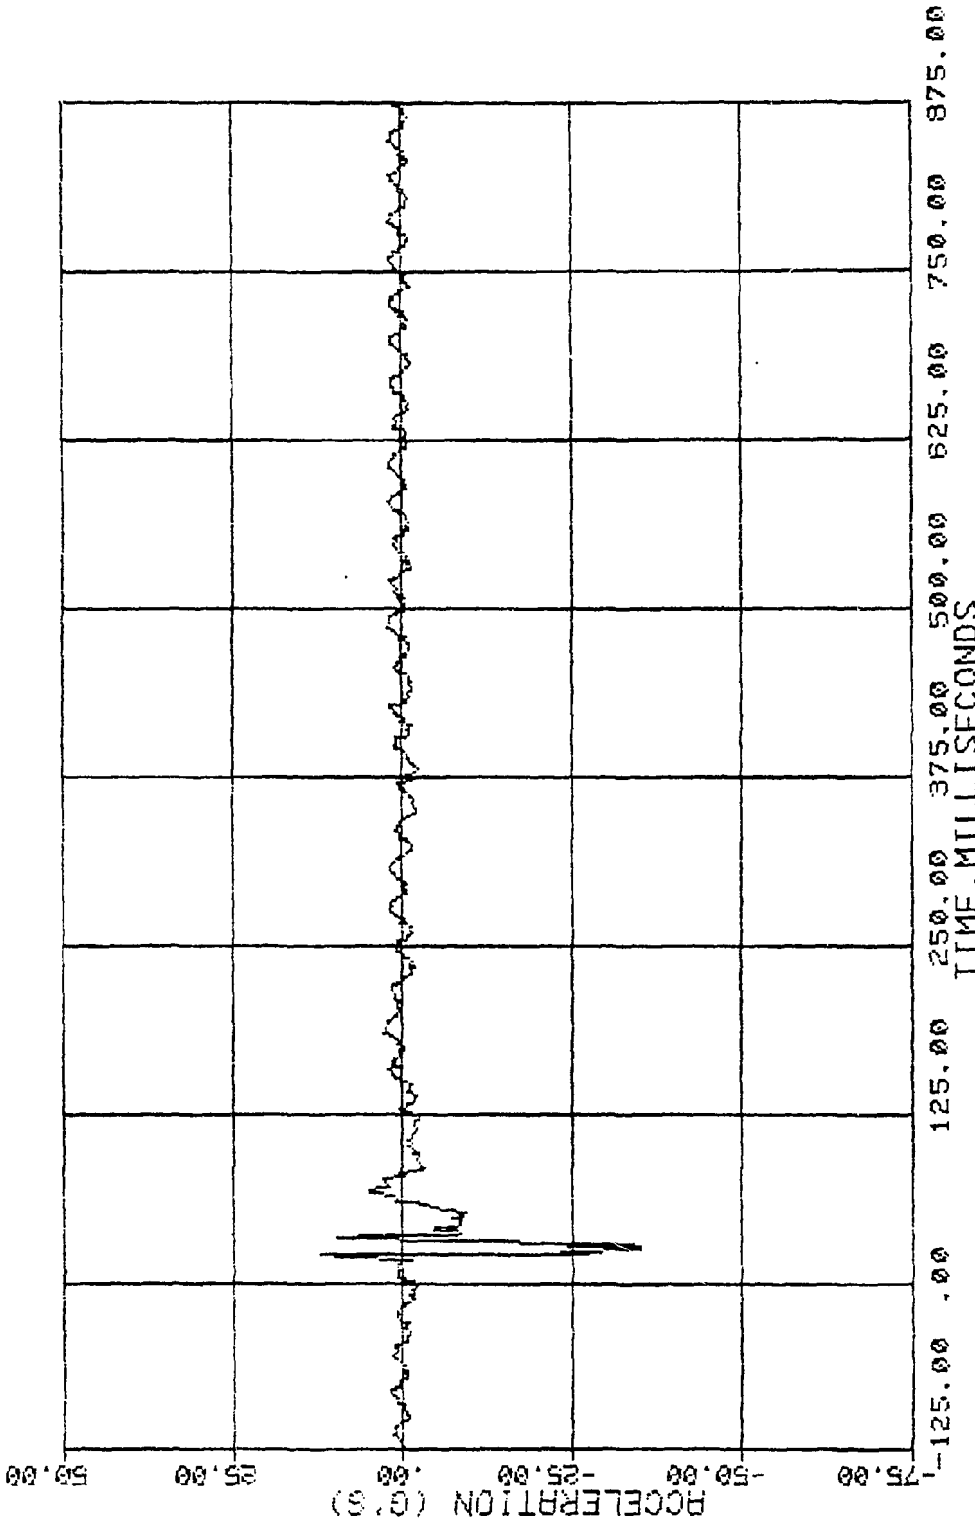
Figure A18. Driver's Pelvis Acceleration, X-Axis, 300 Hz

ENSCO, INC.      CONTRACT NUMBER    DTFHE1-86-Z-00047      TEST NUM1795-S1-1-87  
 30 MI/H BROADSIDE IMPACT OF 80 PLYMOUTH CHAMP INTO LUMINAIRE SUPPORT  
 CHANNEL 16    DRIVER PELVIS ACCELERATION, X-AXIS  
 FILTER CUTOFF FREQ.    300      PEAKS    -35.24 ,    12.24

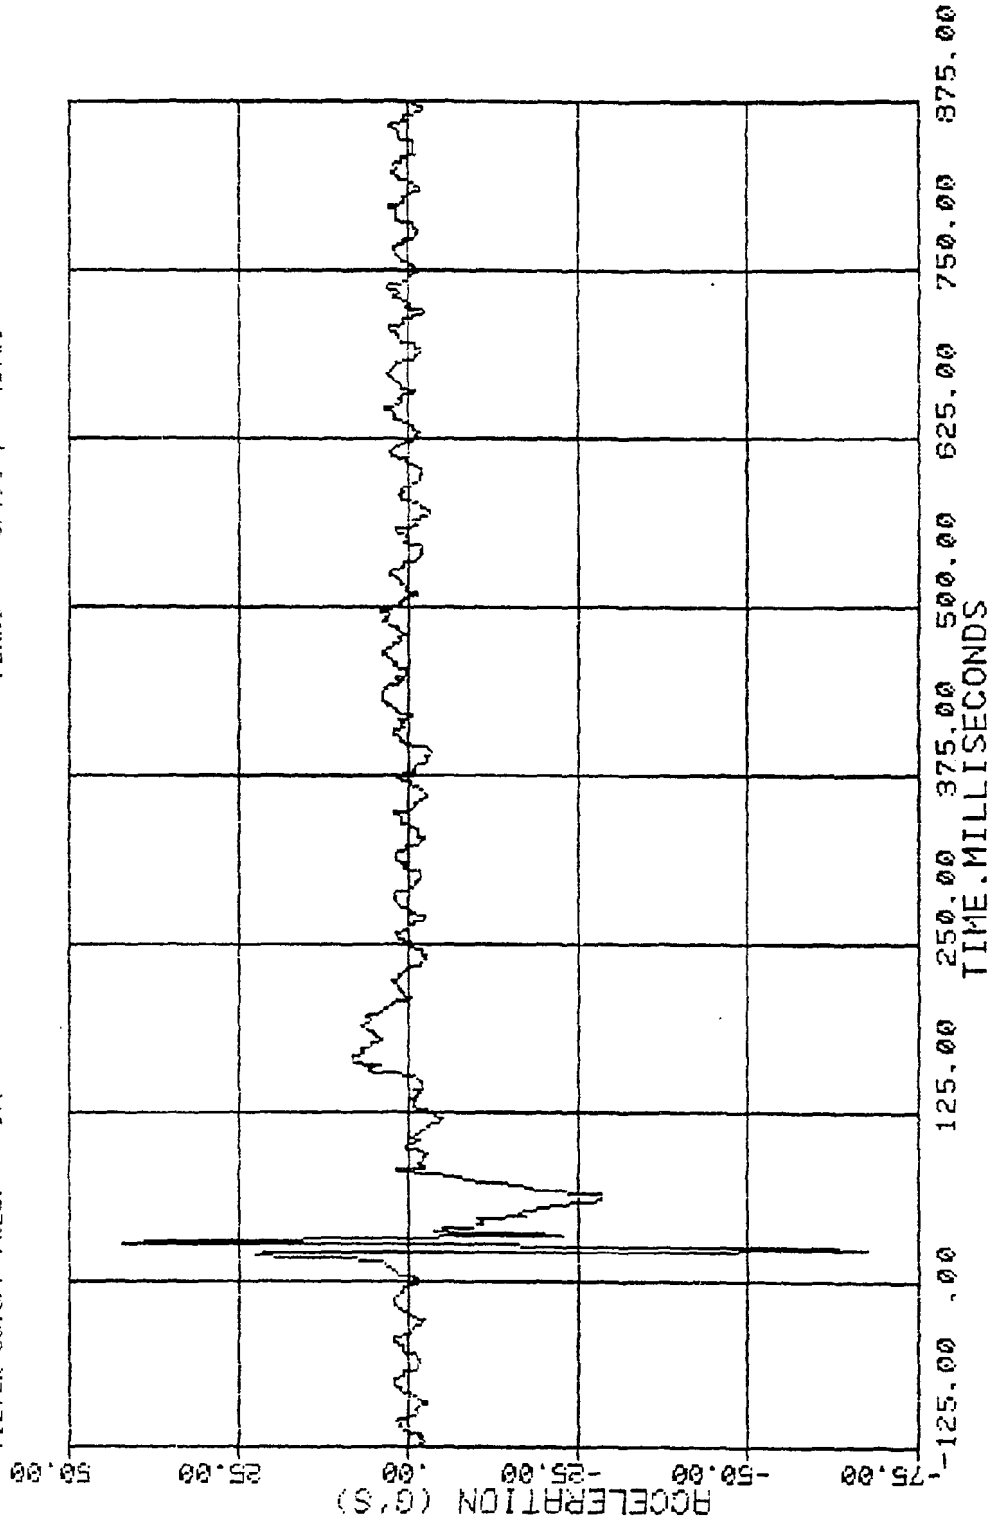
Figure A19. Driver's Pelvis Acceleration, Y-Axis, 300 Hz

ENSCO, INC. CONTRACT NUMBER DTIHEL-86-Z-00047 TEST NUM1705-51-1-87  
 3 1/4 BROADSIDE IMPACT OF 80 PLYWOOD CHAMP INTO LUMINAIRE SUPPORT  
 CHANNEL 17 DRIVER PELVIS ACCELERATION, Y-AXIS  
 FILTER CUTOFF FREQ. 300 PEAKS -67.75 , 41.86

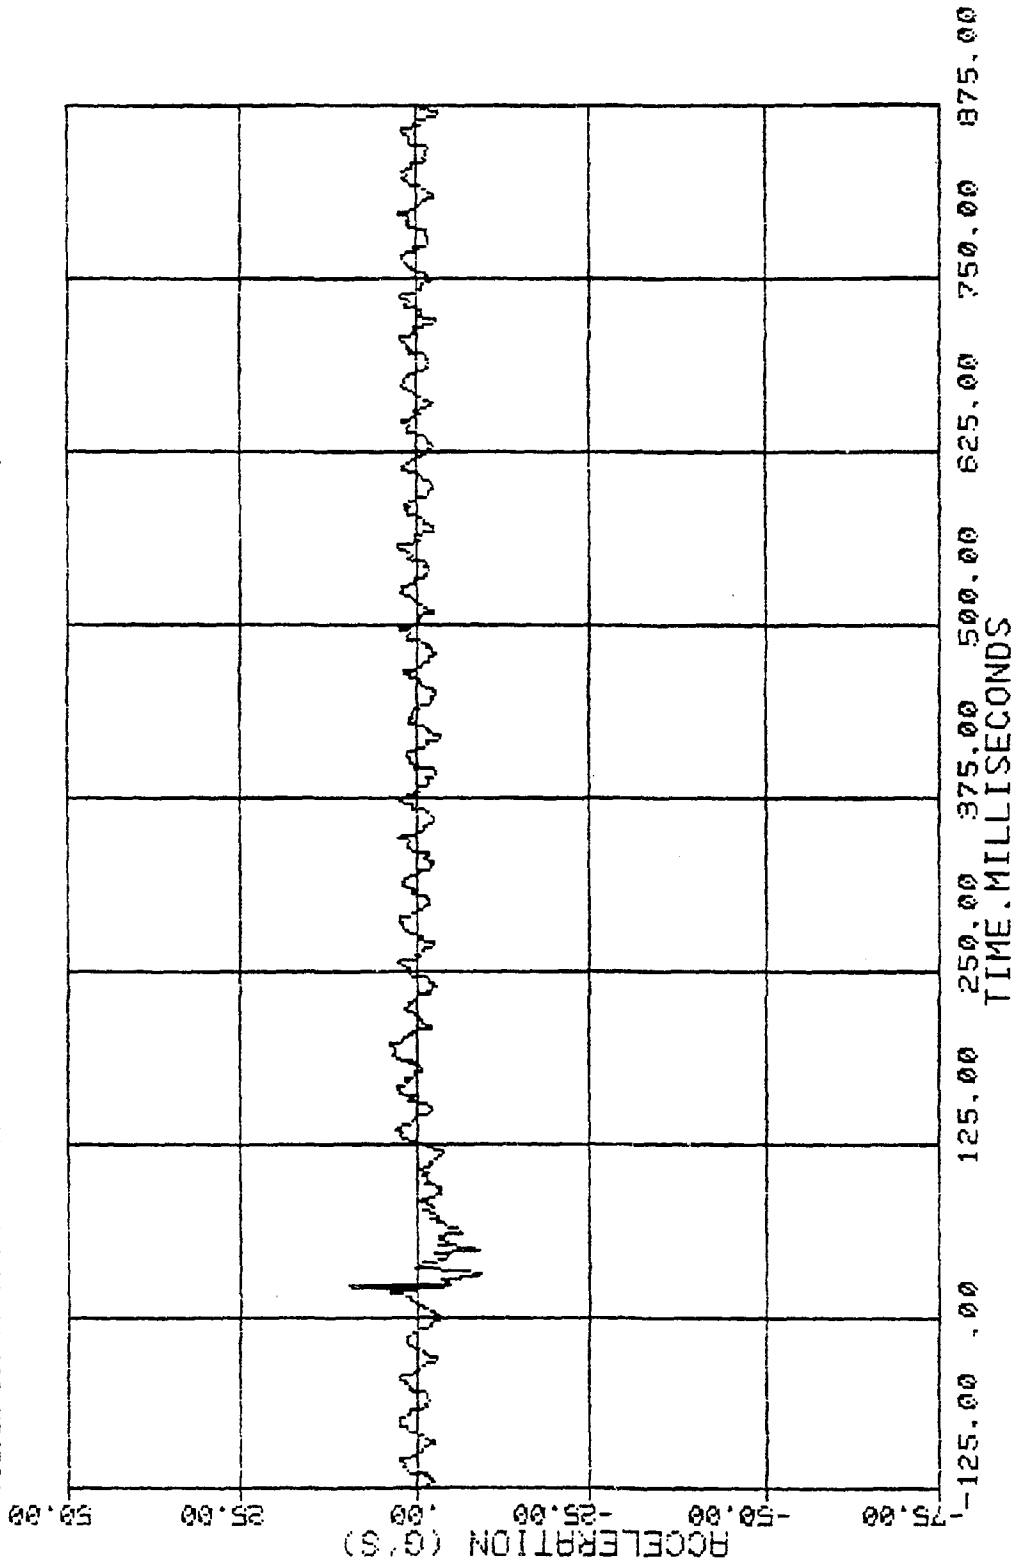
Figure A20. Driver's Pelvis Acceleration, Z-Axis, 300 Hz

ENSO, INC. CONTRACT NUMBER DTFH61-86-Z-00047 TEST NUM1785-SI-1-87  
 30 MI/H BROADSIDE IMPACT OF 80 PLYMOUTH CHAMP INTO LUMINAIRE SUPPORT  
 CHANNEL 12 DRIVER PELVIS ACCELERATION, Z-AXIS  
 FILTER CUTOFF FREQ. 300 PEAKS -0.49 , 3.81

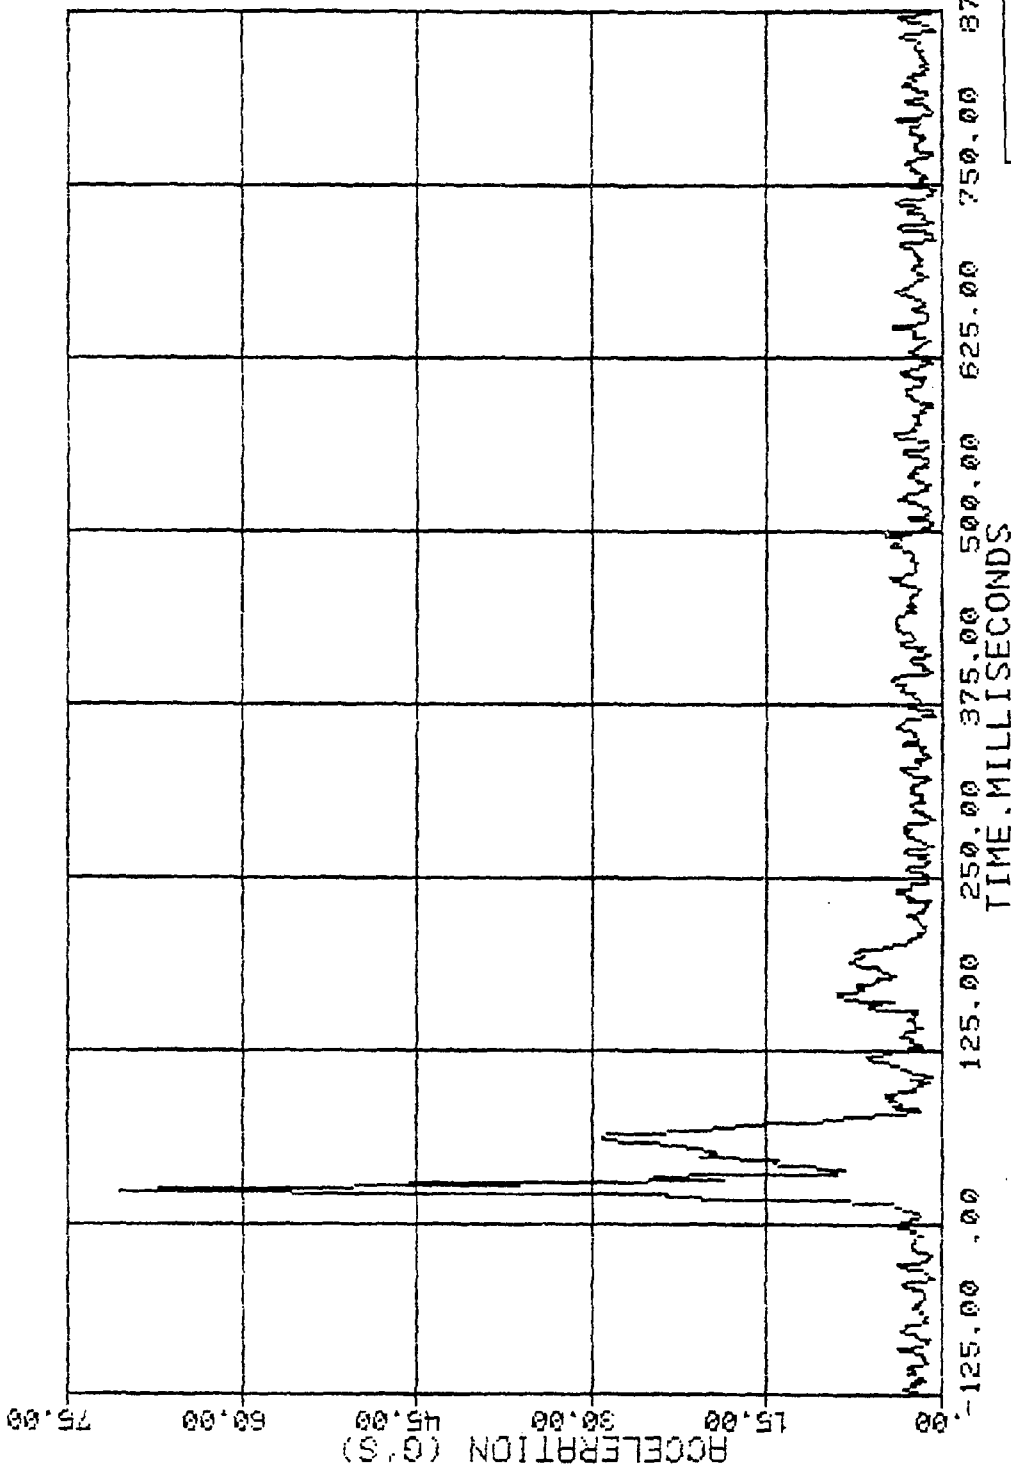
Figure A21. Driver's Pelvis Acceleration, Resultant, 300 Hz

ENSO, INC. CONTRACT NUMBER DTFH61-86-Z-00047 TEST NUM 785-GI-1-87  
 30 MPH BROADSIDE IMPACT OF 80 PLYMOUTH CHAMP INTO LUMINGIRE SUPPORT  
 CHANNEL 0 DRIVER PELVIS ACCELERATION, RESULTANT  
 FILTER CUTOFF FREQ. 300 PEAKS 0.52, 70.72

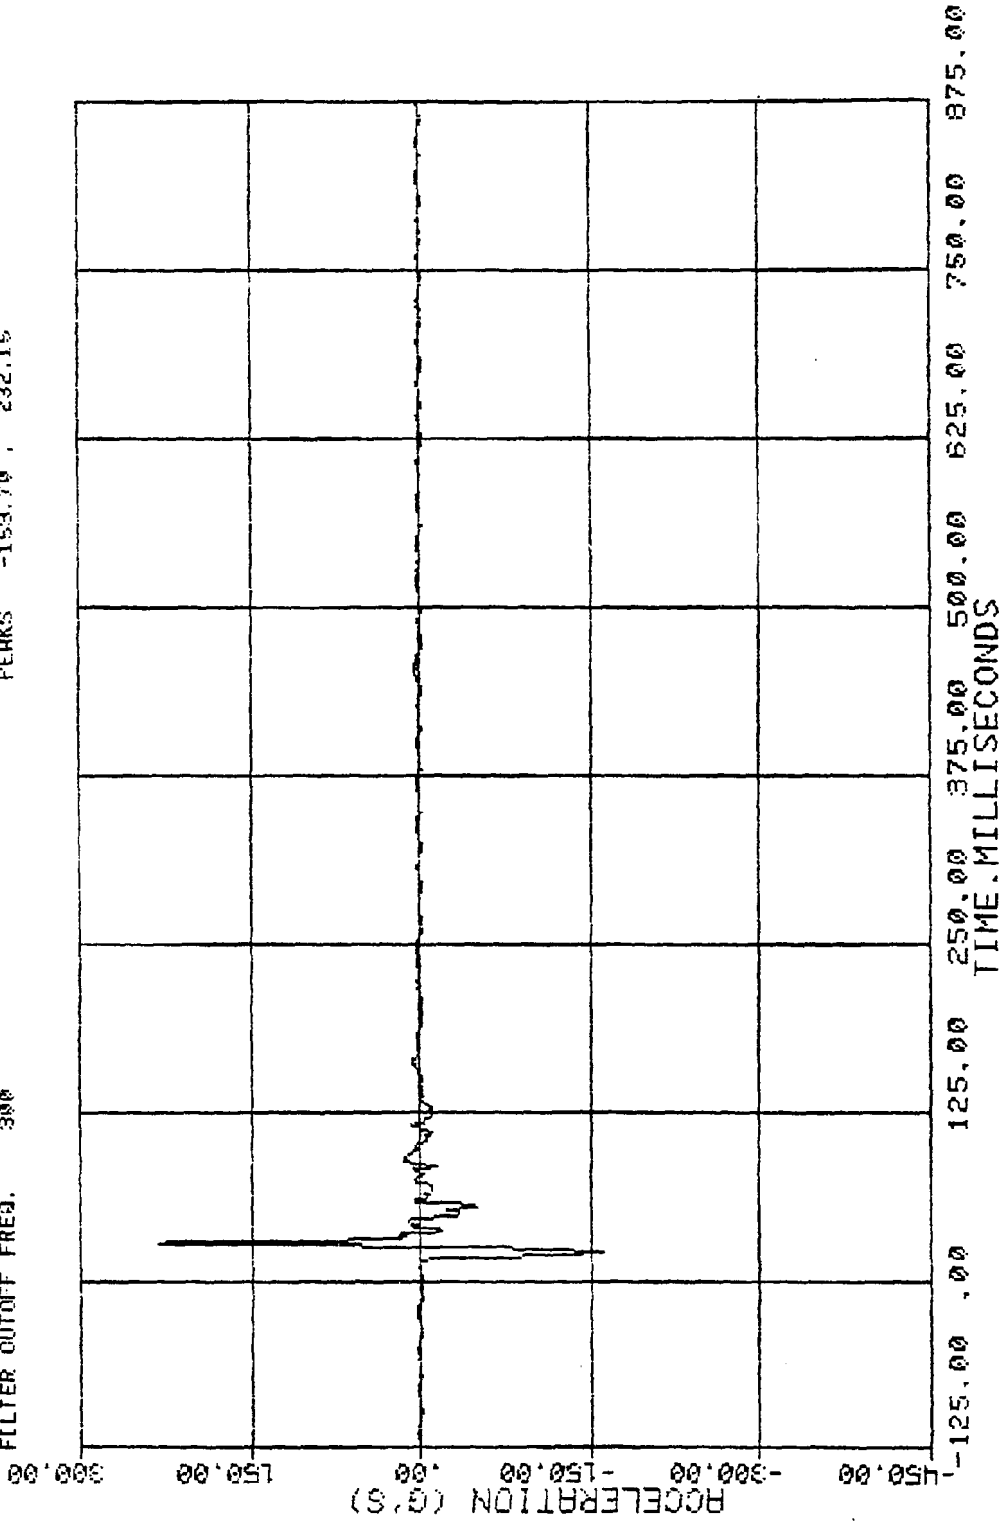
Figure A22. Driver's Upper Sternum Acceleration, USTX, 300 Hz

ENSO, INC. CONTRACT NUMBER DTFH61-86-Z-00047 TEST NUM1735-SI-1-87  
 30 MI/H BROADSIDE IMPACT OF 80 PLYMOUTH CHAMP INTO LUMINAIRE SUPPORT  
 CHANNEL 11 DRIVER THORAX, USTX  
 FILTER CUTOFF FREQ. 300 PEAKS -153.70 , 232.15

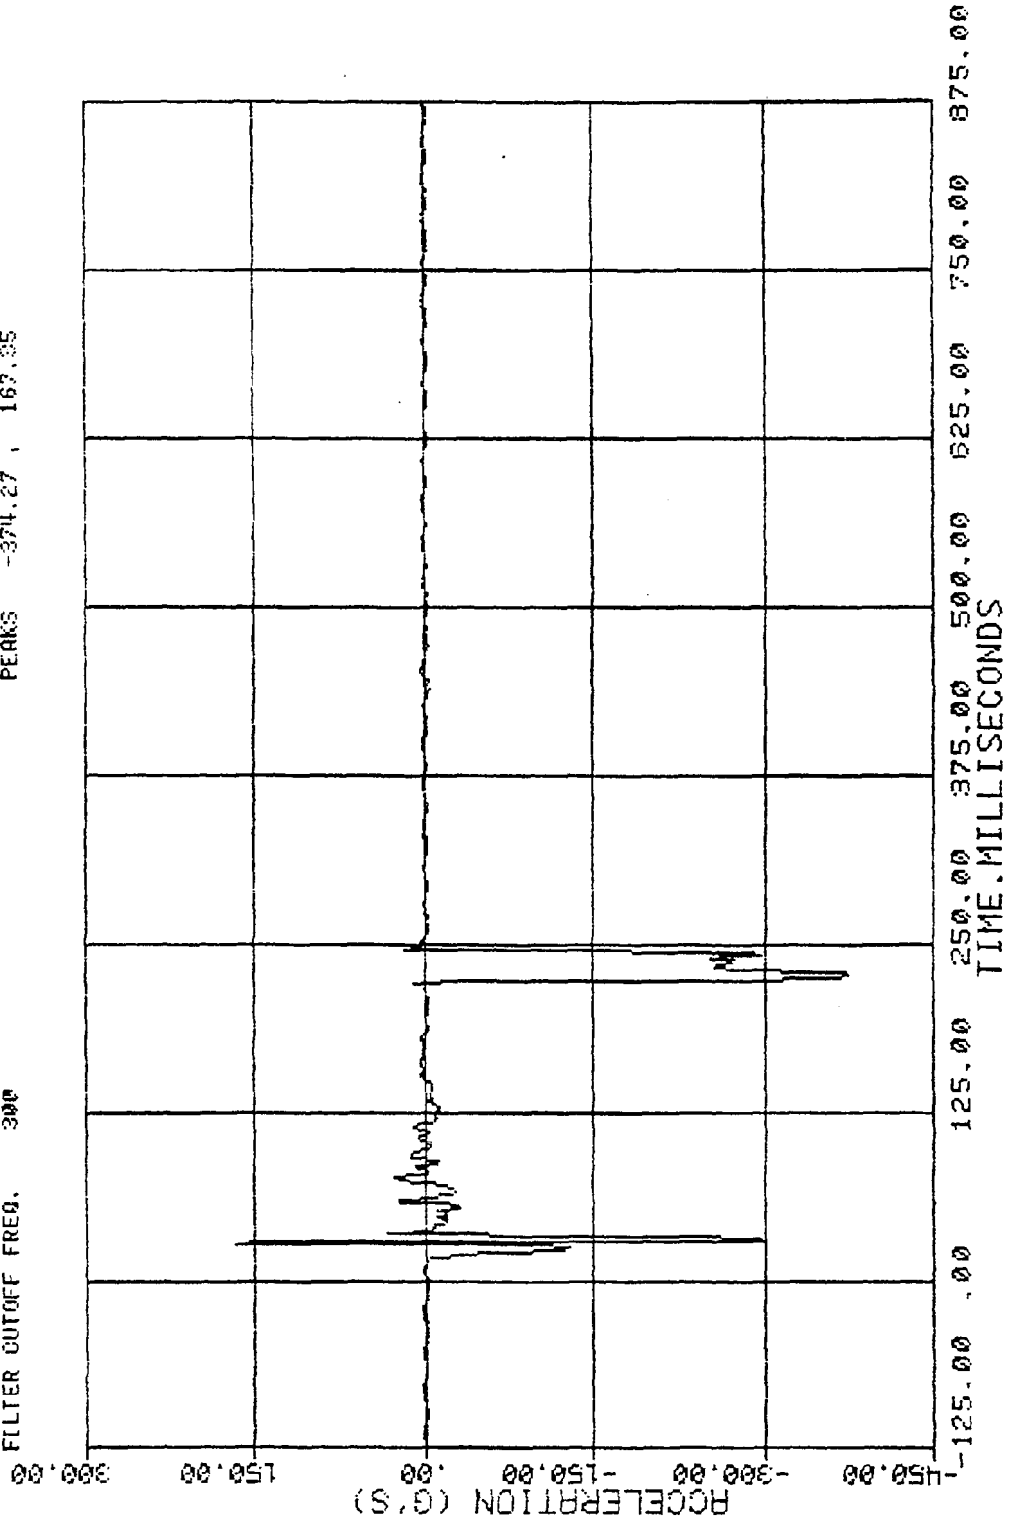
Figure A23. Driver's Lower Sternum Acceleration, LSTX, 300 Hz

ENSCO, INC. CONTRACT NUMBER DTFH61-86-Z-00047 TEST NUM1785-SI-1-87  
 30 MI/H BROADSIDE IMPACT OF 80 PLYMOUTH CHAMP INTO LUMINAIRE SUPPORT  
 CHANNEL 12 DRIVER THORAX, LSTX  
 FILTER CUTOFF FREQ. 300 PEAKS -374.27 , 167.05

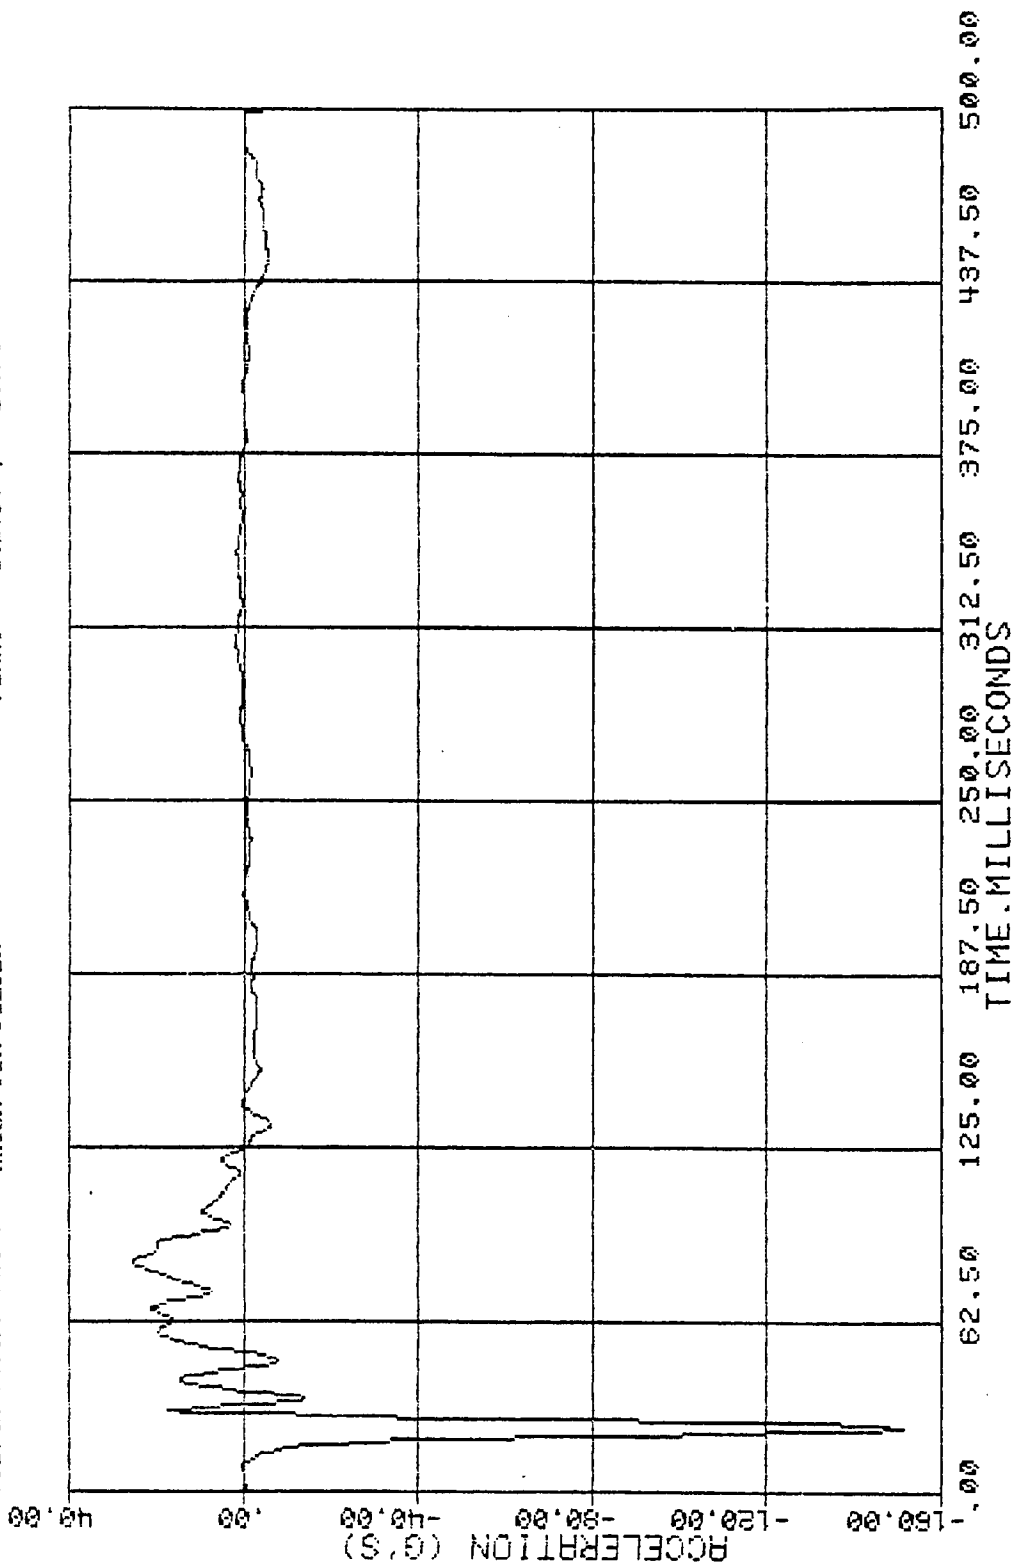
Figure A24. Driver's Lower Spine Acceleration, T12Y, NHTSA FIR Filter

ENSCO, INC. CONTRACT NUMBER DTFH61-86-Z-00047 TEST NUM 1785-SI-1-87  
 34 MI/A GROUNDSIDE IMPACT OF 80 PLYMOUTH CHAMP INTO LUMINAIRE SUPPORT  
 CHANNEL 3 DRIVER THORAX, T12Y  
 FILTER CUTOFF FREQ. NHTSA FIR FILTER PEAKS -151.10 , 25.75

The T12Y data was taken from figure A24. The peak value of T12Y is 151 g's. Thus the TTI index is 151 plus occupant age. This value produces a 87% probability of injury of an AIS greater than 3, 77% probability of injury of an AIS greater than 4 and a 8% probability of injury of an AIS greater than 5 for age 0. See figure 5 for TTI values.
