| 4. Title and Subtitle TESTING OF NEW BRIDGE RAIL AND TRANSITION DESIGNS Volume II: Appendix A Oregon Side Mounted Bridge Railing | | 5. Report Date | 6. Performing Organization Code |
| 7. Author(s) C. Eugene Buth, T. J. Hirsch, and Wanda L. Menges | | 8. Performing Organization Report No. Research Foundation 7069-Vol. II | |
| 9. Performing Organization Name and Address Texas Transportation Institute The Texas A&M University System College Station, Texas 77843-3135 | | 10. Work Unit No. NCP No. 3A5C0042 | 11. Contract or Grant No. DTFH61-86-C-00071 |

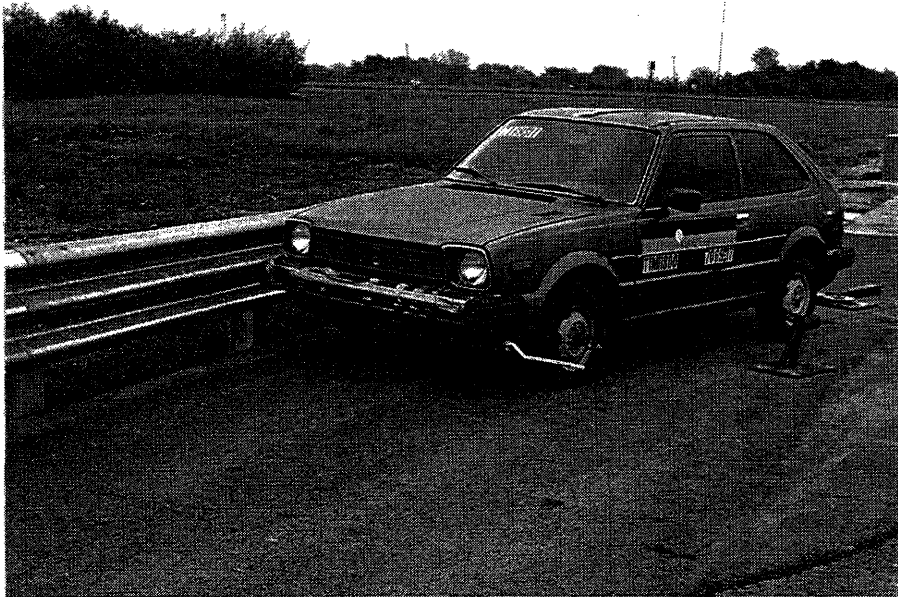
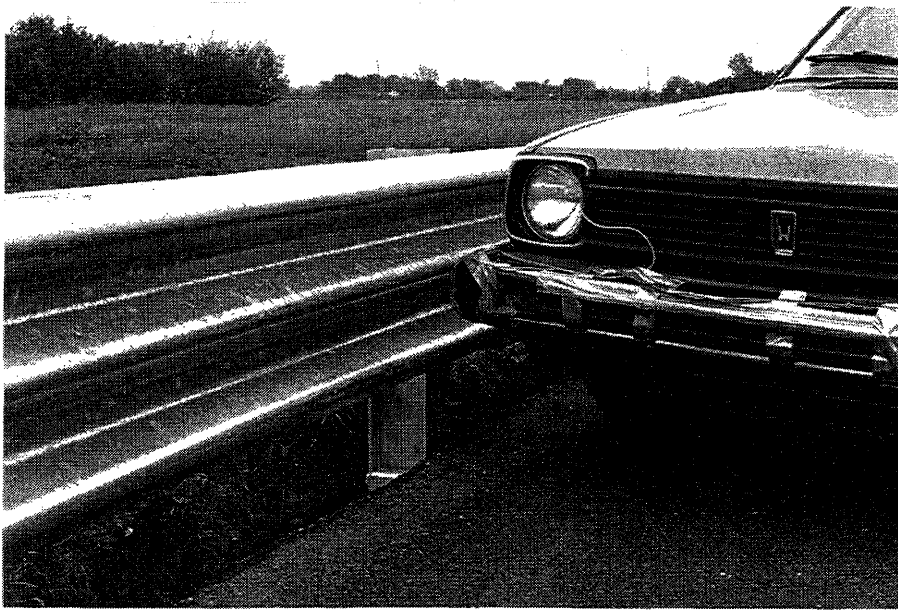
Figure 2. Vehicle/bridge railing geometrics for test 7069-17.

The 1980 Honda Civic (figure 2) was directed into the Oregon side-mounted bridge railing (figures 3 and 4) using a cable reverse tow and guidance system. Test inertia mass of the vehicle was 1,800 lb (817 kg) and its gross static mass was 1,970 lb (894 kg). The height to the lower edge of the vehicle bumper was 14.0 in (356 mm) and it was 19.75 in (502 mm) to the top of the bumper. Other dimensions and information on the test vehicle are given in figure 5. The vehicle was free-wheeling and unrestrained just prior to impact.

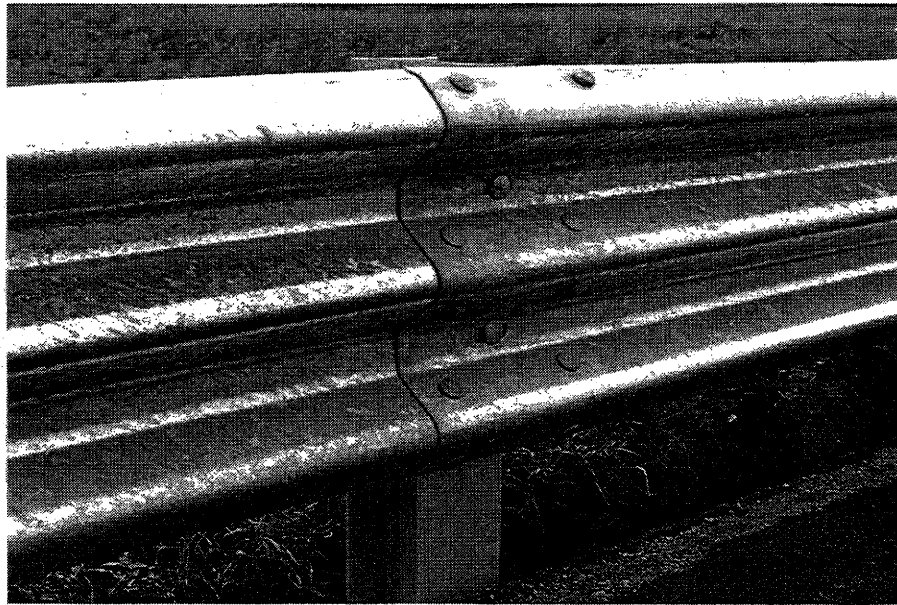
Figure 3. Oregon side-mounted bridge railing (front view) before test 7069-17.

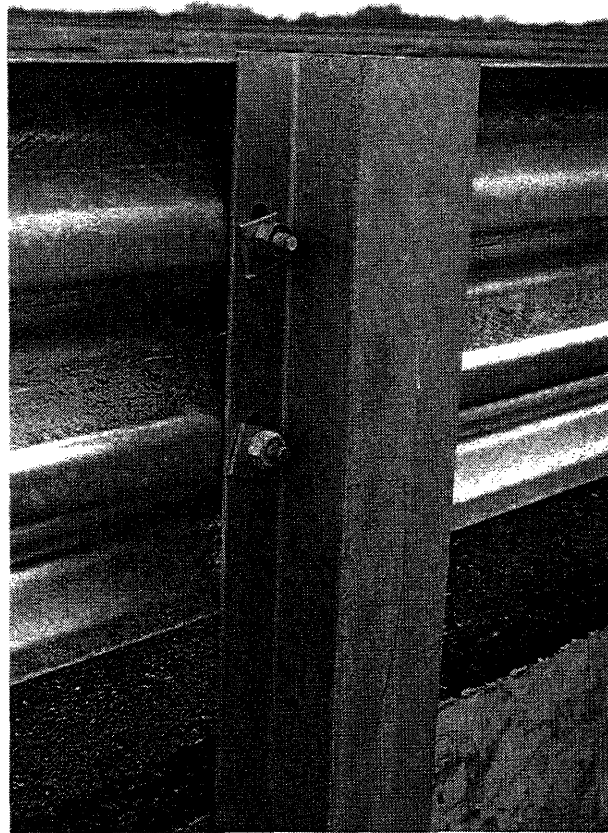
Figure 4. Oregon side-mounted bridge railing (rear view) before test 7069-17.

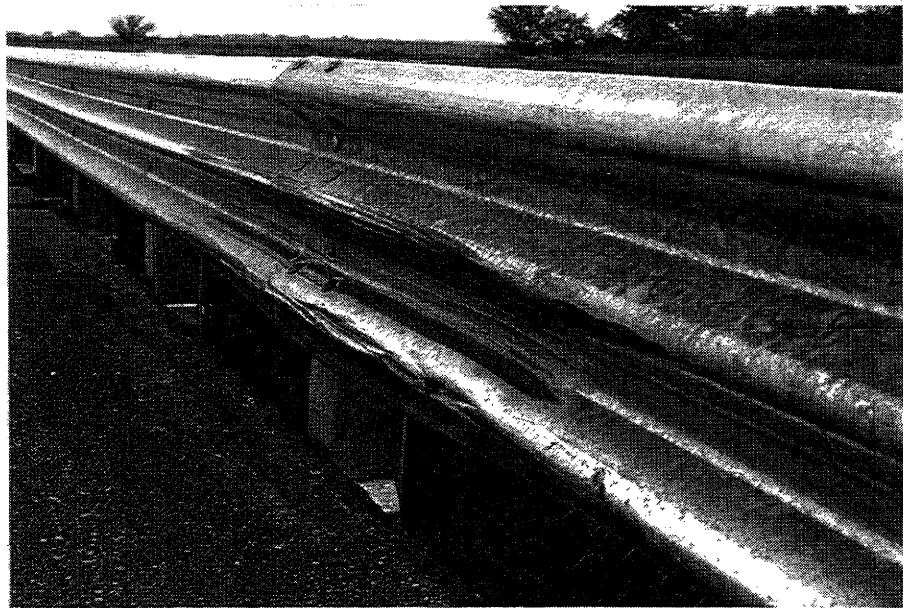
Figure 6. Oregon side-mounted bridge railing after test 7069-17.

As can be seen in figures 6 and 7, the railing received moderated damage. Maximum lateral deflection was 0.5 in (13 mm) at the top of post 5. The vehicle was in contact with the bridge railing for 9.3 ft (2.8 m).

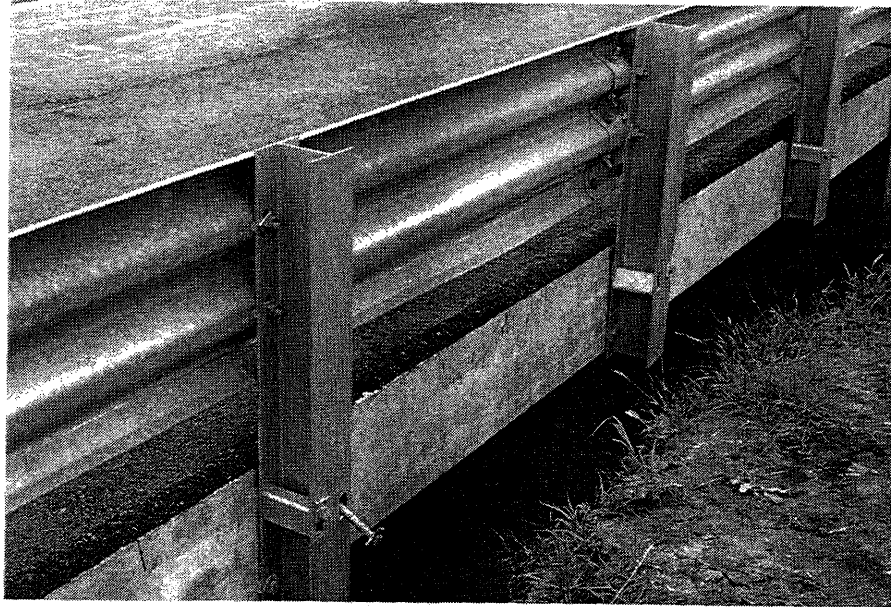
Figure 7. Damage to posts 4 and 5, test 7069-17.

At post 4, the top anchor bolts connecting the post to the bridge deck showed structural distress. One bolt was pulled from the anchor insert in the concrete. Post 5 was bent outward about 0.5 in (13 mm) at the top and the top anchor bolts showed structural distress. One of the bolts in this post was also pulled from the anchor insert.

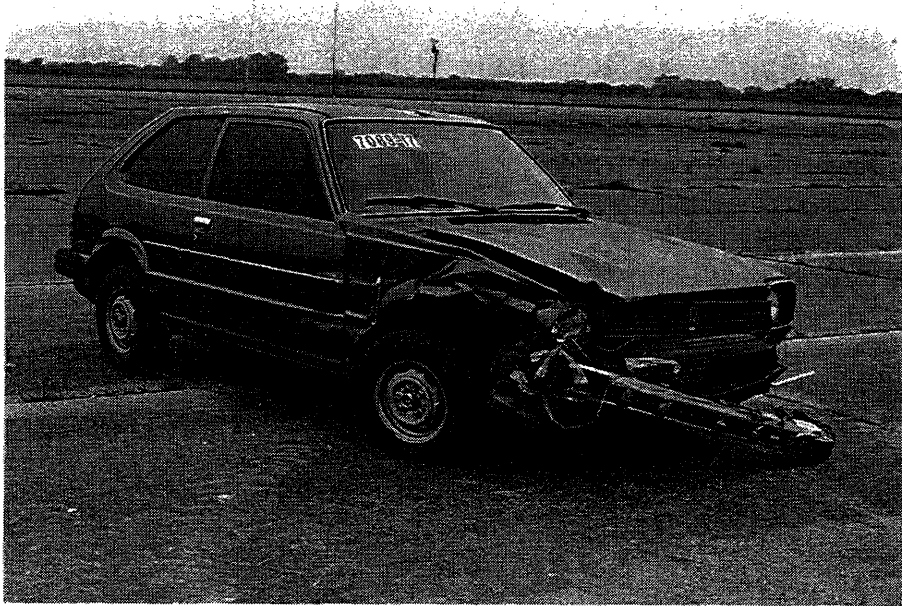
Figure 8. Vehicle after test 7069-17.

The vehicle sustained damage to the right side as shown in figure 8. Maximum crush at the right front corner at bumper height was 9.0 in (229 mm). The strut and constant velocity joint on the right side were damaged. The right front wheel was canted inward at the bottom and pushed back into the fender well. The right side window was broken out by the head of the dummy. Also, damage was done to the front bumper, hood, grill, radiator and fan, the right front quarter panel, and the right door.

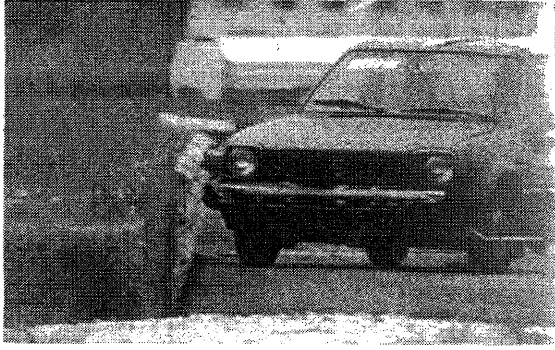
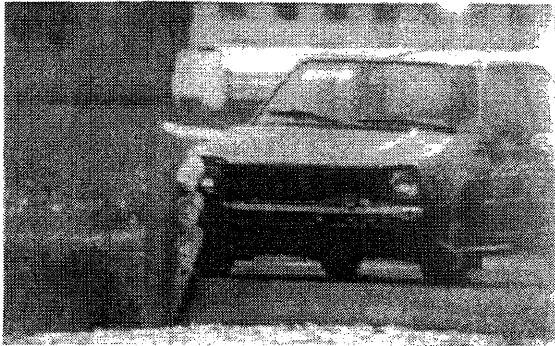
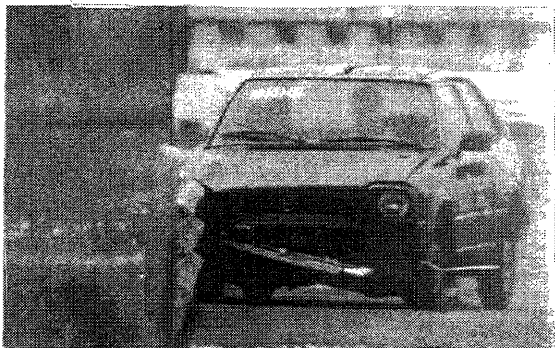
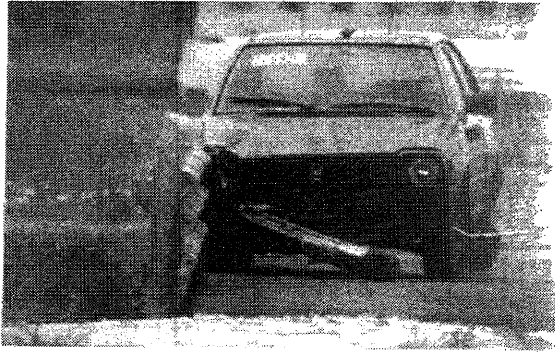
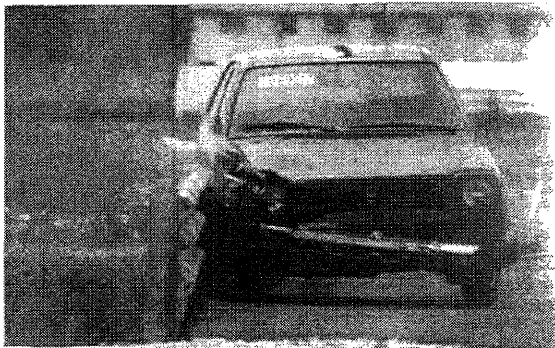
Figure 10. Sequential photographs for test 7069-17.

Figure 10. Sequential photographs for test 7069-17 (continued),

Impact speed was 52.2 mi/h (84.0 km/h) and the angle of impact was 19.7 degrees. The speed of the vehicle at time of parallel was 44.0 mi/h (70.8 km/h). The vehicle lost contact with the railing traveling at 42.7 mi/h (68.7 km/h). The exit angle between the vehicle path and the railing was 7.1 degrees. Occupant impact velocity was 18.8 ft/s (5.7 m/s) in the longitudinal direction and 18.9 ft/s (5.8 m/s) in the lateral direction. The highest 0.010-s occupant ridedown accelerations were -1.8 g (longitudinal) and 4.5 g (lateral). These data and other pertinent information from the test are summarized in figure 9 and tables 1 and 2. Sequential photographs are shown in figure 10 and the initial and final resting positions of the dummy are shown in figure 11. Vehicle angular displacements are displayed in figure 12. Vehicular accelerations versus time traces filtered with SAE J211 filters are presented in figures 13 through 15. These data were further analyzed to obtain 0.050-s average accelerations versus time. The maximum 0.050-s averages measured at the center-of-gravity were -5.2 g in the longitudinal direction and 8.4 g in the lateral direction.

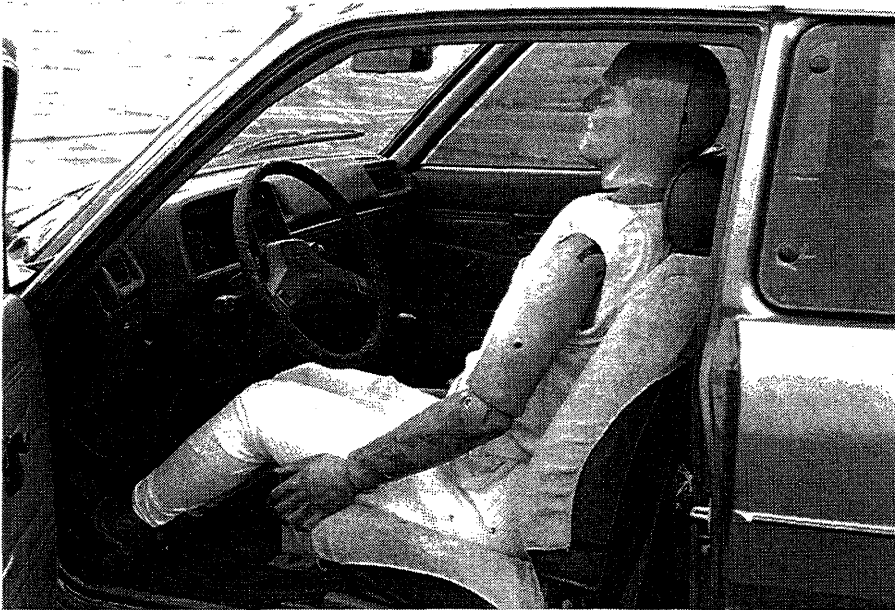
Figure 11. Dummy before and after test 7069-17.

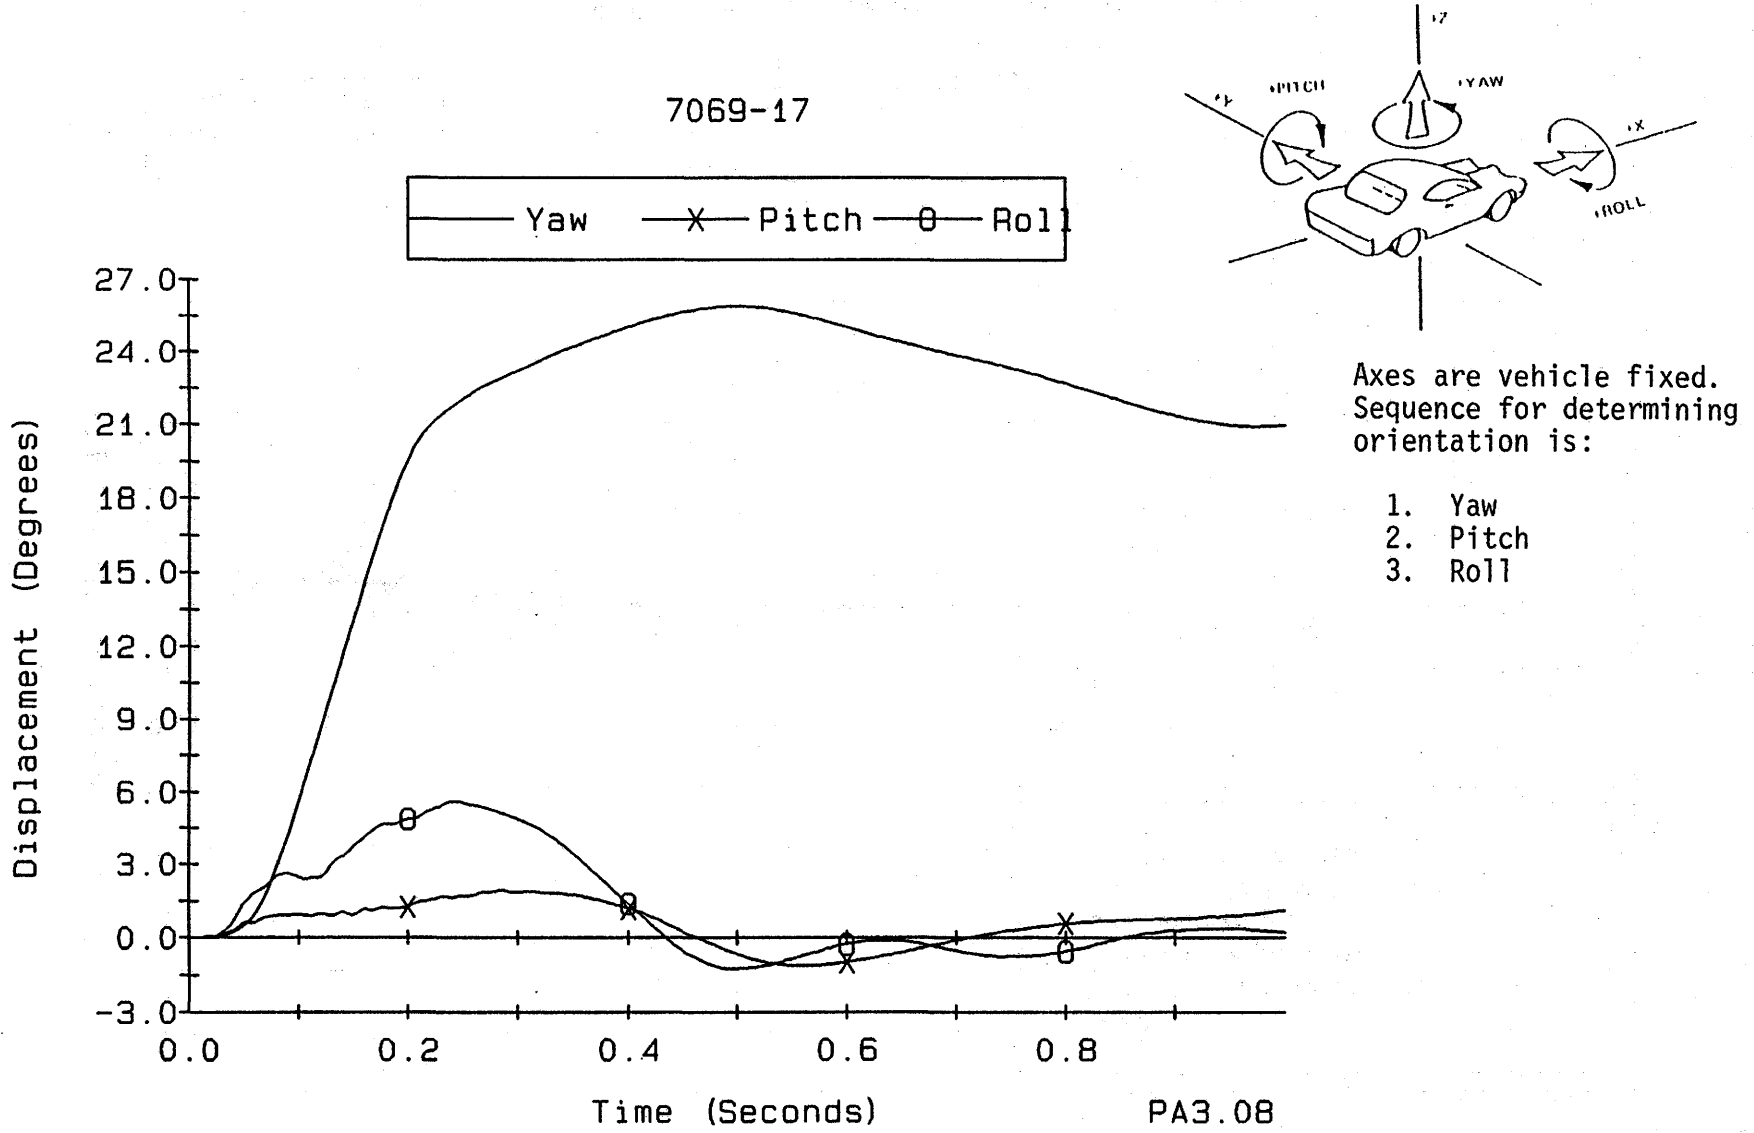
Figure 12. Vehicle angular displacements for test 7069-17

The PLOTANGLE program uses the digitized data from the yaw, pitch, and roll rate charts to compute angular displacement in degrees at 0.001-s intervals and instructs a plotter to draw a reproducible plot: yaw, pitch, and roll versus time. It should be noted that these angular displacements are sequence dependent with the sequence being yaw, pitch, and roll for the data presented herein. These displacements are in reference to the vehicle-fixed coordinate system with the initial position and orientation of the vehicle-fixed coordinate system being that which existed at initial impact.

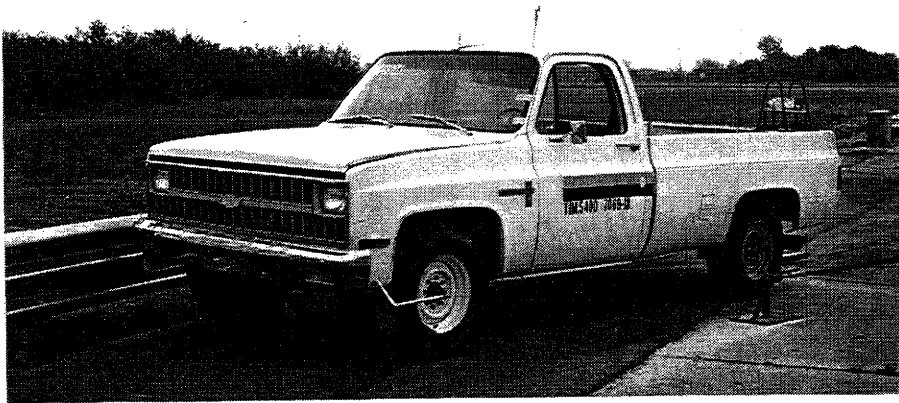
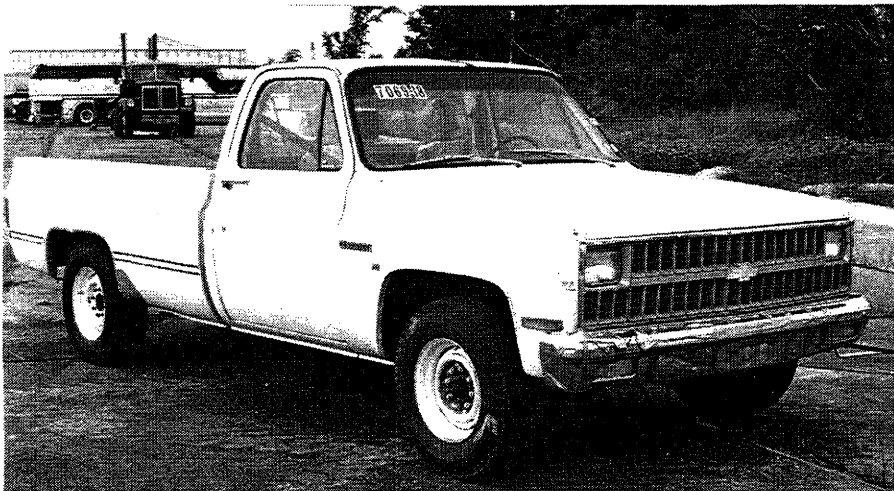
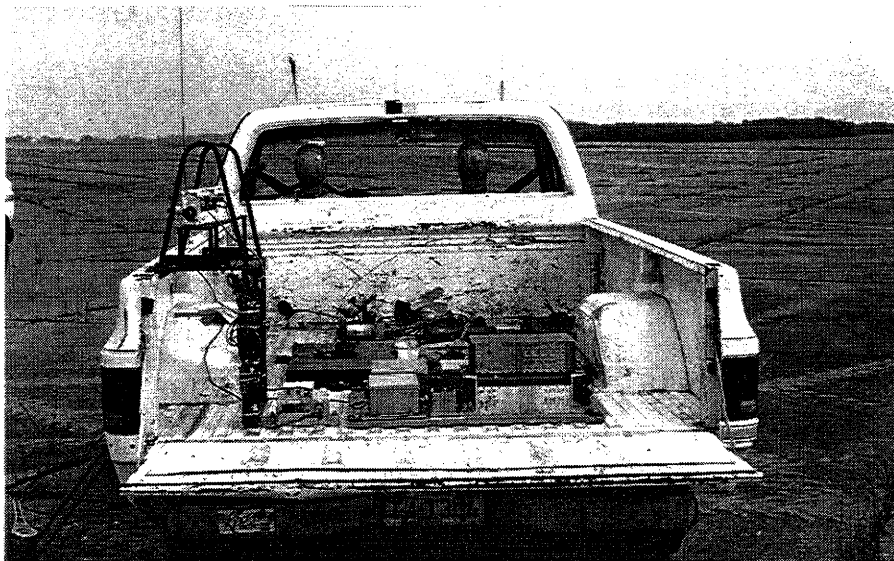
Figure 16. Vehicle before test 7069-18

The 1982 Chevrolet Custom Deluxe truck (figure 16) was directed into the Oregon side-mounted bridge railing (figure 17 and 18) using a cable reverse tow and guidance system. Test inertia mass of the vehicle was 5,400 lb (2 452 kg) and its gross static mass was 5,737 lb (2 605 kg). The height to the lower edge of the vehicle bumper was 17.75 in (451 mm) and it was 27.0 in (686 mm) to the top of the bumper. Other dimensions and information on the test vehicle are given in figure 19. The vehicle was free-wheeling and unrestrained just prior to impact.

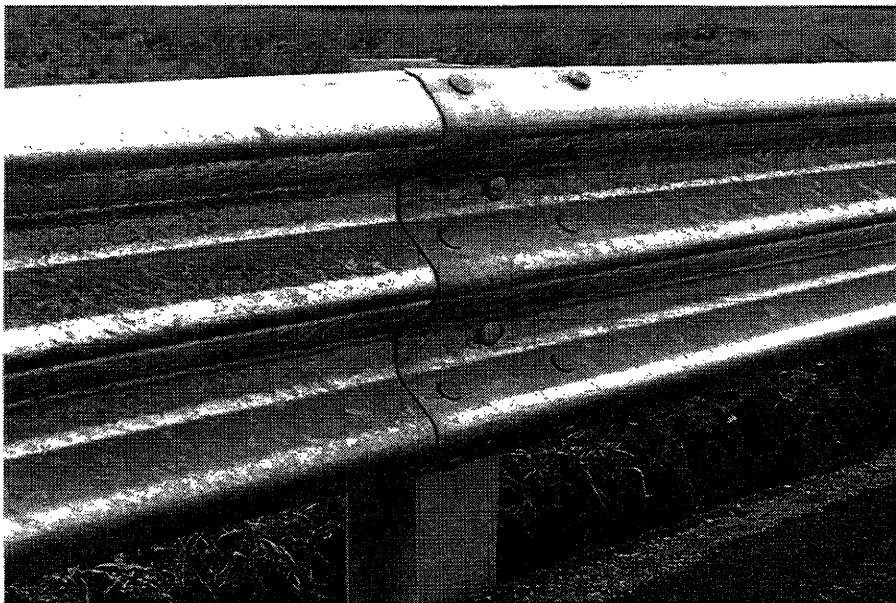
Figure 17. Oregon side-mounted bridge railing (front view) before test 7069-18.

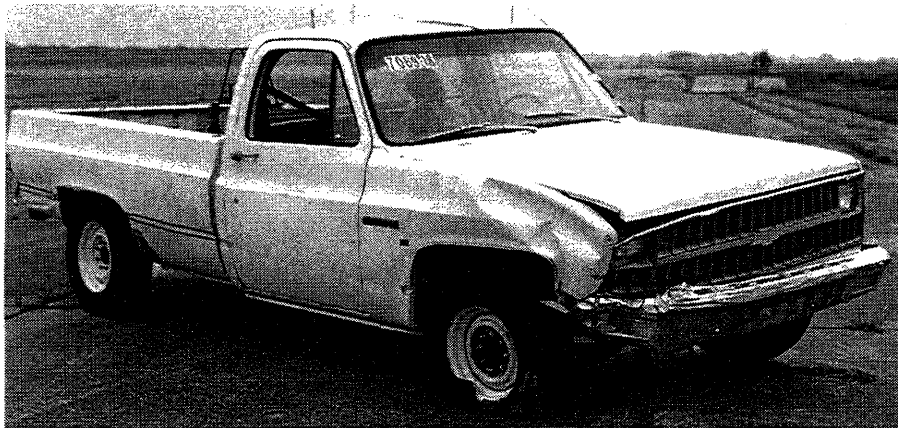
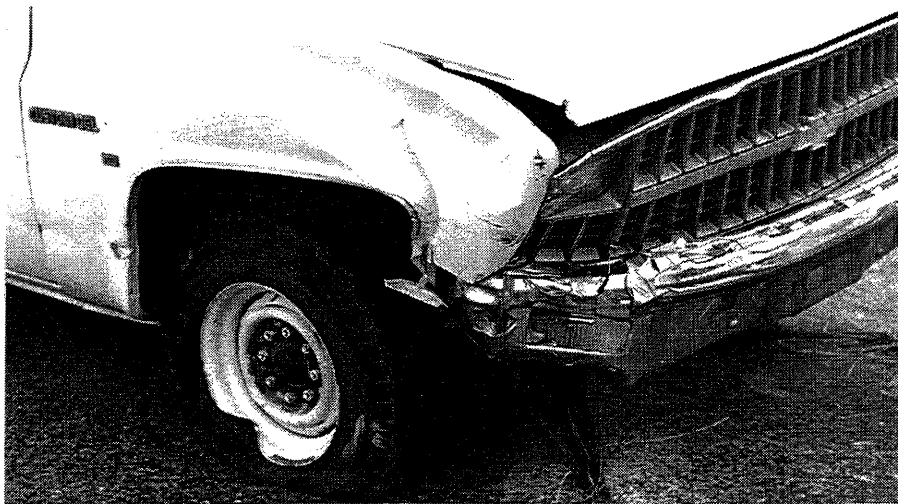
Figure 23. Vehicle after test 7069-18.

The vehicle sustained damage to the right side as shown in figure 23. Maximum crush at the right front corner at bumper height was 6.5 in (165 mm). The right front tire aired out and the rim was bent. The right side window was broken out by the head of the dummy. Also, damage was done to the front bumper, hood, grill, the right front and rear quarter panels, and the right door.

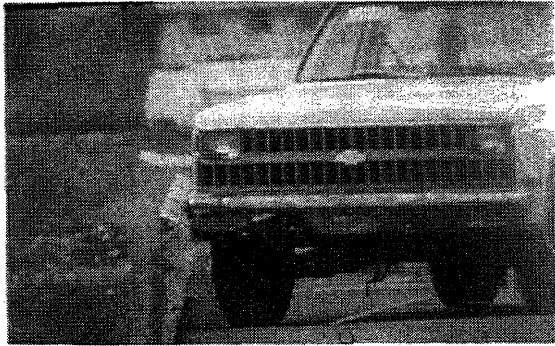
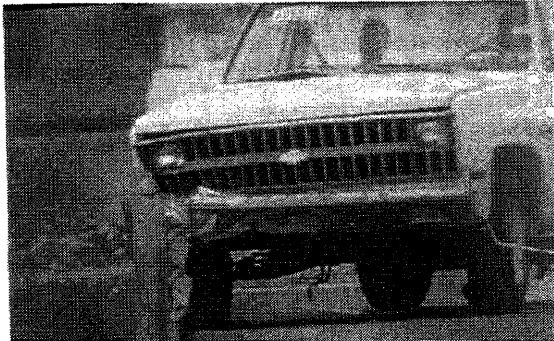
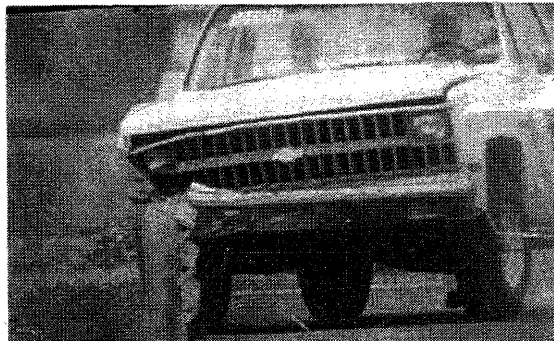
Figure 25. Sequential photographs for test 7069-18.

Figure 25. Sequential photographs for test 7069-18 (continued).

Impact speed was 46.1 mi/h (74.2 km/h) and the angle of impact was 20.8 degrees. The speed of the vehicle at time of parallel was 38.2 mi/h (61.5 km/h). The vehicle lost contact with the railing traveling at 35.9 mi/h (57.8 km/h) and 10.9 degrees. Occupant impact velocity was 17.1 ft/s (5.2 m/s) in the longitudinal direction and 11.7 ft/s (3.6 m/s) in the lateral direction. The highest 0.010-s occupant ridedown accelerations were -3.6 g (longitudinal) and 8.8 g (lateral). These data and other pertinent information from the test are summarized in figure 24 and table 3. Sequential photographs are shown in figure 25 and initial and final resting positions of the dummies is shown in figure 26. Vehicular angular

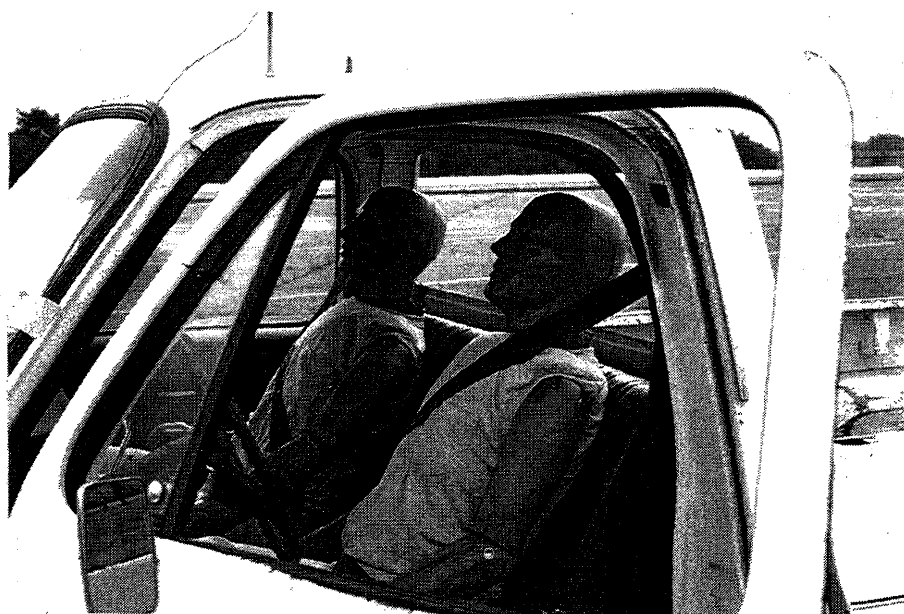
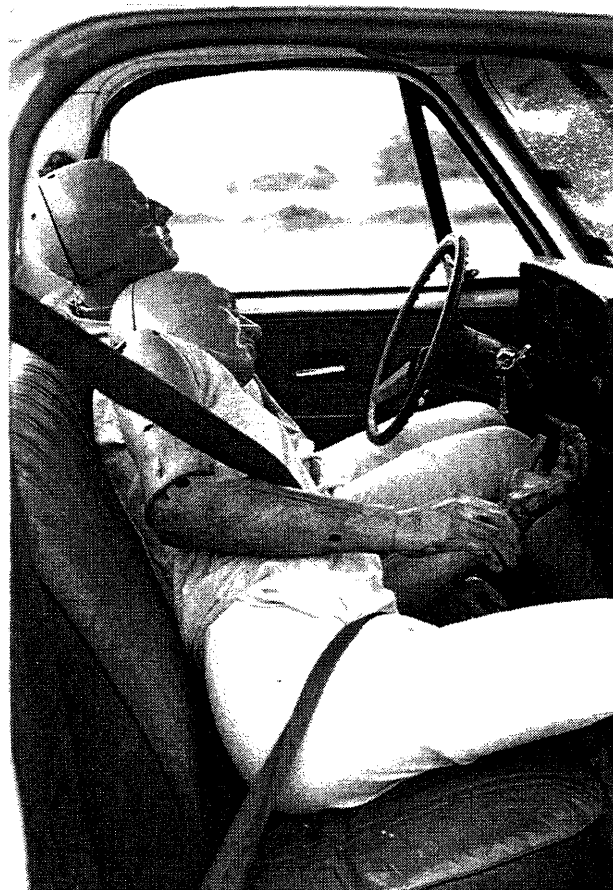
Figure 26. Dummies before and after test 7069-18.

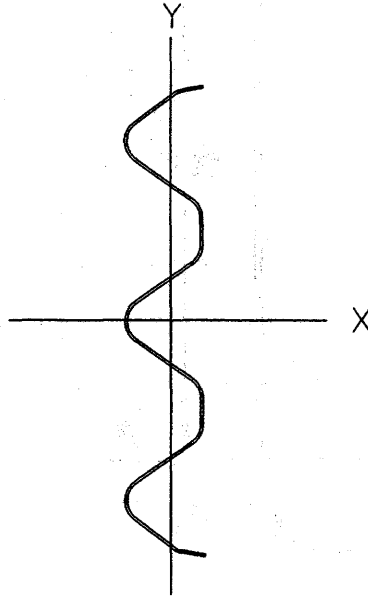
$$F_y = 50 \text{ ksi (345 kPa)}; F_u = 70 \text{ ksi (482 kPa)}; \text{Thickness} = 10 \text{ gauge}$$

$$S_y = 2.80 \text{ in}^3 (46 \times 10^3 \text{ mm}^3); Z_y = 3.92 \text{ in}^3 (64 \times 10^3 \text{ mm}^3)$$

The moment capacity M_p lies somewhere between $F_y S_y$ and $F_y Z_y$; however, exact capacity is unknown because the cross section changes shape as it begins to form a plastic hinge. Additionally, vehicle impact causes it to lose its original shape. For this analysis, M_p will be taken as the average of $F_y S_y$ and $F_y Z_y$.

The strength of the thrie-beam rail element cannot be analyzed accurately with simple procedures. The cross section has thin elements that will buckle before a plastic hinge forms. Also, flattening of the section in the impact area and at posts usually occurs. Computations of moment capacity of the rail element (figure 37) indicate a moment capacity of about 168 in-kips (19.0 kN-m).
