1. Report No. FHWA-RD-93-061		2. Government Accession No.		3. Recipient's Catalog No.	
4. Title and Subtitle TESTING OF NEW BRIDGE RAIL AND TRANSITION DESIGNS Volume IV: Appendix C Illinois 2399-1 Bridge Railing				5. Report Date June 1997

Figure 1. Cross section of Illinois 2399-1 bridge railing.

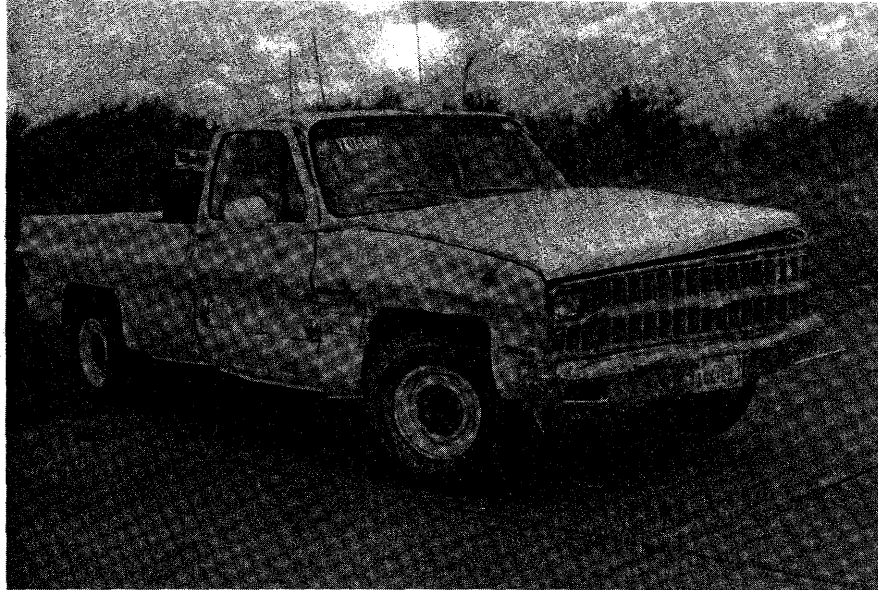
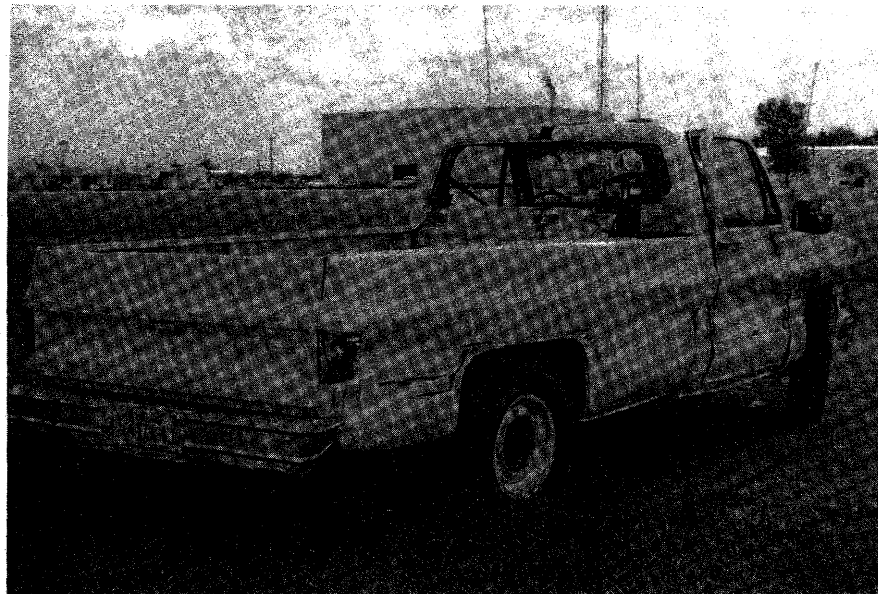
Figure 22. Vehicle after test 7069-2.

The vehicle sustained extensive damage to the right front as shown in figure 22. Maximum crush at the right front corner at bumper height was 5.0 in (127 mm). The right front and right rear wheel rims were bent and the wheel assembly and suspension damaged. The passenger door was bent and jammed and the right rear panel was dented and scraped. The hood was bent and shifted to the left. The windshield frame was bent and the windshield was cracked. The cab of the vehicle was twisted and the frame was bent.

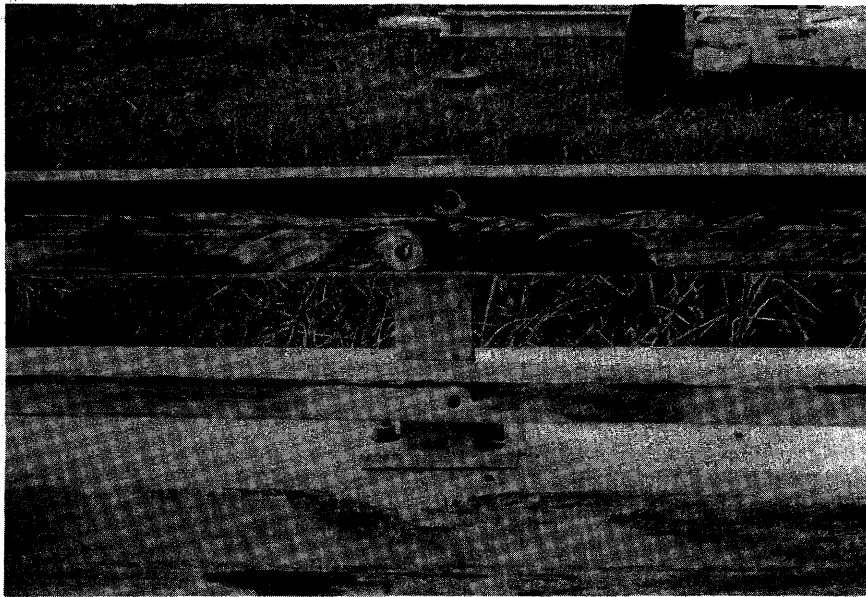
Figure 37. Damage at posts 5 and 6.

Damage to the railing is shown in figures 35 through 39. The bolts connecting the lower railing element to the post were sheared on posts 3 through 7. At post 5 the bolt on the upper railing element was sheared and the face of the element itself was gouged. The flange on post 6 was bent and the concrete curb was cracked at posts 6 through 9. The top of post 8 was bent where it made contact with the box. During the test, the lower railing element was pushed down. After the test, the maximum vertical movement was 3 in (76 mm) at post 5.

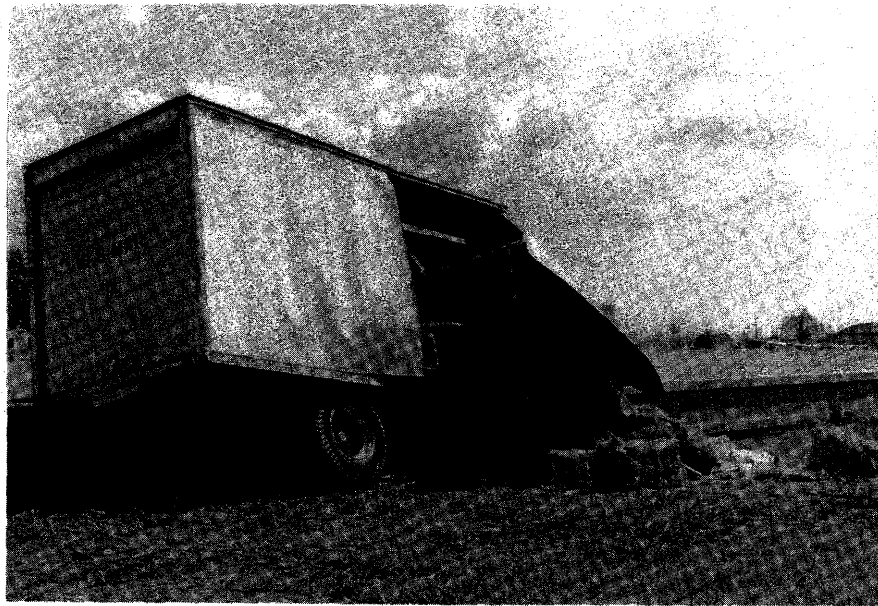
Figure 40. Vehicle after test 7069-15.

Damage to the vehicle was extensive and is shown in figures 40 and 41. The steering arm rod, u-bolts, spring pins, and front and rear spring mounts were damaged. The frame was bent as well as the rear part of the drive shaft, the rear u-joint, the battery box, and the gas tank. The cargo box was torn during the test and as the vehicle left the railing and rolled to the right, the load shifted and tore open the right side of the box.

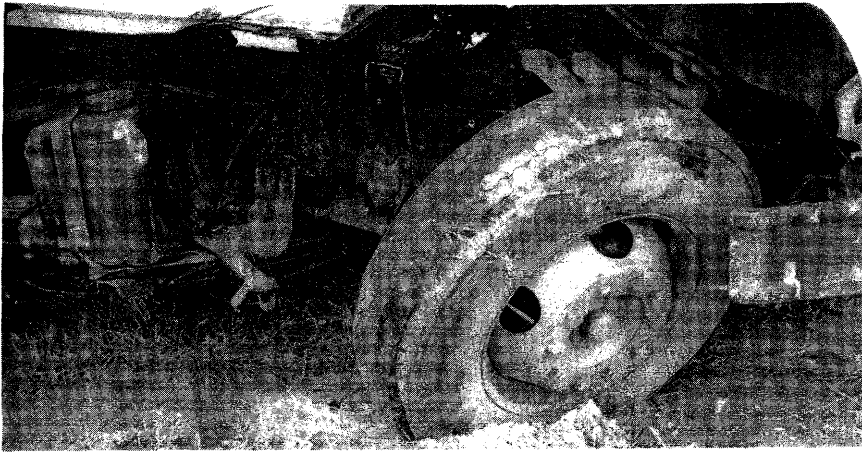
Figure 41. Damage to suspension and undercarriage (7069-15).

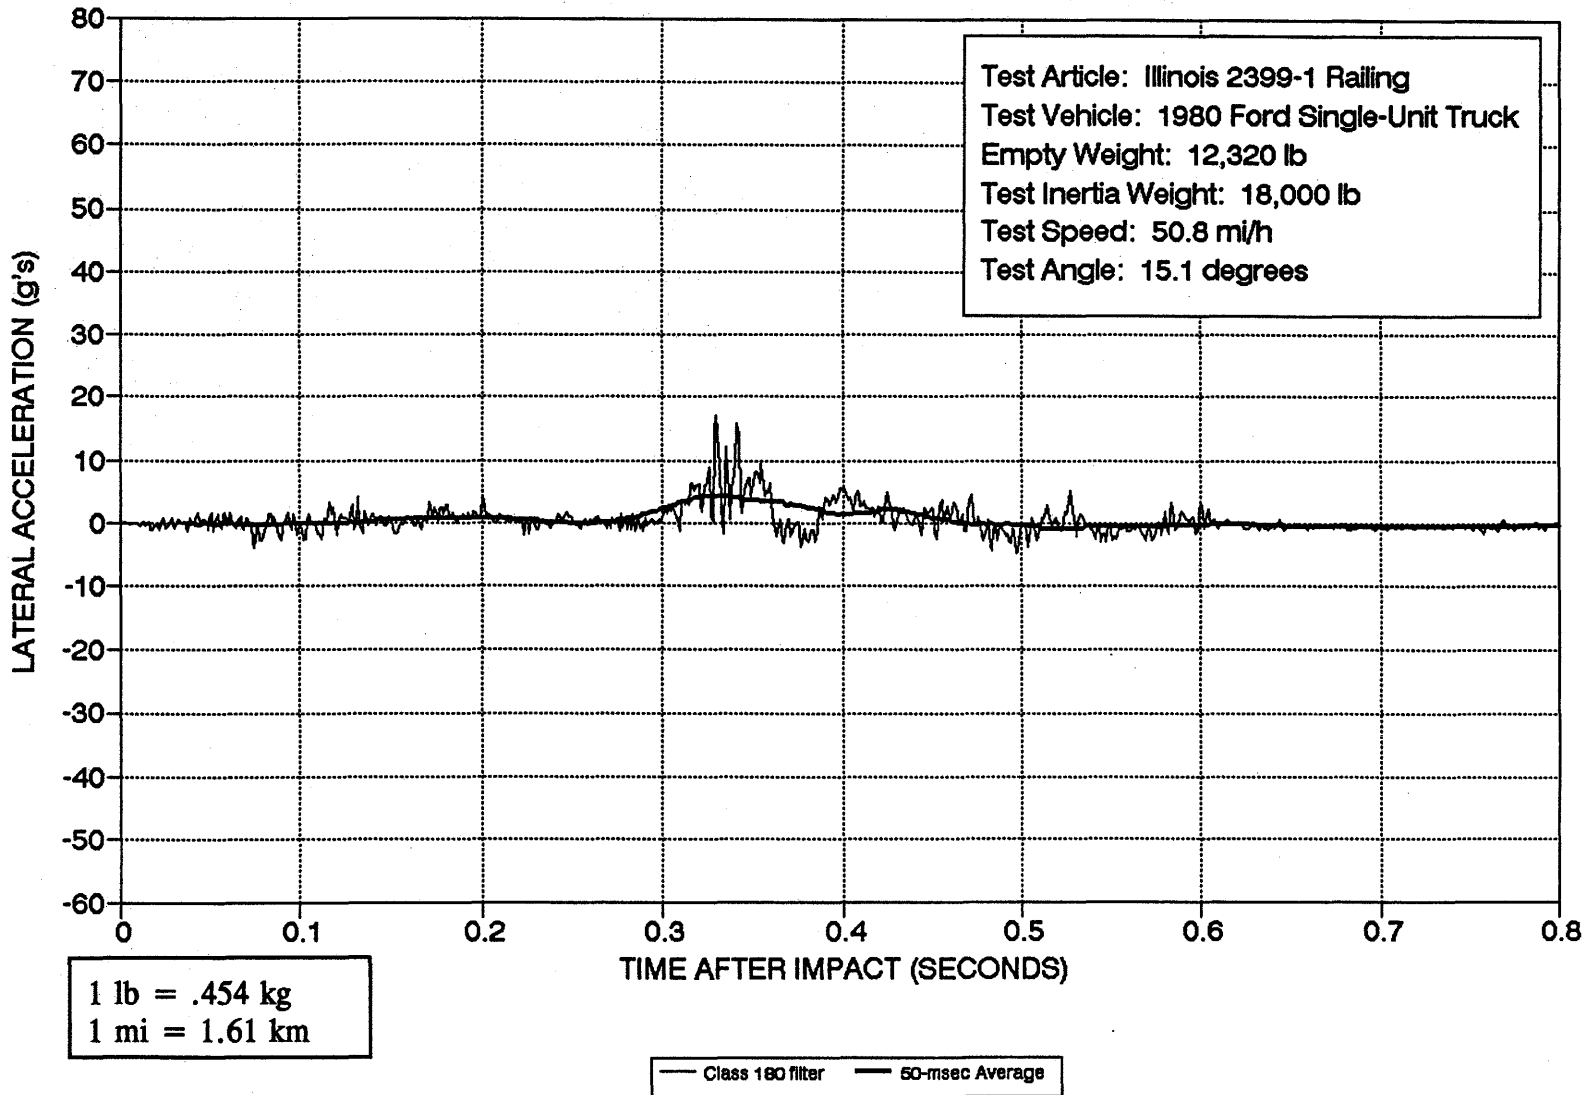
Figure 52. Vehicle lateral accelerometer trace for test 7069-15 (accelerometer located at rear of vehicle).
