1. Report No. FHWA-RD-93-066		2. Government Accession No.		3. Recipient's Catalog No.	
4. Title and Subtitle TESTING OF NEW BRIDGE RAIL AND TRANSITION DESIGNS Volume IX: Appendix H Illinois Side Mount Bridge Railing				5. Report Date

Figure 1. Cross section of Illinois side mount bridge railing.

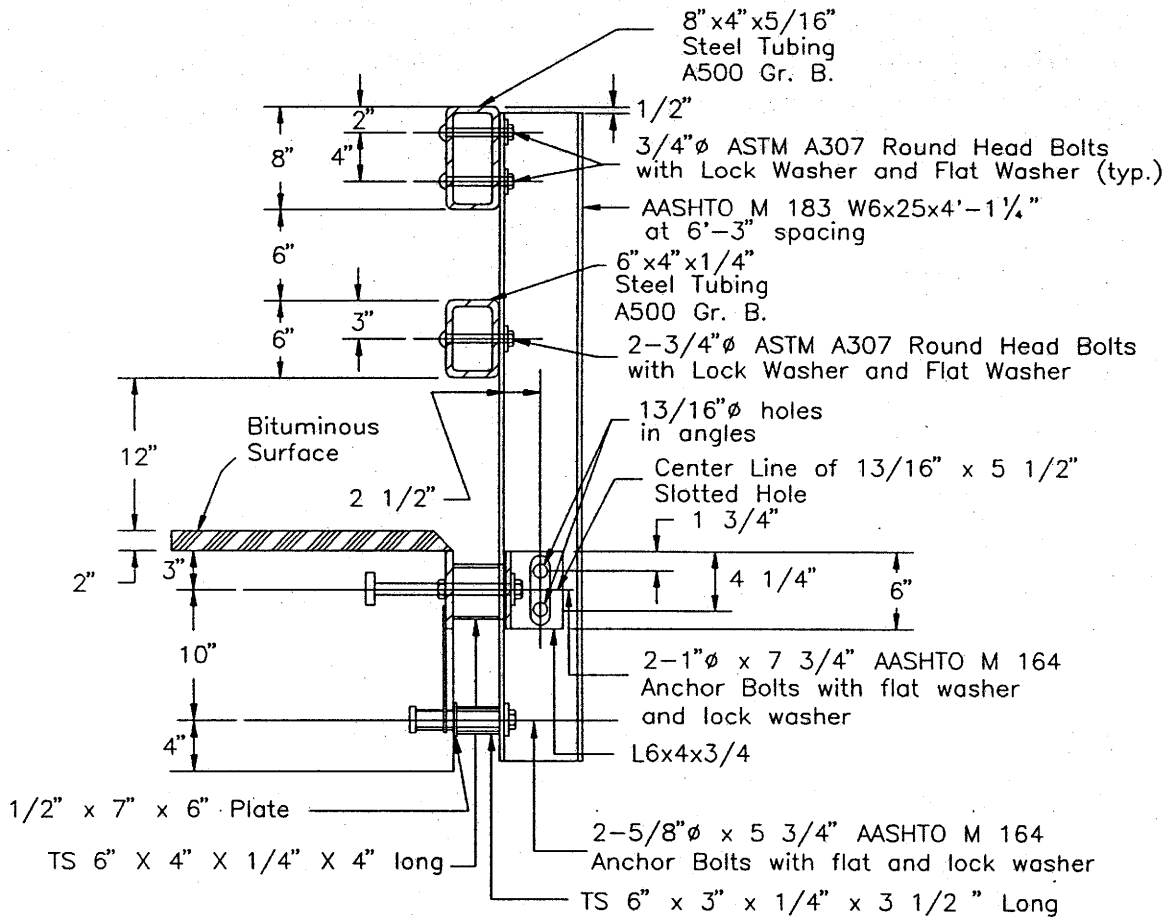
A cross section of the prototype installation is shown in figure 1. The Illinois side mount railing design consists of W6x25 posts spaced at 6 ft-3 in (1.9 m) with a TS 8 by 4 by 5/16-in (203 by 102 by 8-mm) top rail element and a TS 6 by 4 by 1/4-in (152 by 102 by 6-mm) bottom rail element. The height of the metal railing above the asphalt surface is 32 in (813 mm).

At the time the railing was designed, the proposed strength test conditions for performance level two was 18,000 lb (8 172 kg) | 50 mi/h (80.5 km/h) | 15 degrees.⁽¹⁾ The design force for this test condition is a line force of 56 kips (249 kN) uniformly distributed over a longitudinal distance of 42 in (1.07 m) at 29 in (737 mm) above the asphalt surface. Computations of the strength of the railing system indicate that it will resist approximately 69 kips (3-8 kN) at 22.9 in (582 mm) above the asphalt surface.

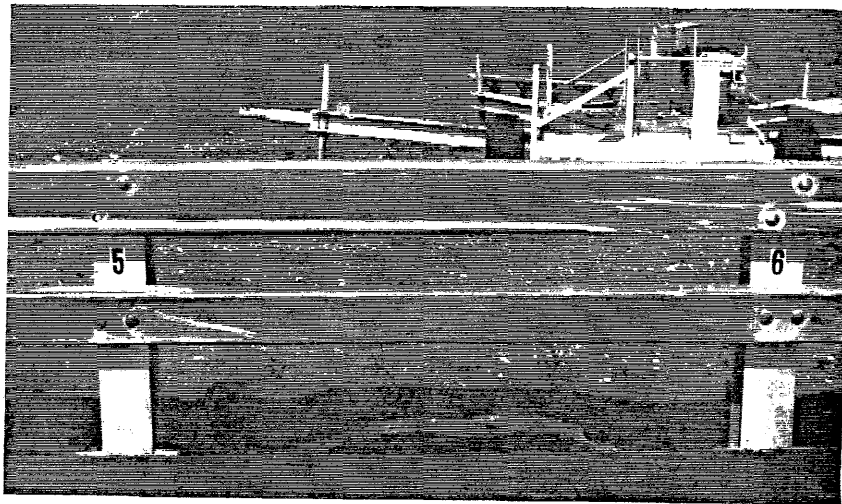
Figure 41. Damage to bridge railing, posts 4 through 7, test 7069-37.

As can be seen in figures 39 through 41, the bridge railing received moderate damage with most being contained within the area between posts 4 through 7. The upper and lower rails sustained gouges between posts 4 and 5 from the lug nuts of the wheel of the vehicle. The head of the lower bolt on the top rail at post 5 was torn off and the bolts on the lower element were loose. The angles at post 4 were slightly bent and those at posts 5 and 6 were deformed. The spacers at posts 4 and 5 were knocked loose and down. There was 2.5-in (64-mm) deformation to the upper rail element at post 5. The vehicle was in contact with the bridge railing for 69 ft (21 m).

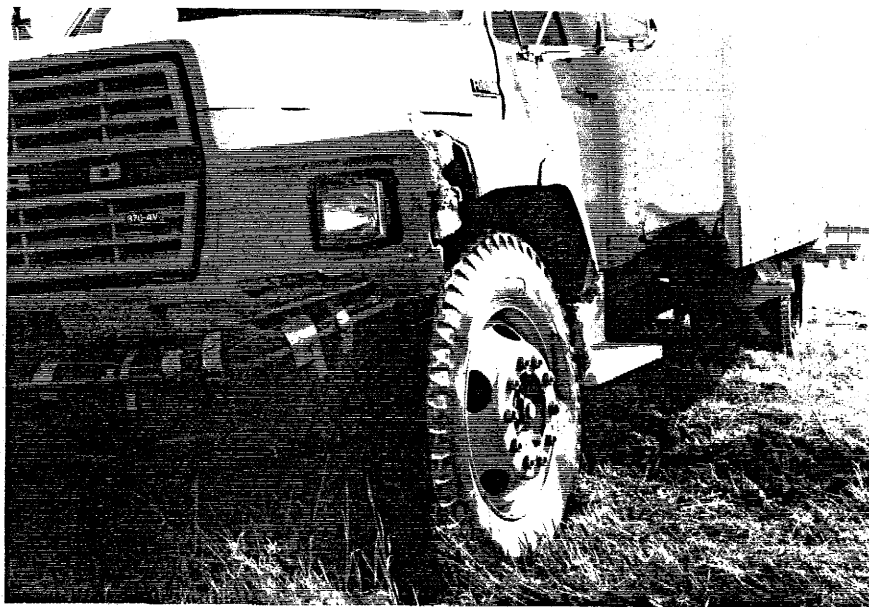
The vehicle sustained damage mostly to the left side as shown in figure 42. Maximum crush at the left front corner at bumper height was 8.0 in (203 mm). The front springs, shackles, and U-bolt were damaged and the box-van shifted off the frame approximately 6 in (150 mm). Also, damage was done to the front bumper, left front quarter panel, left front tire and rim, left rear outside tire and rim, and lower edge of the box-van.

Figure 42. Vehicle after test 7069-37.
