1. Report No. FHWA-RD-93-063		2. Government Accession No.		3. Recipient's Catalog No.	
4. Title and Subtitle TESTING OF NEW BRIDGE RAIL AND TRANSITION DESIGNS Volume VI: Appendix E 32-in (813-mm) New Jersey Safety Shape				5. Report Date June 1997

6. Performing Organization Code	
7. Author(s) C. Eugene Buth, T. J. Hirsch, and Wanda L. Menges				8. Performing Organization Report No. Research Foundation 7069-Vol. VI

9. Performing Organization Name and Address Texas Transportation Institute The Texas A&M University System College Station, Texas 77843-3135				10. Work Unit No. NCP No. 3A5C0042

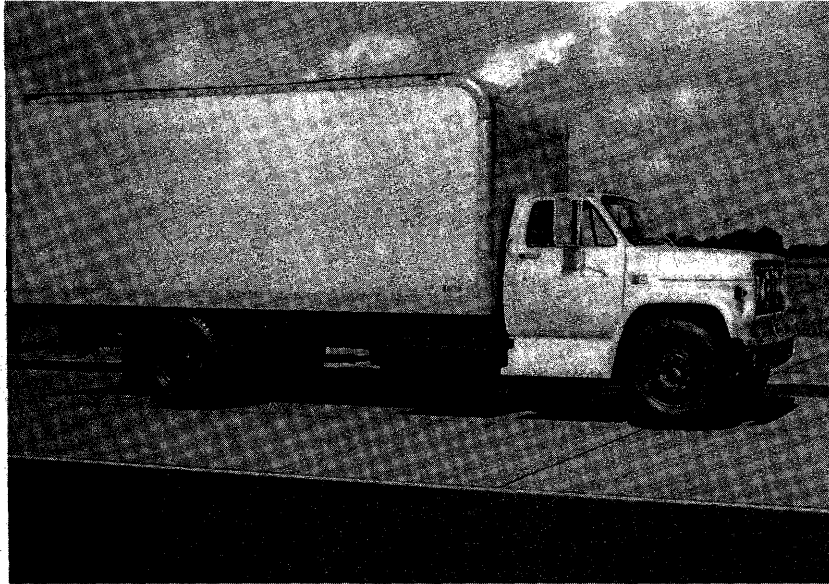
Figure 2. Vehicle before test 7069-12.

The 1982 GMC single-unit truck (figures 2 and 3) was directed into the 32-in (813-mm) New Jersey safety shape (figure 4) using a remote control guidance system. Empty weight of the vehicle was 10,900 lb (4 949 kg) and its test inertia weight was 18,000 lb (8 172 kg). The height to the lower edge of the vehicle bumper was 19.5 in (495 mm) and it was 32.0 in (813 mm) to the top of the bumper. Other dimensions and information on the test vehicle are given in figure 5. The vehicle was free-wheeling and unrestrained just prior to impact.

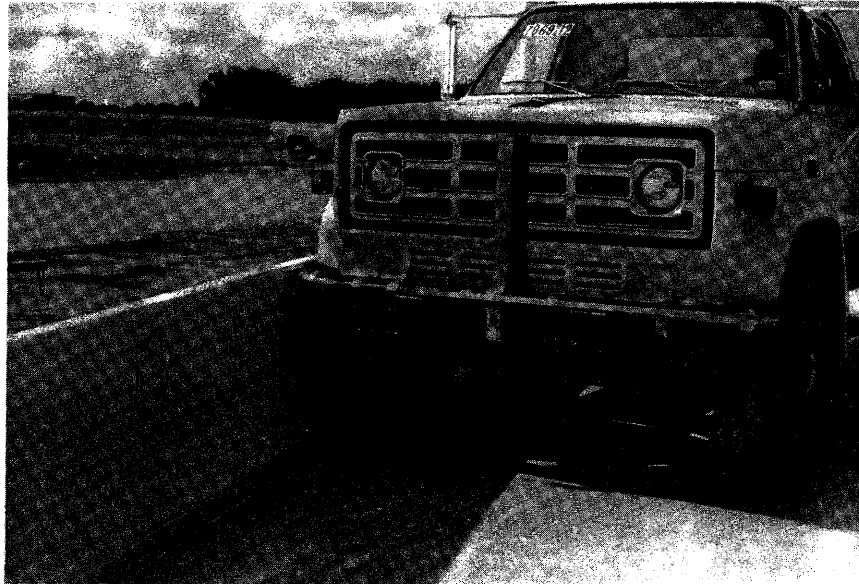
Figure 3. Vehicle/safety shape geometrics for test 7069-12.

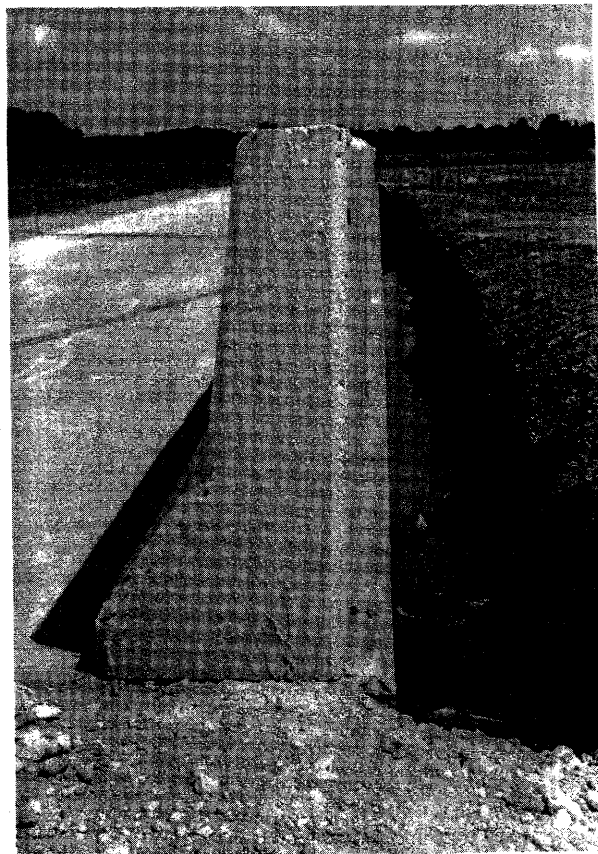
Figure 4. 32-in (813-mm) New Jersey safety shape before test 7069-12.

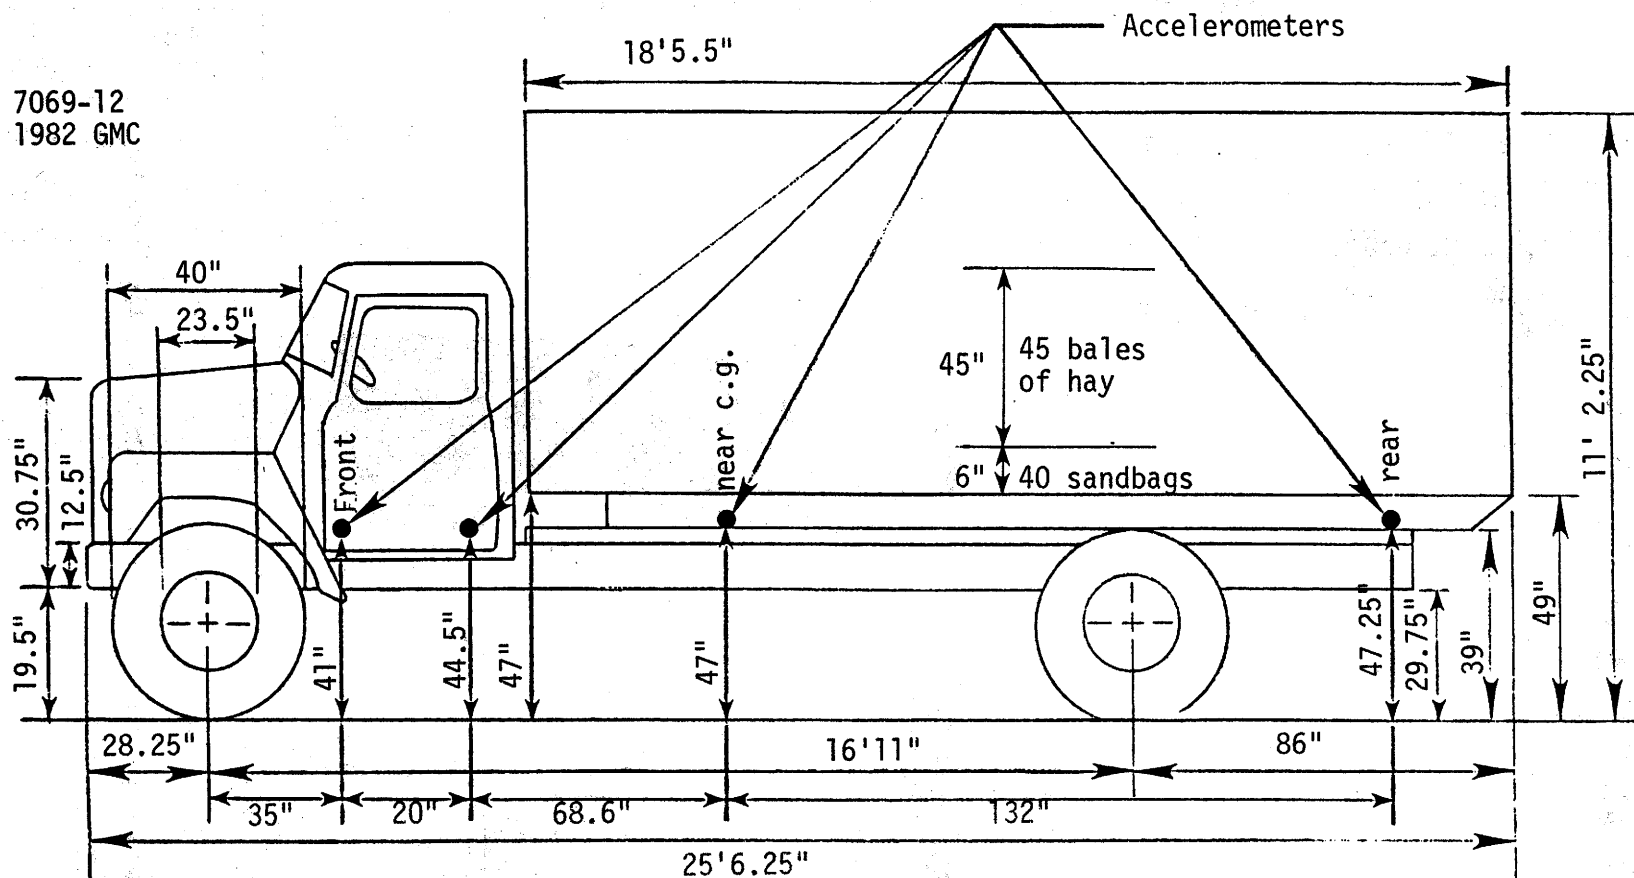
EMPTY WEIGHTSWeight on Front Axle : LF 2,390 RF 2,390Weight on Rear Axle : LR 2,900 RR 3,220TOTAL EMPTY WEIGHT : 10,900LOADED WEIGHTSWeight on Front Axle : LF 3,490 RF 3,550Weight on Rear Axle : RF 5,360 RR 5,600TOTAL LOADED WEIGHT : 18,000

Figure 5. Vehicle properties for test 7069-12.

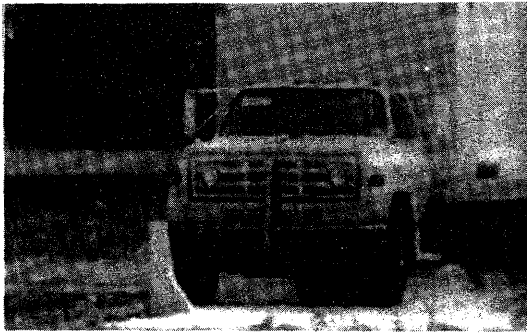
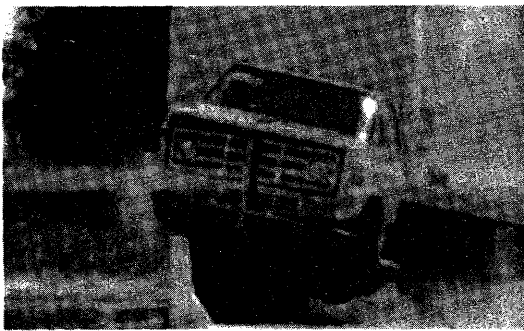
Figure 10. Sequential photographs for test 7069-12.

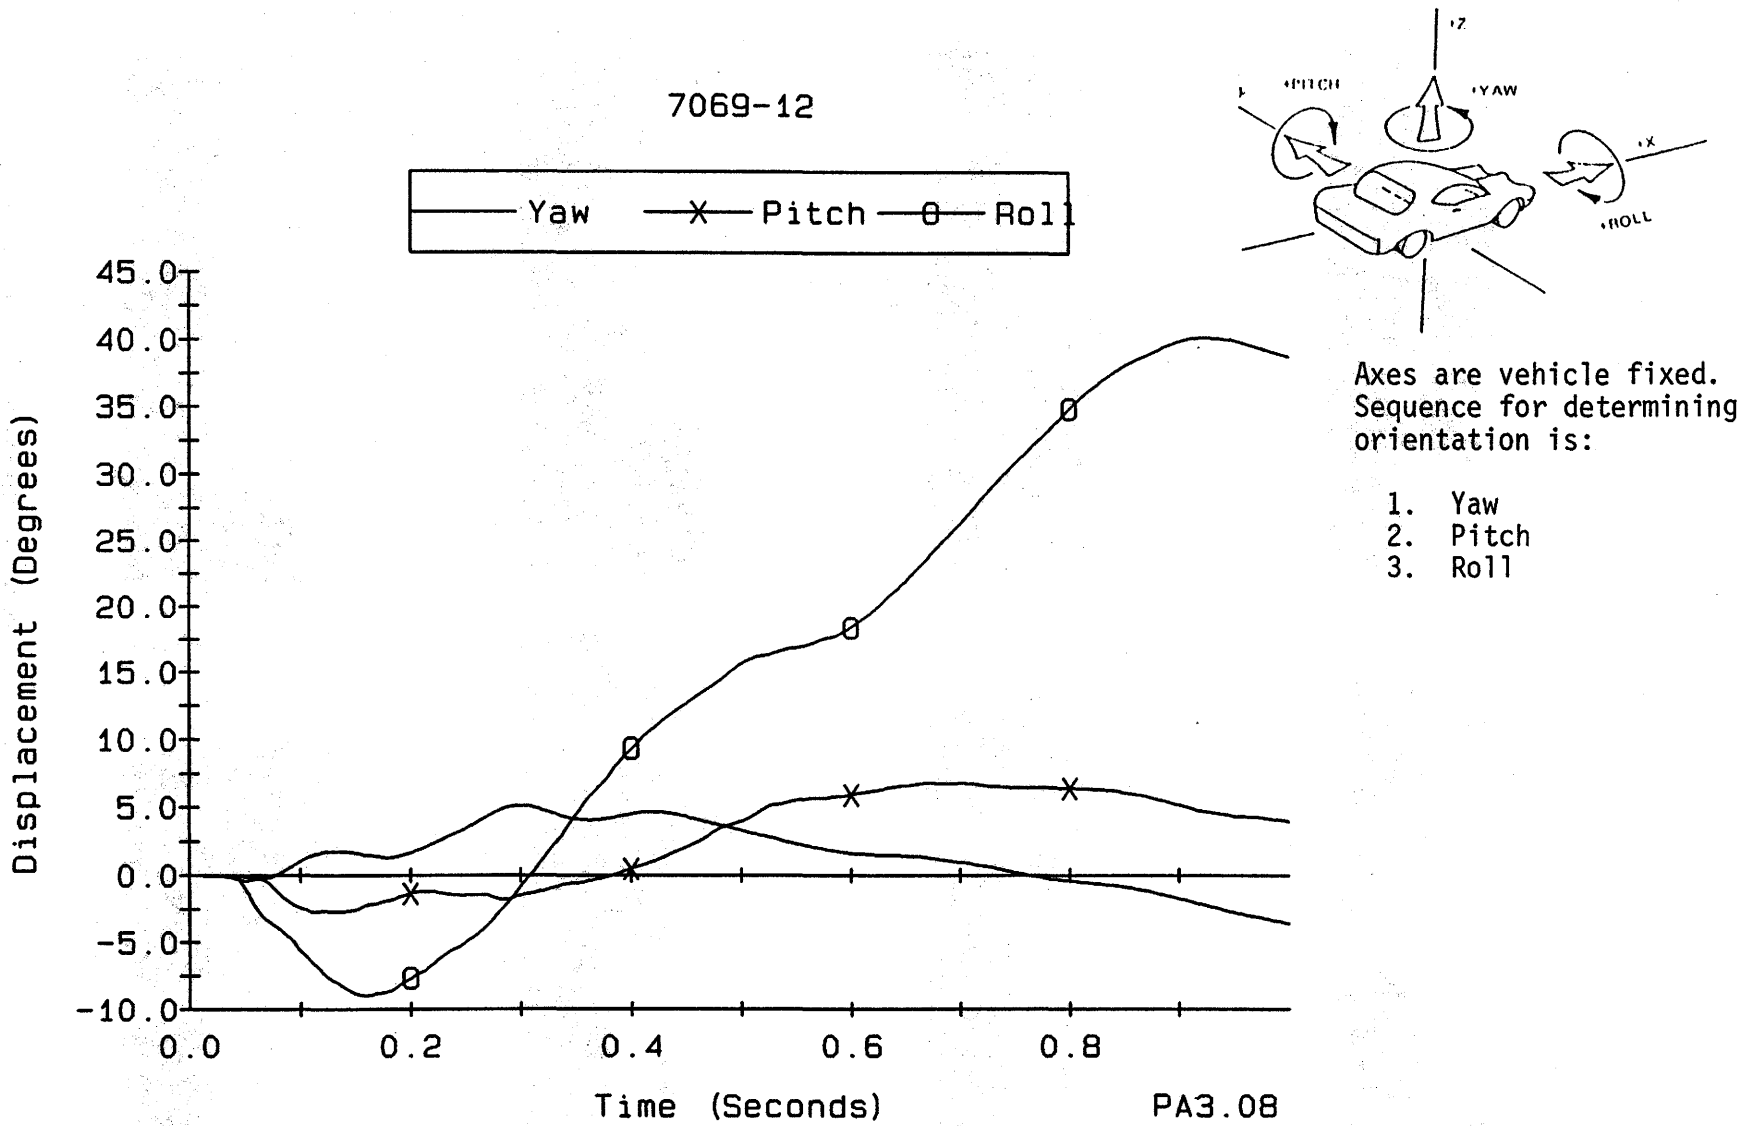
Figure 12. Vehicle angular displacements for test 7069-12.

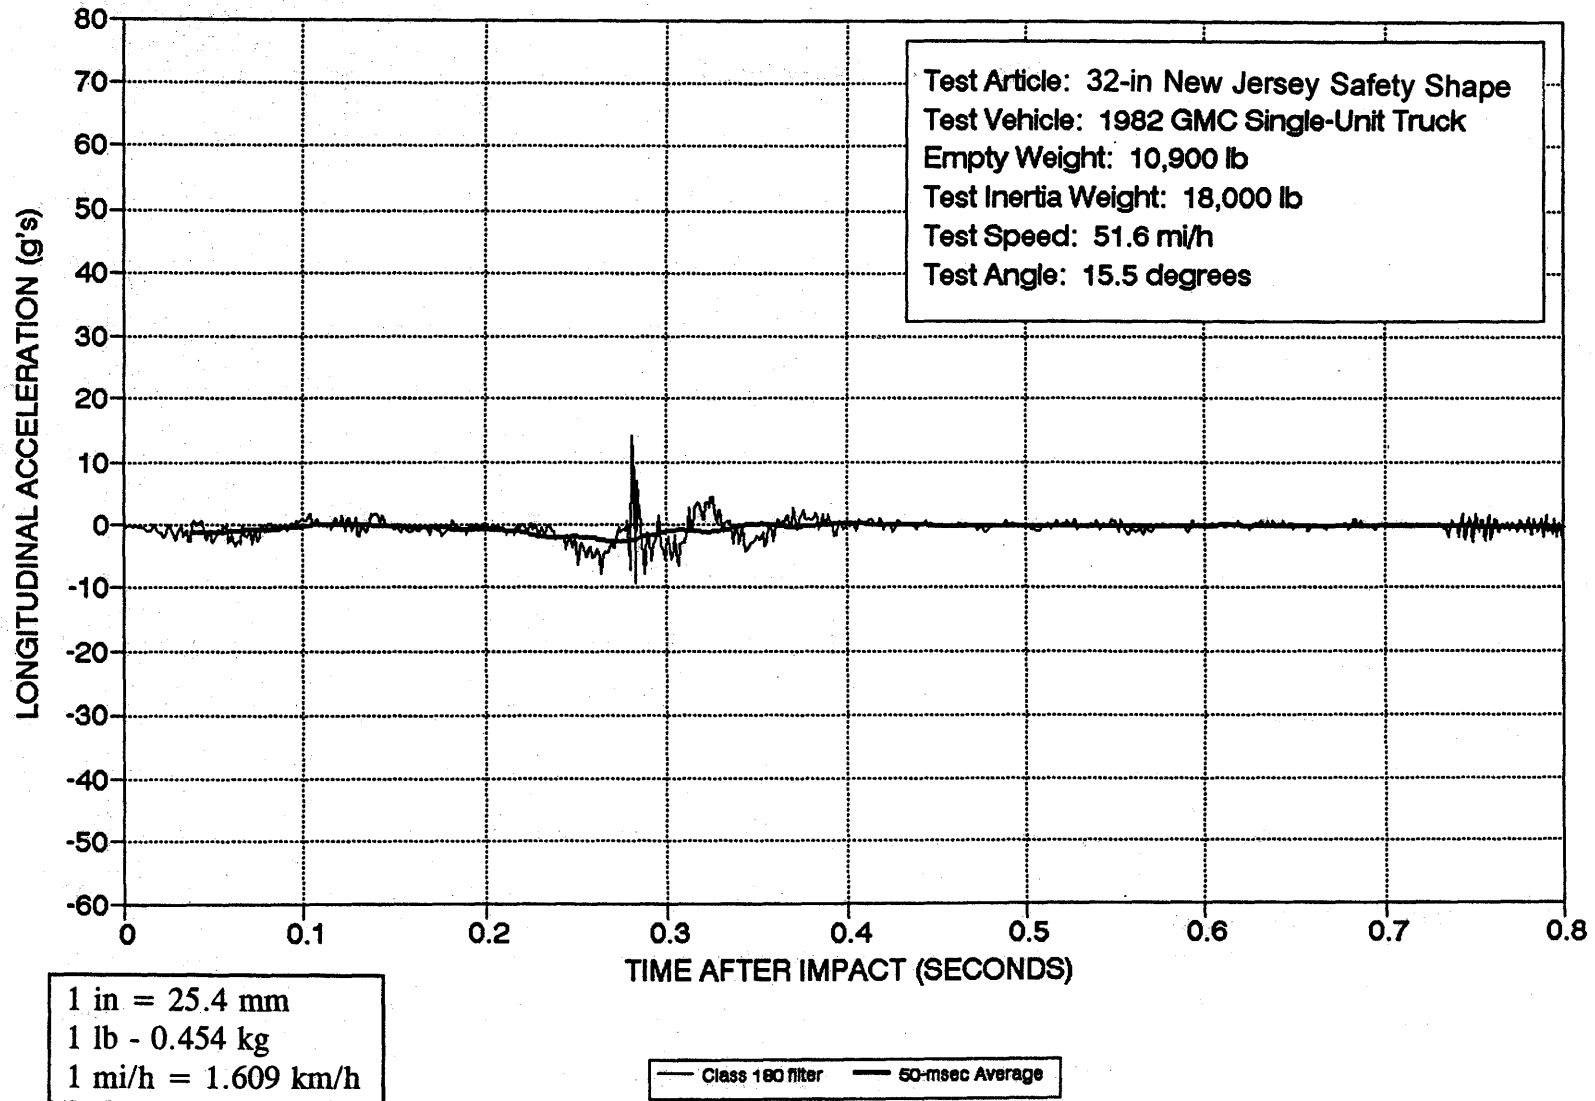
Figure 13. Vehicle longitudinal accelerometer trace for test 7069-12 (accelerometer located near center-of-gravity).

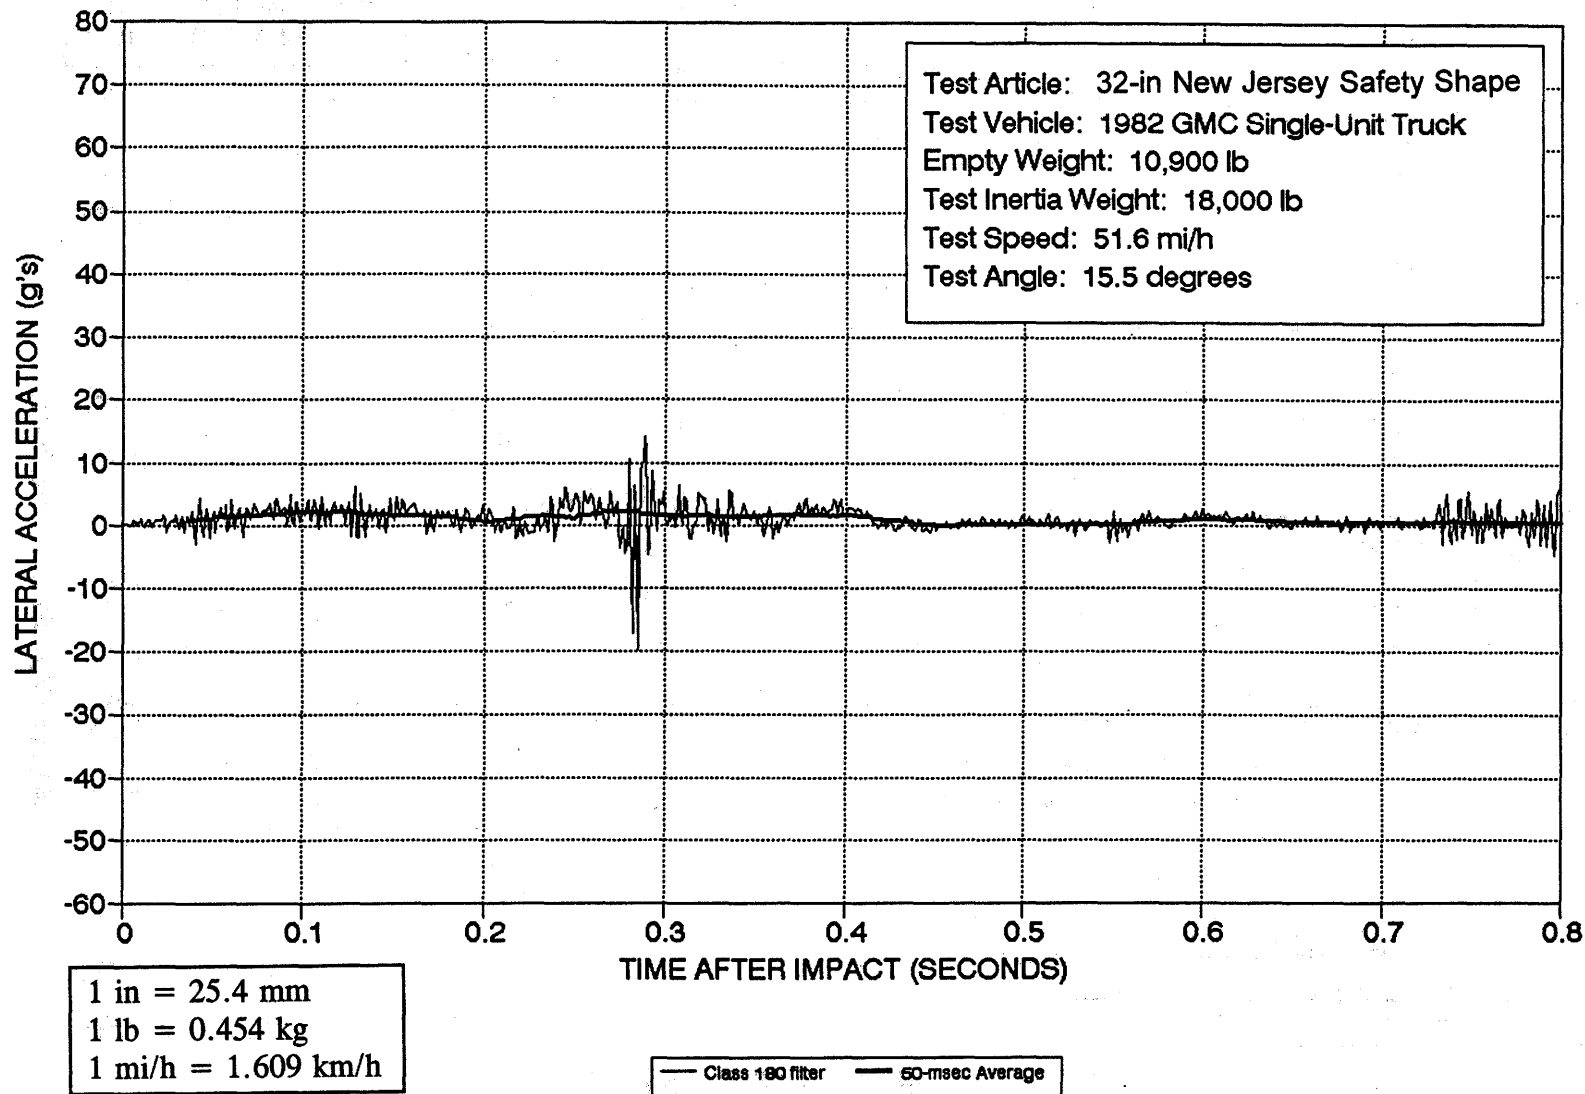
Figure 14. Vehicle lateral accelerometer trace for test 7069-12 (accelerometer located near center-of-gravity).

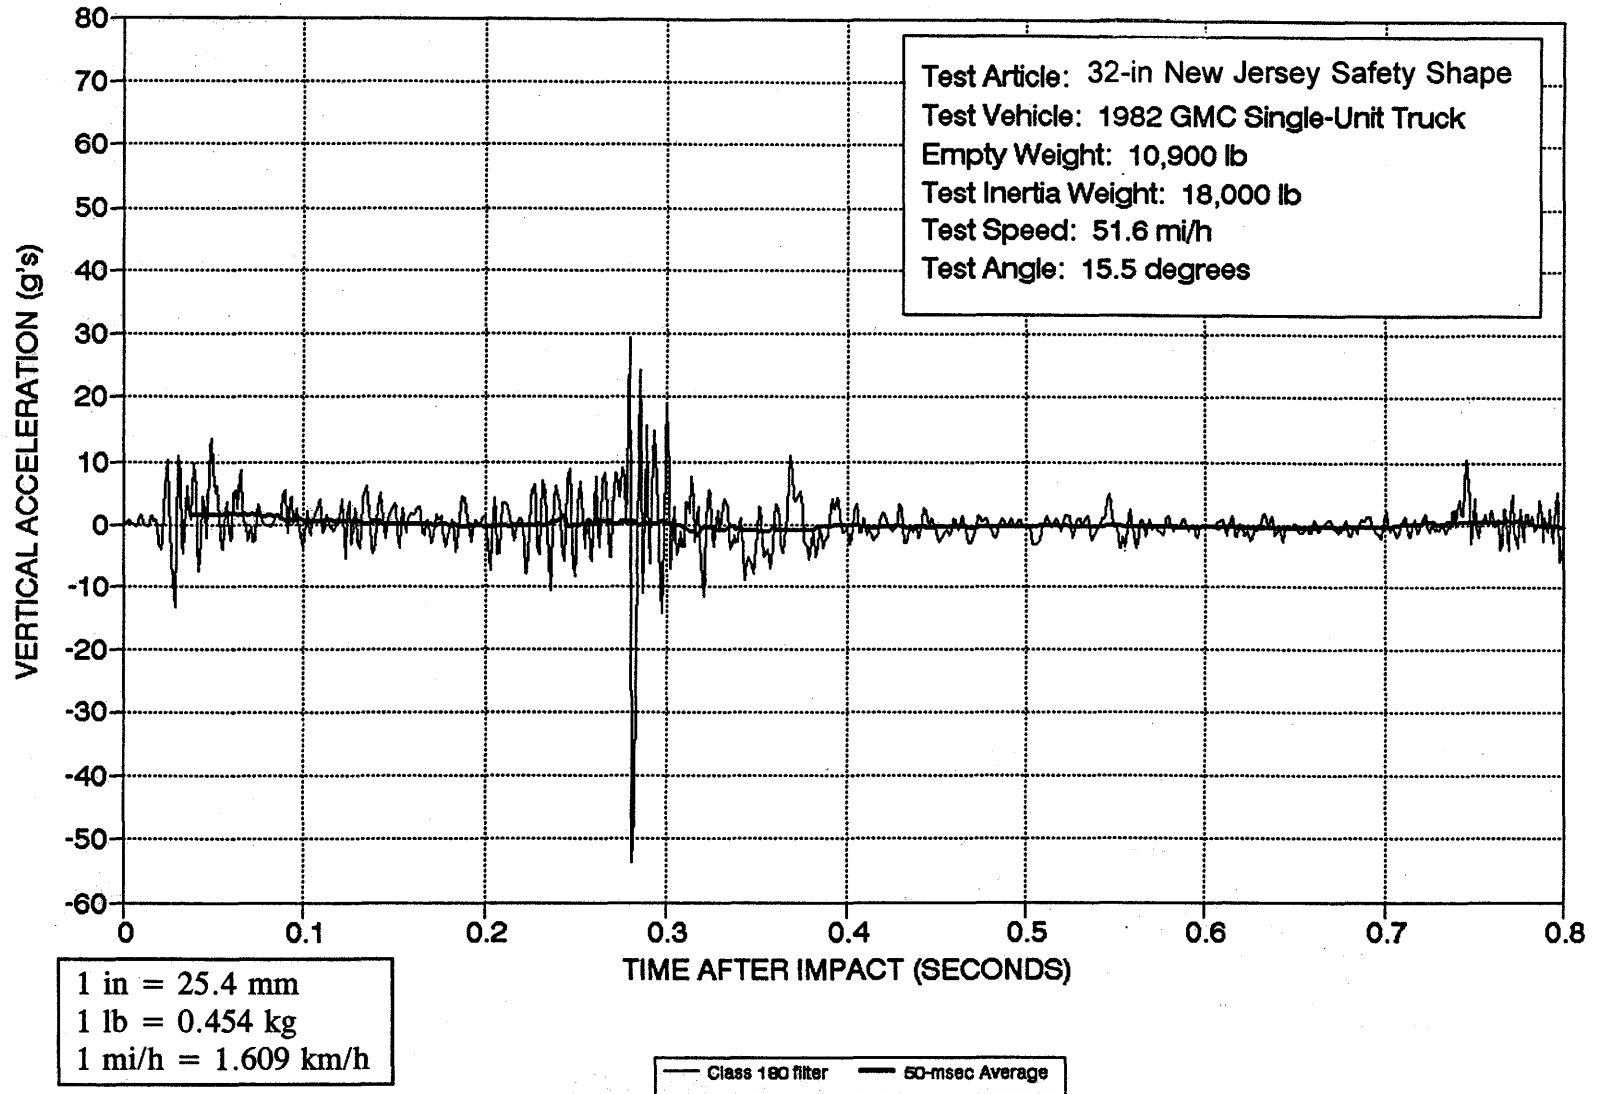
Figure 15. Vehicle vertical accelerometer trace for test 7069-12 (accelerometer located near center-of-gravity).

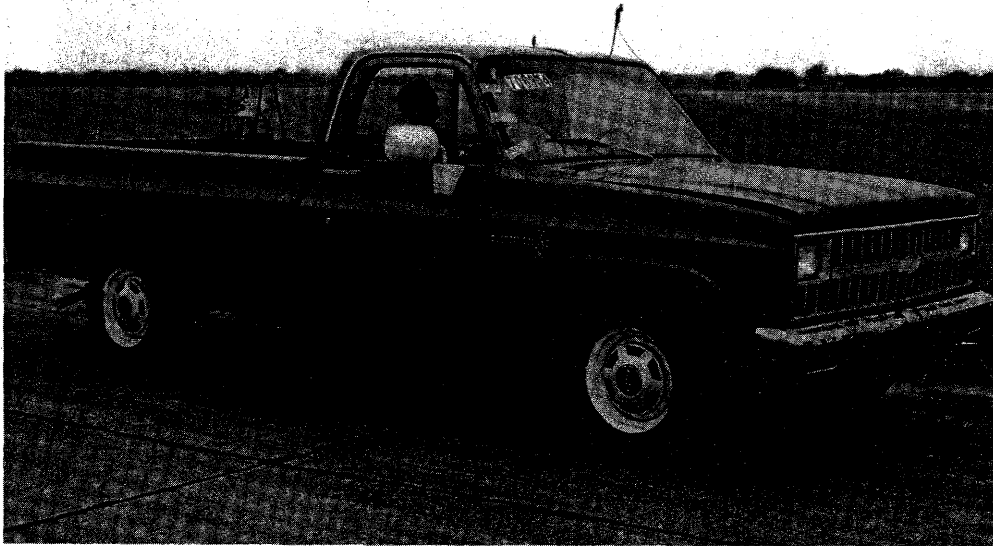
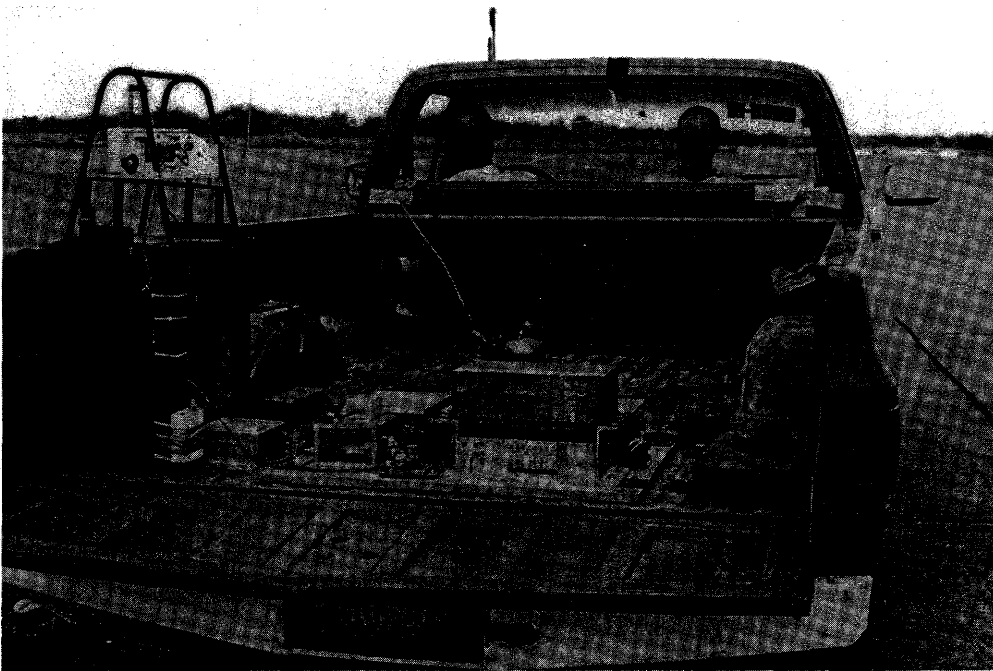
Figure 19. Vehicle before test 7069-14.

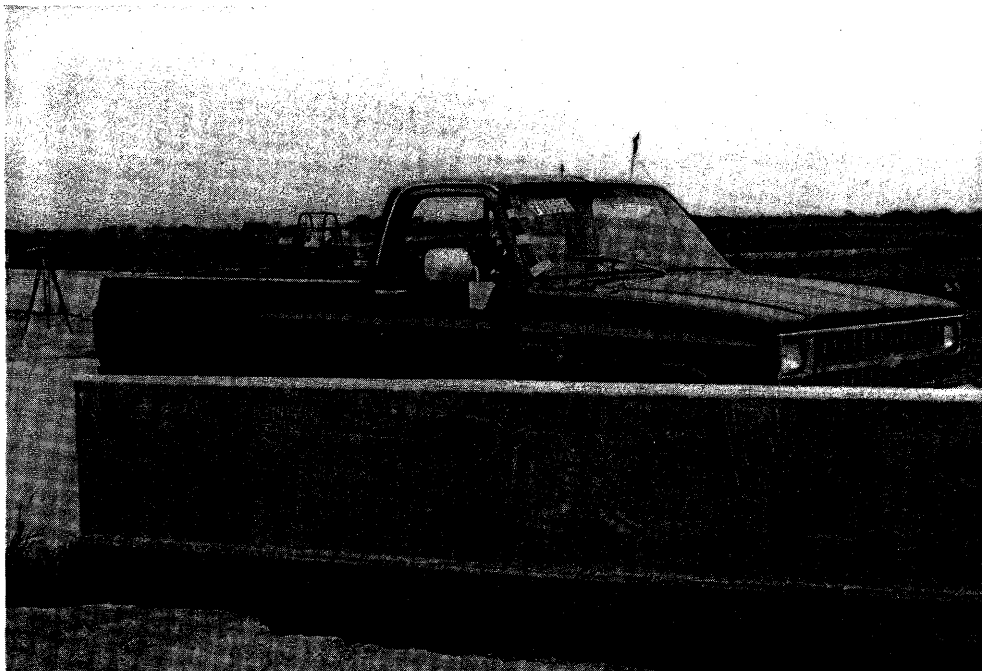
Figure 20. Vehicle/safety shape geometrics for test 7069-14.

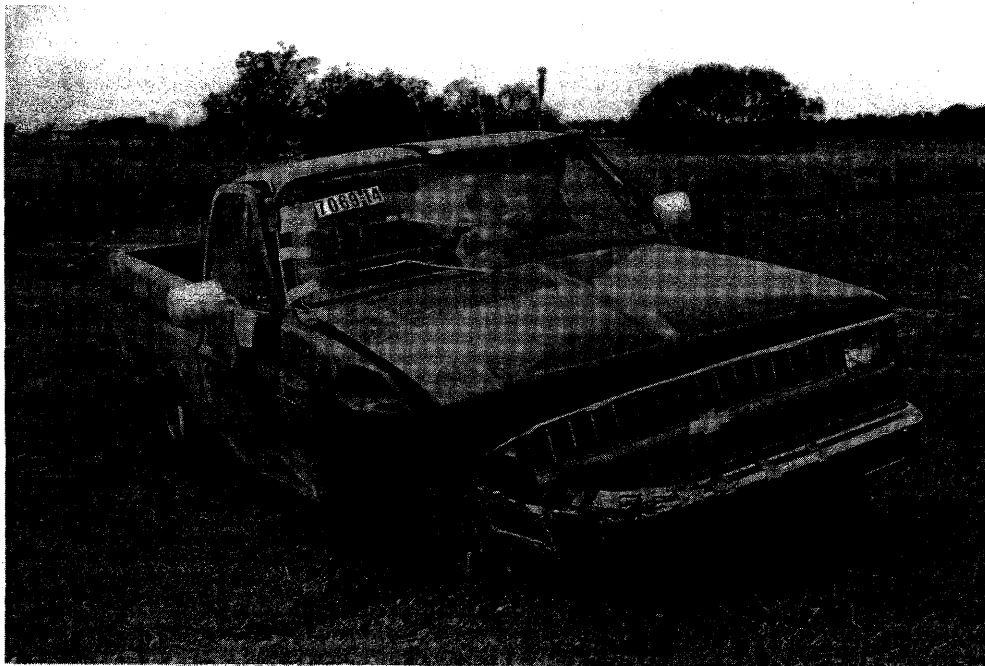
The vehicle sustained extensive damage to the right side as shown in figures 24 and 25. Maximum crush at the right front corner at bumper height was 12.0 in (305 mm). The right front suspension system broke away from the vehicle, and the right rear tire and wheel rim broke at the welded connection points. There was damage to the right ball joints and tie rods, as well as the upper and lower control arms. The left rear tire aired out and is shown in figure 26. Figure 27 shows before and after photographs of the test dummies.

Figure 24. Right side of vehicle after test 7069-14.

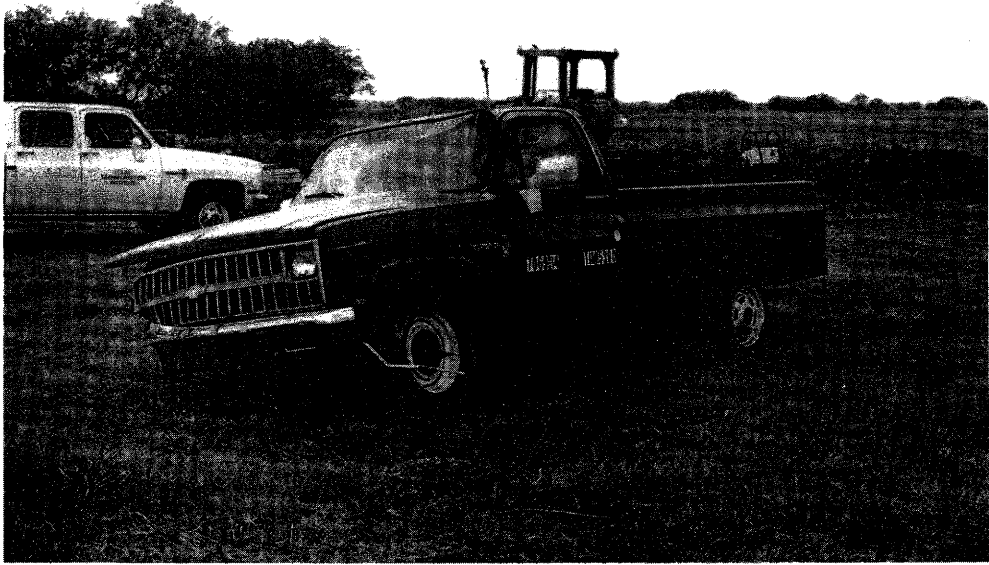
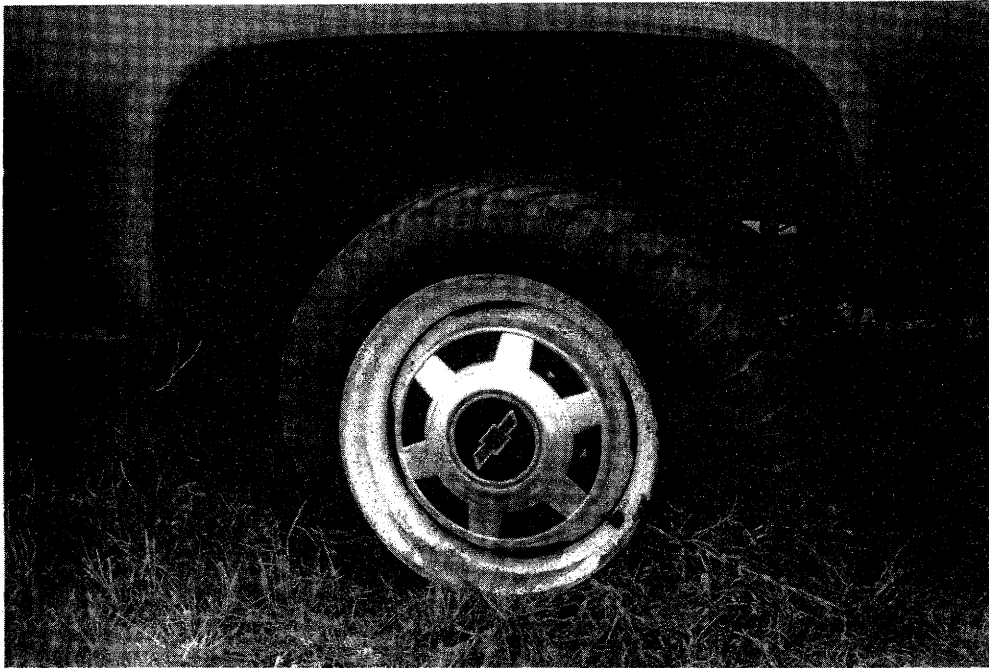
Figure 26. Left side of vehicle after test 7069-14.

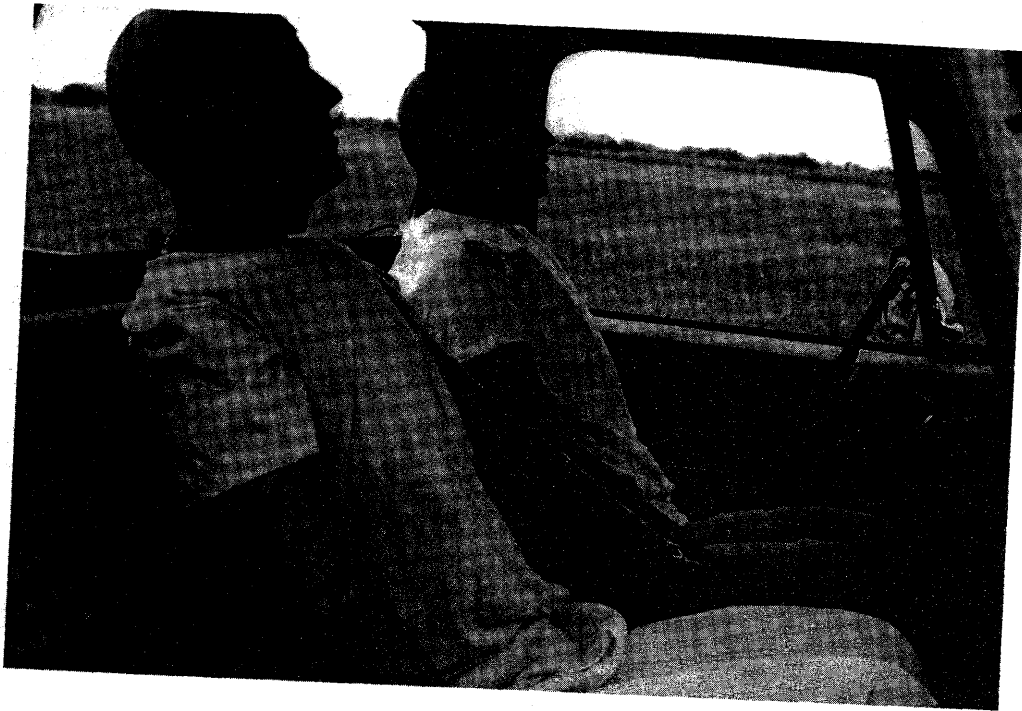
Figure 27. Dummies before and after test 7069-14.
