1. Report No. FHWA-RD-93-157		2. Government Accession No.		3. Recipient's Catalog No.	
4. Title and Subtitle TESTING OF NEW BRIDGE RAIL AND TRANSITION DESIGNS Volume XIV: Appendix M Axial Tensile Strength of Thrie and W-Beam Terminal Connectors				5. Report Date June 1997

6. Performing Organization Code	
7. Author(s) C. Eugene Buth, T. J. Hirsch, and Matt Henderson				8. Performing Organization Report No. Research Foundation 7069-Vol. XIV

9. Performing Organization Name and Address Texas Transportation Institute The Texas A&M University System College Station, Texas 77843-3135				10. Work Unit No. NCP No. 3A5C0042

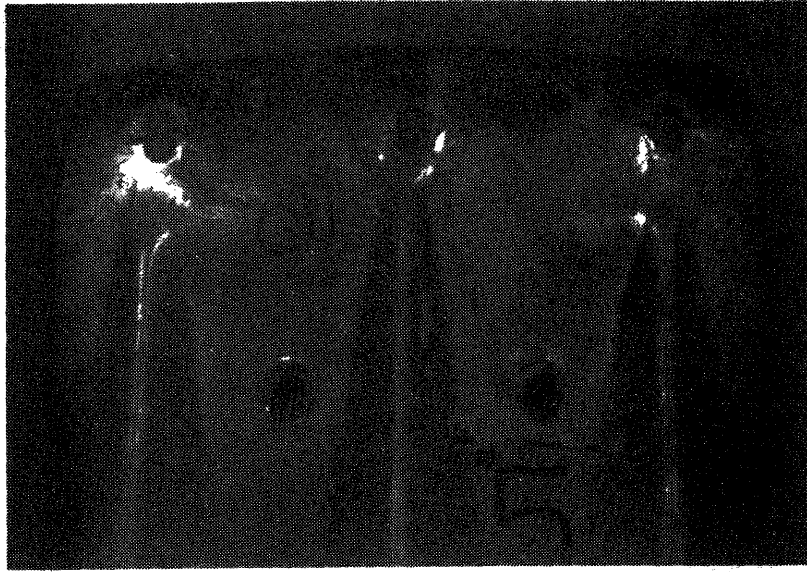
Figure 21. Exterior damage to flat section, sample five.

structural damage occurred at the top three bolt holes. Bearing of the bolts onto the connector followed by tearing normal to the direction of the load accounted for most of damage prior to the ultimate load capacity of the connector. Deformation at the splice bolt connection was once again limited (figures 20, 21, and 22).
