U.S. Department of
Transportation

**Federal Railroad
Administration**

Effectiveness of LED-Enhanced Signs in Reducing Incidents of Vehicles Stopping on Tracks

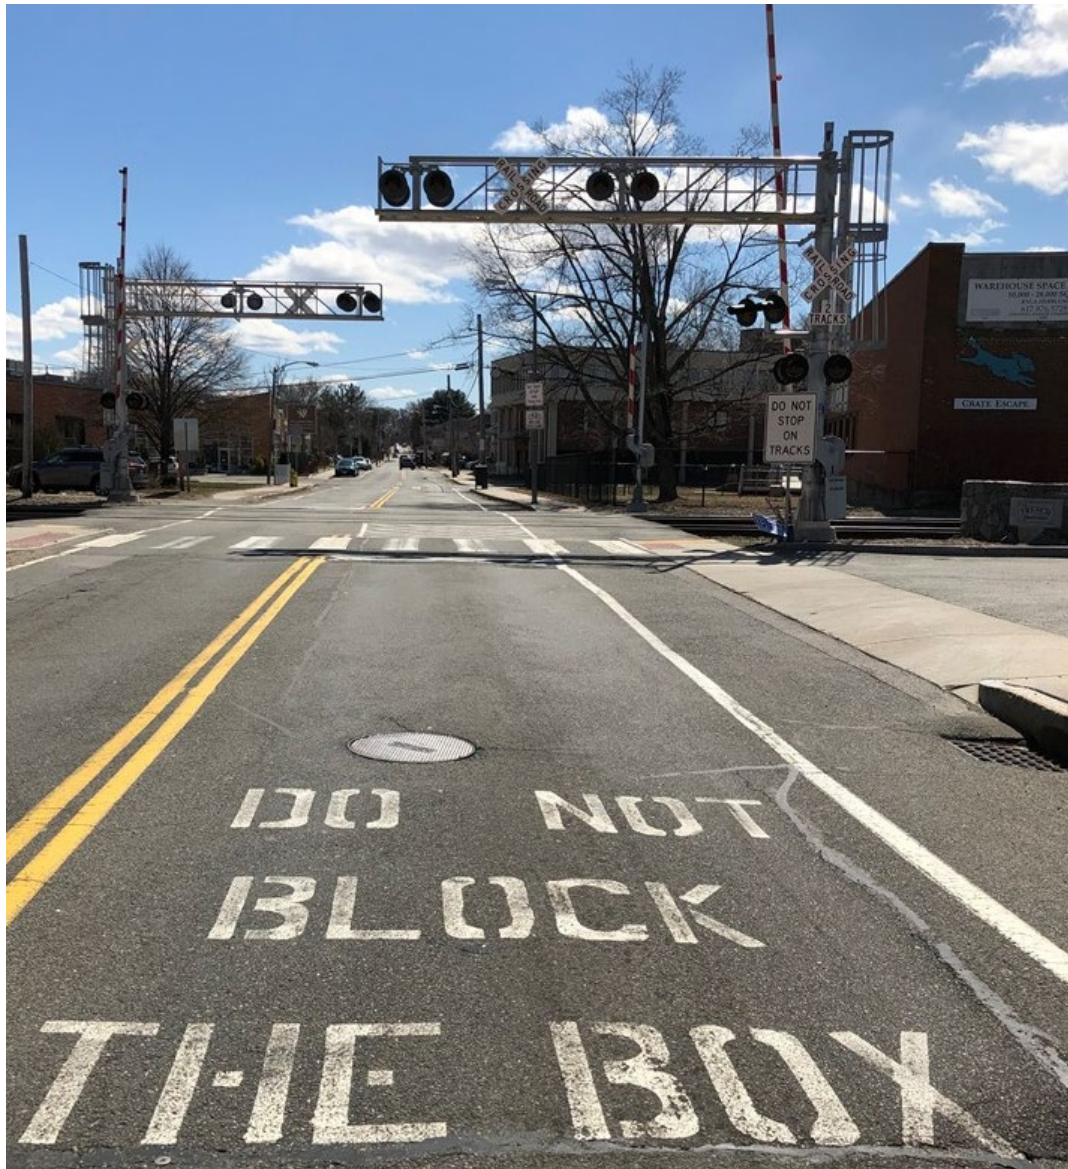
Figure 3. Southbound Approach to the Brighton St. Grade Crossing

There is one lane of traffic in the southbound direction, which traverses a crosswalk immediately before the grade crossing, shown in [Figure 3](#).

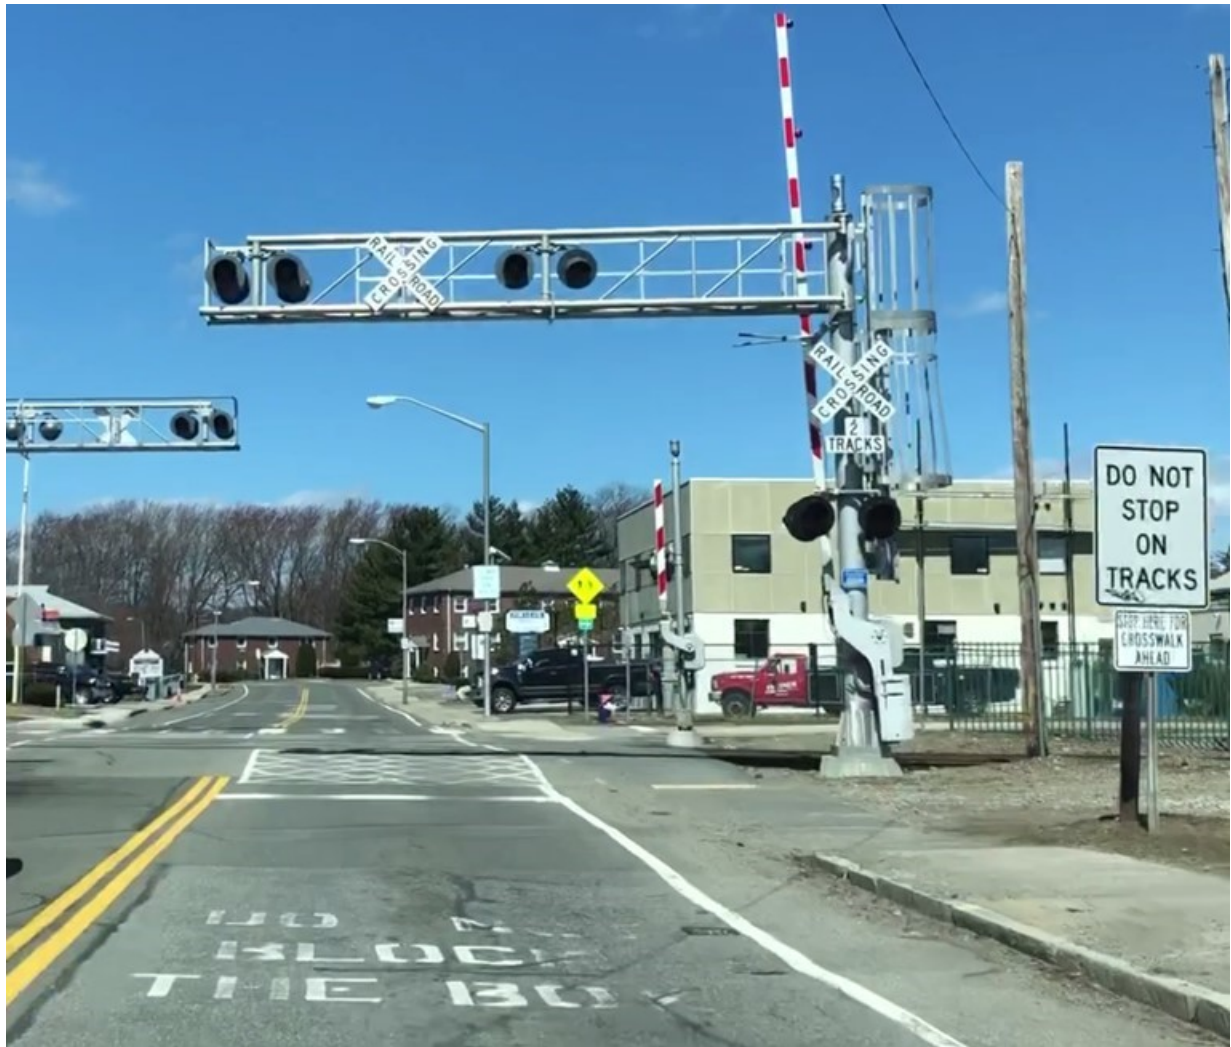
Figure 4. Northbound Approach to the Brighton St. Grade Crossing

There is one lane of traffic in the northbound direction. The crosswalk is immediately after the grade crossing in this direction. A picture of the northbound approach is shown in [Figure 4](#).

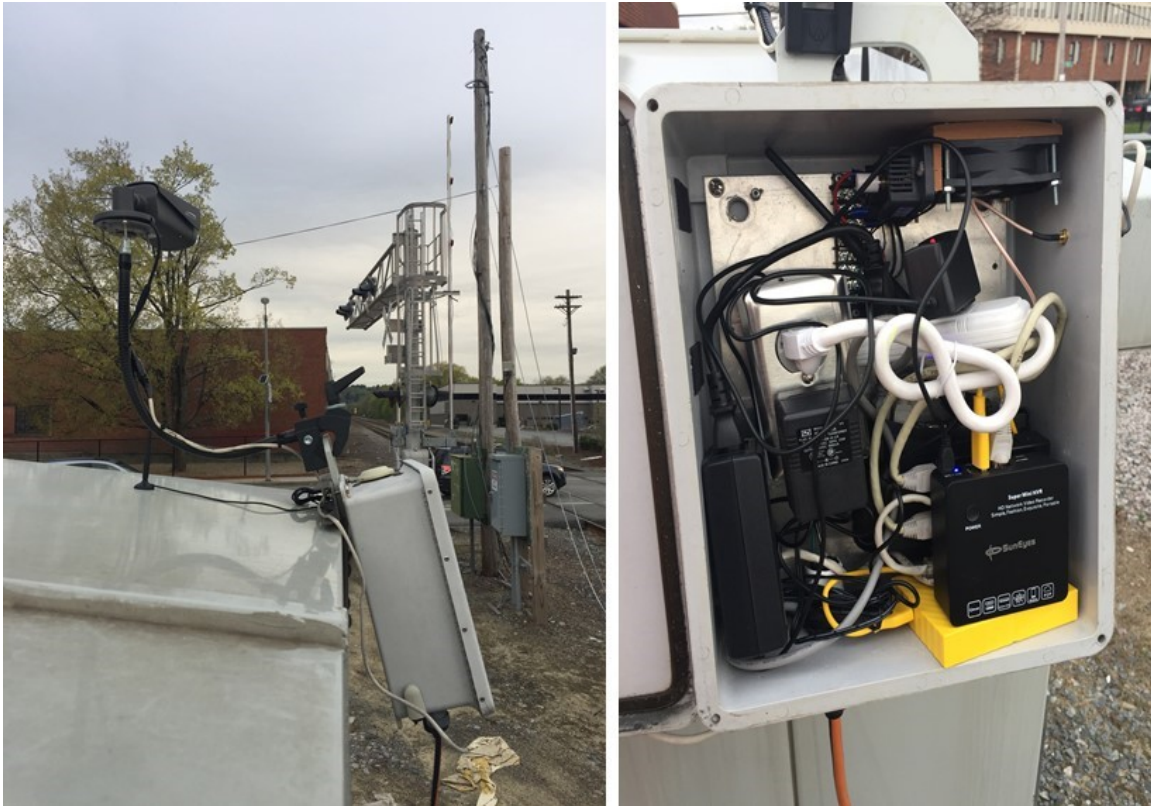
Figure 5. Video Data Capture Equipment at the Brighton St. Crossing

The MBTA and its operator, Keolis Commuter Services, authorized the Volpe Center to attach a video camera and weatherproof enclosure containing a digital video recorder along with supporting hardware to the outside of their Brighton Street bungalow, as shown in [Figure 5](#), to collect the necessary research data. The MBTA also provided AC power to the system from the bungalow.

Video data was collected using a Speco Technologies 3 Megapixel IP camera, model number O3VFBM. It was recorded on a SunEyes Super Mini Network Video Recorder (NVR), model number N6200-8E, using a Western Digital My Passport 4TB USB external hard drive. The

system was used to collect video of vehicles travelling in both directions at the Brighton Street grade crossing.

Video data was collected using the high-definition video camera with a varifocal lens set to its widest angle, which provided a view of all five zones in both directions. It should be noted that only about 8 feet of Zone 1 in the northbound direction was visible in the pre-installation video dataset. The camera was adjusted at the time the LED-enhanced signs were installed to show the full 12 feet of that zone.

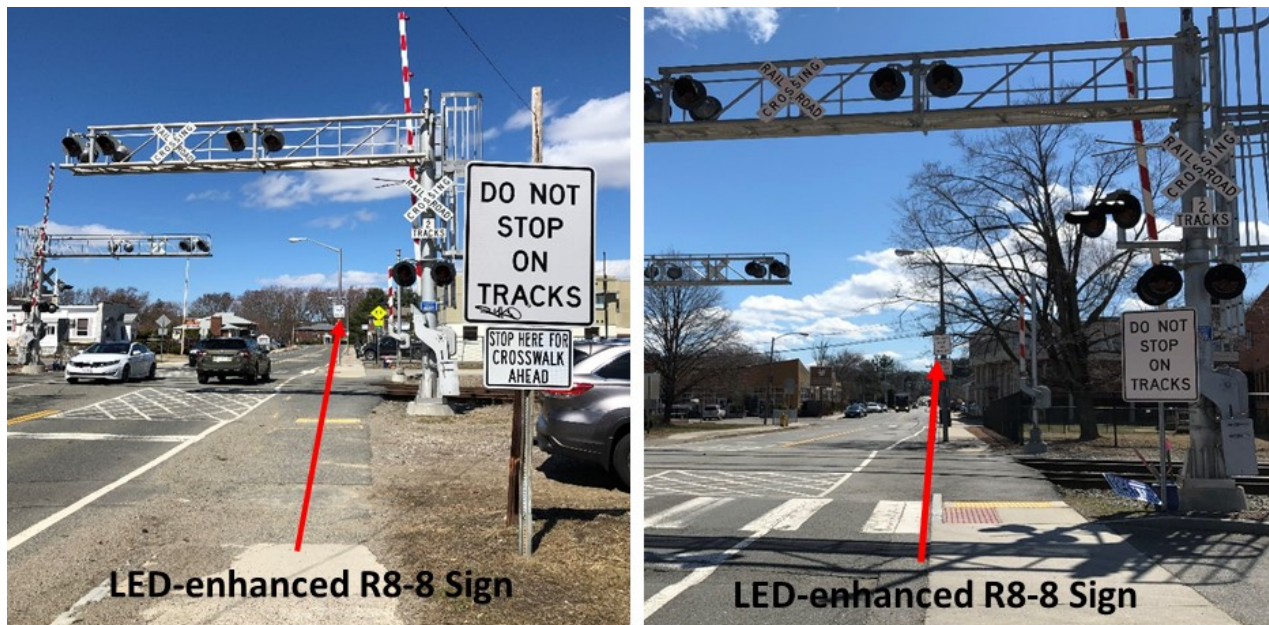
Figure 7. Brighton St. Crossing Northbound Approach (left) and Southbound Approach (right)

The signs used in this study were standard R8-8 signs that read "DO NOT STOP ON TRACKS." The Volpe Center decided to use LED-enhanced signs manufactured by two different companies to compare ease of installation, LED brightness, and durability. One sign was manufactured by Traffic and Parking Control Company ([TAPCO](#)), and the other by Traffic Safety Corporation ([TSC](#)). The signs look identical, and are both 24 inches by 30 inches. The MUTCD guidance states that the sign "should be located on the right-hand side of the highway on either the near or far side of the grade crossing, depending upon which position provides better visibility to approaching drivers" [9]. The Belmont Street crossing had existing R8-8 signs on the near side of the crossing in each direction, as previously shown in Figure 3 and Figure 4. The signs were larger, 36 inches by 48 inches, a size typically used on highways. The northbound sign has a second sign below it reading "STOP HERE FOR CROSSWALK AHEAD." The Volpe Center installed the LED-enhanced signs on the exit side of the crossing in each direction, mounted high enough to provide good visibility on both sides of the crossing, as shown in Figure 7. The existing signs on the approach sides were left in place.

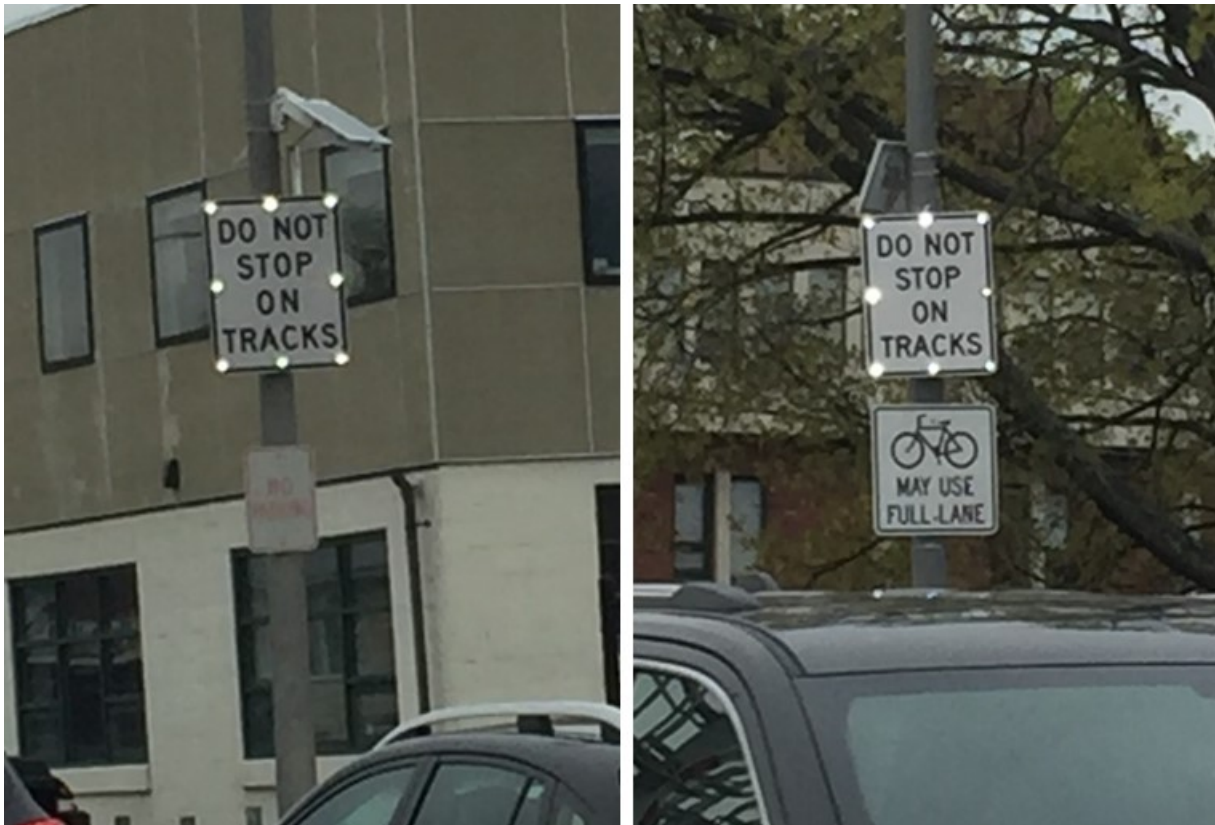
Figure 8. TAPCO (left) and TSC (right) Signs from Approximately 90 Feet

The LEDs of the TAPCO sign were significantly brighter than those used in the TSC sign. This mattered little after dark, when both signs appeared to flash brightly. However, in bright sunshine, the TAPCO sign was substantially more noticeable due to the brighter LEDs. Both signs had their LEDs aimed toward the roadway, so they appeared brighter from a distance than they did directly beneath the sign. The difference in luminosity can be seen in the two distance shots in [Figure 8](#) and from directly beneath the signs in [Figure 9](#), below. The photos were taken within a few minutes of each other, near dusk. However, differences in the way the camera adjusted for ambient light, as well as the way each sign's LEDs were focused, affected the way the LEDs appear in photographs.

The LED-enhanced signs were solar powered, and each came with a small 6 volt solar panel. They were both set to flash constantly. The TAPCO sign used a battery enclosed inside a separate aluminum tube. The battery of the TSC sign was encapsulated within the sign itself. The TSC sign had a security key that could be used to turn the LEDs on or off. The TAPCO sign had to be unplugged inside the battery tube.

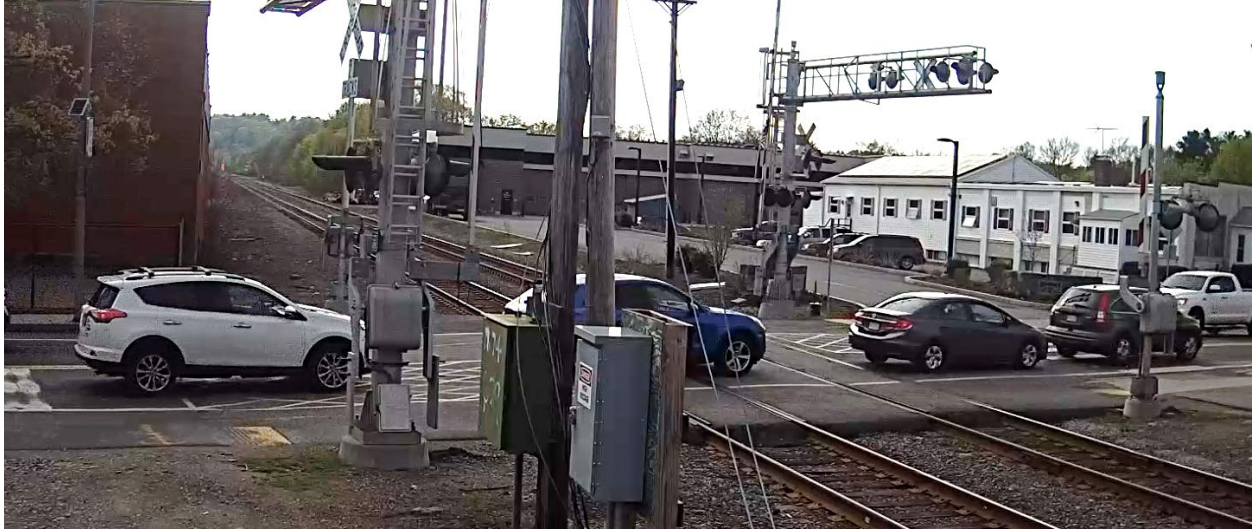
Figure 10. Northbound Vehicles Stopping on Tracks Due to Congestion

Clearly, far more northbound vehicles stopped in one of the violation zones than in the southbound direction. This was the case with those stopping in Zone 3 (directly on the tracks) as well, which was the area of primary concern. However, regardless of direction, roughly 30 percent of all vehicles that stopped in one of the violation zones stopped in Zone 3. An example of how the traffic often stopped during times of high congestion is shown in [Figure 10](#), clearly showing the blue vehicle stopped in Zone 3.

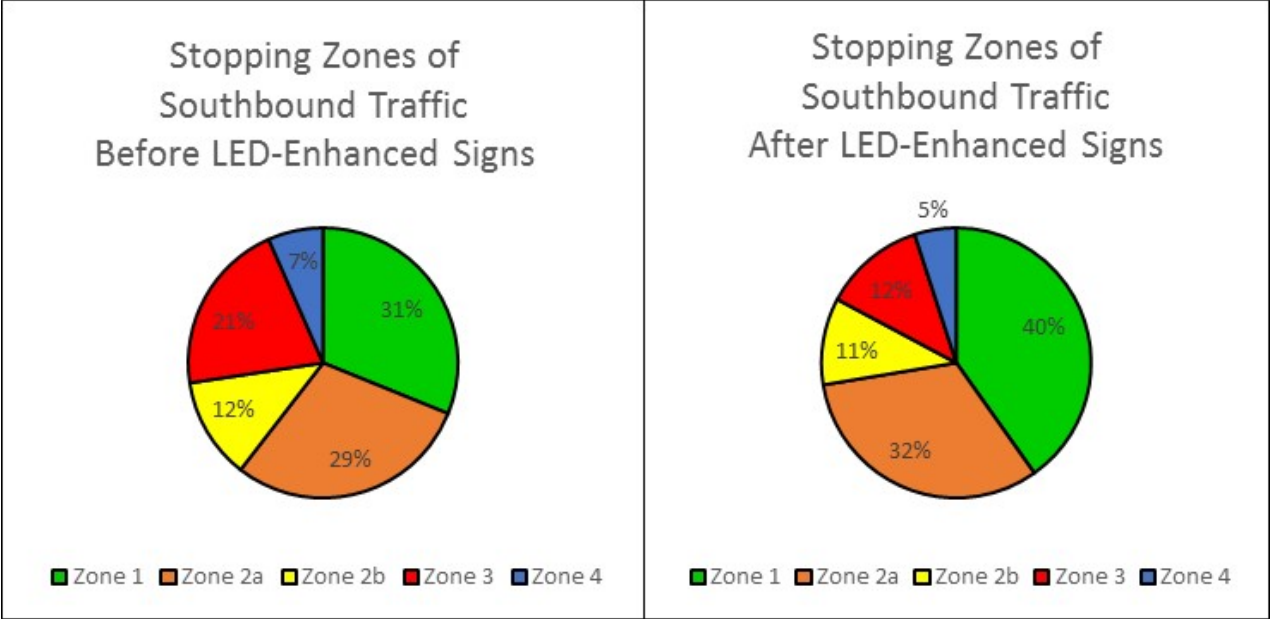
Figure 11. Comparison of Driver Stopping Behavior by Zone Before and After Installation of the LED Signs

In comparing the zones in which vehicles tended to stop, the Volpe Center focused on the southbound traffic because it had more certain Zone 1 data. [Figure 11](#) below shows graphically how the tendency for vehicles to stop in Zone 3 decreased, and that frequency of vehicles stopping in Zone 1 increased after the LED-enhanced signs were installed. In fact, the frequency of vehicles stopping in Zone 3 was reduced by 41.2 percent after the signs were installed.

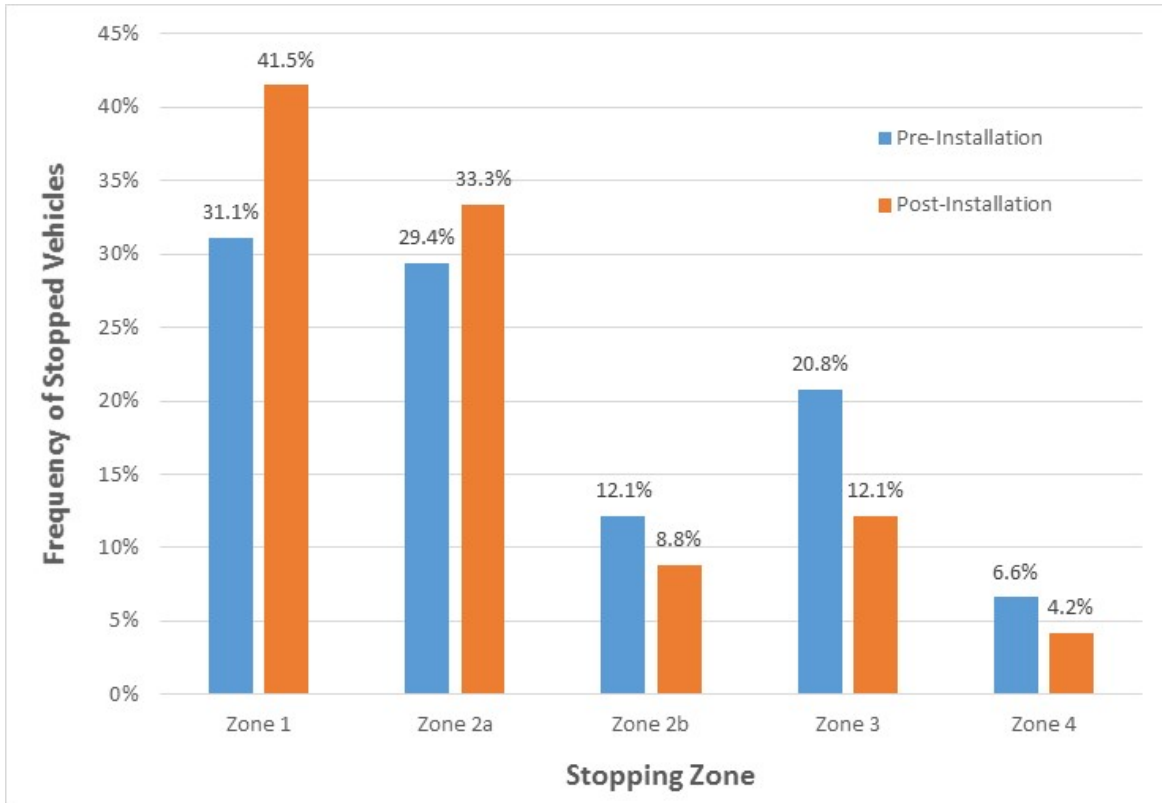
Figure 12. Frequency of Southbound Vehicles Stopping by Zone

For southbound traffic, the installation of the LED-enhanced signage had a profound impact in reducing the number of vehicles that came to stop on the tracks. A chi-square test of independence showed a significant difference between the pre- and post-installation conditions ($\chi^2 = 22.9001$, $df = 4$, $p < 0.01$). These changes included a 41.5 percent reduction in motorists

stopping in Zone 3 (from 94/453 to 55/453), a 36.7 percent reduction in motorists stopping in Zone 4 (from 30/453 to 19/453), and a 33.3 percent increase in motorists stopping appropriately in Zone 1 (from 141/453 to 188/453). Figure 12 shows the frequency of vehicles stopped per zone in the southbound direction before and after the installation of the LED-enhanced signs. This comparison shows that the LED-enhanced signs had a profound impact in reducing the number of vehicles that stopped on the tracks.

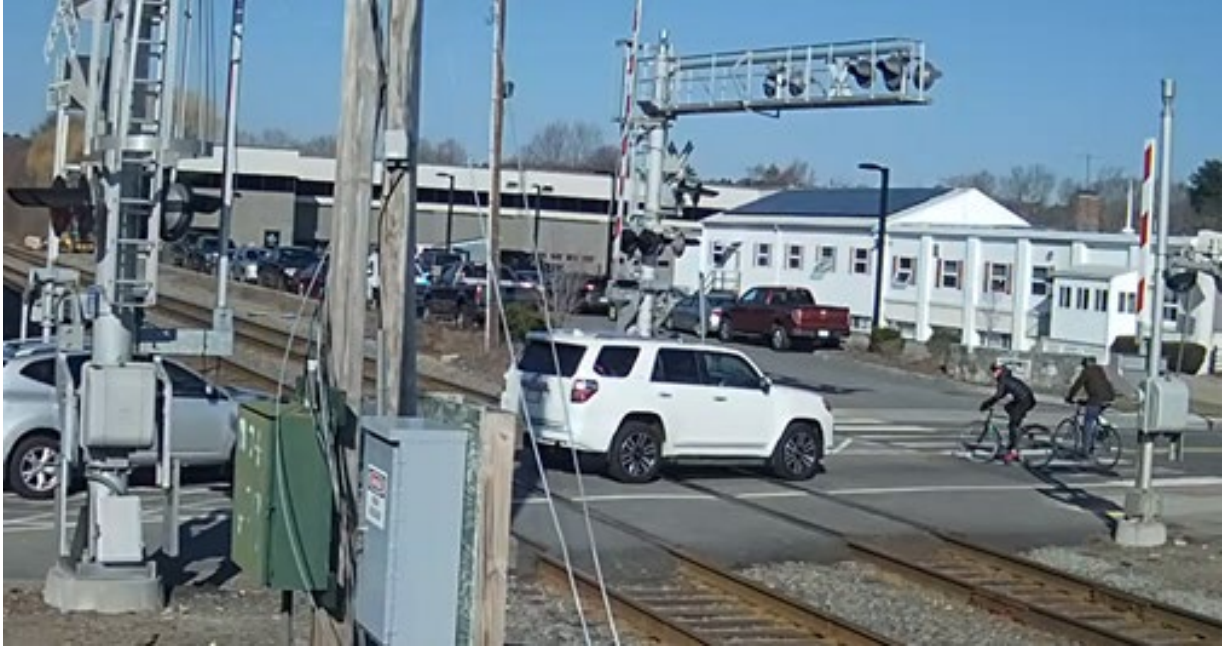
Figure 13. Example of Northbound Vehicles Stopping on Tracks Due to Bicyclists

The statistics also showed that at this crossing, far more vehicles stopped on the tracks in the northbound direction than in the southbound direction. In reviewing the video, one reason for this was clear: Many drivers did not see pedestrians or bicyclists attempting to cross at the crosswalk until they were already within one of the violation zones, so they stopped near or on the tracks to allow them to cross. In fact, 81 of the 223 (36.3 percent) of the vehicles that stopped in Zone 3 (directly on the tracks) in the northbound direction in the pre-installation phase did so to allow a bicyclist or pedestrian to cross the roadway. This number was relatively unaffected by the presence of the LED-enhanced signs. In the post-installation phase, this number was a very similar 89 out of 225, or 39.6 percent. However, this condition rarely trapped these vehicles on the tracks. The pedestrians and bicyclists tended to pass quickly and vehicles could proceed without significant delay. On the other hand, those that stopped on the tracks due to traffic congestion were sometimes trapped there for significant amounts of time, and had limited options for getting off the tracks when trains approached. An example of northbound vehicles stopping for bicyclists in the crosswalk is shown in Figure 13.
