1. Report No. FHWA-RD-74-18		2. Government Accession No. PB 236 424	
4. Title and Subtitle Nonmetallic Coatings for Concrete Reinforcing Bars		5. Report Date February 1974

7. Author James R. Clifton, Hugh F. Beeghly, and Robert G. Mathey		6. Performing Organization Code	
9. Performing Organization Name and Address Materials and Composites Section Center for Building Technology National Bureau of Standards Washington, D. C. 20234		8. Performing Organization Report No.

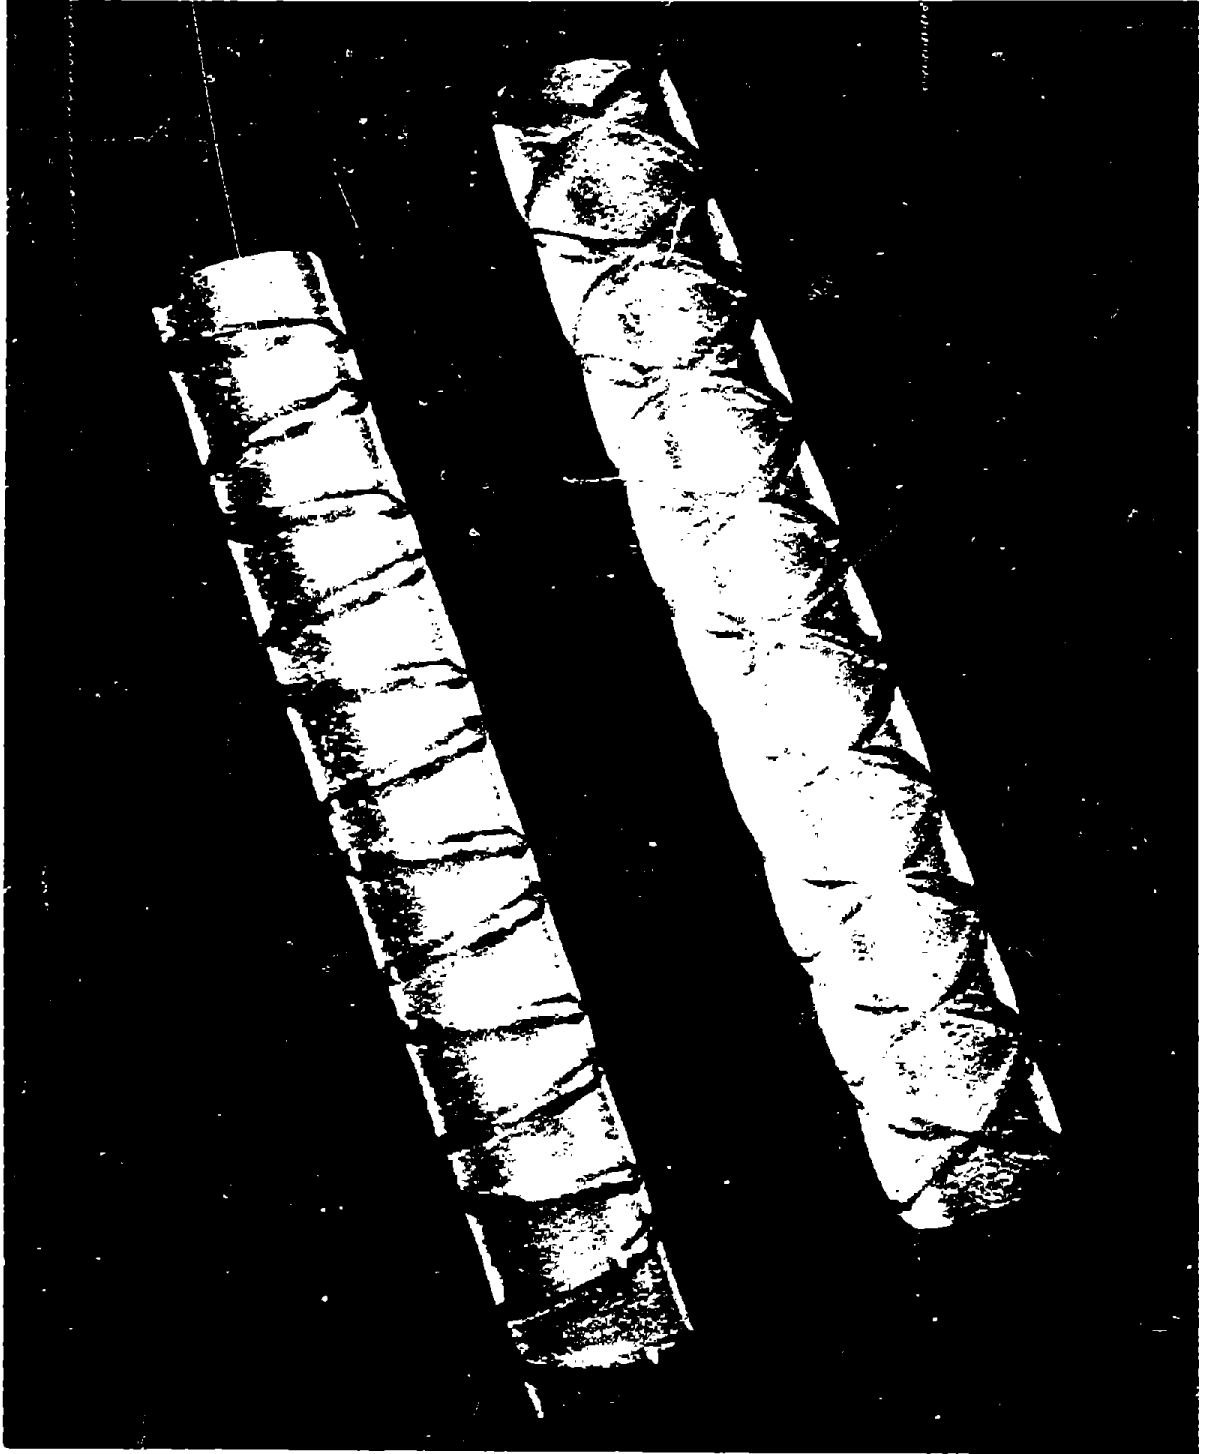
FIGURE 1. View of No. 6D (upper bar) and No. 6B (lower bar) reinforcing bars. D denotes diamond shaped deformation pattern and B indicates barrel pattern.

The tensile reinforcement in the pullout, creep, and corrosion tests consisted of No. 6 deformed bars having either a barrel (B) or diamond shaped (D) deformation pattern as shown in figure 1. The bars were randomly selected and may not all have been the same heat. A 4 foot length of each type of bar was tested to rupture in tension. The yield strengths determined by the "0.2 percent offset" method were 67,600 psi for No. 6 rebars (D) and 62,500 psi for No. 6 rebars (B). These bars did not exhibit a well-defined yield point, however, their stress-strain relationships (figure 2) were linear up to a stress of about 64,000 psi for the (D) rebars and approximately 62,000 psi for the (B) rebars. Tensile properties of the bars are listed in table 2. The yield, tensile strengths and deformations of the bars met the requirements of ASTM A 615-72 [25] for Grade 60 bars. The properties of deformations were determined from three coupons of each type of bar and are given in table 3.

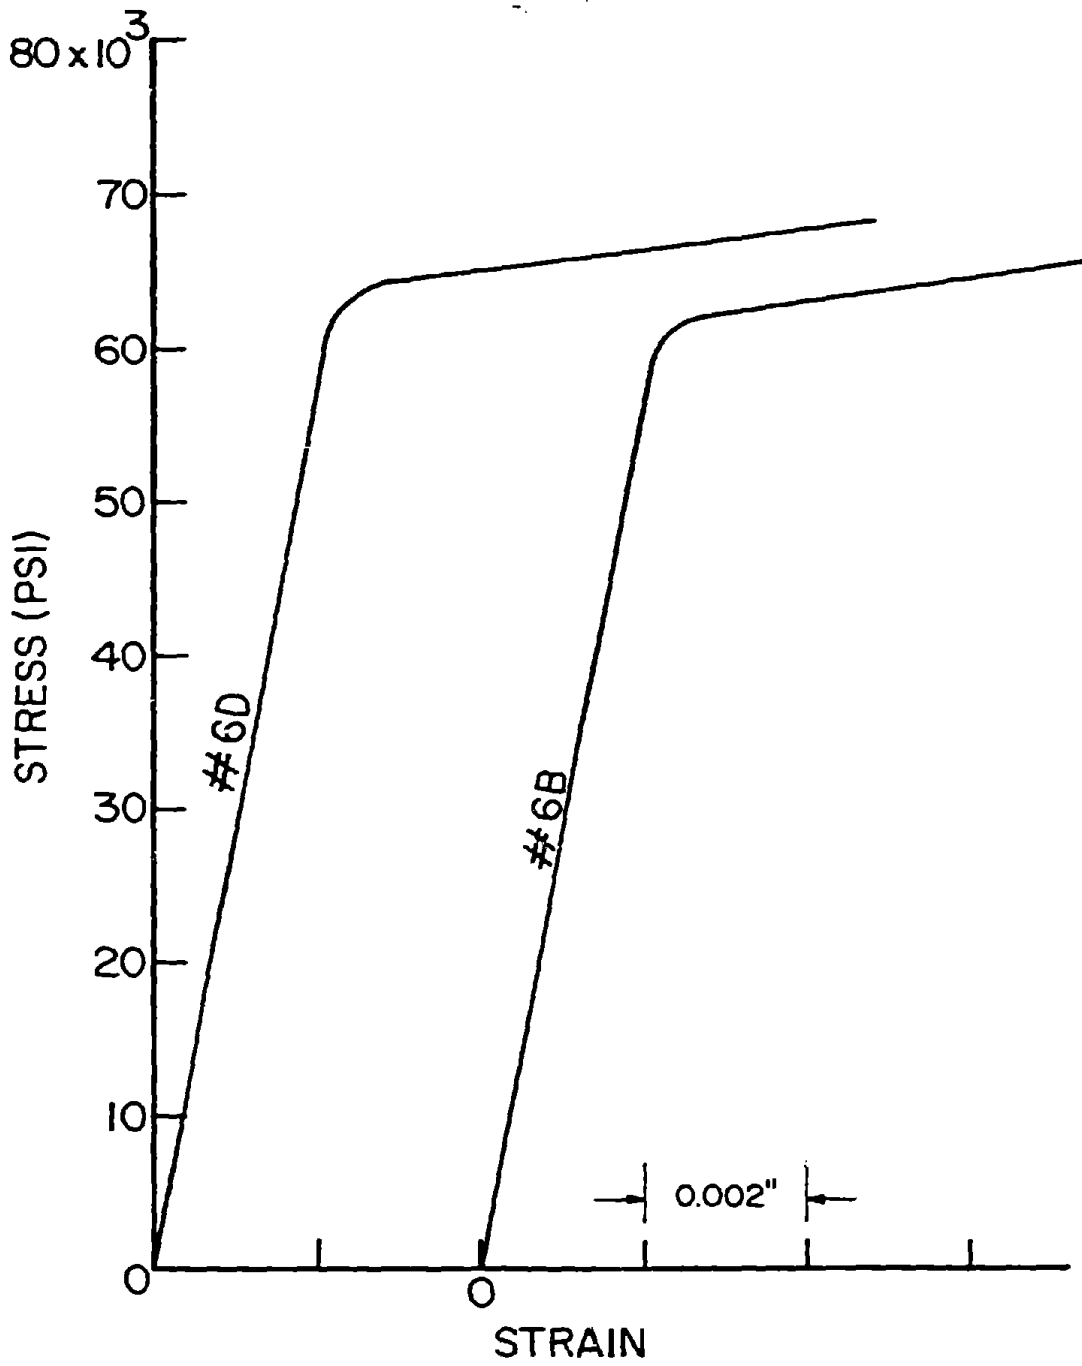
FIGURE 2. Typical stress-strain characteristics of reinforcing bars.

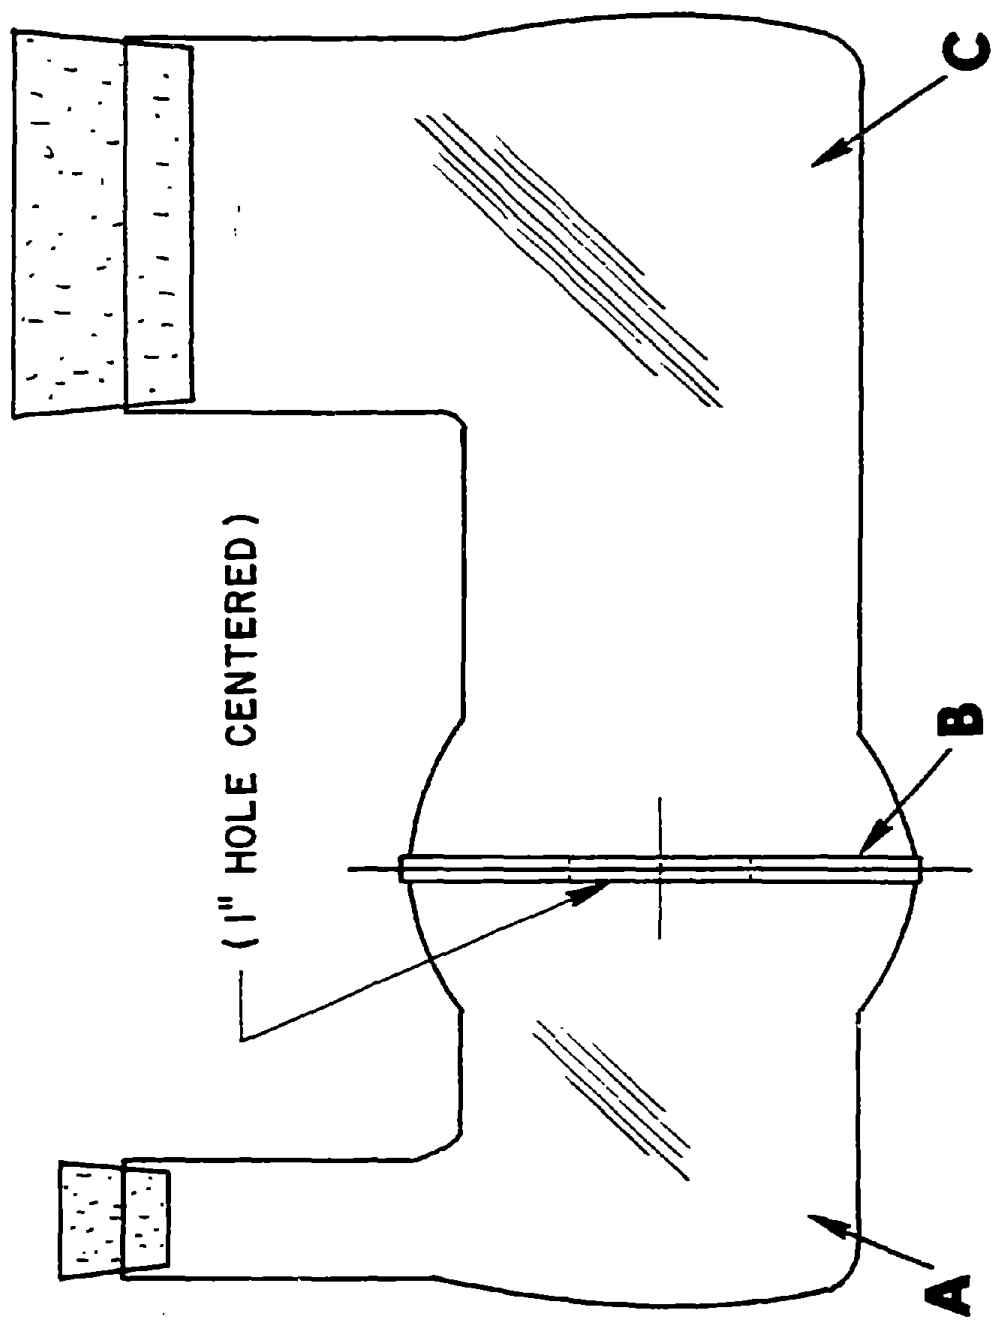
FIGURE 4. Permeability Cell

- Components:
- A. Compartment containing distilled water;
 - B. Epoxy film sandwich between two glass plates each having centered one-inch diameter hole;
 - C. Compartment containing 3M NaCl

The chloride permeability characteristics of thin films (3-7 mils) of cured epoxies were determined using permeability cells of the type shown in figure 4. Films selected for study were carefully handled, and examined for any defects prior to installation in the cell. The cell consisted of two glass compartments separated by an epoxy film sandwiched between two glass plates, each having centered 1 inch diameter holes. One compartment contained 175 ml of 3M NaCl and the other 115 ml of distilled water. The activity of chloride ions passing through the epoxy membrane was measured using a Model 401 Orion Specific Ion Meter, along with a Model 94-17 Orion Chloride Electrode, and a Model 90-02 Orion Double Junction Reference Electrode. Activity measurements were converted into concentration values of mole per liter with a conversion diagram, constructed by plotting measured chloride ion activities versus known chloride ion concentrations.

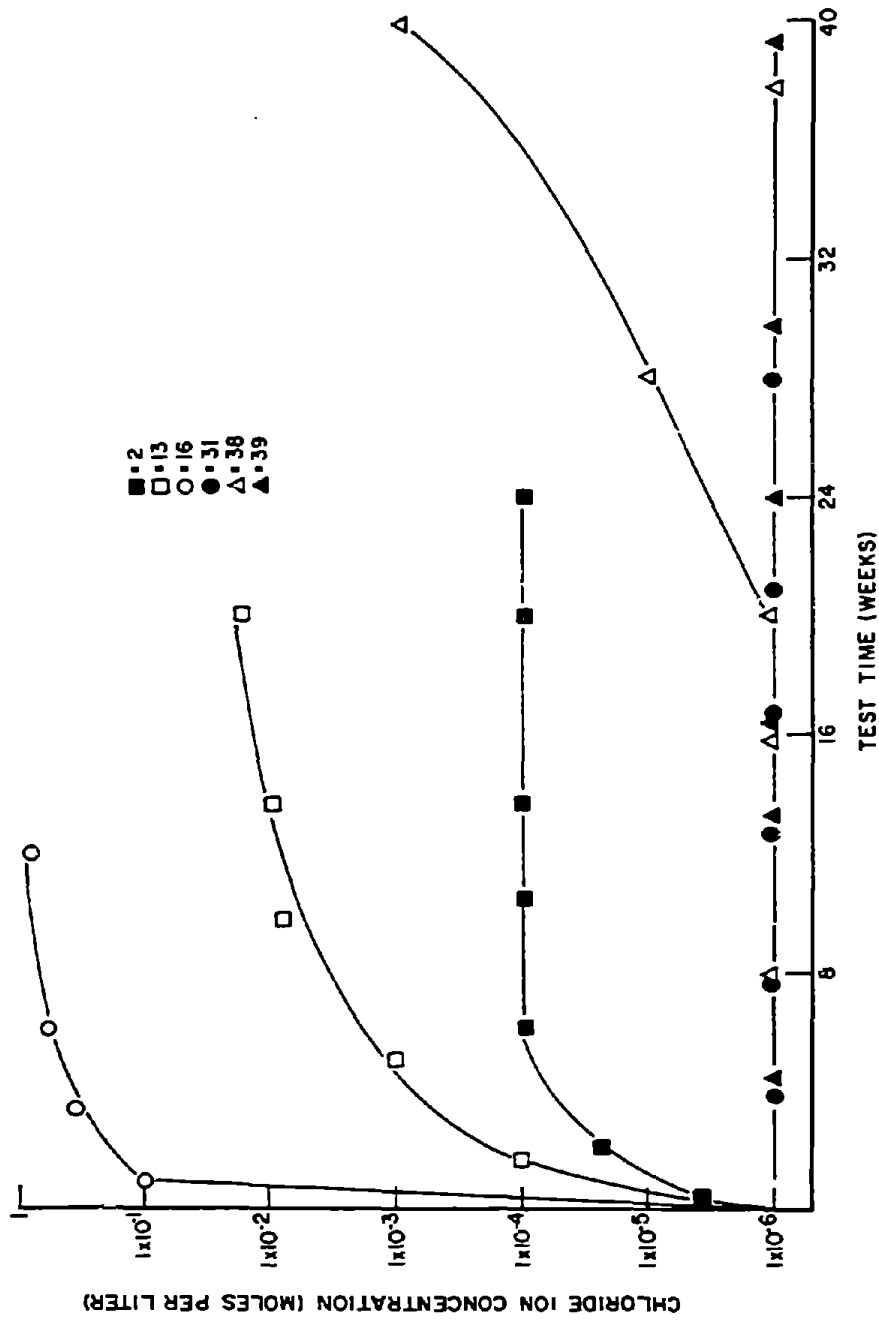
FIGURE 5. Concentration of chloride ions passing through epoxy films of materials Nos. 2, 13, 16, 31, 38 and 39. Film thicknesses were 3 mils.

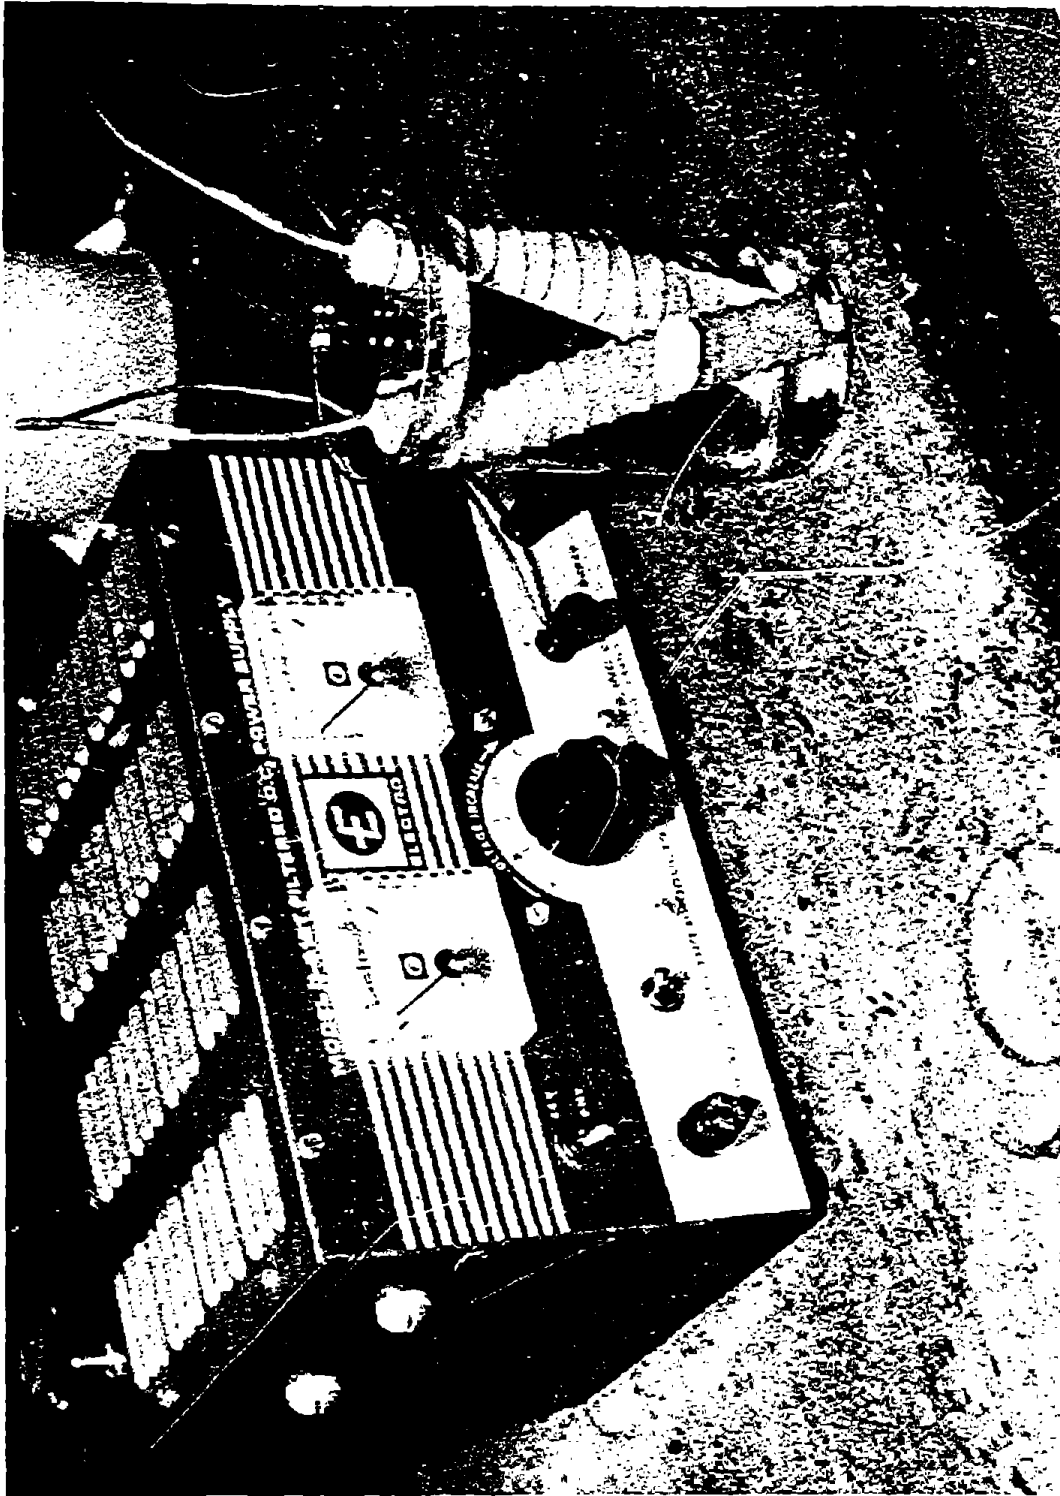
FIGURE 6-A. Applied voltage test at beginning of test. Anode and cathode coated with material No. 16.

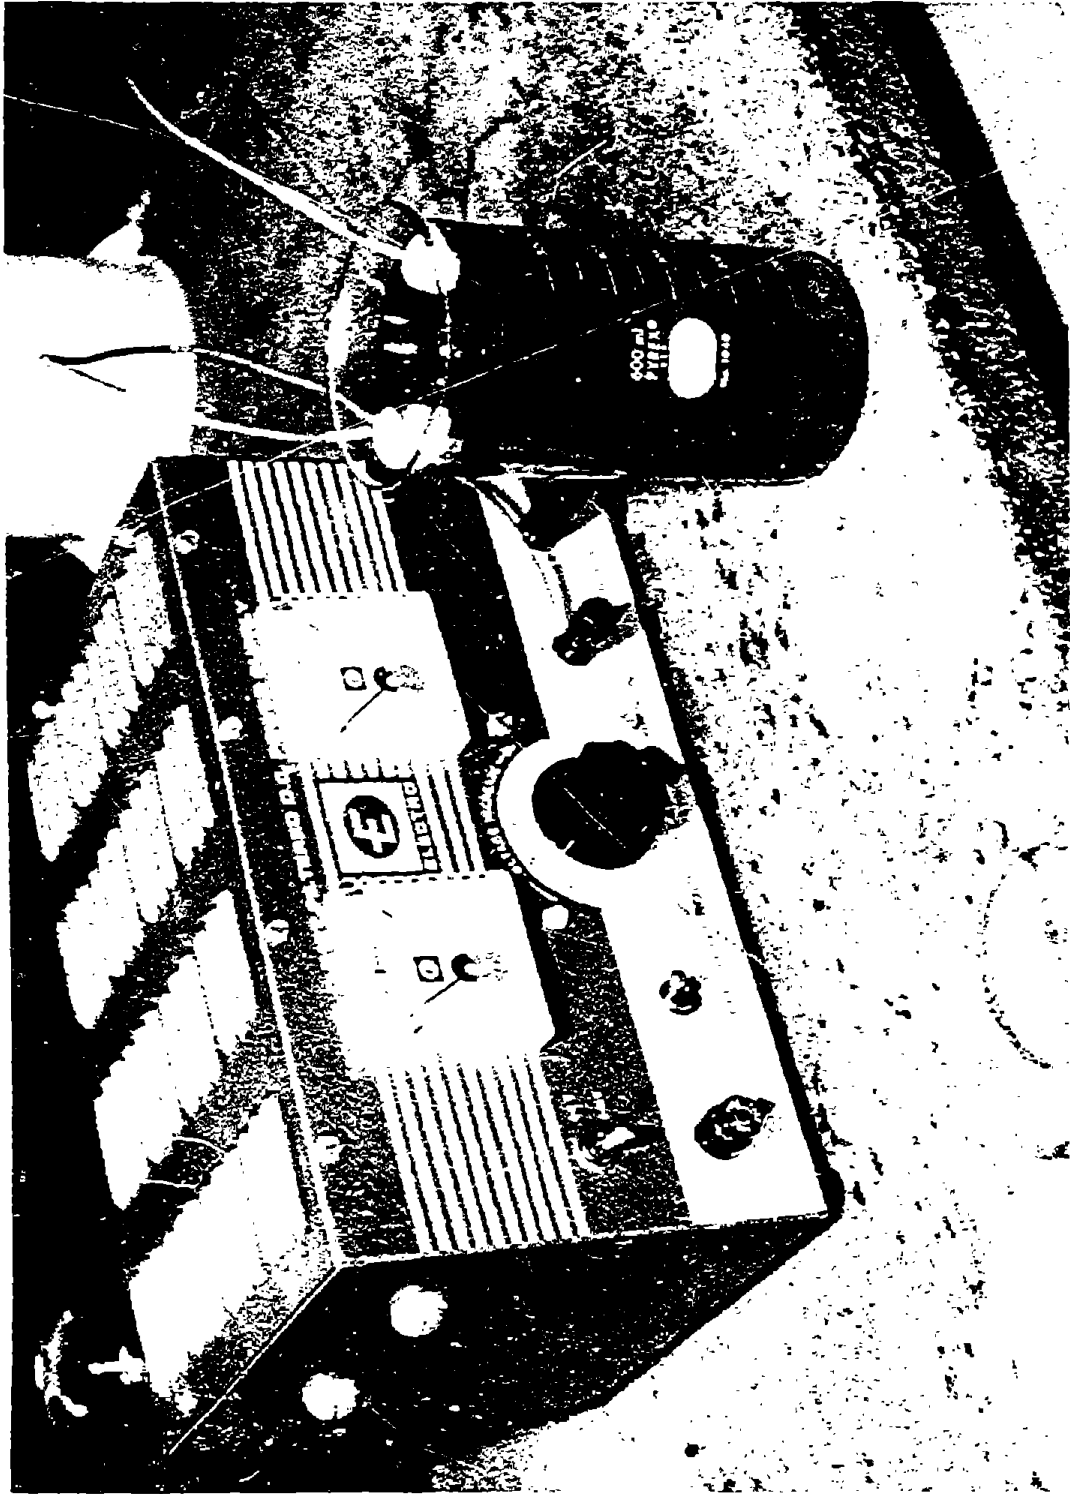
FIGURE 6-5. Results of application of 3 volts for 40 minutes.

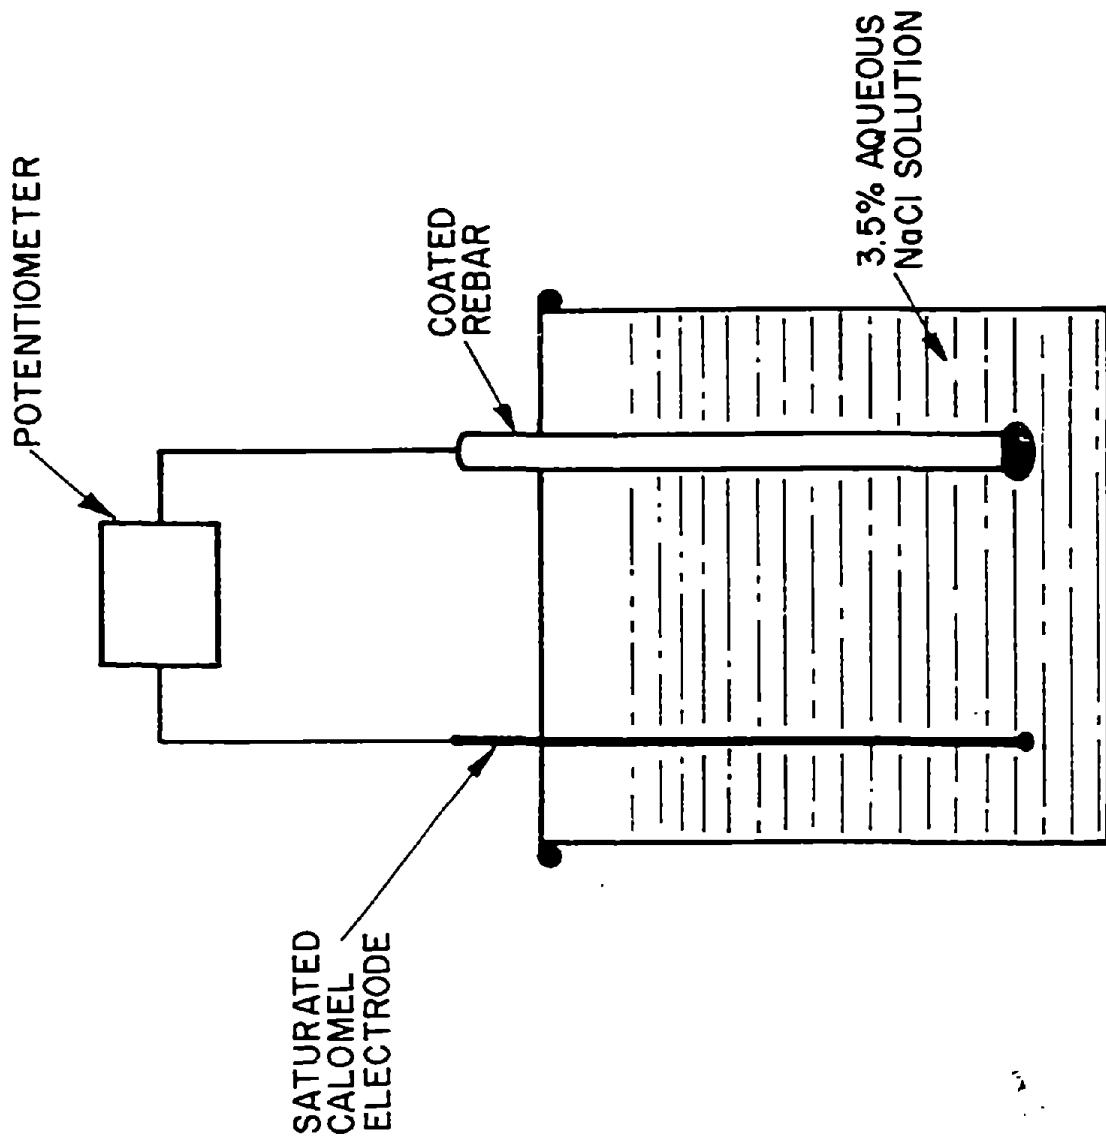
FIGURE 7. Measurement of electrical potentials of coated reinforcing bars immersed in 3.5 percent solution of NaCl.

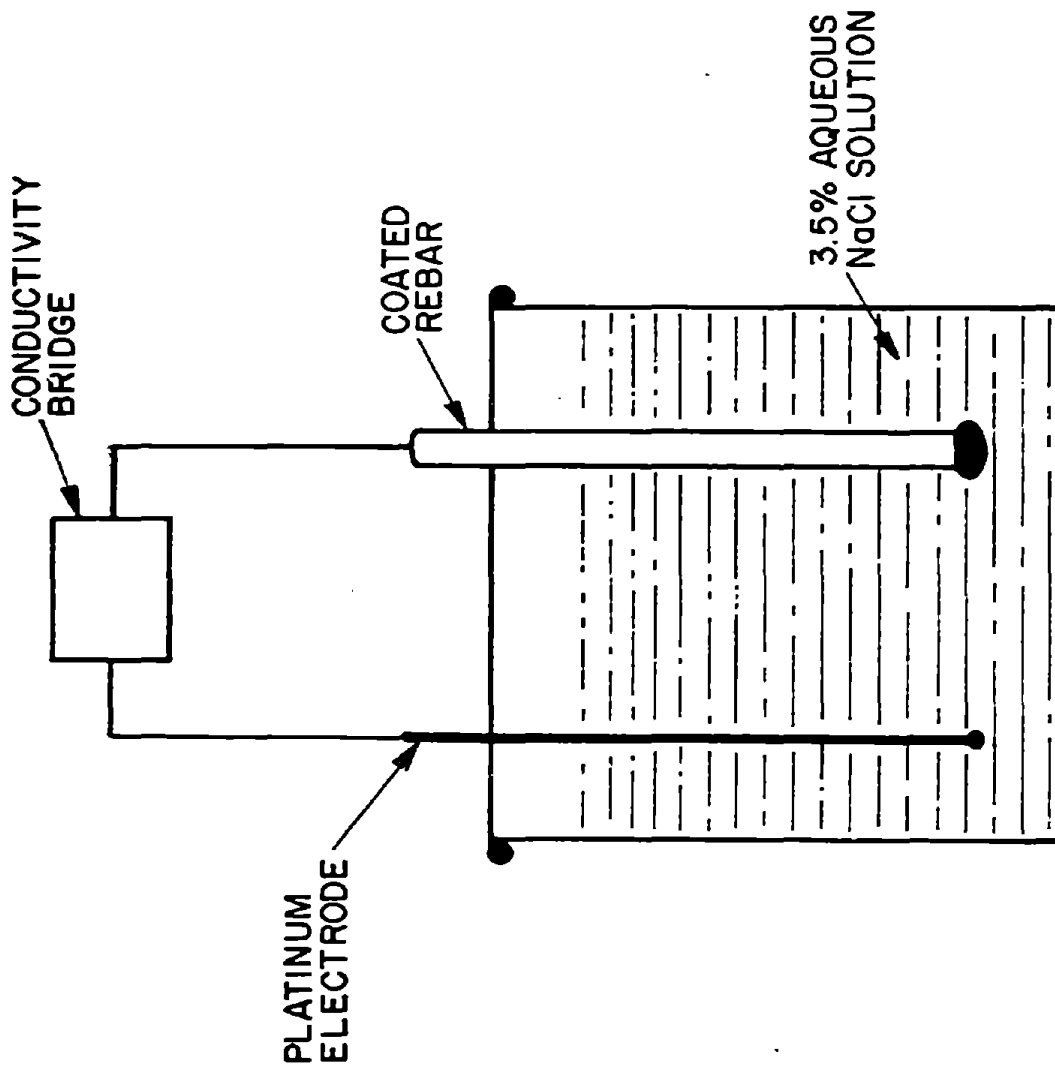
FIGURE 8. Measurement of electrical resistance of coatings on reinforcing bars immersed in 3.5 percent solution of NaCl.

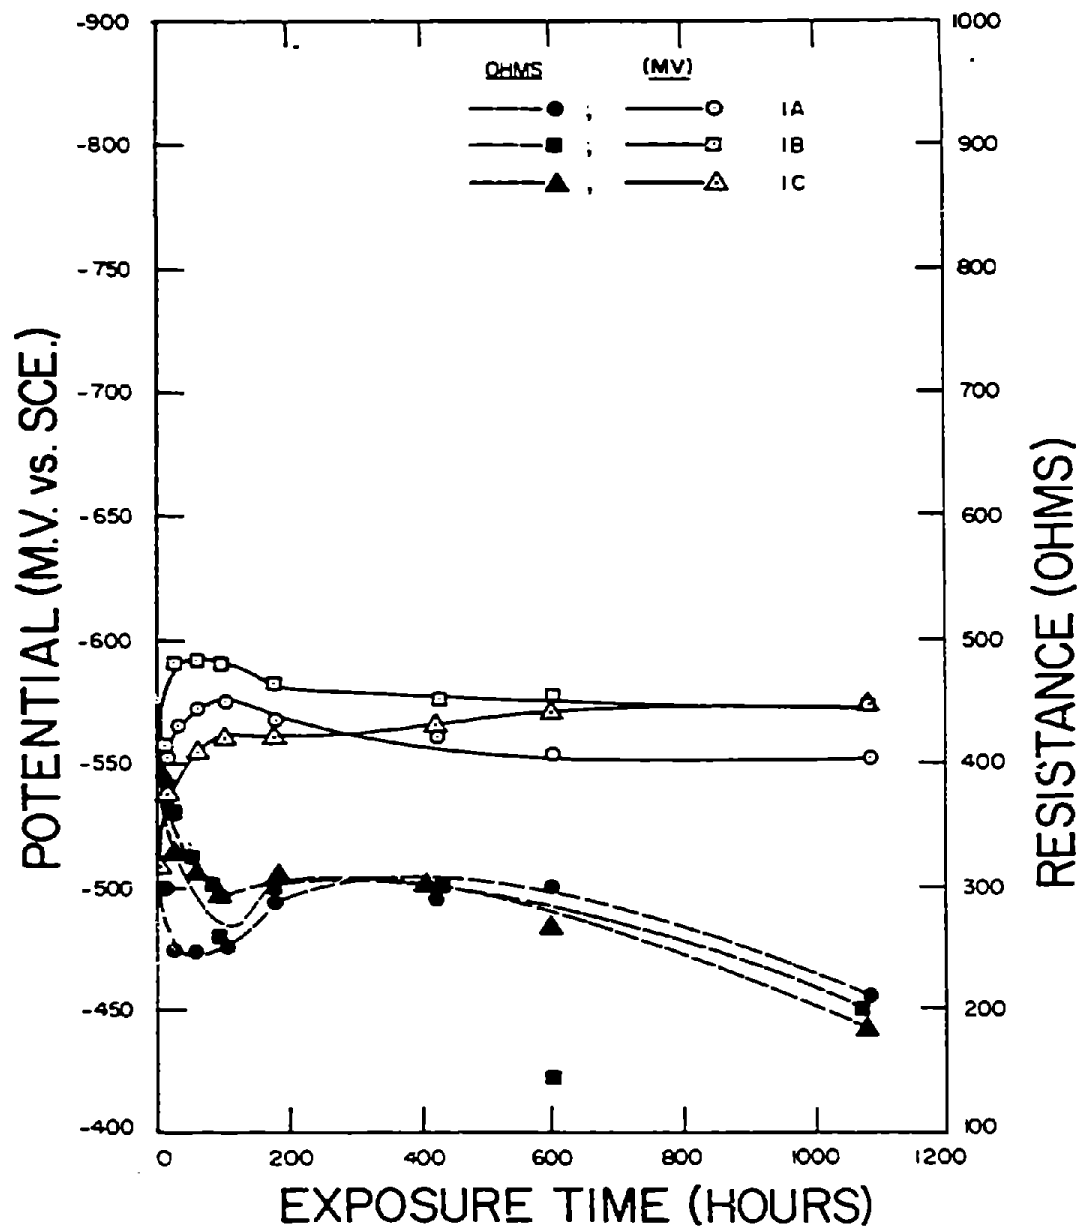
FIGURE 9. Electrical potential and resistance measurements of reinforcing bar coated with material No. 1 immersed in 3 1/2 percent NaCl. In the ordinate caption, M.V. vs. S.C.E. denotes millivolt reading taken using a saturated calomel electrode as the reference.

Potential and resistance data for three sets of reinforcing bars, each set coated with a different epoxy (Nos. 1, 25 and 31) are plotted versus test time in figures 9, 10 and 11 (initial plotted values measured after 24 hours of immersion of coated bars). The wide variance in the initial millivolt and ohmic readings of duplicate and triplicate specimens decreased rapidly during the first 200 hours of testing and after 1000 hours good agreements were obtained for companion specimens. A rapid decrease in the resistance of a coating probably can be attributed to the emergence of holidays, while an increase in resistance is probably indicative of some type of healing mechanism.

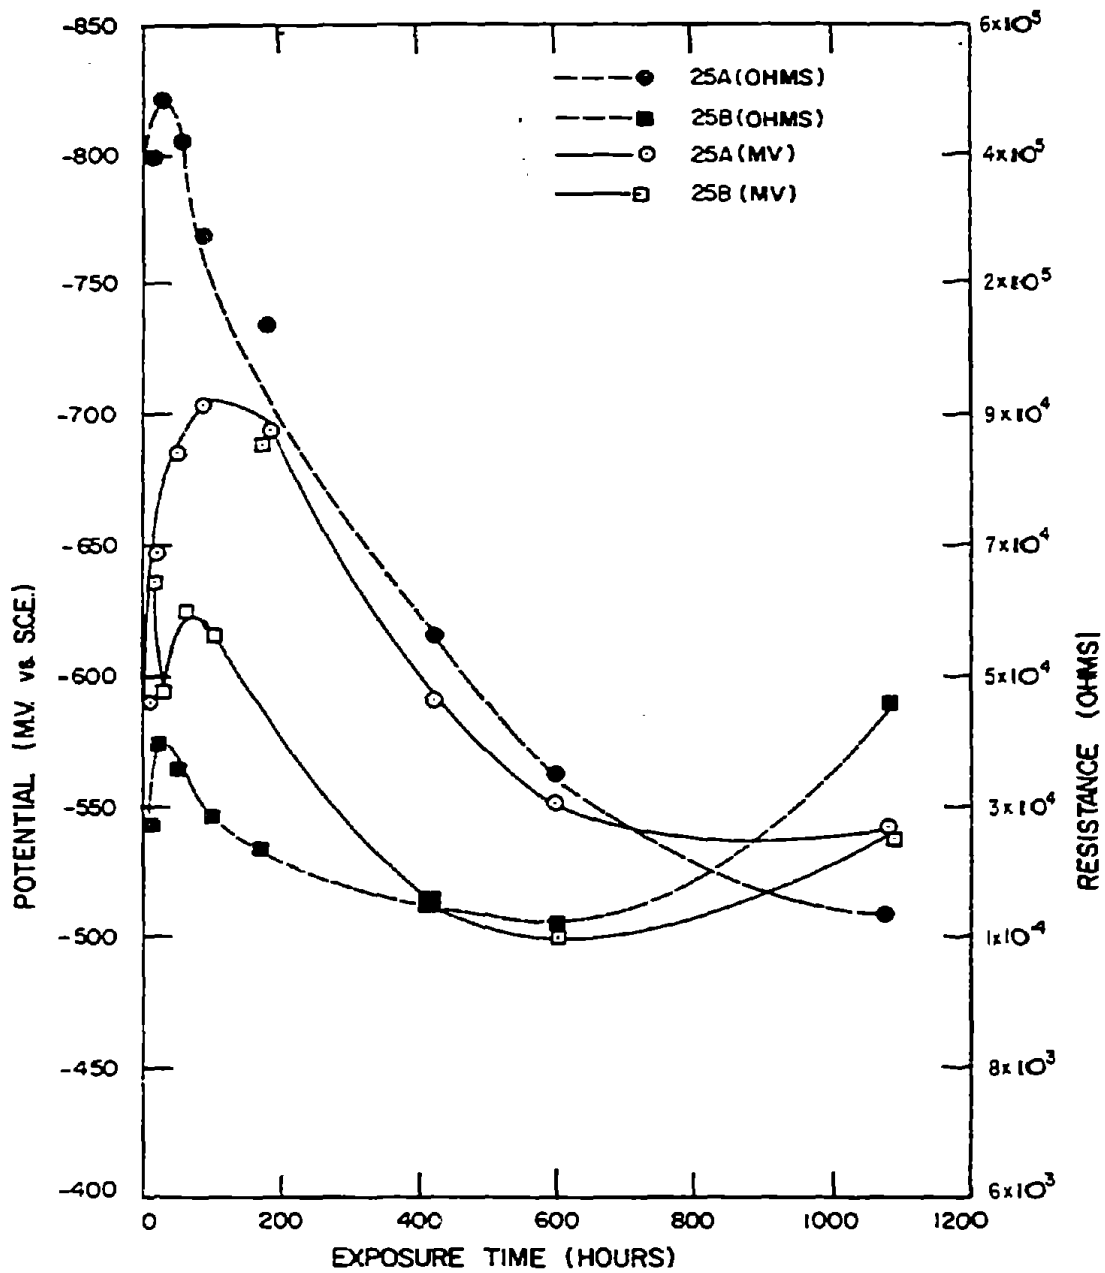
FIGURE 10. Electrical potential and resistance measurements of reinforcing bar coated with material No. 25 immersed in 3 1/2 percent NaCl. In the ordinate caption, M.V. vs. S.C.E. denotes millivolt reading taken using a saturated calomel electrode as the reference.

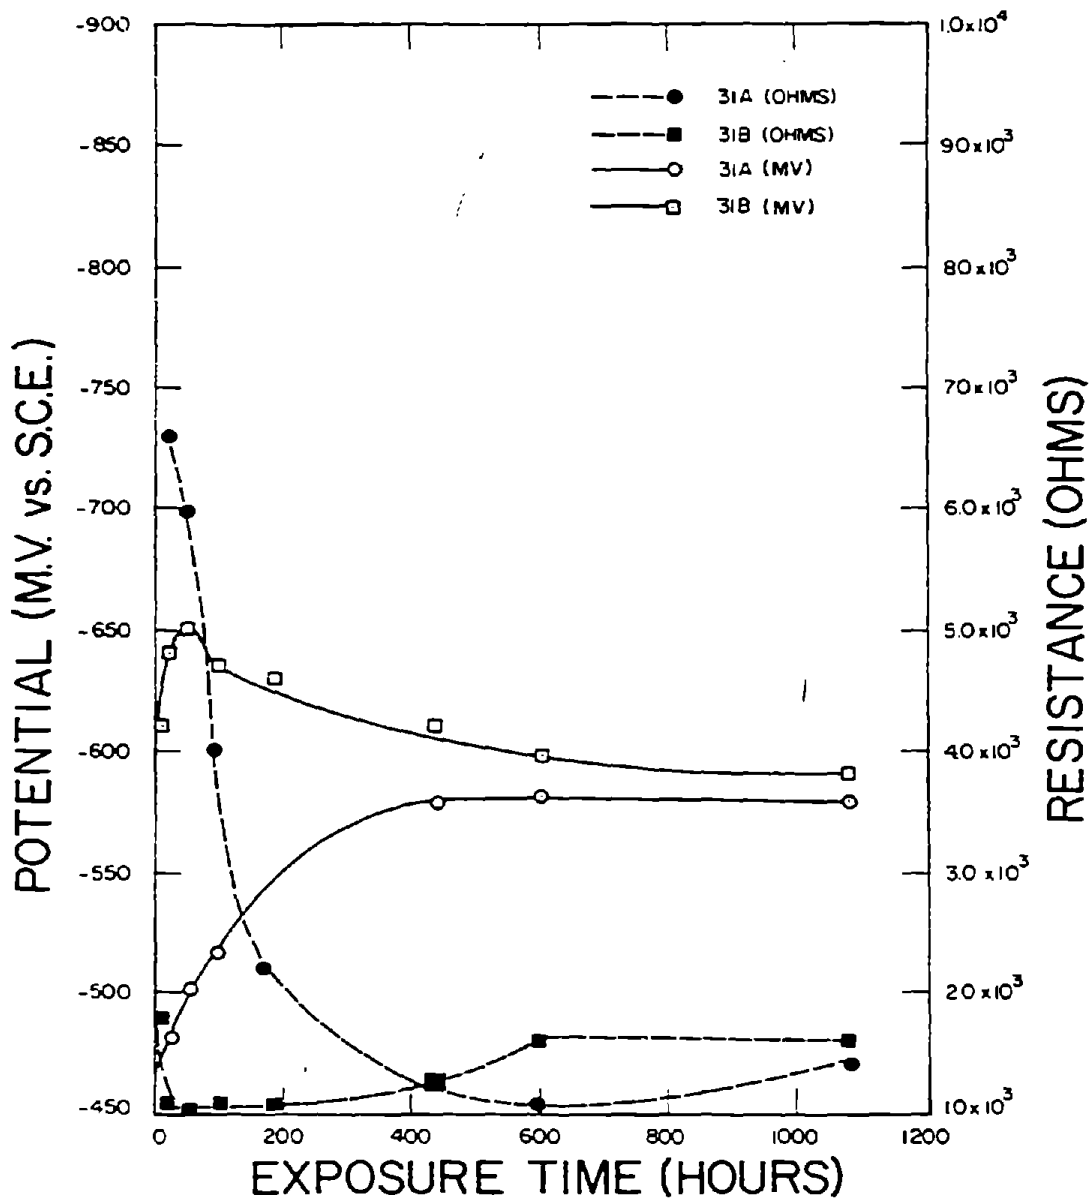
FIGURE 11. Electrical potential and resistance measurements of reinforcing bar coated with material No. 31 immersed in 3 1/2 percent NaCl. In the ordinate caption, M.V. vs. S.C.E. denotes millivolt reading taken using a saturated calomel electrode as the reference.

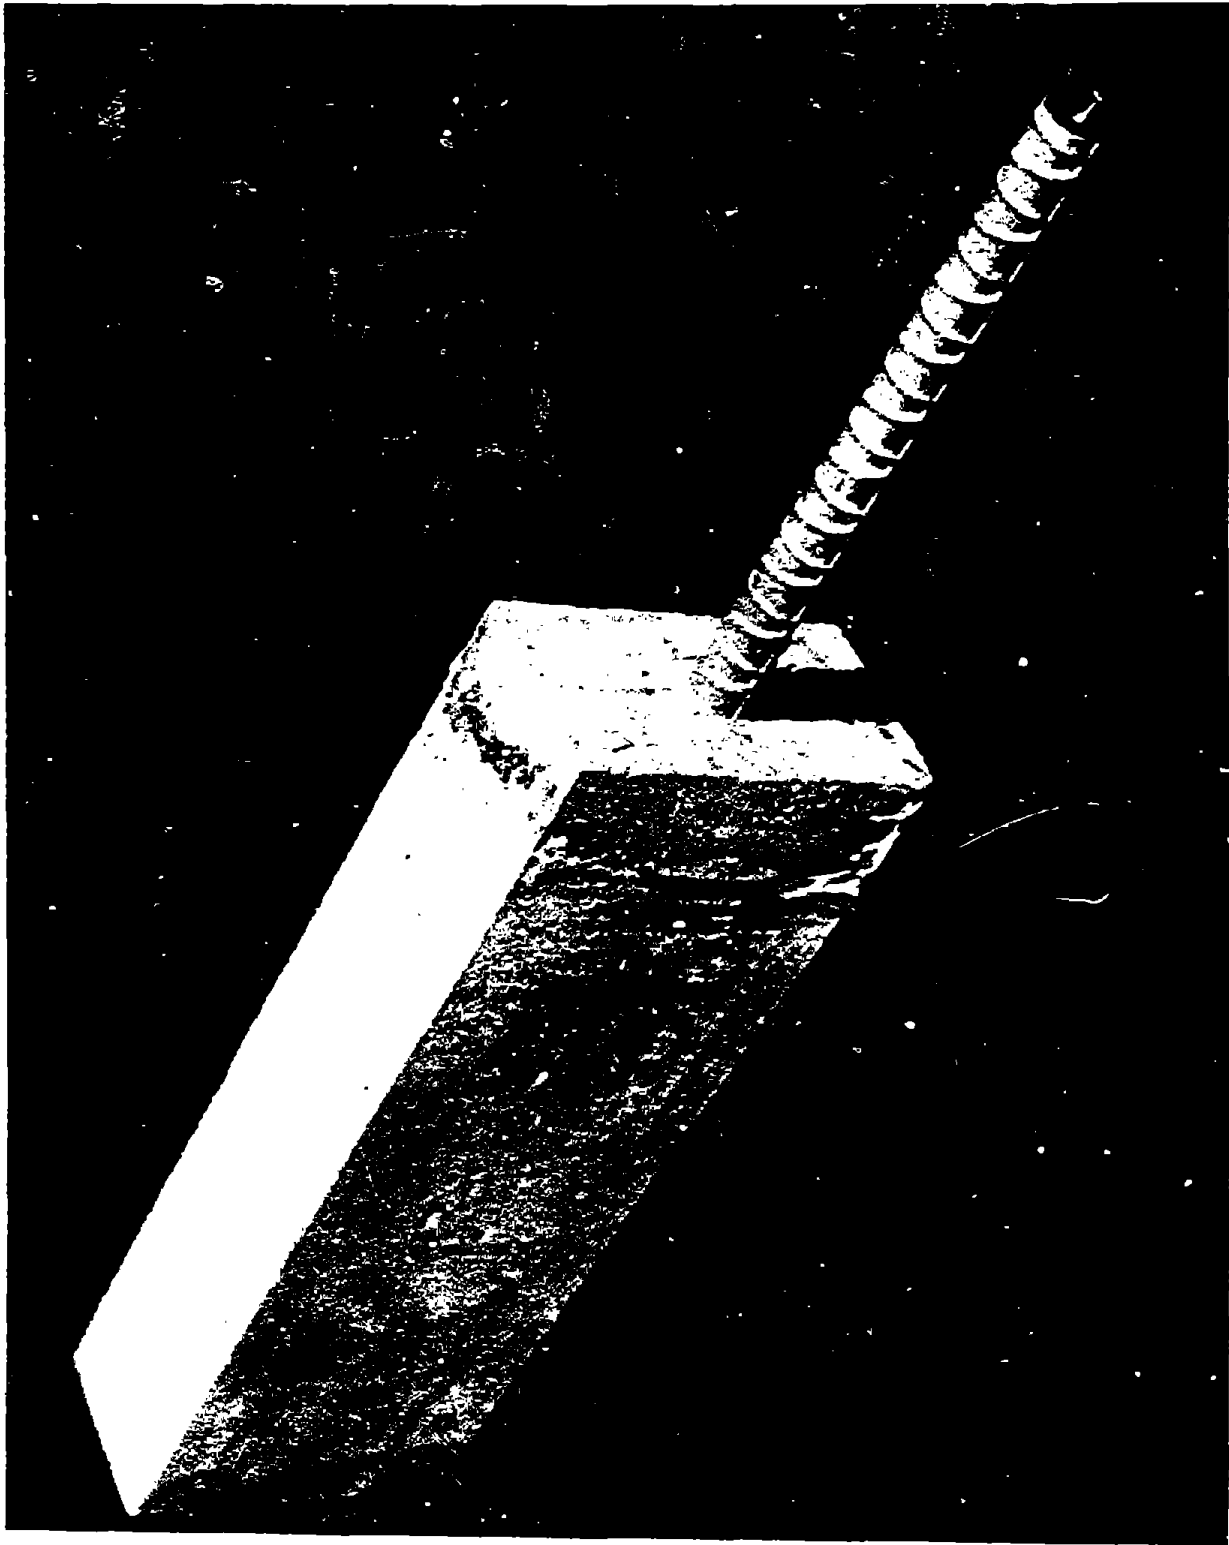
FIGURE 12. Corrosion-test specimen with coated reinforcing bar embedded in concrete block of dimensions $2 \frac{7}{8} \times 4 \frac{7}{8} \times 15$ inches.

The corrosion test specimens were concrete blocks 2 7/8 x 4 7/8 x 15 inches in which were embedded a 24 inch length of No. 6 reinforcing bar concentric with the longitudinal axis of the block. The bars protruded out of the concrete blocks with exposed ends of 1 inch and 8 inches. The end of the block with the 1 inch of bar protruding which was to be immersed in the salt solution, was first coated with an "underwater" type of epoxy which bonded firmly to the concrete. Then the 1 inch exposed end of the bar and the epoxy were coated completely with a heavy layer of silicone rubber. The bond of the rubber to steel and to the epoxy was very good, although its bond to concrete in a salt solution is poor. A terminal was inserted into the long end of each reinforcing bar so that electrical connections could be made to a voltmeter or conductivity bridge.

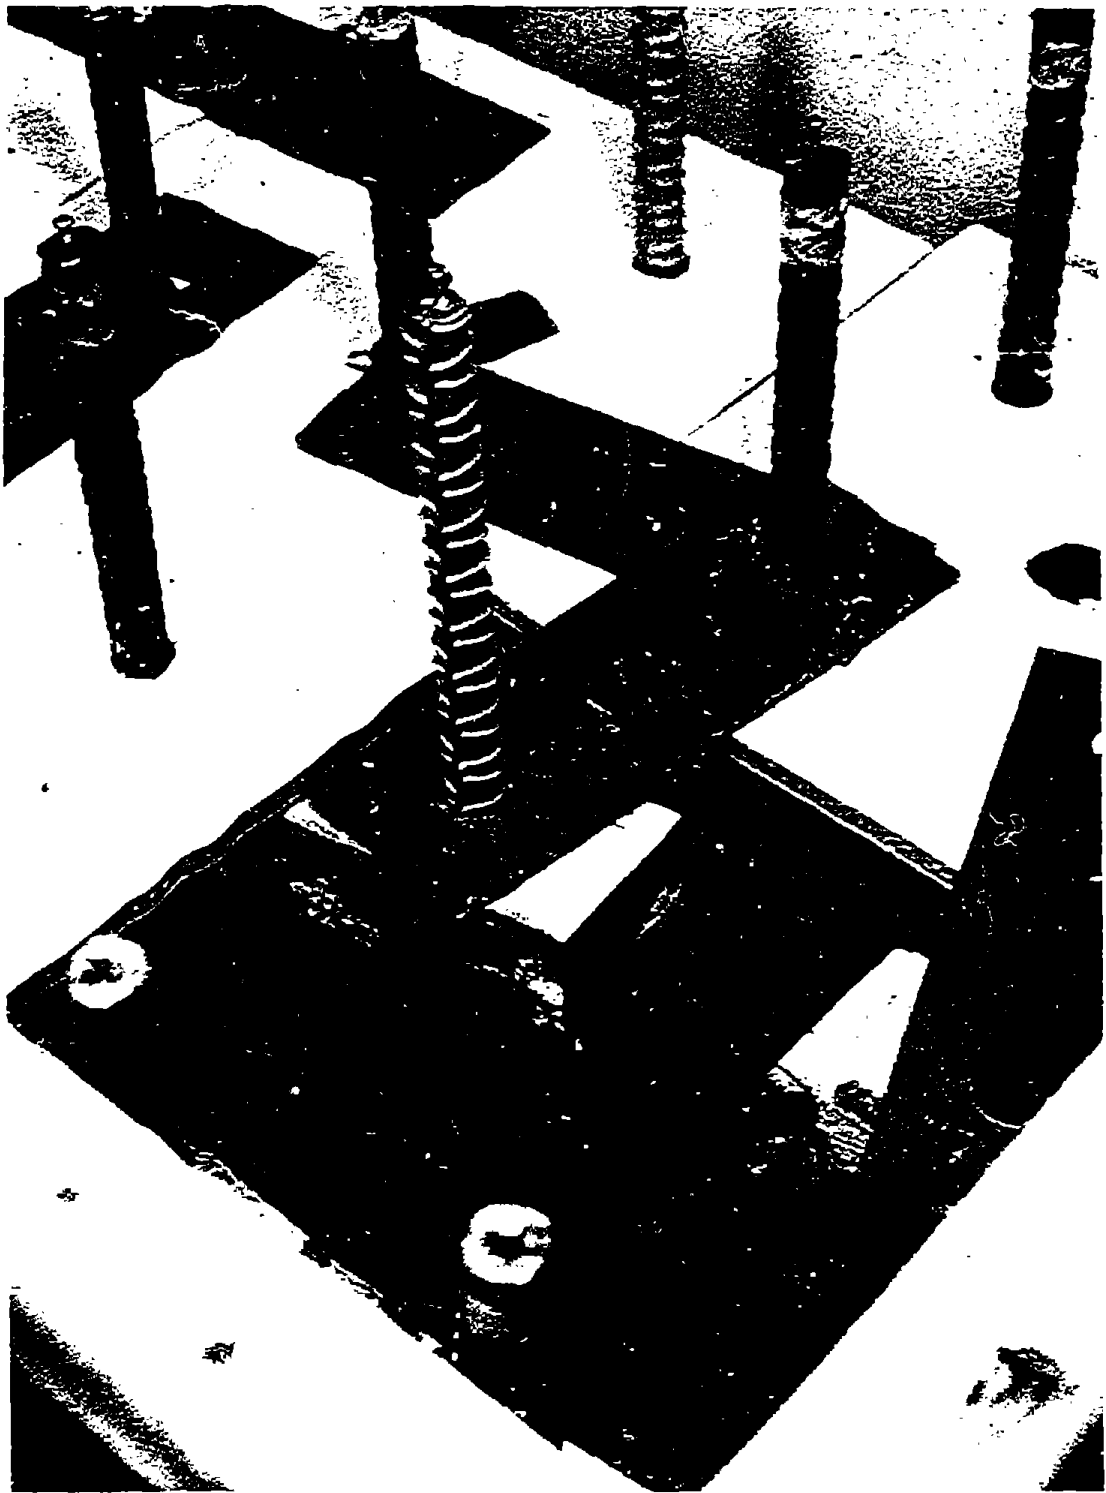
FIGURE 13. Corrosion-test specimens immersed in 3.5 percent solution of NaCl.

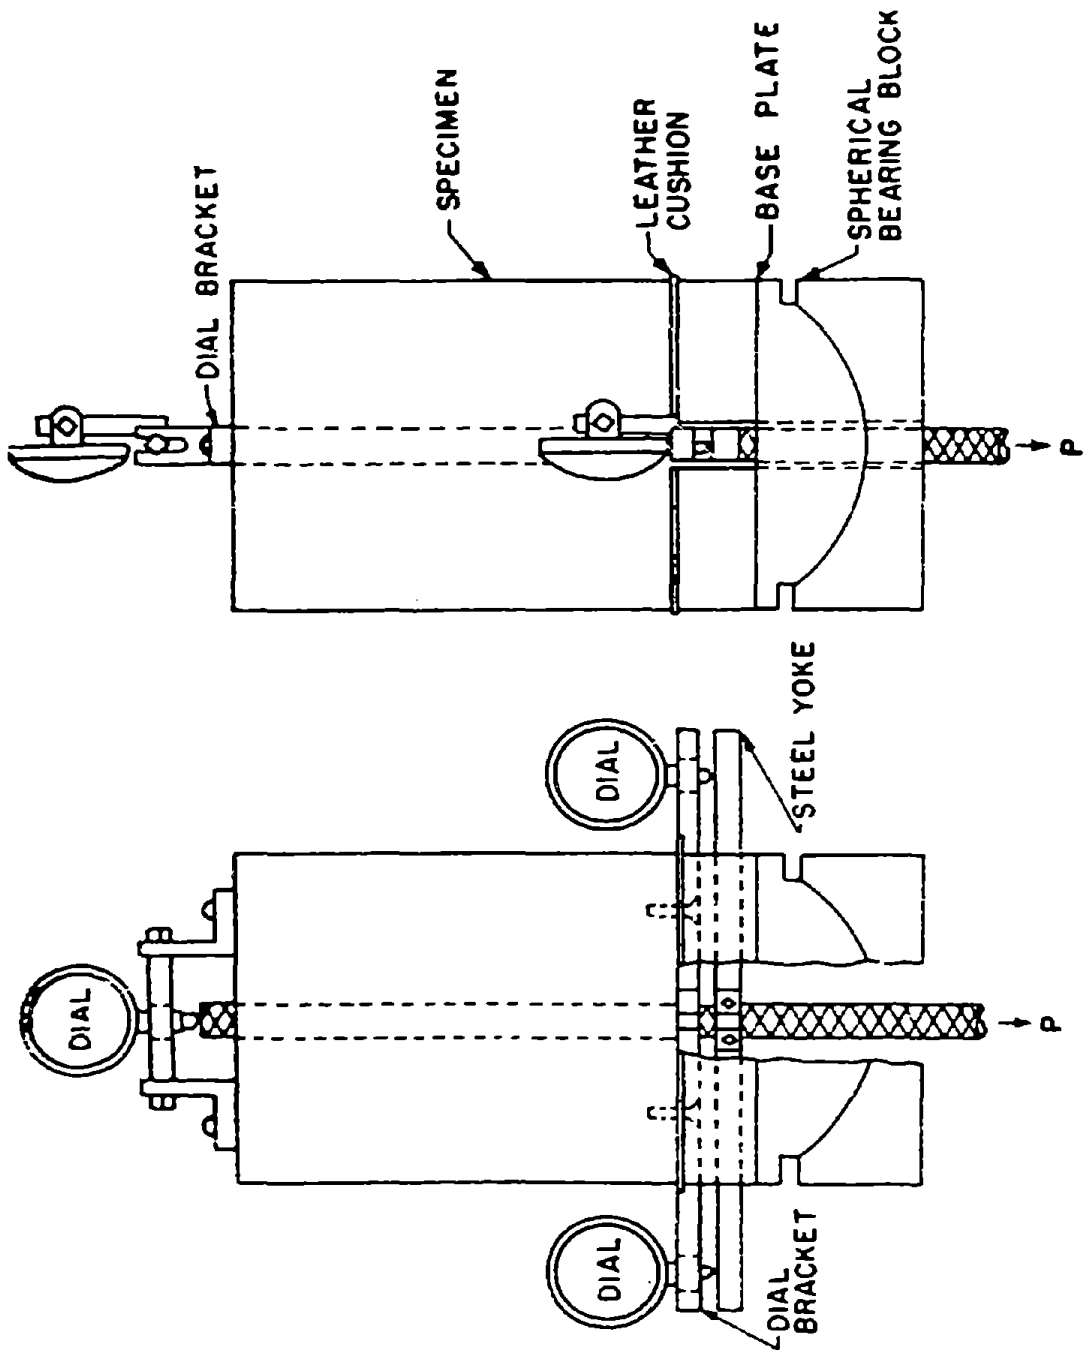
FIGURE 15. Schematic of pullout specimen. Size of concrete prism is 10 x 10 x 12 inches.
