1. Report No. FHWA-RD-74-18		2. Government Accession No. PB 236 424	
4. Title and Subtitle Nonmetallic Coatings for Concrete Reinforcing Bars		5. Report Date February 1974

7. Author James R. Clifton, Hugh F. Beeghly, and Robert G. Mathey		6. Performing Organization Code	
9. Performing Organization Name and Address Materials and Composites Section Center for Building Technology National Bureau of Standards Washington, D. C. 20234		8. Performing Organization Report No.

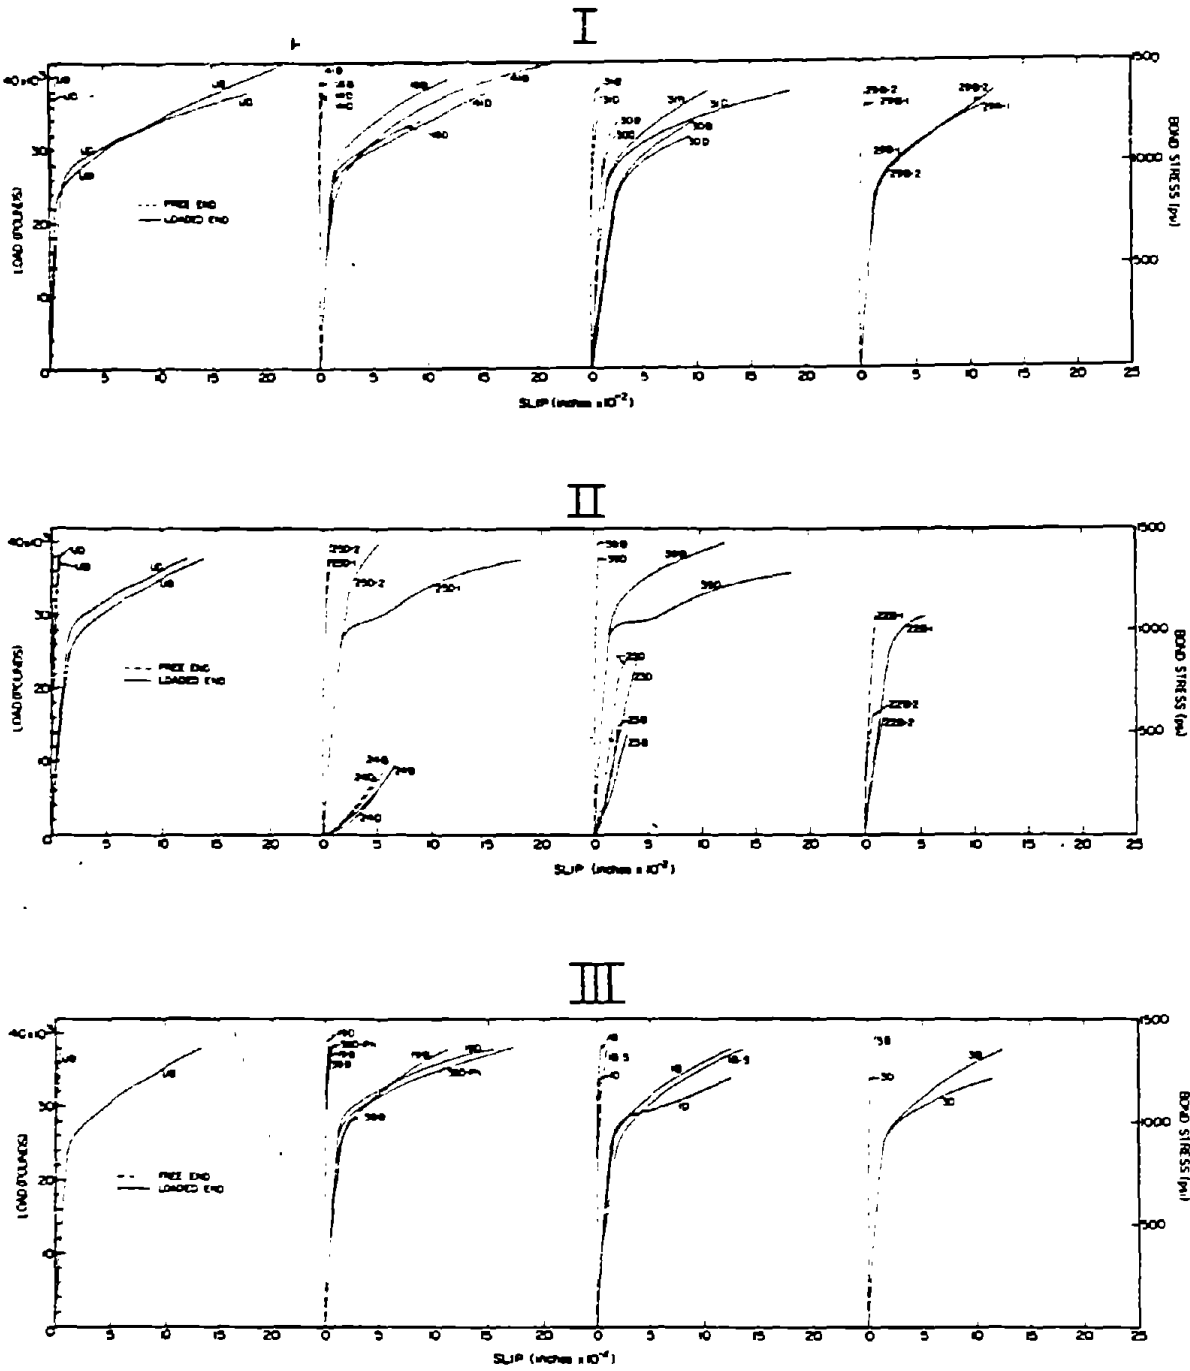
FIGURE 16. Applied load to reinforcing bar in pullout specimens versus free-end and loaded-end slip. Roman numerals indicate concrete batch number, while Arabic numbers identify the coating materials (table 1).

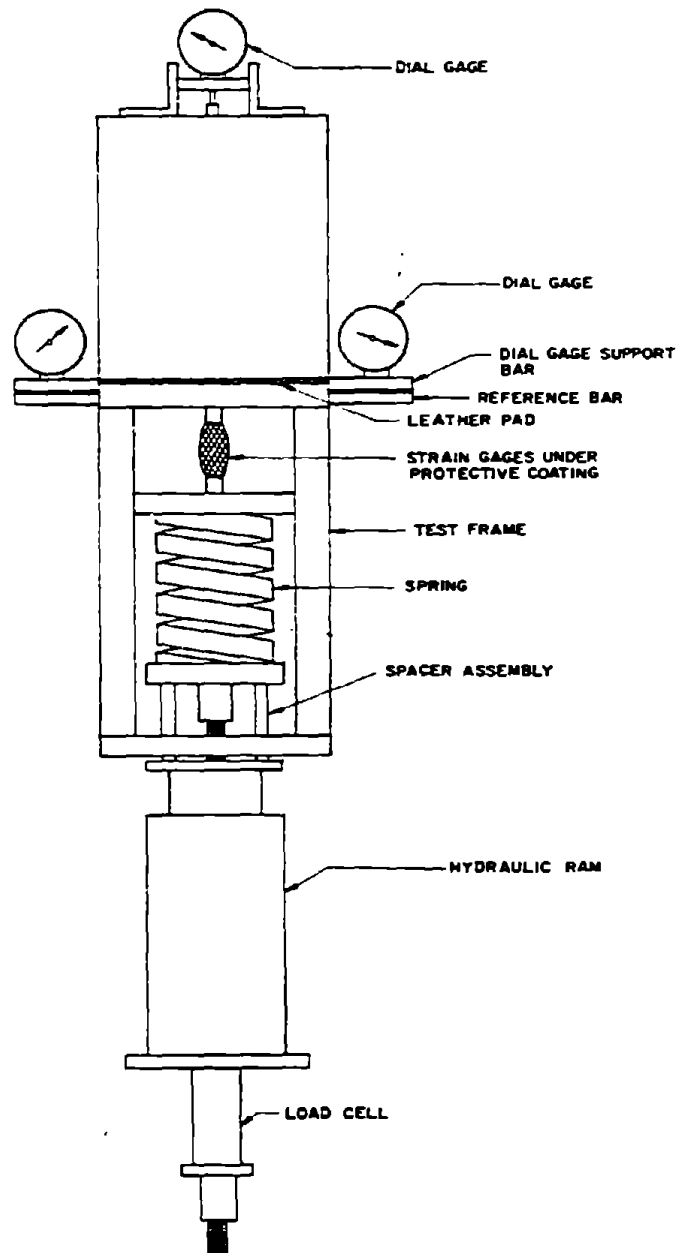
Specimen Loading Assembly

FIGURE 17. Schematic of creep specimen. Size of specimen is the same as the pullout specimen.

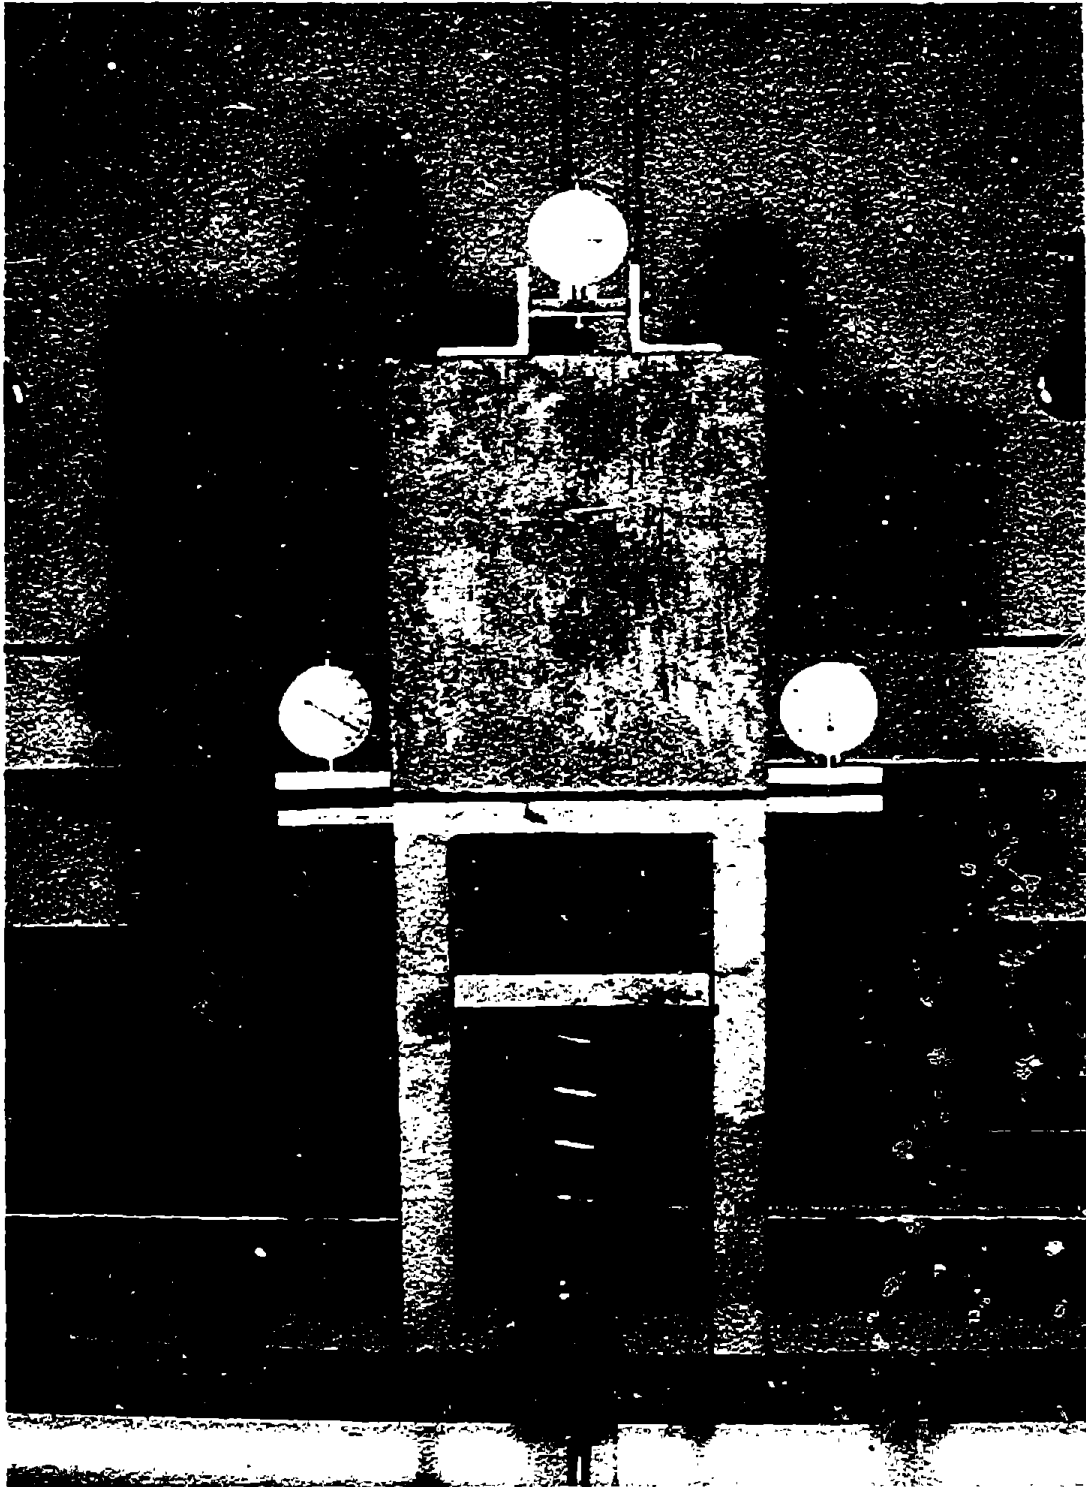
FIGURE 18. Creep specimen loaded to a tensile stress level of 30,000 psi (in the steel reinforcing bar).

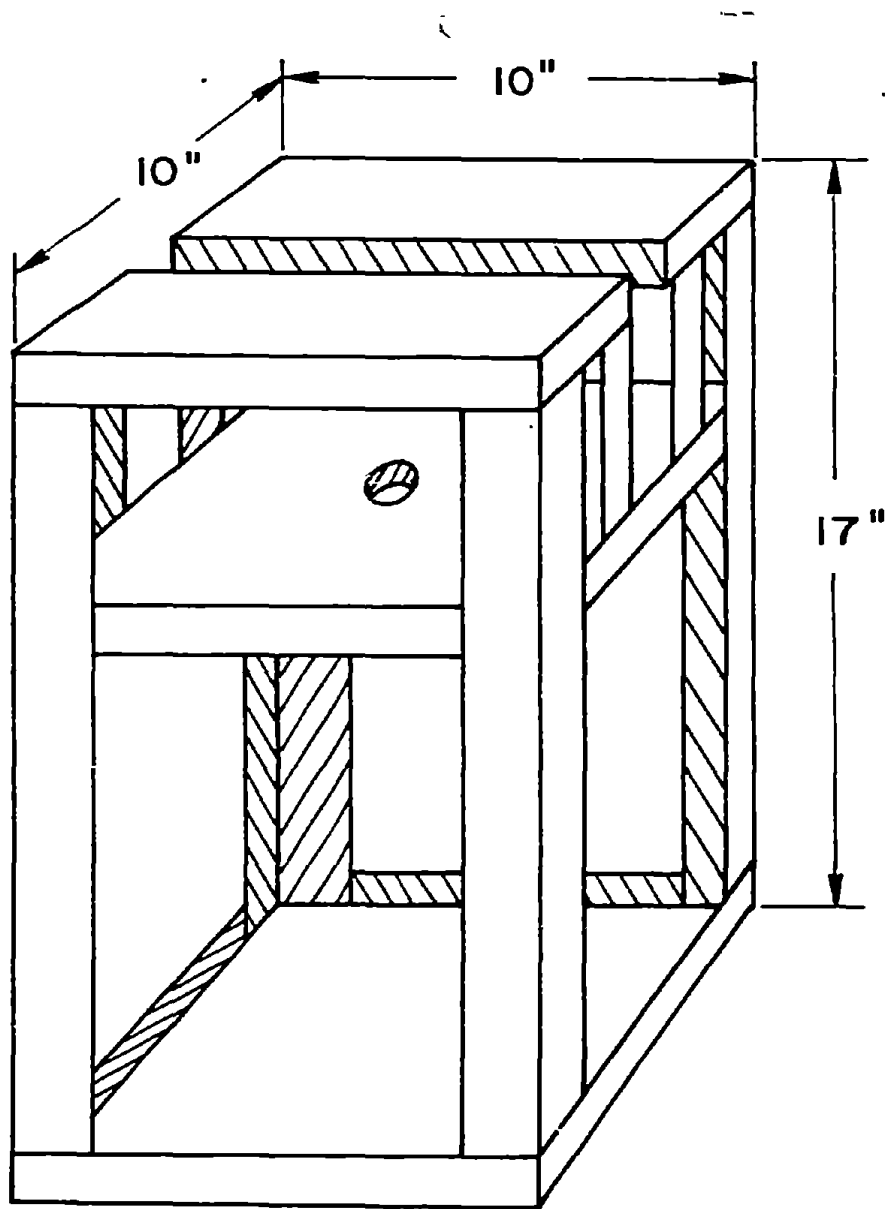
Test Frame

FIGURE 19. Schematic of creep test frame.

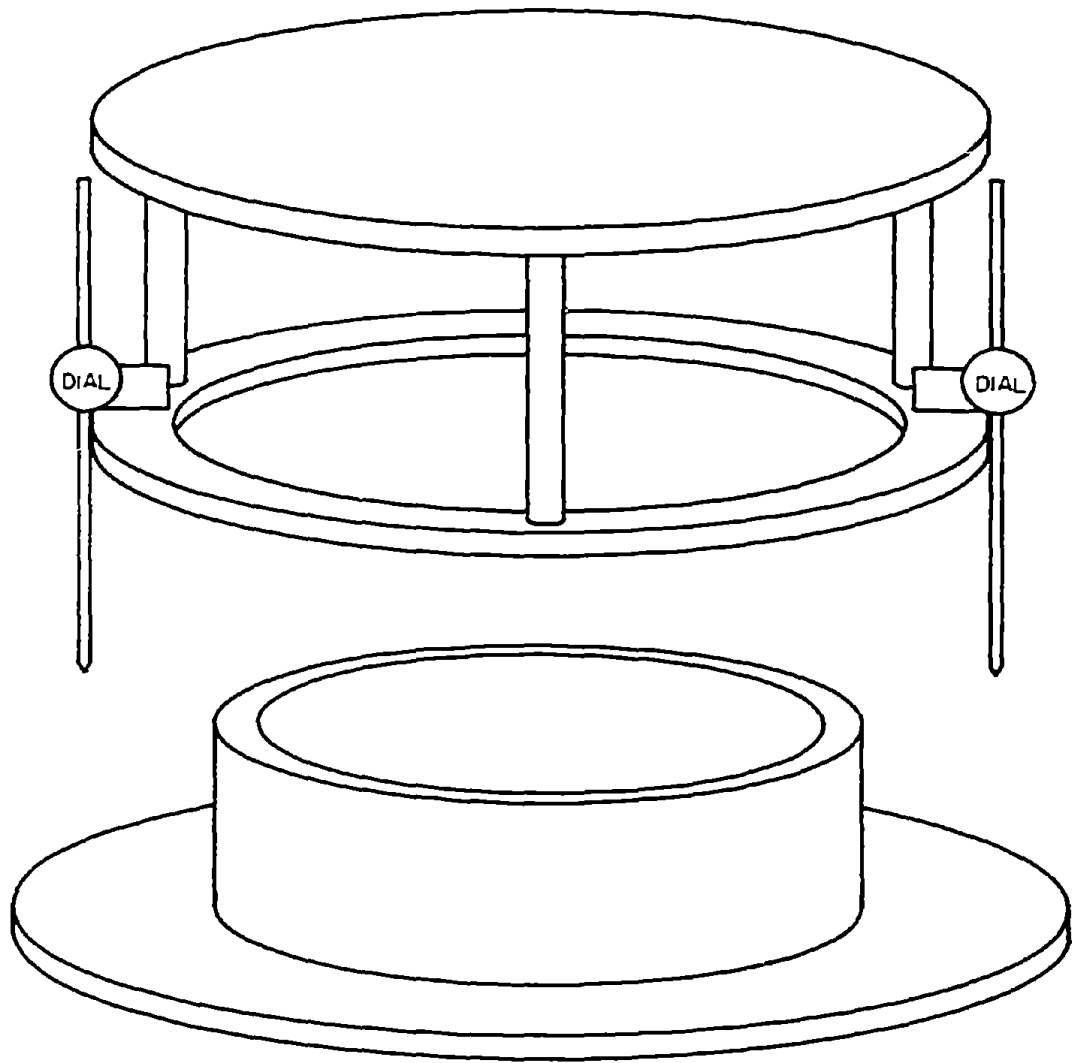
SPRING CALIBRATION APPARATUS

FIGURE 20. Apparatus for calibrating steel springs used to exert tensile stresses in the creep study.

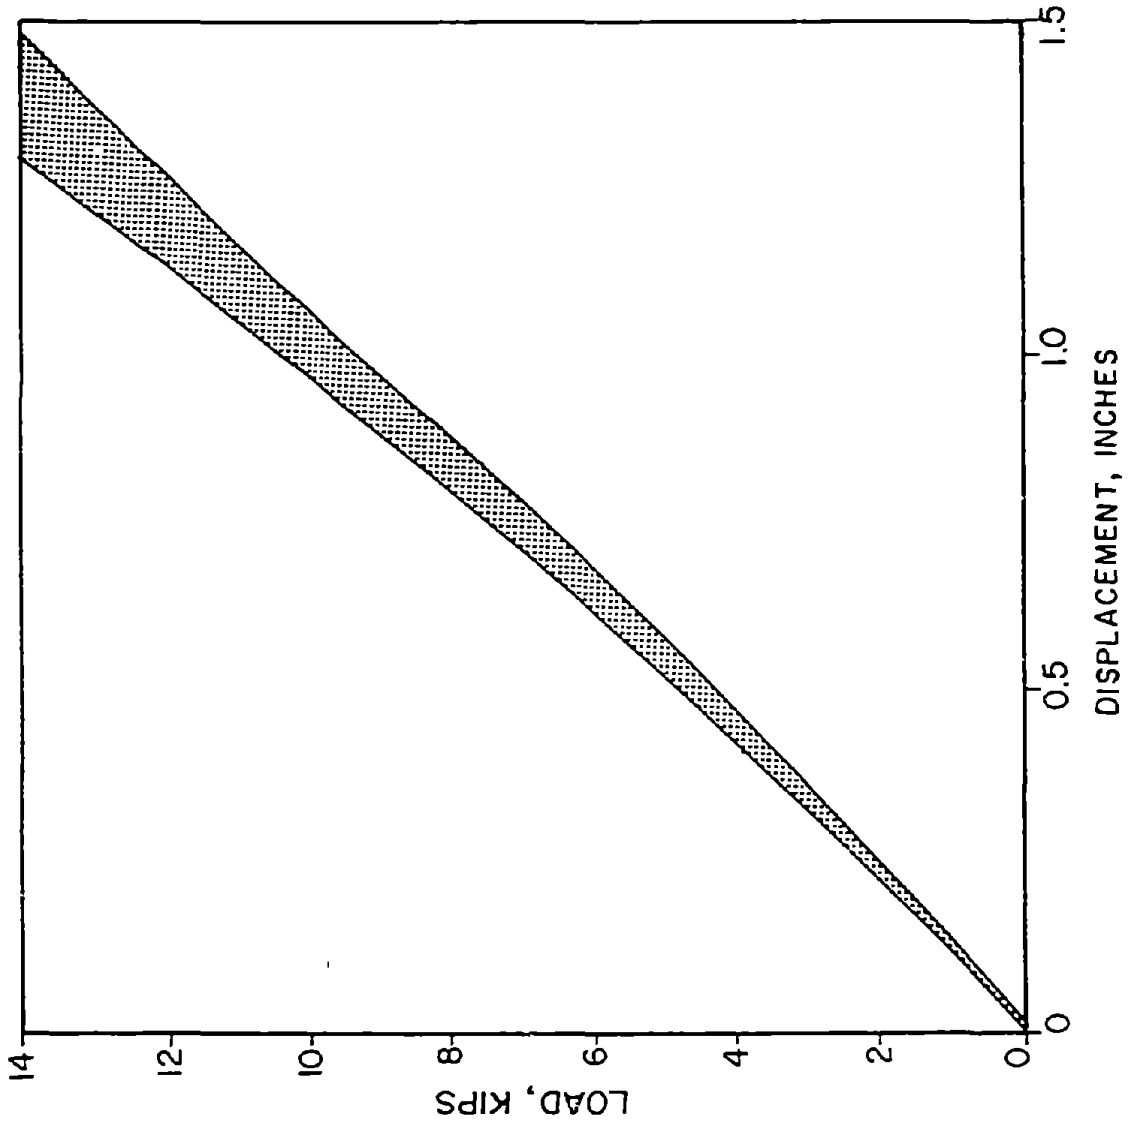
FIGURE 21. Range of displacement response of 24 steel springs used in the creep study.

calibration of the displacement response of springs to loading, any increase in the height of the compressed springs could be directly related to the amount of loss of tensile stress.

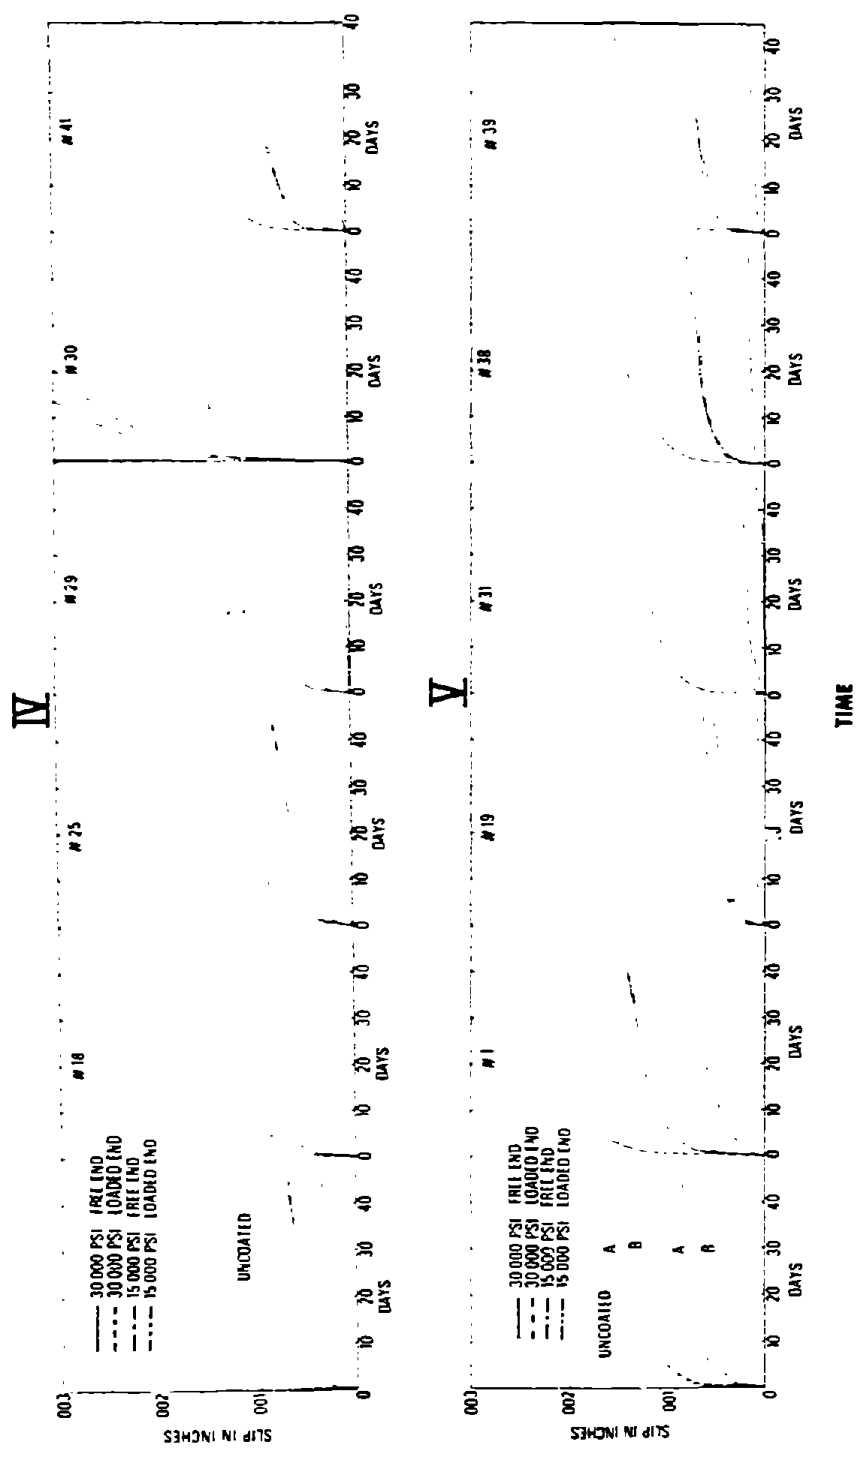
FIGURE 22. Free-end and loaded-end slips in creep specimens versus time. Roman numbers indicate batch number, while Arabic numbers identify the coating materials (table 1).
