**National Highway  
Traffic Safety  
Administration**

DOT HS 812 659

# **Technical Evaluation Of the TRL Pedestrian Upper Legform**

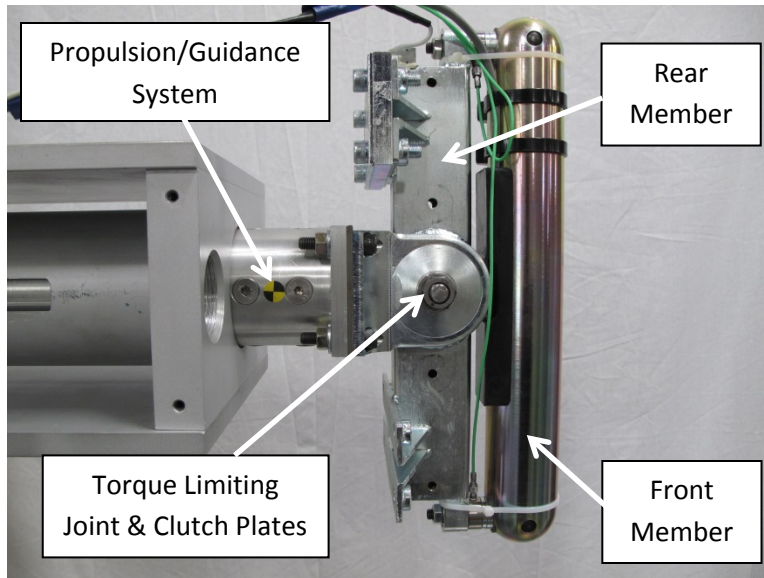
The TRL upper legform impactor consists of a front member and a rear member with a torque limiting joint (Figure 1). The entire upper legform assembly is attached to the propulsion system by the two clutch plates of the torque limiting joint on the rear member. The torque limiting joint is designed so that it only rotates when forces high in magnitude and offset vertically are applied to the impactor, limiting the torque transferred to the propulsion system and thereby protecting it from damage.

**Figure 1. The TRL upper legform and its attachment to the propulsion/guidance system**

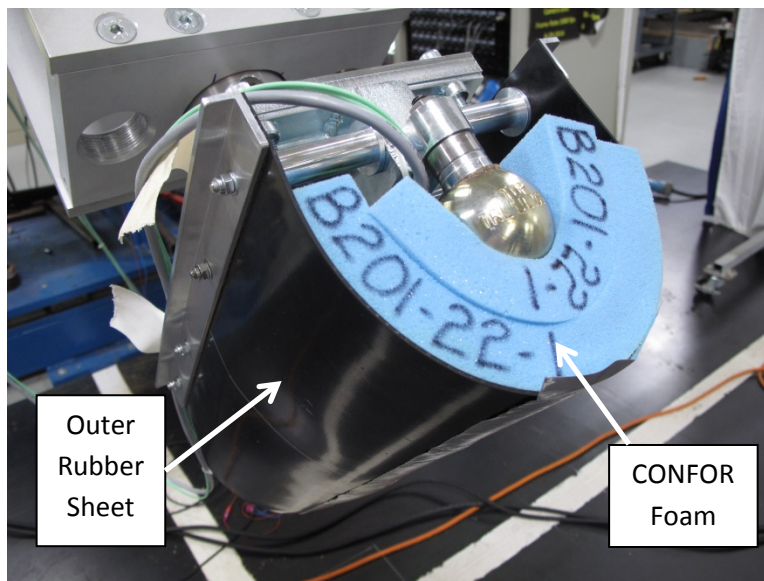
Two 25.4 mm (1 inch) thick sheets of blue CONFOR foam (Type CF-45, CF-45AC, or CF-45M, Aearo Technologies LLC) and an outer rubber sheet to mimic flesh are attached to the rear member and wrapped around the front member (Figure 2).

**Figure 2. Top view of the assembled upper legform**

As shown in Figure 2, two sheets of blue CONFOR foam are wrapped around the front member of the upper legform. It is the properties of this foam, and its sensitivity to humidity, that has prompted the investigation described herein. CONFOR foam is characterized as a highly damped “memory foam” of medium density with open-celled polyurethane construction. The foam provides excellent energy absorption and exhibits temperature-softening behavior such that it will soften on contact with a warm surface. Because of its open-celled structure, CONFOR foam is “breathable” and highly sensitive to humidity (Aearo Technologies LLC).

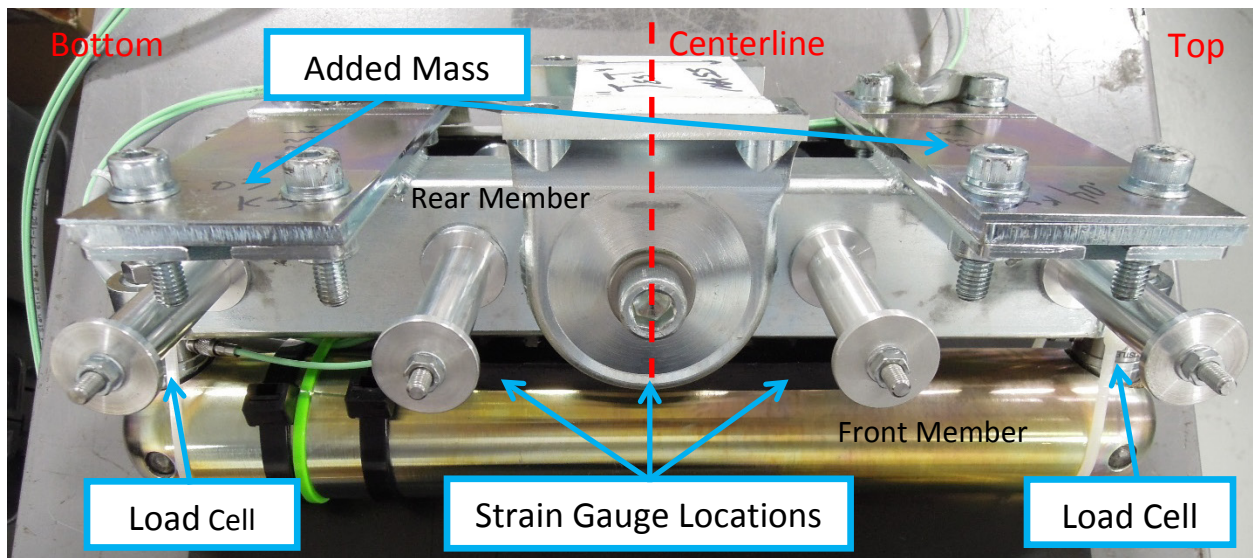
Bending moment is calculated by three full-bridge strain gages mounted at the centerline as well as 50 mm above and below the centerline (Figure 3). Force is measured between the front and rear members with two piezoelectric load transducers, one at the top and one at the bottom, which are powered by a charge amplifier through software (Kistler ManuWare v1.0.2).

**Figure 3. TRL upper legform impactor without flesh and skin**

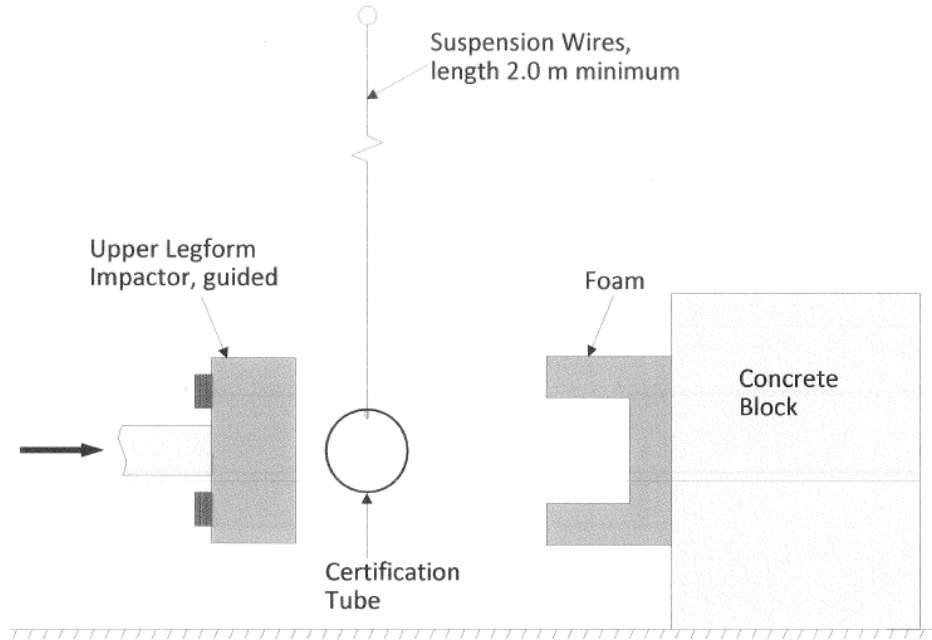
to stop the impactor (if the propulsion system is unable to do so) and prevent the certification tube from swinging away post-impact.

Figure 4. Qualification test set-up<sup>1</sup>

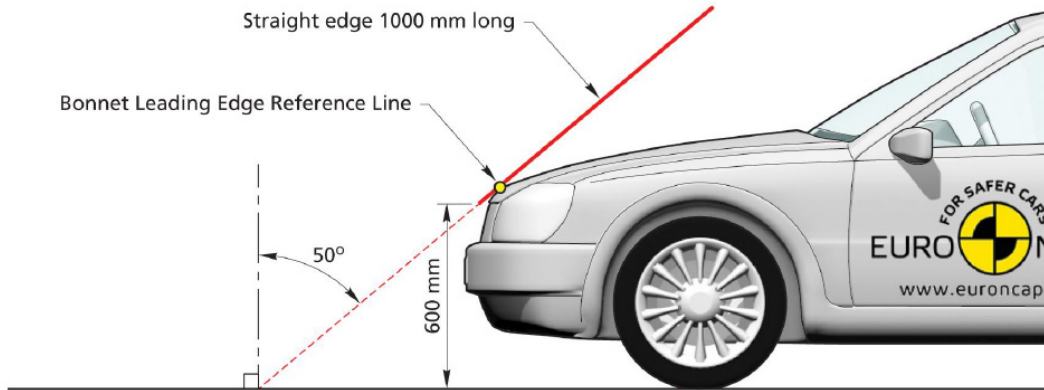
The bonnet leading edge reference line (Figure 5) is the geometric trace of points of contact of the front surface of a vehicle with a 1000 mm long straight edge that begins 600 mm above the ground and held parallel to the vertical-longitudinal plane of the vehicle and inclined 50 degrees towards the vehicle.

**Figure 5. Determination of the bonnet leading edge reference line (Euro NCAP v8.3)**

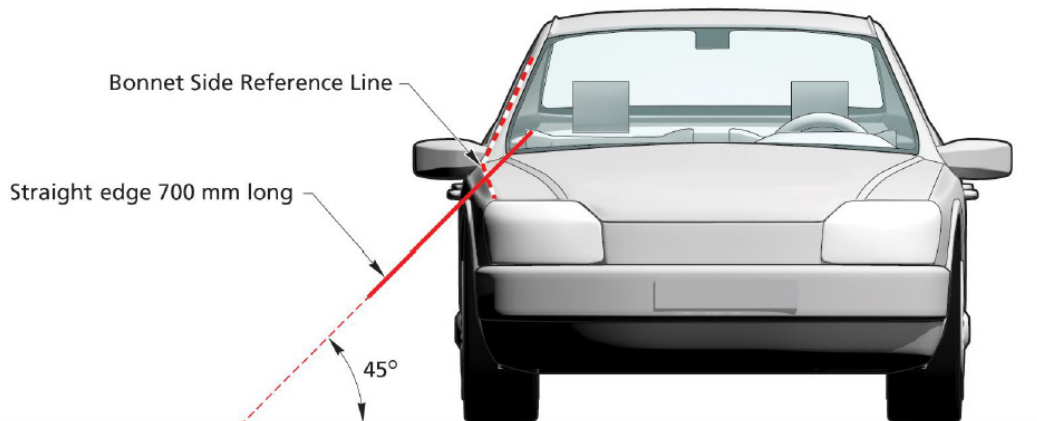
The bonnet side reference line (Figure 6) is the geometric trace of the highest points of contact between the sides of a vehicle’s front structure and a 700 mm long straight edge that is held parallel to the transverse-vertical plane of the vehicle and inclined 45 degrees inward, towards the vehicle.

**Figure 6. Determination of the bonnet side reference line (Euro NCAP v8.3)**

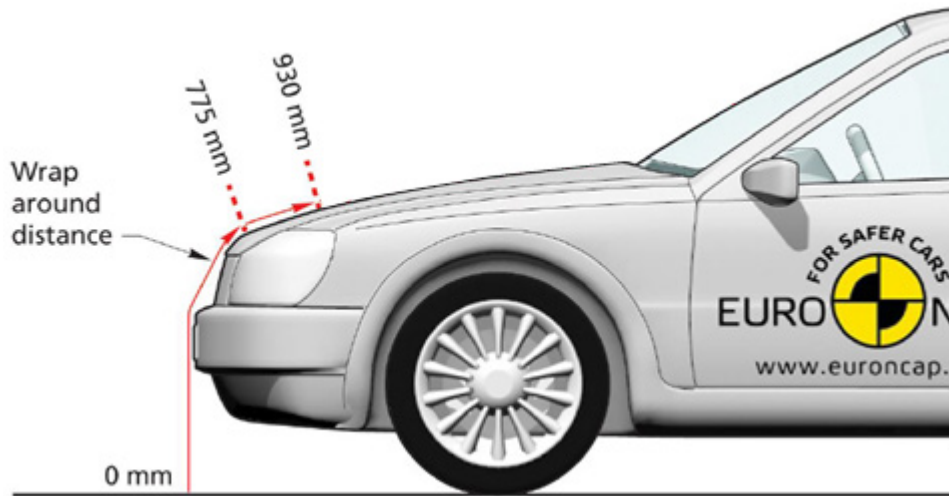
where “U” denotes an upper legform impact, “-” indicates a driver side impact, “+” indicates a passenger side impact, and “#” indicates the 100 mm increment from the centerline. For example, impact location U-5 denotes an upper leg impact point 500 mm from the centerline on the driver side. The same procedure was followed for points along WAD 930 mm. The points along WAD 930 mm are used for defining the angle and speed of the impact. Grid points less than 50 mm from the corner reference points were deleted. The 100 mm distances were measured horizontally in a lateral vertical plane and projected onto the WAD.

**Figure 7. Marking wrap around distances (Euro NCAP v8.3)**

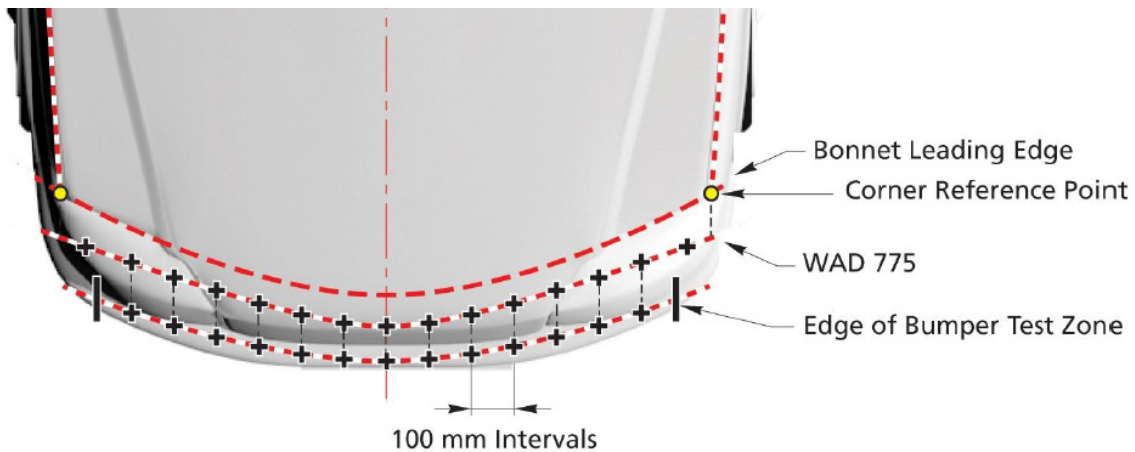
**Figure 8. Division of the upper legform grid points at the WAD 775 (Euro NCAP v8.3)**

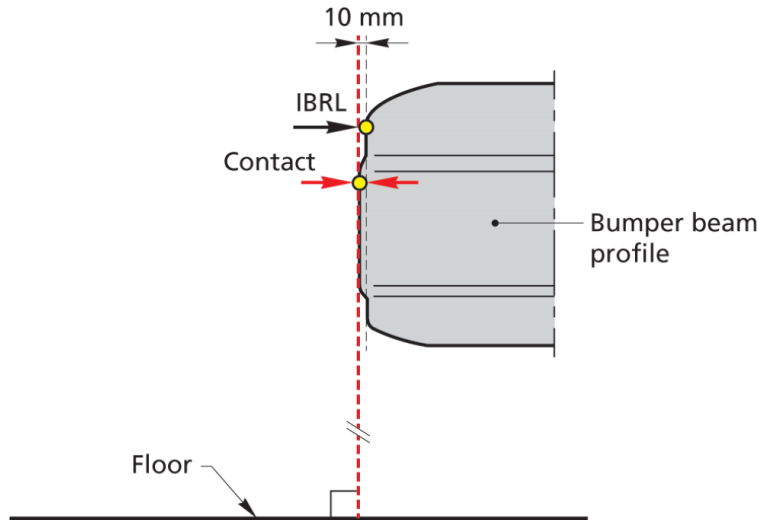
Lastly, the internal bumper reference line (IBRL) is the height of the internal bumper beam measured from the ground in a vertical plane contacting the beam up to 10 mm into the profile at 100 mm intervals outboard of the vehicle centerline (Figure 9). For every upper legform grid point outboard of the bumper beam, the average bumper beam height is allocated to the outermost grid point on the bumper beam, per the Euro NCAP Pedestrian Testing Protocol. The IBRL heights were transferred at each 100 mm interval onto the external bumper fascia. These points in combination with the WAD 930 mm grid points are used for defining the angle and speed of the impact.

Figure 9. Measurement of the internal bumper reference line (IBRL) height (Euro NCAP v8.3)

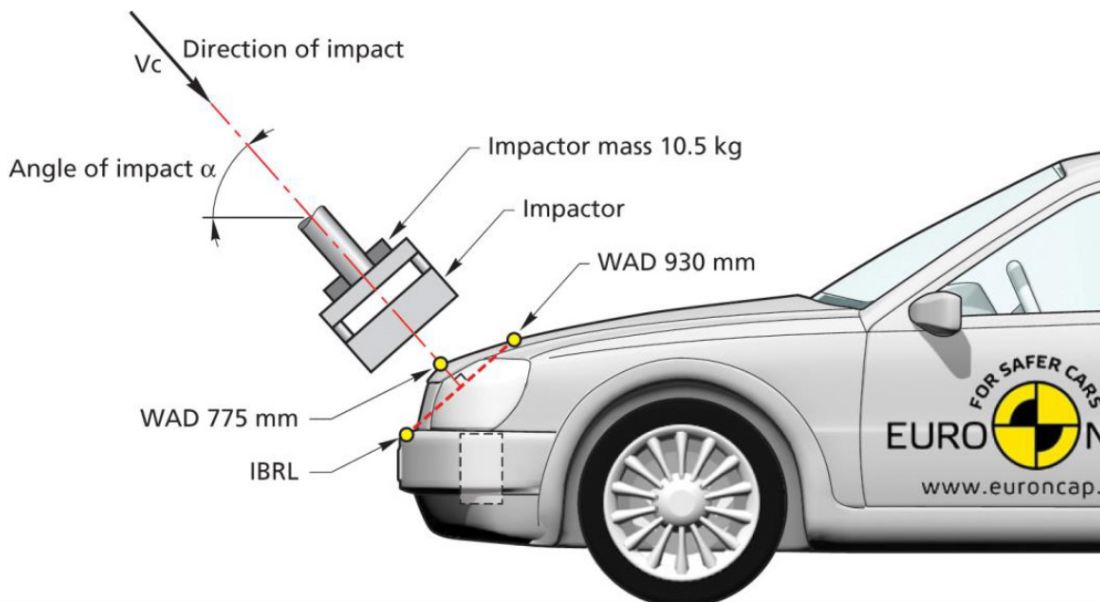
The vehicle was positioned at the desired distance such that the impactor strikes the vehicle after it has been accelerated to the test speed so that the propulsion system does not interfere with the impactor's interaction with the vehicle. A diagram of the upper leg impact setup is shown in Figure 10.

**Figure 10. Setup of upper leg impact test (Euro NCAP v8.3)**

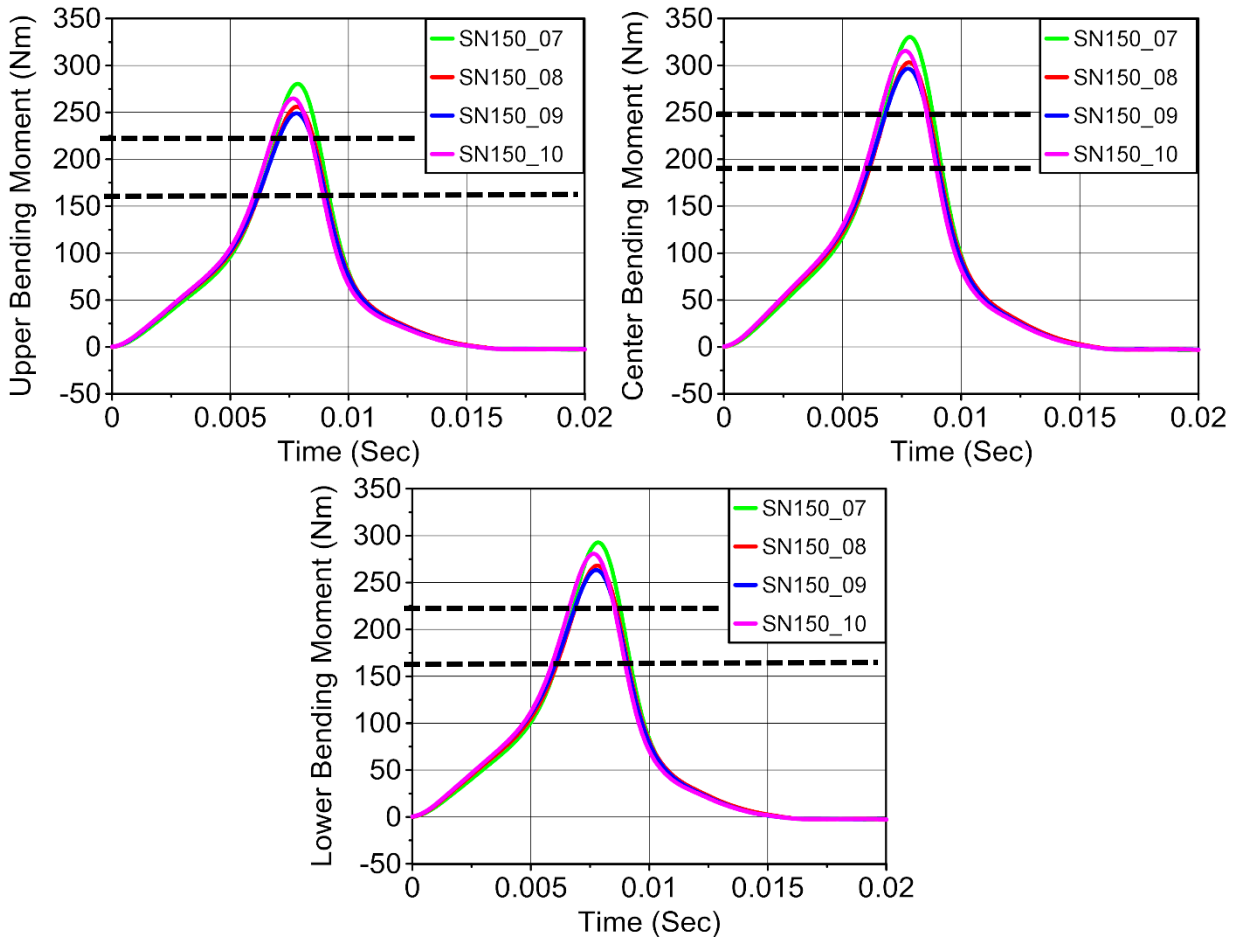
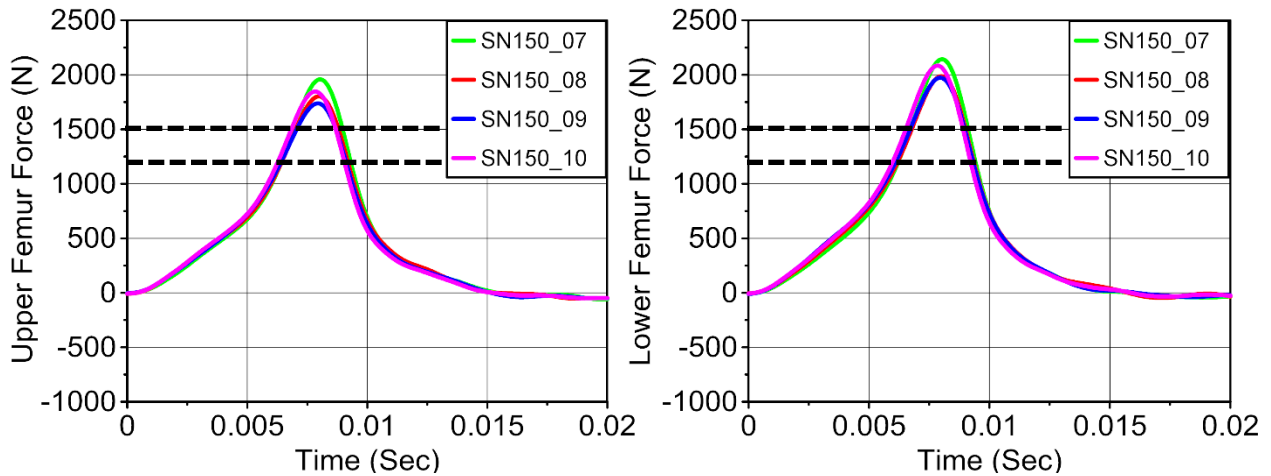
Time histories of the femur bending moment and femur forces for legform SN150 are shown in Figure 11 and Figure 12 below. Peak values, means, standard deviations, and percentage coefficient of variations (%CV) are shown in Table 2. Peak bending moments and peak forces all exceeded the qualification requirements. For reference, the qualification results provided to NHTSA by TRL with the purchase of the upper legforms are plotted and tabulated in Figure 13 and Table 3. According to TRL, the foams “met” the conditioning requirements and the results indicate that the legform performed within the qualification limits.

Figure 11. Femur bending moment time histories of tests at 45 percent RH using upper legform SN150

Figure 12. Femur force time histories of tests at 45 percent RH using upper legform SN150

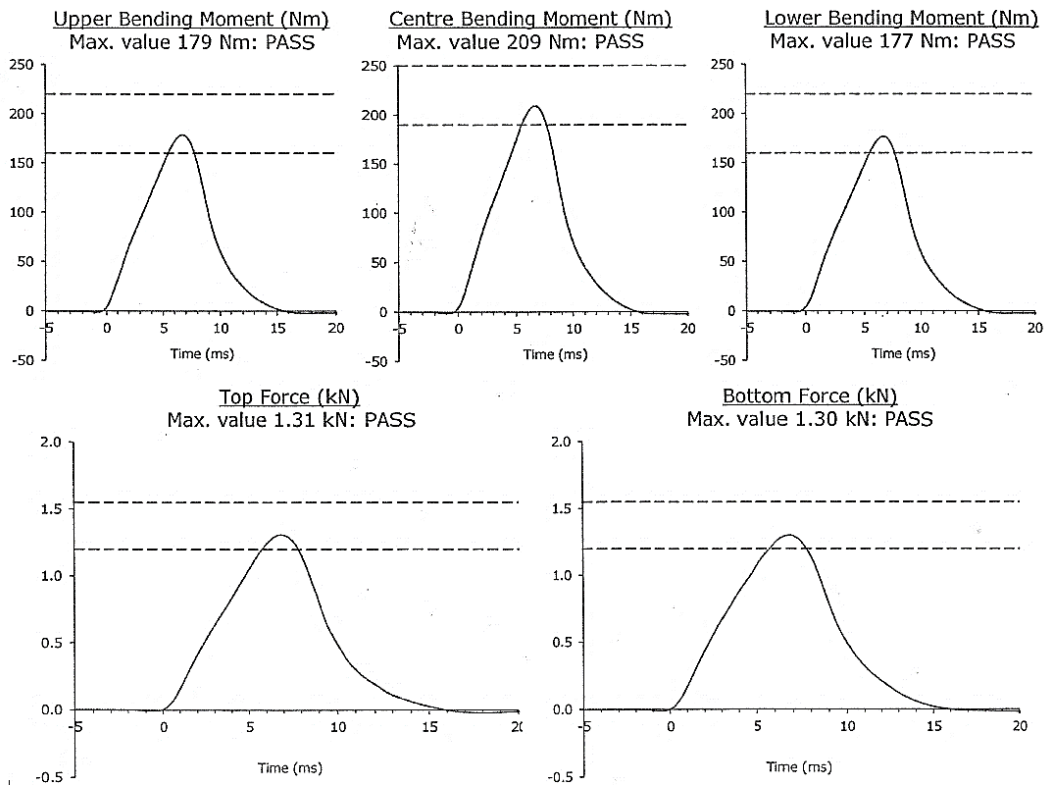
**Figure 13. Upper legform SN 150 qualification results provided by TRL**

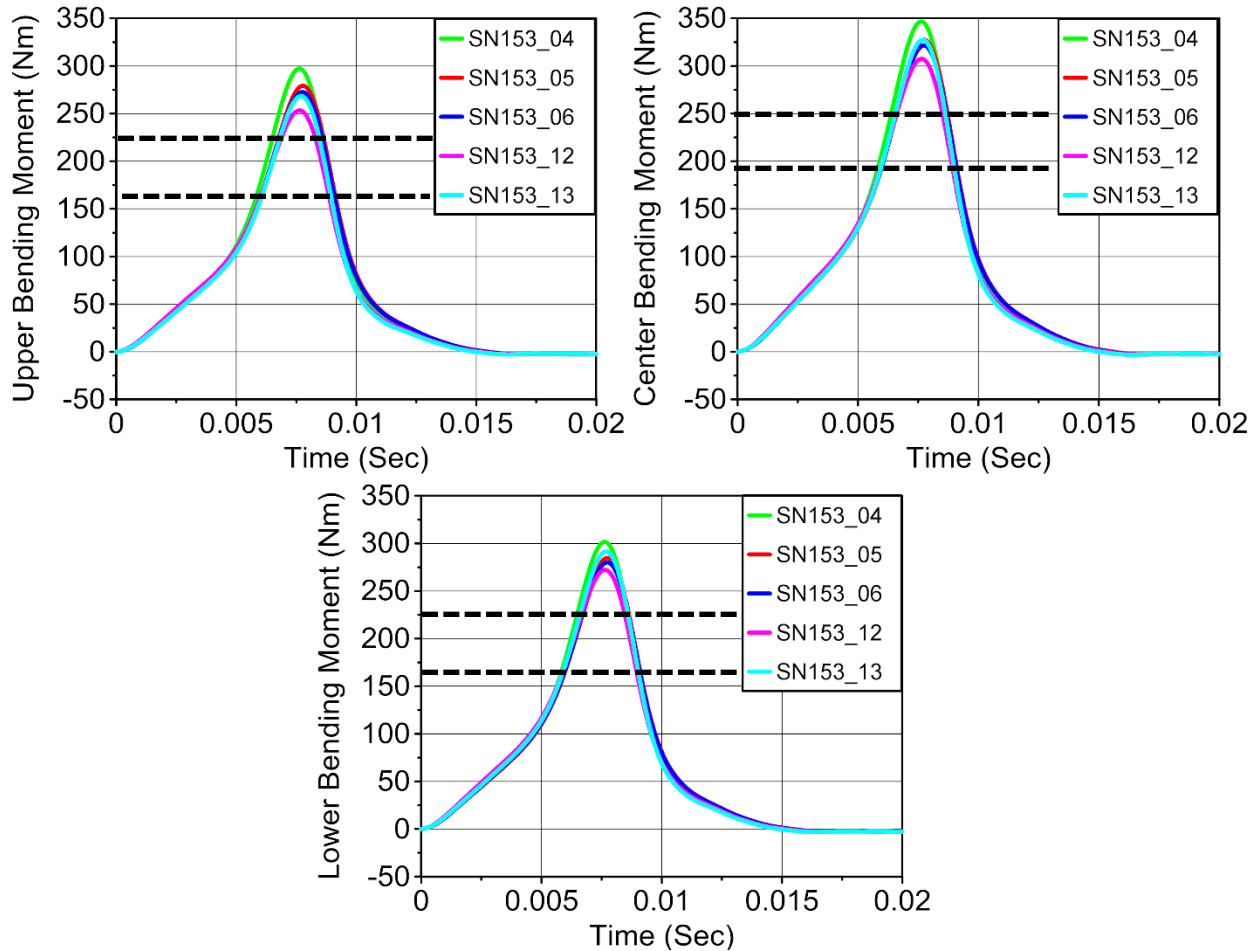
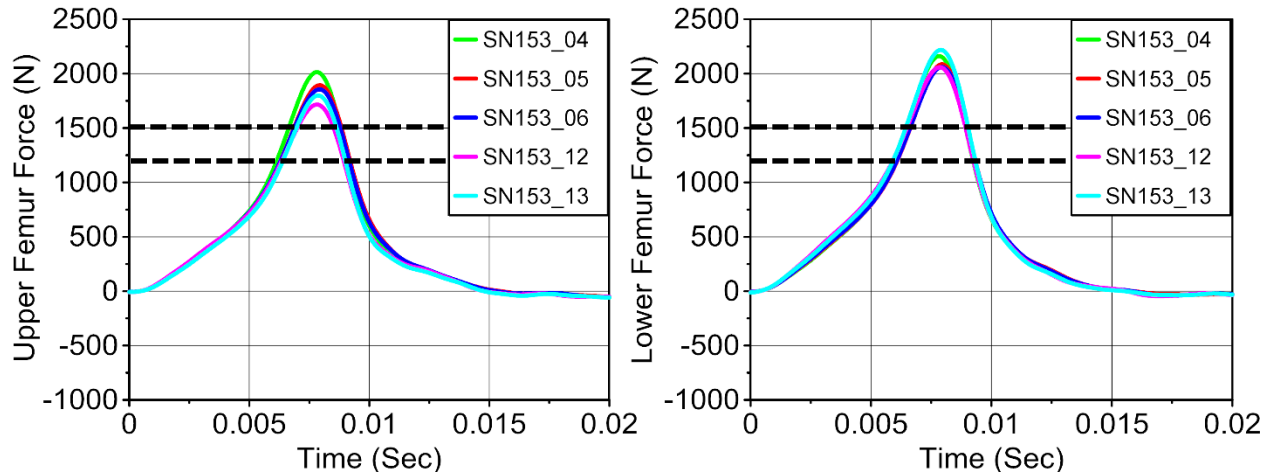
Time histories of the femur bending moments and femur forces for legform SN153 are shown in Figure 14 and Figure 15 below. Peak values, means, standard deviations, and %CV are shown in Table 4. The results are similar to those for SN150 as peak bending moments and peak forces all exceeded the qualification requirements. According to TRL, the foams met the conditioning requirements and the qualification results provided to NHTSA by TRL (plotted and tabulated in Figure 16 and Table 5) indicate that the legform performed within the qualification limits.

Figure 14. Femur bending moment time histories of tests at 45 percent RH using upper legform SN153

Figure 15. Femur force time histories of tests at 45 percent RH using upper legform SN153

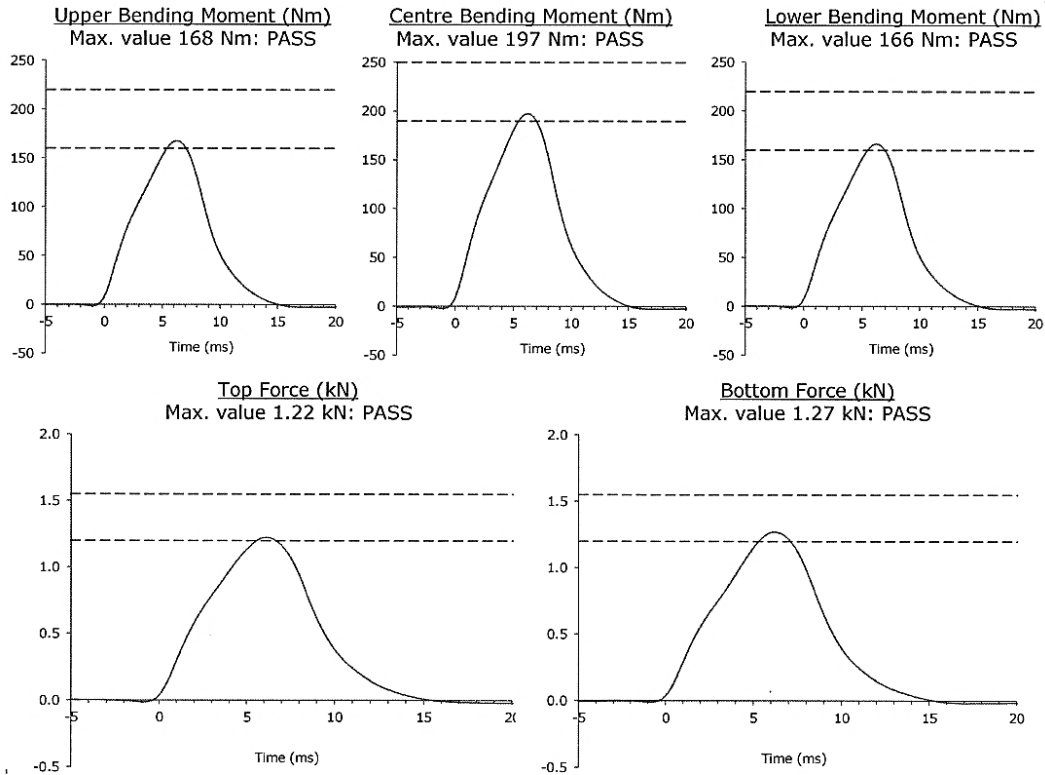
Figure 16. Upper legform SN 153 qualification results provided by TRL

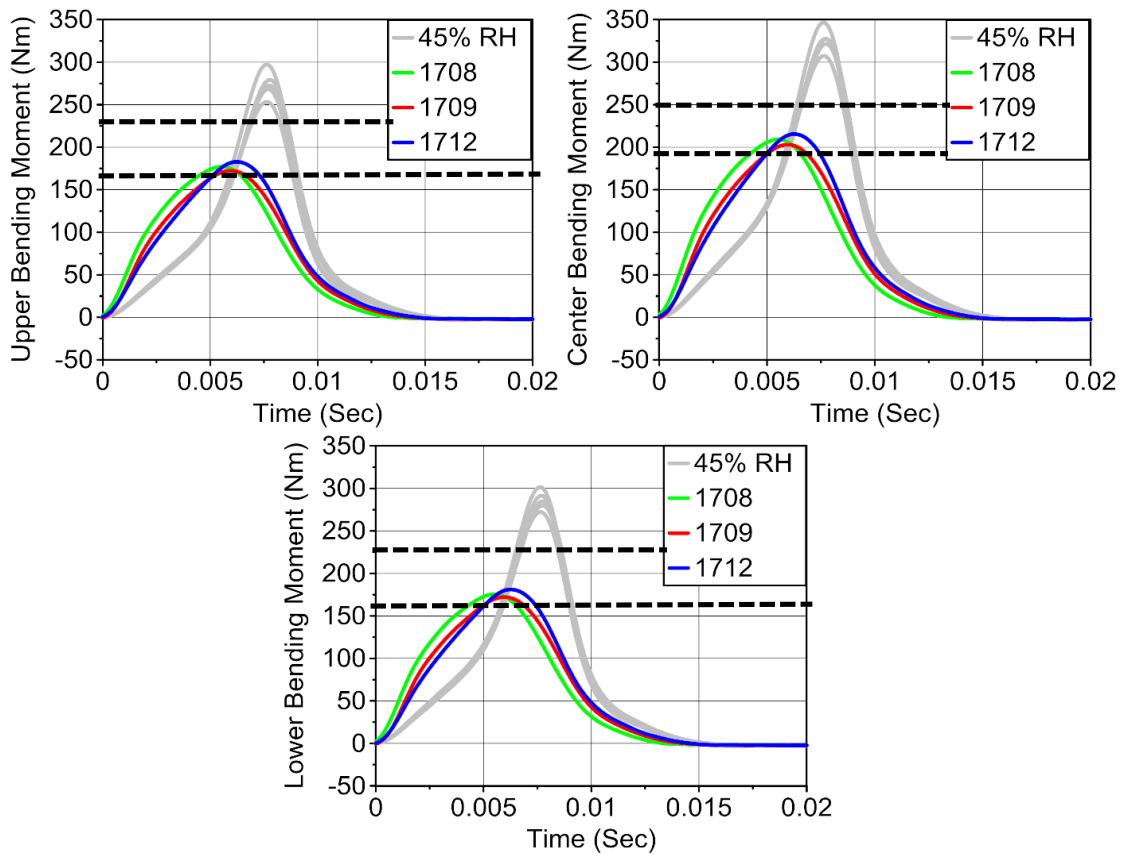
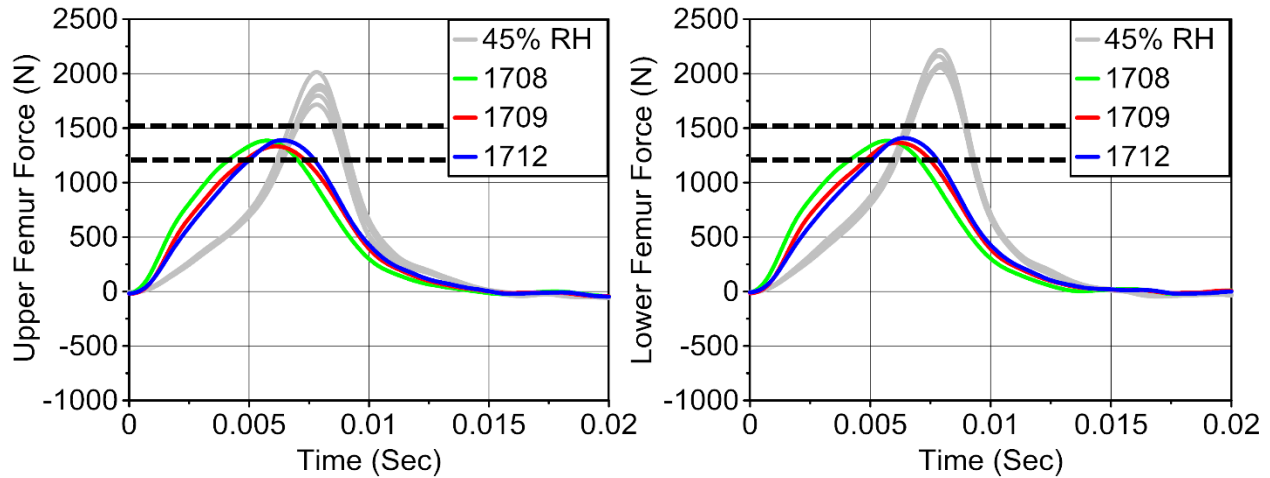
Qualification tests were performed on upper legform SN153 using the same foam samples for each test (test numbers 1708, 1709, and 1712). Time histories of the femur bending moment and femur forces are shown in Figure 17 and Figure 18 below. Results from the 45 percent RH tests are also included in the plots for comparison. Peak values, means, standard deviations, and %CV for each test are shown in Table 6 below. All three tests passed the qualification requirements.

**Figure 17. Femur bending moment time histories of 25 percent RH tests with upper legform SN153 using the same foam.**

Figure 18. Femur force time histories of the 25 percent RH tests with upper legform SN153 using the same foam.

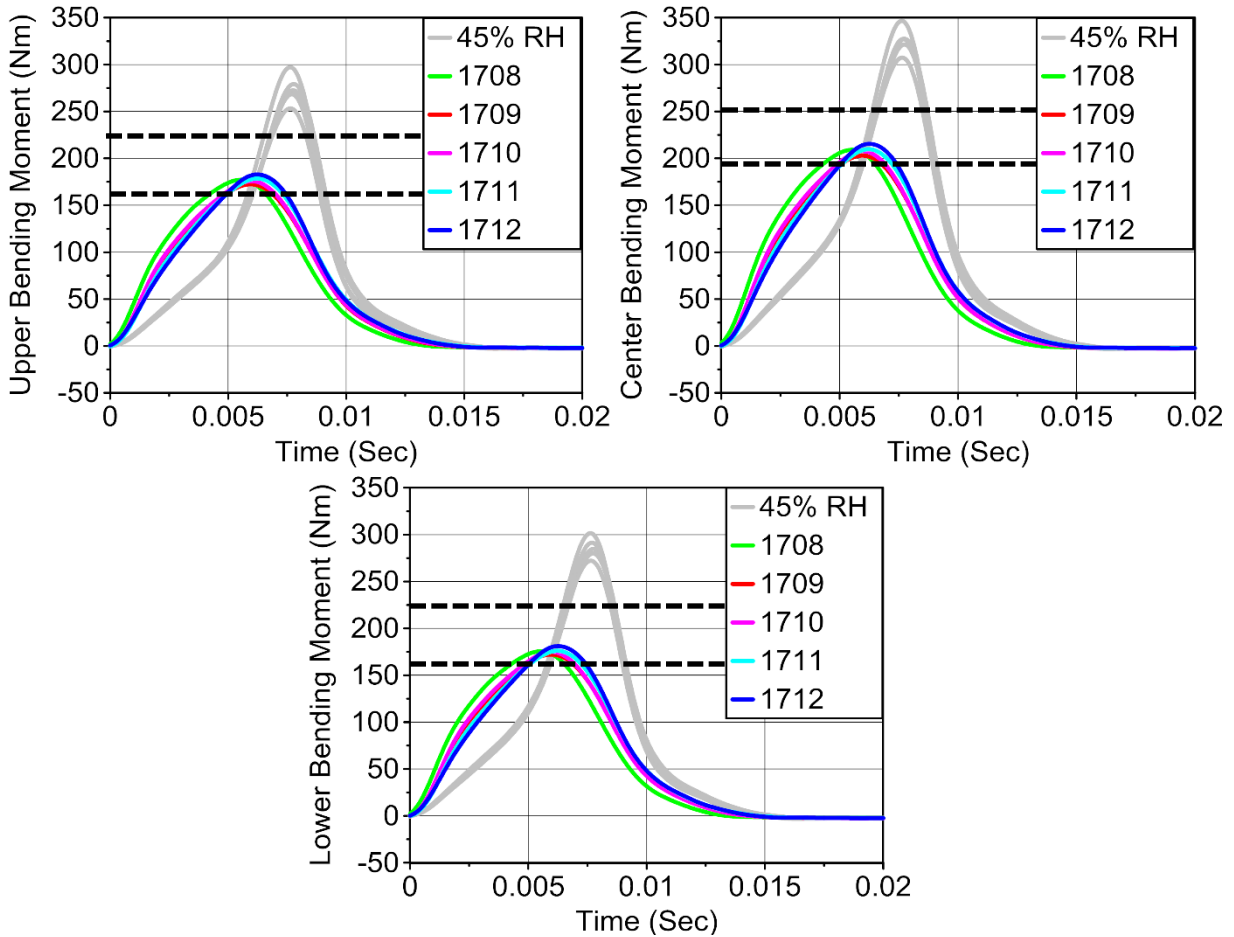
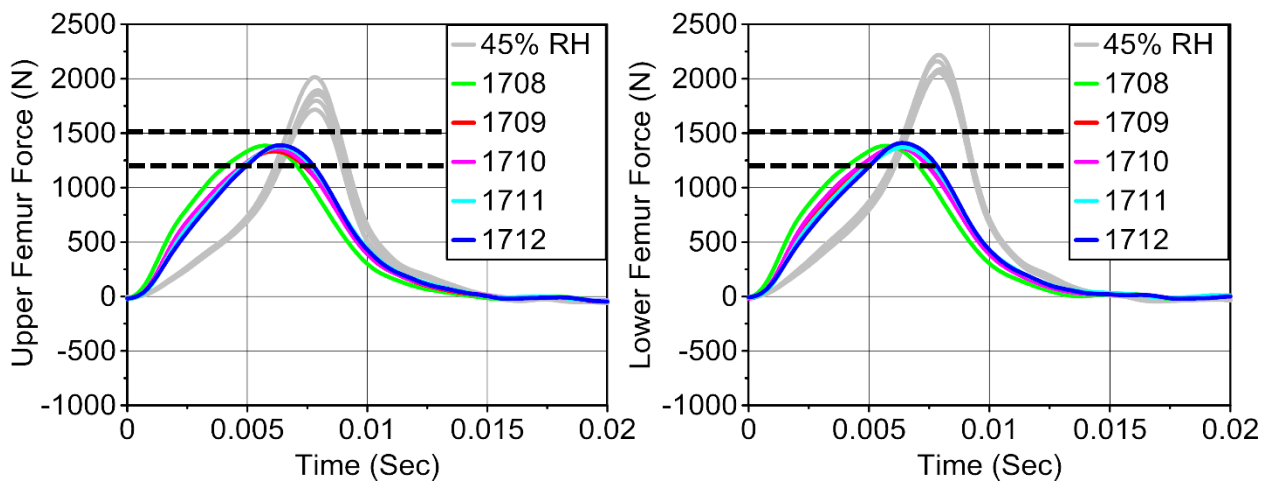
Qualification tests were also performed with upper legform SN153 using new foams (test numbers 1710 and 1711) to verify that other foams can pass the qualification requirements in the same conditions. Time histories of the femur bending moment and femur forces are shown in Figure 19 and Figure 20 below. Peak values, means, standard deviations, and %CV for all qualification tests performed with upper legform SN153 are shown in Table 7 below. All tests passed the qualification requirements.

**Figure 19. Femur bending moment time histories of the 25 percentage RH tests with upper legform SN153 using multiple foams.**

**Figure 20. Femur force time histories of the 25 percentage RH tests with upper legform SN153 using multiple foams.**

In Figure 19 to Figure 22 the shape of the curves of the low humidity tests (colored curves in the figures) are different than in the high humidity tests (grey curves in the figures). The behavior of the CONFOR foam dominates the qualification test results as it is the only effective energy absorber during qualification testing since the certification tube is rigid. As explained through personal communication with TRL, in the colored curves (low humidity tests), the CONFOR foam is working efficiently and the impactor and certification tube reach a common velocity without a large peak in forces and moments. In the grey curves (high humidity tests), the slower initial rise time indicates that the impact is initially less severe due to the foam being less stiff. Later in the event, the foam is severely compressed and the impact forces and moments rise rapidly, indicating that the foam has been severely compressed and has bottomed out.

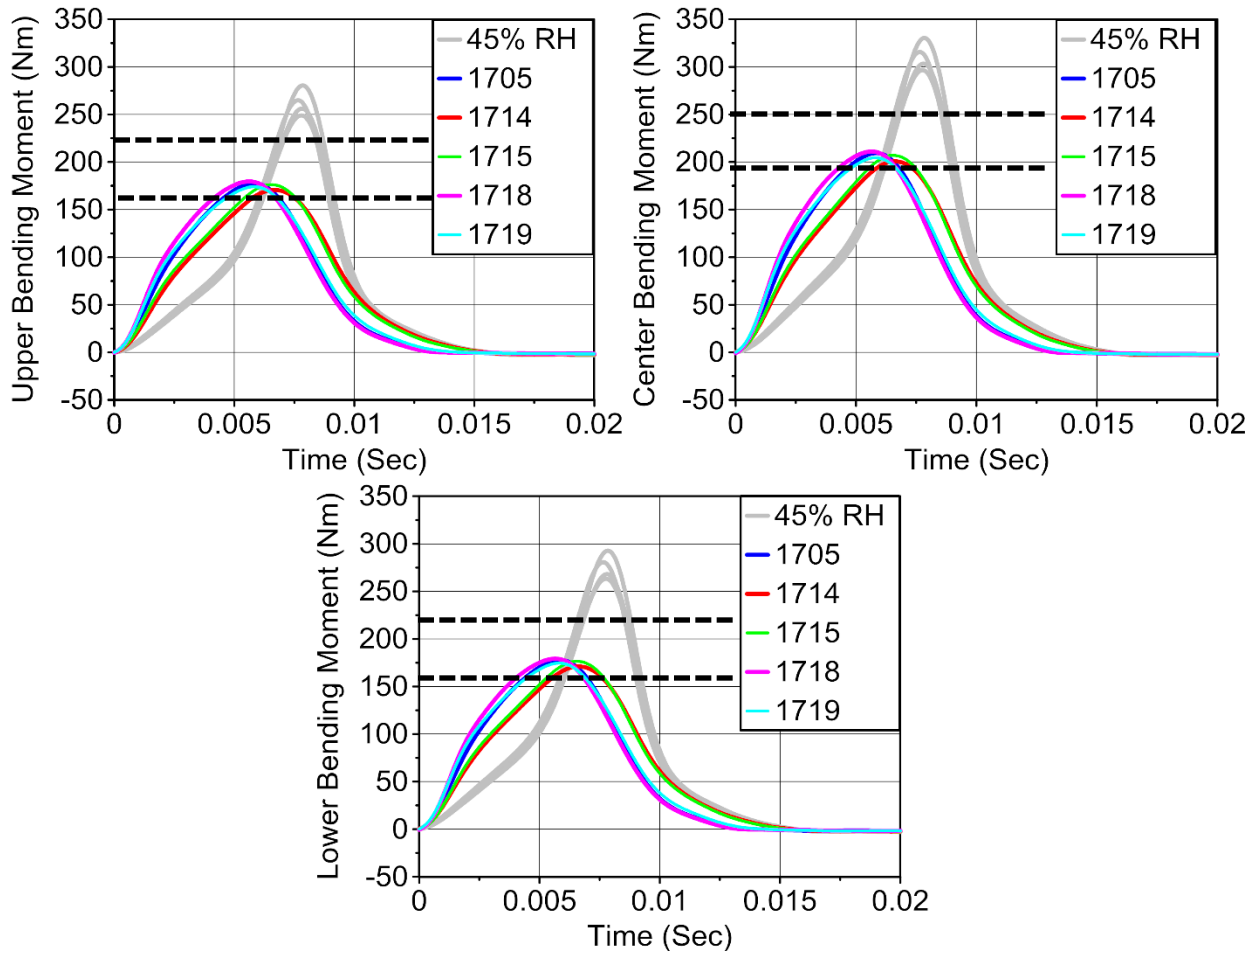
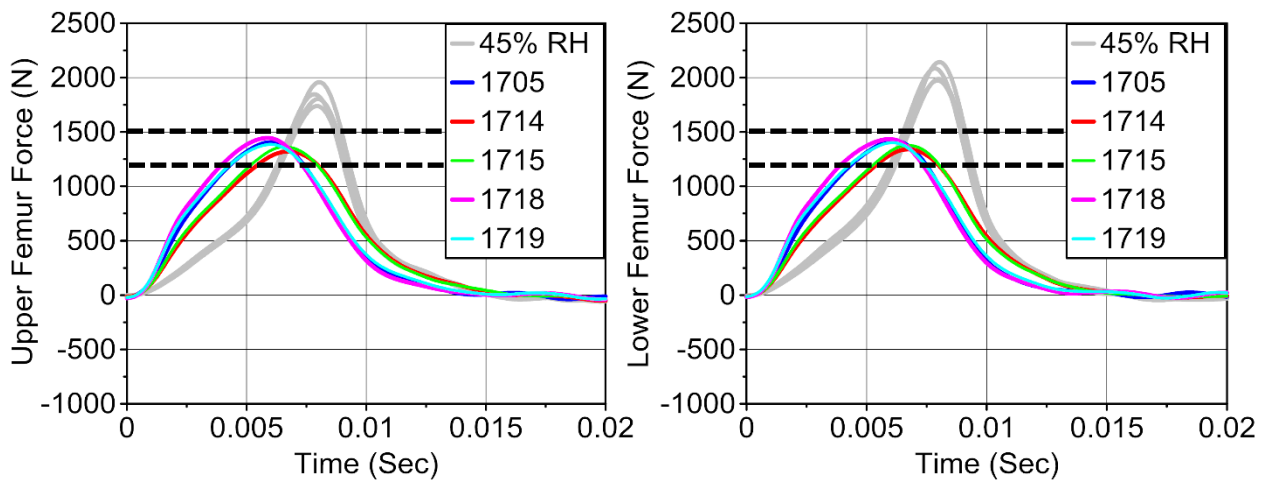
Qualification tests were also performed with upper legform SN150 using new foams (test numbers 1714, 1715, and 1719) as well as previously tested foams (test numbers 1705 and 1718). Time histories of the femur bending moments and femur forces are shown in Figure 21 and Figure 22 below. Peak values, means, standard deviations, and percentage%CV for all qualification tests performed with upper legform SN 150 are shown in Table 8 below. Again, all tests passed the qualification requirements. The shape and response of the upper legform in the low humidity qualification tests also matched the response of TRL's qualification tests.

**Figure 21. Femur bending moment time histories of the 25 percentage RH tests with upper legform SN150 using multiple foams.**

**Figure 22. Femur force time histories of the 25 percentage RH tests with upper legform SN150 using multiple foams.**

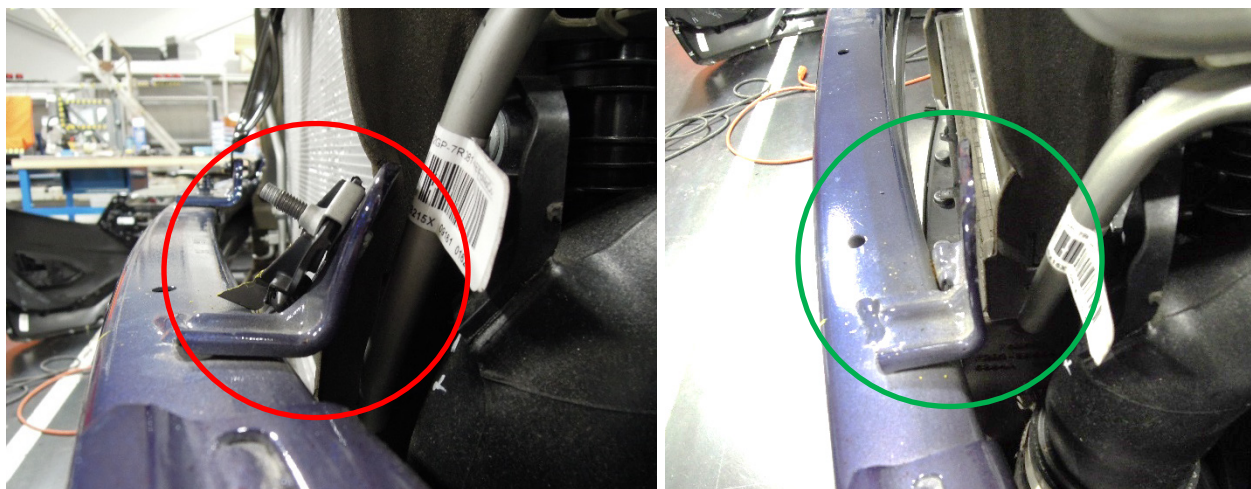
The discrepancies in results from the repeat tests performed at different humidity levels are likely due to a combination of both damage below the bumper fascia that occurred during testing and the foam's sensitivity to humidity. Figure 23 shows an example of damage to a bracket on the bumper beam (circled in red) at a location 100 mm inboard from impact location U-5 that is hidden unless the fascia and headlights are removed. An undamaged bracket (circled in green) should be vertical and there should be a gap between the bracket and the radiator. The damaged bracket was not discovered until after the first set of tests (i.e., the test series run at 45 percentage RH) was complete and parts were being changed out for the 25 percentage RH series of testing. It is unknown after which of the previous tests this had occurred and running a test with a previously damaged bracket could slightly affect the results. The damaged bracket was repaired before the 25 percentage RH series of testing.

**Figure 23. Damaged (red) and undamaged (green) bumper beam bracket in the Ford Edge**
