**National Highway  
Traffic Safety  
Administration**

DOT HS 812 659

# **Technical Evaluation Of the TRL Pedestrian Upper Legform**

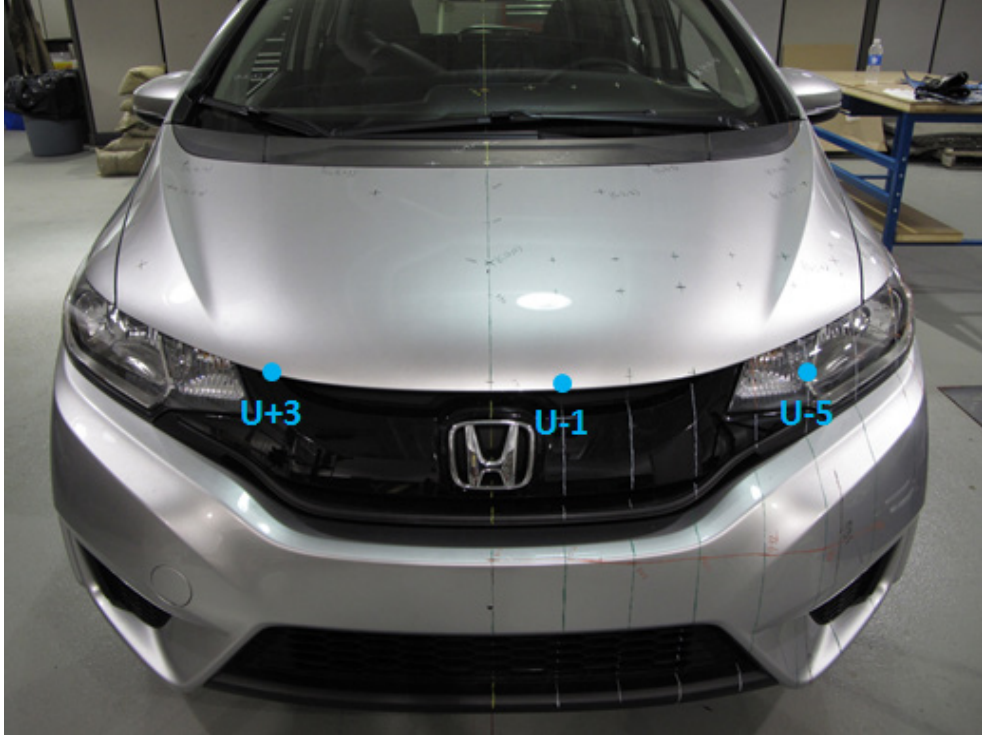
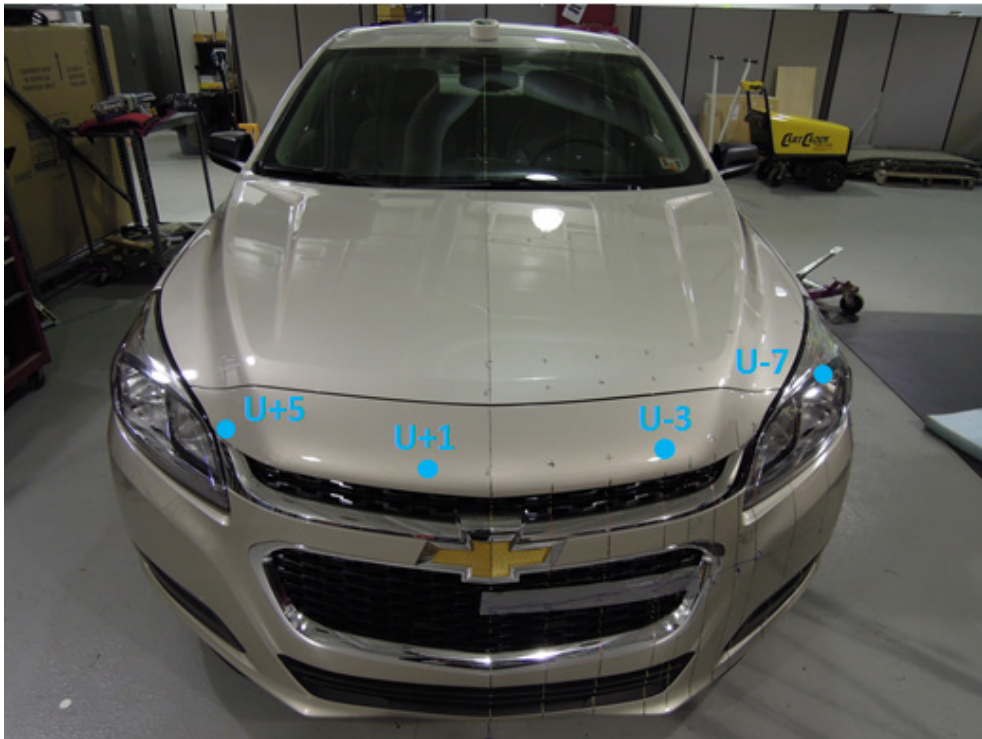
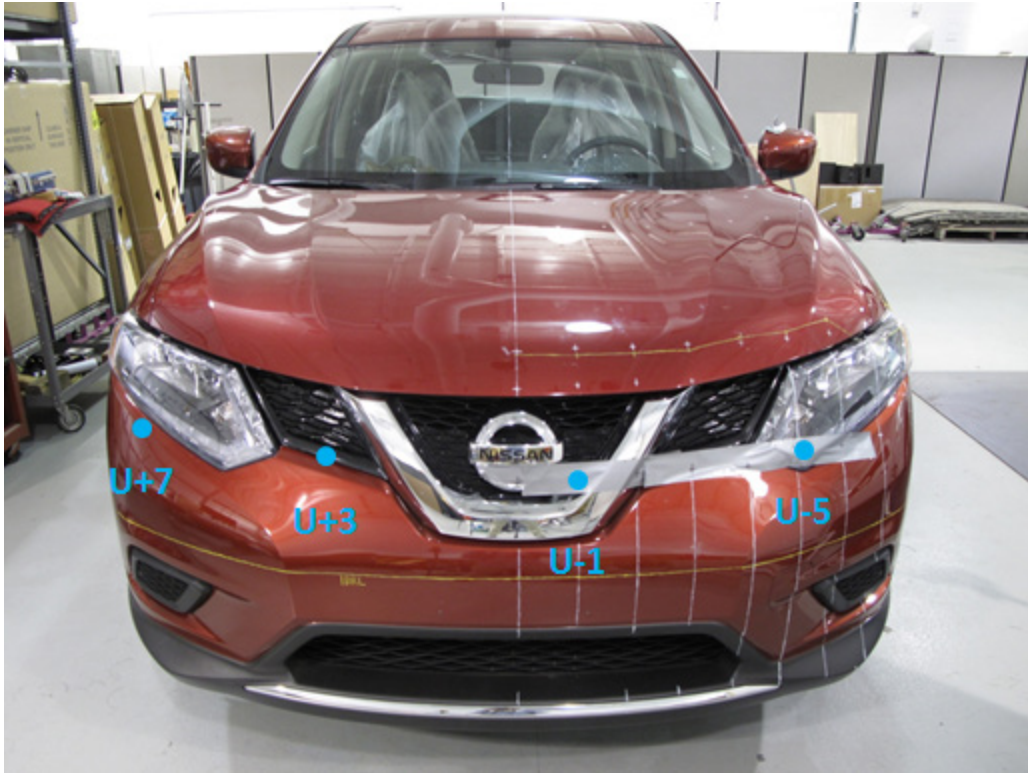
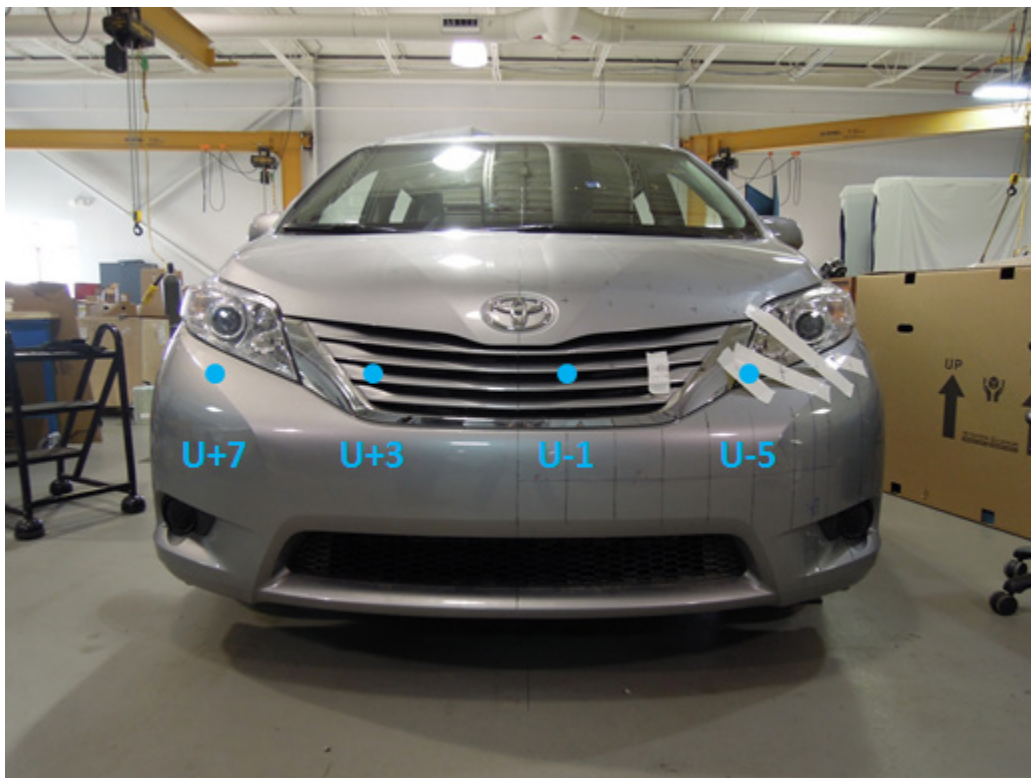
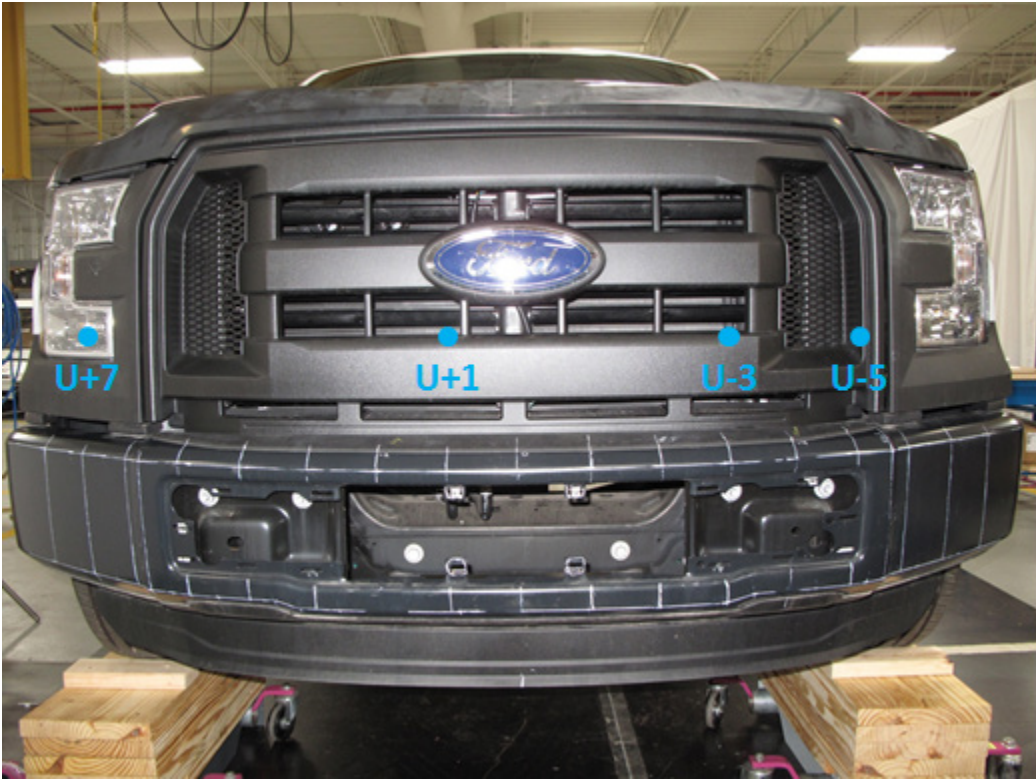
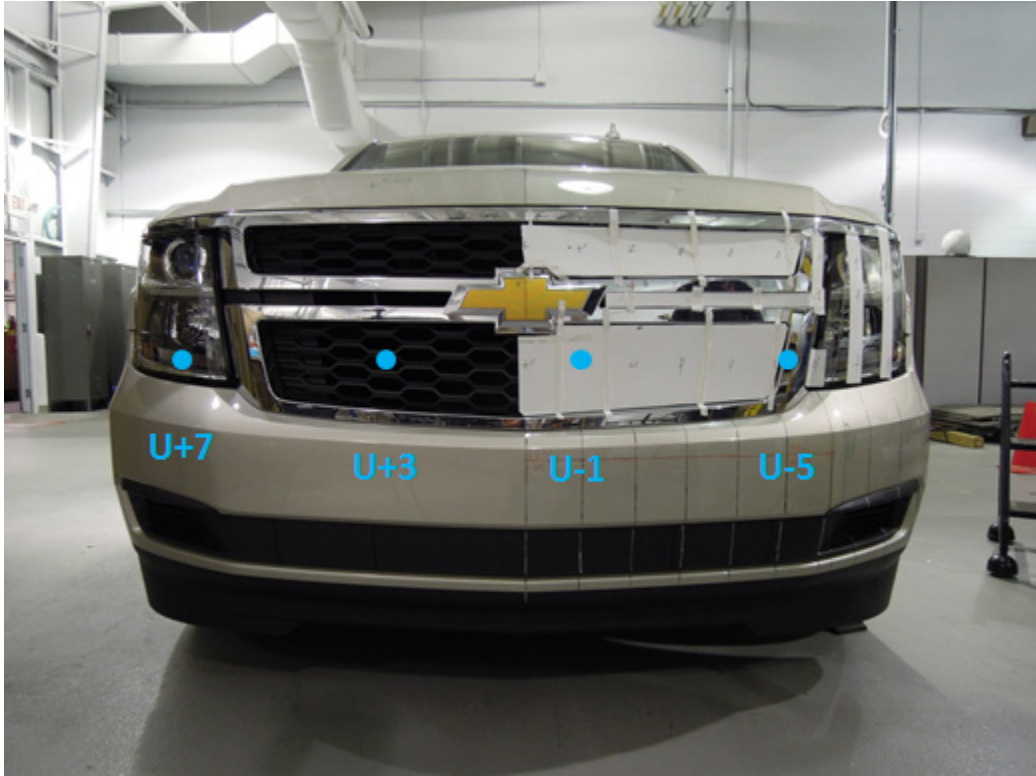
Figure 24 to Figure 29 show the front ends for each of the tested vehicles and the impact locations (dots correspond to WAD 775 line).

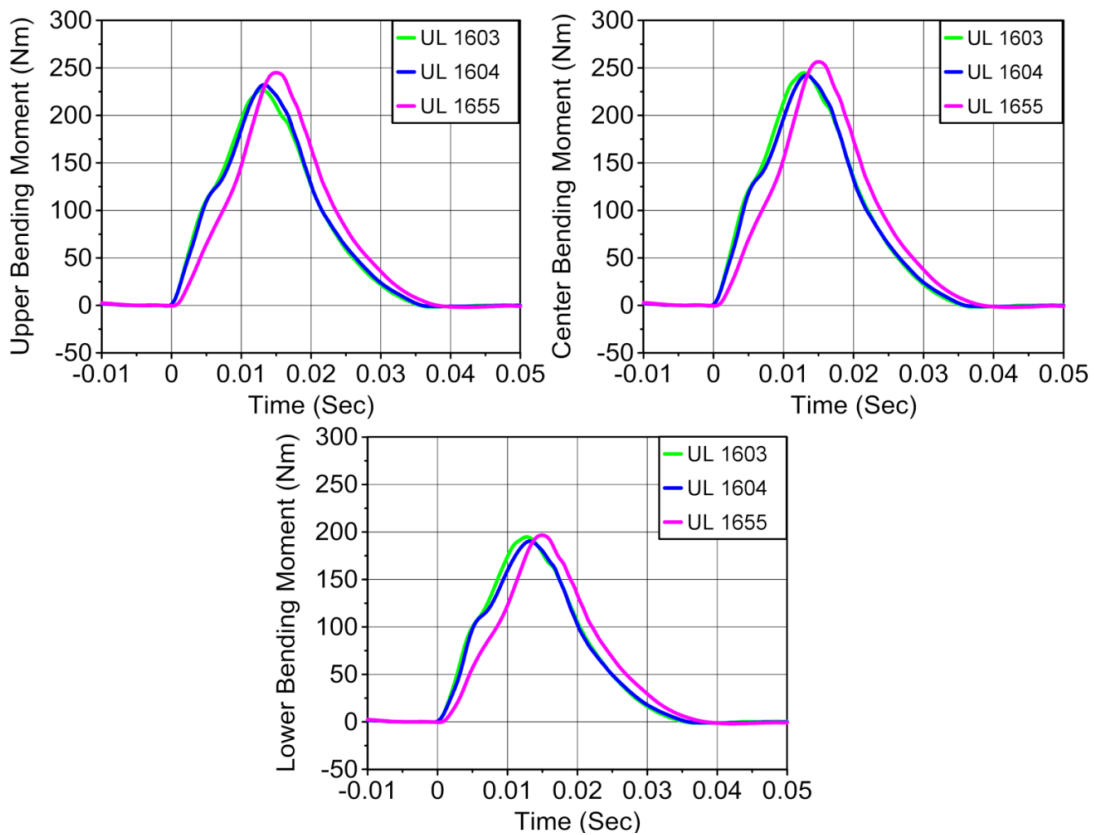
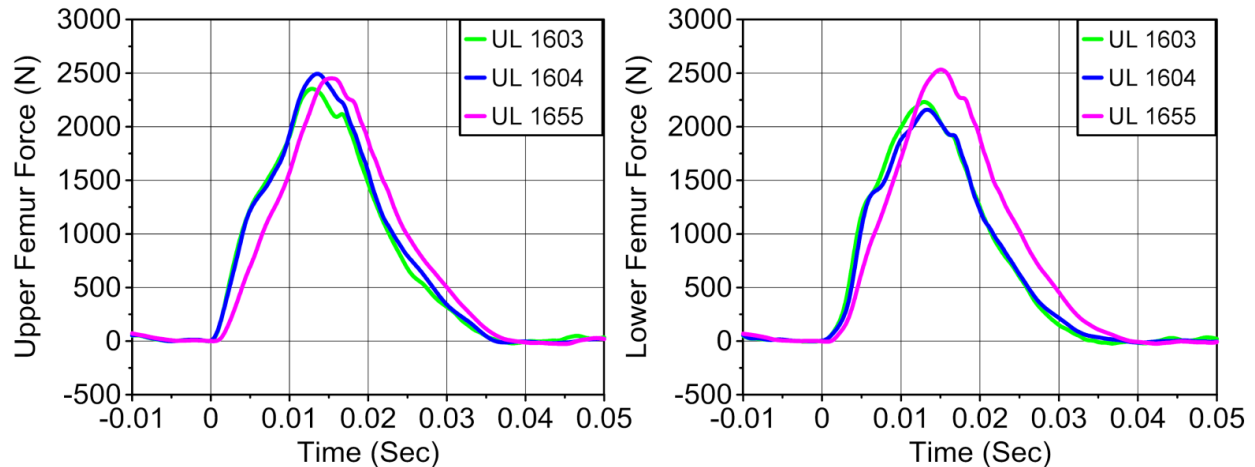
Three tests (UL 1603, UL 1604, UL 1655) were performed on the 2016 Honda Fit at  $\pm 500$  mm from the centerline. Assuming symmetry, these three tests were analyzed for repeatability. Time histories of the femur bending moments and femur forces for the three tests are shown in Figure 30 and Figure 31 below. It should be noted that test UL 1655 was performed four months after UL 1603 and UL 1604.

**Figure 30. Repeatability: 2016 Honda Fit femur bending moment time histories of impacts at  $\pm 500$  mm from centerline using upper legform SN150**

**Figure 31. Repeatability: 2016 Honda Fit femur force time histories of impacts at  $\pm 500$  mm from centerline using upper legform SN150**

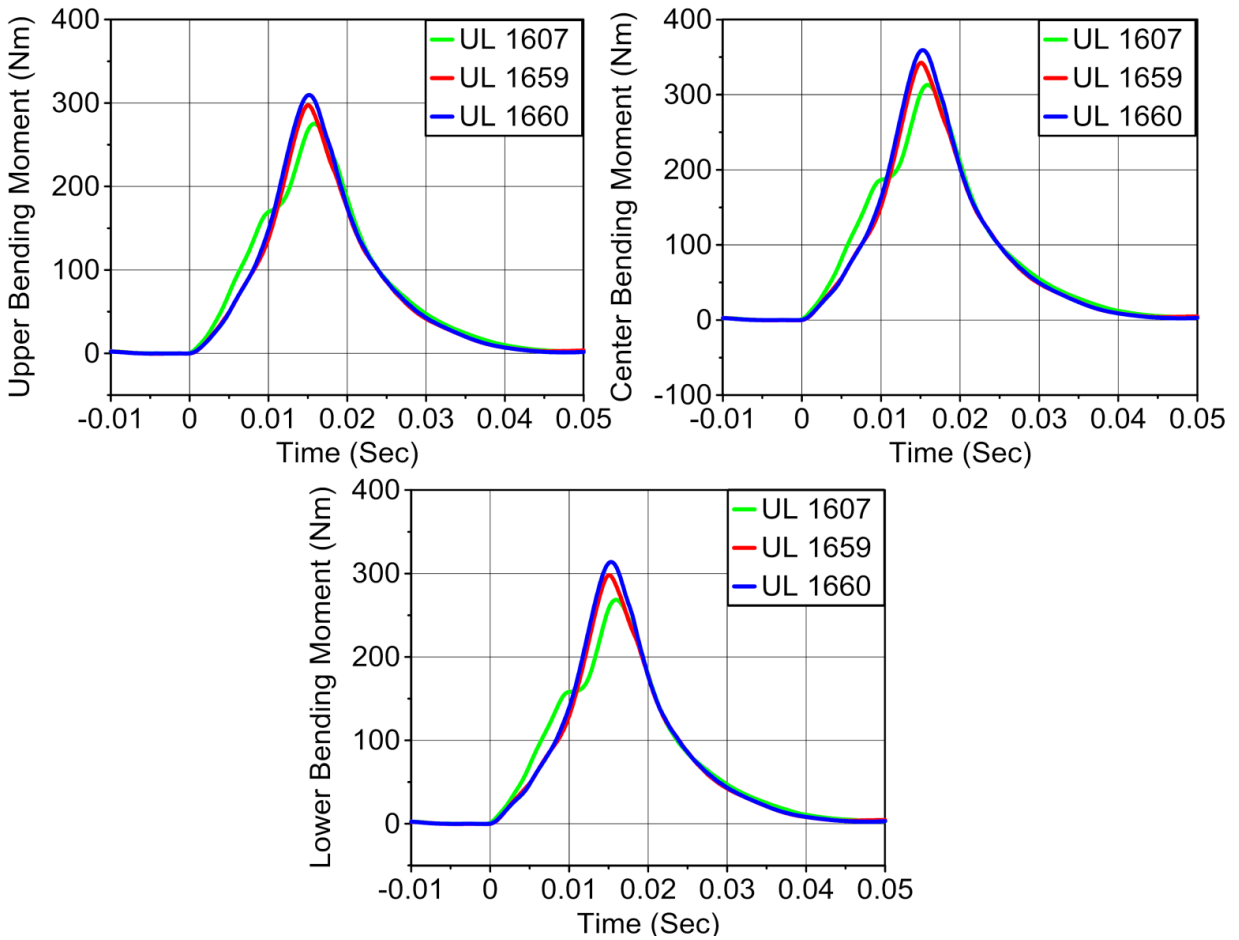
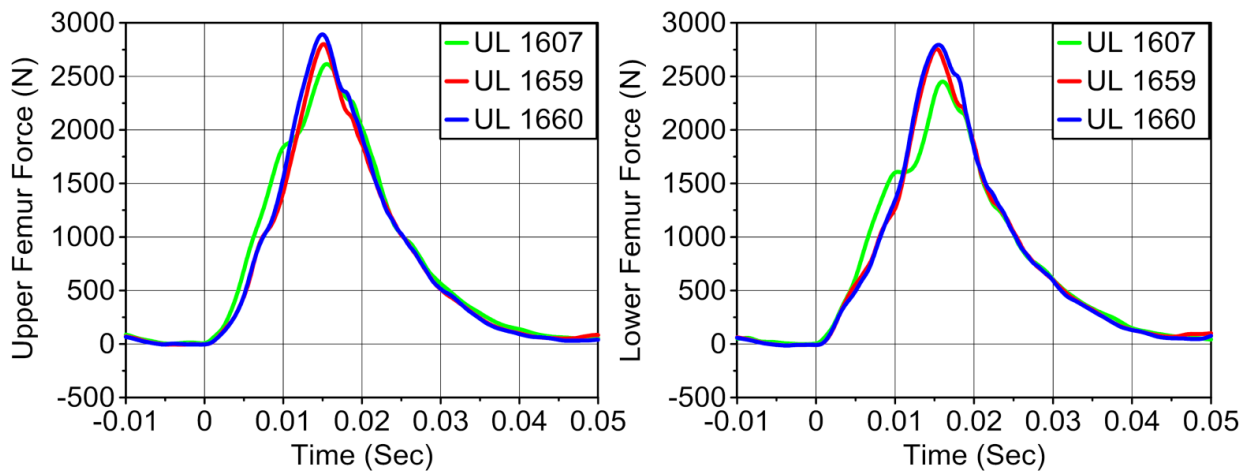
Three tests (UL 1607, UL 1659, UL 1660) were performed on the 2016 Chevrolet Malibu at  $\pm 500$  mm from the centerline. Assuming symmetry, these three tests were analyzed for repeatability. Time histories of the femur bending moments and femur forces for the three tests are shown in Figure 32 and Figure 33 below. It should be noted that tests UL 1659 and UL 1660 were performed several months after UL 1607.

**Figure 32. Repeatability: 2016 Chevrolet Malibu femur bending moment time histories of impacts at  $\pm$  500 mm from centerline using upper legform SN150**

**Figure 33. Repeatability: 2016 Chevrolet Malibu femur force time histories of impacts at  $\pm$  500 mm from centerline using upper legform SN150**

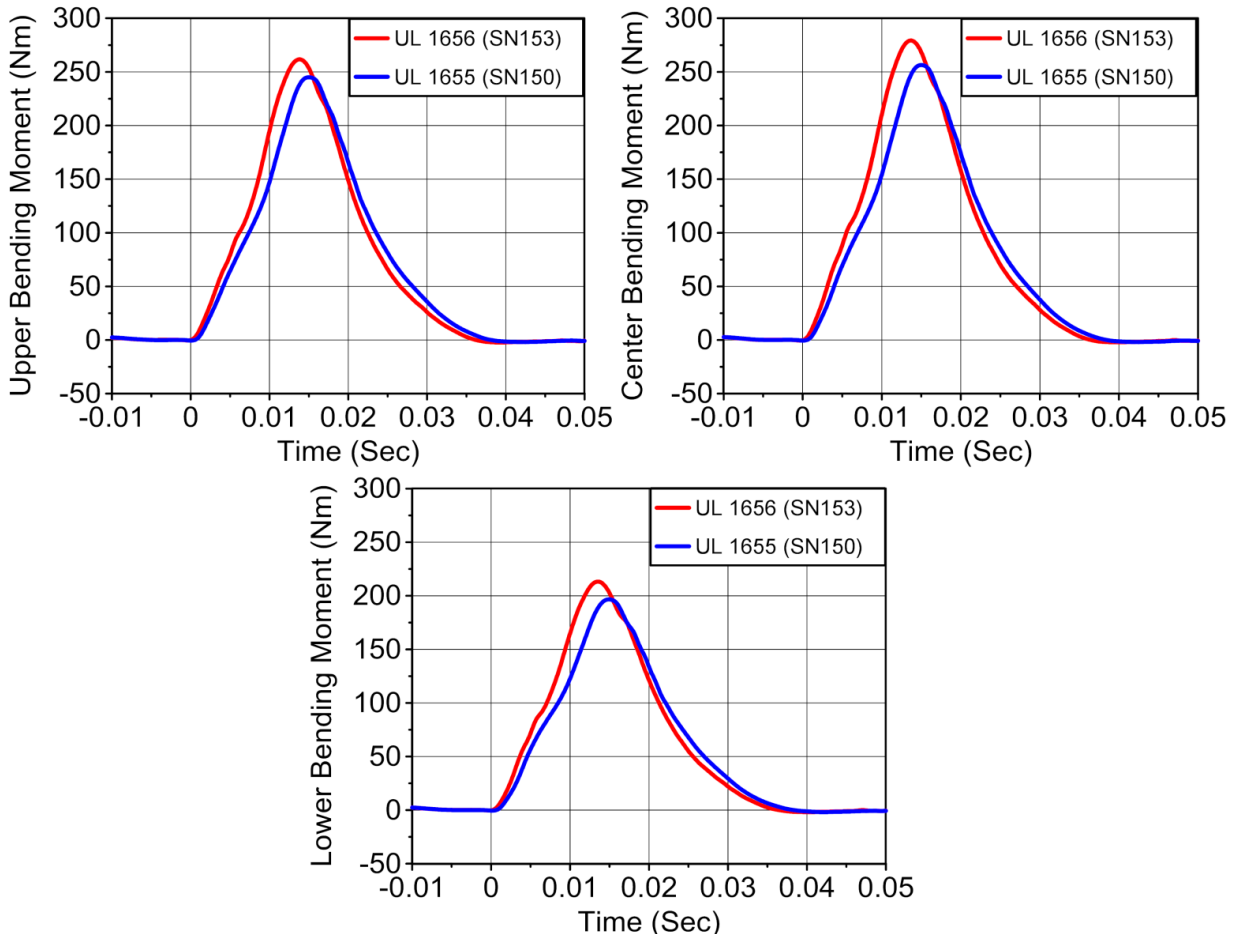
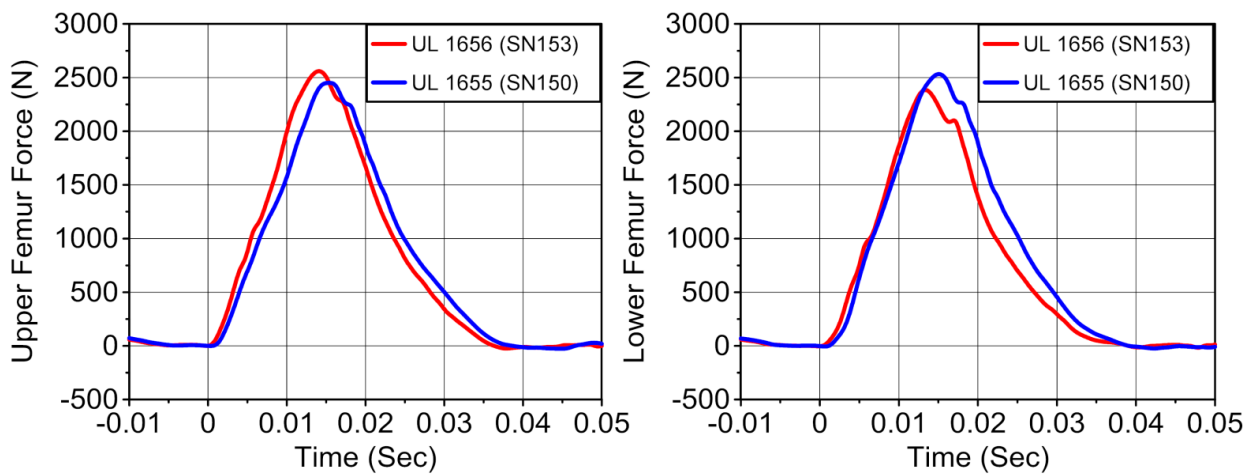
Two tests (UL 1655, UL 1656) were performed on the 2016 Honda Fit at  $\pm 500$  mm from the centerline. Test UL 1655 was performed using upper legform SN150. Test UL 1656 was performed using upper legform SN153. Assuming symmetry, these two tests were analyzed for reproducibility. Time histories of the femur bending moment and femur forces for the two tests are shown in Figure 34 and Figure 35 below.

**Figure 34. Reproducibility: 2016 Honda Fit femur bending moment time histories of impacts at  $\pm 500$  mm from centerline**

**Figure 35. Reproducibility: 2016 Honda Fit femur force time histories of impacts at  $\pm 500$  mm from centerline**

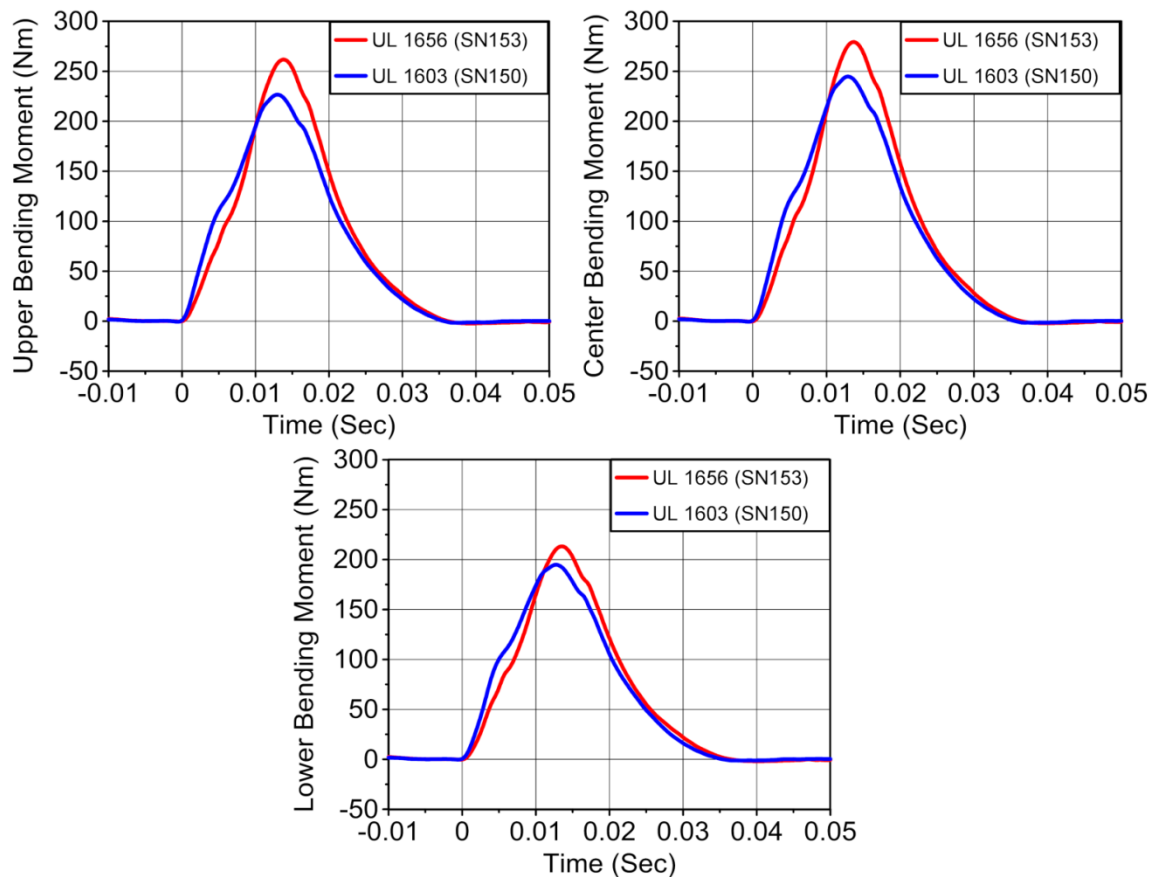
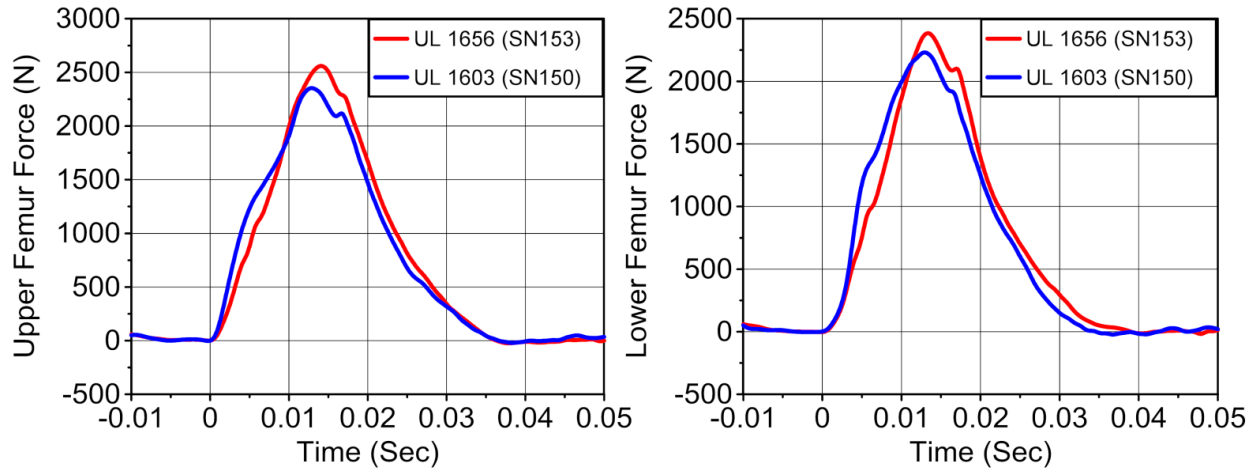
Reproducibility can also be analyzed by comparing two tests that were performed a couple months apart (UL 1603, UL 1656) at the same location. Test UL 1603 was performed with upper legform SN150. Test UL 1656 was performed with upper legform SN153 as mentioned above. Both tests were performed on the 2016 Honda Fit on the driver side, 500 mm from centerline (U-5). Time histories of the femur bending moment and femur forces for the two tests are shown in Figure 36 and Figure 37 below.

**Figure 36. Reproducibility: 2016 Honda Fit femur bending moment time histories of impacts at ± 500 mm from centerline comparing impacts performed a couple months apart**

**Figure 37. Reproducibility: 2016 Honda Fit femur force time histories of impacts at ± 500 mm from centerline comparing impacts performed a couple months apart**

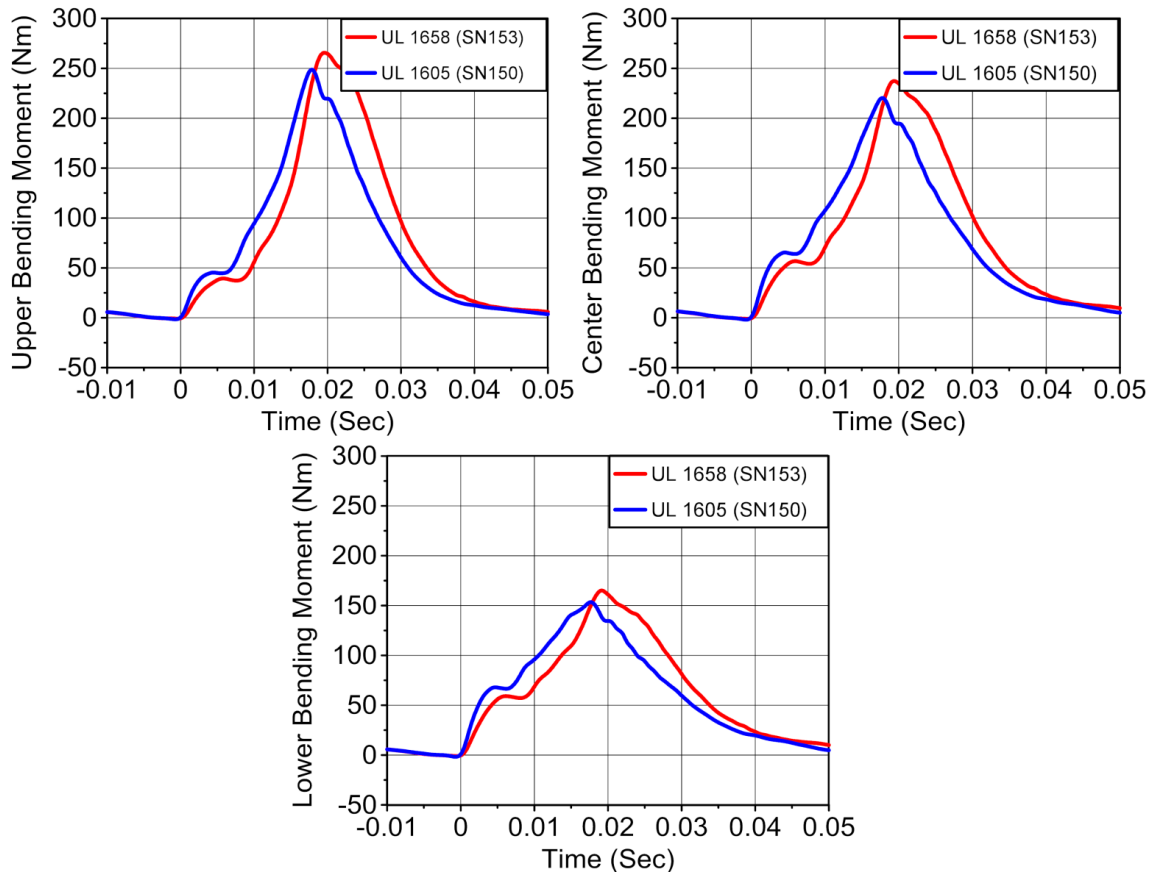
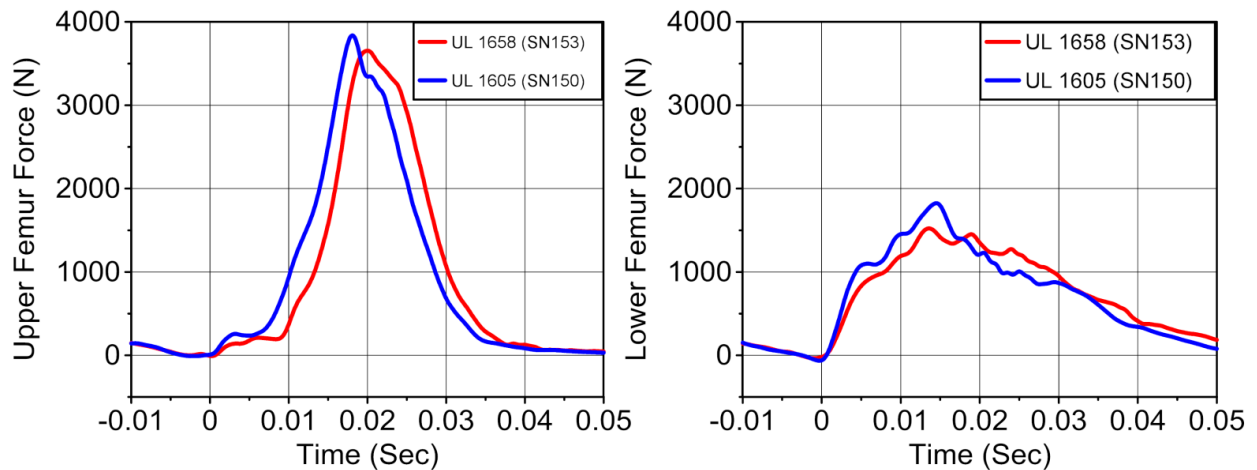
Two tests (UL 1605, UL 1658) were performed on the 2016 Chevrolet Malibu at + 100 mm from the centerline. Test UL 1605 was performed using upper legform SN150. Test UL 1658 was performed using upper legform SN153. Time histories of the femur bending moment and femur forces for the two tests are shown in Figure 38 and Figure 39 below.

**Figure 38. Reproducibility: 2016 Chevrolet Malibu femur bending moment time histories of impacts at + 100 mm from centerline**

**Figure 39. Reproducibility: 2016 Chevrolet Malibu femur force time histories of impacts at + 100 mm from centerline**

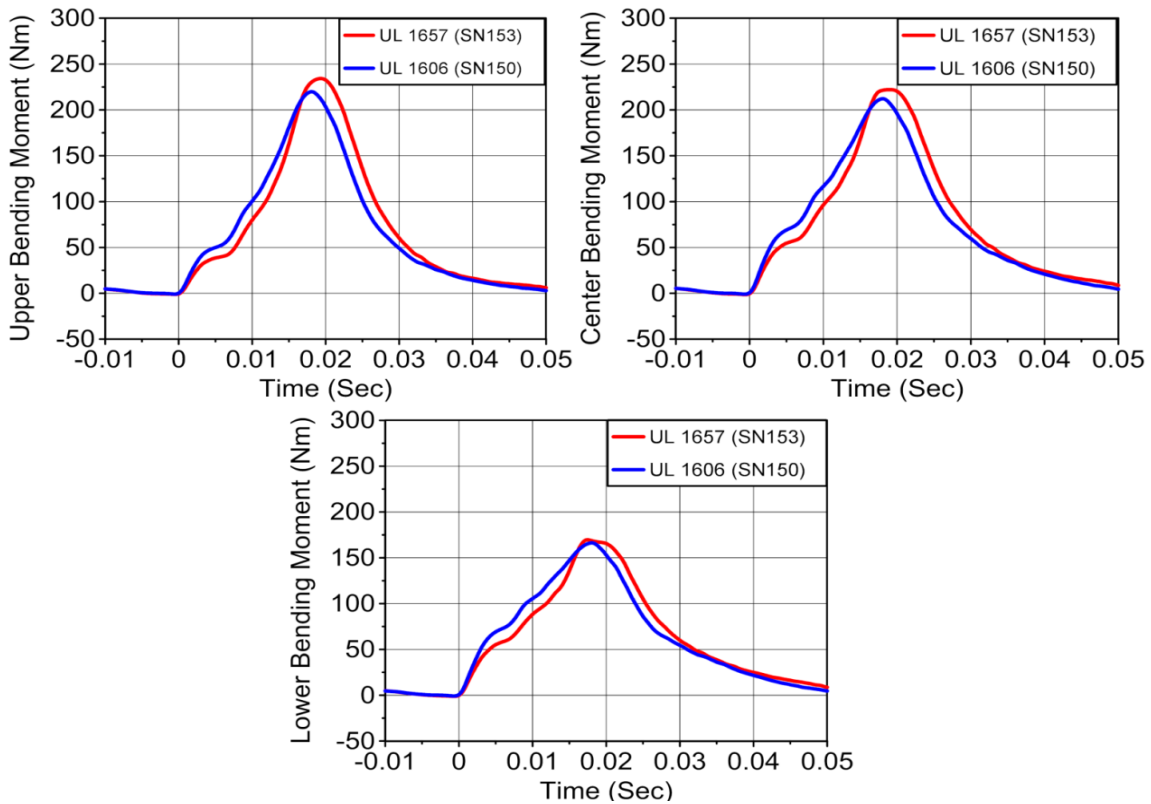
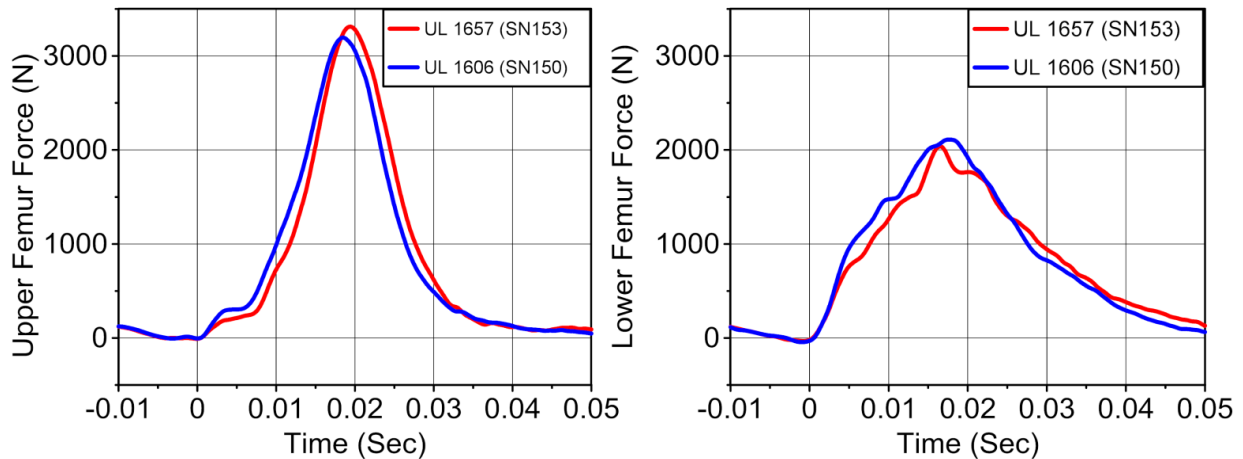
**Figure 40. Reproducibility: 2016 Chevrolet Malibu femur bending moment time histories of impacts at - 300 mm from centerline**

**Figure 41. Reproducibility: 2016 Chevrolet Malibu femur force time histories of impacts at - 300 mm from centerline**

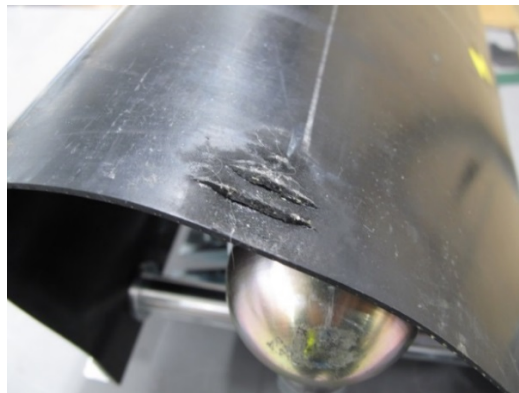
**Figure 42. Minor damage to upper legform impactor**

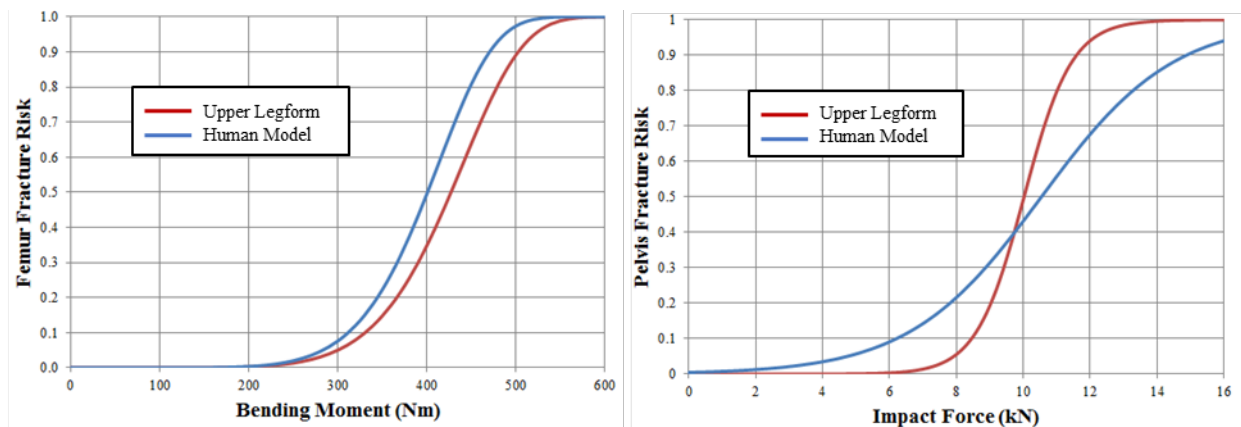
**Figure 43. Comparison of human model-based (THUMS) and upperlegform-based injury risk functions**

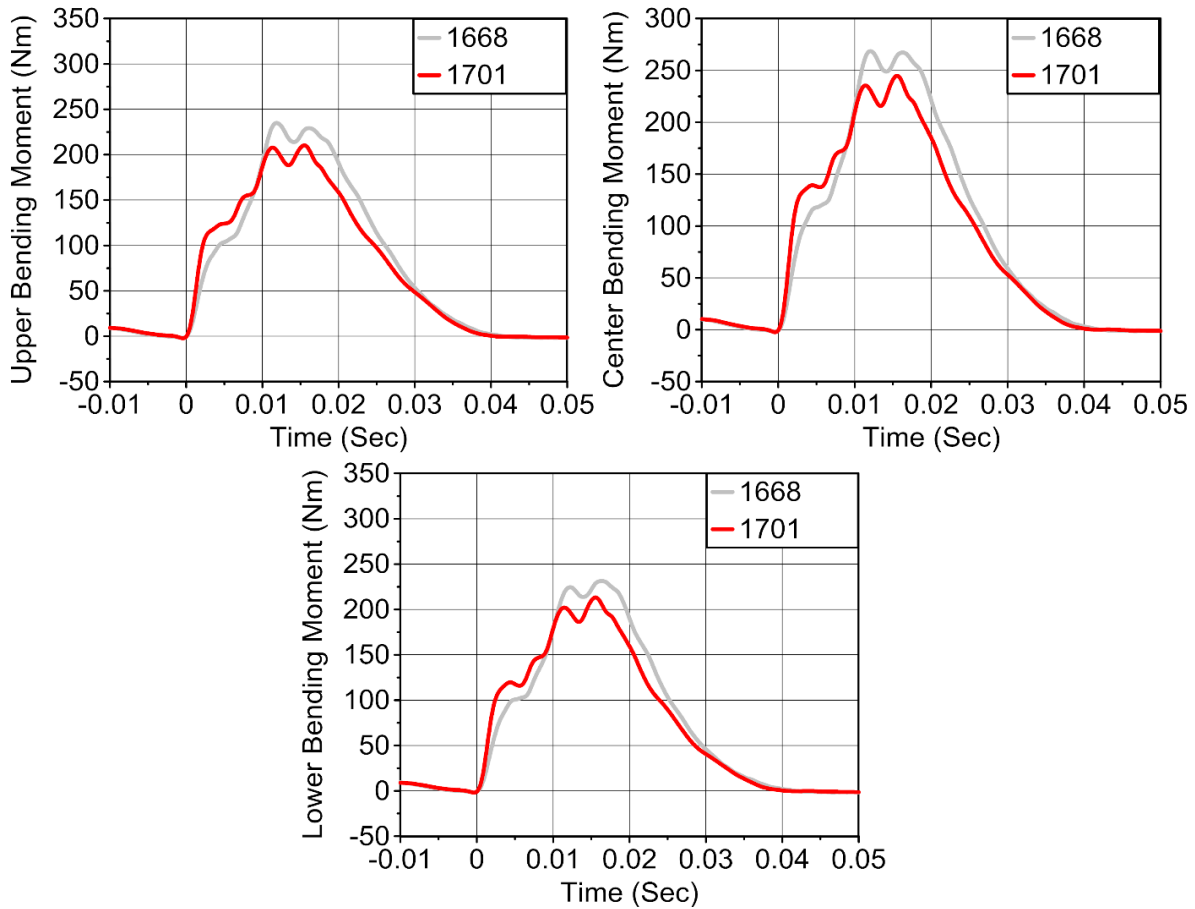
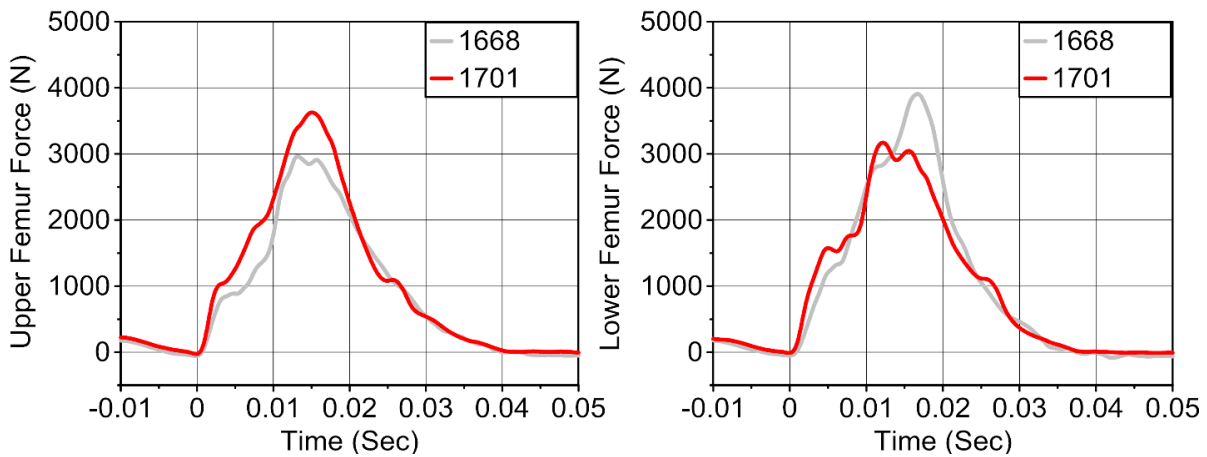
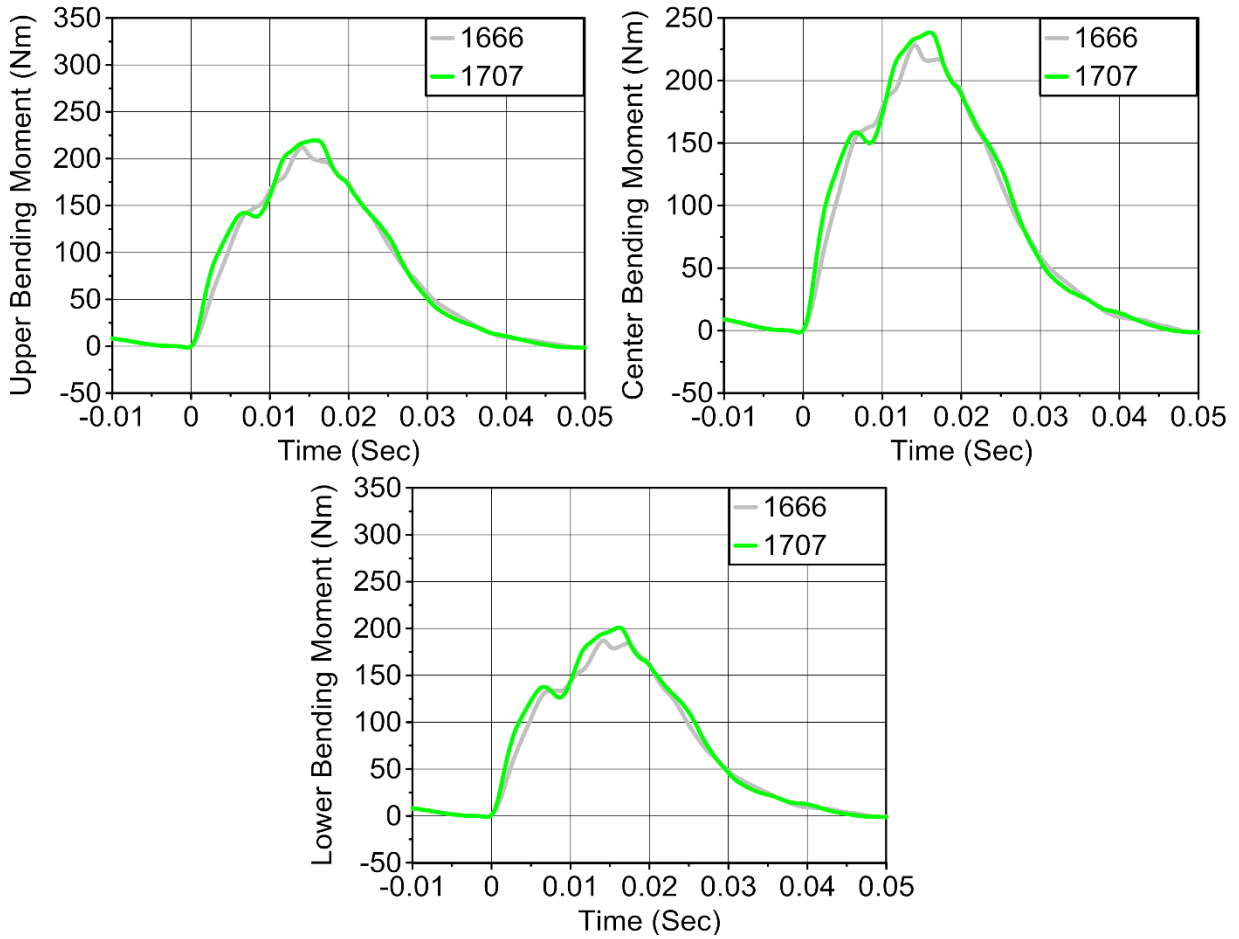
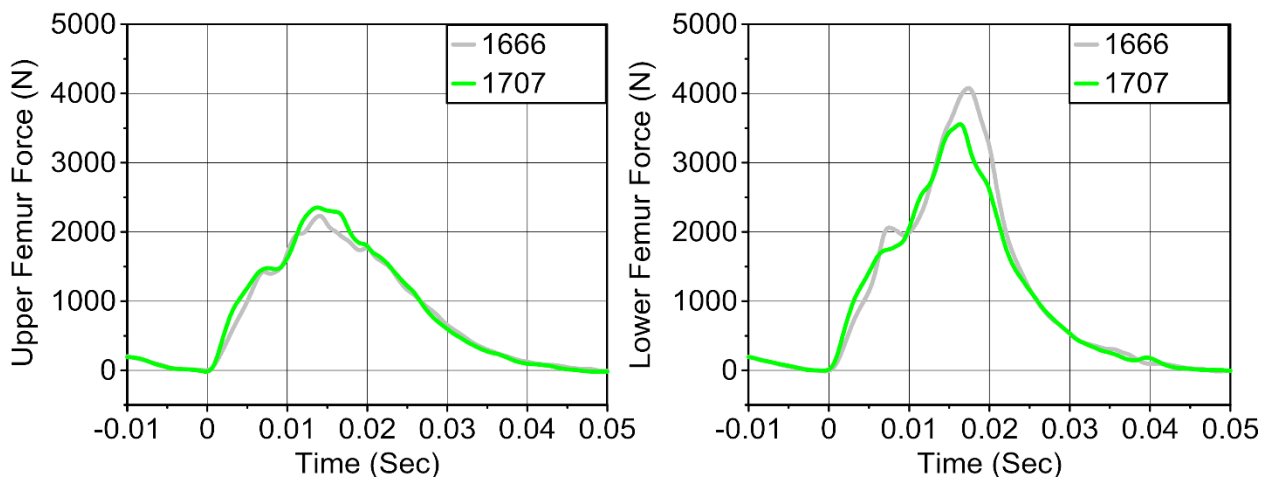
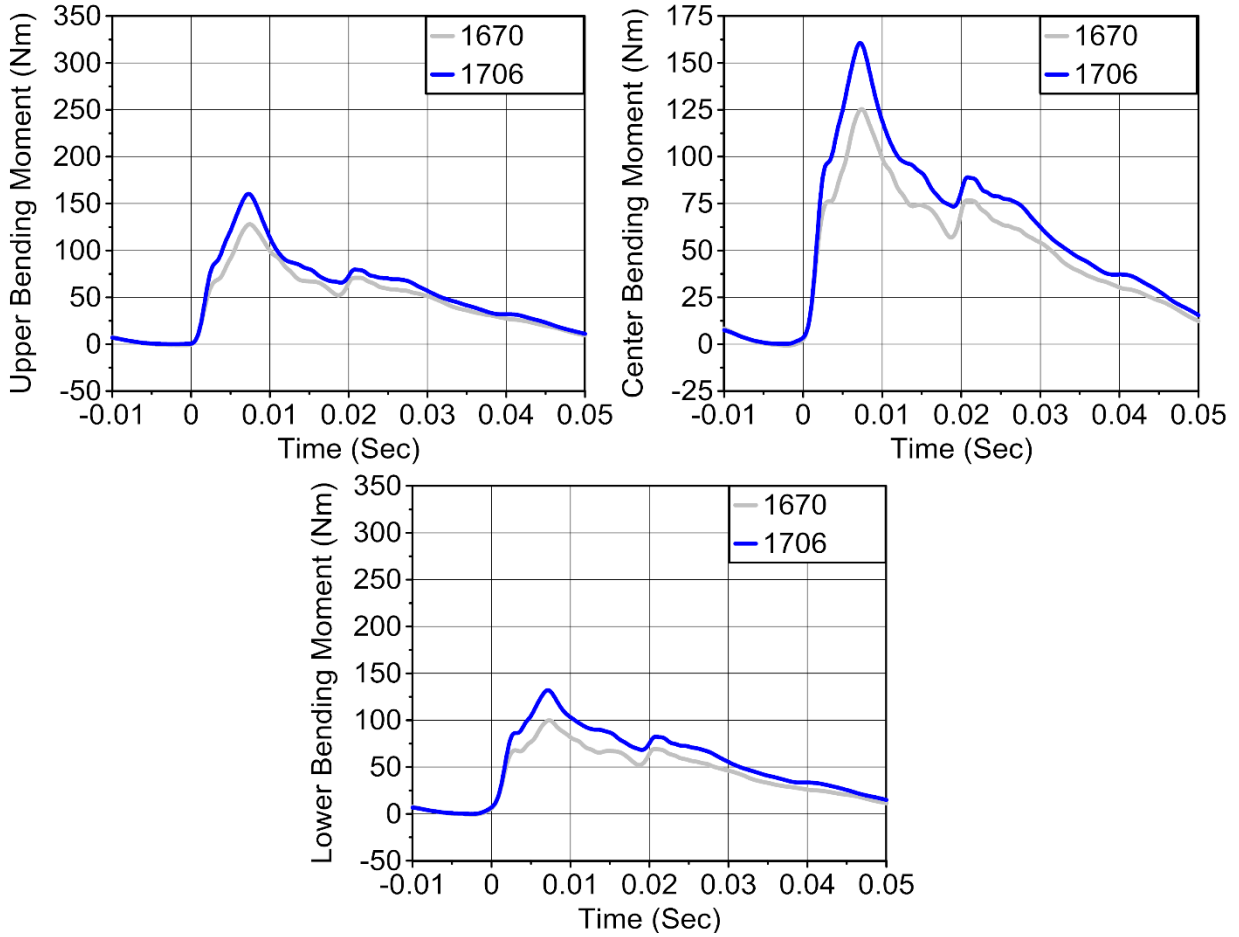
**Figure 44. Femur bending moment time histories of vehicle repeat tests at location U-1. Red (1701): legform that PASSES qualification requirements with CONFOR foam at 25 percent RH. Gray (1668) legform that FAILS (high) qualification requirements CONFOR foam at 45 percent RH.**

**Figure 45. Femur force histories of vehicle repeat tests at location U-1. Red (1701): legform that PASSES qualification requirements with CONFOR foam at 25 percent RH. Gray (1668) legform that FAILS (high) qualification requirements CONFOR foam at 45 percent RH.**

**Figure 46. Femur bending moment time histories of vehicle repeat tests at location U+3. Green (1707): legform that PASSES qualification requirements with CONFOR foam at 25 percent RH. Gray (1666) legform that FAILS (high) qualification requirements CONFOR foam at 45 percent RH.**

**Figure 47. Femur force time histories of vehicle repeat tests at location U+3. Green (1707): legform that PASSES qualification requirements with CONFOR foam at 25 percent RH. Gray (1666) legform that FAILS (high) qualification requirements with CONFOR foam at 45 percent RH.**

**Figure 48. Femur bending moment time histories of vehicle repeat tests at location U-5. Blue (1706): legform that PASSES qualification requirements with CONFOR foam at 25 percent RH. Gray (1670) legform that FAILS (high) qualification requirements CONFOR foam at 45 percent RH.**

**Figure 49. Femur force time histories of vehicle repeat tests at location U-5. Blue (1706): legform that PASSES qualification requirements with CONFOR foam at 25 percent RH. Gray (1670) legform that FAILS (high) qualification requirements CONFOR foam at 45 percent RH.**

Additionally, although the magnitudes in bending moment and force are slightly different between the two humidity conditions, the shapes of their time histories as shown in the Appendix (Figure 44 to Figure 51) appear to be very similar. There is no drastic change in the shape of the responses like what was seen in the qualification tests. This suggests that the foam's changing stiffness due to humidity has less of an effect on the upper legform's response in vehicle impacts as compared to qualification tests.
