**National Highway  
Traffic Safety  
Administration**

DOT HS 812 659

# **Technical Evaluation Of the TRL Pedestrian Upper Legform**

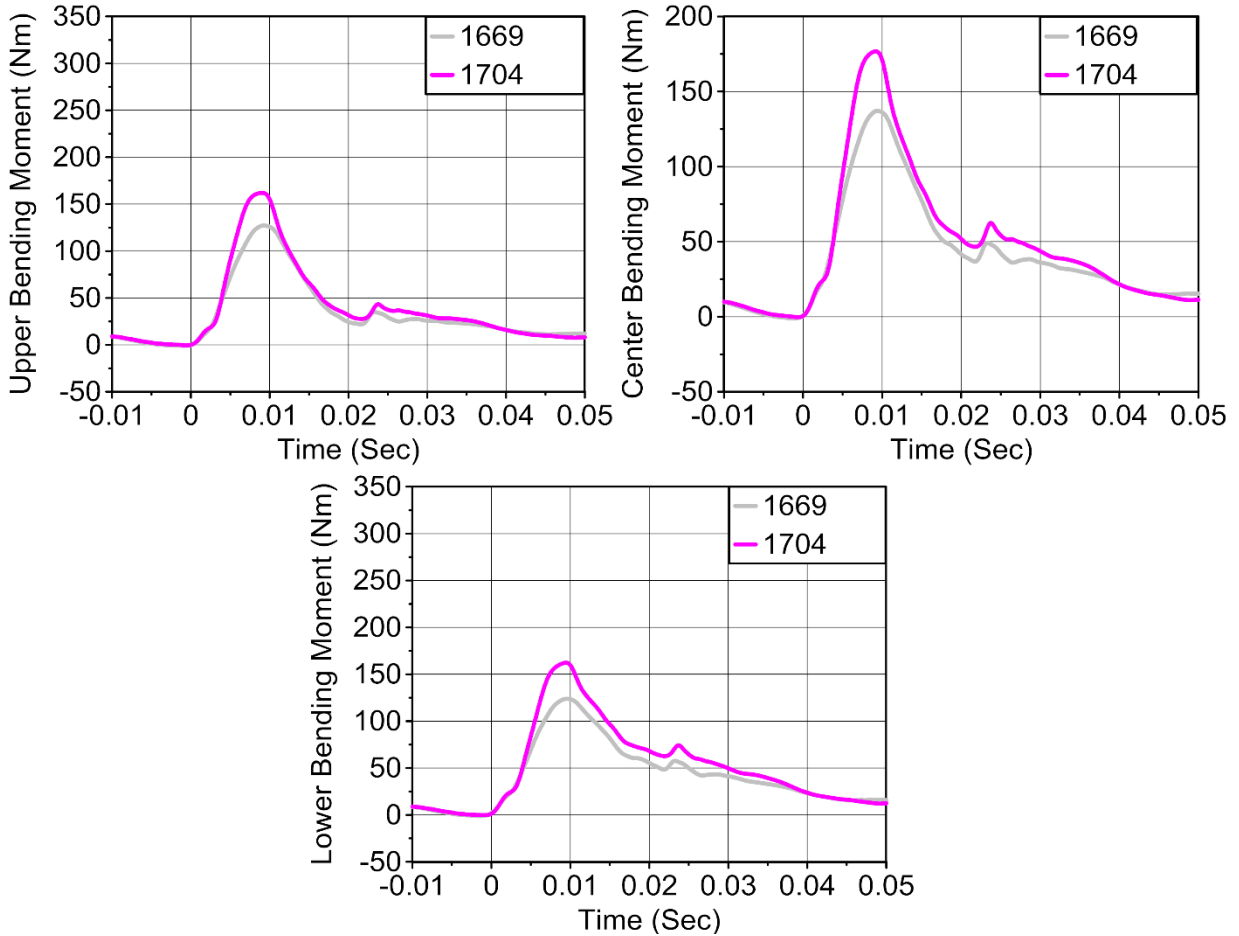
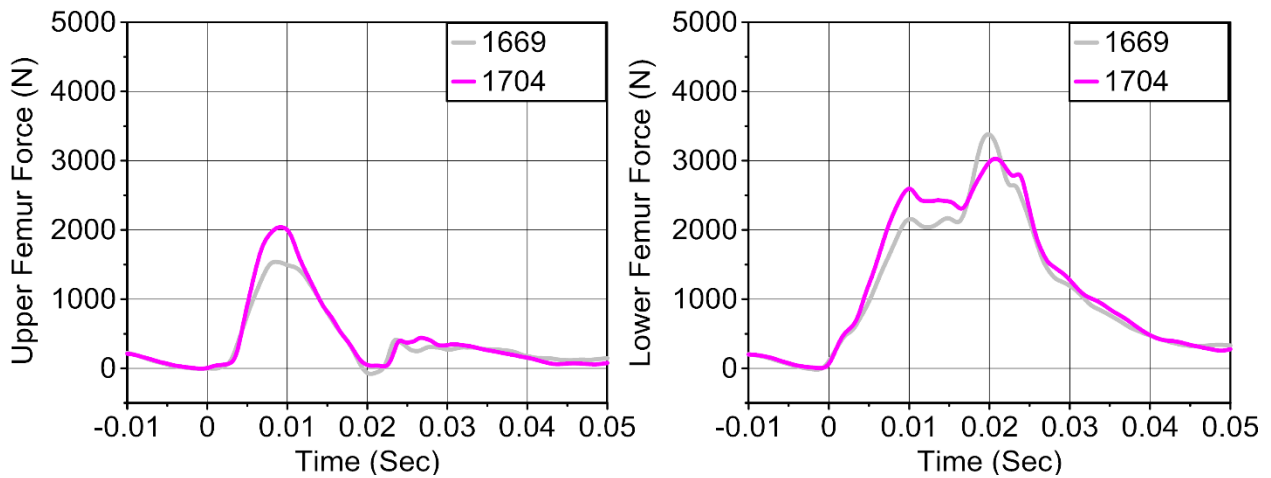
**Figure 50. Femur bending moment time histories of vehicle repeat tests at location U+7. Pink (1704): legform that PASSES qualification requirements with CONFOR foam at 25 percent RH. Gray (1669) legform that FAILS (high) qualification requirements CONFOR foam at 45 percent RH.**

**Figure 51. Femur force time histories of vehicle repeat tests at location U+7. Pink (1704): legform that PASSES qualification requirements with CONFOR foam at 25 percent RH. Gray (1669) legform that FAILS (high) qualification requirements CONFOR foam at 45 percent RH.**

Additionally, although the magnitudes in bending moment and force are slightly different between the two humidity conditions, the shapes of their time histories as shown in the Appendix (Figure 44 to Figure 51) appear to be very similar. There is no drastic change in the shape of the responses like what was seen in the qualification tests. This suggests that the foam's changing stiffness due to humidity has less of an effect on the upper legform's response in vehicle impacts as compared to qualification tests.
