DOT HS 812 635

April 2019

# **Structural Countermeasure Research Program**

Reichert, R., & Kan, S. (2019, April). *Structural countermeasure research program* (Report No. DOT HS 812 635). Washington, DC: National Highway Traffic Safety Administration.

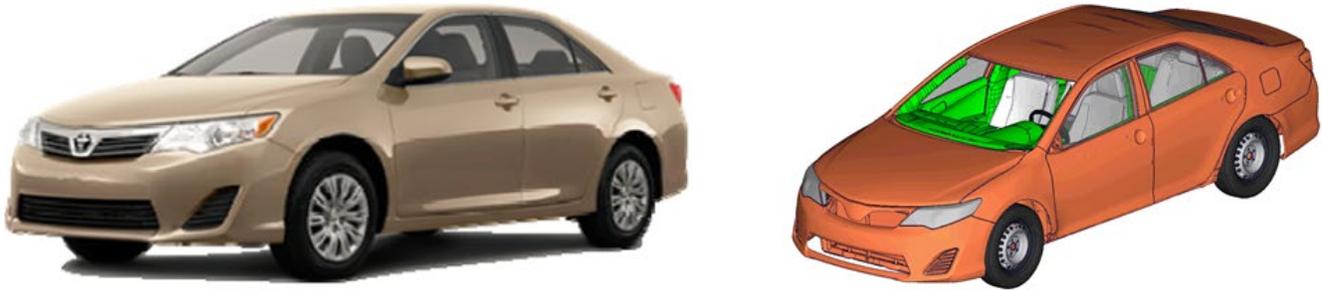
Figure 2 - 2012 Toyota Camry (a) Physical Vehicle and (b) FE Model

Most components were modeled using shell elements with an average element size of 6 millimeters (mm). The model was evaluated and validated using the nonlinear, explicit FE code LS-DYNA<sup>8</sup> with a minimum time-step of 0.7 microseconds using 16 central processing units (cpu's) on a Hewlett-Packard high-performance computer system. Additional details regarding the modeling approach and validation process can be found in “Validation of a Toyota Camry Finite Element Model for Multiple Impact Configurations.”<sup>9</sup> The FE model contains relevant structural and interior components, such as body in white, engine, drivetrain, steering, suspension, seats, trims, etc., which are represented by more than 1,000 parts and approximately 2.25 million nodes and elements.

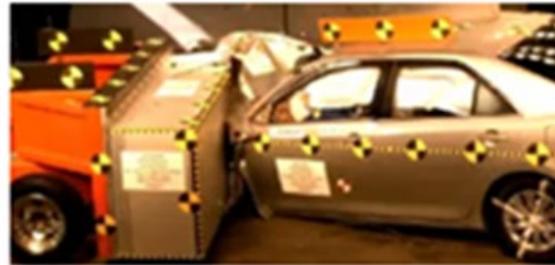
Figure 10 compares overall vehicle deformation and specific occupant compartment intrusion values for a 2015 Toyota Camry in test and simulation. Figure 10(a) shows the overall vehicle deformation in the baseline simulation on the left and in the full-scale crash test on the right. Similar deformation of the frontal structure, door frame, and roof are observed. The A-pillar shows minor buckling in both test and simulation.

Figure 10(b) depicts the door sill deformation. Pre-crash measurement points are shown in green. These points were chosen to be the same in test and simulation. Post-crash measurement points for the simulation are illustrated in blue. Respective post-crash points for the 2015 full-scale crash test are depicted in black with markers. The maximum deformation values are 40 mm for the test and 25 mm for the simulation. It is noted that there is no significant door sill deformation in either test or simulation. Intrusion along the rocker pillar and minor bending of the A-pillar area are well captured in the simulation model.

Figure 10 (a) - 2015 Left Oblique Test Versus Simulation - Overall

Figure 10 (b) - 2015 Left Oblique Test Versus Simulation – Door Sill

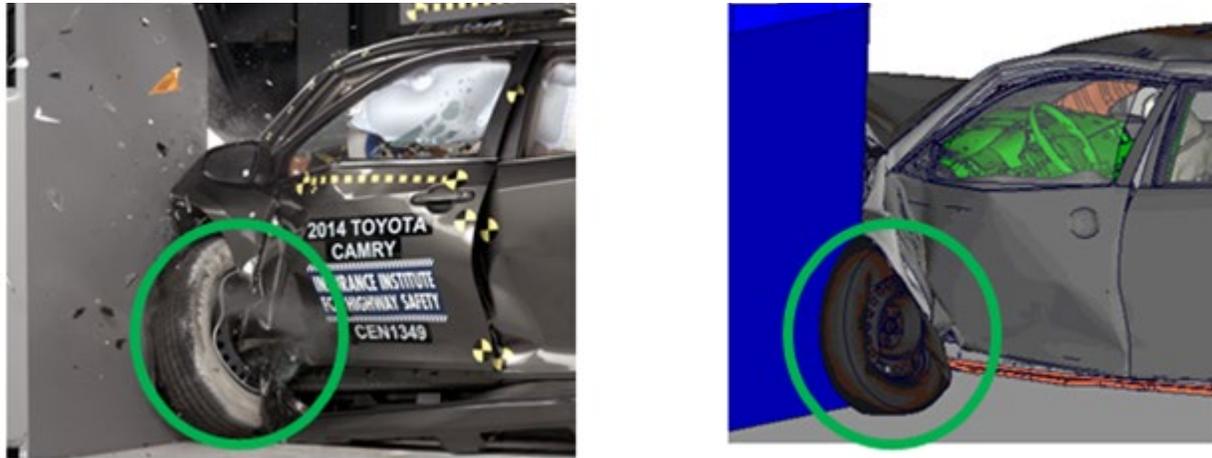
Figure 14 compares overall vehicle deformation and specific occupant compartment intrusion values in test and simulation. Figure 14(a) shows the overall vehicle deformation in the baseline simulation and in the full-scale crash test. Similar deformation of the frontal structure, door frame, and roof were observed. The A-pillar shows noticeable buckling in both test and simulation. The failure mechanism of the wheel to control-arm connection and overall wheel kinematics are well captured. In the later stages of the impact, after maximum intrusion and occupant injury values have occurred, additional material failure of various components in the rocker pillar, door

hinge, door, and sill area were observed in the test which are not completely captured in the simulation. Consequently, some differences in the rebound phase were observed.

Figure 14(a) - IIHS SO - Overall Test and Simulation

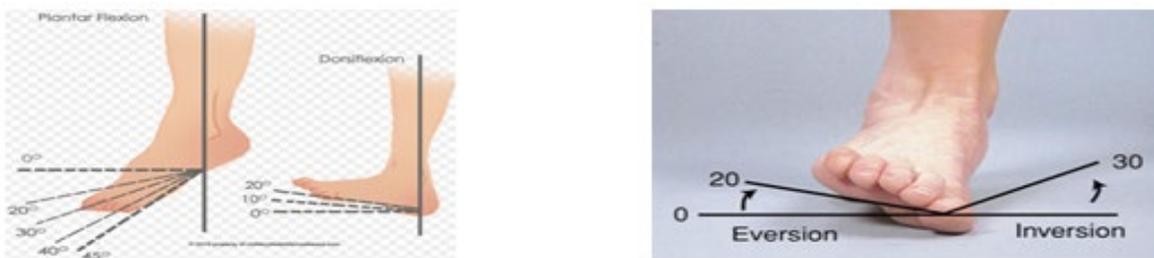
Figure 20 illustrates the biomechanical range of foot motion. Taking initial foot position and initial distances between measurement points into account, a maximum value of 34 mm was determined to be critical for both foot dorsiflexion as well as foot eversion.

Figure 20 - Range of Foot Motion for (a) Dorsiflexion, (b) Eversion
