GEORGIA DOT RESEARCH PROJECT 17-24

FINAL REPORT

**GEORGIA LONG-TERM PAVEMENT
PERFORMANCE (GALTPP) PROGRAM –
MAINTAINING GEORGIA’S CALIBRATION SITES
AND IDENTIFYING THE POTENTIAL FOR USING
MEPDG FOR CHARACTERIZATION OF NON-
STANDARD MATERIALS AND METHODS,
PHASE 2**

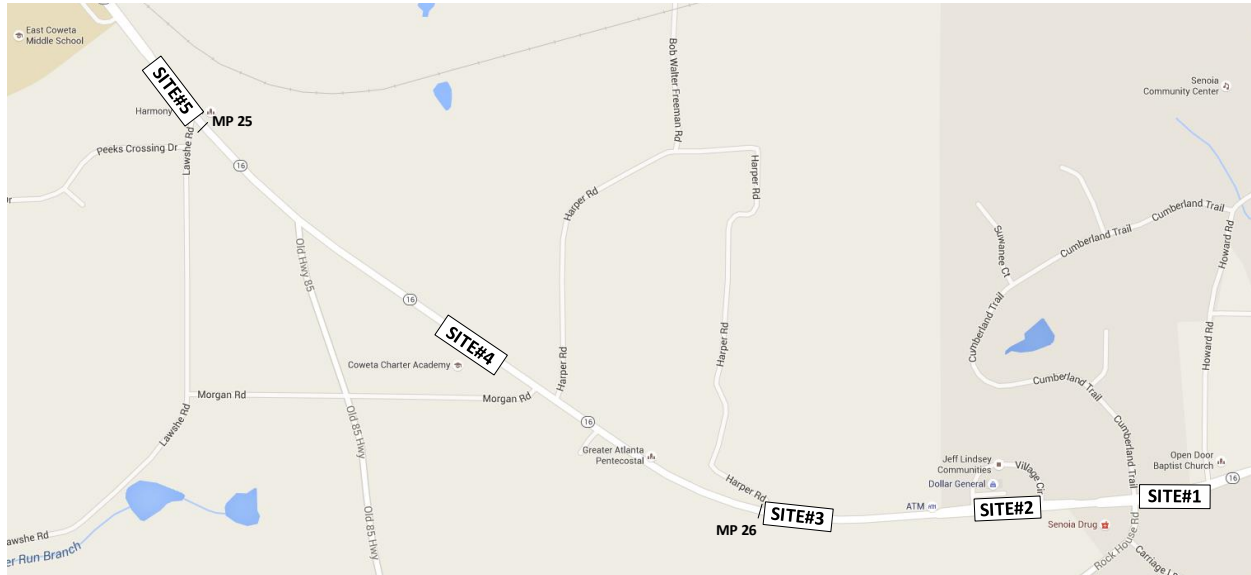
Figure 3-1 Test site location

State Route 16. The five selected sites span a 1.5-mile section on State Route 16 between Milepoints 25 and 26.5, as shown in Figure 3-1. Detailed site information, including route, direction, milepost, lane, and treatments are summarized in Table 3-1.

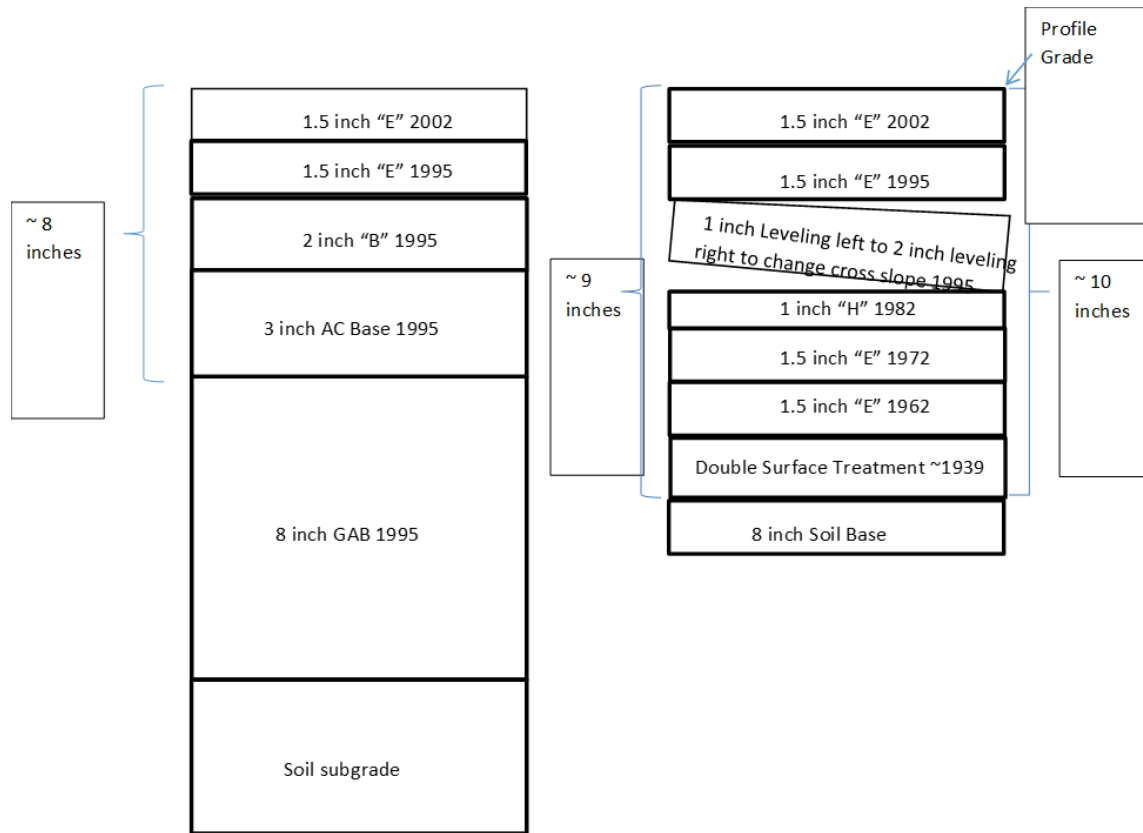
Figure 3-2 Illustration of pavement designs of travel lane (left) and passing lane (right)

Pavement designs of this section are shown in Figure 3-3. As shown in the figure, this road section was built in the late 1930's and was later widened in the 1990's. The asphalt layer thickness ranges from 8 in. to 10 in.

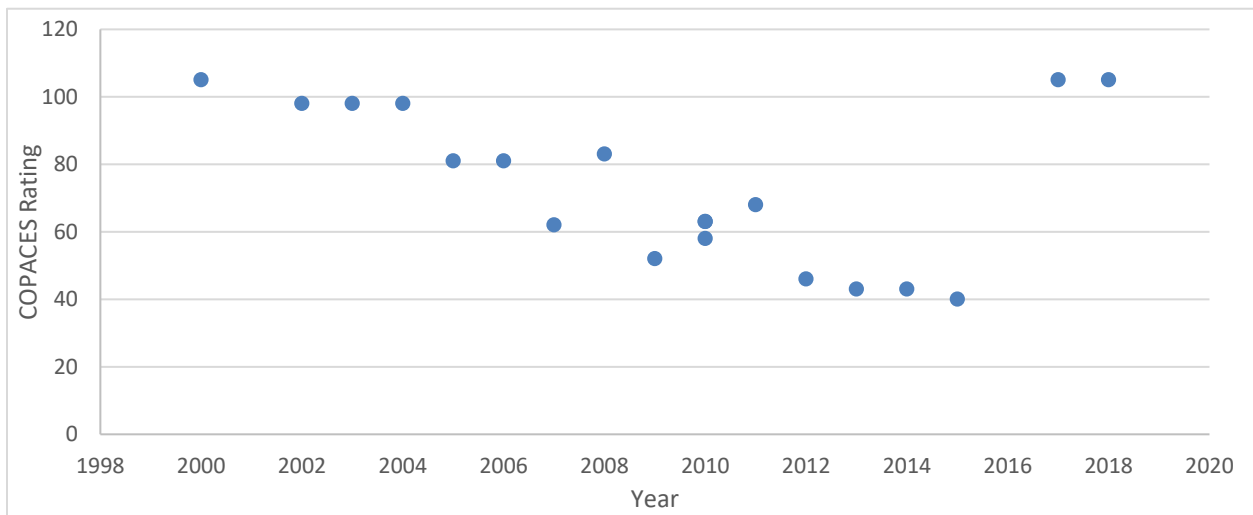
Figure 3-3 Historical COPACES data on State Route 16

Historical COAPCES data were acquired and analyzed to evaluate the performance on this section of pavement. It is noted that there is no COPACES data yet after the completion of CIR and OGI treatment in 2016; a rating of 105 (i.e., under construction) was recorded in 2017 and 2018. A review of historical COPACES data shows this section of pavement was last resurfaced in 2000. The rating dropped below 75 in 2007. It took approximately 7 to 8 years for the project rating to drop from 100 in 2000 to 70 in 2007 or 2008. This provides a performance reference for evaluating the performance after applying CIR and OGI. However, this section of pavement was not resurfaced until 2016 when the rating was in the 40s. The treatment has been delayed significantly for almost 8 years (from 2008 to 2016). Thus this section is ideal for assessing the performance of CIR and OGI as severe crack relief and as an effective crack treatment.

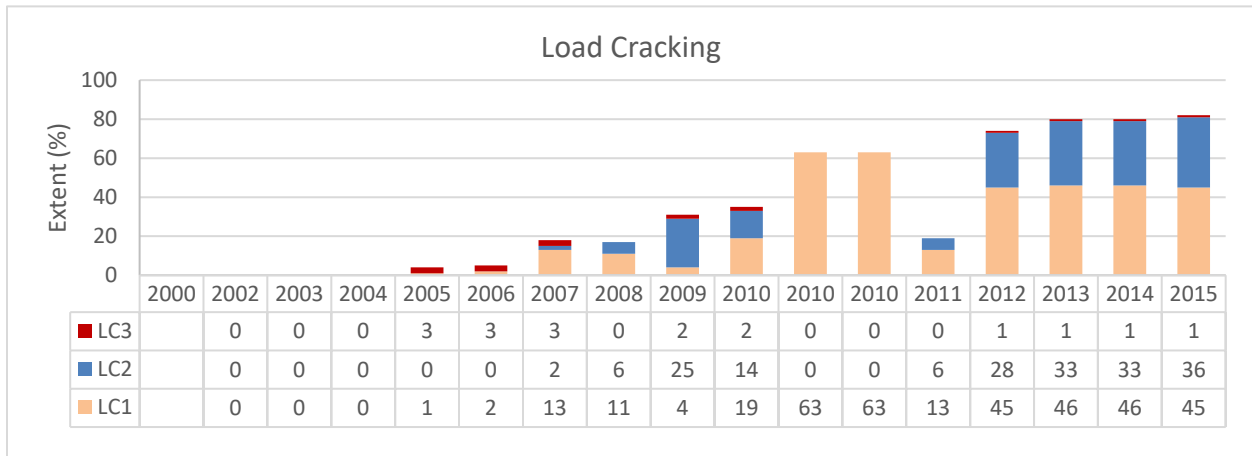
Figure 3-4 Load cracking before CIR and OGI treatment

The extents of load cracking and block cracking are shown in Figure 3-4 and Figure 3-5. Limited load cracking was first reported in 2005 (5 years after resurfacing). Level 2 load cracking had been reported since 2007. Prior to CIR and OGI treatment, 80% of load cracking

(Levels 1, 2, and 3) was reported on the section. Block cracking was first reported in 2005. Extensive block cracking had been reported since 2007. Extensive Level 2 block cracking was reported in 2015 prior to CIR and OGI treatment.

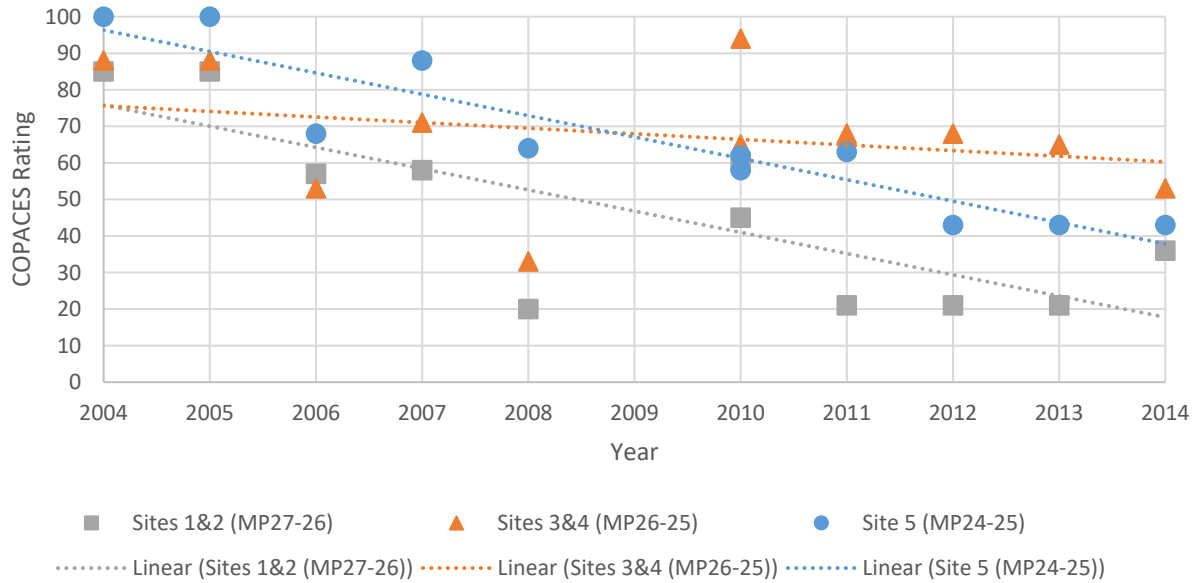
Figure 3-6 Segment-level COPACES Ratings on State Route 16

Pavement conditions of the segments in which the test sites located are depicted in Figure 3-6. All segments selected have extensive pavement cracks, including load cracking, transverse and block cracking, and some reflective cracking. The segment between Milepoints 26 and 27

(e.g., Sites 1 and 2) has worse pavement conditions than other selected sites. Severe load cracking and block cracking can be observed in this segment. Similar but better conditions can be observed in the segments between Milepoints 24 and 26 (e.g., Sites 3, 4, and 5).

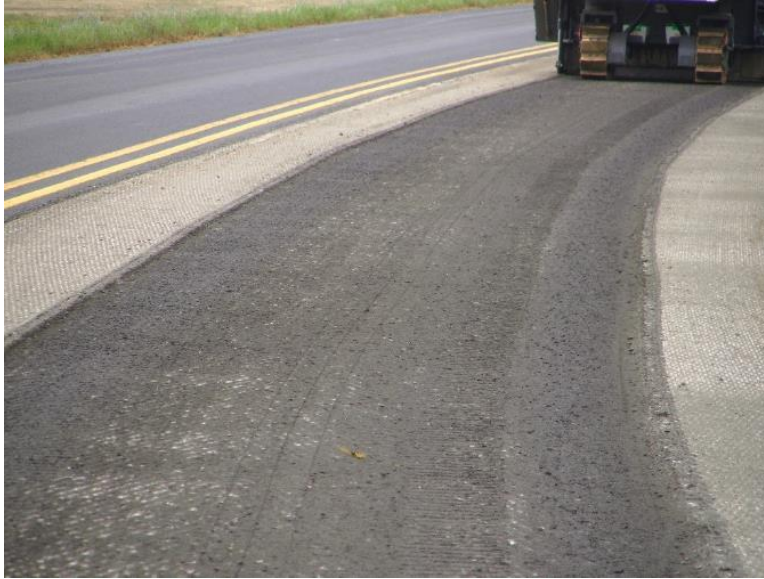
Figure 3-7 Removal of a Thin Layer of Pavement

- **Milling:** A milling machine removes a 1.5-in surface layer of pavement as shown in Figure 3-8. The thin layer removed is disposed of because the CIR process typically causes a bulking effect of the material, and the removal of this layer would ensure an even surface after CIR process is finished.

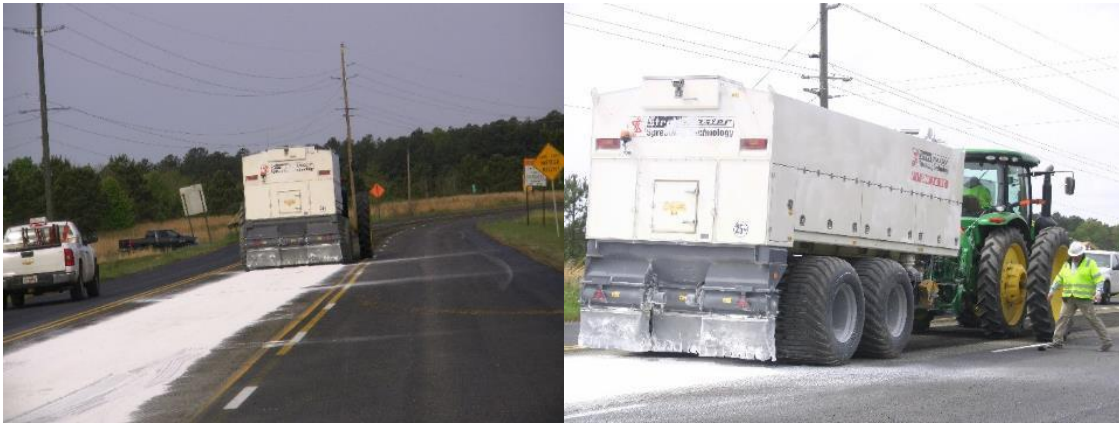
Figure 3-8 Application of Lime on the Milled Surface

- **Applying lime:** A dumper towed by a tractor applies a layer of hydrated lime to the milled surface, as shown in Figure 3-8. This lime is incorporated into the final pavement as an anti-stripping agent.

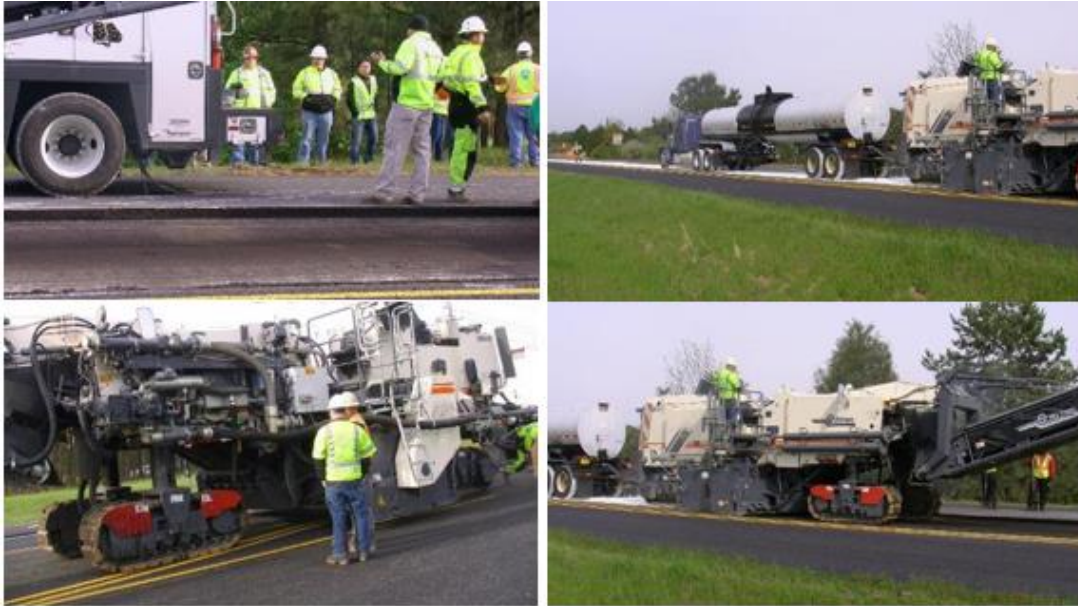
Figure 3-9 Mixture of Pavement and Additives

- **Incorporating additive:** A miller then mills a 3-in layer of pavement and mixes the pulverized pavement and lime with emulsified asphalt, as shown in Figure 3-10.

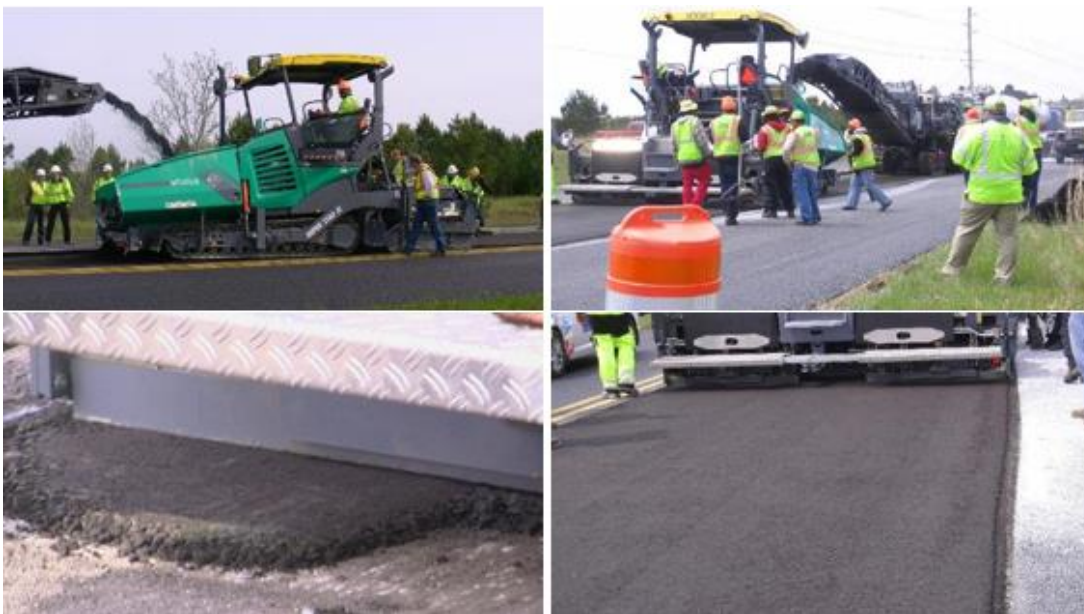
Figure 3-10 Compaction of Recycled Material

- **Mixture placement:** The mixture is then discharged into a paver that puts the material back into the 3-in deep milled trench, as shown in Figure 3-11.

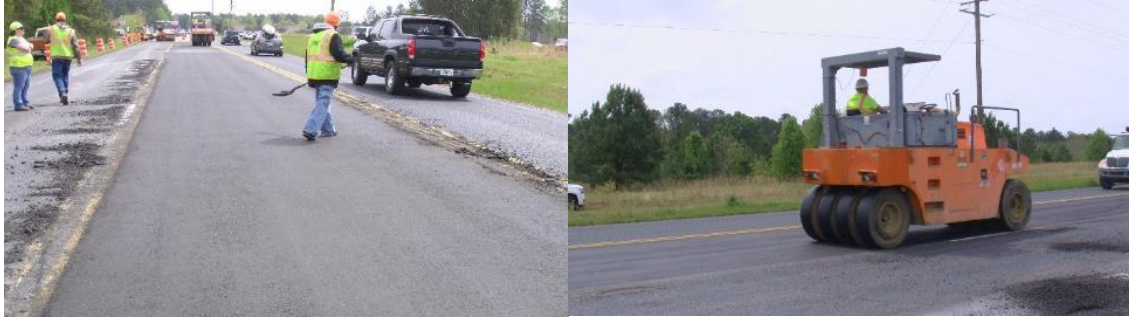
Figure 3-11 Compaction of Recycled Material

- **Compaction:** A rubber-tire roller and a vibratory steel-wheel roller compacts the recycled material into the desired density, as shown in Figure 3-12.

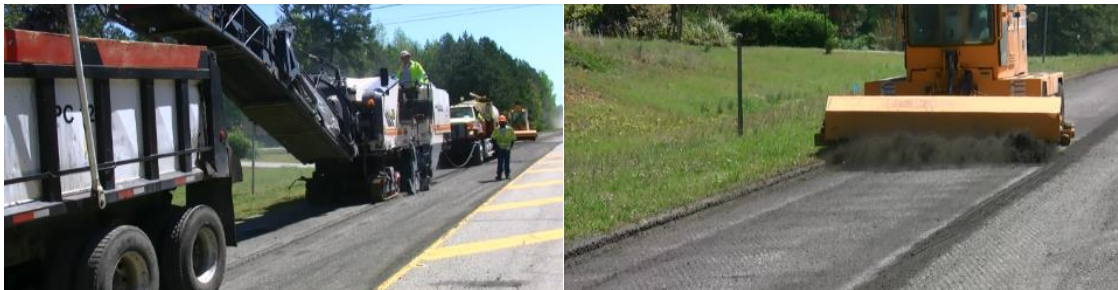
Figure 3-12 Removal of the Existing Pavement Surface

- **Milling and cleaning:** A milling machine removes a 1.5-in surface layer of pavement, and a sweeper and an excavator removes the milled material, as shown in Figure 3-13.

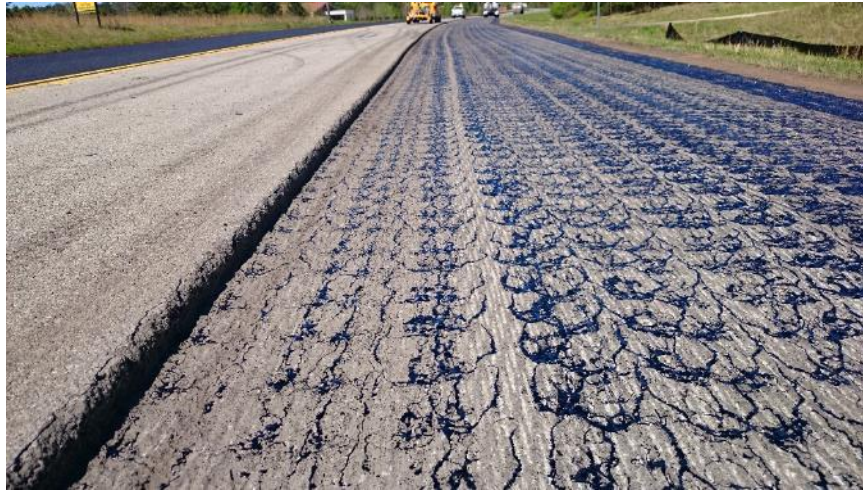
Figure 3-13 Application of Asphalt

- **Applying asphalt binder:** Asphalt is applied onto the milled surface, as shown in Figure 3-14.

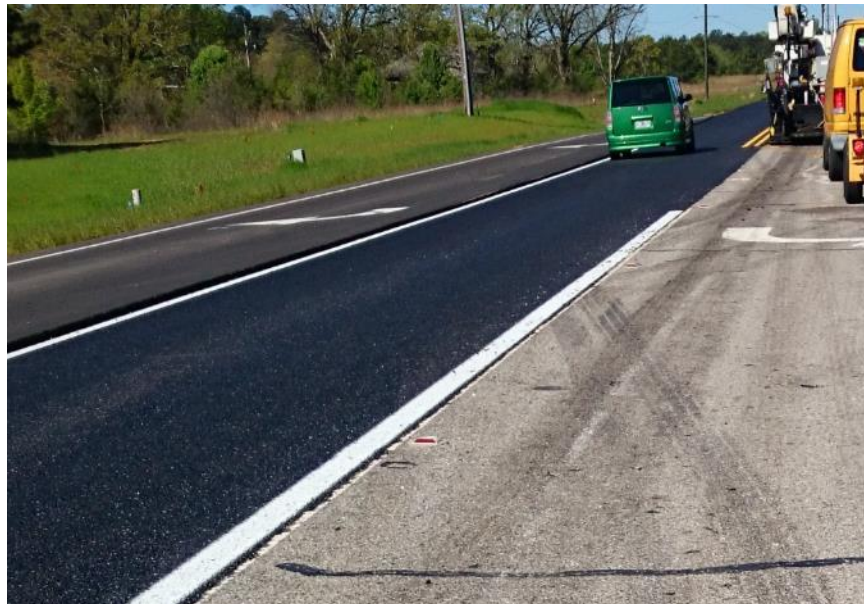
Figure 3-15 Application of 1" OGI

- **Applying the open graded interlayer:** A thin layer of open-graded material, usually under 1 in is applied to the pavement, as shown in Figure 3-15. After the installation of the interlayer, the section can be opened to traffic.

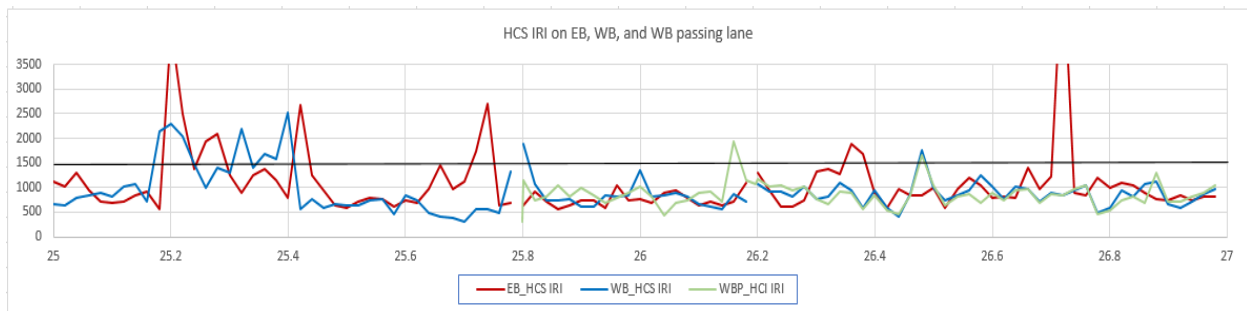
Figure 3-15 Historical COPACES Data Before and After CIR and OGI Application

Cores and international roughness index (IRI) data were collected in March 2018, two years after the CIR and OGI treatments, to assess the condition of the treated pavements. A visual field inspection shows no distresses on either CIR or OGI sites. IRI data were collected on three lanes (east-bound travel lane, west-bound travel lane, and passing lane) between Milepost 25 and 27. Both east- and west-bound lanes were constructed with OGI, and CIR was used in the passing lane, which starts at Milepoint 25.8. Figure 3-16 shows the half-car simulation (HCS) IRIs on three lanes at every 0.02 mile. The majority of the IRIs are between 800 mm/km and 1200 mm/km with some outliers. There are no significant differences observed between CIR (passing lane) and OGI (east- and west-bound travel lanes). The section between Milepoints 25.2 and 25.4 has relatively higher HCS IRI (1000 mm/km and 2000 mm/km) in both directions. The can be further investigated.

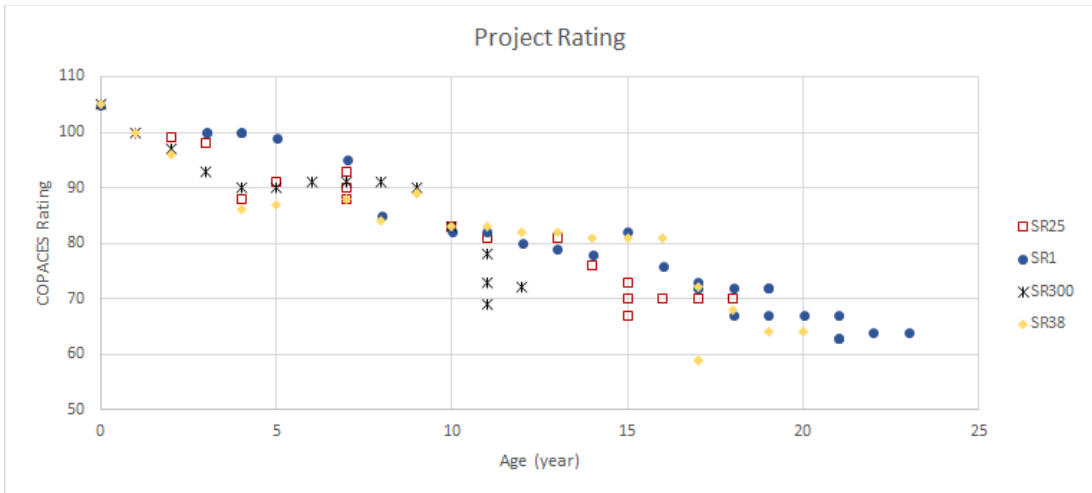
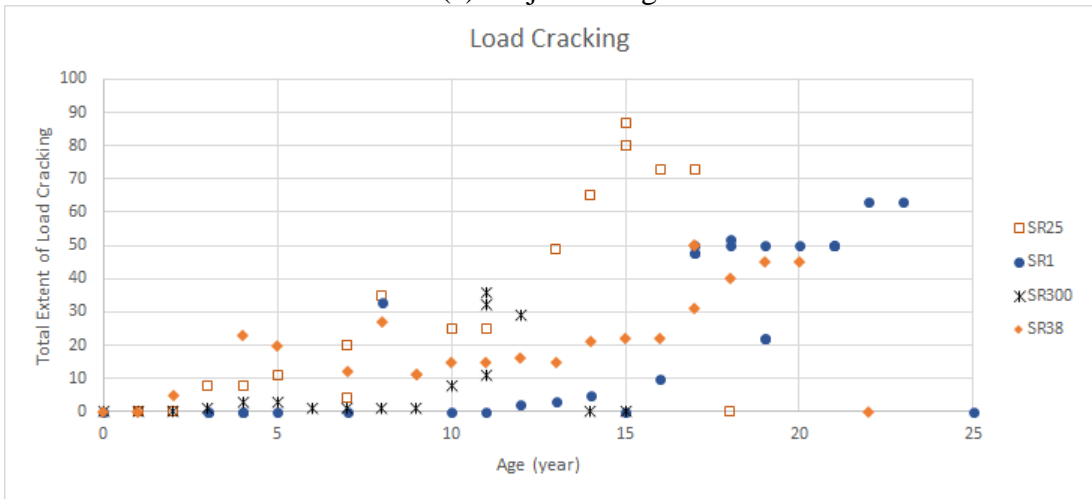
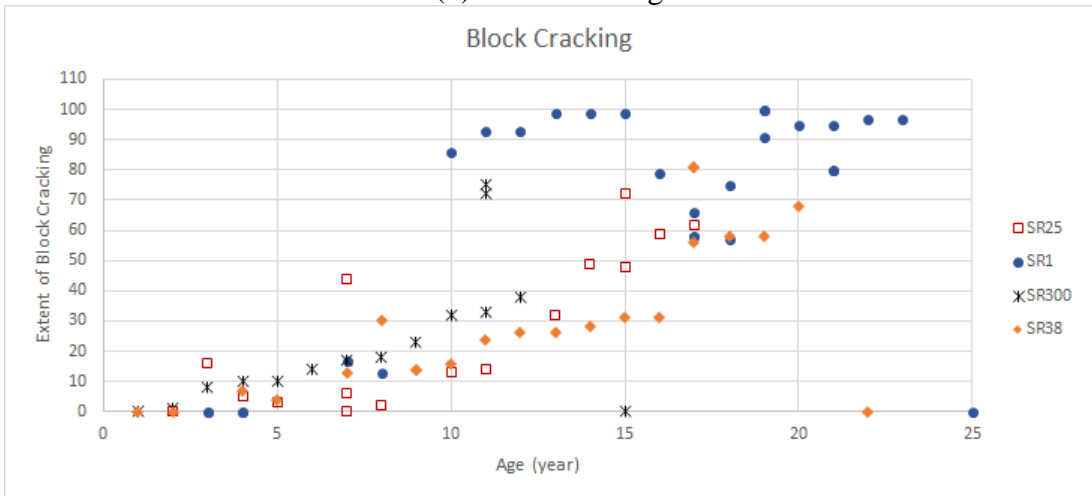
Figure 4-2 COPACES rating and distresses on selected soil cement projects

This section presents the observed distresses on the soil cement sites based on the historical COPACES data. First, the distresses on multiple projects with soil cement bases were presented to provide overall performance. Second, distresses on selected sites were discussed. Figure 4-2 shows the pavement rating, load cracking, and block cracking, on four projects on State Routes 1, 25, 38, and 300 with soil cement bases. In general, it took approximately 15 years to reach a rating of 70, as shown in Figure 4-2 (a), and the predominate distresses were load cracking and block cracking. Level 1 load cracking was typically reported in 2-3 years, and the extent increased slowly each year. Load cracking extent increased at a fast pace (approximately 7%) after 12-13 years, and a 50% of load cracking was reported at 20 years, as shown in Figure 4-2 (b). A review of the data shows Level 2 load cracking was reported on most of the segments within each project, but there were very few segments with load cracking at Levels 3 or 4. Block cracking was observed on all the projects, typically after 2-3 years. The extent increased more rapidly after 10 years at a rate of 8% per year, as shown in Figure 4-2 (c). Level 1 block cracking was mostly reported within the first 10 years; 40% of the segments exhibited Level 2 block cracking after 10 years. According to the historical COPACES data, rutting was not reported as an issue; all projects had less than 3/8 in of rut depth after 10 years.

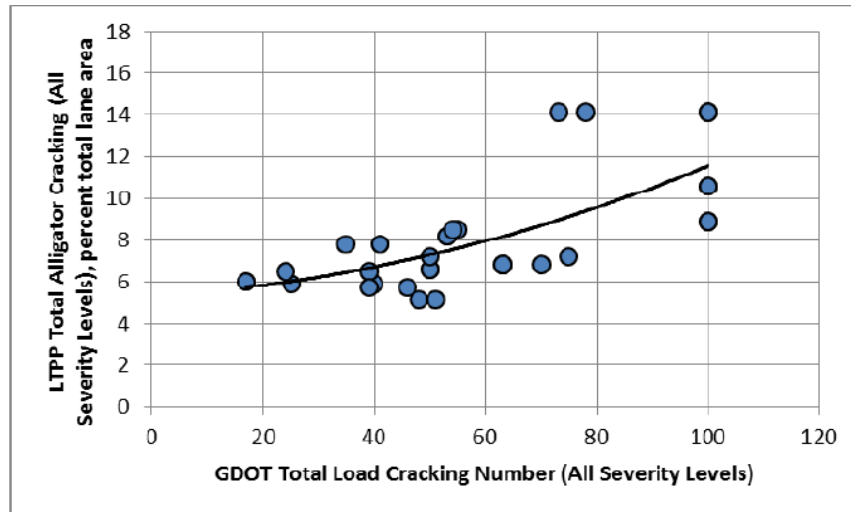
Figure 4-3 Relationship between load cracking from GDOT COPACES and alligator cracking from LTPP (Harold et al., 2016)

It is noted that the COPACES and LTPP distress protocols are different in terms of distress definition, severity, and extent. COPACES defines load cracking as the type of cracking that is caused by repeated heavy loads and always occurring in the wheelpaths. Load cracking has four severity levels, ranging from single longitudinal cracking (Level 1) to alligator cracking (Level 4). Load cracking is recorded as the percent of the length of two wheelpaths (200 ft). The LTPP records longitudinal cracking in wheelpaths (in length) and fatigue cracking (in percent of total area) separately. A function, as depicted in Figure 4-3, was developed by ARA (Harold et al., 2016) to convert COPACES loading cracking into the fatigue cracking predicted in the MEPDG model. Using the conversion function, 40% and 80% of load cracking are approximately 6.5% and 14% of fatigue cracking, respectively. It is noted that the conversion function was developed based on limited data collected in 2014. Similarly, there are differences in block/transverse cracking. COPACES identifies block and transverse cracking as the type of crack that is caused by weathering of the pavement or shrinkage of cement-treated base materials (not load related). Three levels of block and transverse cracking (ranging from a single transverse crack to polygon-patterned block cracking) are defined, but only the predominant severity level is recorded. Block cracking is recorded as a percentage of total area. The LTPP defines block and transverse cracking separately and records the number and length of transverse cracks. Similarly, a conversion function was developed to match the block cracking reported in COPACES into transverse cracking in the LTPP. Note that the variation is larger than the load cracking conversion.

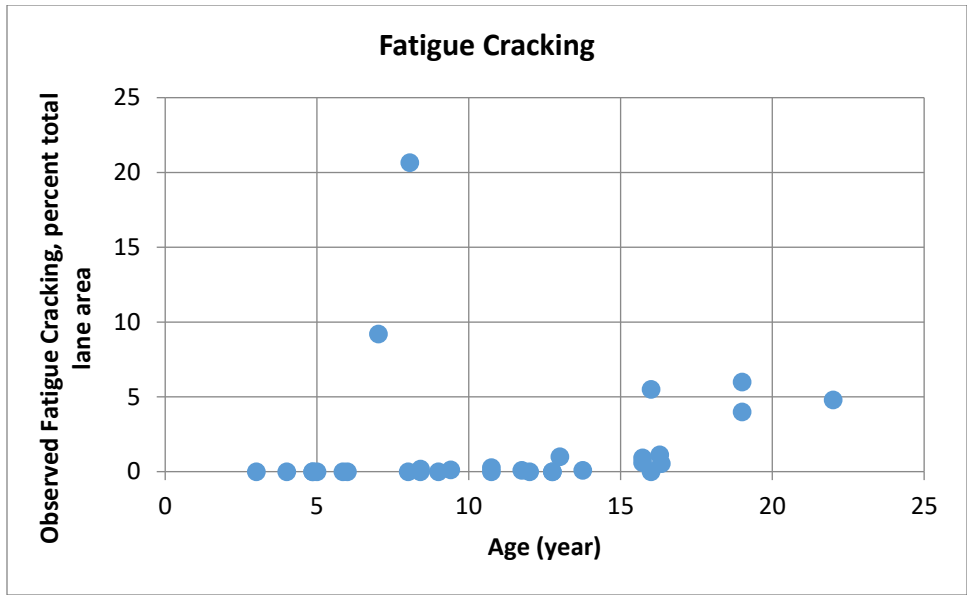
Figure 4-4 Observed fatigue cracking

The observed fatigue cracking, thermal cracking, and rutting on the six soil cement sites are presented in Figures 4-4, 4-5, and 4-6. Figure 4-4 shows the observed fatigue cracking on all of the six soil cement sites. It is noted the last measurements on these projects were at age 8, 13, 19, 19, and 22 years. According to previous research (Tsai and Wu, 2016), most of the pavements in Georgia are resurfaced approximately every 11.6 years. This resurfacing would remove distresses (e.g., cracking and rutting) on the surface layer, which makes it difficult to accumulate cracking data. However, these six soil cement sites have lives longer than the typical resurfacing life of 11.6 years. There were either no fatigue cracks or just little fatigue cracks recorded until the 15-year point. This means these sites had not been resurfaced in more than 15 years, which is much longer than GDOT’s average resurfacing years (Tsai and Wu, 2016). Only one site (4420) recorded 9% and 21% fatigue cracking after 7 or 8 years.

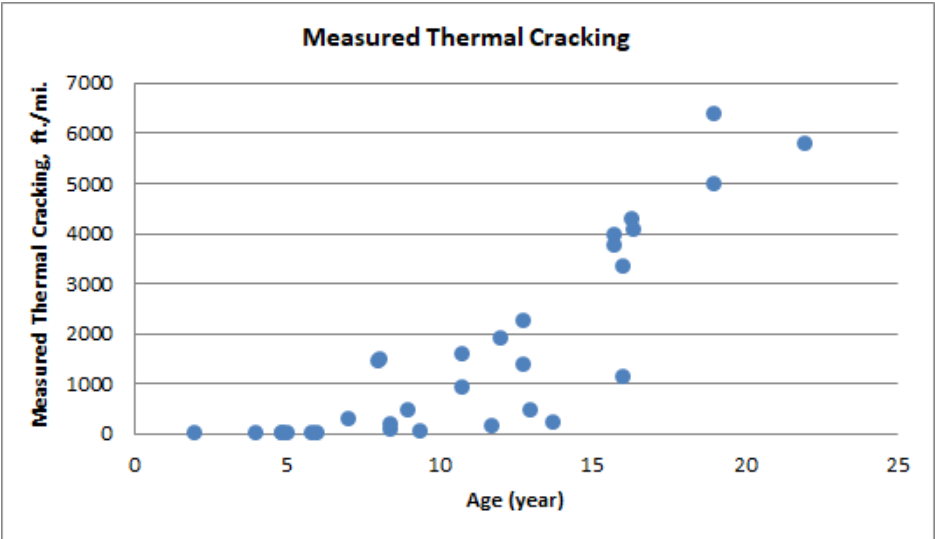
Figure 4-5 Observed longitudinal cracking (non-wheel path)

Figure 4-5 shows the observed thermal cracking. There is dispersion in the thermal cracking with a range of 0 to 7,000 ft per mile among the 5 sites. It is noted that four sites did not exhibit thermal cracking in the first five years. In general, the thermal cracking shows an increasing trend; after approximately 9-10 years, thermal cracking increased significantly. Again, some sites show a minimum of thermal cracking after more than 15 years of service. Sites on State Routes 1 and 38 had the most thermal cracking.

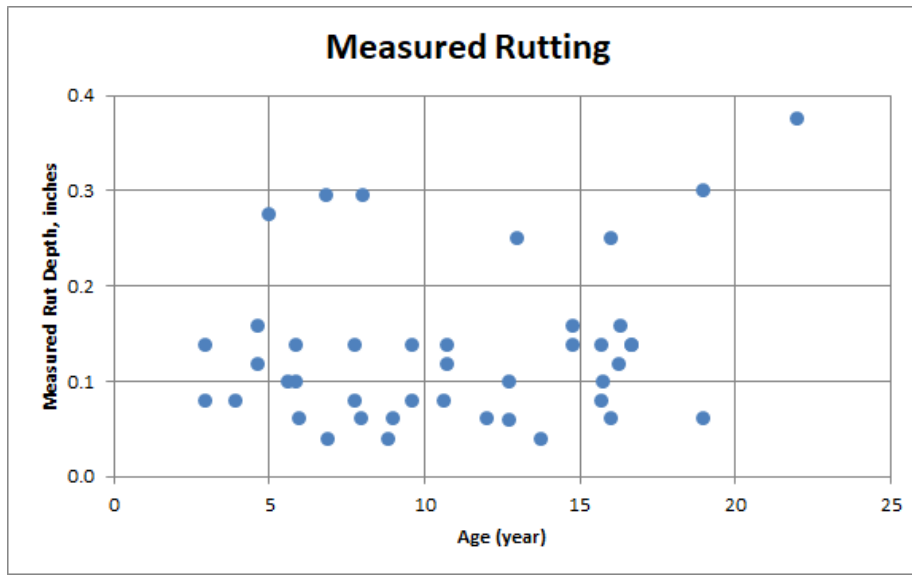
Figure 4-6 Observed rutting

Figure 4-6 shows the observed rutting. Most of the observed rutting was between 0.05 in and 0.25 in. Four sites had rutting less than 0.25 in, even after 10 years; only one site (4420) exhibited rutting greater than 0.25 in. after 5 years.

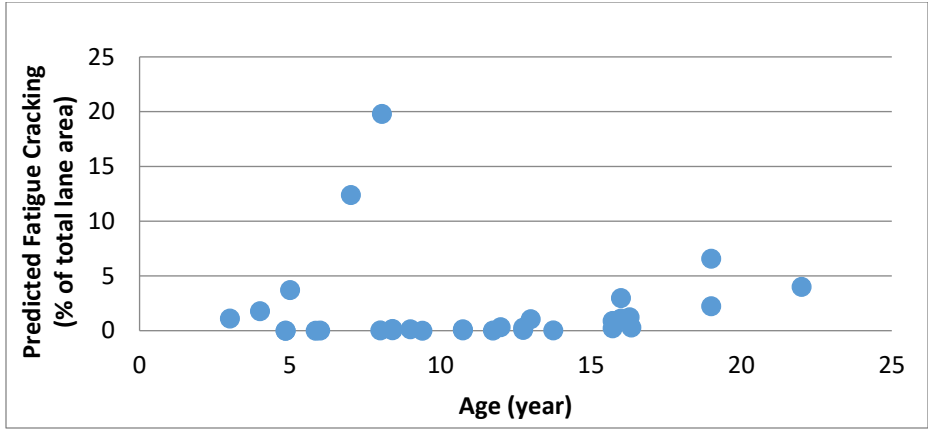
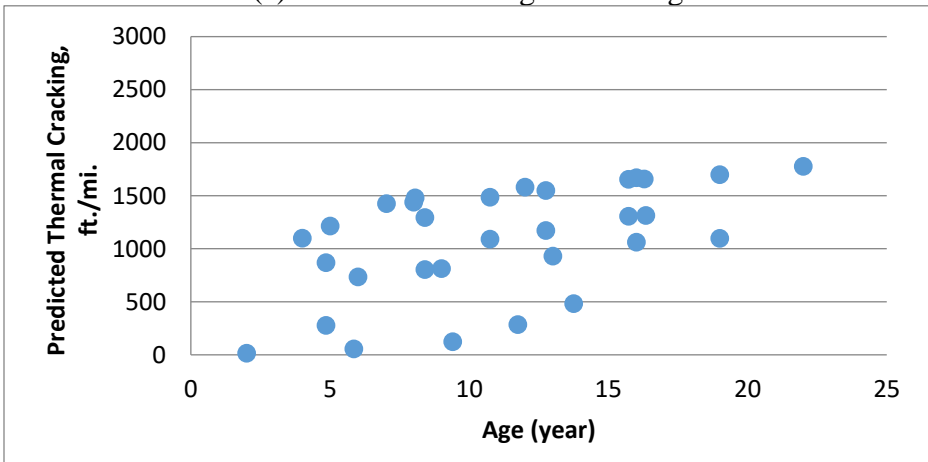
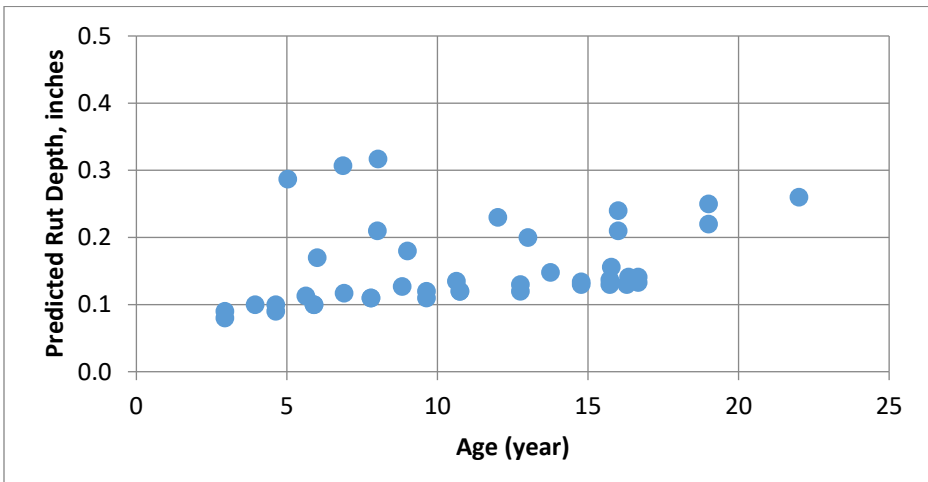
Figure 4-7 Predicted distresses by the ME Design (v2.3.1)

Figure 4-7 (a) shows limited (less than 5%) fatigue cracking are predicted on the soil cement sites. Only one site is predicted with more fatigue cracking at an age of 7 years.

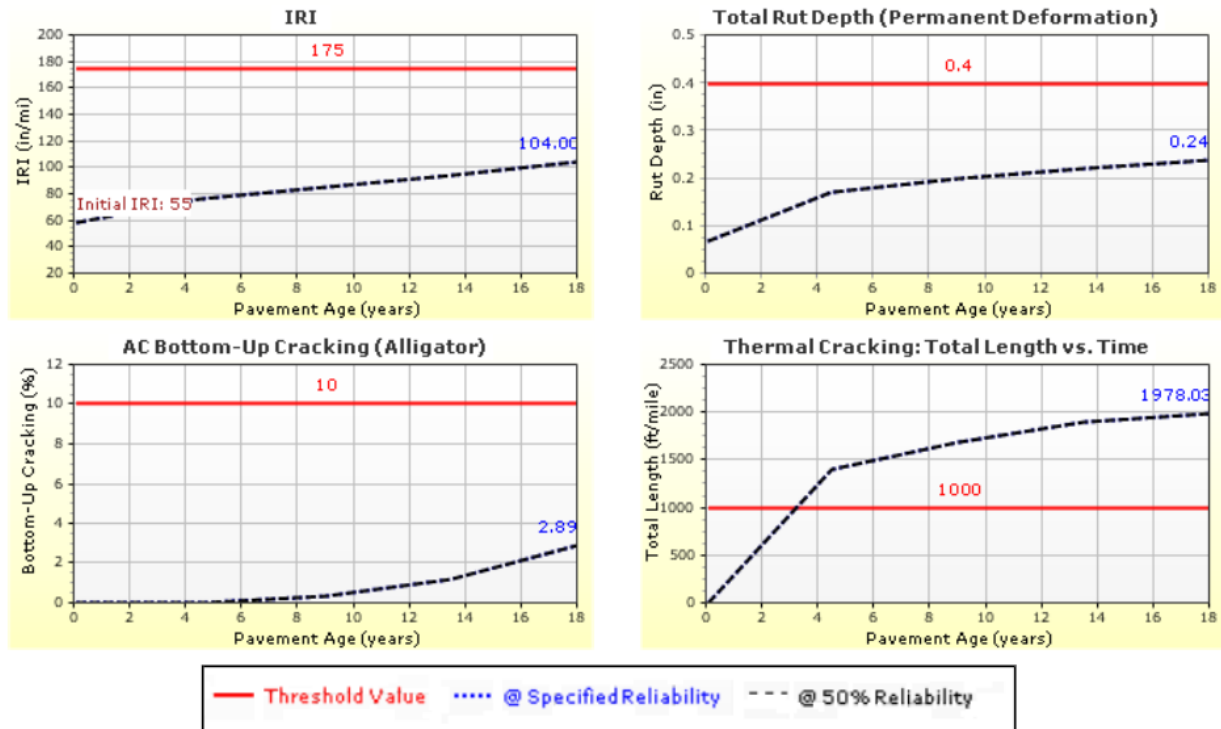
Figure 4-8 Pavement structure analysis using the ME Design (v2.3.1)

The same pavement structure was analyzed using the ME Design software with Georgia's coefficients (ARA 2015a). Results on all five sites are similar. Figure 4-8 shows the results on the site on State Route 38. This pavement structure meets the performance criteria except for thermal cracking. The predicted distresses, including fatigue cracking, rutting, and IRI, at the specified reliability were lower than the threshold values at the end of the 20-year design life because, partly, of its accumulated use by 16 million heavy trucks. It is noted that a 95% reliability is used for fatigue cracking and rutting, as suggested in GDOT's user guide. When 50% reliability was used, the predicted distresses were much lower (0.25 in of rutting, 0.62% of fatigue cracking). When the reliability increased from 50% to 95%, the predicted fatigue cracking significantly increased from 0.62% to 8.61%. This means the selection of reliability level has a big impact on the distress threshold values, which determines whether or not the pavement structure design passes the criteria. At 95% reliability, the MEPDG predicted pavement would have fatigue cracking of 8.61%, rutting of 0.35 in, and thermal cracking of 802 ft per mile at the end of 20 years. The pavement structure can last longer than 20 years and can reach the performance criteria in 21 years with 16 million heavy trucks.

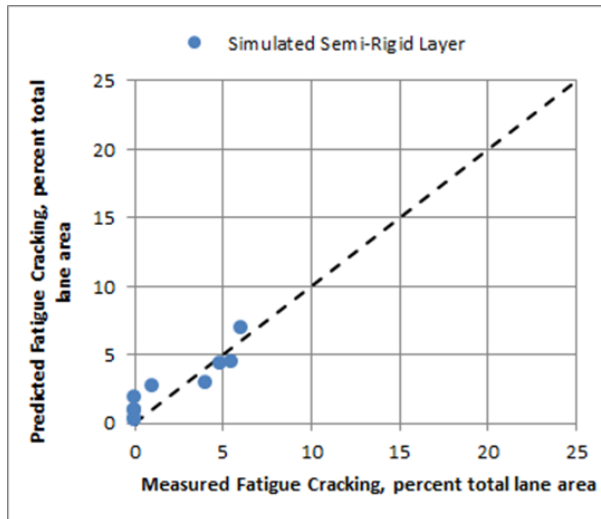
Figure 4-9 Observed vs. Predicted fatigue cracking (percent of total area)

This section compares the predicted and observed pavement performance (e.g. distresses) on the selected sites to verify the accuracy of the prediction models. Figure 4-9 shows the observed and predicted (at 50% reliability) fatigue cracking based on the data used in the calibration (Harold et al., 2016). There is no significant bias (under or overprediction), and the predicted fatigue cracking is reasonable with the data scattered around the equality line ($R^2=0.92$). It is noted that most of the predicted and observed fatigue cracking was less than 6% after 20 years, which meets the performance criteria of 10%. The only site with more fatigue cracking is Site 4420.

- a. Bias has been found in all distresses (transverse cracking, rutting, and IRI) except fatigue cracking.
 - b. The ME Design predicts little or no fatigue cracking for these soil cement sites. The results show fair correlation between the predicted and measured fatigue cracking ($R^2 = 0.92$).

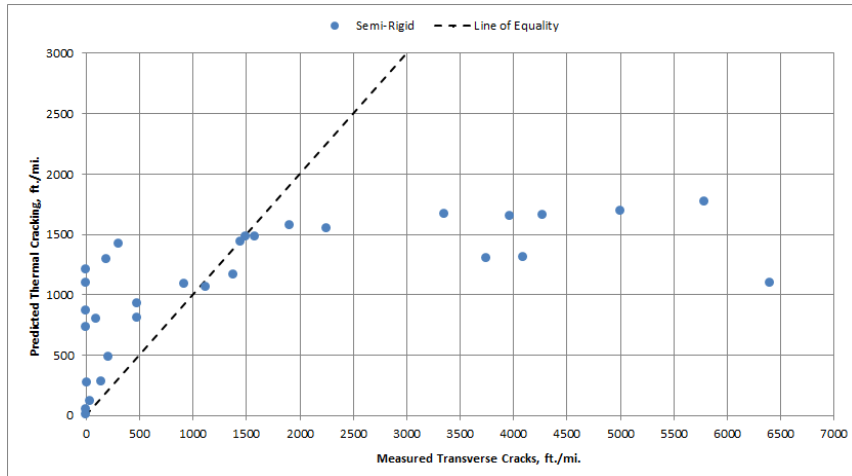
Figure 4-10 Predicted vs. Observed transverse crack (ft per mile)

Figure 4-10 shows the predicted and observed thermal cracking. The points are not close to the equality line, and the R^2 is about 0.41, which indicates a poor fitness between the predicted and observed values. It is noted the thermal cracking is overpredicted when the observed values are less than 1500 ft per mile, and underpredicted when greater than 1500 ft per mile. The predicted values do not exceed 1500 ft per mile given the traffic volume. It is noted there was a gap between the observed and predicted cracking for sites on State Routes 1 and 30. While more than 5000 ft per mile of thermal cracking was observed, the MEPDG file output was only 1500 ft per mile. The MEPDG inputs should be further checked for future recalibration.

- c. The ME Design mostly overpredicts transverse cracking when the observed cracking is less than 1500 ft per mile and underpredicts when the observed

cracking is greater than 1500 ft per mile. The latter case occurs because the ME Design predicts the maximum transverse cracking at about 1500 ft per mile.

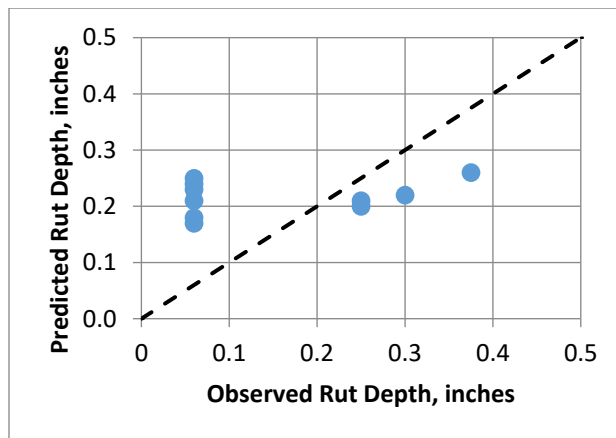
Figure 4-11 Predicted vs. Observed rut depth (in.)

Figure 4-11 shows the predicted and observed rutting. Most of the sites have less than 0.25 in of rutting; only one site exhibited more than 0.25 in of rutting. This site had higher truck traffic and thinner pavement design. Figure 4-12 shows the IRI were overpredicted (approximately 80% higher). The observed values were 40-60 ft per mile, while the predicted values are about 80-100 ft per mile.

- d. The ME Design predicted little rutting on these soil cement sites. Poor correlation ($R^2=0.1$) was found between the predicted and measured rut depths.
- e. The ME Design overpredicted the IRI. The initial IRI was about 50 in per mile, and, on average, IRI was overpredicted by 70%. Poor correlation ($R^2= 0.07$) was found between the predicted and measured IRI.
