**GEORGIA DOT RESEARCH PROJECT 17-12**

**FINAL REPORT**

**MECHANICAL INTEGRITY AND SUSTAINABILITY  
OF PRE-STRESSED CONCRETE BRIDGE  
GIRDERS REPAIRED BY EPOXY INJECTION –  
PHASE III**

TECHNICAL REPORT DOCUMENTATION PAGE

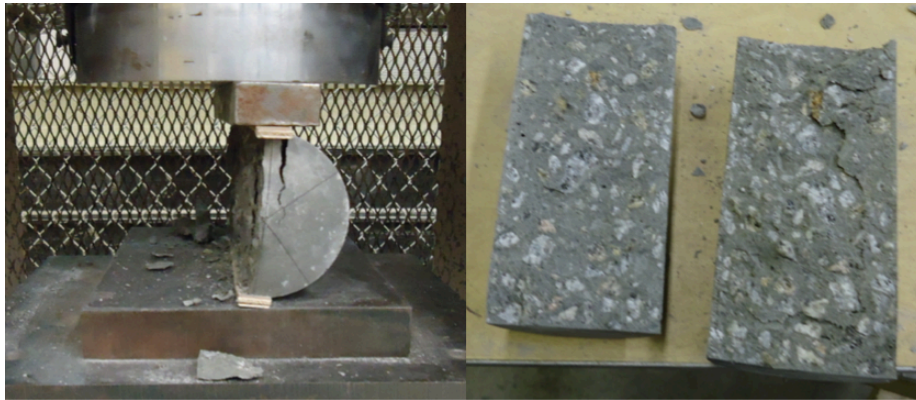
*Figure 1. Undesired tensile splitting failure of initial 4 inch x 8 inch plain concrete specimen.*

The initial tensile splitting tests were also used to verify the ability to capture high speed video of the crack propagation through the face of the sample. These initial tests indicated that the fracture of the 4 inch x 8 inch cylinders happened too quickly for the 1,000 frames per second (fps) high-speed camera to capture quality data. From the literature, it was found that many experiments used 6 inch x 12 inch cylinders to monitor the crack growth with such cameras (Ross et al., 1996; Li, 2004). As a result, it was determined that 6 inch x 12 inch cylinders would be used for future experiments in the study in order to ensure and monitor symmetric crack propagation.

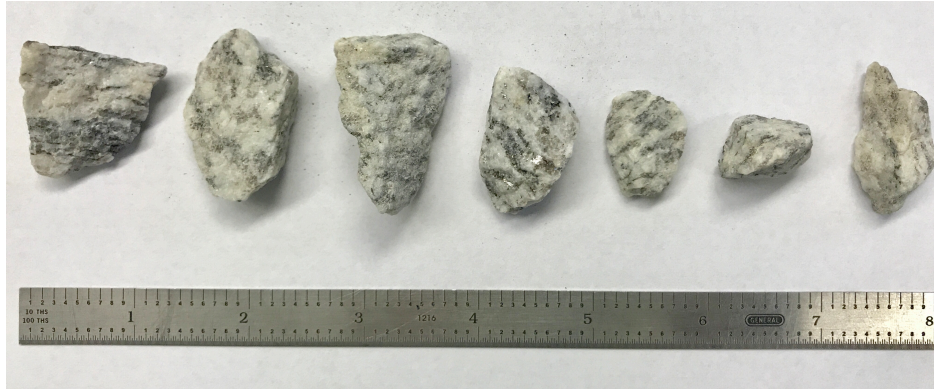
*Figure 2. Granite-Gneiss aggregate used in concrete cylinder mix.*

Granite-Gneiss aggregates, as shown in Figure 2, can be classified as having a surface texture a crystalline, a sub-angular shape, and a low sphericity. Coarse aggregates' texture and shape can affect the presence of stress concentrations and the overall fracture mechanisms of the concrete. Therefore, scans of individual aggregate were conducted to create realistic and precise aggregate shapes for the Phase II models in

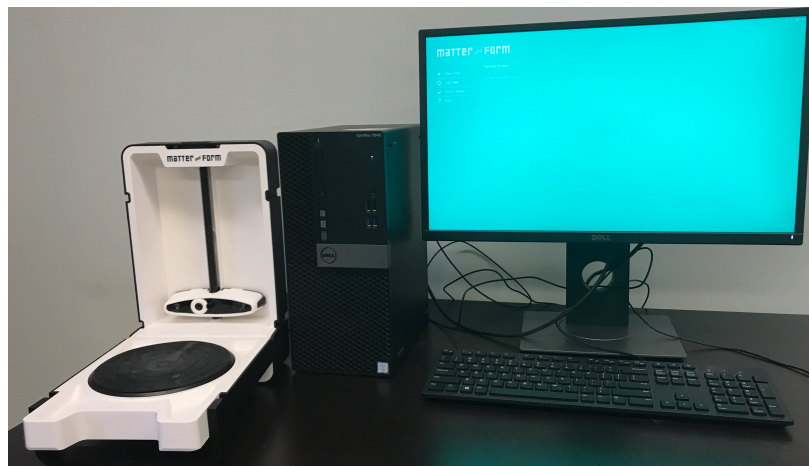
*Figure 3. Matter and Form 3D Tabletop Scanner used for developing realistic aggregate models.*

order to facilitate more accurate prediction of the location and timing of microcracking. A *Matter and Form 3D Tabletop Scanner*, as shown in Figure 3, was used to create three-dimensional point cloud files to generate realistic shapes of aggregate within the model. Examples of the point cloud aggregate scans from this research are shown in Figure 4.

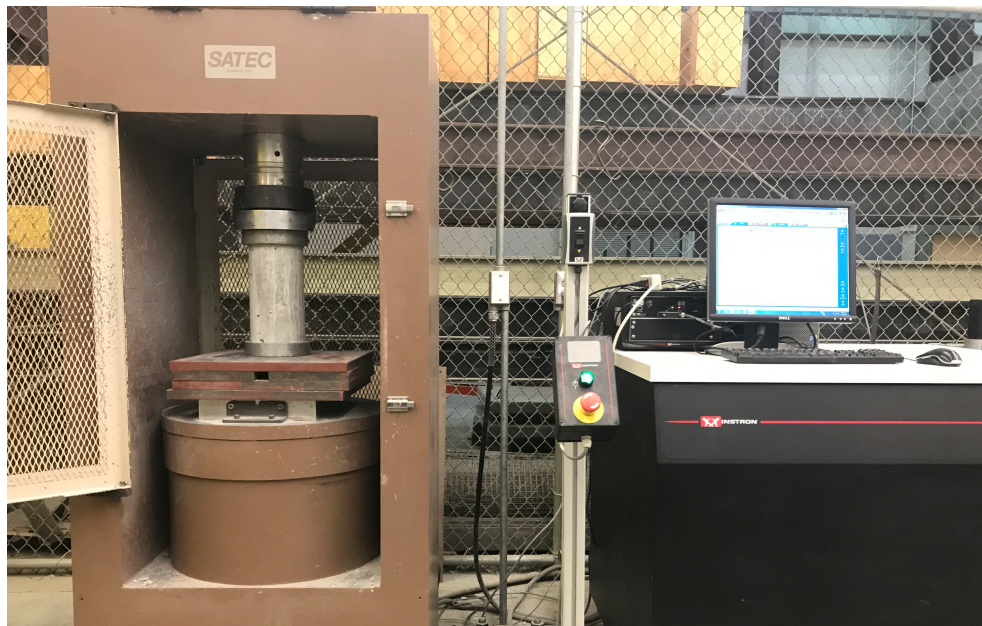
*Figure 5. Uniaxial compression setup as outlined in ASTM C39.*

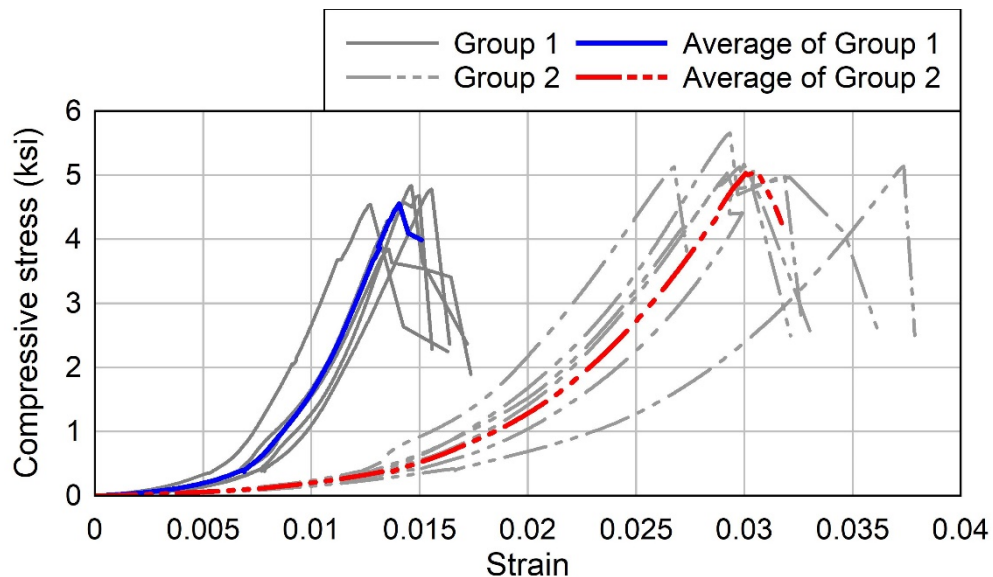
*Figure 8. Compressive test results of plain 6 inch x 12 inch concrete cylinders.*

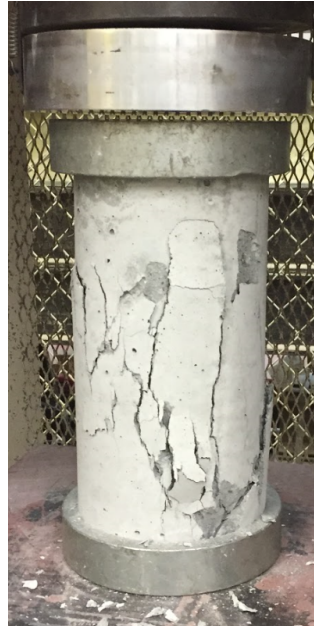
*Figure 9. Typical plain concrete behavior indicative of a type 3 columnar failure.*

Although the two groups exhibited different stress-strain behaviors, both groups had similar failure modes. Utilizing the classifications given in Figure 6, the cylinders primarily demonstrated a columnar failure mode. A posttest photo showing the failure from an example experiment is given in Figure 9.

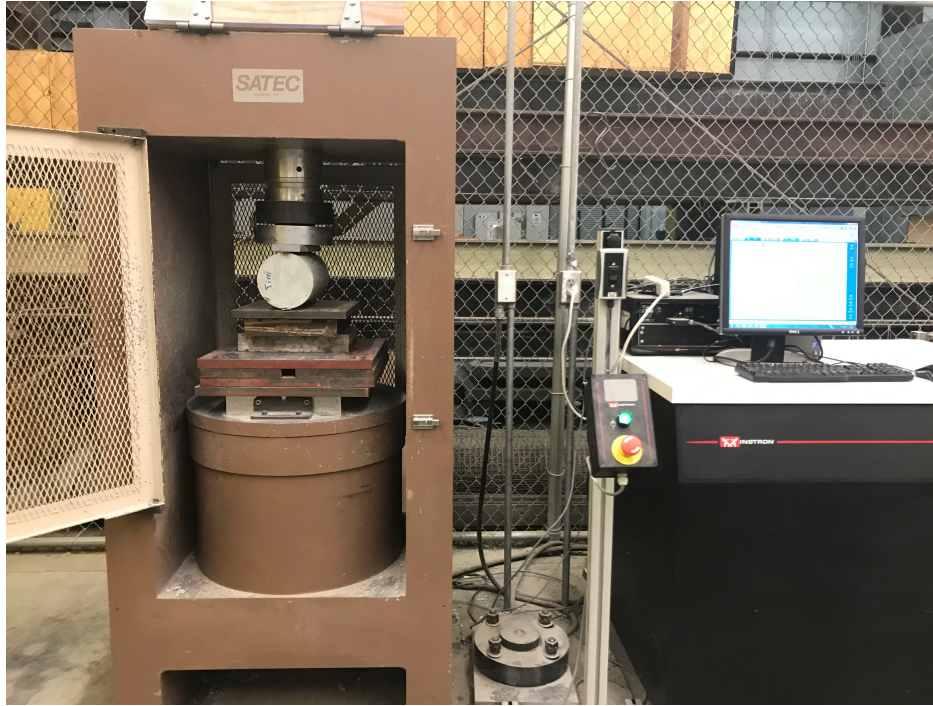
*Figure 11. Splitting tension experimental setup.*

where  $f_{st}$  is the ultimate splitting tensile strength,  $P$  is the maximum applied load as indicated by the testing machine,  $L$  is the length of the cylinder, and  $d$  is the diameter. For this research, the SATEC PRISM MKIII-C with INSTRON 59-R7 controller located at the Georgia Institute of Technology Structural Engineering and Materials Laboratory was used to load at 11.3 kips per minute. The experimental setup is shown in Figure 11.

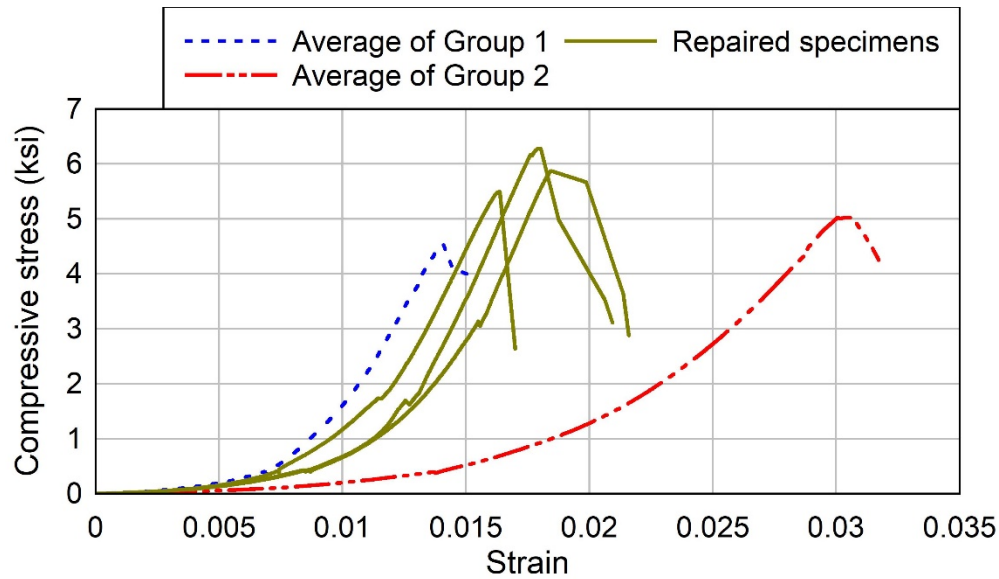
*Figure 17. Compressive stress-strain behavior of epoxy-repaired specimens compared with plain concrete cylinder specimens of the same 6 inch x 12 inch size.*

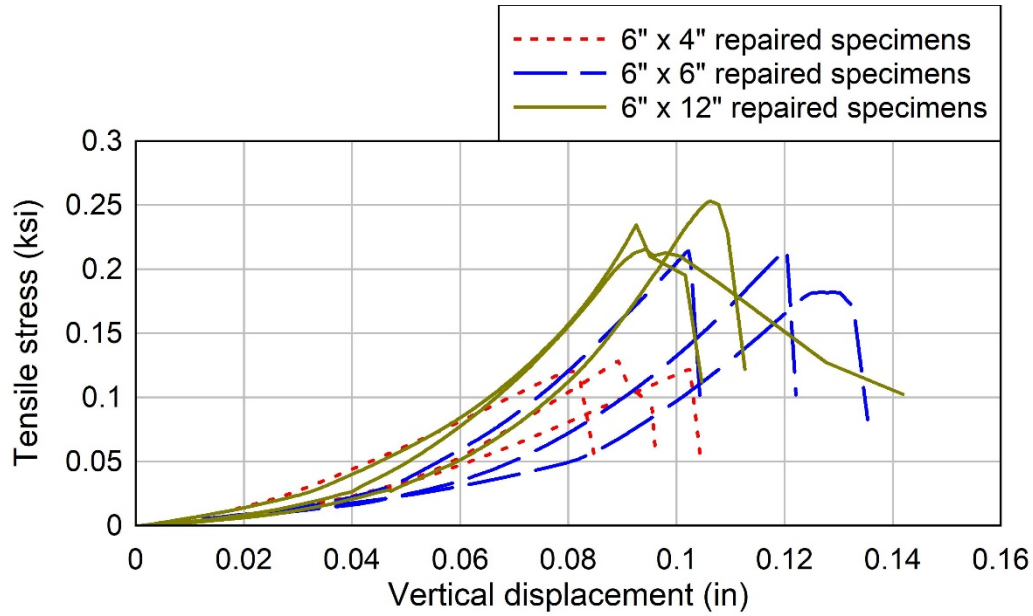
Figure 21. Splitting tension test results of epoxy repaired concrete cylinder specimens of various sizes.

In order to evaluate the effect of sample size of the epoxy-repaired cylinders, six 6 inch x 6 inch and six 6 inch x 4 inch cylinders of epoxy-repaired concrete were tested and compared to the 6 inch x 12 inch cylinders. The primary goal was provide additional data at a reduced size in order to allow using smaller models in Phase II, hence decreasing runtimes. The stress-strain behavior of the repaired cylinder samples in splitting tension is shown in Figure 21 and the results are summarized in Table 5.

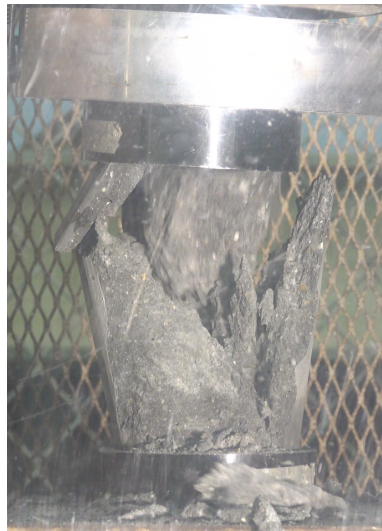
*Figure 25. Typical failure pattern of a mortar specimen.*

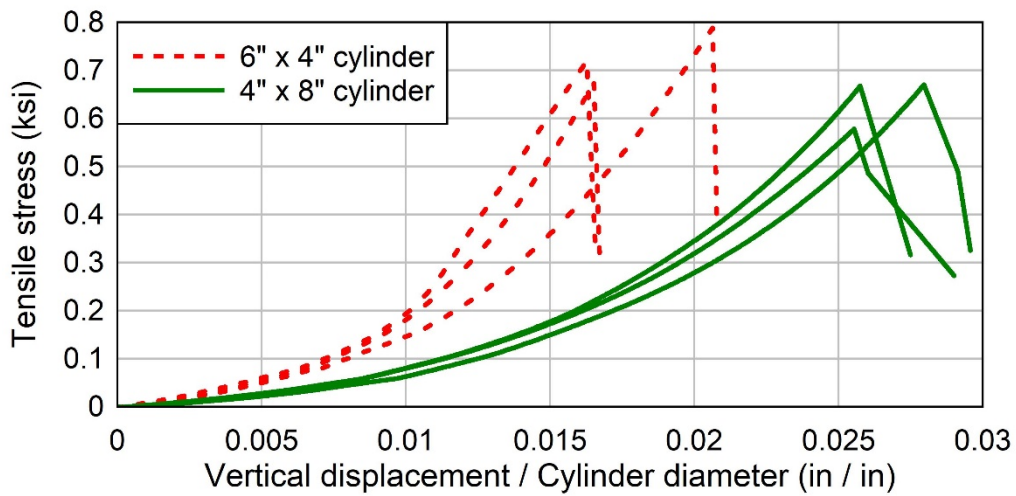
Figure 26. Splitting tension test results of mortar cylinder specimens of various sizes.

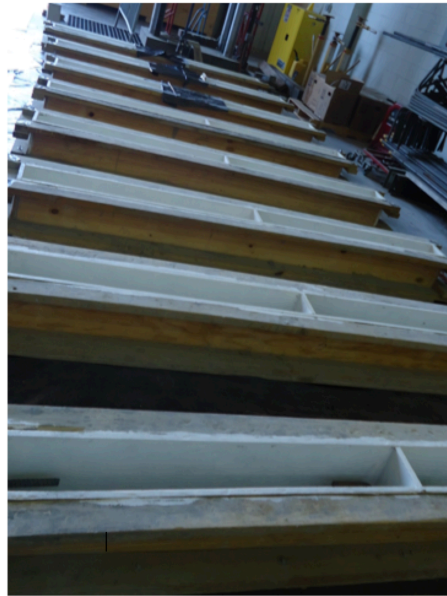
*Figure 29. Concrete beam formwork.*

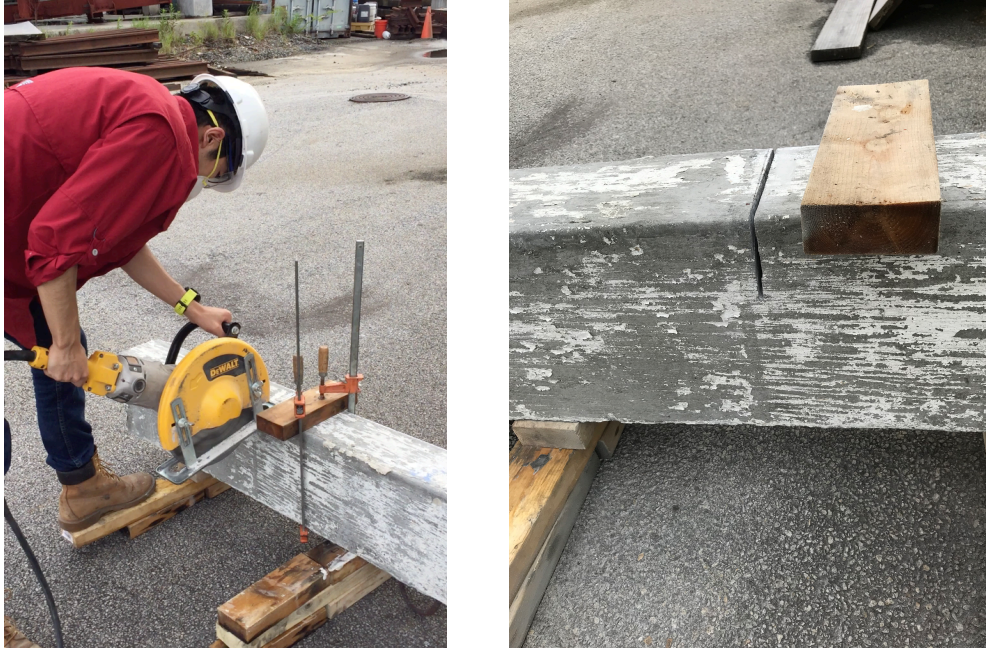
*Figure 30. Notching of concrete beams with masonry saw.*

The unreinforced beams were cast using the same concrete that was used to produce the concrete cylinders discussed in Section 2.1.2. Since the three-point bend test is sensitive to the length of the beam, beams of both three-foot and four-foot lengths were cast using in-house using wooden formworks, shown in Figure 29. Beams of both lengths had a cross-section of 6 inch x 10 inch. Drawings of the beams are included in Appendix A. Seventy-two hours after casting, the beams were demolded and placed in a controlled fog room environment for curing. At 56 days, the beams were removed from the controlled environment and allowed to age at ambient temperatures until their test date. As previously discussed in Chapter 2, plain concrete cylinder samples were tested in uniaxial compression and splitting tension each week throughout the duration of beam testing to quantify the compressive and tensile strength of the beam. The unreinforced beams were notched using a masonry saw to a notch depth of 3.25 inch, shown in Figure 30.

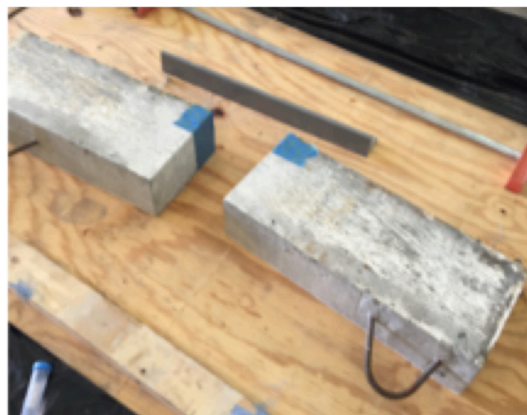
*Figure 31. Preparation of epoxy-repaired beam: beam cut in half with masonry saw.*

1. The unreinforced beam was cut into two halves with a masonry saw (Figure 31).

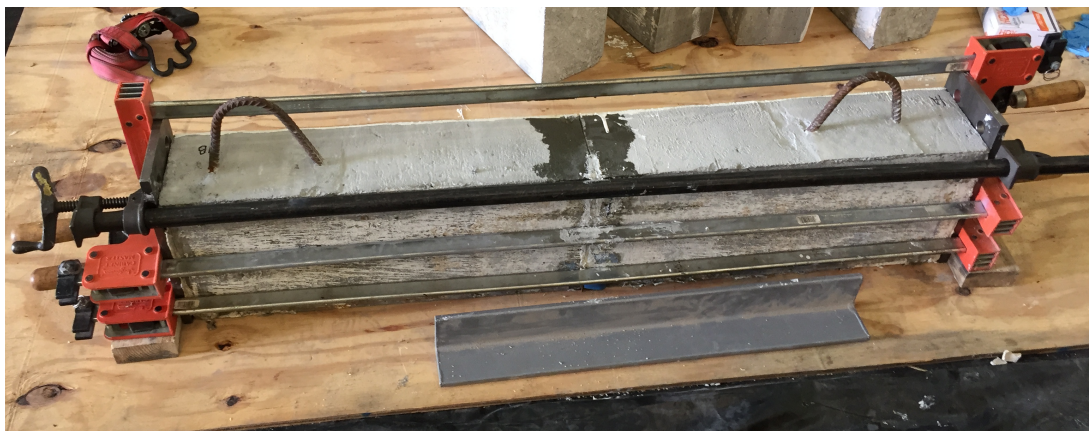
*Figure 33. Preparation of epoxy-repaired beam: repaired beam clamped together for curing.*

4. The two halves were compressed together, making sure they were aligned, and were tighten using long clamps (Figure 33).

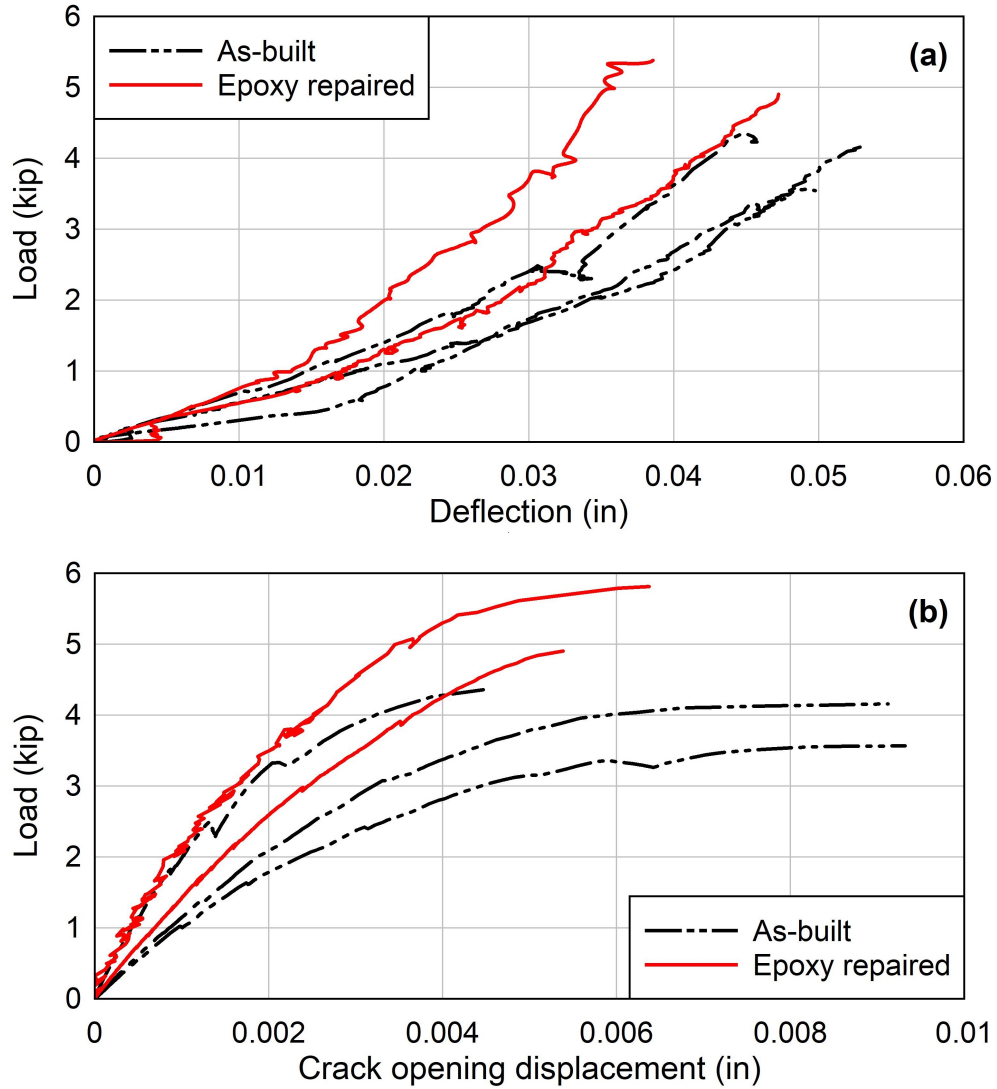
Figure 38. Test results of three-foot unreinforced concrete beams: (a) applied load versus vertical deflection at mid-span; (b) applied load versus crack opening displacement at mid-span.

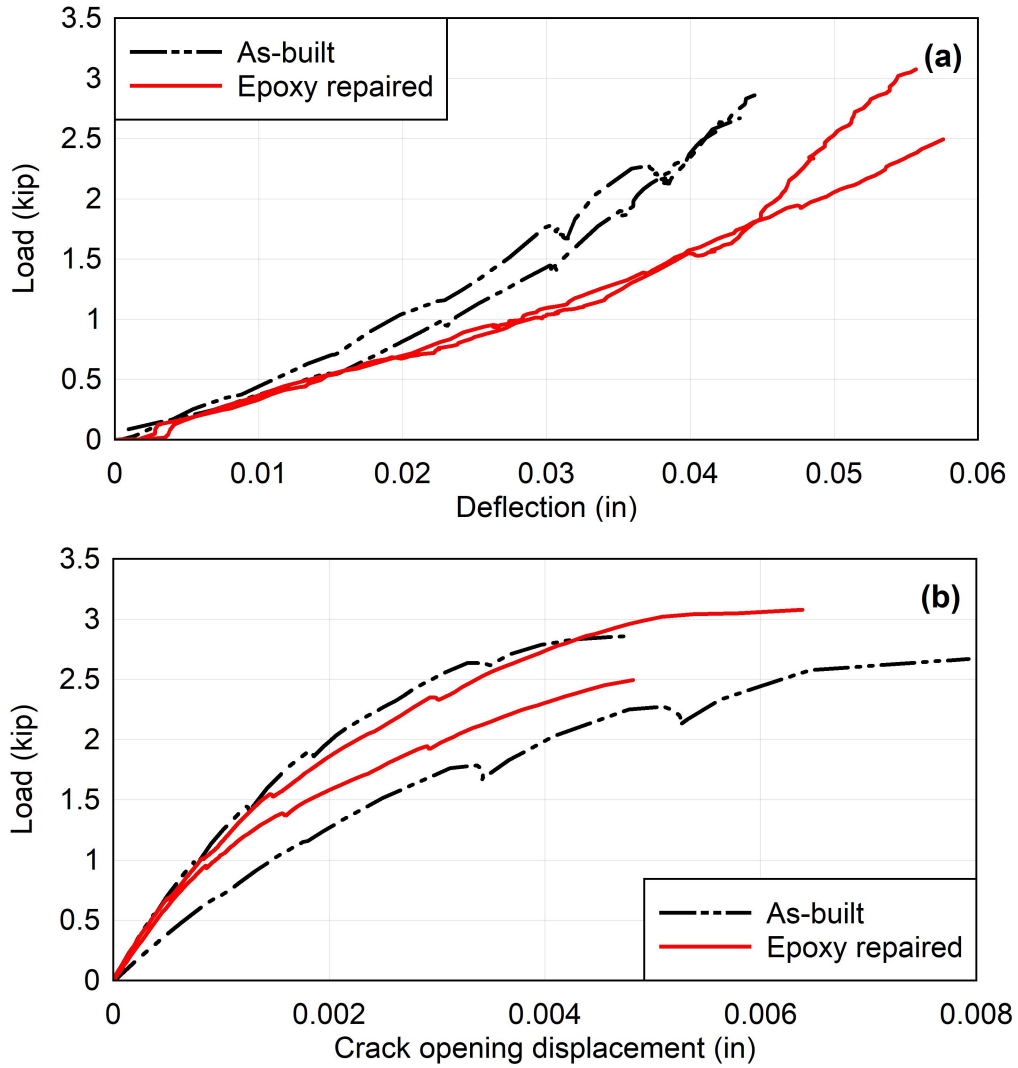
Figure 41. Test results of four-foot unreinforced concrete beams: (a) applied load versus vertical deflection at mid-span; (b) applied load versus crack opening displacement at mid-span.

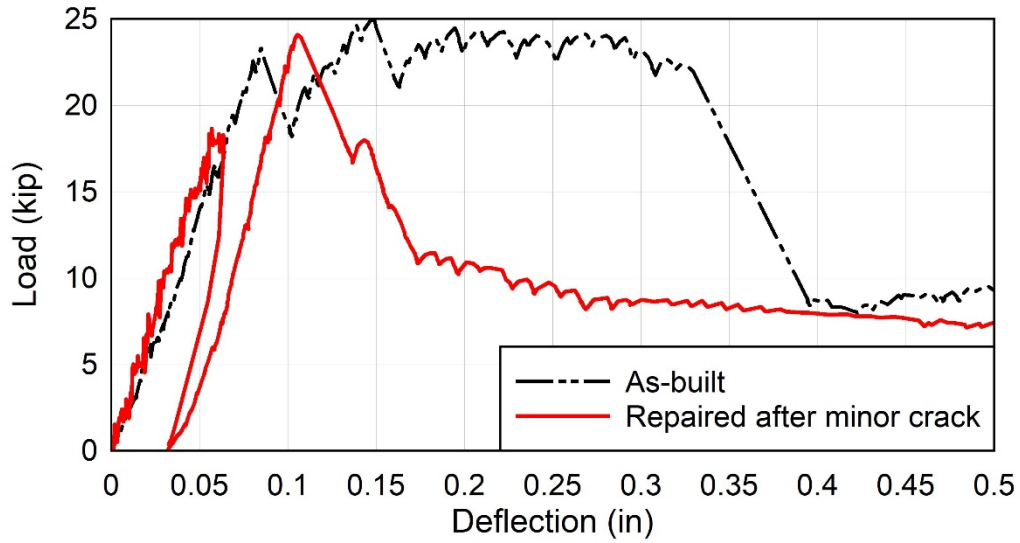
Figure 45. Load-deflection behavior of reinforced concrete beam repaired after minor cracks compared to as-built beam.
