Forces in Wingwalls from Thermal Expansion of Skewed Semi-Integral Bridges

for the
Ohio Department of Transportation
Office of Research and Development

State Job Number 134267

November, 2010

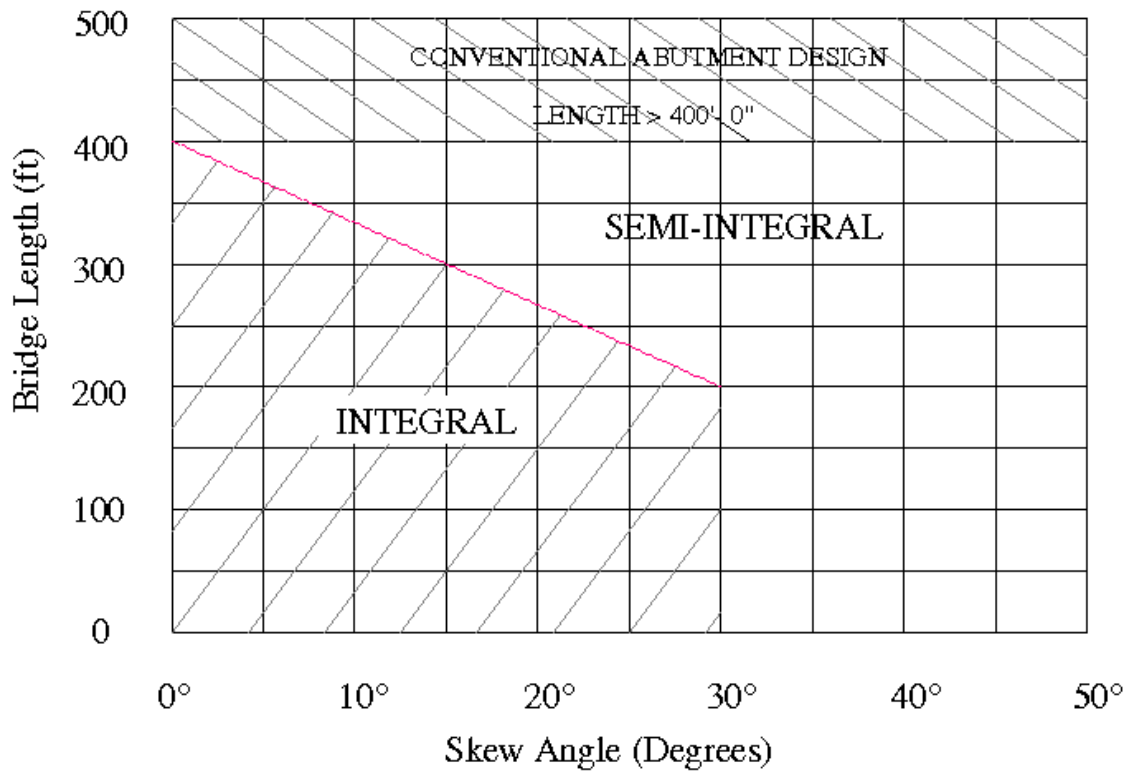
Figure 4: Abutment Type Limitations (Bridge Design Manual, 2007)

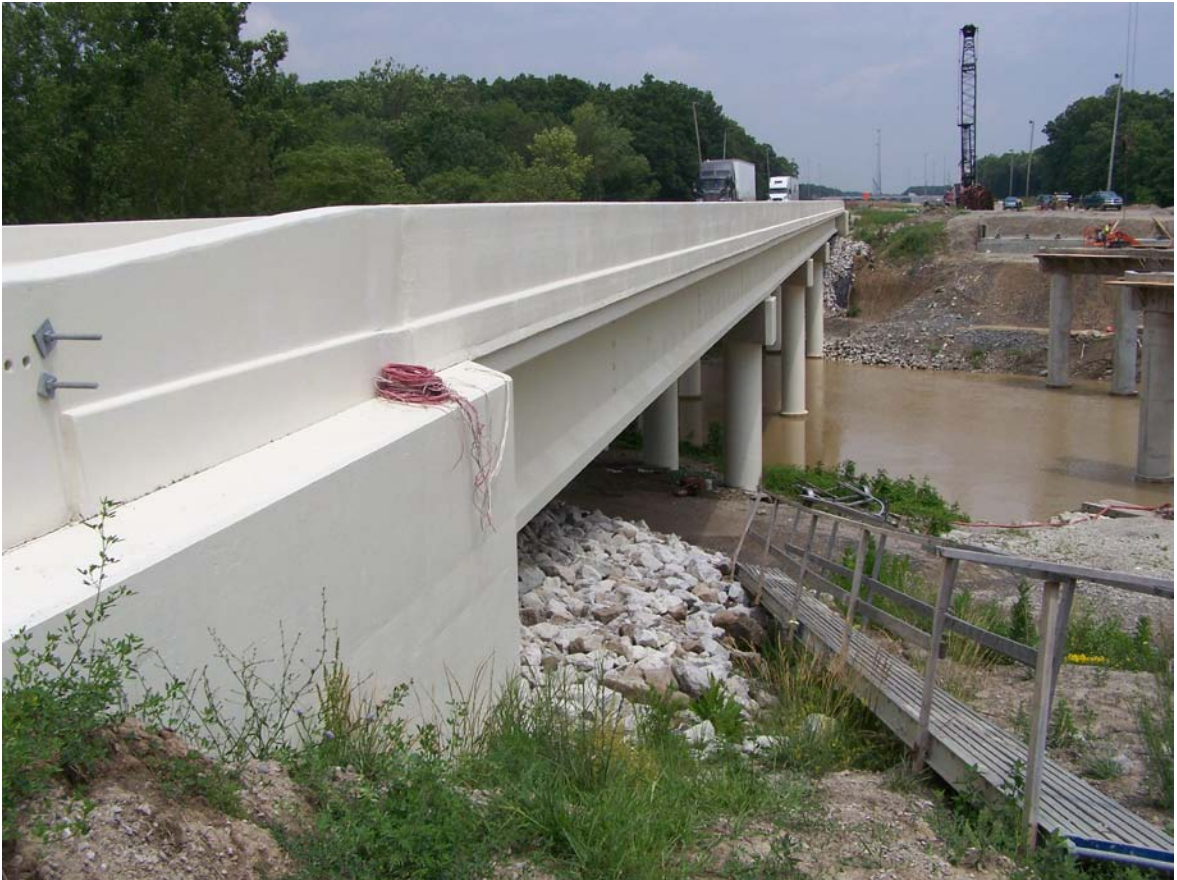
Figure 7: DEF-24-0981

The concrete for the instrumented wingwall was poured on November 29, 2006. Placement of the concrete for the deck and diaphragm was completed on May 18, 2007. The backfill behind the wingwall was placed in early June of 2007, and the approach slab was poured in late June of 2007. Bridge construction was completed and the two westbound lanes opened to the public in August 2007. Figure 7 shows the completed bridge.

This bridge location was on US-24 over the Tiffin River near Defiance, Ohio. Though two similar bridges exist at this location, only the westbound bridge was instrumented and studied. Construction began on the bridge in May 2006. The bridge is a four-span 440-foot composite structure with outside spans of 120 feet and inside spans of 100 feet. It has a skew of 45 degrees and features six 72-inch Modified AASHTO Type IV prestressed concrete I-beams. The roadway width is 42'-0" from toe-to-toe of the parapet wall barriers. The reinforced concrete deck is 8½" thick between girders and 10½" thick over the girders. The approach slabs are 30 feet long and 17 in. thick. The bridge's substructure includes semi-integral abutments and drilled shaft foundations. The wingwalls run parallel to the bridge. The wingwall at the acute corner of the rear abutment for the westbound bridge was instrumented. This wingwall was 18 in. thick, over 18 feet in length, and more than 8 feet high. Seismic pedestals exist at the piers but no guide bearings existed at the abutments.

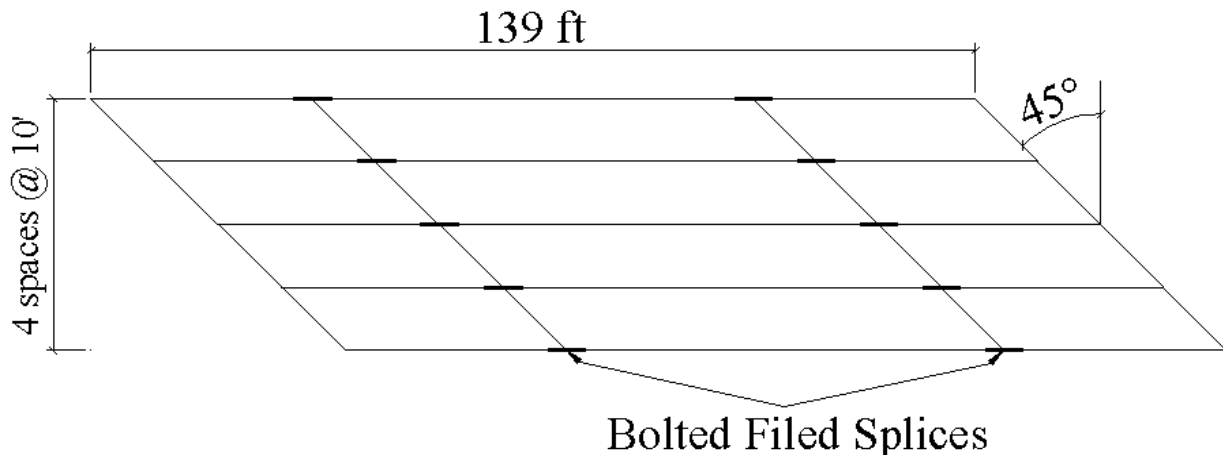
The east and west bound single span bridges have a total span length of 140ft and 139ft from center to center of bearing, respectively. The bridges are 42ft wide from toe to toe of barriers. They are both semi-integral bridges with a skew angle of 45°. The deck is 9 in. deep and is made of 4.5ksi reinforce concrete. Approach slabs on both ends of the bridge are 25ft long. Figure 9 shows the superstructure framing layout of the west bound bridge. The girder sections of the bridges are grade 50 ASTM A572 welded steel plate girders spaced 10ft apart.

Figure 9: Superstructure Framing Layout (MUS-16-0261)

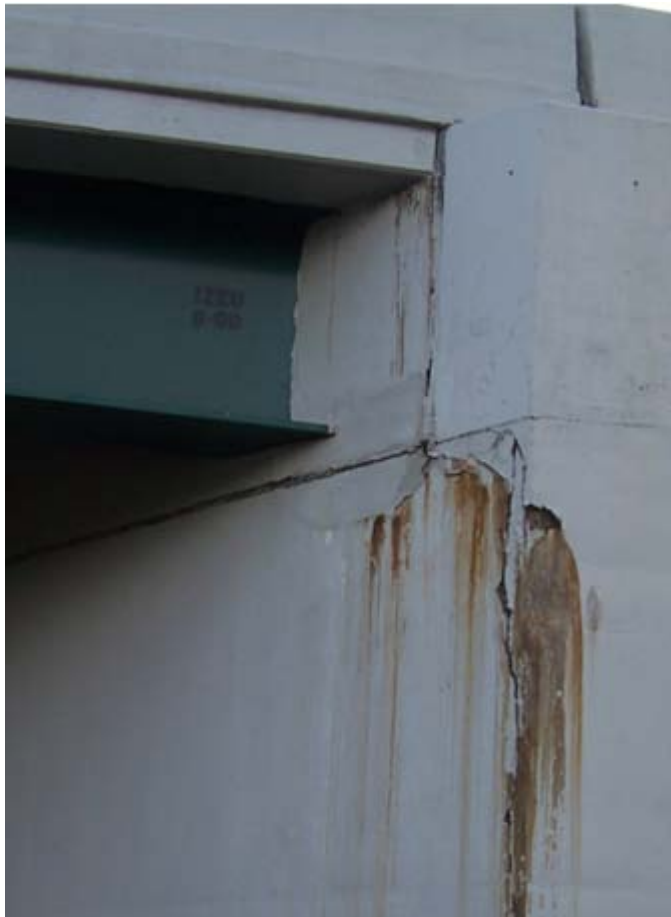
After the bridge was open to traffic, signs of distress were observed as cracks at the abutment/wingwall interface of the west wall of the west bound bridge as well as the east wall of the east bound bridge. Pictures of the observed distresses are shown for the west wall (Figure 11) and the east wall (Figure 12), respectively. Initially, the cracks were patched but only proved to resurface again. Over time, the cracks were observed to have propagated as shown in Figure 13.

Figure 11: Observed Distress of West Wall (West Bound Bridge)

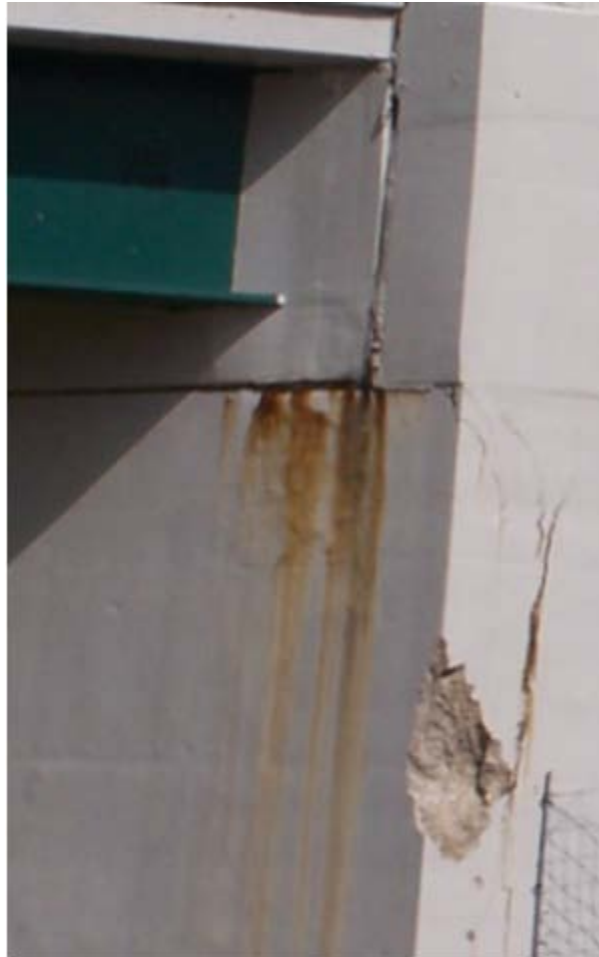
Figure 12: Observed Distress of East Wall (East Bound Bridge)

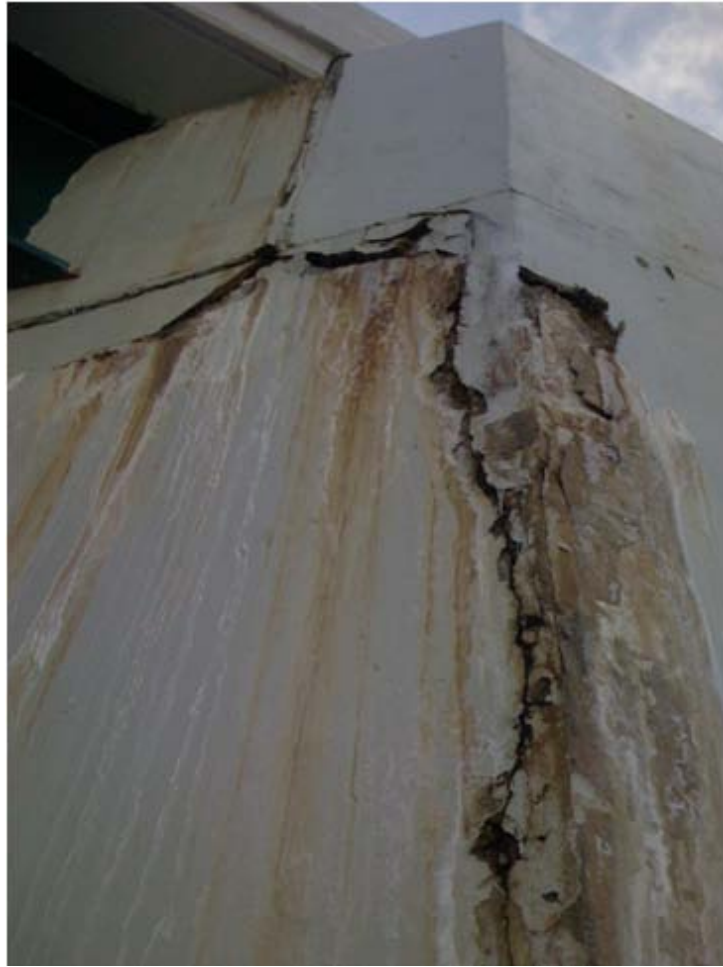
Figure 13: Propagated Cracks of West Wall (West Bound Bridge)

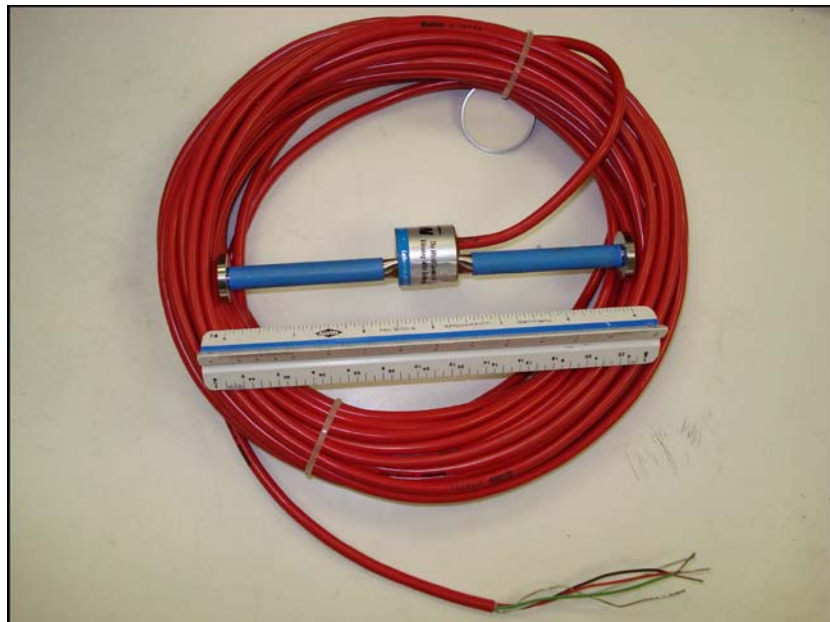
Two types of instrumentation were utilized for this bridge. Geokon Model VCE-4200 Vibrating Wire (VW) Strain Gages were used to measure both strain and temperature inside the wingwall. These VW strain gages are specifically designed for direct embedment in concrete. The Geokon VCE-4200 VW strain gage has a gage length of approximately 6 in (150 mm), a standard range of 3000 microstrains ($\mu\epsilon$), a resolution of 1.0 $\mu\epsilon$, and a temperature range of -68°F (-20°C) to 176°F (80°C). The VW strain gage is commonly used to measure strain in

foundations, piles, bridges, dams, and similar structures and utilize the vibrating wire principle to measure strain. This principle involves a length of steel wire is tensioned between the two end blocks of the gage, which is directly embedded in concrete. Deformations, or strain changes, inside the concrete structure causes the two end blocks to move relative to one another. These changes in strain affect the amount of tension held in the steel wire. This tension is then measured by electronically plucking the wire and measuring its resonant frequency of vibration with the use of an electromagnetic coil inside the gage. The vibrating wire strain gages are primarily designed for long-term strain measurement and thus are not suitable for measuring dynamic strains. The gages are also fully waterproof. Figure 14 depicts one of these strain gages along with its connected wiring which allows for measurement of both strain and resistance in the vibrating wire contained in the gage.

Figure 14: Geokon Model VCE-4200 Vibrating Wire Strain Gage

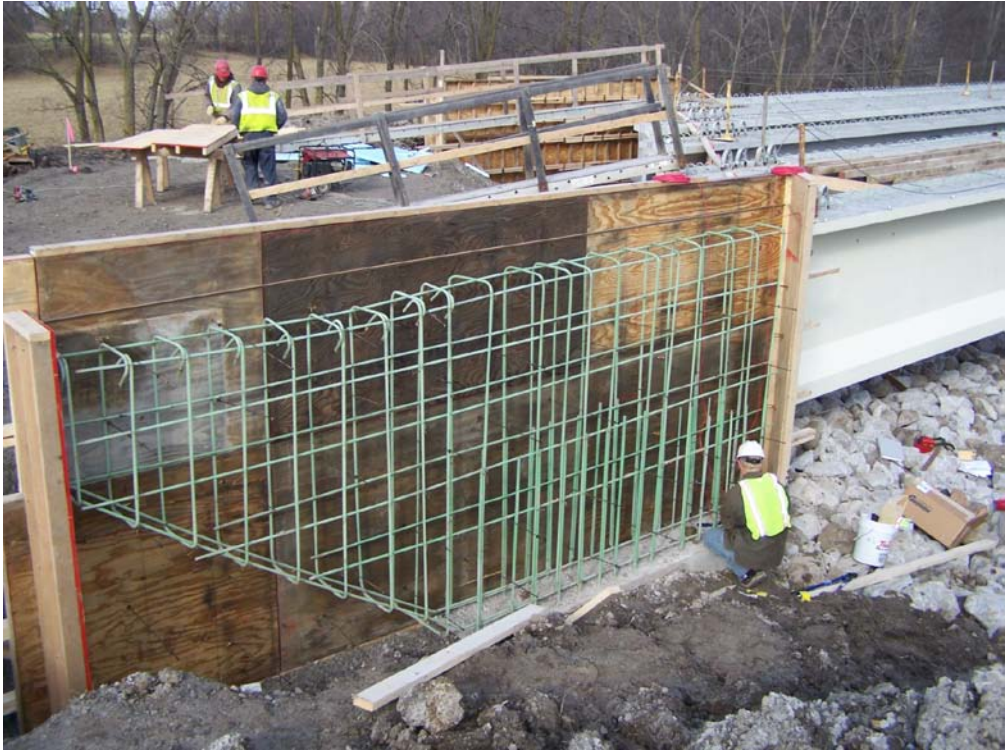
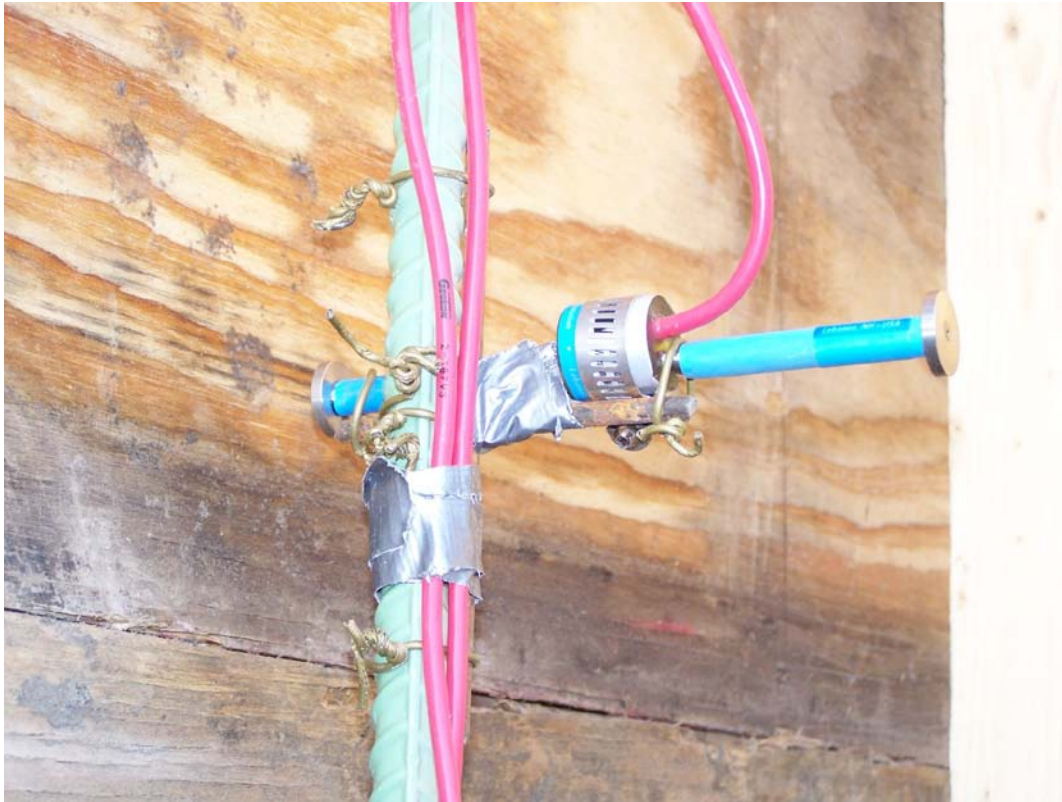
allowed strain measurements within the concrete. Figures 15 and 16 show the installation of the VW strain gages in the wingwall.

Figure 15: Vibrating Wire Strain Gage Installation

Figure 16: Vibrating Wire Strain Gage Tied to Reinforcement

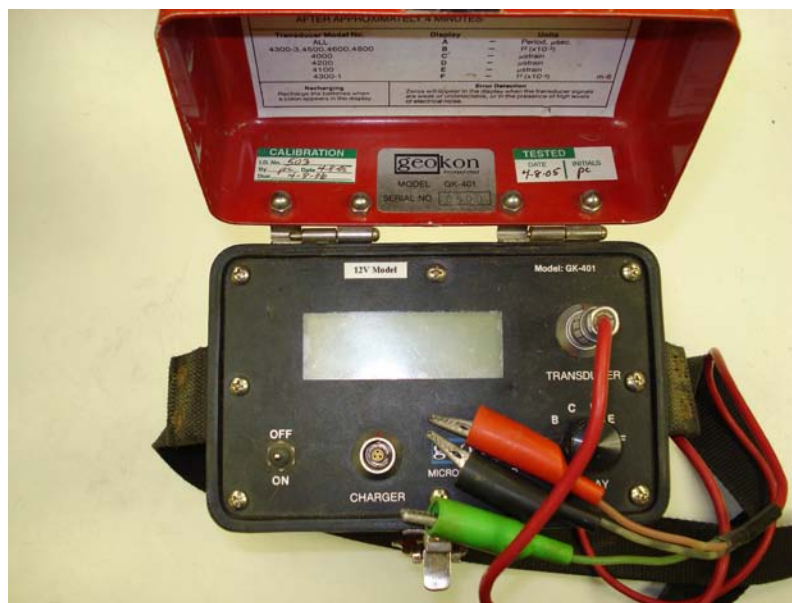
Strain measurements of the vibrating wire strain gages were taken using a Geokon Model GK-401 Microprocessor as shown in Figure 18. The measurement output was in units of microstrain. However, the strain has to be corrected for temperature in order to account for the strain only due to loading. The corrections are necessary due to slight differences in the thermal coefficients of the gages and the concrete. Equation (3) was used to determine the strain from loading.

Figure 18: Geokon Model GK-401 Microprocessor

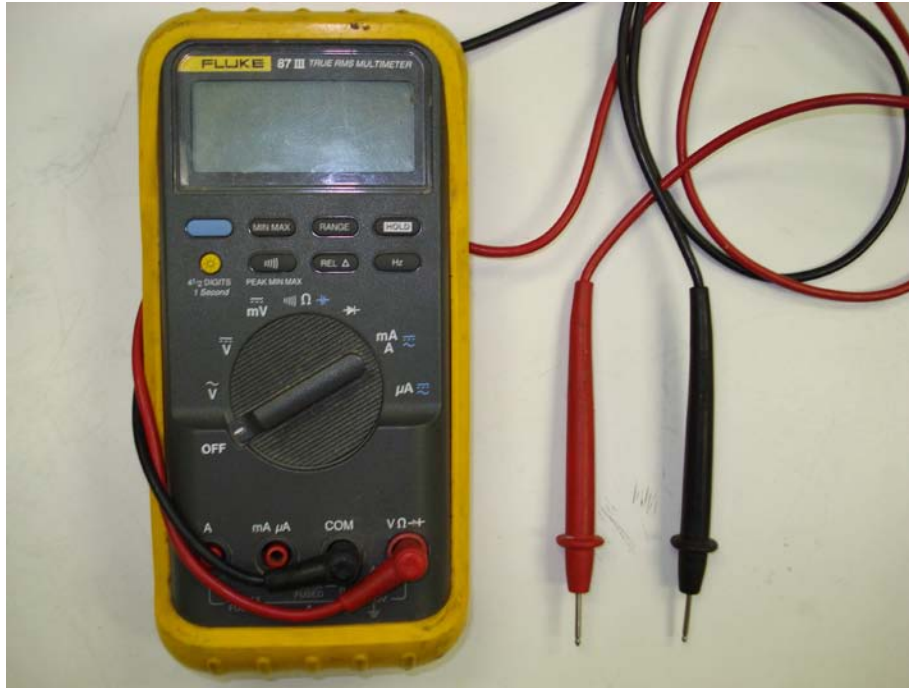
Figure 19: Fluke 87 Series III True RMS Multimeter

In addition, temperature measurements of the VW strain gages were taken with the use of a Fluke 87 Series III True RMS Multimeter as shown in Figure 19. Using the green and white lead wires of the strain gages, a resistance reading in units of kilo-ohms ($\text{k}\Omega$) was measured. The resistance reading was then converted to a temperature in degrees Celsius ($^{\circ}\text{C}$) by using the formula shown in Equation (4).

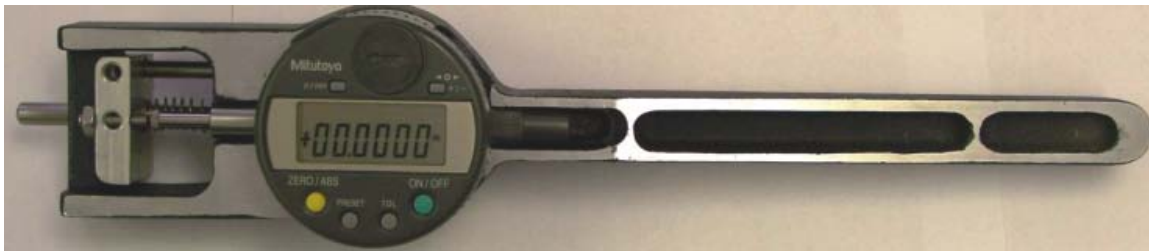
The digimatic indicator target readings were taken with a Mitutoyo Model IDC112T ABSOLUTE Digimatic Indicator (see Figure 21). The indicator has a range of ± 0.5 inches and an accuracy of 0.00012 inches. Readings were taken as a digital readout of four decimal places. In addition, one of the contact points on the indicator can be adjusted so that five different 0.5 inch ranges between approximately 1.7 and 10.24 inches can be used. Each time this contact point was moved, the steel calibration plate shown in Figure 22 was used to calibrate the digimatic indicator to the proper range for data collection.

Figure 21: Top view of Mitutoyo Model IDC112T ABSOLUTE Digimatic Indicator

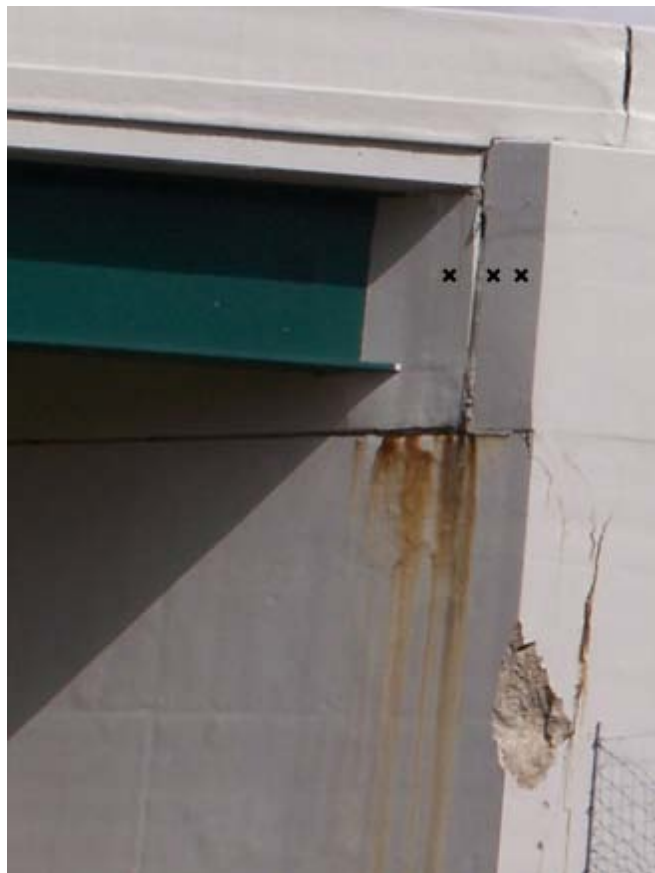
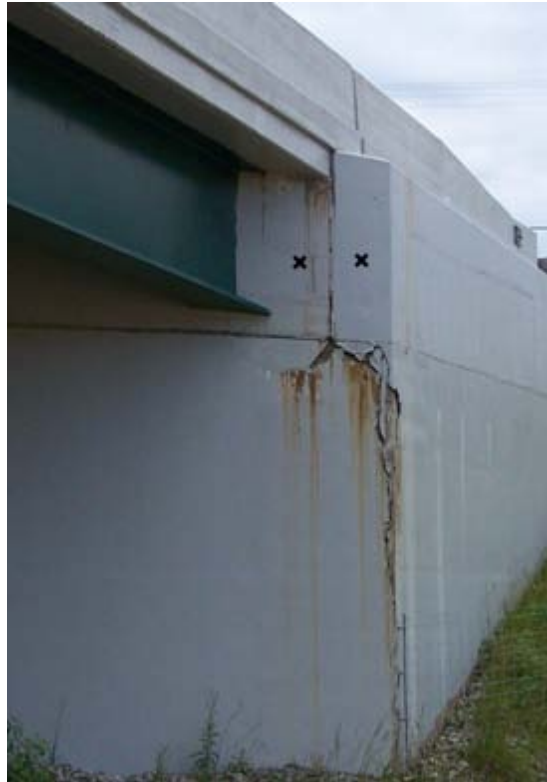
and the concrete. The targets were then embedded into the walls and held in place with the use of a rapid setting two part epoxy. For the east bound bridge, two sets of targets were installed 8in and 10in apart, while on the west bound bridge only one set of targets installed 8in apart was used. Figures 25 and 26 show the approximate locations of the targets. The installation of the west bound bridge metal targets was done several months after the initial installment of instrumentation due to difficulties in gaining access to the height of the desired location. In addition to that, the topography of the ground surface adjacent to the location at which the installation was to take place was very steep and considered dangerous for the installation crew.

Figure 25: Target Location (East Bound Bridge)

Figure 26: Target Location (West Bound Bridge)

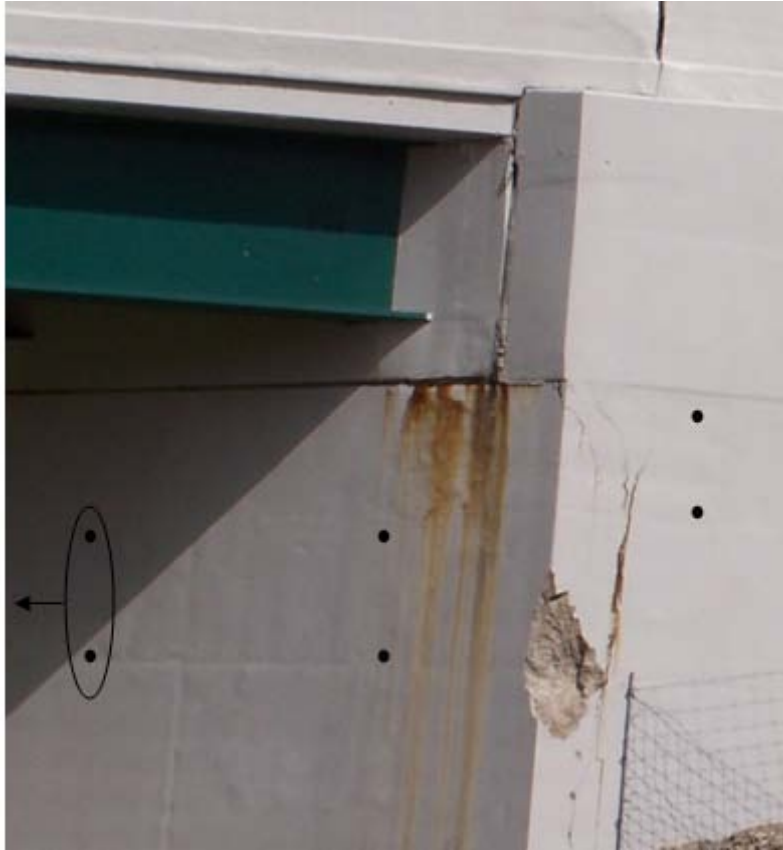
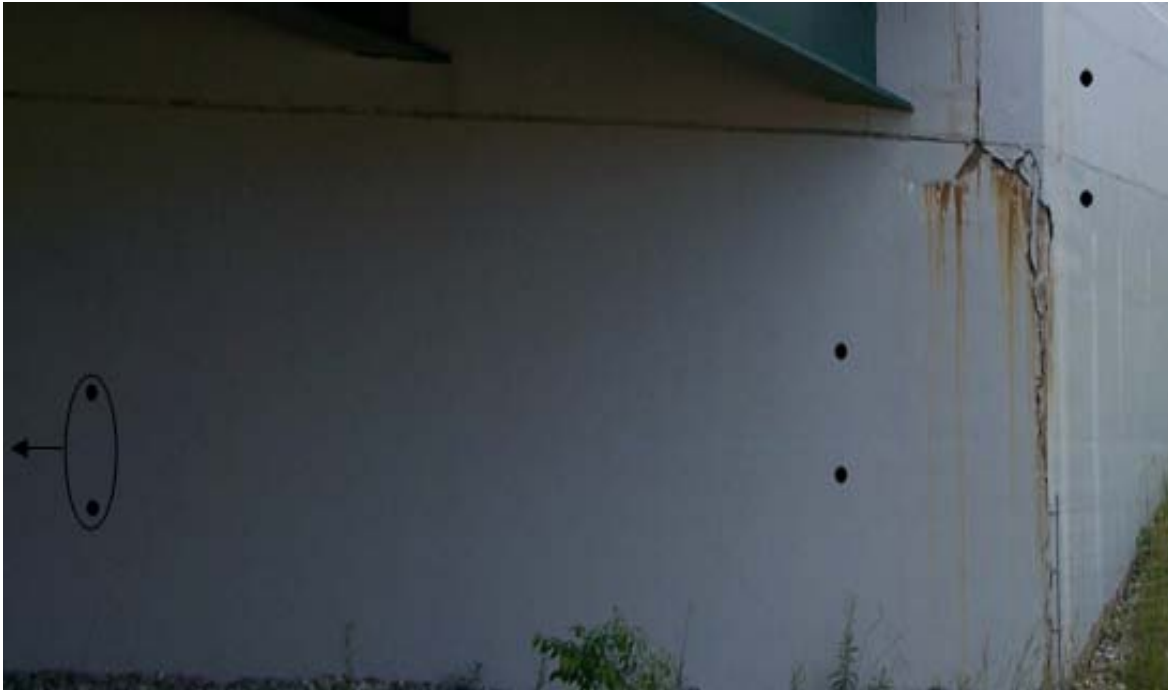
pointing to the left were located further to the left in the picture. For each bridge, one station was established on the wingwall and the other two were established on the wall abutments.

Figure 27: Tilt Reference Stations (East Bound Bridge)

Figure 28: Tilt Reference Stations (West Bound Bridge)

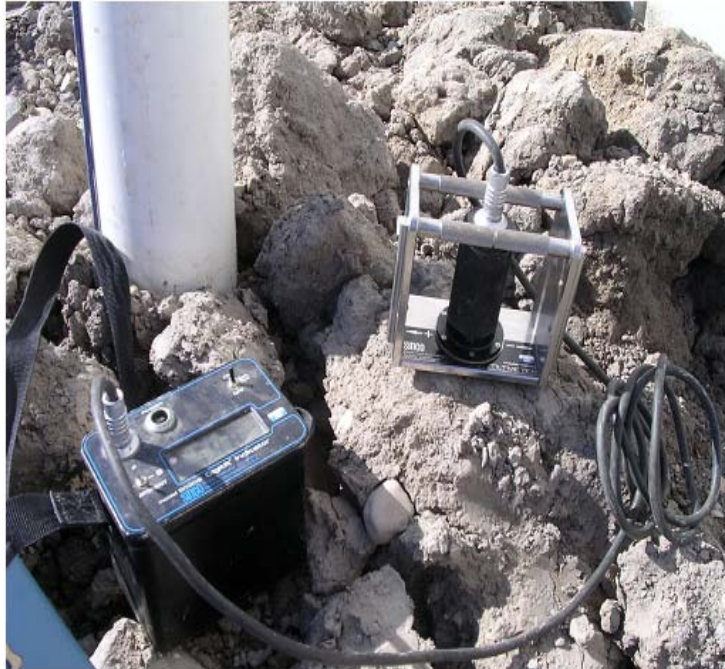
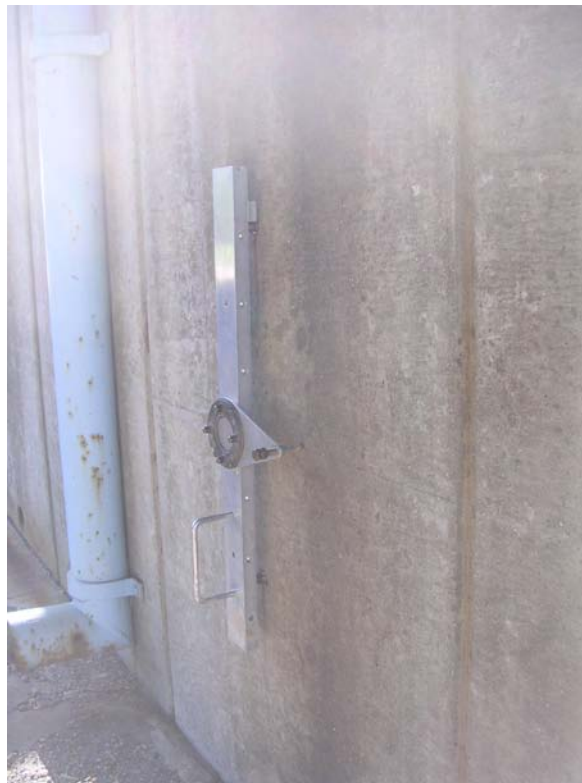
The Digi-Tilt tiltmeter manufactured by Slope Indicator (Seattle, Washington) was used in the tilt measurements. The system comprises of a accelerometer sensor and a digital readout device. In order to take a tilt reading at a given measuring station, a stainless steel ball on a threaded shaft was screwed into each of the established reference points. A reference plate was

then positioned and held against the steel joints, and with the use of an accelerometer, readings were taken. The field set up for the data acquisition is illustrated in Figure 29. In addition, Figure 30 shows the components of the data acquisition equipment (readout device and accelerometer) while Figure 31 shows the reference plate hanging on the wall.

Figure 29: Field Set-Up for Data Acquisition (Masada, 2007)

Figure 30: Digi-tilt Sensor and Readout Device (Masada, 2007)

Figure 31: Reference Plate on Wall Abutment (Masada, 2007)

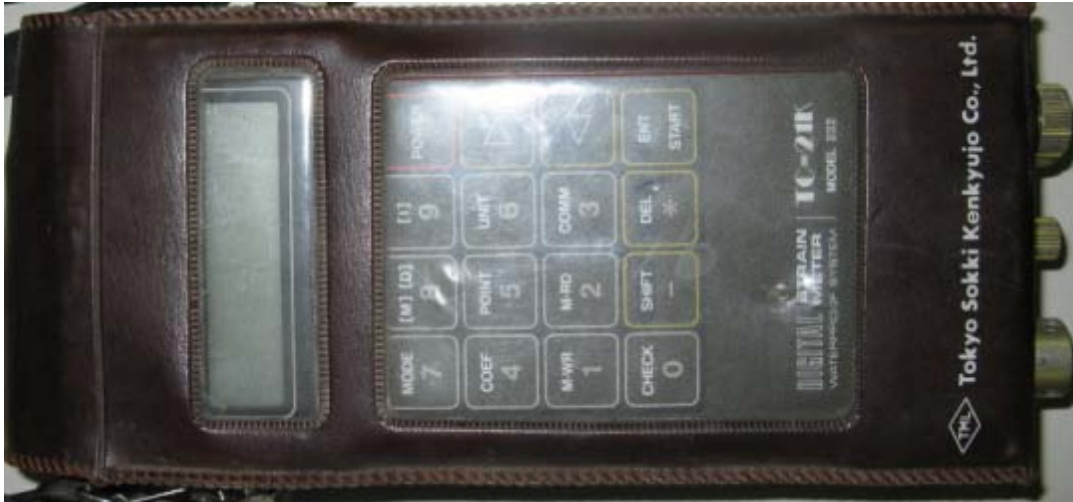
Figure 32: Digital Strain Meter

In order to take the internal temperatures of the wingwalls and wall abutments, Omega type T (Copper – Copper-Nickel) thermocouples were embedded into the walls. These thermocouples have a maximum temperature range of -270 to 400°C (-454 to 752°F) and a tolerance of 1.0°C (Omega Engineering, 2006). A total of two thermocouples were installed each on the west and east bound bridges. One thermocouple was embedded approximately $1 \frac{1}{2}$ ' on each wingwall and wall abutment and were both held in place using epoxy. A Digital Strain meter (TC-21k model 232) was used to record the temperature readings (see Figure 32). Different locations were used to determine if thermal variations existed between the wall abutments and wingwall.

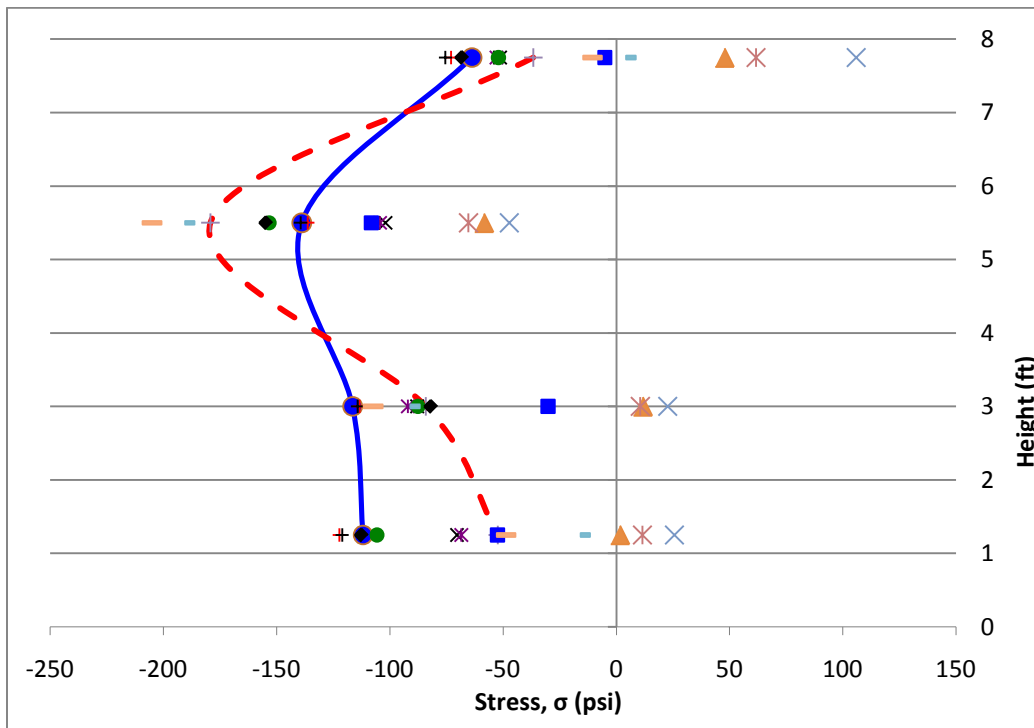
Upon increases in temperatures in the spring of 2008, the general shape of the stress distribution over the wingwall height then changes into a shape depicted by the broken line (Figures 34-36). The data set for the broken line was taken on September 4 of 2008, slightly over a year after the bridge was open to traffic. The average internal temperature from the VW strain gages was 78°F for the data set depicted by the broken line. The broken line depicting the stress distribution for the S gages (Figure 34), B gages (Figure 35), and the average of all gages (Figure 36) shows higher stress near 5.5' above the face of the wall with lower stress existing near the top and base of the wingwall.

For each of the two general stress distributions, the data sets at higher temperatures produce higher compressive stresses, as expected. In addition, the average stress over the height of the wingwall was always larger for S gages than the B gages. This is likely due to the rotational effects causing higher magnitude compression at the back of the diaphragm/wingwall interface compared to the front (bridge) side of the diaphragm/wingwall interface. The majority of stresses for the S gages are 150 psi or less with a few readings showing magnitudes as high as 200 psi. The majority of stresses determined from the B gages are 100 psi or less with a few readings exceeding 150 psi. The majority of the average stress readings on the wingwall based on the VW strain gages are less than 150 psi.

Figure 34: Wingwall Stress – S Gages (DEF-24-0981)

Figure 35: Wingwall Stress – B Gages (DEF-24-0981)

Figure 36: Average Wingwall Stress (DEF-24-0981)

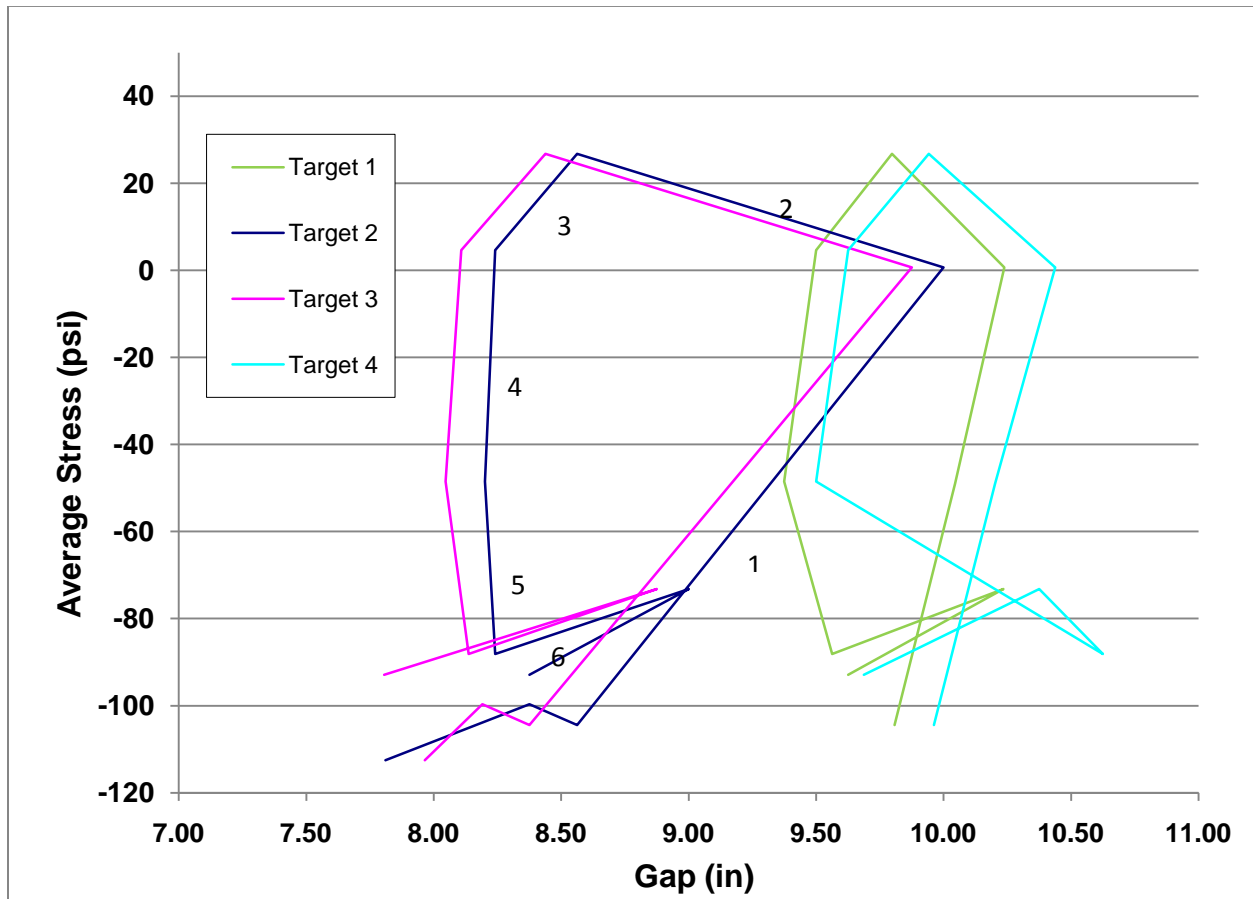
The unexpected behavior of the gap compared to the stress in a few of the stages may be due to the complex behavior exhibited at the wingwall/diaphragm interface caused by the thermal changes. The movement of the bridge's diaphragm at the interface is likely a combination of longitudinal sliding, movement in the direction of the skew into the wingwall, and rotation. This complex movement cannot be fully measured with the instrumentation installed only on the front face the wingwall/diaphragm interface.

Figure 37: Interface Gap vs Average Wingwall Stress (DEF-24-0981)

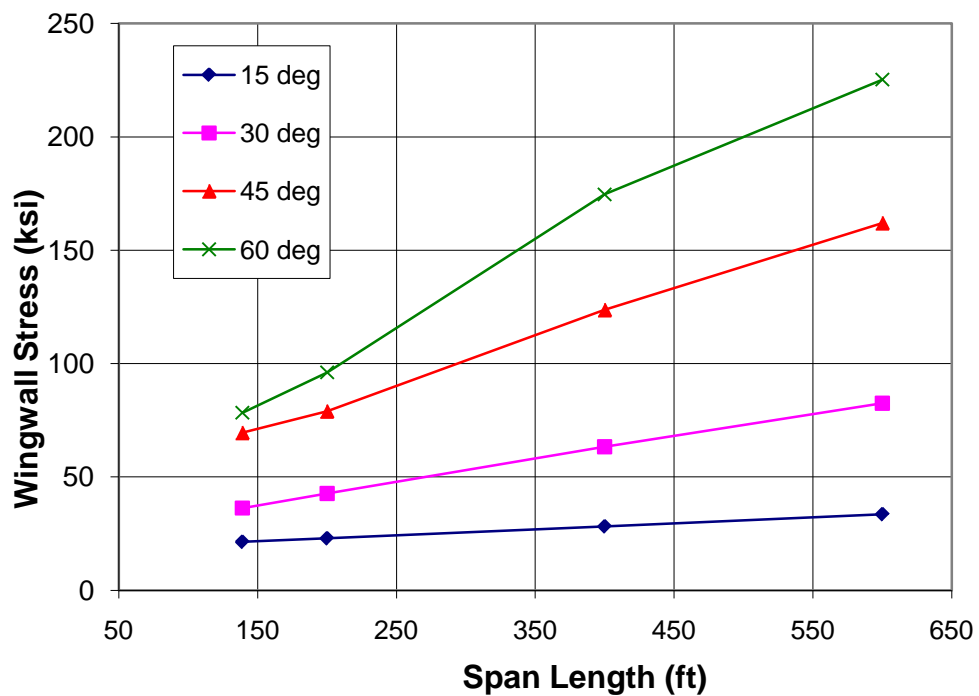
Figure Figures 43 - 45 to investigate the effect of varying the length of superstructure, the skew angle, and the equivalent stiffness on the wingwall stresses for different skews. The difference in Figures 43 - 45 is the assumed equivalent stiffness.

Figure 43: Span Length on Stresses for Different Skews ($k_{Eq} = 35.7\text{lb/in}^3$)

Figure 44: Span Length vs Stresses for Different Skews ($k_{Eq} = 100.57\text{lb/in}^3$)

Figure 45: Span Length vs Stresses for Different Skews ($k_{Eq} = 165.75 \text{ lb/in}^3$)

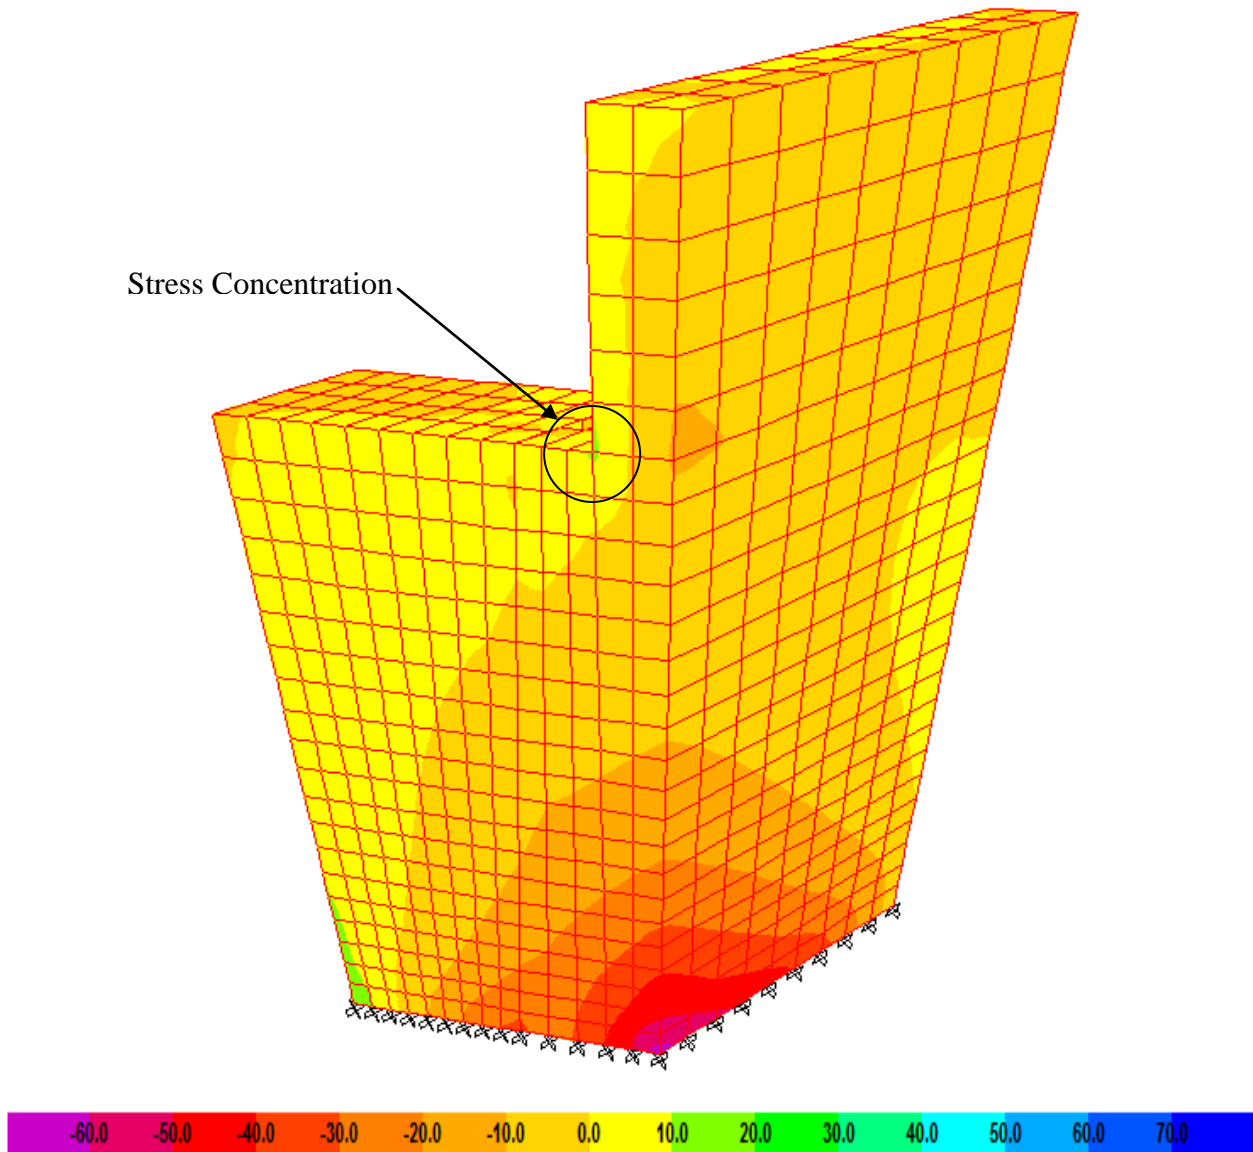
deformed downward slightly due to the applied deck self-weight. Also, the front side of the abutment wall is in compression and backside is in tension due to lateral earth pressure of the backfill acting on the backside. Figure 49 and 50 show the distribution of vertical normal stresses on the front side and the backside of the wall panels, respectively.

Figure 49: Front Side Stresses (ksi)

Figure 50: Backside Stresses (ksi)

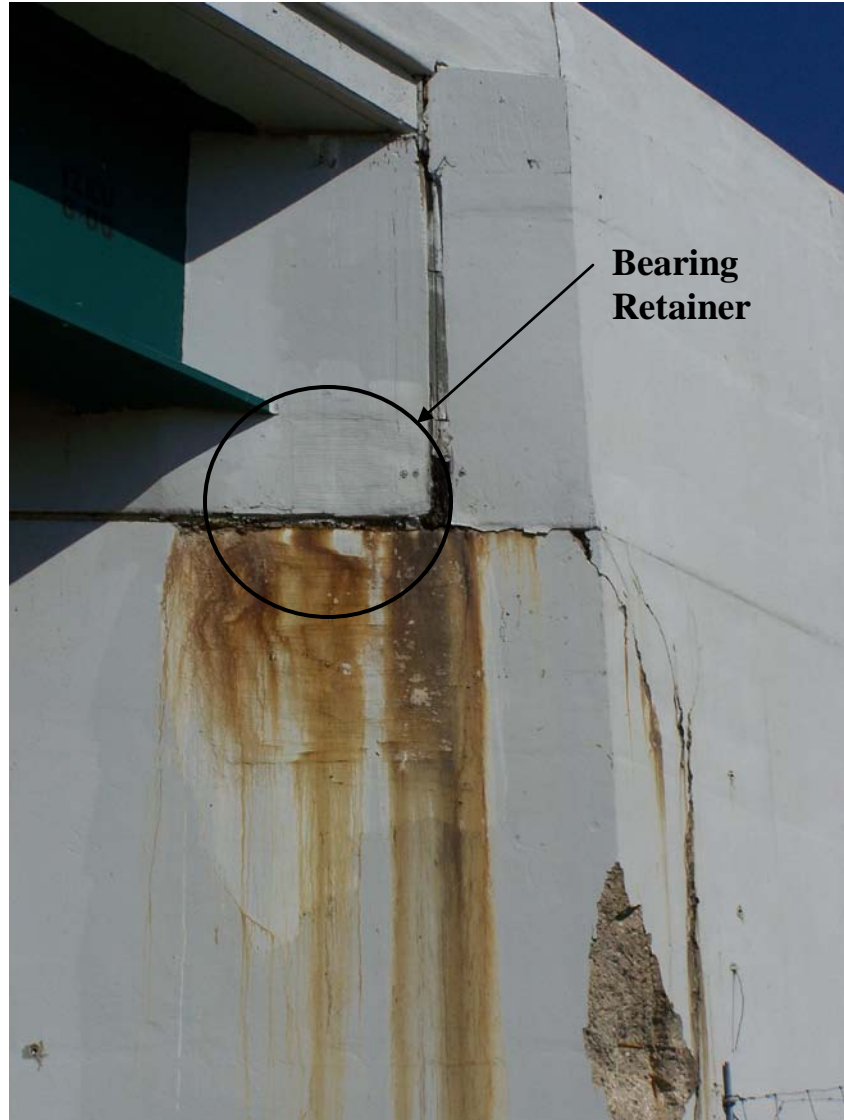
Figure 54: Bearing Retainer (MUS-16-0261)
