DOT/FAA/AR-01/39

In-Pavement Light Emitting Diode (LED) Light Strip Evaluation

August 2001

Interim Report

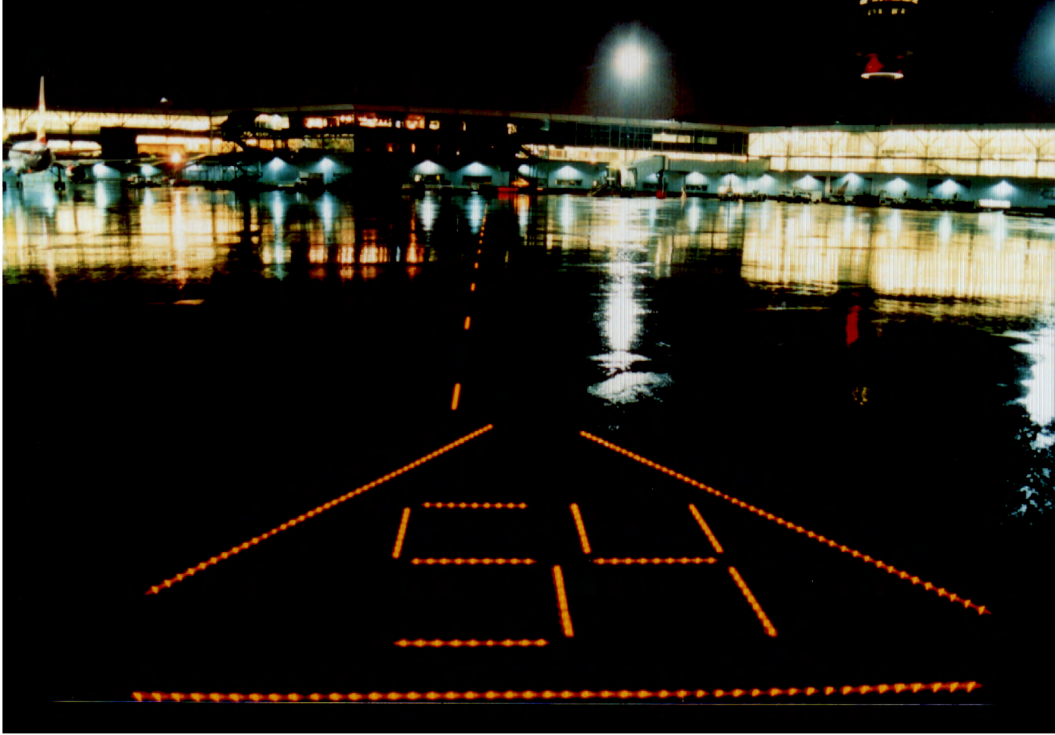
FIGURE 1. VANCOUVER, BRITISH COLUMBIA AIRPORT
DEMONSTRATION INSTALLATION

In addition, a somewhat more complex configuration in the form of a numbered gate indicator with centerline track was installed for demonstration on the Vancouver, British Columbia (BC) Airport apron. A photograph taken under standing water conditions is shown in figure 1.

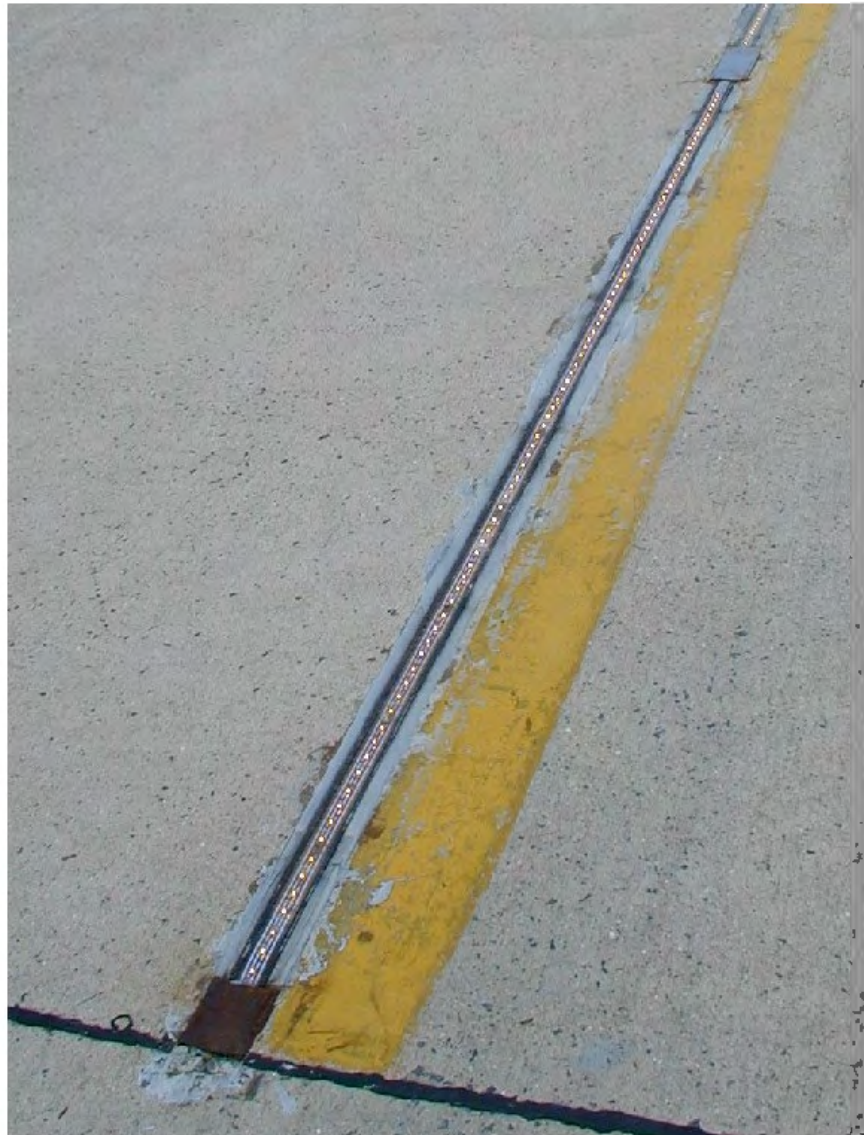
FIGURE 3. LED-STRIP SECTION PHOTOGRAPH

which produces 900 mcd and 0.48 watts. Each individual LED section contained 96 encapsulated LED devices (lights) in groups of four with 32-mm (1.25-inch) spacing between each LED (figure 3). All strips were installed in a saw-cut trench and temporarily supported during pouring of the surrounding sealant so that the top surface of each strip was approximately 2.5 mm (1/10 inch) below the surrounding concrete. Three 120Vac/12Vdc constant voltage power supplies were connected to the individual LED strips at both ends within the two five-strip and one four-strip grouping. Connections were made at both ends of all strips to provide redundancy in the event of an end connector failure.

Some difficulty was experienced with maintaining a constant level with the surrounding pavement within each strip due to what seemed to be excessive flexibility of the “U” channel provided to support the encapsulated LED lights. Even using closely spaced mounting templates, per the manufacturer’s instructions, it was necessary to add 1/2” by 1/2” angles underneath the channel for rigidity during installation in the saw-cut trench.

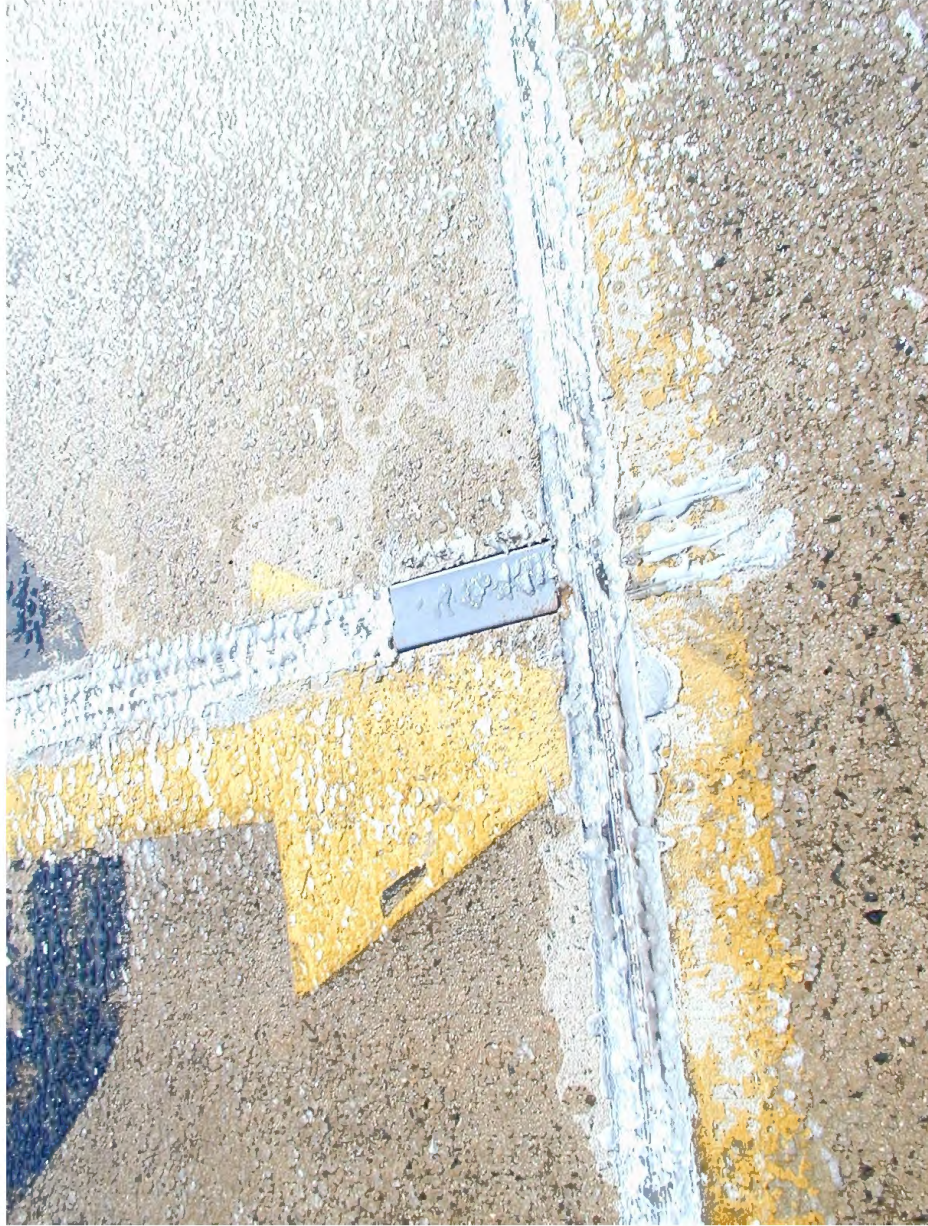
FIGURE 7. POSTSNOW APPEARANCE

During the evaluation period, the LED strips were covered by approximately 1 1/2” to 2” of snow. It was verified that the strips were illuminated but were not visible under the snow. LED lights do not generate any appreciable heat so there will be virtually no chance that they will experience any self-cleaning or melting of the snow/ice covering. Snowplowing should not be a problem, since the LED strips are installed approximately 1/16” to 1/8” below the surrounding surface, but this will also result in a covering being left after plowing. Figure 7 shows a portion of the illuminated parking location display after a period of light snow.

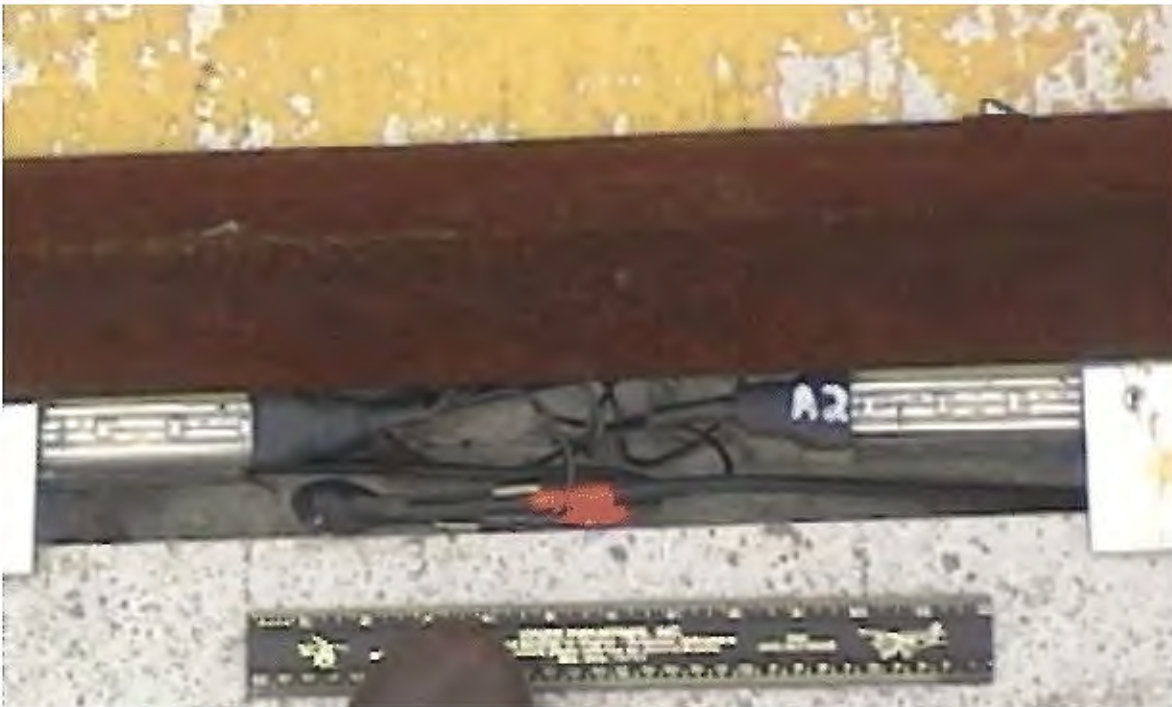
FIGURE 8. CONNECTION SPACE BETWEEN LED SECTIONS

During a period of approximately 6 months, the LED-strip parking position indicator was operated intermittently whenever visiting aircraft arrived. Almost all malfunctions or failures occurred because of the connector design mentioned earlier in this report. A gap between LED sections, of about 10 inches in length, was necessary to provide room for the connectors and for the connections with the feeder cables running beneath the LED strips (see figure 8). This void was filled with a solidified foam and protected with a U-shaped steel cover to protect the wiring and reduce water contamination. Unfortunately, the tops of the original sealed connectors protruded above the surface level of the LED strips. Under pressure from aircraft and vehicles passing over the covers, the connectors soon were bent downward, causing frequent separation of the spring-loaded butt connection. In some cases, a vehicle passing over a cover would cause a section to go out, while another vehicle subsequently passing over would cause the strip to be re-energized. The fact that each section was fed from both ends, also caused disconnections to go unnoticed until both connectors had failed.

The end connectors, provided by the manufacturer and preinstalled at the factory, used spring-loaded contacts butted against the metallic ribbon conductor encapsulated with the LED lamps. This provided only minimum contact area between the feeder wires and the ribbon conductor and was a continuing problem until it was replaced with a more positive connector retrofit.

After repeated failures, the original connectors were removed and replaced with screws inserted directly into the ends of the strips and contacting the ribbon conductor along the thread length. The feeder cables were then attached to the screws with ring connectors. This alternate connection method served well until such time as the screws rusted, breaking the contact once more.
