**REPORT NUMBER: WI 03-02**

**Evaluation of Lumimark Traffic  
Safety Marking System**

**FINAL REPORT**

WisDOT Research Study # WI 00-02

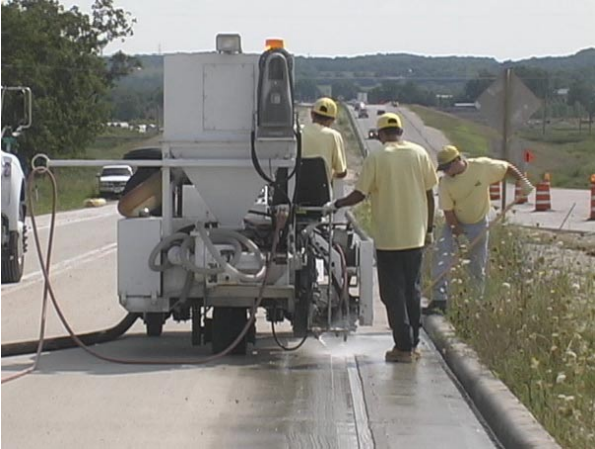
Fig. 2: Milling Operation

A groove approximately  $\frac{1}{4}$  in. was milled into the PCC pavement. The groove was cleared of any debris by the use of a power washer.

An Initial problem was encountered with the milling operations. The milled groove was within  $\frac{1}{2}$  to 1 inch of the edge of the pavement. This left too small of section of the original pavement and subsequently broke off. The milled groove section was then moved in approximately 1 additional inch from the edge of the pavement. No problems were experienced with the milled edge shearing off after the adjustment.

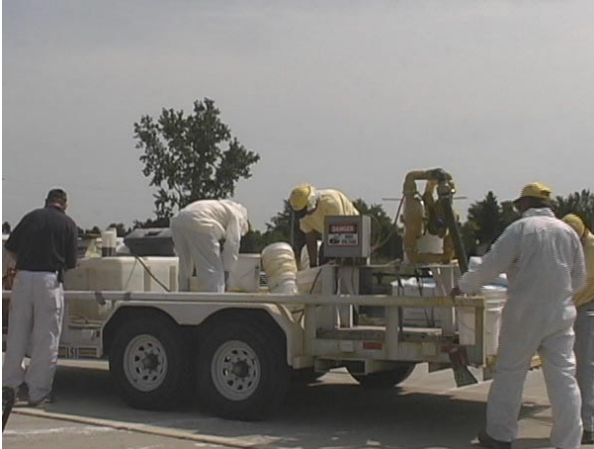
Fig. 3: Hand Mixing

The material, Lumimark HW 100 White and Lumimark HW 100 Yellow, was mixed by hand to a consistent, homogeneous and placed manually into the hand operated machine.

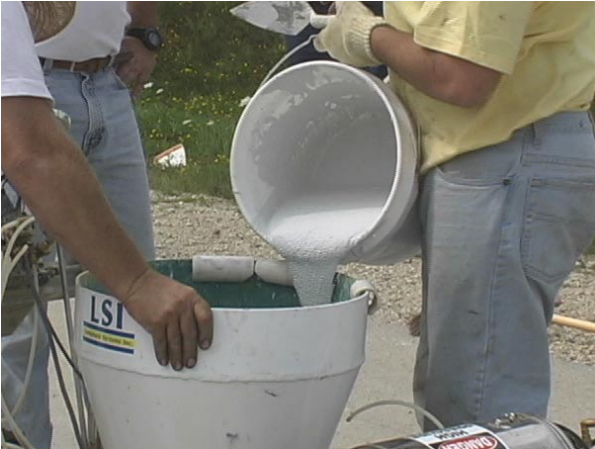
Fig. 4: Placement in Hand Controlled Machine

The machine used to apply the Lumimark in the milled groove, consolidated, struck-off the material, and an applied a broadcasted bead finish on the surface. This machine was not the long line production prototype. The system was a small hand guided machine typically used in shorter work areas not long line applications. The hand held operation was very time consuming and labor intensive. A long line vehicle was in development at the time of this demonstration, but not available for the installation. The use of a long line machine should eliminate a lot of the time and labor concerns along with a more consistent product.

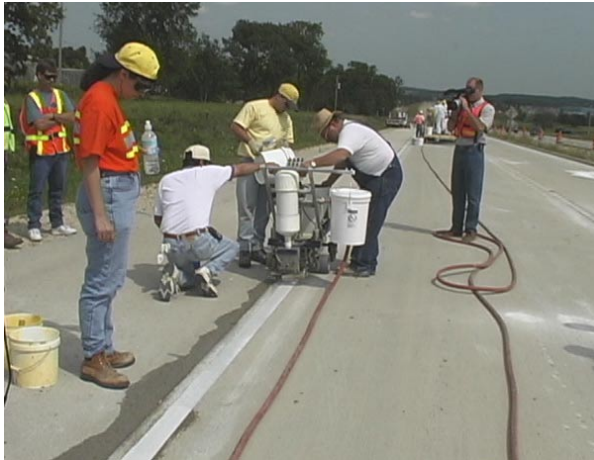
Fig. 5: Placement of White Line

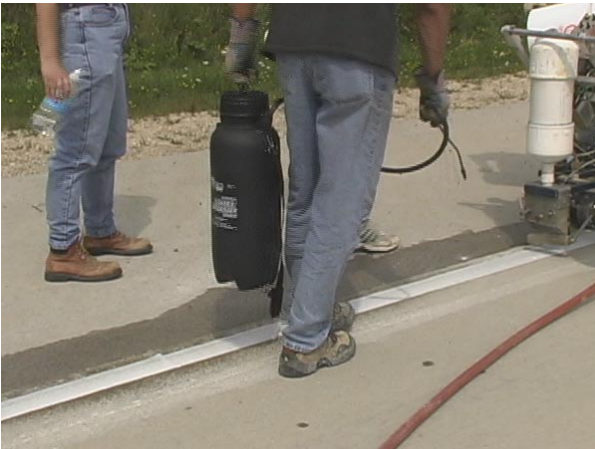
Fig. 6: Spray Cure Application

Control joints were then cut to re-establish existing transverse pavement joints. A uniform application of a curing/sealing compound was then applied to the fresh material. This is done immediately after broadcasting of the beads to control moisture loss and help insure the strength and durability of the system.

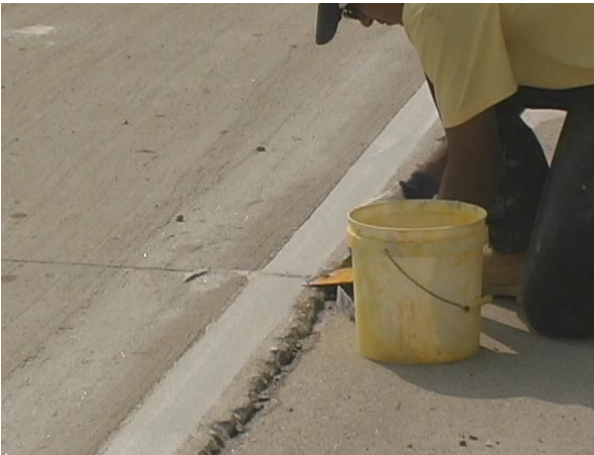
Fig. 7: Cutting of Control Joints

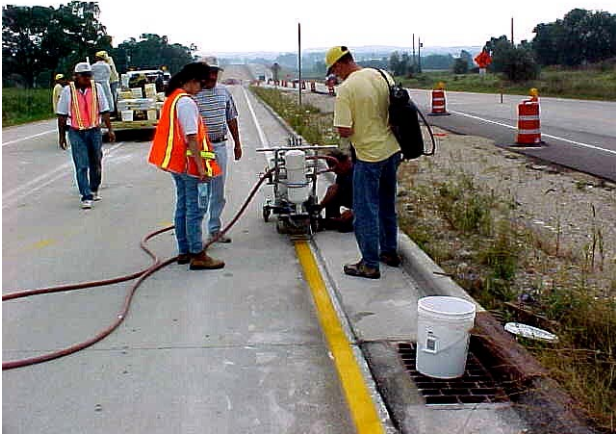
Fig. 8: Lumimark Yellow Edge Line Installation

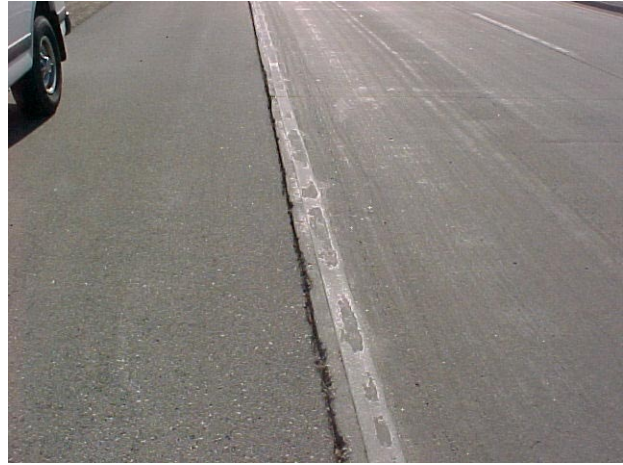
Fig. 9: October 2001 Lumimark White Edge Line

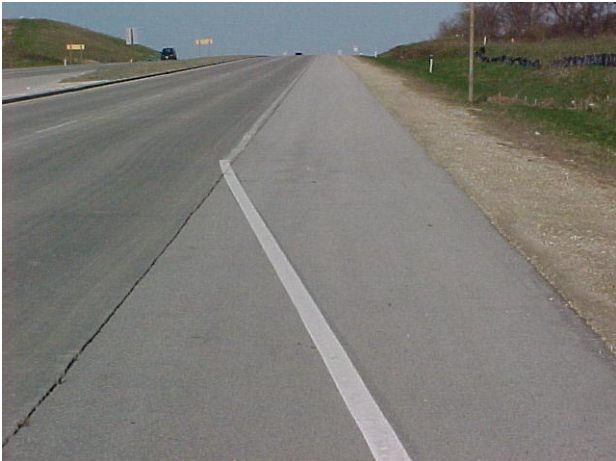
Fig. 10 October 2001 Epoxy Taper Line in Fore Ground Adjoining a White Lumimark Edge Line

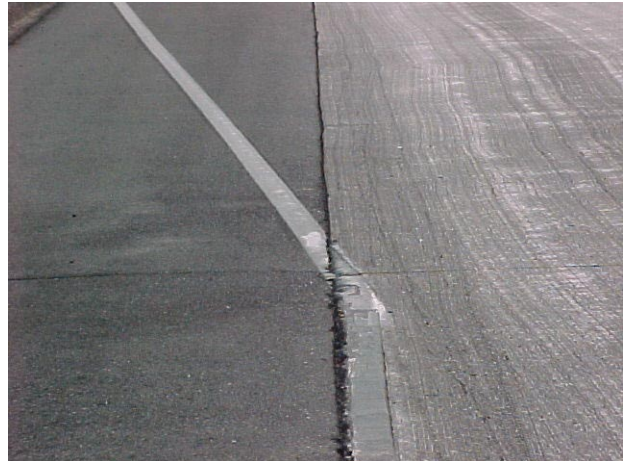
Fig. 11: Epoxy Taper Line in Back Ground Adjoining a White Lumimark Edge Line

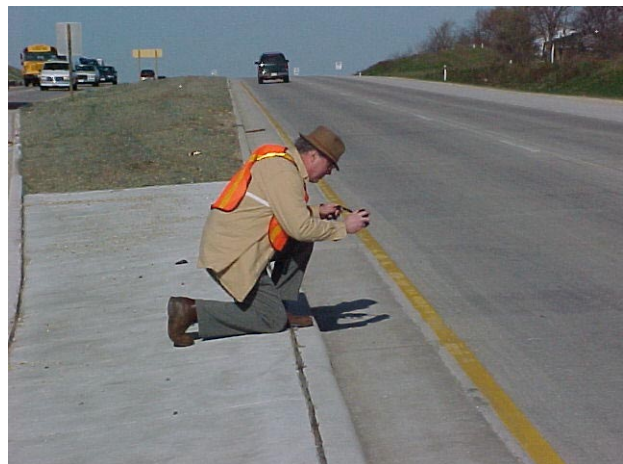
Fig. 13: October 2001, Yellow Lumimark Edge Line
