RR 19-14 | May 2019

TIMBER CROSSTIE SPIKE FASTENER FAILURE INVESTIGATION

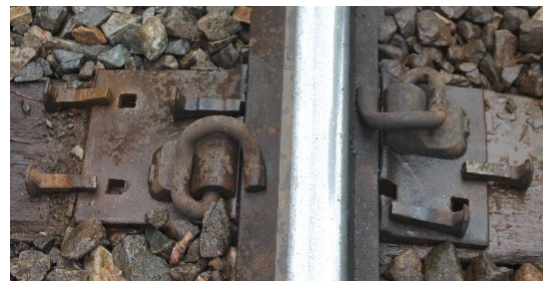
Figure 1. Premium elastic fastener with five broken spikes

During the field visits, researchers found many broken cut spikes and lag screws in track. These failures were almost exclusively in premium elastic fastening systems (Figure 1). Failures were most often found in new crossties installed in curves. UIUC found 121 broken spikes in the high rail in one curve (about 23 percent of the spikes in that section). One railroad reported finding up to 150 broken spikes in one curve.

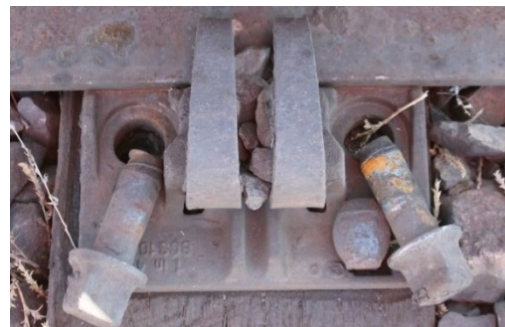
Figure 3. Broken lag screws in McKay fastening system

The literature review and derailment reports reveal that spike failures occur in multiple types of cut spikes and screw spikes ([Figure 3](#)), with various geometries, steel properties, and manufacturers. Spikes have broken in multiple different fastening systems on different railroads. This suggests that spike failure is a mechanism problem due to a certain stress condition, and not a material problem or a matter of manufacturing defects.
