Feasibility of Various Coatings for the Protection of Reinforcing Steel—Corrosion and Bond Testing

Research Report 4904-3

Research Project 7-4904
“Feasibility of Hot Dipped (Zinc) Galvanizing and Other Coatings
for the Protection of Reinforcing Steel”

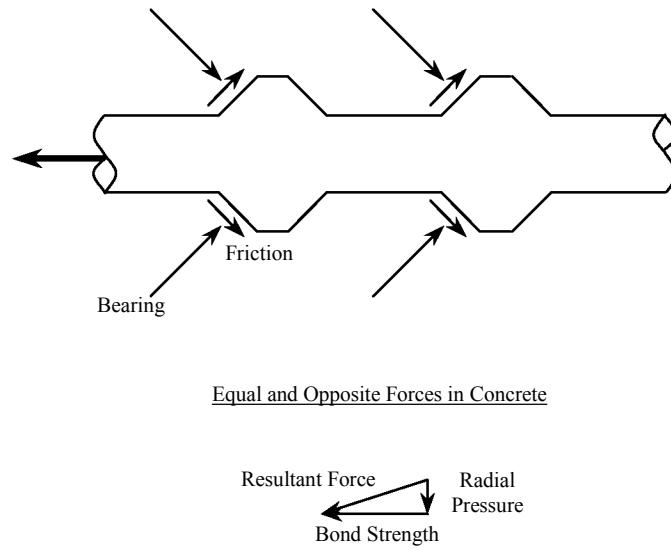
With the loss of adhesion and friction, bearing on the bar deformations is the only component that contributes to the development of coated bars. A comparison of the resulting bond forces for uncoated and epoxy-coated bars is shown in Figures 2.6 and 2.7.

Figure 2.6: Uncoated Reinforcement Bond Forces

The friction and bearing force vectors can be added to determine the resultant force. As can be seen in Figures 2.6 and 2.7, friction is beneficial to bond because it decreases the angle of the resultant force, which results in a smaller radial splitting force. The use of epoxy-coated bars increases the angle of the resultant bond force and causes higher radial splitting force. This indicates that epoxy-coated bars will have less bond capacity because they are more likely to experience a premature splitting failure than are uncoated bars.

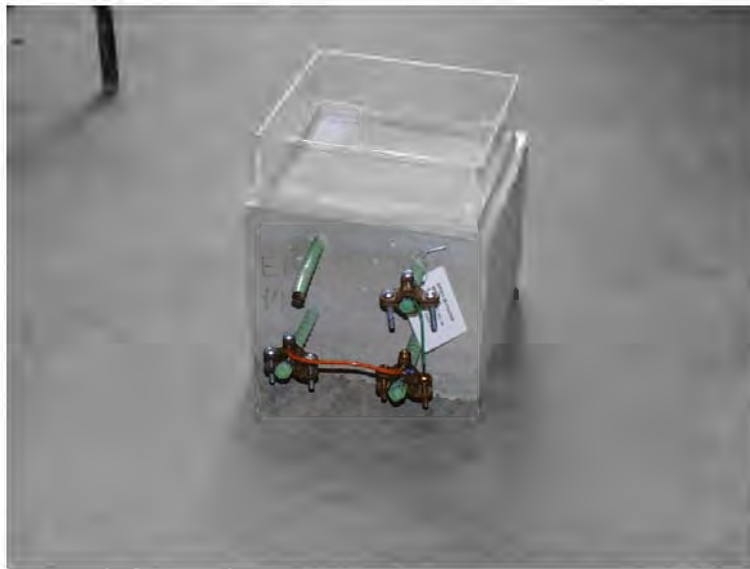
Figure 3.2: Completed Macrocell Specimen

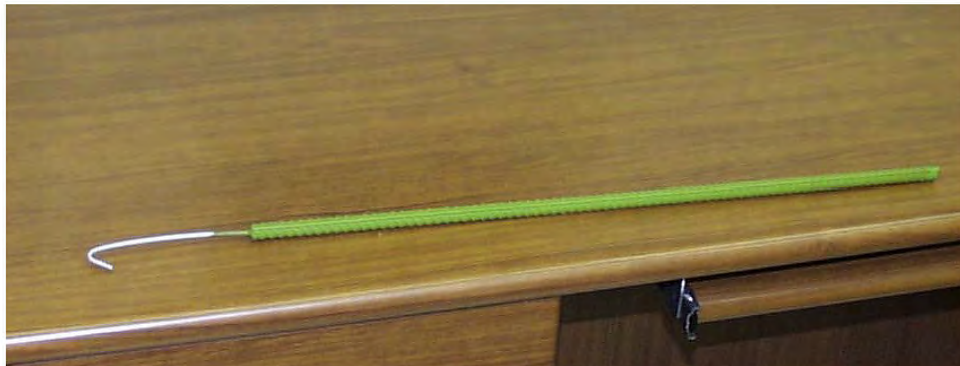
All of the bars submitted by the PVC manufacturer were coated. A hook, which was used to dip the bars to apply the coating, was removed from each bar (see Figure 4.5). The coatings were removed from three bars for use in the control specimens. It is important in the bond testing of coated bars that the control specimens have uncoated bars from the same heat treatment in order to minimize differences in the chemical composition and bar deformation pattern. The PVC coating was removed by submerging the bars in methylene chloride. The methylene chloride softened the PVC coating and the softened coating was removed with a wire brush. A bar with the PVC coating removed can be seen in Figure 4.6.

Figure 4.5: Typical PVC-Coated Bar

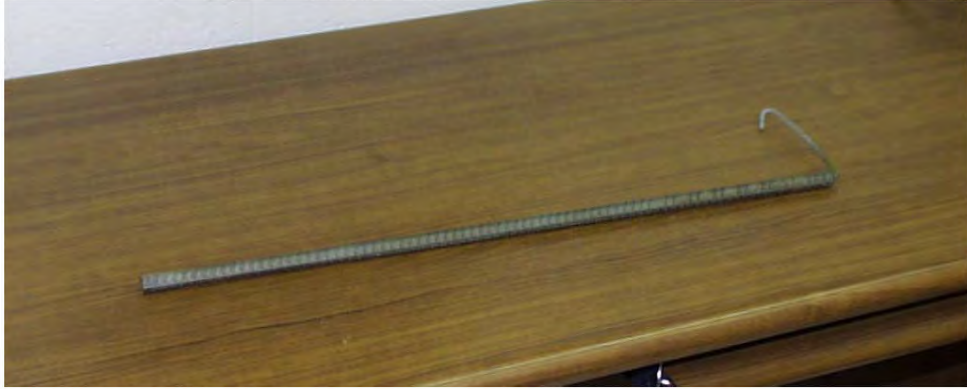
Figure 4.6: Typical Bar After Removal of PVC Coating

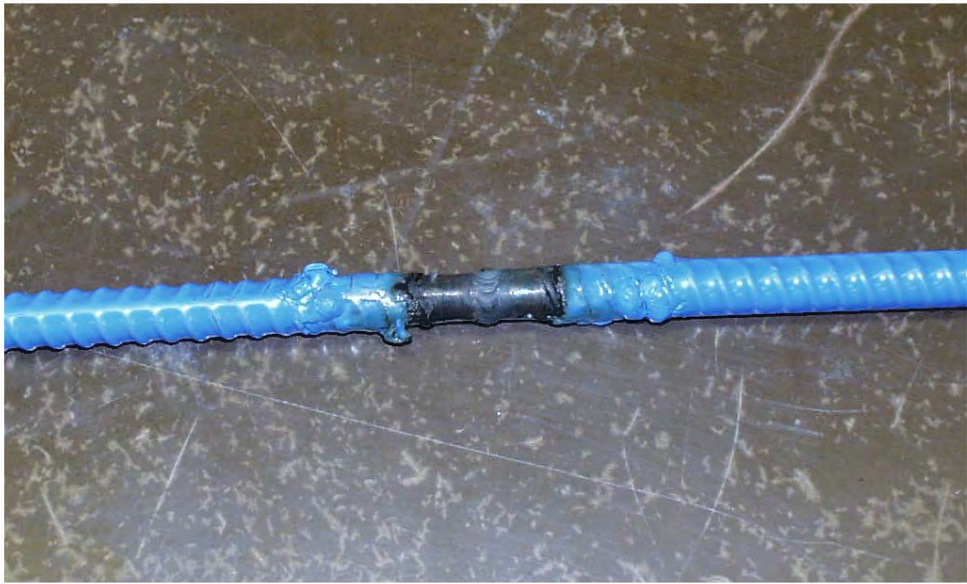
The length of the nylon bars was not sufficient for this particular pullout specimen and test setup. Numerous attempts were made to acquire additional #4 uncoated and nylon-coated bars; however, the nylon -manufacturer was unable to submit these materials. To obtain the length of bar required for the pullout test, two nylon bars were welded together, end-to-end. A picture of the welded bars can be seen in Figure 4.7. The nylon coatings were removed from three bars for use in the control specimens. The nylon was chemically resistant to methylene chloride, so the nylon was burned off with a propane torch instead. The burned section of nylon coating can be seen in Figure 4.8.

Figure 4.7: Typical Nylon-Coated Bar Weld

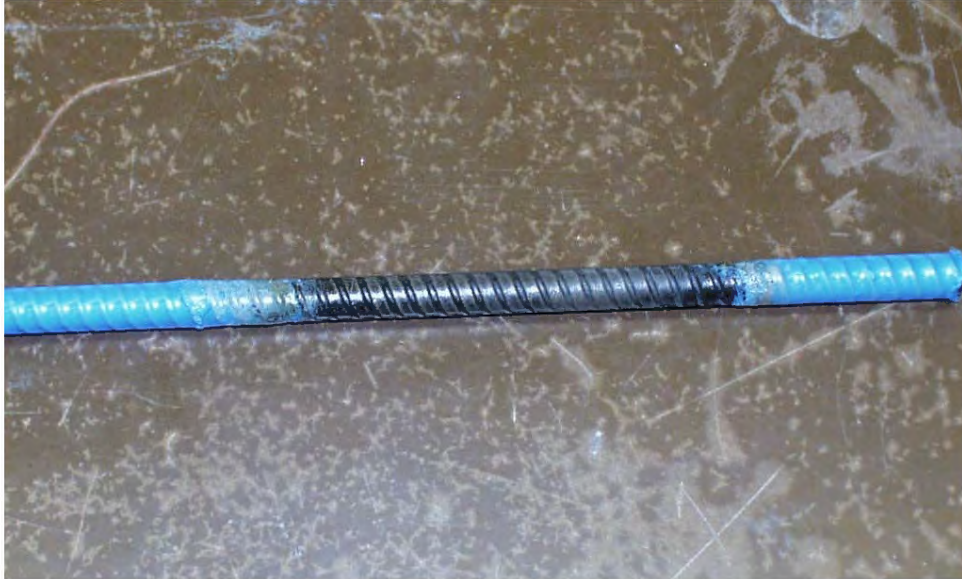
Figure 4.8: Nylon Coating Removed for Control Specimens

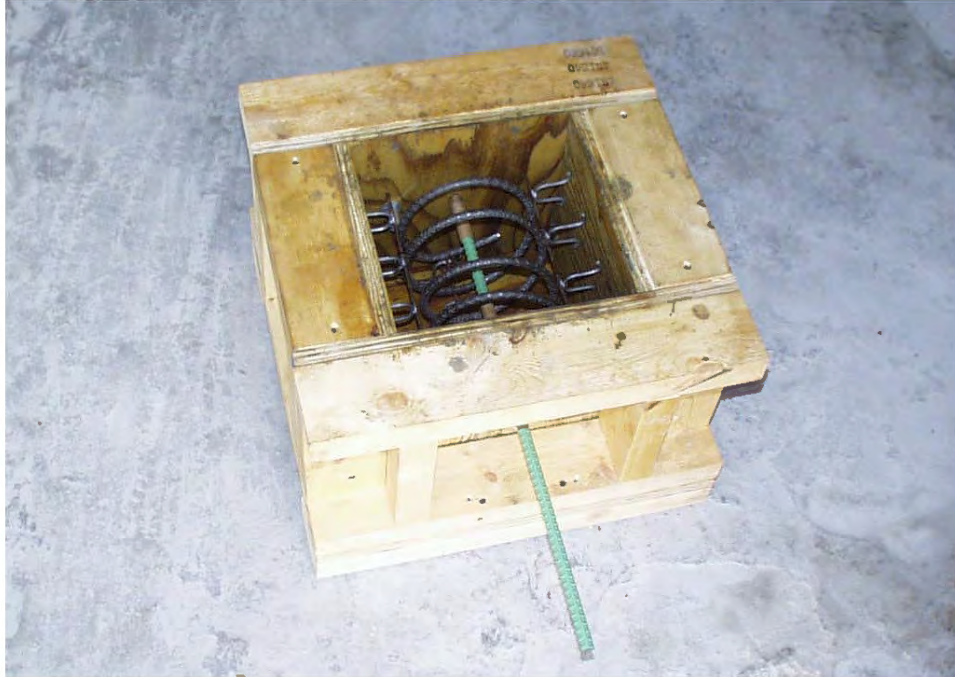
Figure 4.9: Typical Form for Pullout Specimens

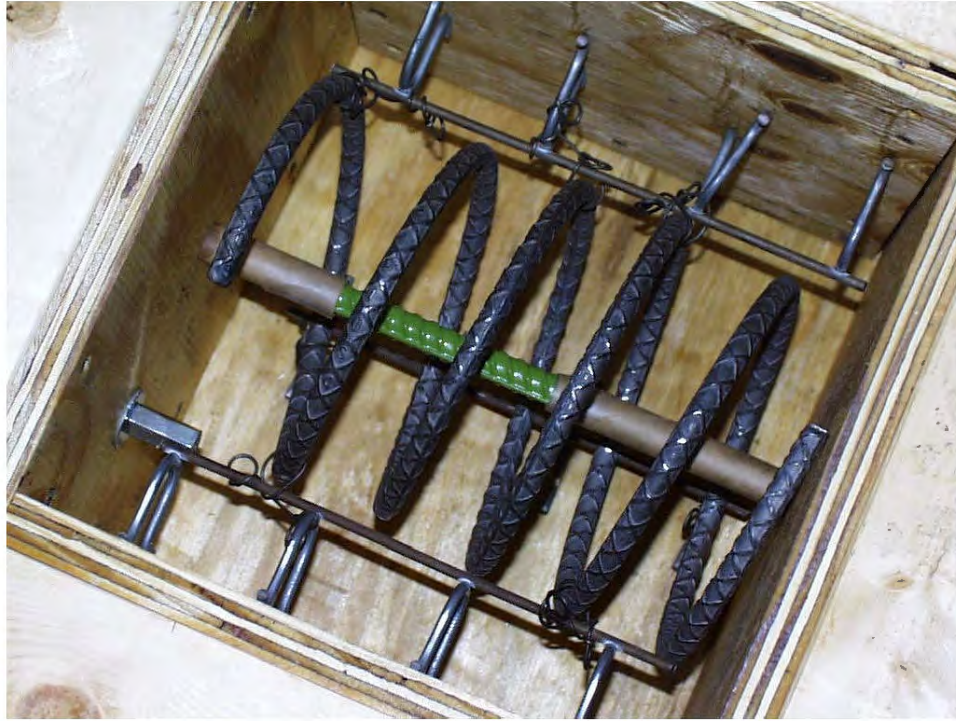
No chairs or other types of supports were used for the placement of the test bar. The pullout specimens were side cast instead, and the ends of the test bars rested directly on the formwork. Both ends of the bar protruded through holes centered in the sides of the formwork. Beam bolsters were used to support the spiral reinforcement in the proper position. The reinforcing steel and test bar set-up can be seen in Figure 4.10.

Figure 4.10: Typical Reinforcing Steel and Test Bar Setup

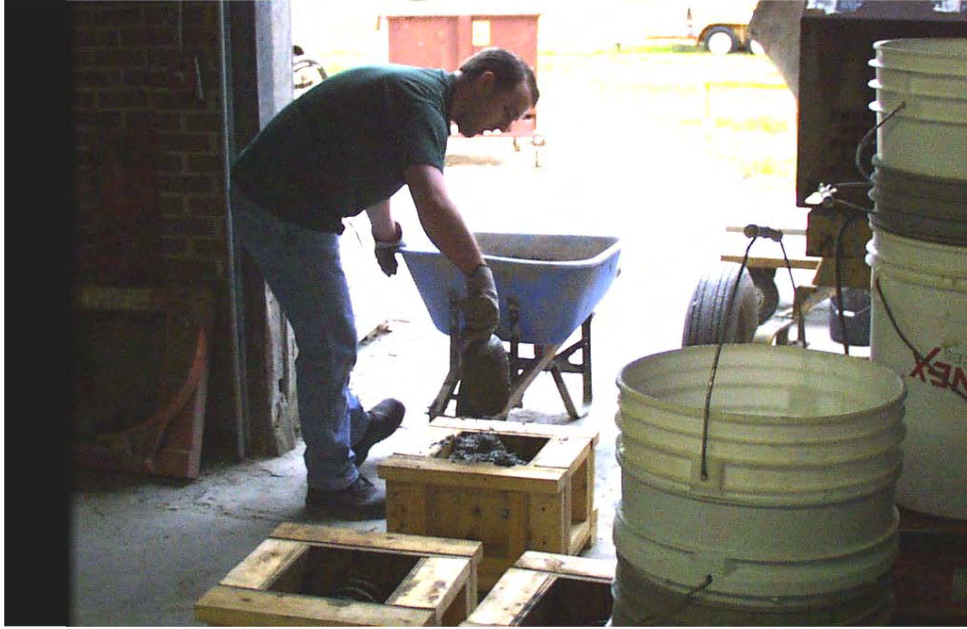
As was stated earlier, six sets of forms were constructed so that all of the pullout specimens for a particular coating could be cast simultaneously. The concrete placement operator is shown in Figure 4.11. The concrete was mixed outside and brought inside with the use of wheelbarrows. The pullout specimens were cast indoors. Scoops were used to place the concrete in the formwork. Then the forms were placed on a vibrating table to consolidate the concrete, as can be seen in Figure 4.12.

Figure 4.11: Concrete Placement for Pullout Specimens

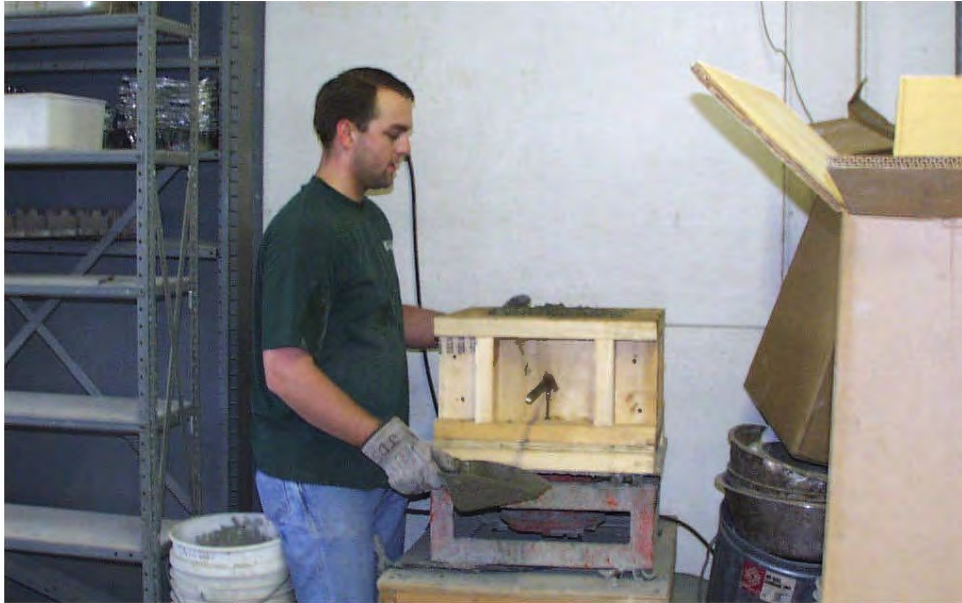
Figure 4.12: Concrete Consolidation

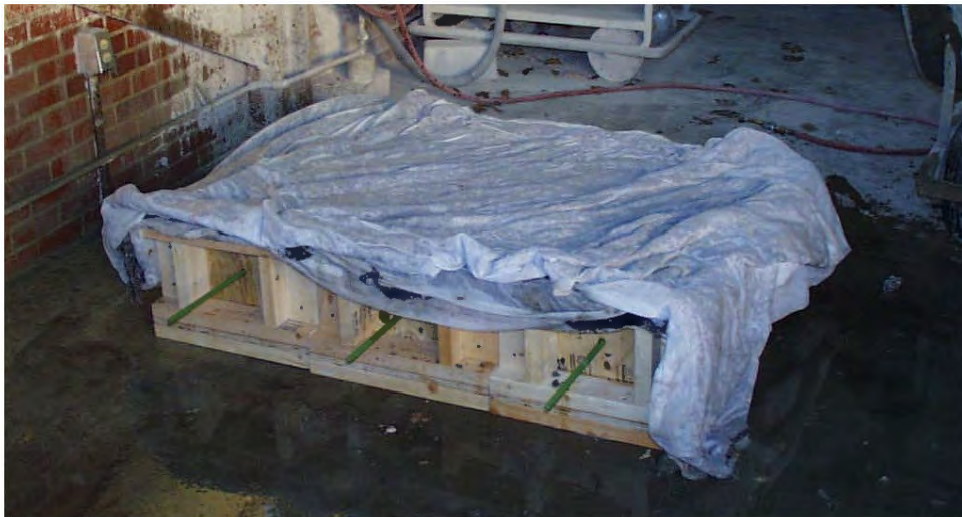
The top surfaces were trowel finished. After the initial set of the concrete, the formwork was covered with wetted curing blankets to create a moist curing environment and to prevent shrinkage cracks. A picture of the initial curing of macrocell specimens is shown in Figure 4.13.

Figure 4.13: Curing of Pullout Specimens

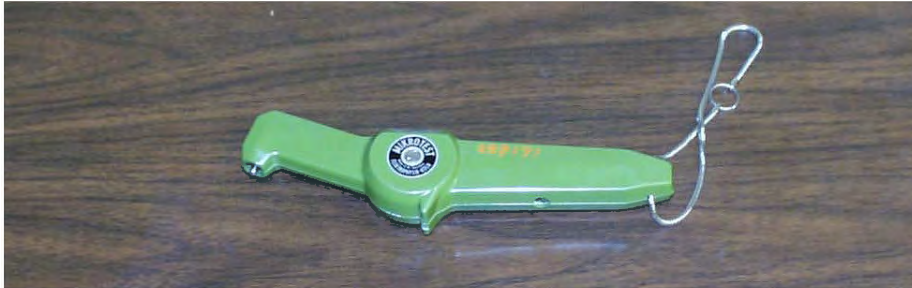
Measurements of the bar deformation and coating properties were taken from a random sampling of bars when received from the manufacturer. The bar deformation properties were recorded using Mitutoyo Digimatic digital calipers, and the coating thickness was measured using a Mikrotest Thickness Gage (Figure 4.14). The measurements are listed in Table 4.2 and include the average deformation spacing, average deformation height, average gap between deformations, and average coating thickness.

Figure 4.14: Digital Calipers and Coating Thickness Gage

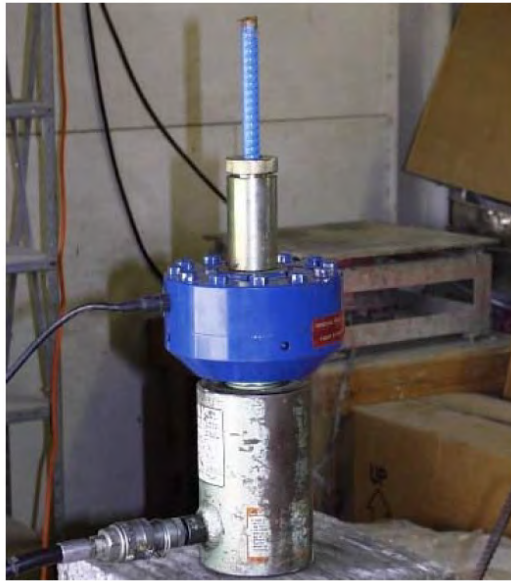
The loading equipment for the pullout tests is pictured in Figure 4.18. Tensile load was applied by using a 20-ton center-hole hydraulic ram, and half-inch prestressed strand grips were used to transfer the load from the ram to the bar. The applied load was measured with an electronic load cell and checked with a pressure gauge. The output from the load cell was powered by a constant voltage supply and was monitored using the Fluke 8060A True RMS Multimeter, as is shown in Figure 4.19.

Figure 4.18: Hydraulic Ram, Load Cell, and Grips

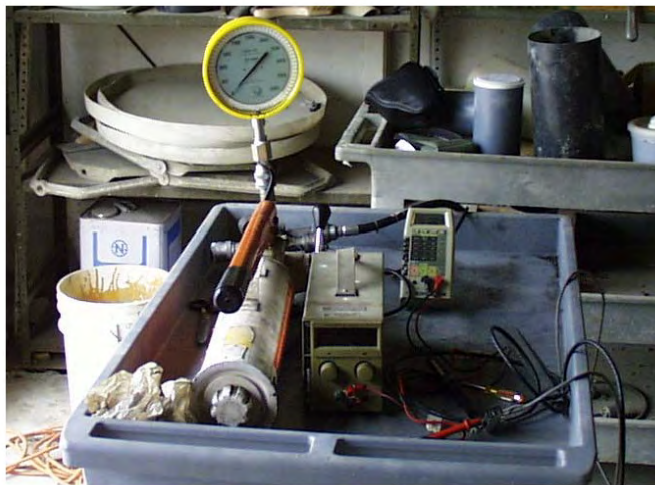
Figure 4.19: Hand Pump and Load Cell Output

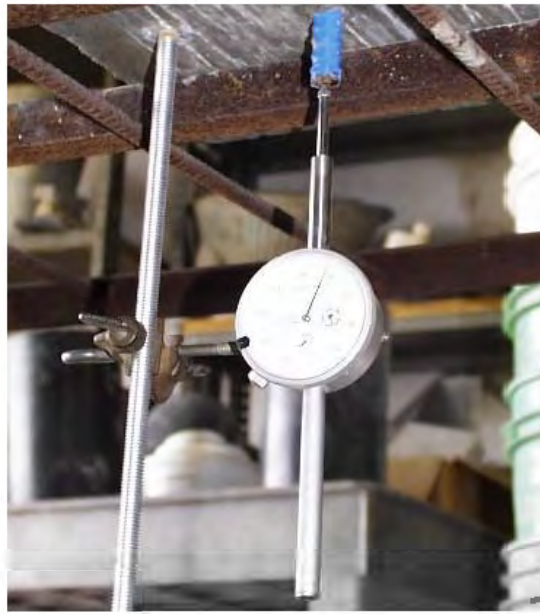
The set-up to measure slip can be seen in Figure 4.20. The slip was measured by using a linear displacement gauge in contact with the free end of the test bar. The gauge was attached to a threaded rod, and the threaded rod was anchored into the coupling that was cast into the pullout specimen.

Figure 4.20: Slip Measured by Linear Displacement Gauge

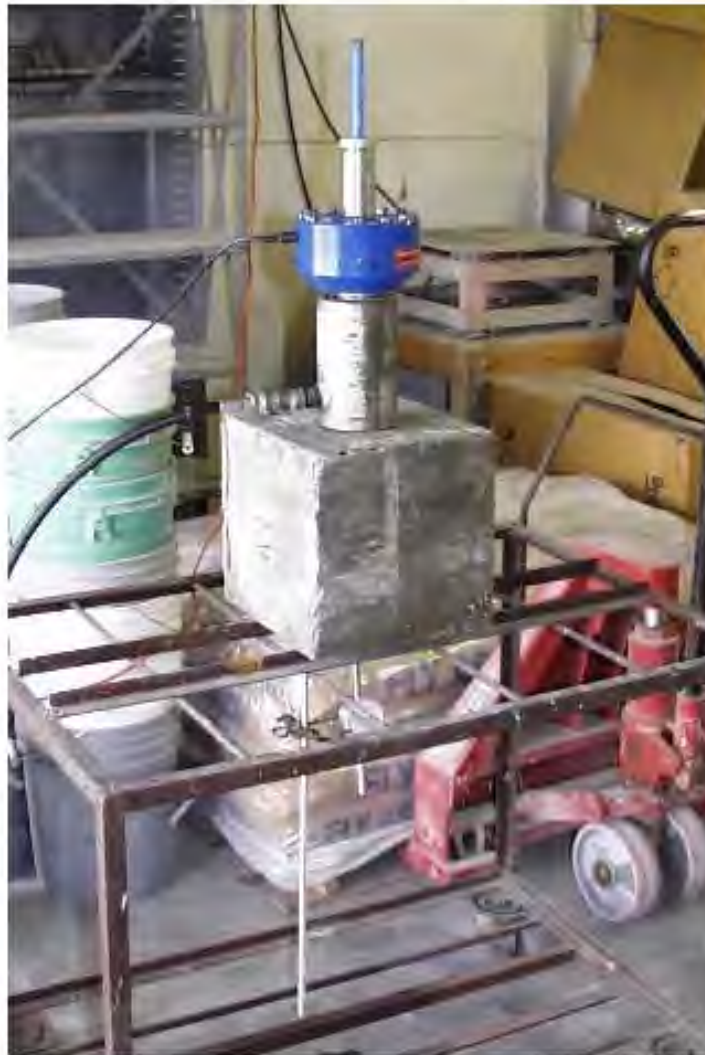
The complete pullout test loading set-up can be seen in Figure 4.21.

Figure 4.21: Complete Pullout Test Loading Setup

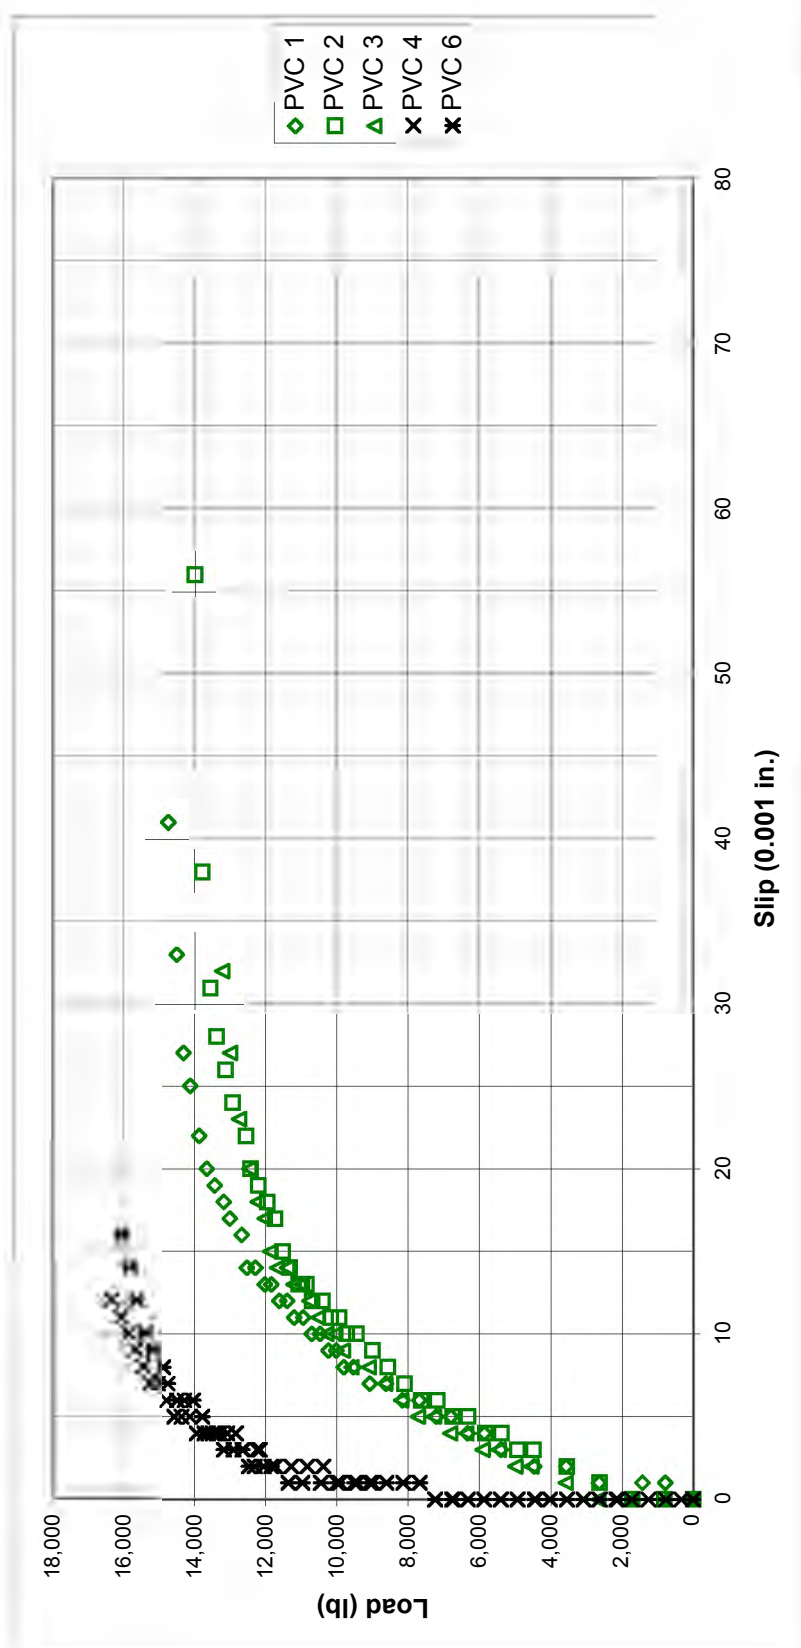
In general, the slip increased as the load increased. The relationship between load and slip is approximately linear at lower loads. As the load approached the capacity of the embedment, the slope of the load-slip curve began to decrease, characterized by large increases in deflection with little increase in load. This general shape for the load-slip curve was observed for all tests, although the ultimate capacities and slips differed. This general shape was also observed for the nylon specimens, despite the premature weld fracture. The pullout failures of the PVC and epoxy specimens were sudden, and the minimal amount of load-carrying capacity that remained after pullout was attributed to sliding friction along the cylinder of concrete between the bar deformations. No splitting cracks were observed before failure.

Figure 5.1: Load-Slip Response of PVC Specimens

The uncoated specimens in the PVC group reached yield and strain hardened. The average measured yield stress for the uncoated PVC bars was 62,200 psi. Yielding and strain hardening would not have affected the slip measurements, because the plastic deformations occur along the loaded portion of the bar and the slip was monitored at the free end.

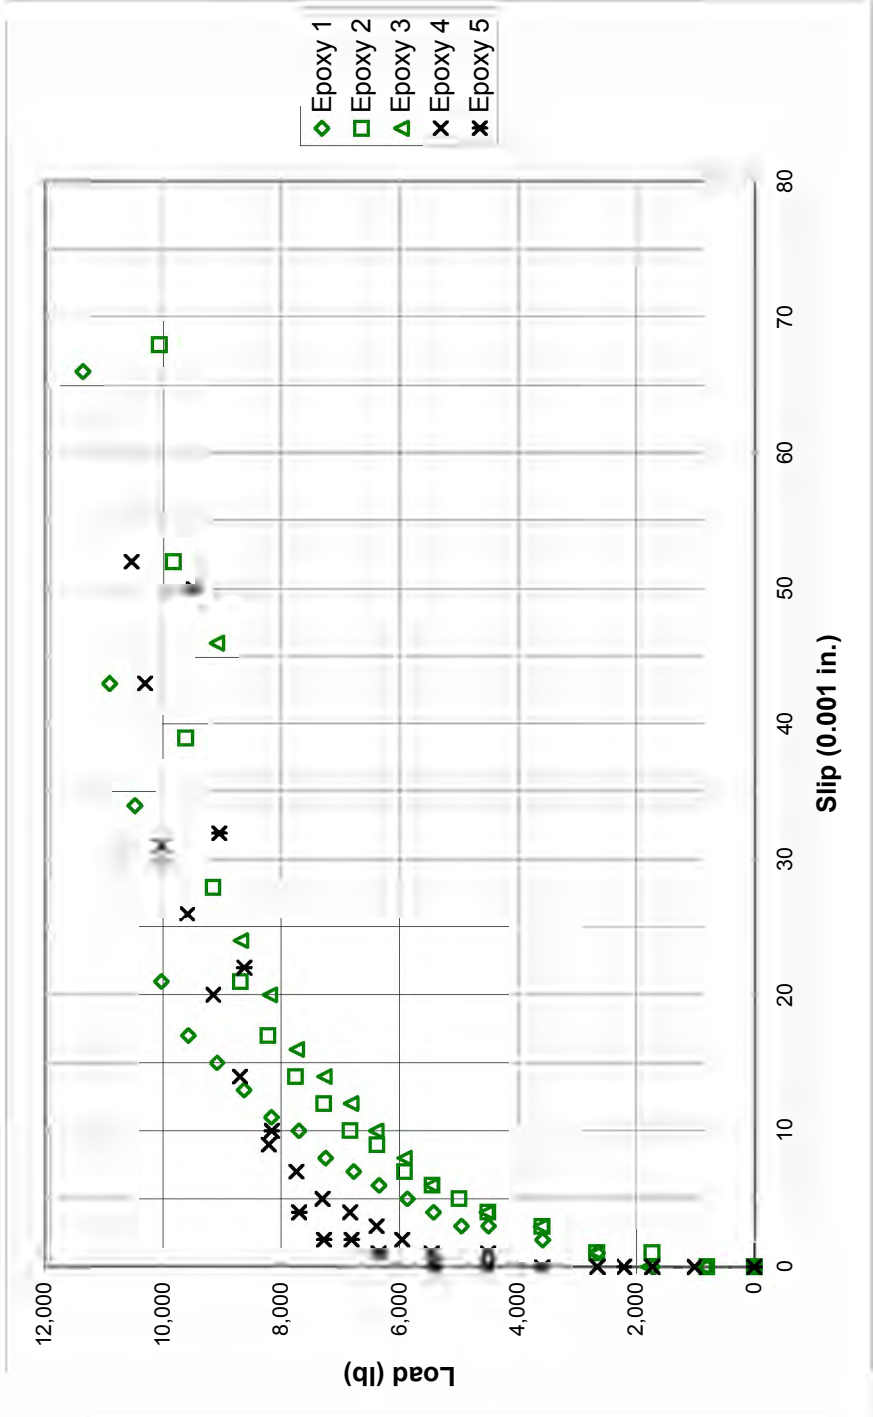
Figure 5.2: Load-Slip Response of Epoxy Specimens

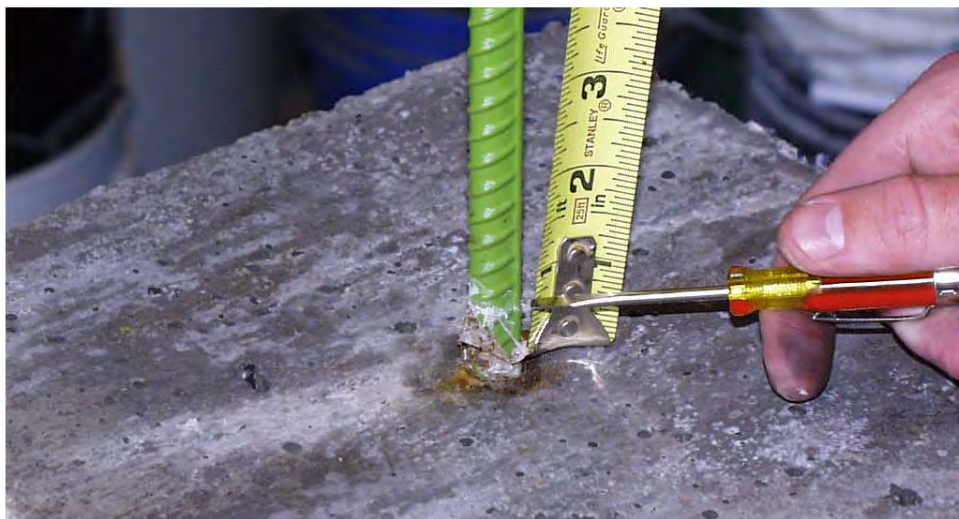
PVC and epoxy specimens that have failed in pullout can be seen in Figures 5.4 and 5.5, respectively. The relative slip between the bar and the concrete prism is indicated. In several cases, additional force was applied after pullout to remove the grips from the bar. A typical weld fracture for the nylon specimens can be seen in Figure 5.6.

Figure 5.4: Typical PVC Pullout Failure

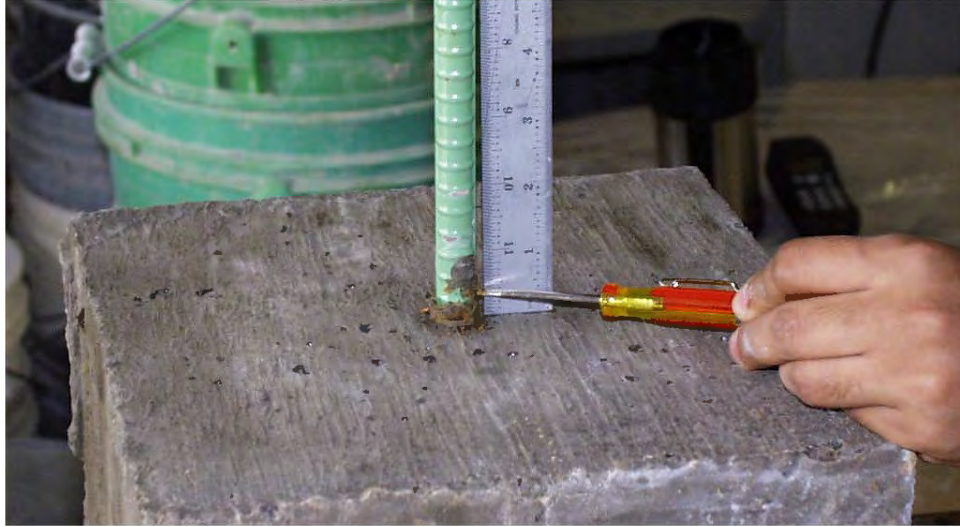
Figure 5.5: Typical Epoxy Pullout Failure

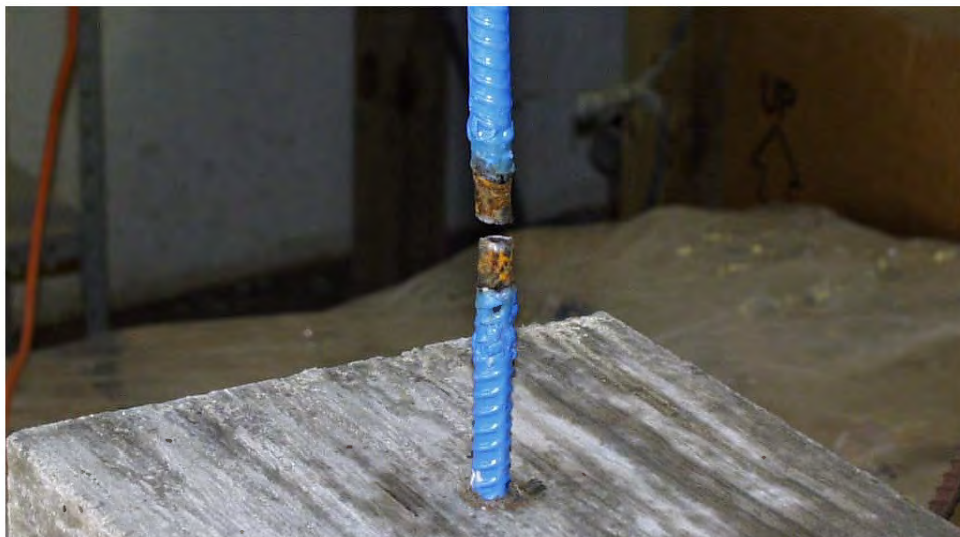
Figure 5.6: Typical Nylon Weld Fracture
