DOT/FAA/AR-99/8,IV

Improved Barriers to Turbine Engine Fragments: Interim Report IV

June 2002

9. Performing Organization Name and Address SRI International 333 Ravenswood Avenue Menlo Park, CA 94025-3493				10. Work Unit No. (TRAIS)	
				11. Contract or Grant No. 95-G-010

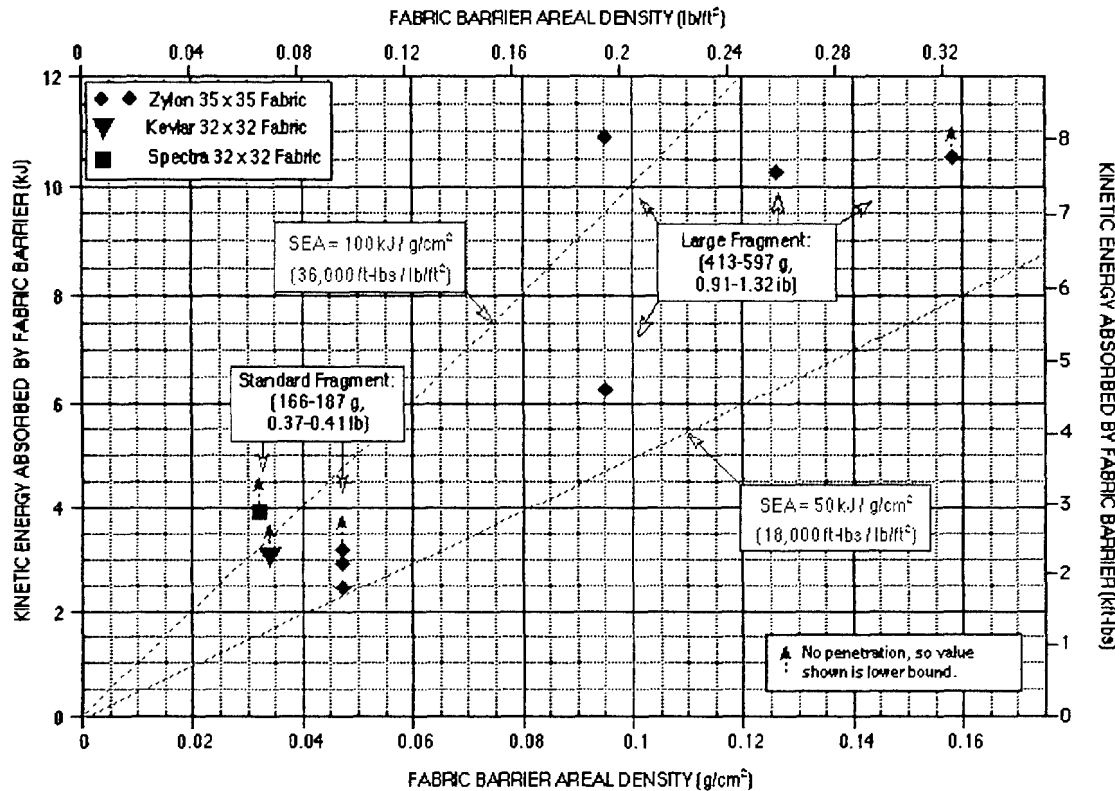
FIGURE 4. ENERGY ABSORPTION RESULTS OF FUSELAGE IMPACT TESTS

The results of the tests showed that for large-real-turbine airfoil fragments, control of the impact orientation was difficult. The airfoils would rotate as they moved from the sabot to the fuselage structure. There was a noticeable decrease in accuracy when the larger 12-inch gas gun was used to fire larger fragments from the earlier full-scale testing with the 6-inch gun [4 and 5]. The motion and impact orientation are, however, well documented in the high-speed film providing valuable test data. The resulting database will be useful for evaluation of the final material and failure models. At the current program stage, the test point scatter makes relative comparison of the materials from this data difficult.

yarns cut. So, for example, Zylon's potential SEA was much greater than the lower bound value shown, while the potential SEA for Kevlar was only negligibly greater than the lower bound value. The Zylon barrier could have taken significantly more additional kinetic energy before it was penetrated than could the Kevlar barrier. Also, the impact orientations for these three tests were different. The different impact areas and number of yarns that needed to be cut for penetration complicates a direct comparison of the tests. A direct comparison of Zylon, Kevlar, and Spectra was described in an earlier report [4].

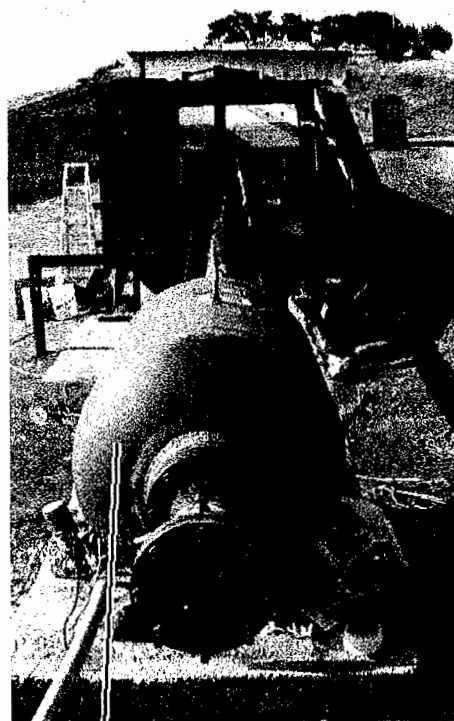
(a) View from behind breech

Gas Gun Breech

(b) Close-up of Muzzle Region

6-in.-bore
Barrel

Velocity
Sensors

(c) View from high-speed camera location

Fragment
Recovery
Chamber

Fuselage
Frame
Section

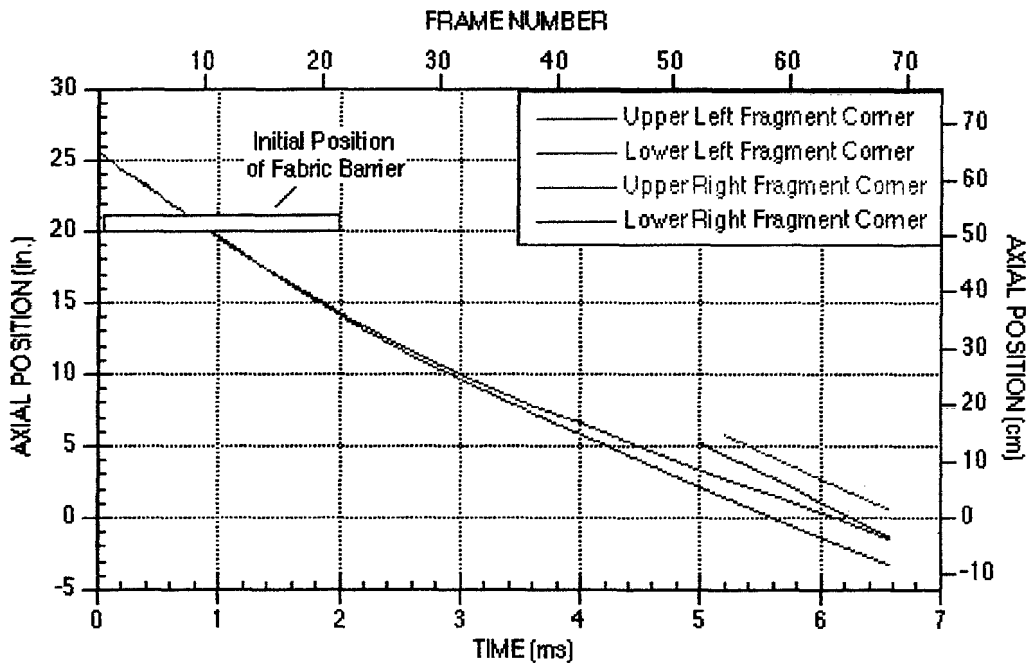
FIGURE 10. AXIAL POSITION OF VISIBLE FRAGMENT CORNERS IN TEST 114

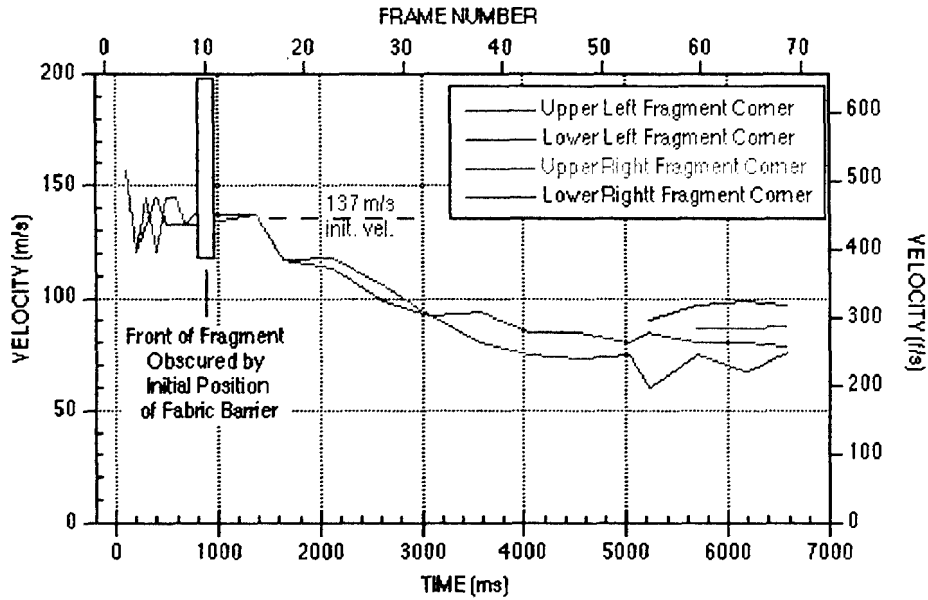
FIGURE 11. AXIAL VELOCITY OF VISIBLE FRAGMENT CORNERS IN TEST 114

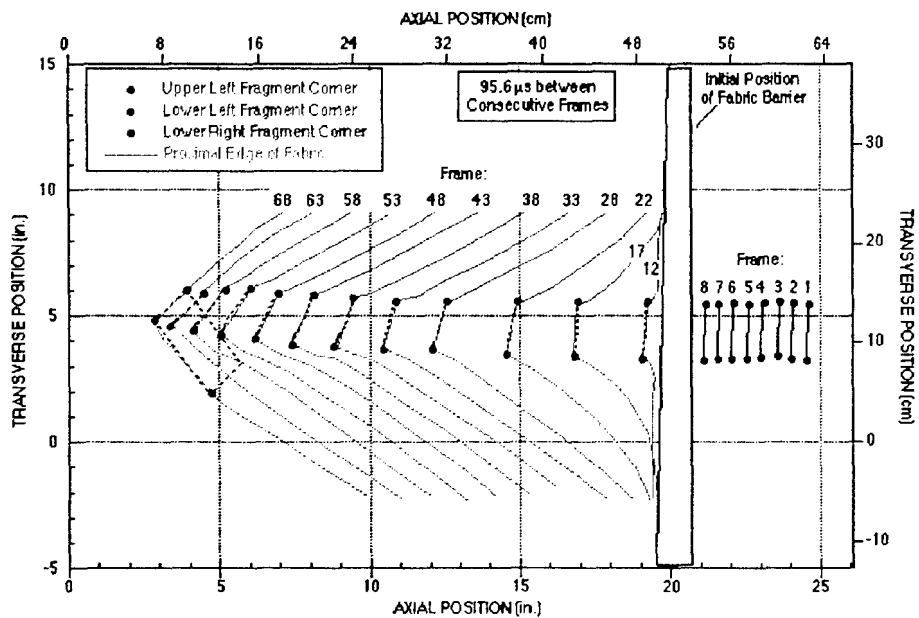
FIGURE 12. SILHOUETTES OF FRAGMENT AND FABRIC MOTION DURING IMPACT TEST 115

Figures 12 through 14 are the same three graphs for test 115. For this test, only the lower front corner of the fragment perforated the fabric (by frame 28). The fragment continued to deform the fabric, while it decelerated and rotated. The location of the lower back fragment corner is apparent in frame 68, but after that no clear outline of the fragment is visible. The fragment did not yet reach zero axial velocity at that time. Since the fragment did not completely perforate the fabric, and since there was no mark on the witness plate to denote any impact, the residual fragment velocity was deemed to be zero (three of the four fabric corners remained fastened to the frame).

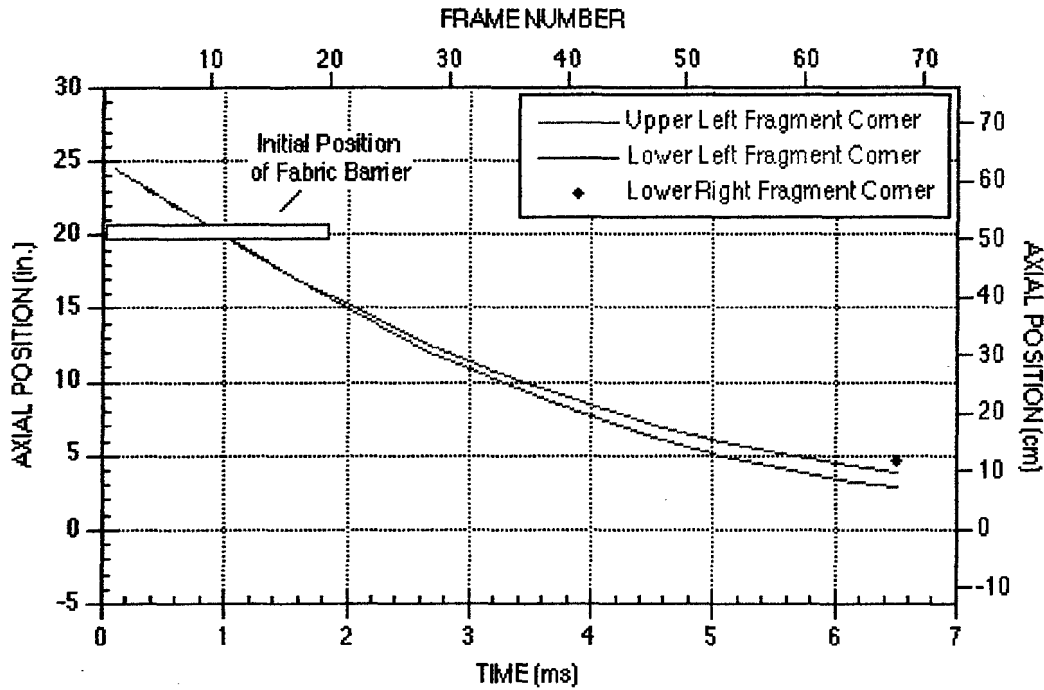
FIGURE 13. AXIAL POSITION OF VISIBLE FRAGMENT CORNERS IN TEST 115

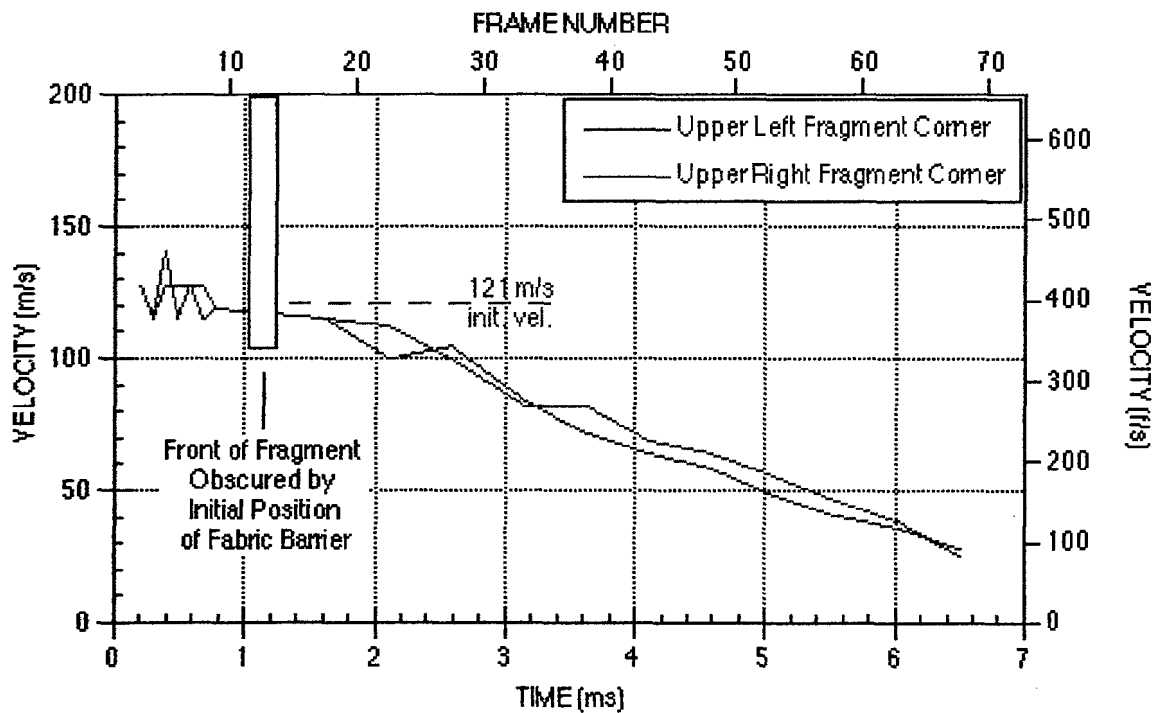
FIGURE 14. AXIAL VELOCITY OF VISIBLE FRAGMENT CORNERS IN TEST 115

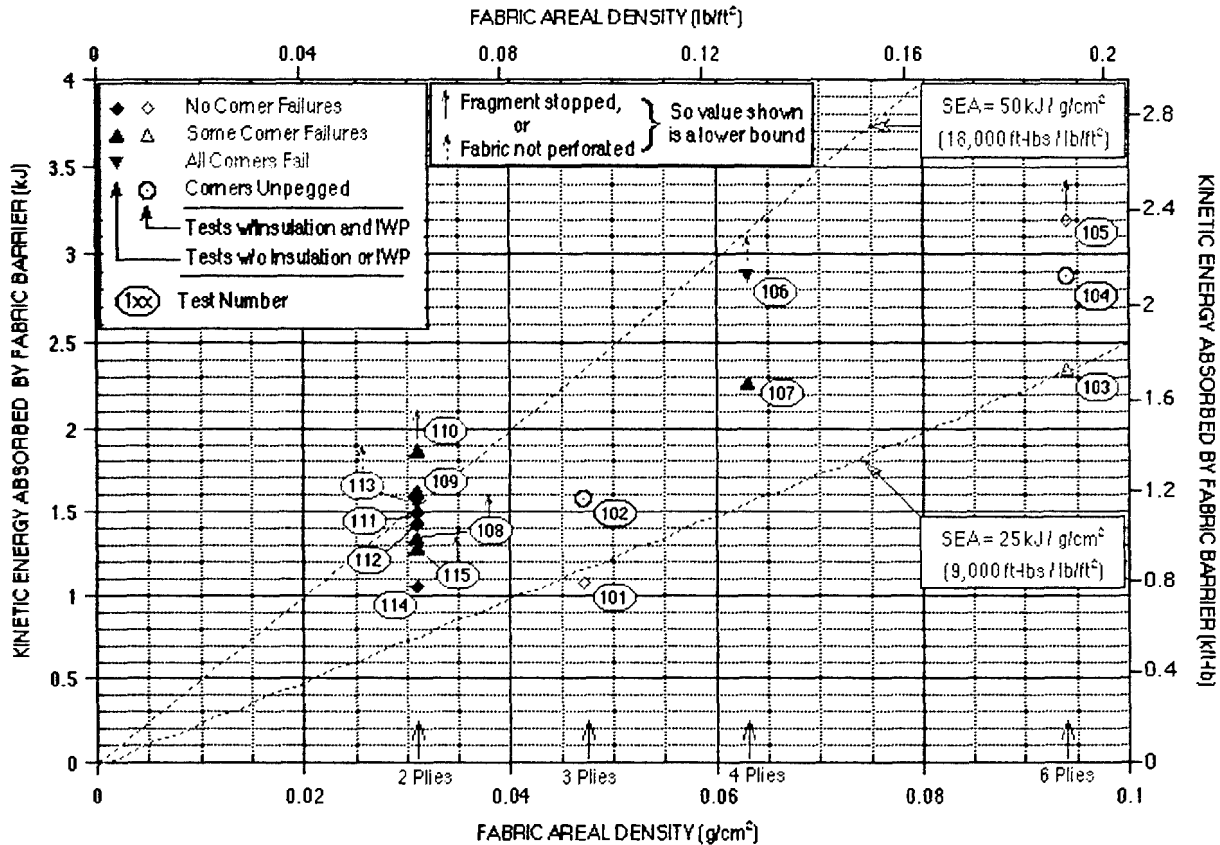
FIGURE 15. RESULTS OF LARGE-SCALE FRAGMENT BARRIER IMPACT TESTS WITH ZYLON FABRIC

TEST RESULTS—ENERGY ABSORPTION. The energy absorption and areal density values shown in table 3 are plotted in figure 15. The SEAs range from 23 to >60 kJ/g/cm^2 (8 to >20 kft-lb/lb/ft^2), which are somewhat less than the 52 to ≥ 66 kJ/g/cm^2 (19 to ≥ 24 kft-lb/lb/ft^2) range of SEAs for the same type of fragment impacting the same Zylon fabric in the second series of fuselage impact tests at China Lake. This is reasonable, since the impact areas (and hence the number of yarns that need to be cut to allow penetration) in these tests were significantly less (because of the nearly 0° yaw attained) than in the China Lake tests (where the yaws were large).

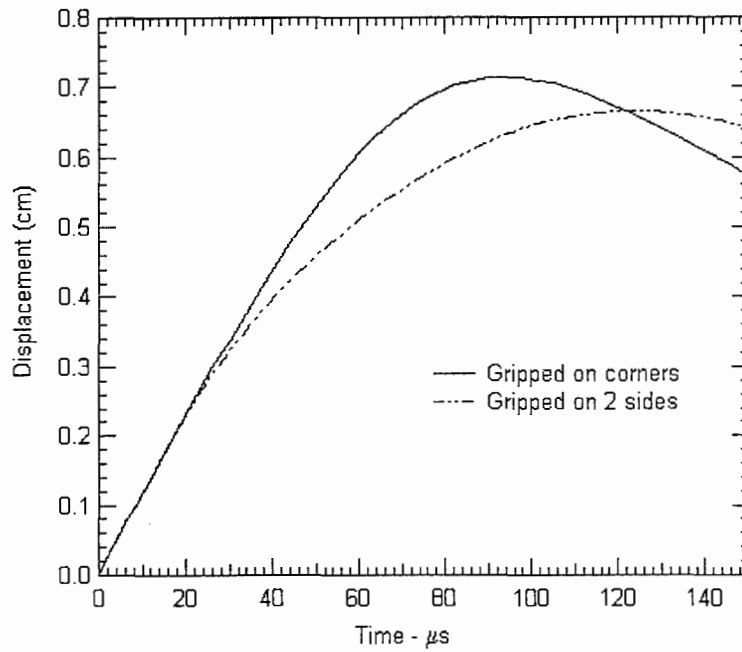
FIGURE 20. CALCULATED DISPLACEMENTS FOR FABRIC IMPACT SIMULATIONS

Figure 20 shows the calculated displacements of the fragment for the two cases. At the time when the fragment is just stopped, the peak displacement of the fabric is slightly higher (0.72 cm vs. 0.66 cm) for the fabric gripped on the corners. These simulations confirm that fabric gripping is a key parameter for optimizing barrier design and suggest that it is advantageous to grip the fabric in such a way that the impacted yarns are not broken.

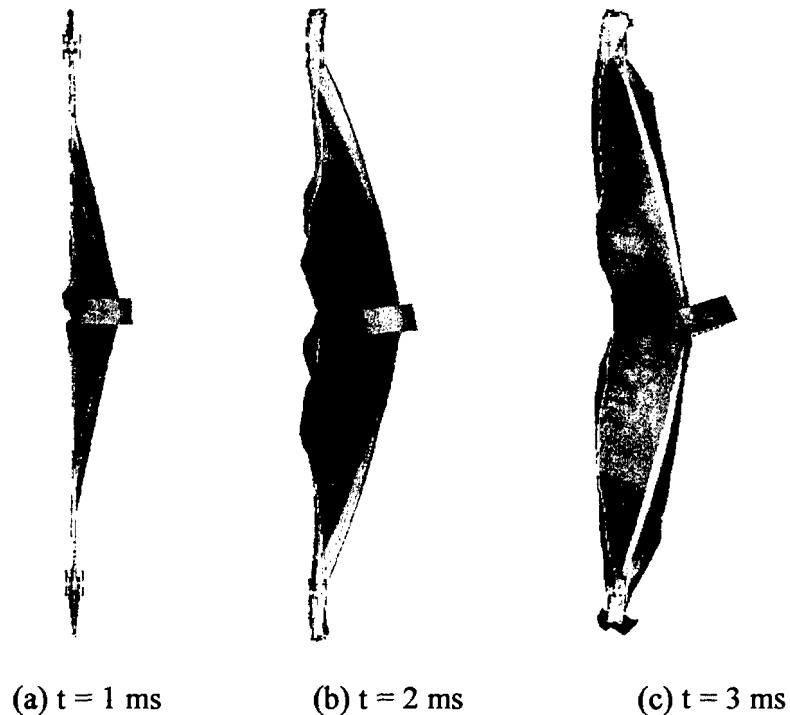
FIGURE 23. SIMULATION OF TEST 114

SIMULATION OF TEST 114. Simulation results for large-scale test 114 are shown in figure 23. Compared to test 101, test 114 was a larger target and had no sag in the fabric. In this figure, the fragment is traveling left to right, and the fabric was made transparent so the fragment could be seen. At 1 ms, the fragment velocity was 100 m/s; at 2 ms, the velocity was 55 m/s; and at 3 ms, the fragment had penetrated the fabric with a residual velocity of 20 m/s. The residual velocity measured in the experiment was 83 m/s. Similar to the simulation of test 101, the model is too strong. In terms of energy, the model overpredicts the energy absorbed by 0.58 kJ. Preliminary investigation of the deformation of the fabric shows that the model is too stiff (i.e., the simulation shows less deformation of the fabric than seen in the experiment).

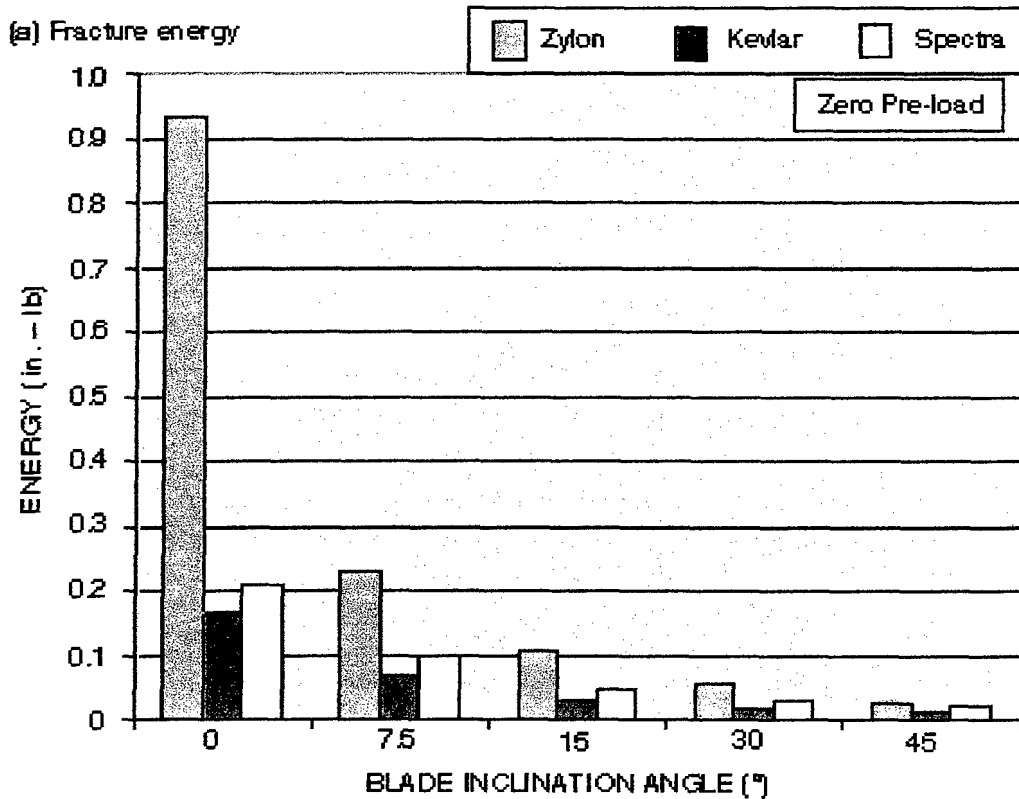
FIGURE A-7. DEPENDENCE OF FRACTURE ENERGY ON BLADE INCLINATION ANGLE FOR TRANSVERSE CUT TESTS WITH UTILITY BLADE

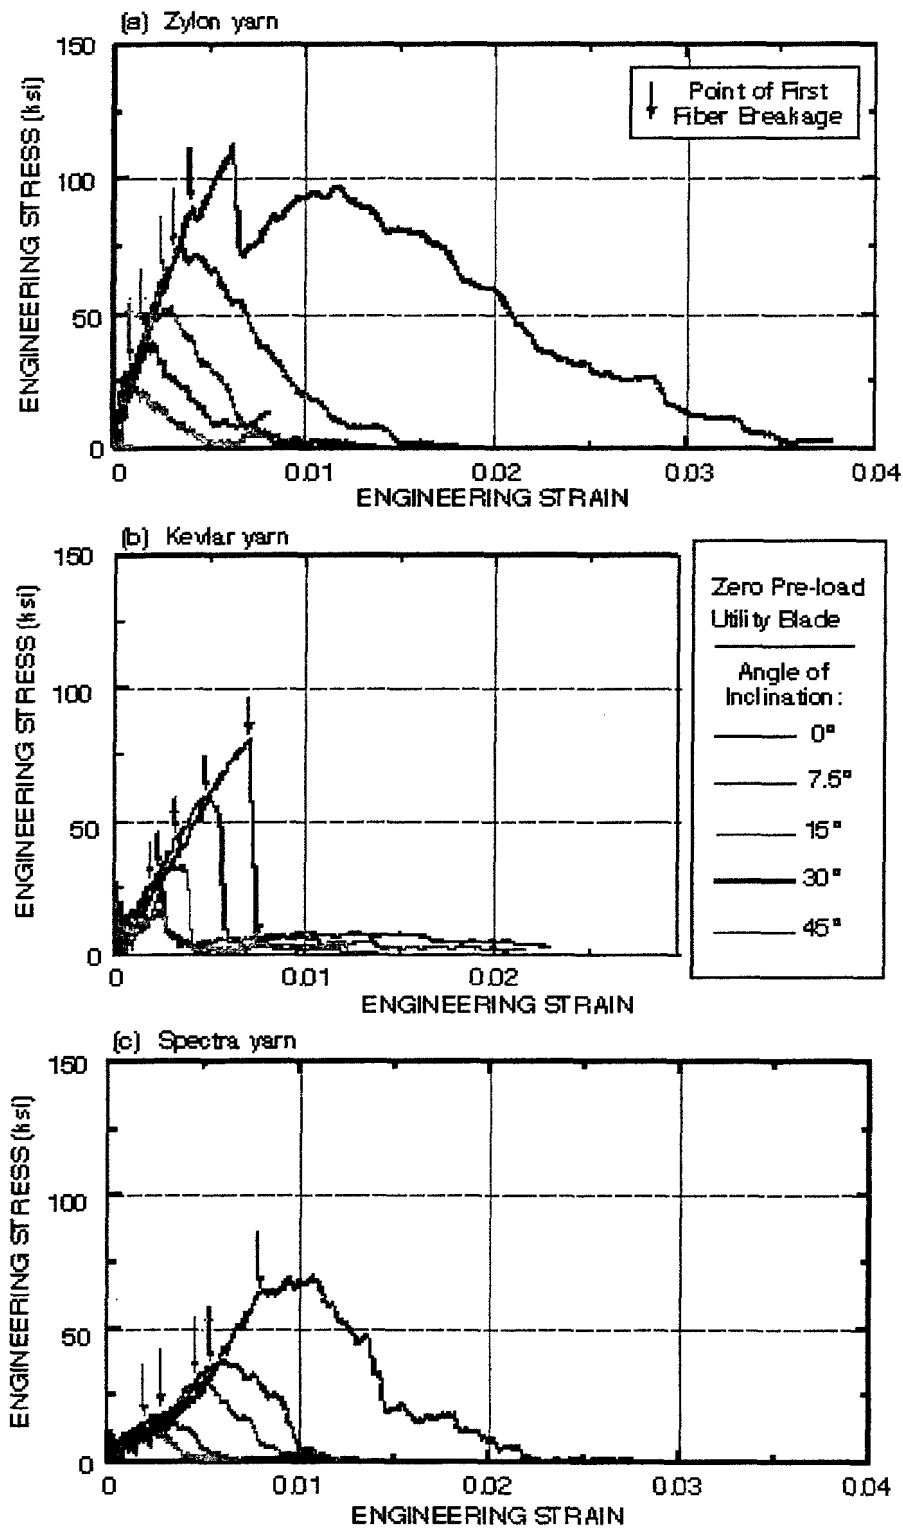
FIGURE A-9. TENSILE STRESS-STRAIN CURVES FROM TRANSVERSE CUT TESTS WITH UTILITY BLADE

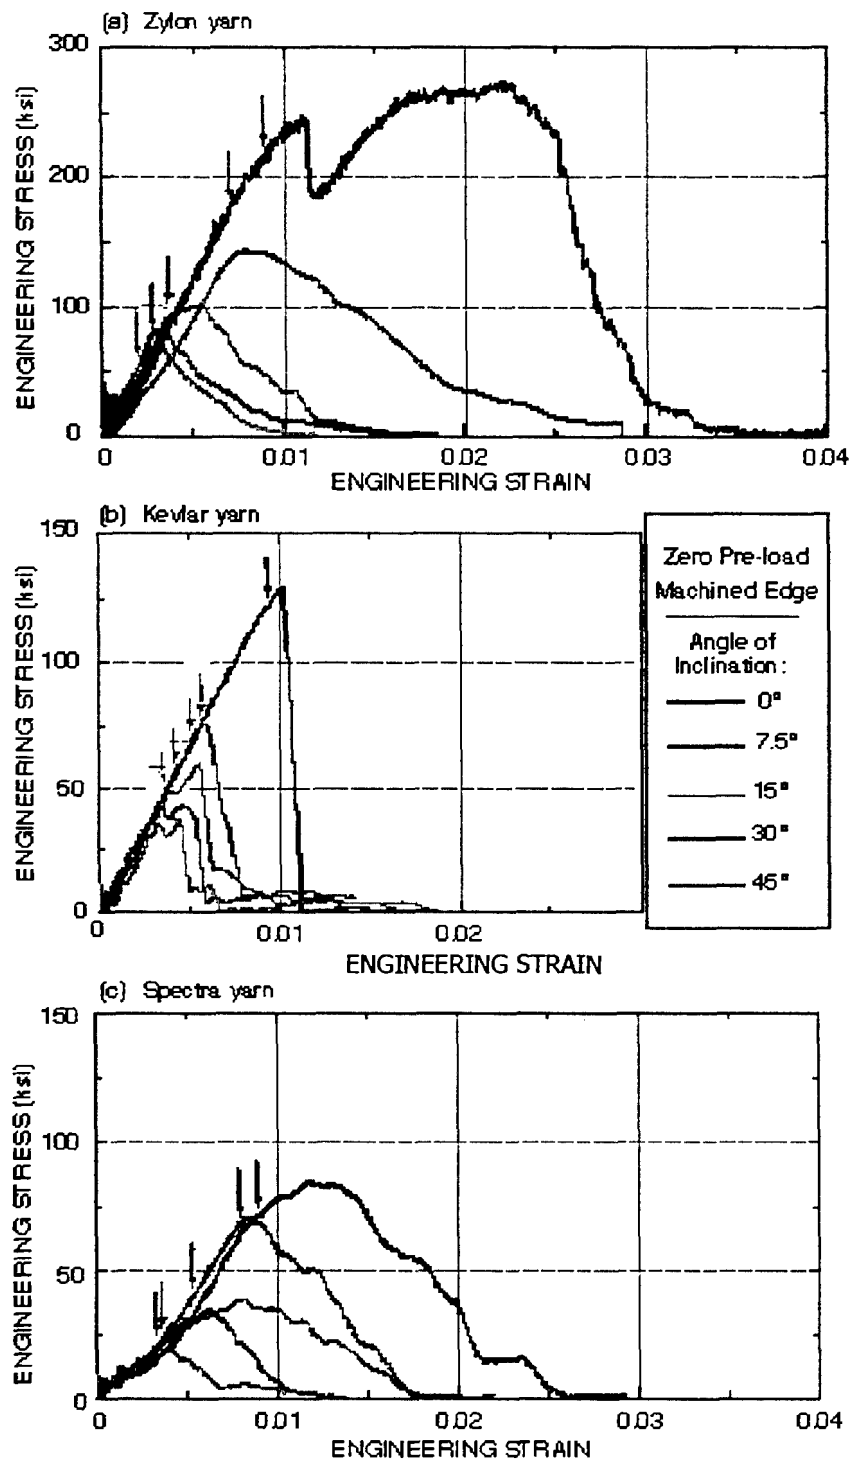
FIGURE A-10. TENSILE STRESS-STRAIN CURVES FROM TRANSVERSE CUT TESTS WITH MACHINED EDGE

A series of transverse cut tests with the machined edge showed results similar to those with the cutter blade (figure A-10), except that the increased radius of curvature of the blade (e.g., decreased cutter sharpness) delayed the initiation of fiber breakage, leading to higher peak stresses and increased fracture energy. Figure A-11 compares the fracture energy for the two different blade sharpnesses. For each material, the fracture energy was significantly lower for the sharper blade. The effect was largest for Zylon and Spectra, where the difference between the two blades was nearly a factor of two or higher for all angles of inclination. Kevlar showed less difference ($\approx 30\%$ to 40%), at least for the two lowest inclination angles.

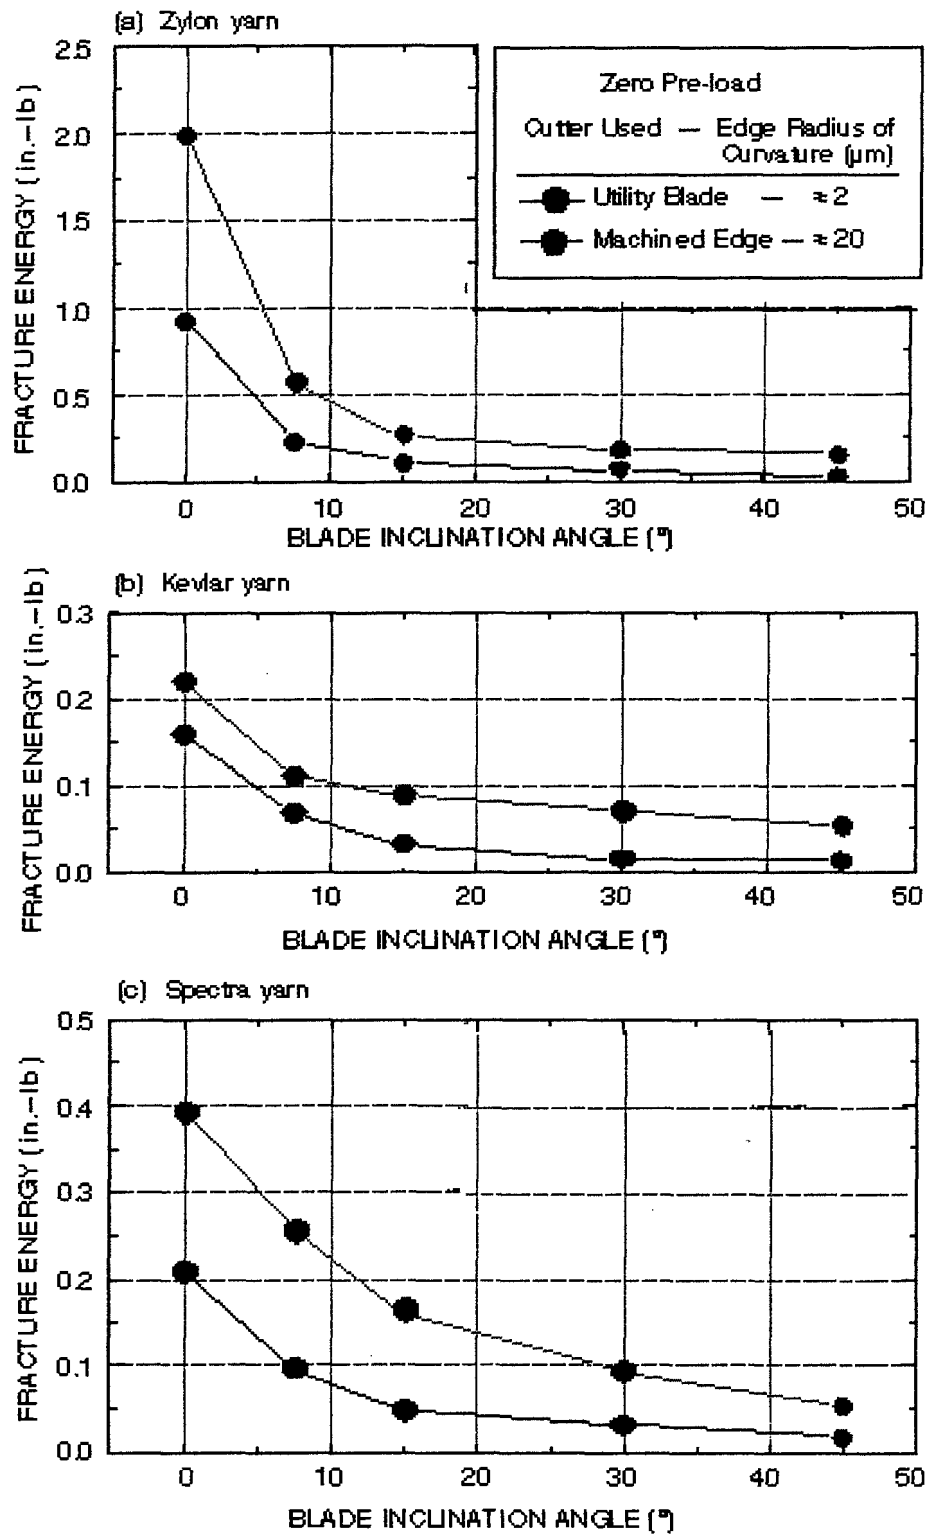
FIGURE A-11. EFFECT OF CUTTER SHARPNESS ON FRACTURE ENERGY IN TRANSFER CUT TESTS

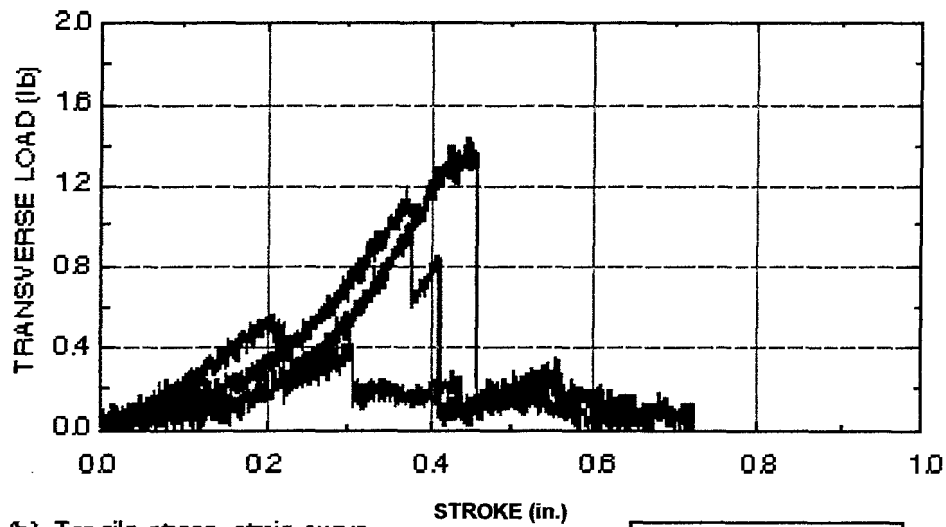
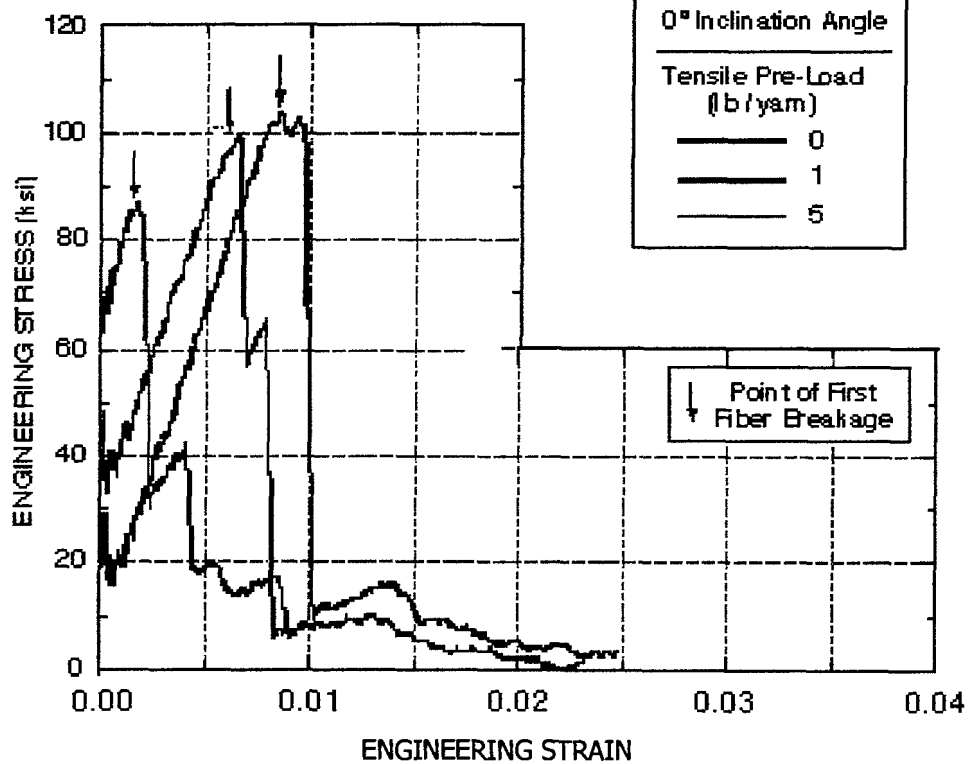
(a) Transverse load-stroke curve

(b) Tensile stress-strain curve

FIGURE A-13. EFFECT OF AXIAL PRE-TENSION ON TRANSVERSE CUT TEST BEHAVIOR OF KEVLAR YARNS

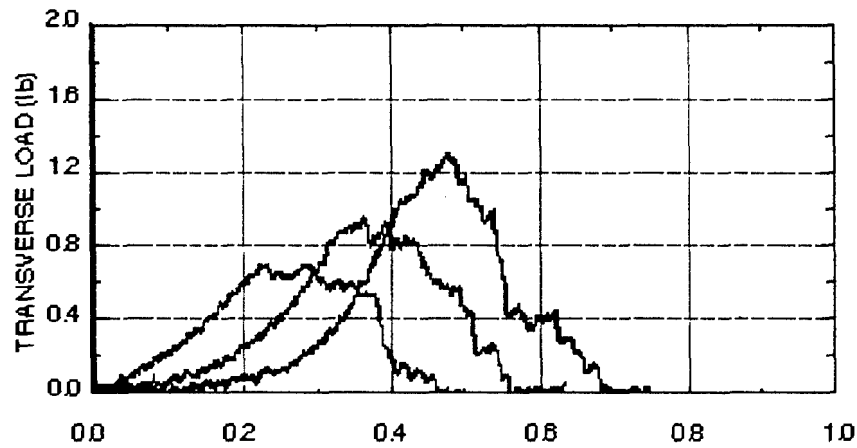
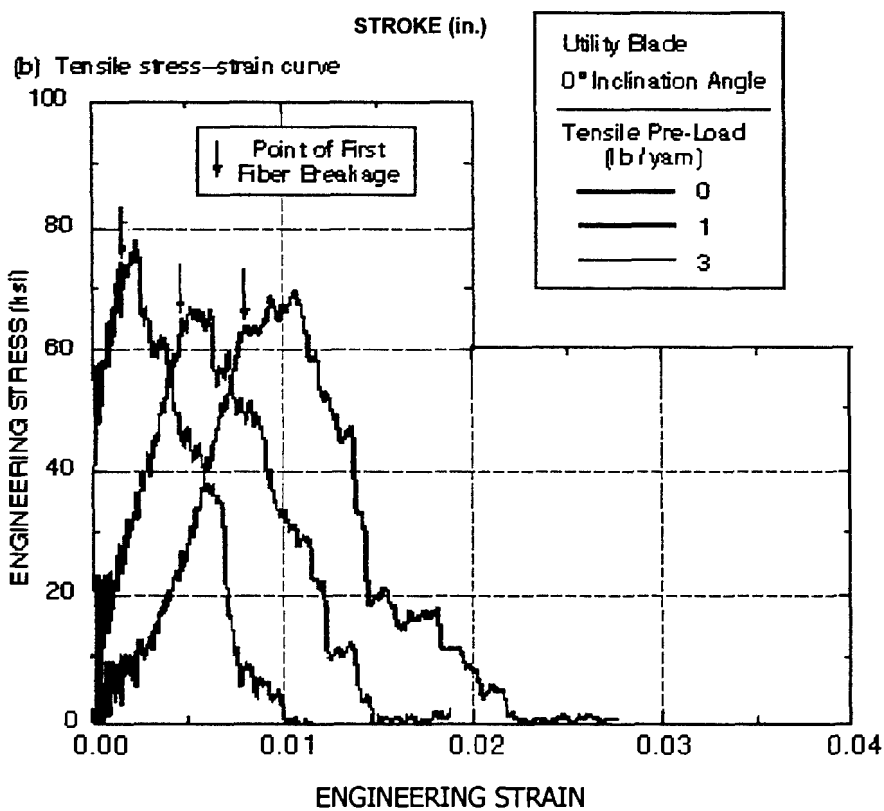
(a) Transverse load-stroke curve

FIGURE A-14. EFFECT OF AXIAL PRE-TENSION ON TRANSVERSE CUT TEST BEHAVIOR OF SPECTRA YARNS
