**FINAL REPORT  
AUGUST 2000**

**REPORT NO. 98-09**

**M3A1 HYUNDAI  
CONTAINER ROLL-IN/ROLL-OUT  
PLATFORM (CROP)  
TP-94-01, Transportability Testing Procedures**

The U.S. Army Defense Ammunition Center (DAC), Validation Engineering Division (SMAAC-DEV), was tasked by the U.S. Army Tank-automotive and Armaments Command to conduct a First Article Test (FAT) on the Container Roll-In/Roll-Out Platform (CROP) manufactured by Hyundai Precision America, San Diego, California.

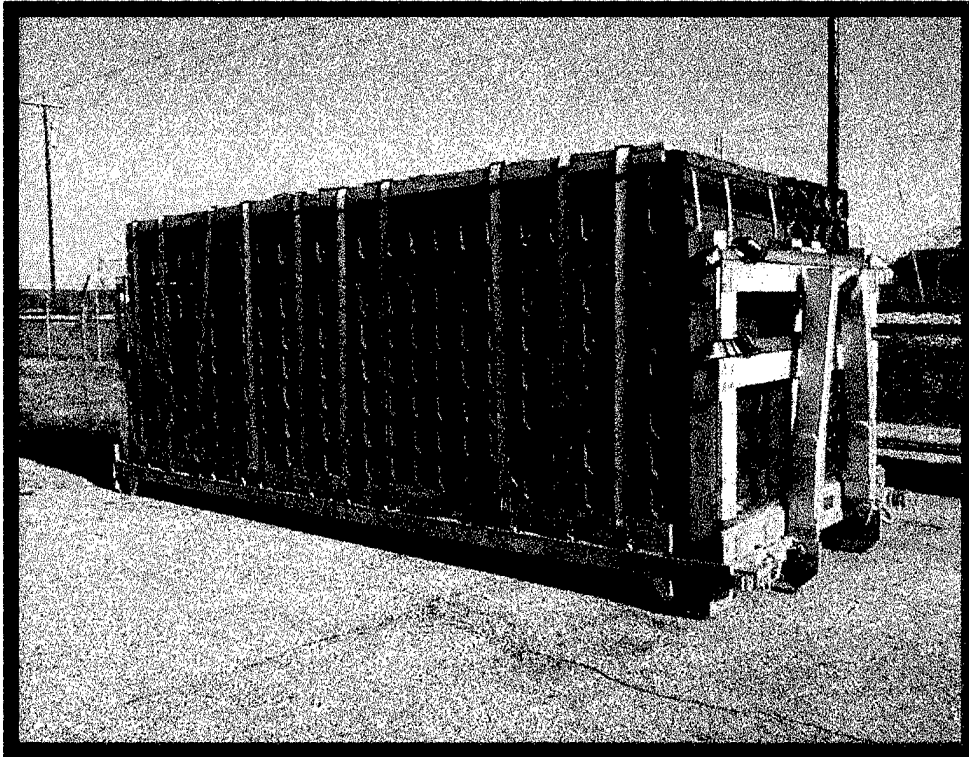
**Photo No. 2. 120MM on the CROP**

Specimen Load: 120MM and 155MM on CROPs and secured to wood deck railcar.

Remarks: No problems with CROPs and/or loads. The CROP with 155MM load has aluminum side strips. (See Photo 2).

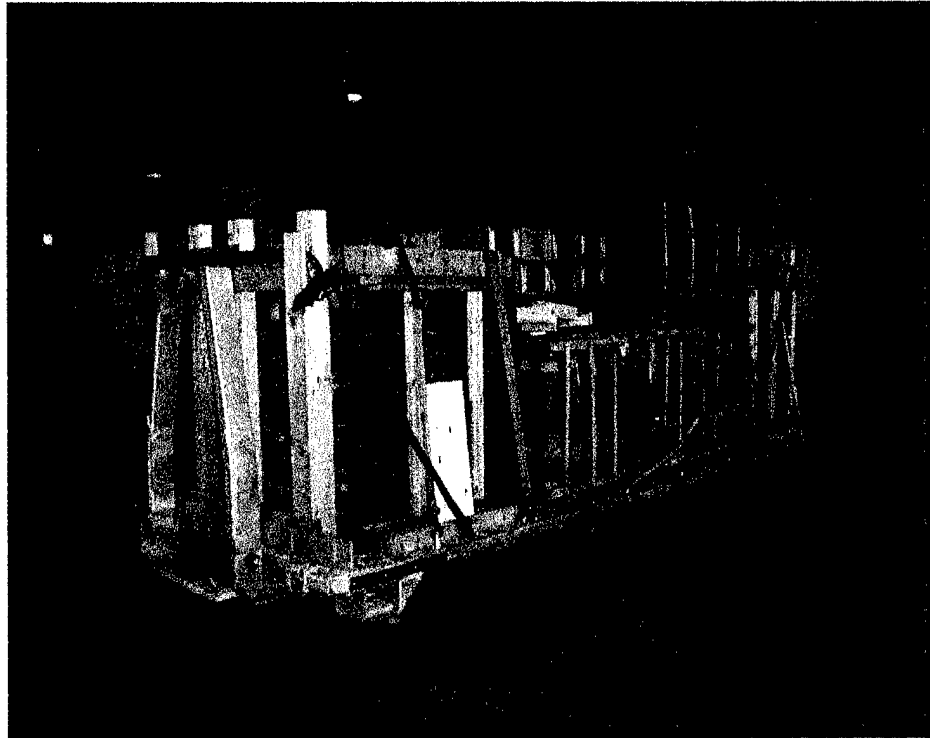
**Photo No. 5. SCL #23 on the CROP**

Specimen Load: Strategic Configured Load (SCL) 23 on the PLS trailer.

Remarks: Pin fell out of right rear restraint wall. Pin fell out of center rear restraint wall. Side blocking needed. Summa trailer interface kit incompatible with Hyundai CROP. (See Photo 5).

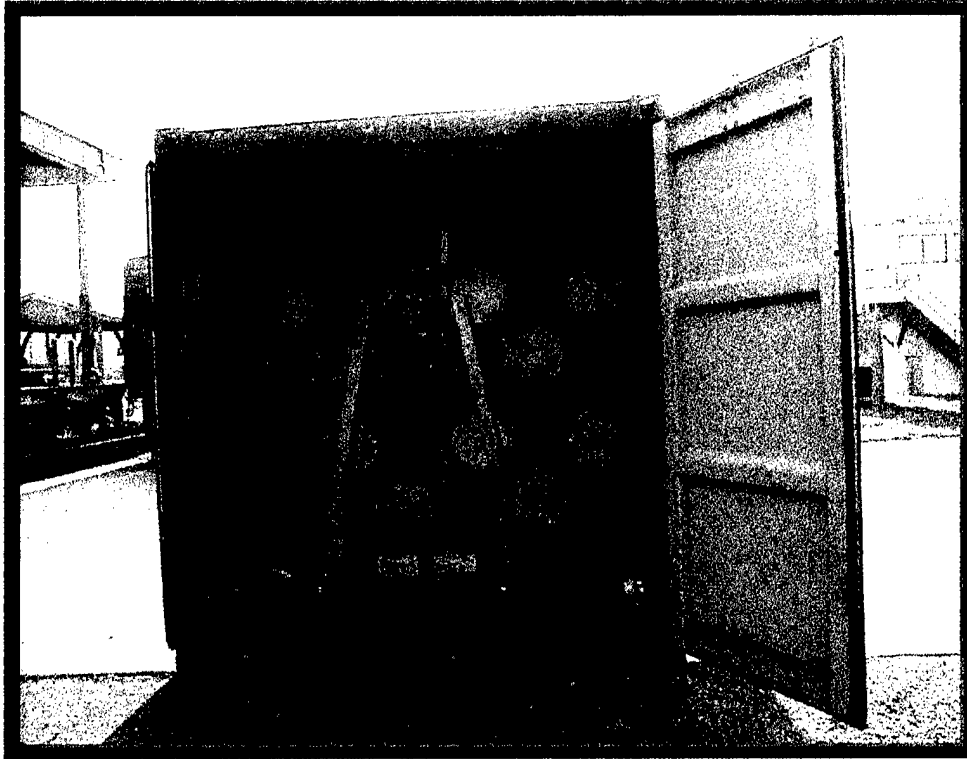
**Photo No. 6. MLRS pods on the CROP in an ISO container**

Specimen Load: 105MM and MLRS in ISO container.

Remarks: No problems with the PLS. On MLRS the skids dished out CROP floor. The forward load restraint device dislodged.

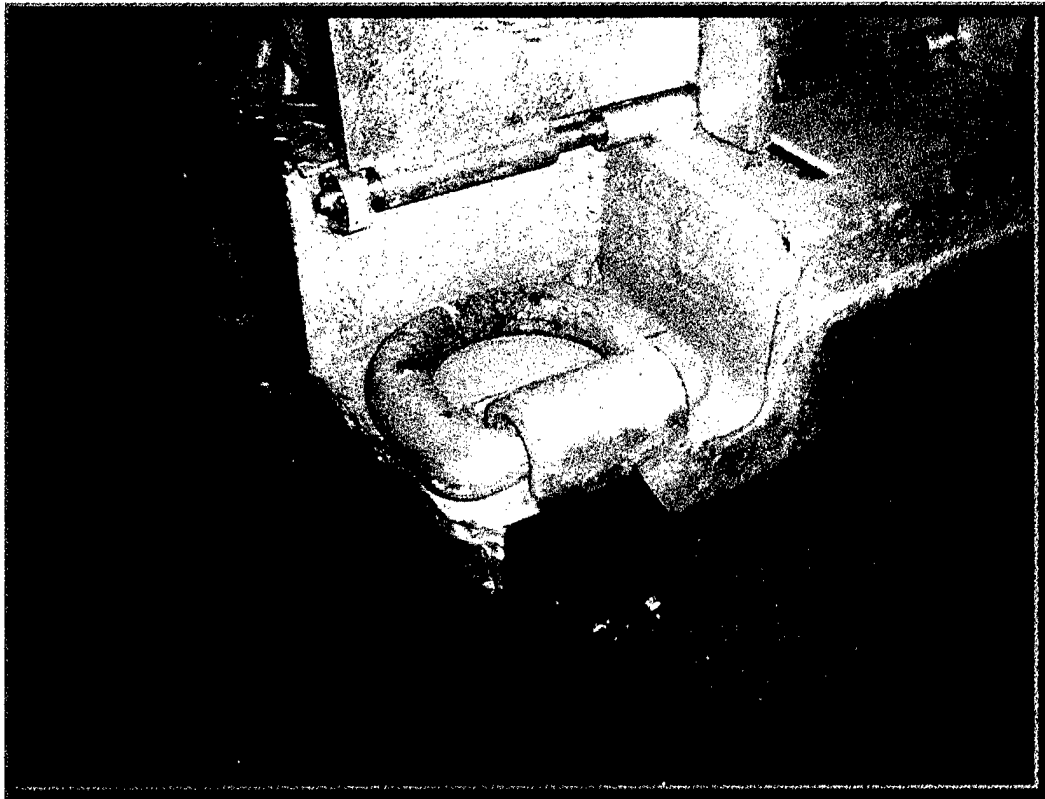
**Photo No. 7. Rear Bumpers**

3. The rear bumpers strike the ground before the rollers. As a result, they wear off very easily. If not corrected the bumpers will not survive in service.
