GEORGIA DOT RESEARCH PROJECT 13-19

**ENHANCING GDOT'S JOINTED PLAIN
CONCRETE PAVEMENT (JPCP)
REHABILITATION PROGRAM USING EMERGING
3D SENSING TECHNOLOGY AND HISTORICAL
CONCRETE CONDITION SURVEY DATA**

1. Report No.: FHWA-GA-17-1319	2. Government Accession No.:	3. Recipient's Catalog No.:	
4. Title and Subtitle: Enhancing GDOT's Jointed Plain Concrete Pavement (JPCP) Rehabilitation Program Using Emerging 3D Sensing Technology and Historical Concrete Condition Survey Data		5. Report Date: December 2016

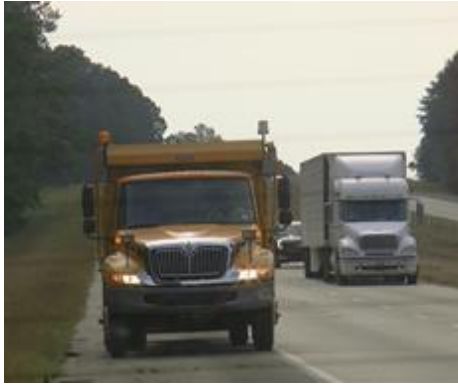
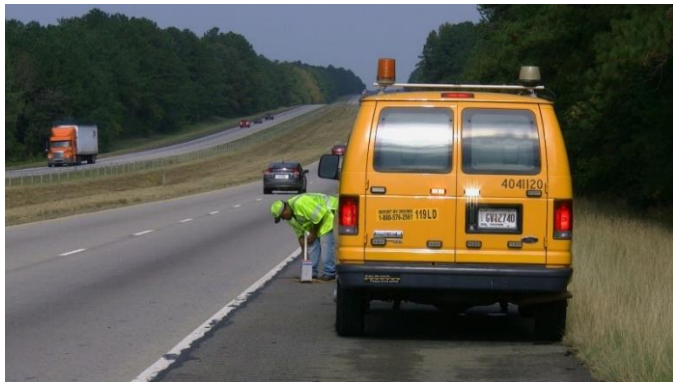
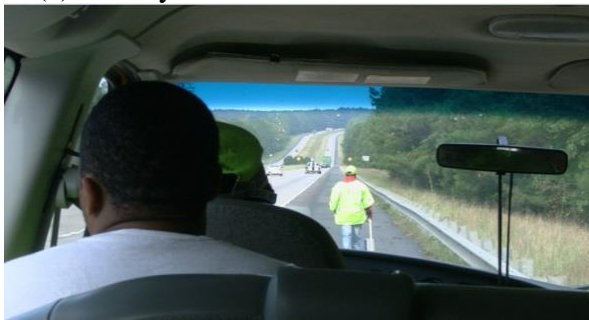
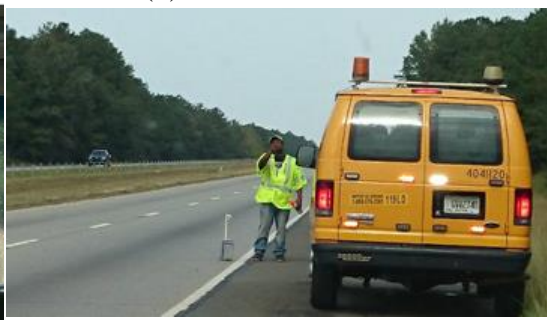
Figure 2.1 CPACES survey

traffic control team (a buffer truck). The survey team rides slowly in the van on the shoulder followed by a buffer truck to provide moving traffic control for safety (see Figure 2.1(a) and (b)). The survey team consists of a driver, a surveyor who visually tallies the distresses on the slabs and records them on the survey form, a faultmeter operator who operates the Georgia faultmeter, and, often, a fourth-person for backup. The van traveled on the shoulder at a slow speed (approximately 20 mph). The surveyor, sitting behind the driver, as shown in Figure 2.1 (c), was responsible for keeping track of the distresses, adding tally marks for distresses, such as broken slab, replaced slab, spalled joint, etc. and noting down the faulting readings signaled by the faultmeter operator. An example of the survey form is shown in Figure 2.2. The faultmeter operator was on foot (or exiting/entering the van at each joint to be measured). He found gaps in the traffic to place the faultmeter at the joint and used hand signals to denote if negative (by drawing hand across the neck) and the total number (using fingers, turning hand back and forth to denote >5, >10), as shown in Figure 2.1 (d). The driver would help keep track of the faulting reading as well. A typical CPACES takes approximately 20-25 minutes per lane-mile for a survey team of 3-4 persons plus a buffer truck. The faulting measurement was clearly the bottleneck in the CPACES survey. It took on average about 5 to 6 seconds to make a faulting measurement and could take longer when the traffic is heavy. The presence of bridges and ramps reduced the time taken as faulting readings were not taken on ramps and bridges.

(a) Survey vehicle

(b) Buffer truck

(c) Visual survey and record distresses

(d) Hand signals a faulting reading

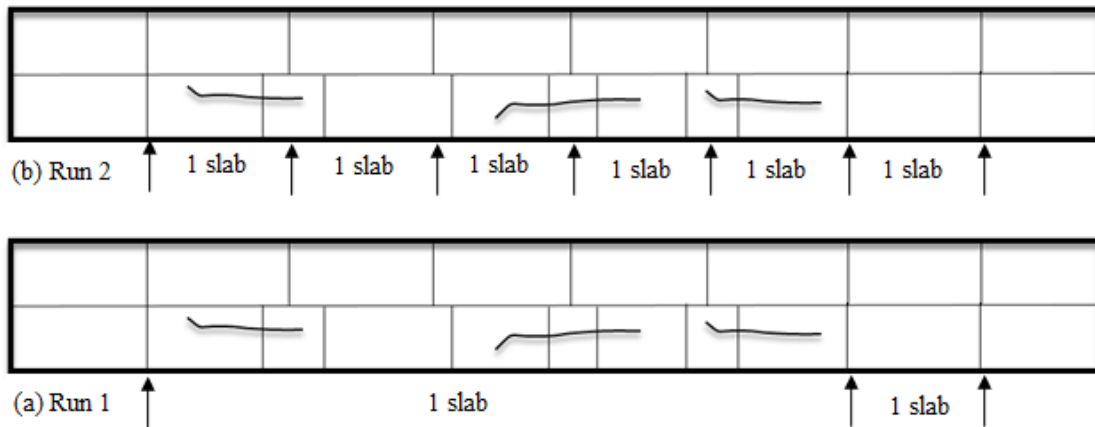
Figure 2.3 Definitions of slabs

those which spanned across both the inner and outer lanes (Figure 2.3 (a)). Due to slab replacement carried out on the outermost lane, the slabs on that lane were much smaller. In the case of multiple distresses in the group of slabs, the most severe distress was recorded. This leads to two issues: 1) a broken slab can be long in length (sometimes more than 100 ft.) and 2) the number of broken slabs may decrease as more slabs are being repaired (this is an issue when studying the trend of broken slabs).

For the modified survey (Run 2), the surveyor found it difficult to keep track of the slabs and record simultaneously, as shown in Figure 2.3 (b). If the surveyor loses track of the slab number once, then the shift will propagate through all subsequent slabs. Hence, it is very difficult to perform this type of survey accurately. A refined slab definition that can describe the increase in broken slabs and is easy to count in the field is needed.

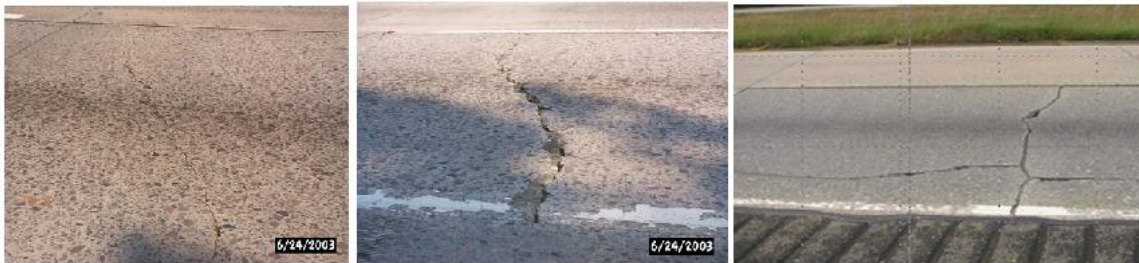
Figure 2.4 Various broken slab severity level 2

a variety of worsening distresses such as spalling, differential settlement or pop out and typically would need to be addressed sooner to maintain roadway safety. Thus, there is a need for refining distress classification to differentiate slabs with severer levels of distresses (e.g., a slab with multiple types of cracks).

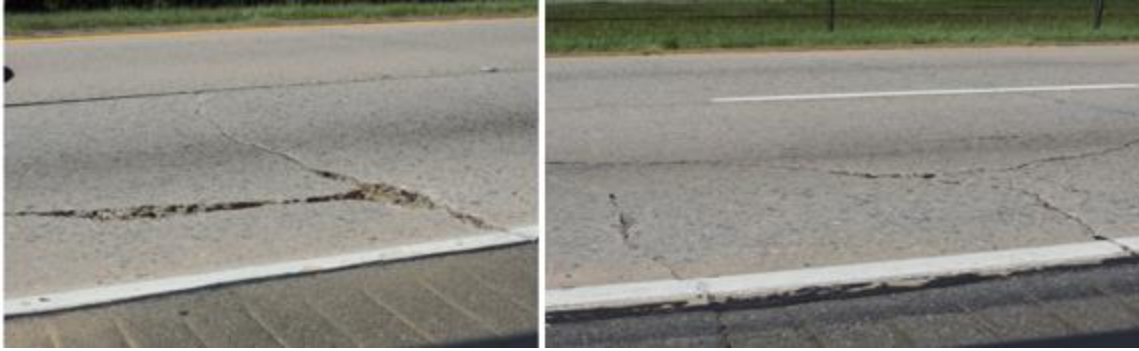
Figure 2.6 Examples of shattered slab

A slab with multiple intersecting cracks such that the slab is separated into three or more pieces is categorized as a Shattered Slab. In this category, the concrete block(s) may pop out and pose safety concerns to the road user. There was no shattered slab in CPACES previously. The number of shattered slabs will be counted and recorded; there is no severity level for Figure 2.6 shows examples of shattered slab.

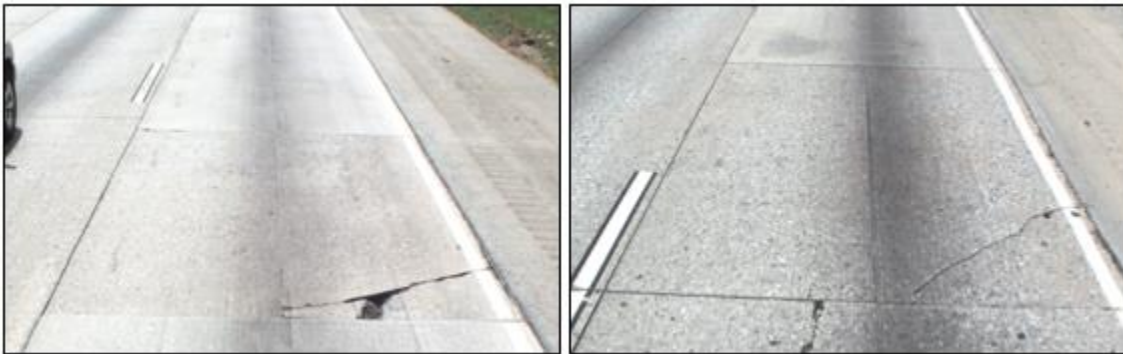
Figure 2.7 Examples of corner break

There is no severity level for a corner break. Figure 2.7 shows examples of corner break.

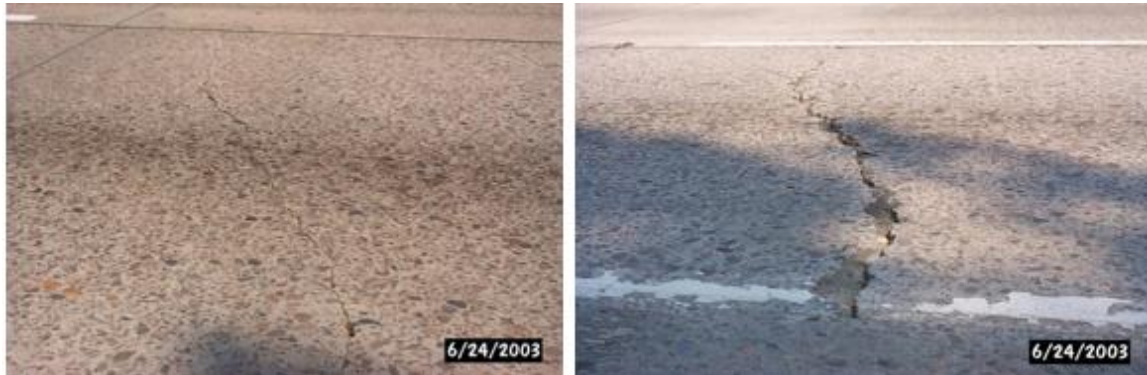
Figure 2.8 Examples of transverse cracking Severity Levels 1 and 2

working crack; Severity level 2 is categorized as moving crack, generally wider and may be spalled. Figure 2.8 (a) and (b) shows transverse crack severity levels 1 and 2, respectively.

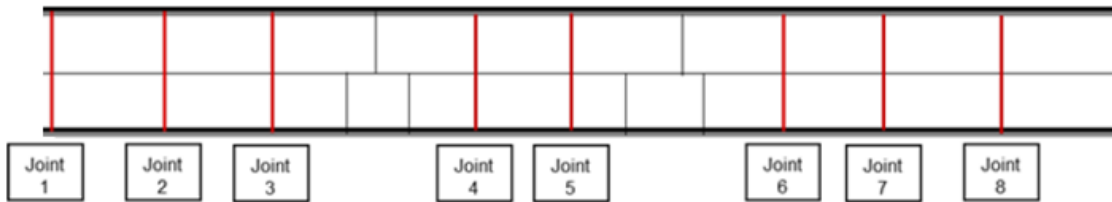
Figure 2.9 Faulting reading taken at 8th original joint

Faulting reading should be taken at every 8th original joint using the Georgia Faultmeter. The original joint refer to a joint that is still intact, typically aligns with the joint in the inside lane, as illustrated in Figure 2.9. If a prior repair (slab replacement) goes beyond a joint, then that joint would not be counted for faulting measurement. It is important to make sure the faultmeter is facing in the right direction, especially if it reads many negative values. The minus sign should be included in the readings (e.g., -1, -2, etc.). If the outside lane was replaced, all joints on the outside lane are considered as the original joint. There is no need to align the joint in the outside lane to the joint on the inside lane.

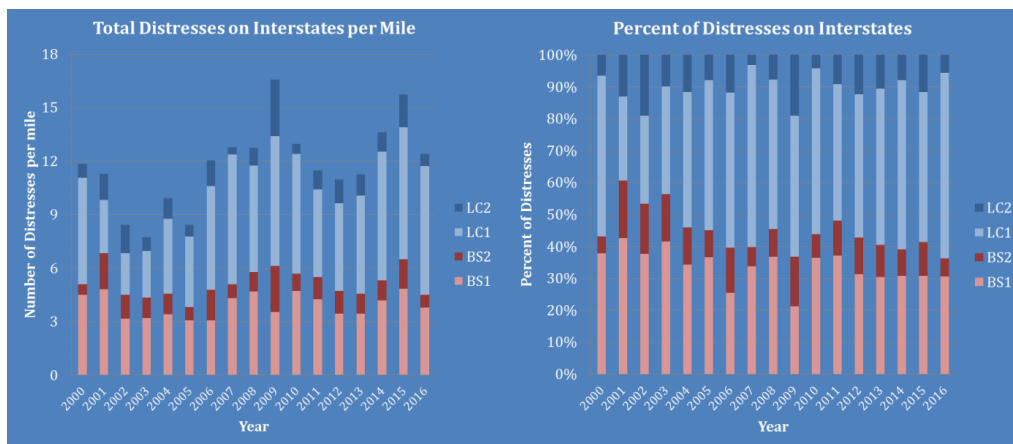
portion of the identified distresses on both the non-interstate and interstate roadways. It is also clear that the number of distresses per mile is higher for the Interstates as a whole, varying from a total of 8 to 16 per mile as compared to less than 8 for non-Interstates. Pavement age is most likely the cause of this difference, while design may also pose a factor, especially between longitudinal (LC) and transverse cracking (BS). A number of truck lane replacements were completed in recent times, but much of the concrete pavements, especially on the interstate, are nearing 50 years old and were originally placed without the benefit of dowels.

Figure 3.4 Interstate distresses 2000-2015

Figure 3.5 Non-interstate distresses 2000-2015

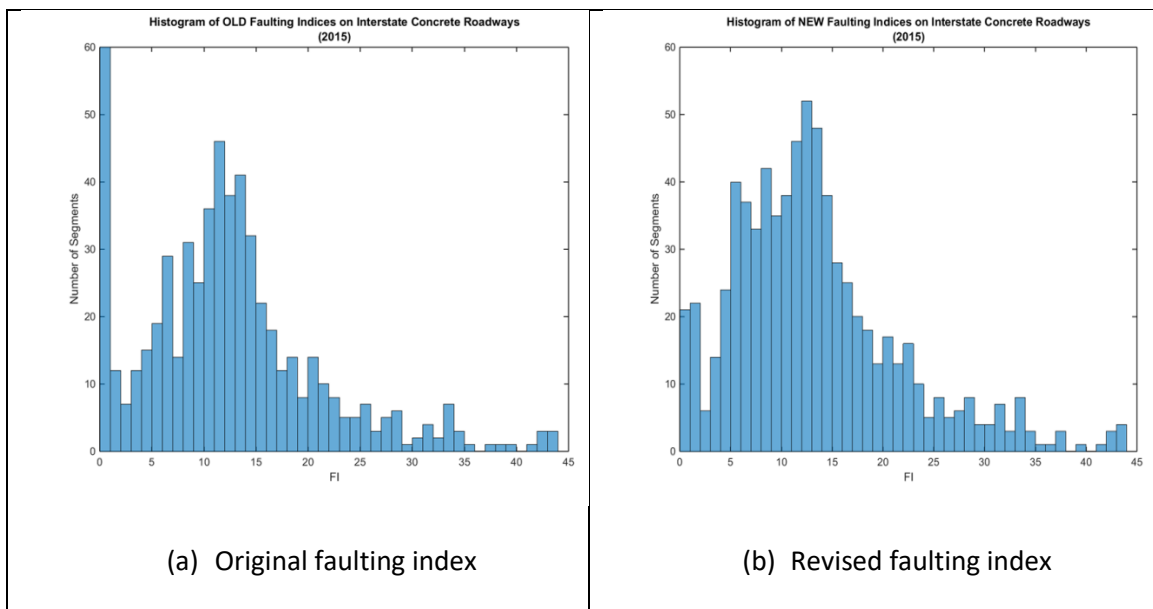
Figure 3.6 Faulting index distribution (original vs. revised)

This section presents the analyses on faulting index at both network and segment level. As noted previously, negative Faulting Index entries were encountered in the historical CPACES. Figure 3.10 shows the distributions of the original and revised faulting index that was recalculated based on the “absolute” faulting readings using Equation 2.1. The revised faulting index clearly reduces the number of faulting index values of 0. It also increases the mode (most common) value about 2 faulting index values, but also maintaining a similar overall distribution and maximum value.

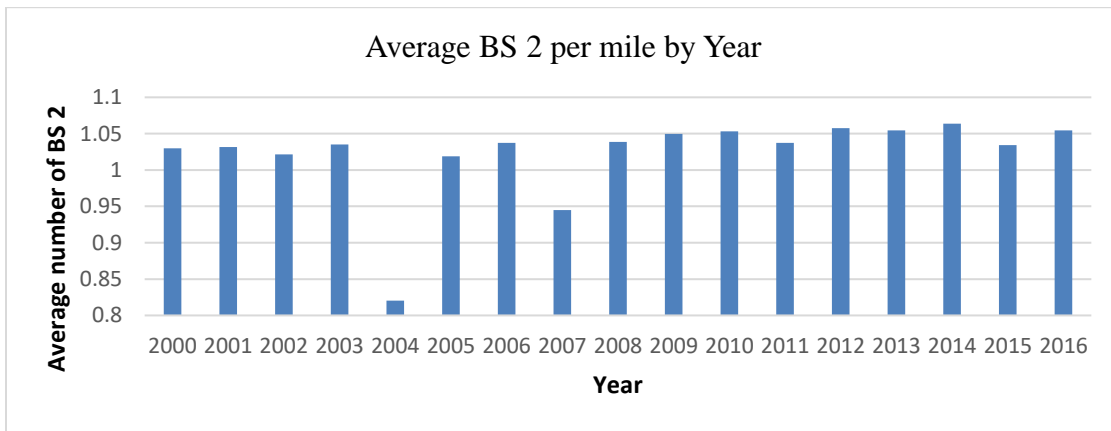
Figure 3.10 Average broken slab severity level 2 per mile

distresses, at least one replaced slab was identified in over 30% of the data collected. A failed replaced slab was only identified in 6% of the segments.

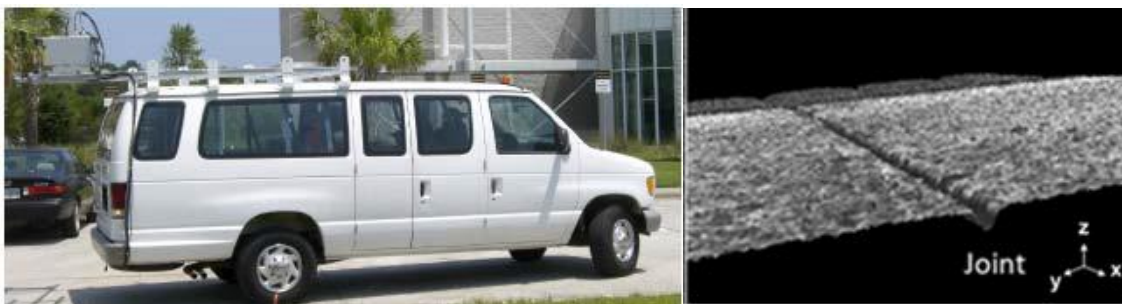
The first step is to collect high-resolution 3D laser data of the JPCP to provide data that has a high level of granularity; this will support the extraction of essential pavement distress information for JPCP, such as cracking, faulting, etc. In the research project entitled “Remote Sensing and GIS-Enabled Asset Management System (RS-GAMS),” sponsored by the US DOT, an intelligent GA Tech sensing vehicle (GTSV) has been developed by integrating a 3D laser system, a global positioning system (GPS), 2D image cameras, two LiDAR systems, an inertial measurement unit (IMU), and a high-resolution distance measurement instrument (DMI). The GTSV, as shown in Figure 4.2(a), was used to collect JPCP data at highway speed without interfering with the traffic flow. With a line scan rate of 5,600 profiles per second, the system can provide a resolution of 1-mm (~0.04 in) in the transverse direction and 5-mm (~0.2-inch) in the longitudinal (or travel) direction at a speed up to 100 km/hr (62.5 mph) (Tsai et al., 2012). On a 30ft slab on I-285, approximately 7.3 million 3D points can be collected; detailed distress information can be extracted from this set of data. Figure 4.2 (b) illustrates the 3D data collected near a joint. The 3D laser data can achieve 0.5-mm accuracy in the z-direction.

(a) GA Tech sensing vehicle

(b) Example of 3D laser data

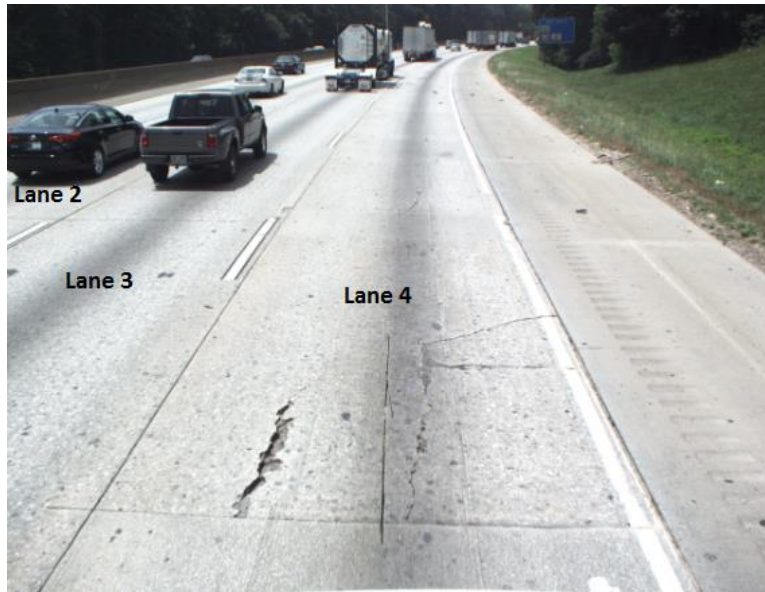
Figure 4.8 An example of pavement condition on I-285

GTSV was used to collect the 3D laser data on a one-mile section in Lane 4 from MP 13 to MP 12 at highway speed. Figure 4.8 shows an example of the pavement condition on the I-285 project. The data was processed by an in-house program that extracted and classified slab-level distress information based on GDOT's CPACES, as shown in Table 4.2. Slab replacement had been conducted in the past; many slabs no longer maintained a 30-ft spacing. Thus, there are a total of 289 slabs, including replaced slabs with small spacing, in this 1-mile section. There are 34 Level 2 broken slabs and 19 Level 2 slabs with longitudinal cracks that need to be replaced based on GDOT's criteria. Figure 4.9 shows the distribution of these distressed slabs within this mile. It is noted that distressed slabs were concentrated in two areas (MP 12.0 – MP 12.4 and MP 12.6 - MP 12.8) as shown in Figure 4.9.

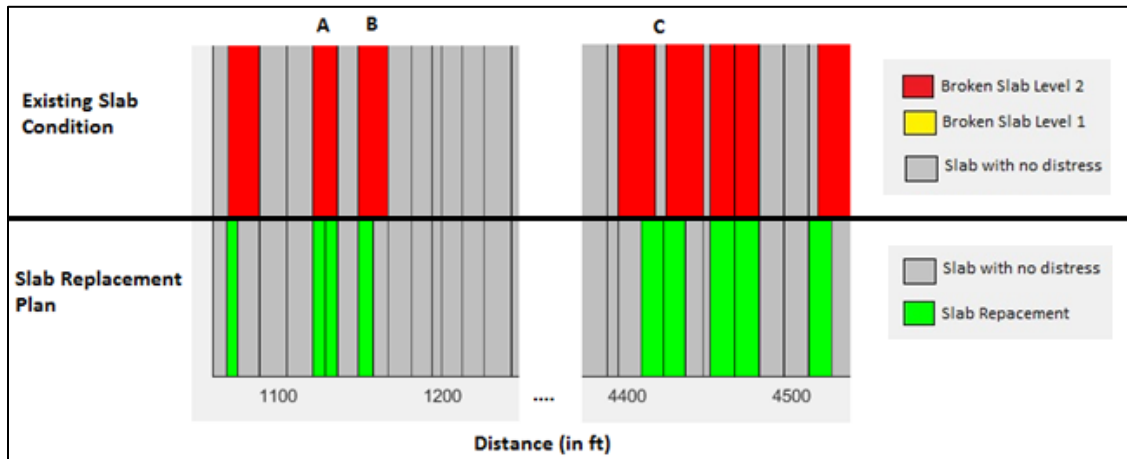
Figure 4.10 Examples of slab replacement outcomes

Based on the slab-level distress information and GDOT's Construction Standards and Details (GDOT, 2016), the in-house program was used to automatically determine the exact extent for slab replacement, including full and partial slab replacement, by taking into account the following factors: 1) a minimum slab replacement length of 6-ft; 2) a minimum retained slab length of 10-ft; 3) a maximum slab replacement length of 20 ft. (divided using transverse joint data), and 4) the removal of existing dowel bars (1 ft.) if within the slab replacement. Figure 4.10 shows examples of the outcomes; this information is available for the entire 1-mile section. The top section of Figure 4.10 shows the existing slabs with respect to length and condition. The slabs requiring slab replacement (e.g., broken slab Level 2 and longitudinal crack Level 2) are highlighted in red; Level 1 broken slabs and slabs with no distresses are in yellow and gray. The bottom section of Figure 4.10 shows the exact extent for the slab replacements. The joint locations for slab replacements are also shown as black lines. It is noted that some full slab replacements longer than the maximum slab length of 20 ft. were split into two slabs (Case A). Case B shows partial slab replacement with the exact extent to treat the distressed area of a broken slab. Case C shows a small portion of a slab (6-ft) with no distress that was replaced because the removal of dowel bars made the retained slab length less than the requirement. In addition, the detailed slab replacement information, including total length and quantity, can be generated, as shown in Figure 4.11. This demonstrates a detailed slab replacement plan that considers GDOT's construction practices can be derived accurately and effectively using the proposed method. Besides using this information for slab replacement planning, this information can then be used

by the project engineer to guide the slab replacement during the construction of slab replacement.

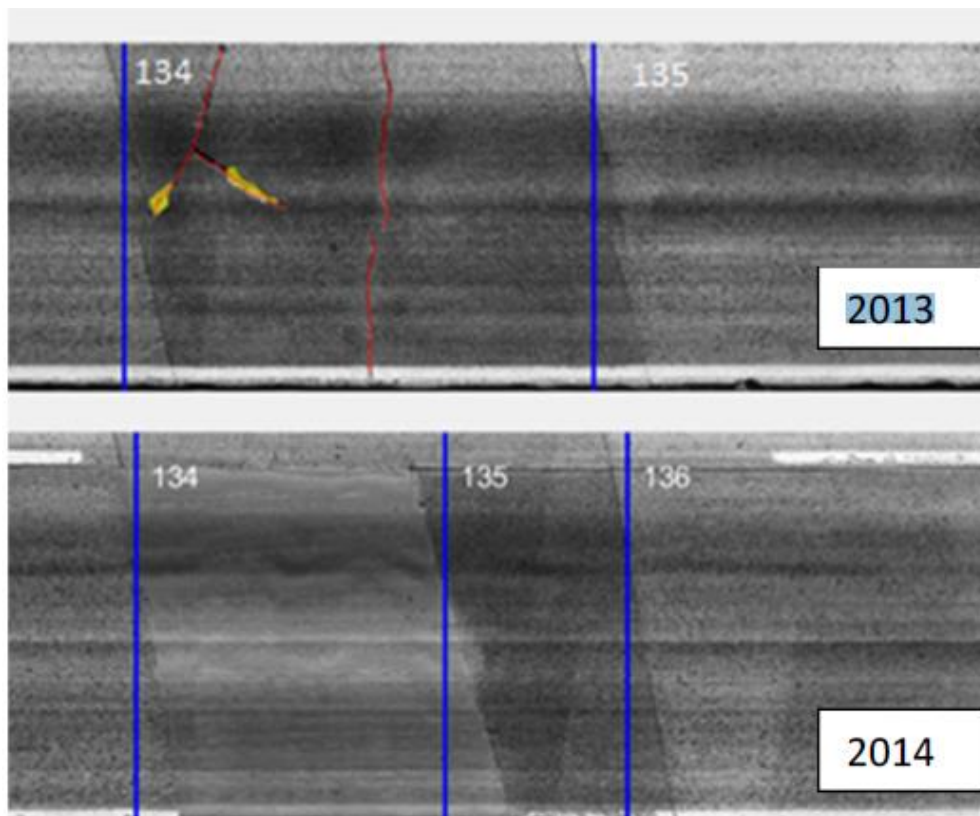
Figure 6.1 Effect of repaired slab on a number of slabs and distress records

beneficial to GDOT. However, because of limited budgets and personnel, only the most highly distressed slabs are being repaired with in-house personnel, and, therefore a simple count of distressed slabs by mile can be inconsistent due to repairs that have been performed. Also, individual slabs that are distressed can be repaired and end up divided into two slabs. Figure 6.1 shows an example in which the same section of pavement is shown in 2013 and 2014, but after repairs there is an additional slab in 2014. These factors make it difficult to predict future slab replacement from current conditions on a mile basis. Therefore, continuous coverage and slab-by-slab comparisons would be beneficial for describing the complete history of the pavement's condition over time.

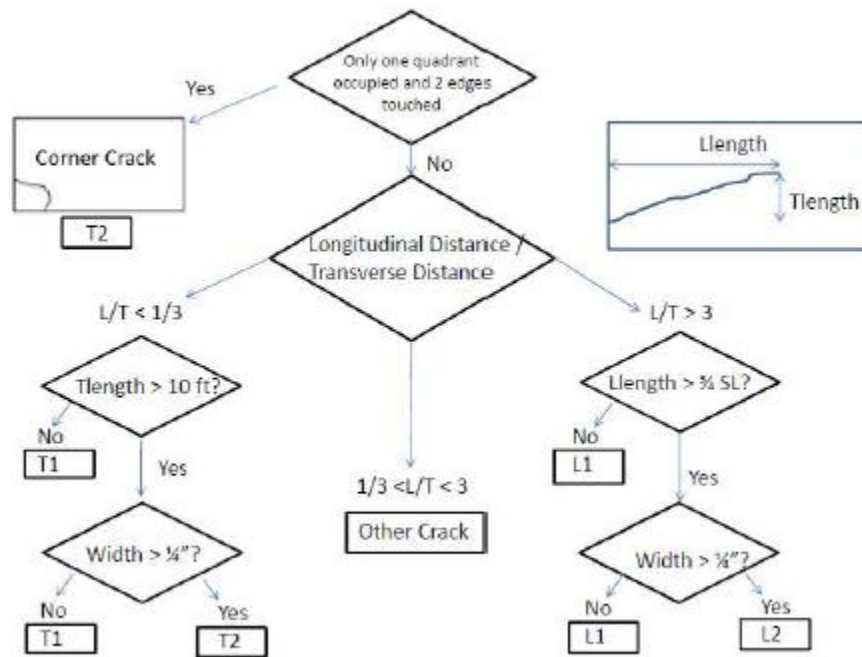
Figure 6.2 Distress classification flow chart

CPACES distress protocol, the flow chart shown in Figure 6.2 was used for classifying distresses. Shattered slabs were considered as slabs with both transverse (Severity Level 2) and longitudinal (Severity Level 2) cracking. With this information it is expected that comparisons of changes in specific slabs over time can be made. GDOT does not currently have a shattered slab definition but it is included in the enhanced CPACES distress protocol; it is assumed that the raters would have called most shattered slabs BS2, since this is the worst distress identified in the CPACES.

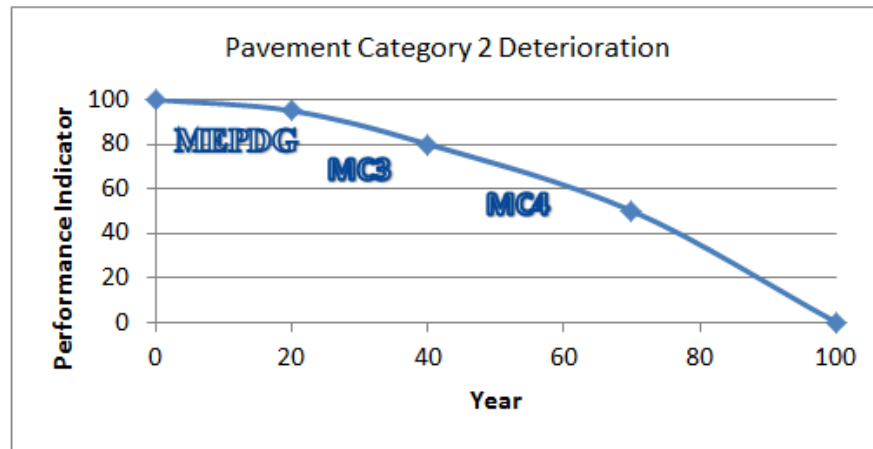
Figure 6.4 Illustration of deterioration based on pavement category

potentially different distresses as shown in hypothetical pavement category 2 in Figure 6.4 (b).

(a) Pavement Category 1

(b) Pavement Category 2

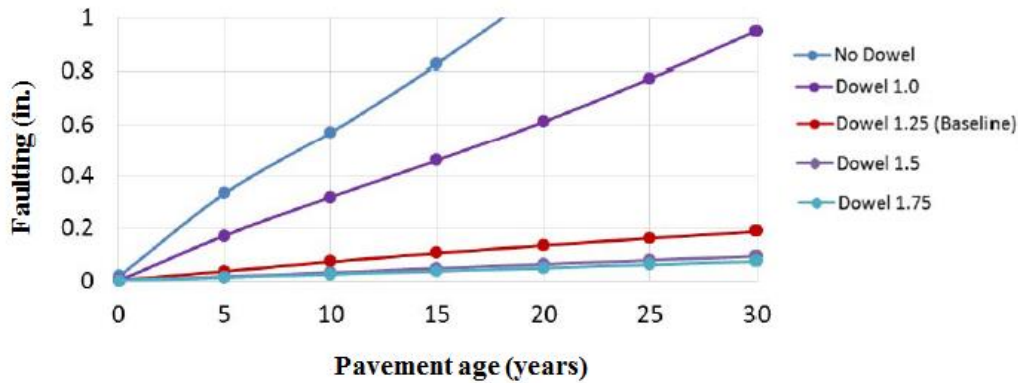
Figure 5.1 Faulting predicted using PavementME (ARA, 2016)

A dynamic linear regression model was proposed to predict segment-level faulting. The proposed method utilizes the historical faulting index of a segment in the CPACES database to develop a linear regression equation and uses that to forecast the next year's faulting index for the segment. Before the decision was made to use the linear regression model, the faulting predicted using the PavementME that was reviewed to provide an understanding of the faulting deterioration behavior. Figure 5.1 shows the faulting (in inches) predicted on dowel and non-dowel JPCPs by the PavementME using Georgia calibration coefficients developed under the project "Verification and Local Calibration/Validation of the MEPEG Performance Models for Use in Georgia" (ARA 2016). It shows the use of dowels and dowel diameter has significant impact on the predicted faulting. The non-dowel JPCP could reach a faulting index of 0.2 in (which is the performance criteria) in three years, while the JPCP with dowel greater than 1 in. will not reach a faulting of 0.2 in. at the end of 30 years. A close look of the deterioration rates shows the faulting increases steadily at approximately the same rate before reaching 0.2 in. After that, the faulting increases at a slower rate.

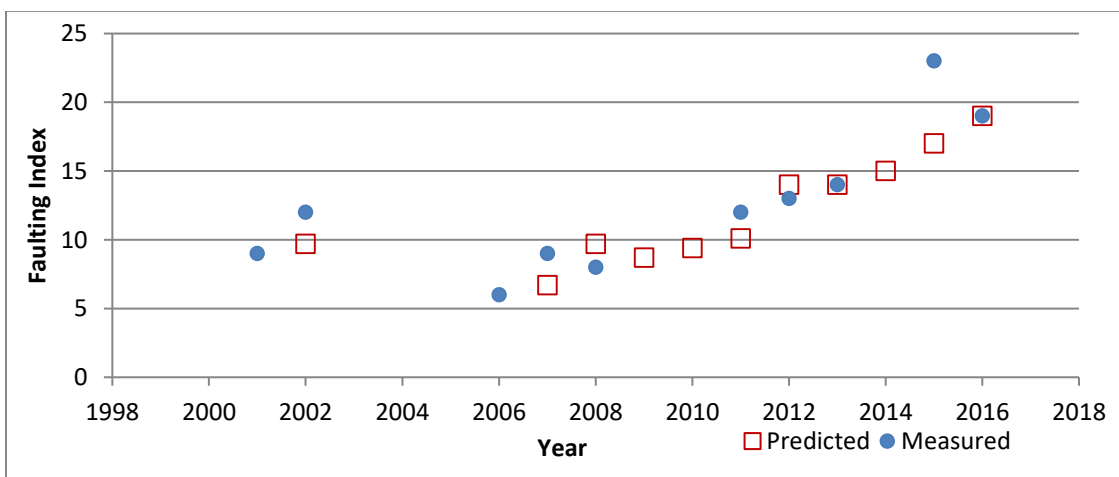
Figure 5.4 Example of predicted and measured faulting index

A case was conducted using the CPACES data on two 1-mile segments on I-16 (eastbound MP 12) to demonstrate the use of the proposed method for predicting faulting. Segment on eastbound MP 12-13 was built in 1968 with non-doweled JPCP, a 30-ft joint spacing, 9 in of PCC on top of 10 in stabilized cement base. Figure 5.4 shows the measured and predicted faulting index from 2000 to 2016. The faulting index measured on this segment is relatively high compared to an average faulting index of 10 at network level in 2016. Faulting index was predicted using the default deterioration rate of 0.7 per year because no sufficient data was available for establishing the linear regression equation. The linear regression was used from 2012 to 2016 and the deterioration rate was updated each year as new data was collected. The differences between the measured and predicted faulting index range from 0 to 6. The maximum difference occurs in 2015 when the measured faulting increased significantly. However, it dropped to 19 in 2016. This case illustrate it is feasible to predicting the faulting index using the proposed method based on the historical CPACES data.
