**Federal Railroad  
Administration**

## Detection of Concrete Tie Rail Seat Deterioration

| 1. AGENCY USE ONLY (Leave blank) | | 2. REPORT DATE<br>September 2019 | | 3. REPORT TYPE AND DATES COVERED<br>Technical Report March 1, 2013 - December 31, 2016 |
| 6. AUTHOR(S)<br>Joseph LoPresti and Mike McHenry | | | | |

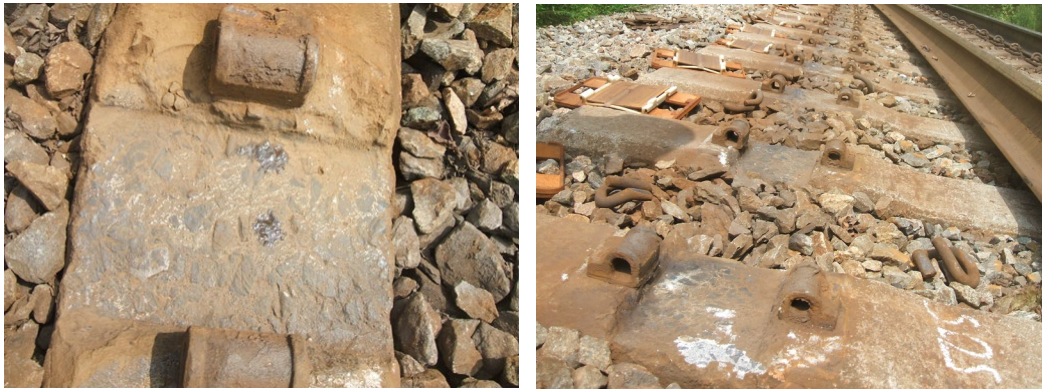
Rail seat deterioration (RSD) of concrete ties is manifested by the loss of concrete tie material under the rail seat area and, in extreme cases, can result in loss of rail clip holding power (toe load), negative (outward) rail cant, gage widening, and rail rollover [1]. [Figure 1](#) shows an example of RSD.

**Figure 1. Rail Seat Deterioration**

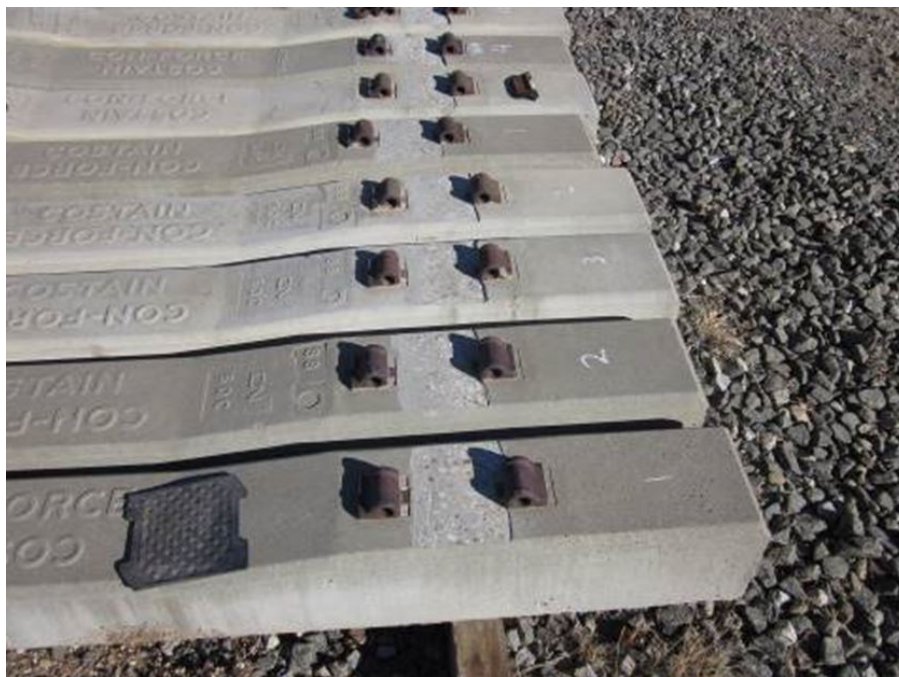
Twelve test ties were installed in the 5-degree curve. Eight of the 12 ties were ground to simulate full triangular RSD in a manner similar to the ties tested in the laboratory. The depth of grinding at the field-side shoulder of the ties ranged from 0.625 inch to 0.25 inch with the center two ties having the deepest grinding. The 2 ties at each end of the 12 were not ground. The 12 test ties were Con-Force Costain CN 60C designs with e-clip shoulders. [Figure 3](#) shows the eight ground rail seats before the ties were installed at FAST. [Figure 4](#) shows a detailed view of a rail seat ground with 0.1875-inch depth of triangular RSD.

**Figure 3. Rail Seats Ground to Simulate Triangular RSD  
before Installation at FAST (0 MGT)**

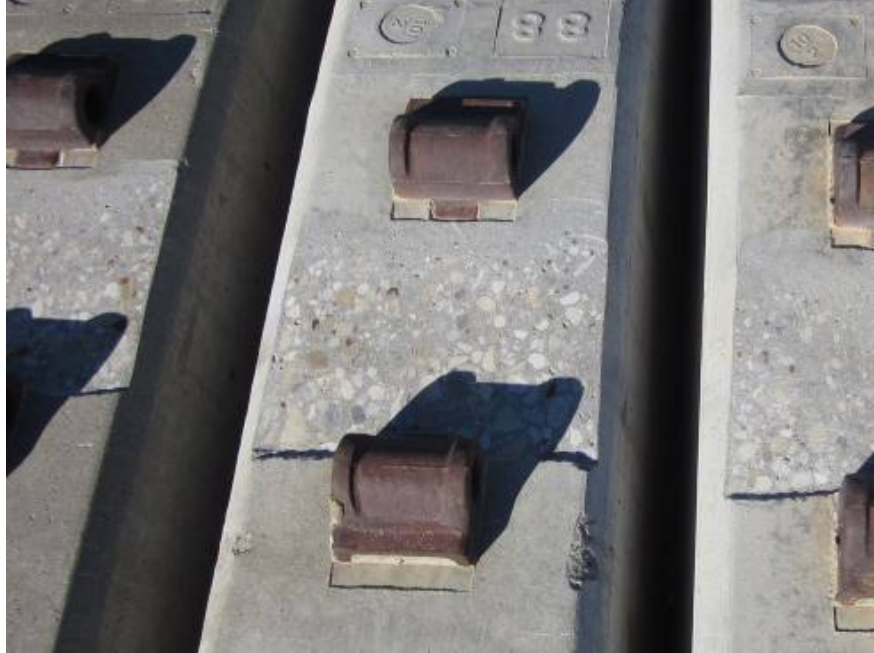
**Figure 4. Detailed View of Ground Rail Seat with 0.1875-inch triangular RSD before installation at FAST**

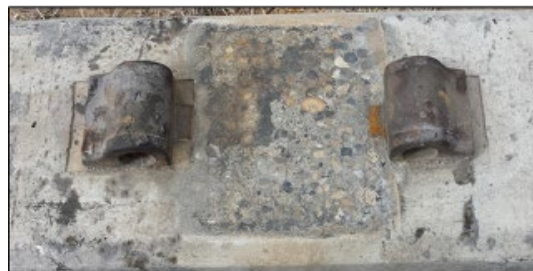
The condition of the ties was photo documented before the ties were installed, and when the ties were removed after accumulating 375 MGT. [Figure 5](#) shows photos of two rail seats after 375 MGT—one that had not been ground at 0 MGT ([Figure 5a](#)), and one that initially had 0.25-inch of triangular RSD ground in ([Figure 5b](#)).

**Figure 5. Rail Seats from the FAST installation. (a) Unground Rail Seat after 375 MGT, and (b) Tie with 0.25-inch Ground Rail Seat after 375 MGT**

The surface conditions of the ground and unground ties before and after the test were similar. To quantify material loss, depth measurements of the rail seats were taken before and after tonnage accumulation. Depth measurements were taken at 32 different locations along the width of the rail seat (from shoulder to shoulder along the length of the tie) using a linear variable displacement transducer (LVDT) and a custom depth gage fixture shown in [Figure 6](#).

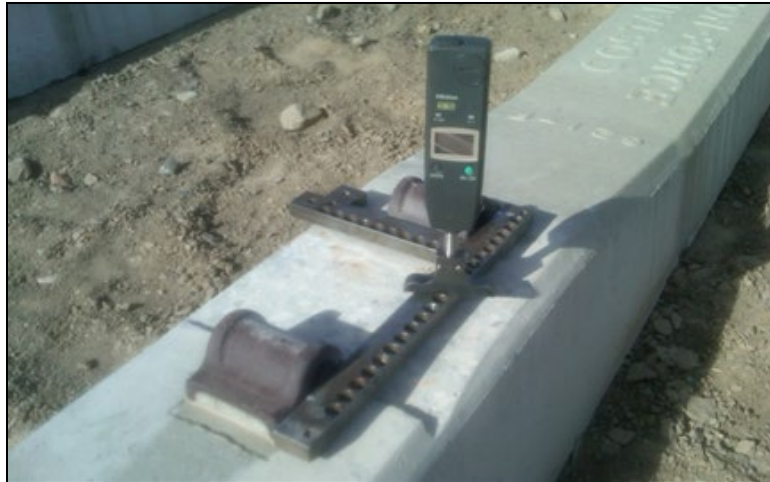
**Figure 6. RSD Depth Measurement Gage used to Measure RSD of Ties  
Installed at FAST at 0 MGT and 375 MGT**

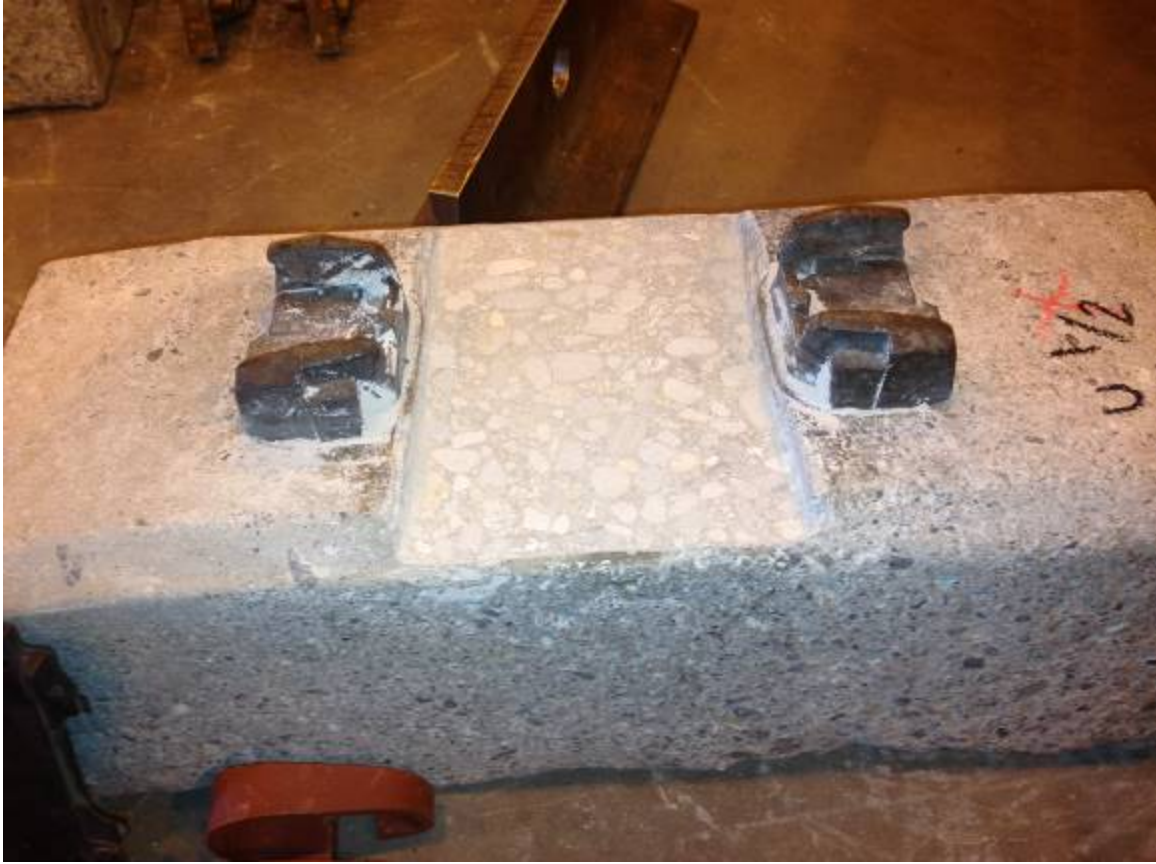
**Figure 9. Example of Concrete Tie Section with Uniform RSD**

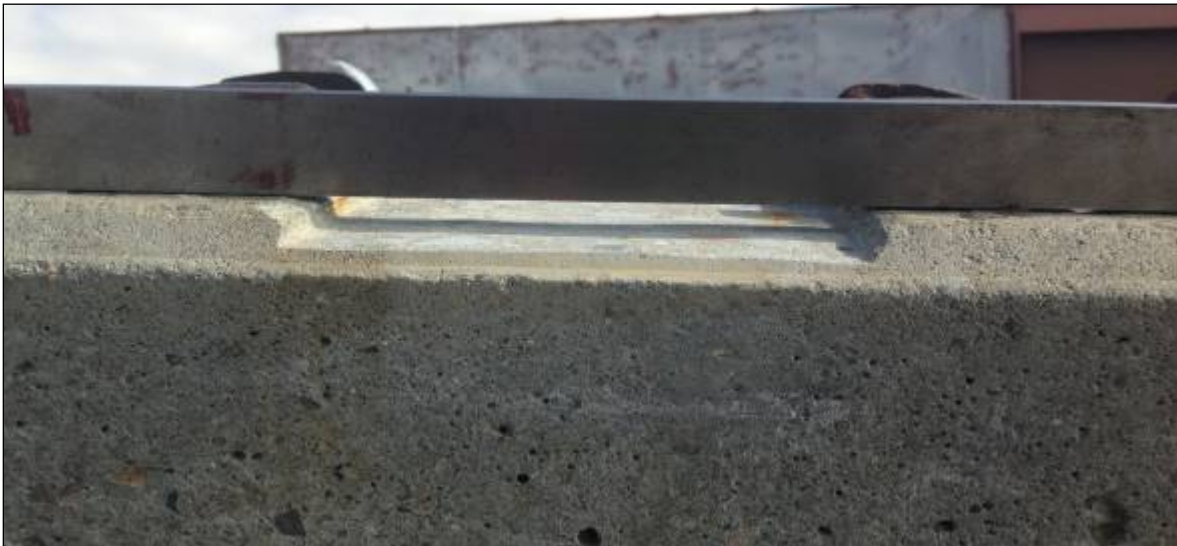
**Figure 10. Example Showing Uniform RSD Depth Profile**

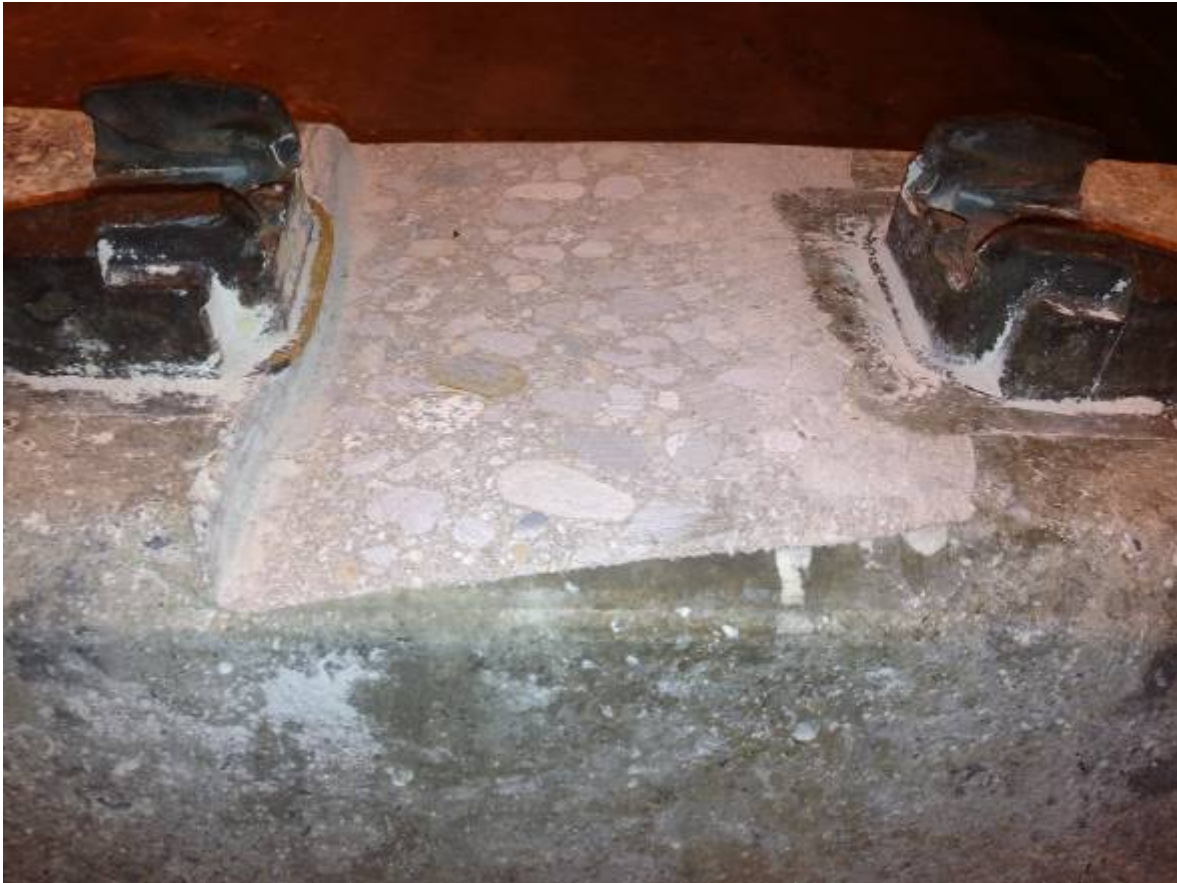
**Figure 11. Example of Concrete Tie Section with Triangular RSD**

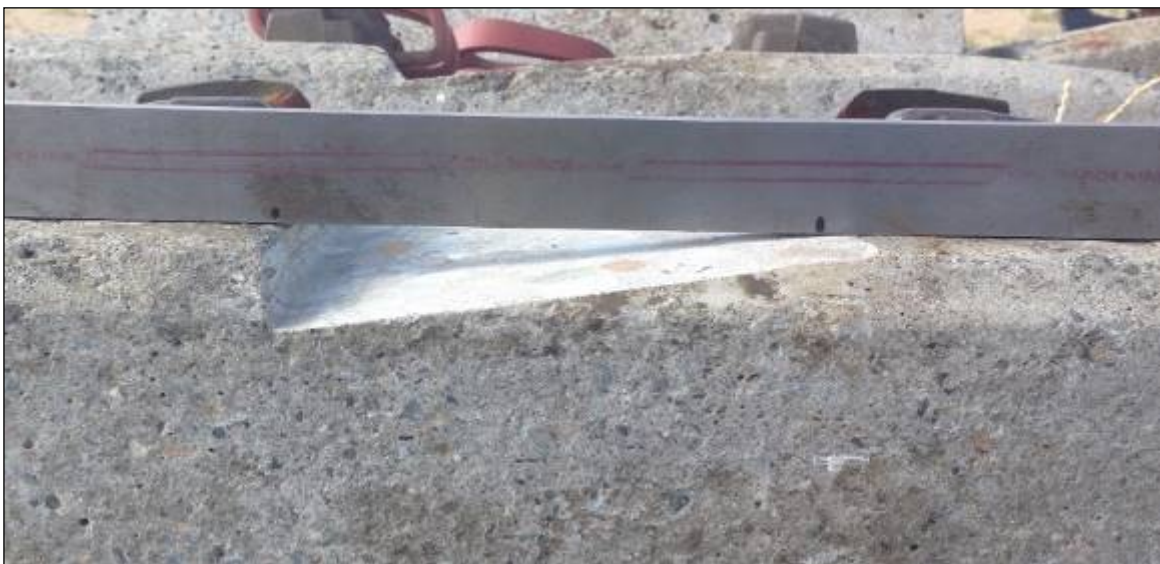
**Figure 12. Example Showing Triangular RSD Depth Profile**

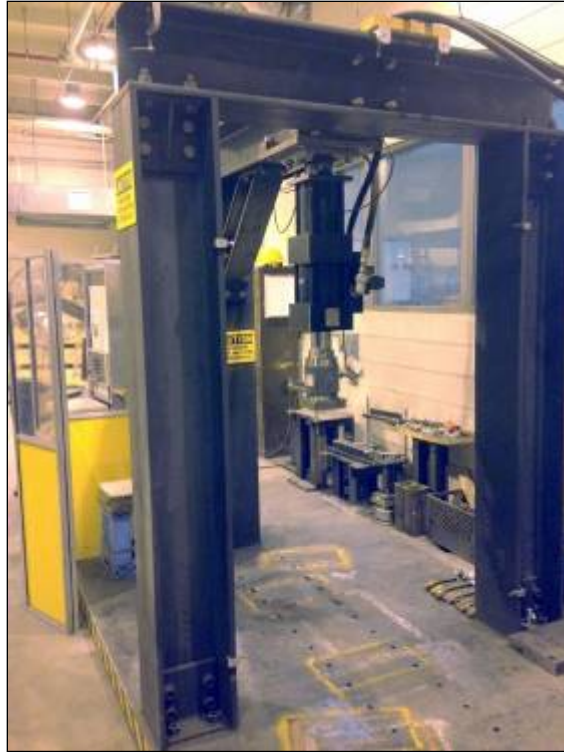
Laboratory testing was conducted on TTCI's Three-Post Load Frame. The load frame consists of a 50,000-pound vertical servo-controlled MTS actuator and controller ([Figure 14](#)). The actuator has an integrated load cell and LVDT. Custom fixtures were constructed for each test to provide sufficient restraint of the tie sections. Additional LVDTs were also used to measure rail displacements as indicated. All testing was conducted at ambient room temperature (70 °F +/-10 °F).

**Figure 14. Three-Post Load Frame**

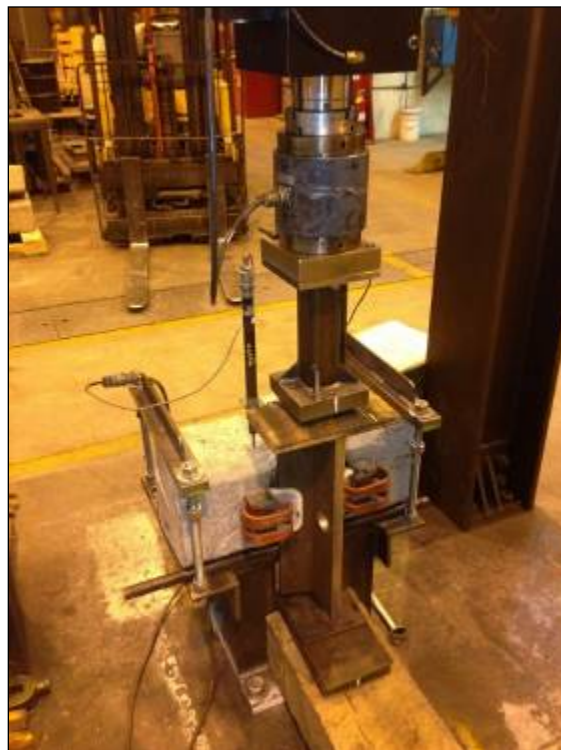
Figure 15 shows a schematic of the test setup [9]. Figure 16 shows a picture of the test setup and fixture used to restrain the tie section.

**Figure 16. Rail Longitudinal Restraint Fixture**

The tie section was fastened to the base of the fixture, and a short length of 136RE rail base was clipped to the tie using the SAFELOK I fastening system components and recommended installation procedure. The following instrumentation channels were collected:

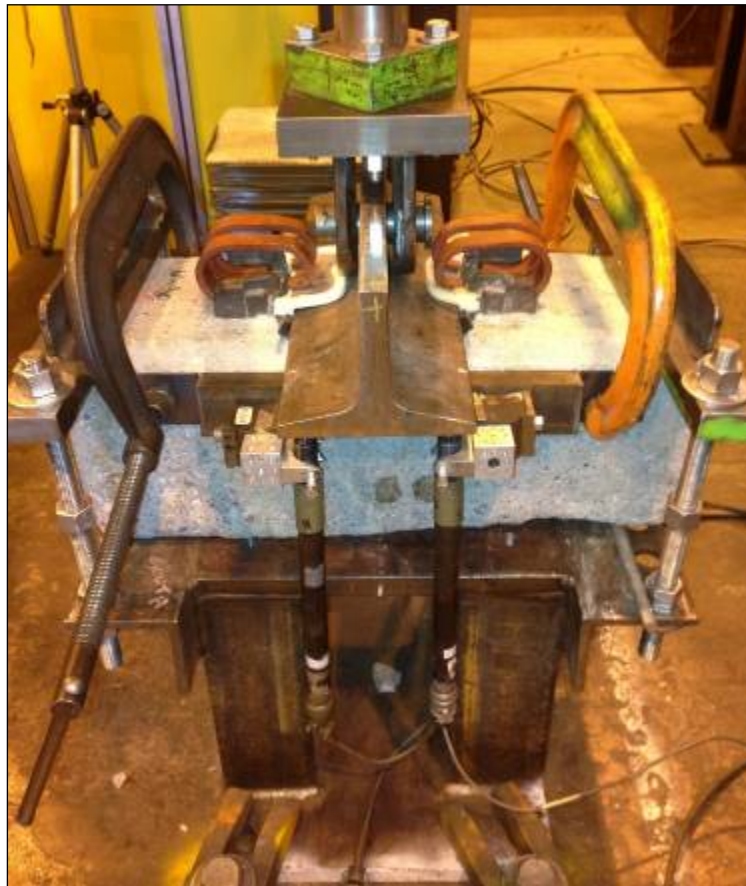
Figure 17 shows a schematic of the test setup. Figure 18 shows a photo of the test setup and fixture used to restrain the tie section. For this test, a single tie section was fastened to the test fixture and a short length of 136RE rail was clipped to the tie using standard SAFELOK I fastening system components and manufacturer recommended installation procedures. The rail fixture used had a 1.5-inch diameter hole drilled in the web. The rail was connected to the actuator with a shear pin and clevis, as Figure 17 shows.

**Figure 18. Vertical Rail Uplift Fixture**

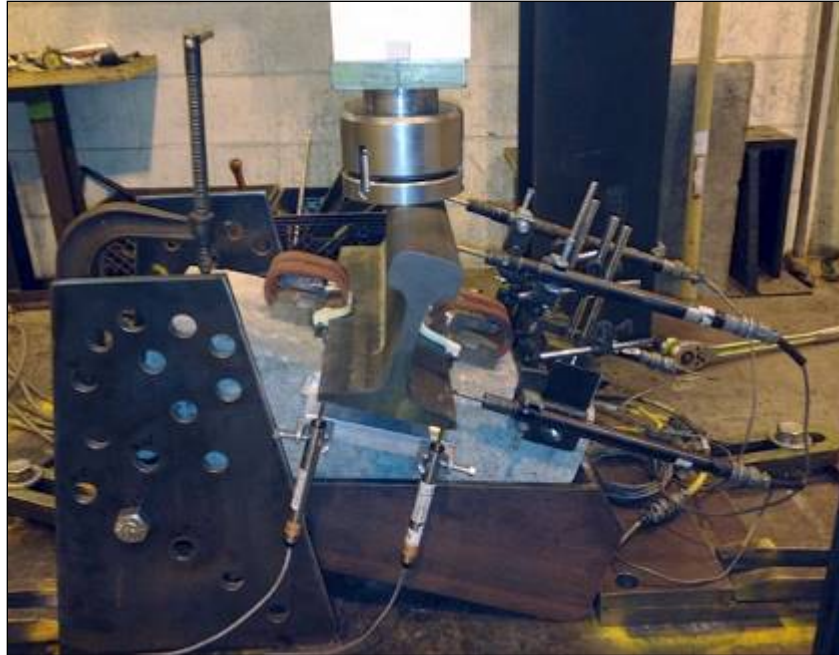
Figure 22 shows a schematic of the test setup for triangular RSD. Figure 23 shows a photo of the test setup and fixture used to restrain the tie section.

**Figure 23. Lateral/Vertical Compliance Fixture**

For this test, a single tie section was fastened to the test fixture and a short length (approximately 1 foot) of 136RE rail was clipped to the tie using standard SAFELock I fastening system components and manufacturer recommended installation procedures. The fixture shown in [Figure 23](#) allowed the angle of the tie to be varied to produce varying L/V ratios. A spherical compression platen was used to apply load to the railhead, through a point approximately 0.50 inch in from the gage side and 0.625 inch from the top of the railhead. This location is also used to define the load application point for AREMA Chapter 30 Test 6 – Wear/Deterioration.

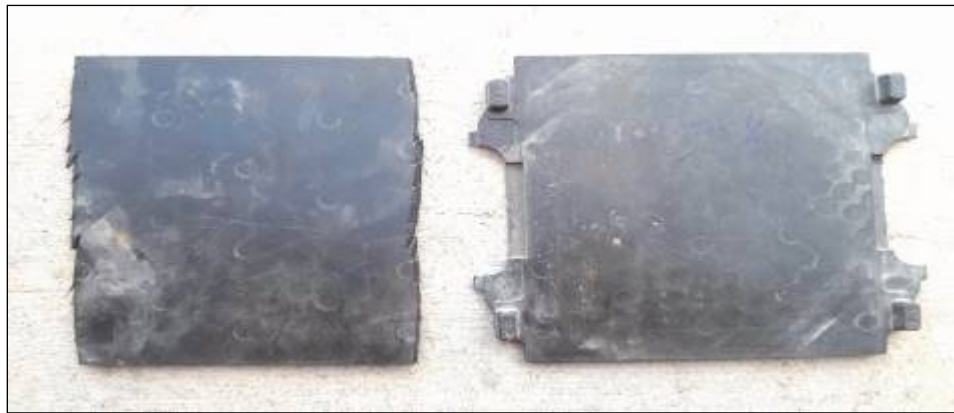
To demonstrate the effect that initial rail position was having on the system, triangular and uniform RSD test ties were set up again with two different pad conditions, one simulating a deteriorated pad, and a new pad, as was used throughout laboratory testing. [Figure 34](#) shows these two pads.

**Figure 34. Cut Pad Simulating Deterioration (left) and Uncut Pad (right)**

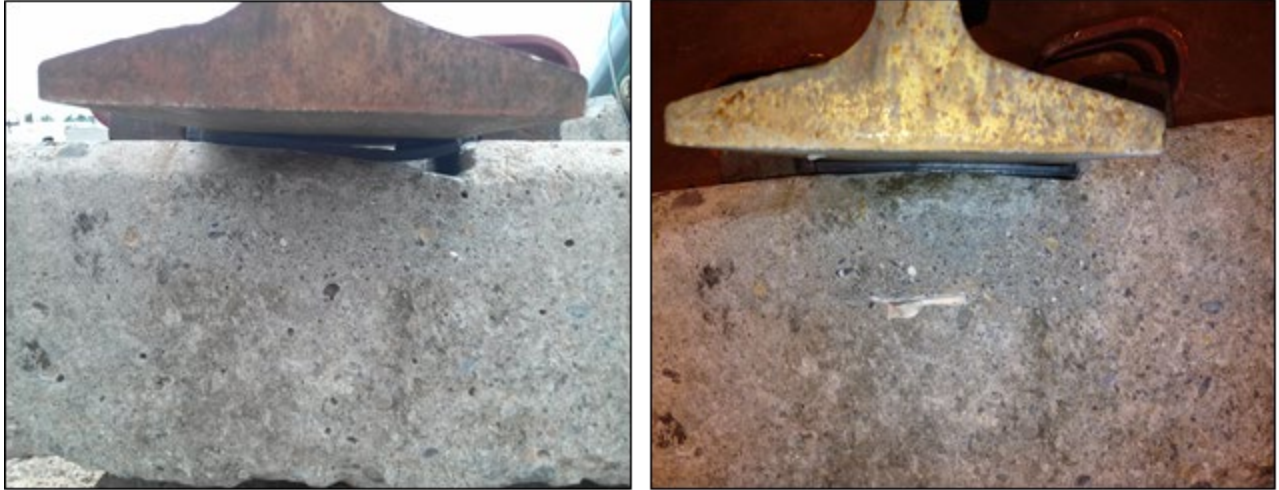
The same lateral/vertical compliance test regime was conducted. [Figure 35](#) shows the difference observed before (left) and after (right) loading suggests that the tie pad influenced the test results by supporting the rail over the RSD initially before loading. After the load was applied, the rail clearly seated deeper into the RSD. Since the rail was not reset after each L/V test case, the rail was likely starting in a different location each time a new test was performed. Worn or modified pads might better replicate in-situ RSD conditions. However, rail temperature and the effects of adjacent ties may also prevent the rail from fully seating in the RSD profile and thus affect the initial position of the rail before it is loaded.

**Figure 35. Using a New Rail Pad, Rail Before (left) and after (right) Lateral/Vertical Compliance Test**

Lateral/vertical compliance testing in the laboratory and GRMS testing indicated the importance of the initial position of the rail before loading. During laboratory testing, it was shown that the rail may or may not fully seat into severe triangular RSD depending on the condition of the pad. All laboratory tests were conducted with a short piece of rail on a single tie. Thus, torsional resistance, the effect of adjacent ties, or rail temperature were not considered in laboratory testing. Lower torsional resistance, or warmer rail temperatures may contribute to the rail fully seating in a triangular RSD profile on the high rail of a curve. Conversely, colder temperatures or lower torsional resistance may influence the rail base in resting outside of the RSD profile. These variables may change over time and may affect the initial, unloaded position of the rail as well as how it behaves under loading. Thus, for GRMS, the initial position of the rail, such as measured in the unloaded gage and unloaded cant channels, should be considered in addition to the channels measured under loading (loaded gage and loaded cant) when inspecting for RSD.

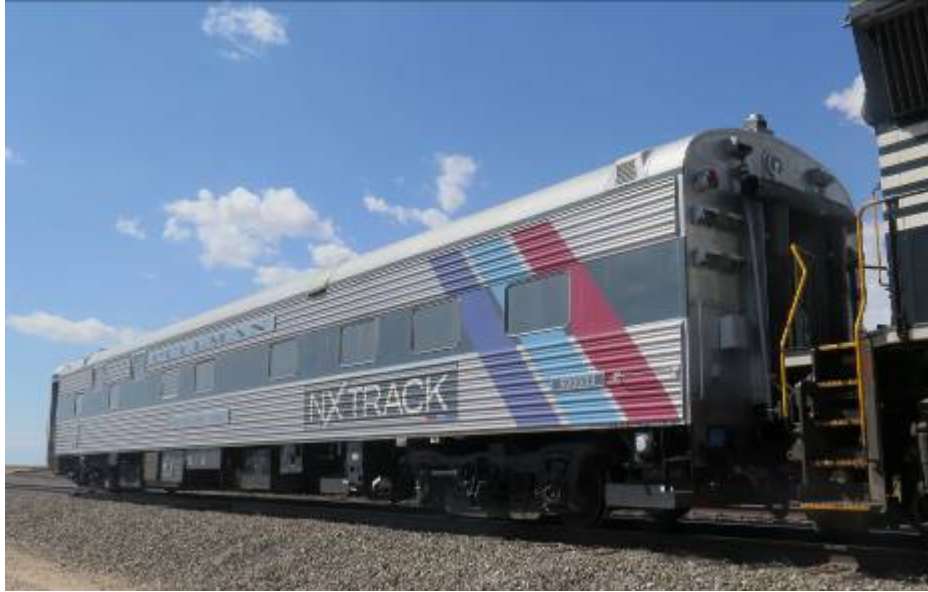
In addition to their track geometry measurement system, NxGen was provided the opportunity to use their machine vision-based inspection system to inspect the RSD zones during the same test runs. [Figure 44](#) shows the NxTrack car during testing. [Figure 45](#) shows three images from the system's video for an inspection run over the RSD zones. [Figure 45c](#) shows a slightly oblique angle of the high rail, field side fastener on Tie 10 of Zone 3, the Heavy, Full Triangular RSD. This camera angle is typically used by the system to inspect joint bars. However, it is evident from this image that the rail is sitting farther into the rail seat than would be typical for a non-RSD affected rail seat (note the top of the rail base flush with the concrete tie surface). These images and other track geometry data collected during testing may be used by NxGen for development of an image processing algorithm potentially capable of sensing RSD during a typical track inspection.

**Figure 44. NxGen and NxTrack Track Geometry and Machine Vision Vehicle**
