Implementation and Evaluation of a Buried Cable Animal Detection System and Deer Warning Sign

Final Report VTRC 19-R28

**IMPLEMENTATION AND EVALUATION OF A BURIED CABLE ANIMAL
DETECTION SYSTEM AND DEER WARNING SIGN**

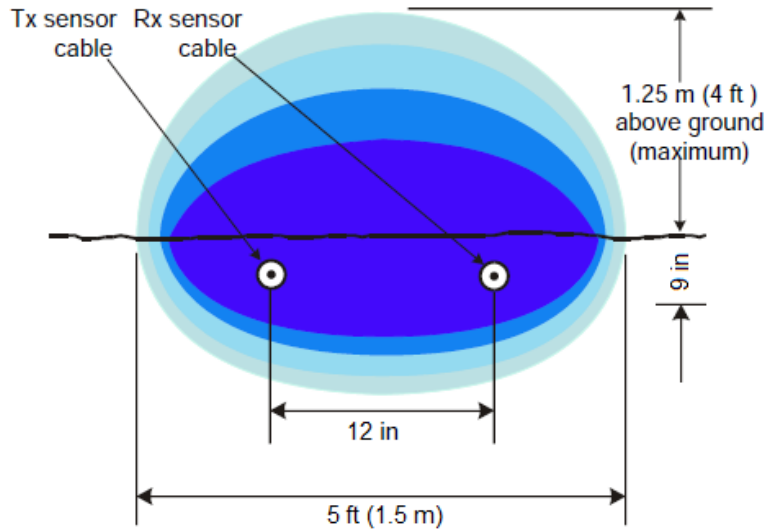
Figure 1 shows the transmit (TX) cable, which distributes radio frequency signals along the cable path, and the receive (RX) cable, which receives the signals and returns them to the processor.

Figure 1. Schematics of the BCADS Showing Cable Spacing along with Detection Field Width and Height. BCADS = buried cable animal detection system.

The radio frequency signals form an invisible electromagnetic detection field around the sensor cables that can detect and locate an animal passing through the field. The processor then triggers an alarm based on animal presence. The system can detect animals or intruders weighing over 32 kg (70 lb) when installed and calibrated according to the manufacturer's directions (Senstar, 2013).

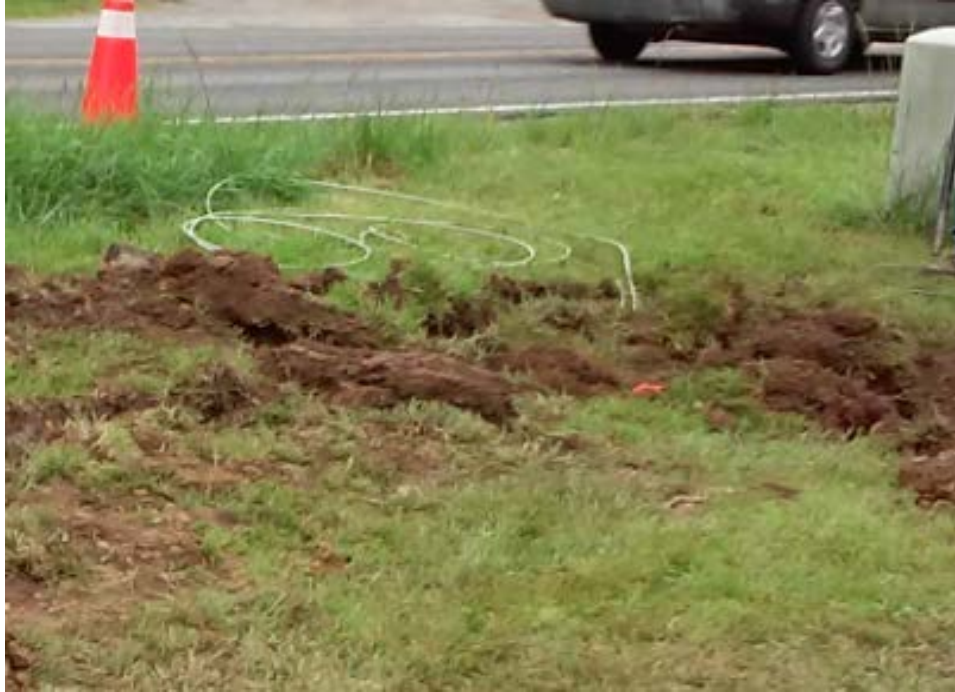
The trench was widened at the south end to house the lead-in cables that connect to the BCADS processor (Figure 7). The cables were installed with some overlap in this area to ensure uniform sensing along the entire length of the cables (Senstar, 2013). Detection field strength

Figure 7. Lead-in Cables That Connect to the Processor Enclosure.

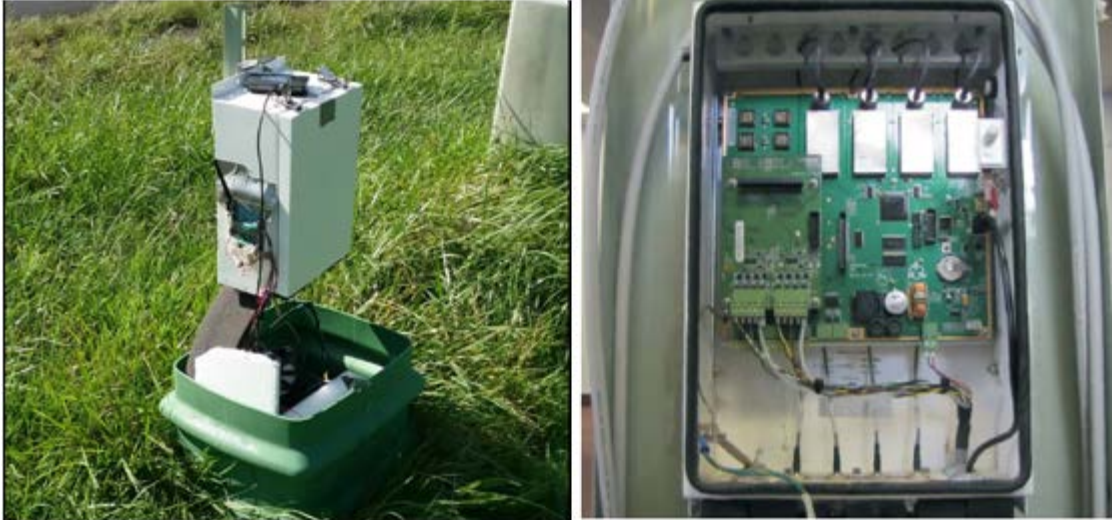
The processor box was installed 60 cm (2 ft) aboveground to prevent the cable connectors from coming into contact with surface water. (Figure 8). This type of enclosure is typically used for outdoor installations to provide additional security and protect the electronics from the elements.

Figure 8. Weatherproof Processor Box Mounted Inside the Telecom Enclosure (Left, Cover Removed) and Processor Board Installed Inside the Weatherproof Box (Right).

The wireless transceiver unit communicated with a paired transceiver located in the telecom box and wired to the BCADS' dry contact closure alert relay (Figure 8, left). The system was configured so that closure of the alerting relay would result in transmission of a wireless activation signal to the warning sign. Remote activation of the warning sign was set to flash the LEDs for 30 sec. The warning sign was angled slightly (~5 deg.) toward the road to properly project the LEDs toward oncoming traffic. When the BCADS declared multiple consecutive alarms, the sign flashed continually until 30 seconds passed after the last alarm.

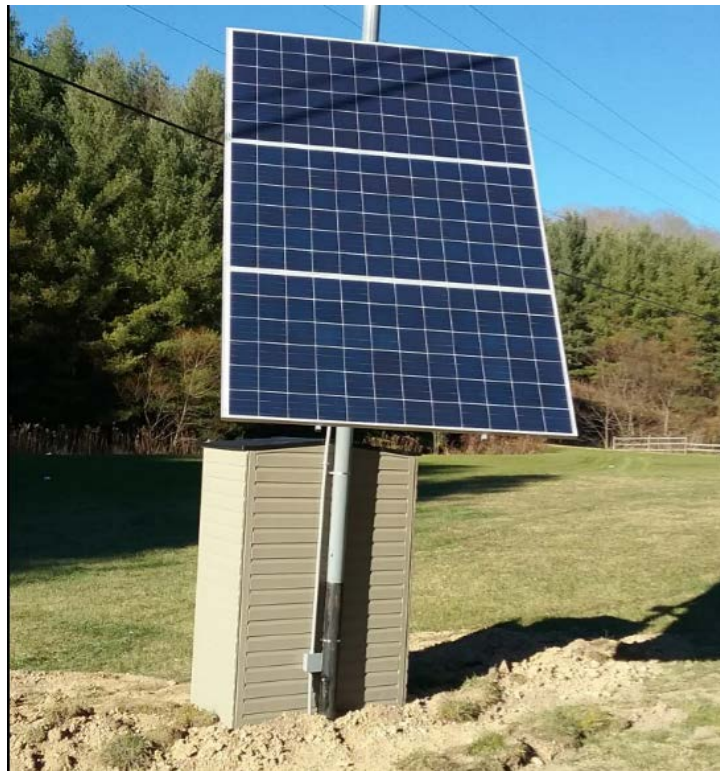
Before calibration, the manufacturer defined the alarm zones in the processor software so that different zone thresholds could be fine-tuned separately if necessary. The processor operates on a 12–48 VDC range (10 W) power supply and can communicate alarms via dry contact closure or a fiber optics or wireless/cellular interface. The BCADS was powered by a solar photovoltaic (PV) system installed 10 m (30 ft) away from the processor box (Figure 9).

Figure 9. Solar Photo-voltaic System Supplying Power to the Buried Cable and Surveillance Equipment.

The solar power system included two absorbent glass mat batteries and a charge controller to maintain battery charge. Additional equipment, including a surveillance camera, mini-computer (for remote access to the system), external hard drive (for data collection), and cellular modem (for wireless data transfer and real-time access for BCADS surveillance) were also powered by the PV system.

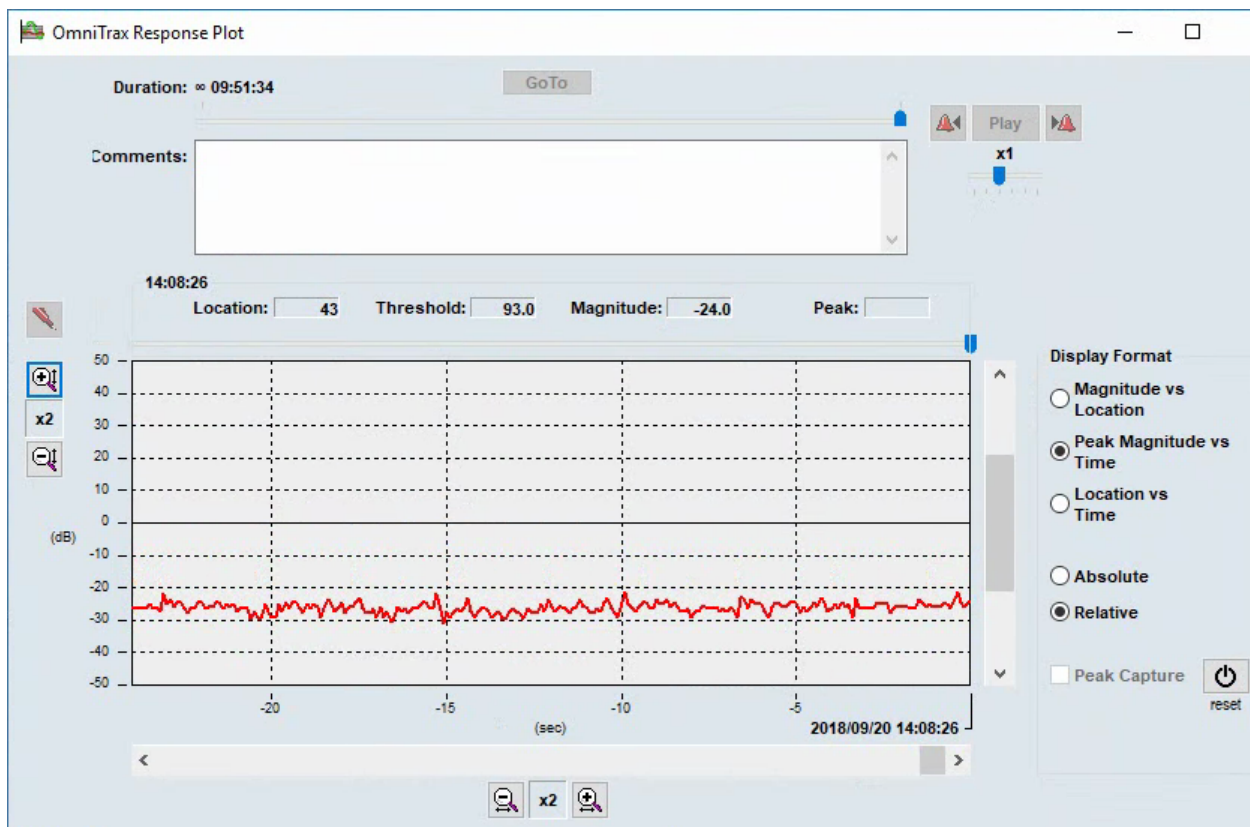
The CM also enabled researchers to determine if power outages or signal interruptions occurred so that troubleshooting could be performed promptly. Generally, regular and timely data entry and/or data quality checks are essential to correct errors, retrieve missing data (by checking alarm history), and verify any unusual data. The CM control window allowed for further system configuration (e.g., node synchronization, network interface selection, and cable side selection) and access to the alarm history file. The program module could be queried to retrieve and save old event history files for future reference. Additionally, a separate response plot window allowed for the real-time monitoring of cable activity and continuous collection of signal data on a daily basis (Figure 11). The plots offered details about the time and date of cable signal monitoring along with the crossing location, threshold at that specific location, and magnitude of the signal (dB).

Figure 11. Example Cable Response Plot Used to Identify Real-time Cable Crossing Events. This Signal Response Indicates No Crossing.

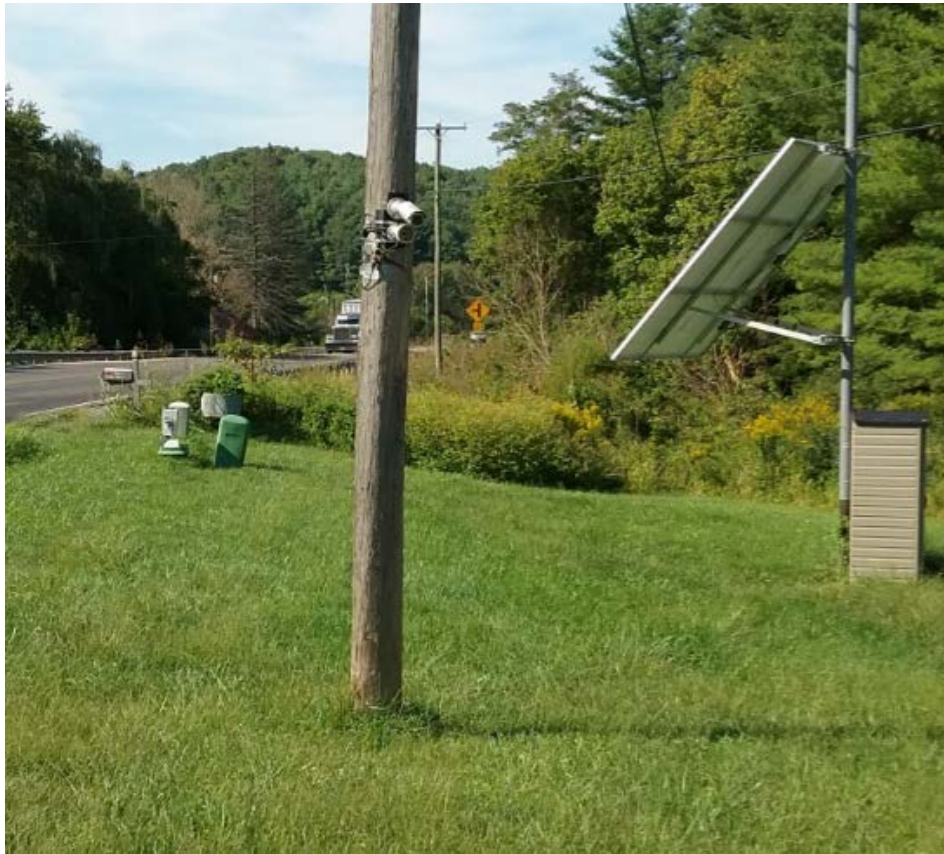
An infrared surveillance camera and a near-infrared illuminator covering distances ranging from 25 m (75 ft) to 100 m (300 ft) were installed near the processor enclosure to monitor side A of the cable toward the Victory Lane driveway (Figure 12). The camera recorded five-minute video clips and automatically adjusted for day/night recording, defogging, and wide dynamic range sensing for enhanced exposure control. Prior to their on-site installation for continuous data acquisition (video and animal crossing detection), the camera and illuminator were tested to assess their capabilities in different weather and natural light conditions, including

Figure 12. Surveillance Camera (Top) and Illuminator Used for Cable/Site Monitoring. The Solar Power System (Far Right) and Processor Enclosure (in the Background) are also Shown.
