## Survey and Economic Analysis of Pavement Impacts from Studded Tire Use in Alaska

**Prof. Osama Abaza, PhD., C. Eng.**

May 2019

FHWA-AK-RD-4000(175), HFHWY00078

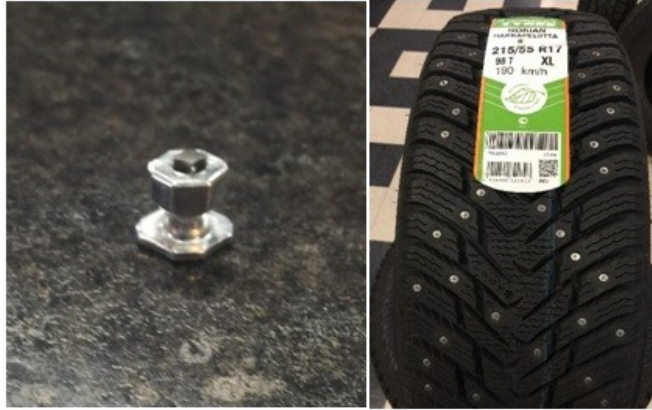
Figure 3.1 New stud technology.

- Quantifying the total number of studs embedded per tire should be regulated by Alaska law. Based on Barter et al. (1996), pavement damage is caused primarily by the total number of studs installed in a tire passing over the road surface. Studded tires have different stud numbers and arrangements. Alaska law does not regulate the number of studs per tire. Manufacturer surveys show new stud technology available in the market. With this new technology, studs have the ability to perform like steel springs, reducing raveling force once the stud hits the hard pavement surface. On ice and snow, the studs engage fully. Figure 3.1 shows the structure of the new studs. It is highly recommended that stud count per tire per tire diameter be enacted in Alaska.

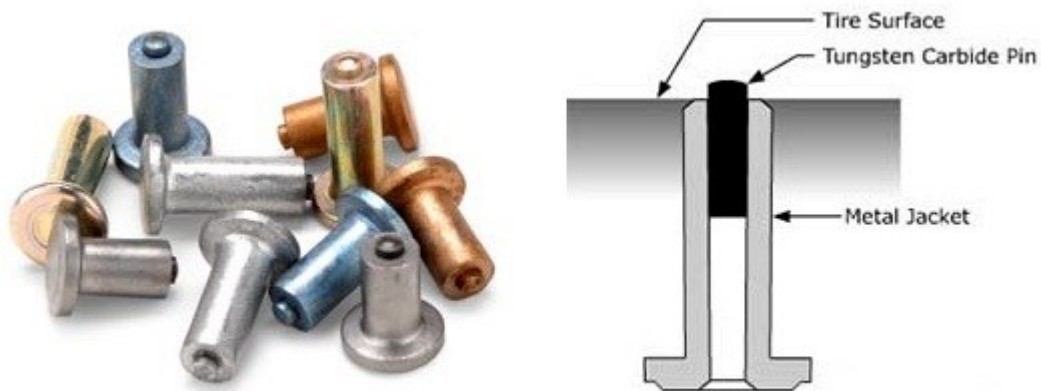
Figure A.1 Stud construction (Vermont Tire and Services, 2017)

A tire stud consists of two basic parts that have varied in size, weight, and composition over the years. The outside part of the stud is referred to as the stud jacket or sleeve; a flange at the base of the stud jacket holds the stud in place. The stud core, pin, or insert is situated within the jacket and protrudes from the tire to make contact with the pavement. After insertion of a tire stud (jacket and pin) into the tire, a “breaking” period occurs, during which the tire rubber completely surrounds the stud jacket, filling any space between the jacket and the rubber. In this way, the rubber secures the jacket in place (Angerinos, 1998).

Conventional studs in the 1960s were approximately 0.307 in. (7.8 mm) long, with a protrusion of about 0.087 in. (2.2 mm). Since the 1970s, because stud weight and protrusion length were shown to be significant factors in pavement wear rates, both weight and protrusion have been reduced. The advent of the controlled protrusion (CP) stud allowed for nearly a 40% reduction in pin protrusion—0.039 to 0.059 in. (1.0 to 1.5 mm)—by using a tapered pin that is able to move back into the stud jacket as the tire rubber wears. In the 1960s, the average weight of the conventional stud was approximately 0.081 oz. (2.3 grams), while the typical CP stud, which is the only stud in use in the U.S. today, weighs 0.059 to 0.067 oz. (1.7 to 1.9 grams) (Angerinos, 1998). In Scandinavian countries, additional efforts have been made to reduce stud protrusion and weight. Studs there now range in length from 0.047 to 0.059 in. (1.2 to 1.5 mm) and weigh approximately 0.039 oz. (1.1 grams). Testing in Scandinavia has shown reduced wear effects for studs with a lightweight plastic jacket (0.025 oz./0.7 gram), as well as studs with a lightweight metal jacket (0.033 oz./0.95 gram) (Brunette et. al., 1996).
