Feasibility Study for Rapid Evaluation of Bridge Decks

Final Report

FHWA-SC-18-09

December 2018

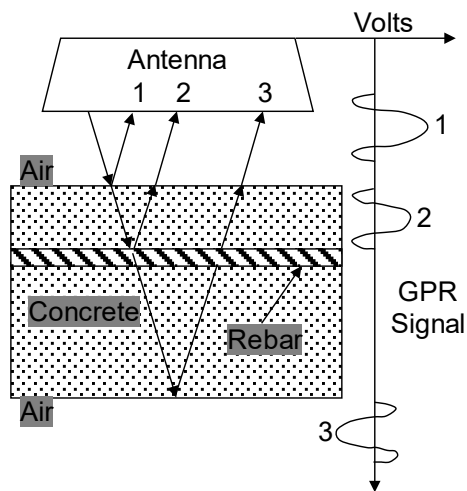
Figure 2.1: GPR signal for concrete bridge deck

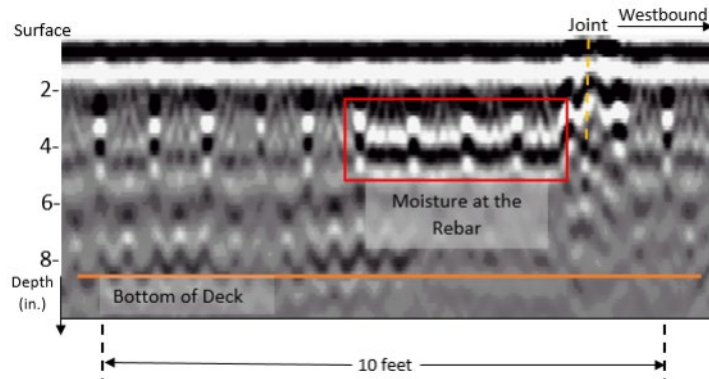
(a) Consistent rebar reflections and varying depths

(b) Evidence of moisture at the bottom of the overlay

(c) Bridge deterioration data

Figure 2.2 presents examples of GPR data used for mapping rebar-depth, evidence of moisture at the rebar-level, and deterioration. The advantages of this method include versatility, portability, applicability to decks with asphalt overlays, and minimal traffic control. On the other hand, the interpretation of results may be complex.

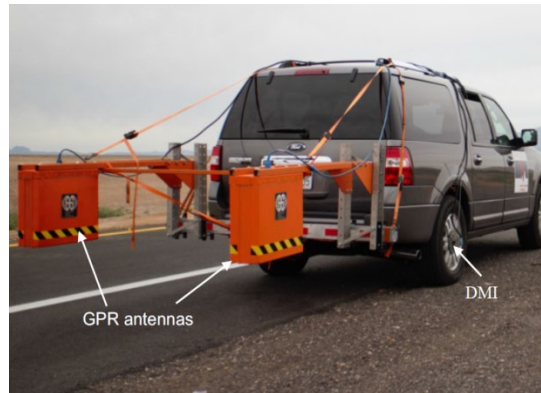
Figure 3.5: GPR survey equipment (BDI and Infrasense Inc., 2017),
(figure reproduced with permission)

Ground penetrating radar (GPR): GPR surveys were carried out on all four bridges in accordance with ASTM D 6087 (2015) using twin air-coupled 2 GHz horn antennas attached to a vehicle as shown in **Figure 3.5**. The GPR data was collected in a series of lines spaced 3 feet transversely across the width of each deck at a vehicle speed of approximately 55 mph. Using a rotary encoder (Distance Measurement Instrument, DMI), the distance data was continuously recorded into each GPR record so that each GPR data scan had an associated distance. The GPR analysis was conducted with Geophysical Survey System, Inc. (GSSI) commercial software, Radan 7, along with proprietary software.

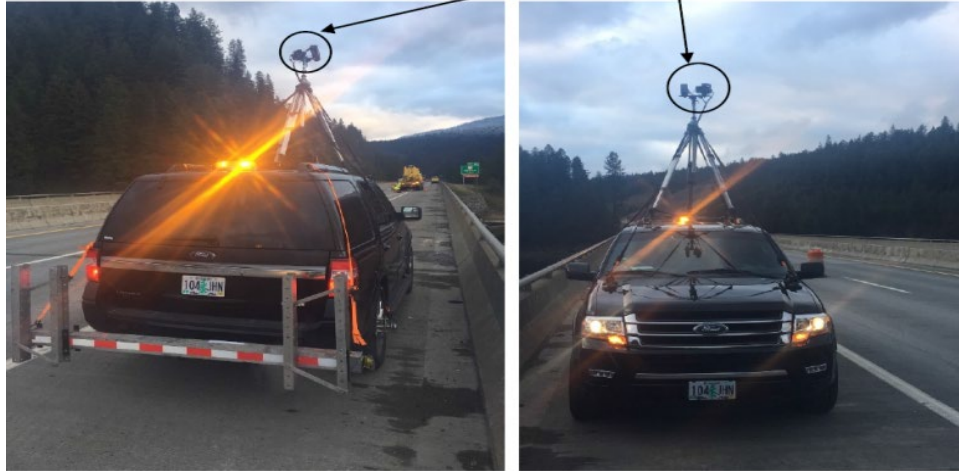
Figure 3.6: Infrared and video survey equipment (BDI and Infrasense Inc., 2017),
(figure reproduced with permission)

Infrared (IR) thermography and HDV scanning: Vehicle mounted infrared thermography scanning was carried out on all four bridge decks in accordance with ASTM D4788 (2013) using a 640*480-pixel FLIR System Model A655sc infrared camera in combination with a Sony-Alpha 74K HRV camera. Both were mounted on an elevated platform on a vehicle as shown in **Figure 3.6**. The infrared and video data were collected across each deck at approximately 55 mph. The infrared data is analyzed simultaneously with HRV data to differentiate delaminated areas from surface features such as oil stains and discolorations.

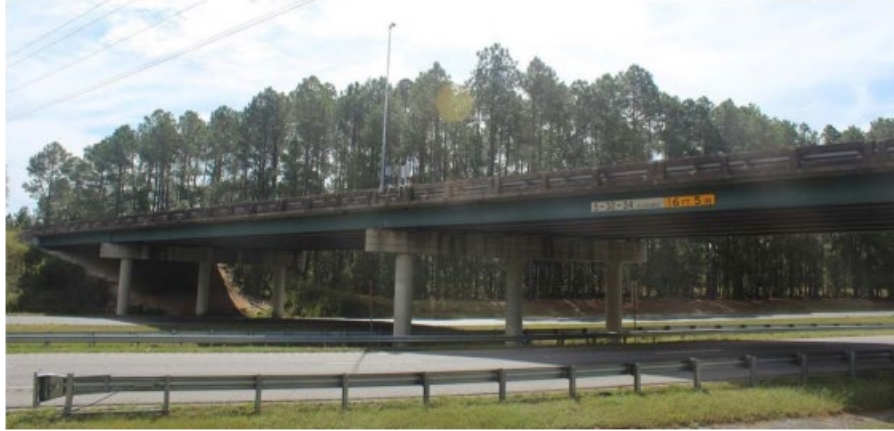
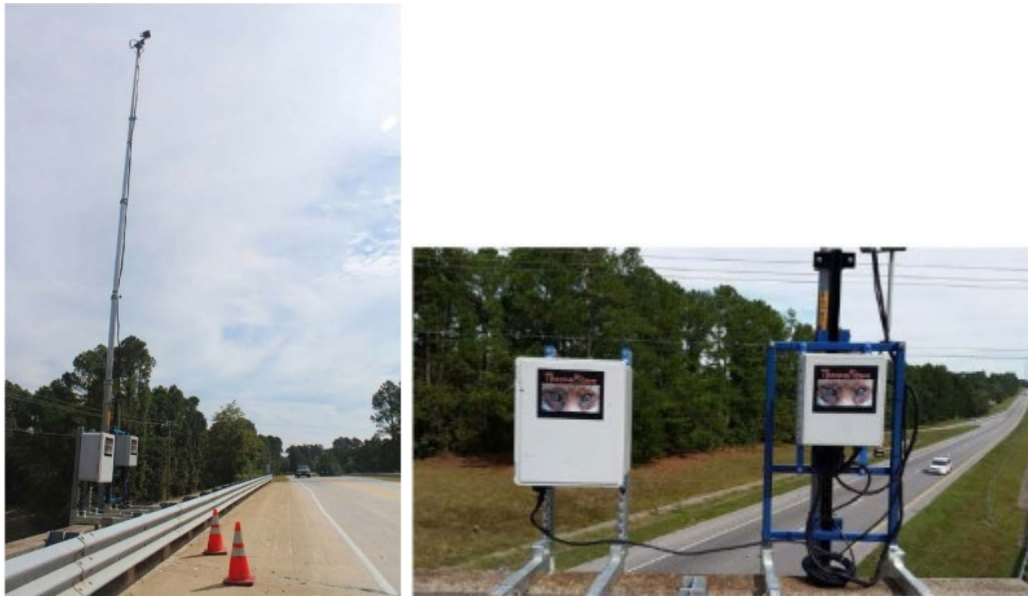
S-34, Pond Branch Road over I-20: The Infrared Ultra-Time Domain (IR-UTD) system was positioned at the middle of the bridge on the north side. The system was installed using a parapet mount system. **Figure 3.7** shows the system mounted on the bridge (ThermalStare, LLC., 2017).

Figure 3.7: IR-UTD setup at S-34, Pond Branch Road over I-20 (ThermalStare, LLC., 2017)
(figures reproduced with permission)

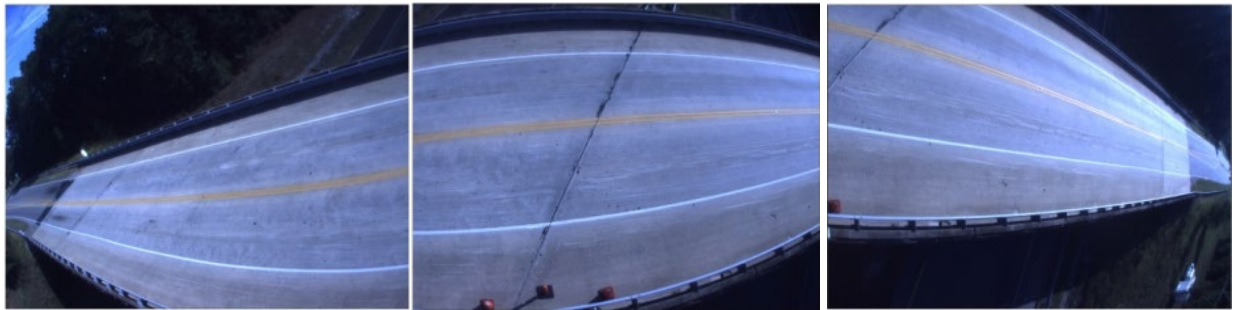
Figure 3.9: IR-UTD visual images at S-34, Pond Branch Road over I-20 (ThermalStare, LLC., 2017) (figure reproduced with permission)

Measurements were collected from three areas, as shown in **Figure 3.8**. The image on the left shows a view looking east from the position of the IR-UTD, the middle image is looking downward, and the right image is looking west from the position of the IR-UTD. **Figure 3.8** shows that the IR-UTD images were optimized to display the structural features supporting the bridge deck. The girder lines are visible (except the girders hidden by the parapets) as well as the joints between the spans. **Figure 3.9** shows visual images of the bridge deck associated with the IR-UTD images shown in **Figure 3.8**.

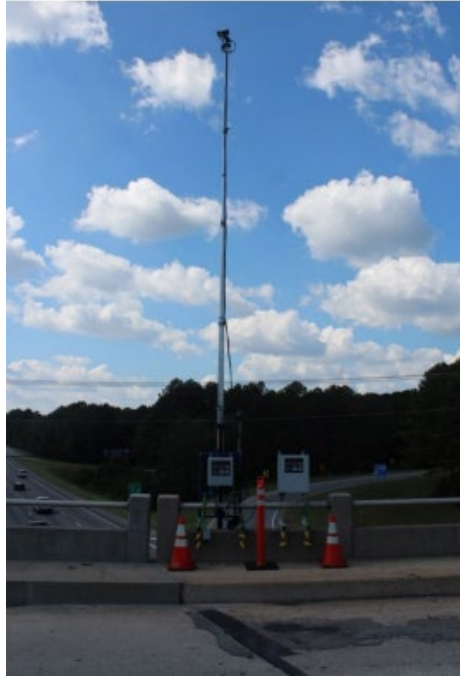
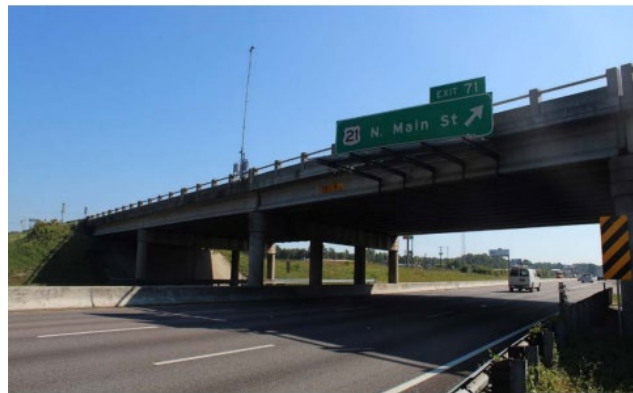
US-21, Wilson Boulevard over I-20: The IR-UTD system was positioned at the middle of the bridge on the west side as shown in **Figure 3.10**. The system was again installed using a parapet mount system.

Figure 3.10: IR-UTD setup at US-21, Wilson Blvd. over I-20 (ThermalStare, LLC., 2017)
(figures reproduced with permission)

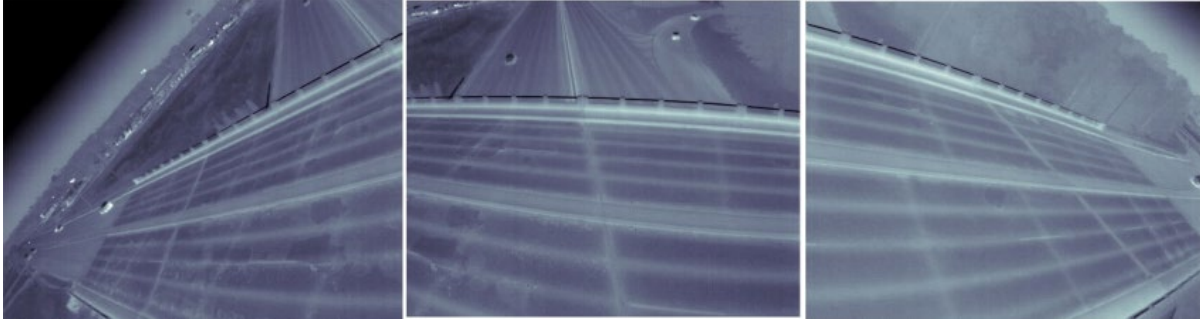
Measurements were collected at three areas as shown in **Figure 3.11**. The image on the left shows a view looking north from the position of the IR-UTD, the middle image is looking downward, and the right image is looking south. **Figure 3.11** shows IR-UTD images optimized to display the structural features supporting the bridge deck. The beam lines are visible (except the beams hidden by the parapet and median berm) as well as the joints between the spans and diaphragms. **Figure 3.12** shows the visual images of the bridge deck corresponding to the IR-UTD data shown in **Figure 3.11**.

Figure 3.11: IR-UTD data showing structural features at US-21 Wilson Blvd. over I-20
(ThermalStare, LLC., 2017) *(figures reproduced with permission)*

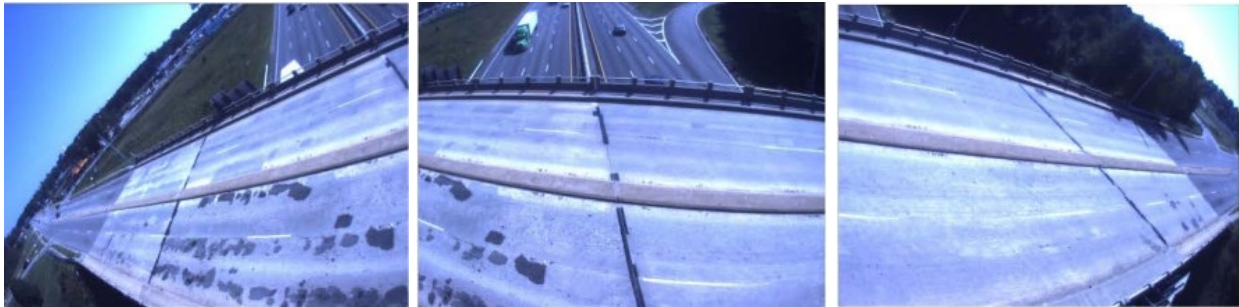
Figure 3.12: IR-UTD visual images at US-21, Wilson Blvd. over I-20
(ThermalStare, LLC., 2017) *(figures reproduced with permission)*

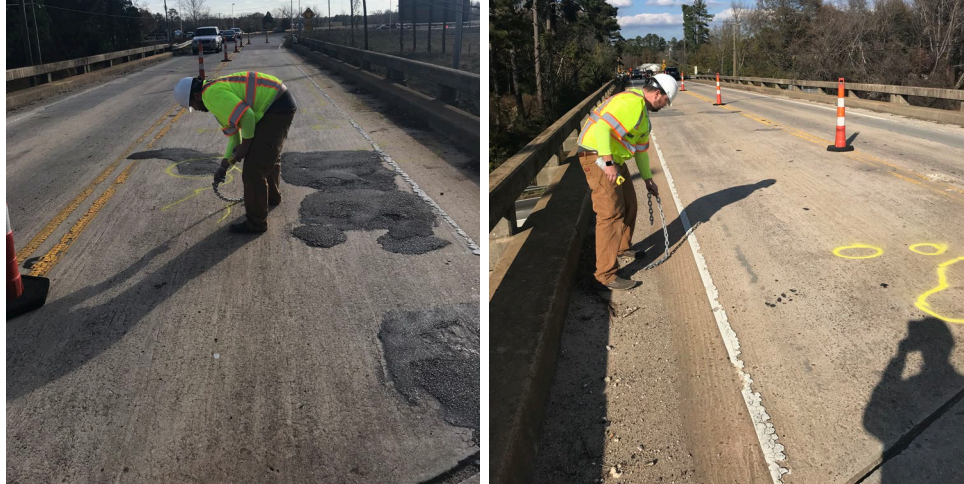
Manual chain dragging using a 3/8 in. galvanized chain was conducted only on the east bound lane and shoulder between bents 4 and 5 of the S-34 Pond Branch Road bridge (structure no. 3270003400300), the south bound right lane between bents 2 and 3 of US-21 Wilson Blvd bridge (structure no. 4020002100300), and the south bound lane and shoulder between bents 3 and 4 of S-106 Mineral Springs Road bridge (structure no. 3270010600200). **Figure 3.13** shows chain dragging conducted on the S-106 Mineral Springs Road bridge.

Figure 3.13: Chain dragging on S-106, Mineral Springs Road bridge over I-20

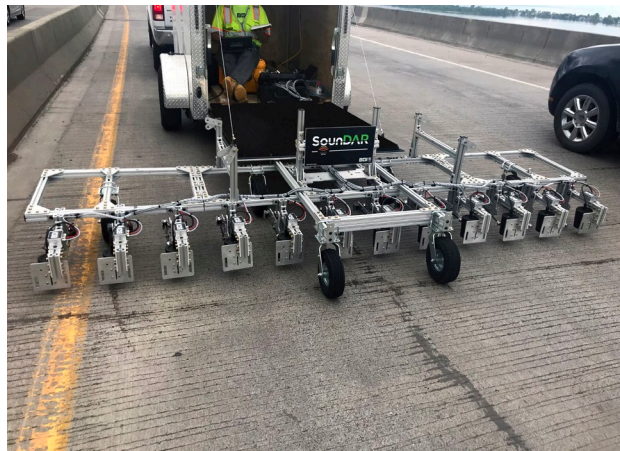
An automated Deck Acoustic Response (DAR) device was used for rapid detection of delamination. This method includes ball-chain assemblies for continual impact excitation and multi-channel microphones for acoustic sensing mounted on a vehicle. The device is designed for individual impacts like hammer sounding (**Figure 3.14**) or ball-chain assemblies may be attached as shown in **Figure 3.15**.

Figure 3.14: Deck acoustic response for individual solenoid impactors (BDI/Infrasense, Phase II Report, 2018) (figure reproduced with permission)

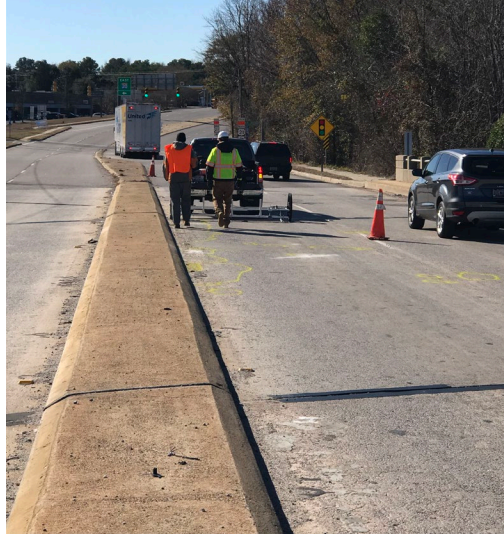
Figure 3.15: DAR ball-chain assembly in use on US-21, Wilson Blvd. over I-20

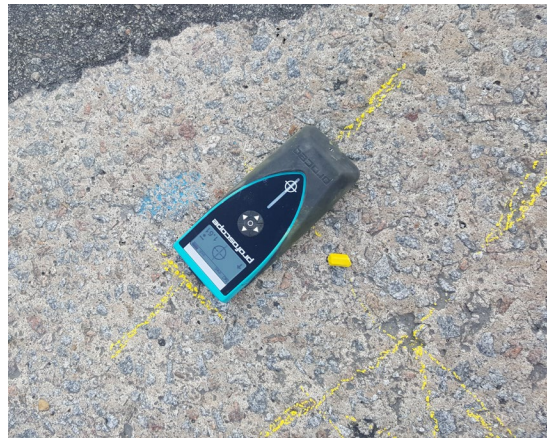
Figure 3.18: Profoscope rebar locator

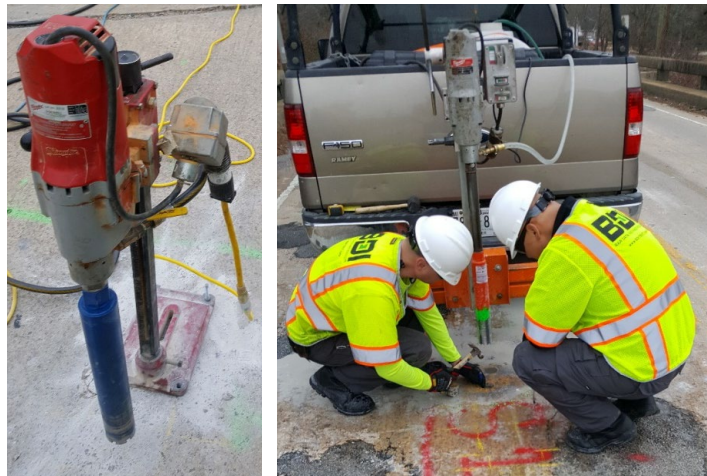
(a) deck-mounted

(b) truck-mounted

A total of 49 cores were extracted from three of the four bridge decks. The number of cores extracted is summarized in **Table 3.2**. Thirteen cores were taken by the U. South Carolina team using a deck-mounted, wet coring device and the remainder were extracted by BDI using a truck-mounted wet coring device. Coring devices are shown in **Figure 3.19**. Each core was labeled and stored in sealed plastic bags after extraction. Severe damage, medium damage, and no damage regions are indicated by “S”, “M”, and “N” in the core labels, respectively. Core holes were cleaned and filled with a repair material as shown in **Figure 3.20**. SikaQuick 2500, a very rapid hardening and repair mortar, was used to fill the holes after coring. According to the SikaQuick manufacturer recommendations 3/8 in. coarse aggregate was added.

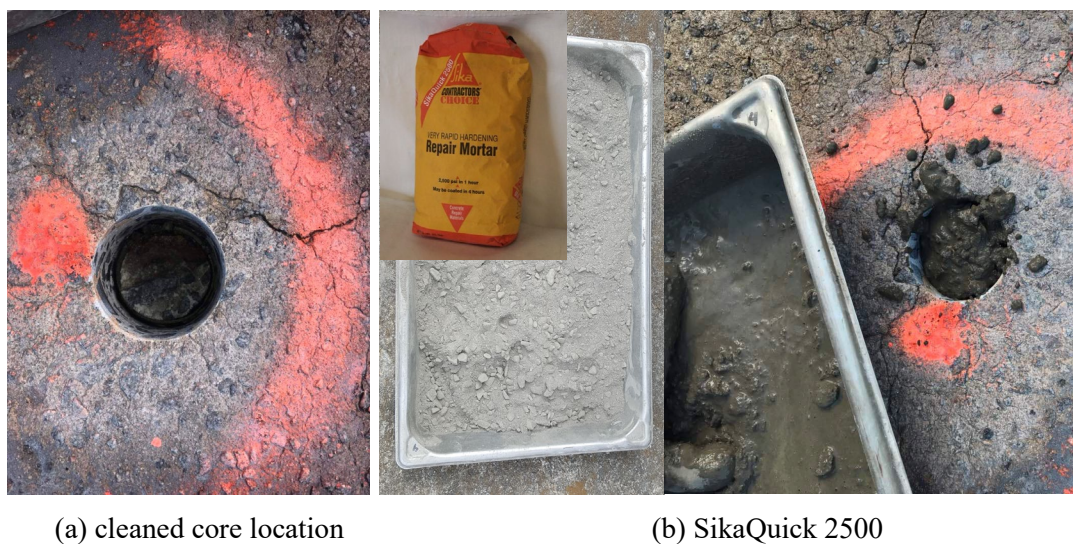
Figure 3.20: Repairing of core locations

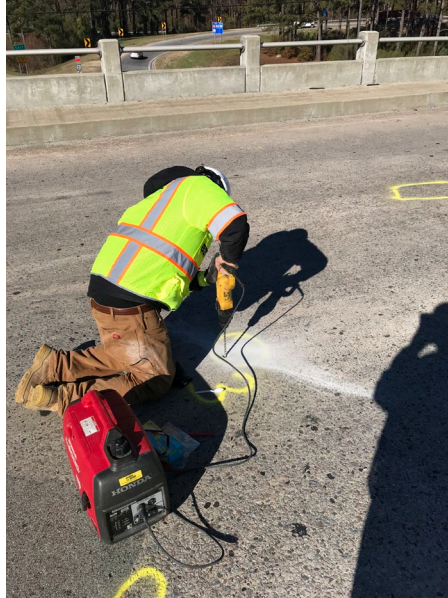
Figure 3.21: Drilling holes to collect concrete powder samples on US-21, Wilson Blvd. over I-20 bridge deck

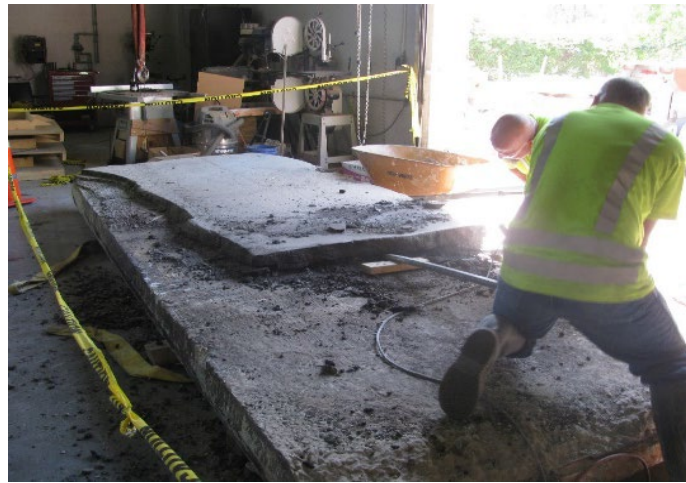
Figure 3.23: Removing the asphalt layer

Since the corrosion process takes years to affect performance an accelerated investigation was performed. Two bridge deck specimens recovered from an SCDOT bridge were used for this study. The bridge was constructed in 1953 and it is now out of service. The slabs are 15 ft. long, 5 ft. wide and 8 in. thick. The asphalt layer overlay was removed as shown in **Figure 3.23**. Scanning using a rebar locator was done to indicate the rebar position (**Figure 3.24**). The specimens were then moved outside the laboratory for preliminary testing by BDI/Infrasense.

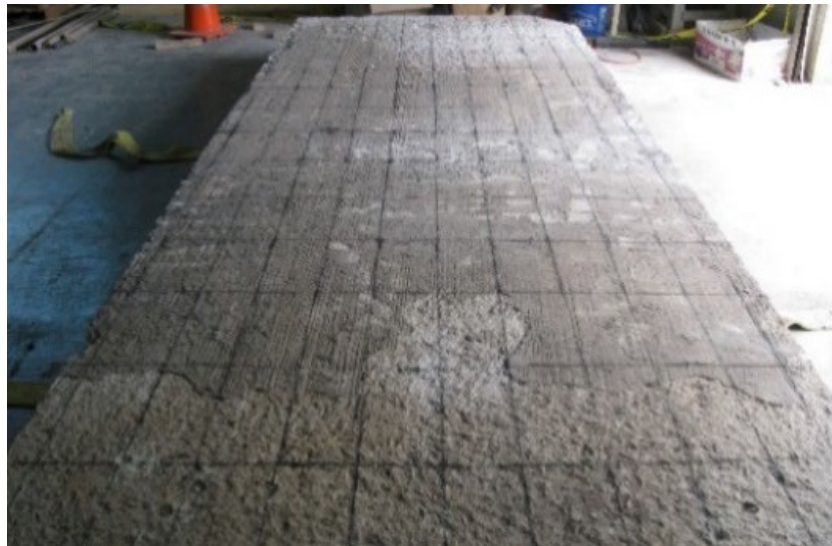
Figure 3.24: Marking positions of reinforcement

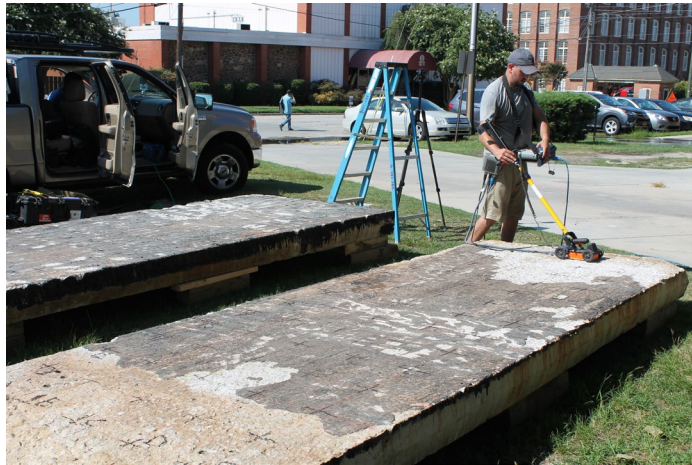
Figure 3.25: GPR scanning

BDI/Infrasense performed visual inspection, ground penetrating radar, infrared thermography, impact echo, and half-cell potential on the bridge deck specimen after establishing a 1 ft.×1 ft. testing grid. For the GPR scanning, a 2.6 GHz GSSI antenna was used to send electromagnetic waves through the concrete deck (**Figure 3.25**). Infrared thermography testing was carried out using a 640 × 480-pixel FLIR System Model A-655sc infrared camera and a high-resolution visual camera as shown in **Figure 3.26**. For IE testing, an Olson Instruments NDE-360 unit was used on the testing grid (**Figure 3.27**) while half-cell potential testing was conducted with a James Instruments Cor-Map II HCP device (**Figure 3.28**).

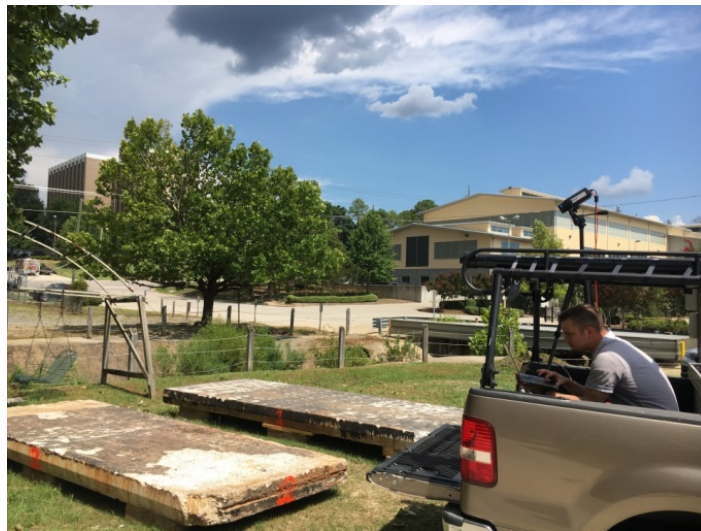
Figure 3.26: Infrared thermography scanning

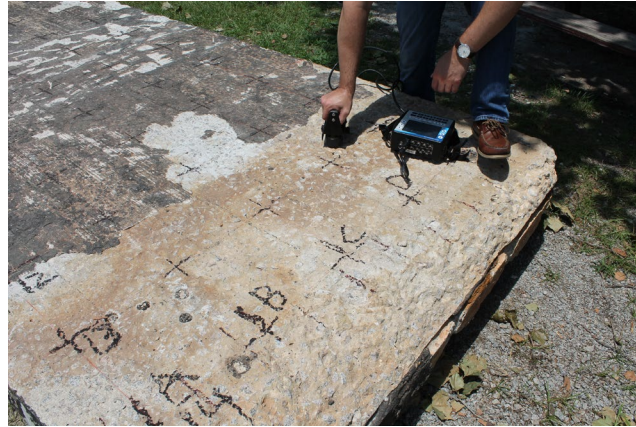
Figure 3.27: IE testing

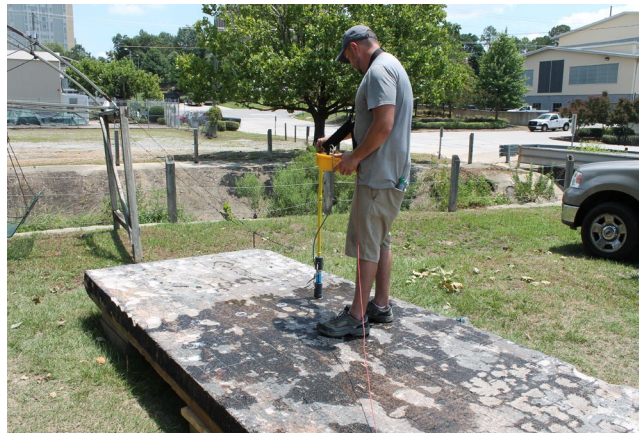
Figure 3.28: Half-cell potential testing

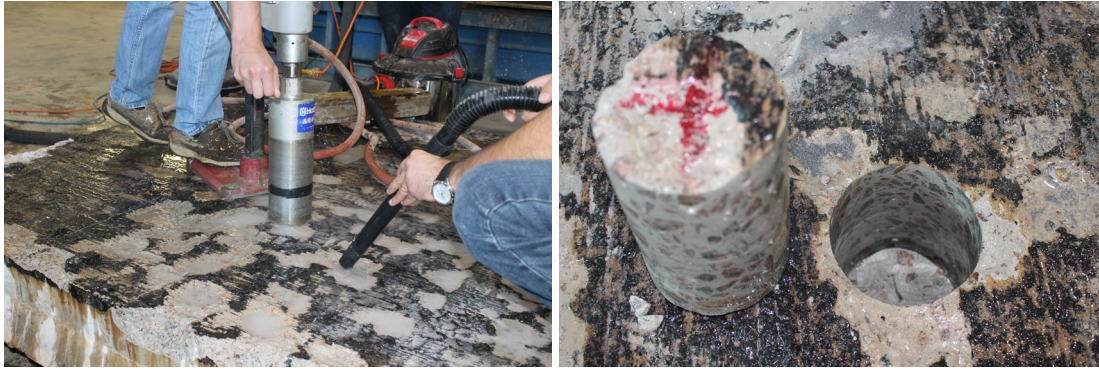
After the initial assessment, an accelerated test was conducted to corrode eight different areas. Eight concrete cores were drilled (4 in. diameter x 6 in. deep) to access the rebar as shown in **Figure 3.29**. The deck was set vertically to provide access to both sides which is needed for the ultrasonic pulse velocity test (**Figure 3.30**). Wet/dry cycles were conducted (three days wet/four days dry) with 3% NaCl Chloride solution to accelerate the corrosion process. To monitor the corrosion process, half-cell potential and linear polarization resistance measurements were recorded at the end of the wet period to ensure better concrete conductivity. The objective of these measurements was to provide insight related to the corrosion process of the reinforcement at the selected locations.

Figure 3.29: Extraction of cores

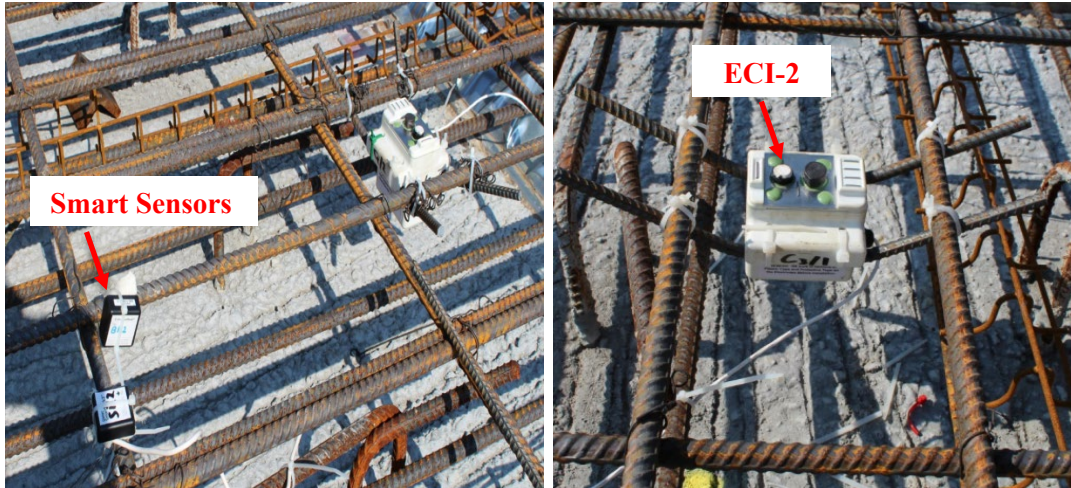
Figure 3.36: ECI-2 and smart sensors during installation and prior to casting

On September 19, 2017, two ECI-2 devices and ten wireless smart sensors were installed in a bridge deck for long-term corrosion monitoring (**Figure 3.36**). This bridge is in Columbia at the intersection of Leaphart Road and I-26. The two ECI-2 devices and the datalogger are powered by a rechargeable battery connected to a solar panel mounted on the bridge (**Figure 3.37**). LoggerNet software was used to create a program for the data logger and to collect data from the two ECI-2 devices. Five BlueRock and five Smart Rock 2 sensors were also installed to monitor the temperature, humidity, and strength of the concrete. **Figure 3.38** shows the location of each sensor.

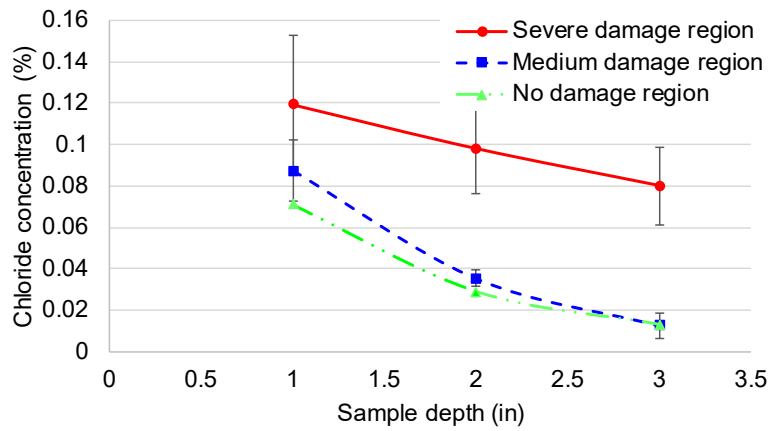
Figure 4.2: Chloride concentration results (S-34, Pond Branch Road over I-20, good condition)

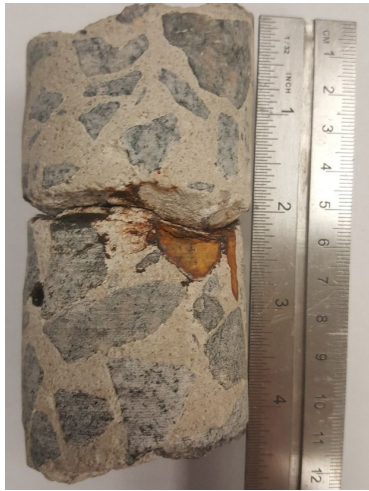
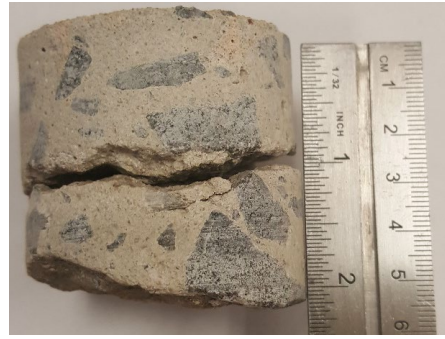
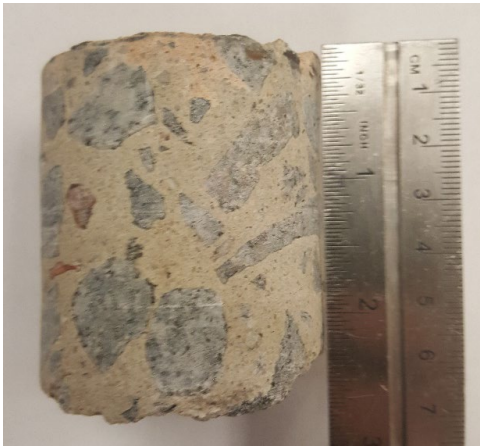
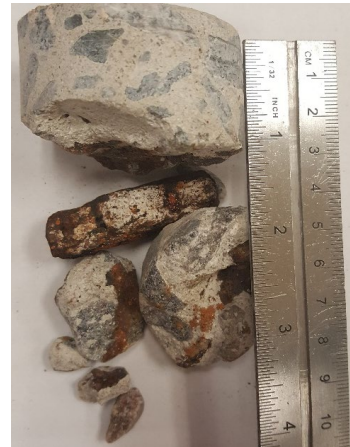
Figure 4.4: Cores taken from 'severe damage' region (S-34, Pond Branch Road over I-20, good condition)

Results of visual inspection for the extracted cores are shown in **Table 4.1**. Average diameter, length, weight, number of pieces, presence of reinforcement, visible cracking, and delamination are reported. The cores were taken by either BDI/Infrasense or U. South Carolina as indicated in the last column. Photographs of the cores for severe, medium, and no damage regions are shown in **Figures 4.4, 4.5 and 4.6**.

Core	Diameter (in)	Length (in)	Weight (lb.)	Number of pieces	Rebar	Visible crack	Delamination	Taken by
S-34-S1	2.2	4.3	1.25	2	No	Yes	Yes	BDI
S-34-S2	2.2	2.0	0.60	2	No	Yes	Yes	BDI
S-34-S3	2.2	2.5	0.85	1	No	Yes	Yes	BDI
S-34-S4	2.3	1.3	0.40	7	Yes	Yes	Yes	BDI
S-34-M1	2.2	5.3	1.70	1	No	No	No	BDI
S-34-M2	2.2	5.3	1.65	1	No	No	No	BDI
S-34-M3	2.2	5.4	1.70	1	No	No	No	BDI
S-34-M4	2.2	5.9	1.90	1	No	No	No	BDI
S-34-N1	2.2	2.8	0.90	2	No	No	No	BDI
S-34-N2	2.3	4.0	1.30	1	No	No	No	BDI
S-34-N3	2.3	5.5	1.85	1	No	No	No	USC
S-34-N4	2.3	4.6	1.60	1	Yes	No	No	USC
S-34-N5	2.2	2.7	0.80	1	No	No	No	USC
S-34-N6	2.3	6.1	2.05	1	No	No	No	USC

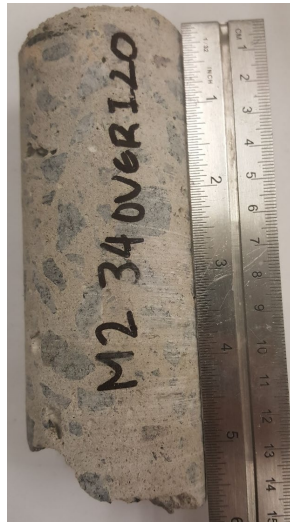
b) S-34-M2

Figure 4.5: Cores taken from 'medium damage' regions (S-34, Pond Branch Road over I-20, good condition)

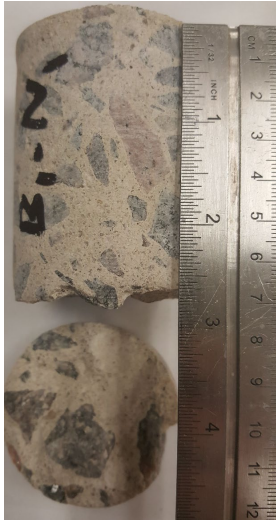
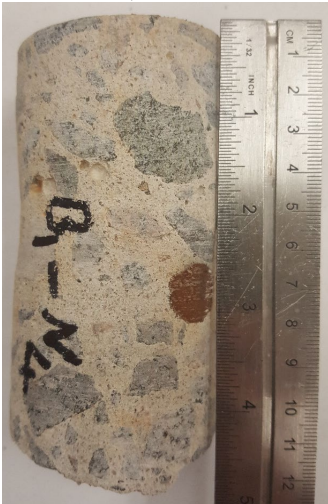
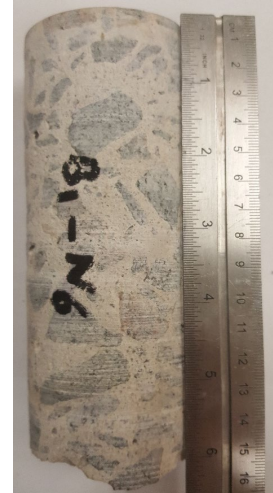
Figure 4.6: Cores taken from 'no damage' region (S-34, Pond Branch Road over I-20, good condition)

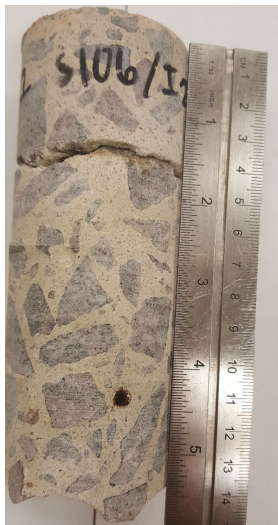
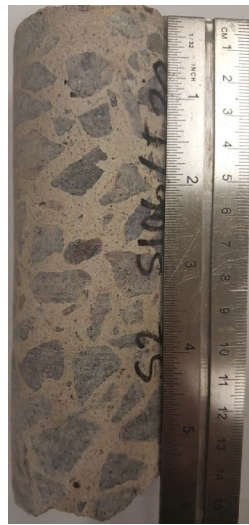
Core	Diameter (in)	Length (in)	Weight (lb.)	Number of pieces	Rebar	Visible crack	Delamination	Taken by
S-106-S1	2.24	5.46	1.85	2	Yes	No	Yes	BDI
S-106-S2	2.25	5.71	1.90	1	No	No	No	BDI
S-106-S3	2.24	4.98	1.65	1	No	No	No	BDI
S-106-S4	2.25	4.91	1.60	2	No	No	Yes	BDI
S-106-S5	2.30	2.89	0.95	2	No	No	Yes	BDI
S-106-M1	2.30	3.57	1.20	1	No	No	Yes	BDI
S-106-M2	2.31	4.63	1.35	1	No	No	No	BDI
S-106-M3	2.31	4.90	1.60	1	No	No	No	BDI
S-106-M4	2.30	3.14	1.00	1	No	No	Yes	BDI
S-106-M5	2.31	4.41	1.45	1	No	No	No	BDI
S-106-M6	2.31	4.78	1.65	1	No	No	No	USC
S-106-M7	2.30	5.24	1.80	1	No	No	No	USC
S-106-N1	2.31	4.61	1.40	1	No	No	No	BDI
S-106-N2	2.31	4.78	1.65	1	No	No	No	BDI
S-106-N3	2.31	4.83	1.55	1	No	No	No	BDI
S-106-N4	2.31	4.44	1.55	1	No	No	No	BDI
S-106-N5	2.31	4.19	1.40	1	No	No	No	USC
S-106-N6	2.31	5.69	1.90	1	No	No	No	USC

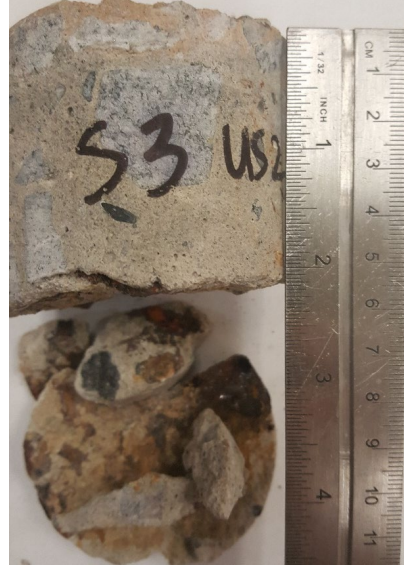
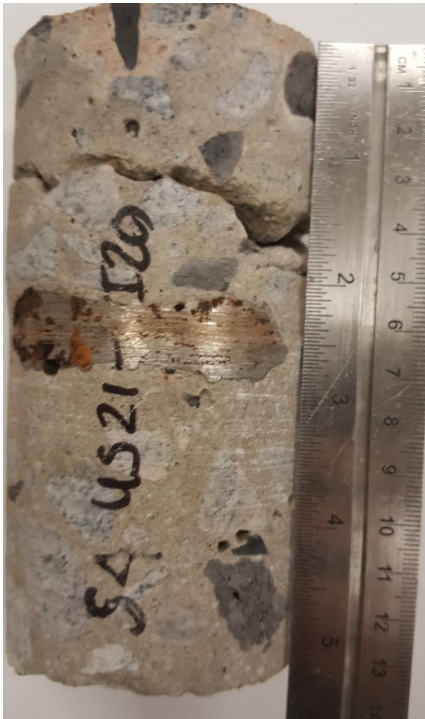
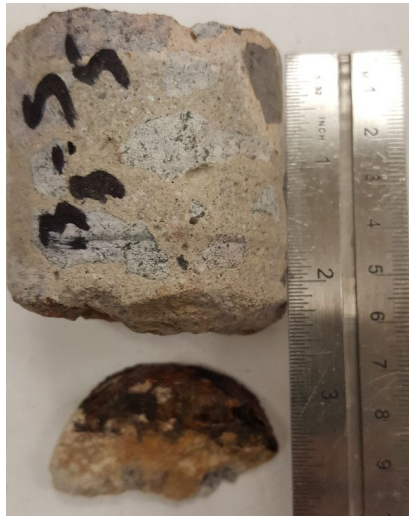
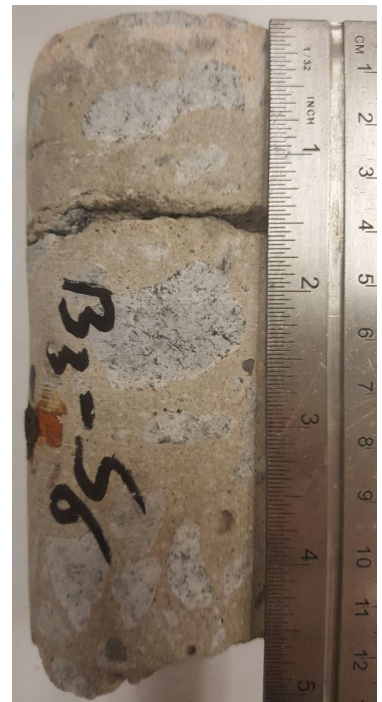
Figure 4.18: Cores taken from 'severe damage' region (US-21, Wilson Blvd over I-20, poor condition)

Visual inspection results for the cores is presented in **Table 4.7**. Average diameter, length, weight, number of pieces, presence of rebar, visible cracking, and delamination are reported. The cores were taken by either BDI or U. South Carolina as indicated in the last column. Photographs of cores for severe, medium, and no damage regions are shown in **Figures 4.18, 4.19 and 4.20**, respectively. Equation (4) was used for quantifying the accuracy of the different methods in terms of delamination and defects.

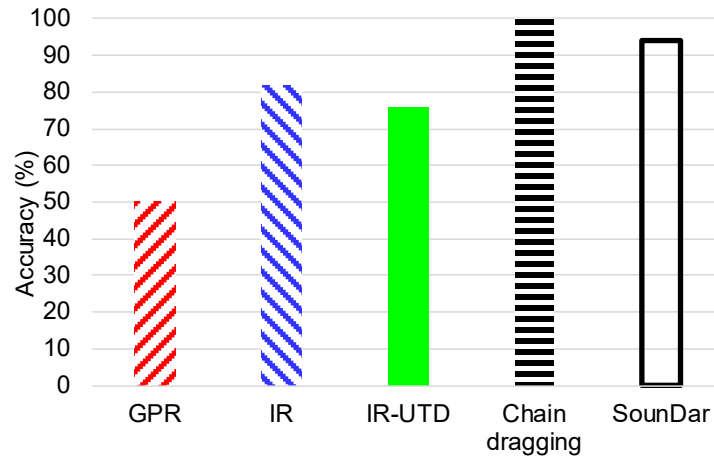
Figure 4.21: Accuracy of evaluation methods (S-34, Pond Branch Road over I-20, poor condition)

Percent accuracy for all evaluation methods was calculated according to the chloride concentrations and the visual condition of the cores (**Figure 4.21**). Accuracy for vehicle mounted GPR was calculated based on samples with chloride concentration within the highest defined range (0.12 to 0.18) because the samples did not follow expected trends in the medium and undamaged regions. The accuracy of chain dragging was calculated based on the cores taken between bents 2 and 3.

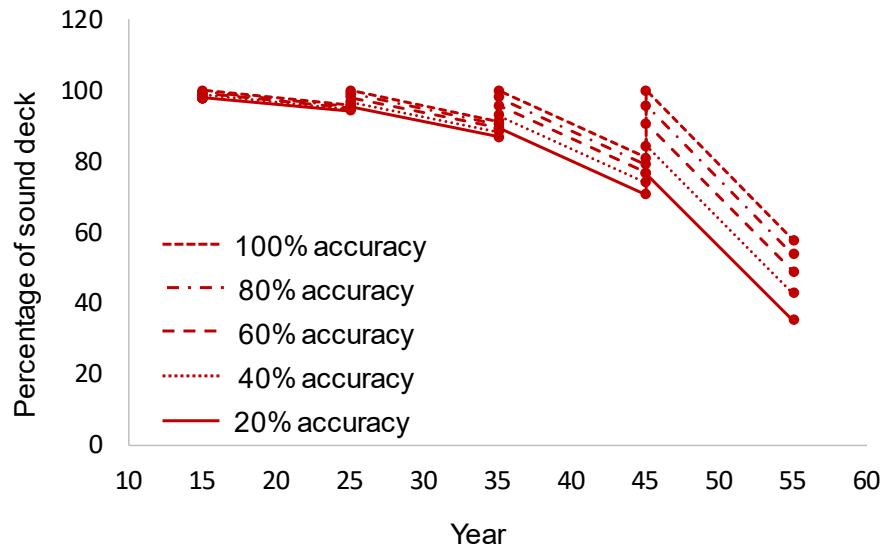
Figure 5.3: Effect of evaluation method accuracy on percentage of remaining sound deck
