Federal Railroad  
Administration

## Feasibility Study of Fiber-Optic Technology for Broken Rail Detection

9. SPONSORING/MONITORING AGENCY NAME(S) AND ADDRESS(ES) U.S. Department of Transportation Federal Railroad Administration Office of Research and Development Washington, DC 20590		10. SPONSORING/MONITORING AGENCY REPORT NUMBER  DOT/FRA/ORD-13/44

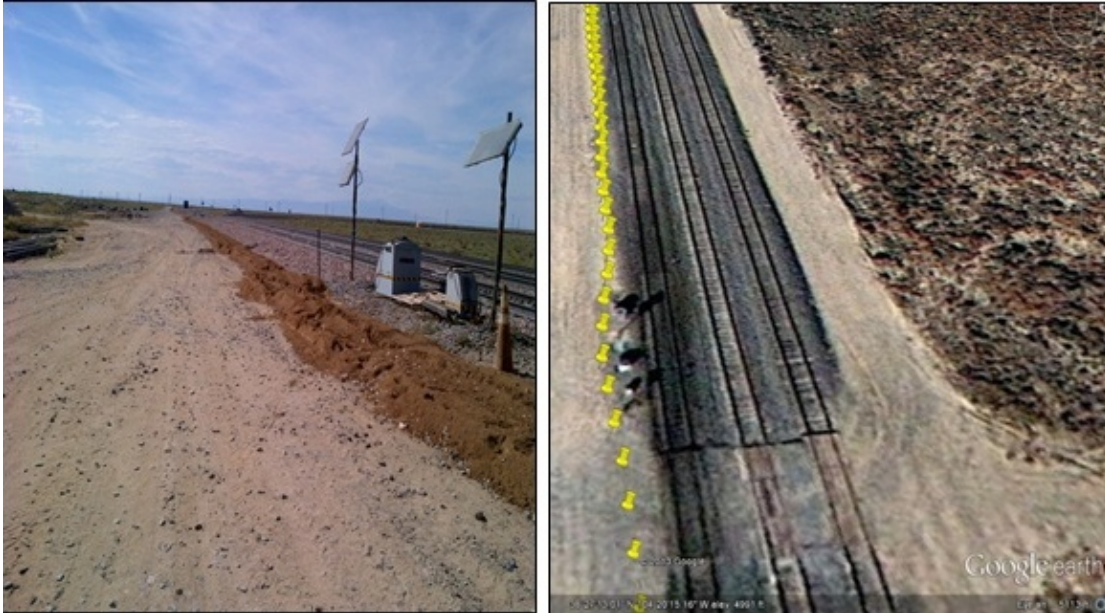
**Figure 3: Side-by-Side Comparison of Installation Photo and GPS Survey Overlay**

The test area also incorporates smaller test sections with the capability of adding customized experimental zones designed to collect specific event data. These test zones will be multifunctional and can be easily reconfigured to test additional events. Installation location varies according to track geometry in the given track section (i.e., edge of ballast installation location varies with superelevation of track).

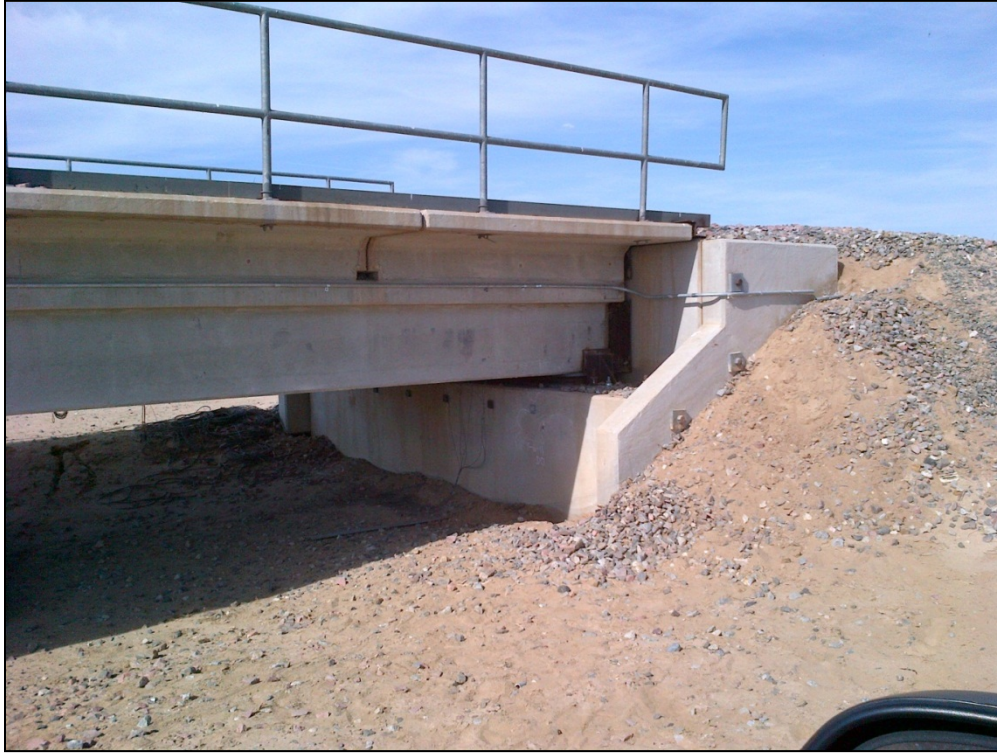
**Figure 5: HTL Bridge with Fiber-Optic Conduit**

There are three bridges on the HTL, two precast concrete and one steel in composition. Each of the bridge spans hosts a different set of test objectives and materials. TTCI concluded after studying railroad bridge fiber-optic transition methods used on revenue service lines that the use of a small diameter ridged steel conduit affixed to the lower side of the bridge ballast curb (see Figure 5) was the most prominent installation method to use. This installation method coincidentally also provides a secure connection between the bridge structure and the fiber-optic cable, allowing for a usable amount of acoustic coupling. During testing, TTCI test personnel observed that the bridge sections generated a large amount of incipient noise from wind and acoustic coupling of other activities taking place on the same track farther down the line.

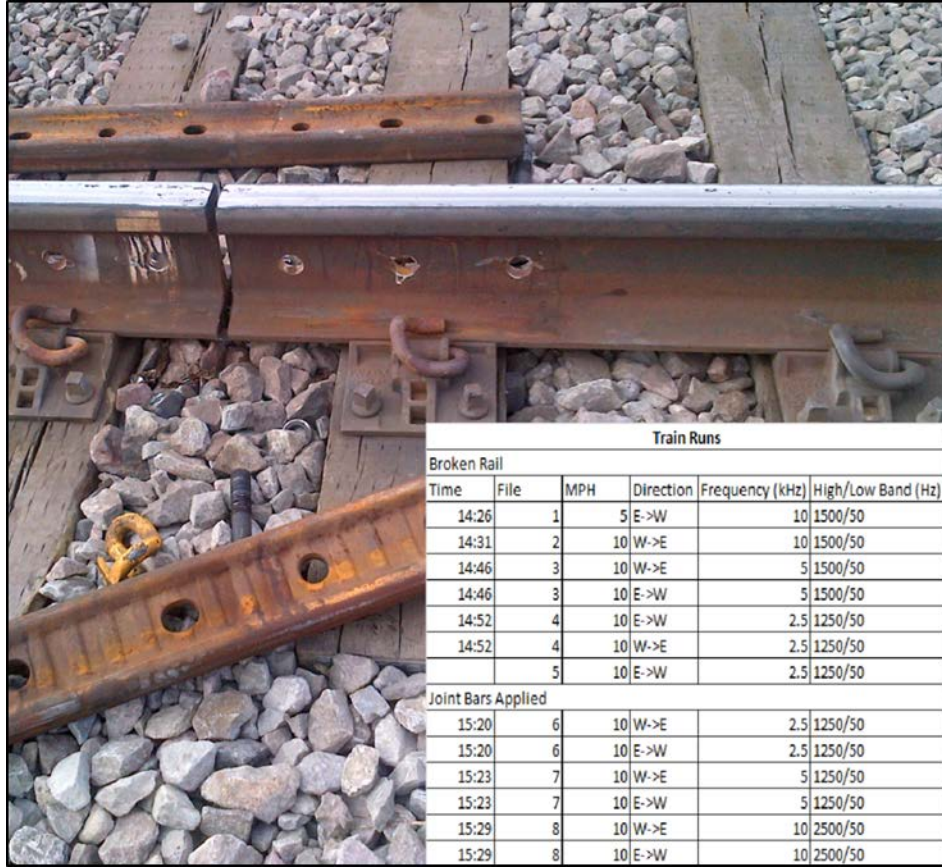
**Figure 9: Light Locomotive Broken Rail Test**

There were also a few small-scale verification tests performed during testing. These small-scale tests involved the use of a light locomotive making low speed passes over a known broken rail, while the Helios recorded the acoustic events generated (see Figure 9). This type of testing was performed early in the testing phase to help TTCI engineers understand what type of acoustic frequencies and magnitudes are generated by a broken rail event under a passing train. In the controlled environment, rail break acoustic data was able to be collected with the most control and least amount of background noise available. The small-scale testing proved to be valuable for the remainder of testing, as it demonstrated clearly the acoustic frequencies and magnitudes generated by wheel and rail impacts in a broken rail event.
