Concrete Beams Prestressed Using Carbon Fiber Reinforced Polymer

Final Report VTRC 19-R29

A bridge structure on Clarksville Road / Earl Davis Gregory Highway (Route 49) over Aaron's Creek in Halifax County, Virginia, was selected for study. It has a low traffic volume and is away from the aggressive coastal environment. Although this location will not expose the beams to an aggressive environment, it was thought that this bridge would provide valuable information with regard to the production of beams with CFRP reinforcement and advance the state of practice for future use of CFRP in bridge elements placed in a severe environment.

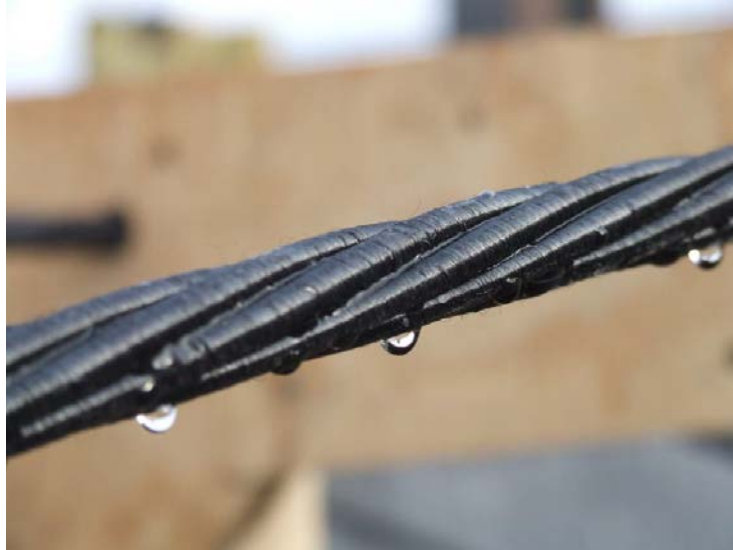
Figure 1. Water Drops on a Corrosion-Free Carbon Fiber Reinforced Polymer Strand

CFRP strands, called carbon fiber composite cable (CFCC) by the manufacturer, are manufactured by Tokyo Rope Mfg. Co, a Japanese company. Initially, this type of CFRP strand was manufactured only in Japan, but the company recently expanded and now produces CFRP in Canton, Michigan. There have been many applications of CFRP technology in Japan over the past 25 years (Enomoto et al., 2012). VDOT used these same CFRP strands in 18 piles of the Nimmo Parkway Bridge (AASHTO, n.d.; Ozyildirim and Sharp, 2014).

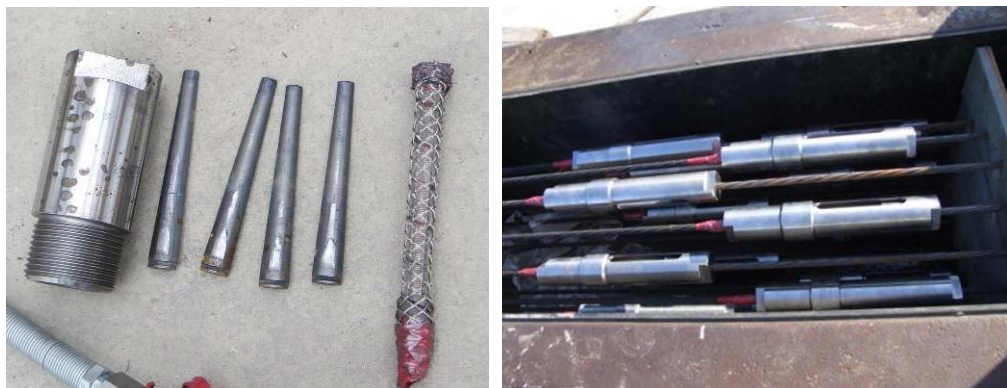
Figure 3. Elements of End Preparation: left, disassembled wedge, chuck, and braided grip; right, couplers in a pile

CFRP strands need special end preparation to avoid crushing of the ends during prestressing (Roddenberry et al., 2014). The end preparation involved wrapping the strand in a buffer material of mesh sheet and braided grip, attaching four wedges, placing the assembly in a chuck, and then threading together the couplers shown in Figure 3. The wedges and chucks used were longer than those used with steel strand so that the CFRP strand could be held without damaging it. The longer chuck was placed in one end of a coupler; the other end had a conventional chuck holding a steel strand. The prestressing force was applied to the steel strand.

Installing each coupler takes time. There were 96 coupled connections for each pair of beams cast. The couplers used to connect CFRP and ASTM A416 steel prestressing had a diameter greater than the spacing of the strands; therefore, the couplers were staggered at the ends of the bed to prevent contact during tensioning. The prestressing force was applied in increments; initially, a low tensioning force of 5 kips or less was applied to the strands. The uniform low tension helped ensure that all couplers had been installed correctly and that no strands had been cross coupled to different end positions. After the initial prestressing load, the 40 strands that had been designated to be fully stressed were tensioned to the full load of 35 kips. During prestressing, an error in the staggered layout resulted in two of the couplers coming in contact, causing the steel chuck to slip, which bent and broke the strand. This strand was replaced.

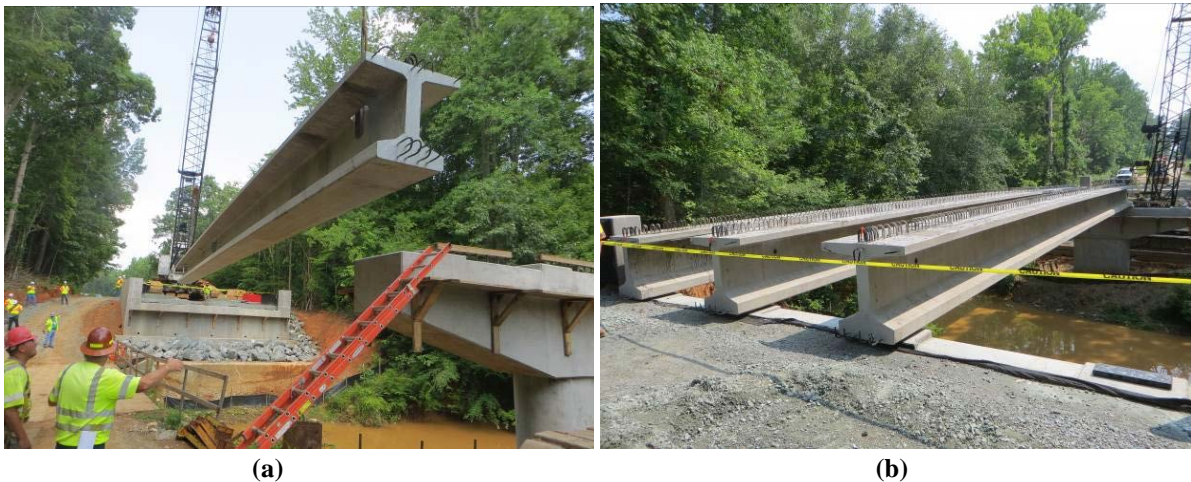
Figure 4. Bridge Construction: (a) beams being delivered to the jobsite and erection of first beam; (b) three beams in place

After the beams reached the minimum 28-day strength, they were delivered to the jobsite, with each truck and trailer transporting one beam. Two cranes were then used to place each beam. Figure 4 shows the erection and placement of the beams, with each span requiring four beams. The fabricator and contractor collaborated on a special connection to lift the beams that included blockouts in the flange and web to avoid conventional strand lifters being added to the beams and creating a corrosion issue. Conventional strand lifters using the CFRP strand were not used because of the reduction in strength when bent. The blockout is shown in Figure 4(a).

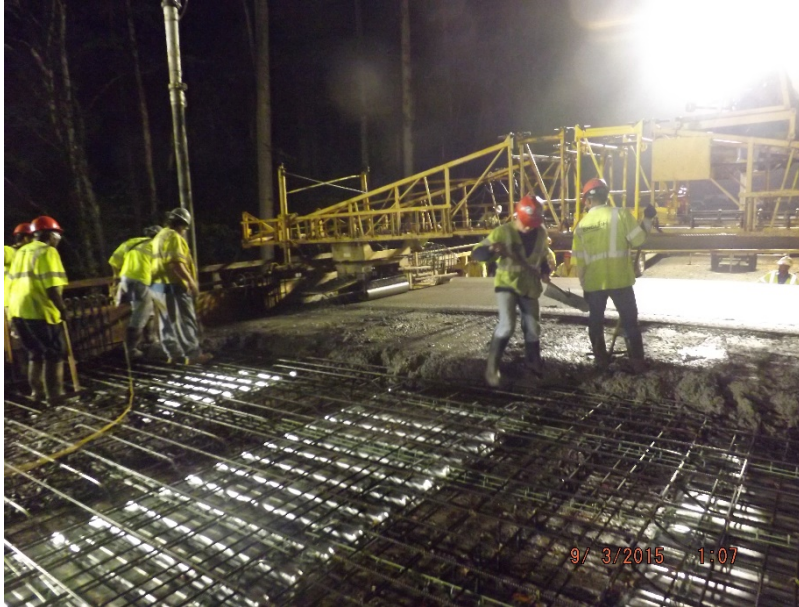
Figure 5. Bridge Construction Showing Nighttime Deck Concrete Placement

The results indicated that VDOT specifications were met; satisfactory strengths and very low permeability values were obtained. The deck has two spans, and both were placed on the same night. Figure 5 shows the night placement. The deck was placed at night since a reduced rate of evaporation would minimize the early cracking potential. The closure over the pier, with a length of 4 ft and a width of 32 ft 4 in, was placed during the daytime.
